NC DEPARTMENT OF TRANSPORTATION
 DIVISION OF HIGHWAYS
 STRUCTURE MANAGEMENT UNIT

ATTENTION: **NEW REPAIRS, SNOOPER USED, NEW LMC REPLACES AWS, NEWLY STRUCTURALLY DEFICIENT, CHANGE IN NBI RATING FOR ITEMS 58, 60, AND 61, CHANGE IN STRUCTURE DATA.**

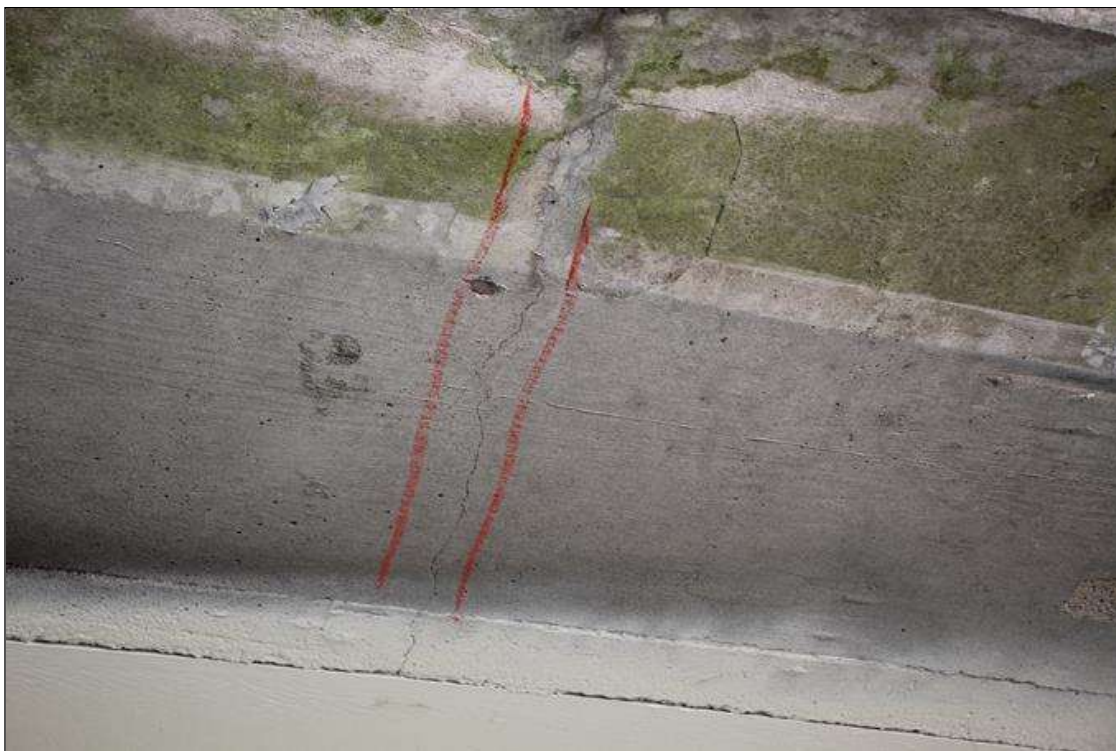
Span 1 Deck: SIX (6) UP TO 0.02 IN WIDE TRANSVERSE CRACKS UNDER LEFT OVERHANG, SCATTERED.

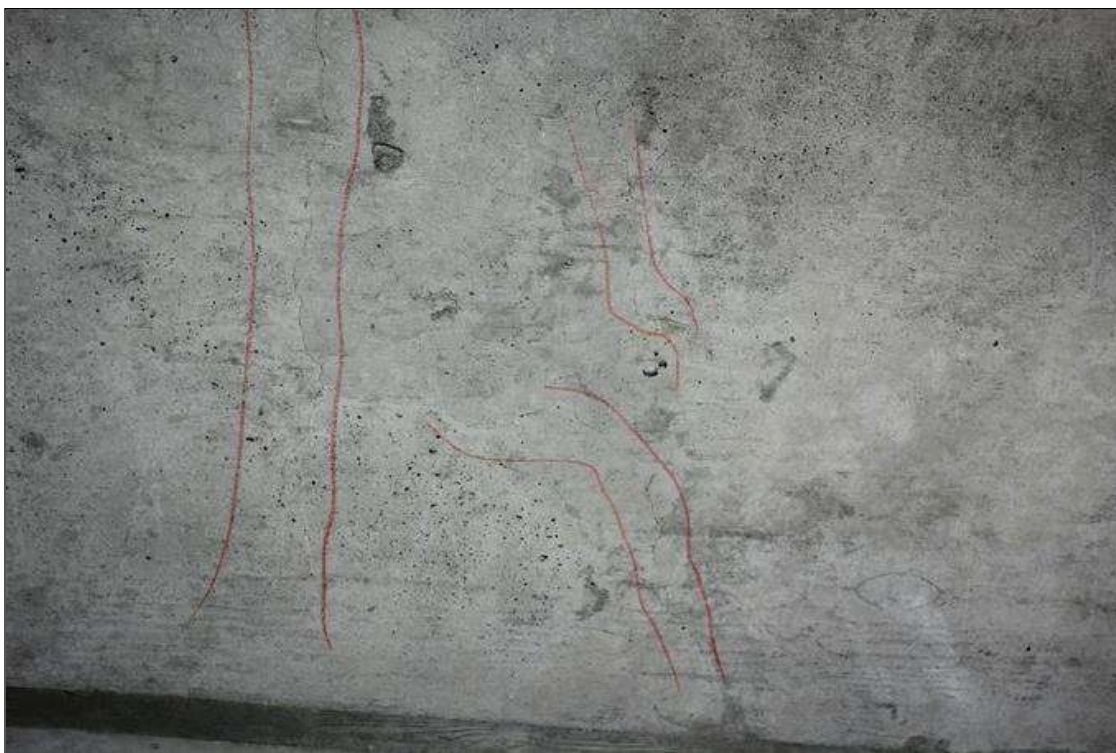
Span 1 Deck: UP TO 0.02 IN WIDE TRANSVERSE CRACKS IN DECK UNDERSIDE IN BAY 1 BETWEEN INTERMEDIATE DIAPHRAGMS TYPICAL IN BAYS 2 AND 3.

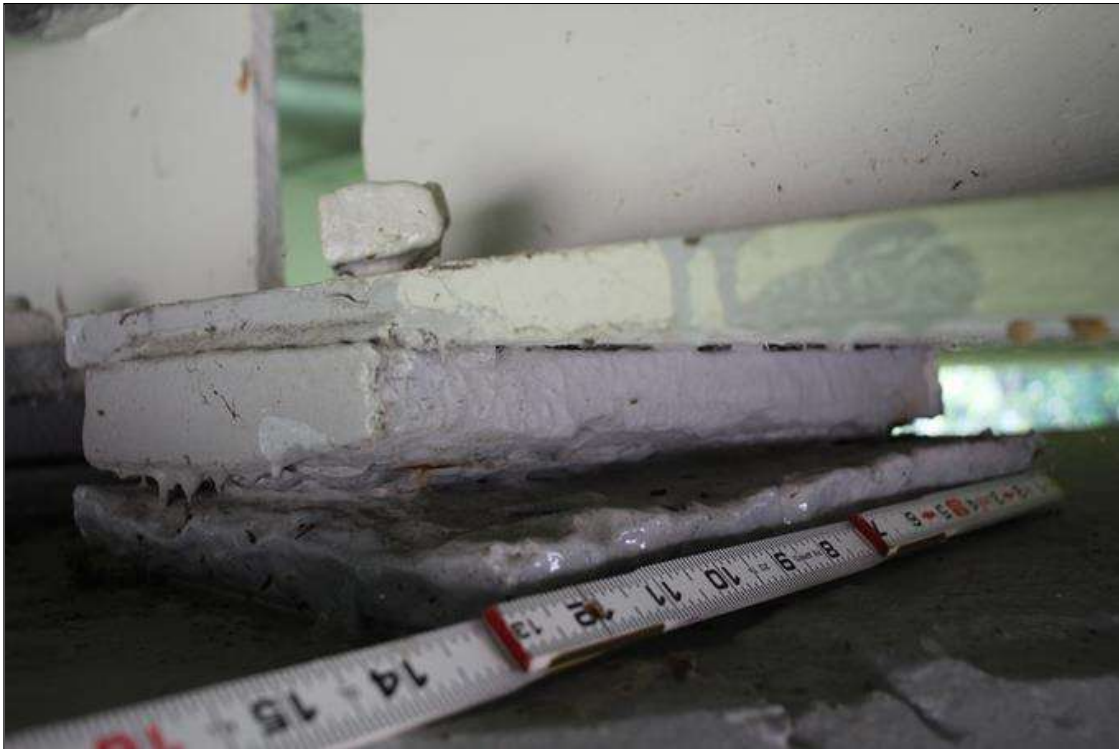
Span 1 Beam 2 Far Bearing: BEARINGS HAVE BEEN PAINTED SINCE PREVIOUS INSPECTION. SECTION LOSS EXISTS BENEATH THE PAINTED SURFACES IN BOTH MASONRY AND SOLE PLATES. UP TO 80% SECTION REMAINING.

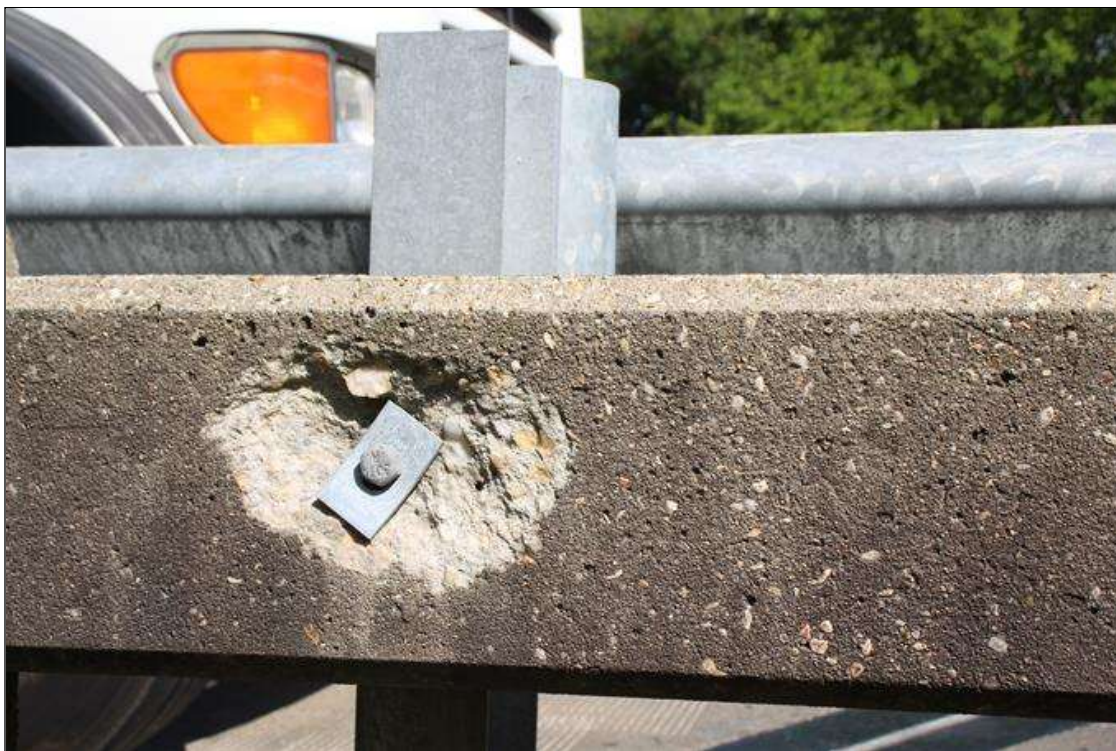
Span 2 Right Bridge Rail: UP TO 6 IN DIAMETER X 1.5 IN DEEP SPALL IN EXTERIOR FACE AT ANCHOR BOLT CONNECTION. TYPICAL AT SEVERAL CONNECTIONS.

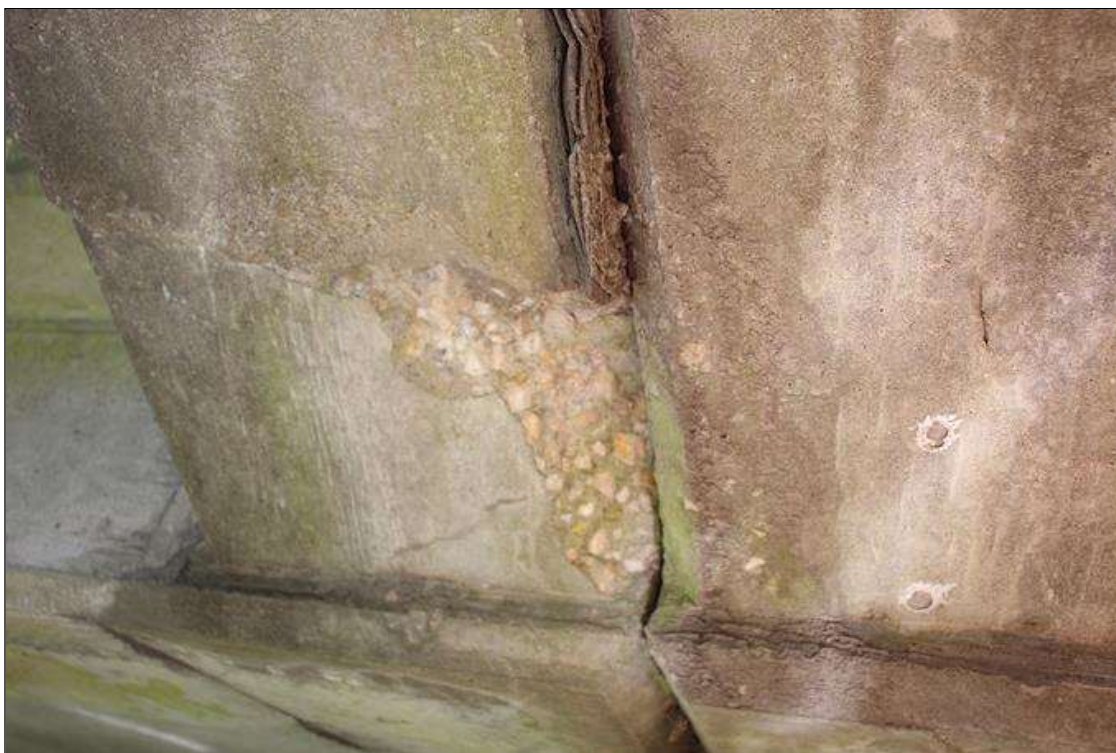
Span 1 Deck: 9 IN LONG X UP TO 4 IN WIDE X UP TO 2.5 IN DEEP SPALL IN RIGHT DECK OVERHANG ABOVE BENT 1.

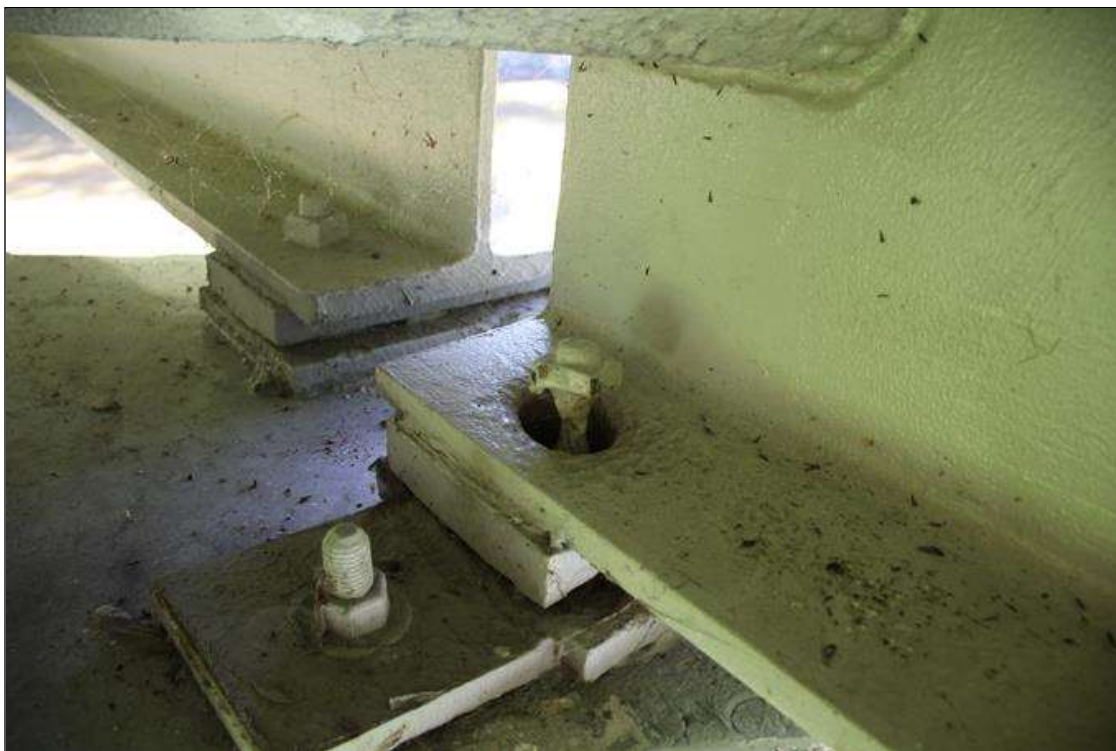
Span 2 Beam 4 Far Bearing: WELDED REPAIR WITH NEW ANCHOR BOLT. UP TO 50% SECTION LOSS IN OLD ANCHOR BOLT. PAR NOT ISSUED DUE TO NEW ANCHOR BOLT REPAIR.

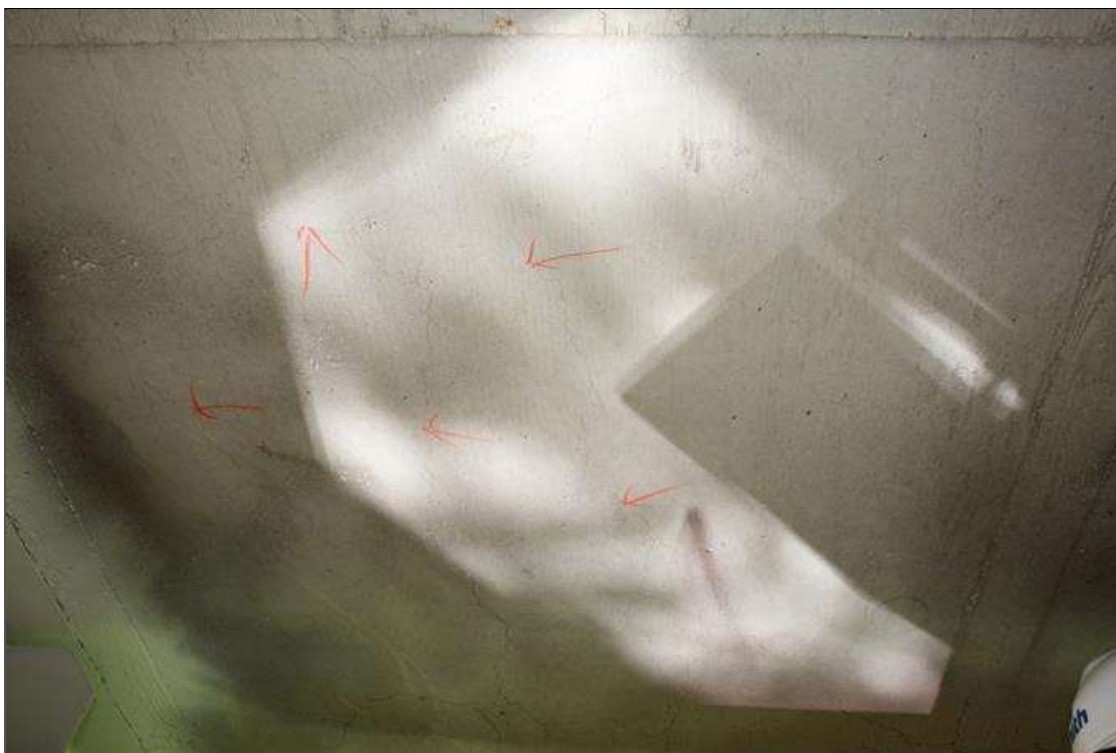
Span 3 Deck: UP TO 0.03 IN WIDE RANDOM CRACKING IN DECK UNDERSIDE, SCATTERED THROUGHOUT. BAY 2 AT BENT 2 SHOWN IN PHOTO.

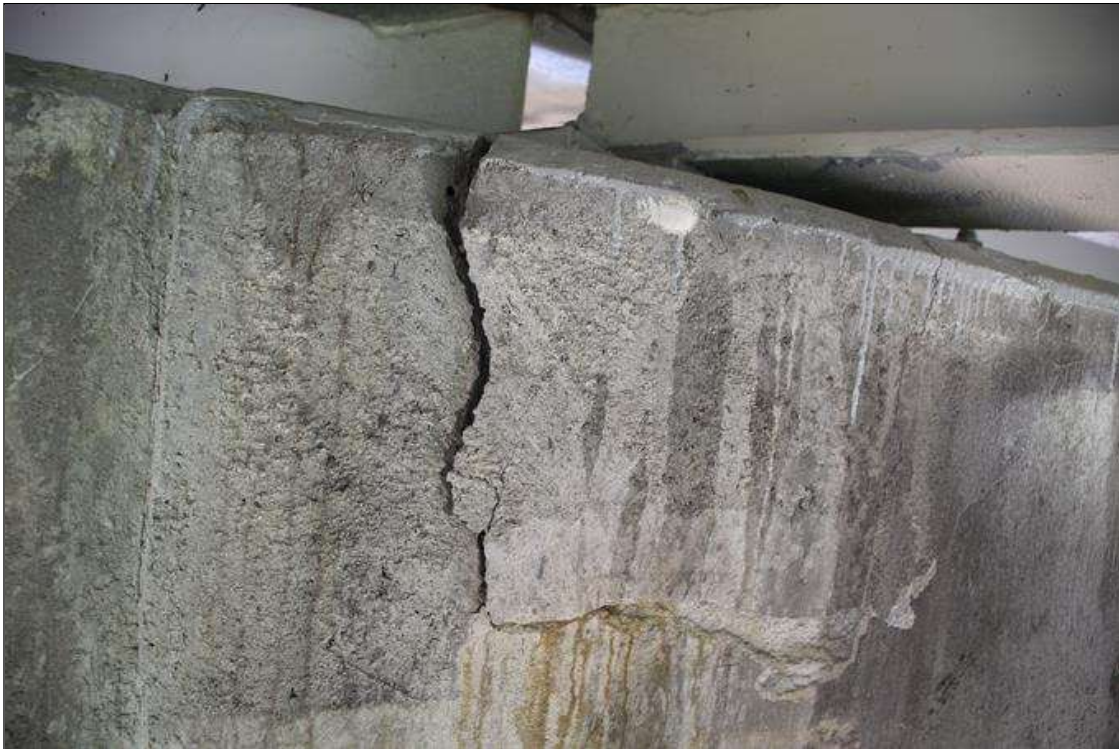
Bent 4 Cap 1: UP TO 2 FT DIAMETER UNSOUND CONCRETE PATCH REPAIR TO PREVIOUSLY SPALLED AREA. PHOTO TAKEN BEFORE AREA WAS SOUNDED WITH HAMMER.

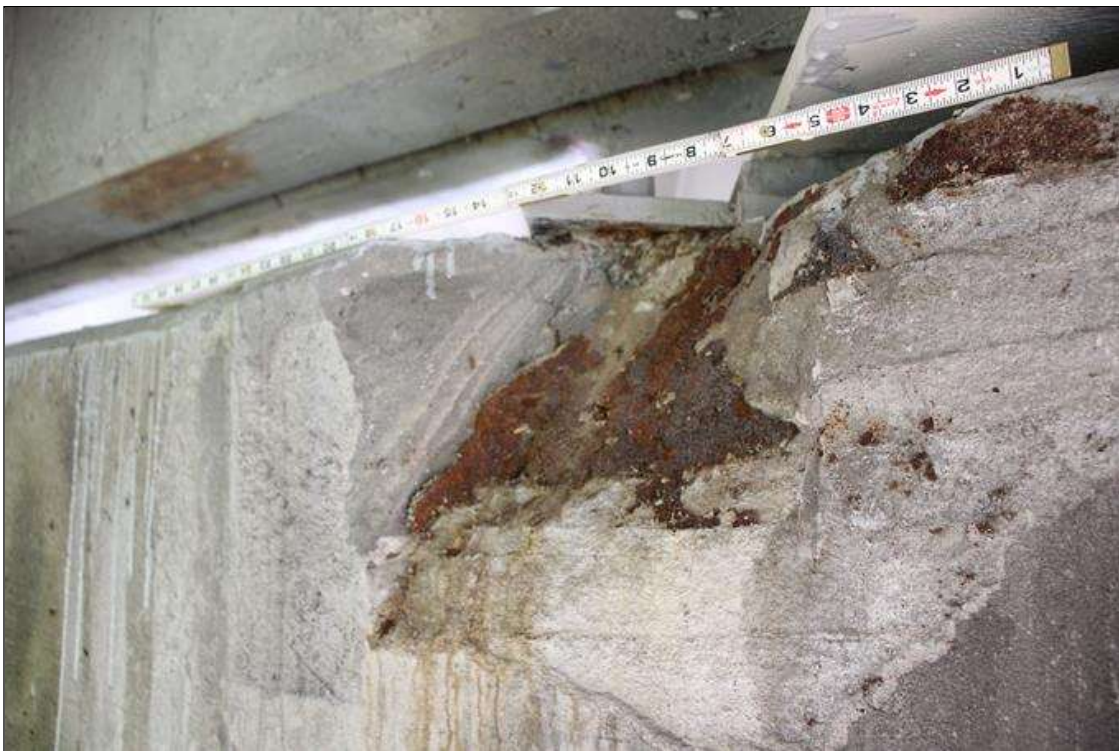
Bent 4 Cap 1: 17 IN WIDE X UP TO 11 IN HIGH X UP TO 6 IN DEEP SPALLED PATCHED AREA, TOP OF SOUTH FACE, EXTENDING BELOW BEAM 3 BEARING ASSEMBLY, BEARING IS NOT SEATED LEVEL (PAR).

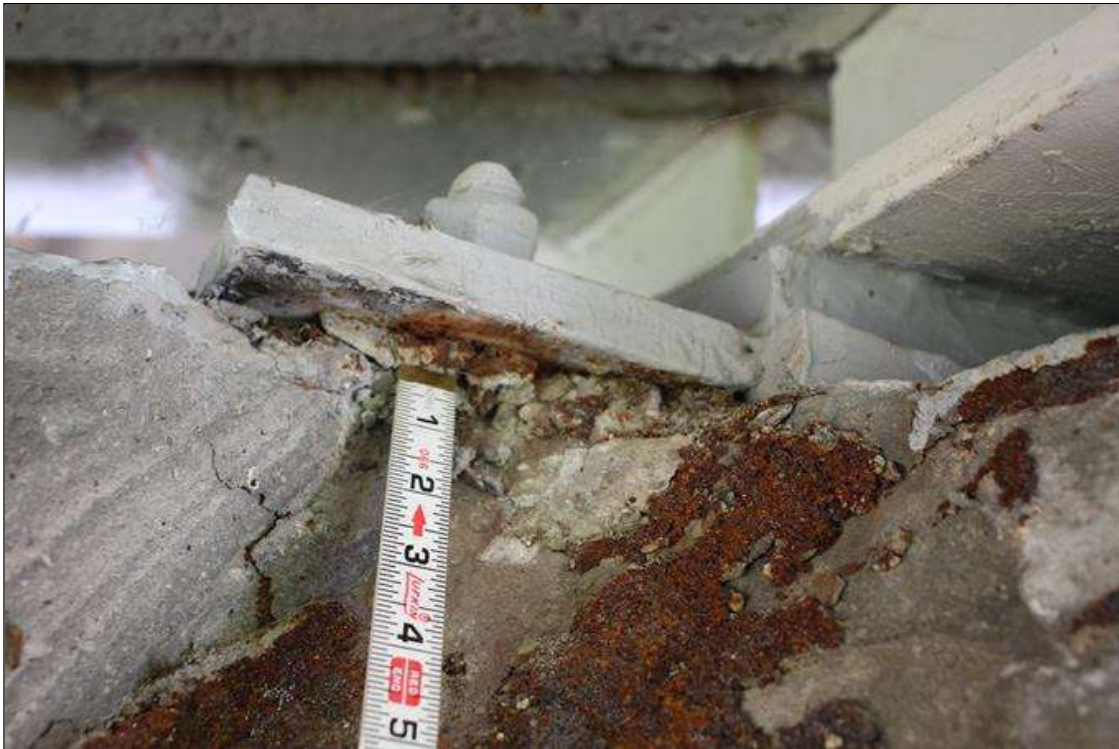
Span 4 Beam 3 Far Bearing: NEW BEARING HAS A LOSS OF BEARING AREA DUE TO SPALL ON CAP. 5 IN WIDE X 1 IN DEEP AREA OF BEARING PLATE IS UNDERMINED (PAR).

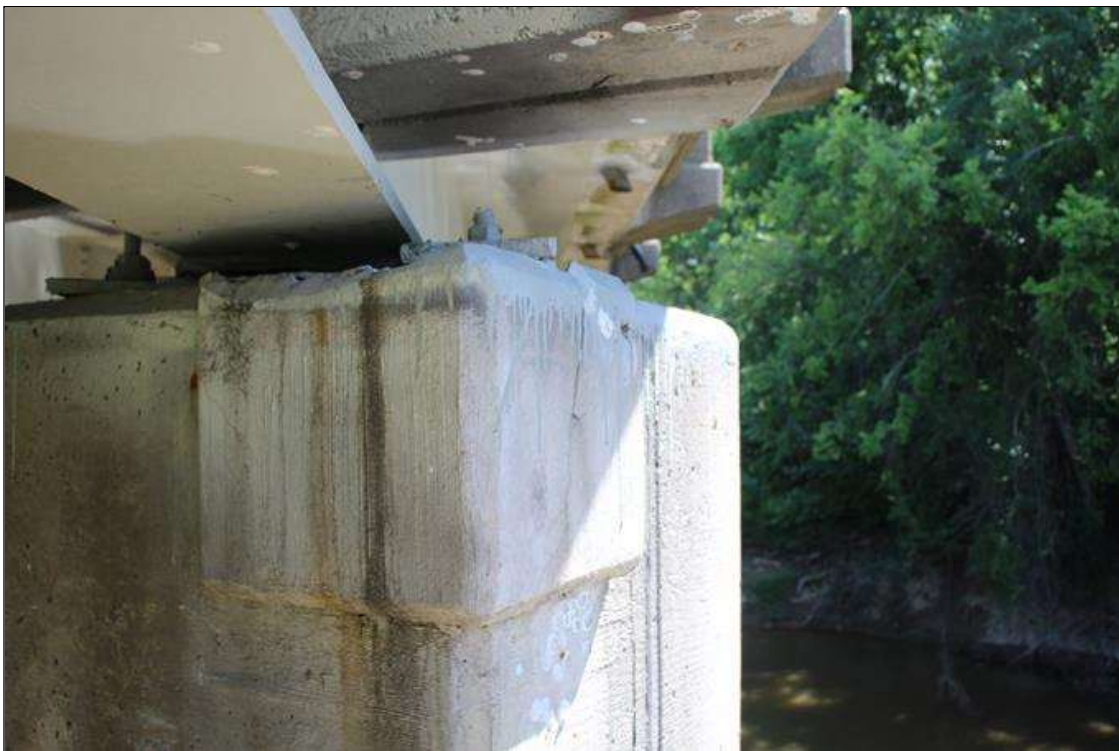
Bent 4 Cap 1: 15 IN HIGH X 21 IN WIDE SOUND CONCRETE PATCH AREA, TOP SOUTHEAST CORNER OF CAP, BELOW NEW BEARING ASSEMBLY OF BEAM 4. PATCH EXHIBITS A 8 IN LONG X 0.02 IN WIDE DIAGONAL CRACK STARTING AT TOP LEFT CORNER IN SOUTH FACE AND A UP TO 0.03 IN WIDE X 15 IN LONG VERTICAL CRACK IN EAST FACE.

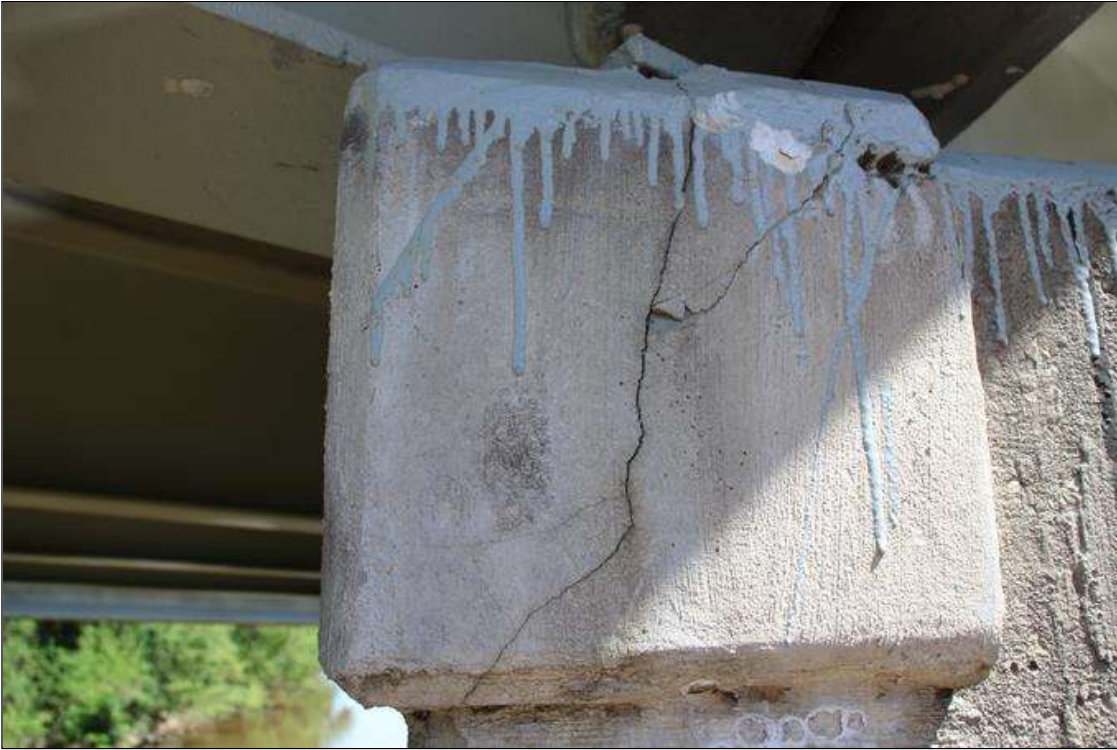
Bent 4 Cap 1: 15 IN HIGH X 21 IN WIDE SOUND CONCRETE PATCH AREA, TOP SOUTHEAST CORNER OF CAP, BELOW NEW BEARING ASSEMBLY OF BEAM 4. PATCH EXHIBITS A 8 IN LONG X 0.02 IN WIDE DIAGONAL CRACK STARTING AT TOP LEFT CORNER IN SOUTH FACE AND A UP TO 0.03 IN WIDE X 15 IN LONG VERTICAL CRACK IN EAST FACE.

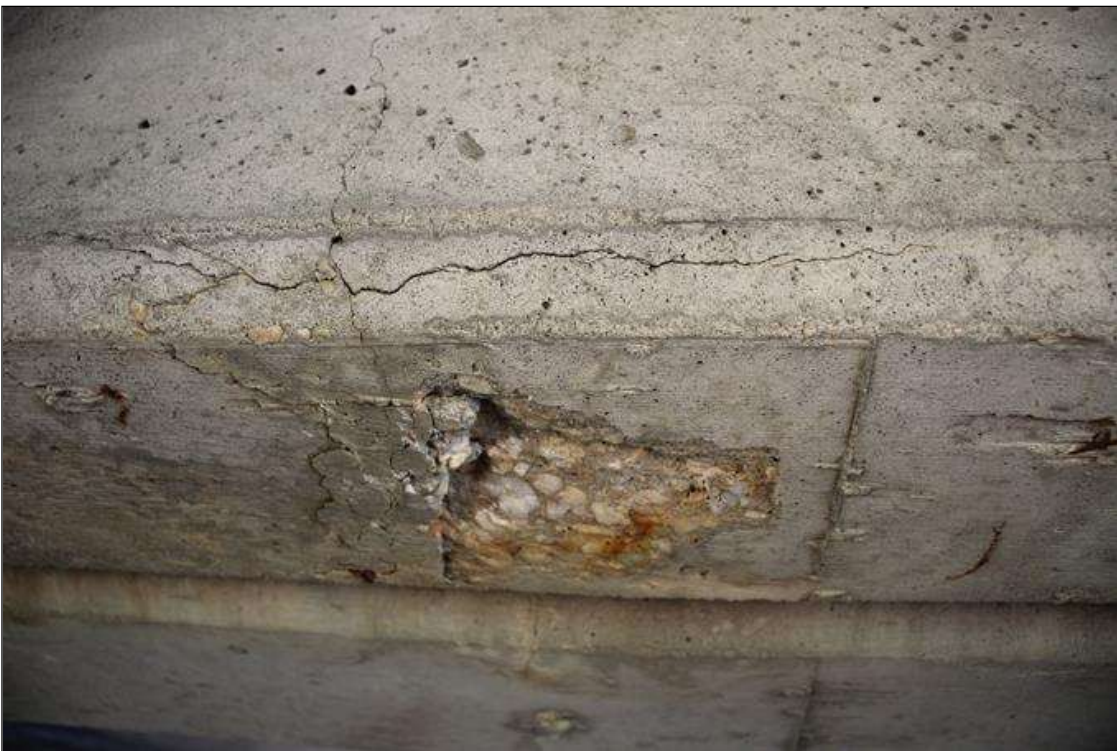
Span 5 Deck: 6 IN DIAMETER X 3/4 IN DEEP SPALL IN INTERMEDIATE DIAPHRAGM IN BAY 2 ABOVE BENT 6.

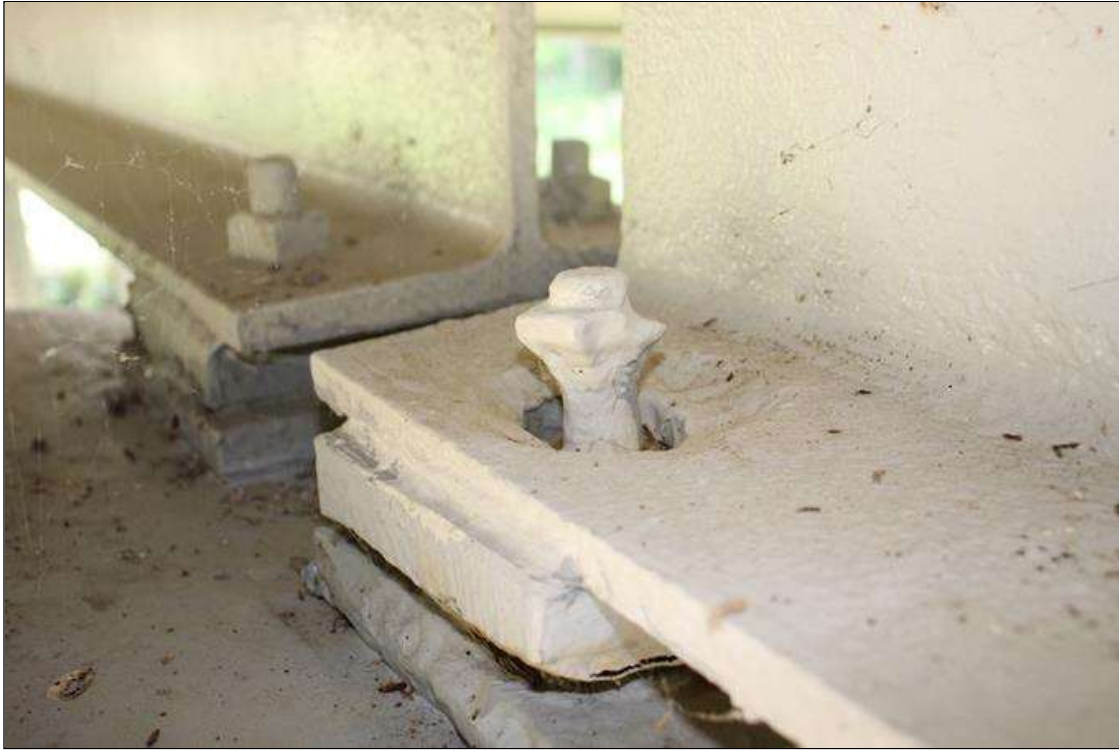
Span 6 Beam 3 Far Bearing: LEFT ANCHOR BOLT HAS UP TO 80% SECTION REMAINING AND ANCHOR BOLT NUT HAS UP TO 50% SECTION REMAINING.

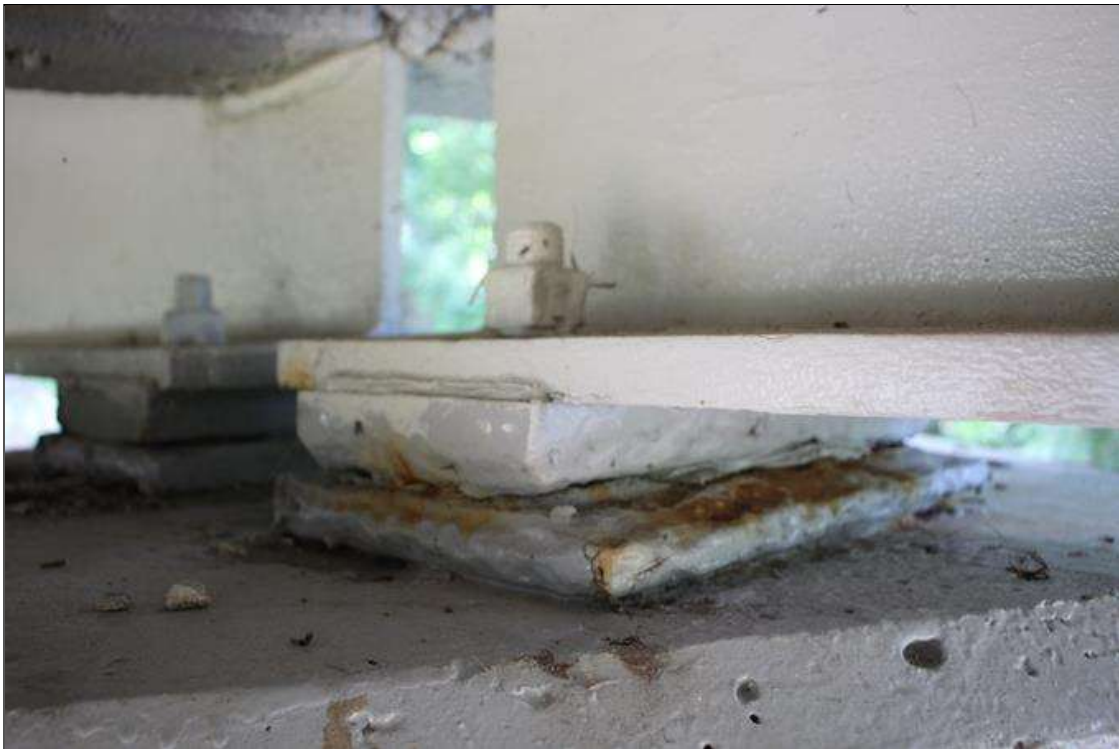
Span 6 Beam 4 Far Bearing: BEARINGS HAVE BEEN PAINTED SINCE PREVIOUS INSPECTION. SECTION LOSS EXISTS BENEATH THE PAINTED SURFACES IN BOTH MASONRY AND SOLE PLATES. UP TO 80% SECTION REMAINING. RUST STAINING PRESENT IN NEWLY PAINTED SURFACES.

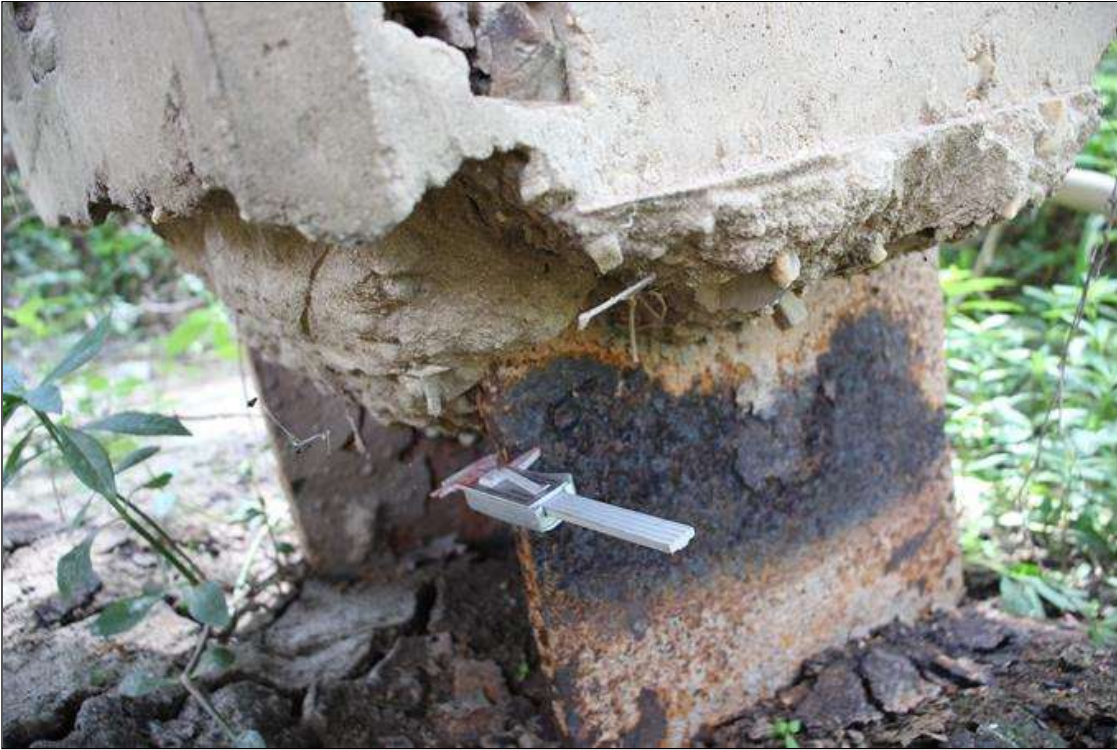
Bent 7 Pile 7: 15 IN WIDE X 10 IN HIGH AREA OF THE SOUTH FLANGE EXHIBITS HEAVY SURFACE CORROSION WITH SECTION LOSS ON WEB AND FLANGES OF EXPOSED STEEL PILE AT GROUNDLINE. UP TO 0.50 IN SECTION REMAINING (PAR). NORTH FLANGE AND THE WEB EXHIBIT HEAVY SURFACE CORROSION WITH NO MEASUREABLE SECTION LOSS.

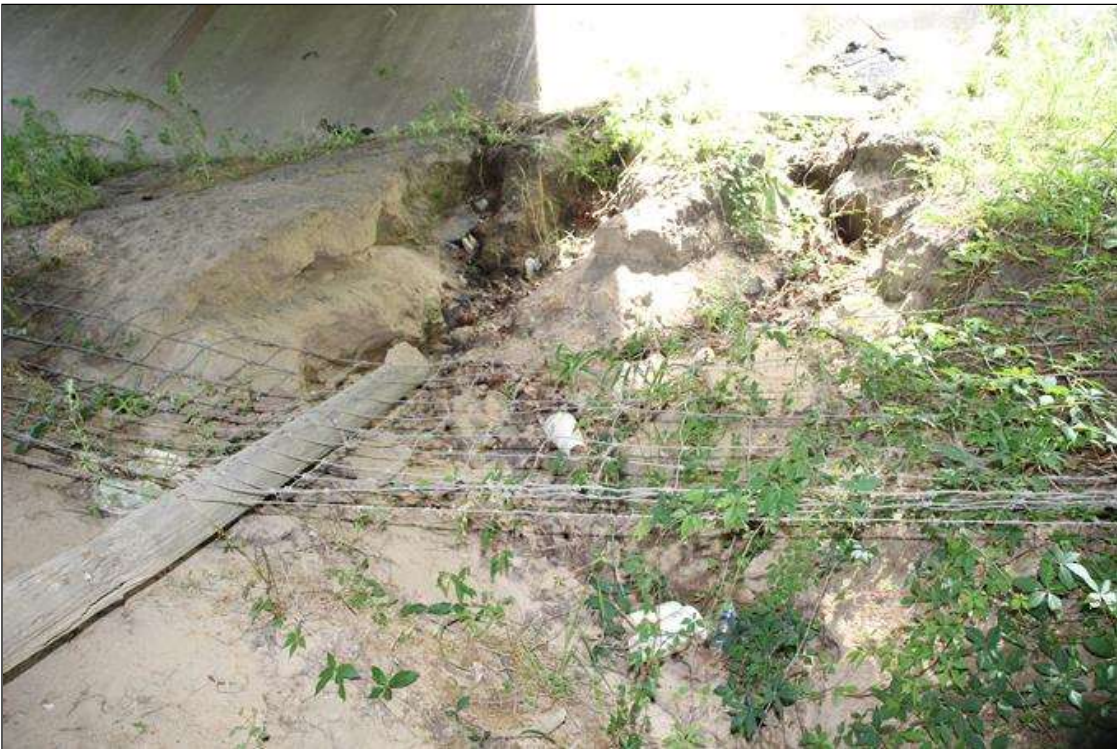
9 FT WIDE X 15 FT LONG X UP TO 3 FT DEEP AREA OF EROSION UNDER SPAN 8 WITH BROKEN AND FALLEN FENCE POSTS.

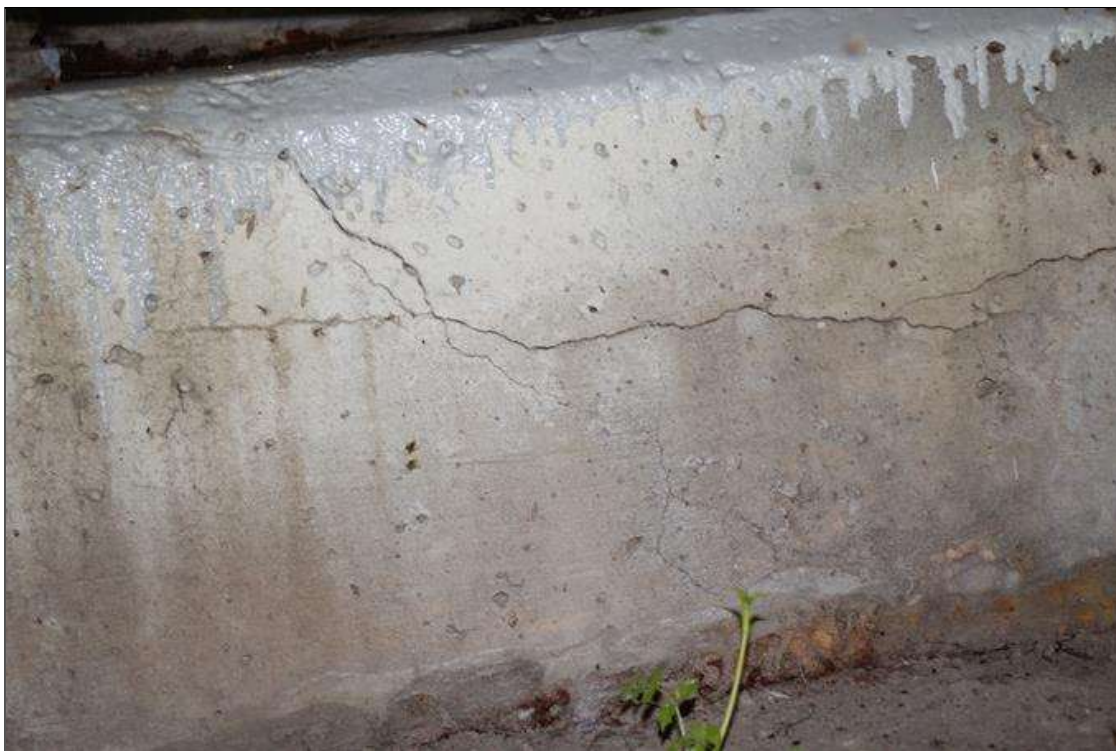
End Bent 2 Abutment/Backwall : UP TO 1/16 IN WIDE X 15 FT LONG HORIZONTAL CRACK IN BAYS 1 AND 2.

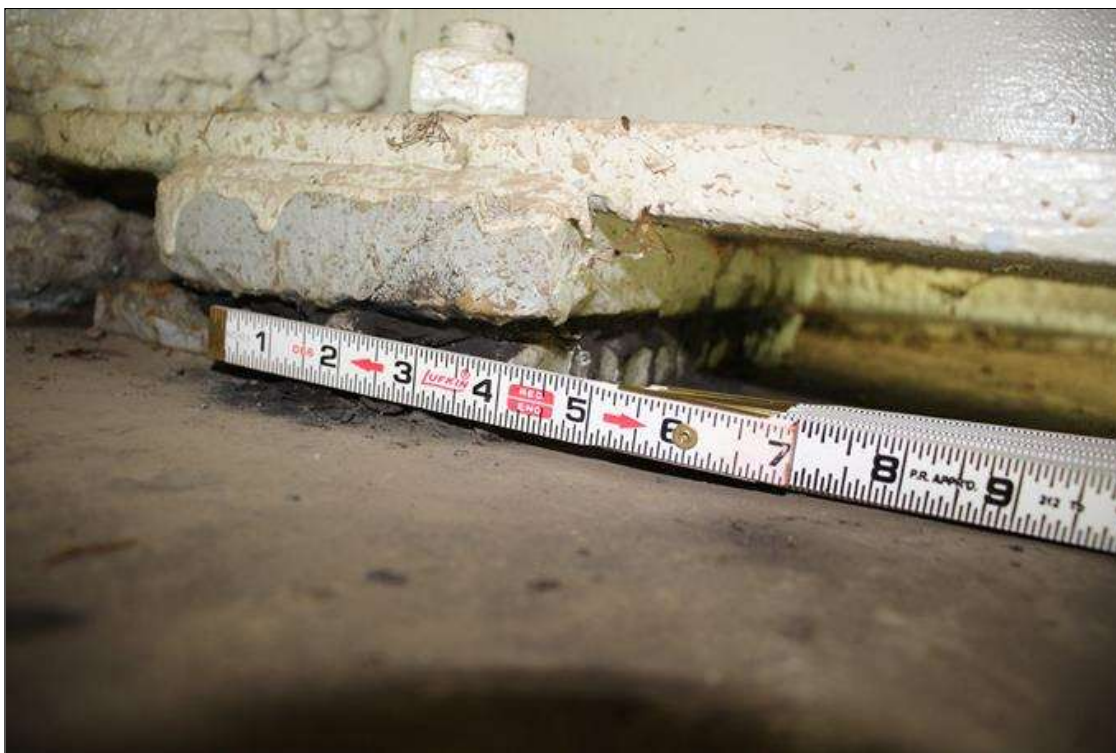
Span 8 Beam 4 Far Bearing: UP TO 1/2 IN MOVEMENT TOWARDS THE SOUTH LEFT HALF OF THE MASONRY PLATE.

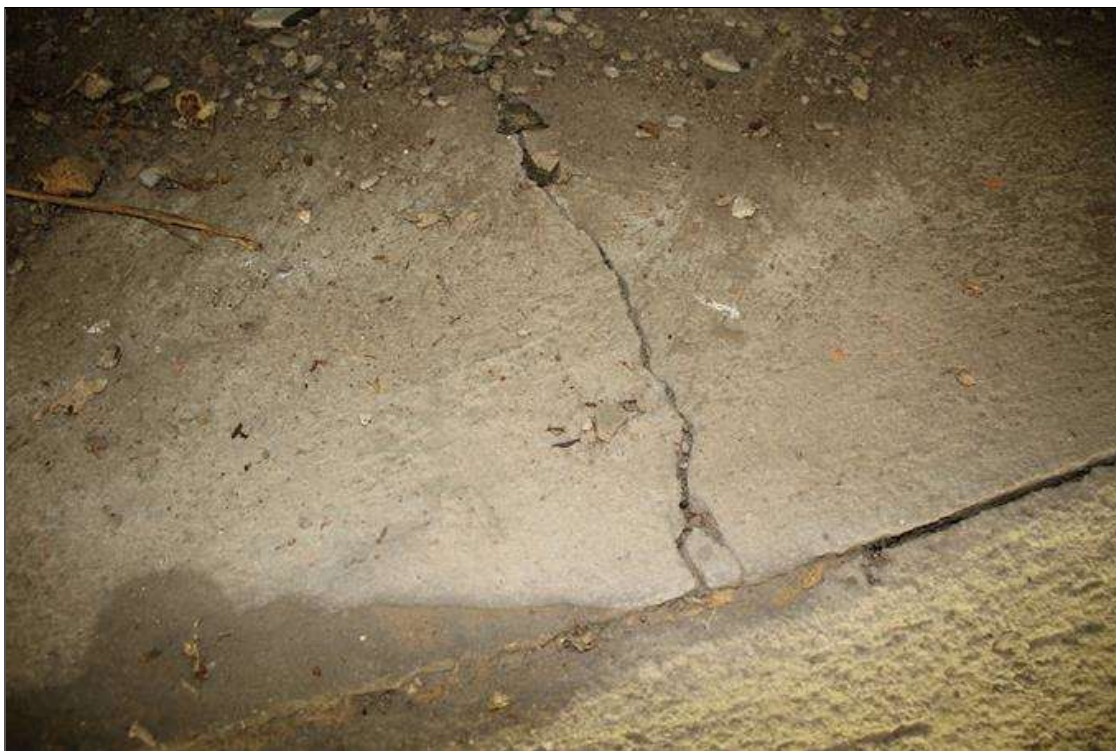
End Bent 2 Cap 1: 3 FT LONG X UP TO 1/16 IN WIDE HORIZONTAL CRACK, BELOW BAY 1.

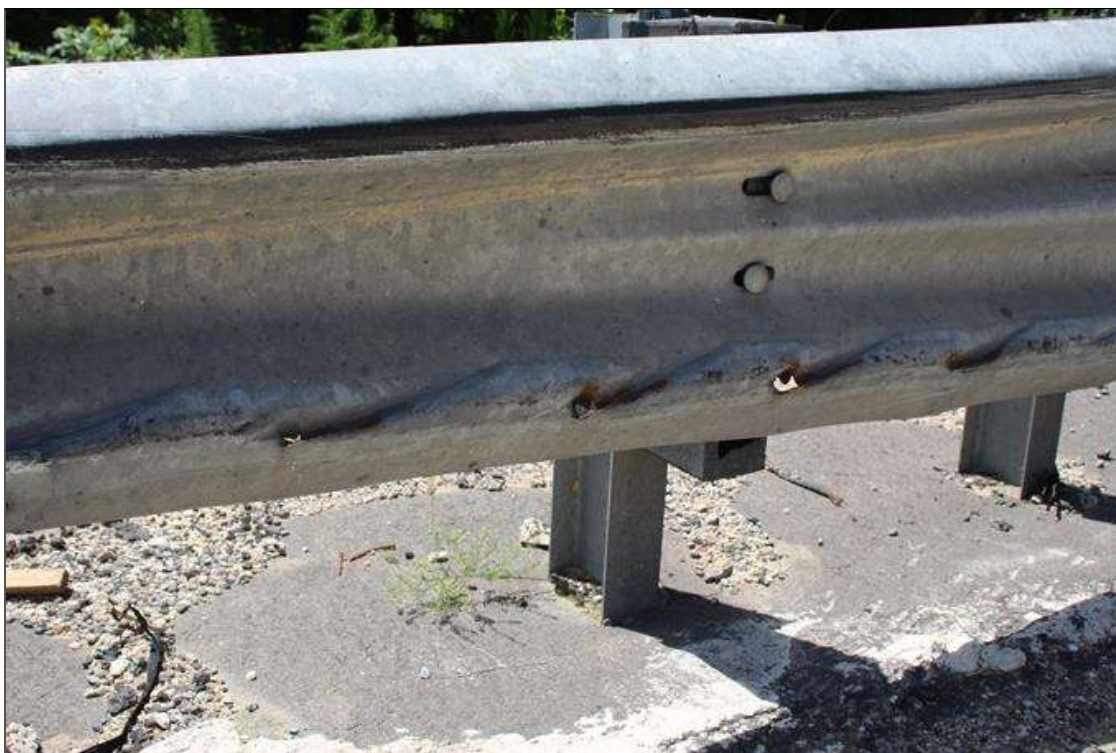
HEAVY IMPACT DAMAGE WITH UP TO 1.5 IN DIAMETER HOLES IN THE APPROACH GUARDRAIL TRANSITION AT NORTHEAST CORNER. FOR 25 FT LONG STARTING AT END BENT 1

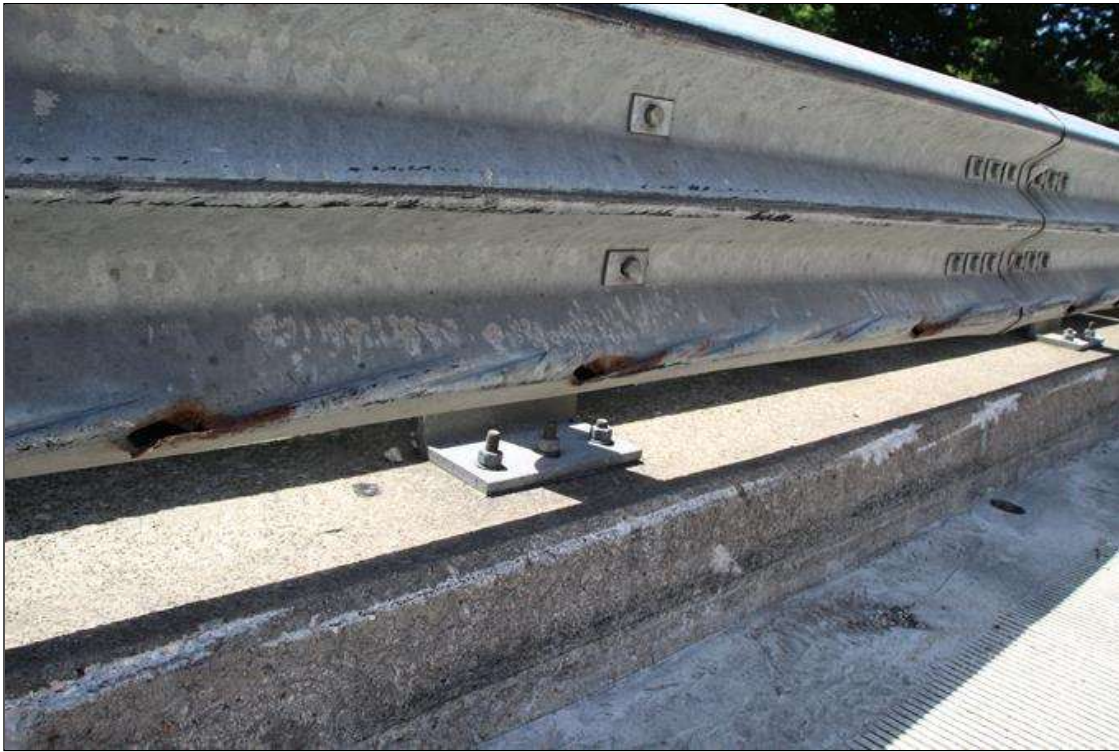
Span 8 Right Bridge Rail: HEAVY IMPACT DAMAGE WITH UP TO 3 IN LONG X 1 IN HIGH HOLES AND DENTS IN THE BOTTOM OF CONCRETE SUPPLMENTAL BRIDGE RAIL FOR FULL SPAN LENGTH. DAMAGE EXTENDS INTO SPANS 7 AND 6.

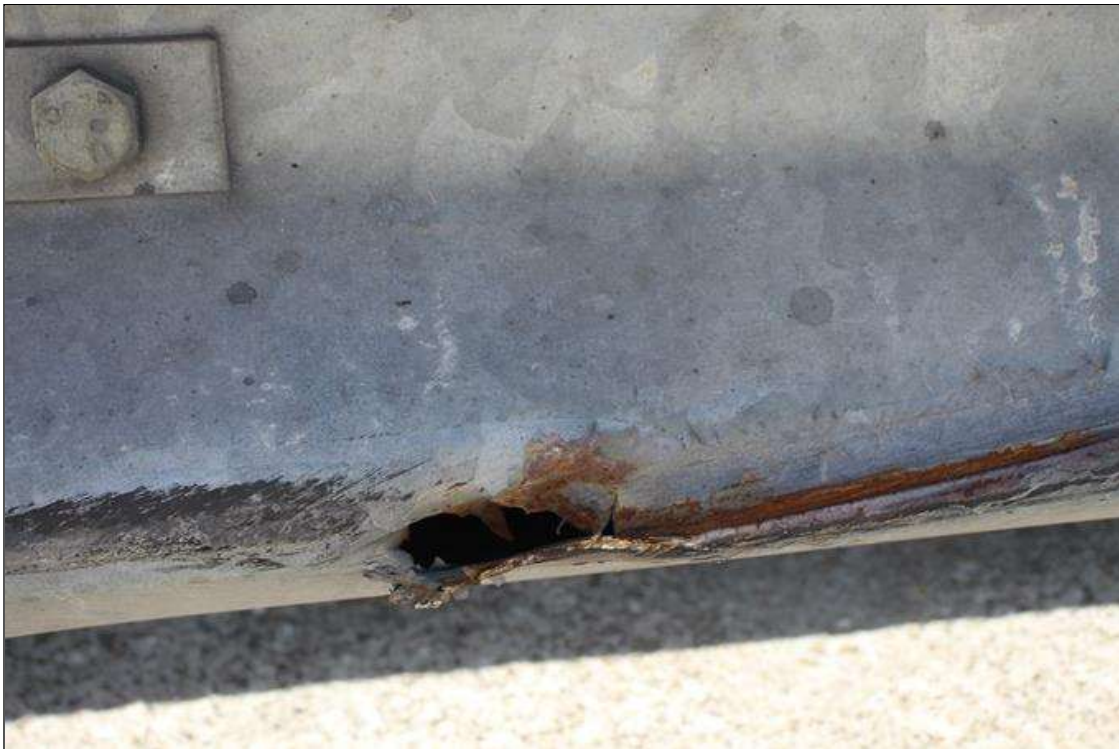
Span 8 Right Bridge Rail: HEAVY IMPACT DAMAGE WITH UP TO 3 IN LONG X 1 IN HIGH HOLES AND DENTS IN THE BOTTOM OF CONCRETE SUPPLMENTAL BRIDGE RAIL FOR FULL SPAN LENGTH. DAMAGE EXTENDS INTO SPANS 7 AND 6.

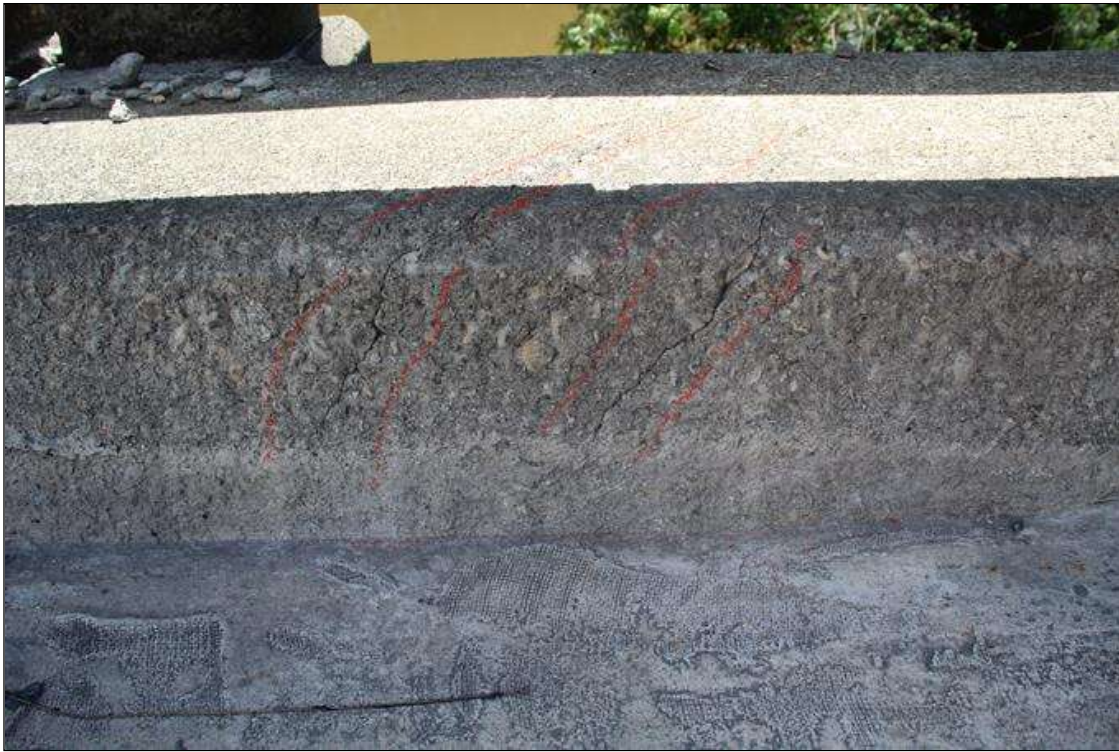
Span 2 Right Bridge Rail: UP TO 0.03 IN WIDE X 2 FT LONG DIAGONAL CRACKS IN BOTTOM OF CURB AT 1 FT FROM BENT 2.

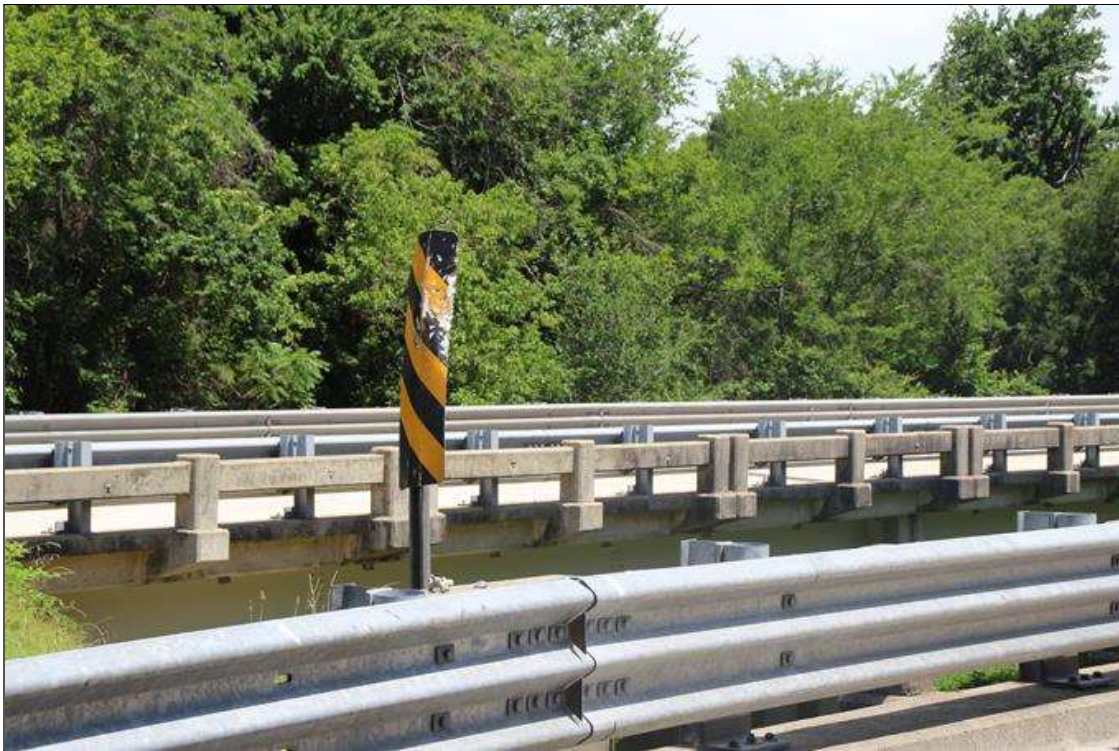
MODERATE IMPACT DAMAGE TO DELINEATOR AT SOUTHWEST CORNER.

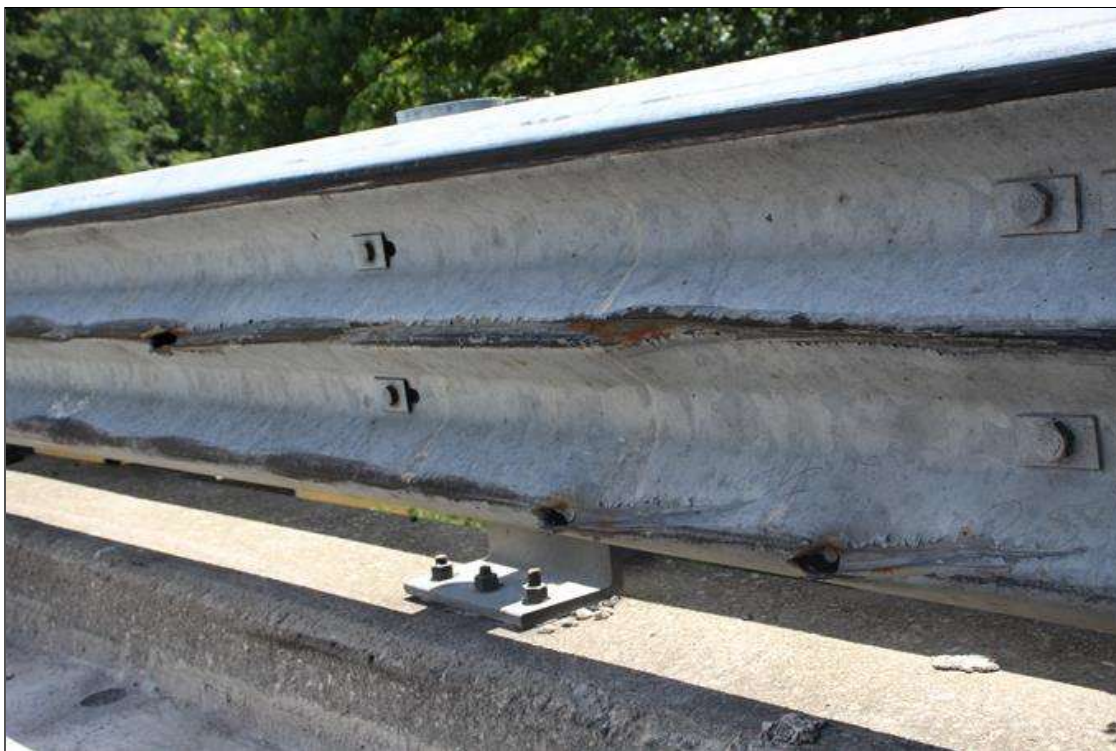
HEAVY IMPACT DAMAGE WITH 1 IN WIDE CRACK AND 4 IN WIDE X 1 IN HIGH HOLES IN RIGHT BRIDGE RAIL AT END BENT 1.
