NC DEPARTMENT OF TRANSPORTATION
 DIVISION OF HIGHWAYS
 STRUCTURE MANAGEMENT UNIT

ATTENTION: **NEW REPAIRS, SNOOPER USED, NEW LMC REPLACES AWS, NEWLY STRUCTURALLY DEFICIENT, CHANGE IN NBI RATING FOR ITEMS 58, 60, AND 61, CHANGE IN STRUCTURE DATA.**

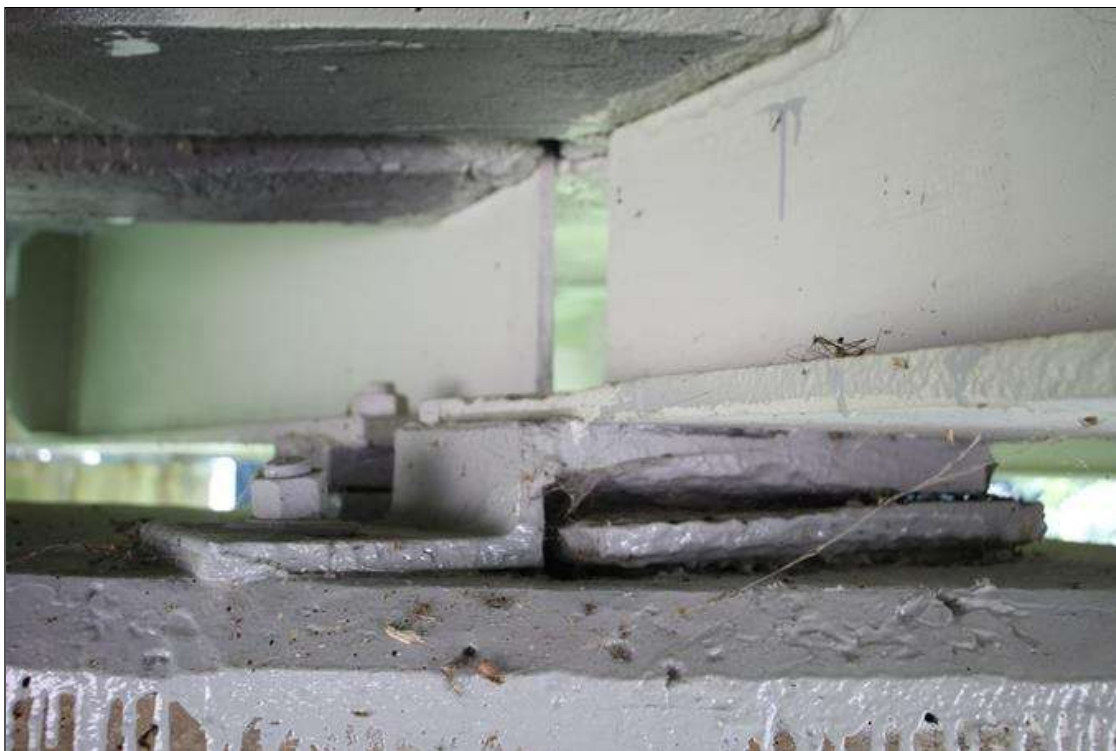
PREVIOUS REPAIR TO FAR BEARING IN SPAN 1 BEAM 3. TYPICAL AT BEAM 1.

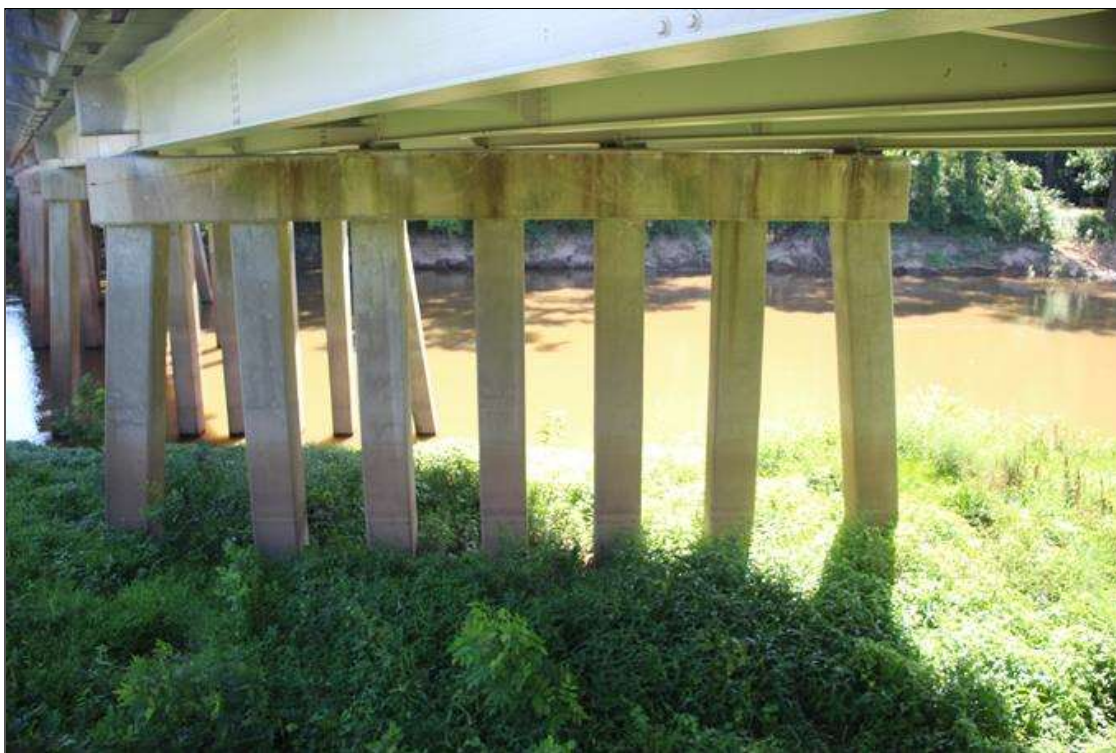
BENT 2 PROFILE. OTHER INTERIOR BENTS SIMILAR.

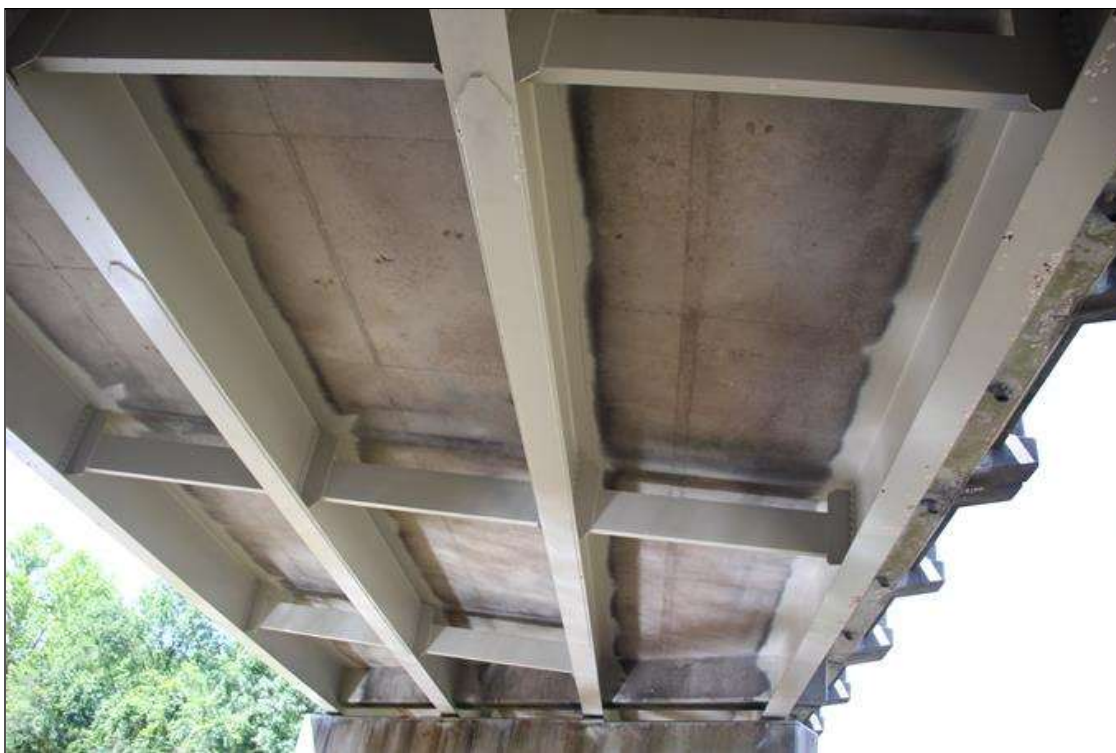
SUPERSTRUCTURE UNDERSIDE SPAN 5. NOTE NEW PAINT REPAIRS SINCE PREVIOUS INSPECTION.

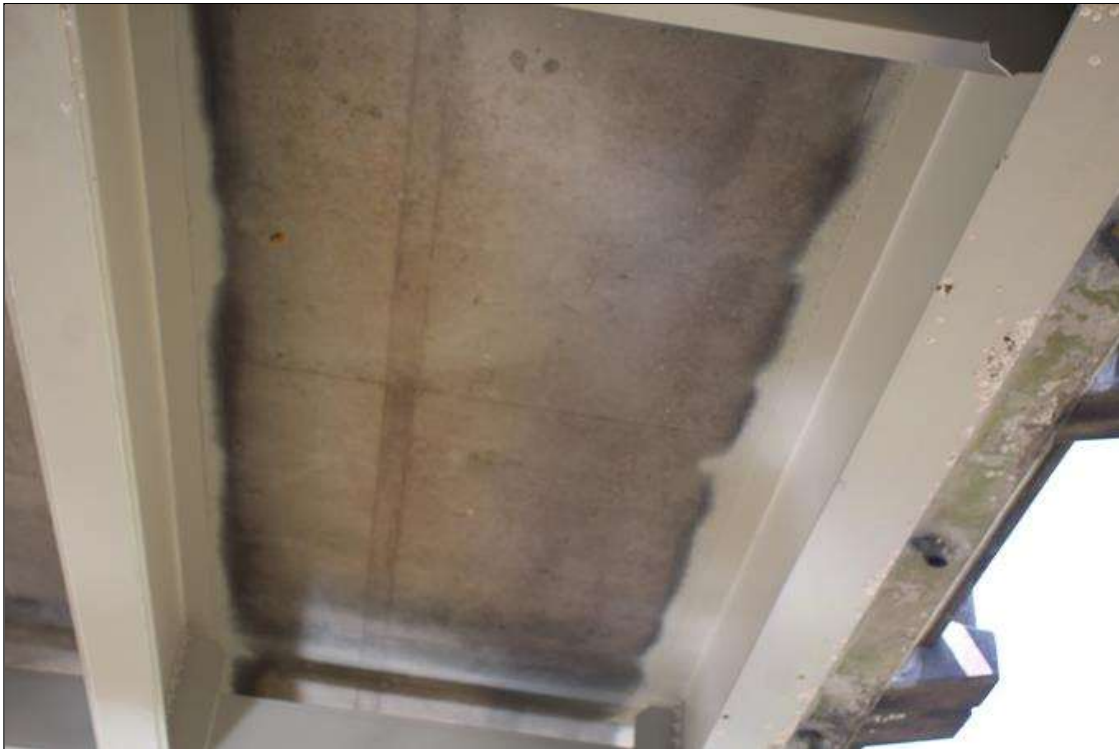
TPYICAL DECK UNDERSIDE SPAN 5 BAY 1. NOTE NEW DECK SINCE PREVIOUS INSPECTION.

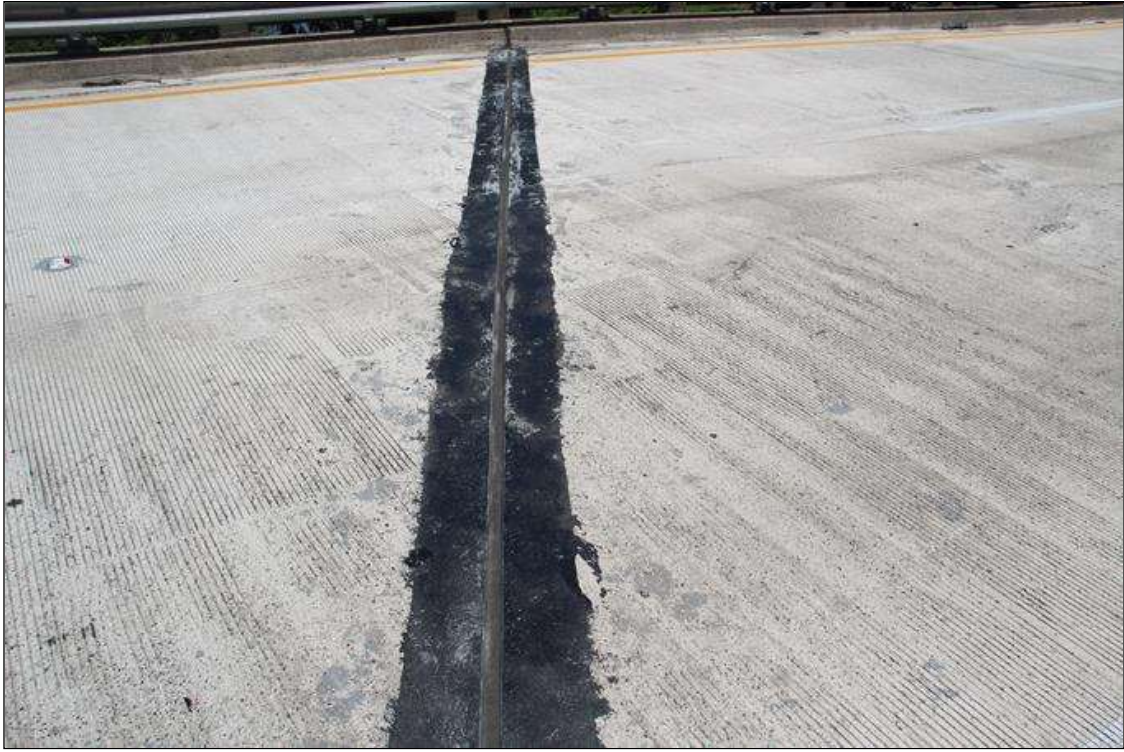
DECK JOINT ALONG BENT 7. OTHER BENTS SIMILAR.

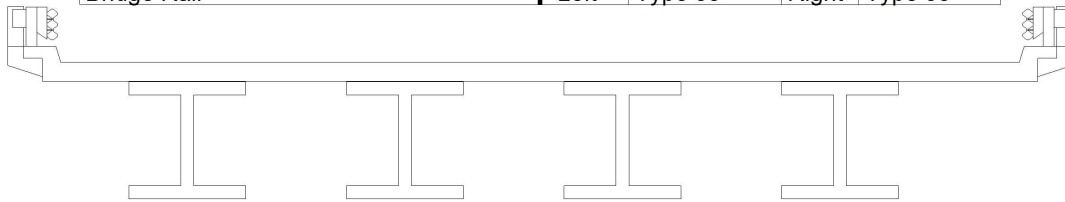
Measurements for Span #	1	TYPICAL IN OTHER SPANS	
Deck Thickness	0.895ft	Left Overhang	4.75'
Top of Rail to Bottom of Beam	6.541ft	Right Overhang	4.75'

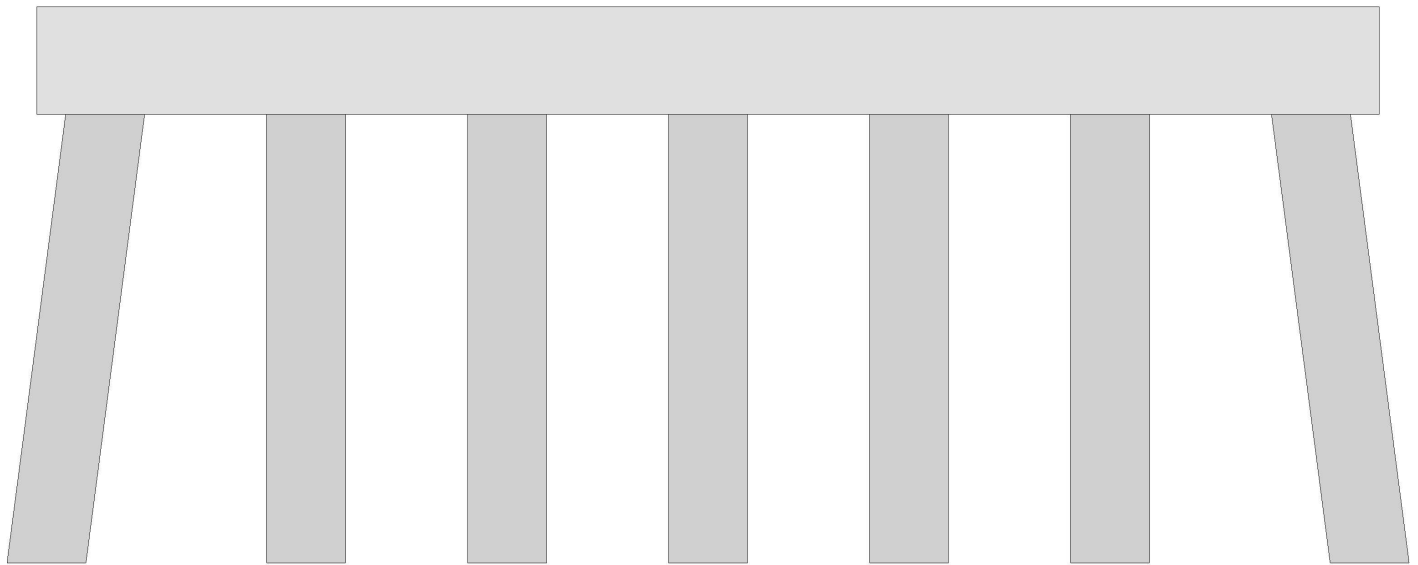
Cap Information			Material Cast-in-Place Concrete							
Length	Width	Height	Left Overhang	Right Overhang	Left Beam to End of Cap.	Right Beam to End of Cap.
