NC DEPARTMENT OF TRANSPORTATION
 DIVISION OF HIGHWAYS
 STRUCTURE MANAGEMENT UNIT

ATTENTION: **SNOOPER USED, NEW REPAIRS, NEW LMC OVERLAY, PAR SUBMITTED, CHANGE TO STRUCTURE DATA, NEWLY STRUCTURALLY DEFICIENT, CHANGE IN NBI RATING FOR ITEMS 60 AND 61.**

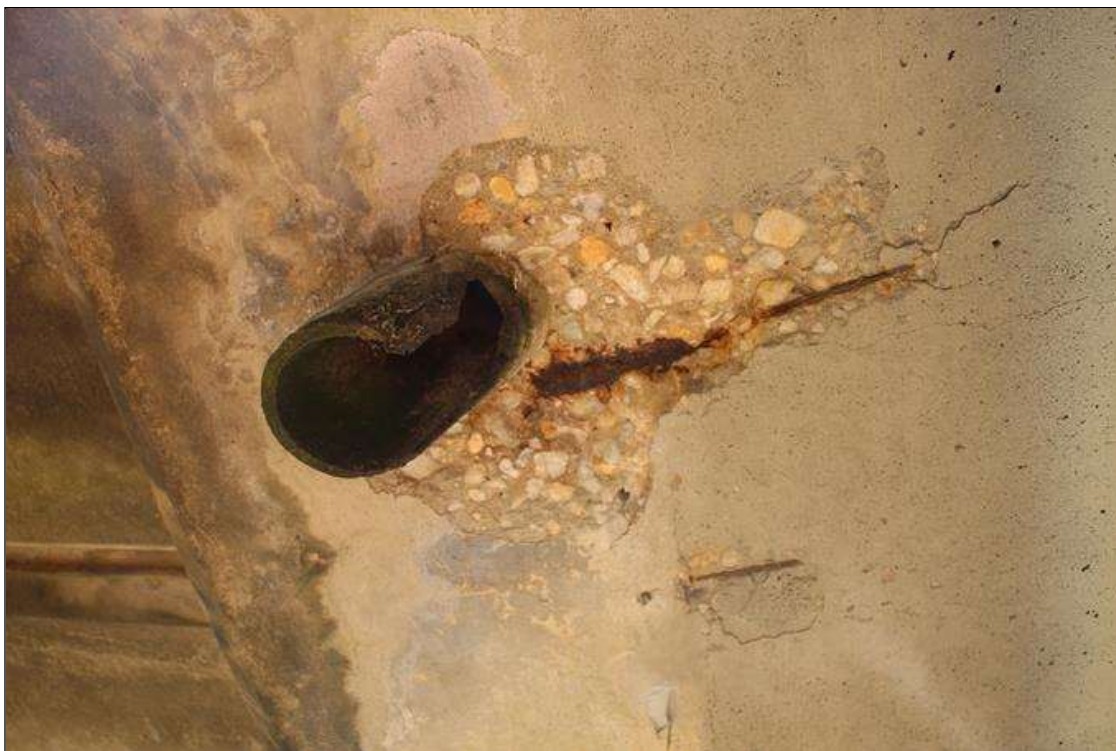
Span 1 Deck: UP TO 1 FT WIDE X 9 IN LONG X UP TO 1 IN DEEP SPALL WITH EXPOSED REINFORCEMENT IN RIGHT OVERHANG, LOCATED AT THIRD DRAIN PIPE. 80% SECTION REMAINING IN EXPOSED REINFORCEMENT.

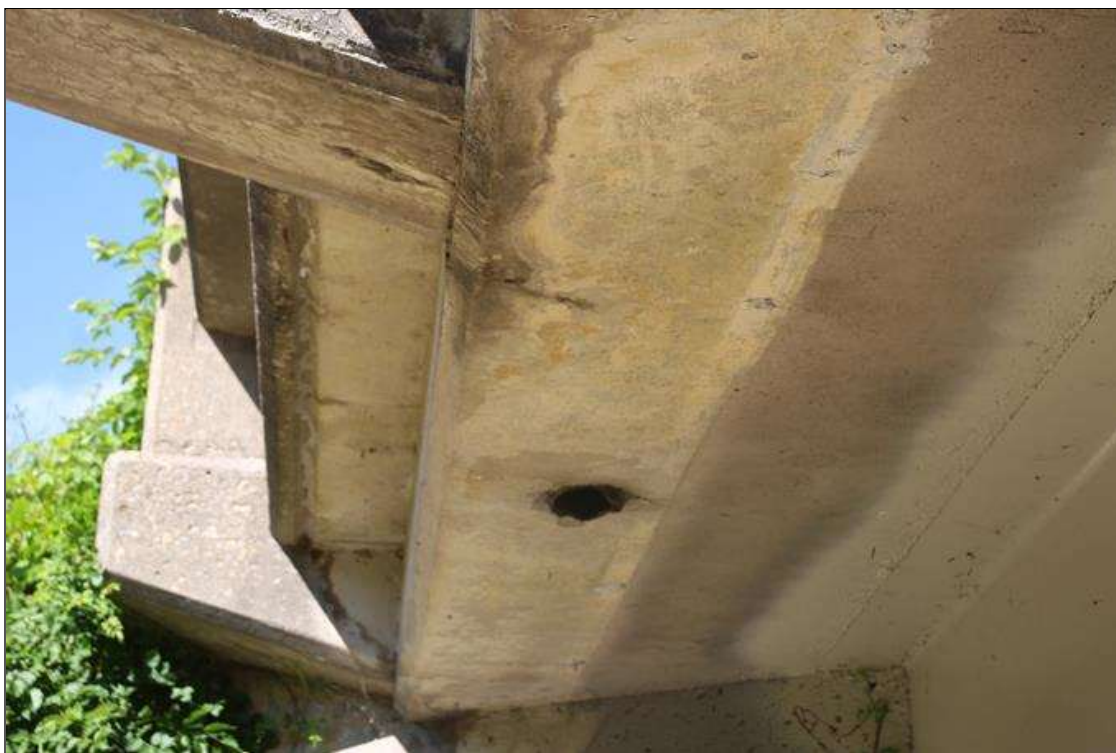
ONE BROKEN DRAIN PIPE AND THREE (3) PARTIALLY BROKEN DRAIN PIPES IN SPAN 1 RIGHT OVERHANG.

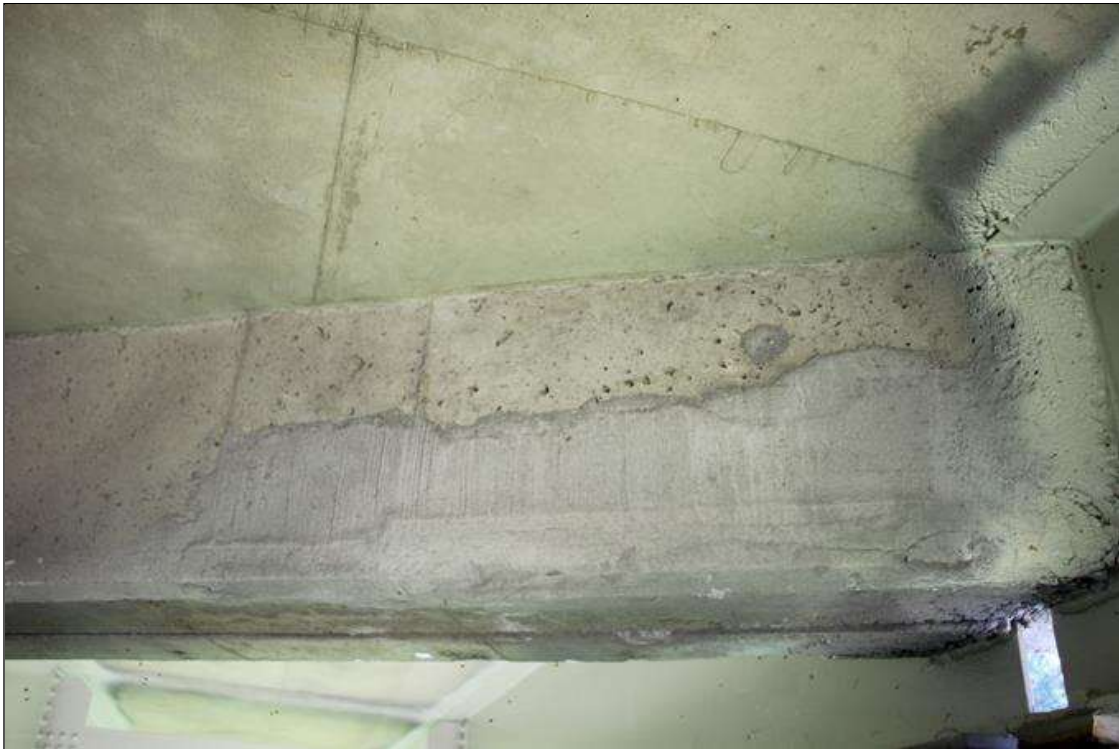
Span 1 Deck: 5 FT WIDE X 1 FT HIGH SOUND CONCRETE PATCH IN BAY 3 END DIAPHRAGM, AT BENT 1. PATCH EXHIBITS A HAIRLINE X 1 FT LONG CRACK IN BOTTOM RIGHT CORNER.

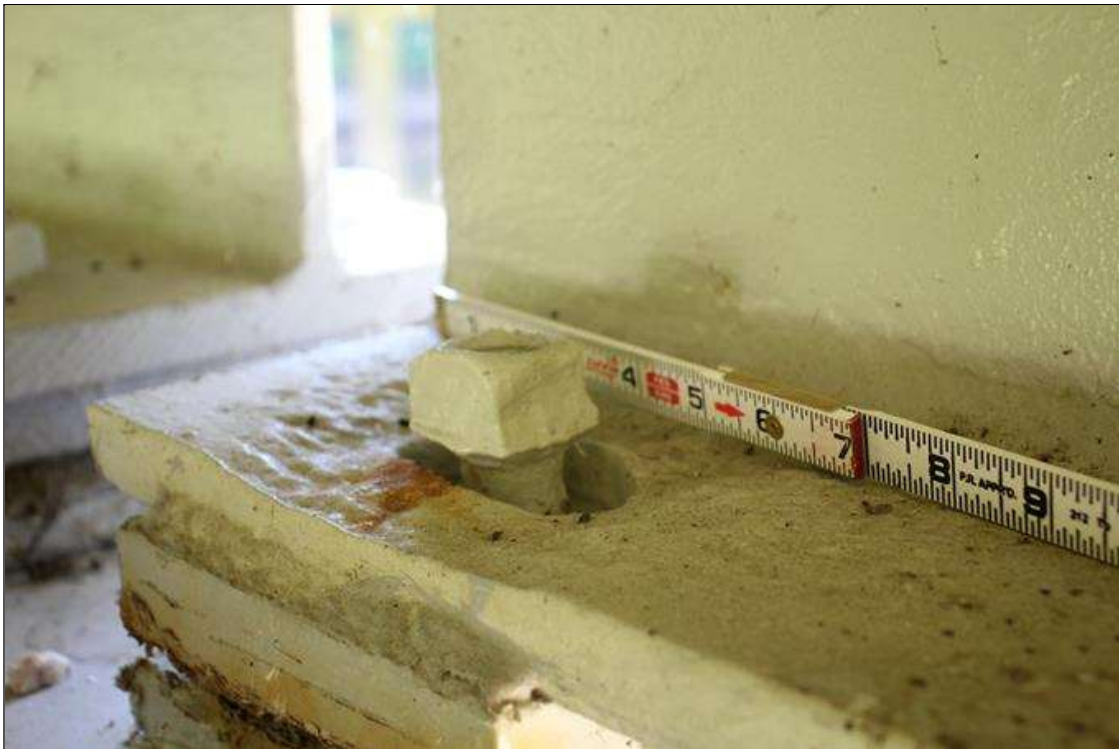
Span 1 Beam 4: 5 IN LONG X 5 IN WIDE AREA OF HEAVY SURFACE CORROSION BENEATH THE PAINTED SURFACES IN BOTTOM FLANGE OF LEFT FLANGE ABOVE BEARING AT BENT 1. UP TO 0.8 IN SECTION REMAINING.

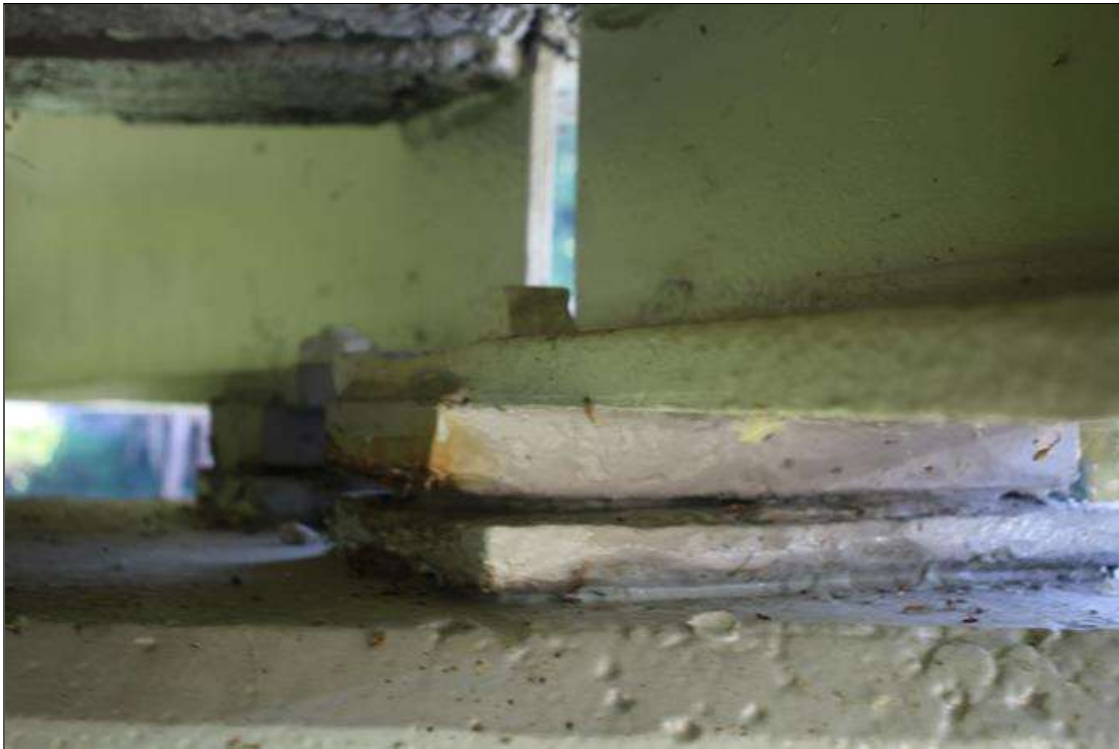
Span 1 Beam 4 Far Bearing: SECTION LOSS IN THE RIGHT ANCHOR BOLT. 75% SECTION REMAINING.

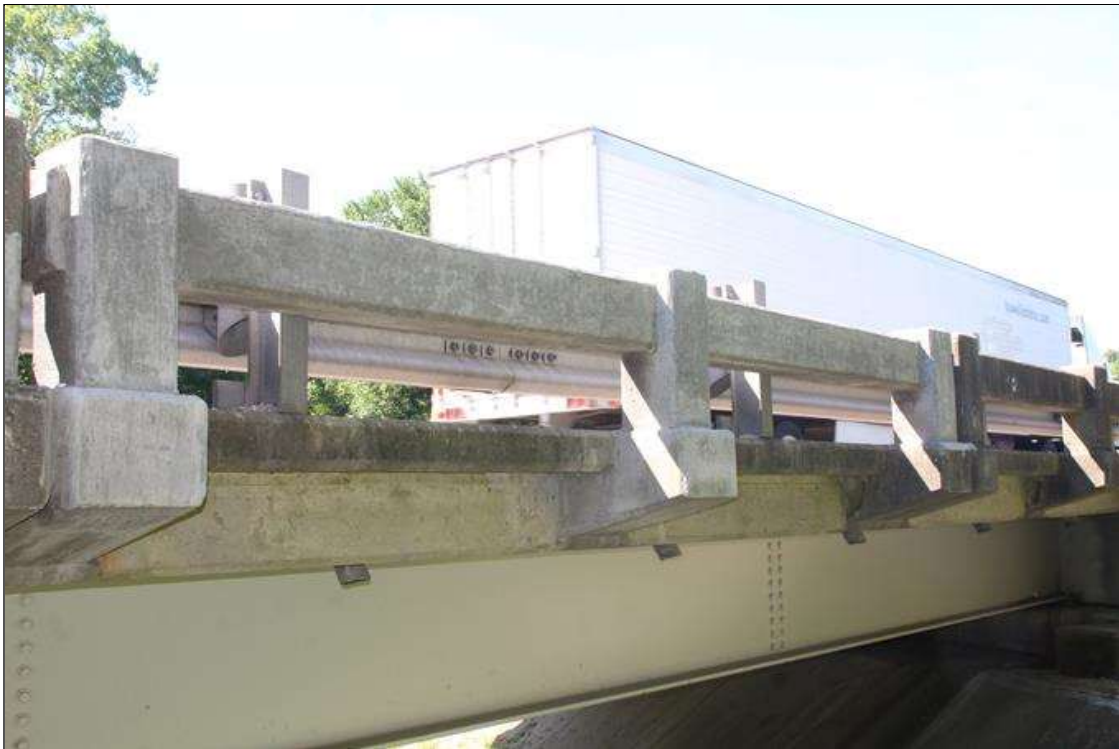
Span 1 Left Bridge Rail: 15 FT LONG AREA OF SOUND CONCRETE PATCHING TO CONCRETE RAIL, BEGINNING AT 15 FT FROM END BENT 1. PREVIOUS REPAIR.

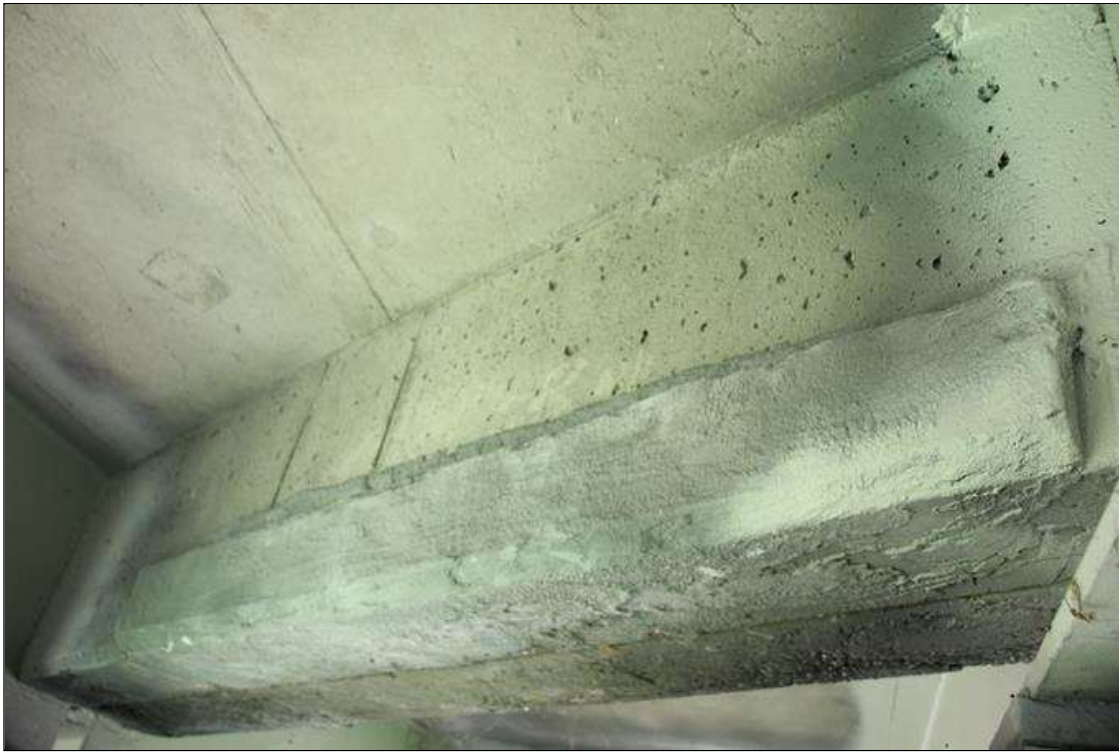
Span 2 Deck: 82 IN WIDE X 1 FT HIGH SOUND CONCRETE PATCH AREA, BAY 2 END DIAPHRAGM, AT BENT 1.

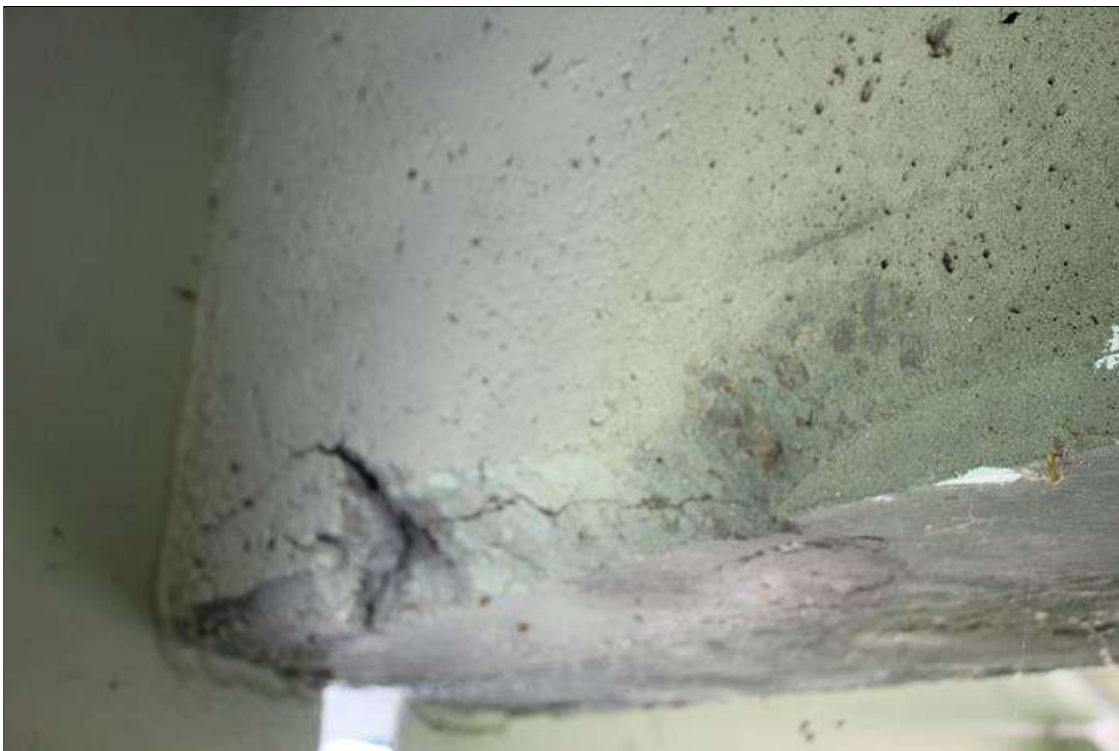
Span 2 Deck: UP TO 1.5 FT WIDE X 4 IN LONG X UP TO 2 IN DEEP SPALL IN DIAPHRAGM IN BAY 3 AT BENT 1.

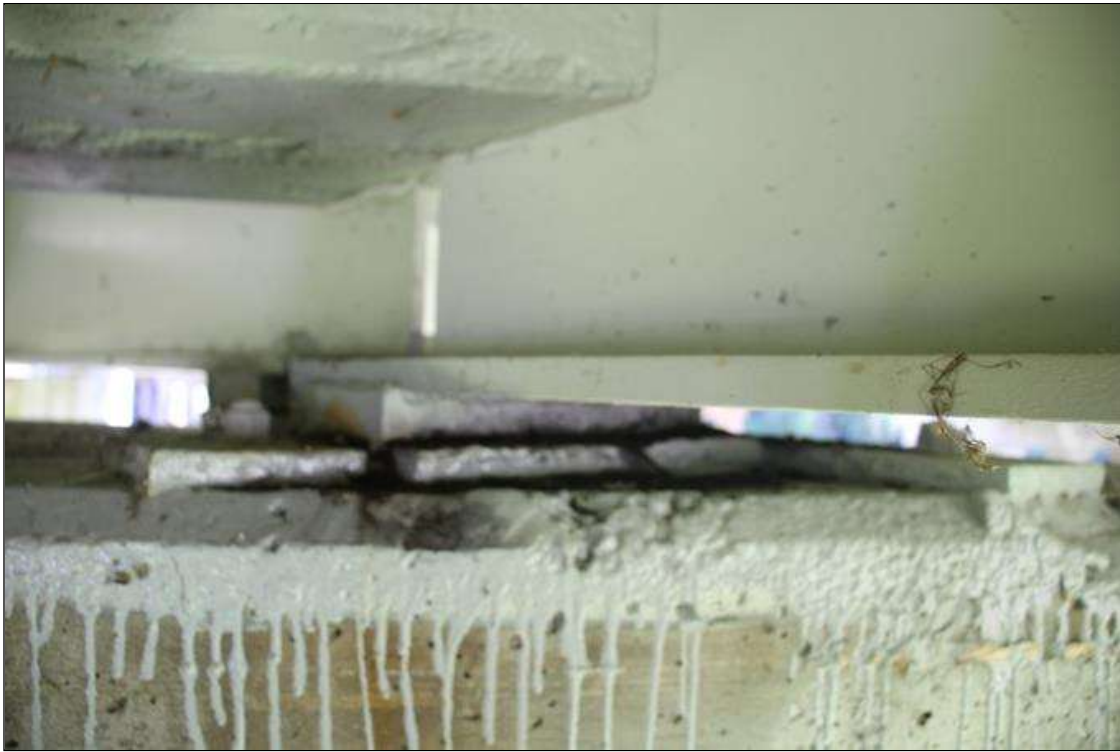
Span 2 Beam 3 Far Bearing: WELDED BEARING REPAIR WITH ANCHOR ROD. TYPICAL AT BEAMS 1, 2, AND 4.

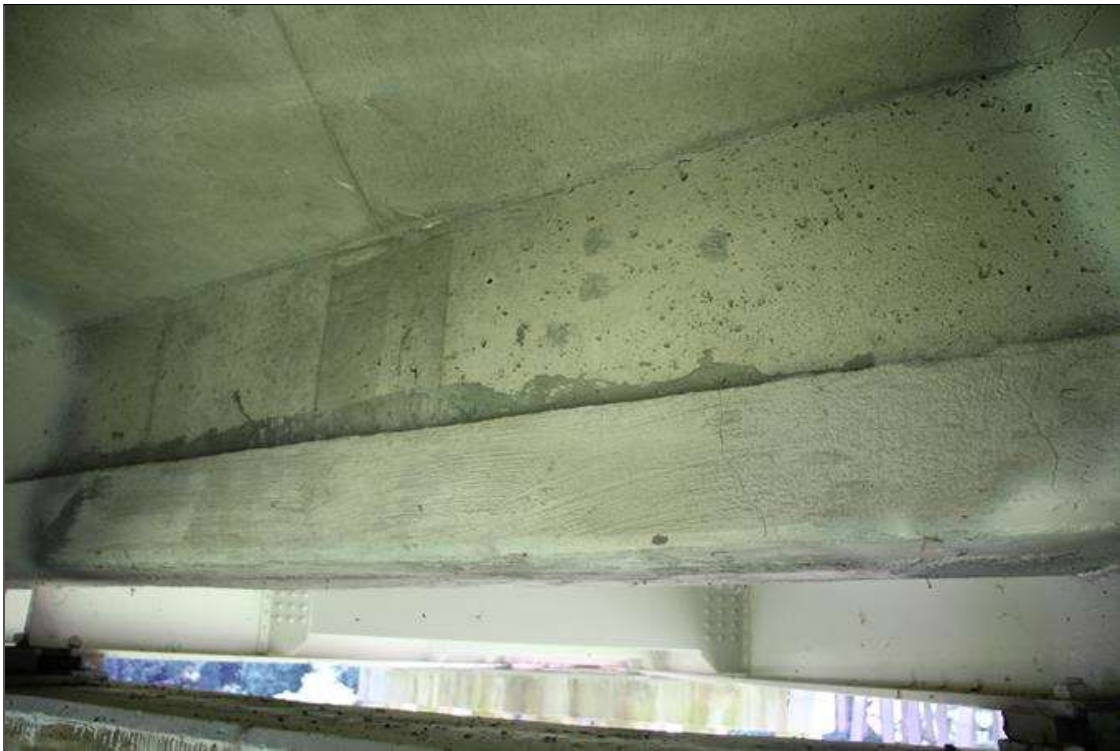
Span 2 Deck: 9 FT LONG X 1 FT HIGH CONCRETE PATCH, BAY 2 END DIAPHRAGM, AT BENT 2. PATCH EXHIBITS UP TO 1/8 IN WIDE X 5 FT LONG CRACK IN THE BOTTOM FACE WITH A 5 FT LONG X 5 IN WIDE UNSOUND CONCRETE AND UP TO 0.02 IN WIDE VERTICAL CRACKS IN FRONT FACE, SCATTERED.

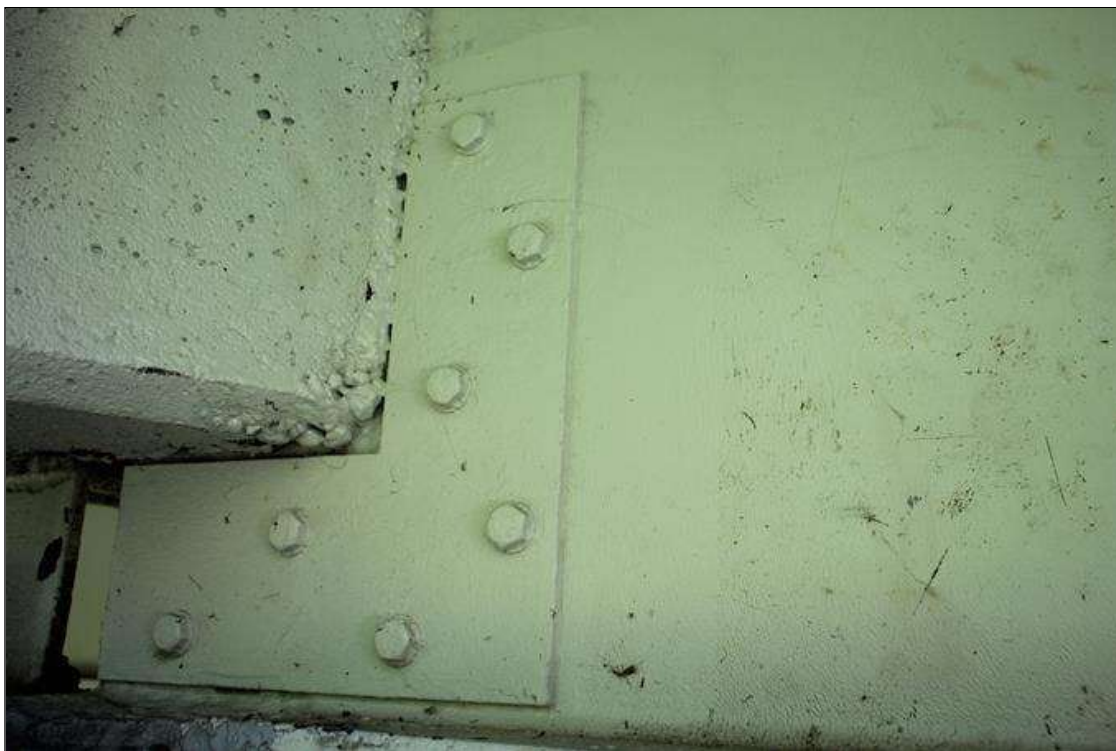
NEW REPAIR TO SPAN 2 BEAM 1 BEAM END IN BOTH FACES OF THE WEB ABOVE BENT 2.

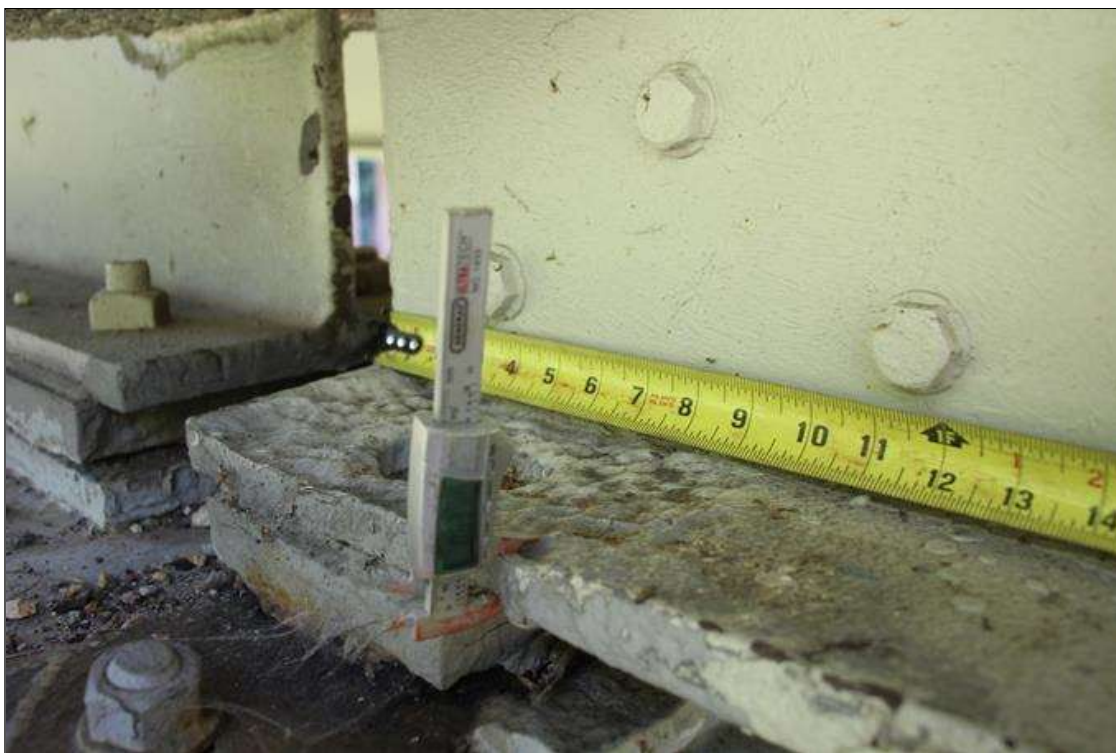
Span 2 Beam 1: 10 IN LONG X 5 IN WIDE AREA OF SECTION LOSS BENEATH THE PAINTED SURFACE ABOVE THE BEARING AT BENT 2. 0.60 IN SECTION REMAINING (PAR).

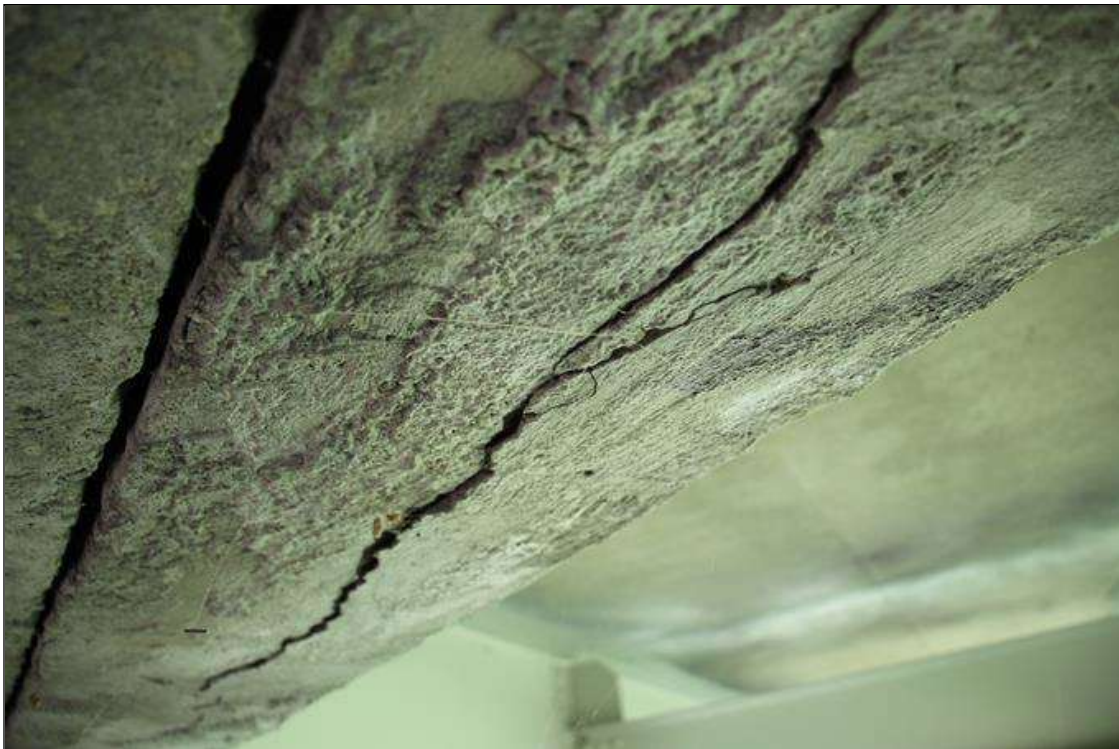
Span 2 Deck: 9 FT LONG X 1 FT HIGH SOUND CONCRETE PATCH, BAY 2 END DIAPHRAGM, AT BENT 2. PATCH EXHIBITS UP TO 1/8 IN WIDE X 5 FT LONG CRACK IN THE BOTTOM FACE WITH A 5 FT LONG X 5 IN WIDE UNSOUND CONCRETE AND UP TO 0.02 IN WIDE VERTICAL CRACKS IN FRON FACE, SCATTERED.

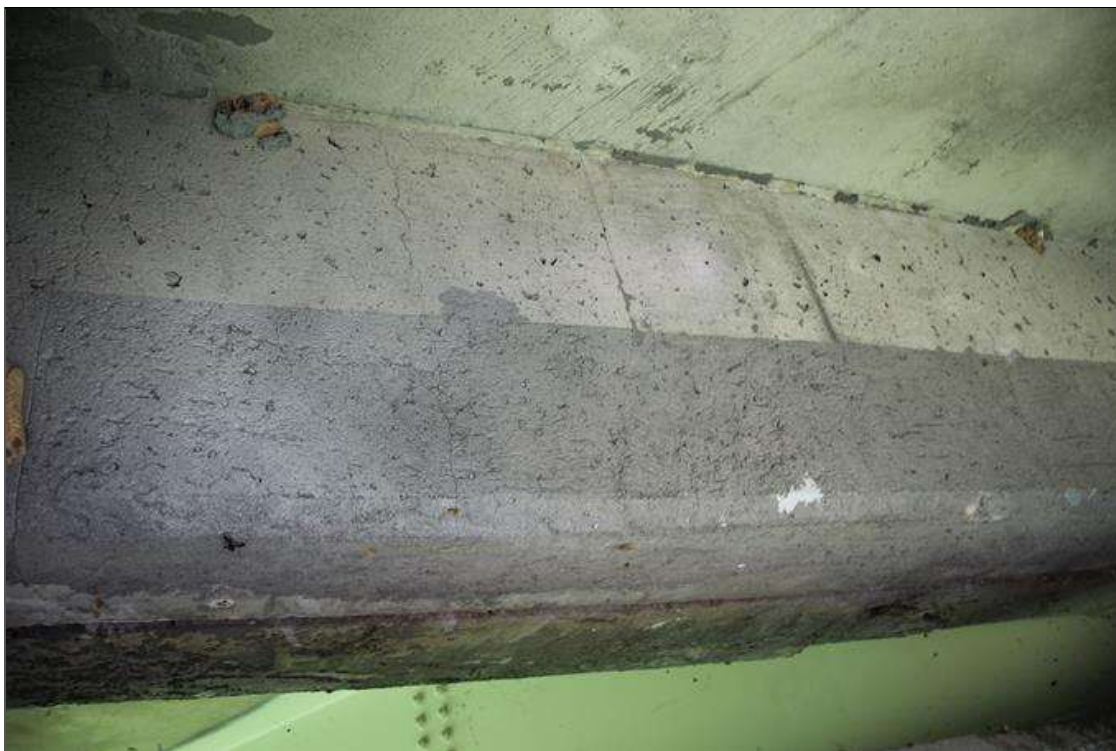
Span 3 Deck: NEW REPAIR: 9 FT LONG X 1 FT HIGH SOUND CONCRETE PATCH IN BAY 3 AT BENT 2.

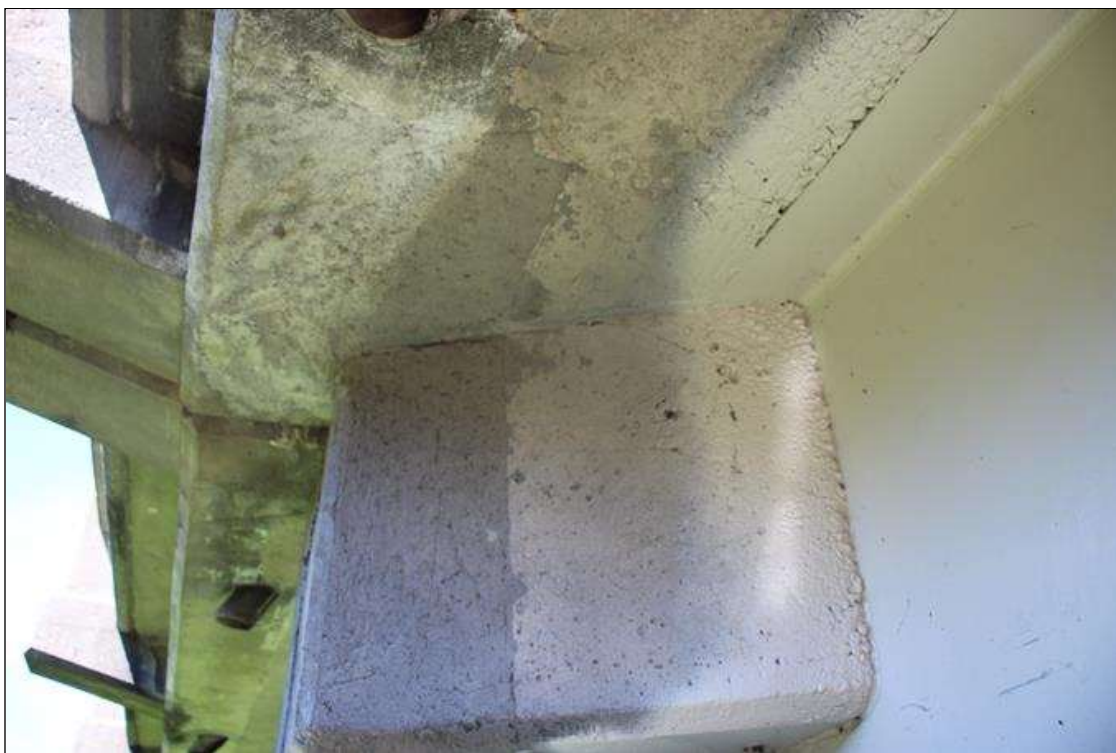
Span 2 Deck: NEW REPAIR: 3 FT WIDE X 1 FT HIGH SOUND CONCRETE PATCH IN OVERHANG IN EAST FACE AT BENT 2 AND A 1 FT WIDE X 2 FT HIGH SOUND CONCRETE PATCH IN DIAPHRAGM OUTSIDE OF BEAM 4 AT BENT 2.

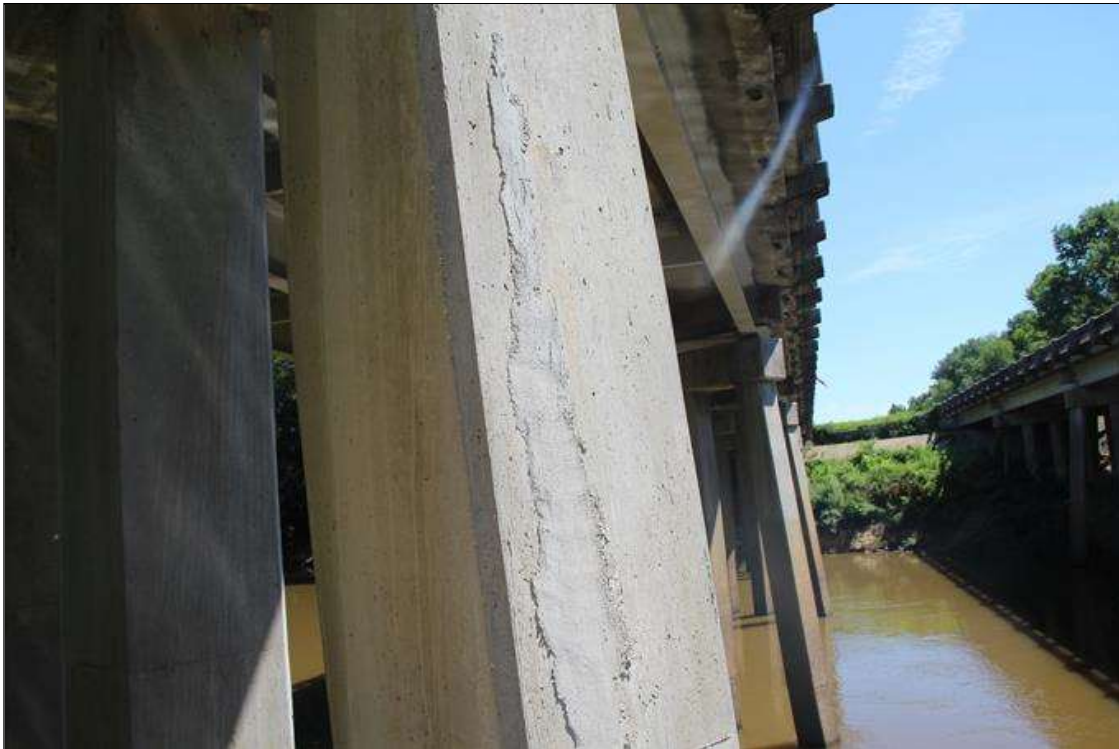
Bent 3 Pile 7: 5 FT HIGH X UP TO 6 IN WIDE CONCRETE PATCH WITH HAIRLINE VERTICAL CRACKS IN EAST FACE, LOCATED AT 4 FT BELOW THE CAP.

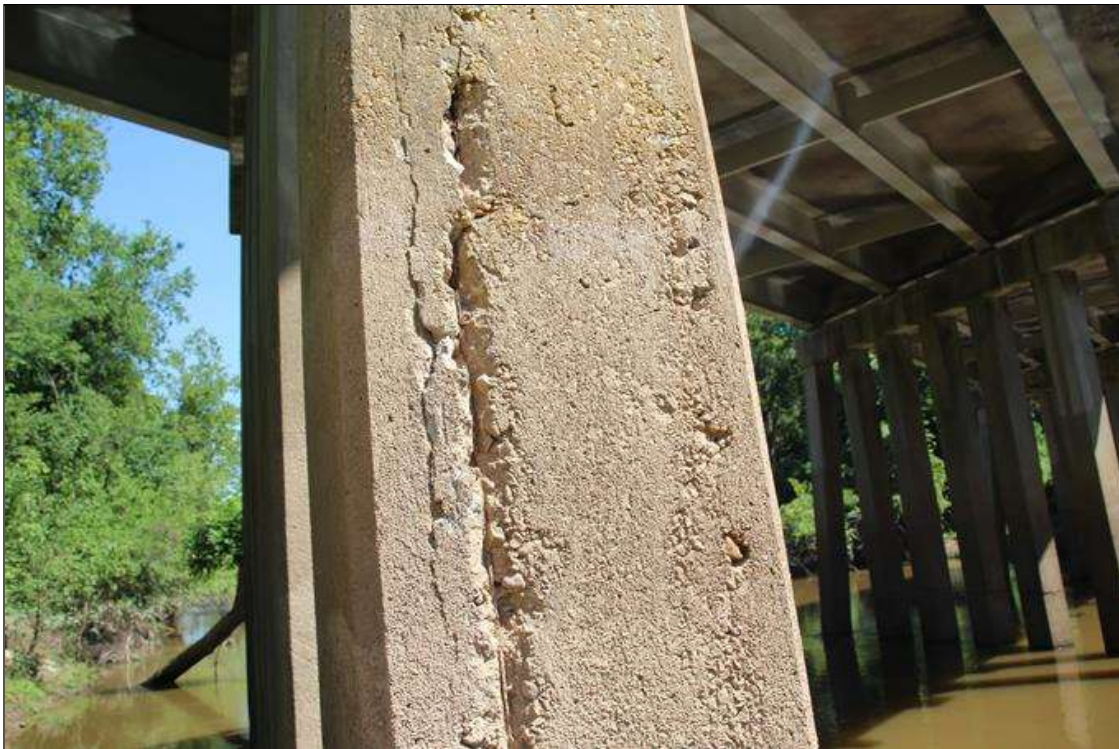
Bent 3 Pile 7: 4 FT HIGH X 4 IN WIDE SPALL WITH EXPOSED REINFORCEMENT IN EAST FACE. 90% SECTION REMAINING IN EXPOSED REINFORCEMENT (PAR).

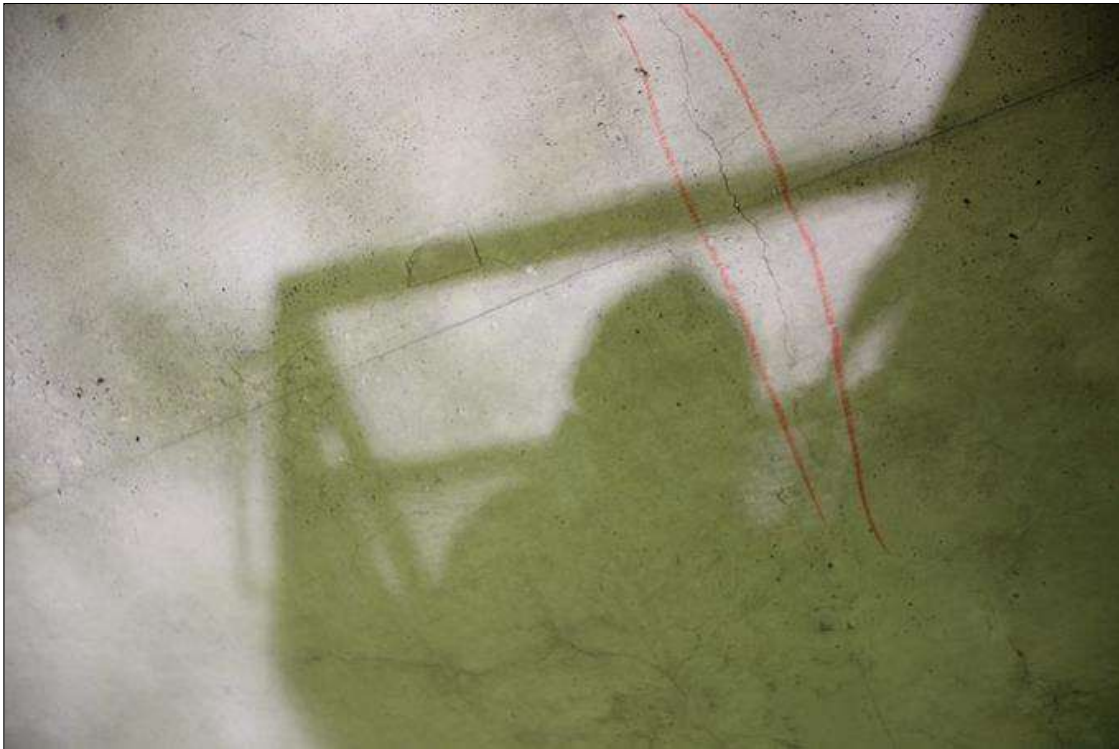
Span 3 Deck: UP TO 0.03 IN WIDE TRANSVERSE AND RANDOM CRACKING IN DECK UNDERSIDE IN ALL BAYS, SCATTERED THROUGHOUT. BAY 3 SHOWN IN PHOTO.

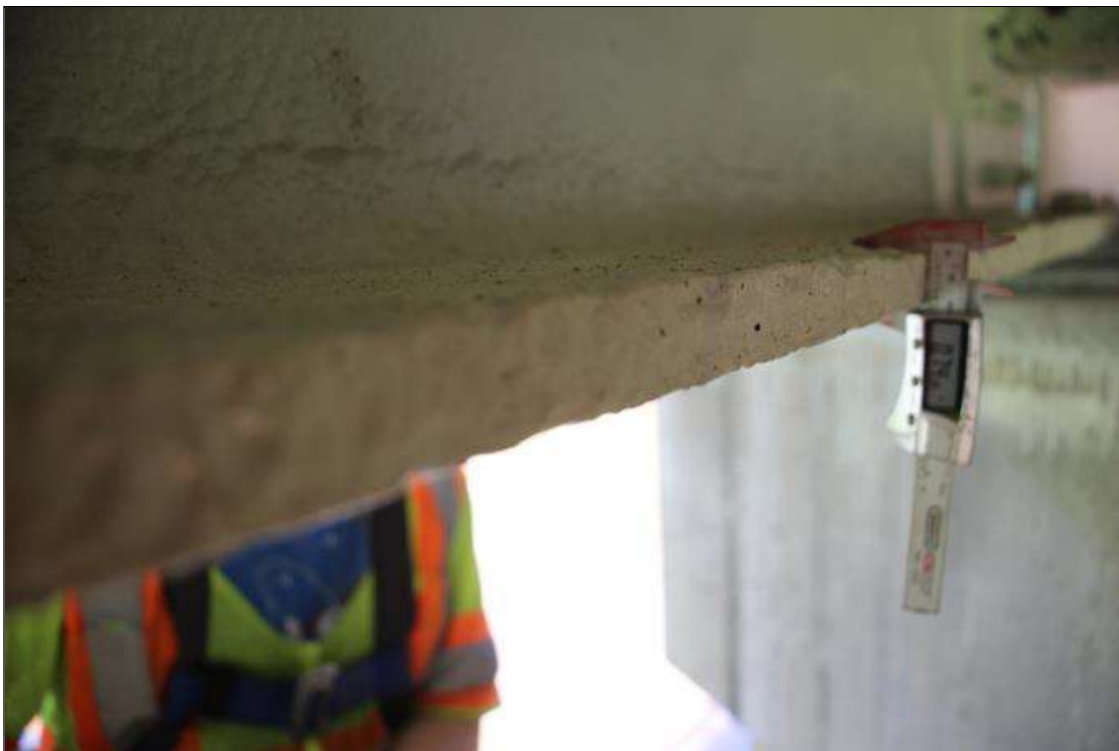
Span 3 Beam 1: 2 FT LONG X 5 IN WIDE AREA OF BOTTOM FLANGE HAS SECTION LOSS BENEATH THE PAINTED SURFACE, LOCATED AT 2 FT FROM BEAM END AT BENT 3. 0.74 IN SECTION REMAINING.

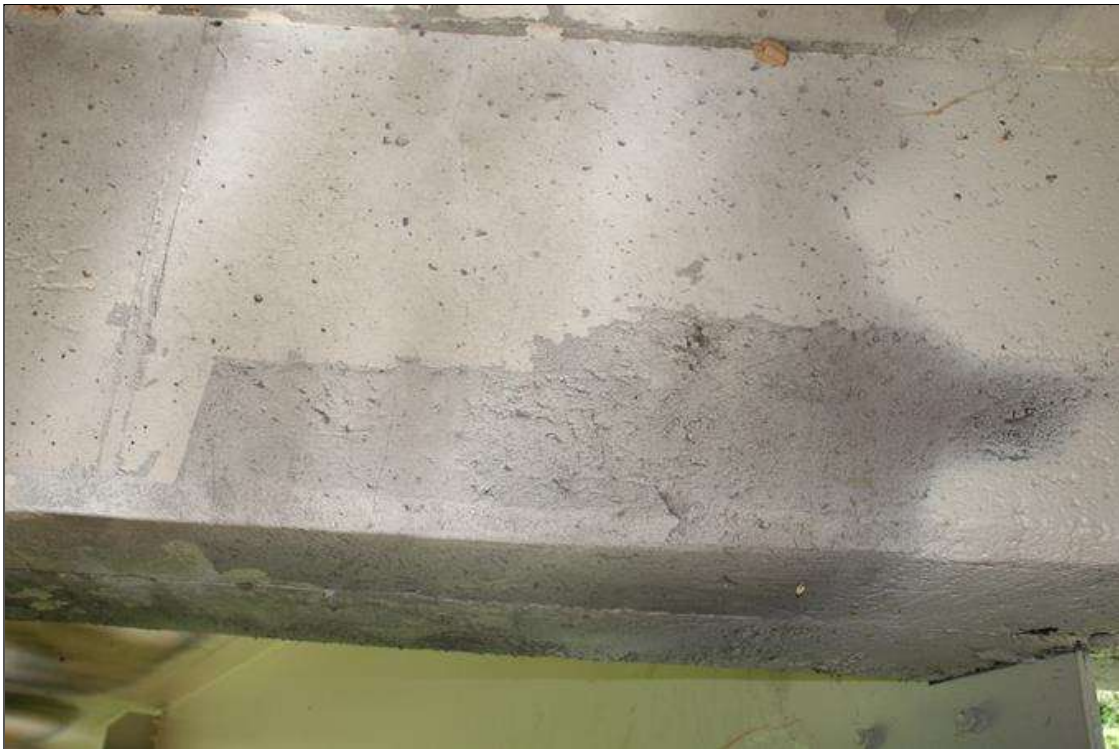
Span 4 Deck: 2.5 FT LONG X 6 IN HIGH SOUND CONCRETE PATCH WITH HAIRLINE VERTICAL CRACKS IN BAY 1 ABOVE BENT 3.

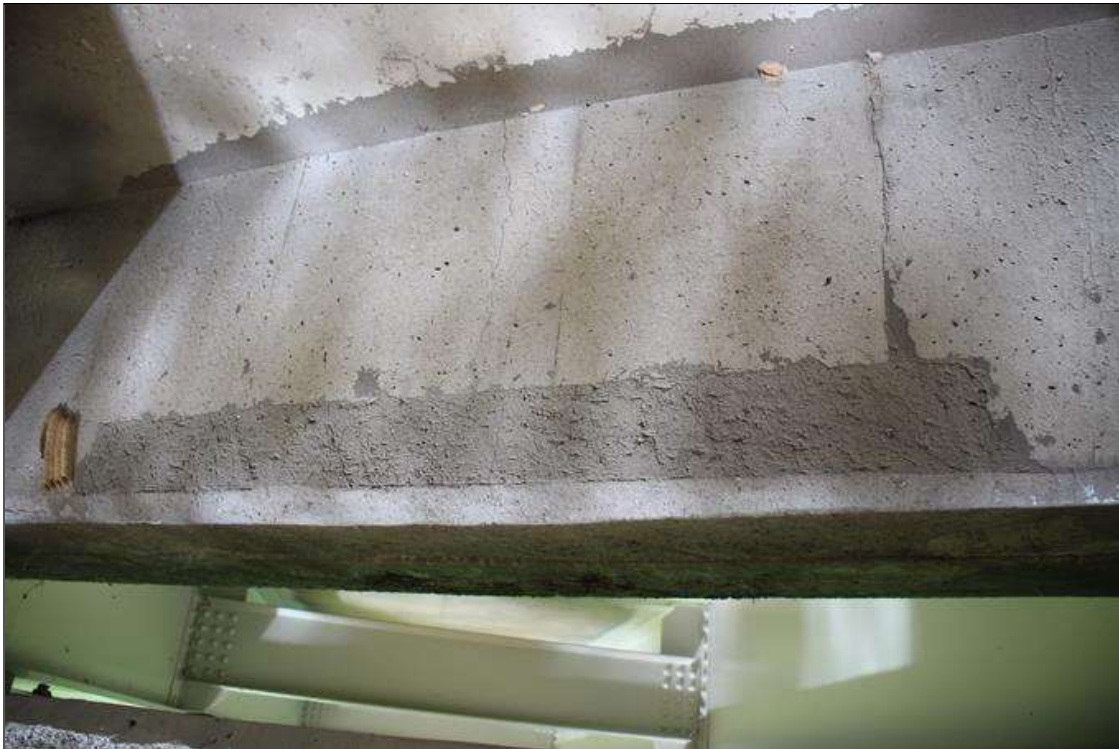
Span 4 Deck: 4 FT LONG X 6 IN HIGH SOUND CONCRETE PATCH WITH HAIRLINE VERTICAL CRACKS IN BAY 2 AT BENT 3.

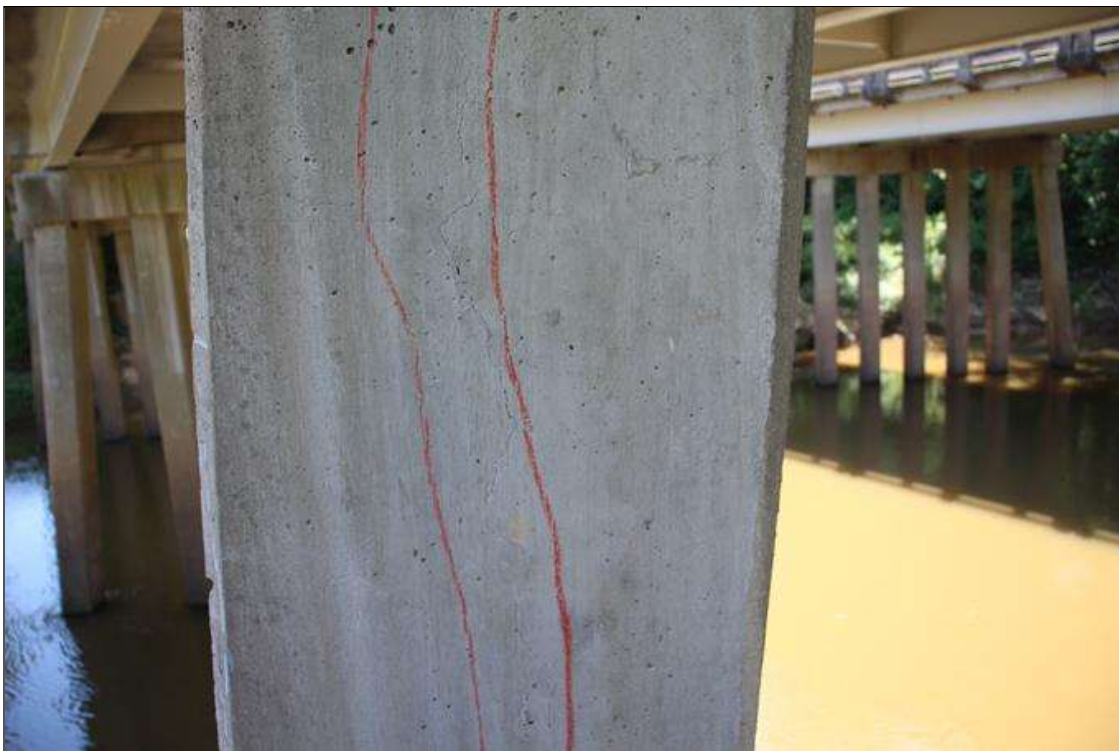
Bent 4 Pile 1: 5 FT LONG X 0.02 IN WIDE VERTICAL CRACK, SOUTH FACE BEGINNING AT CAP.

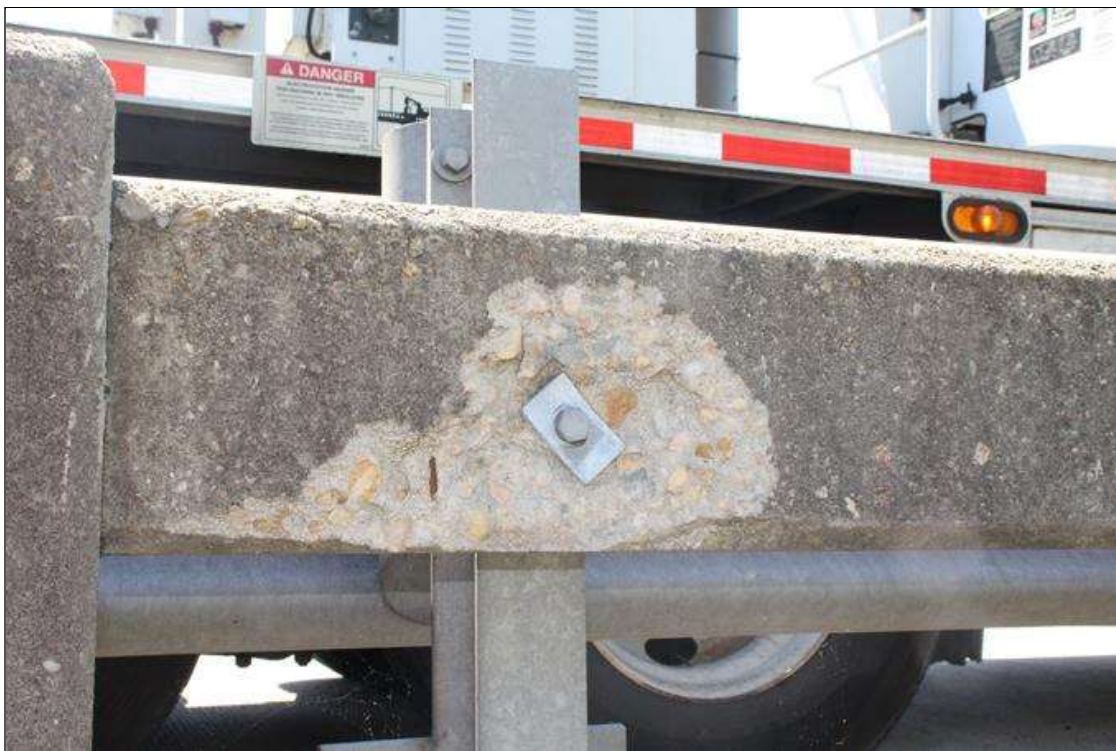
Span 4 Right Bridge Rail: 1.5 FT LONG X 9 IN HIGH X UP TP 1.5 IN DEEP SPALL IN EXTERIOR FACE OF RAIL, LOCATED AT MID SPAN.

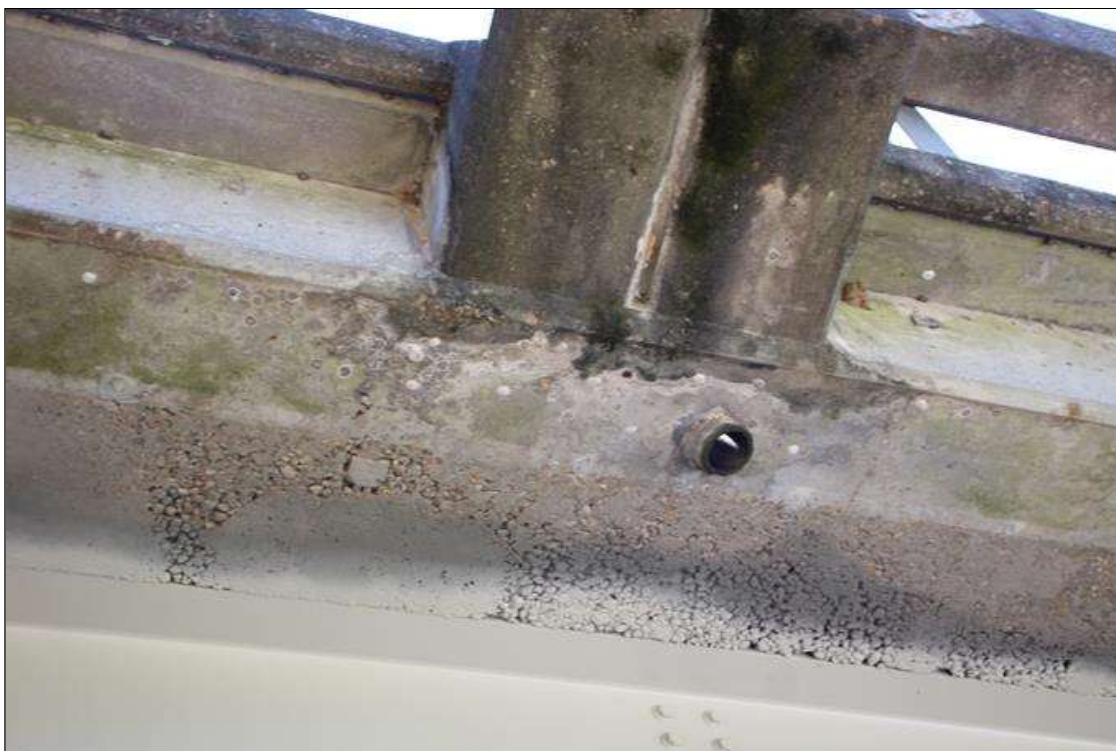
Span 4 Deck: 7 FT LONG X 2 FT LONG AREA OF HONEYCOMBING LOCATED AT MID SPAN.

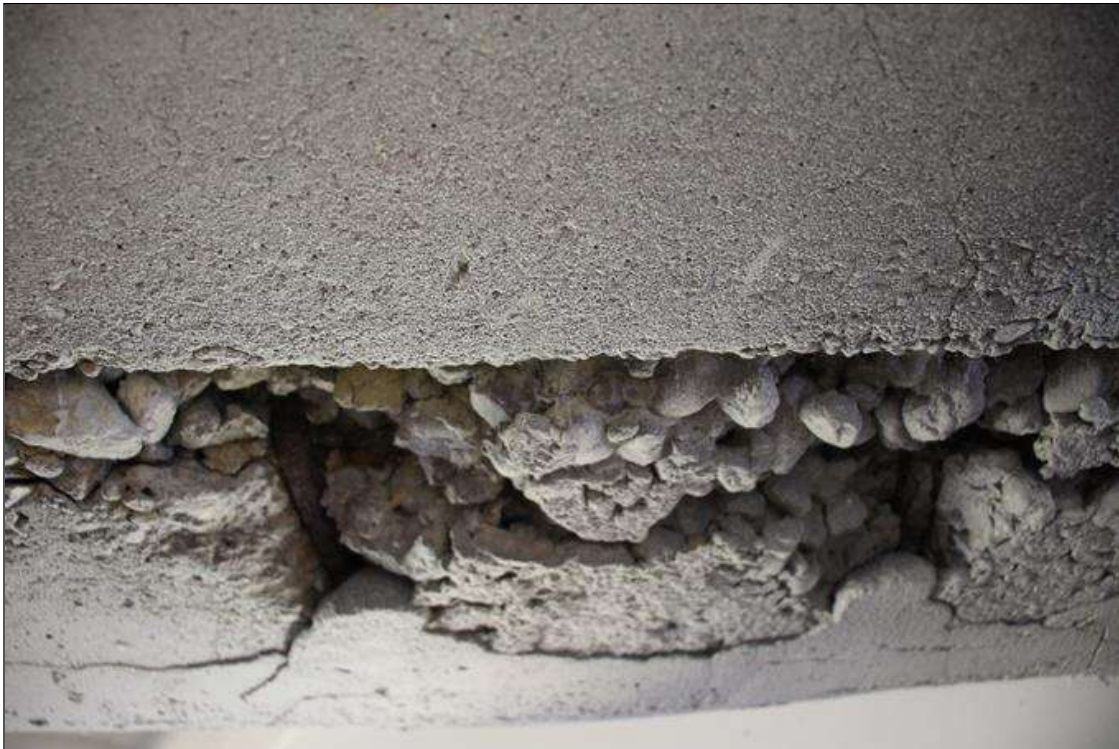
Span 4 Deck: 2 IN WIDE X 7 IN LONG X UP TO 2 IN DEEP SPALLS AND HONEYCOMBING WITH EXPOSED REBAR IN BOTTOM OF DIAPHRAGM IN BAY 1 AT BENT 4. NO MEASUREABLE SECTION LOSS IN EXPOSED REINFORCEMENT.

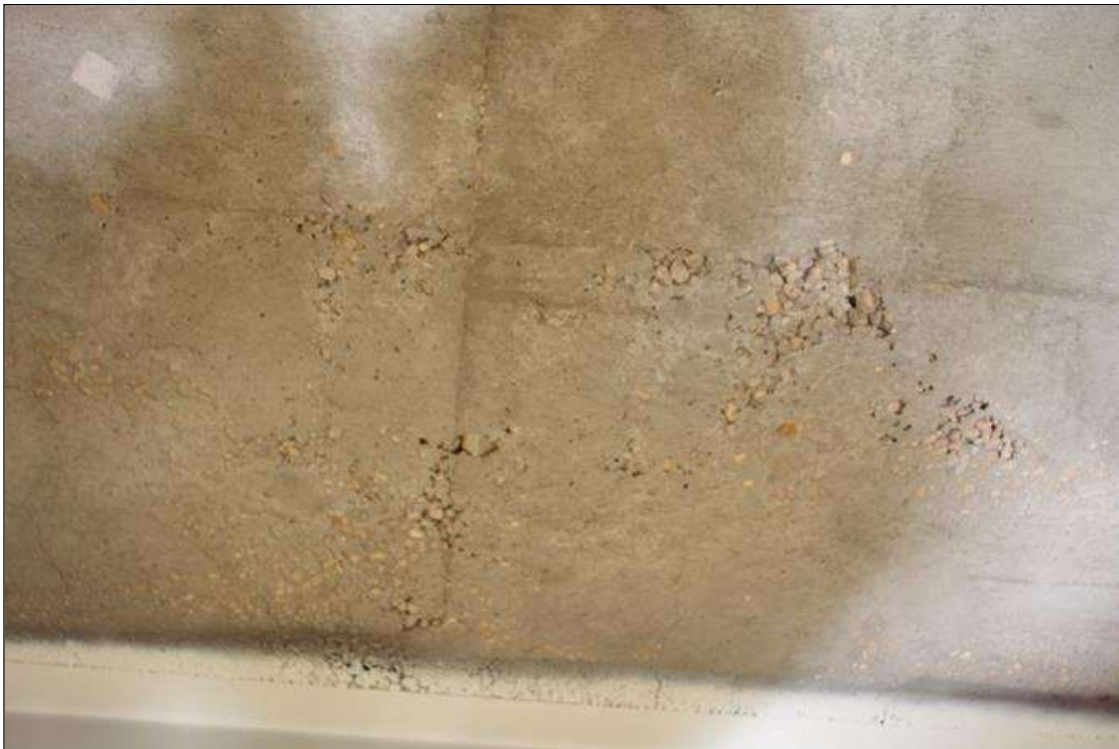
Span 5 Deck: 6 FT LONG X 3 FT WIDE X UP TO 3/4 IN DEEP AREA OF HONEYCOMBING IN BAY 3 NEAR BENT 5.
