NC DEPARTMENT OF TRANSPORTATION
 DIVISION OF HIGHWAYS
 STRUCTURE MANAGEMENT UNIT

ATTENTION: **SNOOPER USED, NEW REPAIRS, NEW LMC OVERLAY, PAR SUBMITTED, CHANGE TO STRUCTURE DATA, NEWLY STRUCTURALLY DEFICIENT, CHANGE IN NBI RATING FOR ITEMS 60 AND 61.**

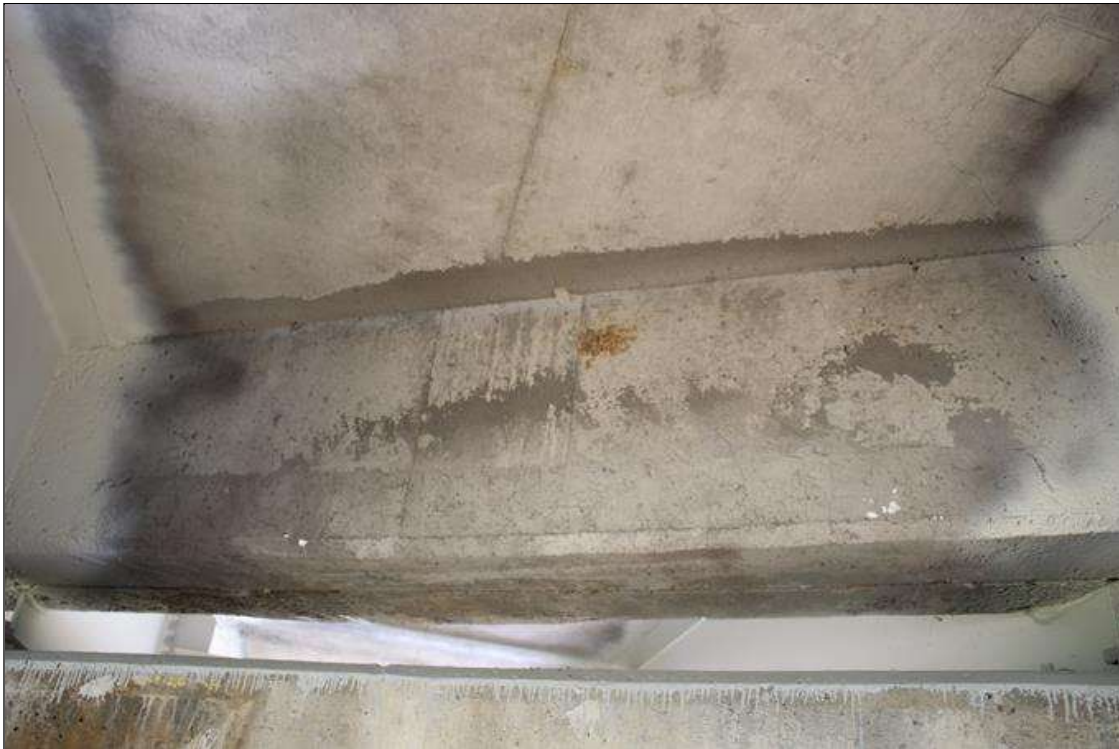
Span 5 Deck: NEW REPAIR: 8 FT LONG X 6 IN HIGH SOUND CONCRETE PATCH IN BAY 2 END DIAPHRAGM, AT BENT 5.

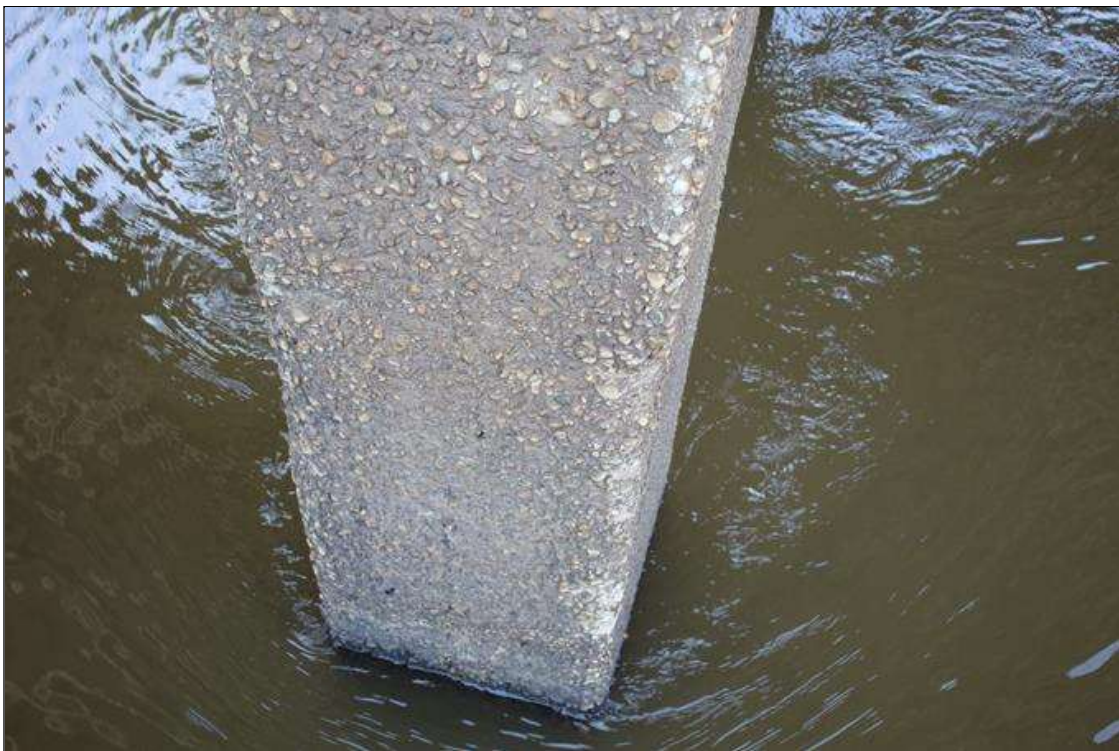
Bent 5 Pile 1: ABRASION WITH COARSE AGGREGATE EXPOSED 1/16 IN TO 1/4 IN LOSS OF FACIAL CONCRETE.

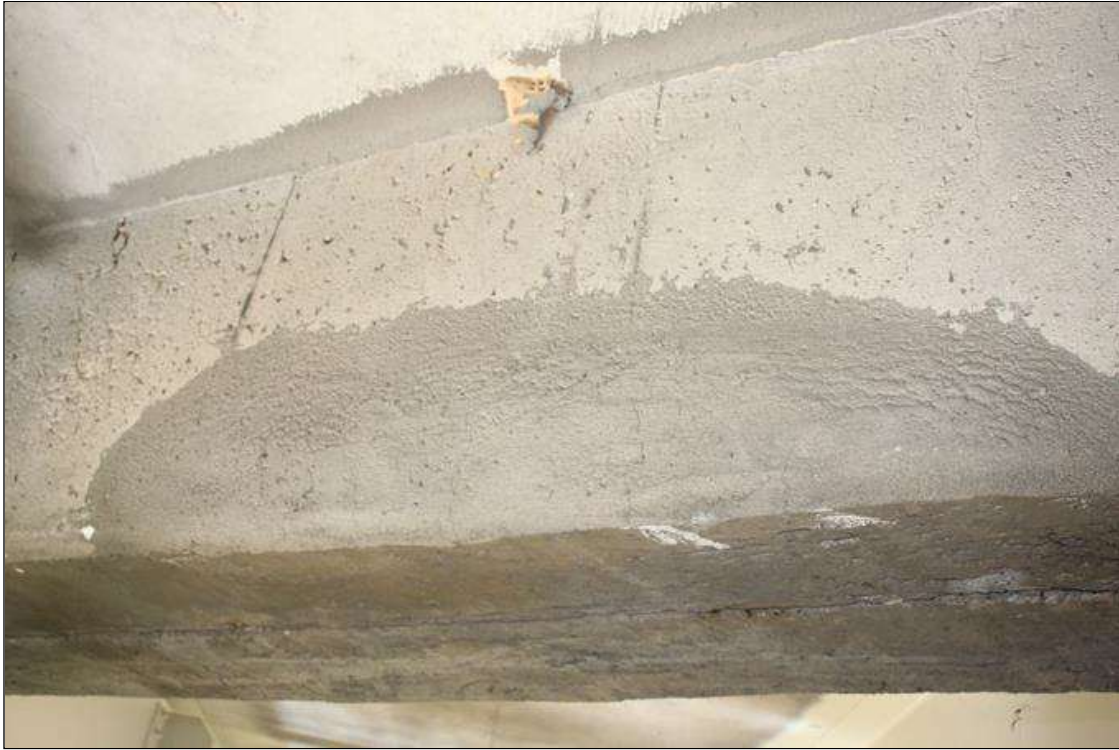
Span 6 Deck: NEW REPAIR: 28 IN LONG X 1 FT HIGH SOUND CONCRETE PATCH IN BAY 2 END DIAPHRAGM, AT BENT 5. PATCH EXHIBITS HAIRLINE VERTICAL CRACKING, SCATTERED.

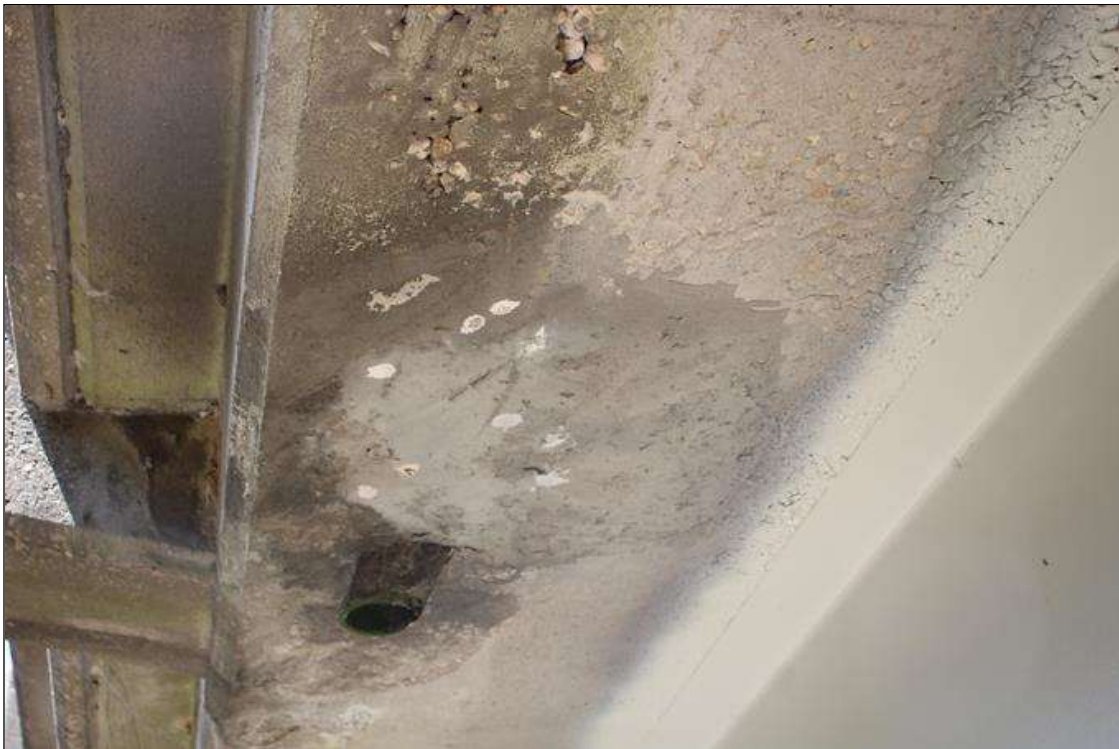
Span 6 Deck: NEW REPAIR: 12 IN DIAMETER SOUND CONCRETE PATCH IN EAST OVERHANG AT DRAIN ONE.

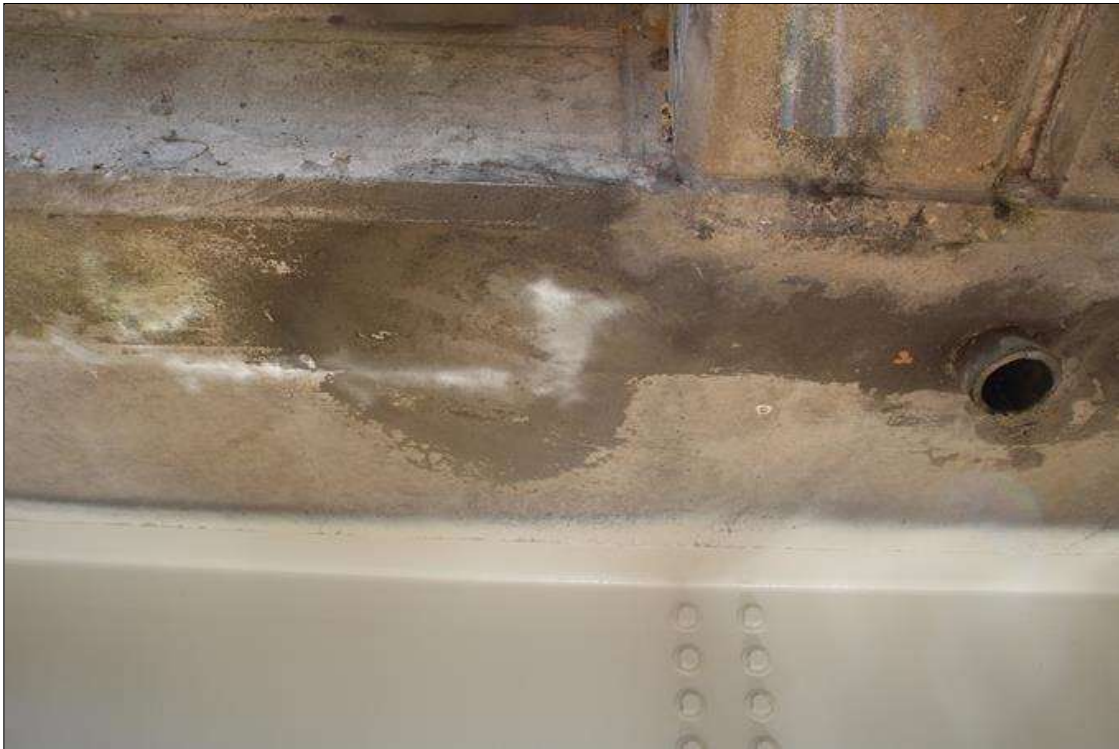
Span 6 Deck: NEW REPAIR: 18 IN DIAMETERE SOUND CONCRETE PATCH IN EAST OVERHANG BETWEEN 5TH AND 6TH DECK DRAINS.

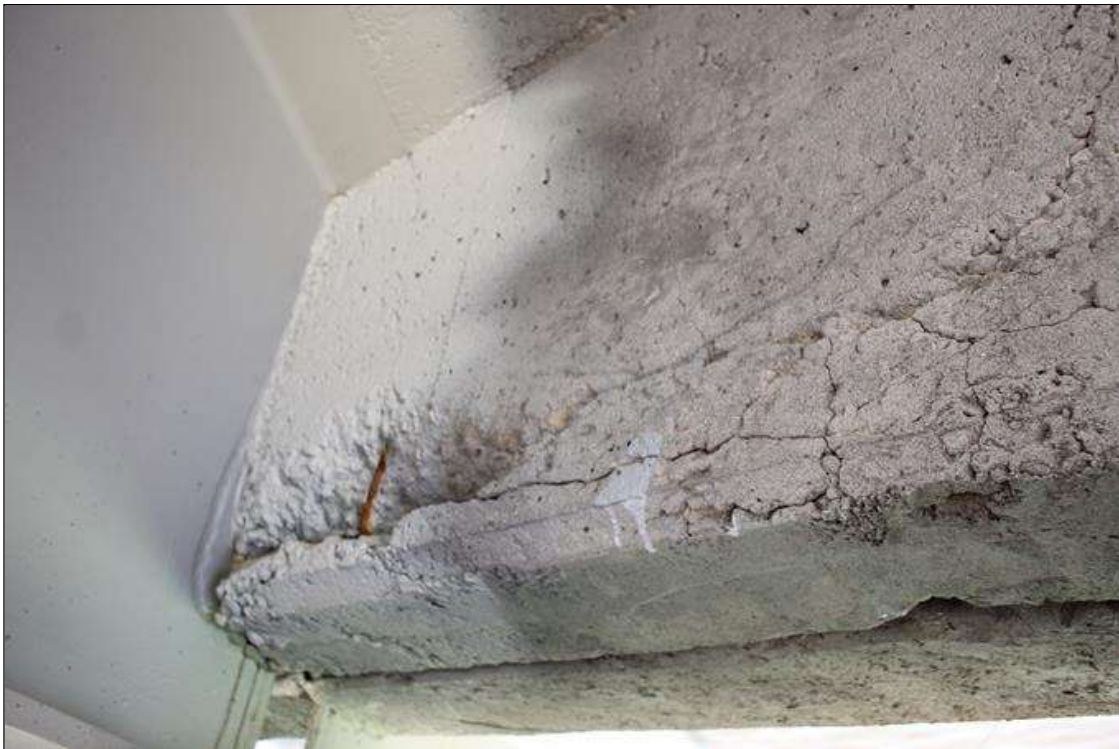
Span 6 Deck: 2.5 FT WIDE X 10 IN LONG X UP TO 6 IN HIGH AREA OF UNSOUND CONCRETE AND SPALL UP TO 2 IN DEEP WITH EXPOSED REINFORCEMENT IN BAY 3 END DIAPHRAGM AT BENT 7. NO MEASUREABLE SECTION LOSS IN EXPOSED REINFORCEMENT.

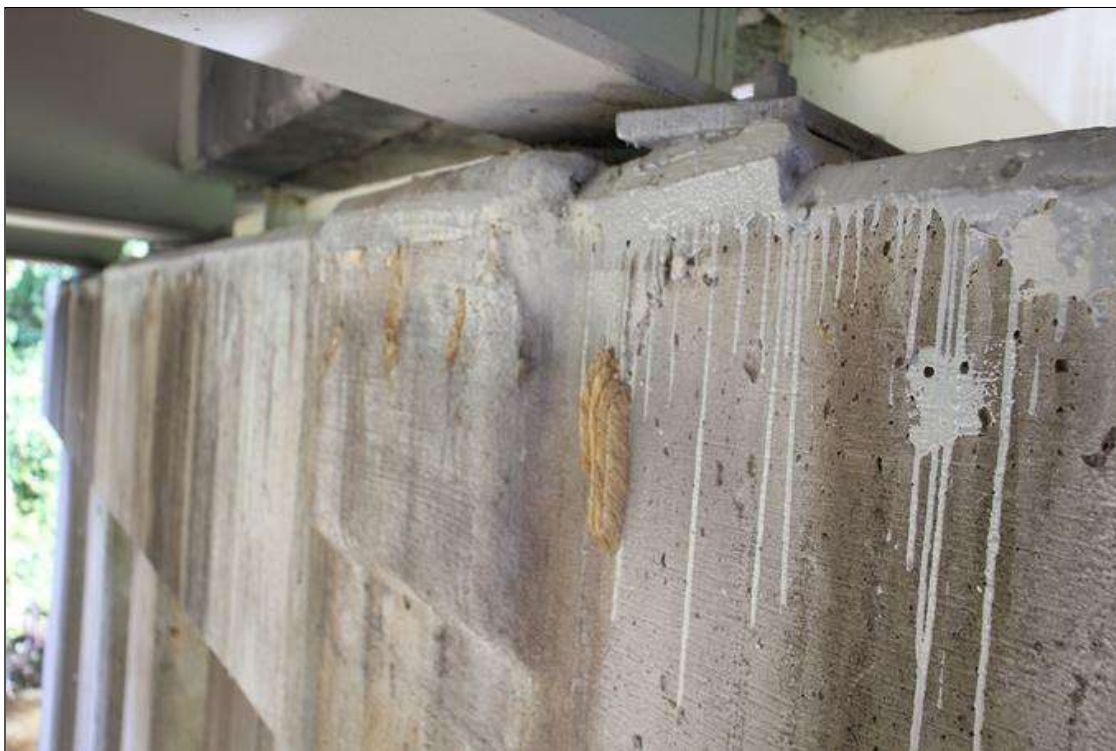
Bent 6 Cap 1: 2 FT LONG X 17 IN HIGH PATCHED AREA, TOP OF SOUTH FACE, BELOW BEAM 3.

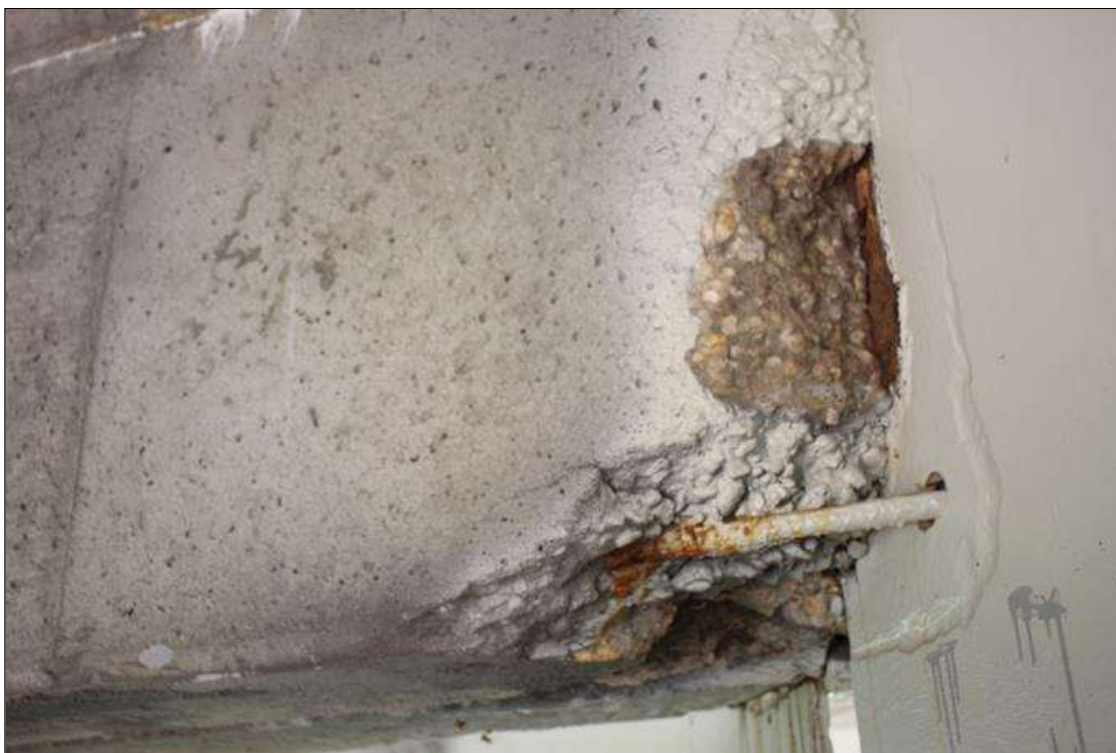
Span 6 Deck: 12 IN WIDE X 9 IN LONG X 14 IN HIGH IN SOUTH FACE SPALL UP TO 3.5 IN DEEP WITH EXPOSED REINFORCEMENT IN BAY 2 AT BENT 6. NO MEASUREABLE SECTION LOSS IN EXPOSED REINFORCEMENT.

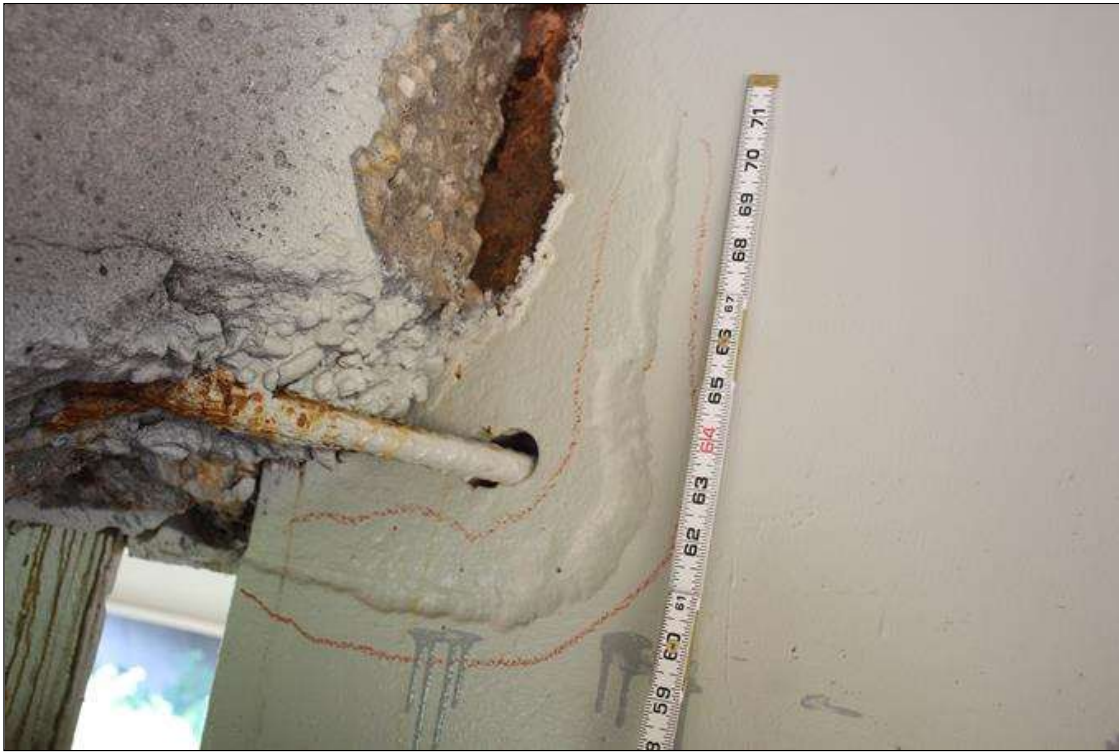
Span 6 Beam 3: UP TO 11 IN HIGH X 10 IN LONG AREA OF SECTION LOSS IN THE WEB BENEATH THE PAINTED SURFACE AT BEAM END AT BENT 6. 0.575 IN SECTION REMAINING.

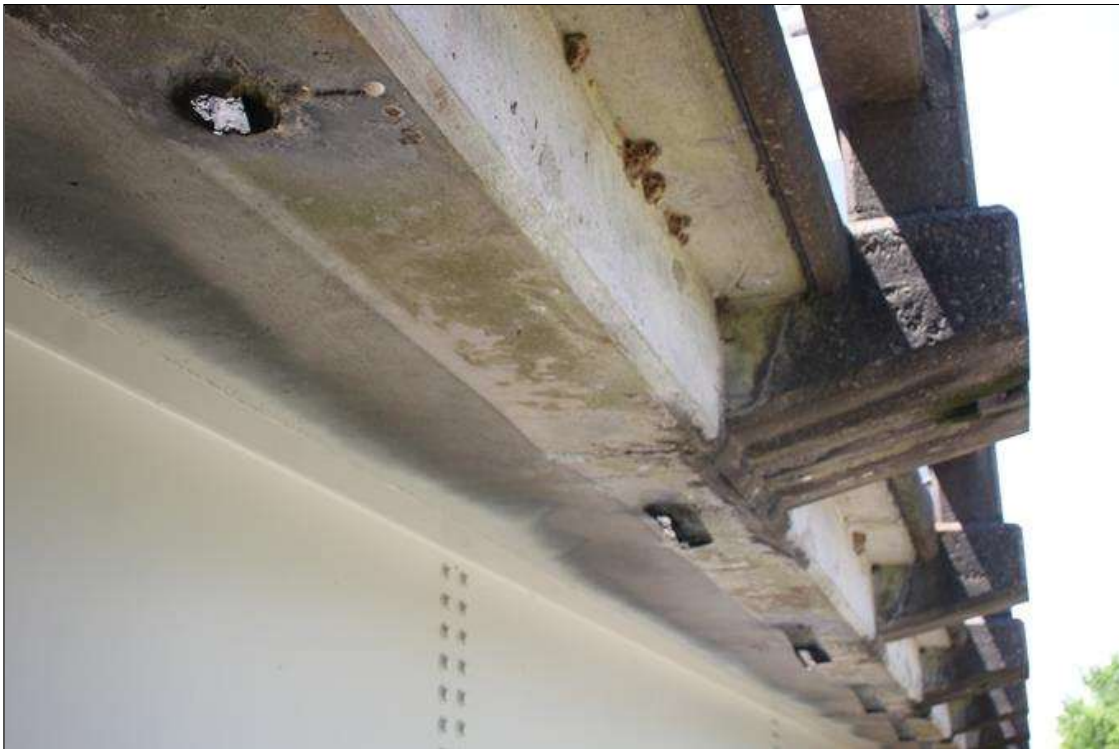
DECK DRAINS ALONG LEFT BRIDGE RAIL IN SPAN 6. ONE DRAIN BROKEN OFF AND TWO (2) PARTIALLY BROKEN.

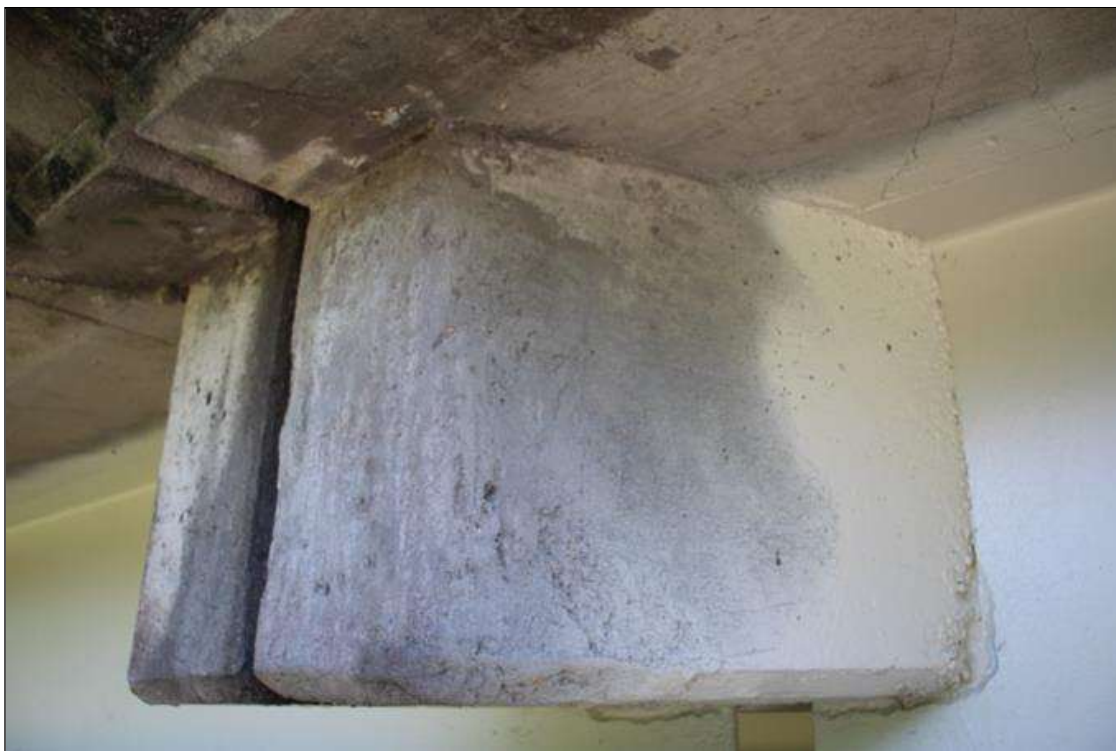
Span 6 Deck: NEW REPAIR: 2 FT HIGH X 1 FT WIDE SOUND CONCRETE PATCH IN END DIAPHRAGM OUTSIDE BEAM 1 AT BEAM 6.

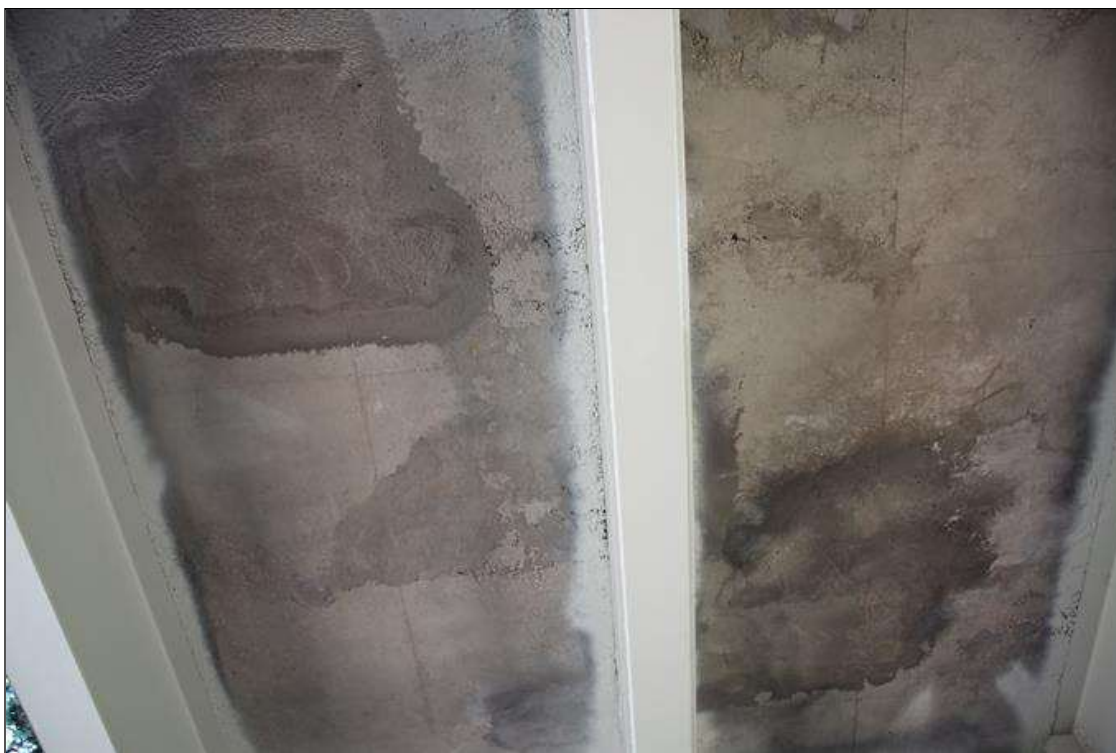
Span 7 Deck: 75 SQ FT OF PATCHED AREA, UNDERSIDE OF DECK, AT RANDOM THROUGHOUT ALL BAYS. PHOTO SHOWS BAYS 1 AND 2.

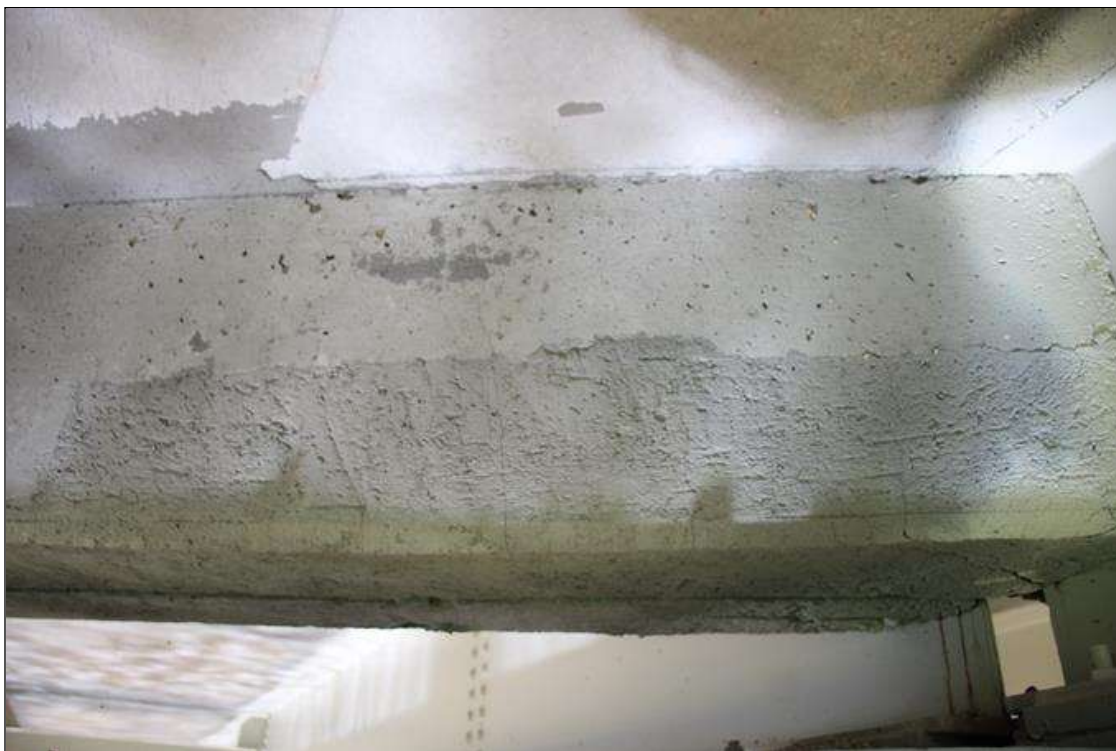
Span 7 Deck: NEW REPAIR: 6 FT LONG X 12 IN HIGH SOUND CONCRETE PATCH BOTTOM OF BAY 3 END DIAPHRAGM, NEXT TO BEAM 3, AT BENT 6. PATCH EXHIBITS UP TO 0.03 IN WIDE VERTICAL CRACKS, SCATTERED.

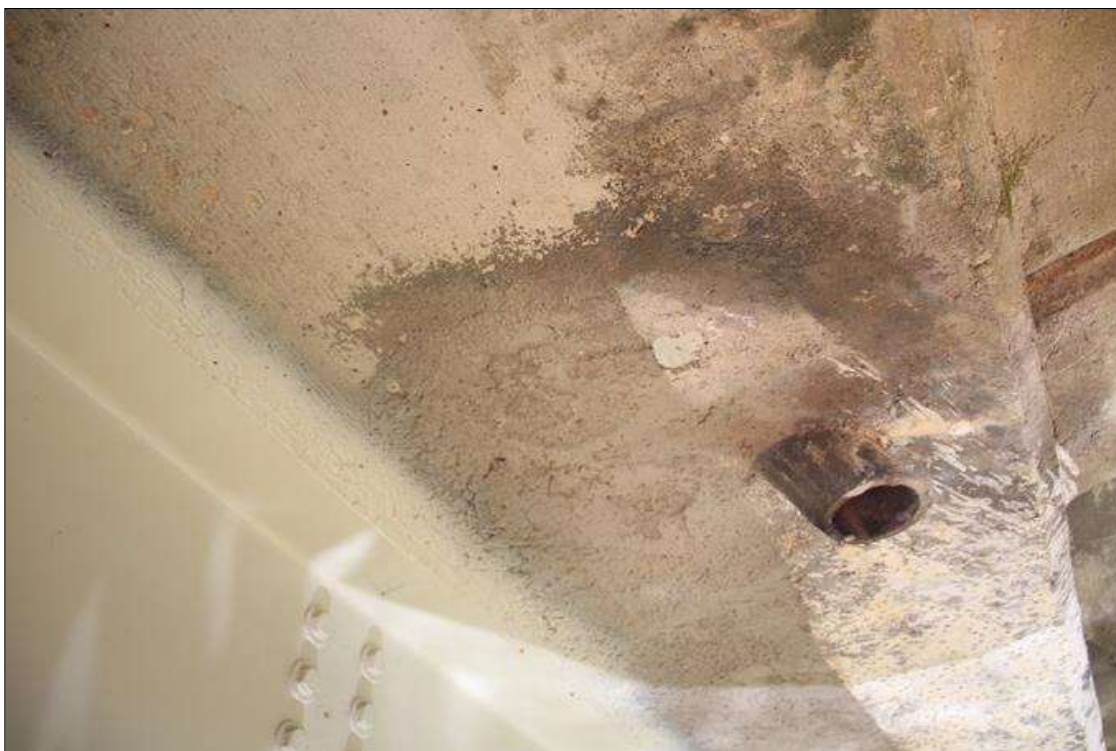
Span 7 Deck: NEW REPAIR: 18 IN DIAMETER SOUND CONCRETE PATCH IN EAST OVERHANG AT THIRD DRAIN PIPE.

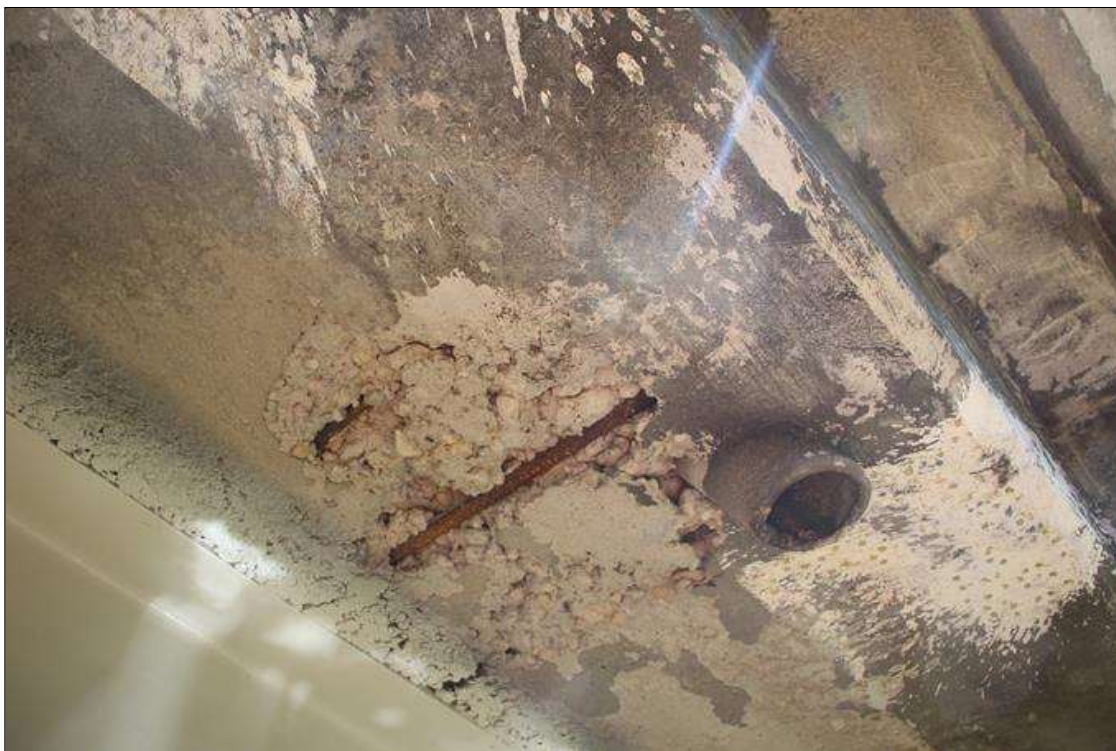
Span 7 Deck: 24 IN LONG X 2 FT WIDE X 2 IN DEEP DELAMINATION/SPALL WITH EXPOSED REINFORCING, UNDERSIDE OF EAST OVERHANG AT 2/3 POINT. NO MEASUREABLE SECTION LOSS IN EXPOSED REINFORCEMENT.

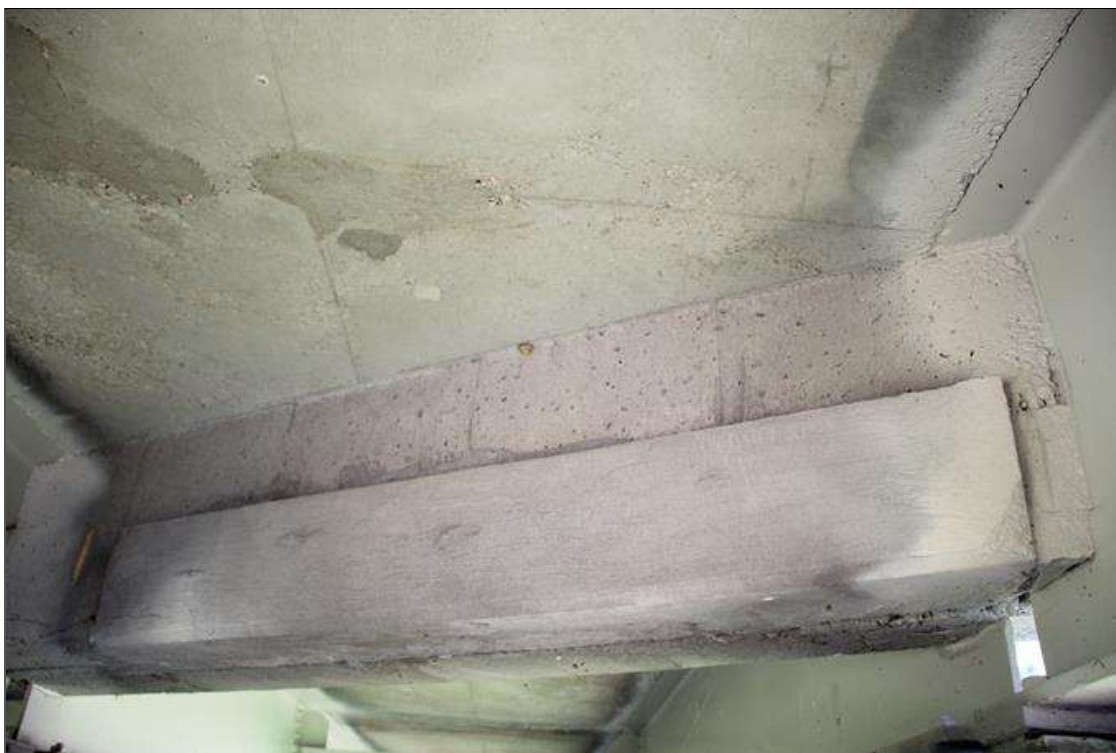
Span 7 Deck: 7 FT LONG X 1 FT HIGH SOUND CONCRETE PATCH IN INTERMEDIATE DIAPHRAGM IN BAY 3 AT BENT 7.

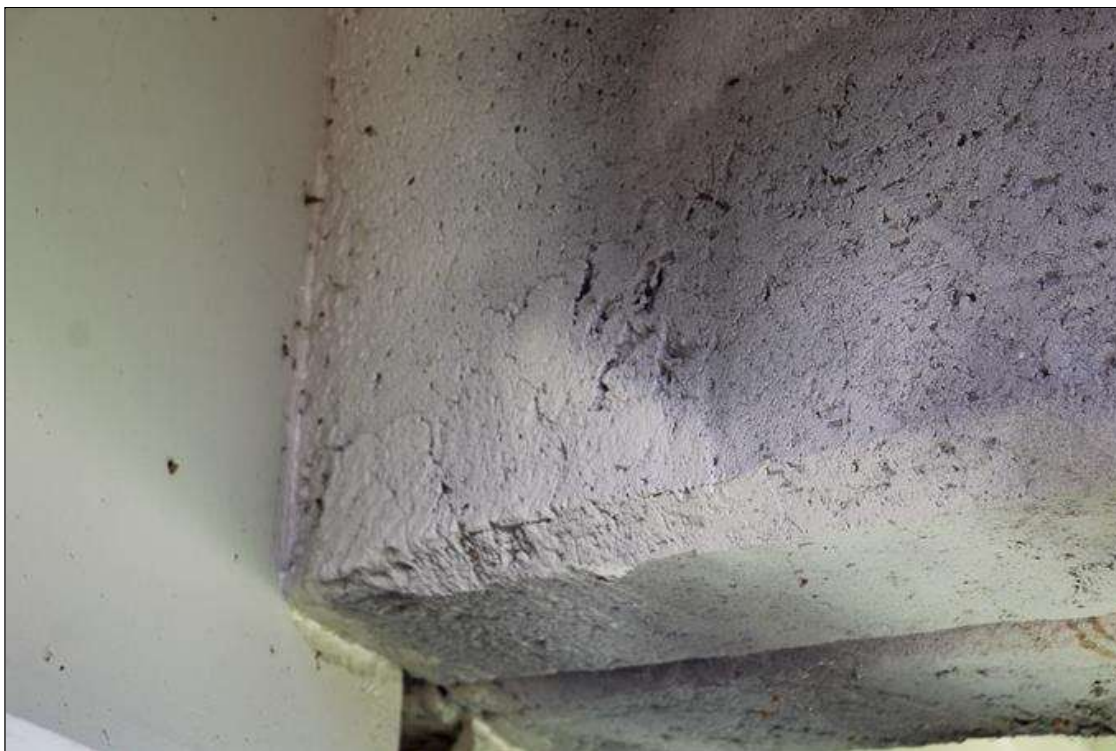
Span 7 Deck: NEW REPAIR: 2 FT HIGH X 1 FT WIDE SOUND CONCRETE PATCH IN DIAPHRAGM OUTSIDE BEAM 4 AT BENT 7.

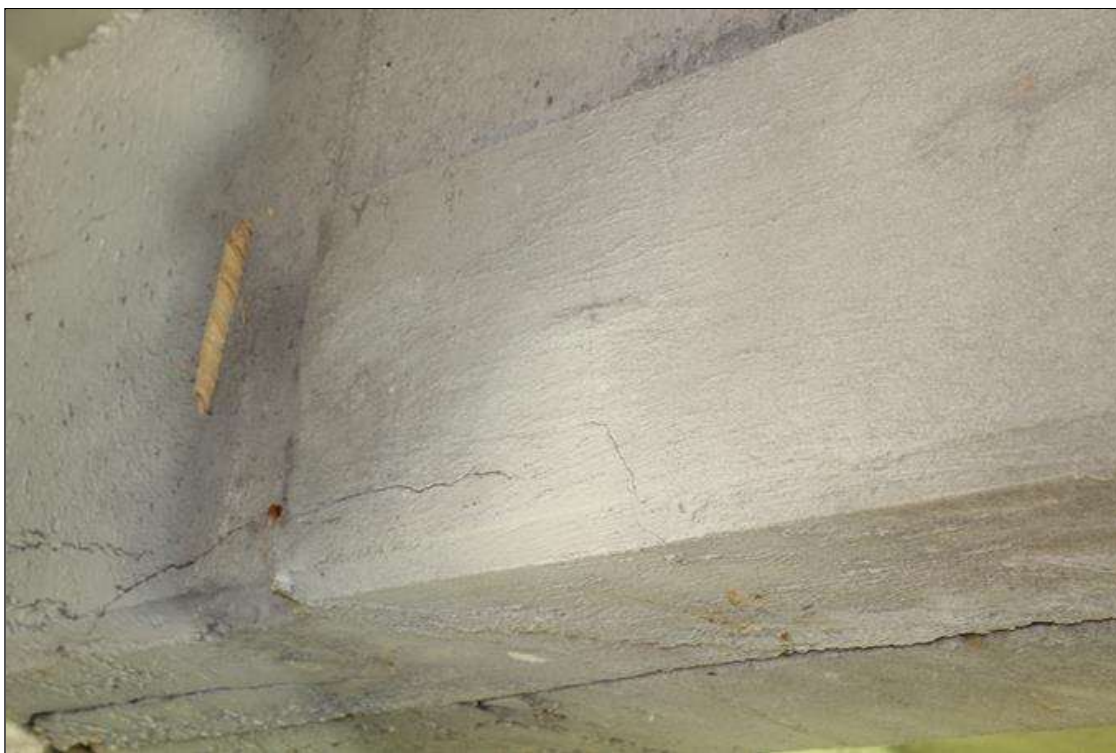
Span 7 Deck: 7 FT LONG X 1 FT HIGH SOUND CONCRETE PATCH IN INTERMEDIATE DIAPHRAGM IN BAY 3 AT BENT 7.

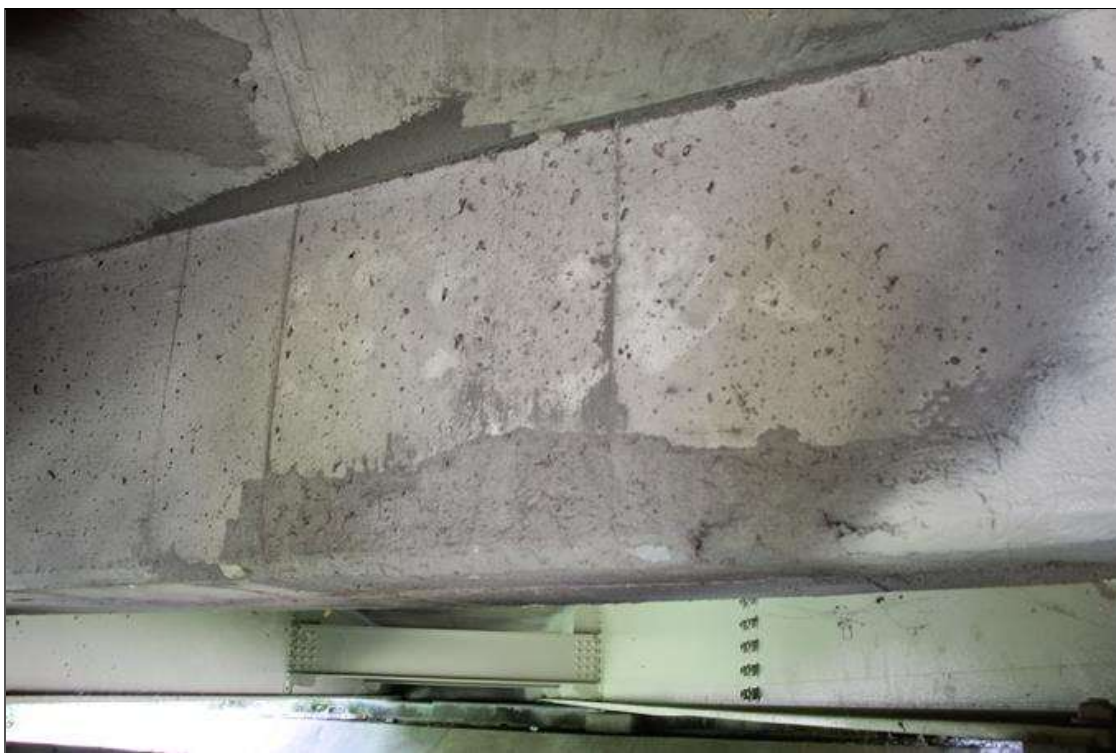
Span 7 Deck: NEW REPAIR 2 FT HIGH X 1 FT WIDE SOUND CONCRETE PATCH IN DIAPHRAGM OUTSIDE BEAM 4 AT BENT 7.

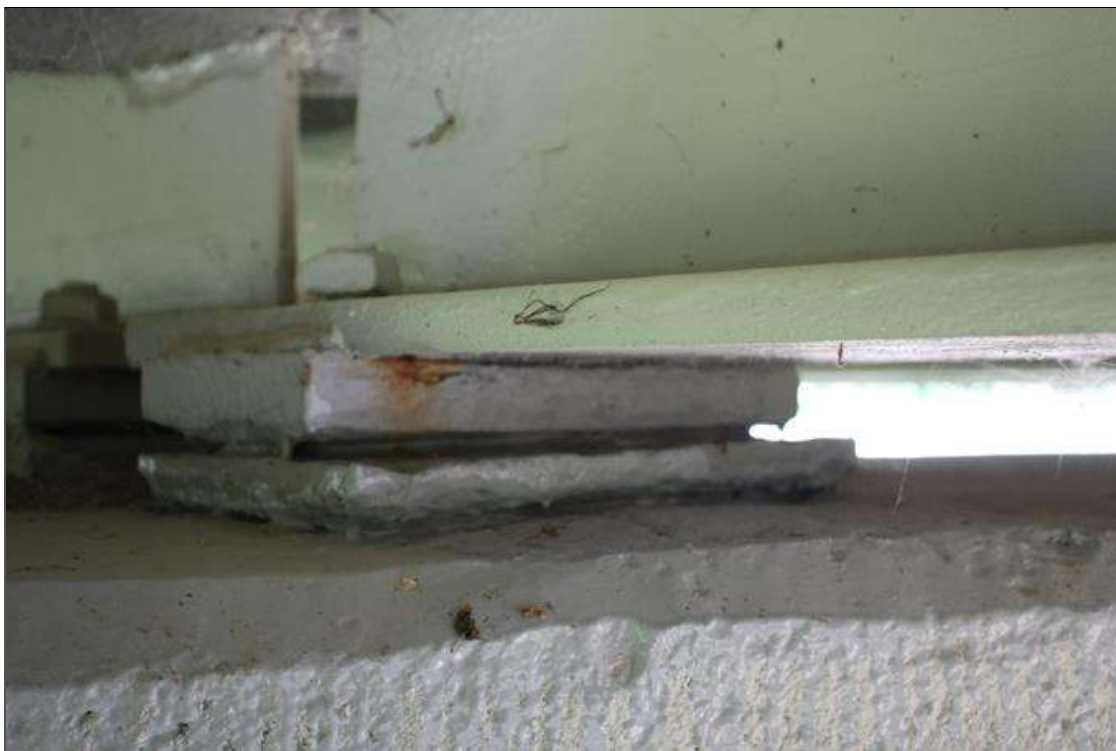
Span 7 Beam 2 Far Bearing: BEARINGS HAVE BEEN PAINTED SINCE PREVIOUS INSPECTION. SECTION LOSS REMAINS BENEATH THE PAINTED SURFACES. UP TO 80% SECTION REMAINING IN BOTH MASONRY AND SOLE PLATES.

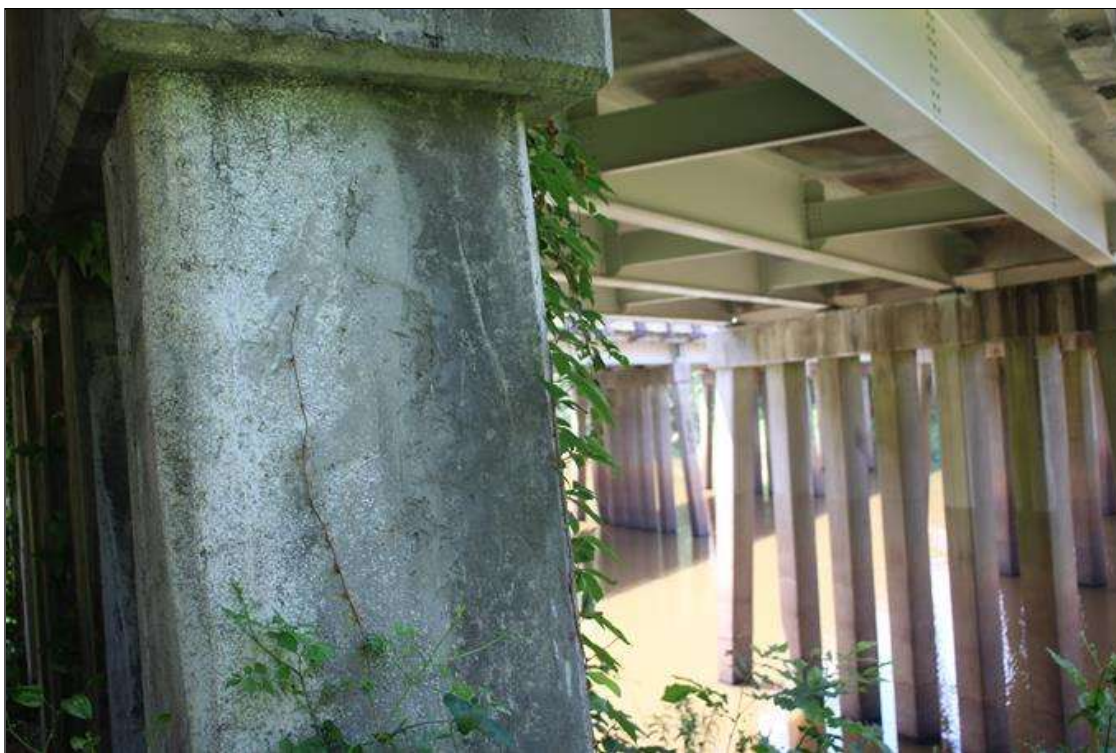
Bent 7 Pile 1: NEW REPAIR 8 FT HIGH X 1 FT WIDE SOUND CONCRETE PATCH IN WEST FACE.

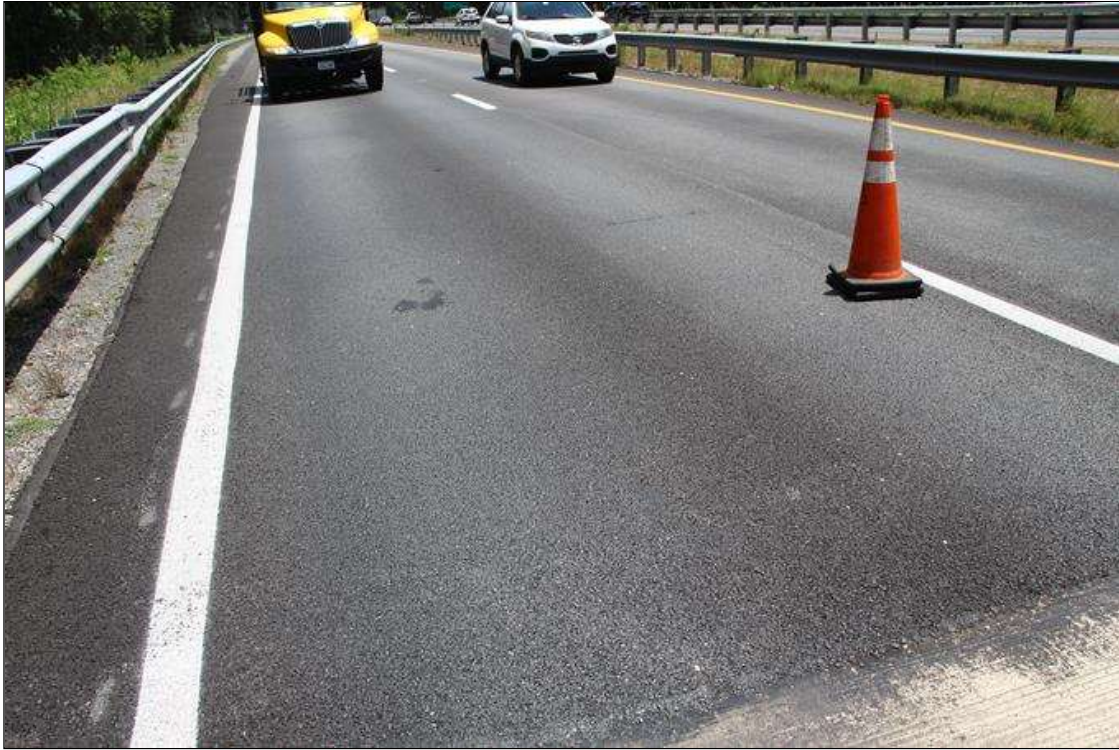
NEW APPROACH PAVEMENT IN NORTH APPROACH. TYPICAL IN SOUTH APPROACH.

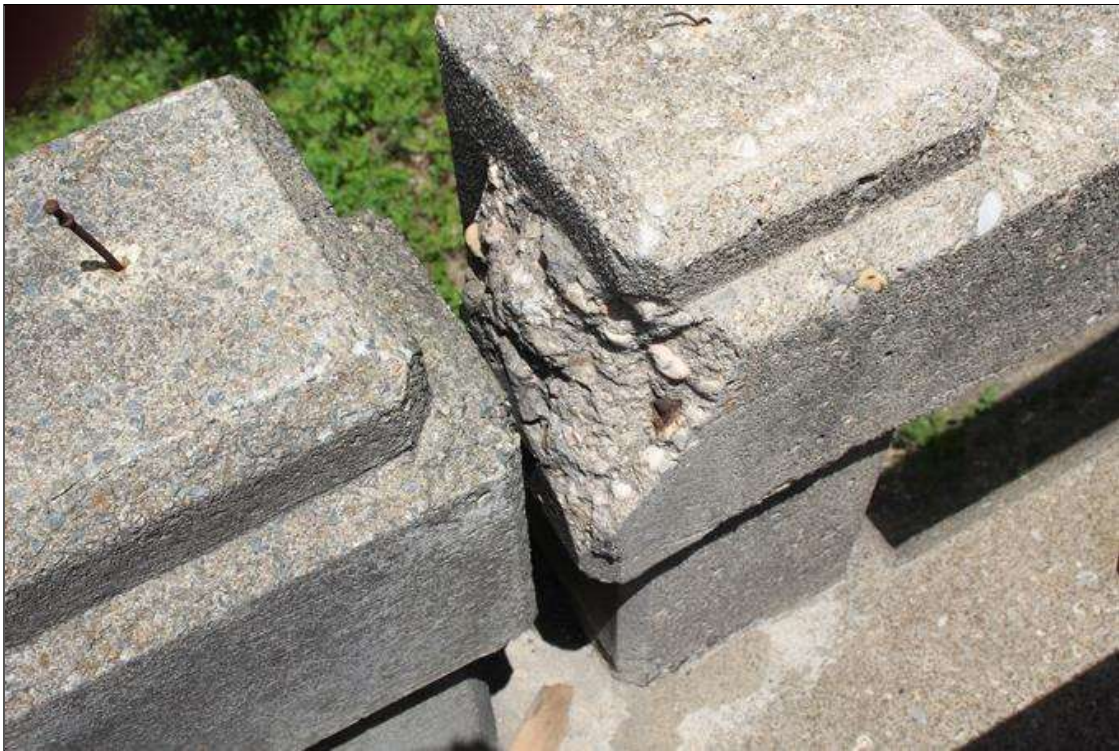
Span 8 Left Bridge Rail: 8 IN WIDE X 8 IN HIGH X UP TO 3 IN DEEP SPALL WITH EXPOSED REINFORCEMENT IN TOP OF RAIL AT FIRST RAIL JOINT FROM END BENT 2. 90% SECTION REMAINING IN EXPOSED REINFORCEMENT.

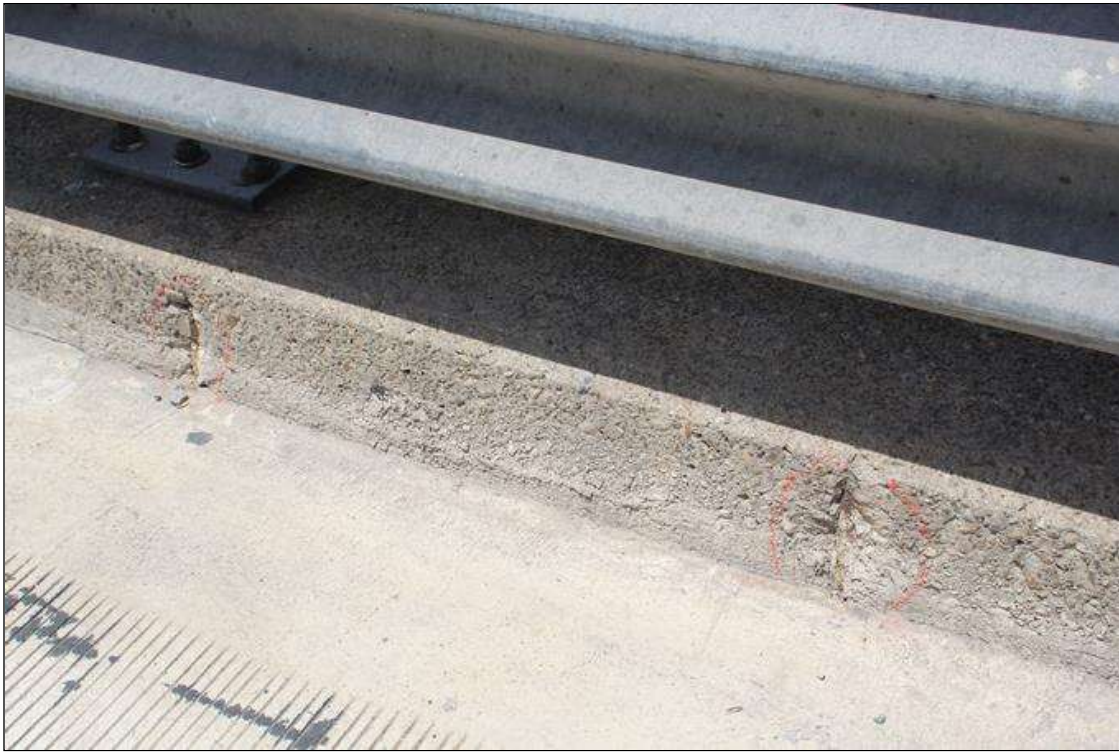
Span 3 Left Bridge Rail: TWO (2) SPALLS UP TO 8 IN IN DIAMETER X 1 IN DEEP WITH EXPOSED REINFORCEMENT IN BOTTOM OF CURB AT 6 FT AND 10 FT FROM BENT 3 JOINT. NO MEASURABLE SECTION LOSS IN EXPOSED REINFORCEMENT.

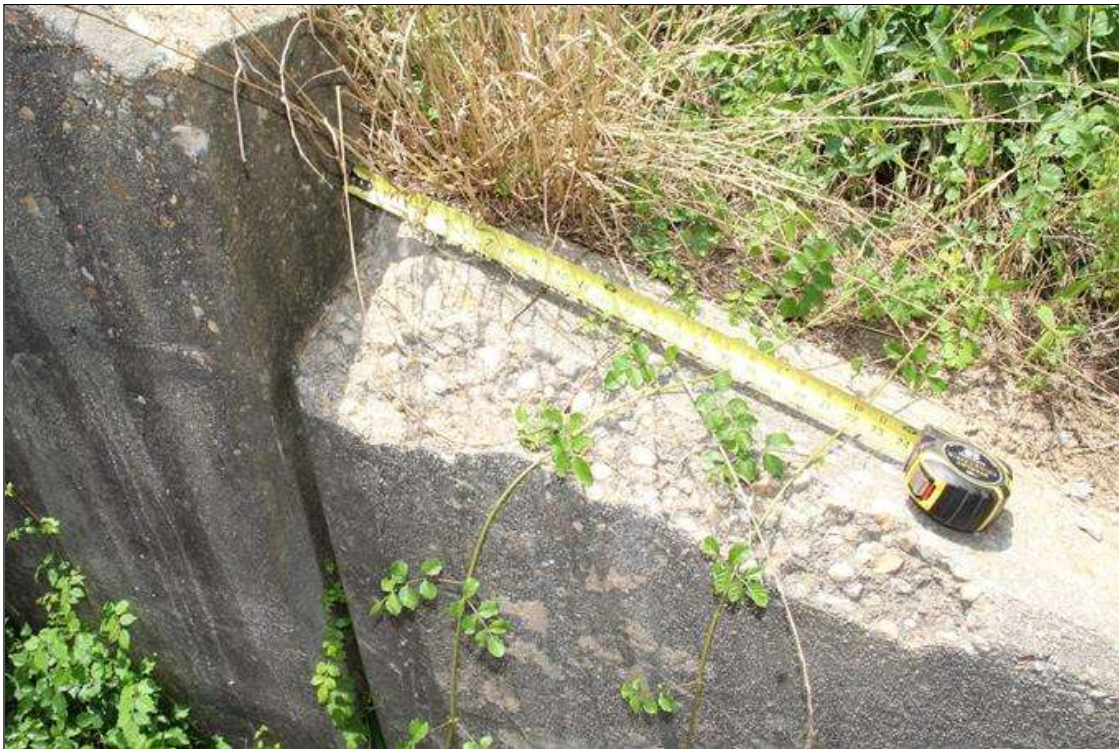
2 FT WIDE X 8 IN LONG X UP TO 5 IN DEEP SPALL IN THE TOP OF WINGWALL AT SOUTHWEST CORNER.

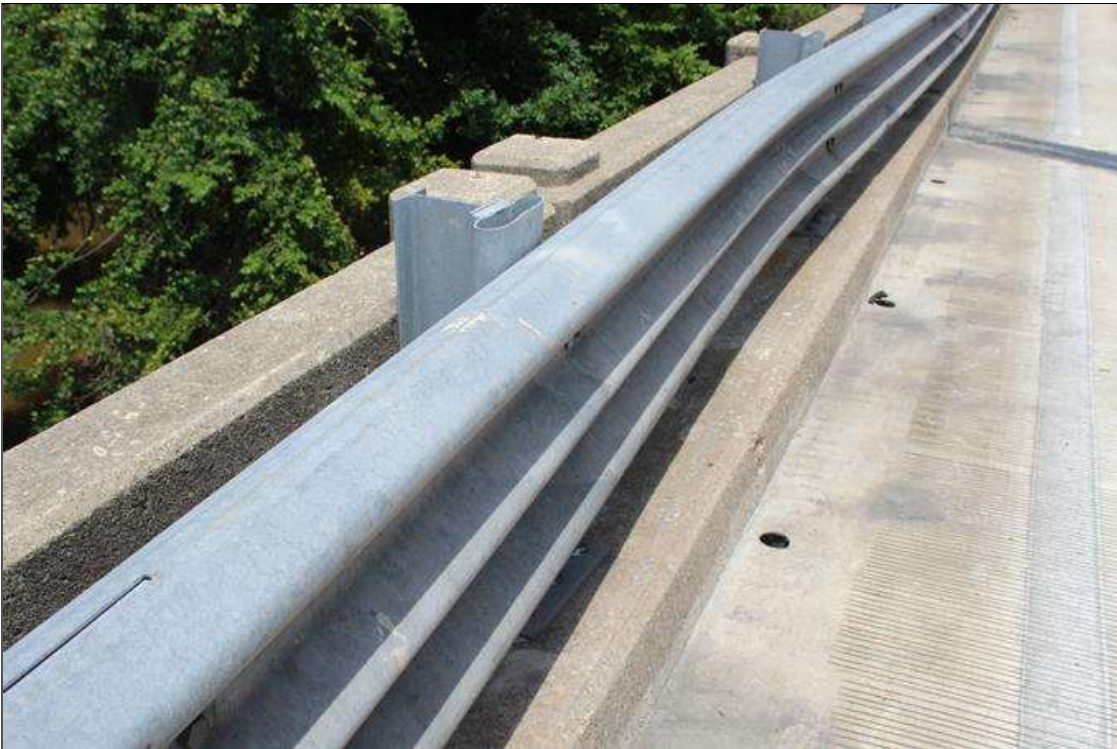
Span 6 Left Bridge Rail: MODERATE TO HEAVY IMPACT DAMAGE WITH UP TO 5 IN DEFLECTION TOWARDS WEST TO THE SUPPLEMENTAL BRIDGE RAIL FOR 20 FT LONG STARTING AT BENT 6. TWO (2) SPACER BLOCKS CONNECTING THE GUARDRAIL TO POSTS ARE PARTIALLY CRUSHED.
