NC DEPARTMENT OF TRANSPORTATION
 DIVISION OF HIGHWAYS
 STRUCTURE MANAGEMENT UNIT

ATTENTION: **SNOOPER USED, NEW REPAIRS, NEW LMC OVERLAY, PAR SUBMITTED, CHANGE TO STRUCTURE DATA, NEWLY STRUCTURALLY DEFICIENT, CHANGE IN NBI RATING FOR ITEMS 60 AND 61.**

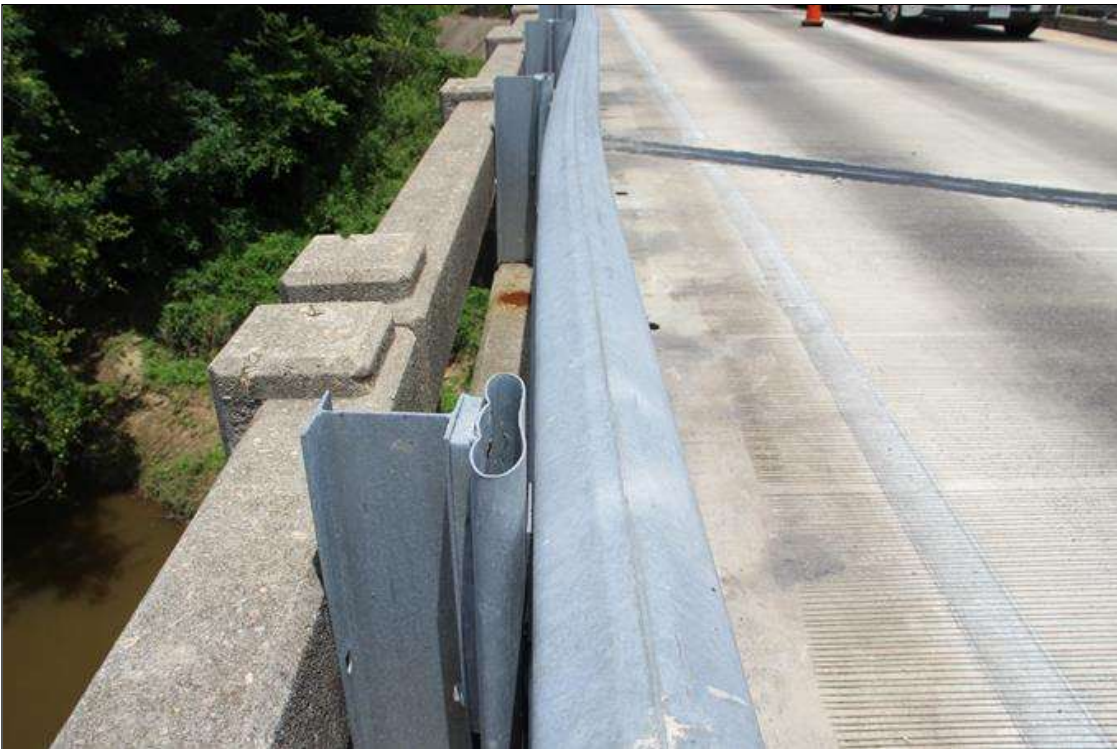
Span 6 Left Bridge Rail: MODERATE TO HEAVY IMPACT DAMAGE WITH UP TO 5 IN DEFLECTION TOWARDS WEST TO THE SUPPLEMENTAL BRIDGE RAIL FOR 20 FT LONG STARTING AT BENT 6. TWO (2) SPACER BLOCKS CONNECTING THE GUARDRAIL TO POSTS ARE PARTIALLY CRUSHED.

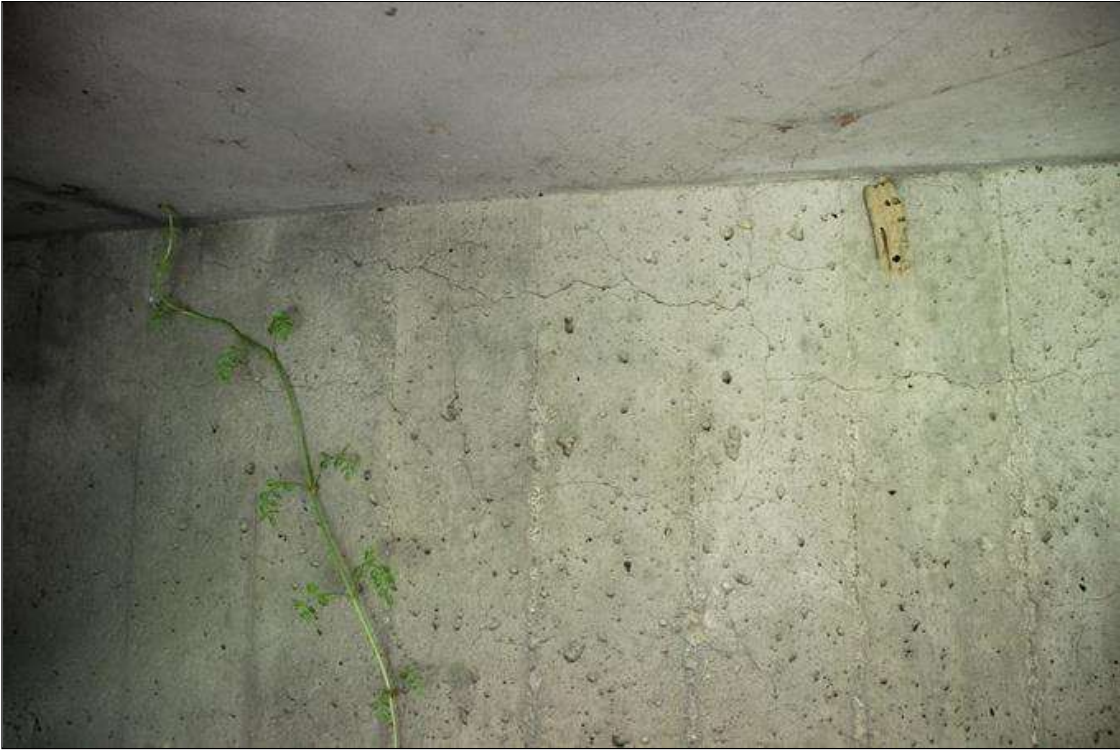
End Bent 1 Abutment/Backwall : UP TO 0.03 IN WIDE RANDOM CRACKING IN BACKWALL FOR FULL LENGTH.

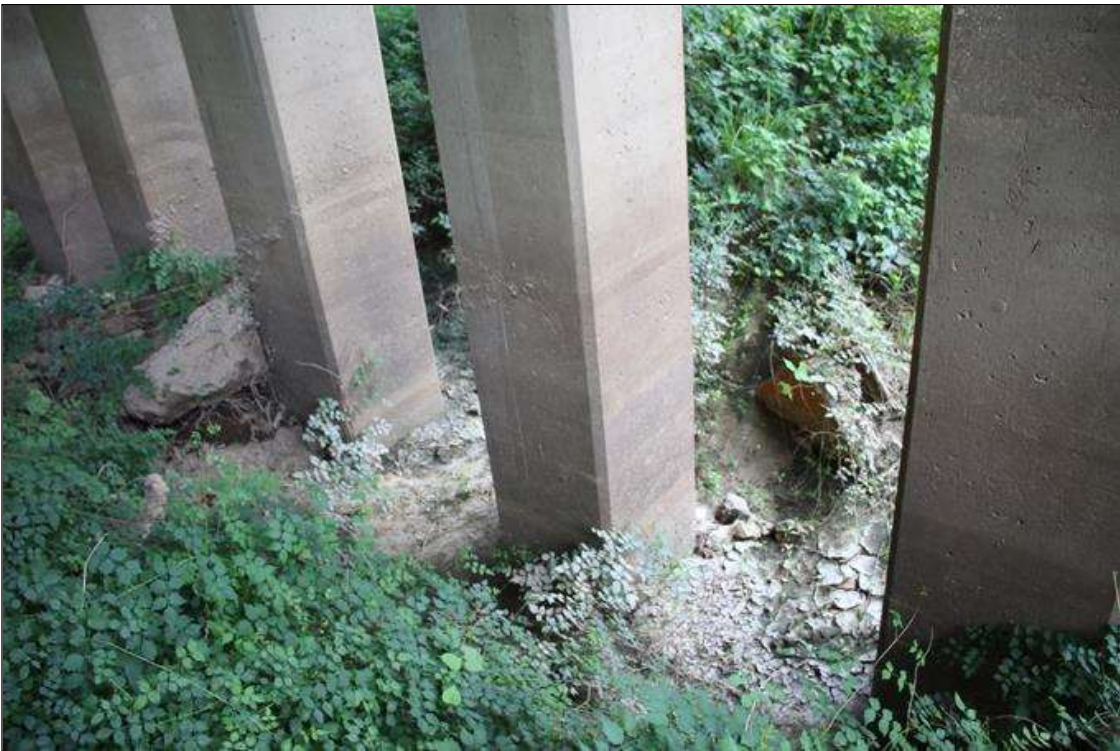
UP TO 2 FT OF EROSION ALONG THE PILES AT BENT 1.

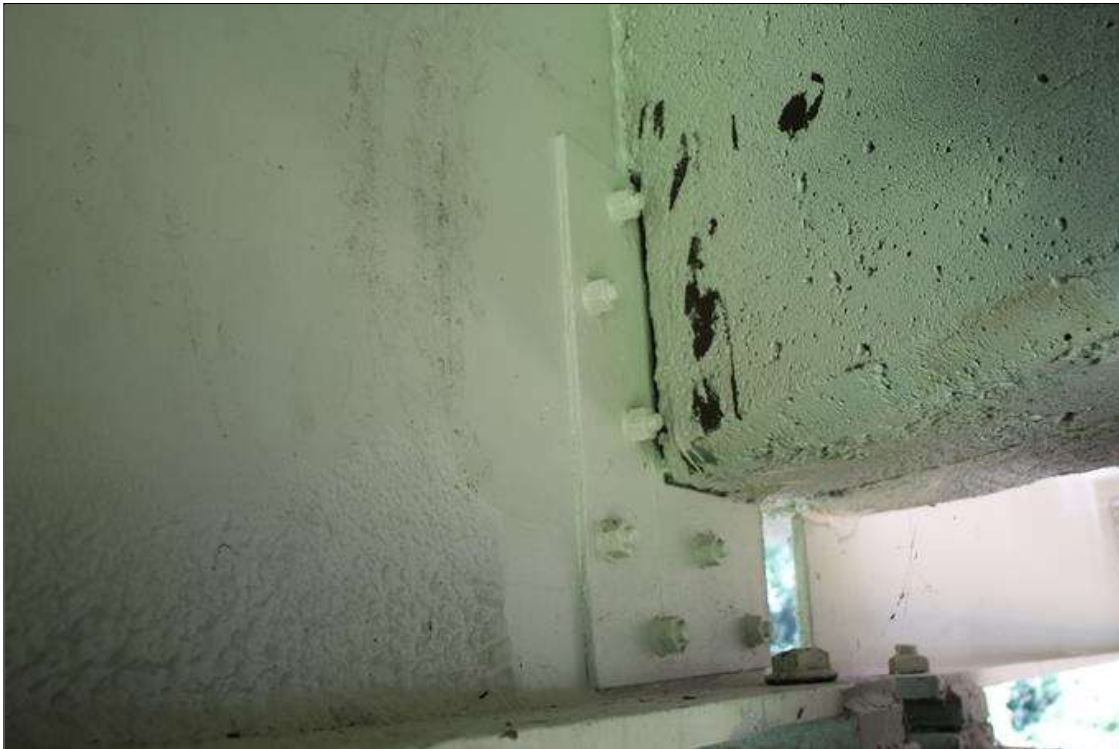
NEW REPAIR TO SPAN 3 BEAM 1 BEAM END IN BOTH FACES OF THE WEB ABOVE BENT 3.

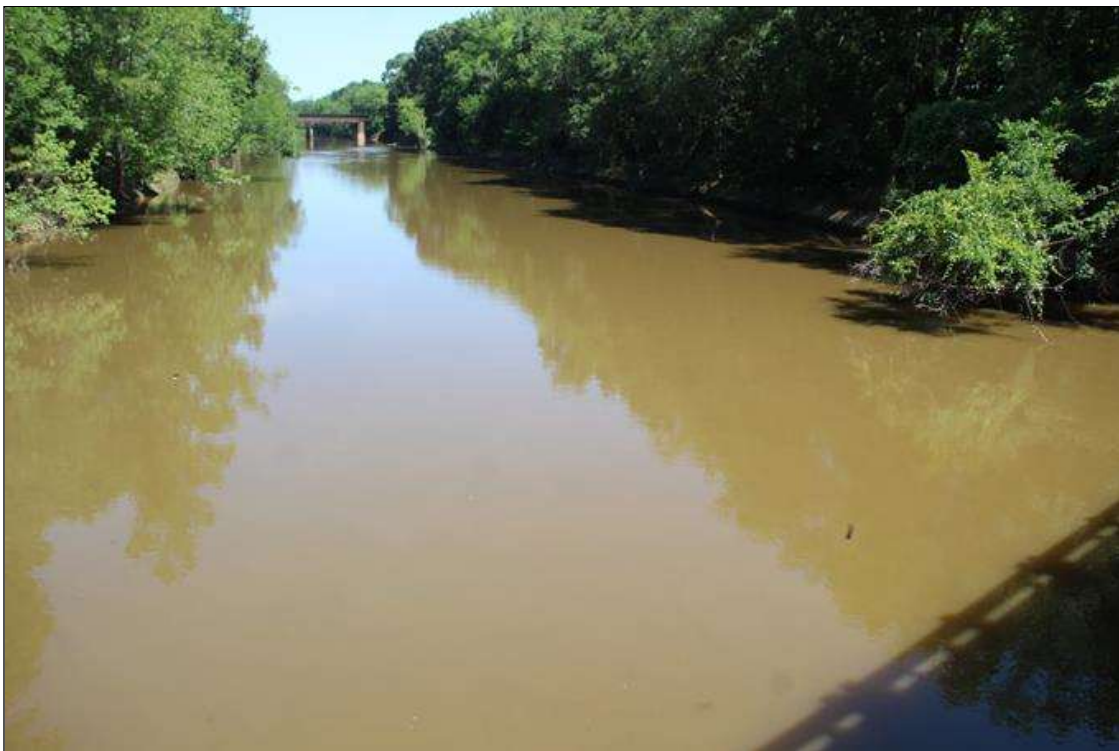
UPSTREAM FROM UNDER THE BRIDGE

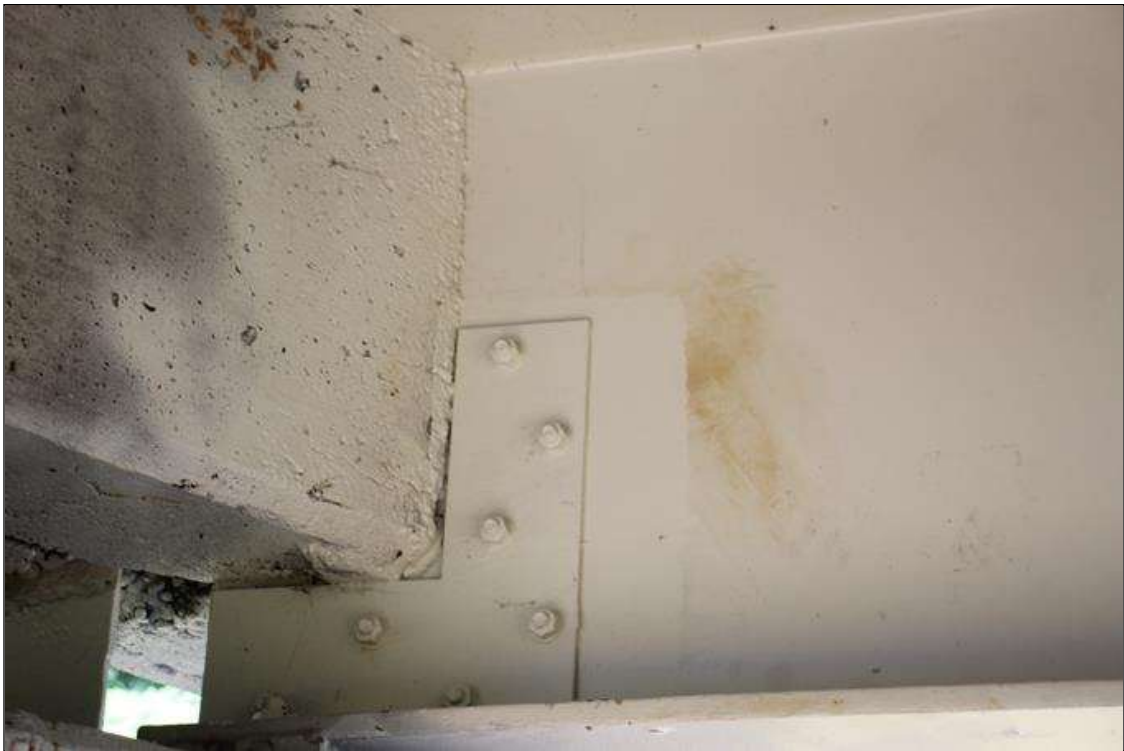
NEW REPAIR TO SPAN 5 BEAM 1 BEAM END IN BOTH FACES OF THE WEB ABOVE BENT 4.

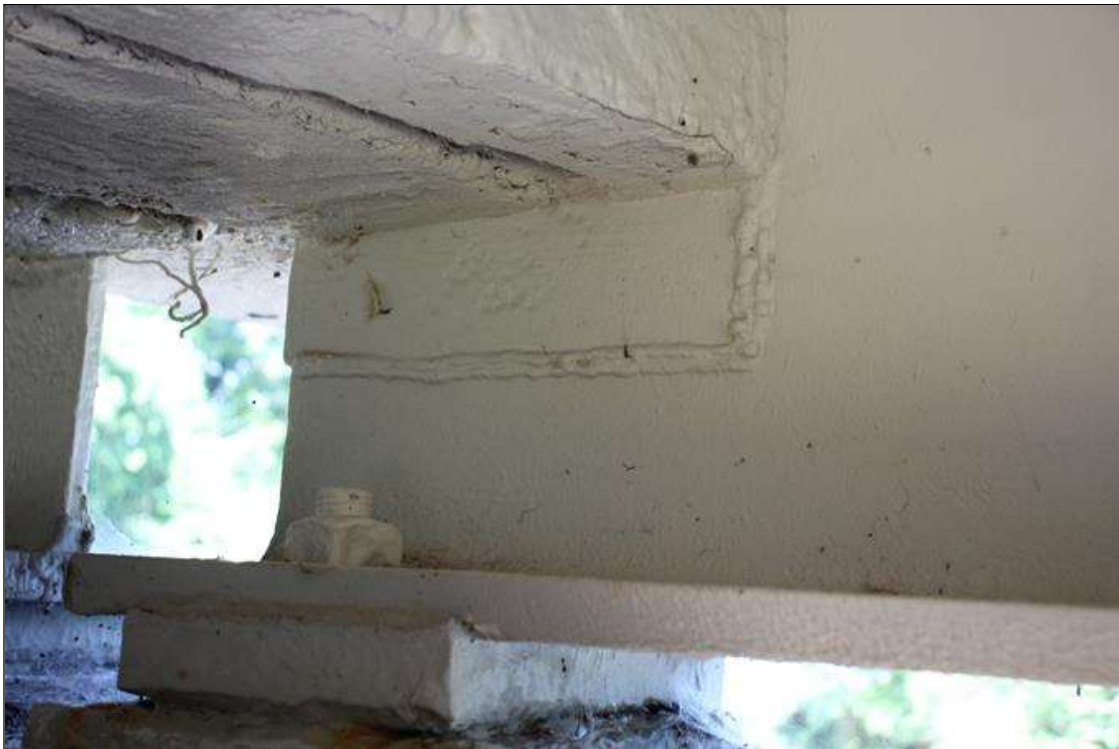
WELDED REPAIR TO WEB BELOW END DIAPHRAGM, AT BENT 5.

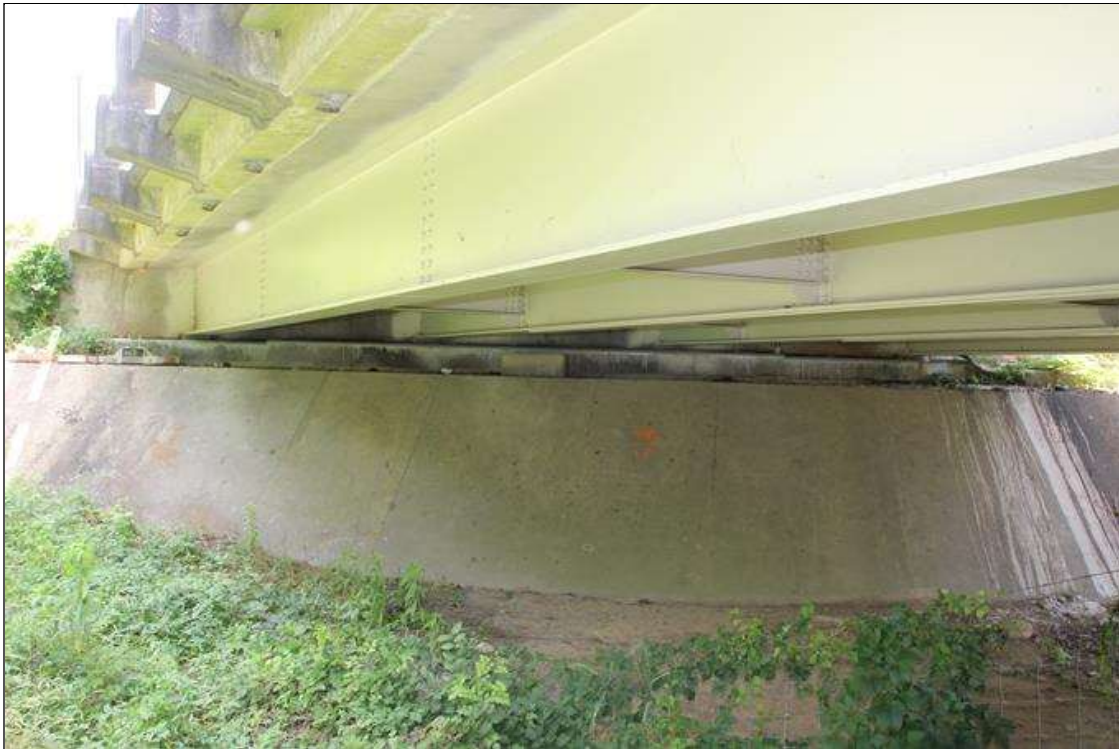
SLOPE PROTECTION AT END BENT 2

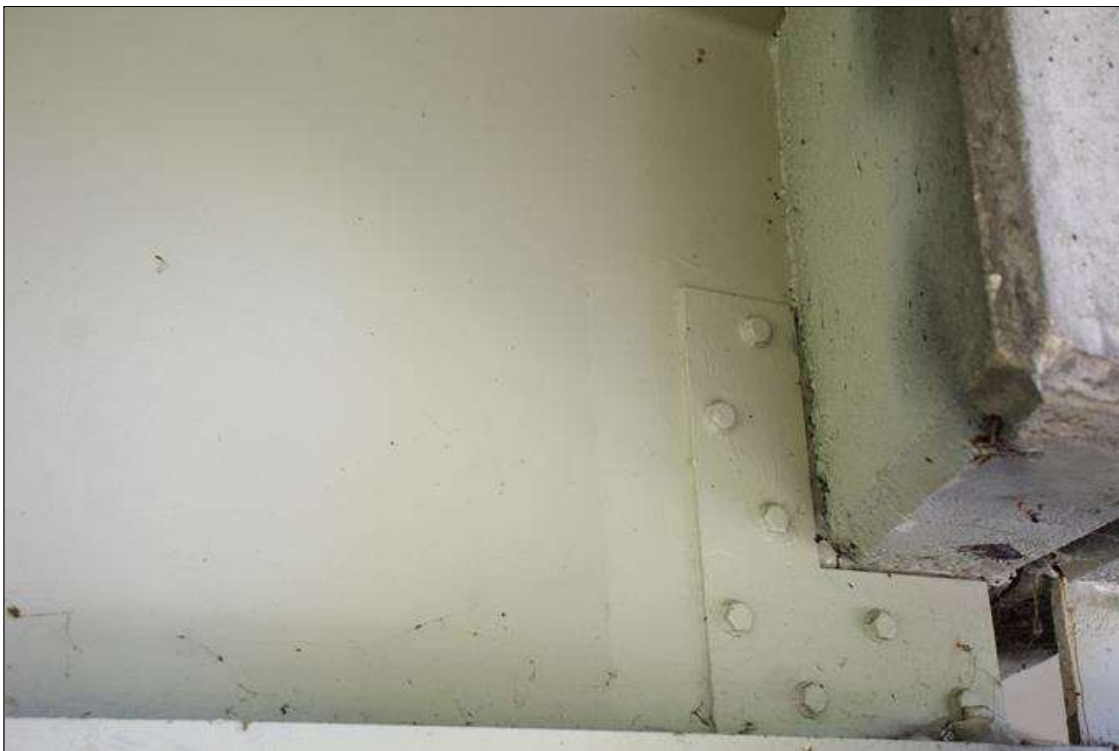
NEW REPAIR TO SPAN 8 BEAM 1 BEAM END IN BOTH FACES OF THE WEB ABOVE BENT 7.

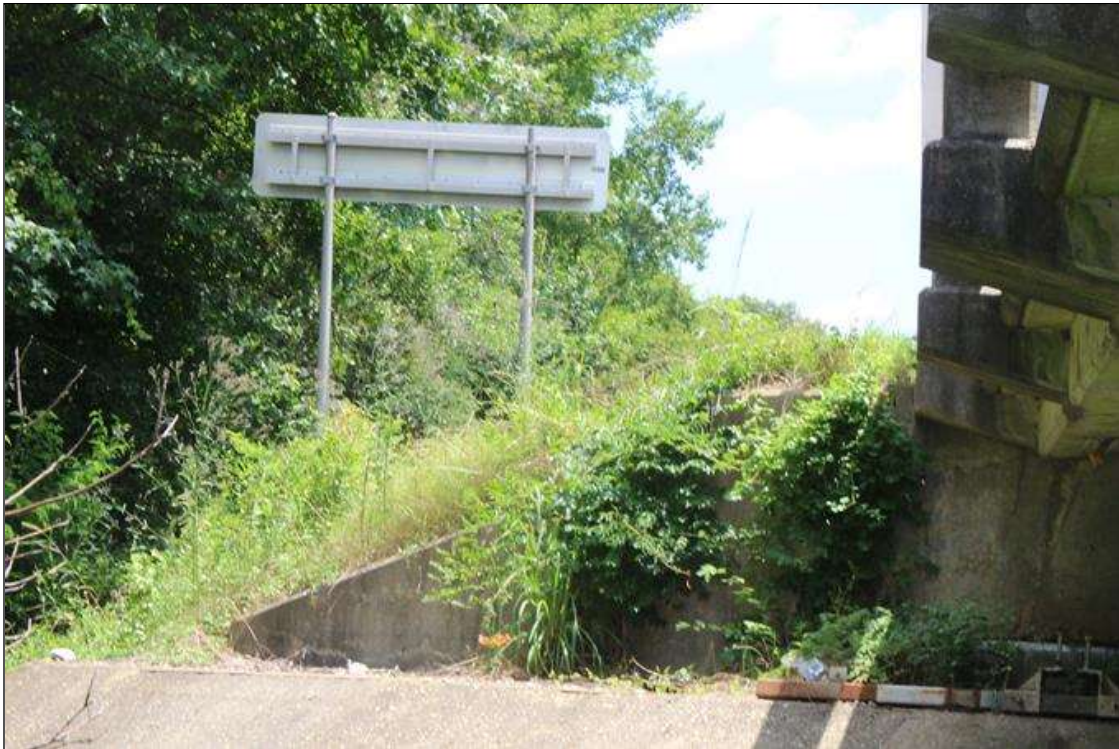
NORTHWEST WINGWALL. NOTE HEAVY VEGETATION GROWTH.

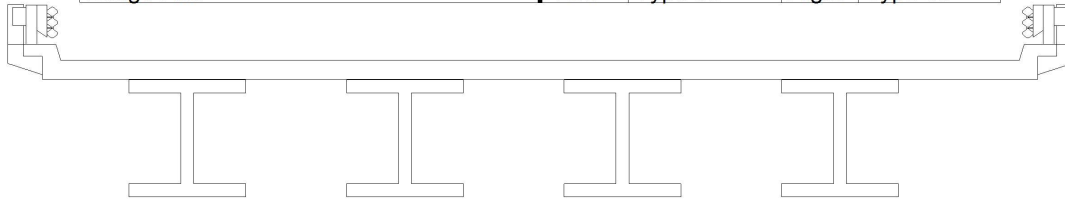
Measurements for Span #	1		
Deck Thickness	0.875'	Left Overhang	4.75'
Top of Rail to Bottom of Beam	6.5'	Right Overhang	4.75'

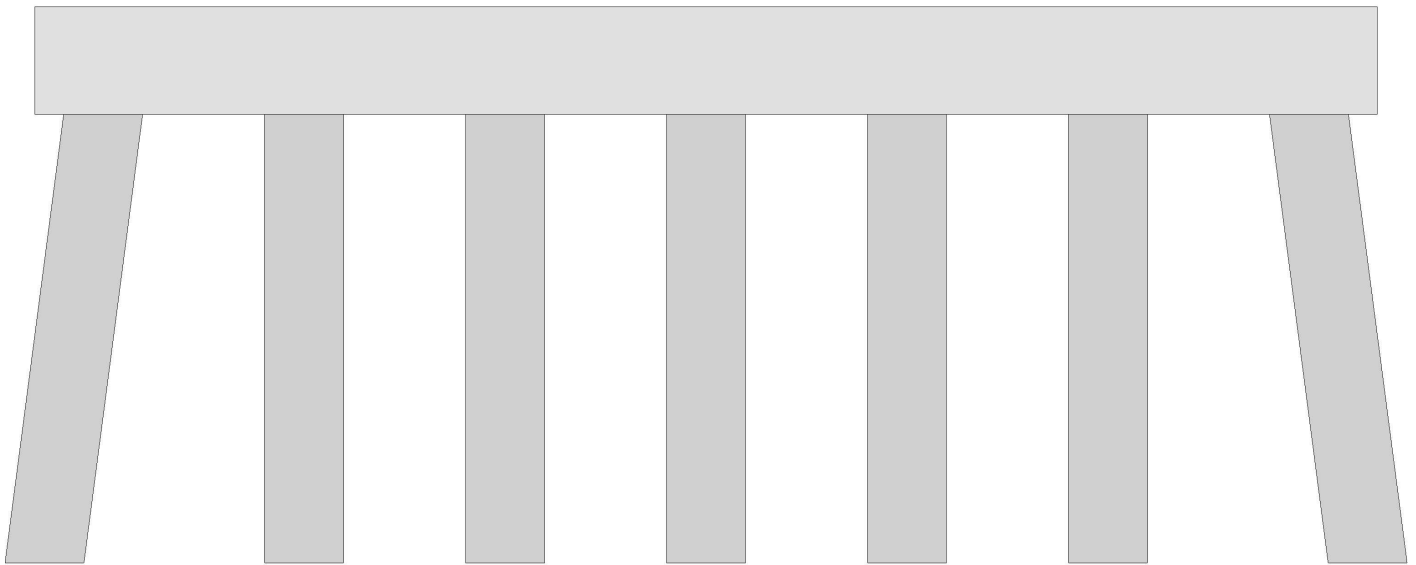
Cap Information			Material Cast-in-Place Concrete							
Length	Width	Height	Left Overhang	Right Overhang	Left Beam to End of Cap.	Right Beam to End of Cap.
