NC DEPARTMENT OF TRANSPORTATION
DIVISION OF HIGHWAYS
STRUCTURE MANAGEMENT UNIT

Structure Safety Report

Routine Element Inspection - Contract

FEATURE INTERSECTED: ALLIGATOR RIVER

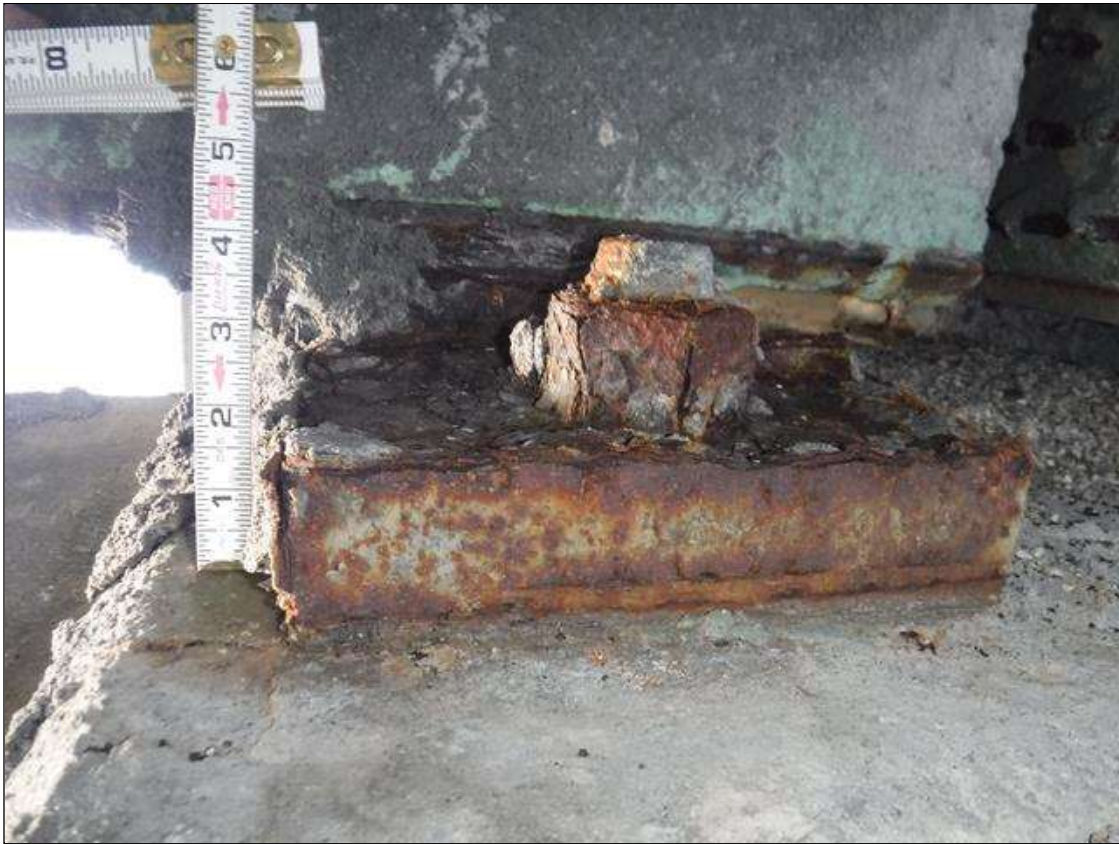
Span 10 Beam 2: (2) UP TO 24" X 6" X 12" CORNER PATCHED AREAS, NORTH AND SOUTH FACES, AT BENT 9.

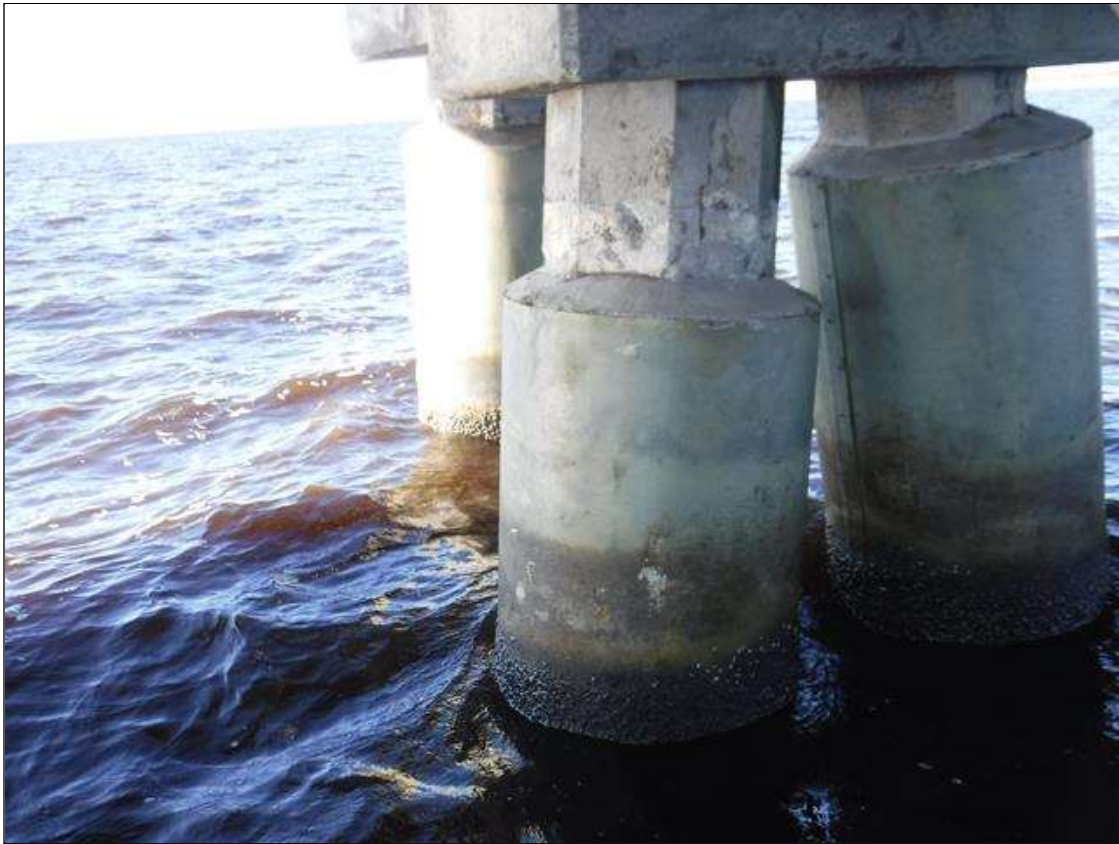
Bent 9 Saved Pile 5: 18" X 8" DELAMINATION ON NORTH FACE BEOW BOTTOM OF CAP, SOUTH FACE SIMILAR

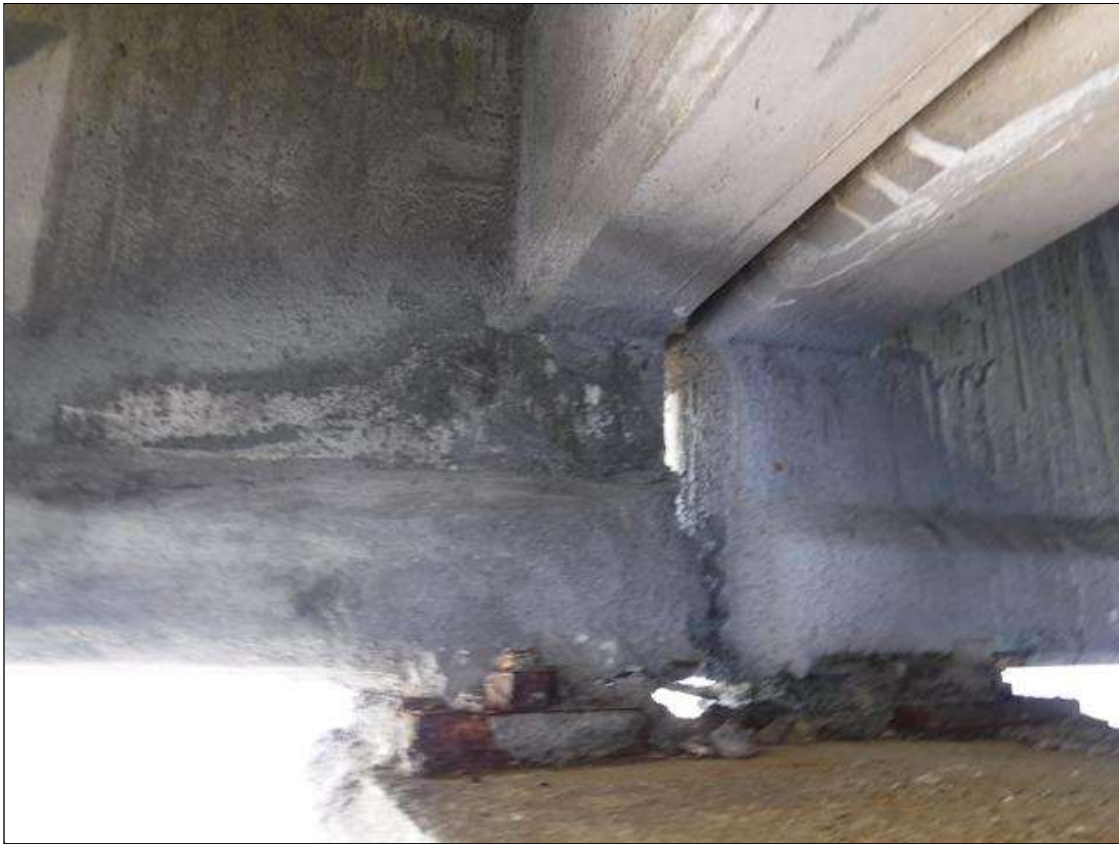
Bent 12 Saved Pile 1: (PAR) 3' X 2' X UP TO 2" SPALL ON PILE JACKET, WITH EXPOSED REINFORCING WITH COMPLETE SECTION LOSS, NORTH FACE, 5' FROM BOTTOM OF CAP AND EXTENDING BELOW WATERLINE.

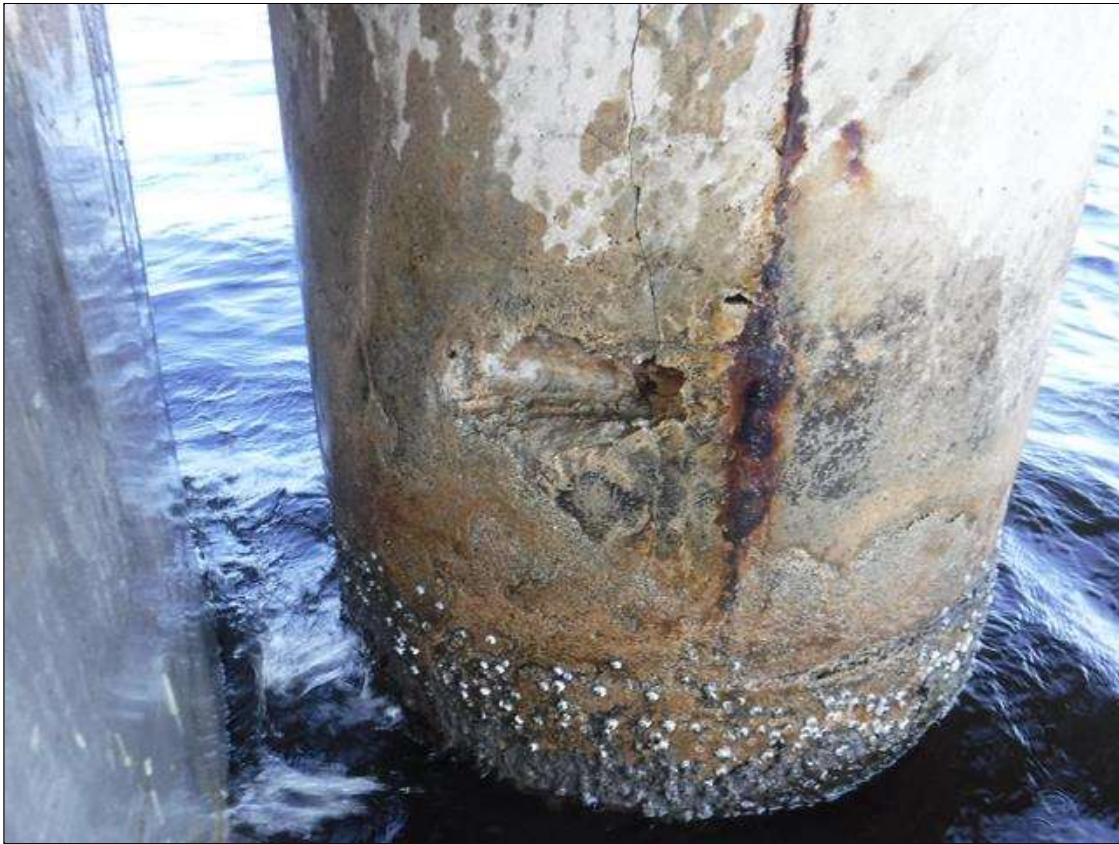
Bent 14 Saved Pile 1: 2' X 1' DELAMINATION ON SOUTH FACE AT BOTTOM OF CAP

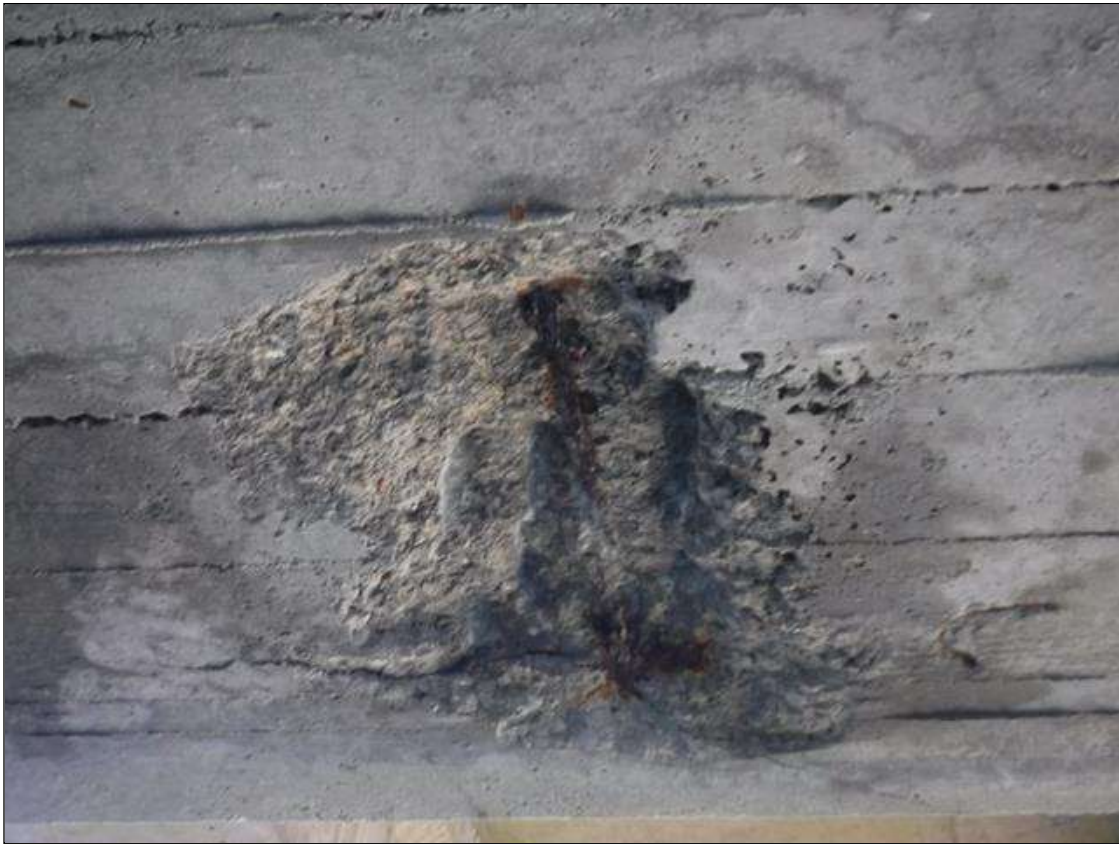
Span 15 Beam 3: (2) UP TO 12" X 18" PATCHED AREAS, NORTH AND SOUTH FACES, AT BENT 15.

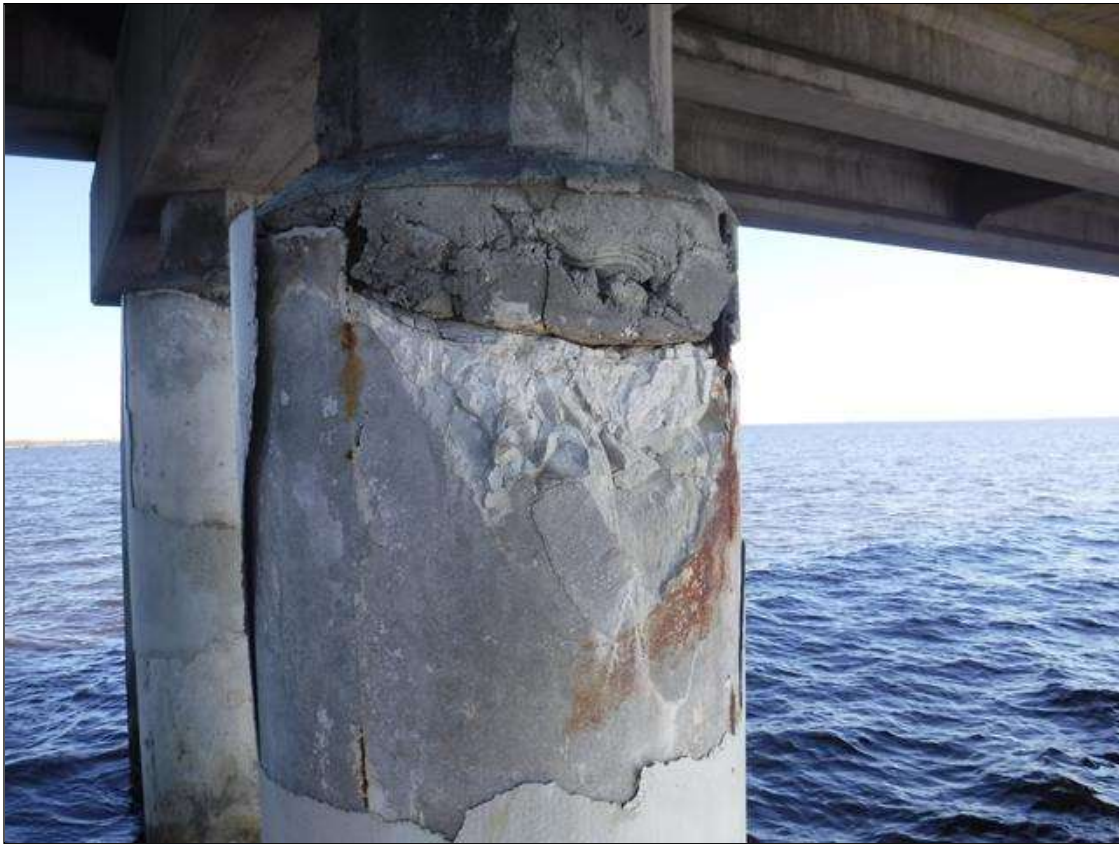
Bent 15 Saved Pile 2: (PAR) 6" X 12" X UP TO 1/2" SPALL WITH EXPOSED REBAR, REBAR HAS 50% SECTION LOSS, NORTH FACE, 2' FROM BOTTOM OF CAP.

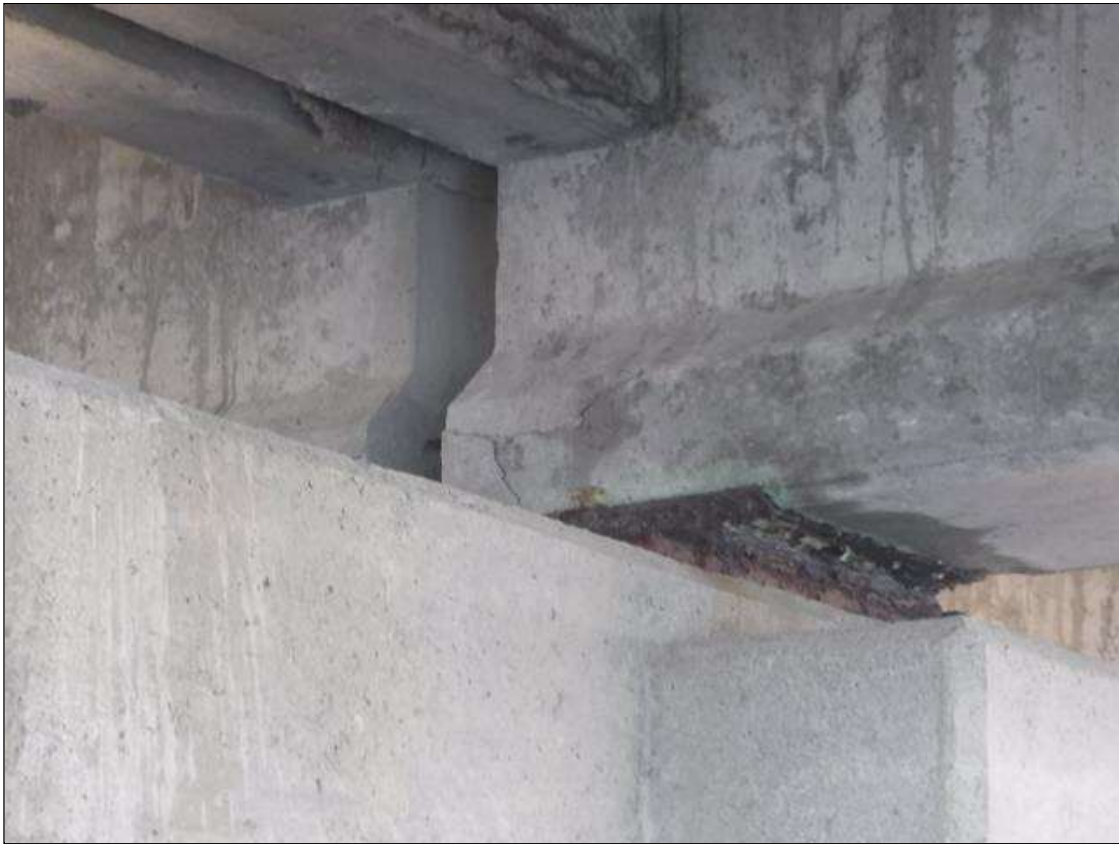
Span 16 Beam 4: 16" TALL X 12" LONG PATCHED AREA AT BENT 16 ON EXTERIOR SIDE.

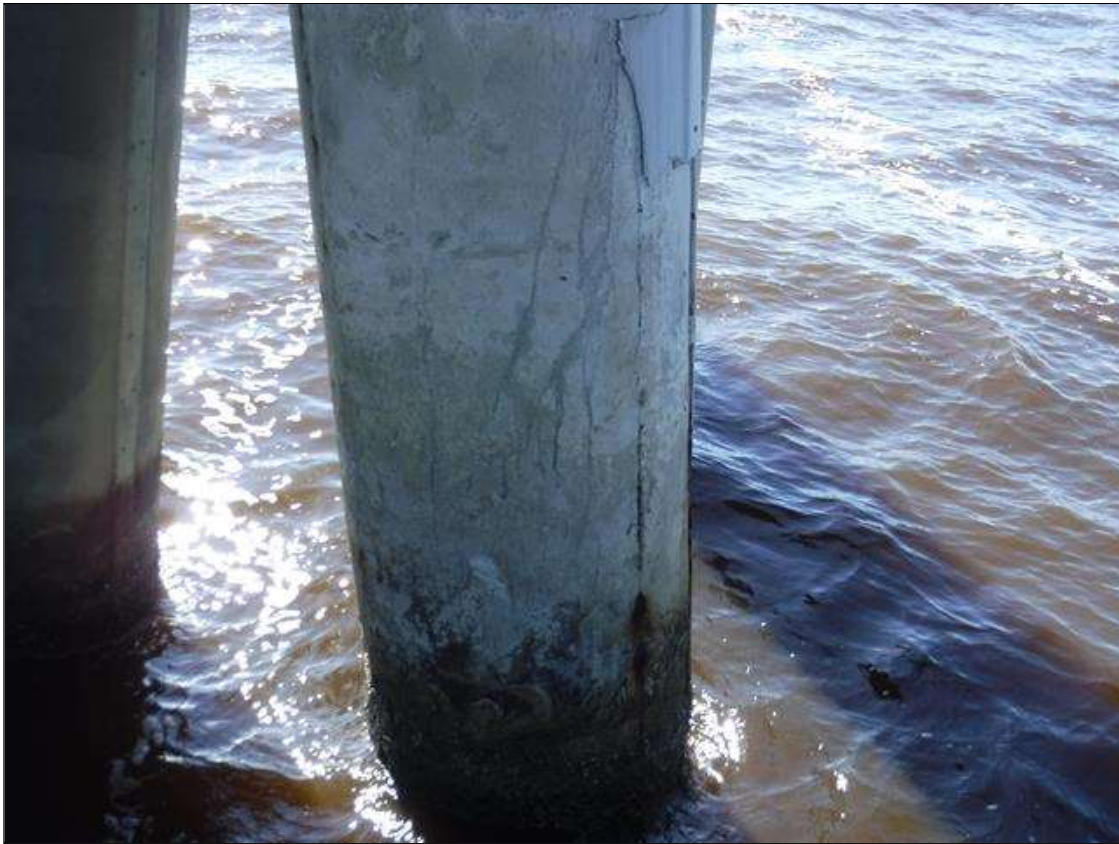
Bent 17 Saved Pile 2: JACKETED. SCALING TO 1" WITH LOOSE AGGREGATE FROM BOTTOM OF JACKET TO MUDLINE.

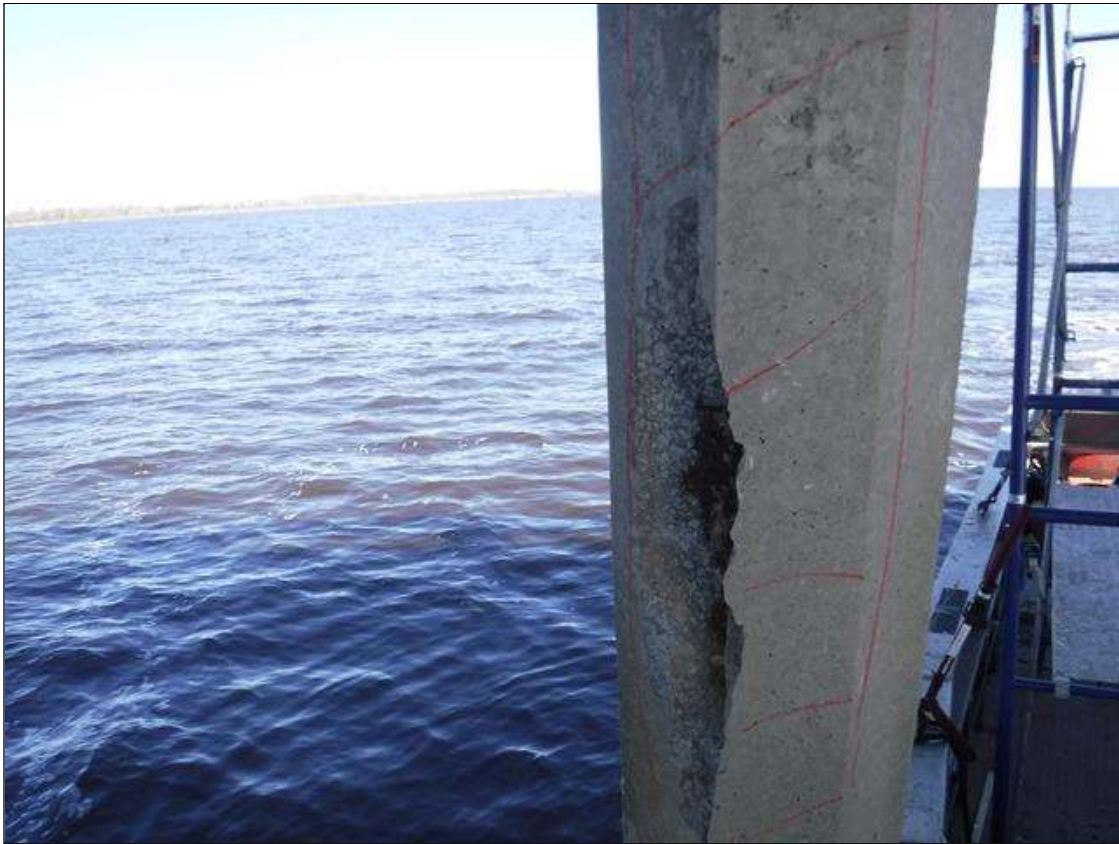
Bent 17 Saved Pile 4: 5' X 1' AREA OF CRACKED DELAMINATION, WITH RUST STAINING, WEST FACE OF PILE JACKET, BEGINNING 4' FROM BOTTOM OF CAP AND EXTENDING BELOW WATERLINE.

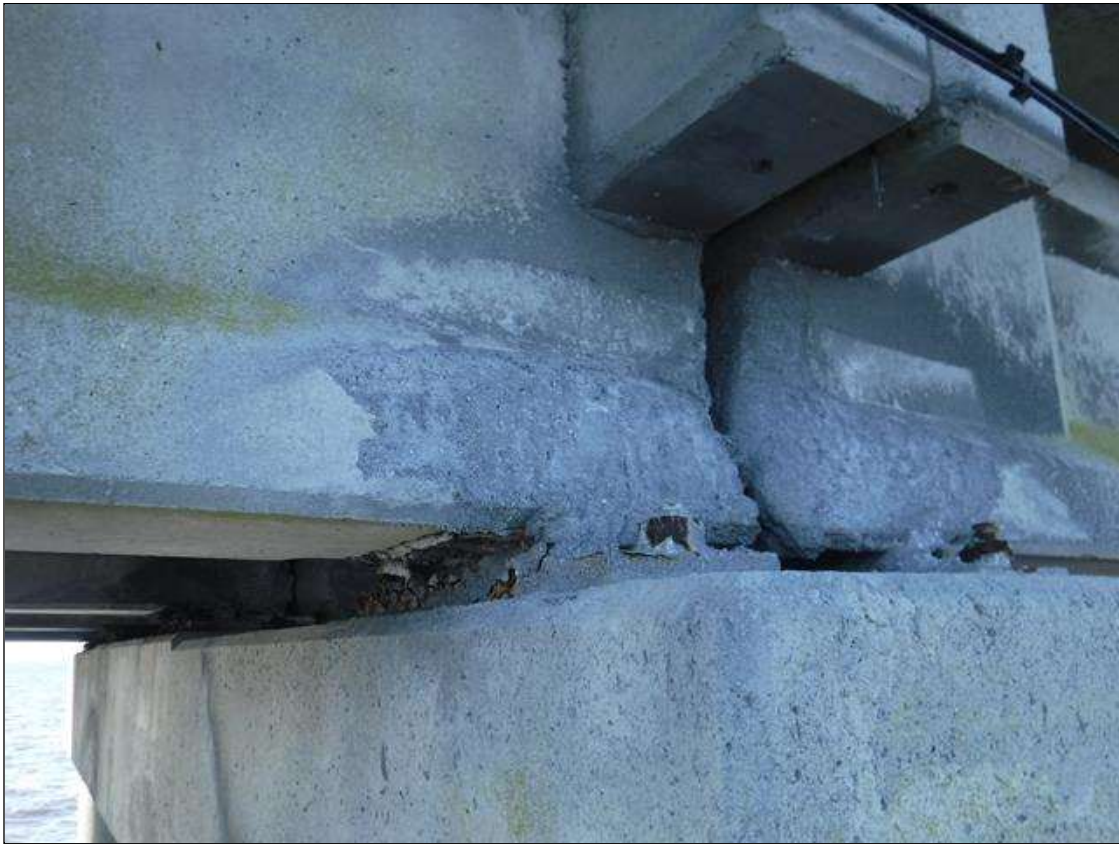
Bent 18 Saved Pile 1: (PAR) 9' X 2' WIDE DELAMINATION WITH 3' X 1' X 3" DEEP SPALL WITH EXPOSED PRESTRESSING ON SOUTH FACE, BEGINNING AT BOTTOM OF CAP AND EXTENDING BELOW WATERLINE. PRESTRESSING HAS 10% SECTION LOSS

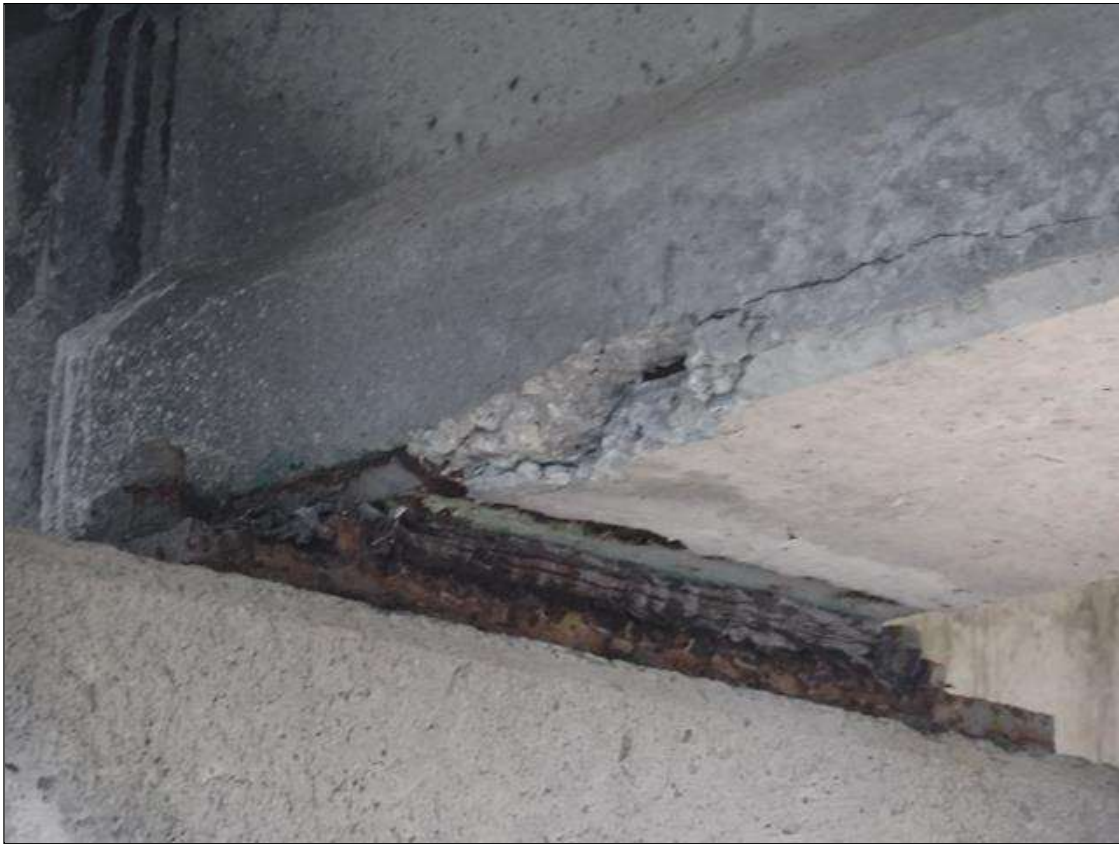
Span 19 Beam 3 Near Bearing: CORROSION WITH LESS THAN 1/16" LOSS. (2" REMAINING).

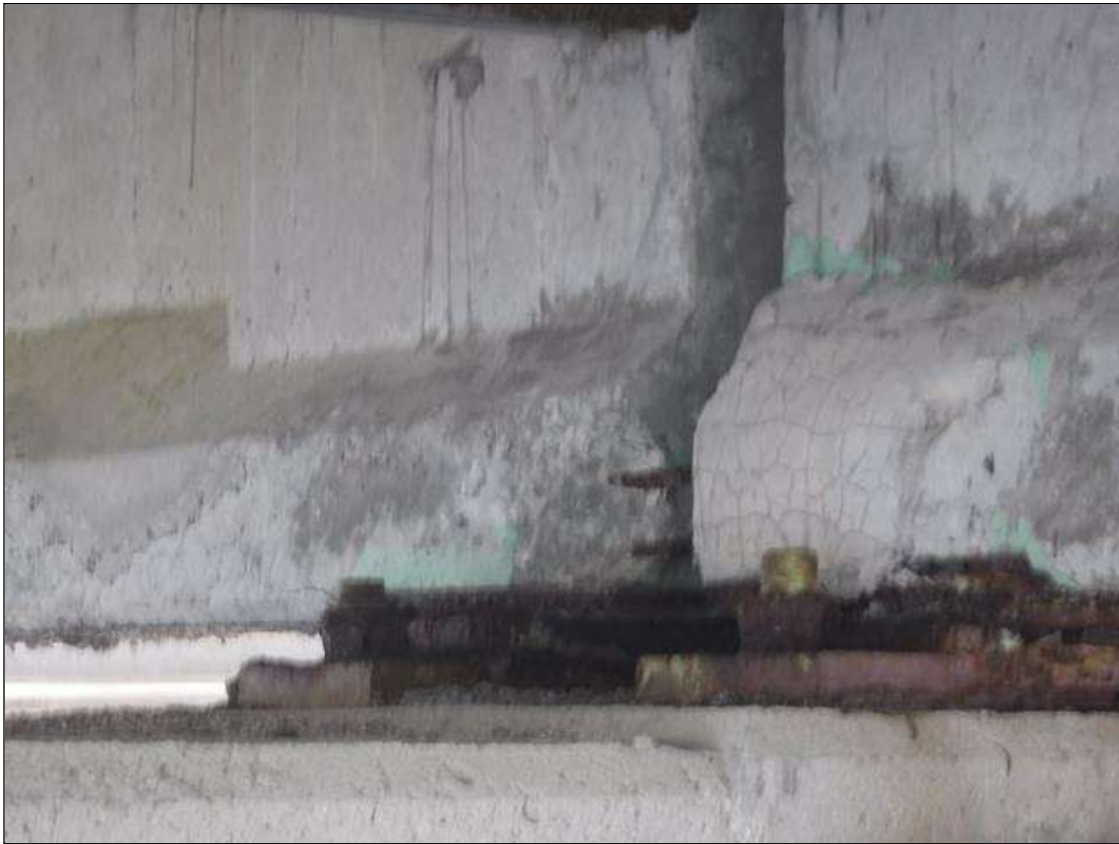
Span 21 Beam 4: (PAR) 12" X 12" X 6" SPALL, WITH EXPOSED PRESTRESSING STRAND, NORTH FACE, AT BENT 21.

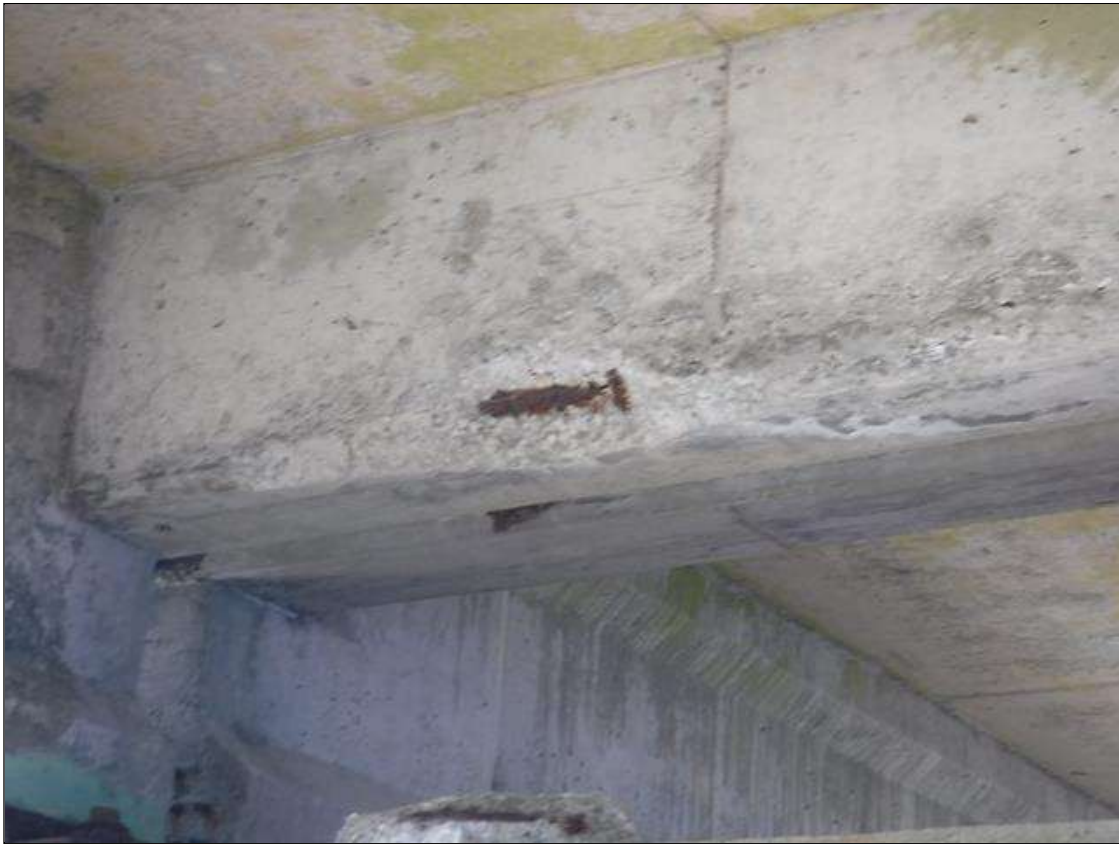
Span 23 Beam 1: 16" LONG X 10" TALL PATCHED AREA ON SOUTH FACE AT BENT 22.

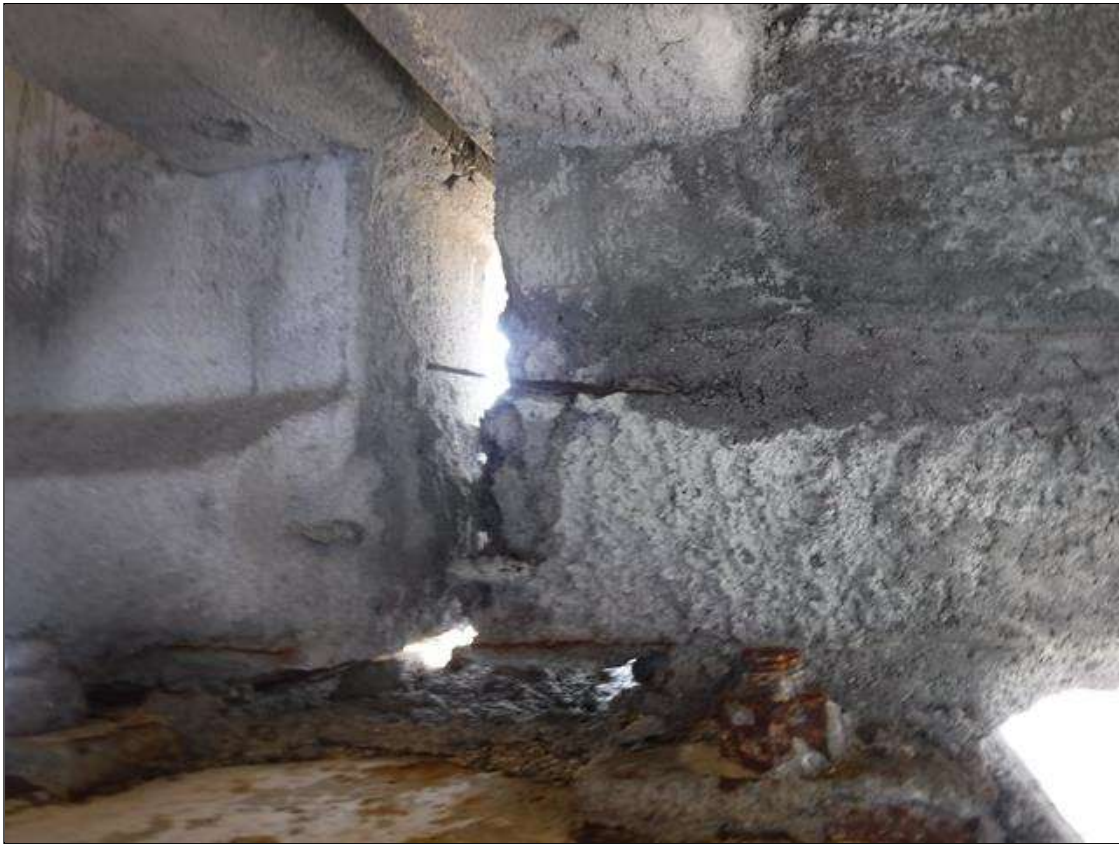
Bent 23 Cap 1: (PAR) 12" LONG, 12" TALL, AND 6" DEEP SPALL WITH EXPOSED REBAR IN BOTTOM OF BENT 23 CAP AT PILE 2. REBAR HAS 10% SECTION LOSS

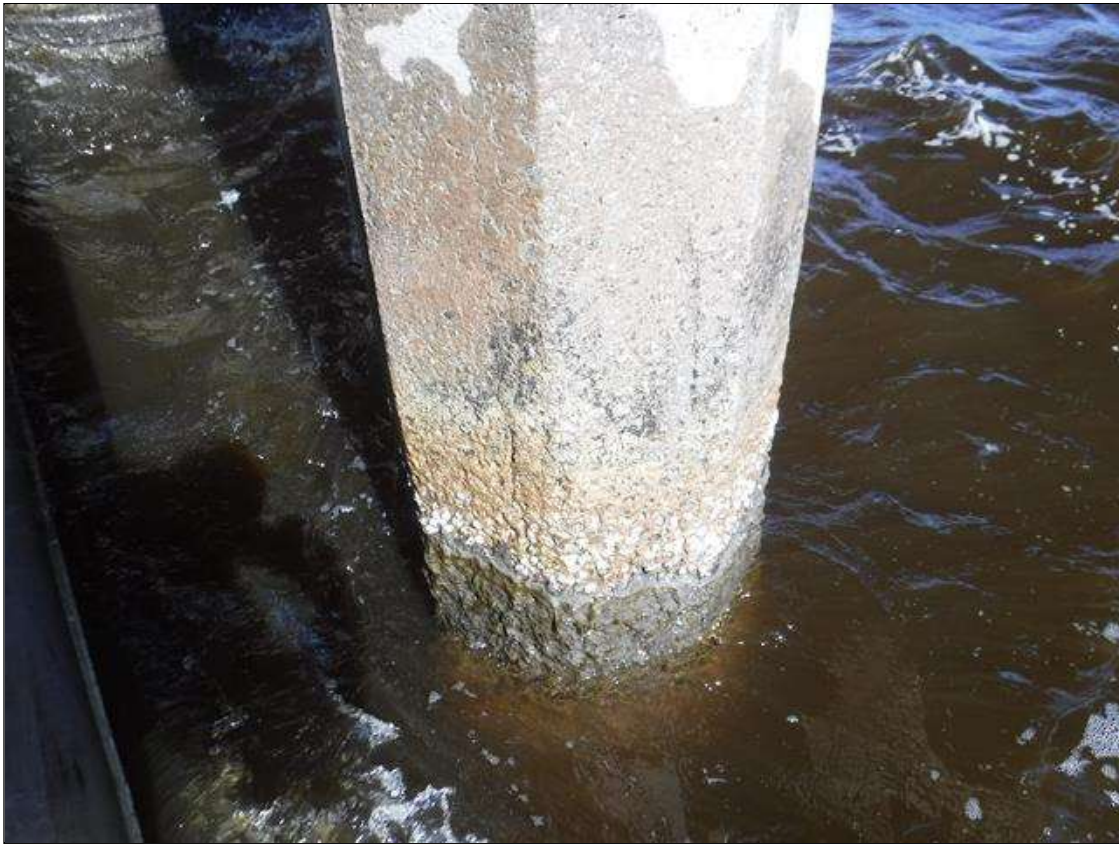
Bent 25 Saved Pile 3: (PAR) HAIRLINE TO 1/8" CRACK, 8' BELOW CAP, DOWN 5', EAST QUAD. SCALING TO 1" DEEP FROM WATERLINE TO MUDLINE.

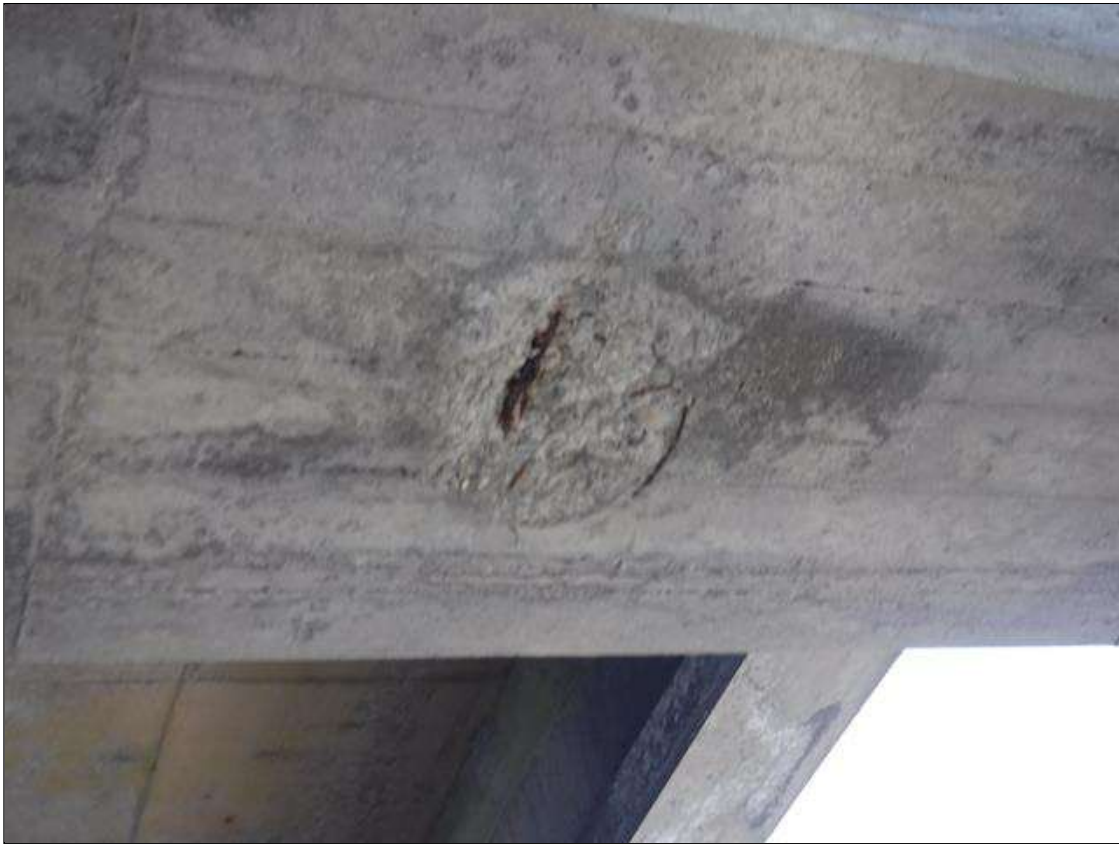
Bent 25 Cap 1: 24" X 12" PATCHED AREA IN EAST FACE ABOVE PILE 5

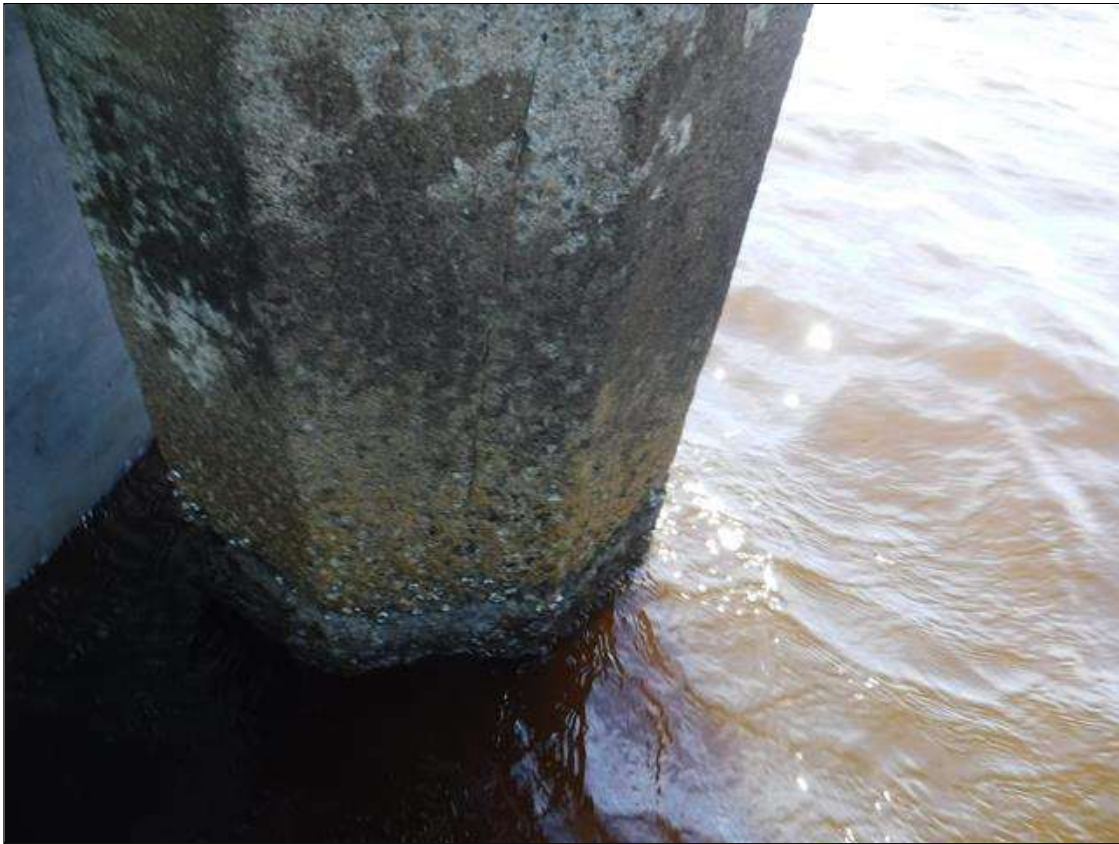
Bent 26 Saved Pile 1: (PAR) HAIRLINE TO 1/8" CRACK, 8' BELOW CAP, DOWN 6', SOUTH QUAD. SCALING TO 1" DEEP FROM WATERLINE TO MUDLINE.

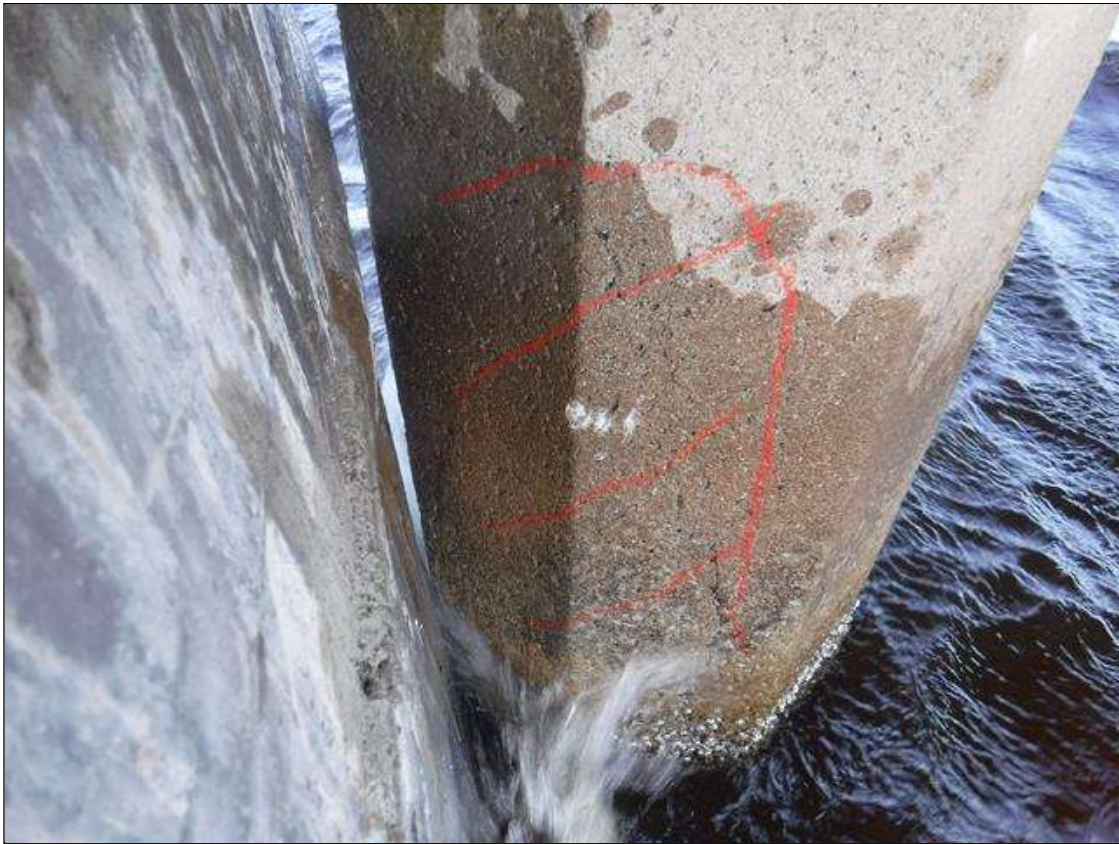
Bent 28 Saved Pile 1: (PAR) H/L TO 1/8" CRACK, 8' BELOW CAP, DOWN 6', SOUTH QUAD. SCALING TO 1" DEEP FROM WATERLINE TO MUDLINE.

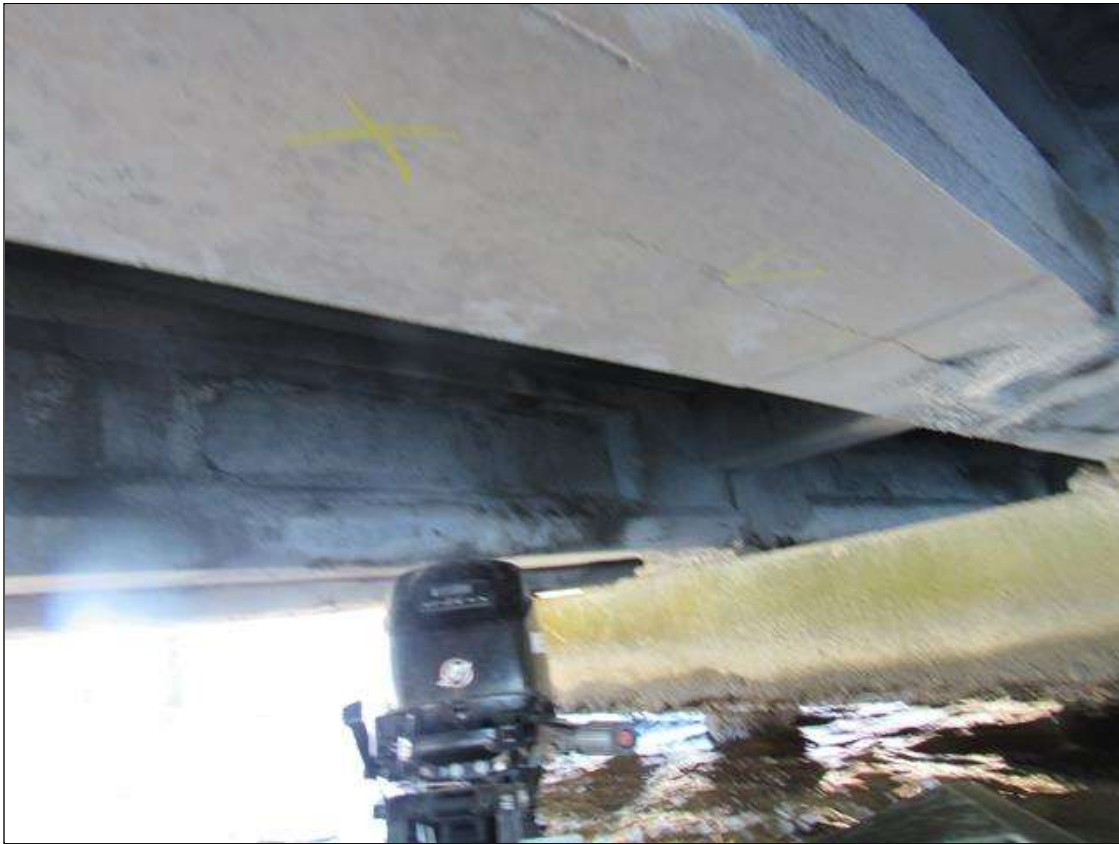
Span 3 Beam 1 Far Bearing: RUST SCALE, BEARING ASSEMBLY.

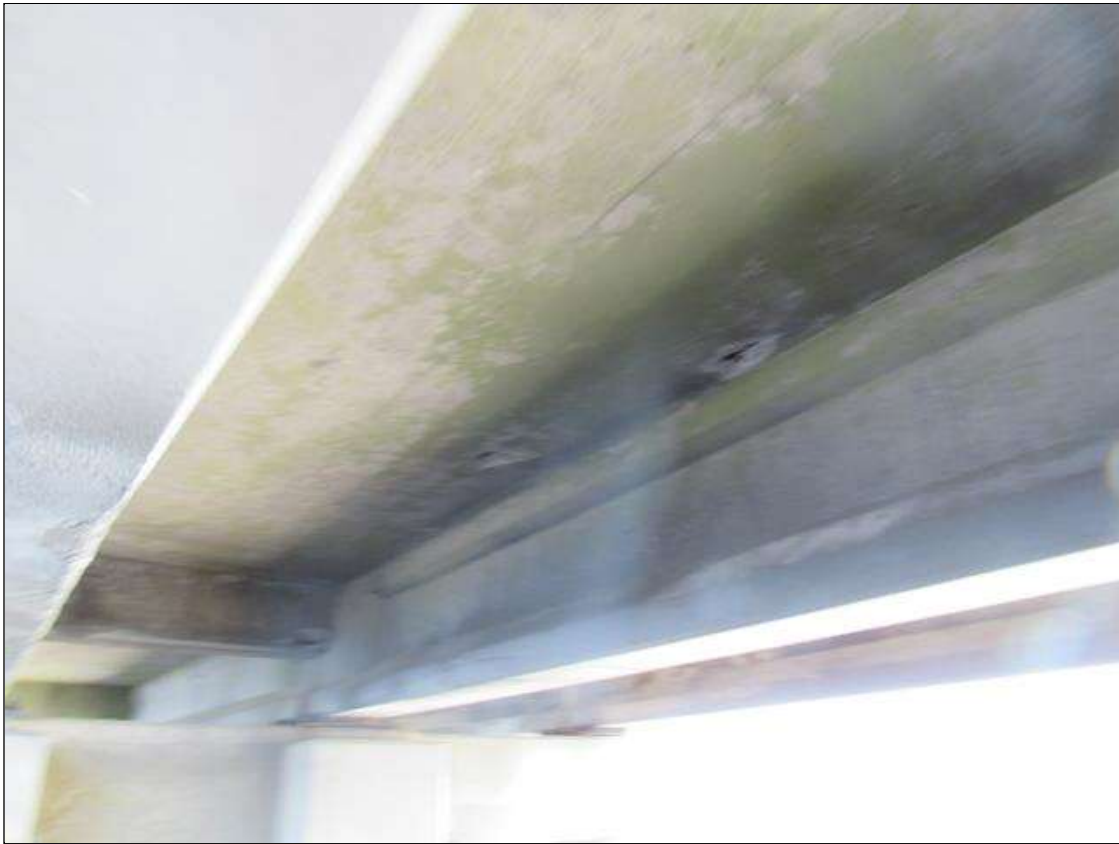
Span 4 Deck: 8" X 8" X 1" SPALL, DECK UNDERSIDE, BETWEEN BEAMS 2 AND 3, AT BENT 3.

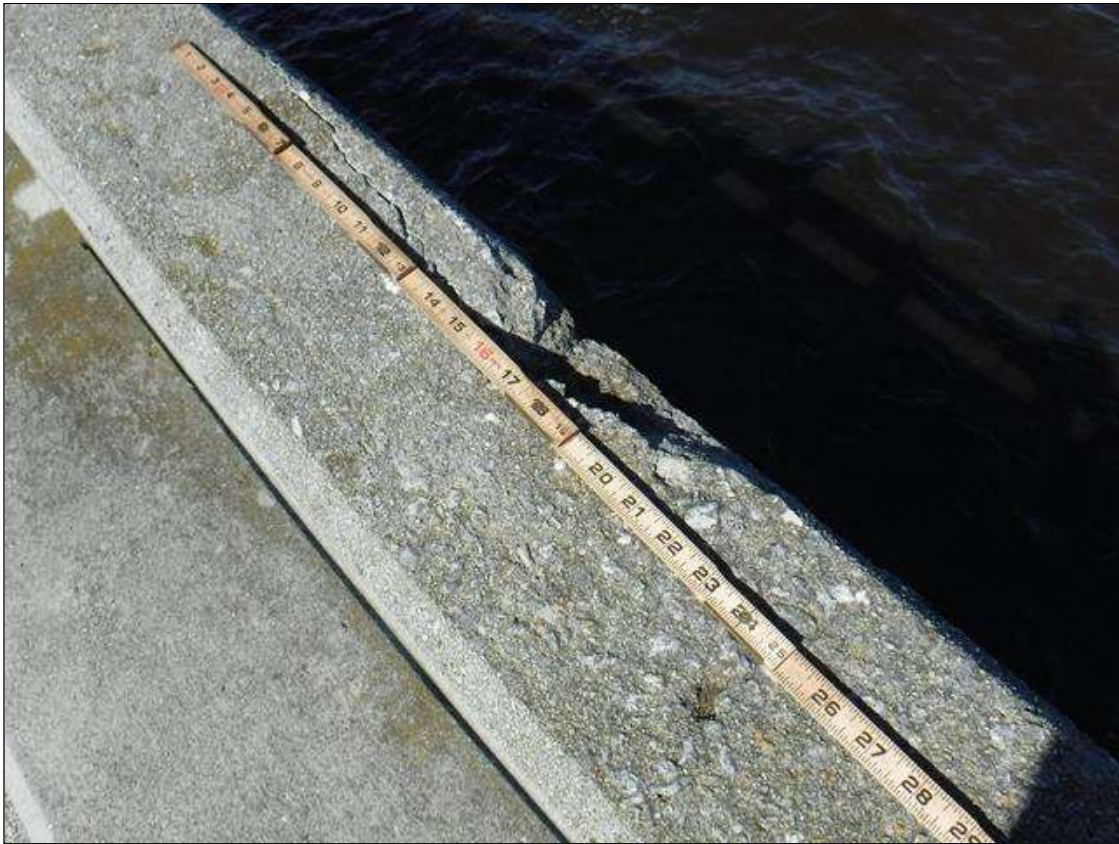
Span 99 Right Bridge Rail: 3" X 10" X UP TO 3" SPALL, WITH EXPOSED REINFORCING, TOP OF RAIL POST AT BENT 99.

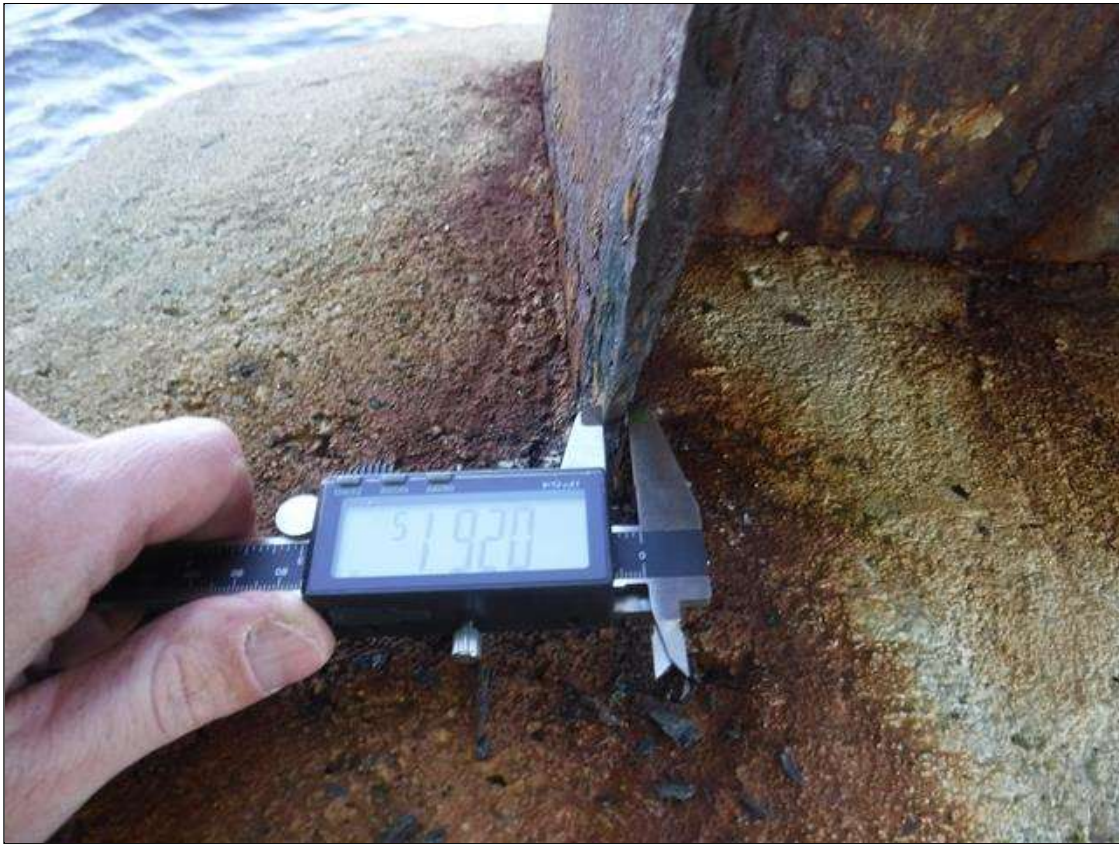
Bent 120 Cap 1: 8" DIAMETER X 1/2" SPALL, WITH EXPOSED REINFORCING, BOTTOM FACE, NEAR PILE 2.

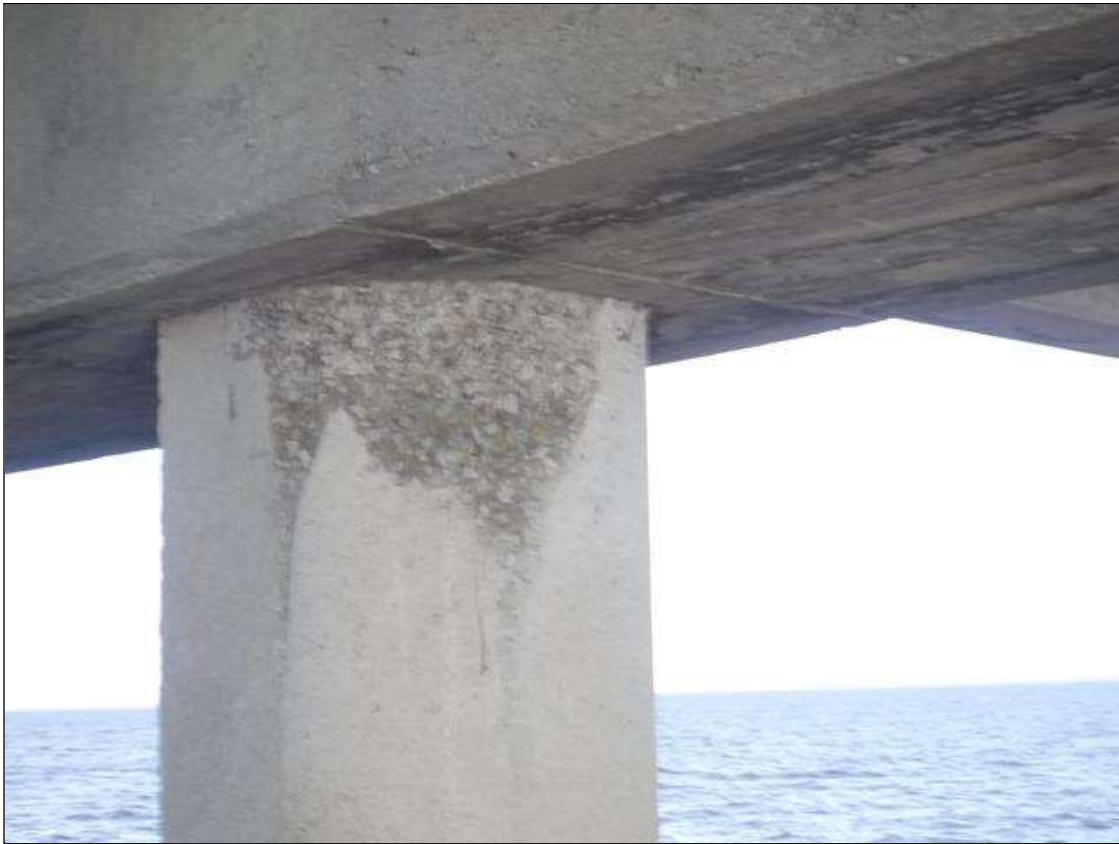
Bent 121 Pile 4: (PAR) UP TO 6' X 0.062" VERTICAL CRACKS, AT RANDOM THROUGHOUT.
