NC DEPARTMENT OF TRANSPORTATION
DIVISION OF HIGHWAYS
STRUCTURE MANAGEMENT UNIT

Structure Safety Report

Routine Element Inspection - Contract

FEATURE INTERSECTED: ALLIGATOR RIVER

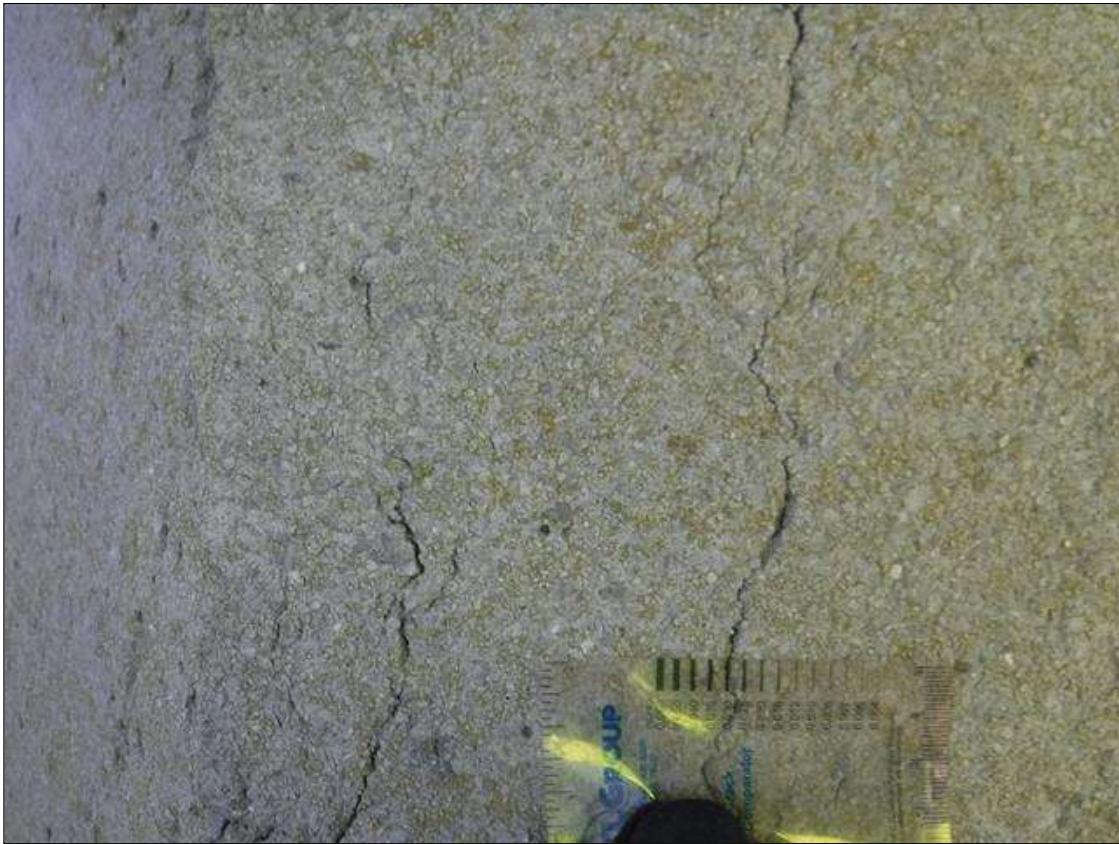
Bent 124 Pile 2: 2' X 1' DELAMINATIONS, SOUTH FACES, 9' FROM BOTTOM OF CAP, EXTENDING BELOW WATERLINE.

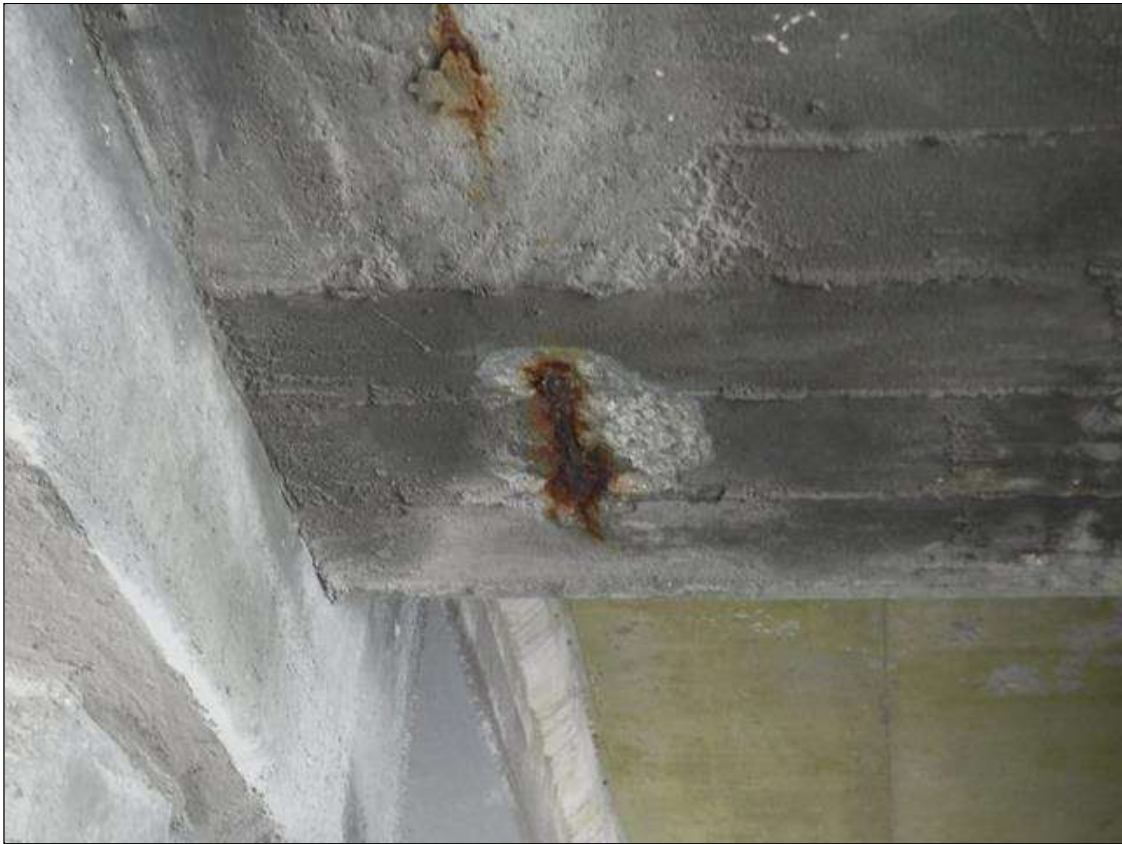
Bent 127 Cap 1: (PAR) 10" X 6" X 2" SPALL, WITH EXPOSED REINFORCING, NORTH FACE OF PILE 4 AND 5 BLOCK-OUT. REINFORCING HAS 10% SECTION LOSS

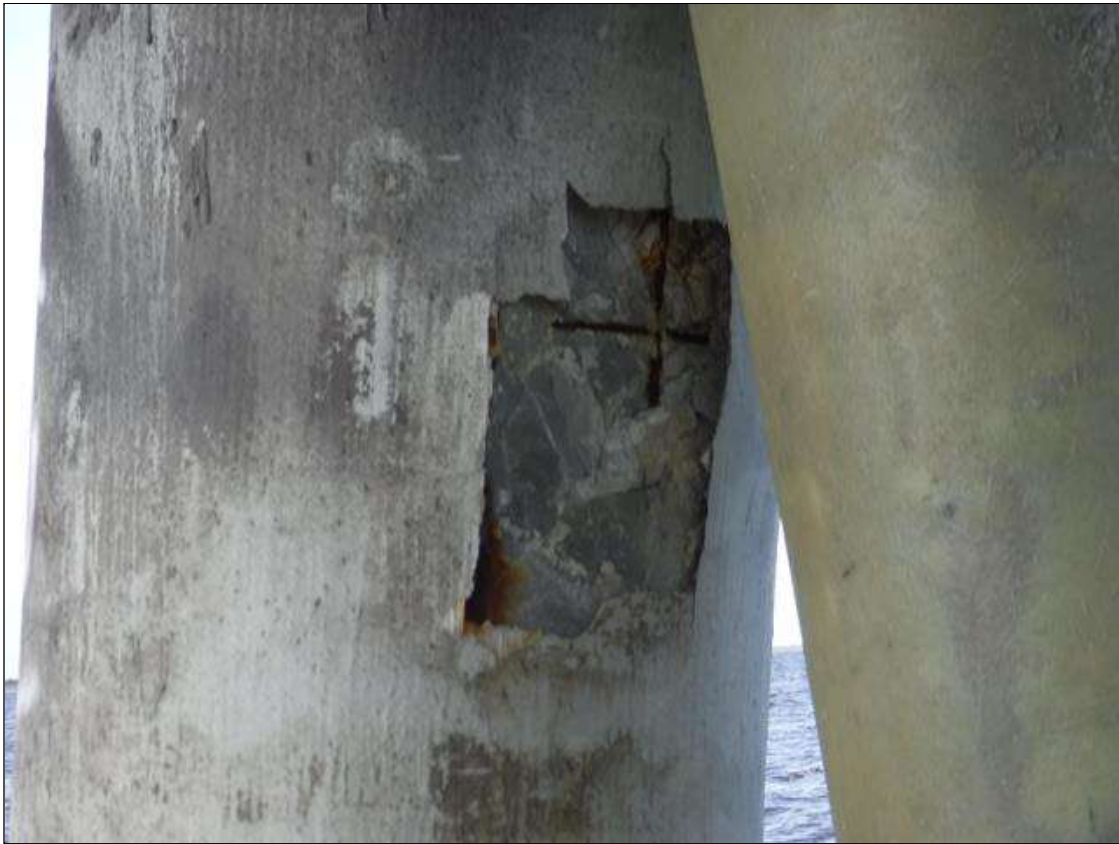
Bent 127 Cap 1: 12" X 1" DEEP SPALL WITH EXPOSED REBAR ON BOTTOM FACE, RIGHT OF PILE 2

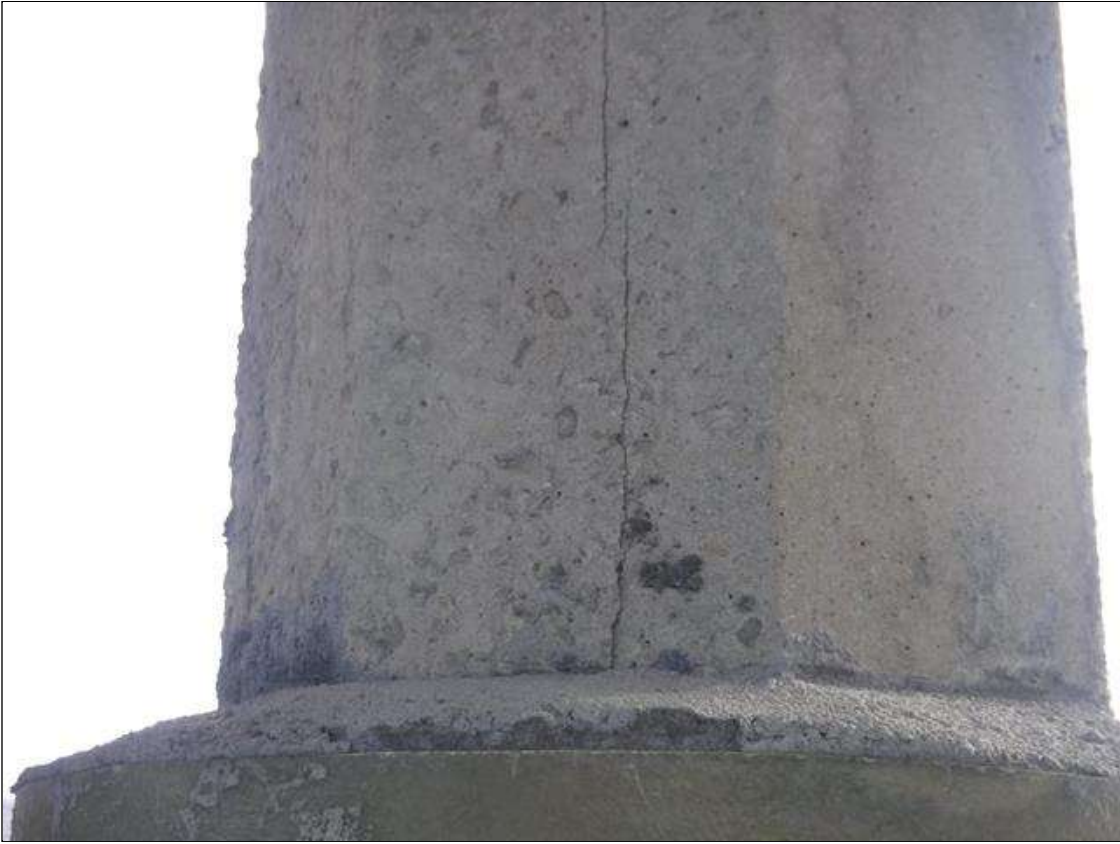
Bent 131 Pile 1: (PAR) 1' X UP TO 0.16" VERTICAL CRACKS, AT RANDOM THROUGHOUT.

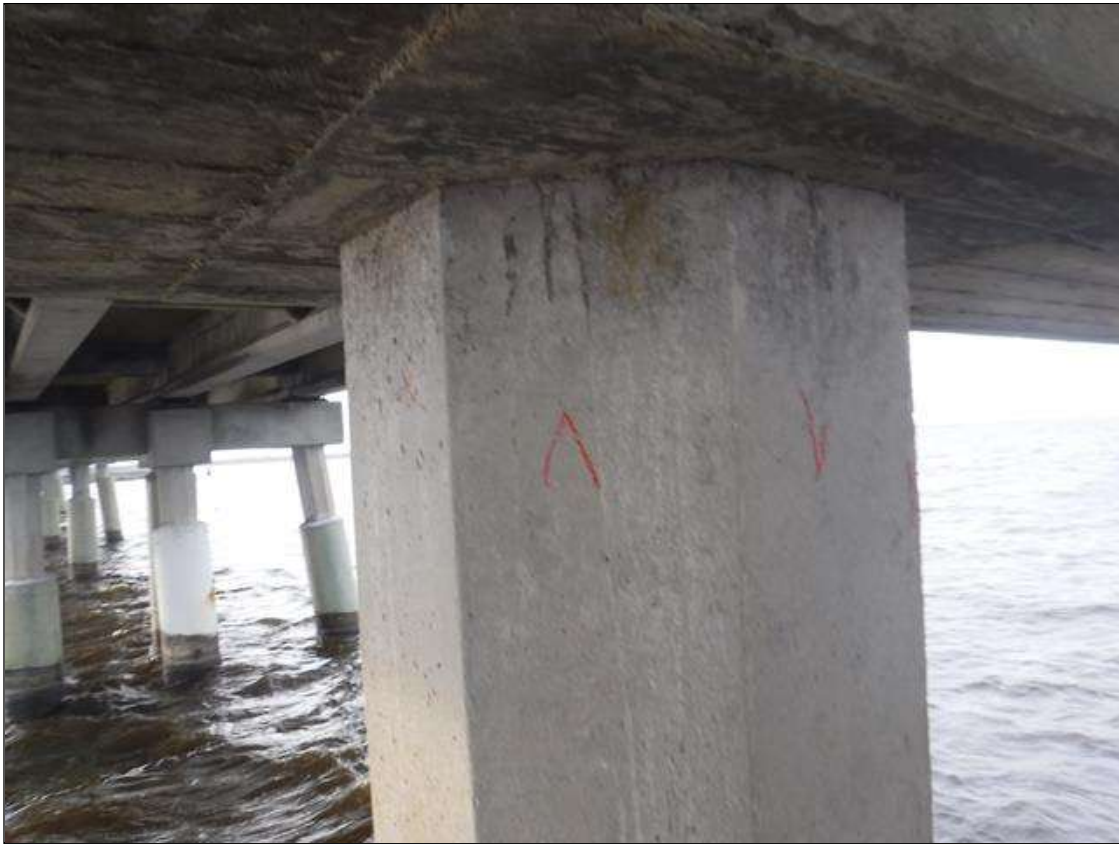
Bent 136 Saved Pile 3: 32" LONG X 0.006" HORIZONTAL CRACK ON EAST FACE 11" FROM TOP

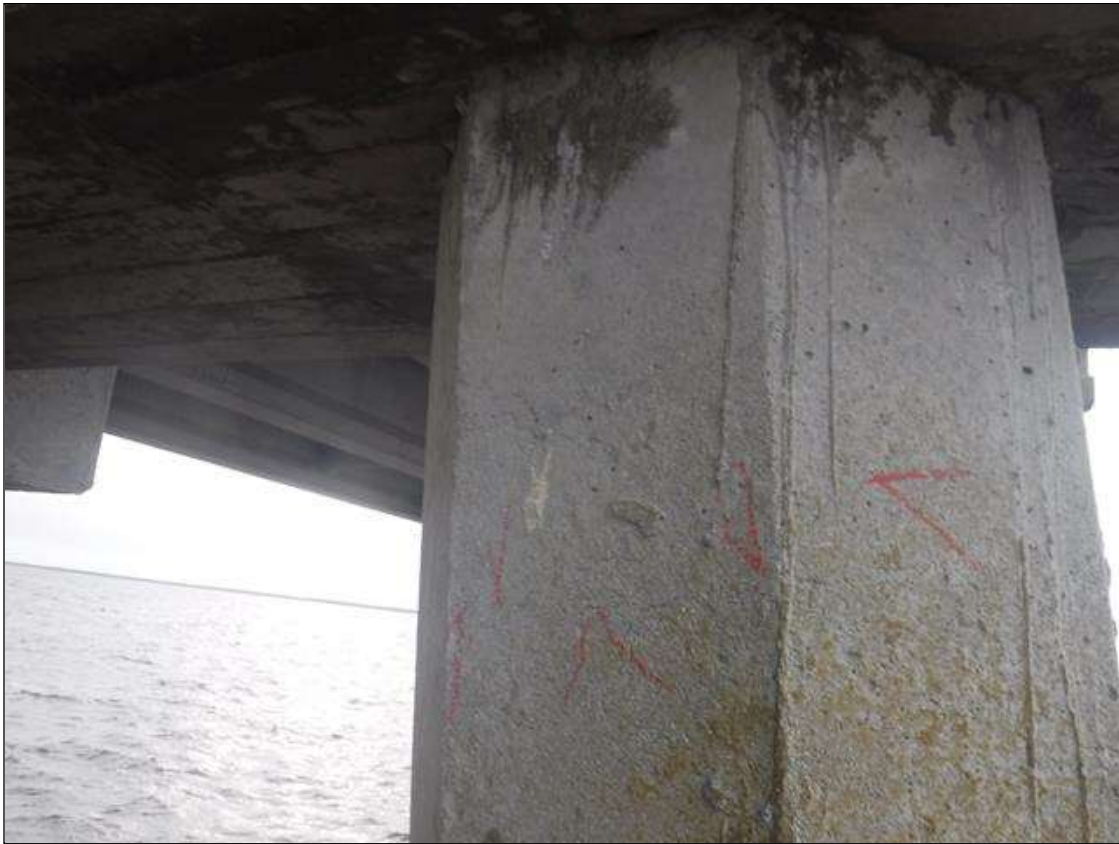
Bent 139 Pile 1: UP TO 2' X 0.009" VERTICAL CRACKS, AT RANDOM THROUGHOUT.

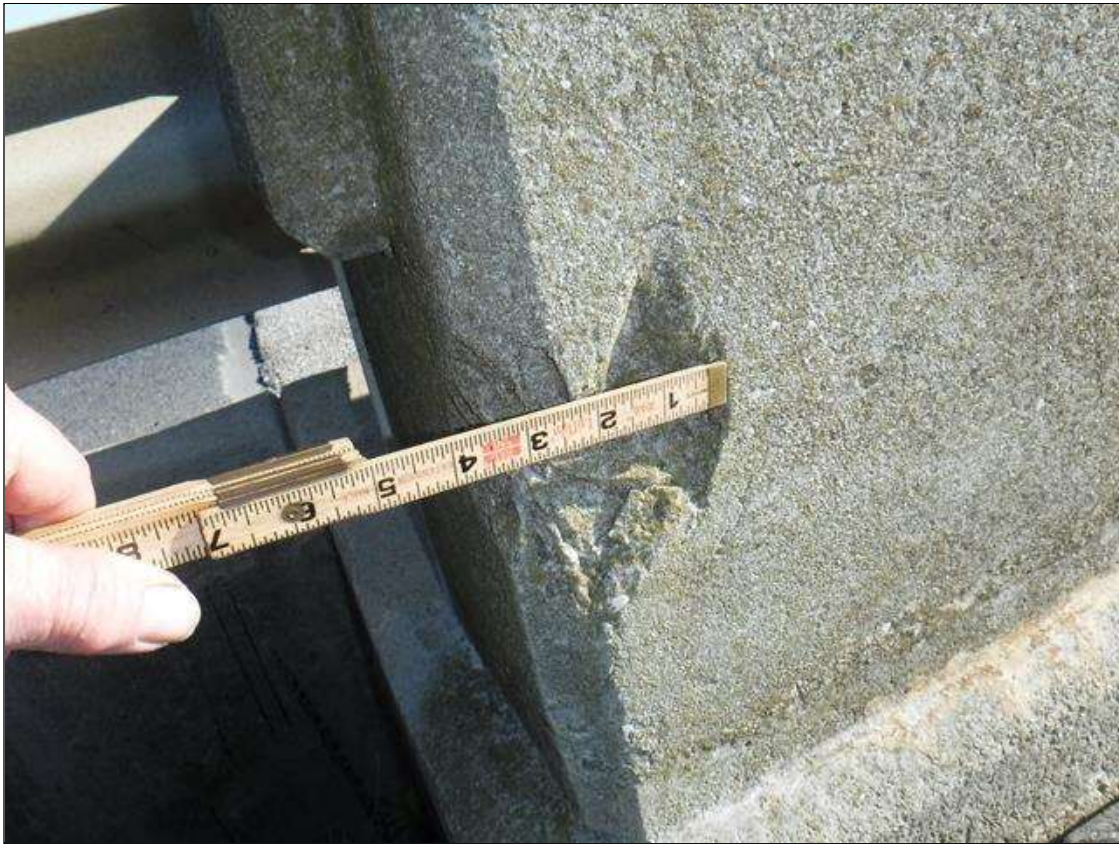
Span 1 Right Bridge Rail: 3 1/2" X 5" X 2" SPALL ON RIGHT FACE LOCATED AT NEAR RIGHT END POST

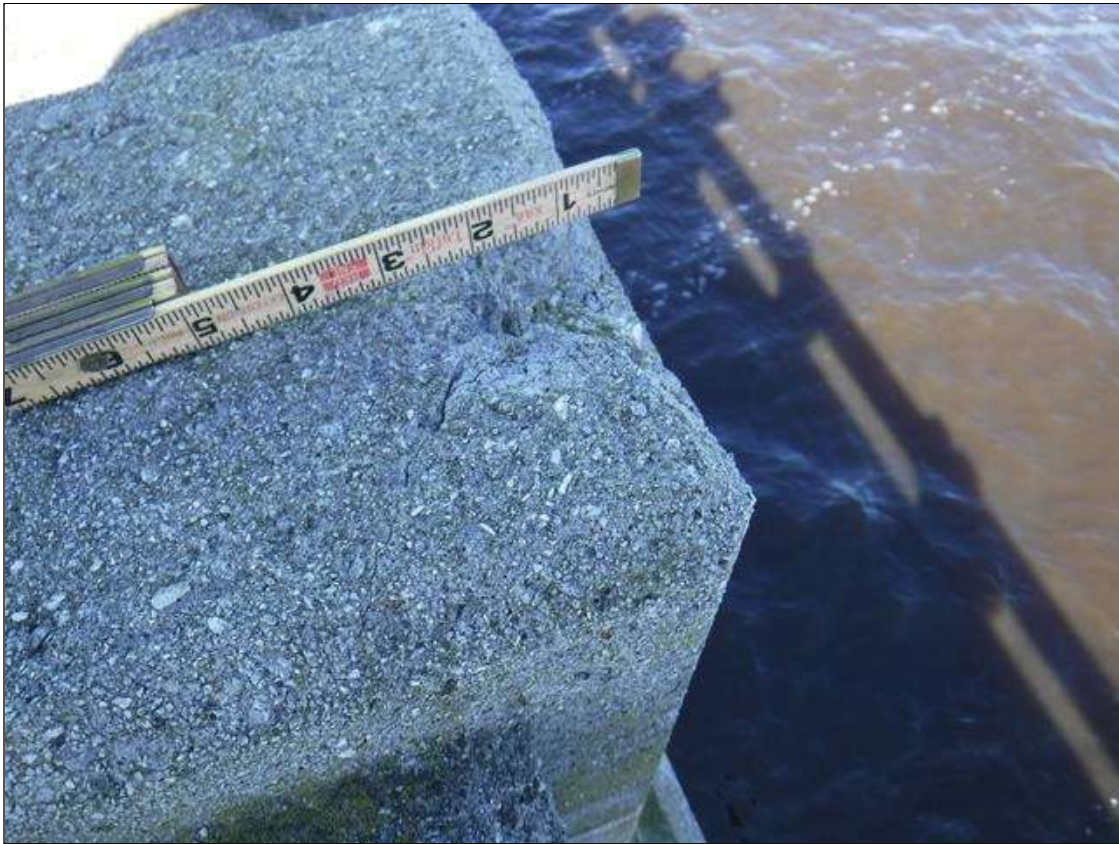
Span 18 Left Bridge Rail: 2 1/2" X 4" X 1 1/2" SPALL ON TOP FACE LOCATED FIRST POST AT BENT 17

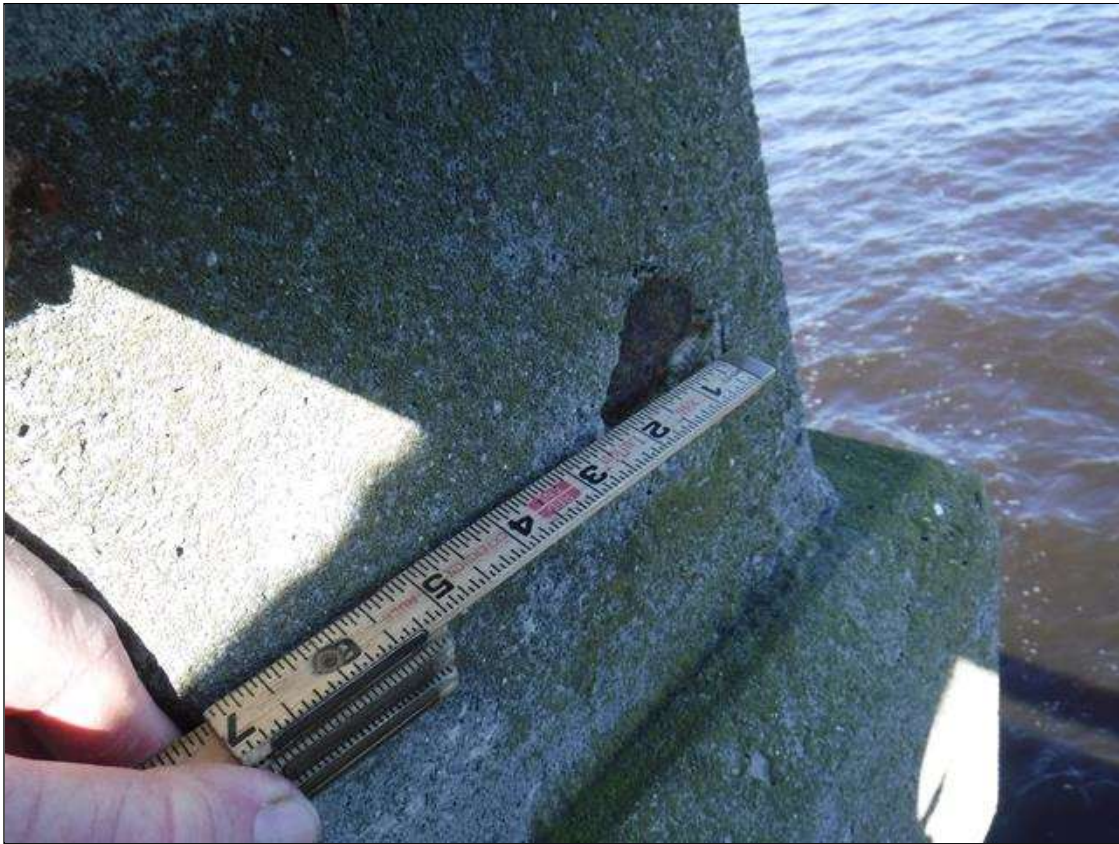
Span 31 Left Bridge Rail: 3" DIAMETER SPALL ON NEAR FACE LOCATED 5TH POST FROM BENT 30

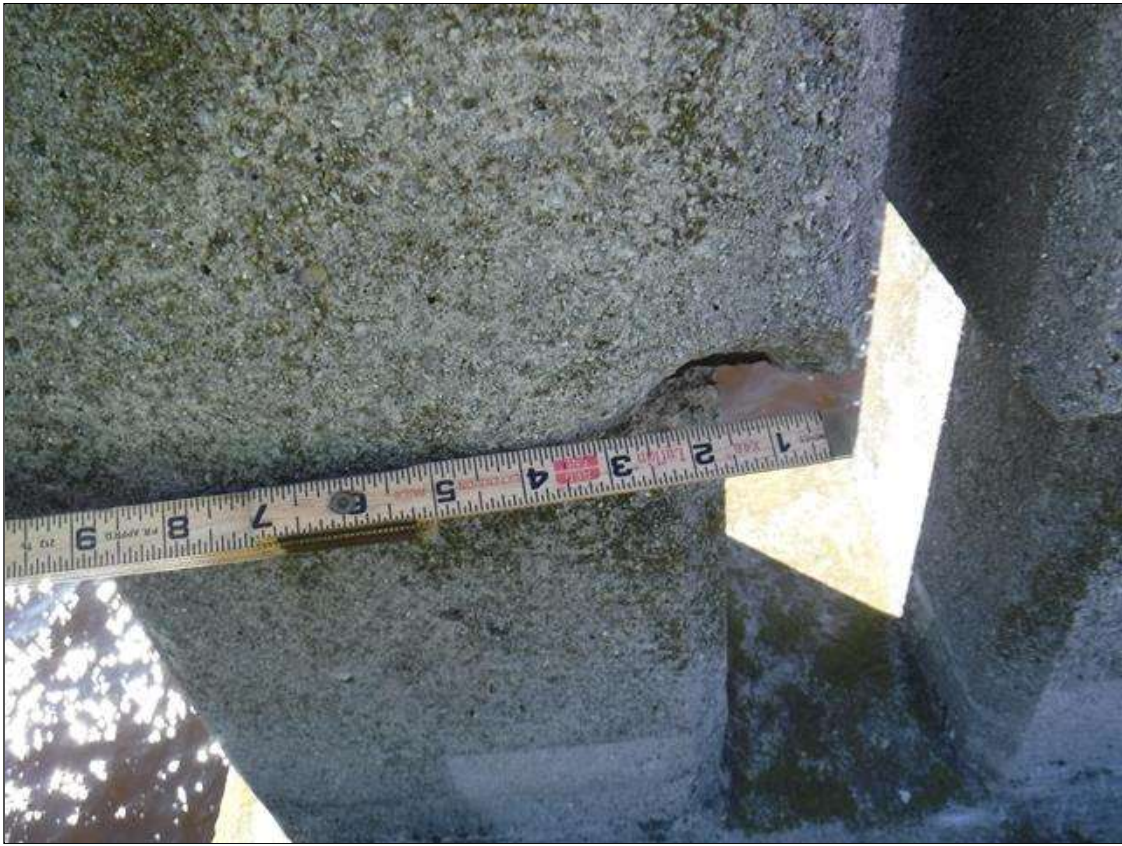
Span 40 Right Bridge Rail: 4" X 3" X 2" SPALL WITH EXPOSED REBAR ON LEFT FACE LOCATED AT 4TH POST FROM BENT 39

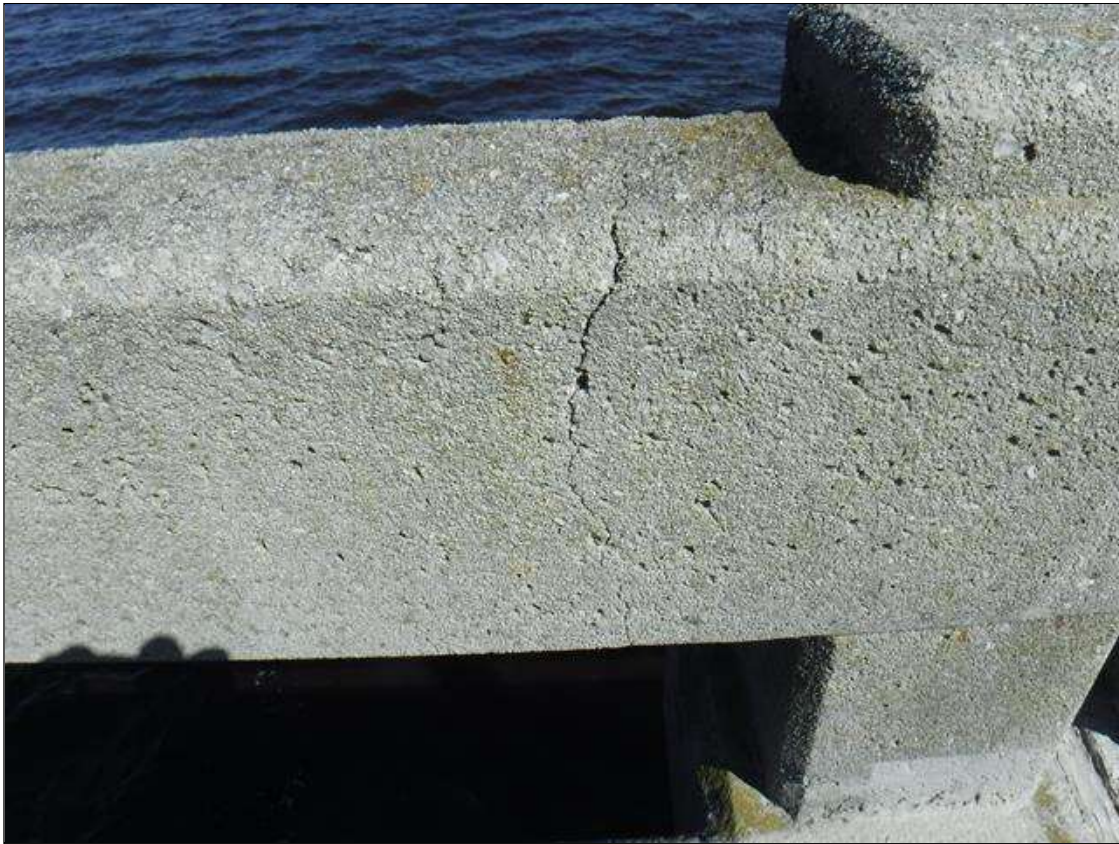
Span 43 Right Bridge Rail: WRAP AROUND CRACK IN RAIL UP TO 1/16" WIDE CRACK LOCATED AT POST 9 AT BENT 43

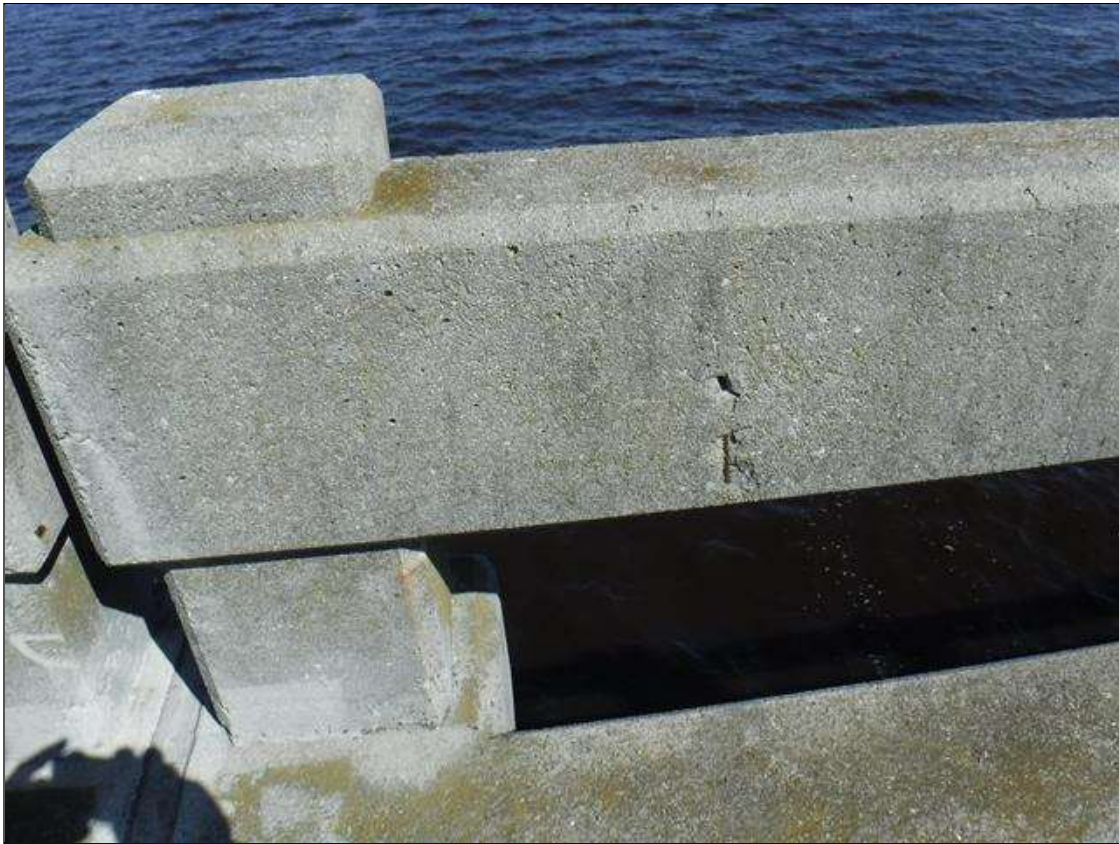
Span 49 Left Bridge Rail: 5" X 1" X 1/2" SPALL WITH EXPOSED REBAR ON RIGHT FACE LOCATED 2' FROM BENT
48

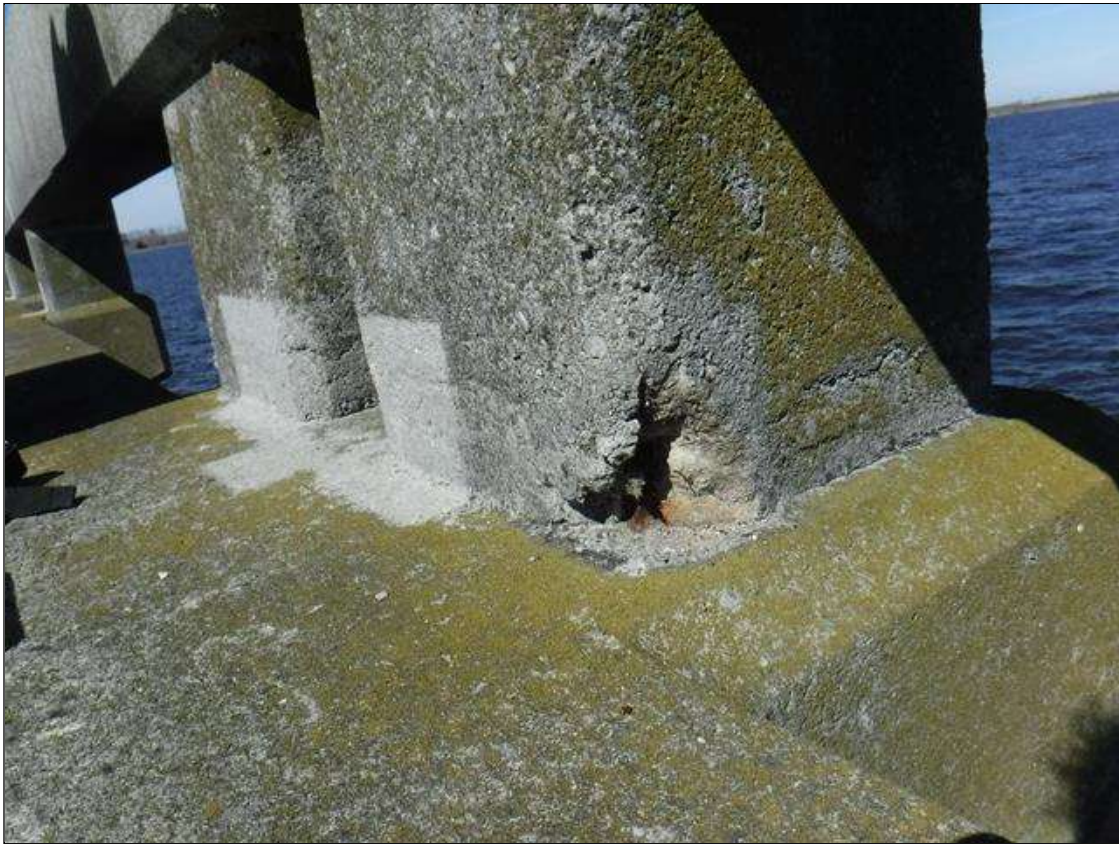
Span 66 Left Bridge Rail: 3" X 3" X 2" SPALL WITH EXPOSED REBAR AT BOTTOM RIGHT CORNER LOCATED AT POST 4

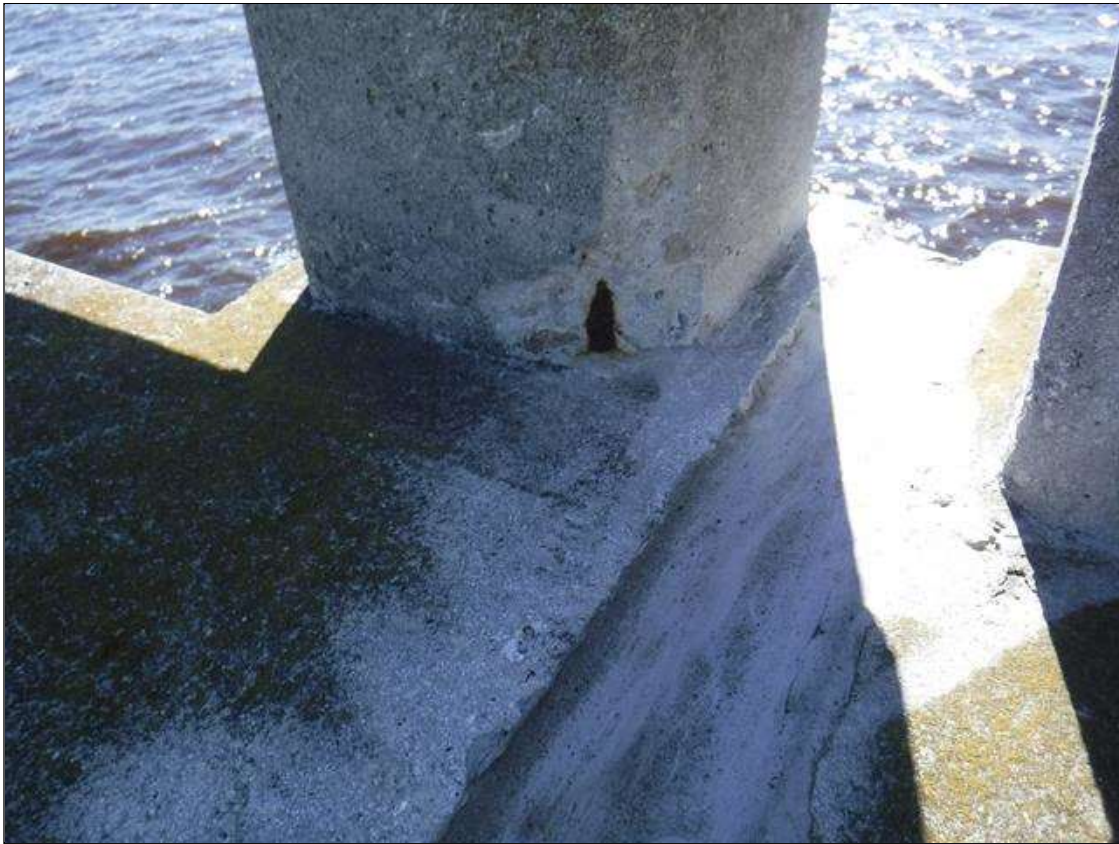
Span 82 Right Bridge Rail: 4" X 2 1/2" X 5" SPALL WITH EXPOSED REBAR AT BOTTOM LEFT CORNER LOCATED AT POST 1

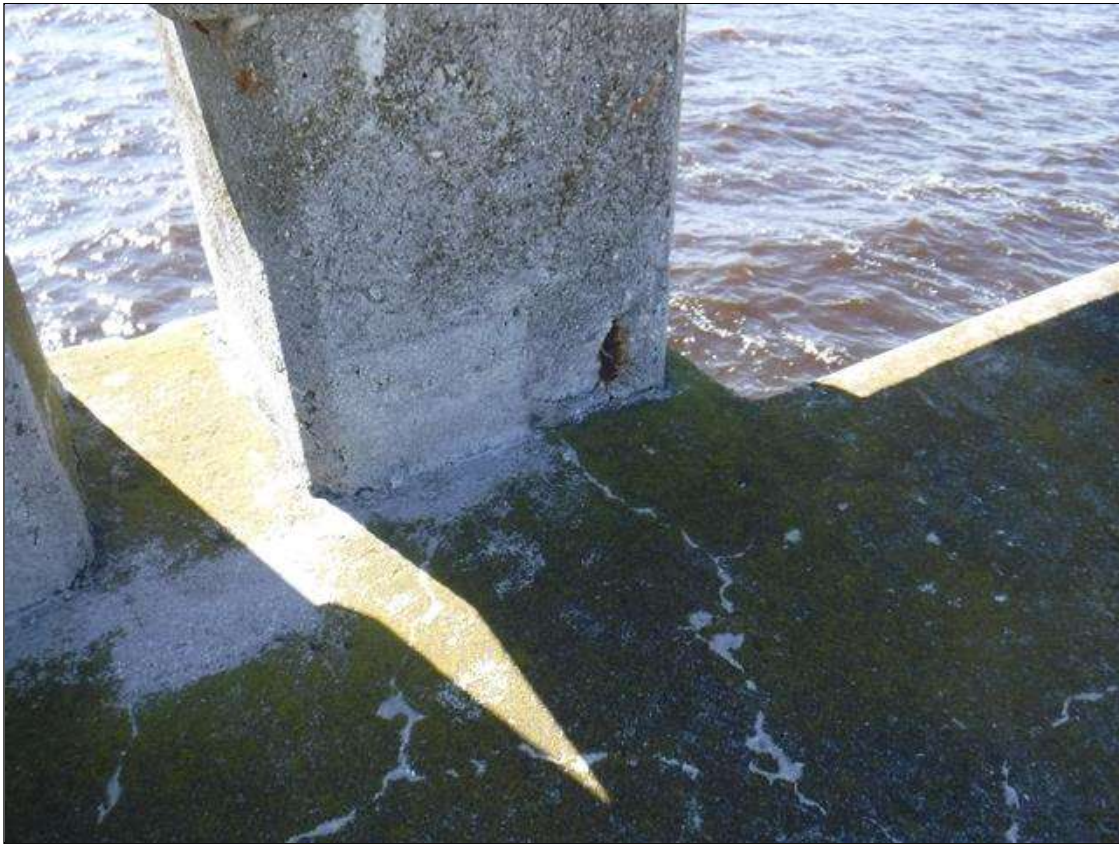
Span 84 Right Bridge Rail: 2" X 2" X 3/4" SPALL WITH EXPOSED REBAR AT BOTTOM LEFT CORNER LOCATED ON POST 6

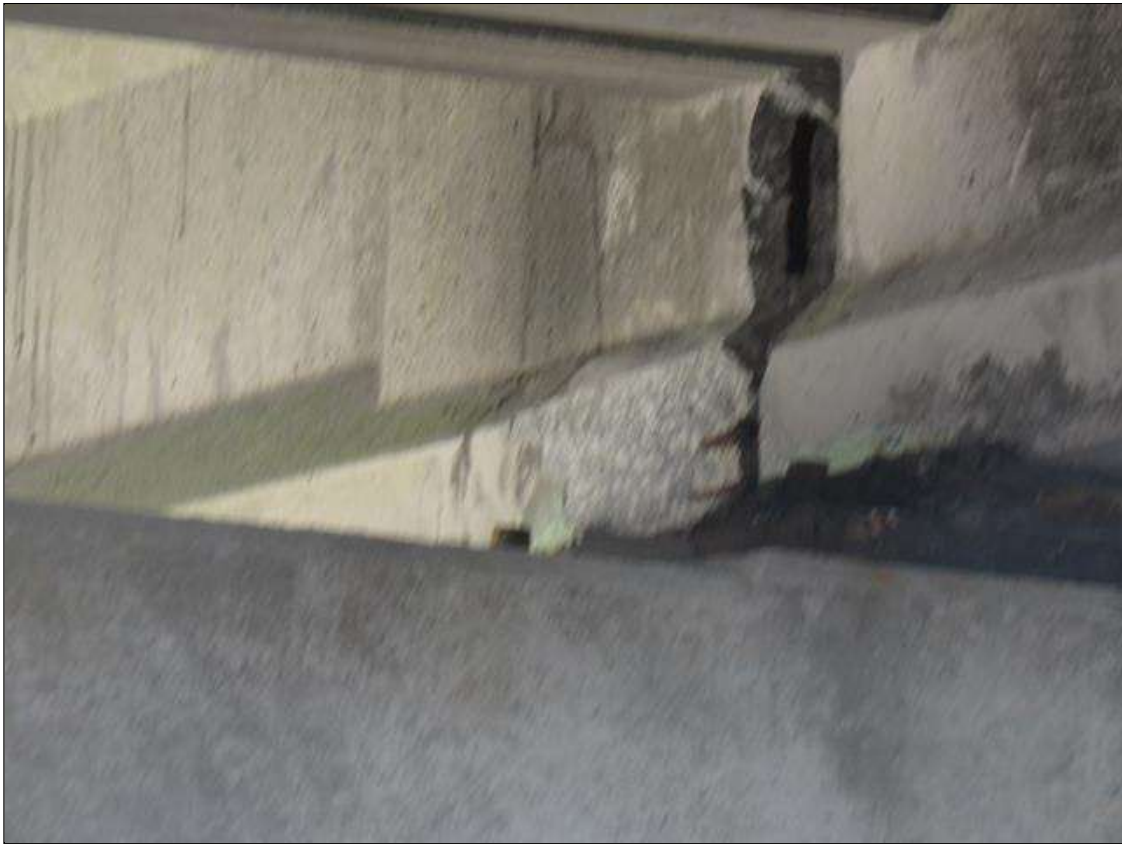
Span 7 Beam 3: (PAR) 12" X 8" X 2" SPALL WITH EXPOSED STRAND, NORTH FACE, AT BENT 7.

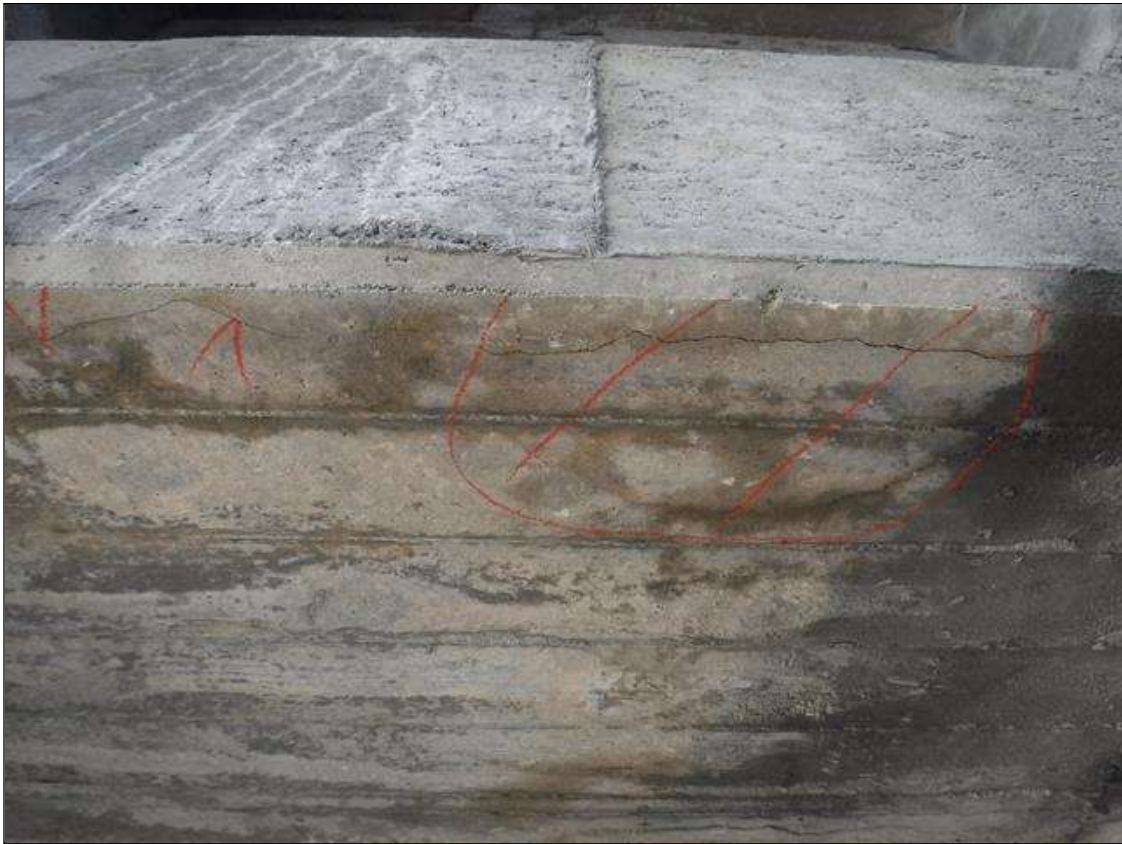
Bent 170 Cap 1: 2' DIAMETER DELAMINATION WITH 3' LONG HAIRLINE CRACK IN BOTTOM OF CAP BETWEEN PILES 2 AND 3

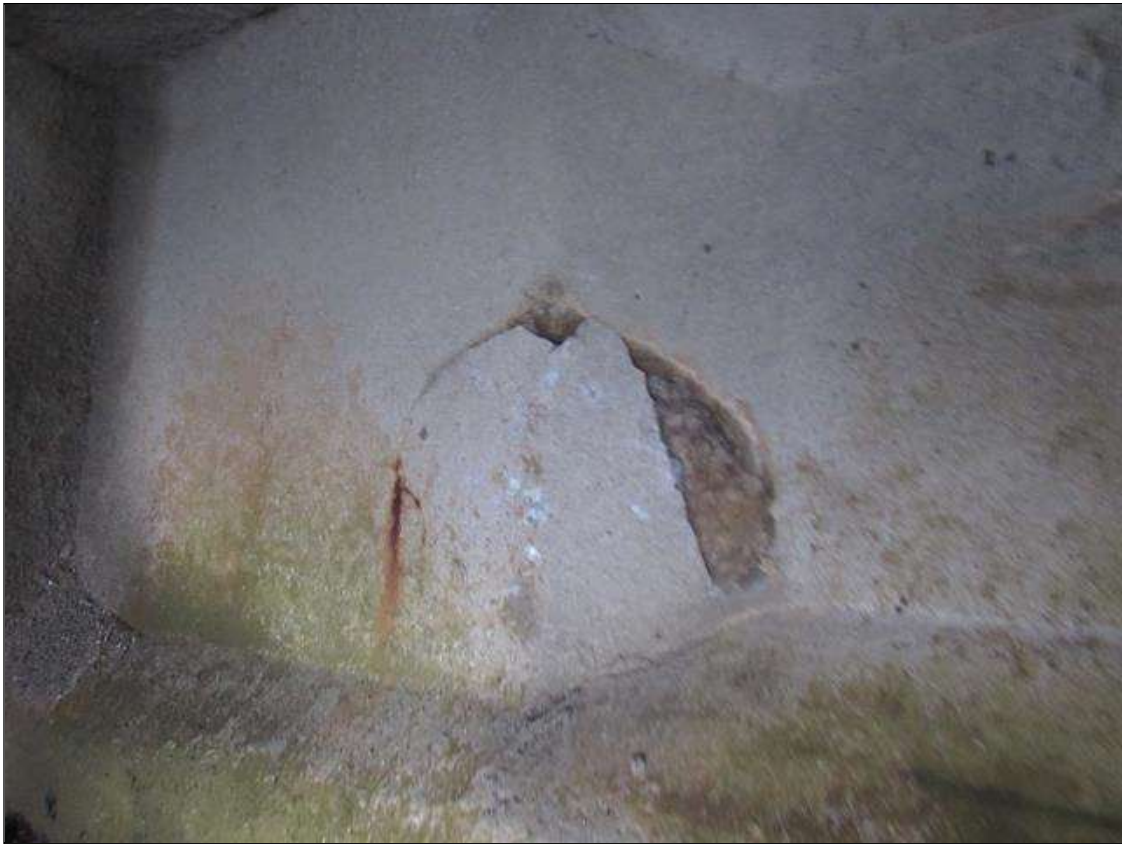
Span 1 Beam 2: 12" DIAMETER DELAMINATION ON RIGHT FACE LOCATED AT END BENT 1

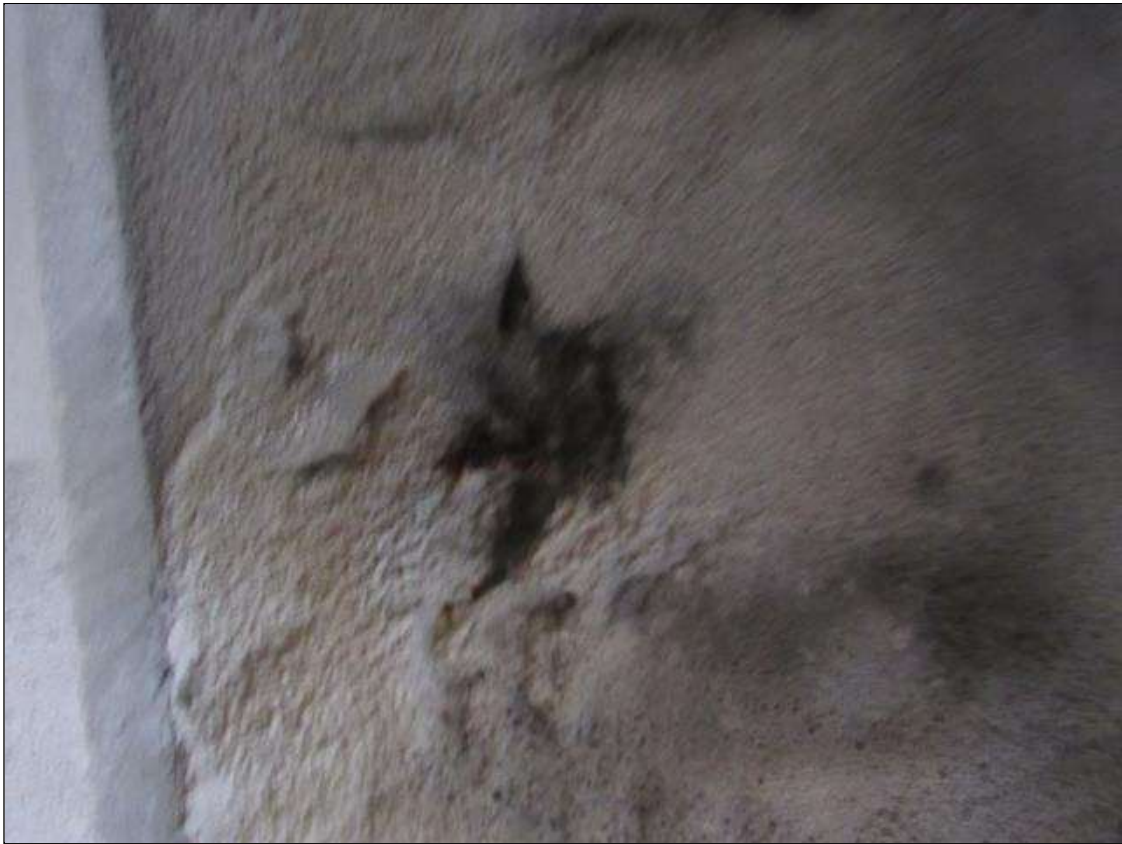
Span 1 Deck: 12" DIAPHRAGM FAILED PATCHED AREA ON UNDERSIDE OF DECK LOCATED 4' FROM END BENT 1 IN BAY 2

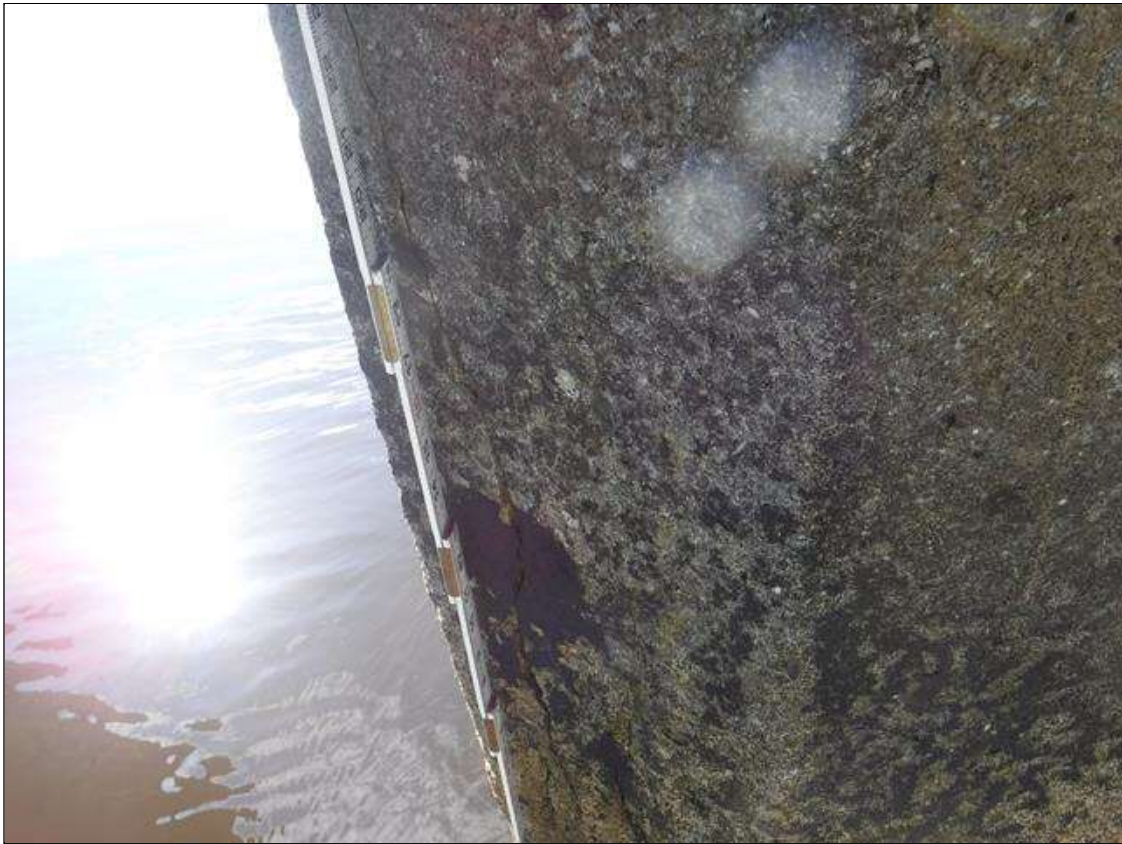
Bent 212 Pile 4: (PAR) 3' LONG HAIRLINE TO 1/8" CRACK, 8' BELOW CAP, DOWN 4' , MULTIPLE FACES. SCALING TO 1" DEEP WITH LOOSE AGGREGATE FROM WATERLINE TO MUDLINE.

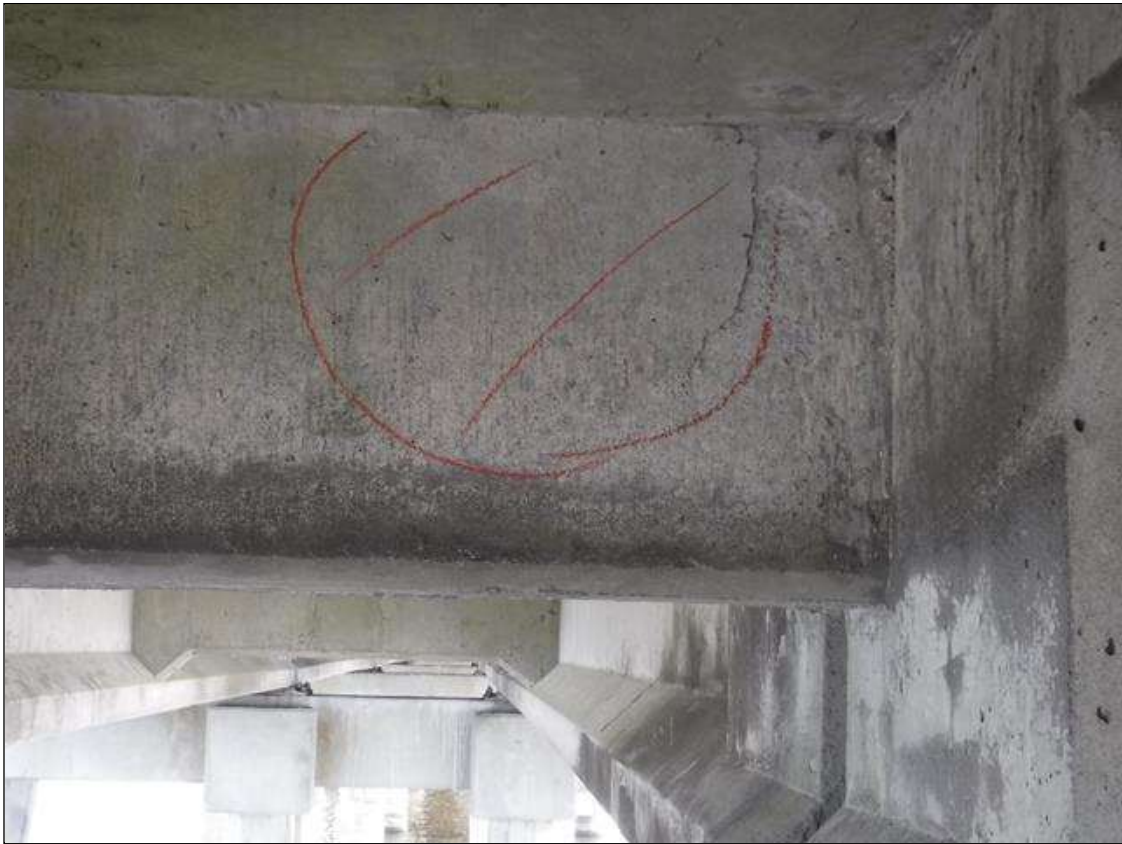
Span 230 Beam 2: 18" DIAMETER DELAMINATION ON END DIAPHRAGM BETWEEN BEAMS 2 AND 3 AT BENT 230

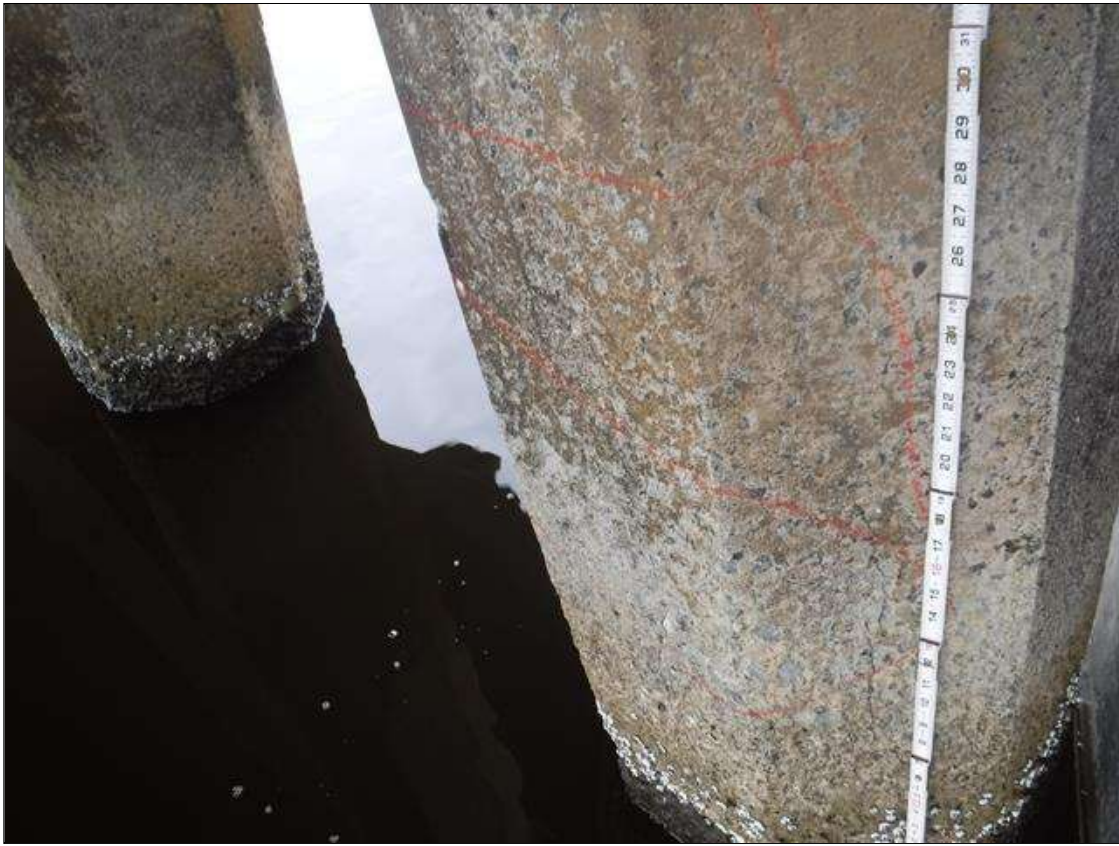
Bent 247 Pile 3: (PAR) (3) UP TO 4' X 0.03" VERTICAL CRACKS ON EAST AND SOUTH FACES WITH 3' X 2' SURROUNDING DELAMINATION ON SOUTH FACE, BEGINNING 6' FROM BOTTOM OF CAP, AT RANDOM THROUGHOUT.

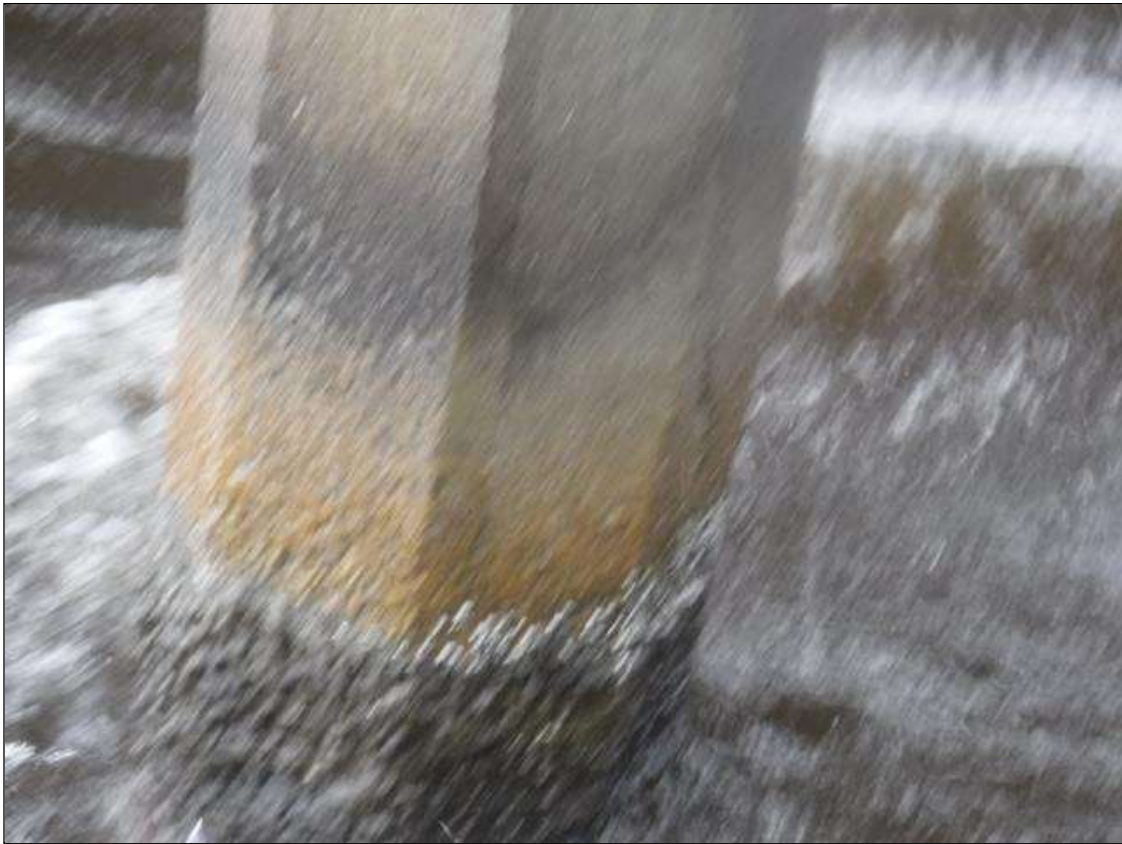
Bent 88 Pile 1: (PAR) UP TO 3' X 0.06" VERTICAL CRACKS WITH 4' X 2' DELAMINATION ON NORTH AND WEST FACE, BEGINNING 8' BOTTOM OF CAP.
