NC DEPARTMENT OF TRANSPORTATION
DIVISION OF HIGHWAYS
STRUCTURE MANAGEMENT UNIT

Structure Safety Report

Routine Element Inspection - Contract

FEATURE INTERSECTED: ALLIGATOR RIVER

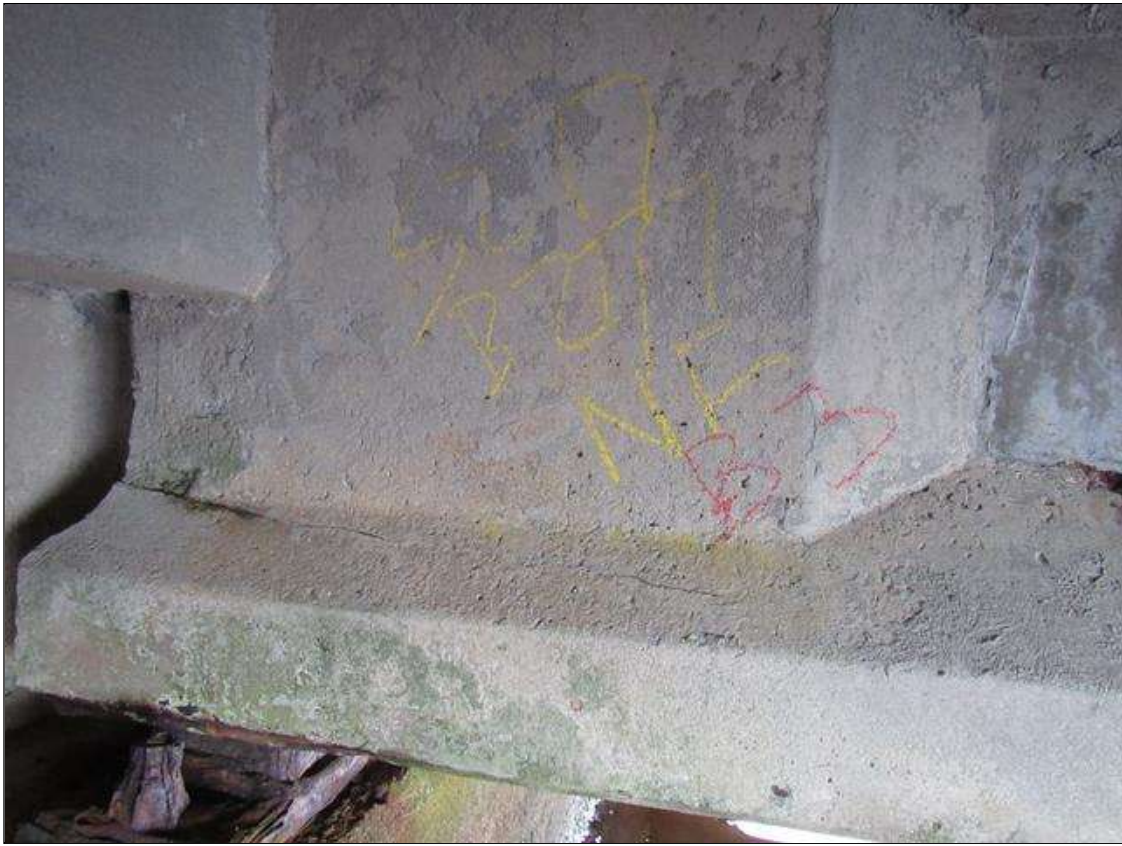
Span 277 Beam 3: UP TO 24" X 8" CRACKED DELAMINATION ON NORTH AND SOUTH FACES, AT BENT 277.

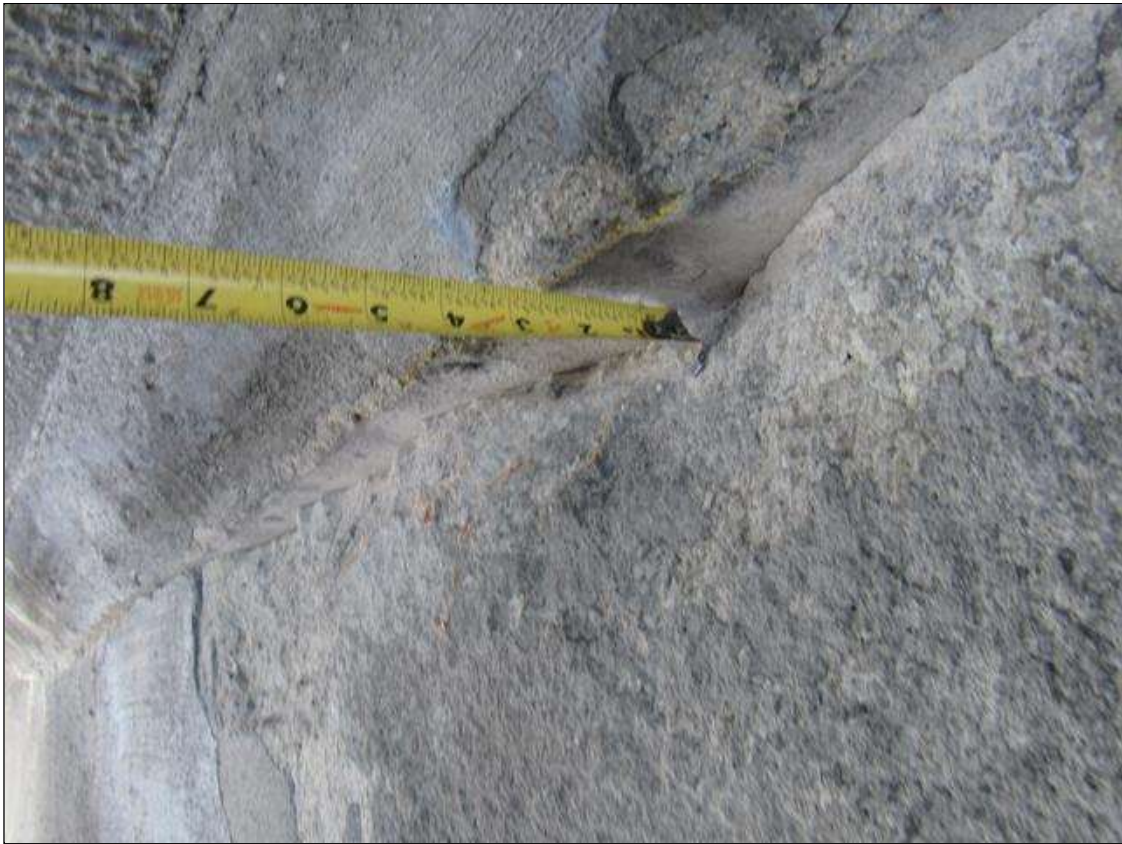
Bent 277 Cap 1: (PAR) 12' LONG X 18" HIGH X 2.5" DEEP SPALL LOCATED ON TOP EDGE OF EAST FACE, BEGINNING 8' FROM SOUTH END. SPALL CAUSING LOSS OF BEARING AREA IN SLAB.

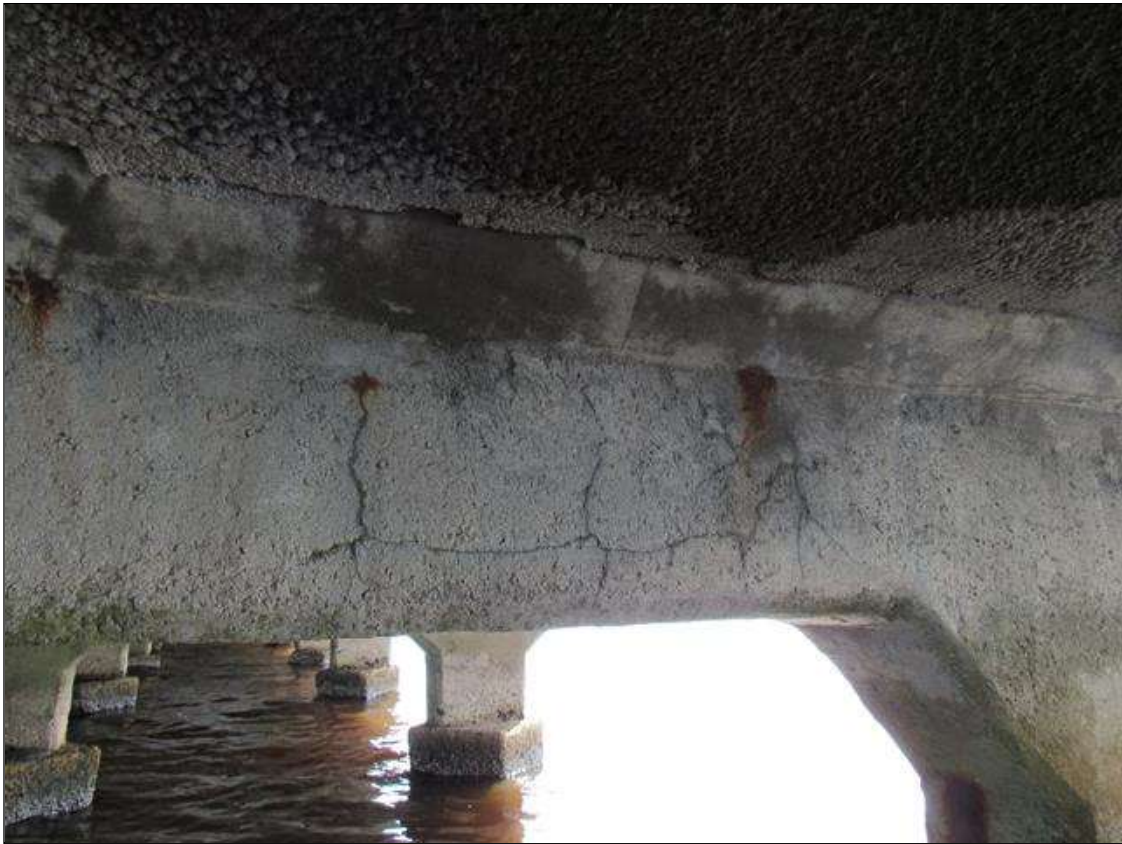
Bent 280 Cap 1: (PAR) 3' X 1' AREA OF UP TO 1/16" WIDE MAP CRACKING WITH RUST STAINING, WEST FACE, BAY 3.

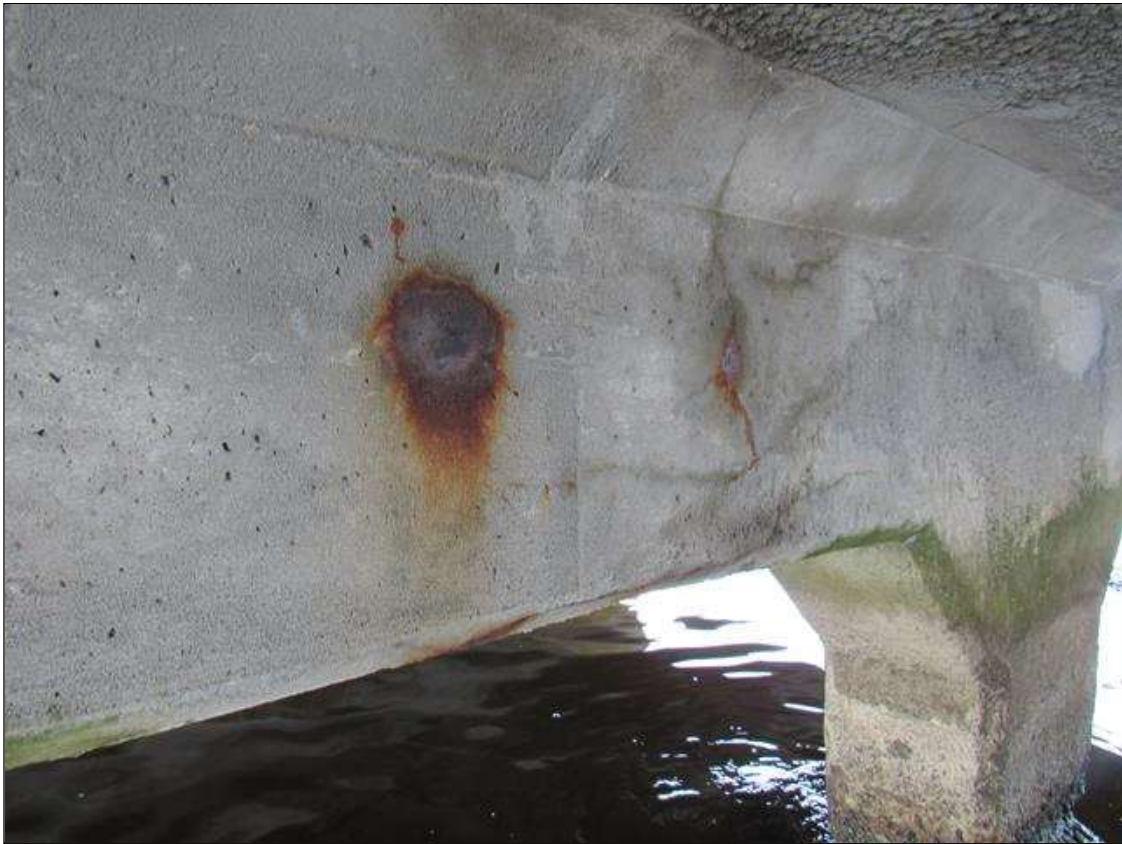
Bent 287 Cap 1: (PAR) 4' OF HAIRLINE TRANSVERSE AND LONGITUDINAL CRACKS, WITH RUST STAINING, AT RANDOM THROUGHOUT EAST FACE.

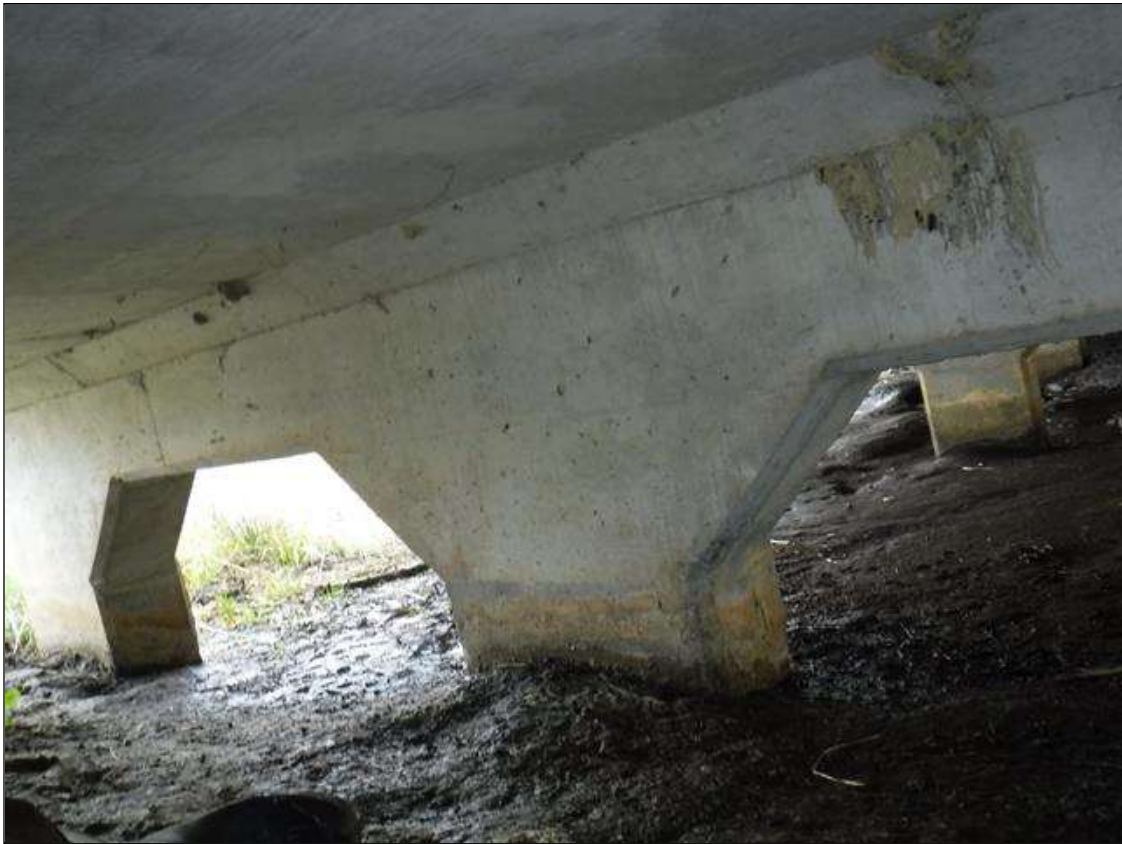
Bent 342 Cap 1: 4' LONG X UP TO 1/16" WIDE LONGITUDINAL CRACK ON EAST FACE LOCATED ABOVE PILE 3

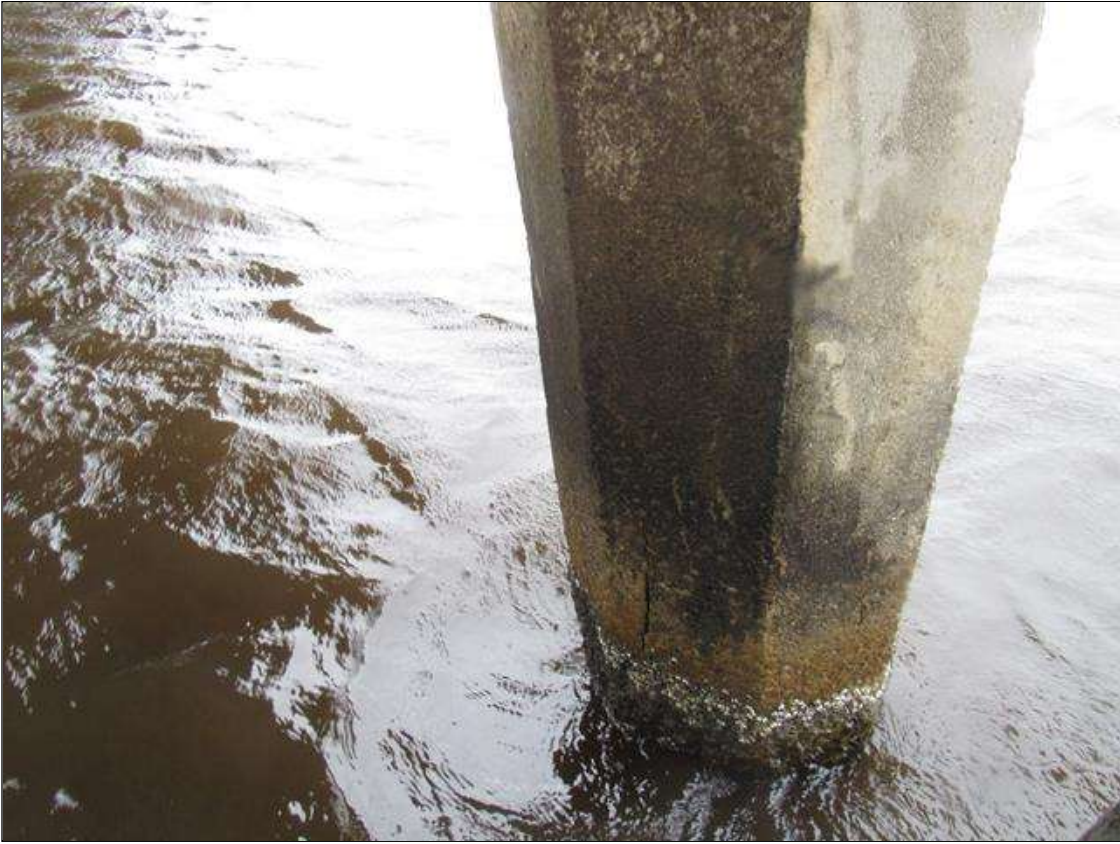
Bent 81 Pile 6: (PAR) 4' X 0.25" VERTICAL CRACK WITH SURROUNDING DELAMINATION ON NORTH FACE, BEGINNING 8' FROM BOTTOM OF CAP

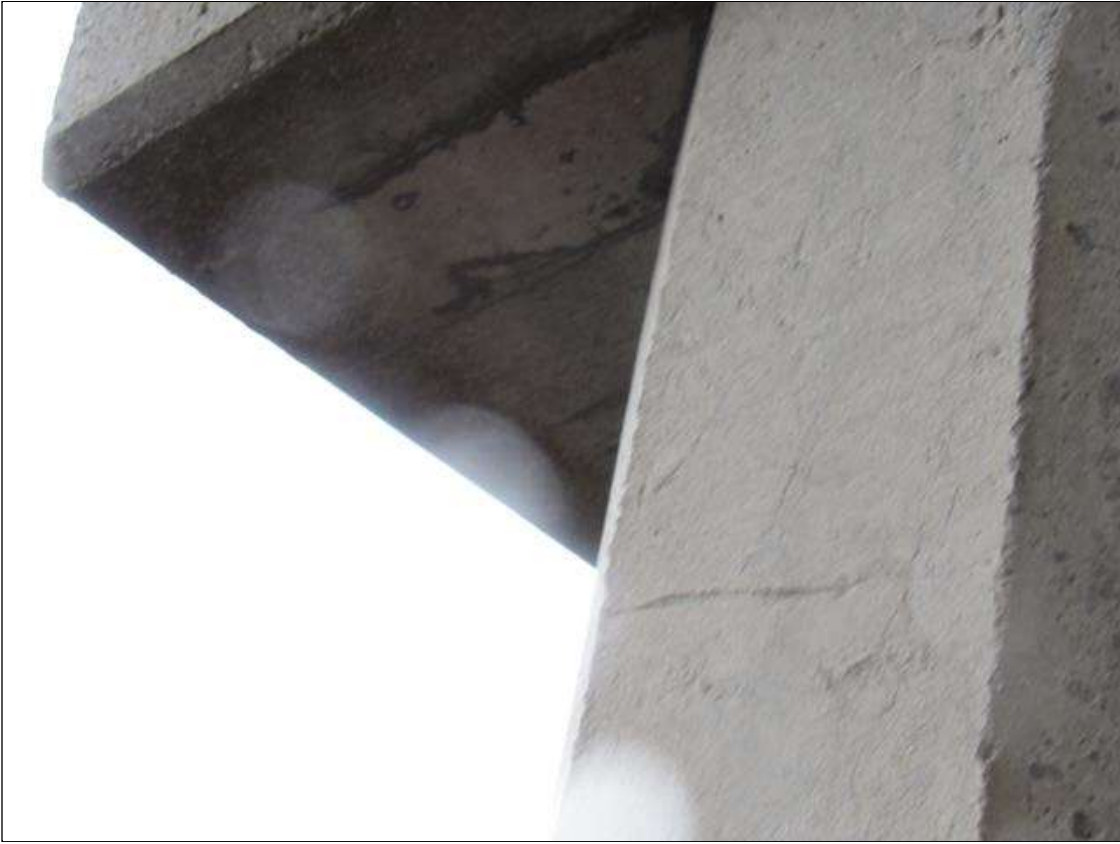
Bent 104 Pile 1: 5' X 9' AREA OF UP TO 0.009" MAP CRACKING, WEST FACE, BEGINNING AT BOTTOM OF CAP.

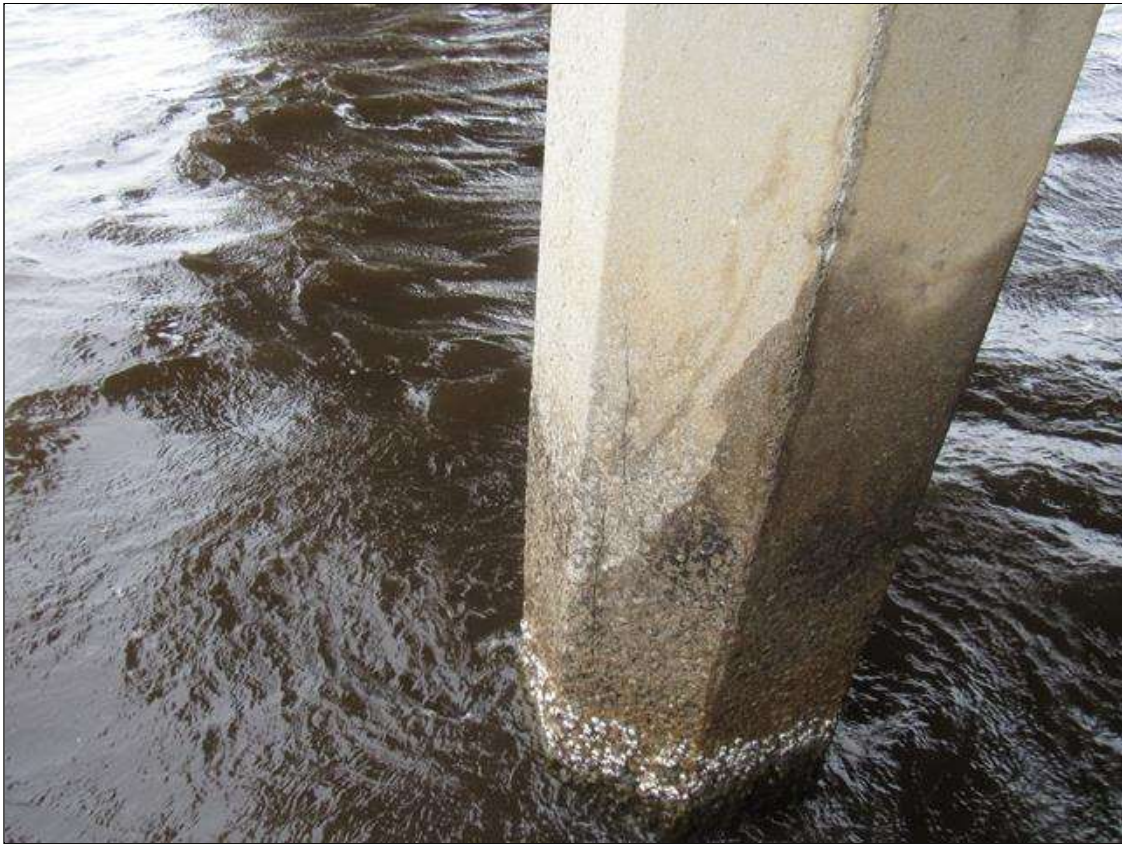
Bent 107 Pile 4: (PAR) (2) UP TO 3' X 0.02" VERTICAL CRACKS, SOUTH FACE, BEGINNING 9' FROM BOTTOM OF CAP, WITH ADJACENT 2' X UP TO 1' DELAMINATION.

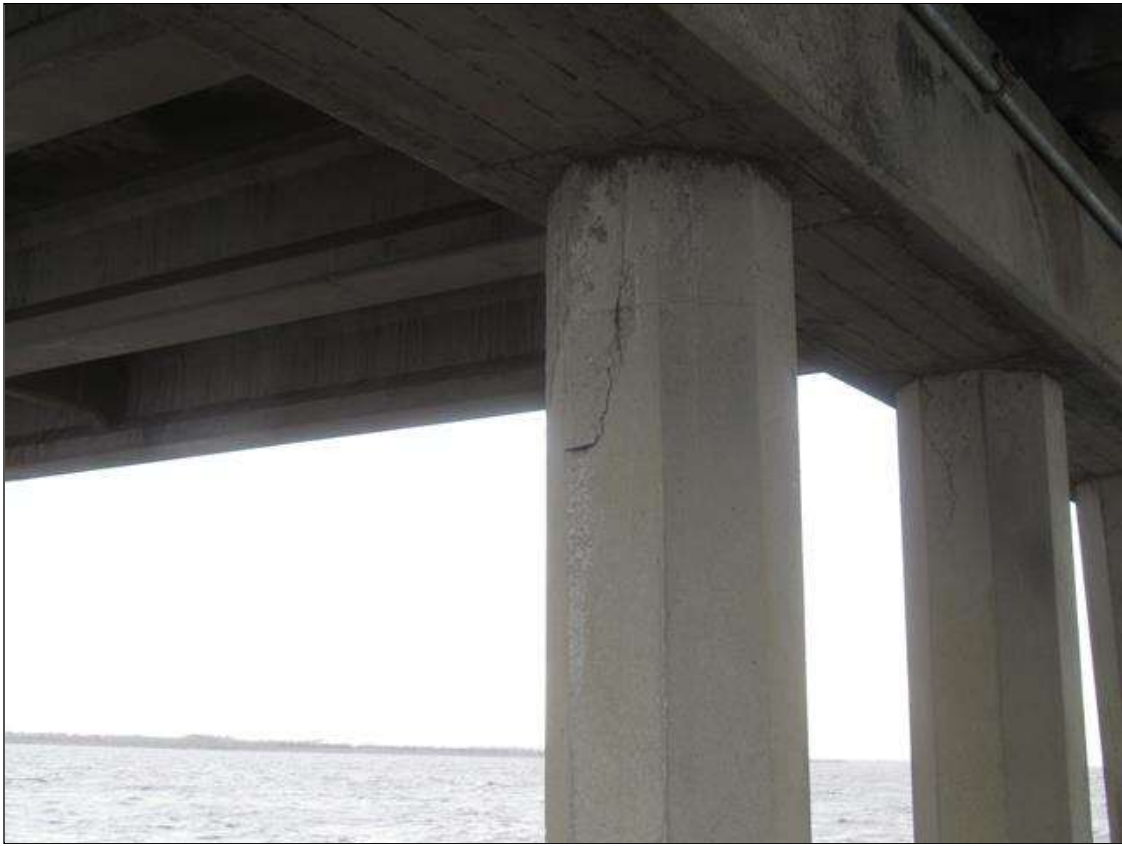
Bent 110 Pile 3: 2' X UP TO 6" X 1 1/2" DEEP SPALL ON SOUTH FACE WITH SURROUNDING DELAMINATION, AT BOTTOM OF CAP, SOUTH FACE.

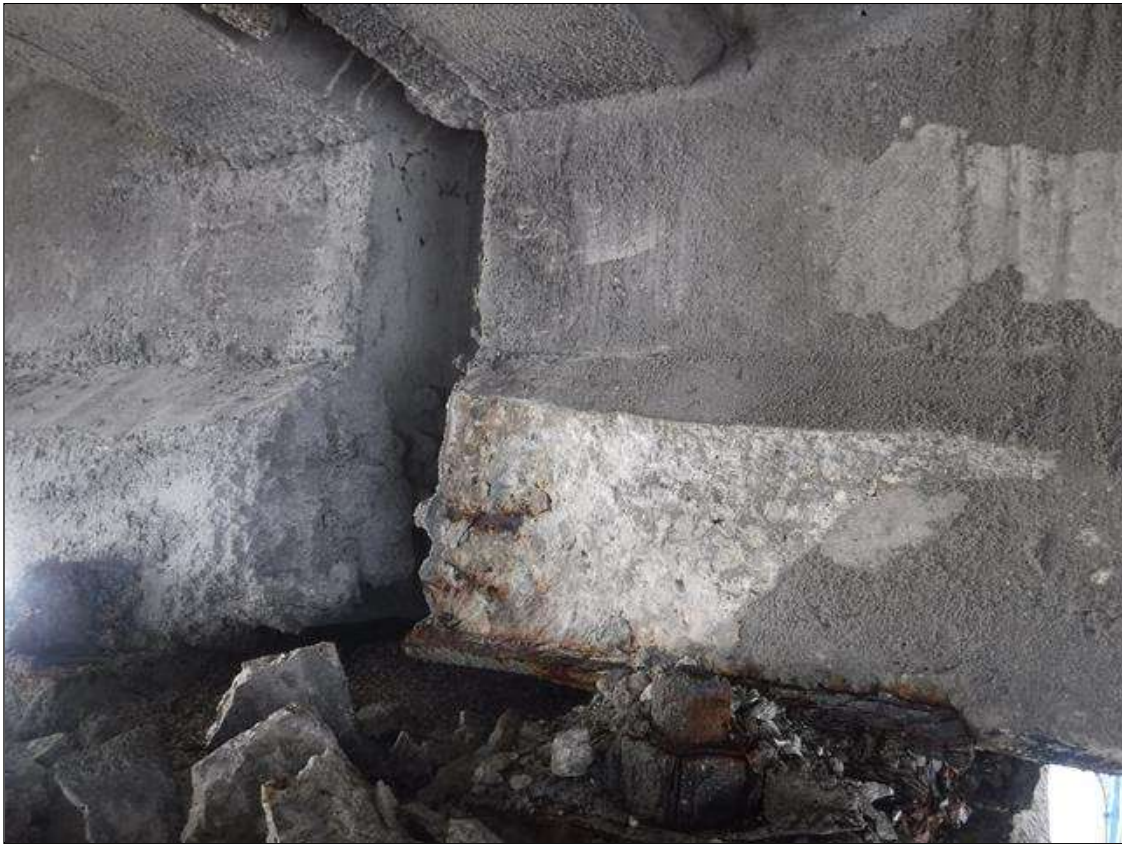
Span 76 Beam 3: (PAR) 15" X 6" X 3" DEEP SPALL WITH EXPOSED STRAND ON SOUTH FACE AT BENT 76

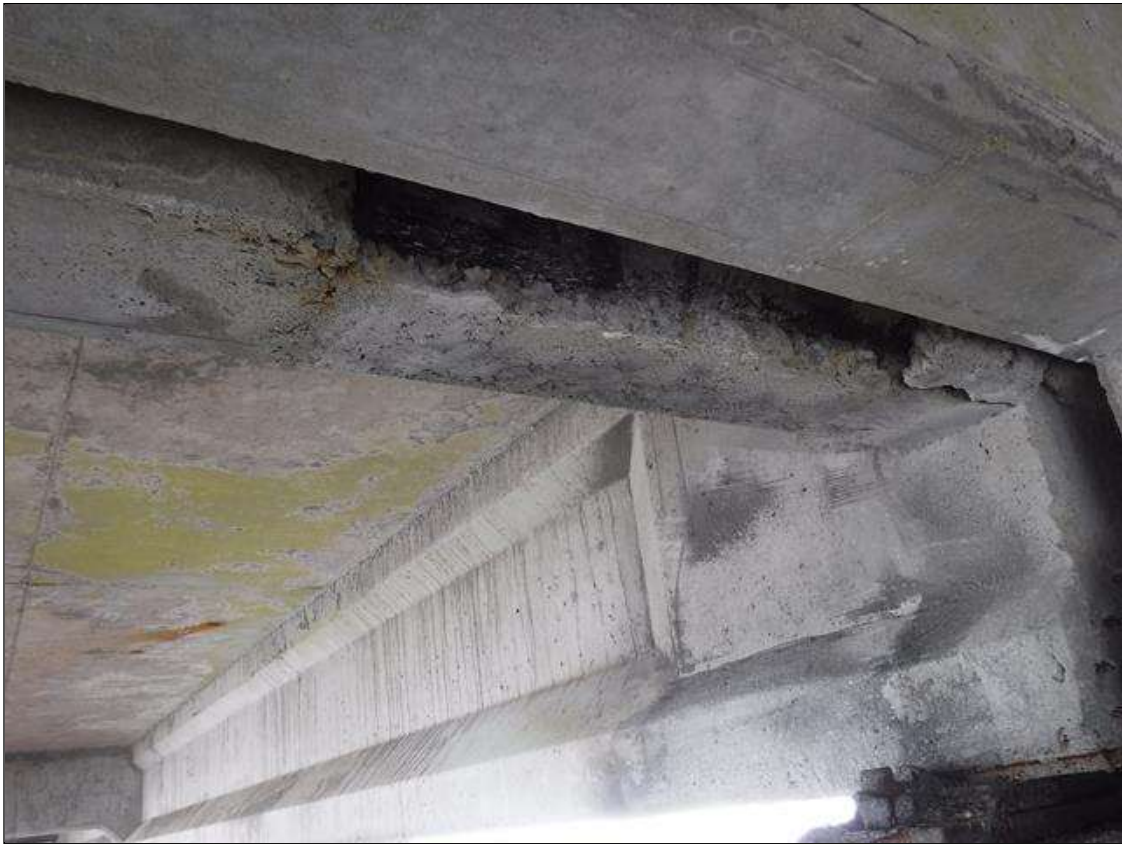
Span 89 Beam 1: (PAR) 3' X 3" X 6" SPALL WITH EXPOSED REBAR IN BAY 1 DIAPHRAGM AT BENT 88

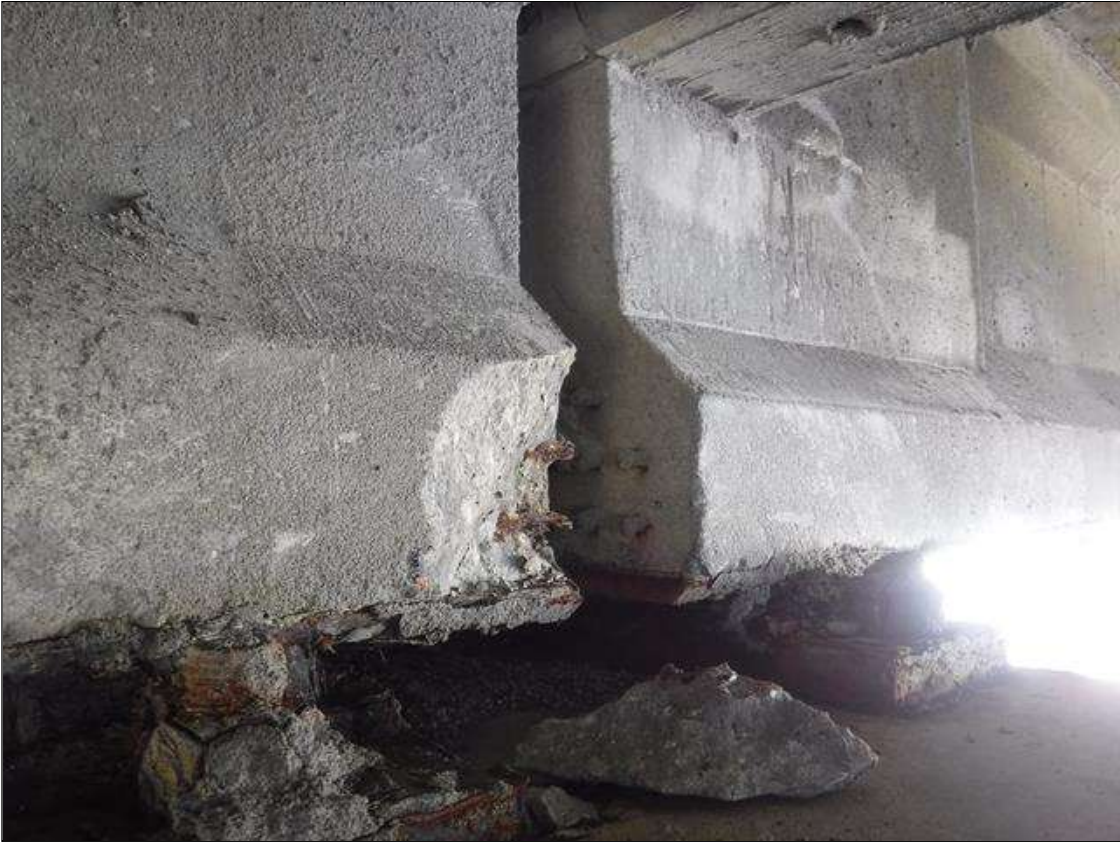
Span 118 Beam 2: (PAR) 6" X 6" X 2" DEEP SPALL WITH EXPOSED STRAND ON SOUTH FACE AT BENT 118
