NC DEPARTMENT OF TRANSPORTATION  
DIVISION OF HIGHWAYS  
STRUCTURE MANAGEMENT UNIT

## Structure Safety Report

### 4 Year Underwater Element Inspection

DIVISION: 1 COUNTY: TYRRELL STRUCTURE NUMBER: 880007 FREQUENCY: 48 MONTHS

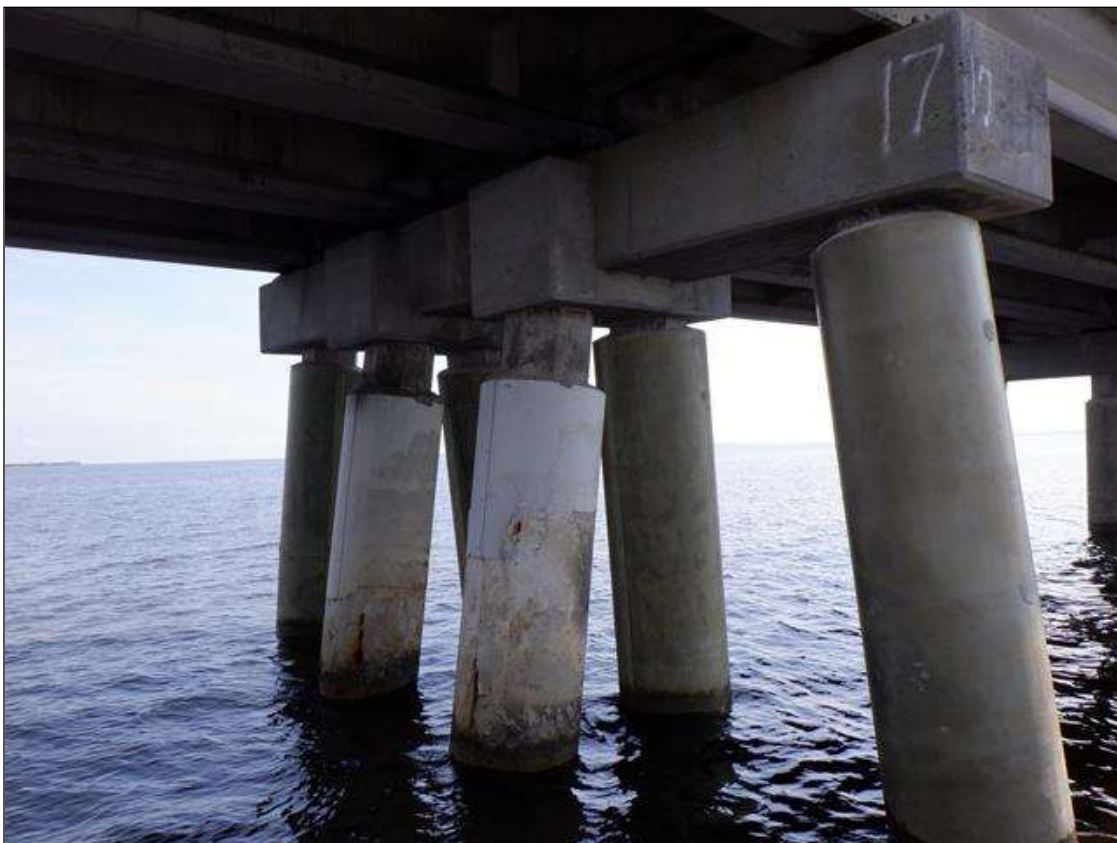
BENT 17 ALL PILES JACKETED, P-2 & P-4 JACKETES ARE IN POOR CONDITION

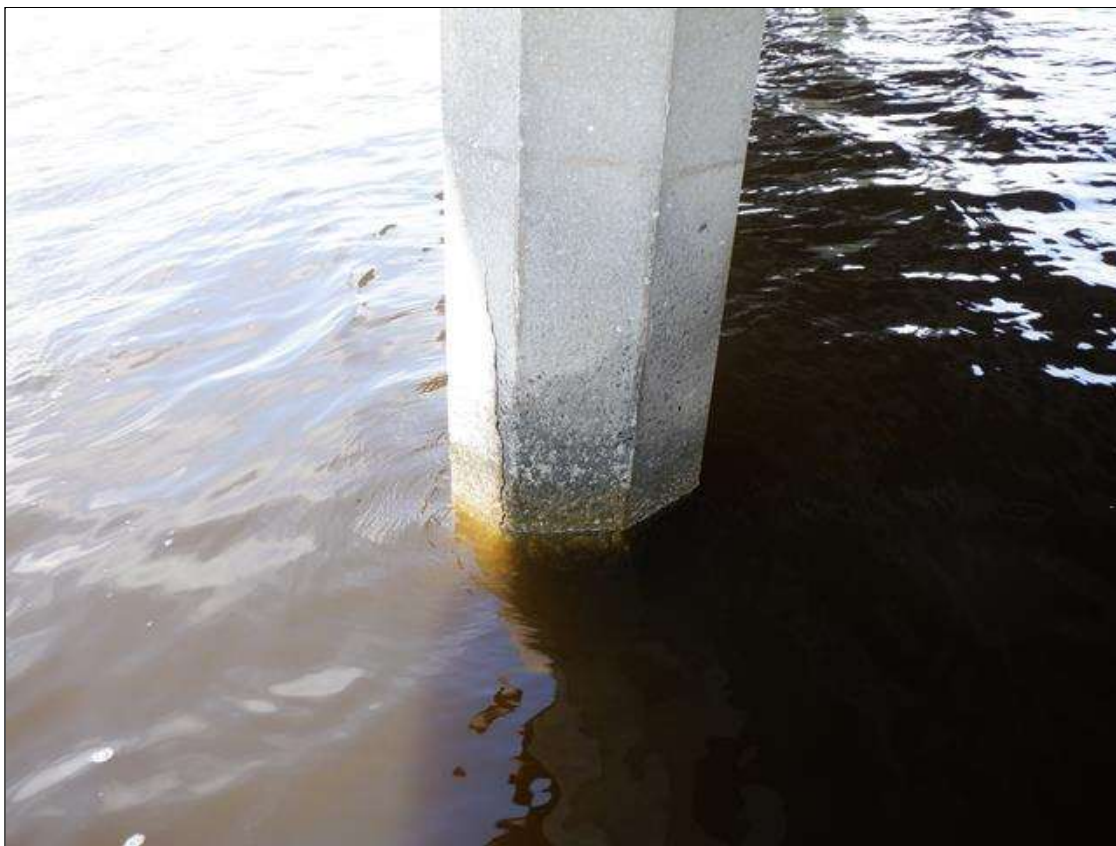
Bent 19 Saved Pile 4: UW (PAR): H/L TO 1/8" CRACKS MULTIPLE FACES, FROM ABOVE THE HIGH WATER MARK DOWN THROUGH THE SPASH ZONE AND TAPERING TO HAIRLINE 1' TO 3' BELOW THE WATERLINE. SCALING TO 1" DEEP FROM WATERLINE TO MUDLINE.

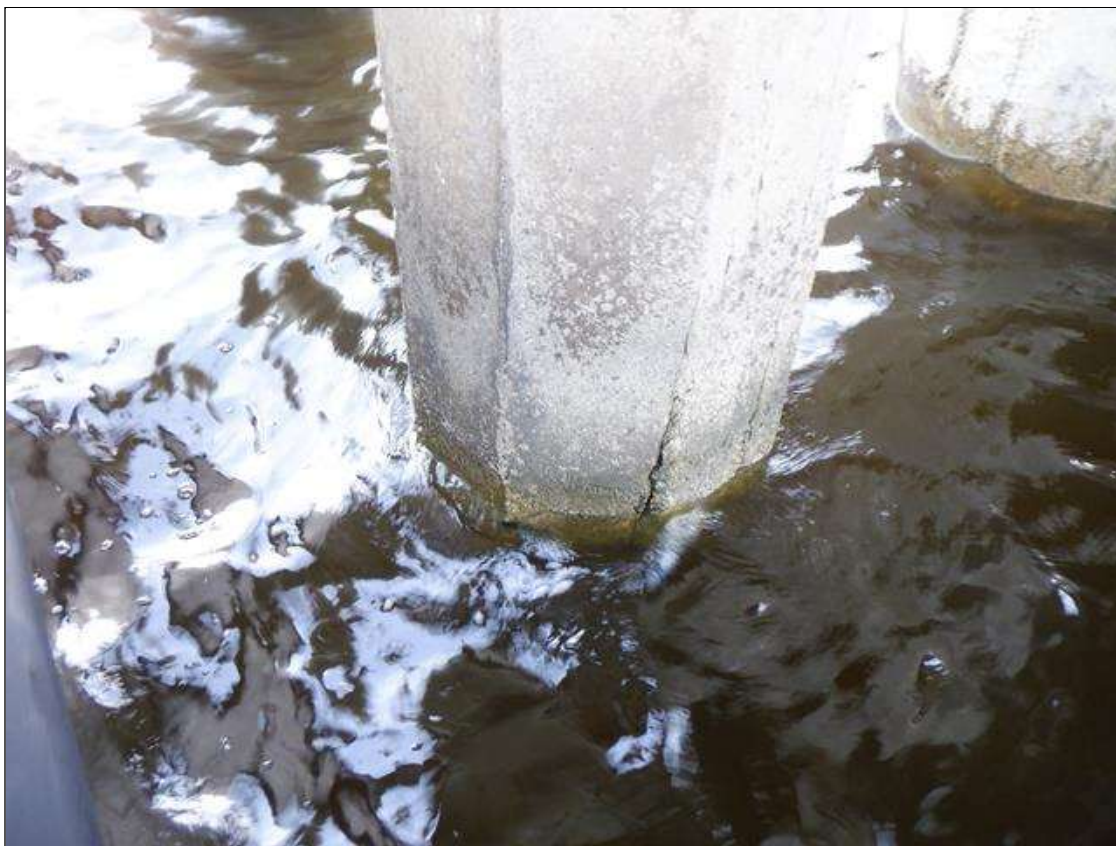
Bent 21 Saved Pile 5: UW (PAR): H/L TO 1/8" CRACKS MULTIPLE FACES, FROM ABOVE THE HIGH WATER MARK DOWN THROUGH THE SPASH ZONE AND TAPERING TO HAIRLINE 1' TO 3' BELOW THE WATERLINE. SCALING TO 1" DEEP FROM WATERLINE TO MUDLINE.

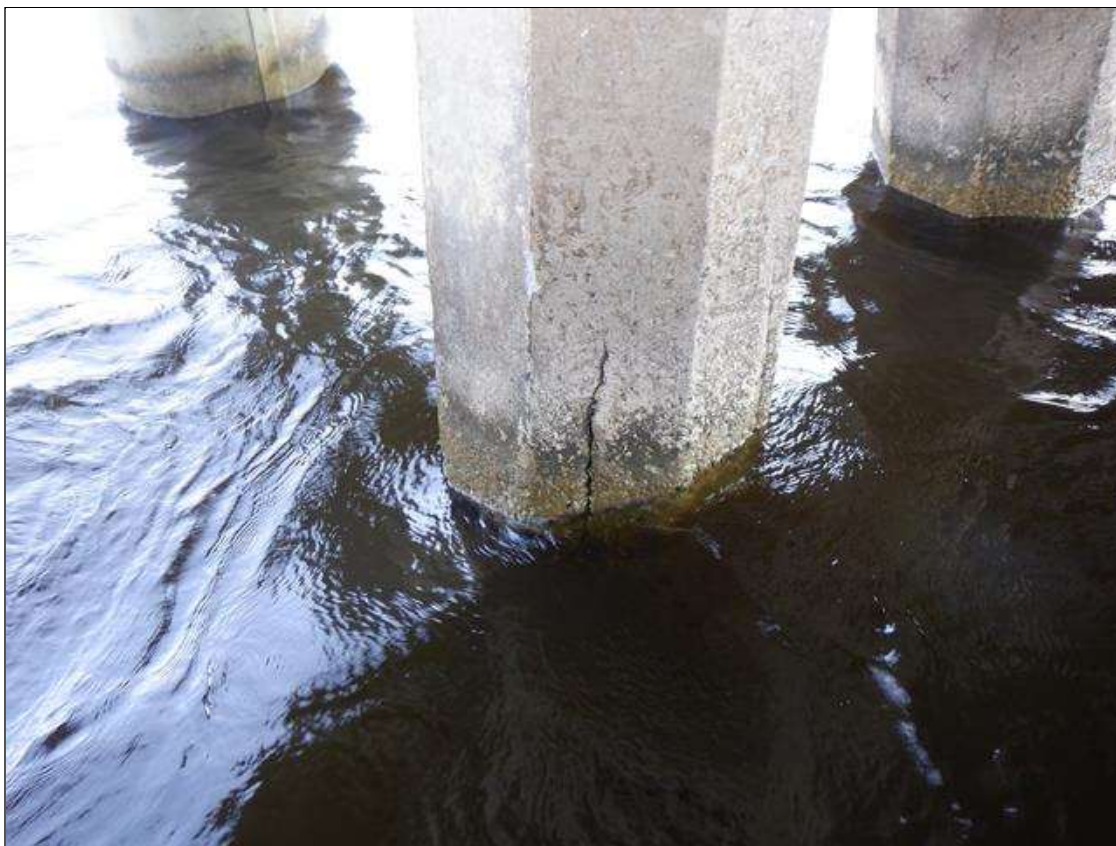
Bent 25 Saved Pile 2: UW (PAR): H/L TO 1/8" CRACKS MULTIPLE FACES, FROM ABOVE THE HIGH WATER MARK DOWN THROUGH THE SPASH ZONE AND TAPERING TO HAIRLINE 1' TO 3' BELOW THE WATERLINE. SCALING TO 1" DEEP FROM WATERLINE TO MUDLINE.

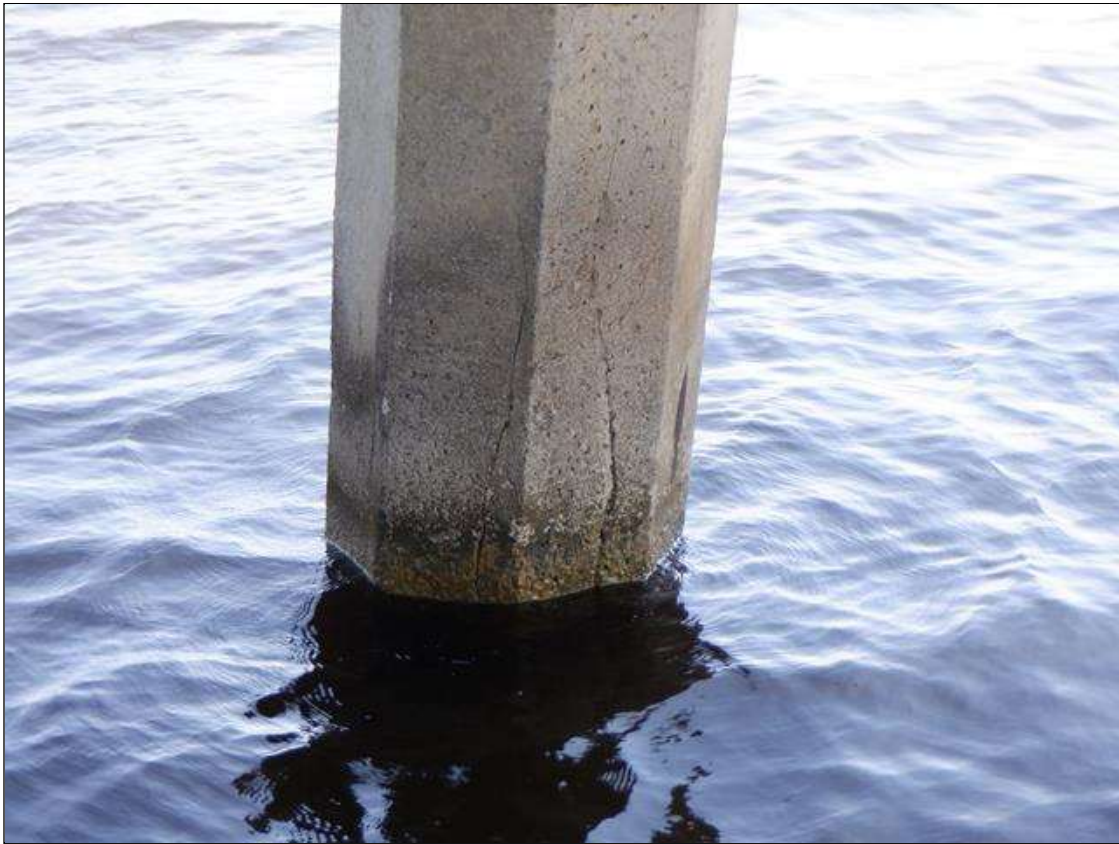
Bent 27 Saved Pile 1: UW (PAR): H/L TO 1/8" CRACKS MULTIPLE FACES, FROM ABOVE THE HIGH WATER MARK DOWN THROUGH THE SPASH ZONE AND TAPERING TO HAIRLINE 1' TO 3' BELOW THE WATERLINE. SCALING TO 1" DEEP FROM WATERLINE TO MUDLINE.

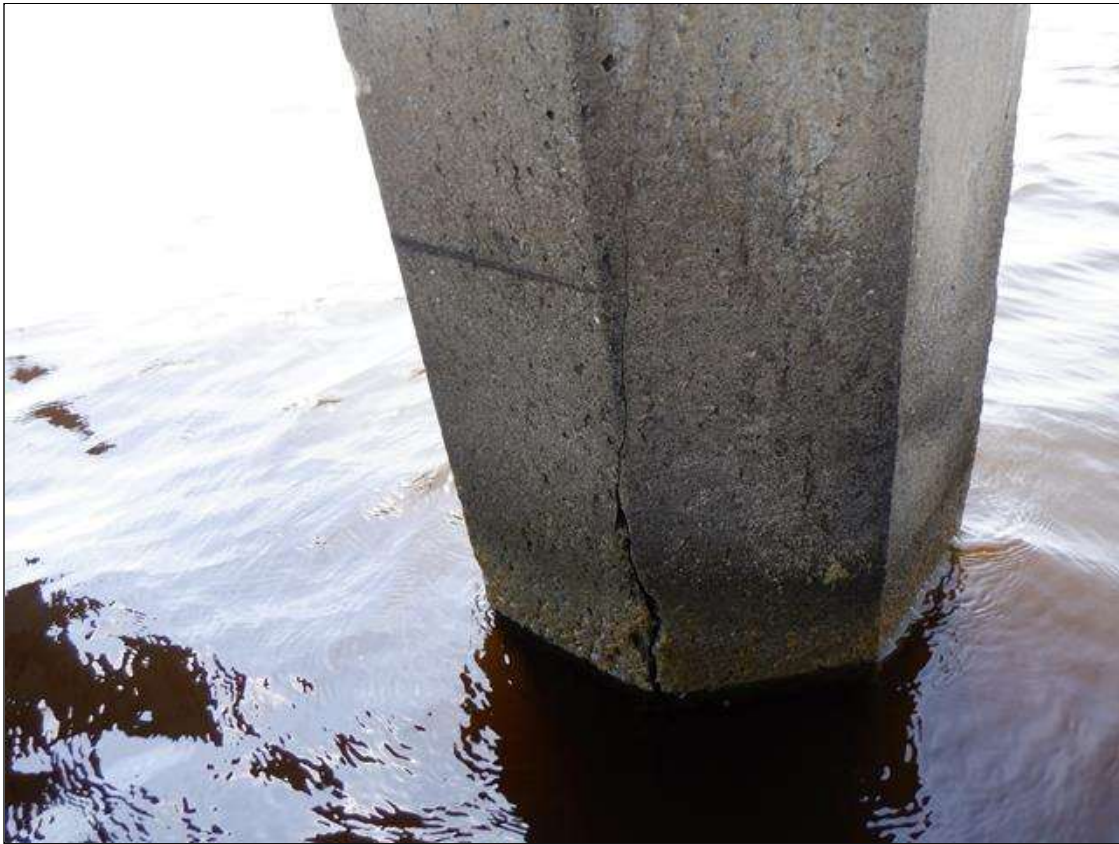
Bent 27 Saved Pile 4: UW (PAR): H/L TO 1/8" CRACKS MULTIPLE FACES, FROM ABOVE THE HIGH WATER MARK DOWN THROUGH THE SPASH ZONE AND TAPERING TO HAIRLINE 1' TO 3' BELOW THE WATERLINE. SCALING TO 1" DEEP FROM WATERLINE TO MUDLINE.

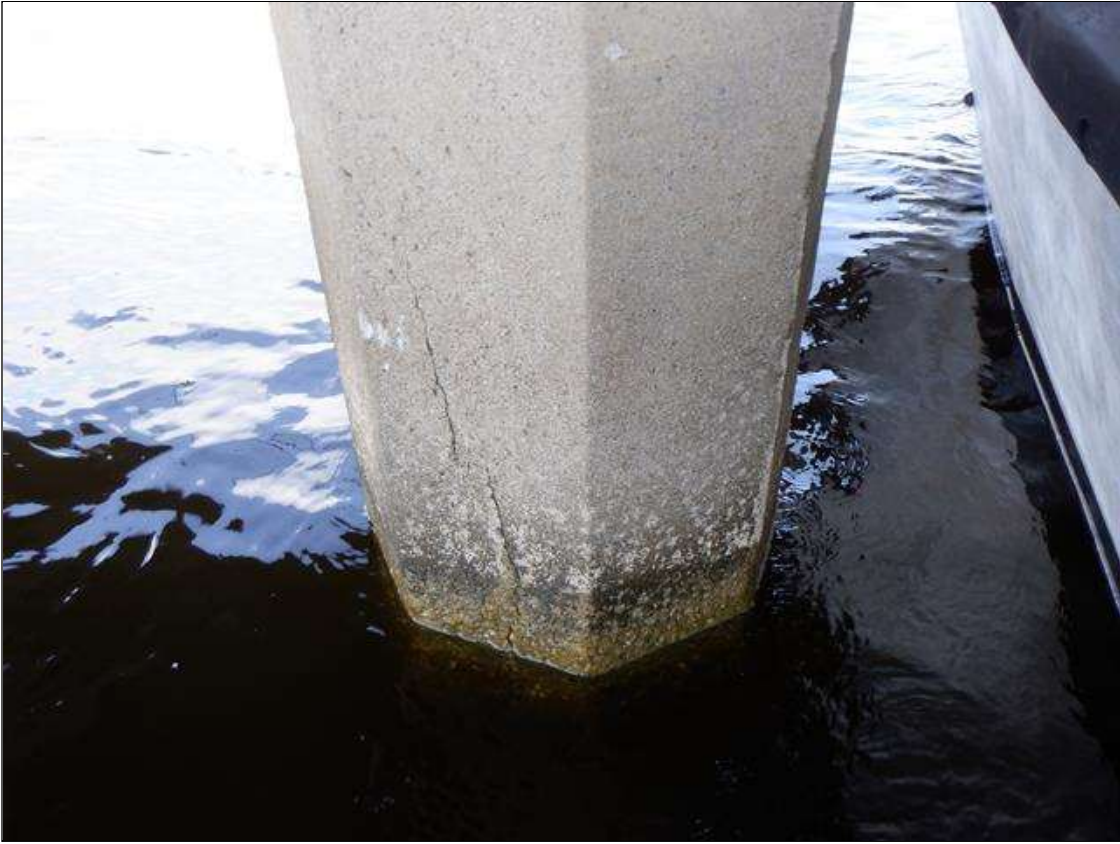
Bent 28 Saved Pile 2: UW (PAR): H/L TO 1/8" CRACKS MULTIPLE FACES, FROM ABOVE THE HIGH WATER MARK DOWN THROUGH THE SPASH ZONE AND TAPERING TO HAIRLINE 1' TO 3' BELOW THE WATERLINE. SCALING TO 1" DEEP FROM WATERLINE TO MUDLINE.

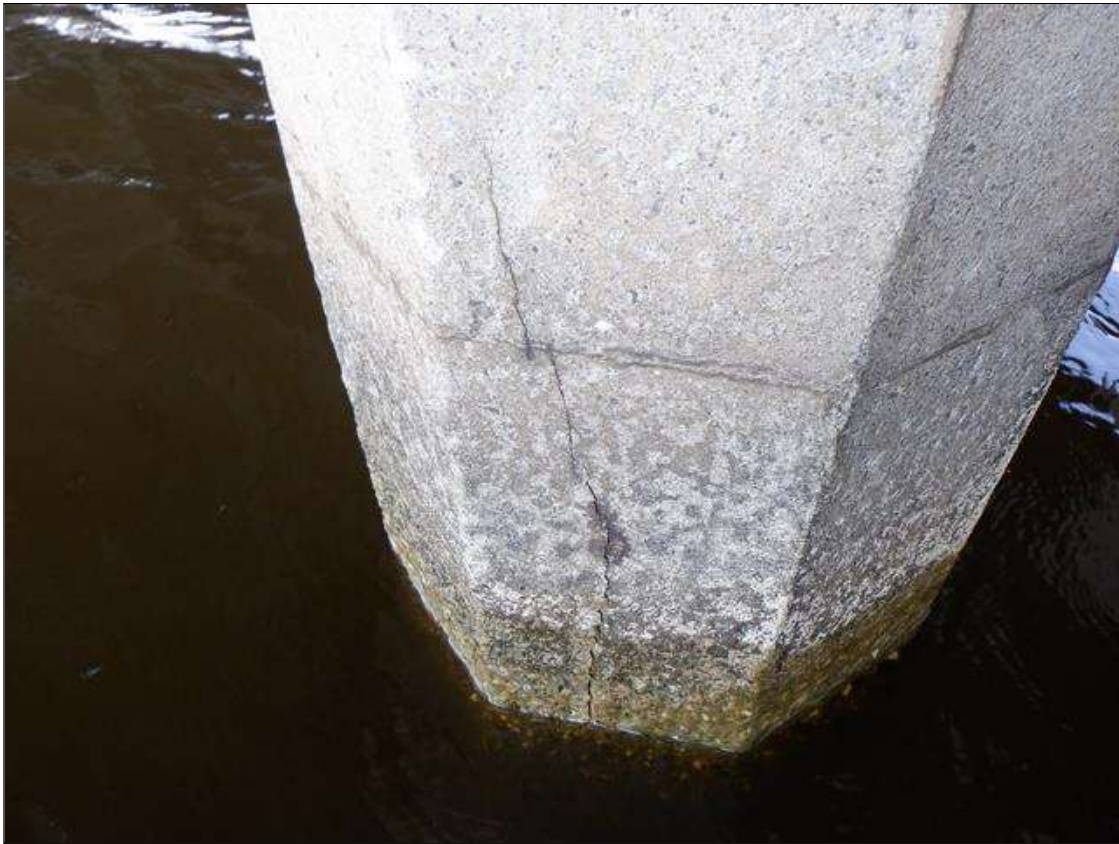
Bent 28 Saved Pile 3: UW (PAR): H/L TO 1/8" CRACKS MULTIPLE FACES, FROM ABOVE THE HIGH WATER MARK DOWN THROUGH THE SPASH ZONE AND TAPERING TO HAIRLINE 1' TO 3' BELOW THE WATERLINE. SCALING TO 1" DEEP FROM WATERLINE TO MUDLINE.

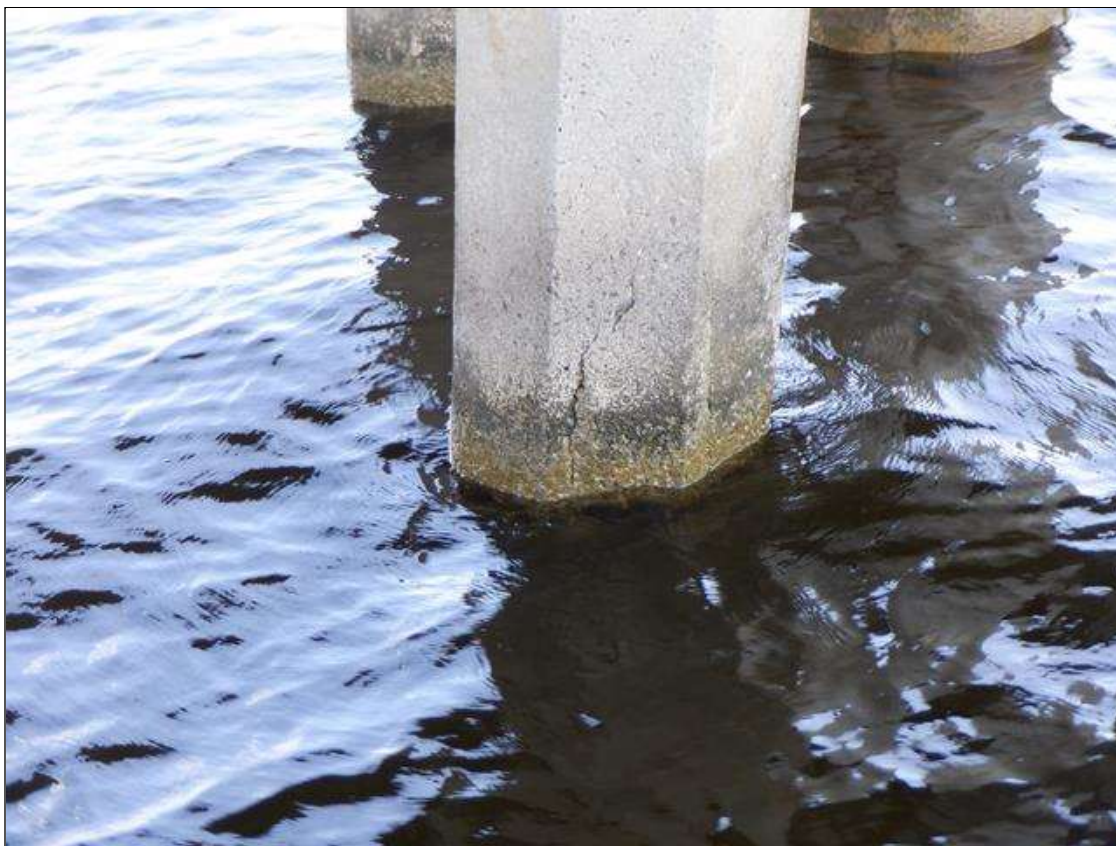
Bent 29 Saved Pile 4: UW (PAR): H/L TO 1/8" CRACKS MULTIPLE FACES, FROM ABOVE THE HIGH WATER MARK DOWN THROUGH THE SPASH ZONE AND TAPERING TO HAIRLINE 1' TO 3' BELOW THE WATERLINE. SCALING TO 1" DEEP FROM WATERLINE TO MUDLINE.

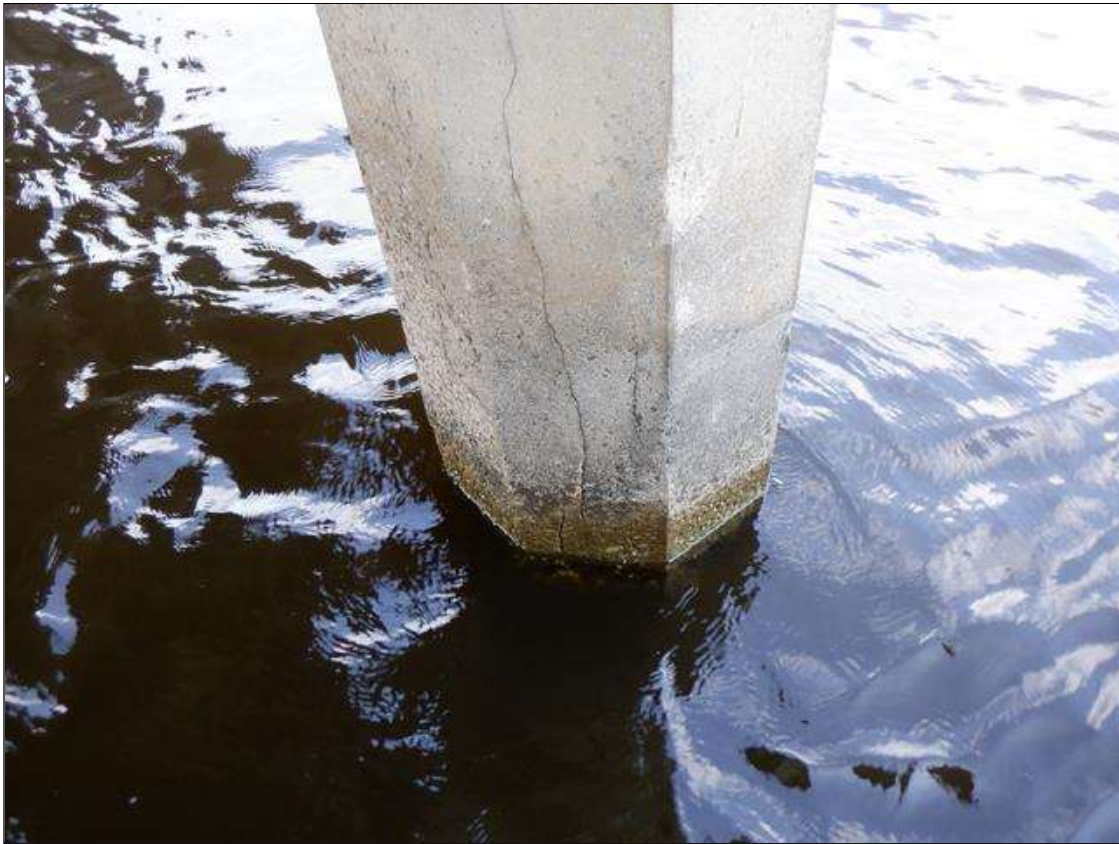
Bent 31 Saved Pile 1: UW (PAR): H/L TO 1/8" CRACKS MULTIPLE FACES, FROM ABOVE THE HIGH WATER MARK DOWN THROUGH THE SPASH ZONE AND TAPERING TO HAIRLINE 1' TO 3' BELOW THE WATERLINE. SCALING TO 1" DEEP FROM WATERLINE TO MUDLINE.

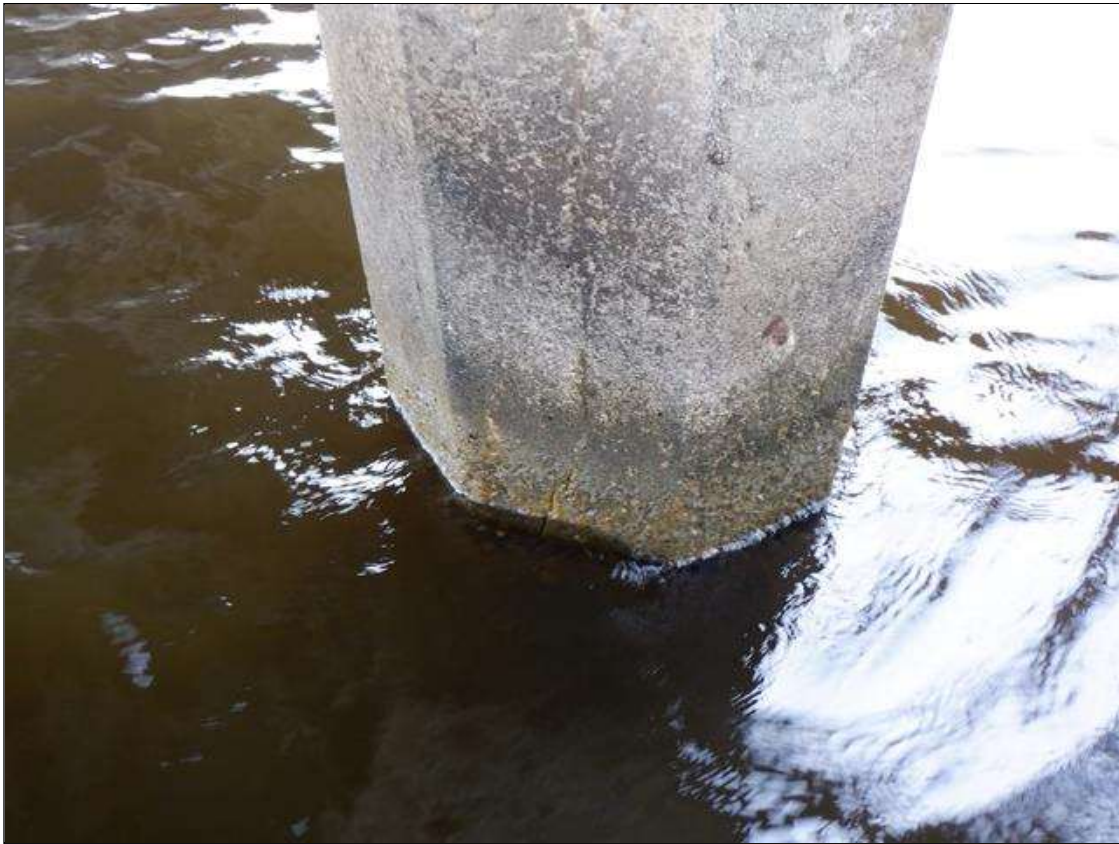
Bent 31 Saved Pile 3: UW (PAR): H/L TO 1/8" CRACKS MULTIPLE FACES, FROM ABOVE THE HIGH WATER MARK DOWN THROUGH THE SPASH ZONE AND TAPERING TO HAIRLINE 1' TO 3' BELOW THE WATERLINE. SCALING TO 1" DEEP FROM WATERLINE TO MUDLINE.

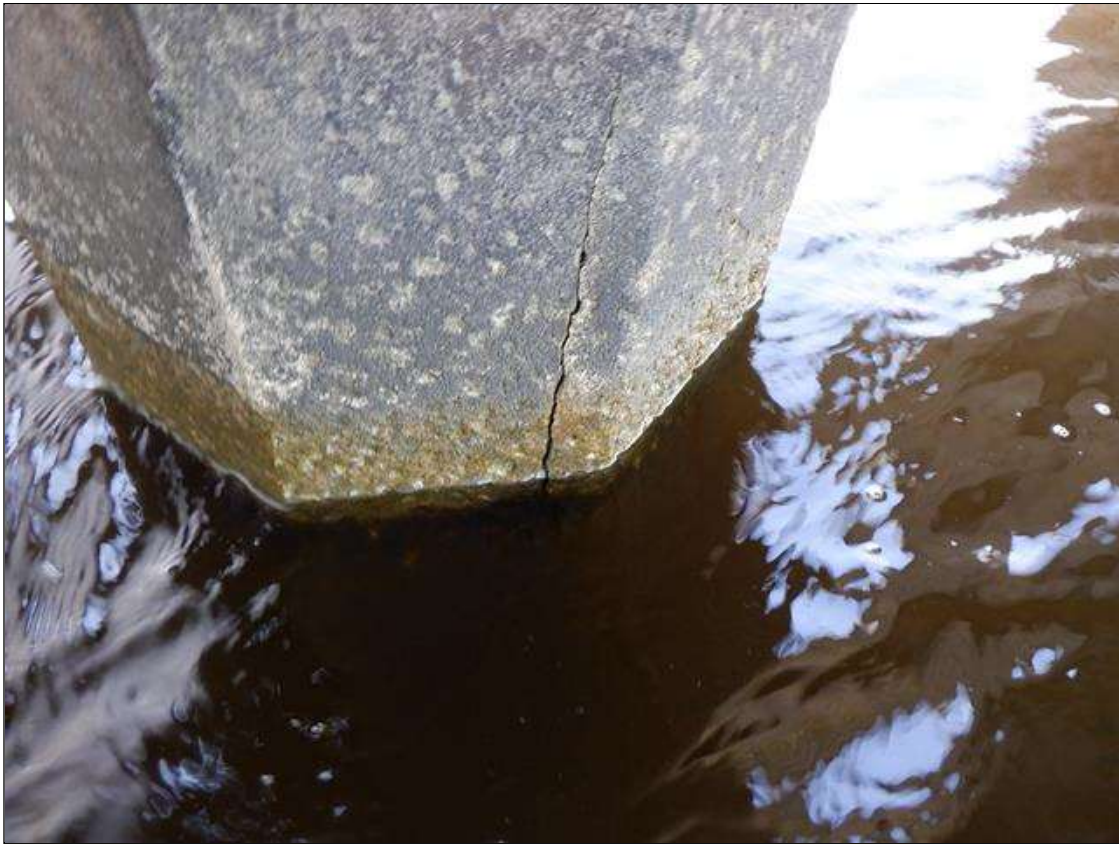
Bent 40 Saved Pile 4: UW (PAR): H/L TO 1/8" CRACKS MULTIPLE FACES, FROM ABOVE THE HIGH WATER MARK DOWN THROUGH THE SPASH ZONE AND TAPERING TO HAIRLINE 1' TO 3' BELOW THE WATERLINE. SCALING TO 1" DEEP FROM WATERLINE TO MUDLINE.

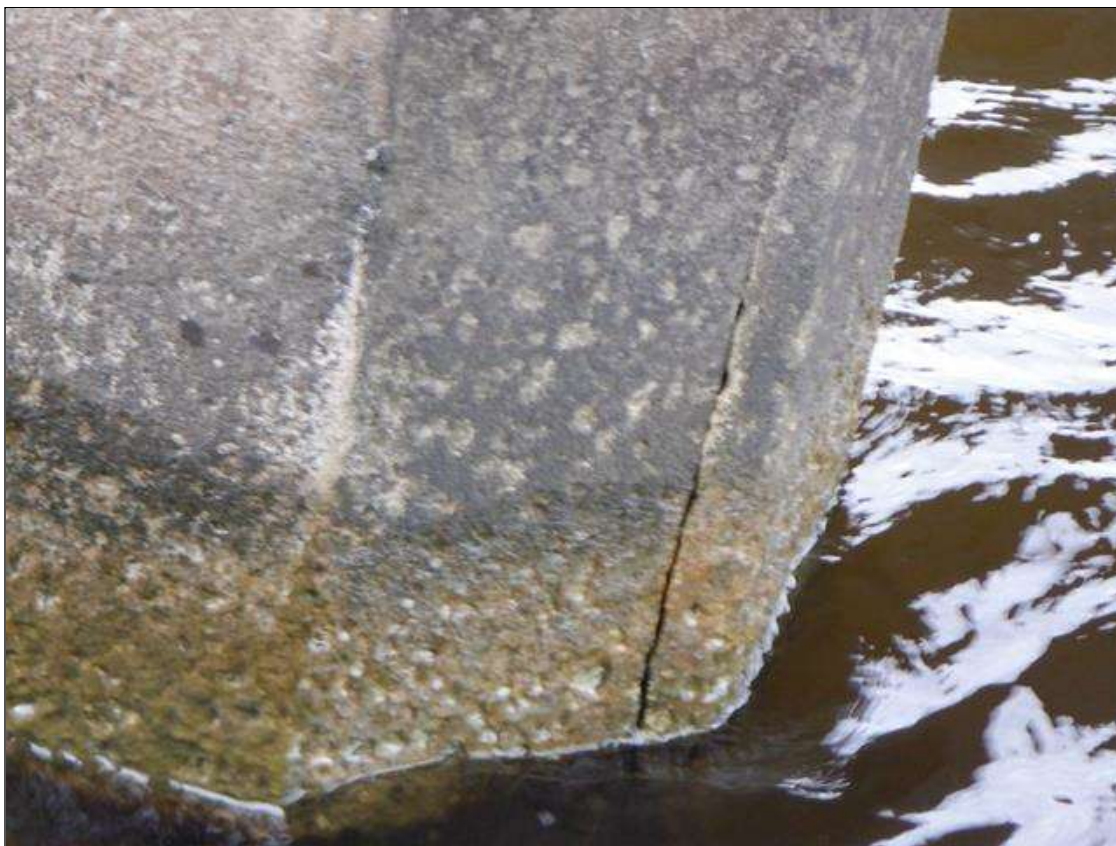
Bent 43 Saved Pile 4: UW (PAR): H/L TO 1/8" CRACKS MULTIPLE FACES, FROM ABOVE THE HIGH WATER MARK DOWN THROUGH THE SPASH ZONE AND TAPERING TO HAIRLINE 1' TO 3' BELOW THE WATERLINE. SCALING TO 1" DEEP FROM WATERLINE TO MUDLINE.

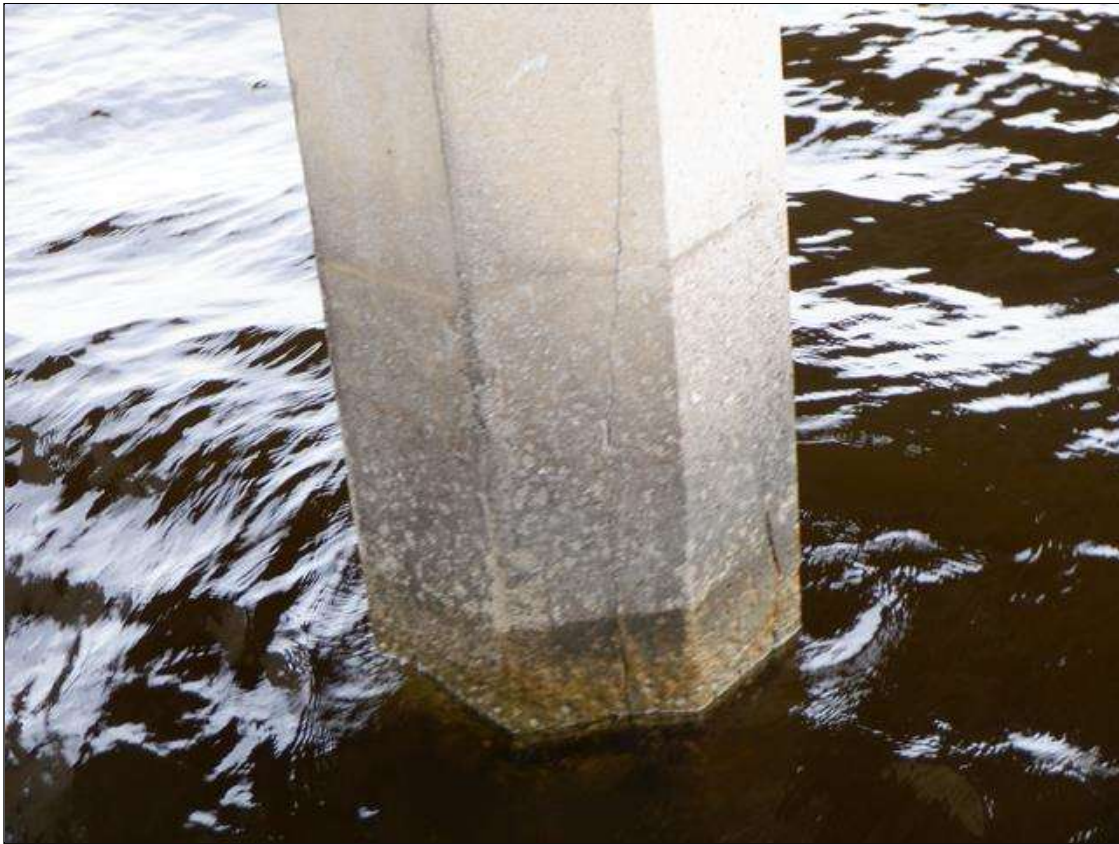
Bent 46 Saved Pile 2: UW (PAR): H/L TO 1/8" CRACKS MULTIPLE FACES, FROM ABOVE THE HIGH WATER MARK DOWN THROUGH THE SPASH ZONE AND TAPERING TO HAIRLINE 1' TO 3' BELOW THE WATERLINE. SCALING TO 1" DEEP FROM WATERLINE TO MUDLINE.

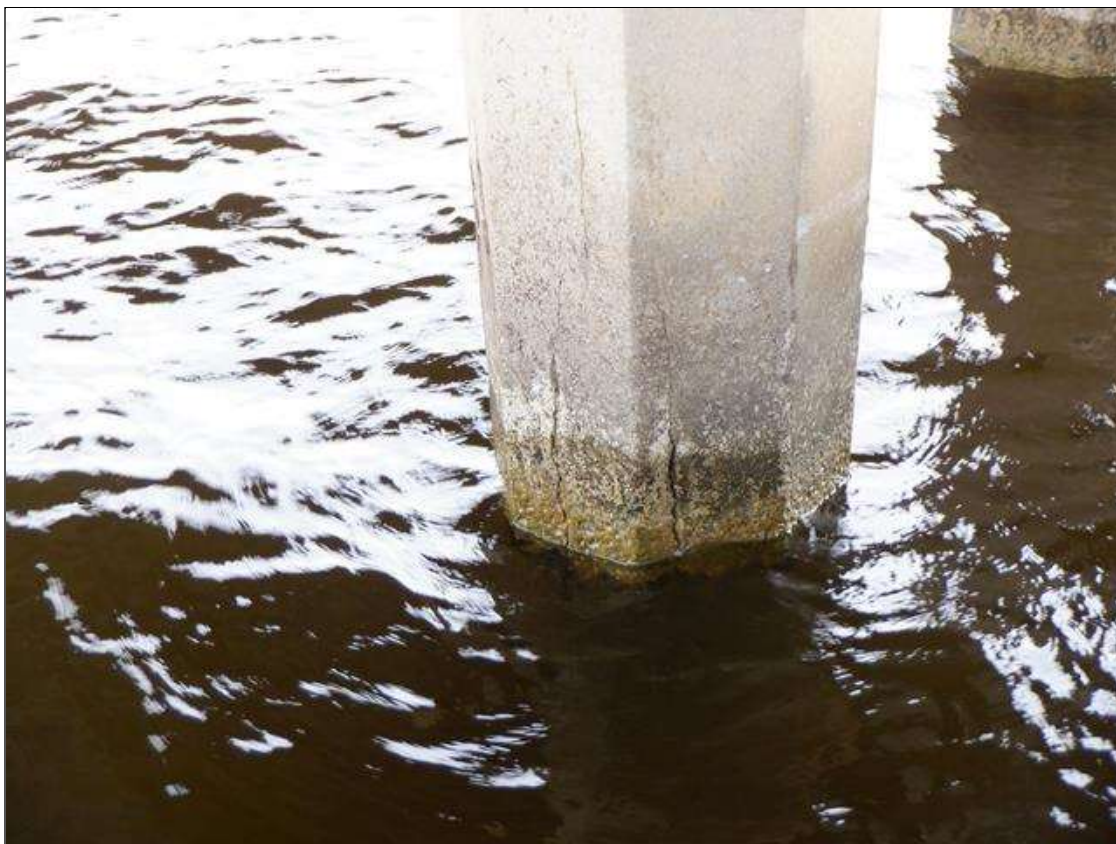
Bent 47 Saved Pile 3: UW (PAR): H/L TO 1/8" CRACKS MULTIPLE FACES, FROM ABOVE THE HIGH WATER MARK DOWN THROUGH THE SPASH ZONE AND TAPERING TO HAIRLINE 1' TO 3' BELOW THE WATERLINE. SCALING TO 1" DEEP FROM WATERLINE TO MUDLINE.

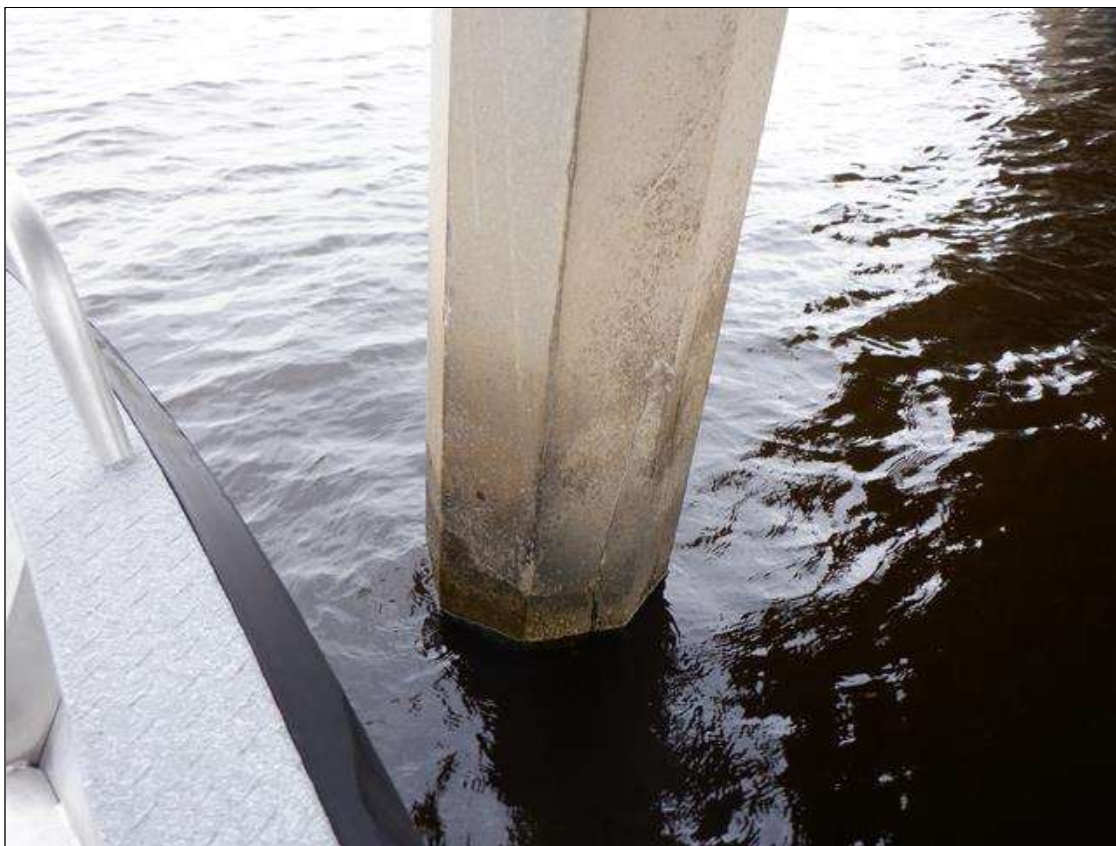
Bent 47 Saved Pile 4: UW (PAR): H/L TO 1/8" CRACKS MULTIPLE FACES, FROM ABOVE THE HIGH WATER MARK DOWN THROUGH THE SPASH ZONE AND TAPERING TO HAIRLINE 1' TO 3' BELOW THE WATERLINE. SCALING TO 1" DEEP FROM WATERLINE TO MUDLINE.

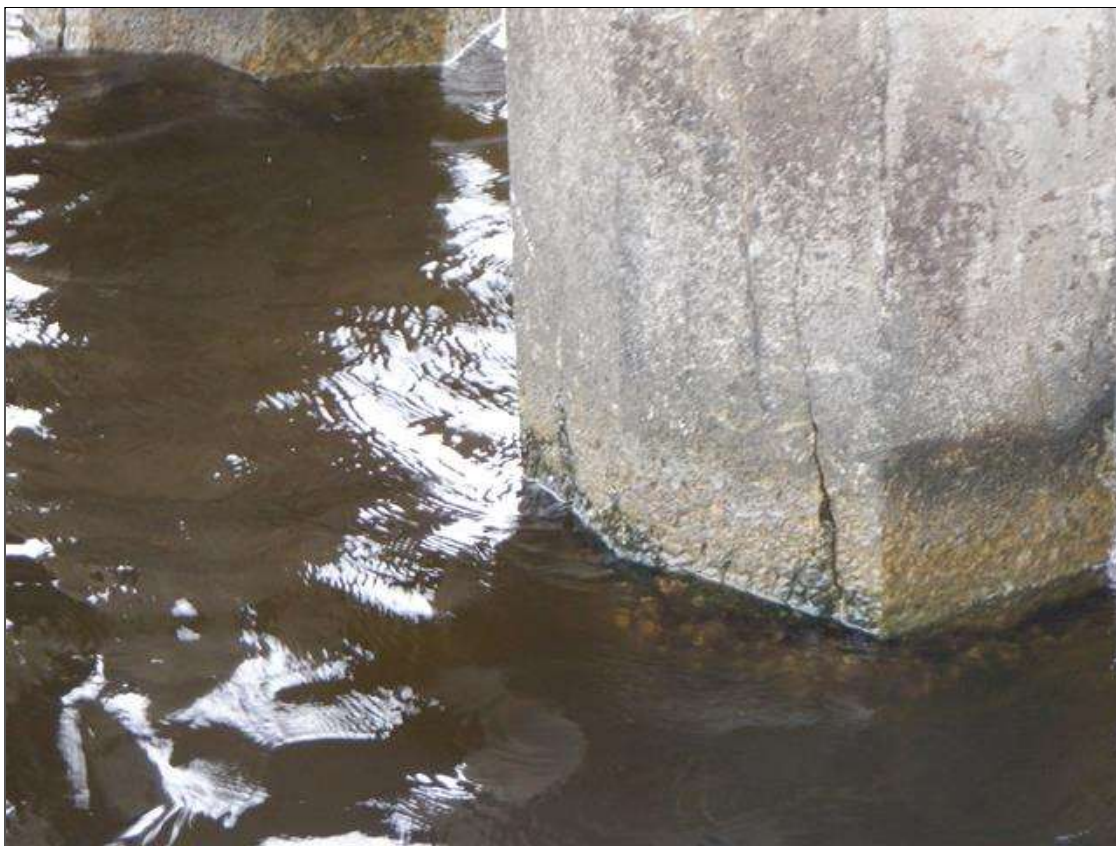
Bent 49 Saved Pile 4: UW (PAR): H/L TO 1/8" CRACKS MULTIPLE FACES, FROM ABOVE THE HIGH WATER MARK DOWN THROUGH THE SPASH ZONE AND TAPERING TO HAIRLINE 1' TO 3' BELOW THE WATERLINE. SCALING TO 1" DEEP FROM WATERLINE TO MUDLINE.

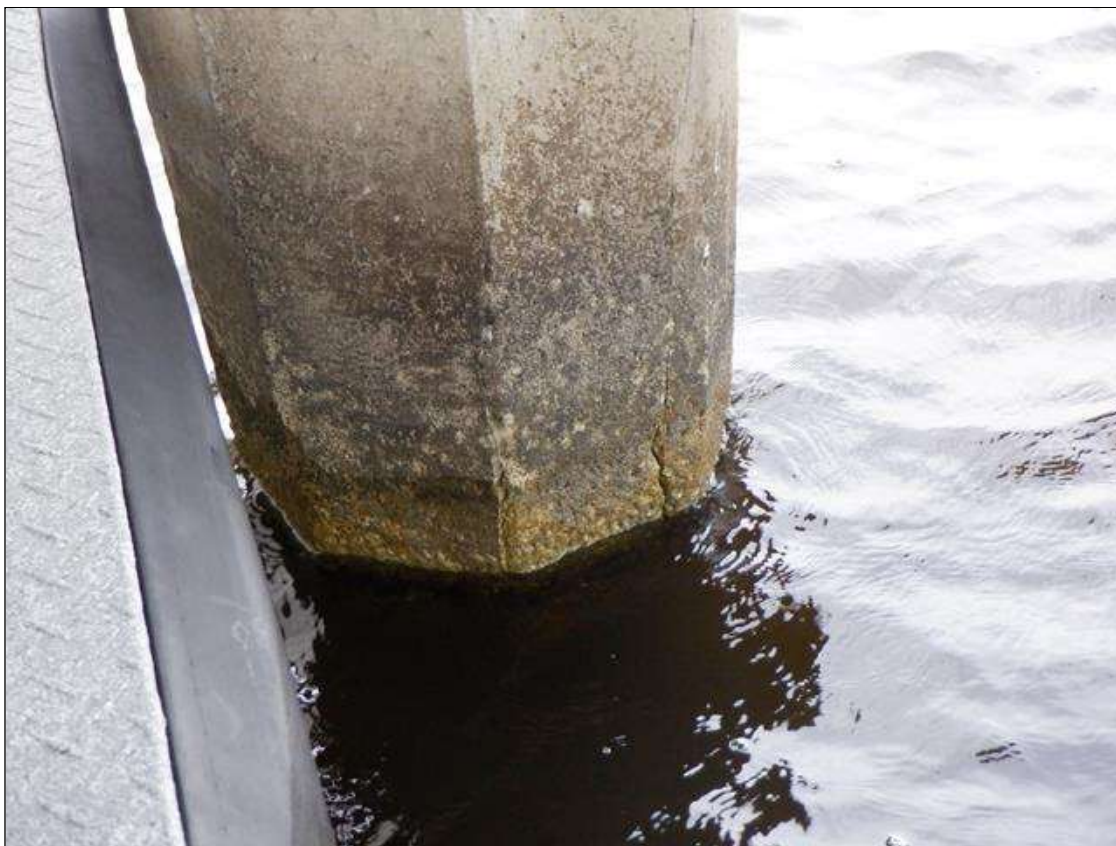
Bent 55 Saved Pile 4: UW (PAR): H/L TO 1/8" CRACKS MULTIPLE FACES, FROM ABOVE THE HIGH WATER MARK DOWN THROUGH THE SPASH ZONE AND TAPERING TO HAIRLINE 1' TO 3' BELOW THE WATERLINE. SCALING TO 1" DEEP FROM WATERLINE TO MUDLINE.

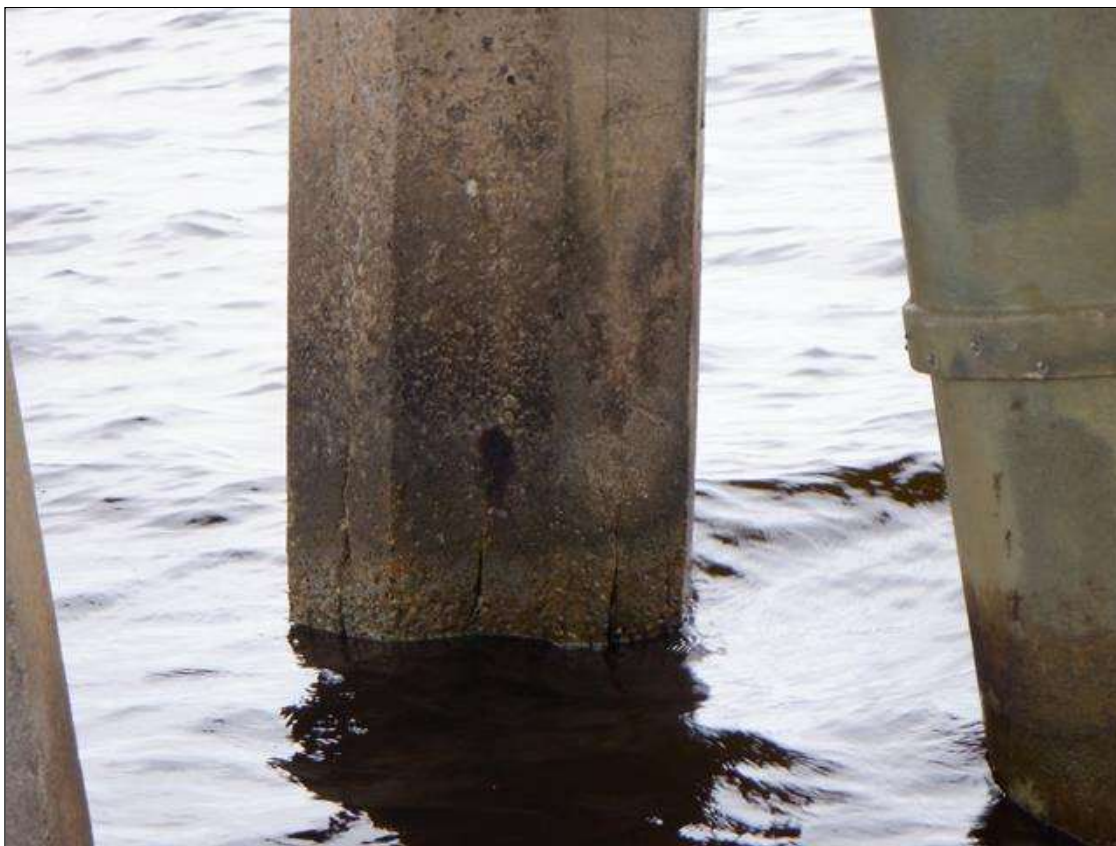
Bent 65 Pile 5: UW (PAR): H/L TO 1/8" CRACKS MULTIPLE FACES, FROM ABOVE THE HIGH WATER MARK DOWN THROUGH THE SPASH ZONE AND TAPERING TO HAIRLINE 1' TO 3' BELOW THE WATERLINE. SCALING TO 1" DEEP FROM WATERLINE TO MUDLINE.

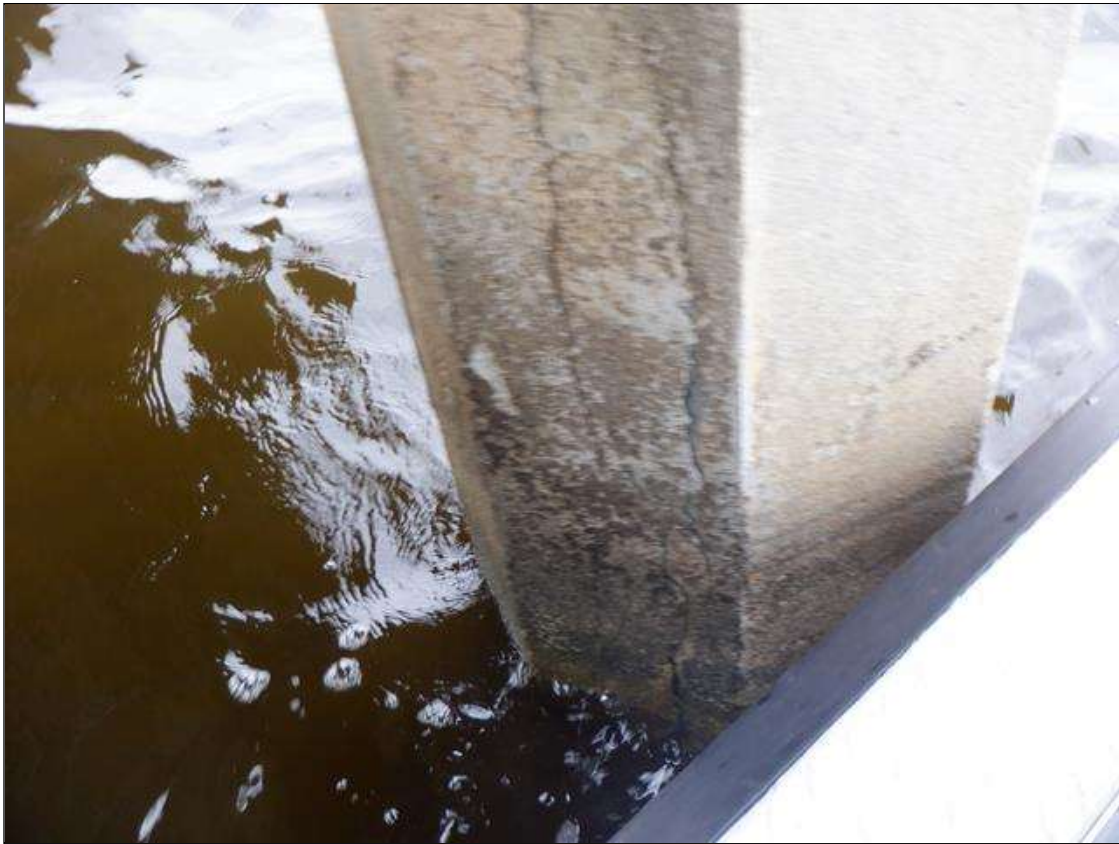
Bent 65 Pile 6: UW (PAR): H/L TO 1/8" CRACKS MULTIPLE FACES, FROM ABOVE THE HIGH WATER MARK DOWN THROUGH THE SPASH ZONE AND TAPERING TO HAIRLINE 1' TO 3' BELOW THE WATERLINE. SCALING TO 1" DEEP FROM WATERLINE TO MUDLINE.

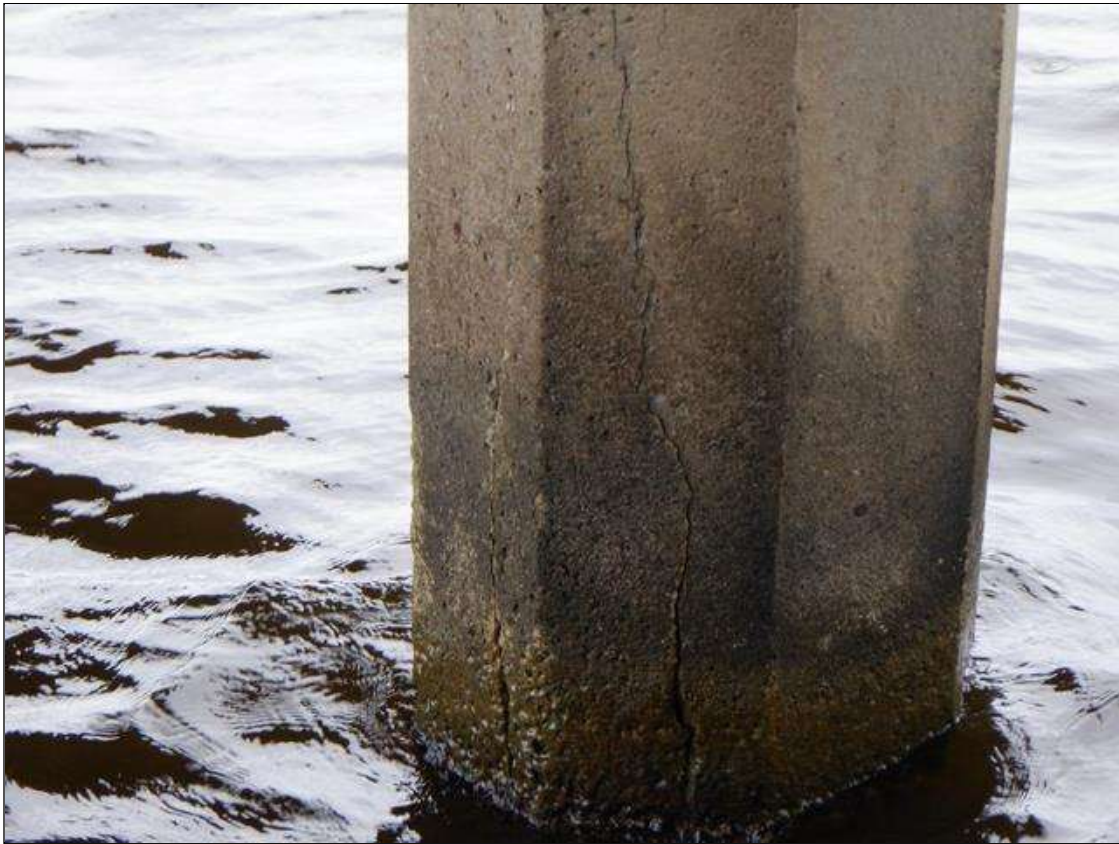
Bent 69 Pile 5: UW (PAR): H/L TO 1/8" CRACKS MULTIPLE FACES, FROM ABOVE THE HIGH WATER MARK DOWN THROUGH THE SPASH ZONE AND TAPERING TO HAIRLINE 1' TO 3' BELOW THE WATERLINE. SCALING TO 1" DEEP FROM WATERLINE TO MUDLINE.

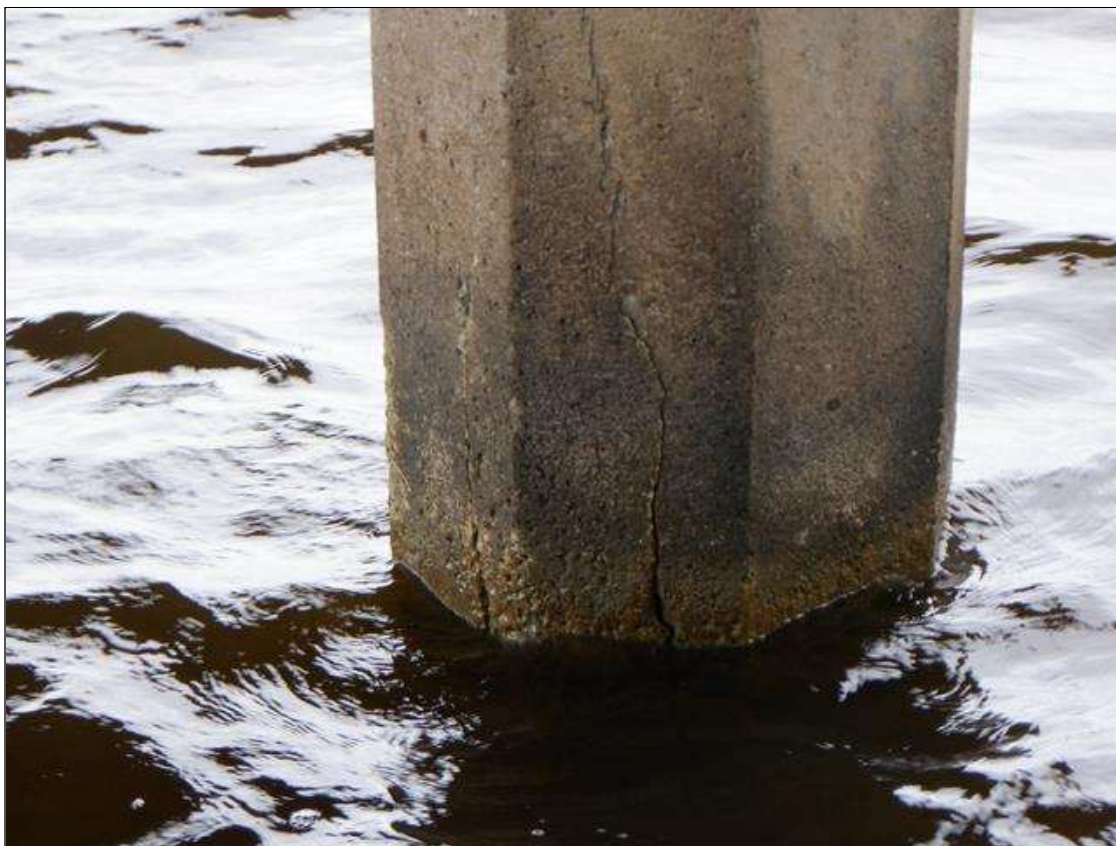
Bent 191 Pile 1: UW (PAR): H/L TO 1/8" CRACKS MULTIPLE FACES, FROM ABOVE THE HIGH WATER MARK DOWN THROUGH THE SPASH ZONE AND TAPERING TO HAIRLINE 1' TO 3' BELOW THE WATERLINE. SCALING TO 1" DEEP FROM WATERLINE TO MUDLINE.

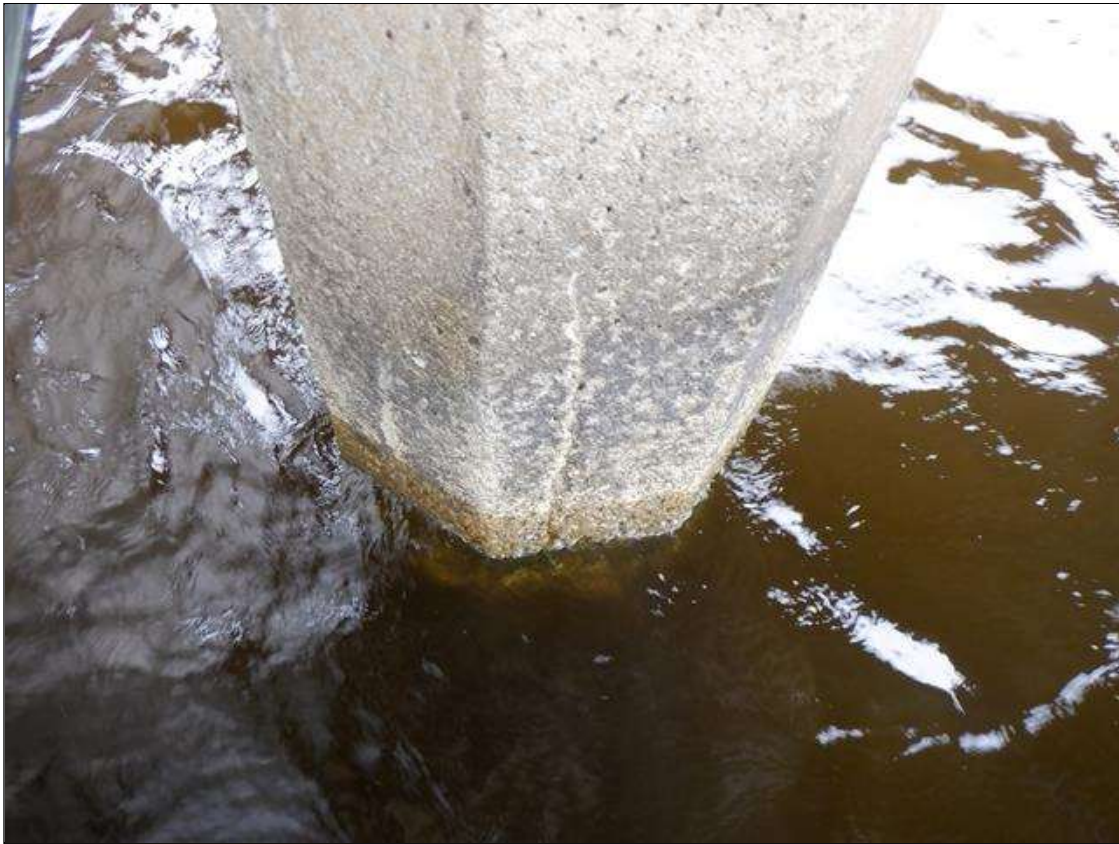
Bent 194 Pile 3: UW (PAR): H/L TO 1/8" CRACKS MULTIPLE FACES, FROM ABOVE THE HIGH WATER MARK DOWN THROUGH THE SPASH ZONE AND TAPERING TO HAIRLINE 1' TO 3' BELOW THE WATERLINE. SCALING TO 1" DEEP FROM WATERLINE TO MUDLINE.
