NC DEPARTMENT OF TRANSPORTATION  
DIVISION OF HIGHWAYS  
STRUCTURE MANAGEMENT UNIT

## Structure Safety Report

### 4 Year Underwater Element Inspection

DIVISION: 1 COUNTY: TYRRELL STRUCTURE NUMBER: 880007 FREQUENCY: 48 MONTHS

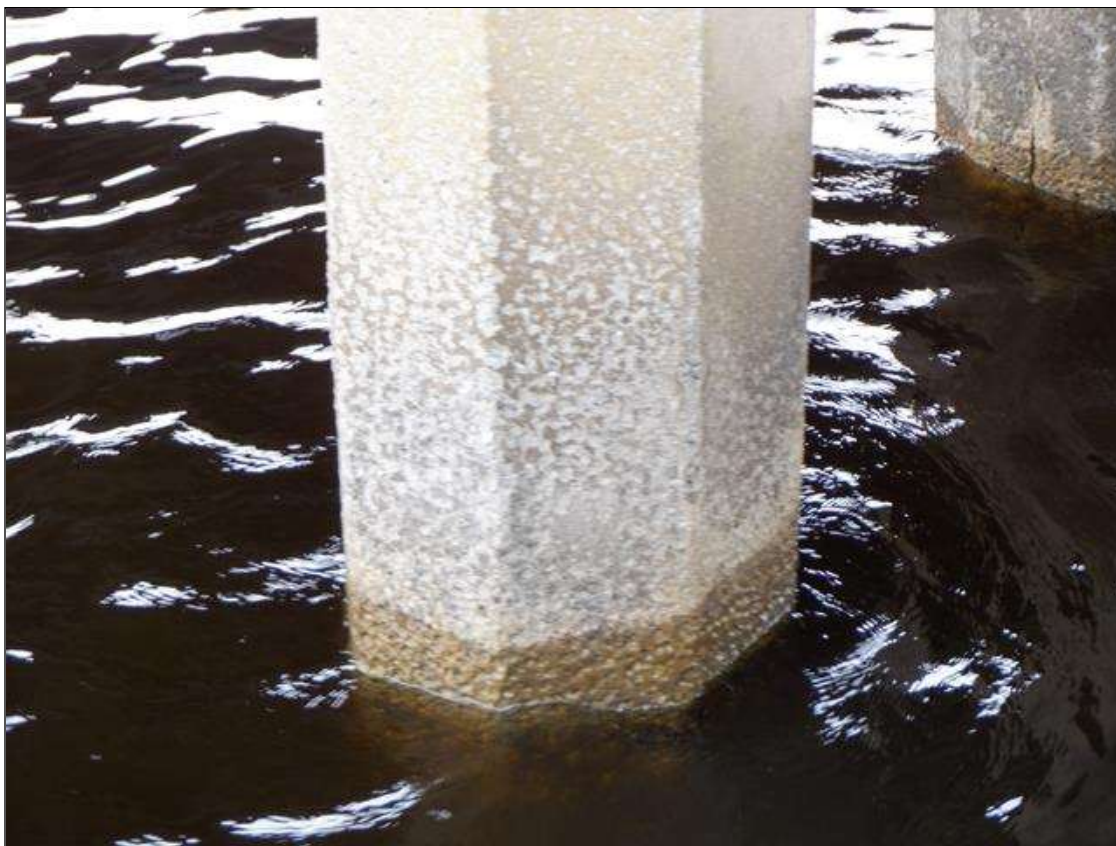
SCALING DETAIL

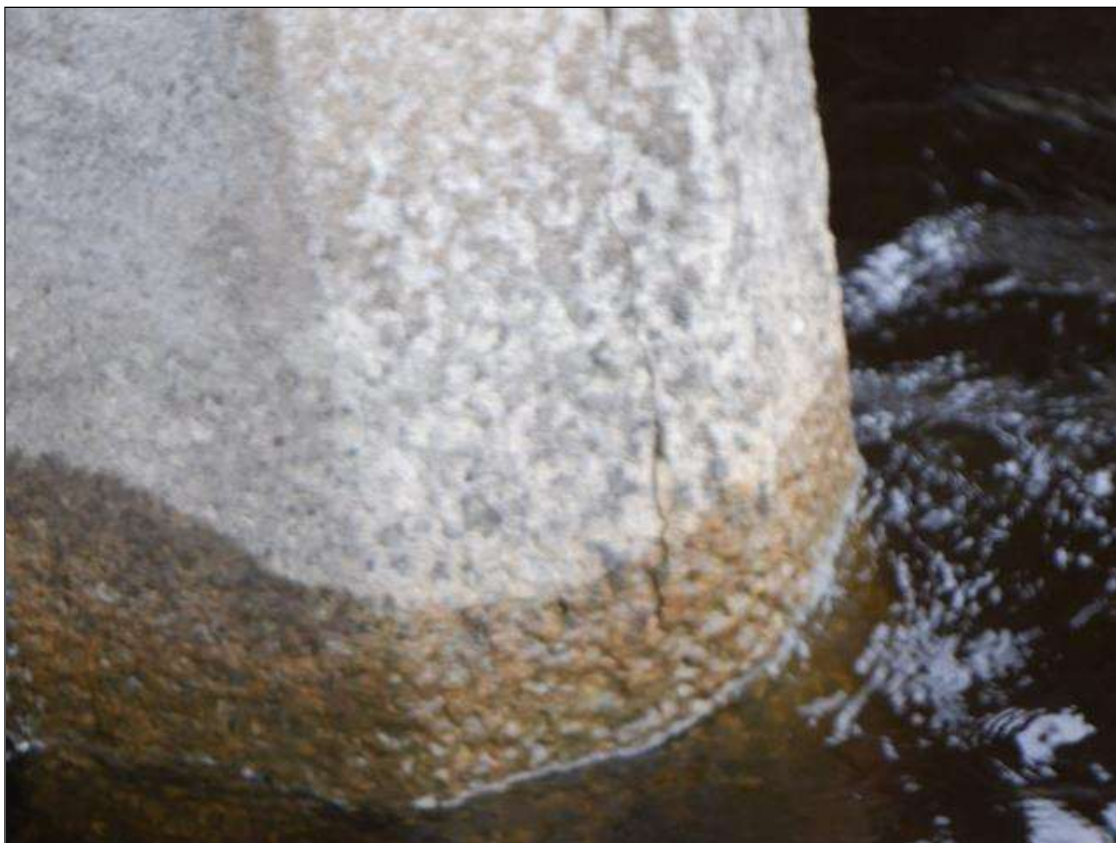
TYPICAL H/L TO 1/16" CRACKS

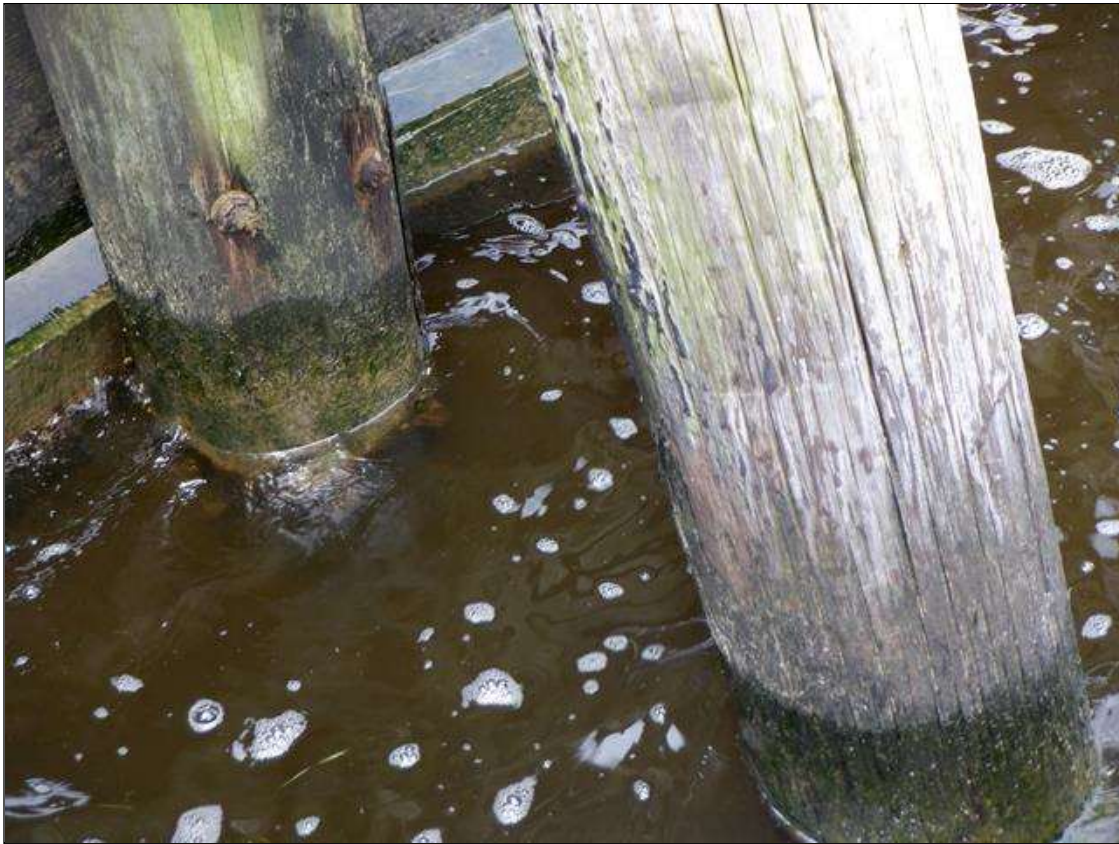
CHECKS TO 1/4" ON FENDER PILES

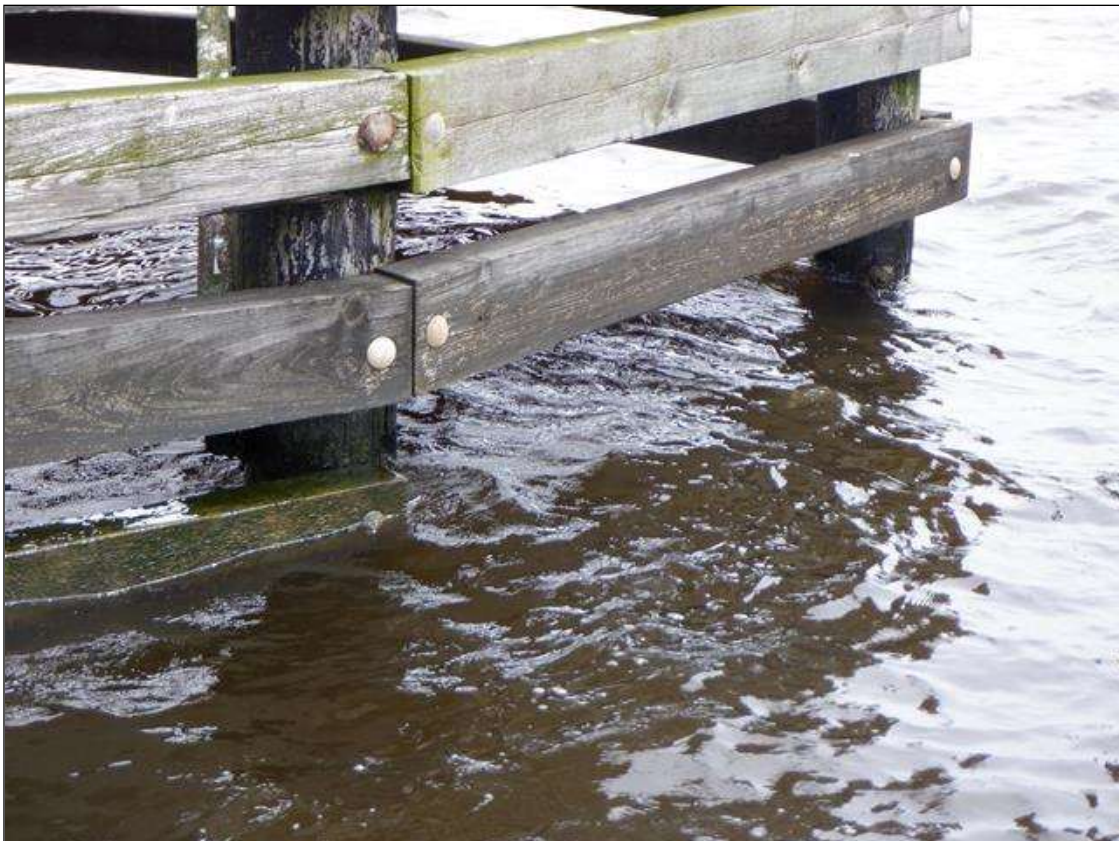
MISSING WHALER BOARD

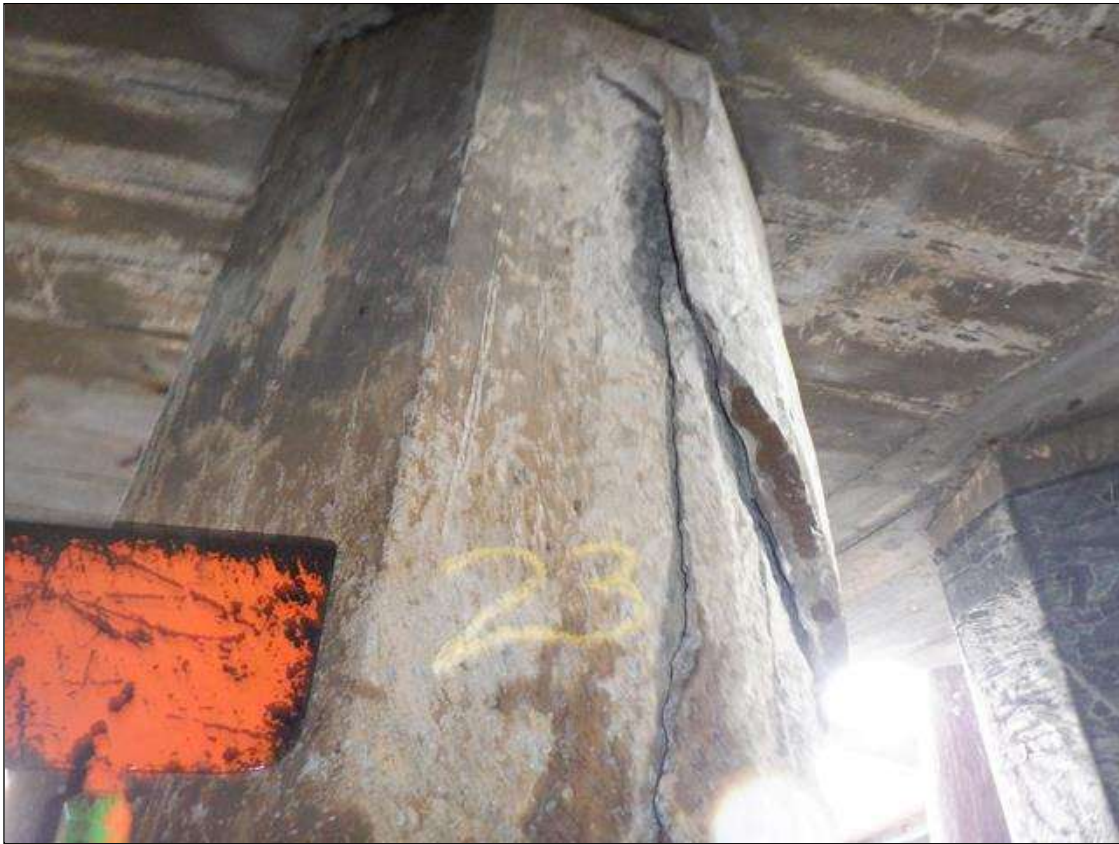
Bent 116 PIVOT Pile 23: U/W (PAR): CRACKED TO 1/8", DELAMINATED 1" TO 3" DEEP, MULTIPLE FACES, FROM CAP DOWN 4'. SCALING TO 1" DEEP FROM WATERLINE TO MUDLINE.

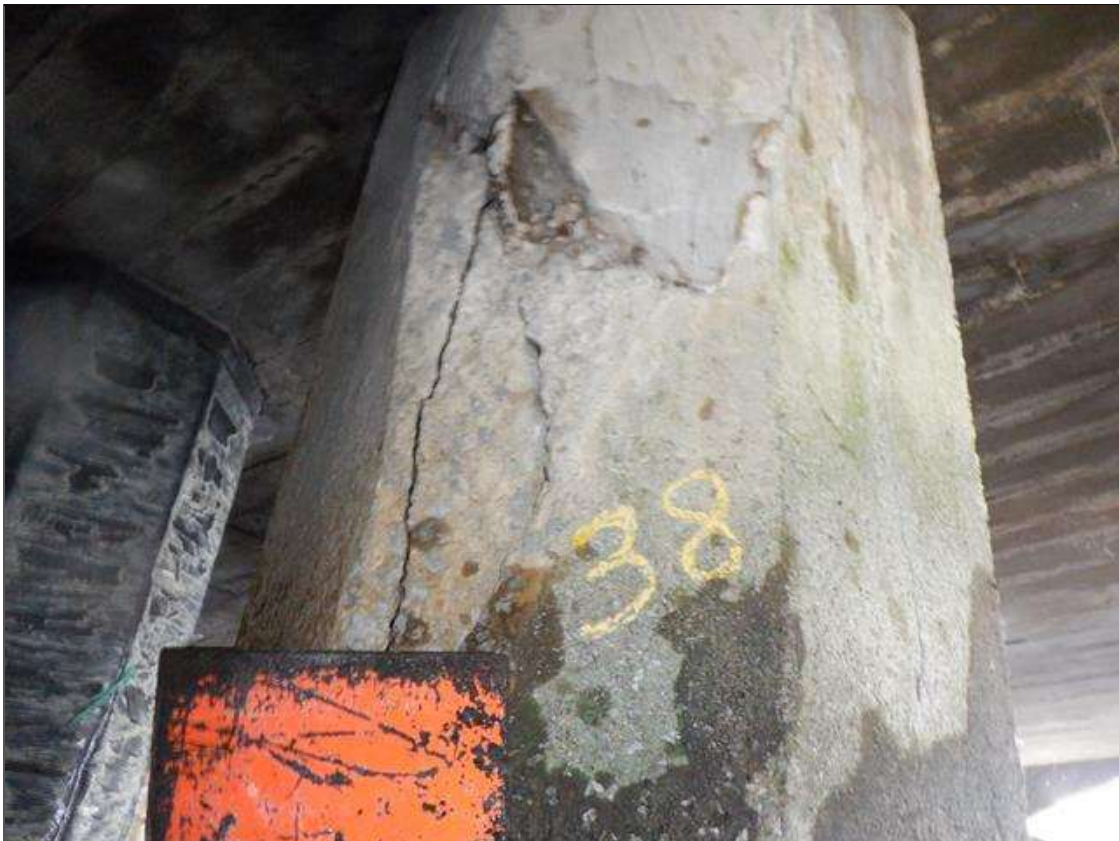
Bent 116 PIVOT Pile 38: U/W (PAR): CRACKED TO 1/8", DELAMINATED 1" TO 3" DEEP, MULTIPLE FACES, FROM CAP DOWN 4'. SCALING TO 1" DEEP FROM WATERLINE TO MUDLINE.

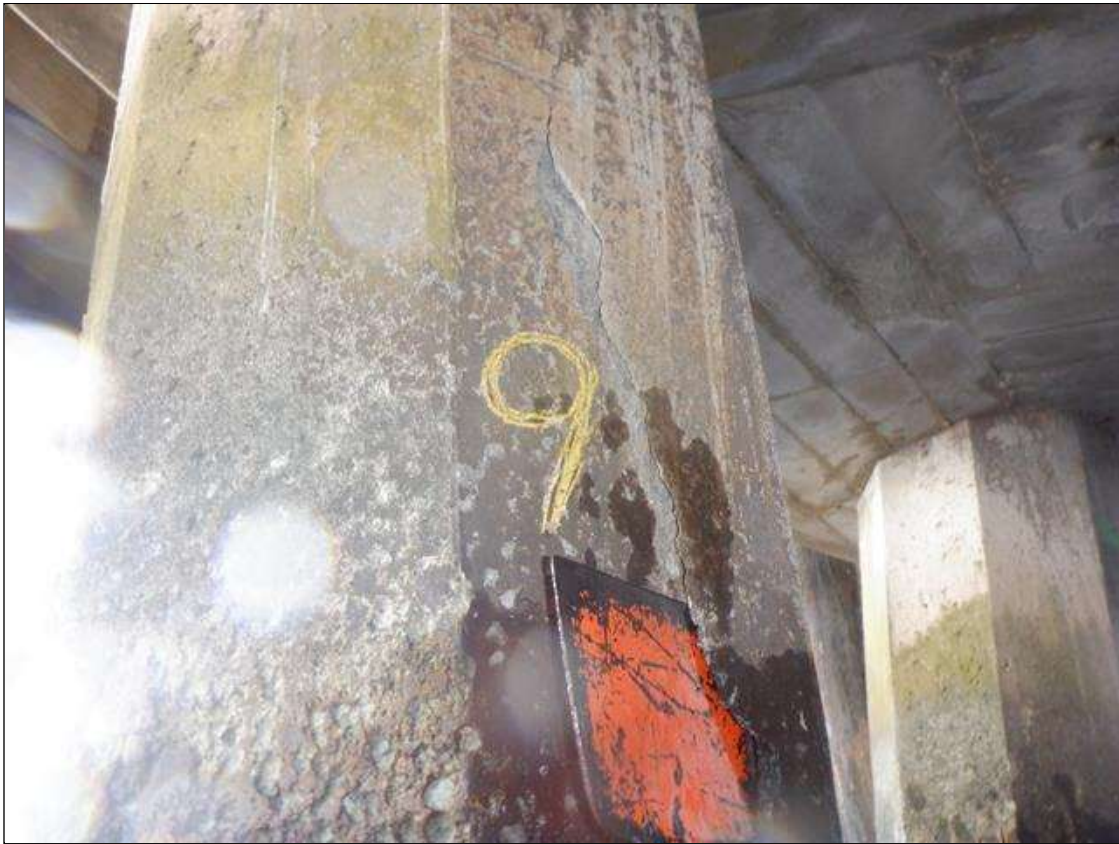
Bent 116 PIVOT Pile 9: U/W (PAR): CRACKED TO 1/8", DELAMINATED 1" TO 3" DEEP, MULTIPLE FACES, FROM CAP DOWN 4'. SCALING TO 1" DEEP FROM WATERLINE TO MUDLINE.

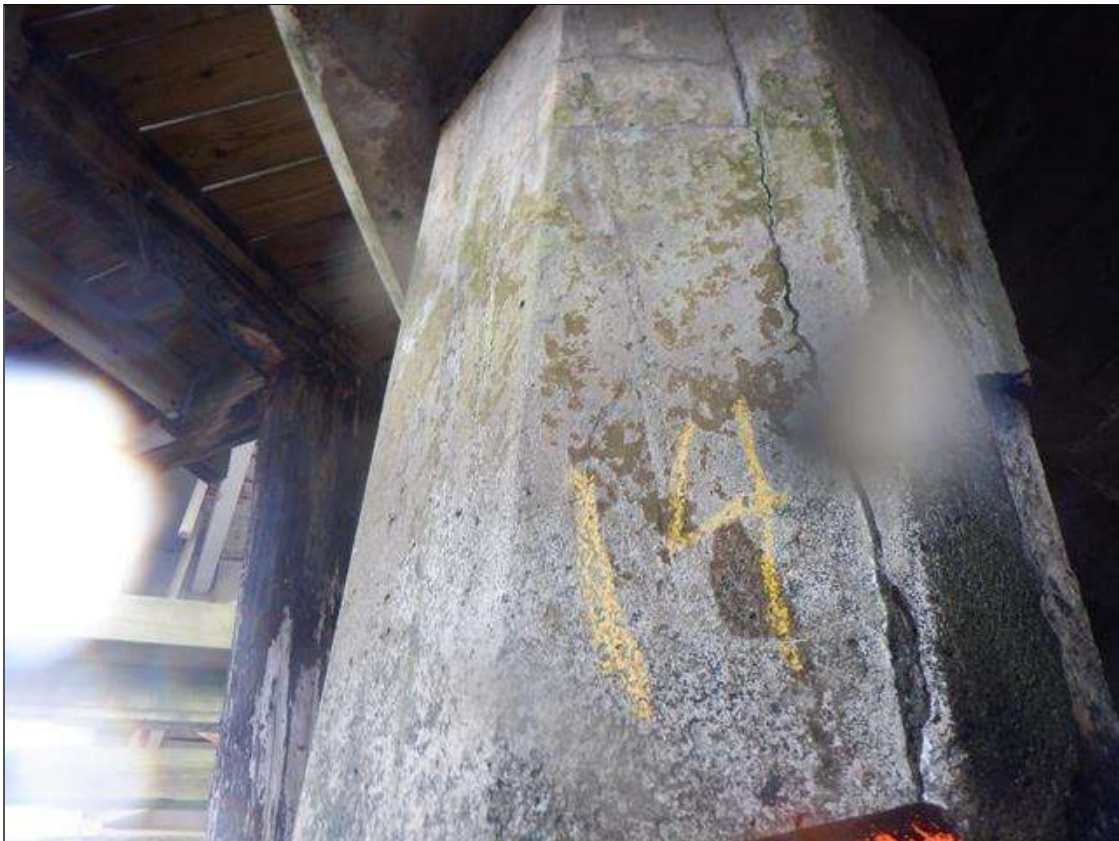
Bent 116 PIVOT Pile 14: U/W (PAR): CRACKED TO 1/8", DELAMINATED 1" TO 3" DEEP, MULTIPLE FACES, FROM CAP DOWN 4'. SCALING TO 1" DEEP FROM WATERLINE TO MUDLINE.

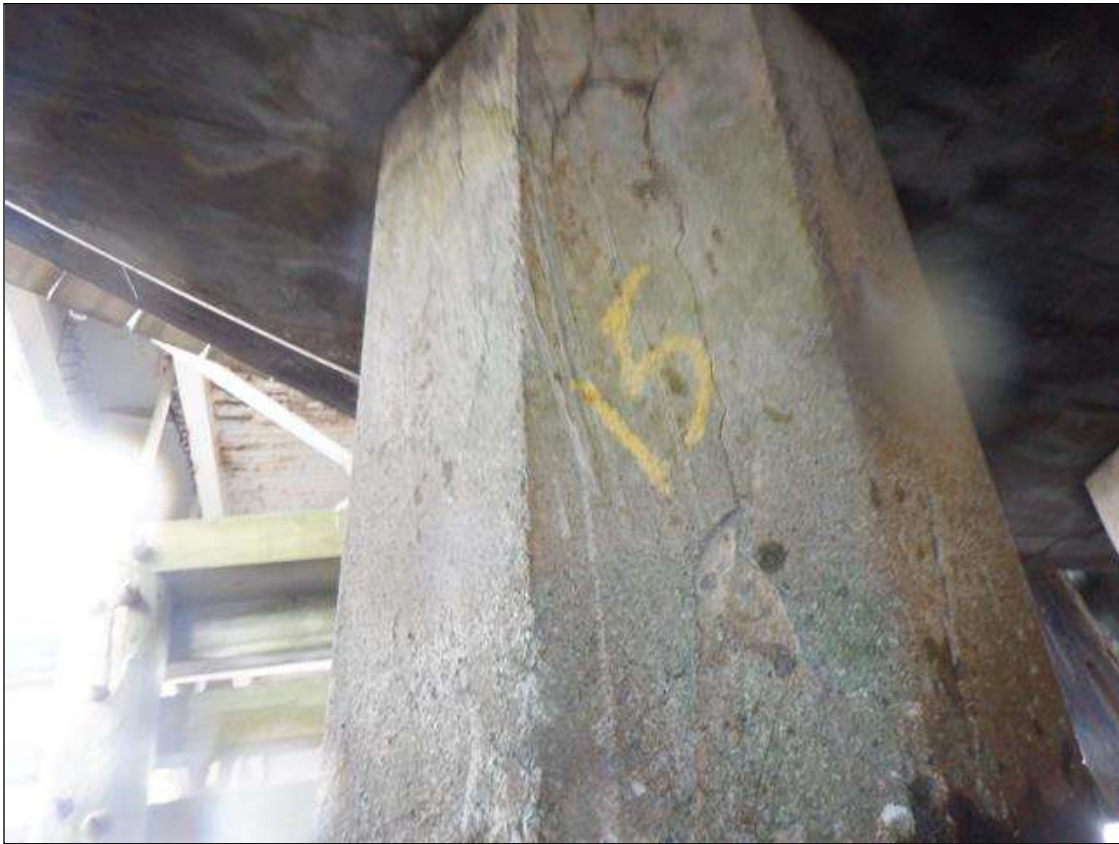
Bent 116 PIVOT Pile 15: U/W (PAR): CRACKED TO 1/8", DELAMINATED 1" TO 3" DEEP, MULTIPLE FACES, FROM CAP DOWN 4'. SCALING TO 1" DEEP FROM WATERLINE TO MUDLINE.

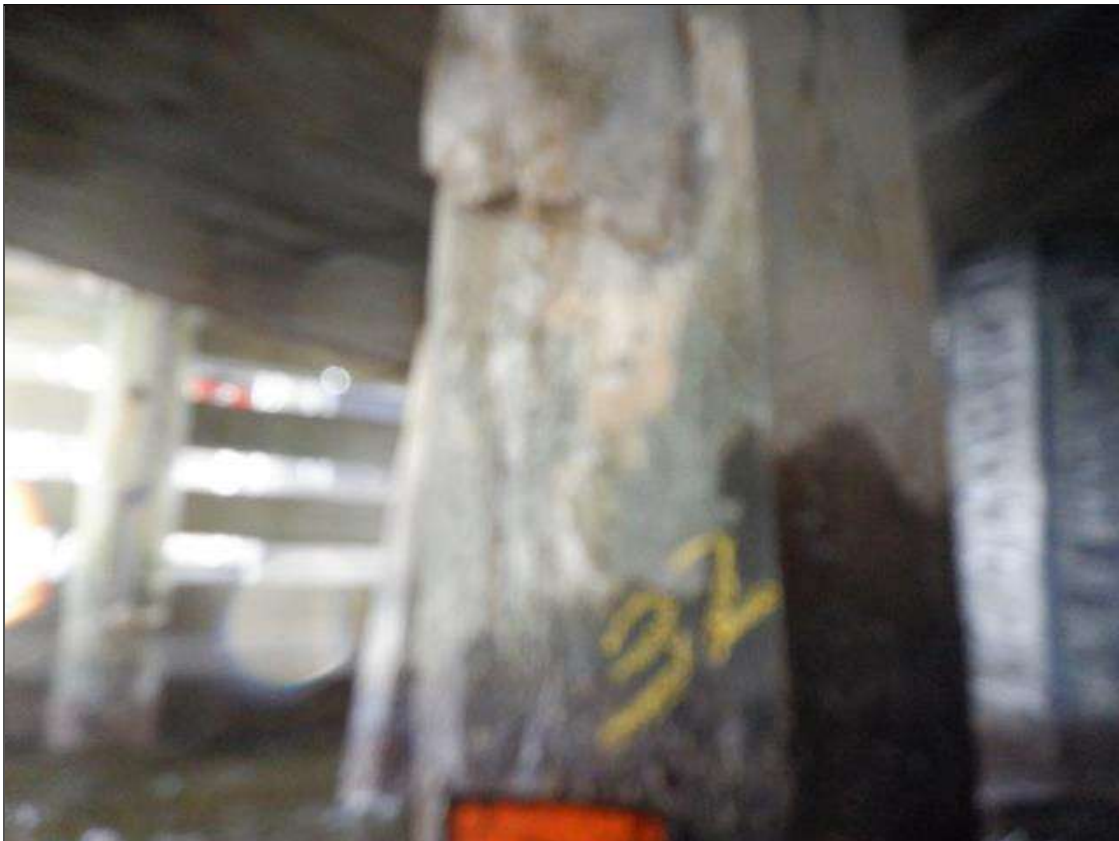
Bent 116 PIVOT Pile 32: U/W (PAR): CRACKED TO 1/8", DELAMINATED 1" TO 3" DEEP, MULTIPLE FACES, FROM CAP DOWN 4'. SCALING TO 1" DEEP FROM WATERLINE TO MUDLINE.

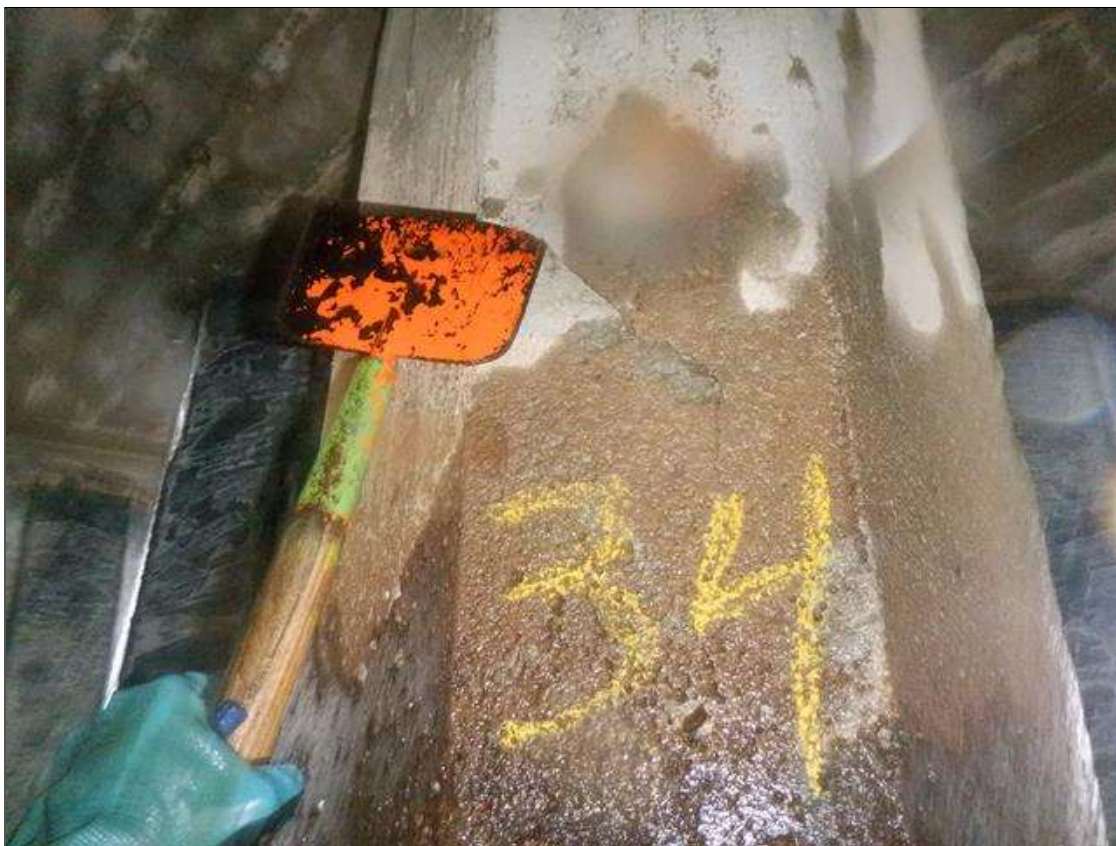
Bent 116 PIVOT Pile 34: U/W (PAR): CRACKED TO 1/8", DELAMINATED 1" TO 3" DEEP, MULTIPLE FACES, FROM CAP DOWN 4'. SCALING TO 1" DEEP FROM WATERLINE TO MUDLINE.

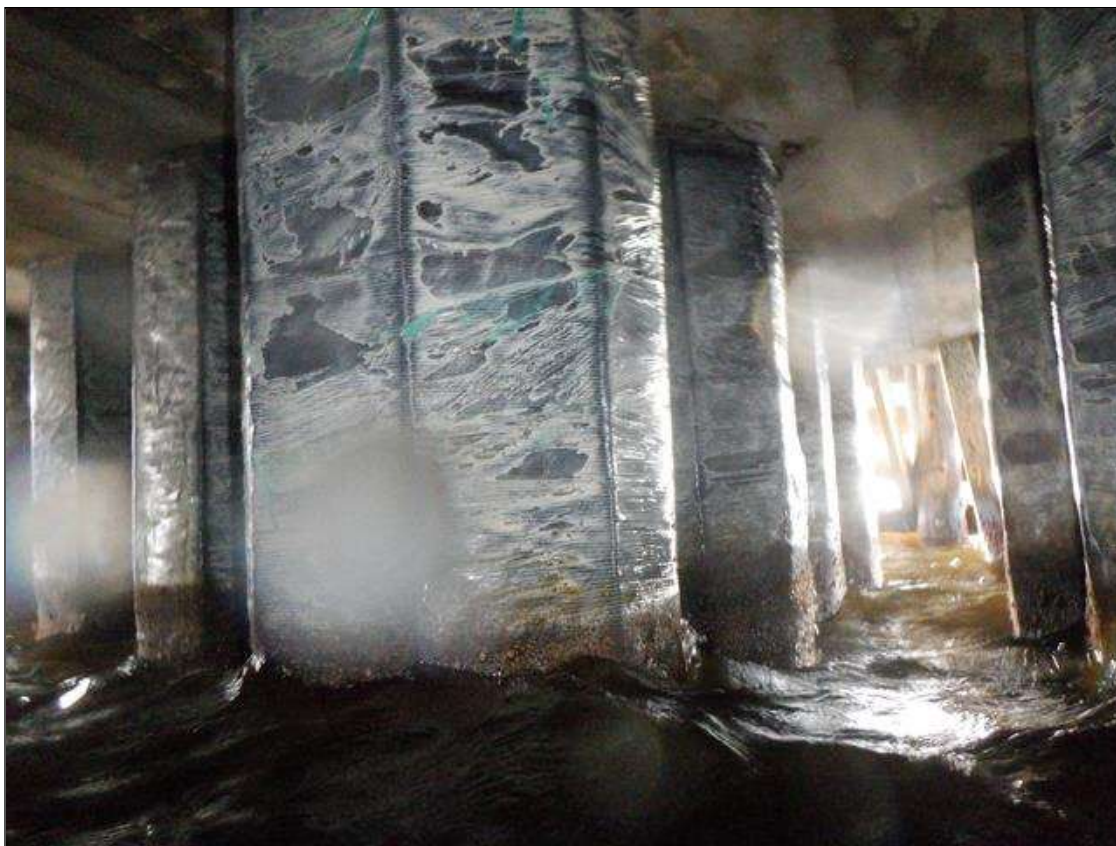
REPAIRED PIVOT PIER PILES

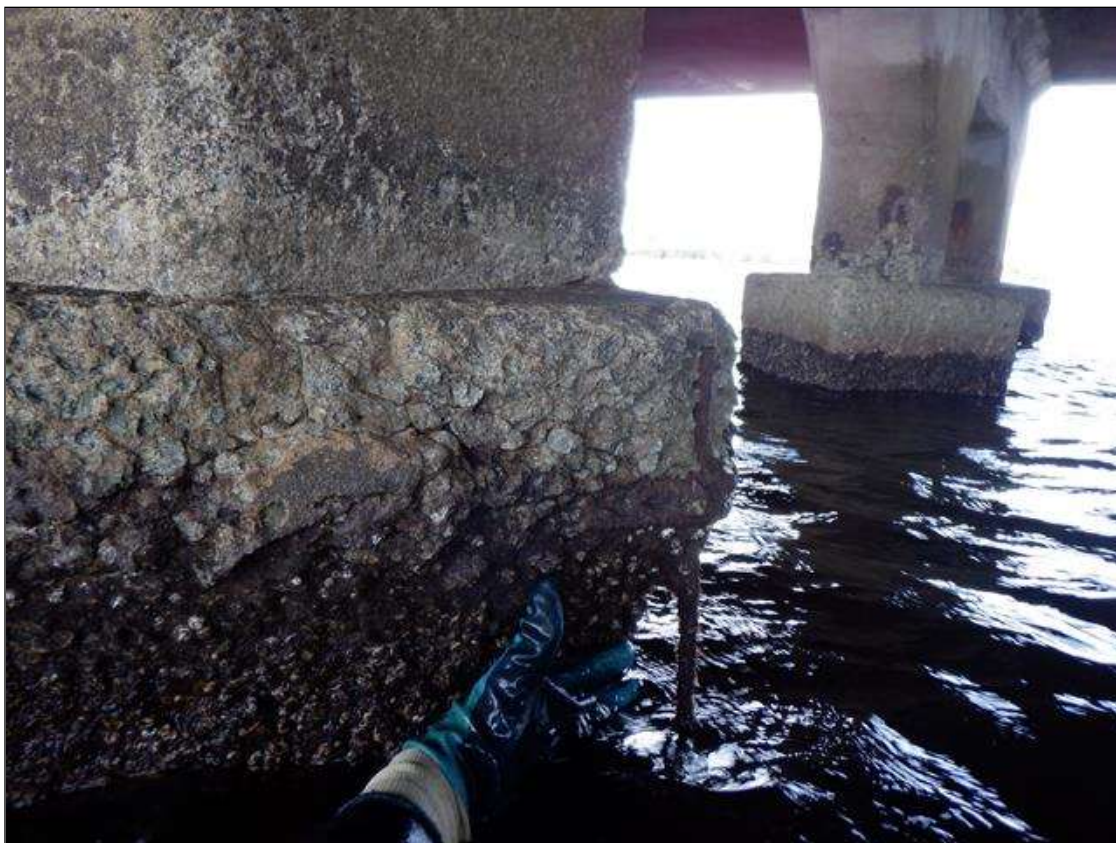
TYPICAL FOOTING CONDITION ON EAST END

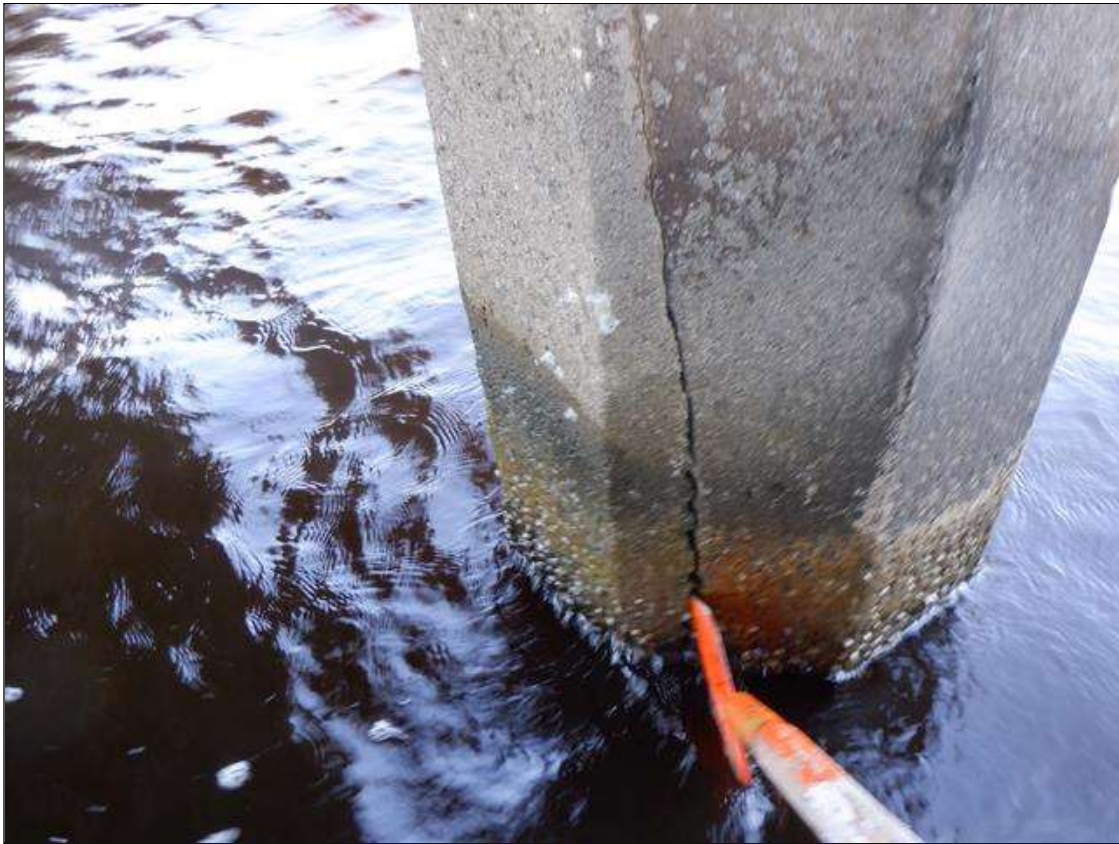
Bent 35 Saved Pile 1: UW (PAR): H/L TO 1/8" CRACKS MULTIPLE FACES, FROM ABOVE THE HIGH WATER MARK DOWN THROUGH THE SPASH ZONE AND TAPERING TO HAIRLINE 1' TO 3' BELOW THE WATERLINE. SCALING TO 1" DEEP FROM WATERLINE TO MUDLINE.

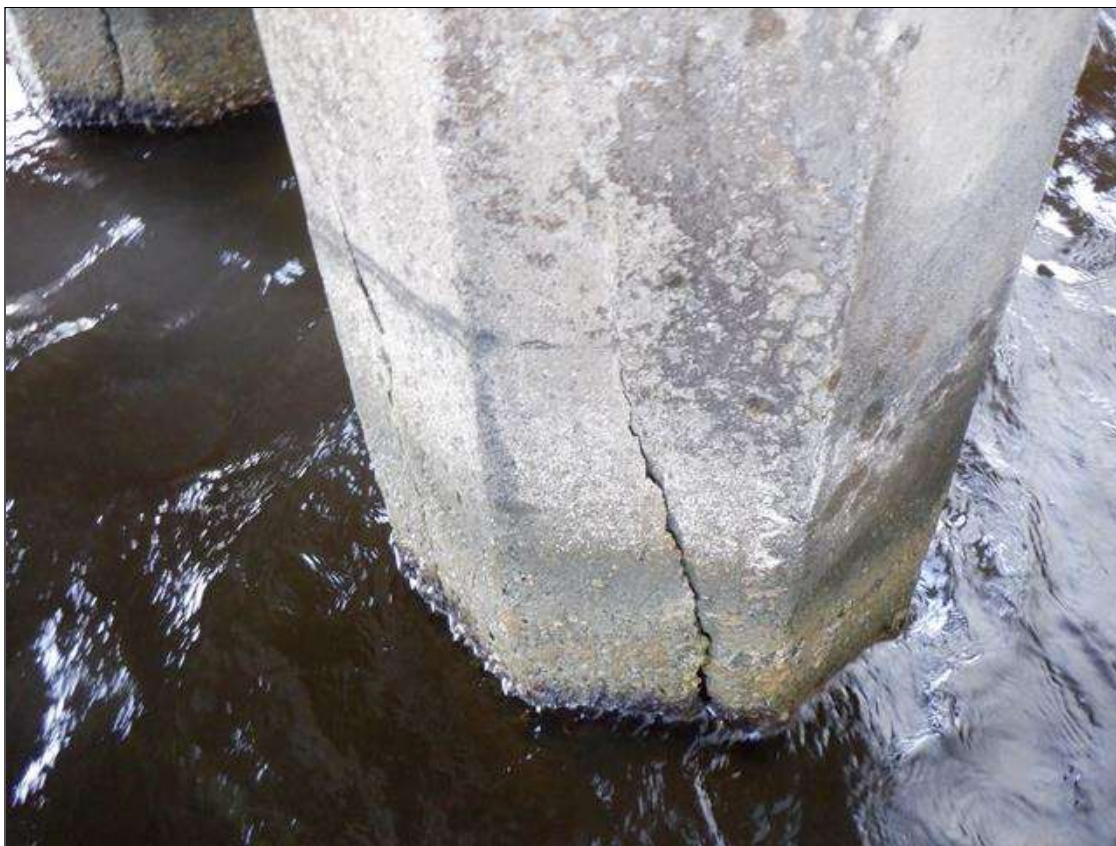
Bent 37 Saved Pile 4: UW (PAR): H/L TO 1/8" CRACKS MULTIPLE FACES, FROM ABOVE THE HIGH WATER MARK DOWN THROUGH THE SPASH ZONE AND TAPERING TO HAIRLINE 1' TO 3' BELOW THE WATERLINE. SCALING TO 1" DEEP FROM WATERLINE TO MUDLINE.

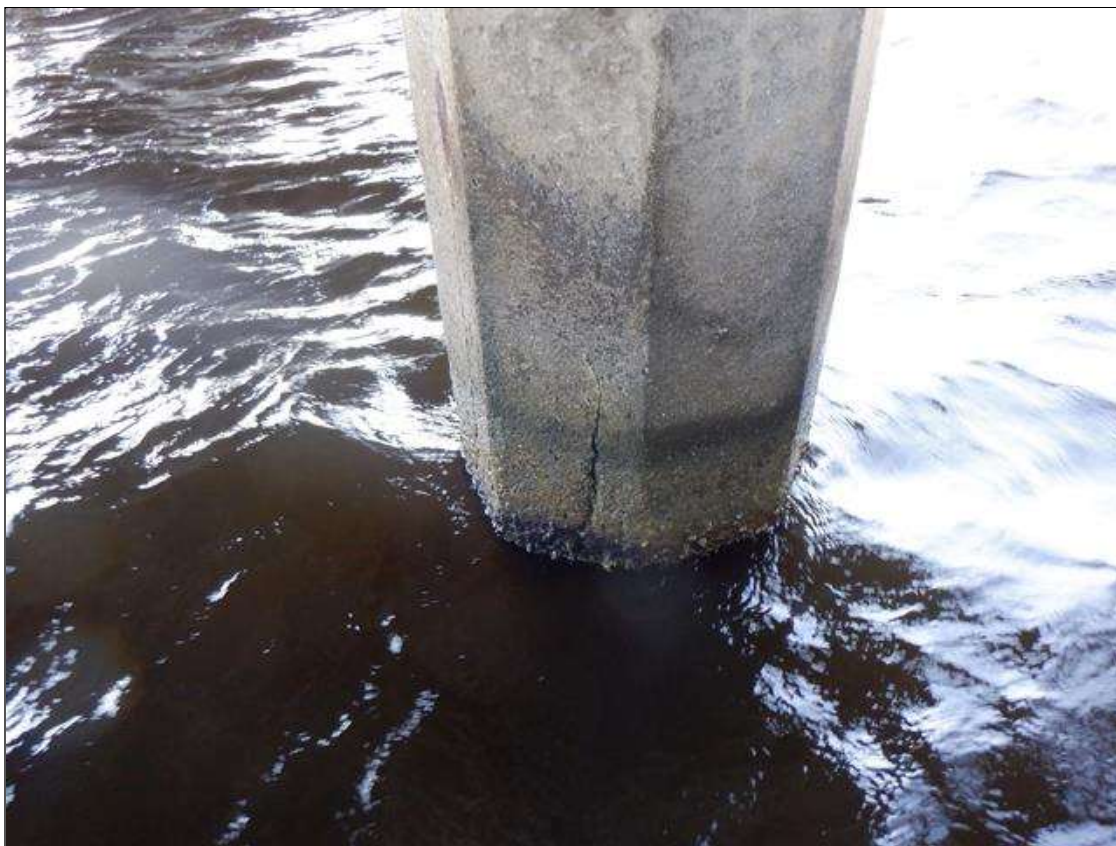
Bent 37 Saved Pile 5: UW (PAR): H/L TO 1/8" CRACKS MULTIPLE FACES, FROM ABOVE THE HIGH WATER MARK DOWN THROUGH THE SPASH ZONE AND TAPERING TO HAIRLINE 1' TO 3' BELOW THE WATERLINE. SCALING TO 1" DEEP FROM WATERLINE TO MUDLINE.

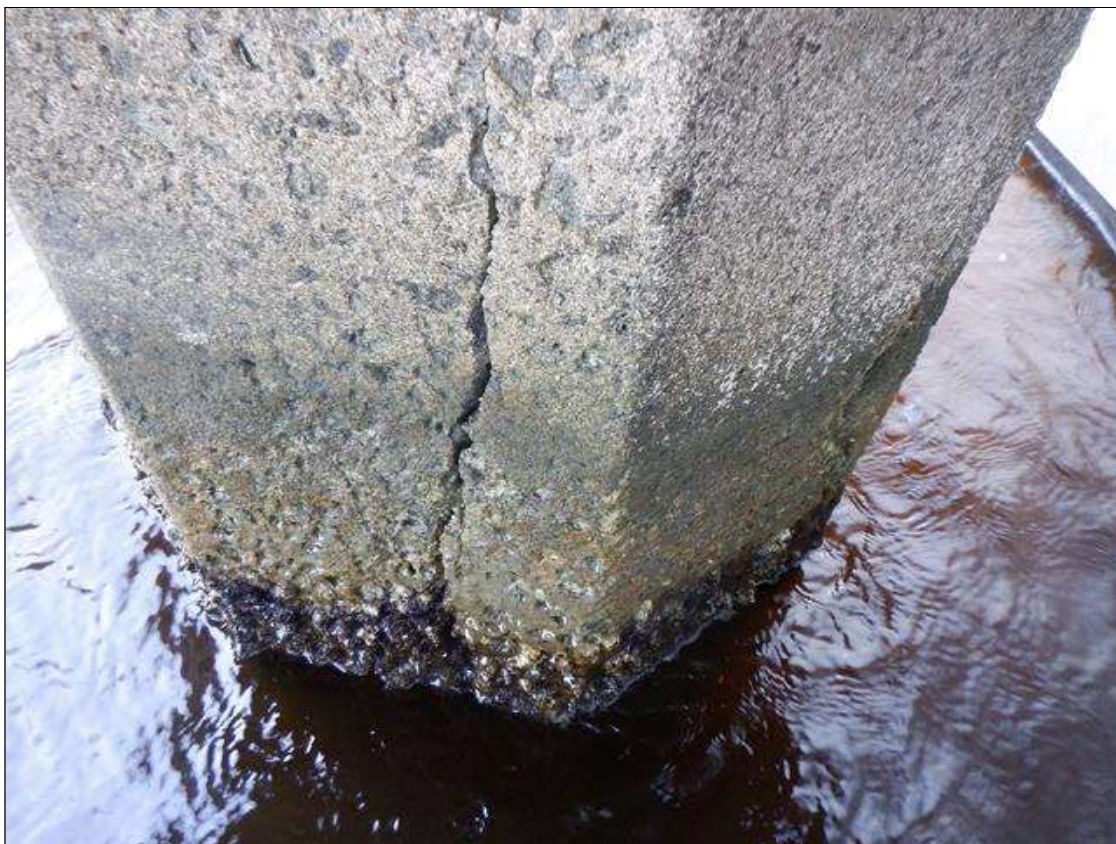
Bent 37 Saved Pile 6: UW (PAR): H/L TO 1/8" CRACKS MULTIPLE FACES, FROM ABOVE THE HIGH WATER MARK DOWN THROUGH THE SPASH ZONE AND TAPERING TO HAIRLINE 1' TO 3' BELOW THE WATERLINE. SCALING TO 1" DEEP FROM WATERLINE TO MUDLINE.

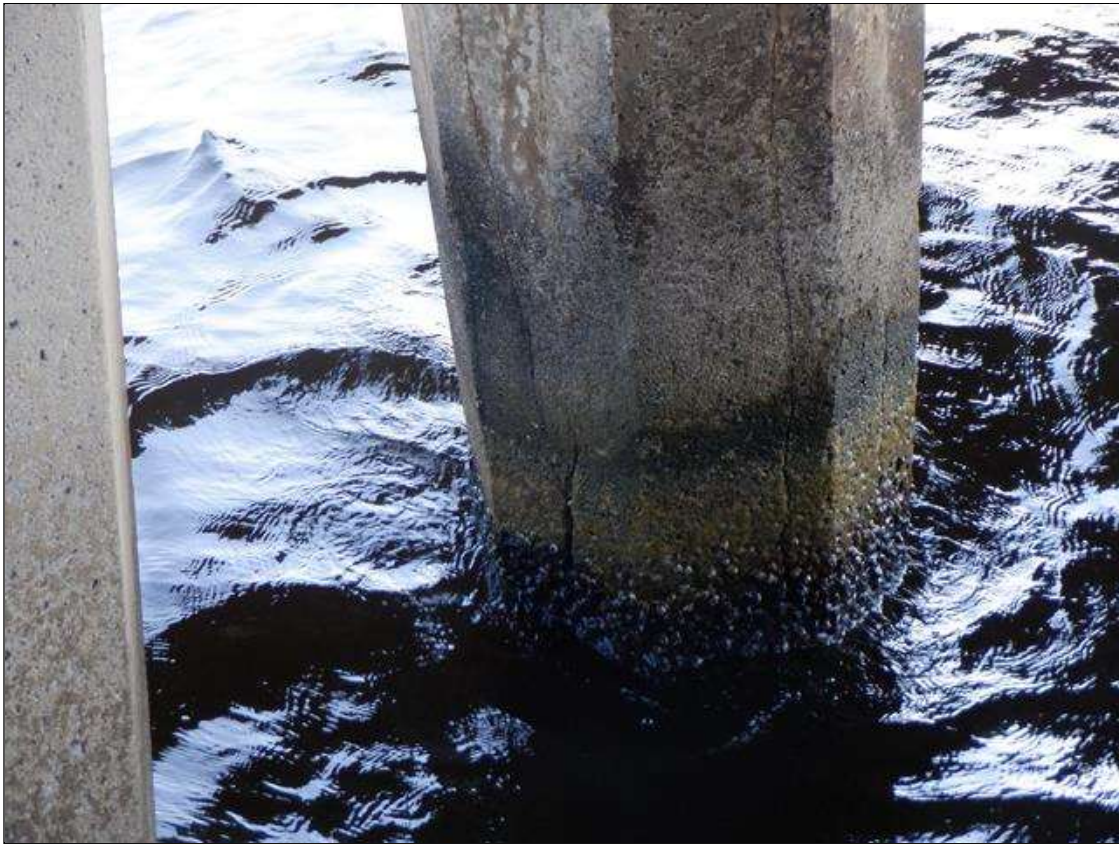
Bent 41 Saved Pile 4: UW (PAR): H/L TO 1/8" CRACKS MULTIPLE FACES, FROM ABOVE THE HIGH WATER MARK DOWN THROUGH THE SPASH ZONE AND TAPERING TO HAIRLINE 1' TO 3' BELOW THE WATERLINE. SCALING TO 1" DEEP FROM WATERLINE TO MUDLINE.

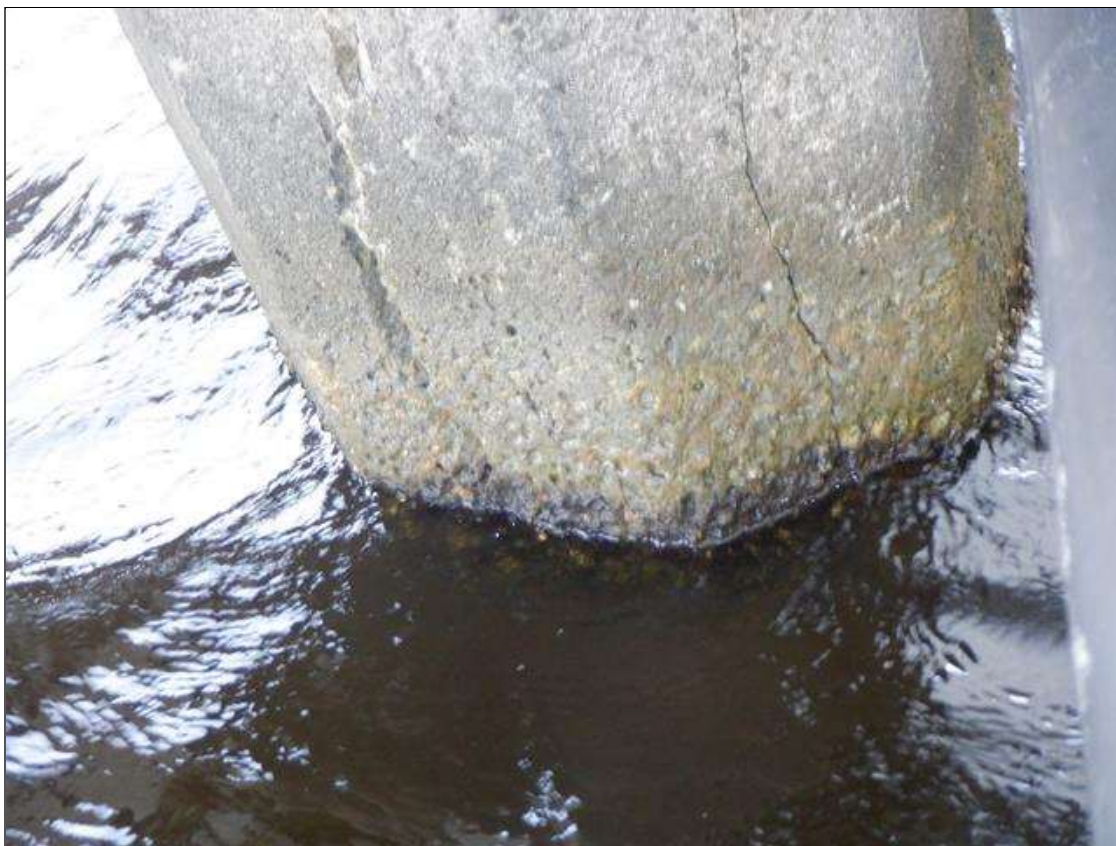
Bent 41 Saved Pile 2: UW (PAR): H/L TO 1/8" CRACKS MULTIPLE FACES, FROM ABOVE THE HIGH WATER MARK DOWN THROUGH THE SPASH ZONE AND TAPERING TO HAIRLINE 1' TO 3' BELOW THE WATERLINE. SCALING TO 1" DEEP FROM WATERLINE TO MUDLINE.

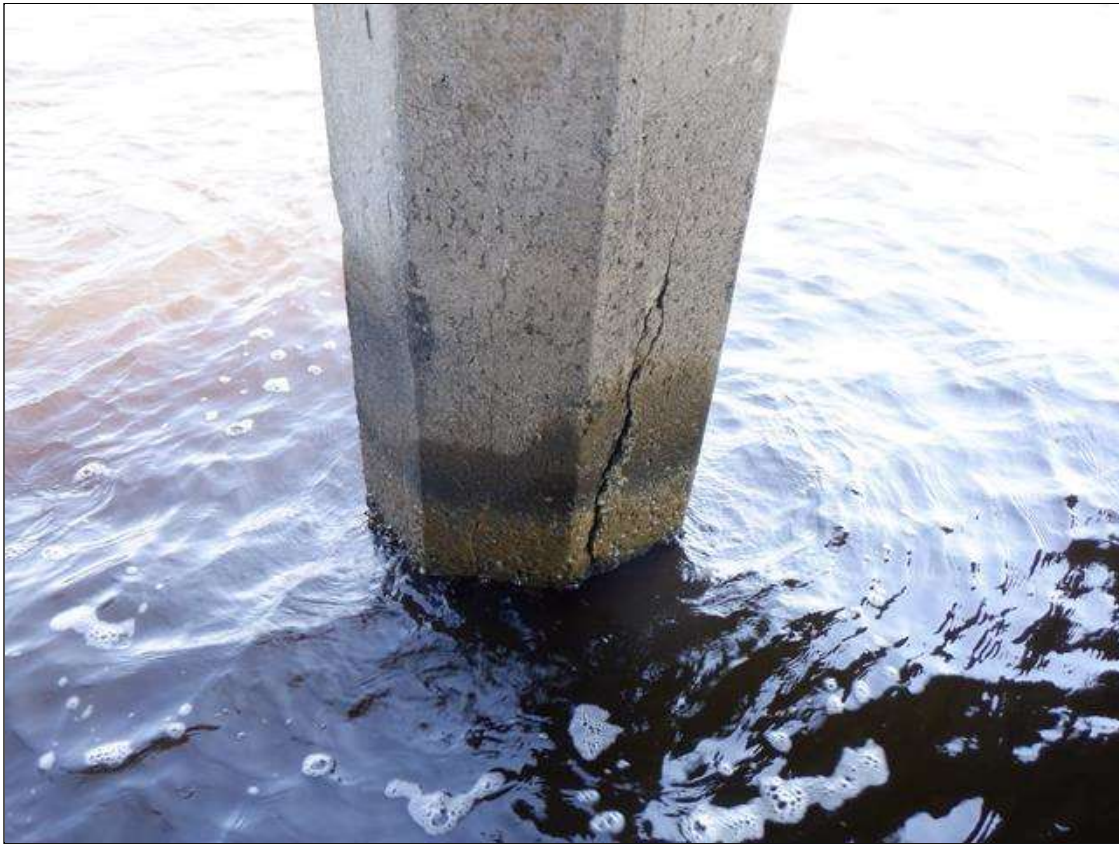
Bent 46 Saved Pile 4: UW (PAR): H/L TO 1/8" CRACKS MULTIPLE FACES, FROM ABOVE THE HIGH WATER MARK DOWN THROUGH THE SPASH ZONE AND TAPERING TO HAIRLINE 1' TO 3' BELOW THE WATERLINE. SCALING TO 1" DEEP FROM WATERLINE TO MUDLINE.

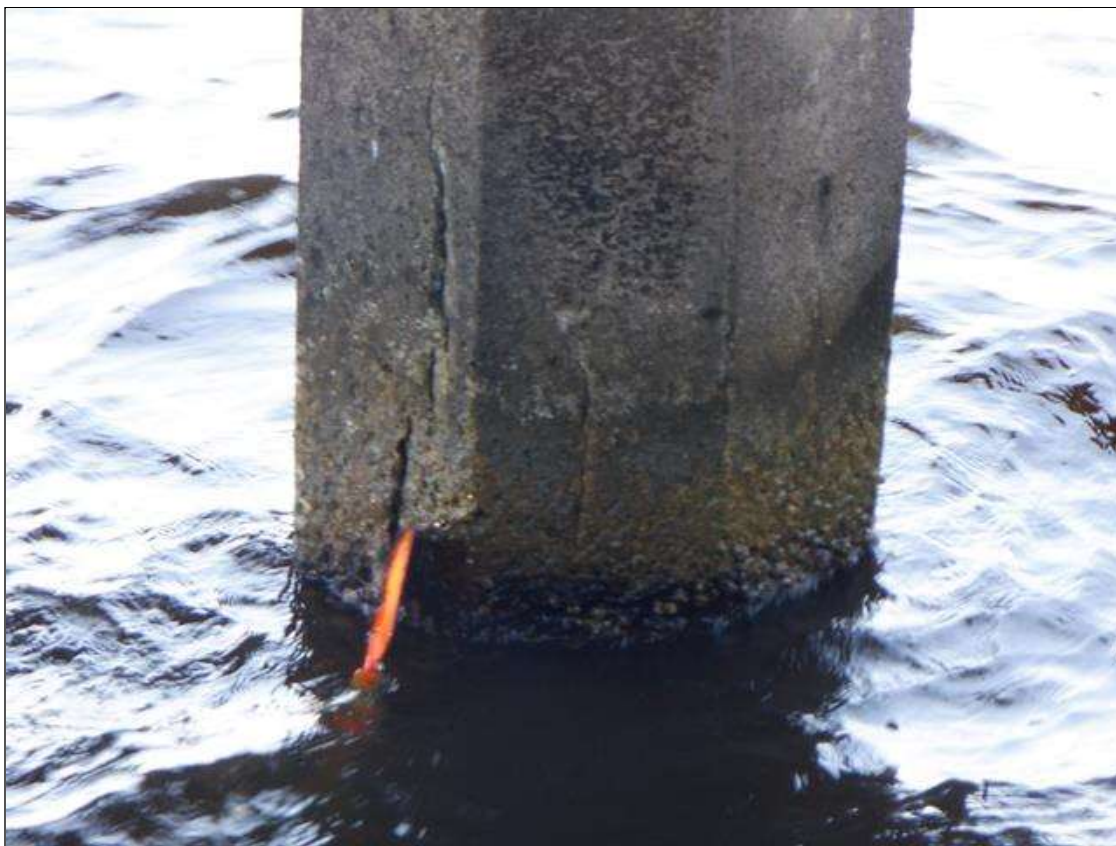
Bent 49 Saved Pile 5: UW (PAR): H/L TO 1/8" CRACKS MULTIPLE FACES, FROM ABOVE THE HIGH WATER MARK DOWN THROUGH THE SPASH ZONE AND TAPERING TO HAIRLINE 1' TO 3' BELOW THE WATERLINE. SCALING TO 1" DEEP FROM WATERLINE TO MUDLINE.

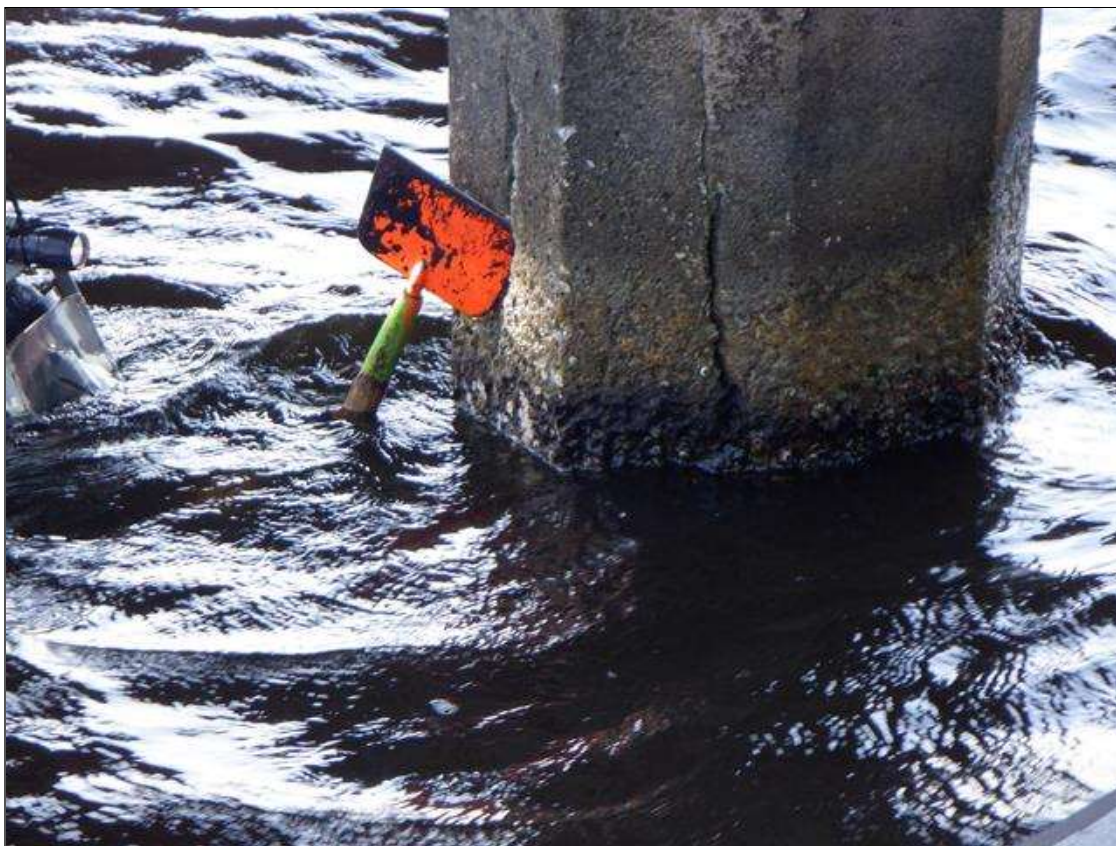
Bent 49 Saved Pile 3: UW (PAR): H/L TO 1/8" CRACKS MULTIPLE FACES, FROM ABOVE THE HIGH WATER MARK DOWN THROUGH THE SPASH ZONE AND TAPERING TO HAIRLINE 1' TO 3' BELOW THE WATERLINE. SCALING TO 1" DEEP FROM WATERLINE TO MUDLINE.

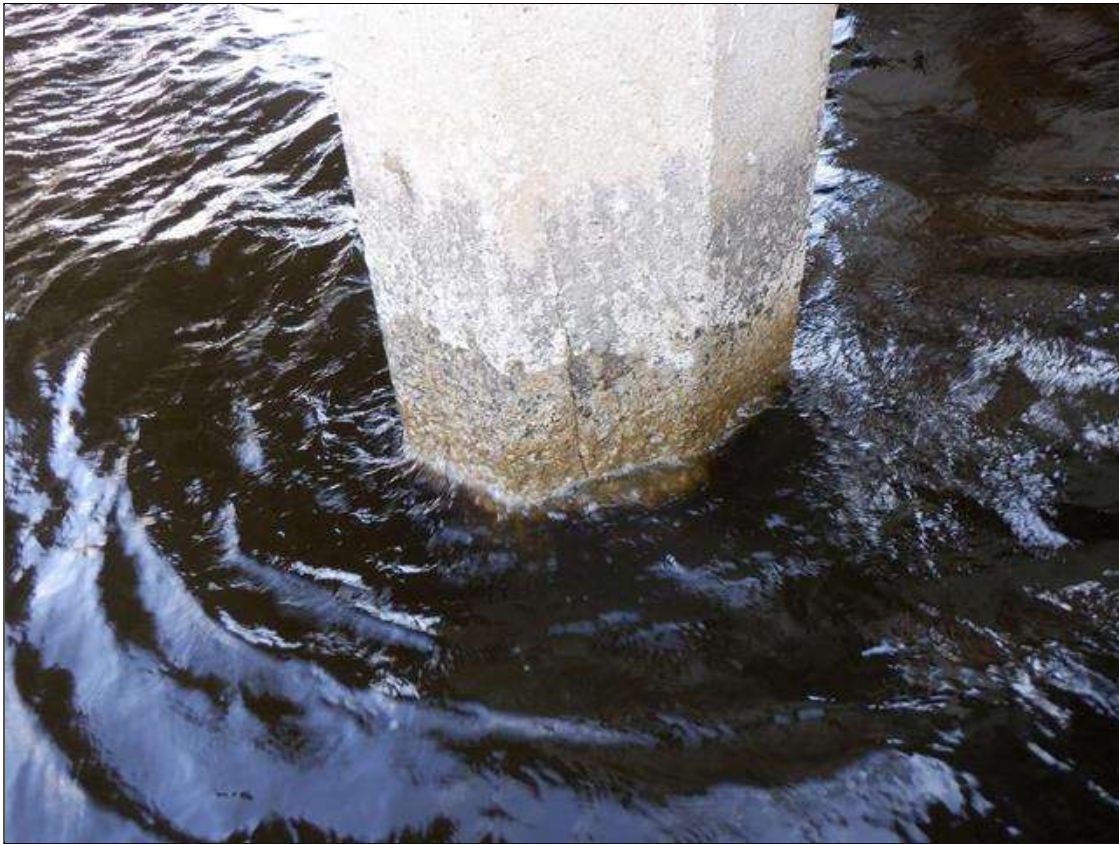
Bent 127 Pile 6: UW (PAR): H/L TO 1/8" CRACKS MULTIPLE FACES, FROM ABOVE THE HIGH WATER MARK DOWN THROUGH THE SPASH ZONE AND TAPERING TO HAIRLINE 1' TO 3' BELOW THE WATERLINE. SCALING TO 1" DEEP FROM WATERLINE TO MUDLINE.
