NC DEPARTMENT OF TRANSPORTATION  
DIVISION OF HIGHWAYS  
STRUCTURE MANAGEMENT UNIT

## Structure Safety Report

### 4 Year Underwater Element Inspection

DIVISION: 1 COUNTY: TYRRELL STRUCTURE NUMBER: 880007 FREQUENCY: 48 MONTHS

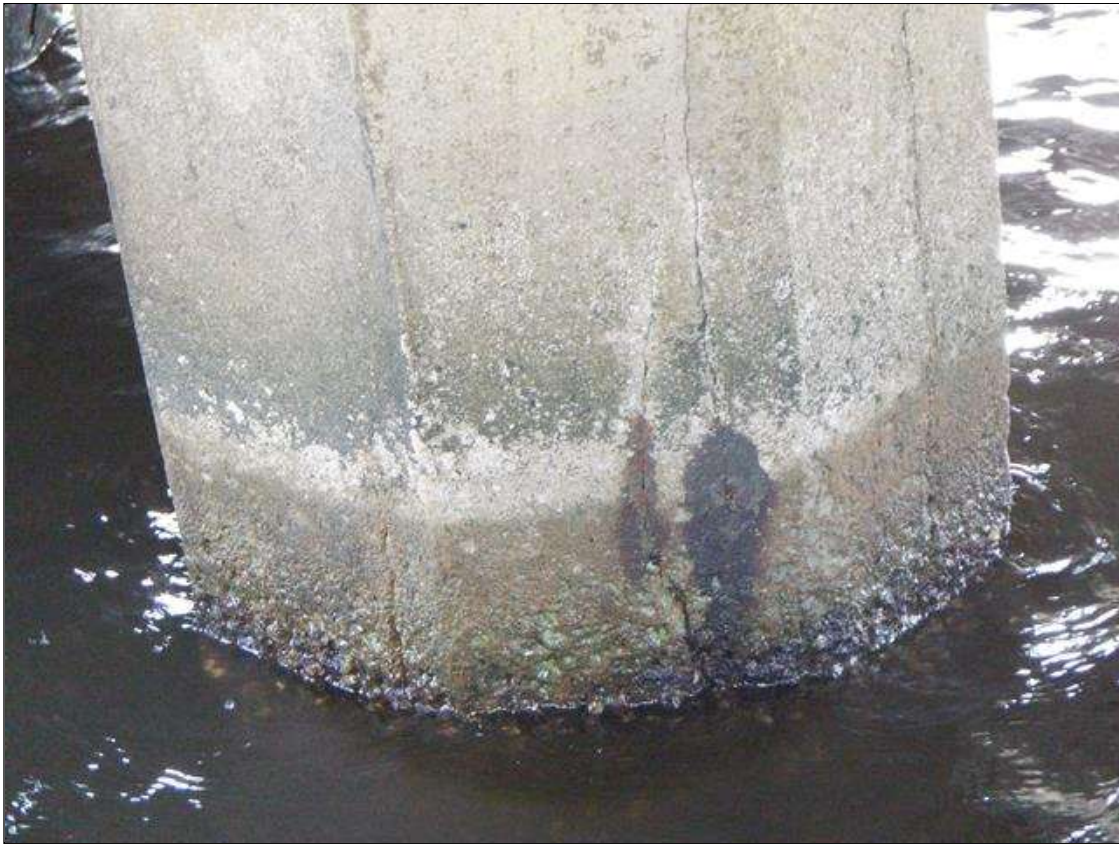
Bent 115 REST PIER 1 Pile 5: UW (PAR): H/L TO 1/8" CRACKS MULTIPLE FACES, FROM ABOVE THE HIGH WATER MARK DOWN THROUGH THE SPASH ZONE AND TAPERING TO HAIRLINE 1' TO 3' BELOW THE WATERLINE. SCALING TO 1" DEEP FROM WATERLINE TO MUDLINE.

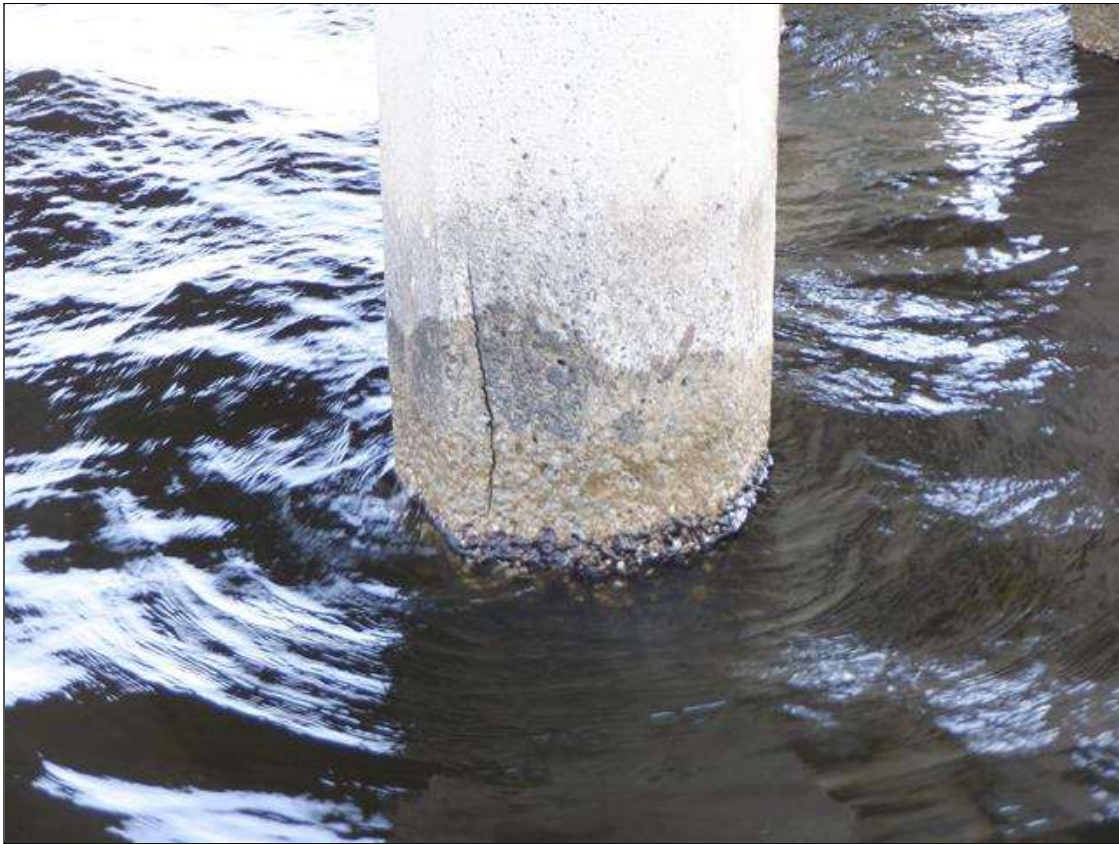
Bent 139 Pile 6: UW (PAR): H/L TO 1/8" CRACKS MULTIPLE FACES, FROM ABOVE THE HIGH WATER MARK DOWN THROUGH THE SPASH ZONE AND TAPERING TO HAIRLINE 1' TO 3' BELOW THE WATERLINE. SCALING TO 1" DEEP FROM WATERLINE TO MUDLINE.

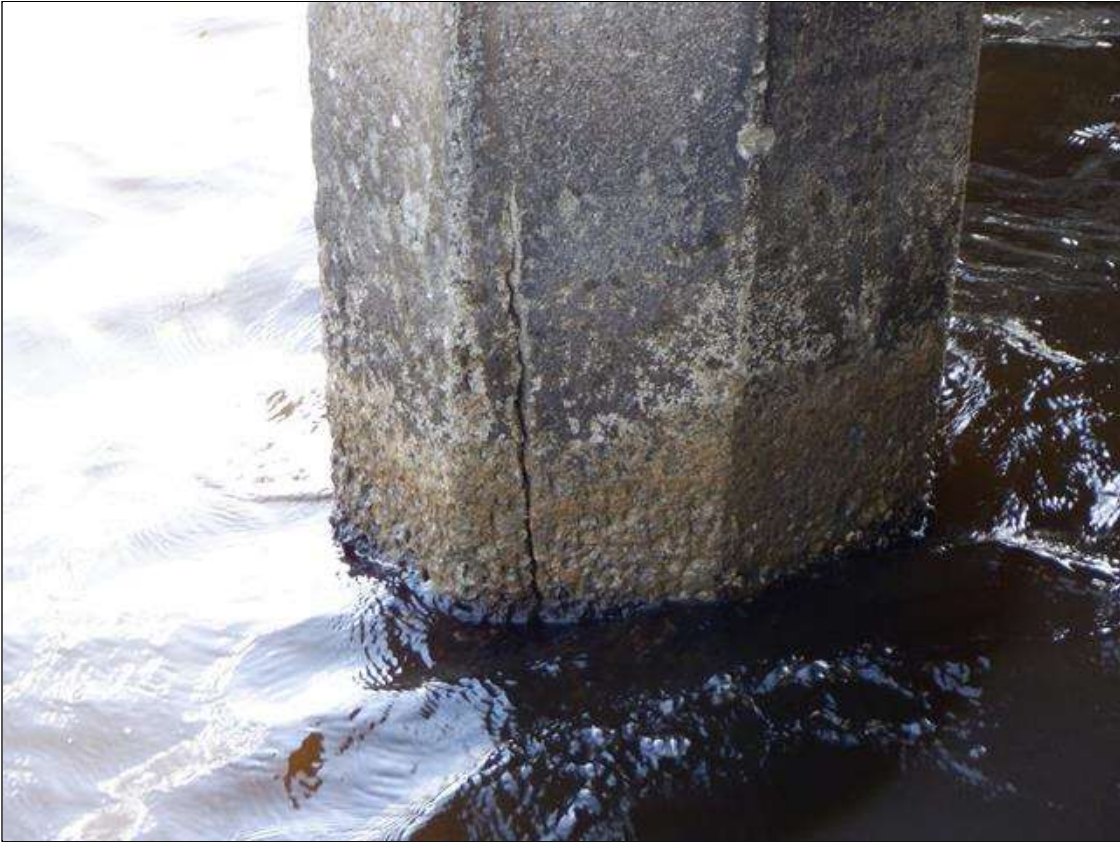
Bent 147 Pile 1: UW (PAR): H/L TO 1/8" CRACKS MULTIPLE FACES, FROM ABOVE THE HIGH WATER MARK DOWN THROUGH THE SPASH ZONE AND TAPERING TO HAIRLINE 1' TO 3' BELOW THE WATERLINE. SCALING TO 1" DEEP FROM WATERLINE TO MUDLINE.

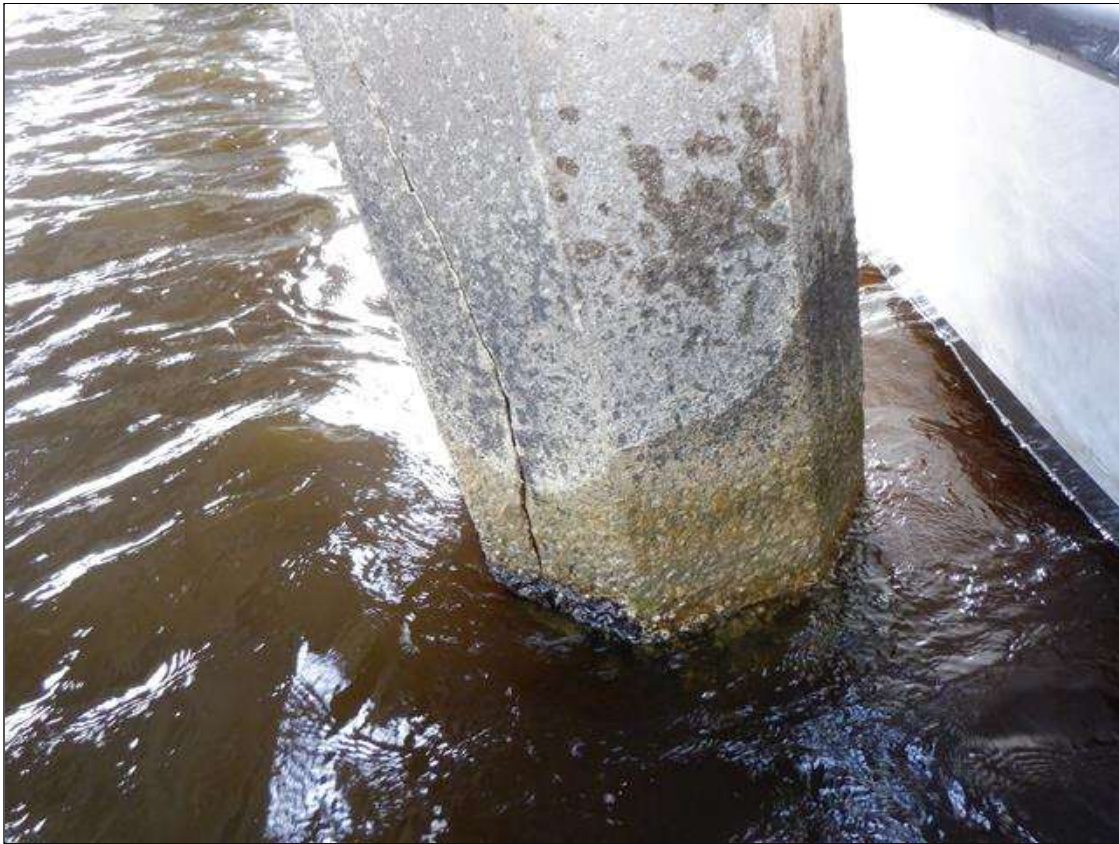
Bent 200 Pile 4: UW (PAR): H/L TO 1/8" CRACKS MULTIPLE FACES, FROM ABOVE THE HIGH WATER MARK DOWN THROUGH THE SPASH ZONE AND TAPERING TO HAIRLINE 1' TO 3' BELOW THE WATERLINE. SCALING TO 1" DEEP FROM WATERLINE TO MUDLINE.

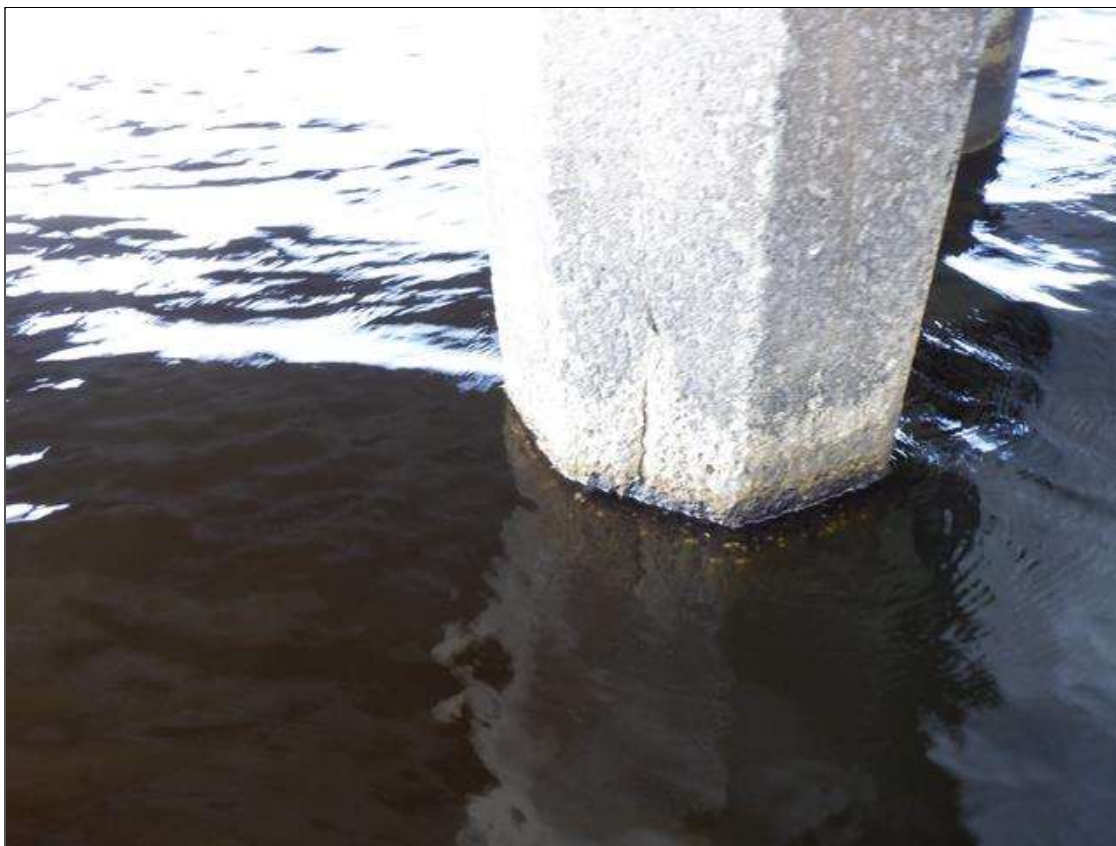
Bent 266 Pile 2: UW (PAR): H/L TO 1/8" CRACKS MULTIPLE FACES, FROM ABOVE THE HIGH WATER MARK DOWN THROUGH THE SPASH ZONE AND TAPERING TO HAIRLINE 1' TO 3' BELOW THE WATERLINE. SCALING TO 1" DEEP FROM WATERLINE TO MUDLINE.

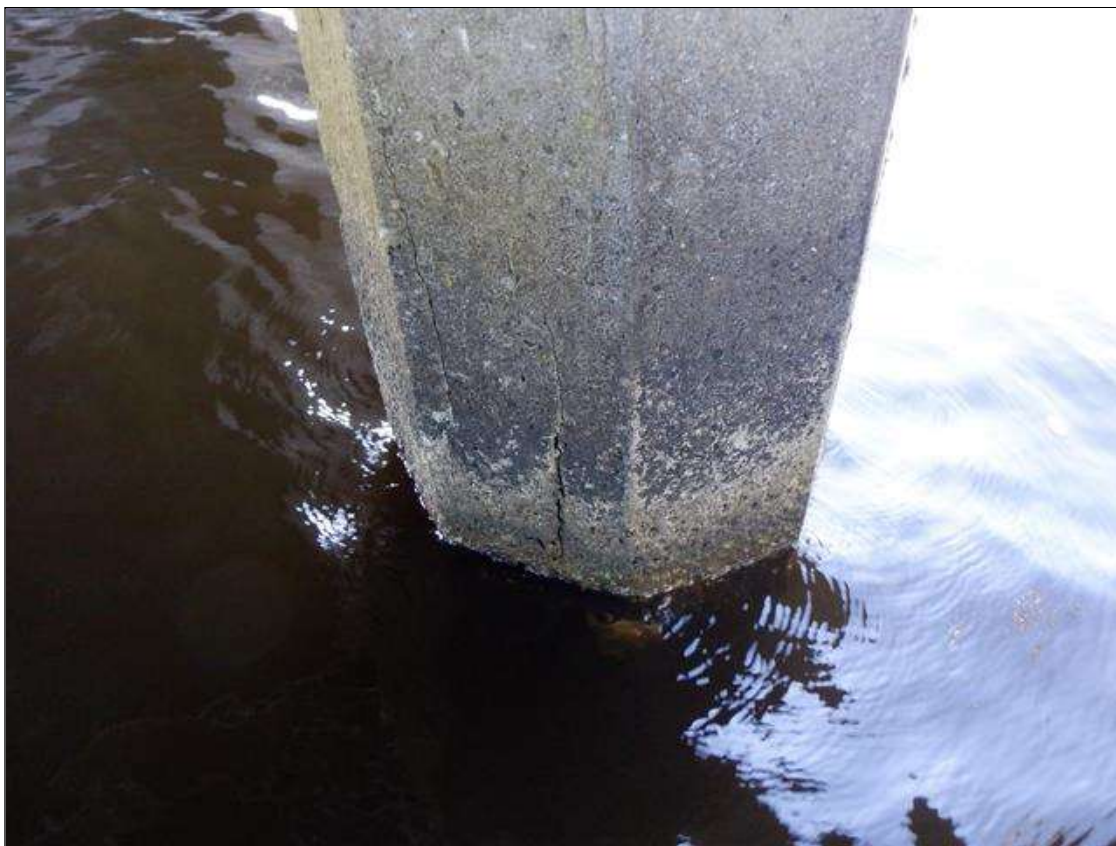
Bent 271 Pile 6: UW (PAR): H/L TO 1/8" CRACKS MULTIPLE FACES, FROM ABOVE THE HIGH WATER MARK DOWN THROUGH THE SPASH ZONE AND TAPERING TO HAIRLINE 1' TO 3' BELOW THE WATERLINE. SCALING TO 1" DEEP FROM WATERLINE TO MUDLINE.

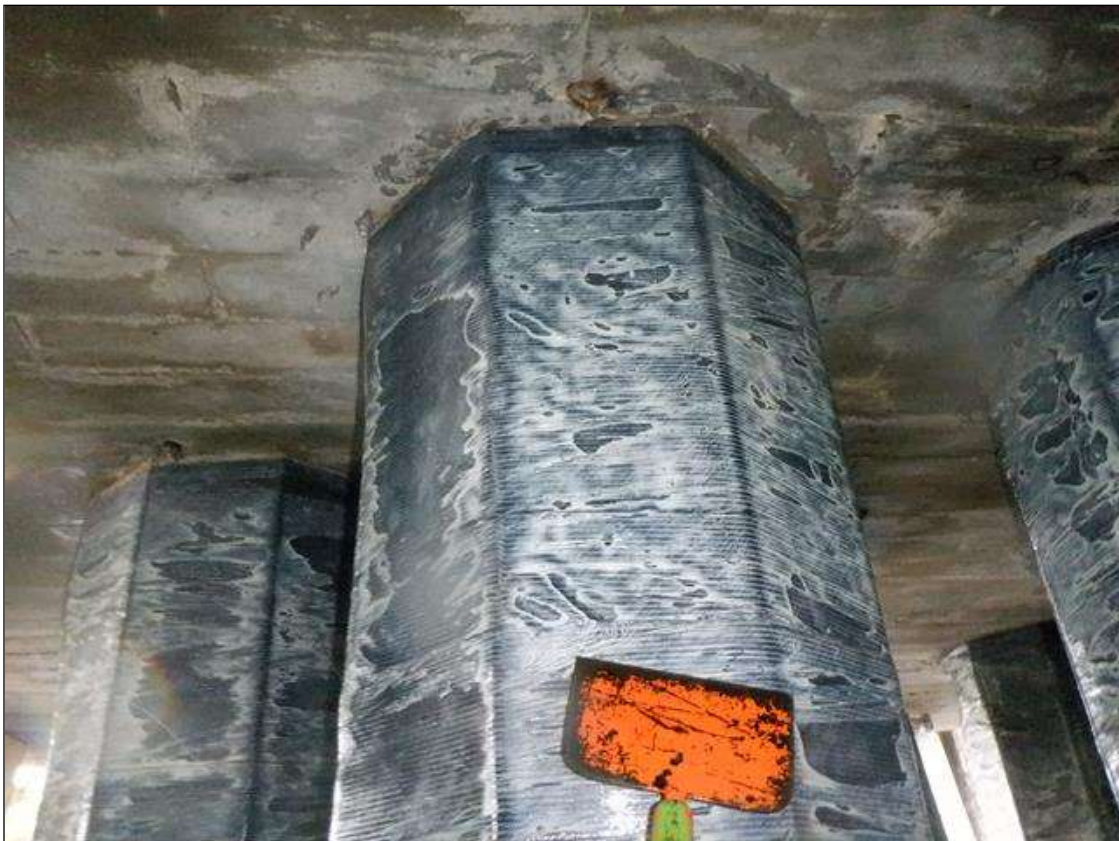
PIVOT BENT 116, P-51, REPAIRED
