NC DEPARTMENT OF TRANSPORTATION  
 DIVISION OF HIGHWAYS  
 STRUCTURE MANAGEMENT UNIT

ATTENTION: **PRIORITY ACTION REQUEST, "DANGER" SIGNS ON ALL BENT COLUMNS**

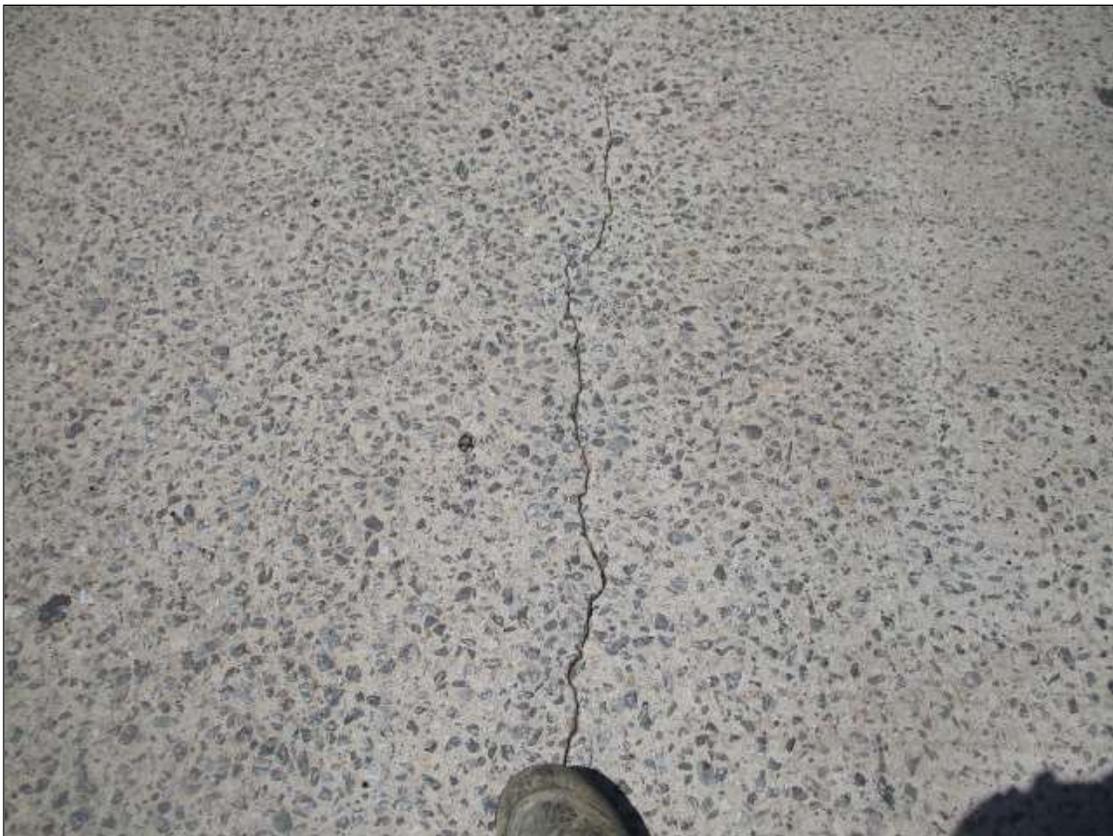
Approach 1 : 70 square feet up to 1/16" longitudinal cracks

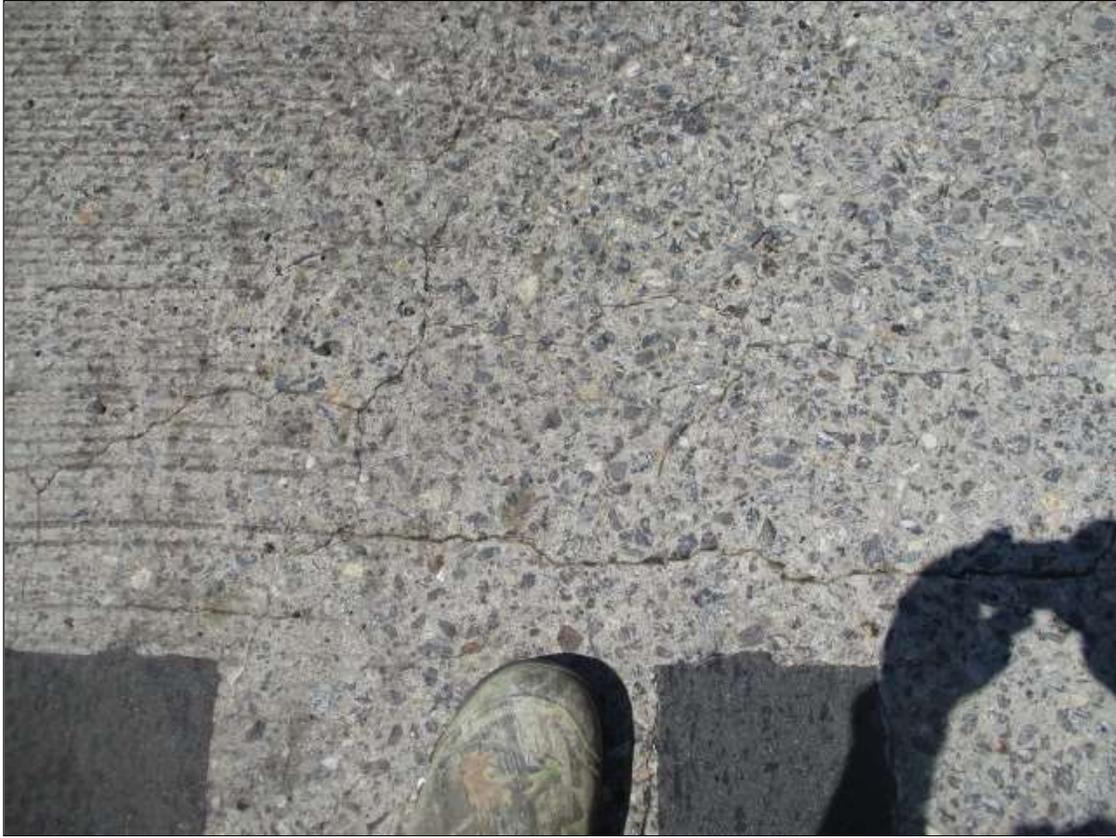
Span 1 Deck: throughout span multiple transverse cracks [up to 15ft x 1/8in]

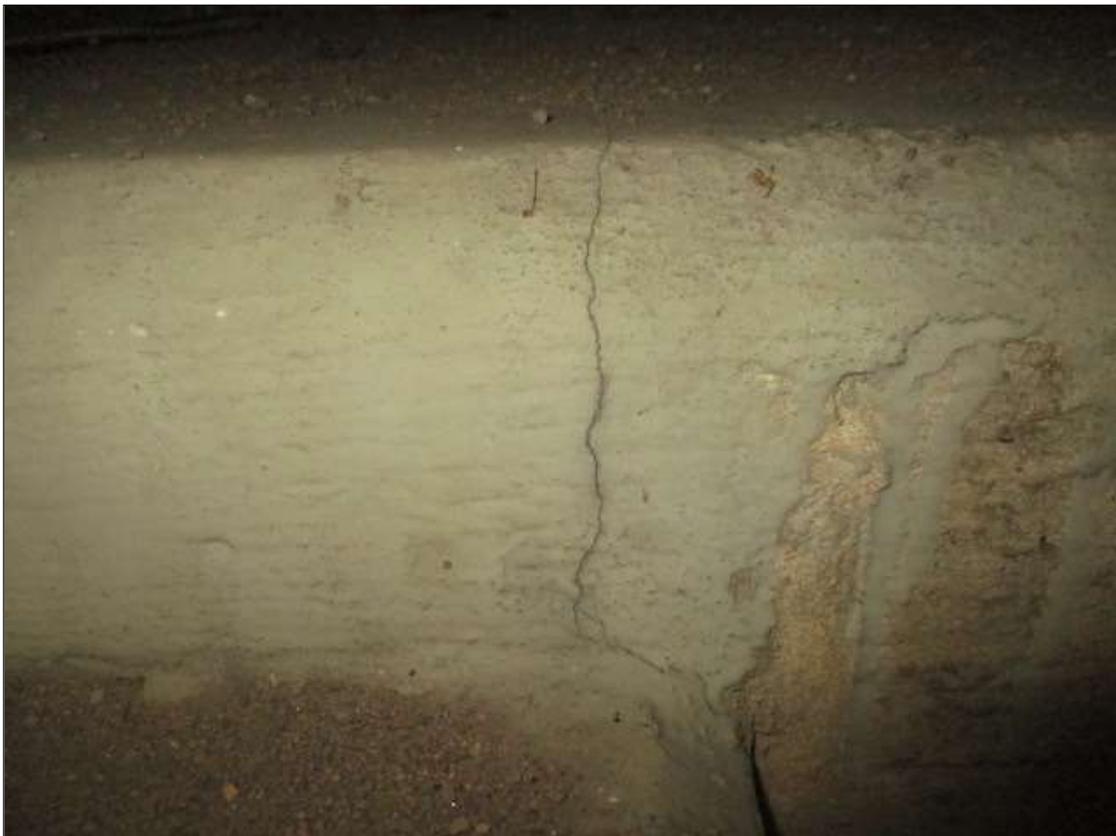
End Bent 1 Cap 1: along length of cap, multiple vertical cracks [up to 5in x hairline]

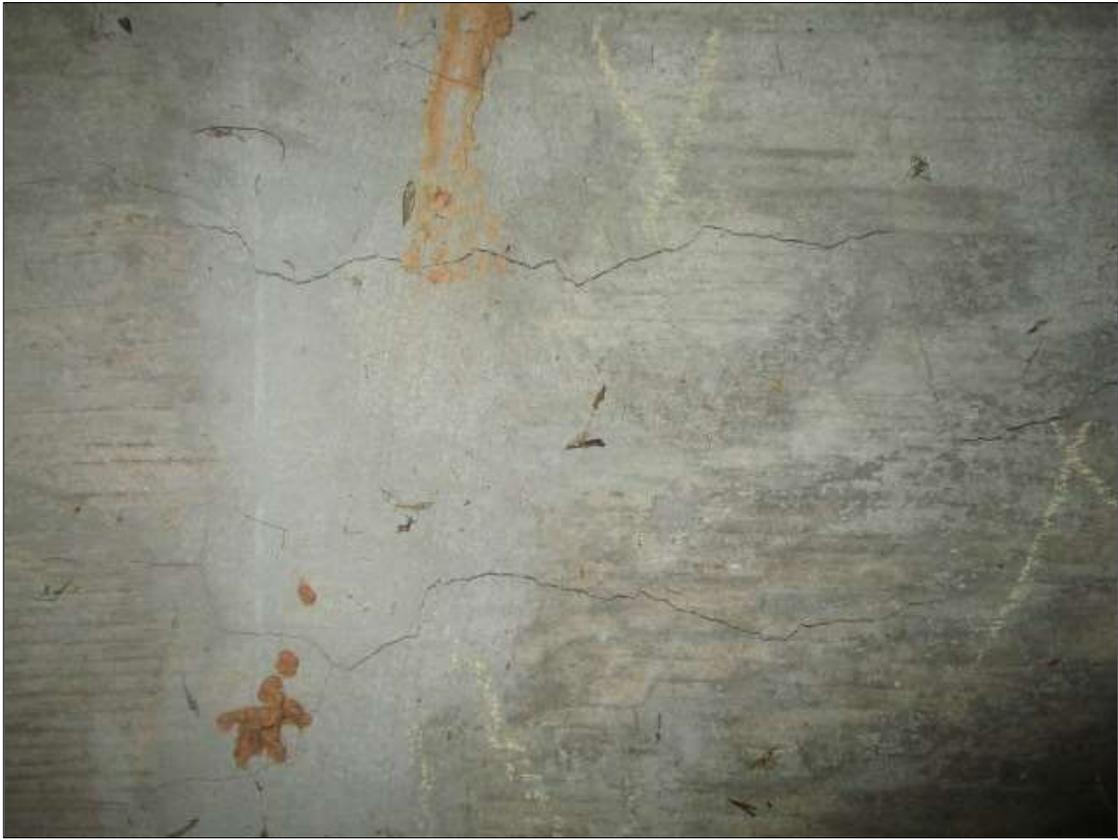
End Bent 1 Abutment: 7' x 3' area of hairline vertical and horizontal cracks in Bay 1 (Bays 2-5 similar)

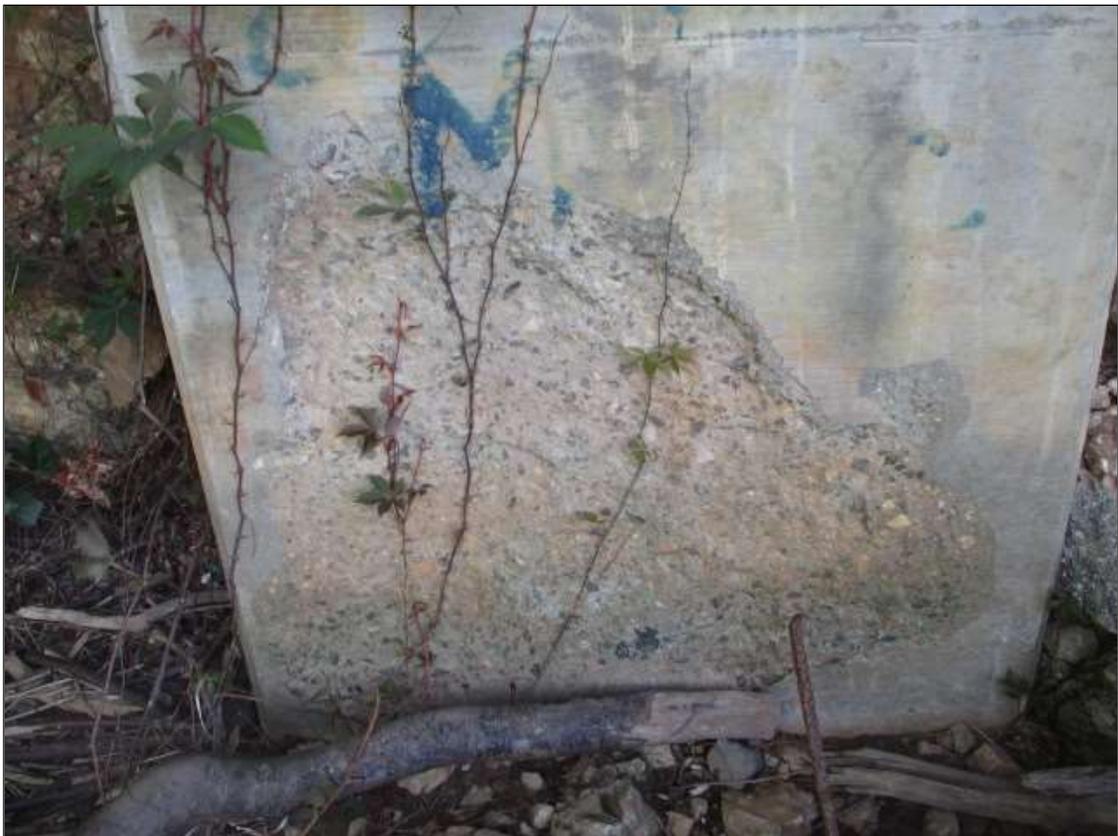
Bent 1 Pile 1: 24" x 32" x 1" deep spall on East face

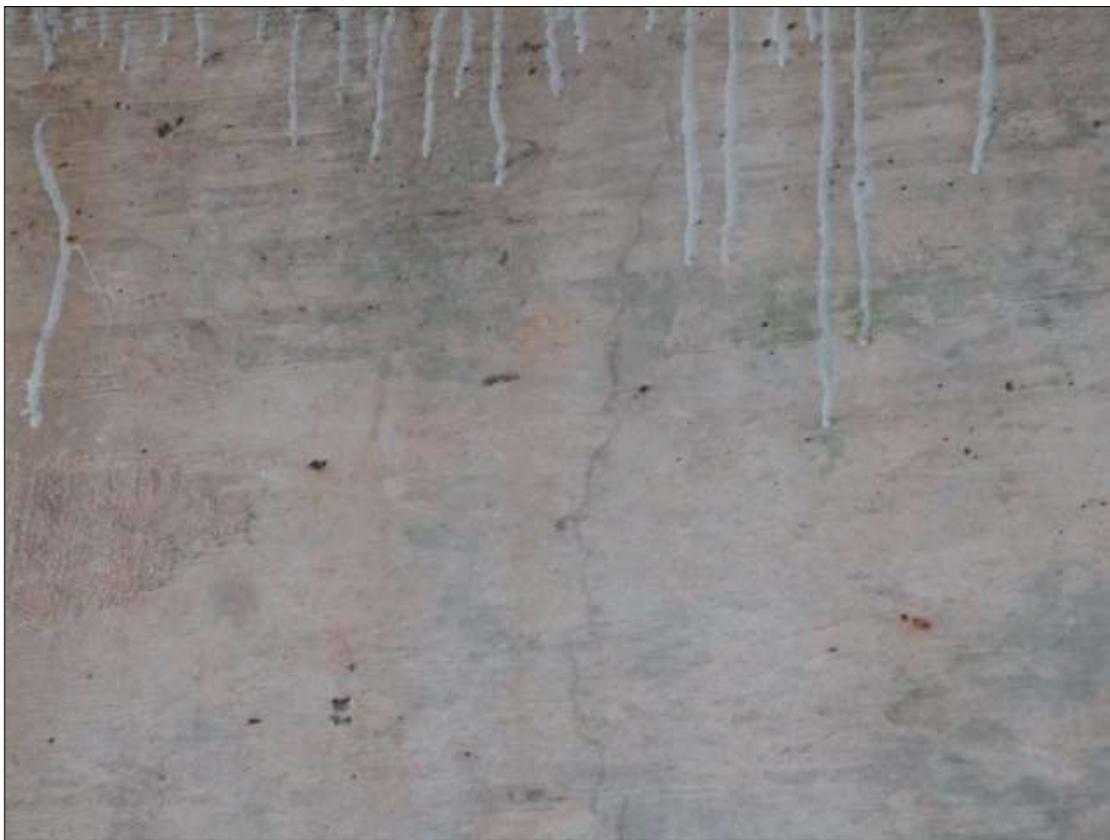
Bent 1 Cap 1: 3' hairline vertical crack on Span 2 face under Bay 3

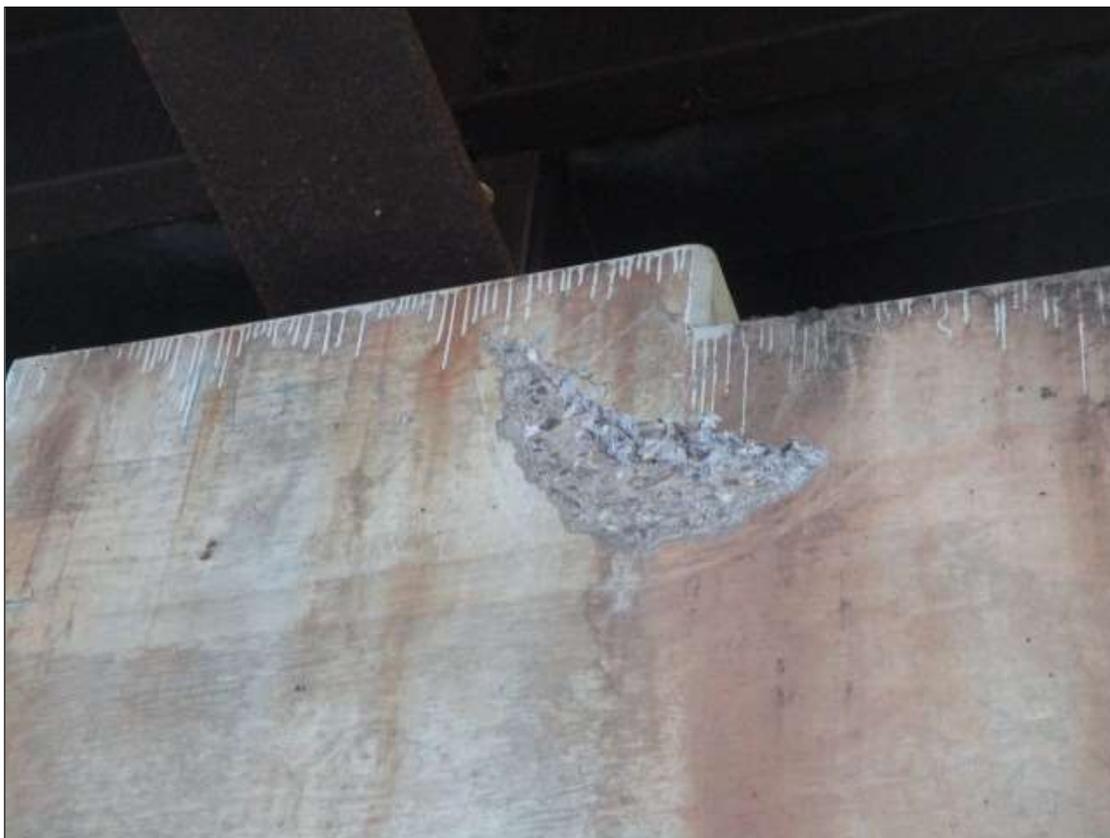
Bent 2 Cap 1: 18" x 20" area of delamination on Span 2 face under Beam 4

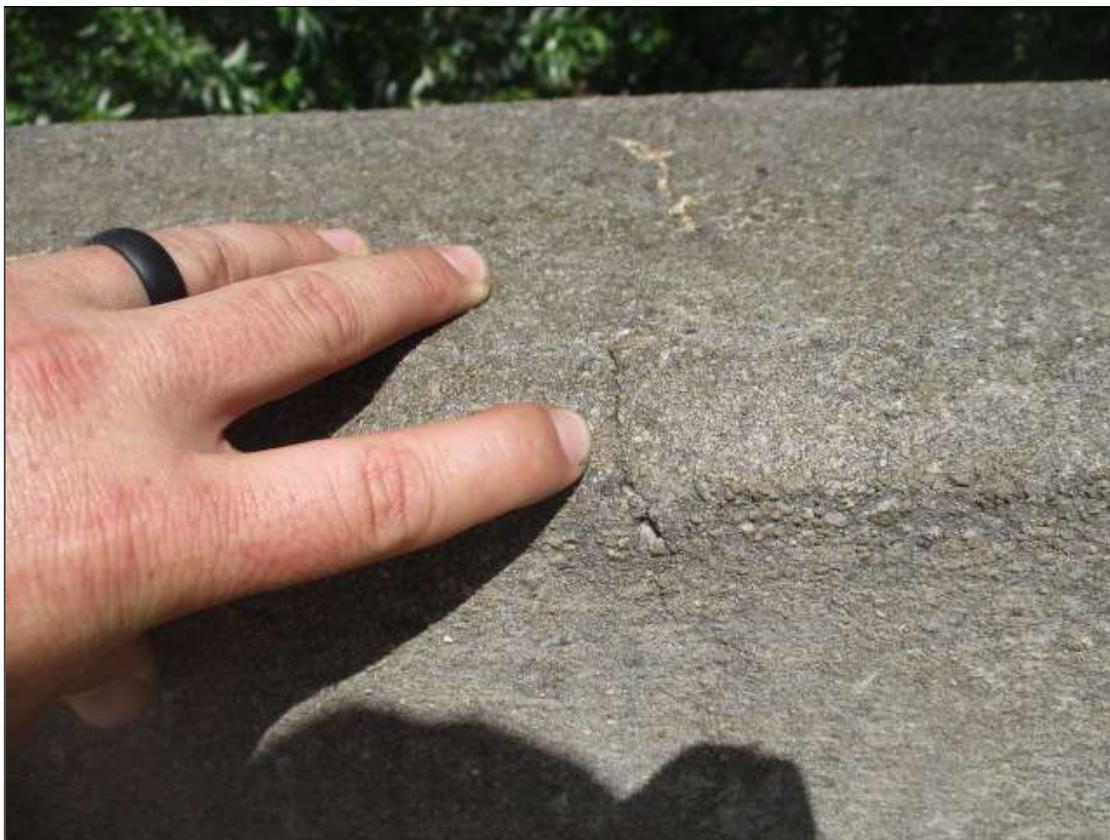
Span 2 Right Bridge Rail: (20) hairline vertical and transverse cracks with efflorescence

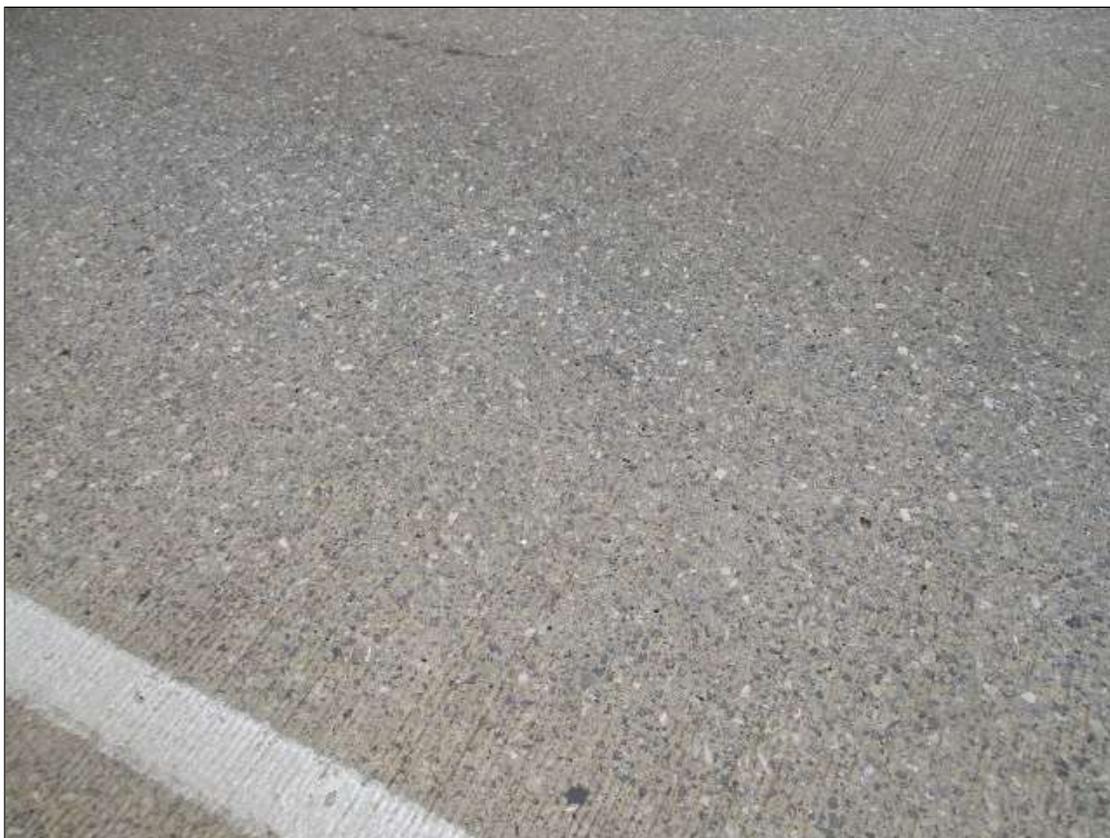
Span 4 Deck: along length of span in both travel lane wheel paths, abrasion with exposed aggregate

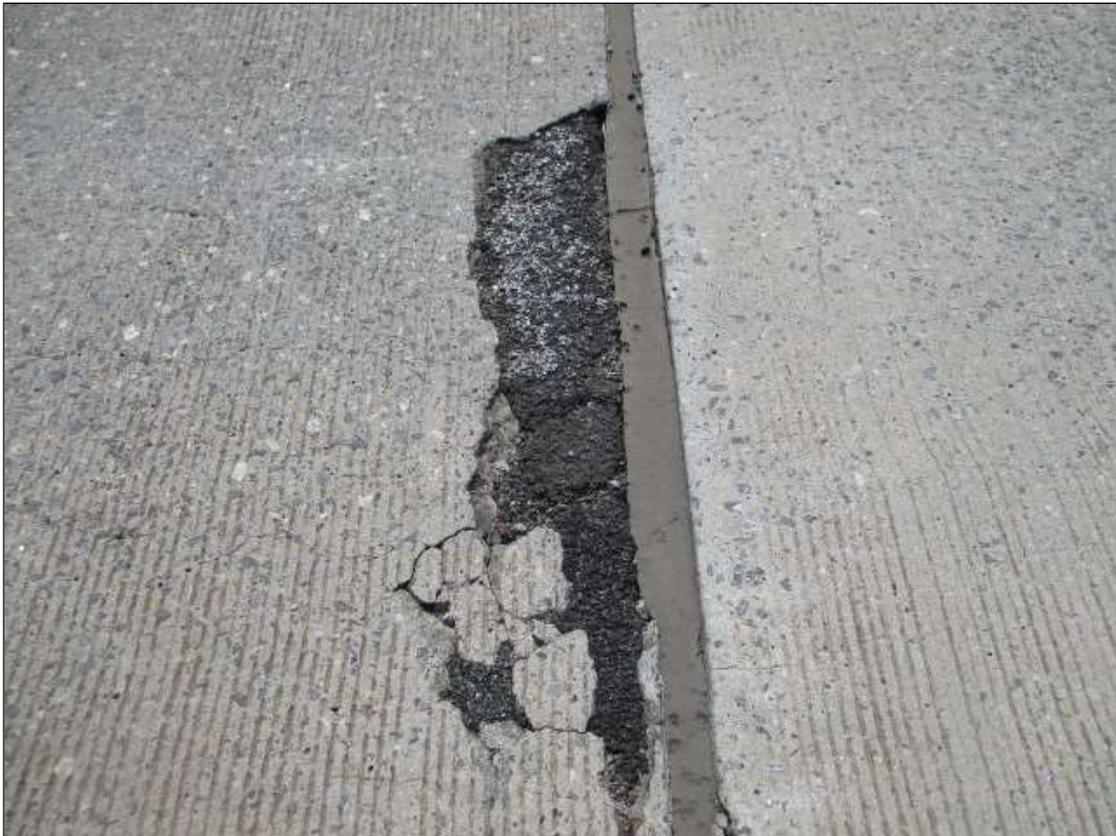
Span 10 Expansion Joint Over Bent 9: (5) up to 30" x 6" area of depressed and spalled patches

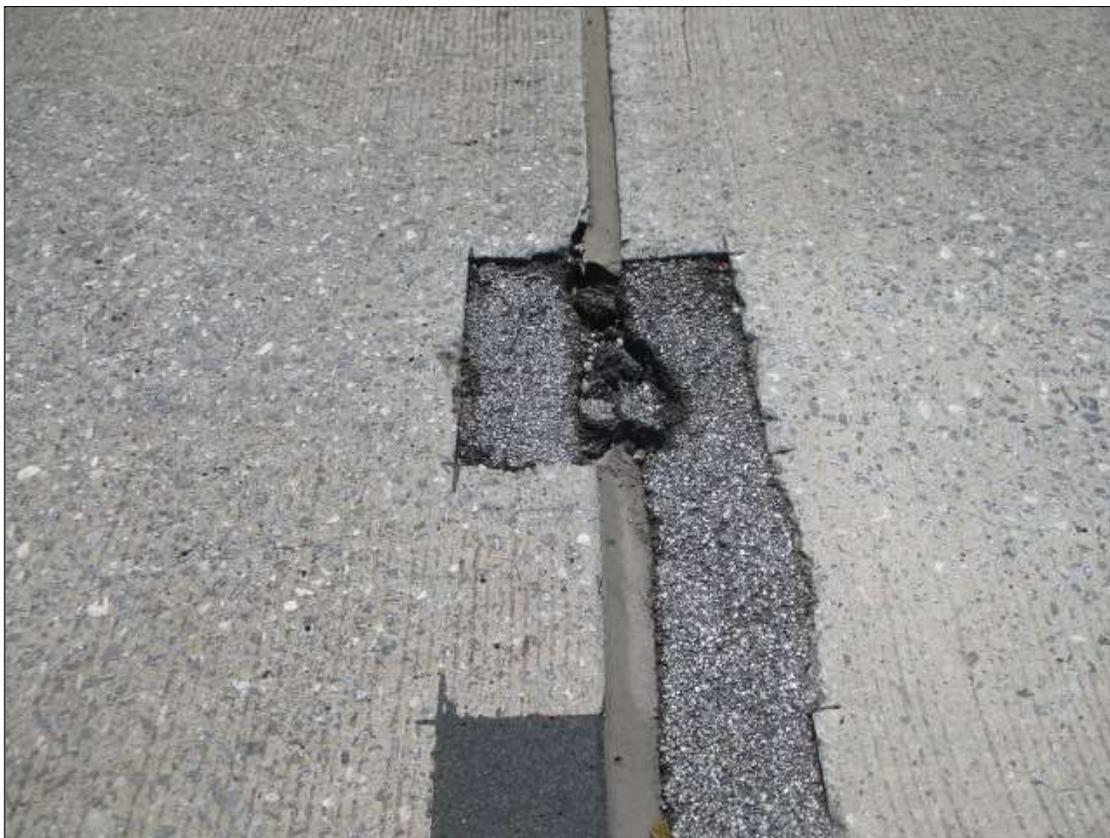
Span 10 Expansion Joint Over Bent 9: (5) up to 30" x 6" area of depressed and spalled patches

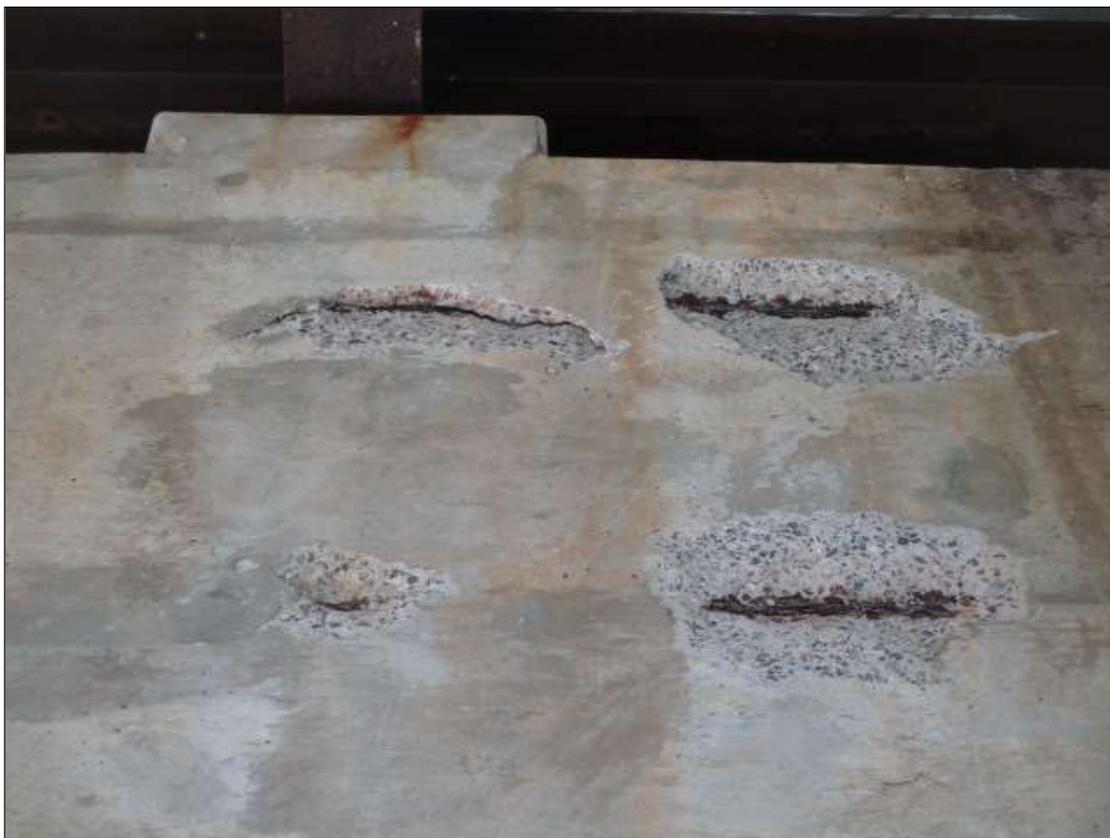
Bent 11 Cap 1: 70" x 67" x 2" deep spall with exposed rebar and area of delamination on Span 11 face under Bay 3 (PAR)

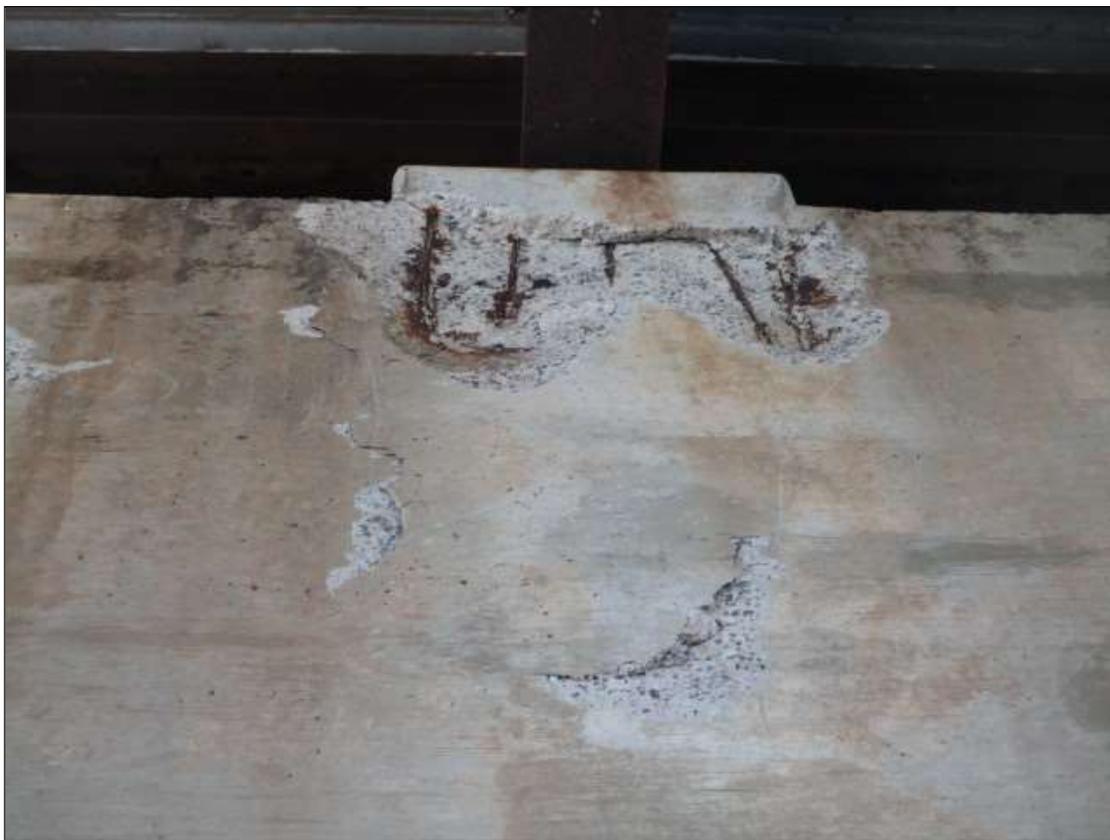
Bent 11 Cap 1: 45" x 74" x 2" deep spall with exposed rebar and area of delamination on Span 11 face under Beam 4 (PAR)

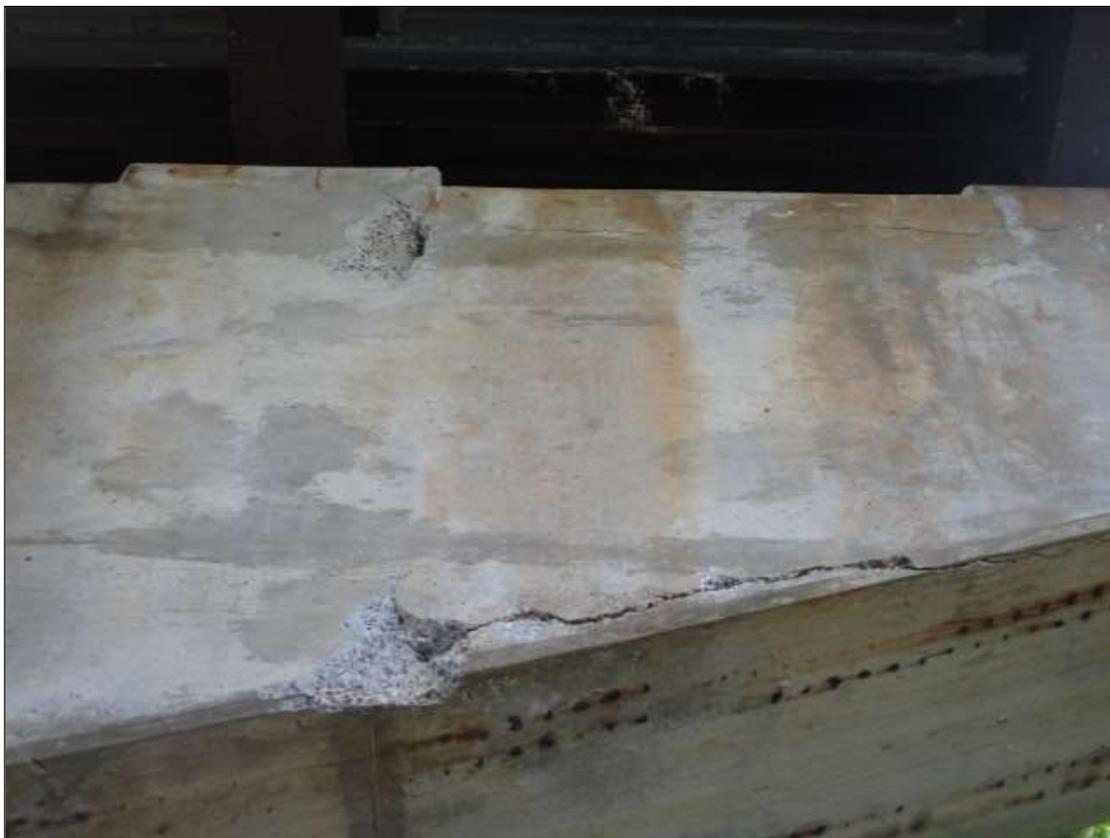
Bent 11 Cap 1: 9' x 3'-6" x 4" deep spall with exposed rebar and area of delamination on Span 11 face under Bay 5 (PAR)

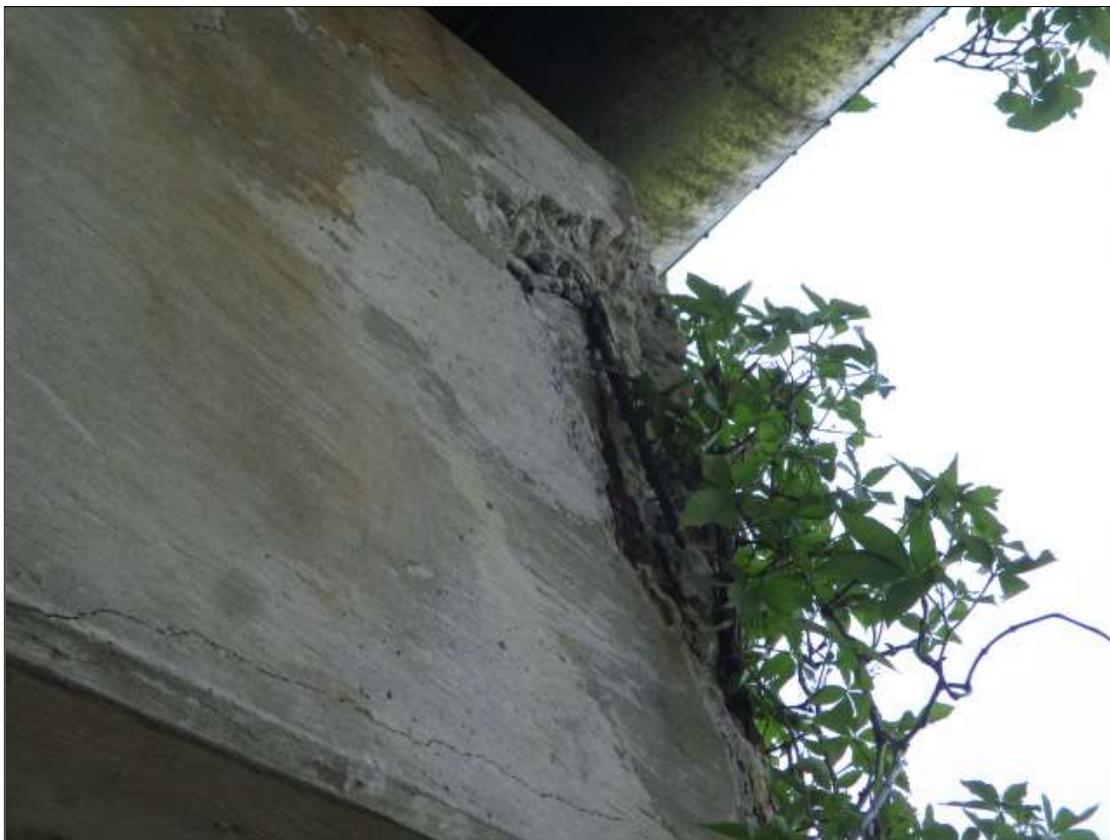
Bent 11 Cap 1: PAR: 18" LONG X FULL HEIGHT X 2" DEEP SPALL WITH EXPOSED REBAR ON SOUTHEAST CORNER OF CAP

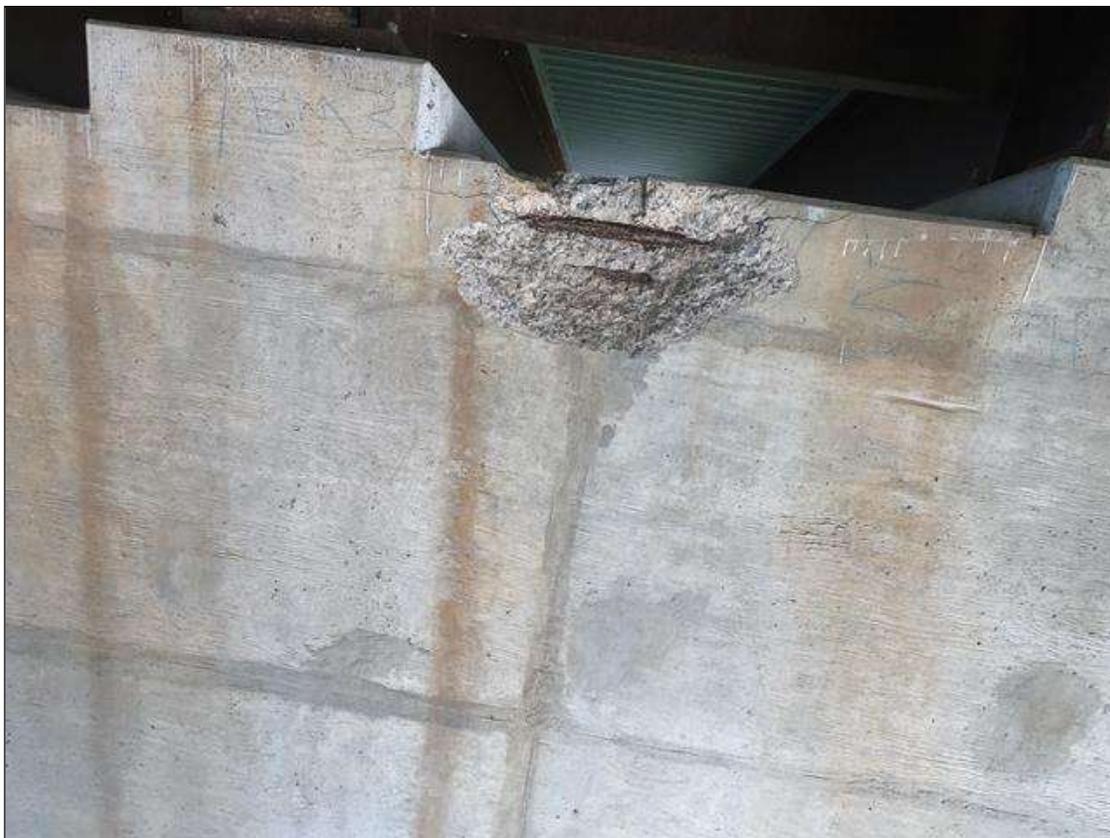
Bent 5 Cap 1: 42" x 29" x 3" deep spall with exposed rebar and area of delamination on Span 5 face under Bay 3 (PAR)

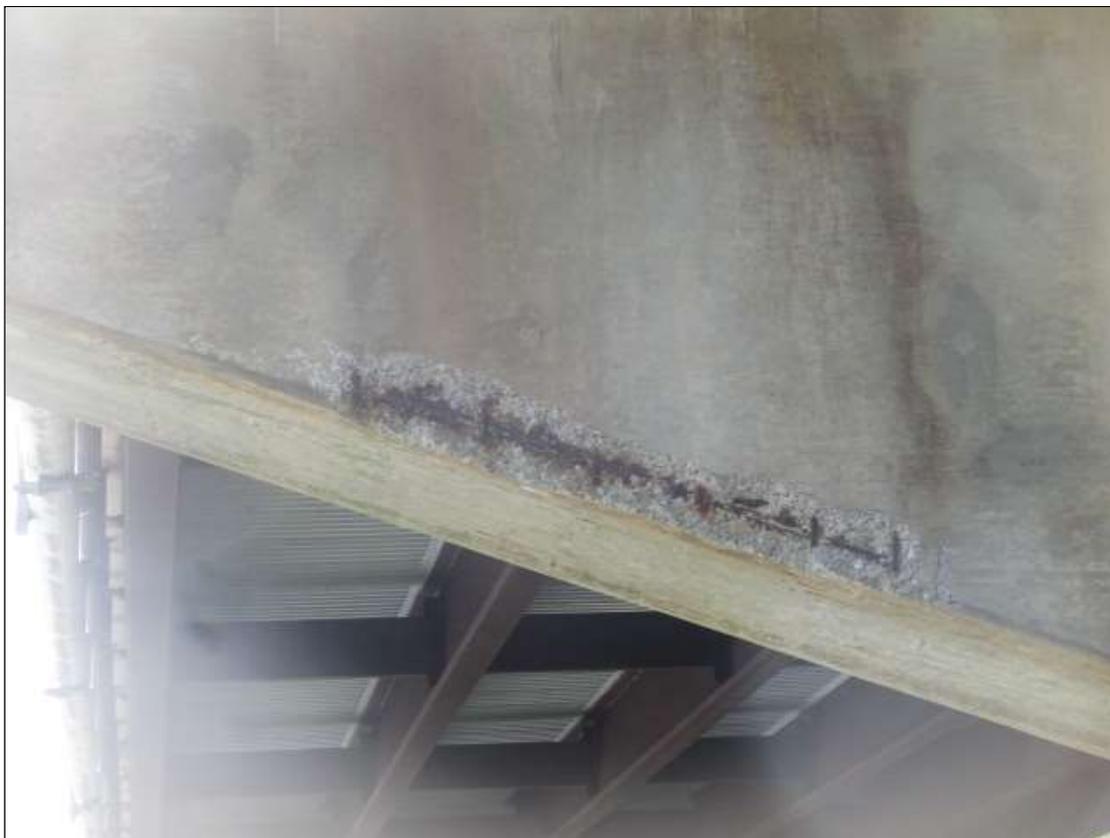
Bent 7 Cap 1: 6' x 9" x 2 1/2" deep spall with exposed rebar on Span 8 face under Bay 5 (PAR)

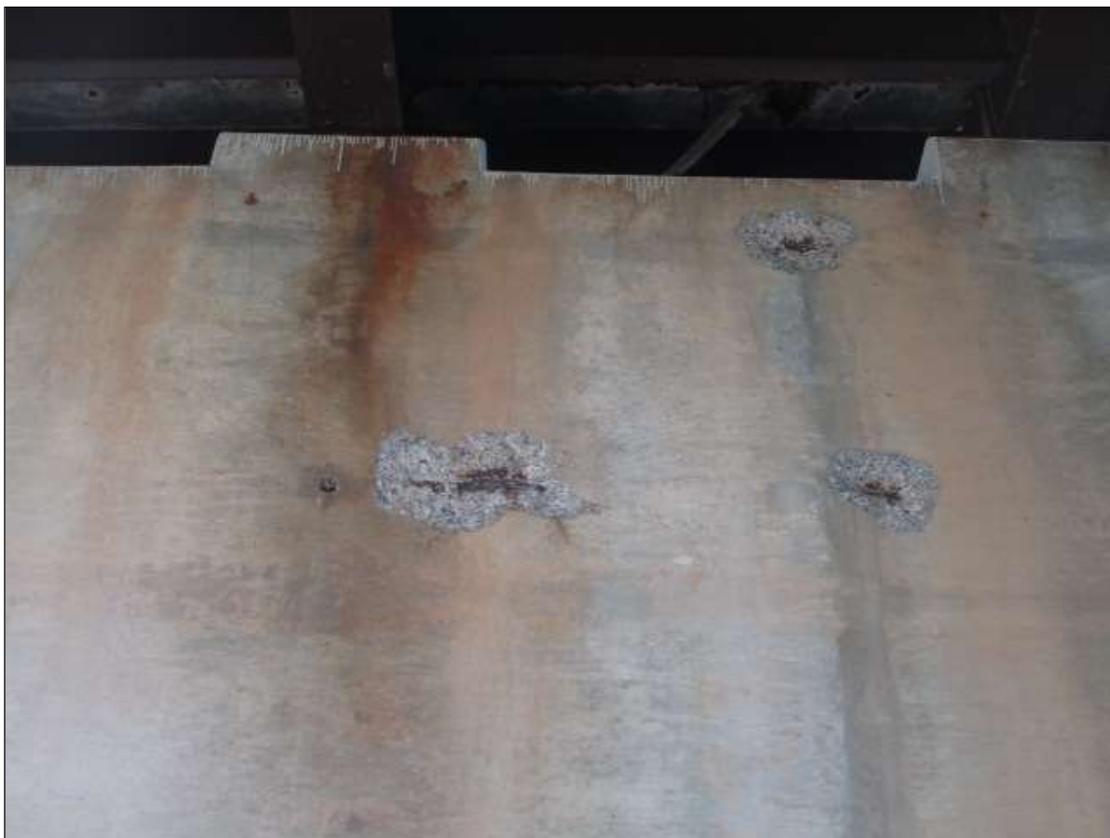
Bent 7 Cap 1: 6' x 9" x 2 1/2" deep spall with exposed rebar on Span 8 face under Bay 5 (PAR)

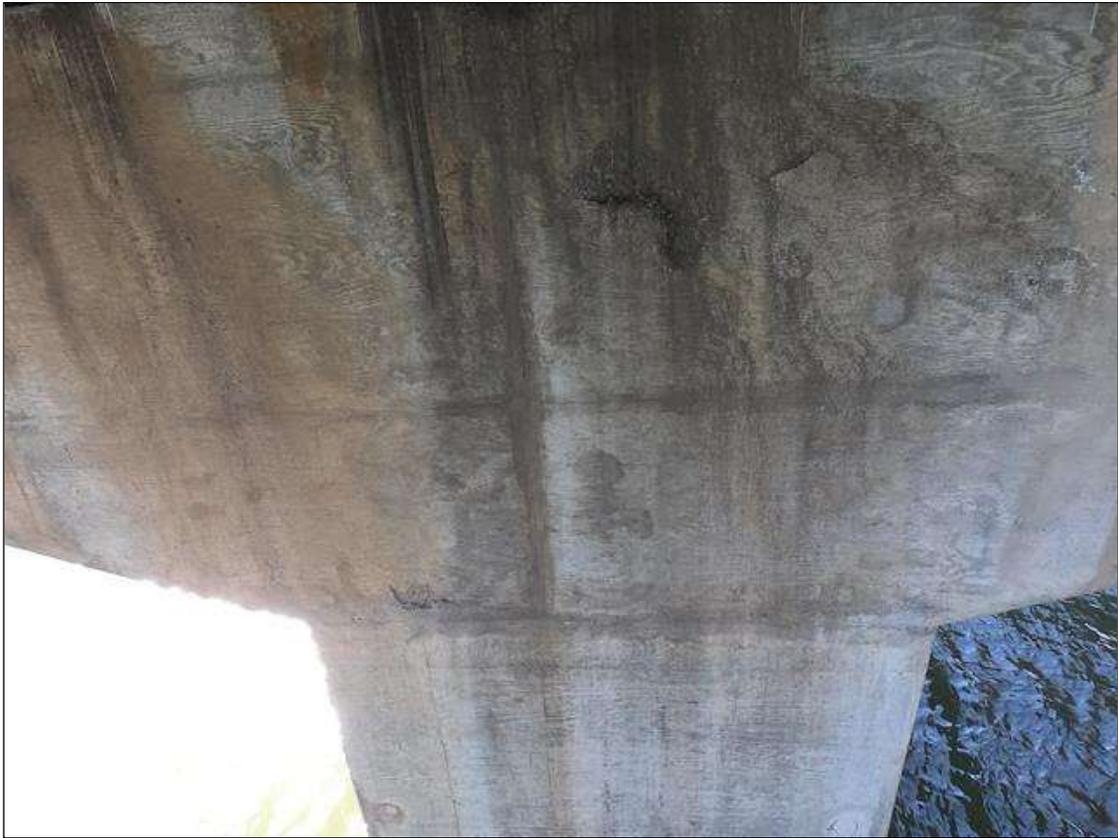
Bent 8 Cap 1: 25" x 8" x 2 1/2" deep spall with exposed rebar on Span 9 face under Bay 3 (PAR)

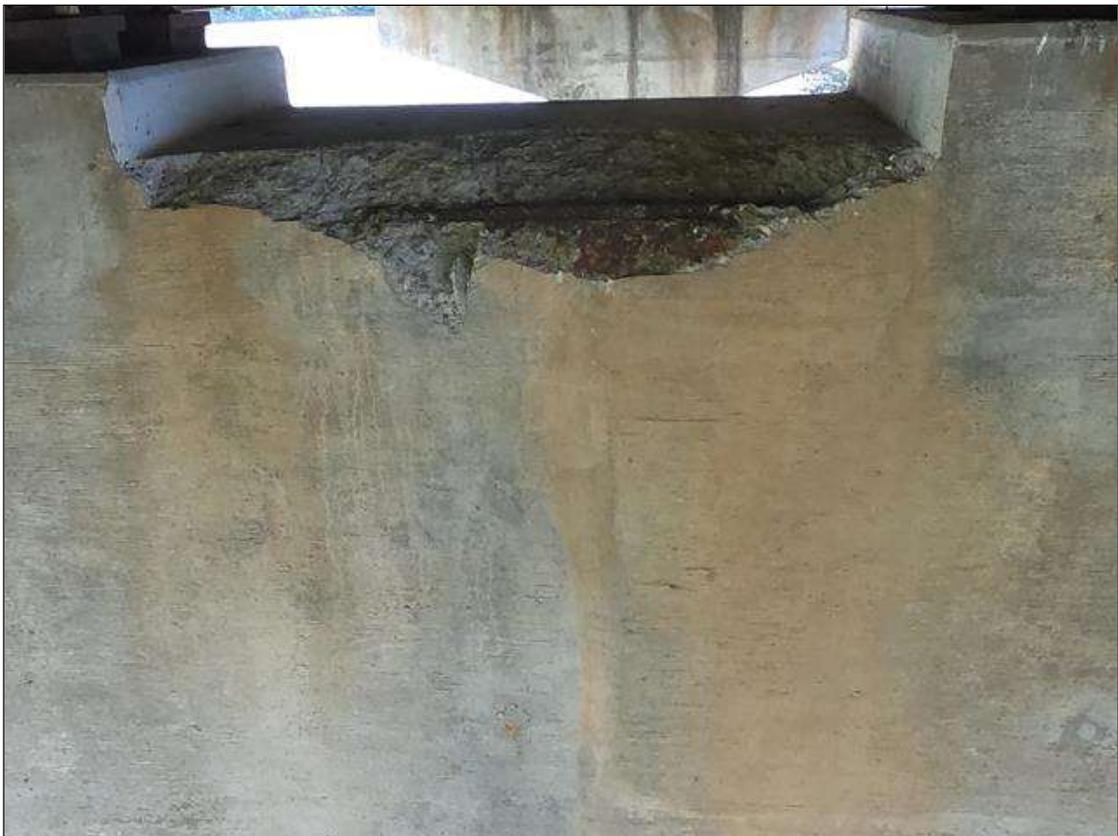
Bent 10 Cap 1: 58" x 17" x 4" deep spall with exposed rebar and area of delamination on Span 11 face under Bay 3 (PAR)

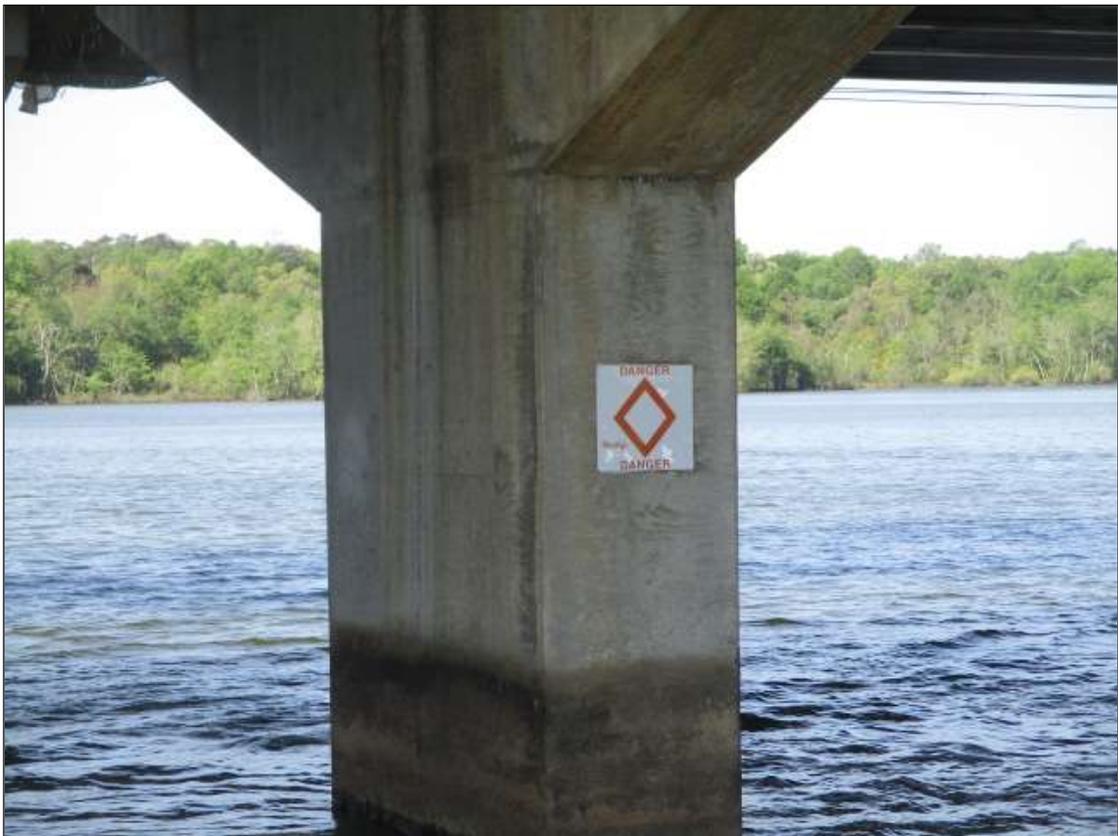
DANGER SIGNS ON ALL BENT COLUMNS

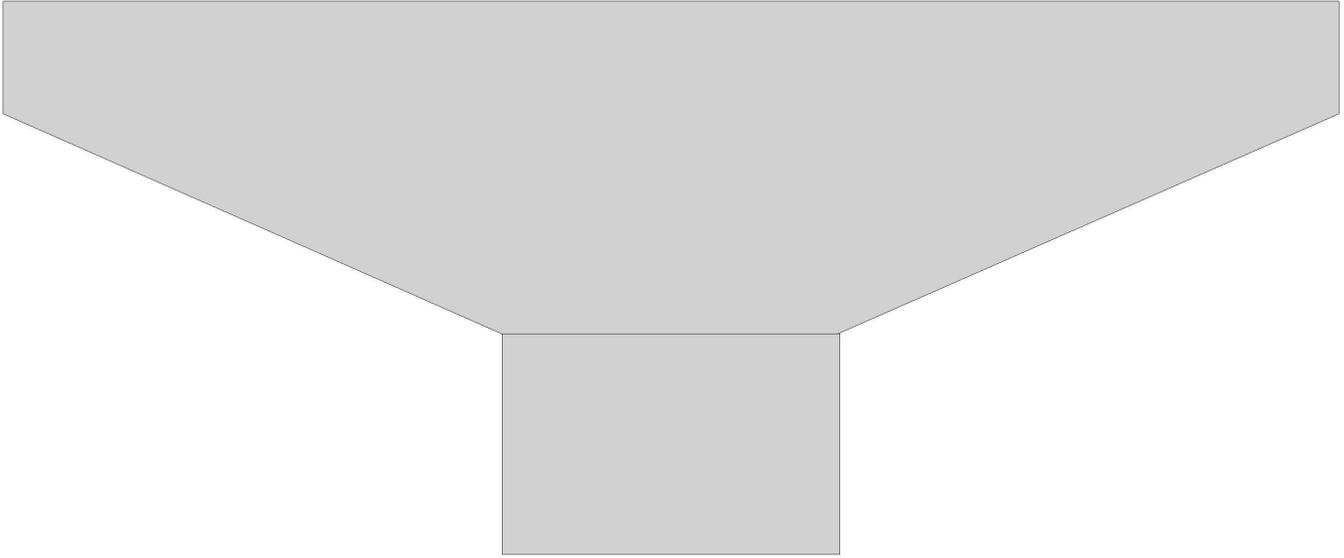
<b>Cap Information</b>			<b>Material</b> Cast-in-Place Concrete							
Length	Width	Height	Left Overhang	Right Overhang	Left Beam to End of Cap.	Right Beam to End of Cap.				
41.500 ft.	3.170 ft.	3.500 ft.	20.750 ft.	20.750 ft.	2.000 ft.	2.000 ft.				
<b>Subcap Information</b>			<b>Material</b>							
Length	Width	Height	Left Overhang	Right Overhang	Left Pile to Splice.					
<b>Sill Information</b>			<b>Material</b>							
Length	Width	Height								
Pile #	Material	Spacing	Width/Dia.	Height	Length	Orientation	Driven?	Replacement?	Removed?	Collar?
1	Concrete		10.5 ft.			Vertical	No	No	No	No
<p>9-28-2021 UNDERWATER INSPECTED BENTS 3 THRU 10 FROM MUDLINE TO WATER SURFACE</p> <p><b>MEASUREMENTS VERIFIED 4-28-22 JWD</b></p> <p style="text-align: right;">SKETCH VERIFIED 4/21/20 BY COG</p>										
<b>Bent/Abutment #:</b> 1			<b>Similar Bents:</b> 2 THRU 11
