NC DEPARTMENT OF TRANSPORTATION
 DIVISION OF HIGHWAYS
 STRUCTURE MANAGEMENT UNIT

Structure Safety Report

Routine Element Inspection - Contract

STRUCTURE NUMBER: 130367 SAP STRUCTURE NO: 0140367 FHWA STRUCTURE NO: 00000000270367

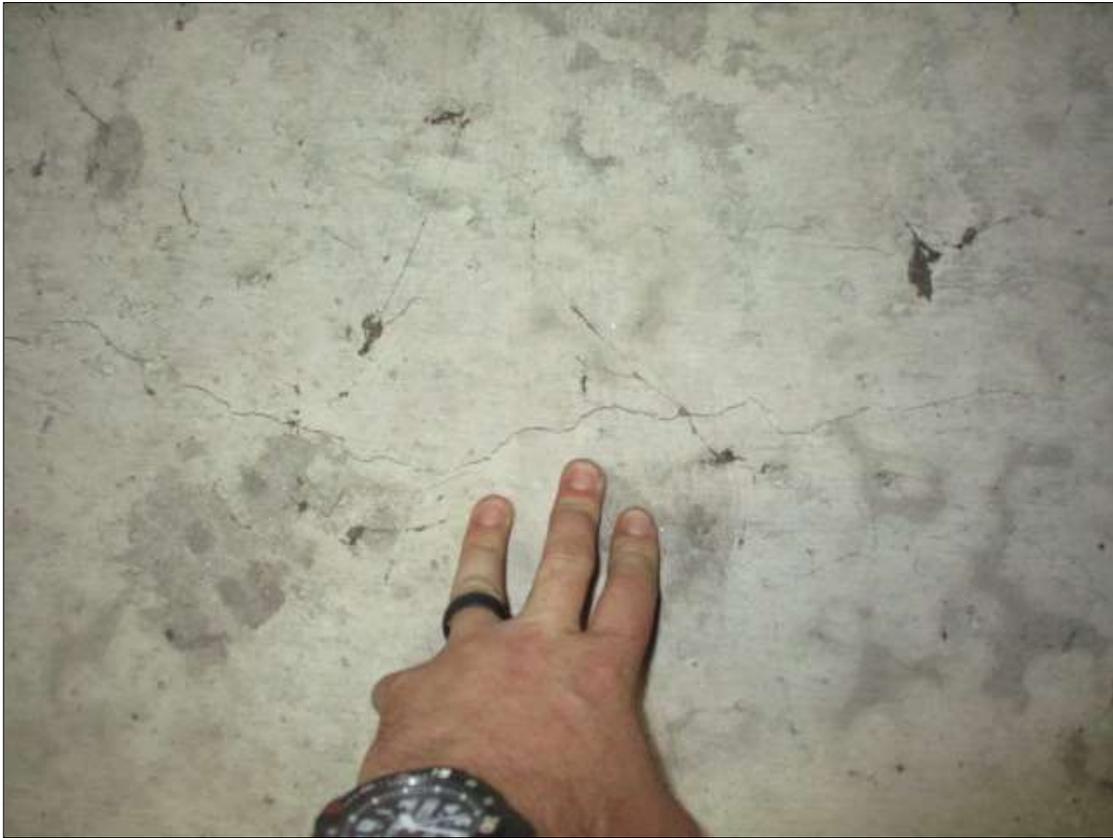
Bent 2 Abutment: 7' hairline horizontal cracks in Bay 1 (Bays 2 and 3 similar)

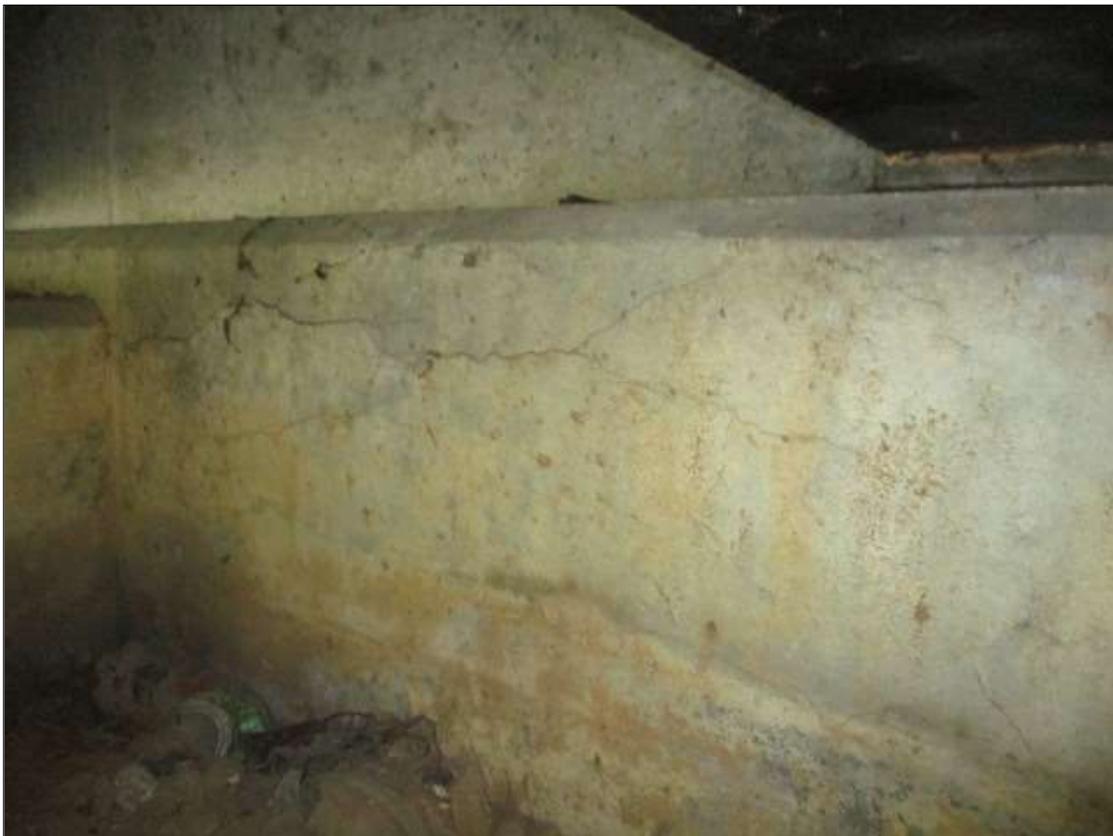
Bent 2 Cap 1: 11' up to 1/16" horizontal cracks under Bays 2 and 3

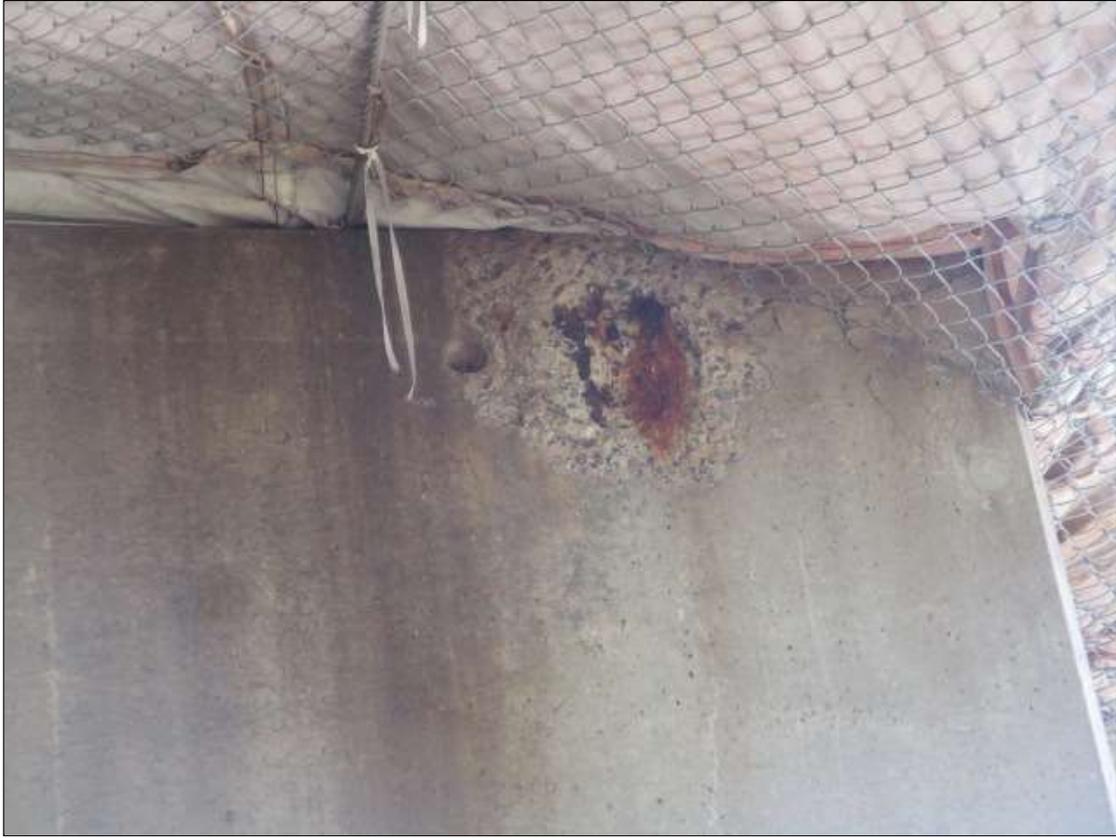
Bent 9 Cap 1: North face at West end, spall with exposed rebar and area of delamination [32in x 20in x 1- 3/4in deep] with two [2] exposed vertical rebar

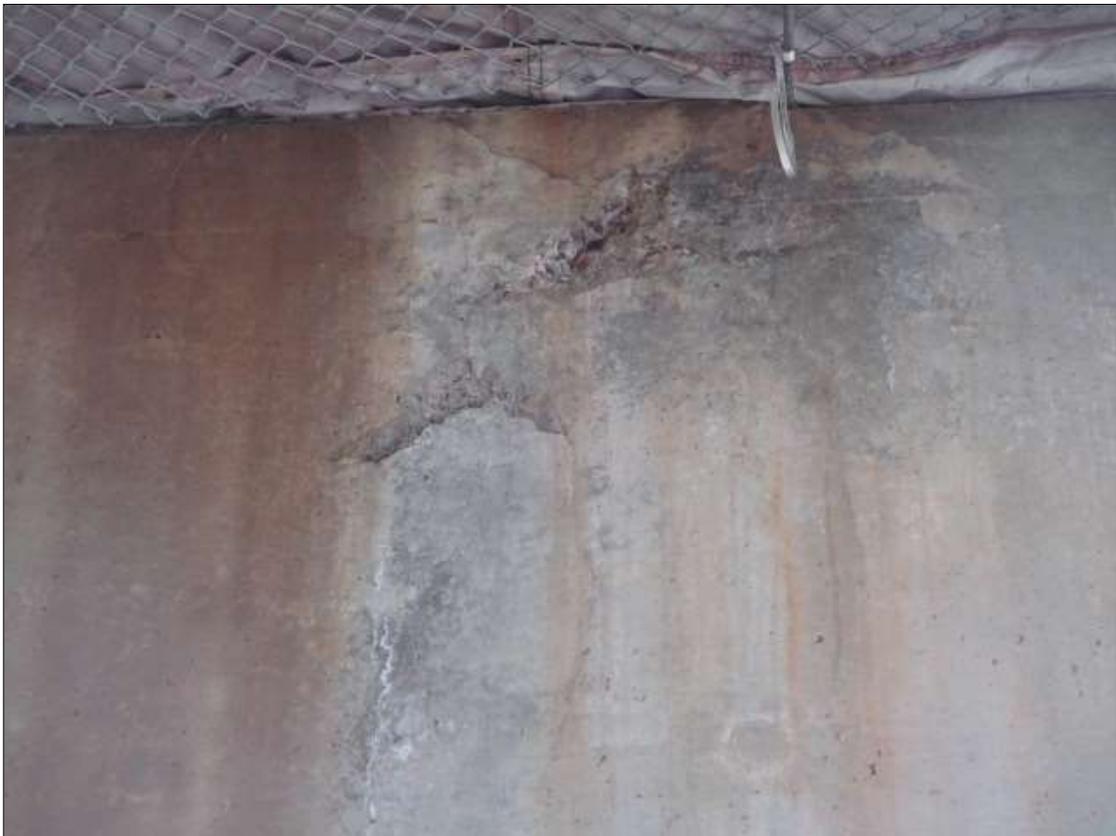
Bent 9 Cap 1: North face under beam 2, spall with exposed rebar and area of delamination [34in x 32in x 1-1/2in deep]

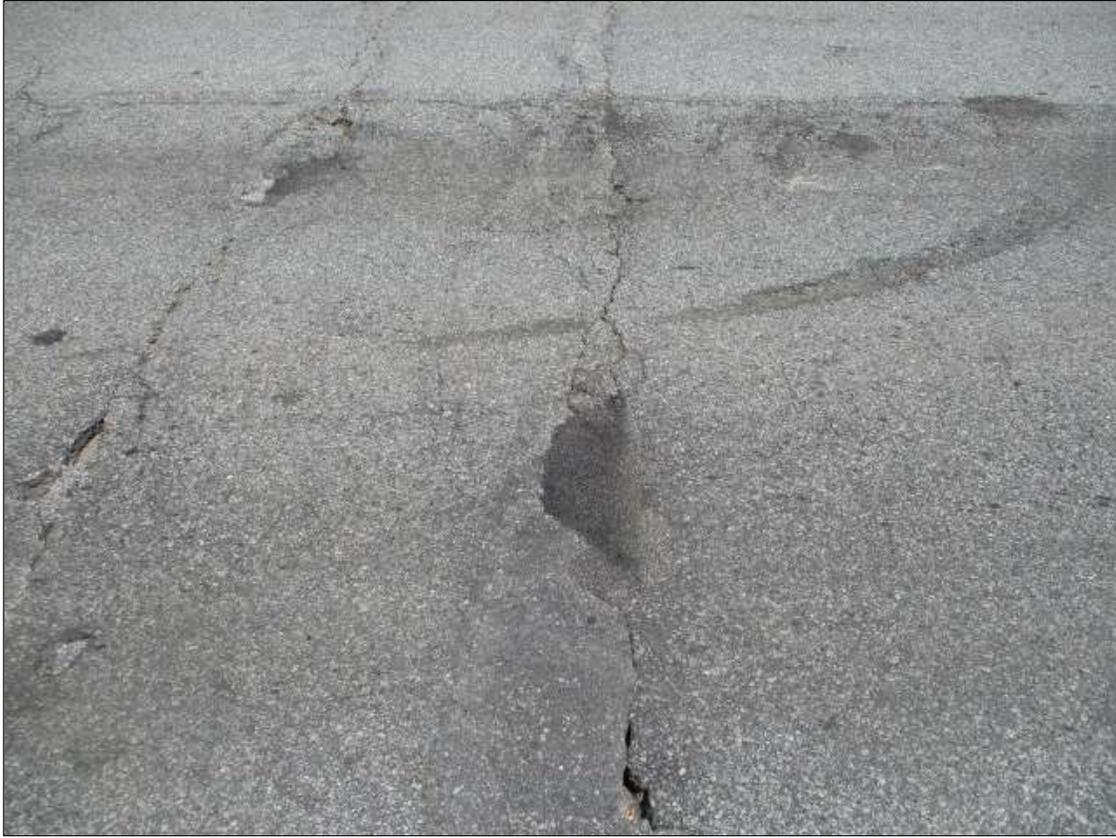
Span 10 Wearing Surface: asphalt over end bent 2, multiple transverse cracks [up to full width x up to 1/4in]

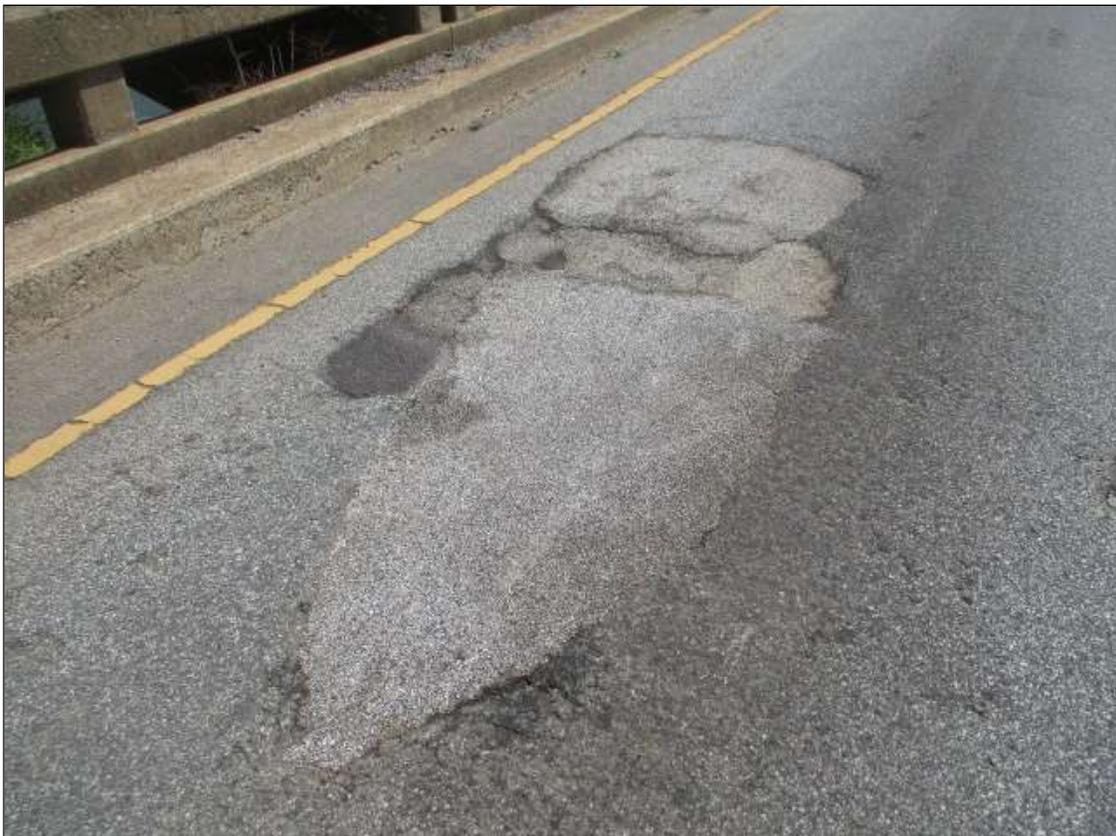
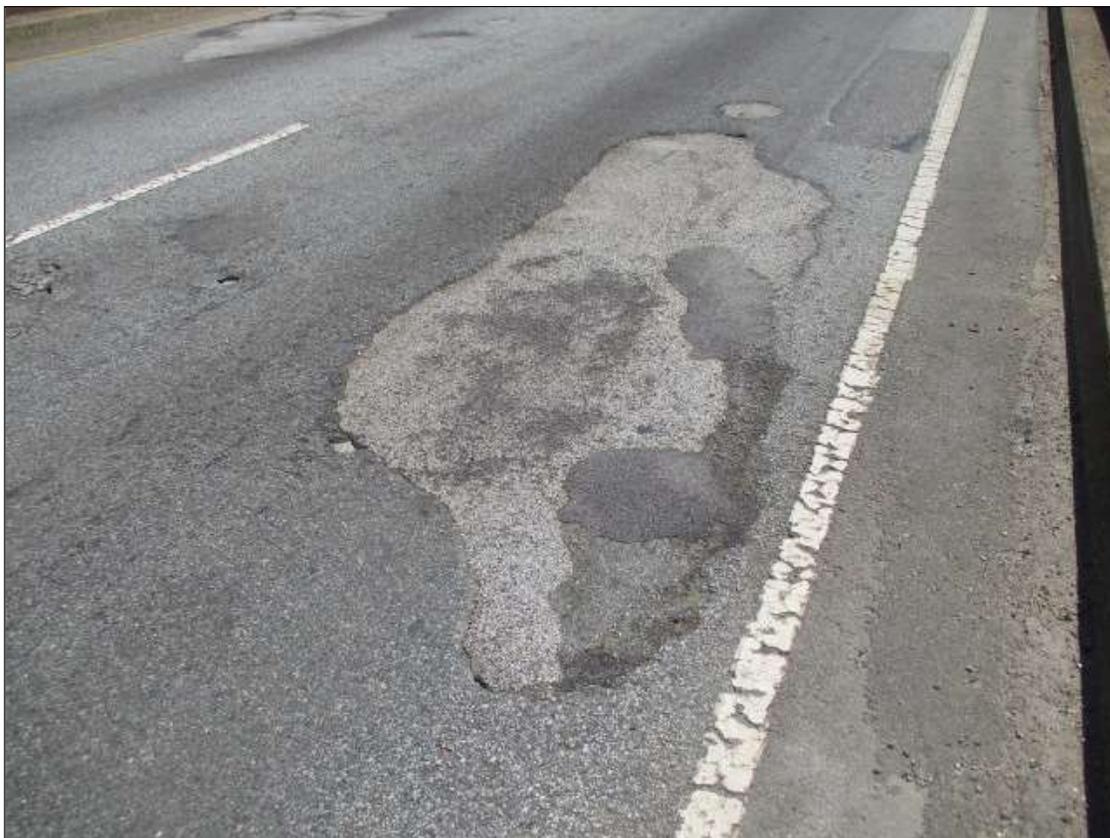
Span 10 Wearing Surface: (2) up to 9'-6" x 4' x 2" deep area of missing asphalt wearing surface with exposed rebar
(PATCHED PRIOR TO 2022 INSPECTION)

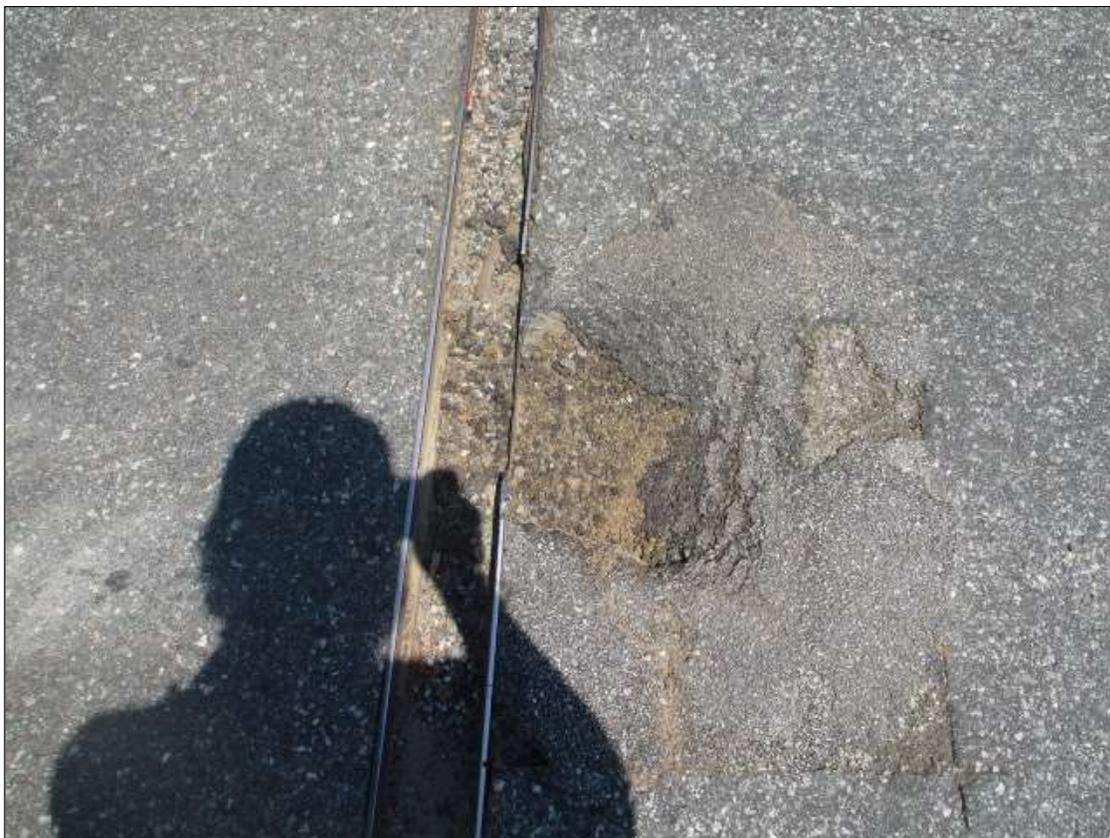
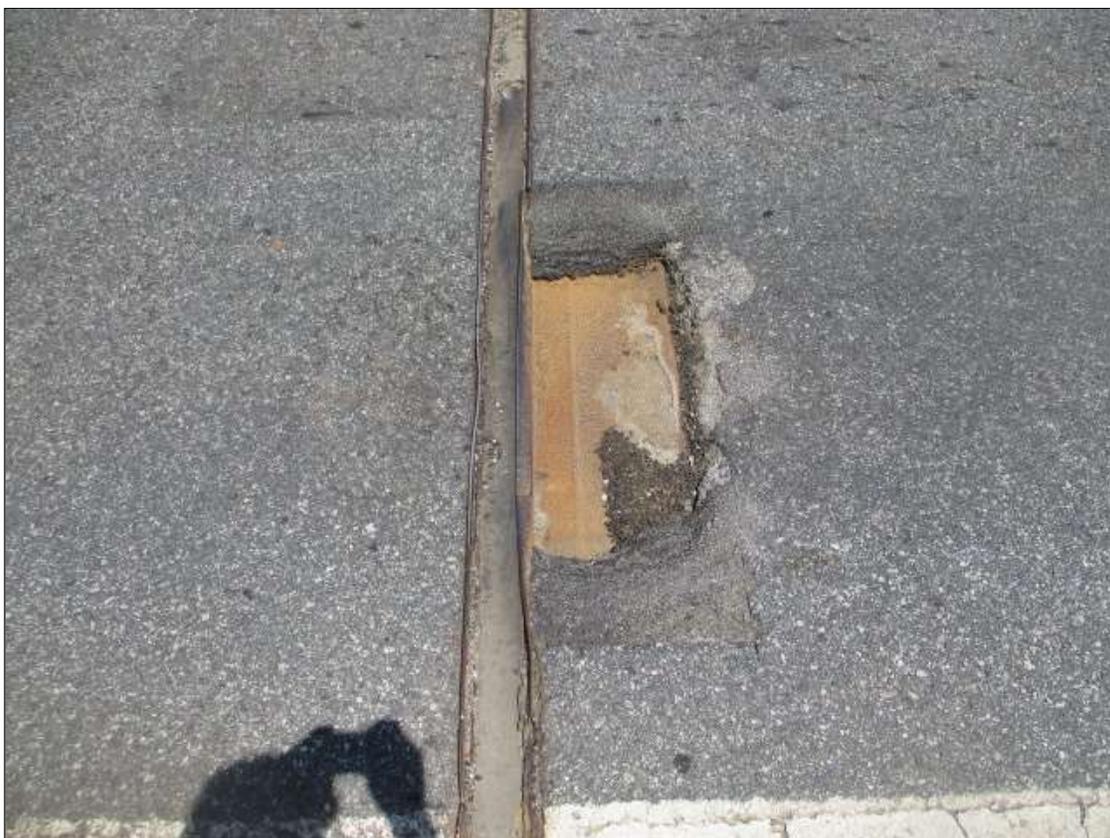
Span 10 Expansion Joint: (2) up to 14" x 12" x 2" deep area of missing asphalt wearing surface with exposed rebar along Bent 9 joint (PAR)

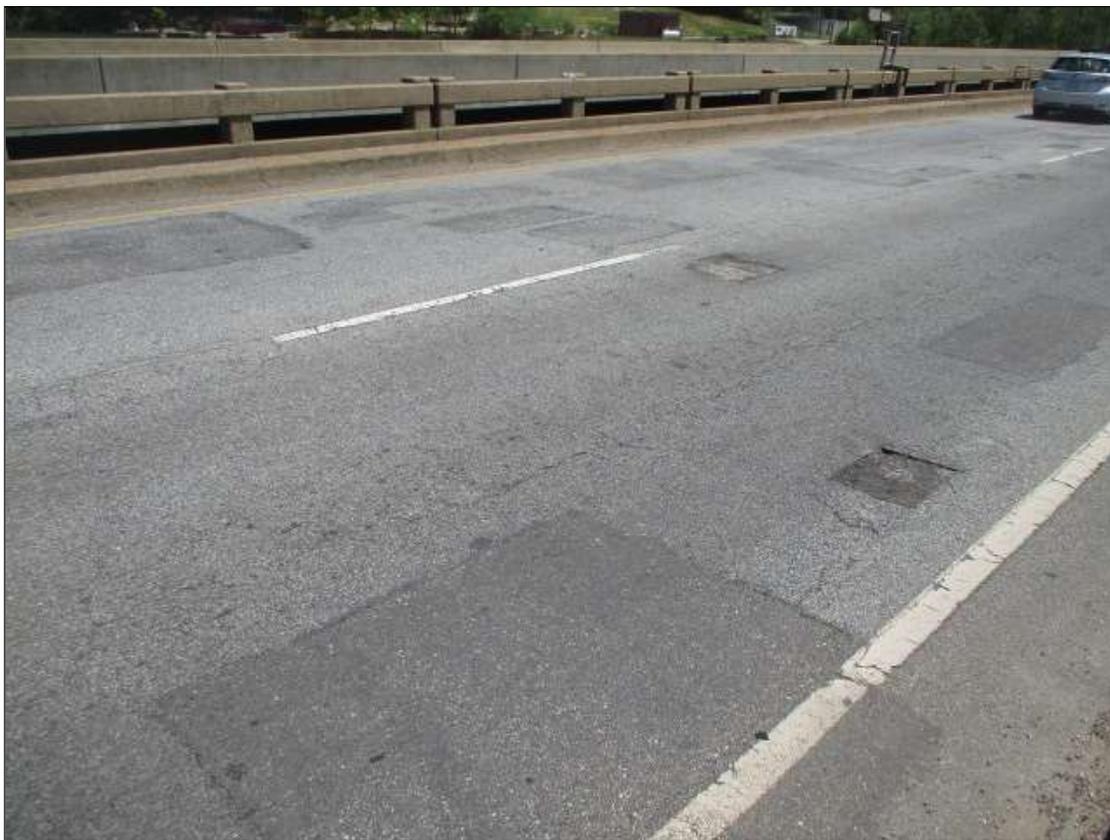
Span 9 Wearing Surface: throughout Span, (22) sound patches [up to 18ft x 9ft]

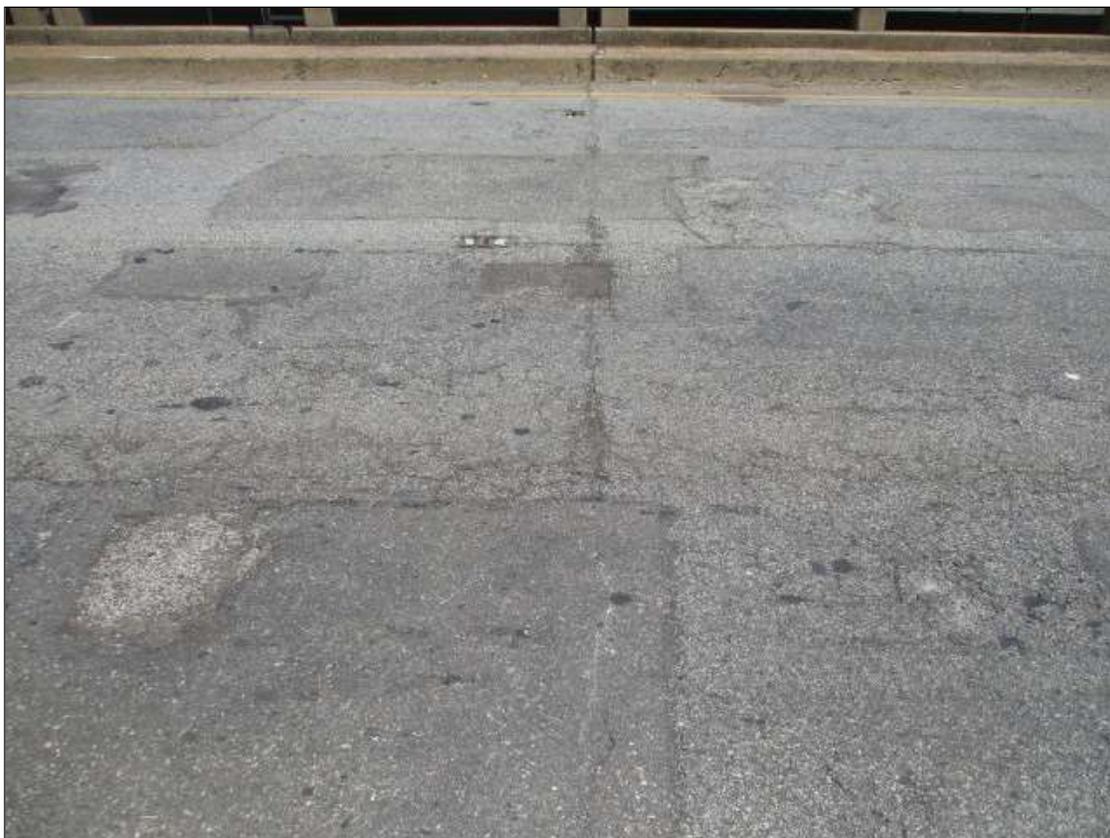
Span 9 Wearing Surface: 1/2" TRANSVERSE CRACKING OVER BENT 8

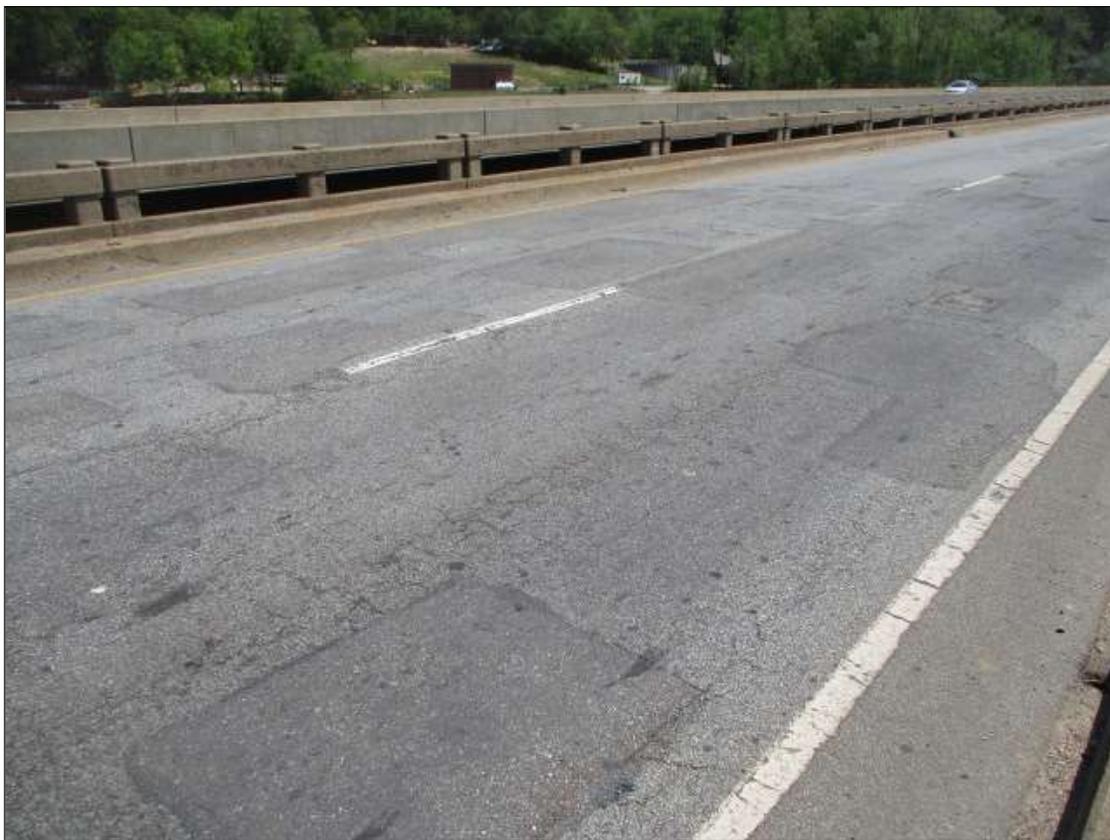
Span 8 Wearing Surface: (25) up to 15' x 4' area of sound patches

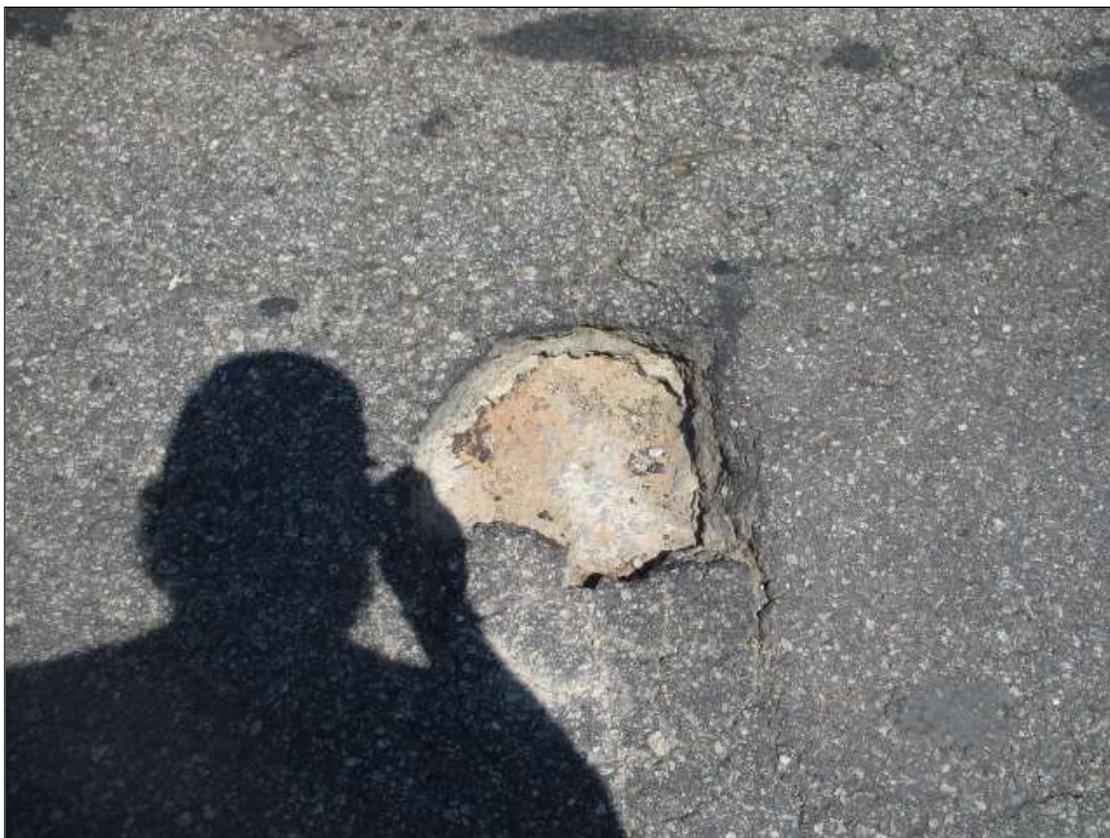
Span 8 Wearing Surface: PAR: 18" DIAMETER X 2" DEEP POT HOLE WITH EXPOSED DECK IN LEFT LANE AT 25' FROM BENT 7

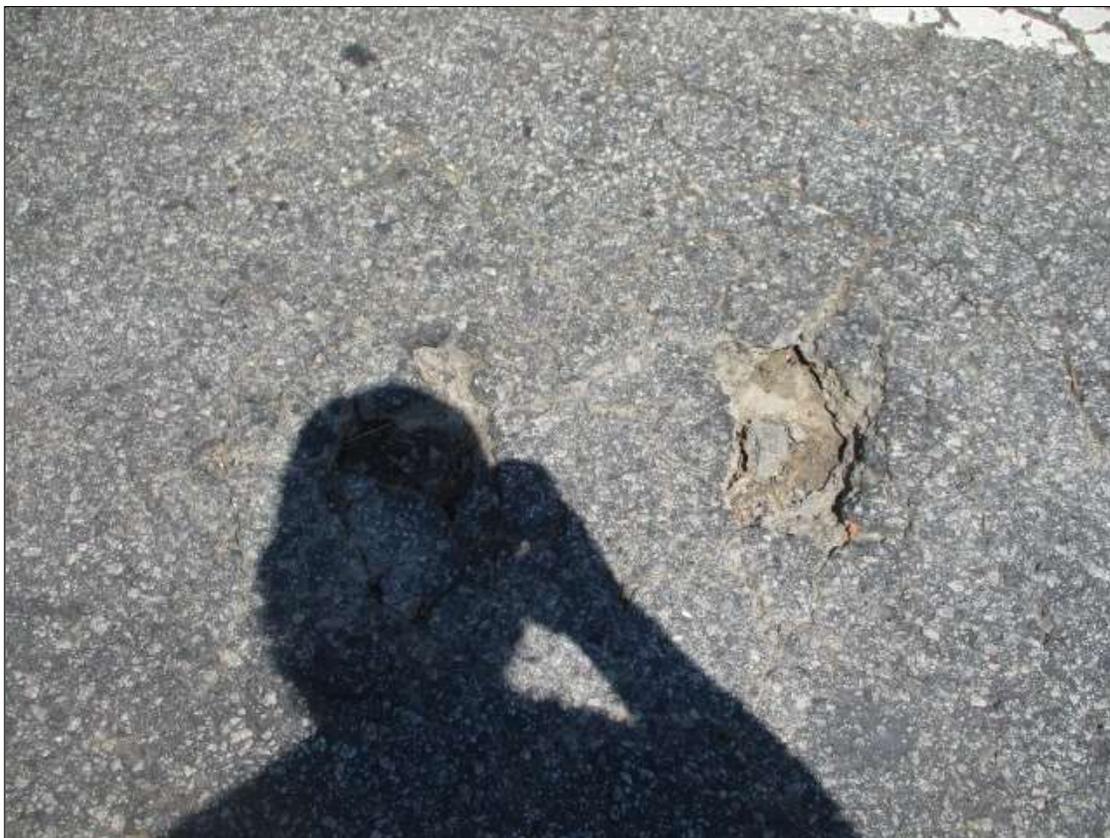
Priority Level	Defect Type	Quantity	Defect Description
2	Patched Area/Pothole	2	Span 8 Wearing Surface: [PAR] in both travel lanes, two [2] potholes in right travel lane near midspan: [12in diameter x up to 2in deep]; in left travel lane 20ft from bent 8 [1.5ft x 1ft x 2in deep] both exposing the top of deck
2	Patched Area/Pothole	3	Span 8 Wearing Surface: PAR: 18" DIAMETER X 2" DEEP POTHOLE WITH EXPOSED DECK IN LEFT LANE AT 25' FROM BENT 7

Span 8 Wearing Surface: [PAR] in both travel lanes, two [2] potholes in right travel lane near midspan: [12in diameter x up to 2in deep]; in left travel lane 20ft from bent 8 [1.5ft x 1ft x 2in deep] both exposing the top of deck

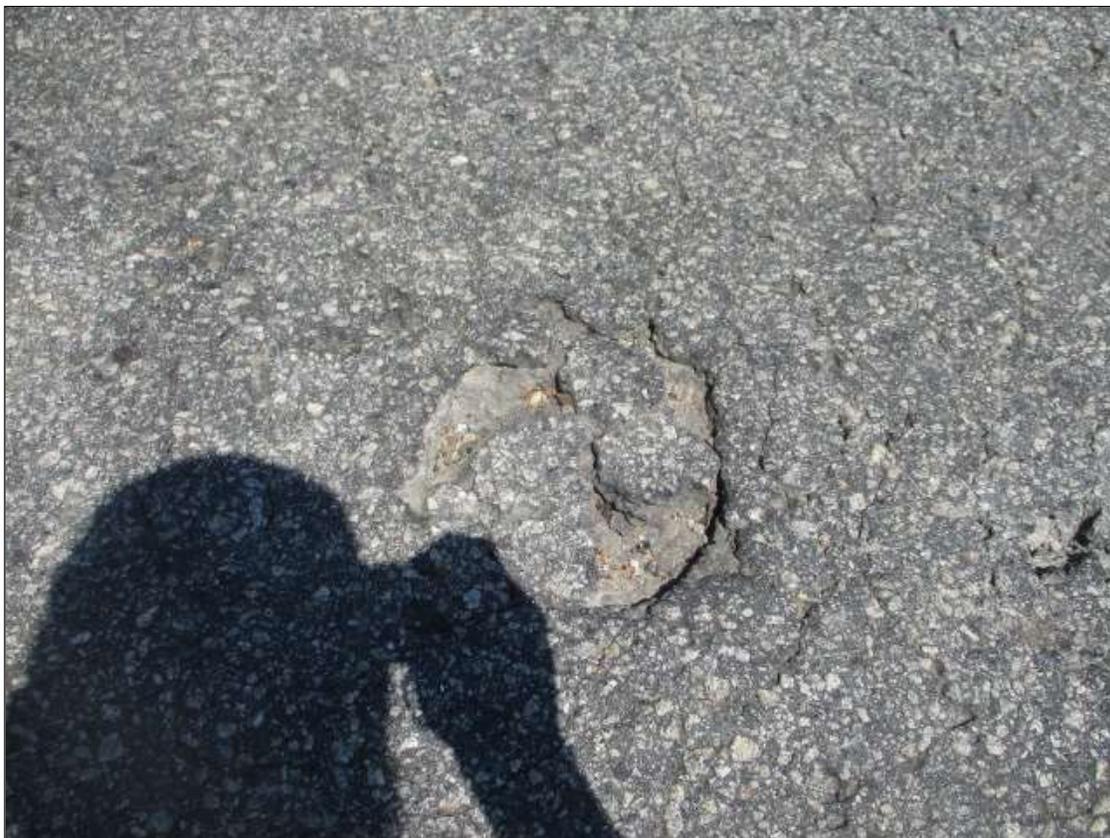
Priority Level	Defect Type	Quantity	Defect Description
2	Patched Area/Pothole	1	Span 9 Wearing Surface: [PAR] 13ft from bent 9 in West travel lane, pothole [8in diameter x 3in deep] exposing top of deck

Span 9 Wearing Surface: [PAR] 13ft from bent 9 in West travel lane, pothole [8in diameter x 3in deep] exposing top of deck

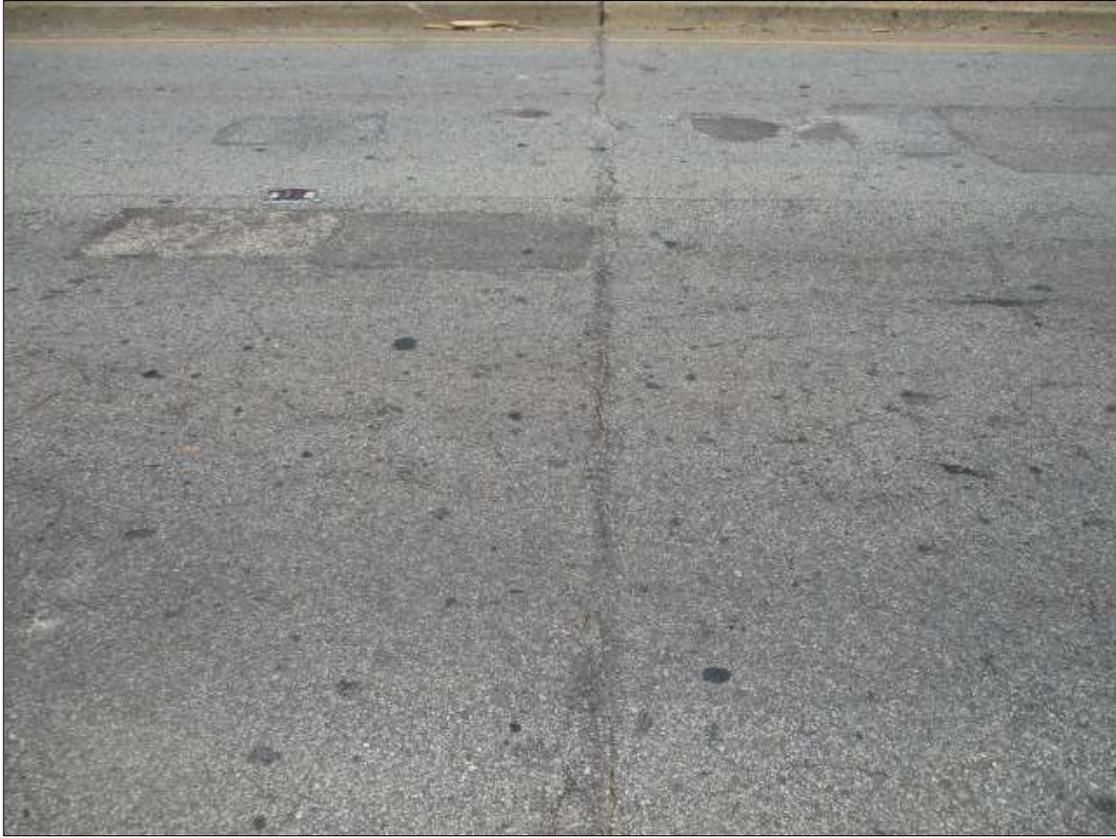
Span 8 Wearing Surface: 1/4" TRANSVERSE CRACKING OVER BENT 7

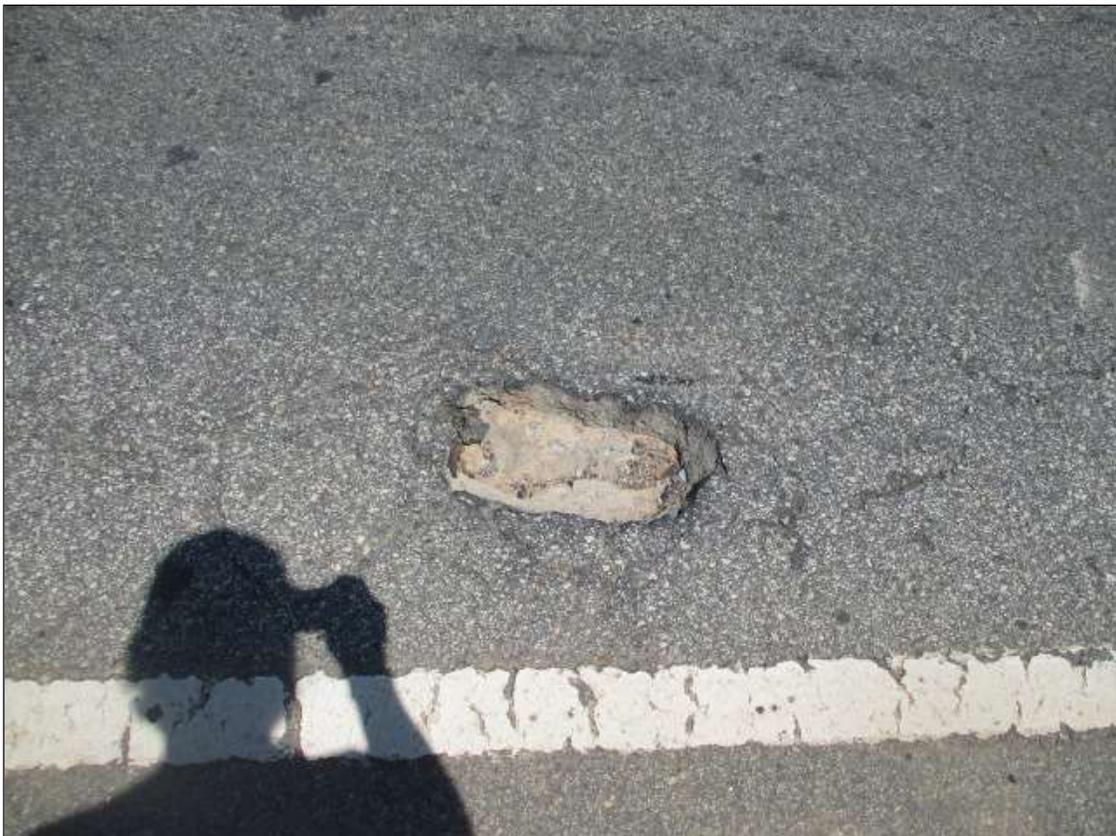
Priority Level	Defect Type	Quantity	Defect Description
2	Patched Area/Pothole (Wearing Surface)	1	Span 7 Wearing Surface: PAR: 12" DIAMETER X 2" DEEP POTHOLE WITH EXPOSED TOP OF DECK IN LEFT LANE AT 10' FROM BENT 6 AND 1' FROM WHITE LINE
2	Delamination/Spall (Wearing Surface)	1	Span 7 Wearing Surface: [PAR] in LEFT travel lane, spall [9in x up to 9in x 2in deep] exposing the top of deck AT 6' FROM BENT 6 AND 2' FROM WHITE LINE

Span 7 Wearing Surface: PAR: 12" DIAMETER X 2" DEEP POTHOLE WITH EXPOSED TOP OF DECK IN LEFT LANE AT 10' FROM BENT 6 AND 1' FROM WHITE LINE

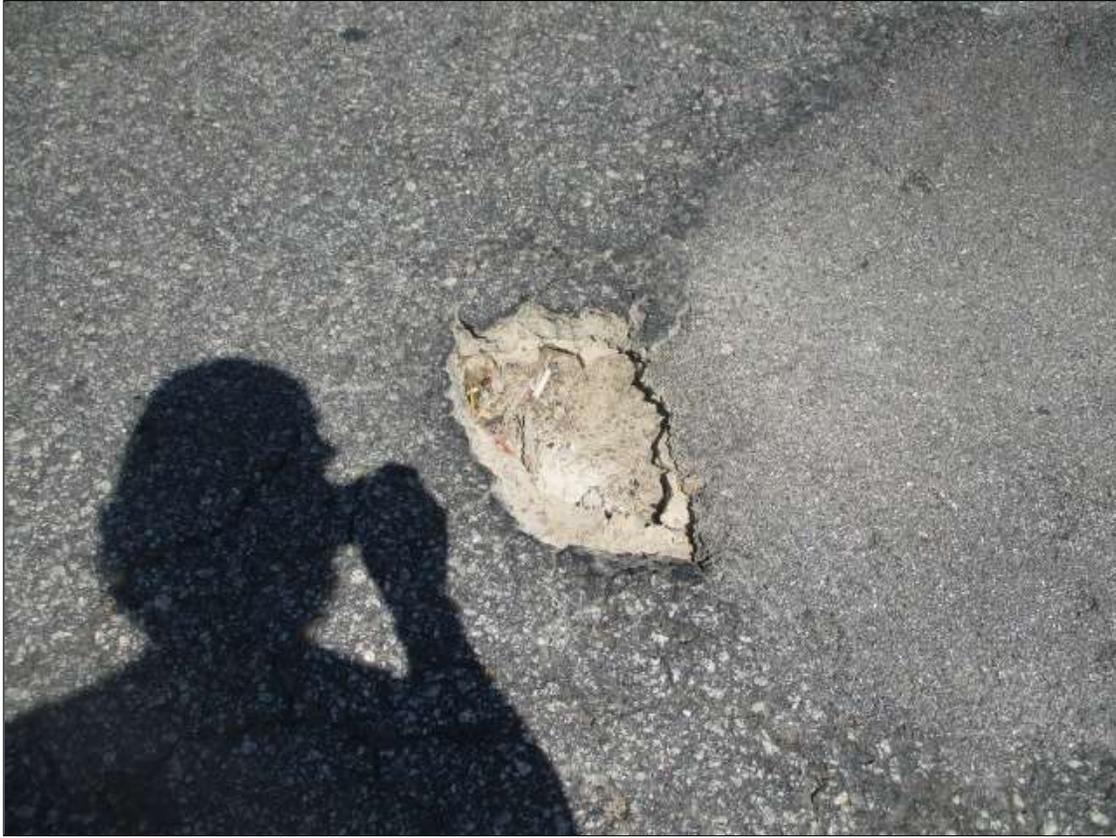
Span 7 Wearing Surface: [PAR] in LEFT travel lane, spall [9in x up to 9in x 2in deep] exposing the top of deck AT 6' FROM BENT 6 AND 2' FROM WHITE LINE

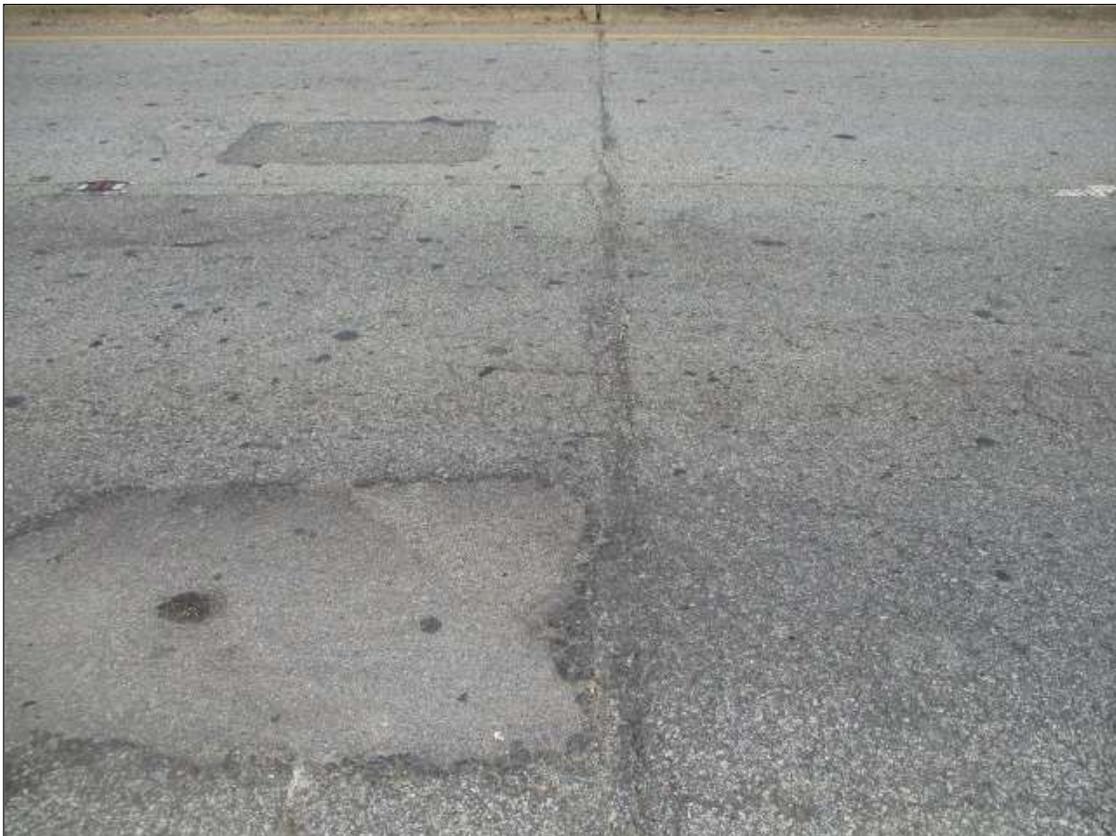
Span 7 Wearing Surface: asphalt over bent 6, multiple transverse cracks [up to full width x up to 1/4in]

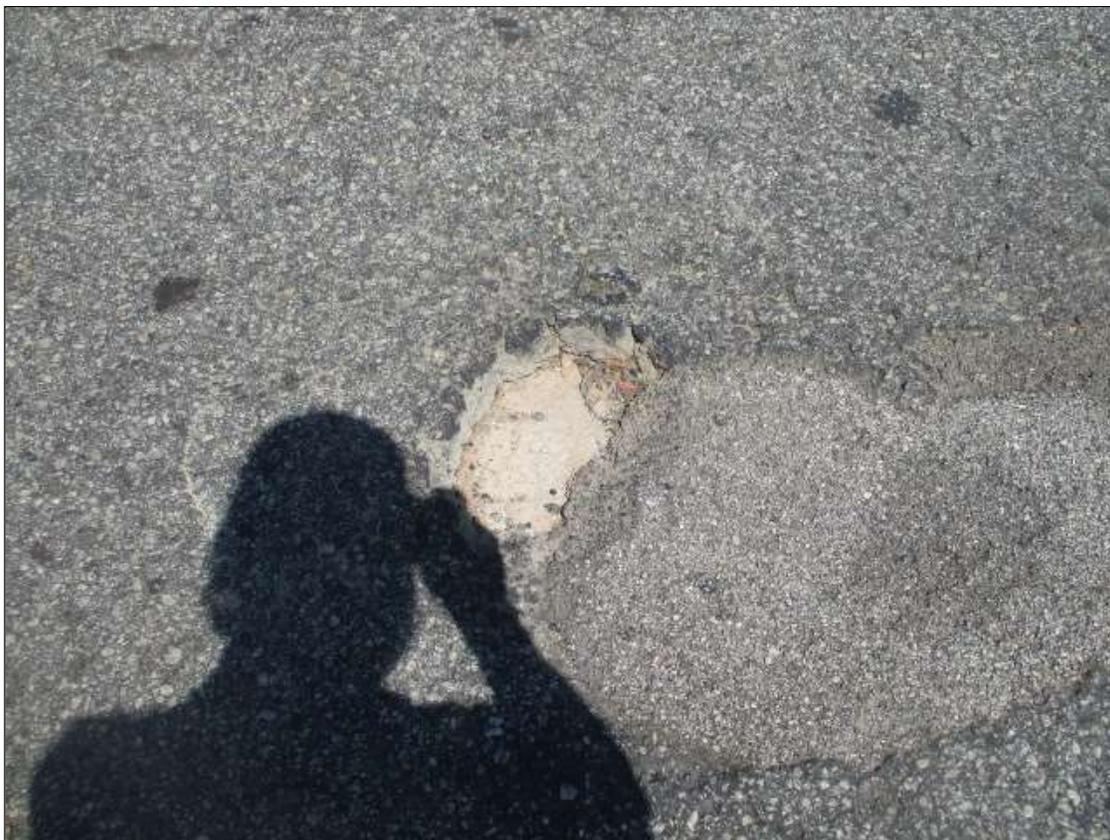
Priority Level	Defect Type	Quantity	Defect Description
2	Patched Area/Pothole (Wearing Surface)	1	Span 6 Wearing Surface: PAR: 8" DIAMETER X 2" DEEP POTHOLE WITH EXPOSED TOP OF DECK IN LEFT LANE AT 15' FROM BENT 5 AND 2' FROM CENTERLINE

Span 6 Wearing Surface: PAR: 8" DIAMETER X 2" DEEP POTHOLE WITH EXPOSED TOP OF DECK IN LEFT LANE AT 15' FROM BENT 5 AND 2' FROM CENTERLINE

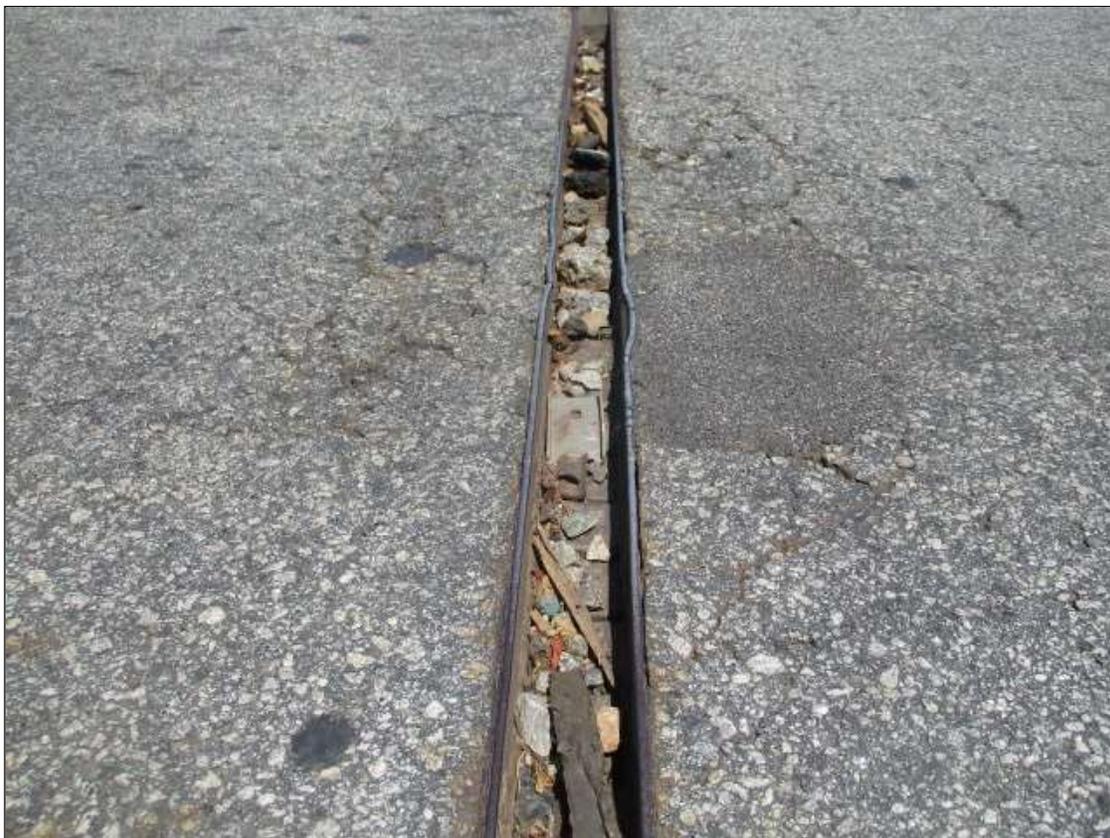
Priority Level	Defect Type	Quantity	Defect Description
2	Seal Adhesion	16	Span 6 Expansion Joint: PAR: (2) up to 8' missing joint material IN BOTH LANES

Span 6 Expansion Joint: PAR: (2) up to 8' missing joint material IN BOTH LANES

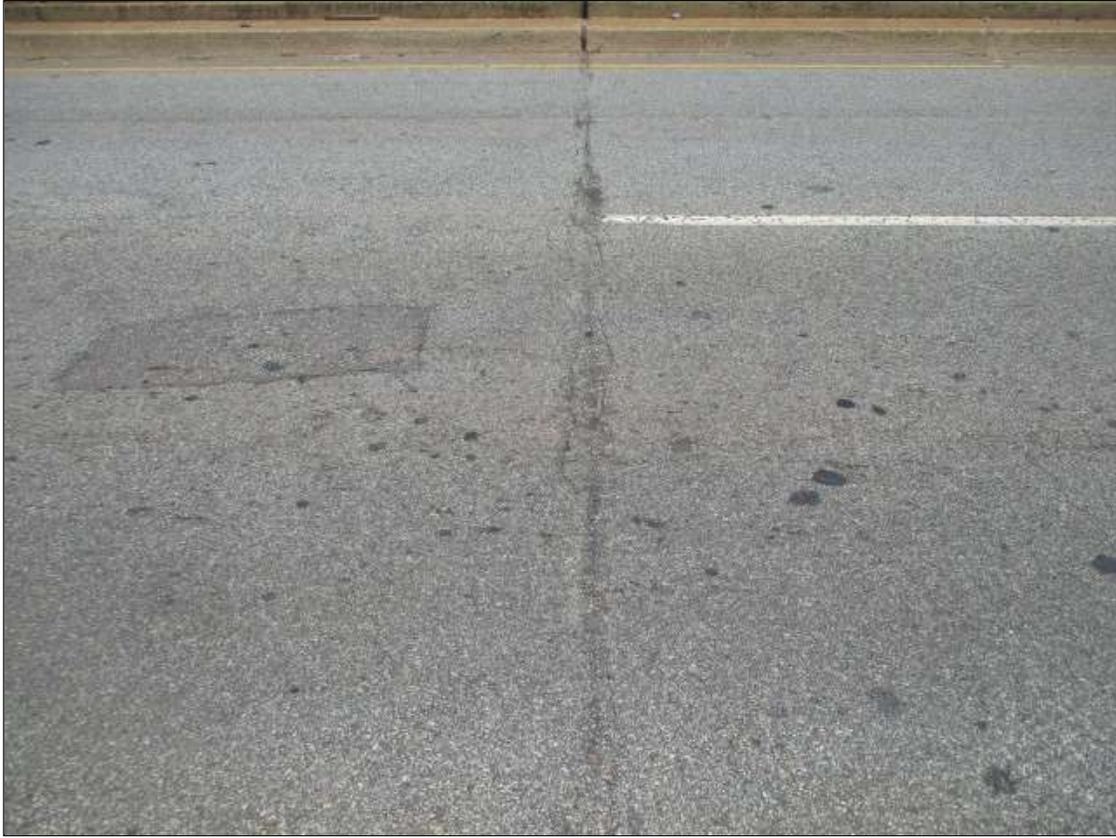
Span 5 Wearing Surface: asphalt over bent 4, multiple transverse cracks [up to full width x up to 1/4in]

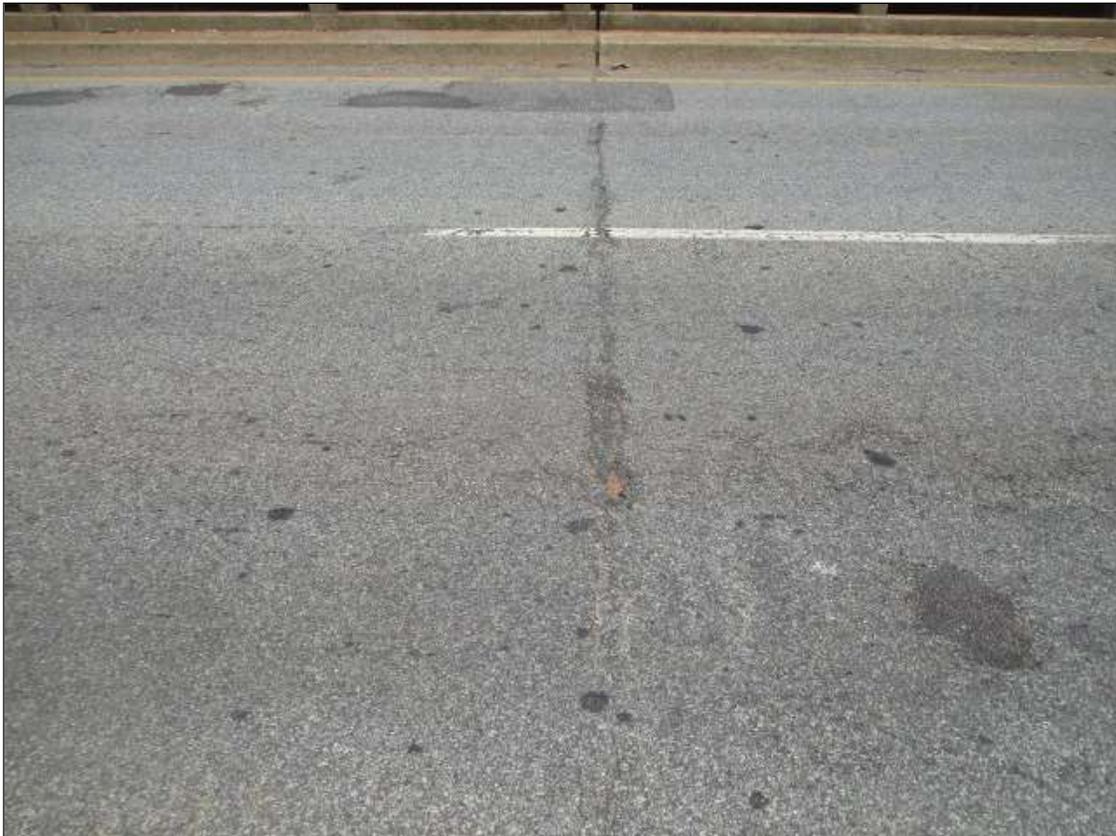
Span 4 Wearing Surface: asphalt over bent 3, multiple transverse cracks [up to full width x up to 1/4in]
