NC DEPARTMENT OF TRANSPORTATION
 DIVISION OF HIGHWAYS
 STRUCTURE MANAGEMENT UNIT

Structure Safety Report

Routine Element Inspection - Contract

STRUCTURE NUMBER: 130367 SAP STRUCTURE NO: 0140367 FHWA STRUCTURE NO: 00000000270367

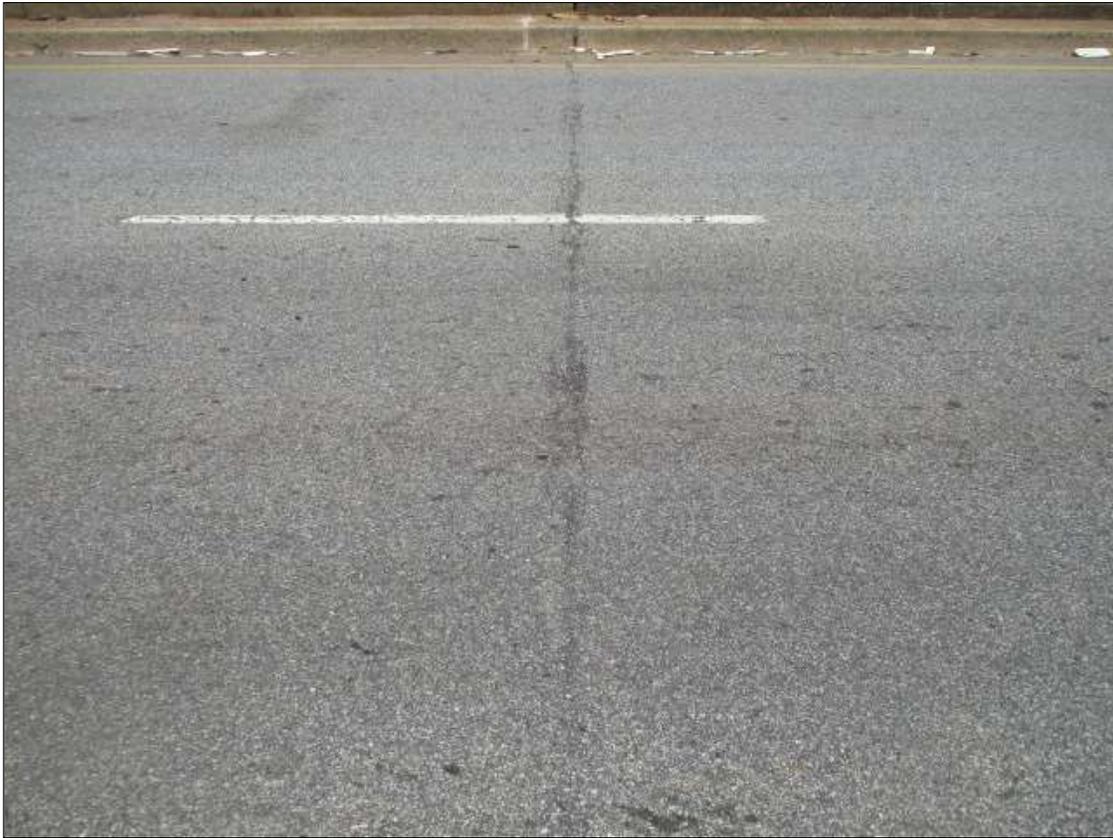
Span 3 Wearing Surface: asphalt over bent 2, multiple transverse cracks [up to full width x up to 1/4in]

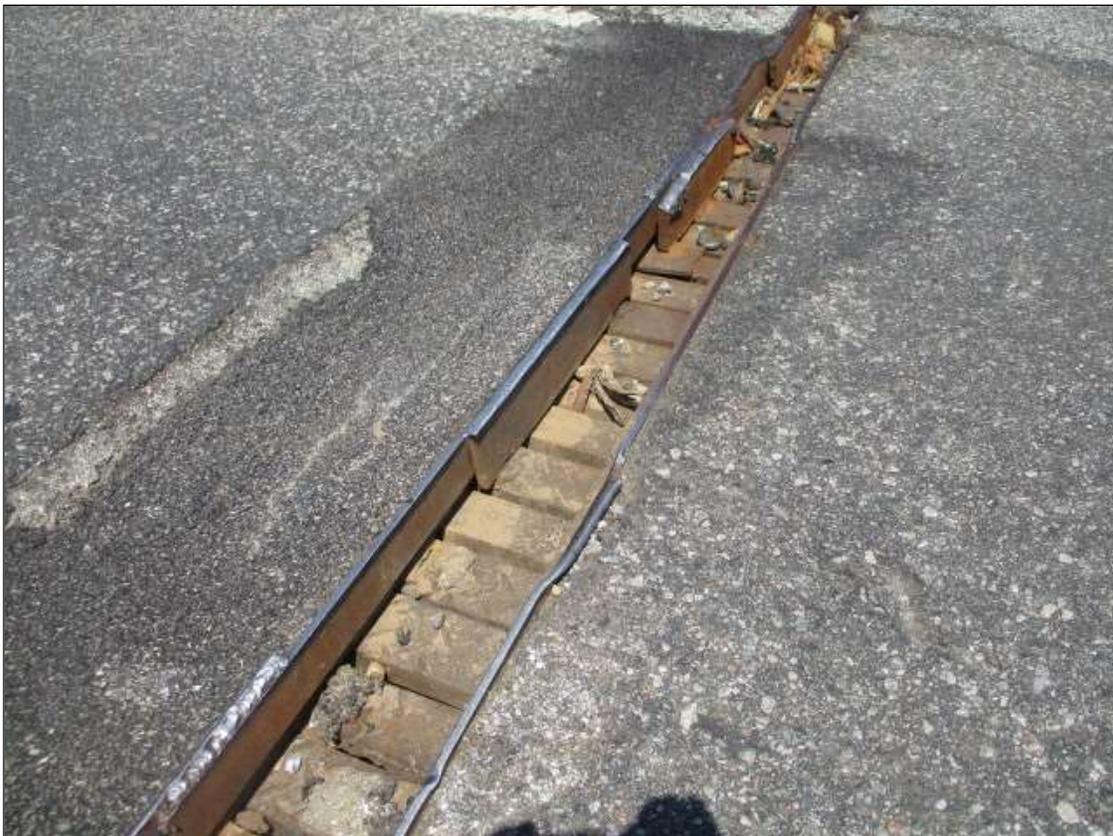
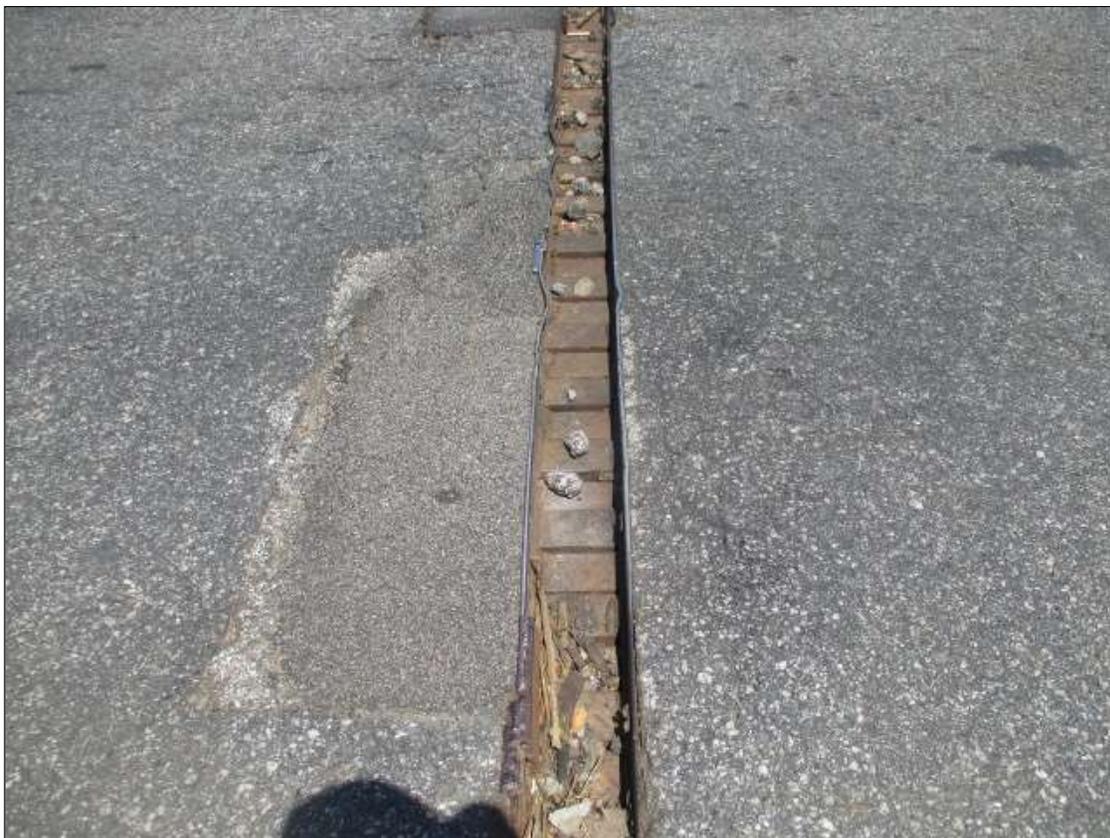
Priority Level	Defect Type	Quantity	Defect Description
3	Metal Deterioration or Missing Sealant	3	Span 2 Expansion Joint: [PAR] in right travel lane near dashed line, seal completely missing and adjacent metal angle distorted and sharp

Span 2 Expansion Joint: [PAR] in right travel lane near dashed line, seal completely missing and adjacent metal angle distorted and sharp

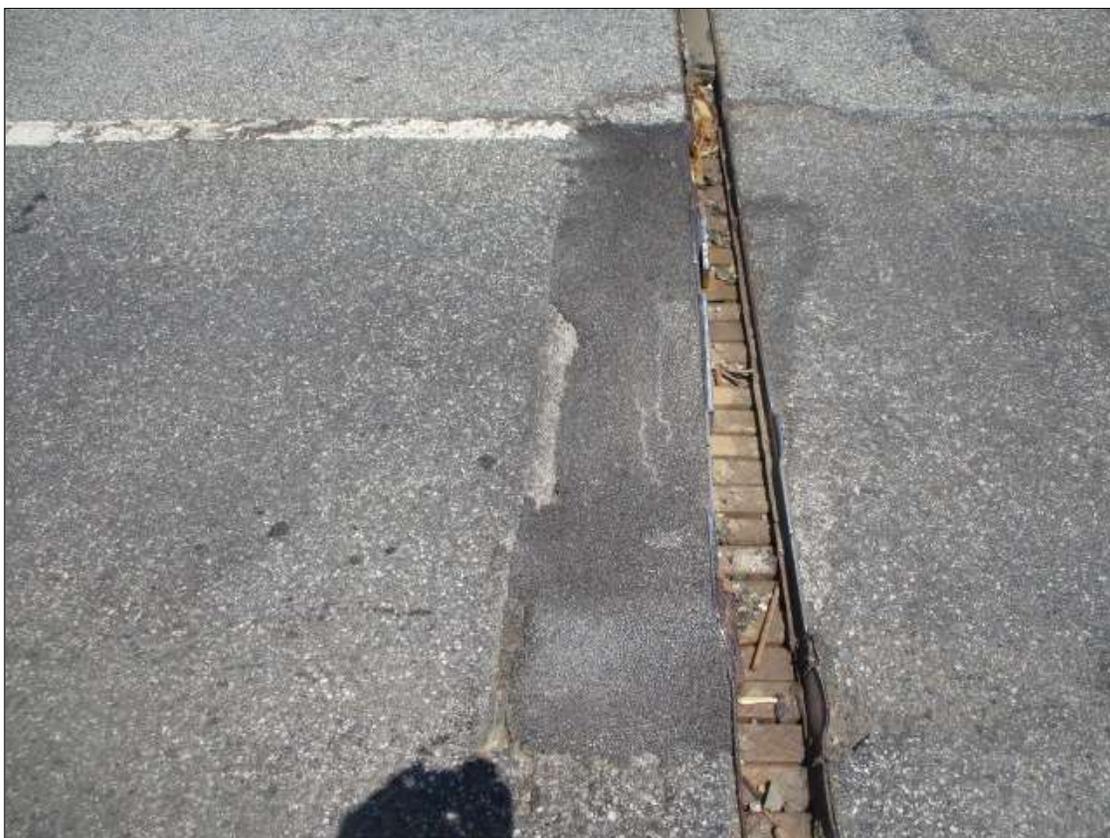
Span 2 Wearing Surface: in right travel lane near bent 1, sound patch [4ft x 2ft]

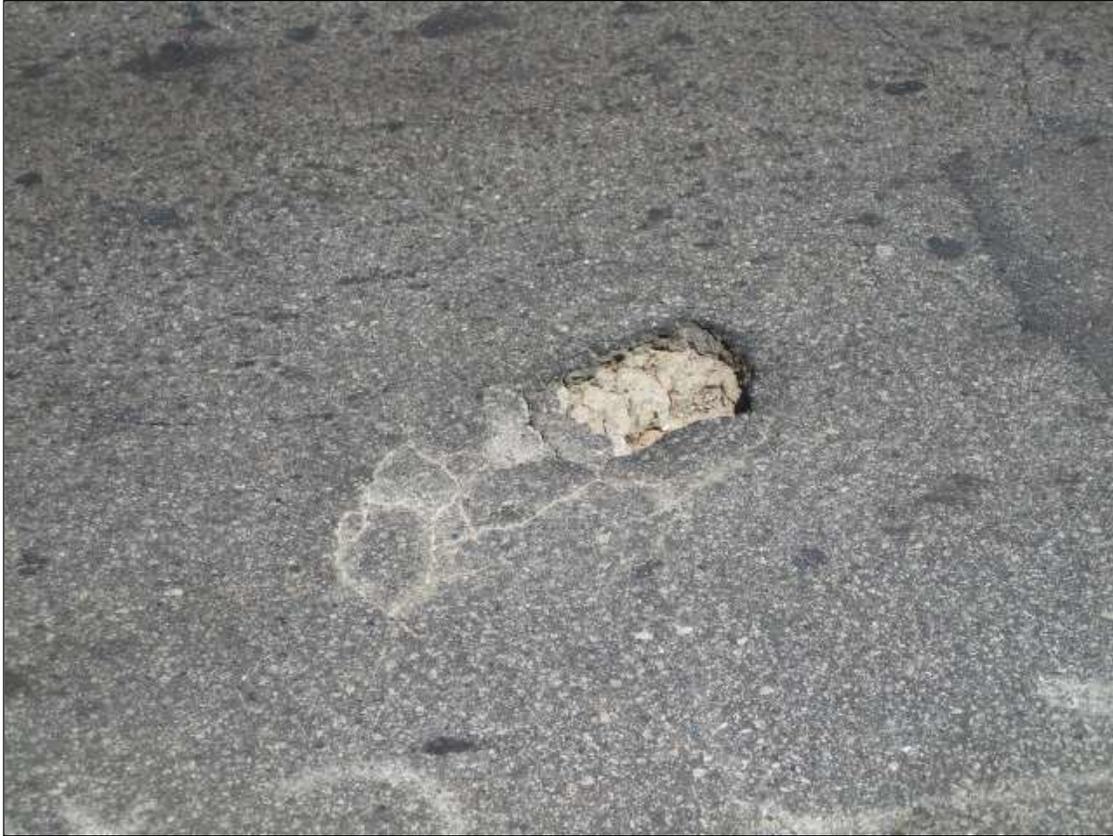
Priority Level	Defect Type	Quantity	Defect Description
2	Patched Area/Pothole (Wearing Surface)	1	Span 1 Wearing Surface: PAR: 8" DIAMETER X 2" DEEP POTHOLE WITH EXPOSED TOP OF DECK IN LEFT LANE AT 15' FROM END BENT 1 AND 4' FROM WHITE LINE

Span 1 Wearing Surface: PAR: 8" DIAMETER X 2" DEEP POTHOLE WITH EXPOSED TOP OF DECK IN LEFT LANE AT 15' FROM END BENT 1 AND 4' FROM WHITE LINE

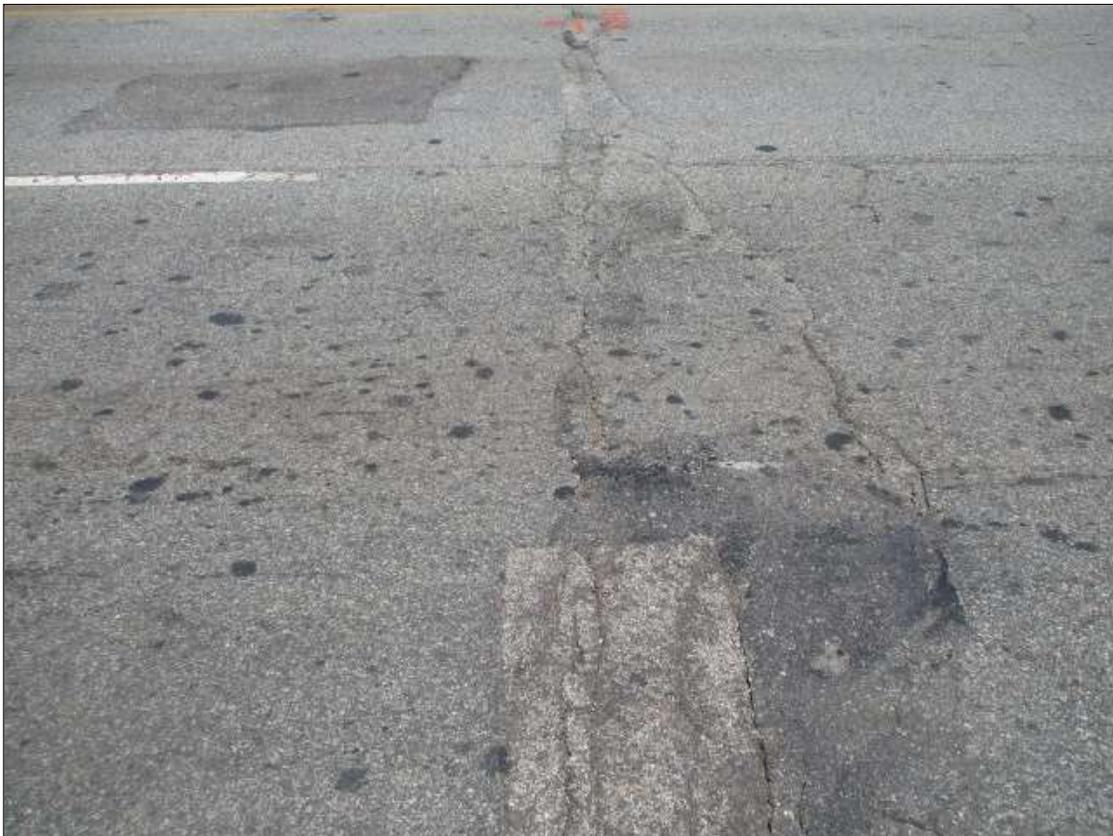
Span 1 Wearing Surface: asphalt over end bent 1 joint, alligator cracking [up to full width x up to 1/8in]

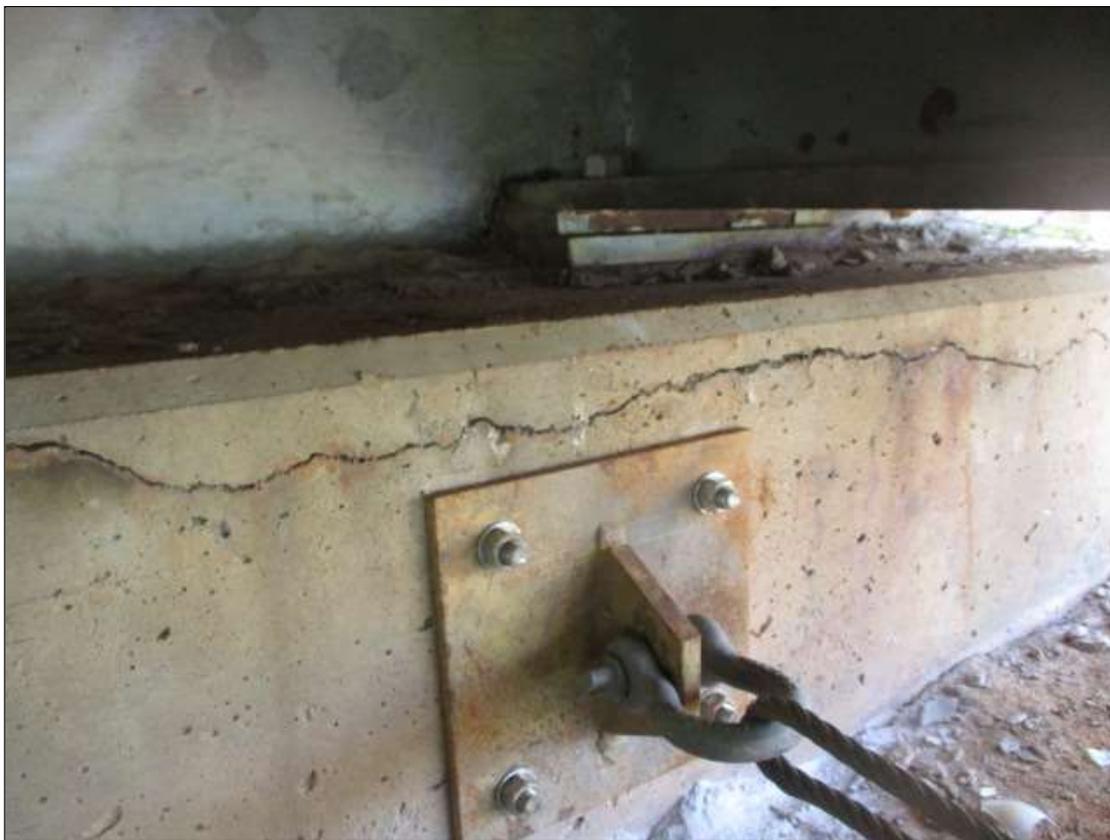
Bent 1 Cap 1: along length of cap below Bay 1, horizontal crack [up to 10ft x up to 1/16in] with 48" x 8" area of delamination

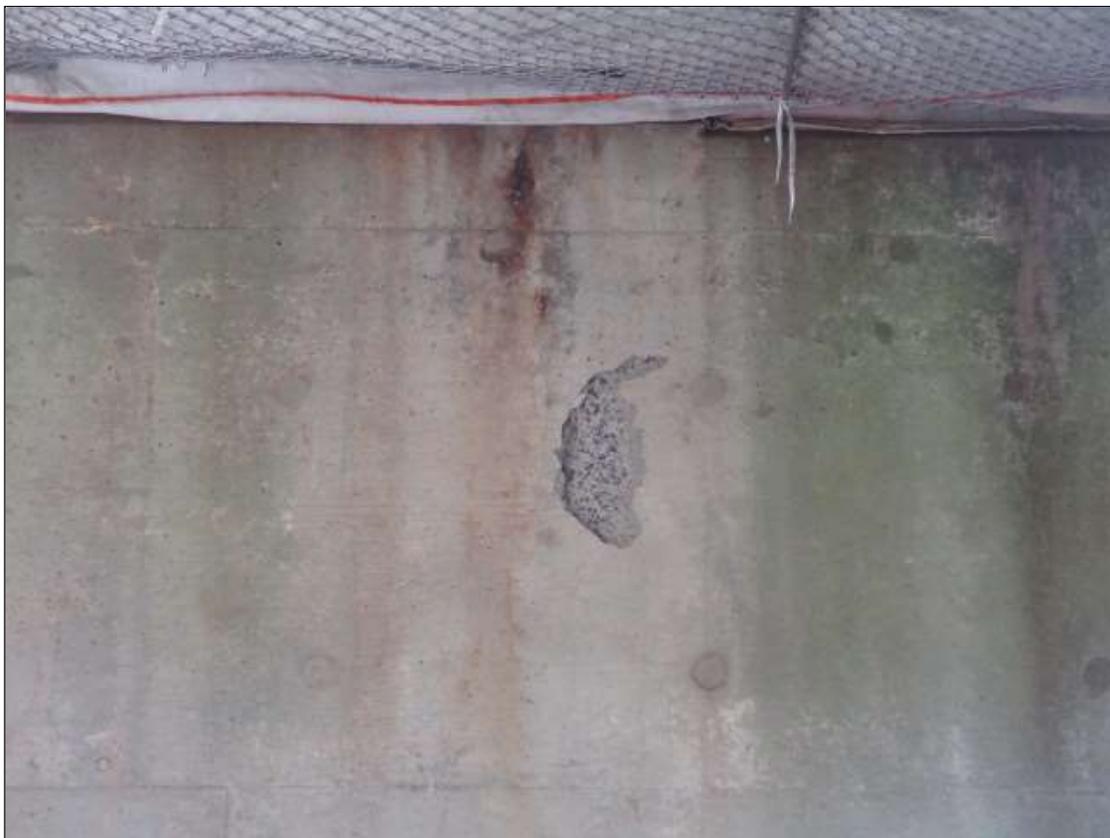
Bent 1 Cap 1: 22" x 33" x 1" deep spall and area of delamination on Span 1 face under Beam 3

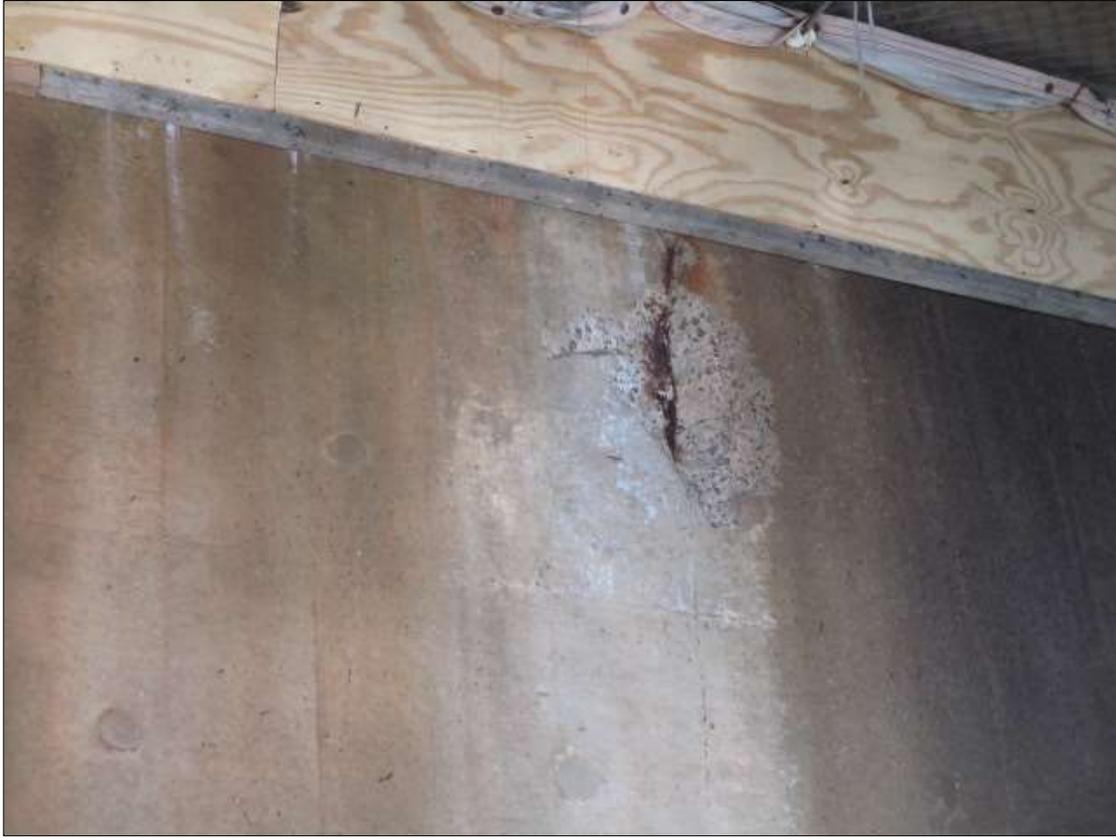
Bent 9 Cap 1: South face at beam 3, spall with exposed rebar [27in x 21in x up to 2in deep] with one [1] exposed vertical rebar

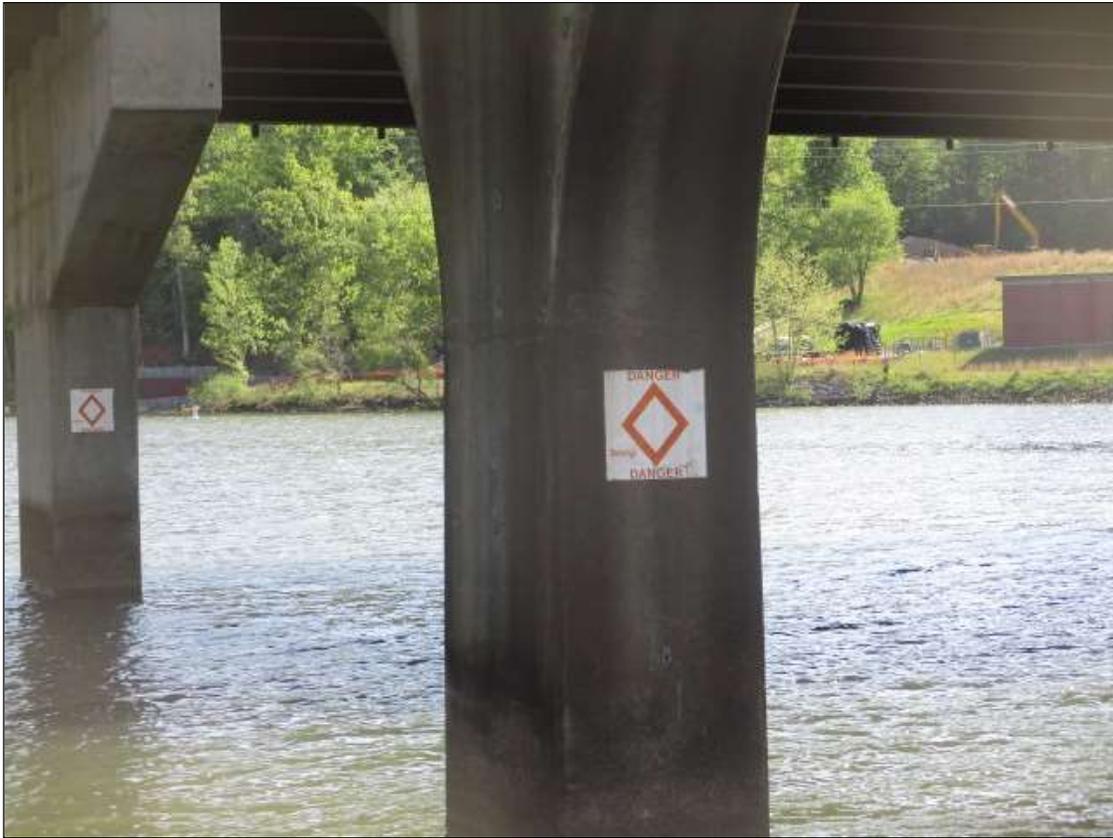
DANGER SIGNS ON EVERY BENT PILE
