**NCDOT Prestress Standard Repair Procedure for Non-Conformance Report (NCR)
SRP-05: Bottom Spalls at Girder End for Prestressed Concrete Girders– 04/05/2022**

Standard Repair Procedures – In-plant Repairs Only

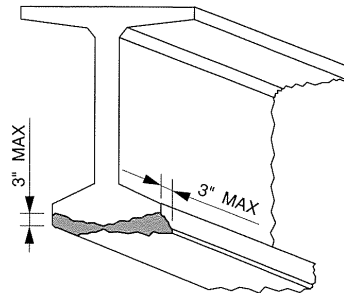
These standard procedures will only be applicable for corner spalls that have the following characteristics:

1. 3" maximum depth. (See photo below)
2. Steel may or may not be exposed.

- Provide sawcut a minimum of 1" beyond the perimeter of the repair area, to a minimum depth of $\frac{1}{2}$ ".
- Remove all unsound concrete within the repair area. Remove all concrete – unsound and sound – within the sawcut to a minimum depth of $\frac{1}{2}$ ".

- If more than half the circumference of a reinforcing bar is exposed, remove additional concrete to 1" behind the bar. This does not apply to prestressed strands.

- For areas in which no steel is exposed, use adhesively anchored anchors, with a minimum $\frac{1}{4}$ " diameter, spaced at 6" grid, and a minimum 2" embedment into member, to provide mechanical bond for repair material. Provide the design concrete cover for studs.

- Do not damage rebar or strand.
- Form and place repair material to original shape.
- The repair material shall have a minimum compressive strength equal to or greater than that of the original beam concrete.

- The maximum size of aggregate in repair material should not exceed $\frac{2}{3}$ of the minimum depth of the repair area.
- The repair material shall be on the NCDOT Approved Products List.

- Surface preparation, proportioning, mixing, placement, and curing of repair material should follow all manufacturer's recommendations.
- Perform repair operations in the presence of and to the satisfaction of the on-site NCDOT inspector.
