NC DEPARTMENT OF TRANSPORTATION  
DIVISION OF HIGHWAYS  
STRUCTURE MANAGEMENT UNIT

## Structure Safety Report

### Routine Element Inspection - Contract

STRUCTURE NUMBER: 260016 SAP STRUCTURE NO: 0270016 FHWA STRUCTURE NO: 000000000530016  
DIVISION: 1 COUNTY: CURRITUCK INSPECTION DATE: 09/21/2022 FREQUENCY: 24 MONTHS  
FACILITY CARRIED: US158E MILE POST: \_\_\_\_\_  
LOCATION: .01 MI.E.JCT.SR1187  
FEATURE INTERSECTED: CURRITUCK SOUND  
LATITUDE: 36° 5' 11.69" LONGITUDE: 75° 46' 0.21"  
SUPERSTRUCTURE: RC FLOOR ON PPC GIRDERS & CORED SLAB  
SUBSTRUCTURE: EBTS:RC CAP/PPC PILES;IBTS:RCP&B & RC CAPS/PPC PILES  
SPANS: 248 SPANS. SEE SPAN PROFILE SHEET FOR SPAN DETAILS  
☐ FRACTURE CRITICAL ☐ TEMPORARY SHORING ☐ SCOUR CRITICAL ☐ SCOUR PLAN OF ACTION  
GRADES: (Inspector/NBI Coding) DECK 6 / 6 SUPERSTRUCTURE 5 / 5 SUBSTRUCTURE 6 / 6 CULVERT N / N  
POSTED SV: Not Posted POSTED TTST: Not Posted  
OTHER SIGNS PRESENT: None

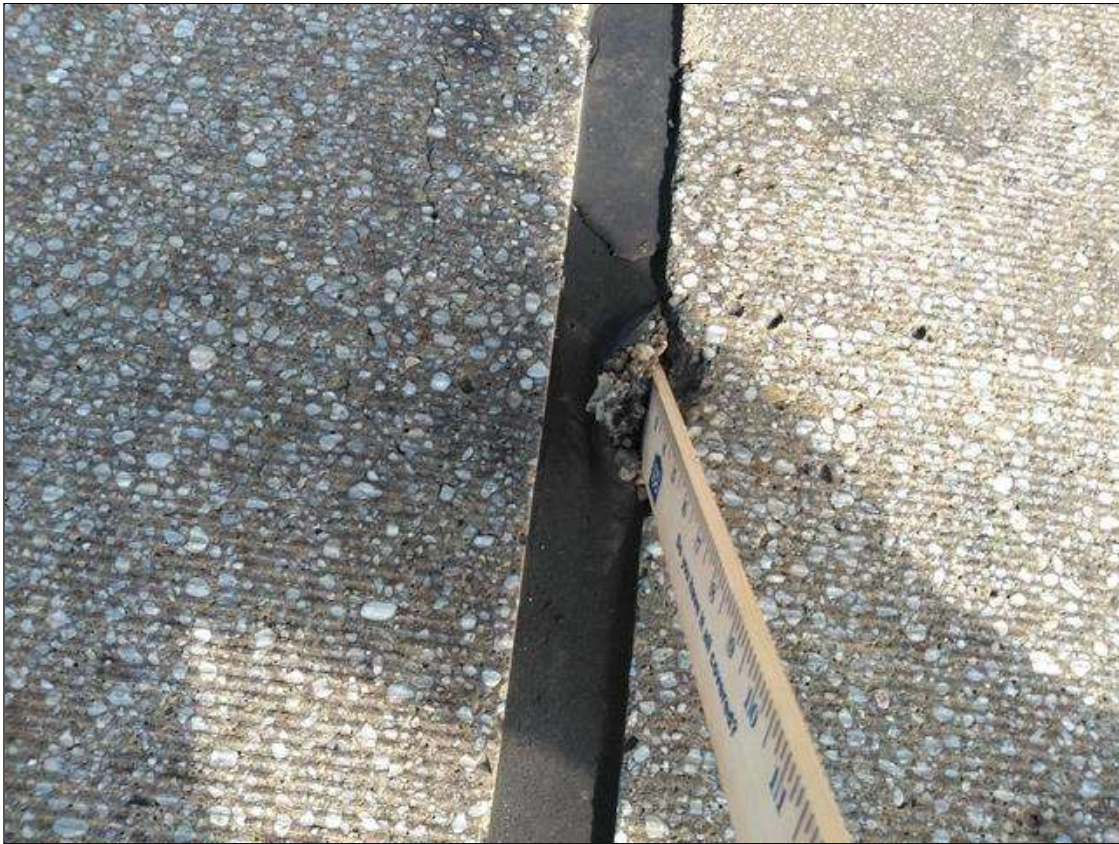
Span 16 Expansion Joint Bent 15: LEFT LANE, DELAMINATION 16 INCH WIDE X 2 INCH LONG

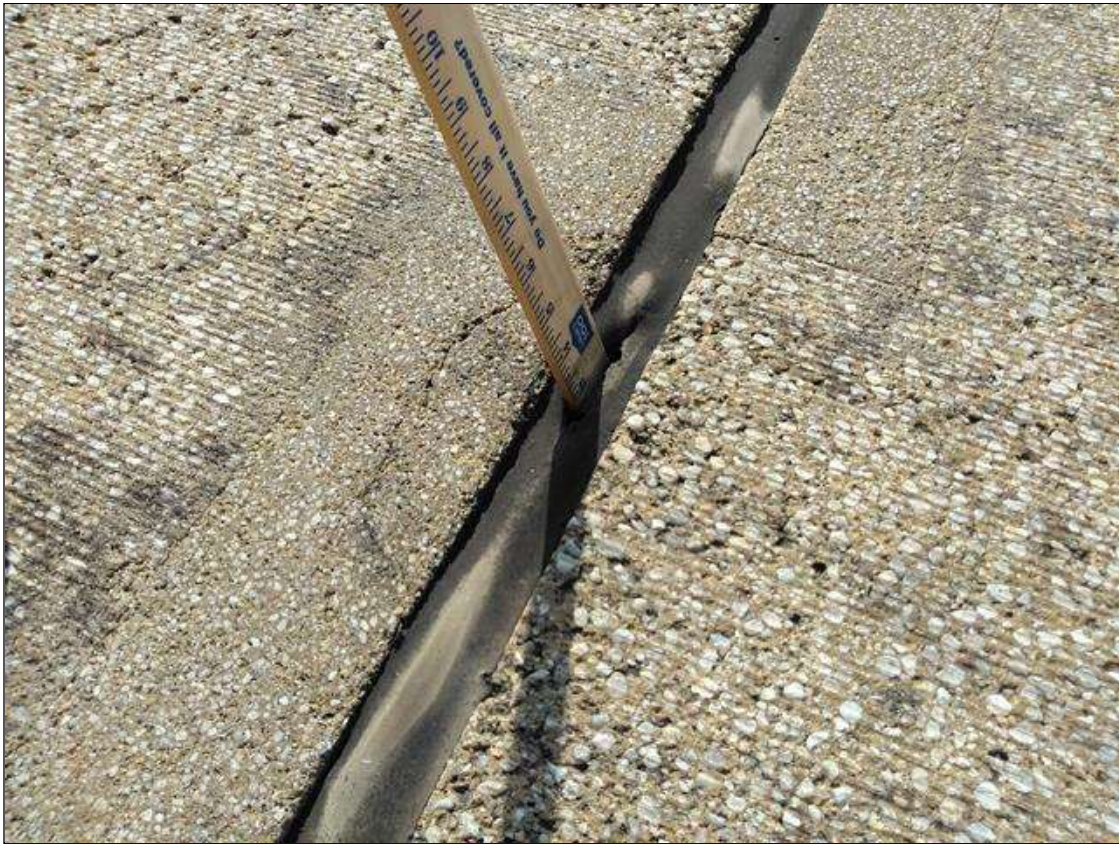
Span 23 Expansion Joint Bent 22: BENT 22 JOINT, MISSING JOINT MATERIAL LEFT LANE 5 INCH LONG PARTIAL DEPTH

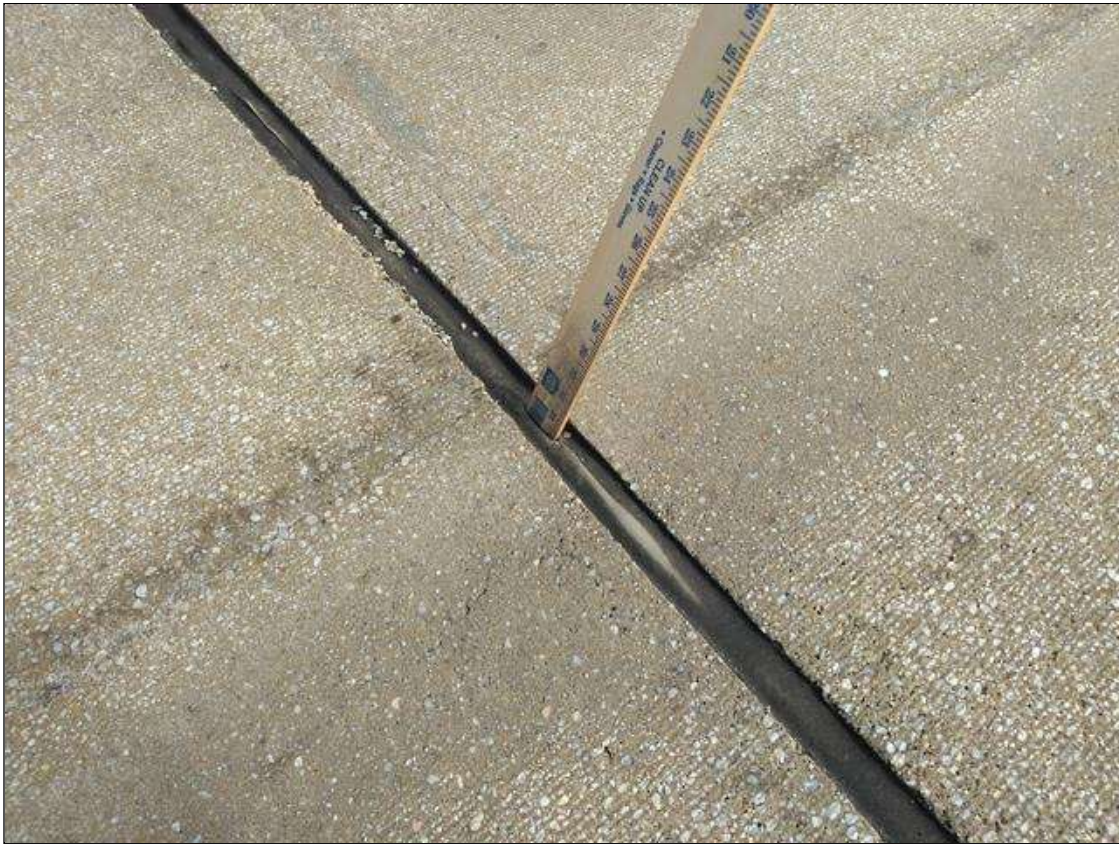
Span 26 Expansion Joint Bent 25: AT BENT 25, SEAL CRACKING UP TO 6 INCH TOTAL ACROSS 3 LOCATIONS IN RIGHT LANE

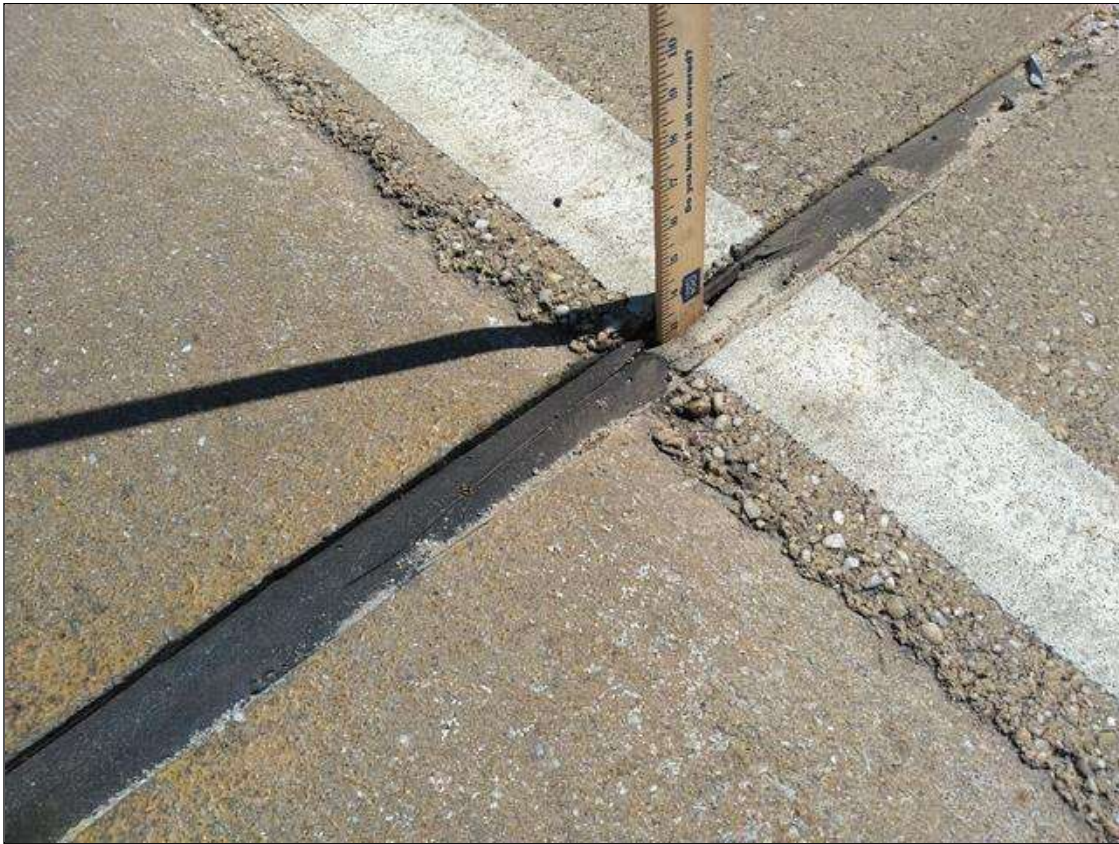
Span 41 Expansion Joint Bent 40: AT BENT 40, RIGHT LANE FULL DEPTH CRACK 2 INCHES WIDE

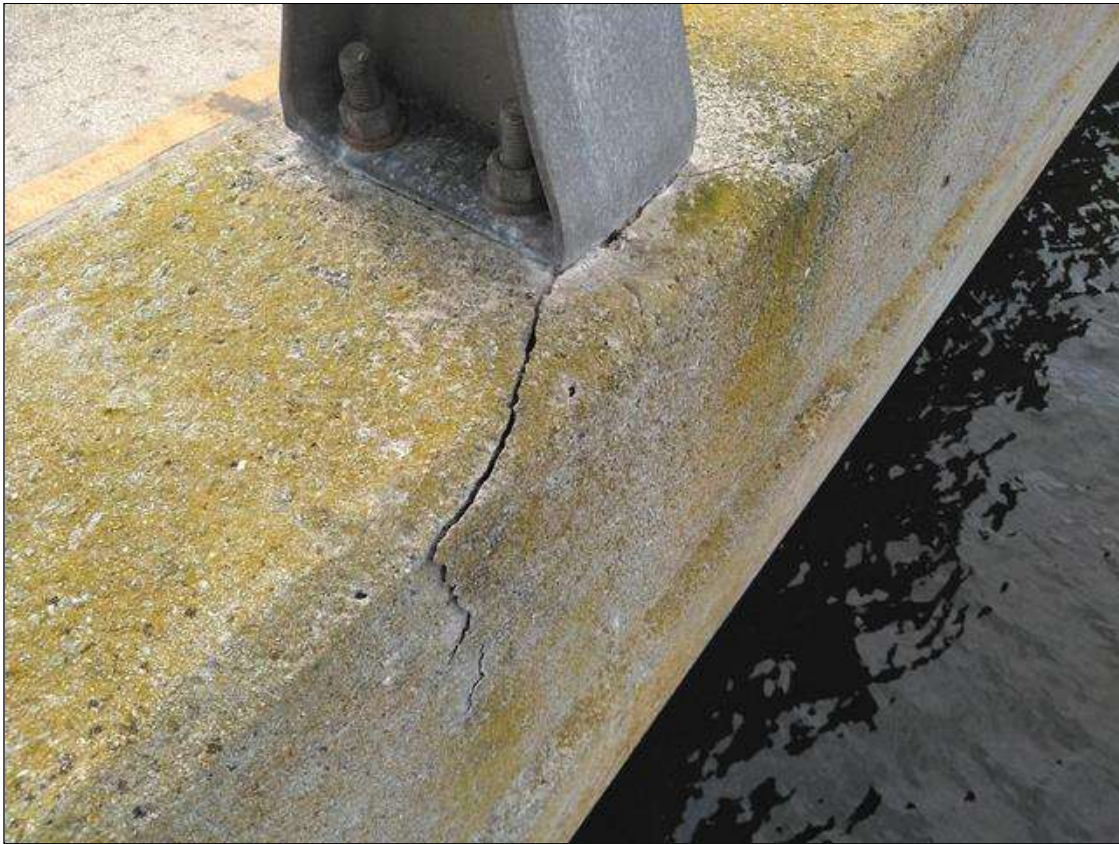
Span 57 Left Bridge Rail: BACK OF RAIL AT POST 1, 12 INCH LONG X 9 INCH HIGH X 2.5 INCH DEEP SPALL WITH EXPOSED REBAR WITH CORROSION

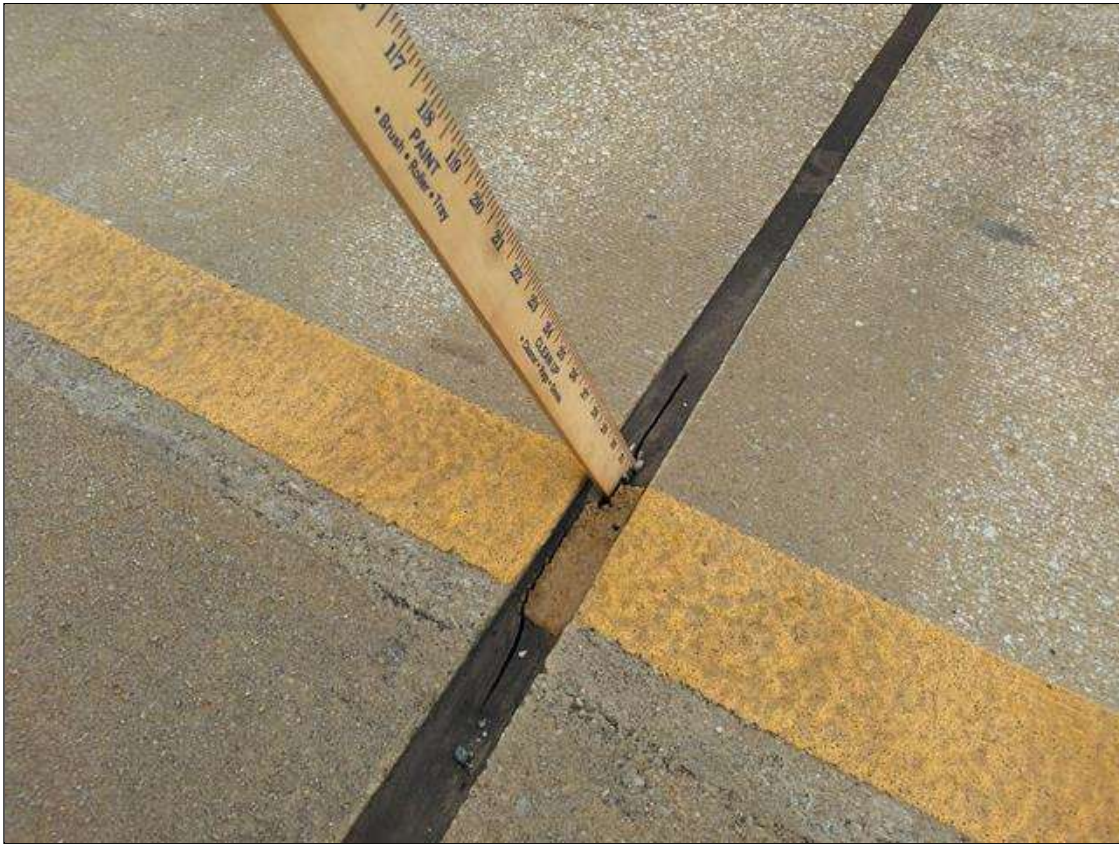
Span 77 Expansion Joint Bent 76: (PAR) AT BENT 76, RIGHT LANE SPALL WITH EXPOSED REINFORCEMENT WITH CORROSION. 2 FEET WIDE X 4 INCHES LONG X 3 INCHES DEEP.

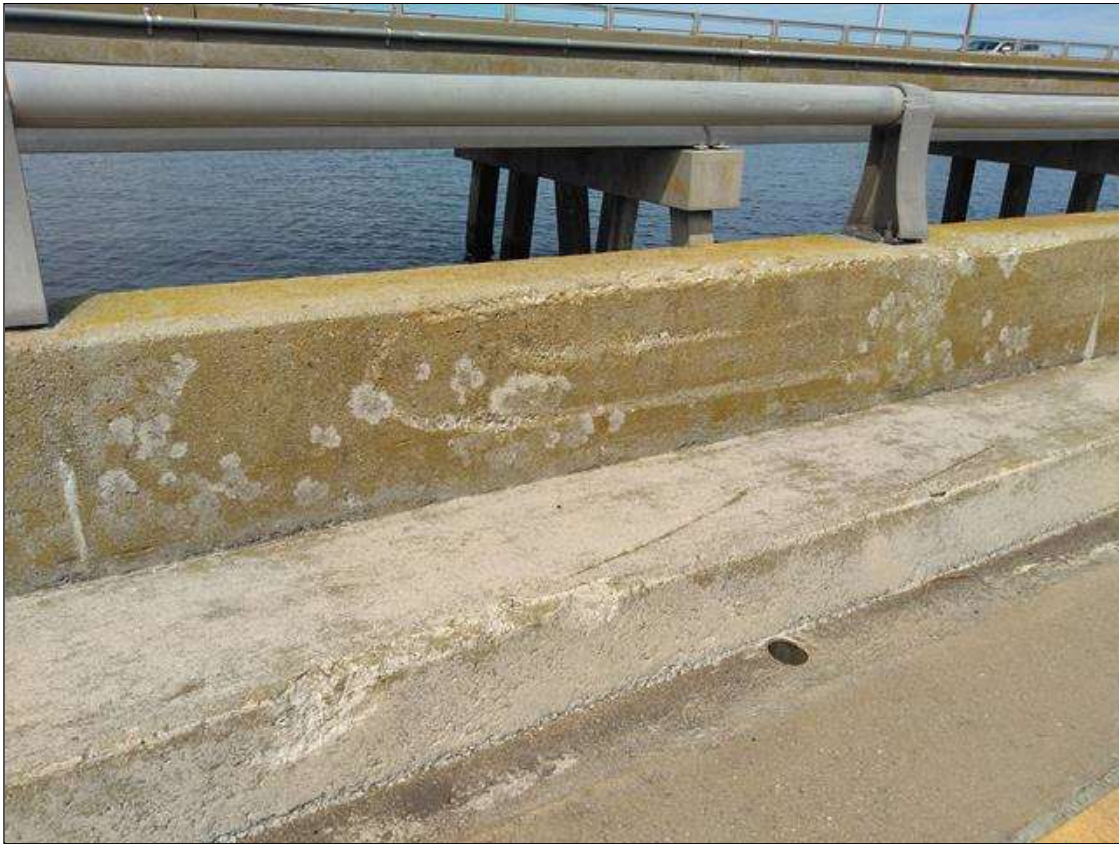
Span 83 Left Bridge Rail: BETWEEN POSTS 2 AND 4, IMPACT SCRAPES ON RAIL AND SPALLS ON CURB UP TO 3 FEET LONG X 3 INCHES HIGH X 1 INCH DEEP

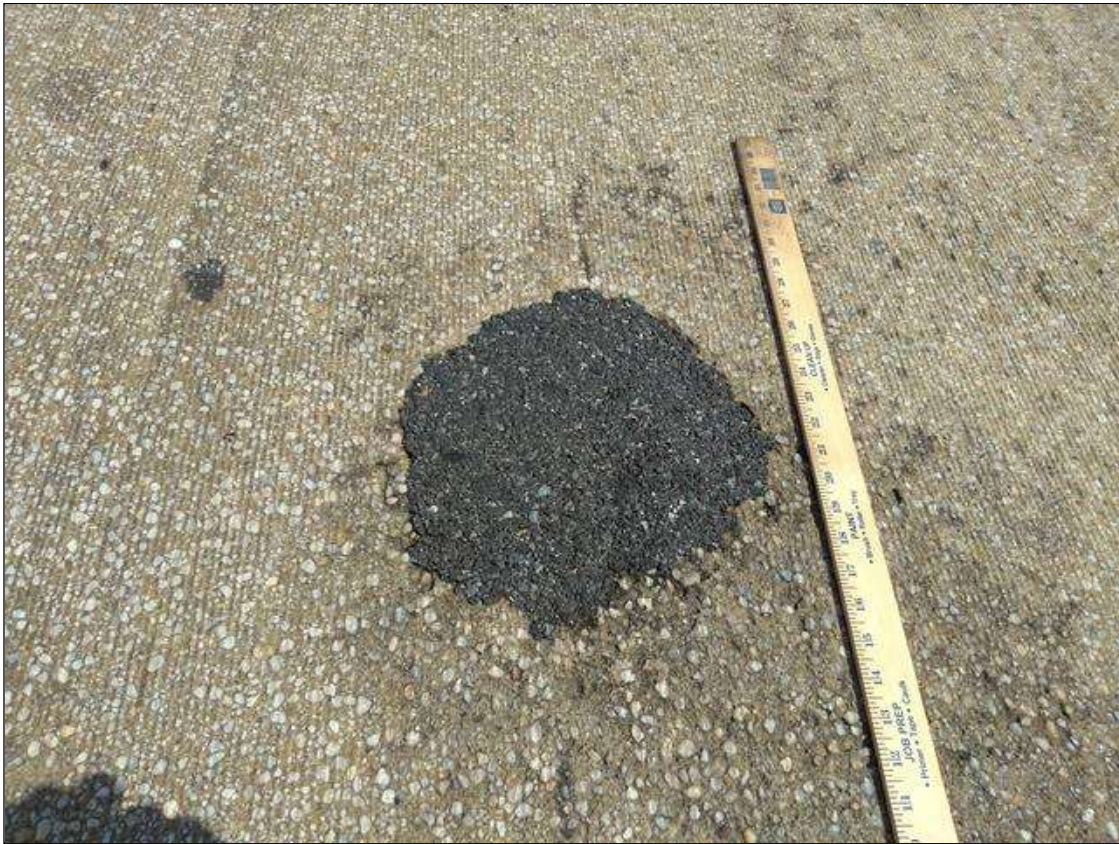
Span 2 Deck: DECK SURFACE 12 FEET FROM BENT 2 NEAR LEFT CURB, PATCHED AREA (12INCHES X 16 INCHES) (DEFECT NOT FOUND 9/12/22)

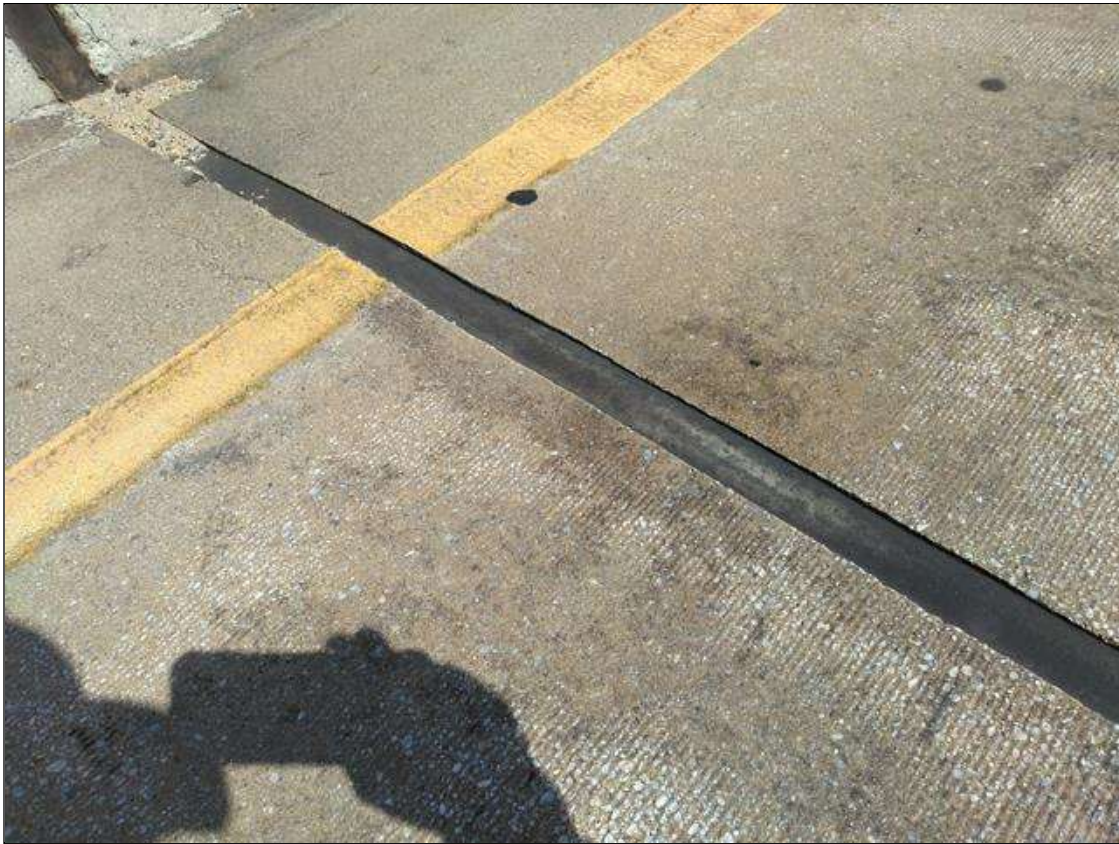
Span 44 Expansion Joint Bent 43: 1 FEET LONG AREA OF FULL DEPTH LOSS OF ADHESION STARTING 3 FEET FROM LEFT RAIL INCHES LEFT EASTBOUND TRAVEL LANE OVER PIER 43. (DEFECT NOT FOUND 9/12/22)

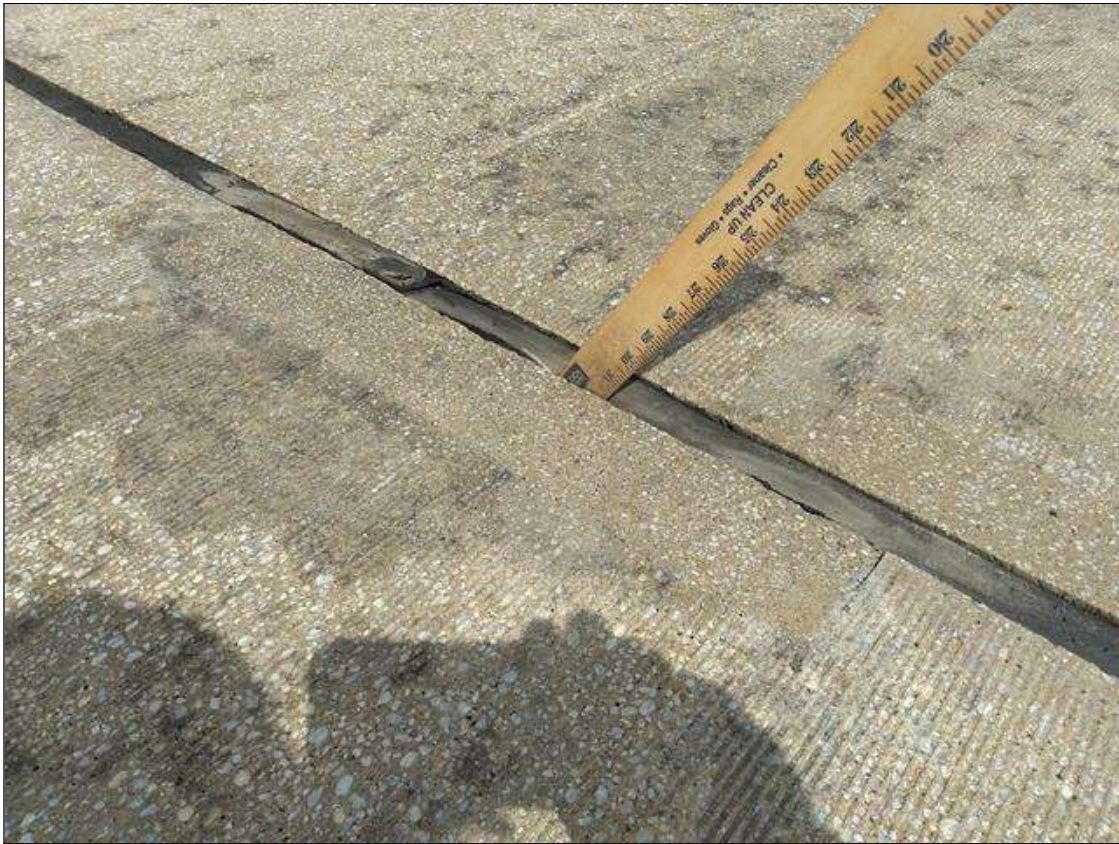
Span 68 Expansion Joint Bent 67: LEFT LANE NEAR CENTERLINE OF ROADWAY, (2) PATCHED AREAS (UP TO 1FEET X 6 INCHES). NO ADHESION AT PATCHES

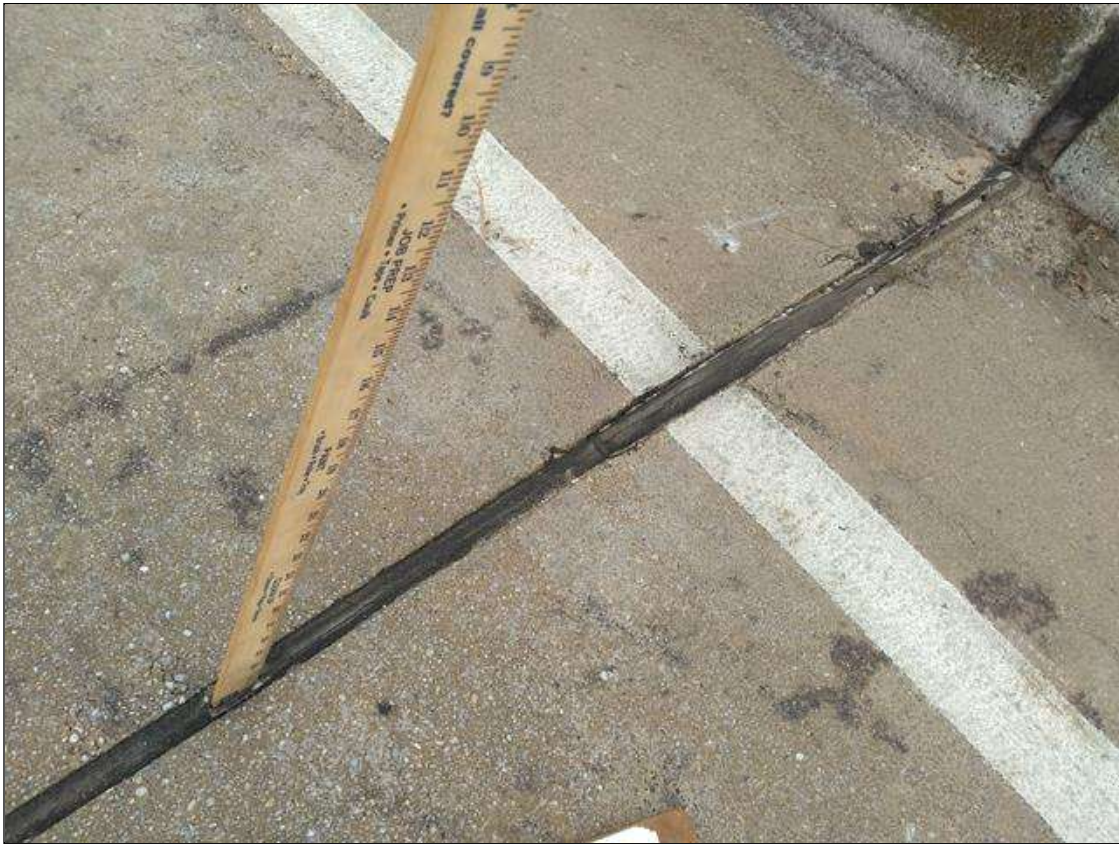
Span 100 Expansion Joint Bent 99: SCATTERED THROUGHOUT BOTH LANES, SEAL DAMAGED AND TORN (18 FEET)

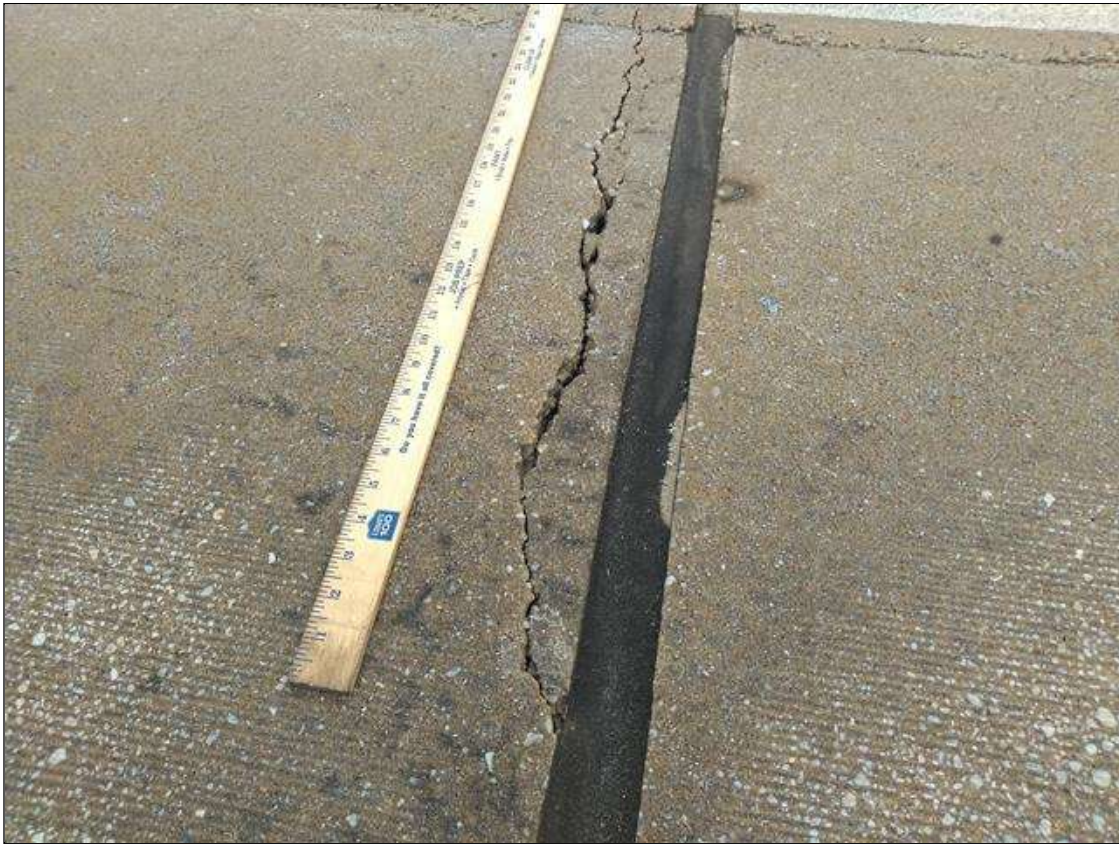
Span 70 Expansion Joint Bent 69: EXTENDING 4 FEET FROM RIGHT SHOULDER AT BENT 69, CRACK UP TO 0.50 INCH WIDE RUNNING 3 INCHES FROM JOINT UP TO 1.5 INCH DEEP

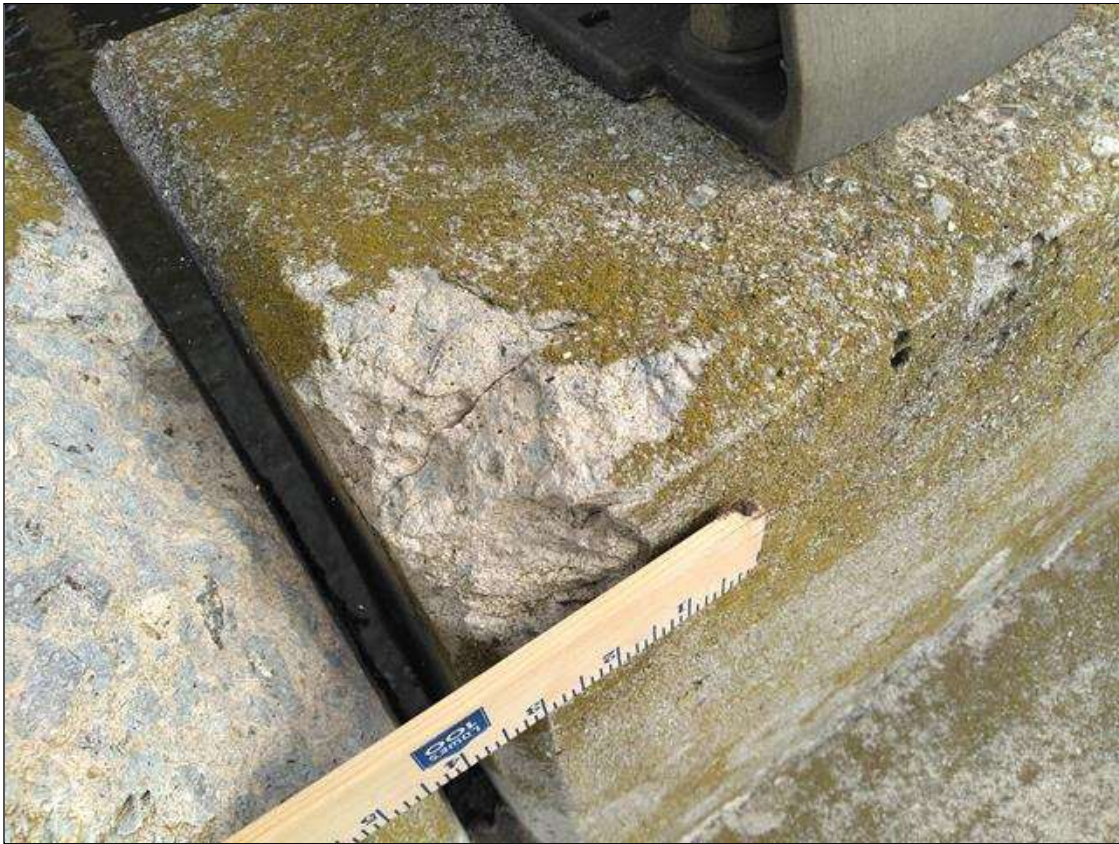
Span 6 Left Bridge Rail: AT BENT 5, SPALL (6INCHES X 6INCHES X 1/2 INCHES)

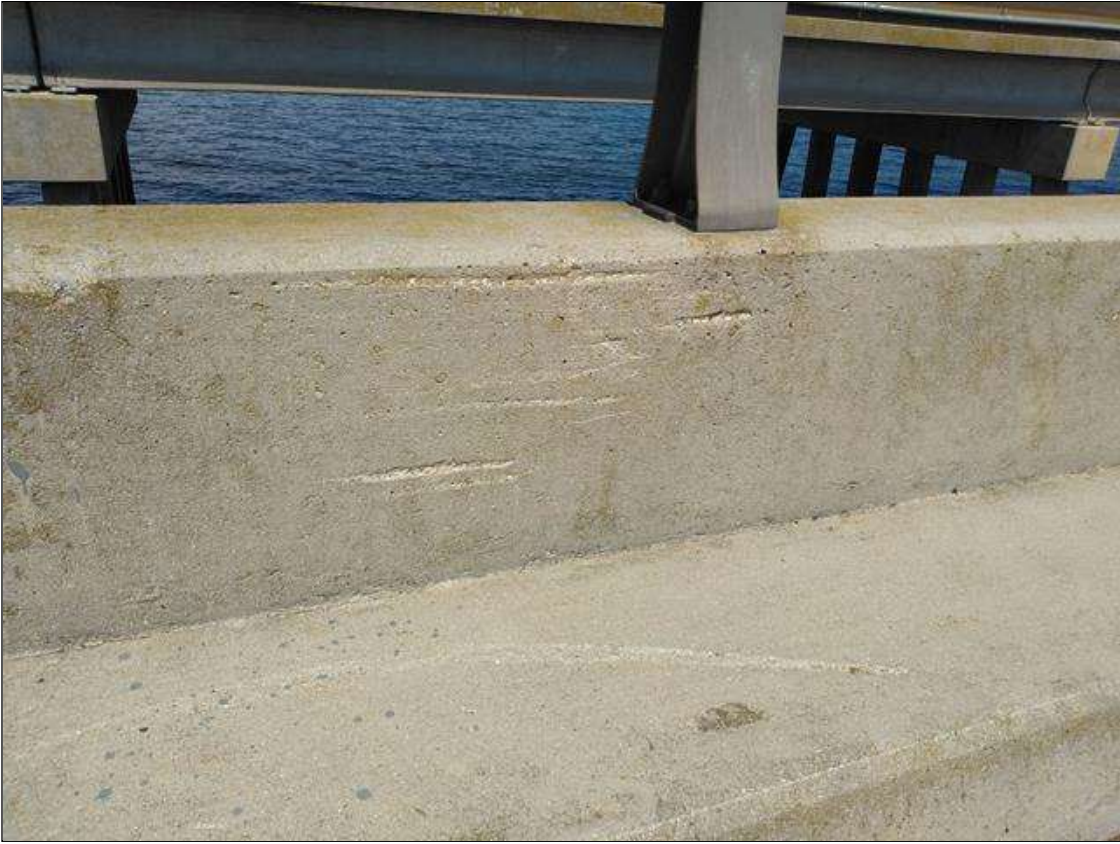
Span 50 Left Bridge Rail: RAIL AT RAILPOST 2, IMPACT SPALLS (4) UP TO 2 FEET LONG X 0.50 INCH DEEP

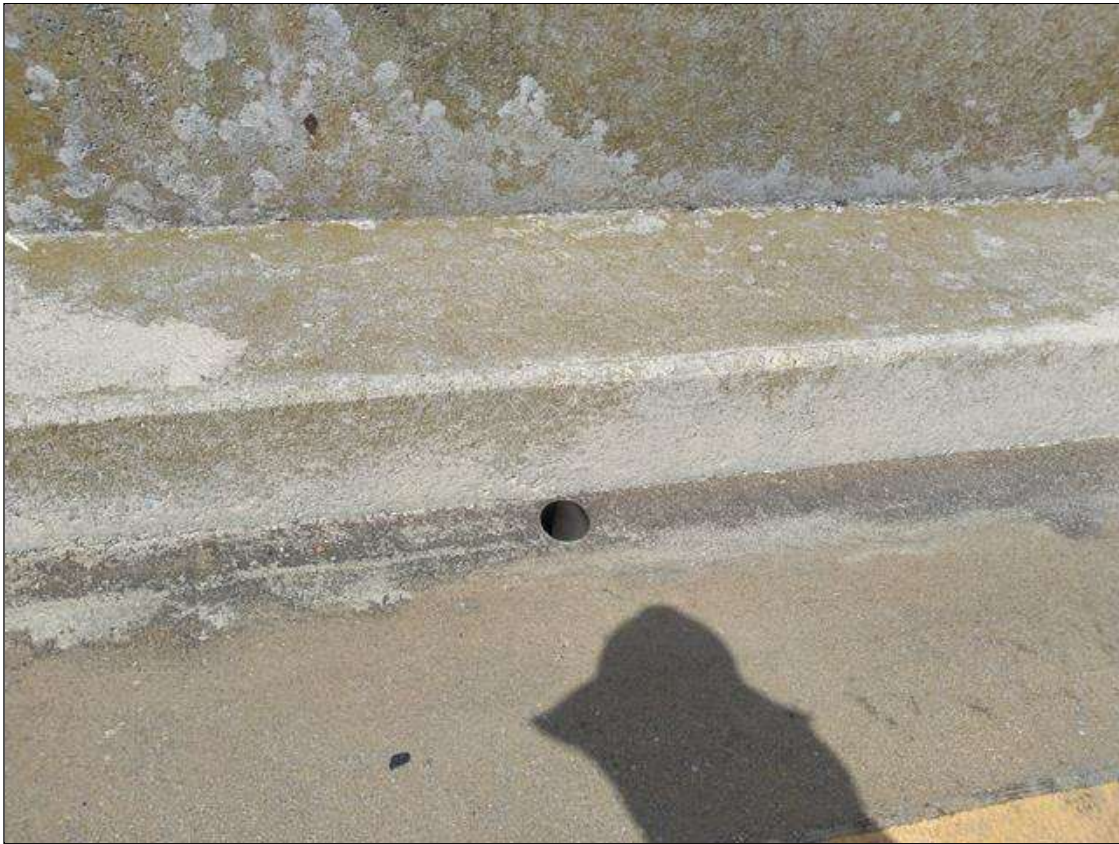
Span 65 Left Bridge Rail: CURB AT 6FEET FROM BENT 64, SPALL (4INCHES X 6INCHES X 1/2 INCHES) WITH EXPOSED RUSTED REBAR (DEFECT NOT FOUND 9/12/22)

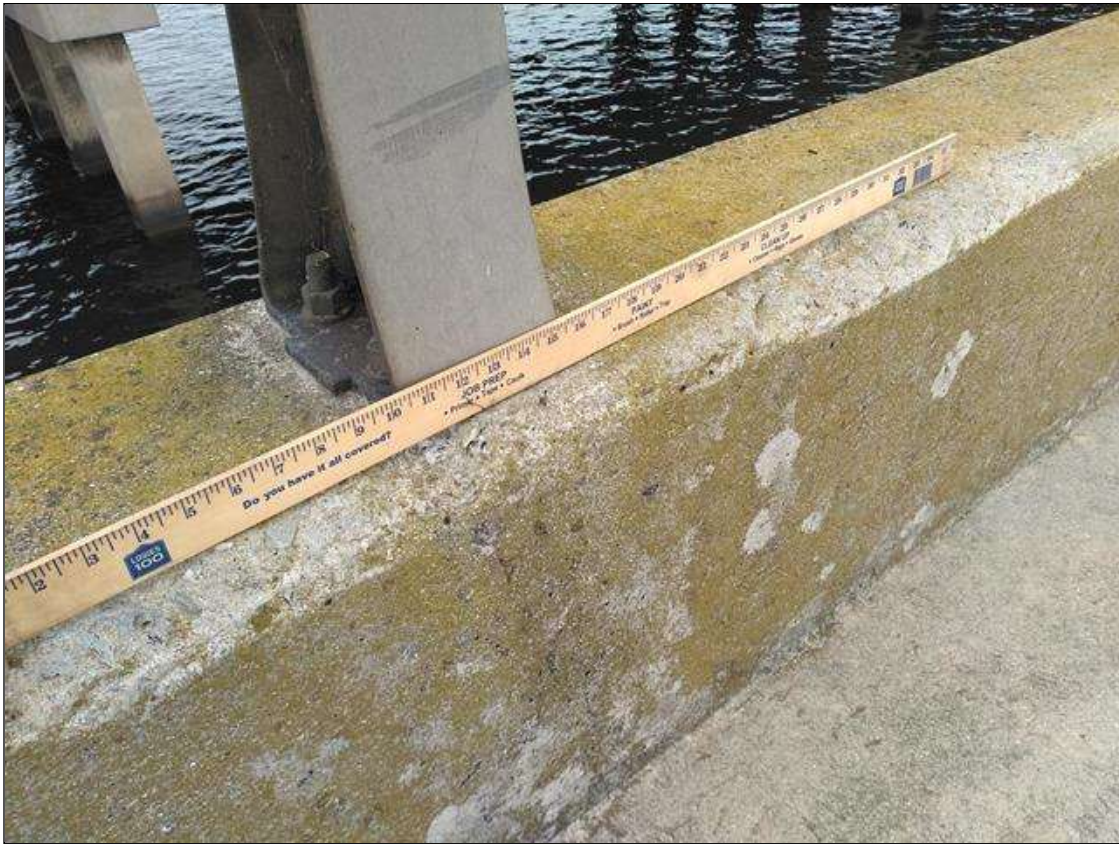
Span 82 Left Bridge Rail: RAILPOST 8, IMPACT SPALL (4FEET X 6INCHES X 1/2 INCHES)

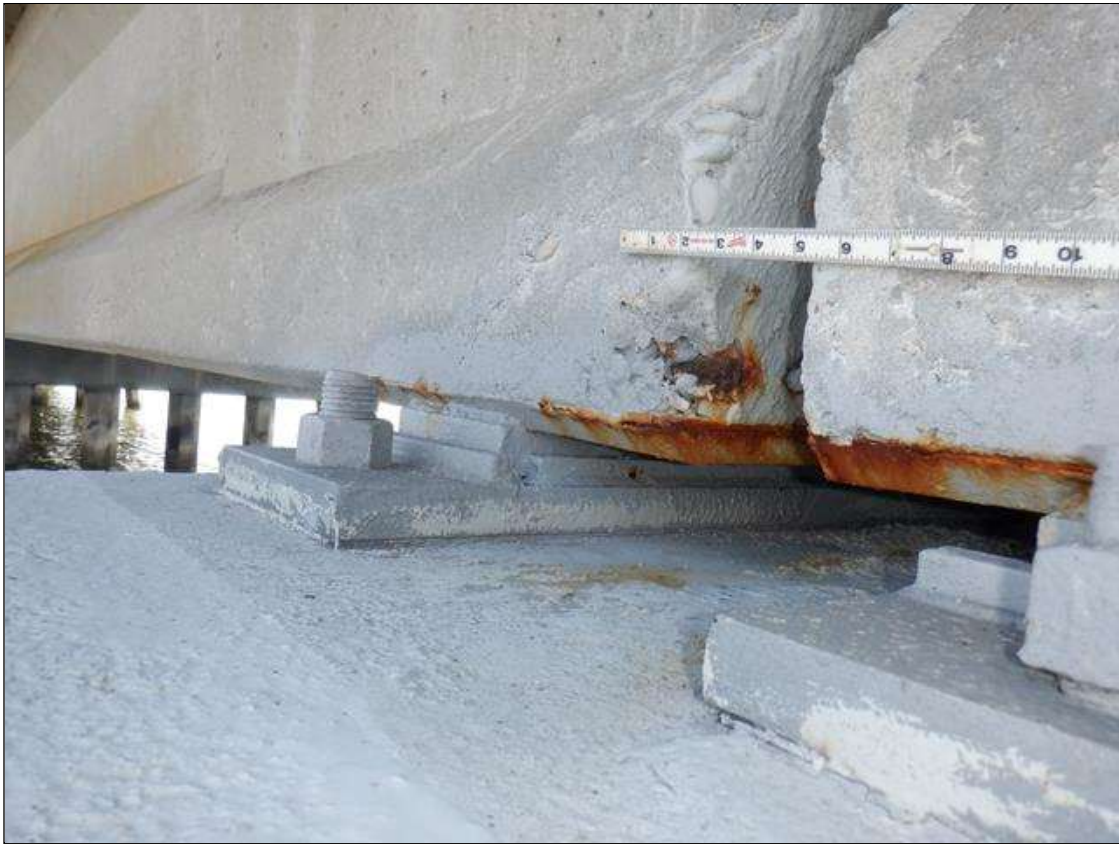
Span 9 Beam 1: NORTH FACE OF BOTTOM FLANGE, AT BENT 8, SPALL (5INCHES X 3INCHES X 2 INCHES)  
WITH EXPOSED RUSTED STRANDS

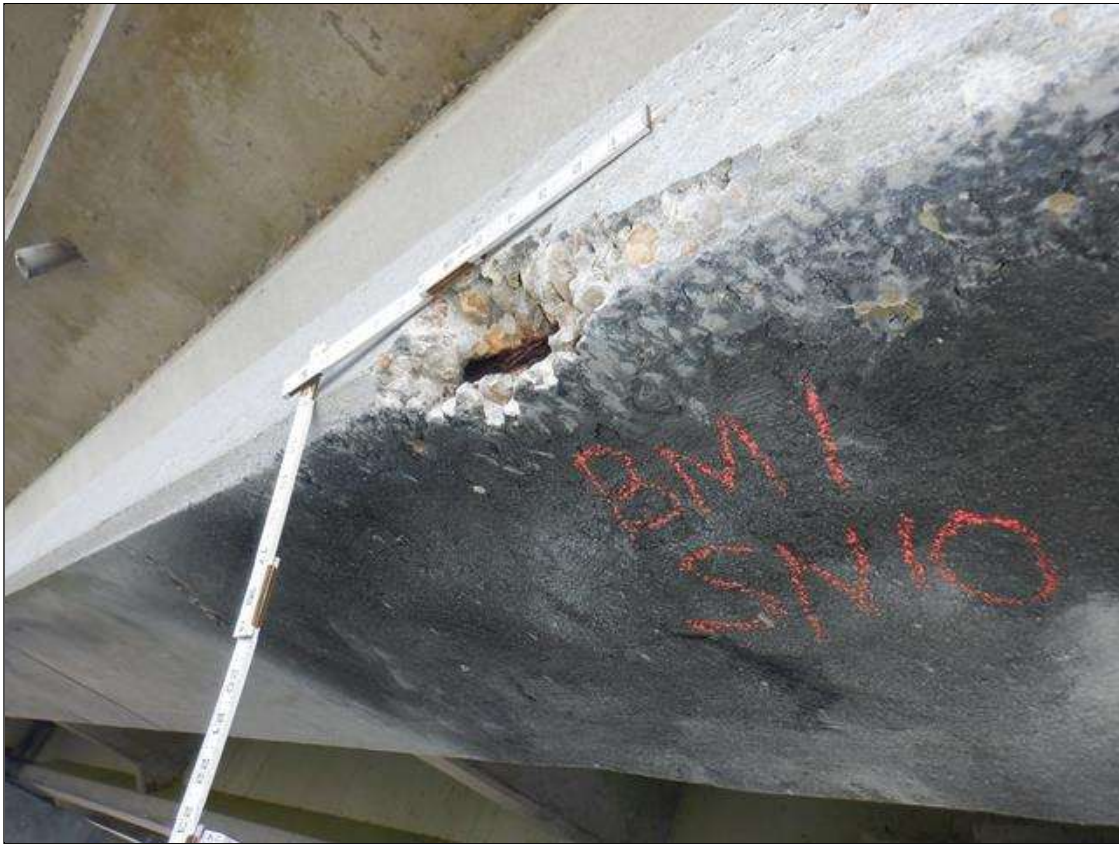
Priority Level	Defect Type	Quantity	Defect Description
2	Exposed Rebar	4	Span 10 Beam 1: (PAR) SOUTH FACE OF BOTTOM FLANGE AND WEB AT 7 FEET FROM BENT 9, PATCHED AREA (48 INCHES X 18 INCHES), WITH SPALL (10 INCHES X 3 INCHES X UP TO 2 INCHES DEEP) WITH EXPOSED RUSTED STRANDS (UP TO 50% SECTION LOSS)

Span 10 Beam 1: (PAR) SOUTH FACE OF BOTTOM FLANGE AND WEB AT 7 FEET FROM BENT 9, PATCHED AREA (48 INCHES X 18 INCHES), WITH SPALL (10 INCHES X 3 INCHES X UP TO 2 INCHES DEEP) WITH EXPOSED RUSTED STRANDS (UP TO 50 PERCENT SECTION LOSS)

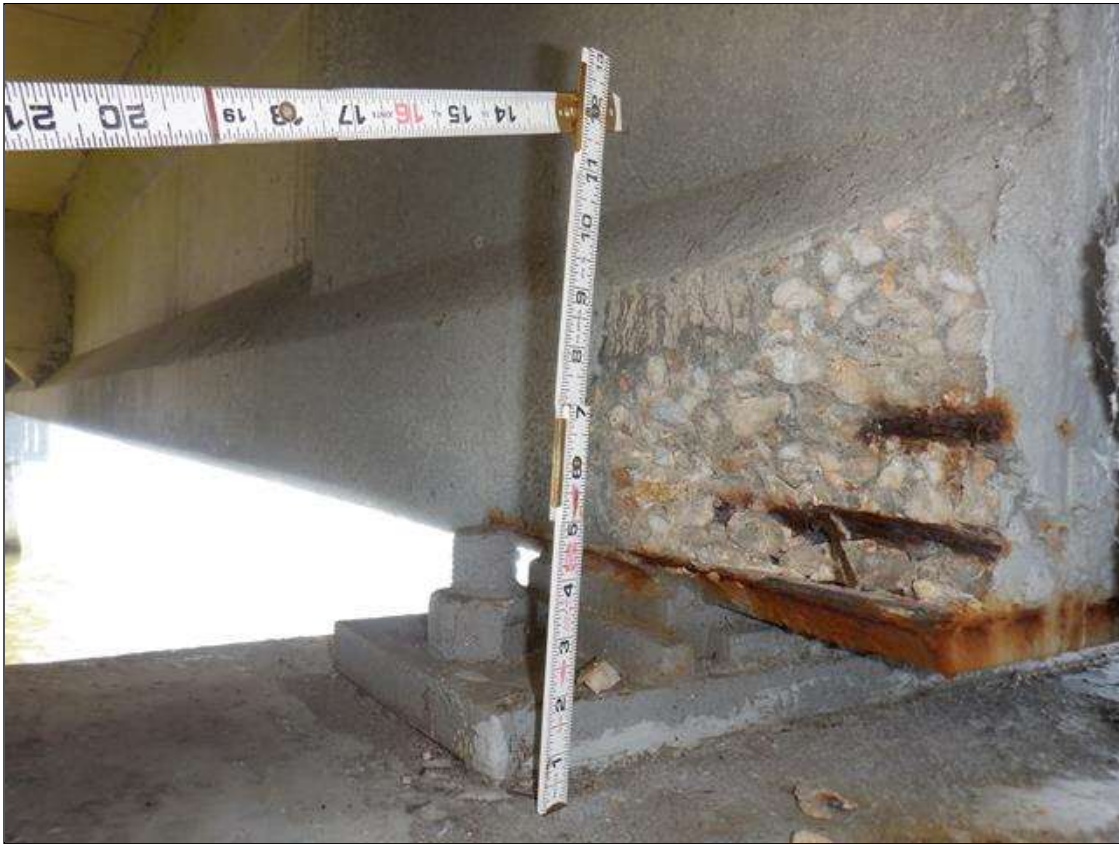
Priority Level	Defect Type	Quantity	Defect Description
2	Exposed Prestressing	1	Span 11 Beam 4: (PAR) NORTH FACE BOTTOM FLANGE, AT BENT 10, SPALL (1: INCHES X 7 INCHES X 2 INCHES) WITH (2) EXPOSED RUSTED STRANDS, SECTION LOSS (30 PERCENT) ON BOTTOM STRAND

Span 11 Beam 4: (PAR) NORTH FACE BOTTOM FLANGE, AT BENT 10, SPALL (12 INCHES X 7 INCHES X 2 INCHES) WITH (2) EXPOSED RUSTED STRANDS, SECTION LOSS (30 PERCENT) ON BOTTOM STRAND

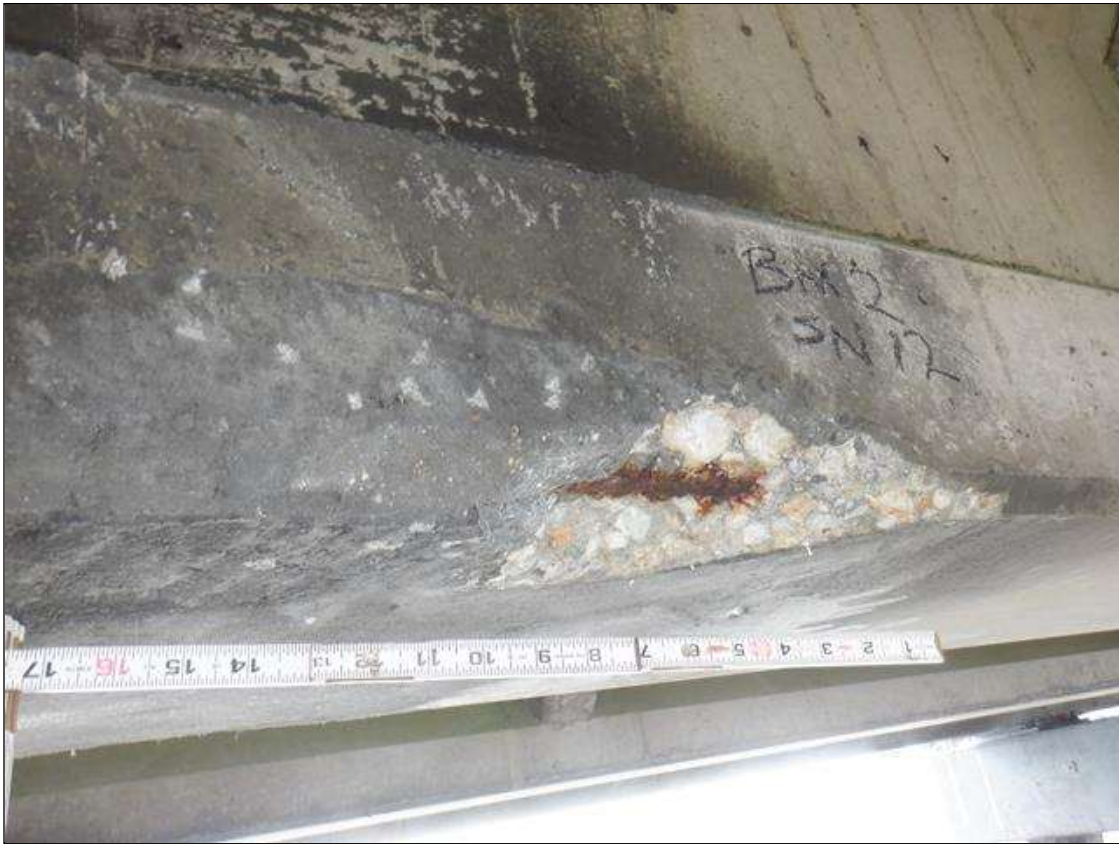
Priority Level	Defect Type	Quantity	Defect Description
2	Exposed Prestressing	3	Span 12 Beam 2: (PAR) BOTH FACES OF BOTTOM FLANGE AT 23 FEET FROM BENT 11, (2) PATCHED AREAS (UP TO 30 INCHES X 12 INCHES), WITH SPALL (12 INCHES X 3 INCHES X 3 INCHES DEEP) WITH EXPOSED RUSTED STRANDS (20% SECTION LOSS)

Span 12 Beam 2: (PAR) BOTH FACES OF BOTTOM FLANGE AT 23 FEET FROM BENT 11, (2) PATCHED AREAS (UP TO 30 INCHES X 12 INCHES), WITH SPALL (12 INCHES X 3 INCHES X 3 INCHES DEEP) WITH EXPOSED RUSTED STRANDS (20 PERCENT SECTION LOSS)

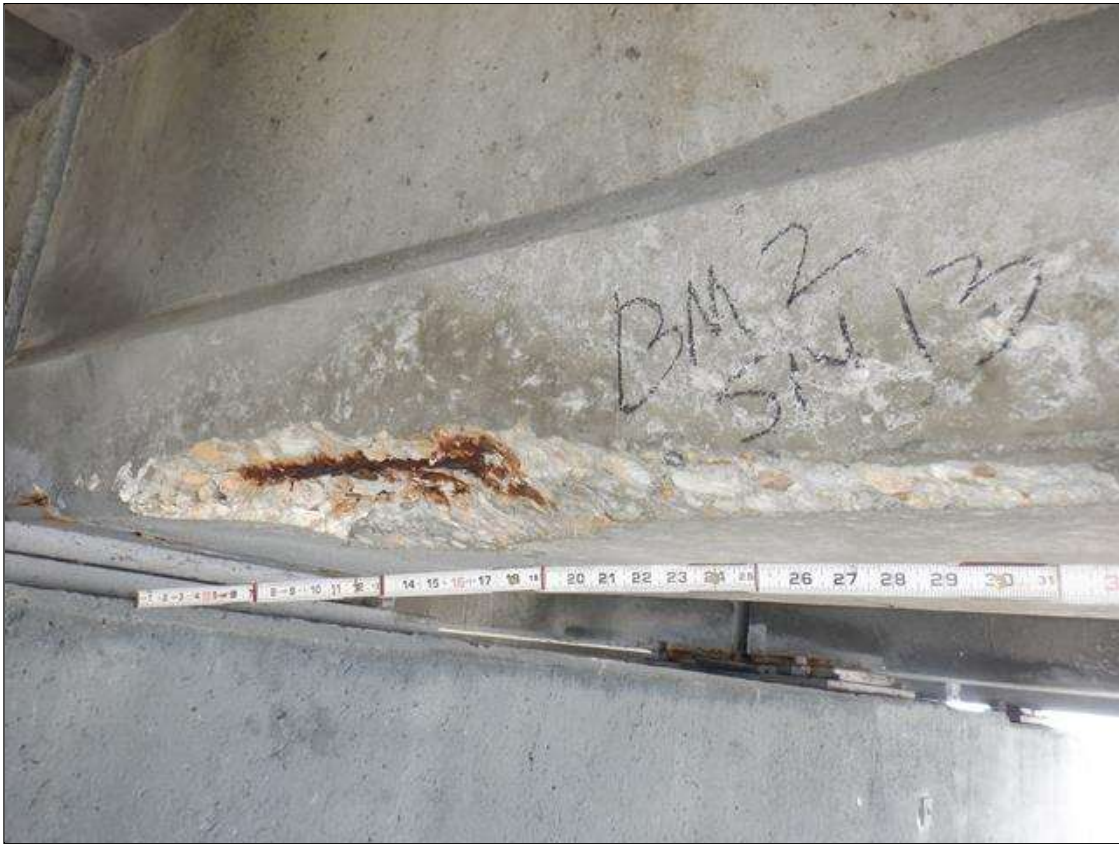
<b>3306</b>	<b>Beam 2</b>	Prestressed Concrete Girder	
Priority Level	Defect Type	Quantity	Defect Description
<b>2</b>	Exposed Prestressing	3	Span 13 Beam 2: (PAR) BOTTOM FLANGE NORTH FACE, AT BENT 23, SPALL (34 INCHES X 8 INCHES X 2 INCHES DEEP) WITH EXPOSED RUSTED STRANDS (20% SECTION LOSS)

Span 13 Beam 2: (PAR) BOTTOM FLANGE NORTH FACE, AT BENT 13, SPALL (34 INCHES X 8 INCHES X 2 INCHES DEEP) WITH EXPOSED RUSTED STRANDS (20 PERCENT SECTION LOSS)

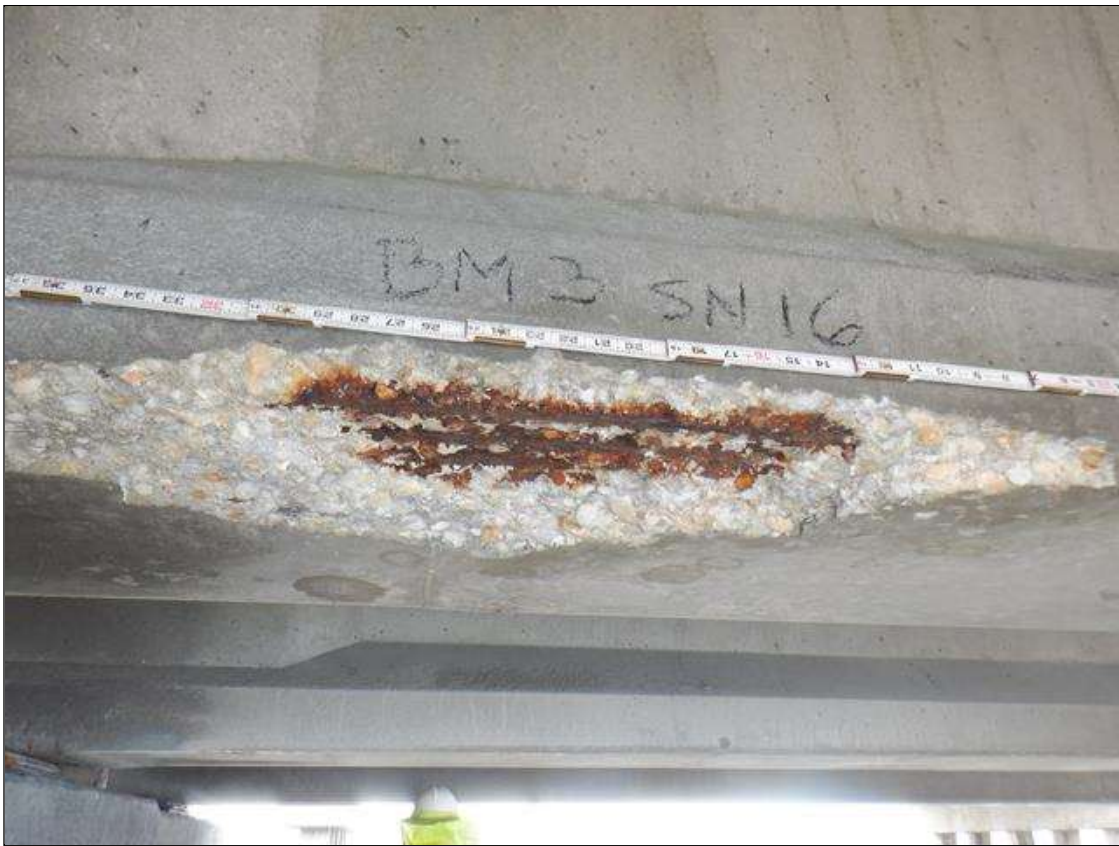
<b>3306</b>	<b>Beam 3</b>	Prestressed Concrete Girder	
Priority Level	Defect Type	Quantity	Defect Description
<b>2</b>	Exposed Prestressing	4	Span 16 Beam 3: (PAR) BOTTOM FLANGE SOUTH FACE, AT BENT 15, SPALL ( 4 FEET X UP TO 12 INCHES X 2 INCHES DEEP) WITH MULTIPLE EXPOSED RUSTED STRANDS (20% SECTION LOSS)
<b>2</b>	Exposed Prestressing	1	Span 16 Beam 3: (PAR) SOUTH FACE BOTTOM FLANGE, AT BENT 16, SPALL (8 INCHES X 7 INCHES X 2 INCHES) WITH (2) EXPOSED RUSTED STRANDS, SECTION LOSS (20 PERCENT) ON BOTTOM STRAND

Span 16 Beam 3: (PAR) BOTTOM FLANGE SOUTH FACE, AT BENT 15, SPALL ( 4 FEET X UP TO 12 INCHES X 2 INCHES DEEP) WITH MULTIPLE EXPOSED RUSTED STRANDS (20 PERCENT SECTION LOSS)
