NC DEPARTMENT OF TRANSPORTATION  
DIVISION OF HIGHWAYS  
STRUCTURE MANAGEMENT UNIT

## Structure Safety Report

### Routine Element Inspection - Contract

STRUCTURE NUMBER: 260016 SAP STRUCTURE NO: 0270016 FHWA STRUCTURE NO: 000000000530016  
DIVISION: 1 COUNTY: CURRITUCK INSPECTION DATE: 09/21/2022 FREQUENCY: 24 MONTHS  
FACILITY CARRIED: US158E MILE POST: \_\_\_\_\_  
LOCATION: .01 MI.E.JCT.SR1187  
FEATURE INTERSECTED: CURRITUCK SOUND  
LATITUDE: 36° 5' 11.69" LONGITUDE: 75° 46' 0.21"  
SUPERSTRUCTURE: RC FLOOR ON PPC GIRDERS & CORED SLAB  
SUBSTRUCTURE: EBTS:RC CAP/PPC PILES;IBTS:RCP&B & RC CAPS/PPC PILES  
SPANS: 248 SPANS. SEE SPAN PROFILE SHEET FOR SPAN DETAILS  
☐ FRACTURE CRITICAL ☐ TEMPORARY SHORING ☐ SCOUR CRITICAL ☐ SCOUR PLAN OF ACTION  
GRADES: (Inspector/NBI Coding) DECK 6 / 6 SUPERSTRUCTURE 5 / 5 SUBSTRUCTURE 6 / 6 CULVERT N / N  
POSTED SV: Not Posted POSTED TTST: Not Posted  
OTHER SIGNS PRESENT: None

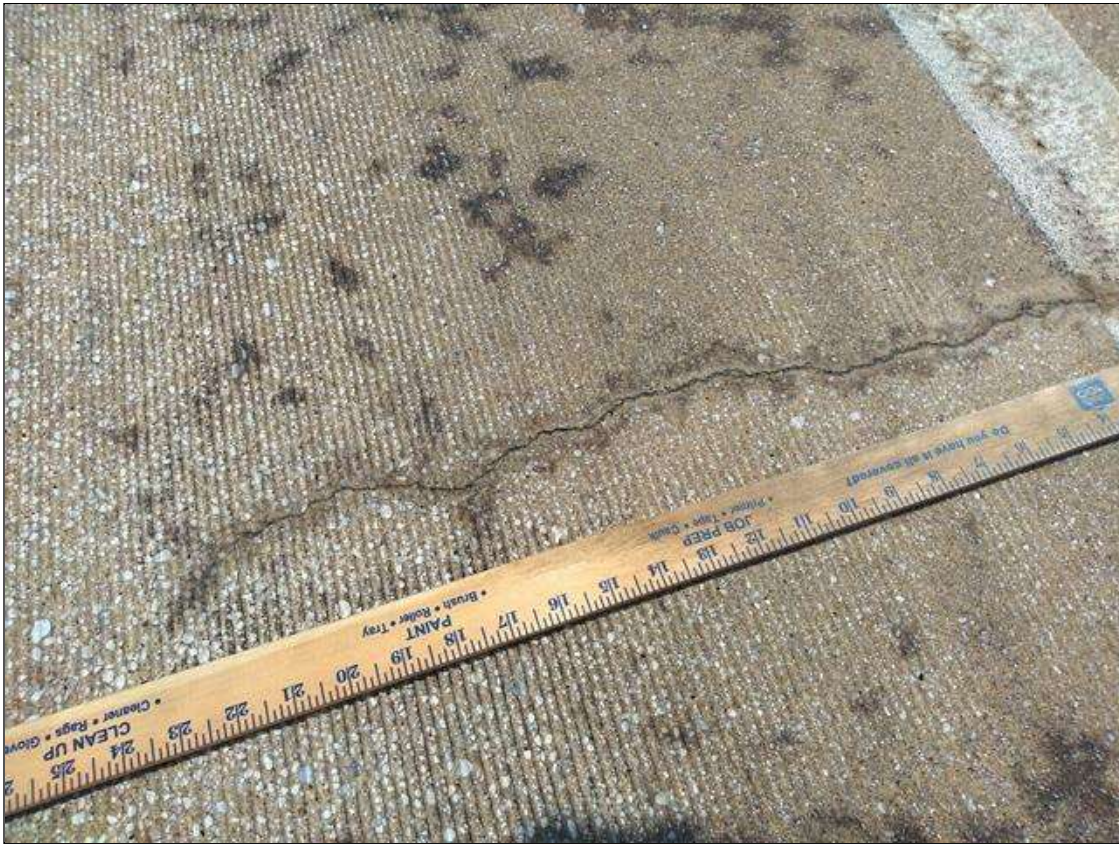
Span 139 Deck: WITHIN 8 FEET OF BENT 139 IN RIGHT SHOULDER (2) 2 FOOT X 0.06 INCH TRANSVERSE CRACKS

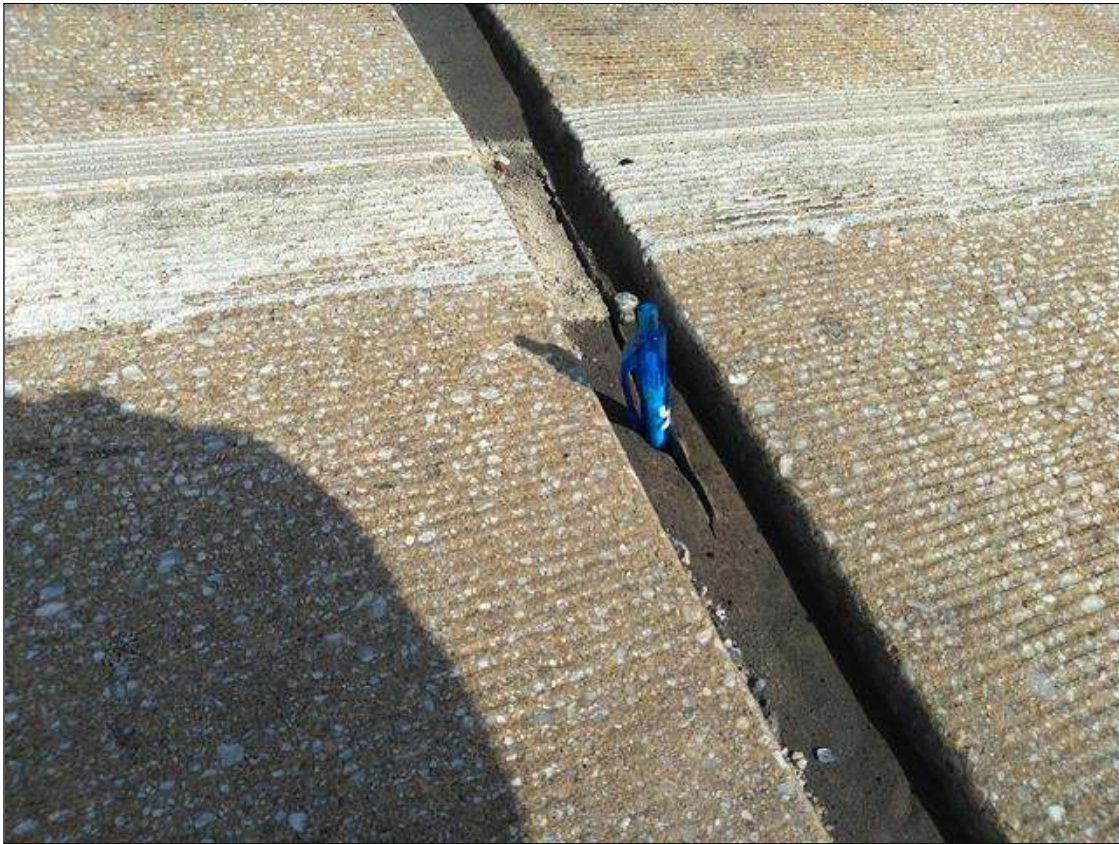
Span 125 Expansion Joint Bent 124: BENT 124, CRACK AT CENTERLINE 8 INCH LONG FULL DEPTH

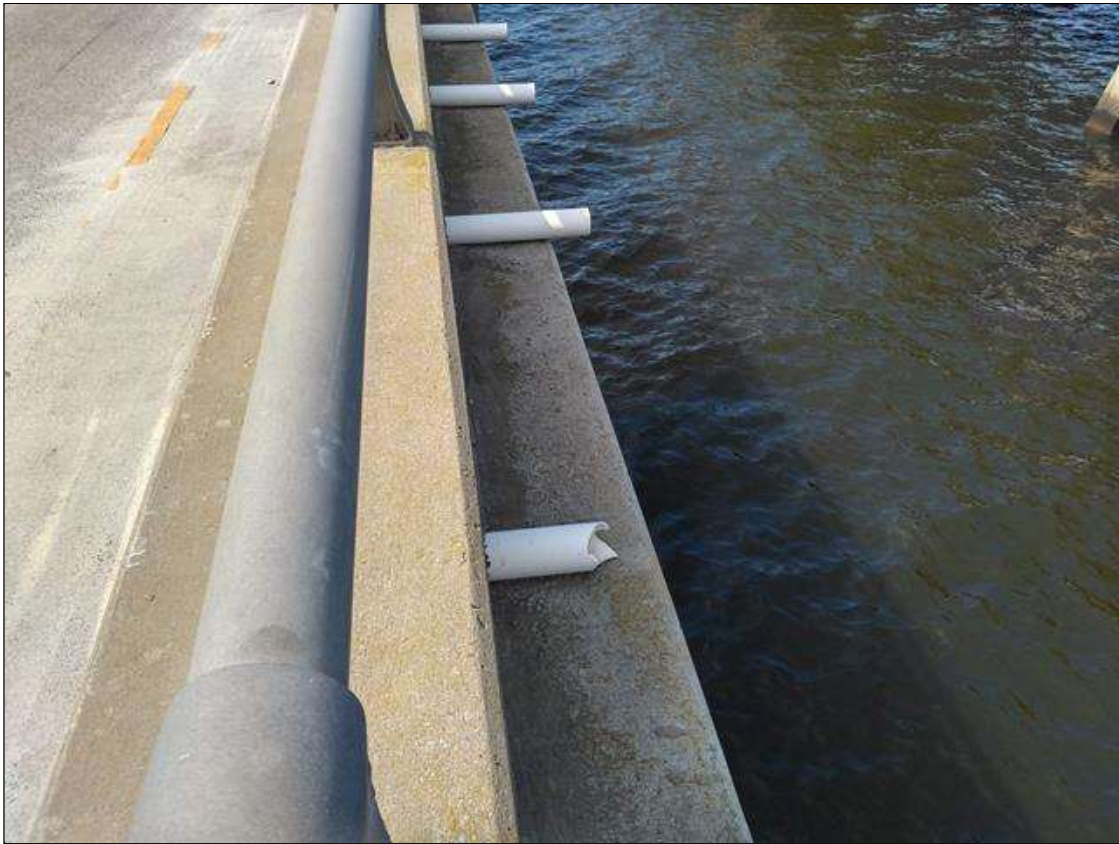
(PAR) BEHIND LEFT BARRIER ON SPAN 154 NEAR BENT 155, BROKEN SCUPPER EXTENSION PIPES

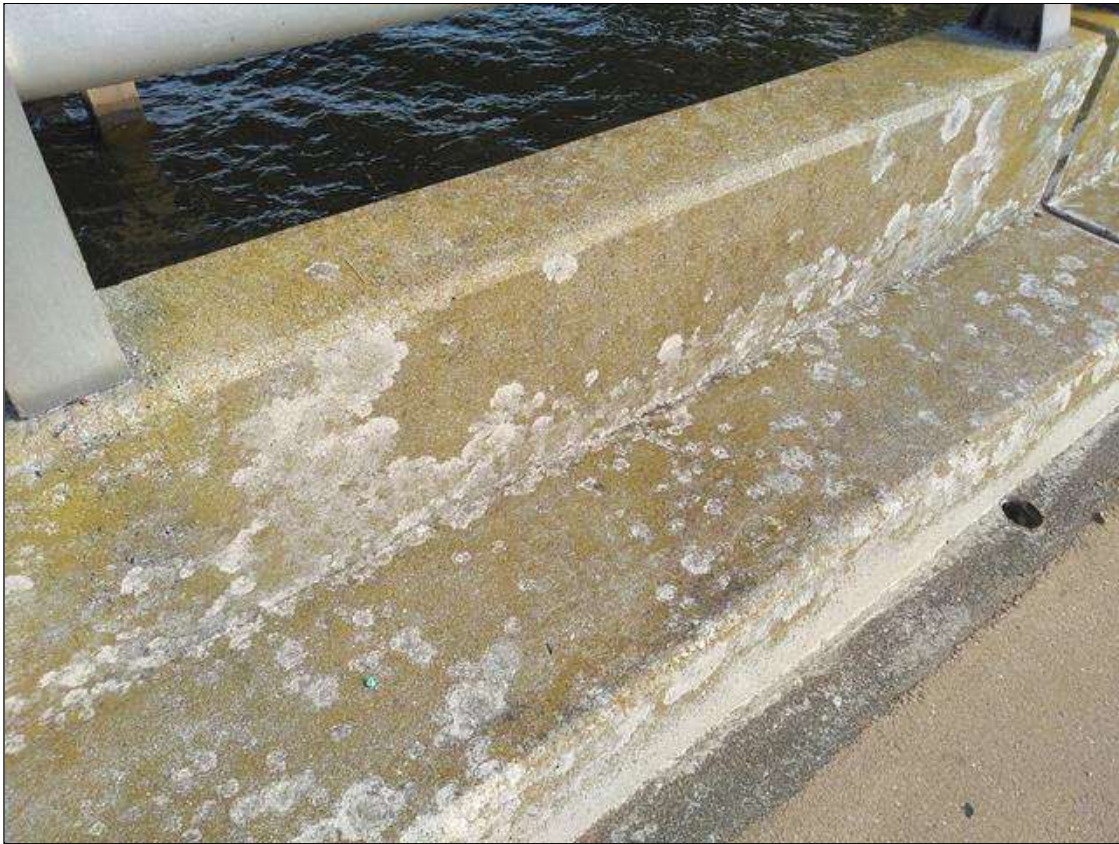
Span 116 Left Bridge Rail: TOP OF RAIL BETWEEN POSTS 8 AND 9, SPALL (8INCHES X 3INCHES X 1/2 INCHES)  
(DEFECTS NOT FOUND 9/23/22)

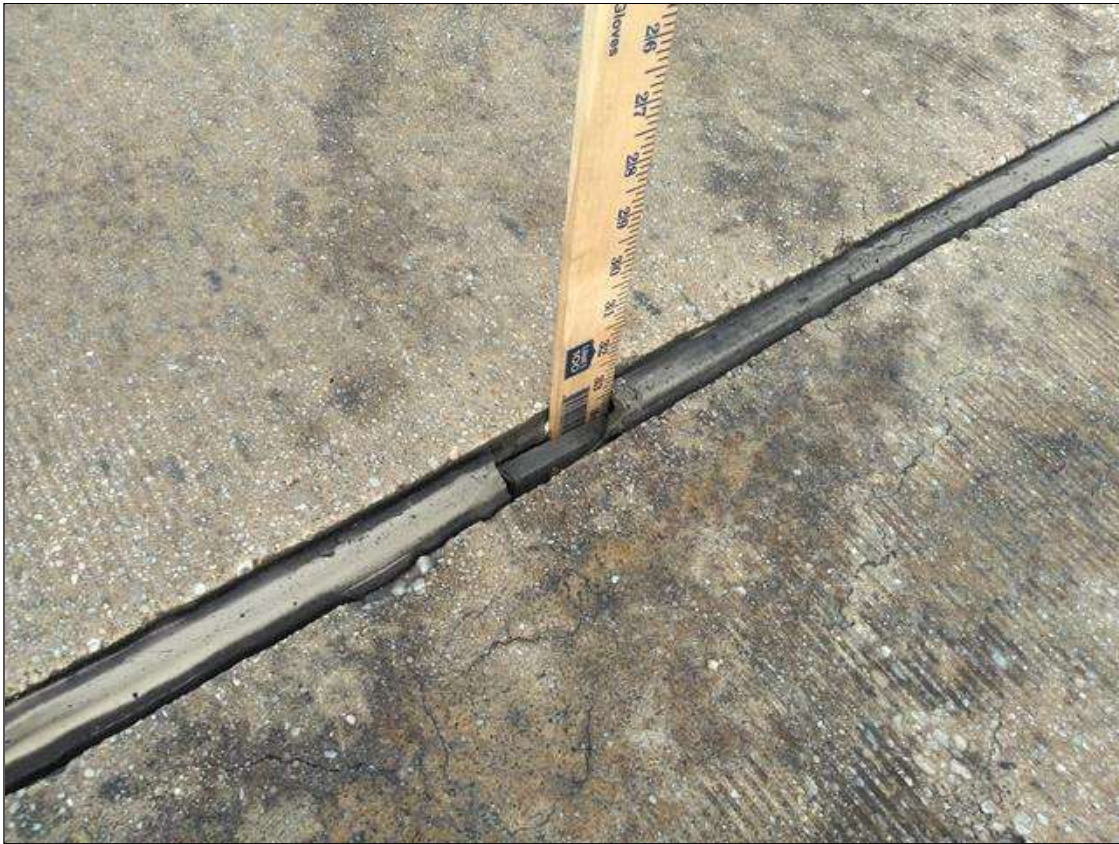
Span 103 Expansion Joint Bent 102: BOTH LANES SCATTERED THROUGHOUT, LOSS OF ADHESION (5FEET X FULL DEPTH)

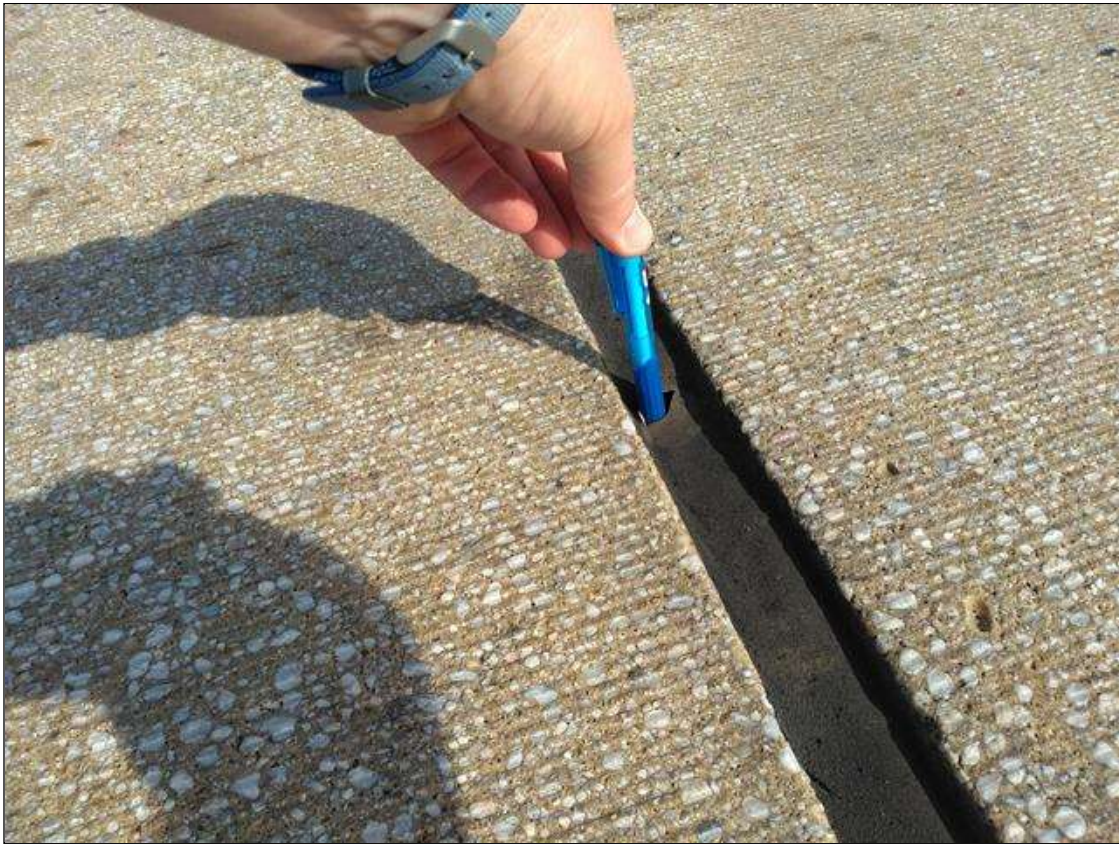
Span 118 Expansion Joint Bent 117: BENT 117, 1 INCH LONG FULL DEPTH CRACK LEFT LANE

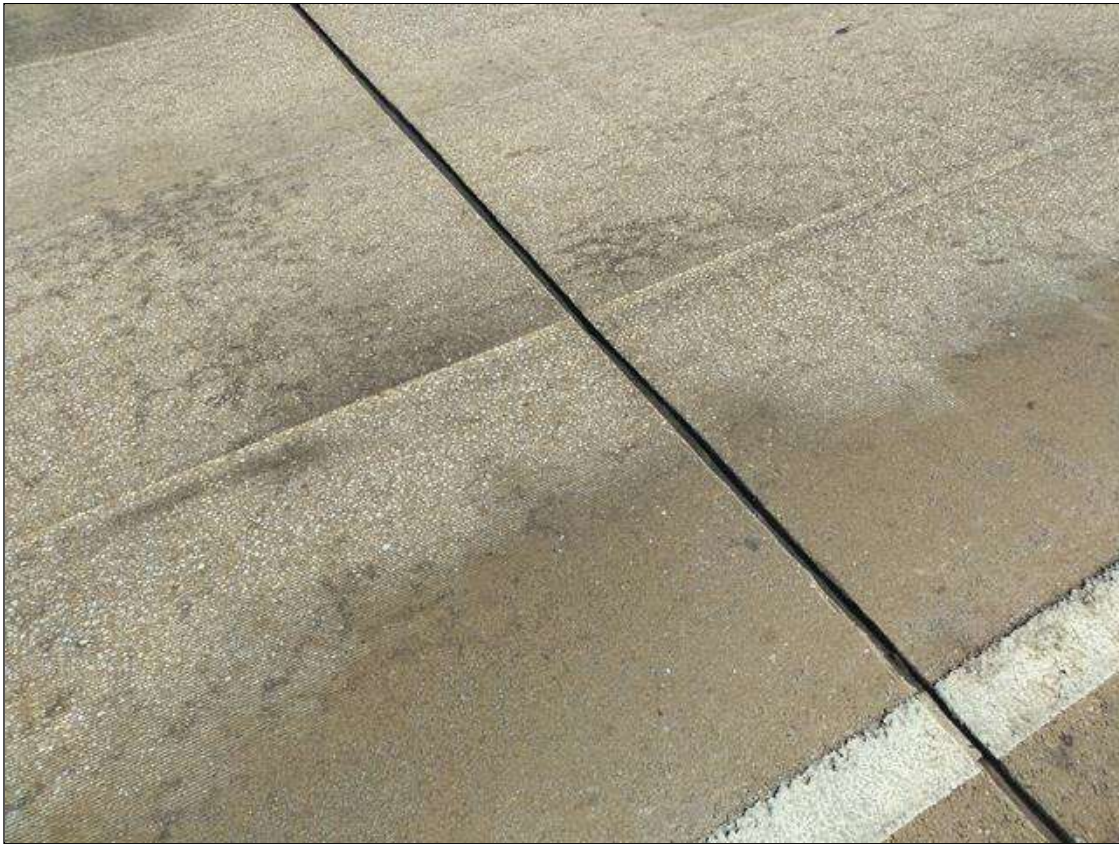
Span 118 Expansion Joint Bent 117: RIGHT LANE NEAR CENTERLINE OF ROADWAY, (3) PATCHED AREAS (3FEET X 3 INCHES) (NOT FOUND 9/13/22)

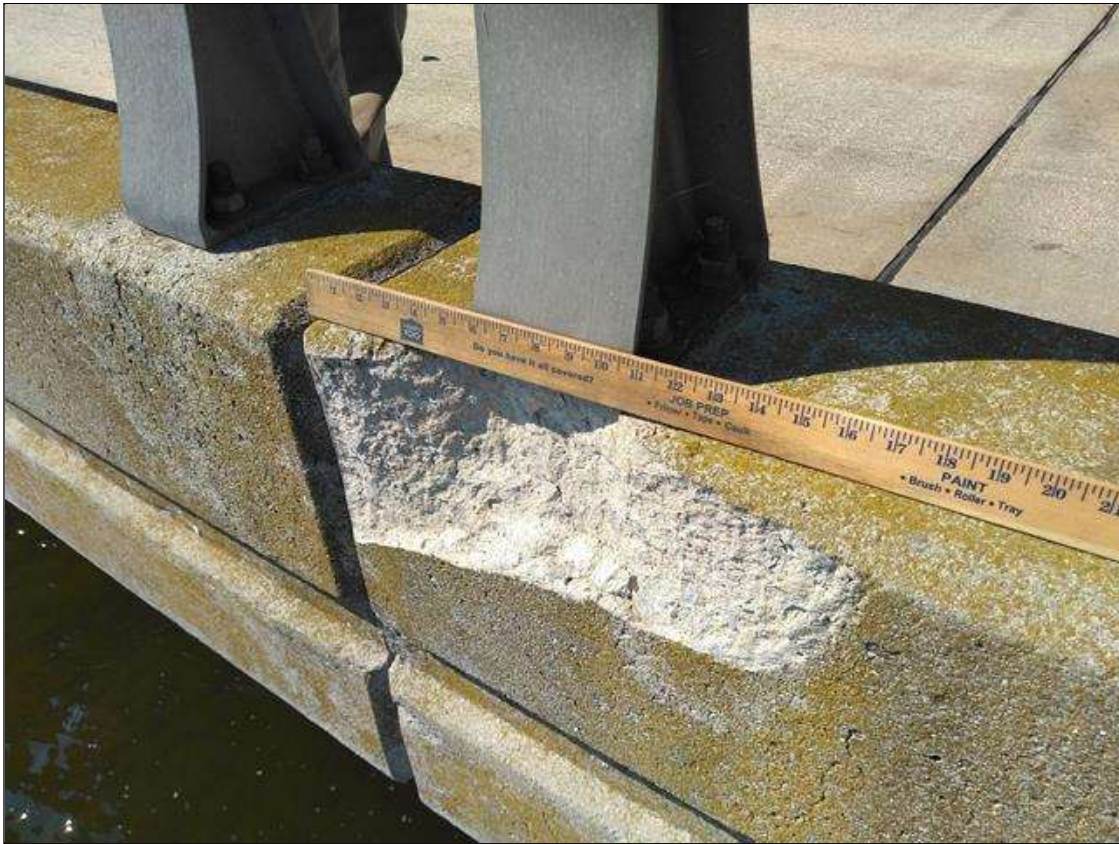
Span 195 Right Bridge Rail: AT FIRST RAIL POST (OUTSIDE) SPALL 16 INCH X 7 INCHES HIGH X 1.5 INCHES DEEP

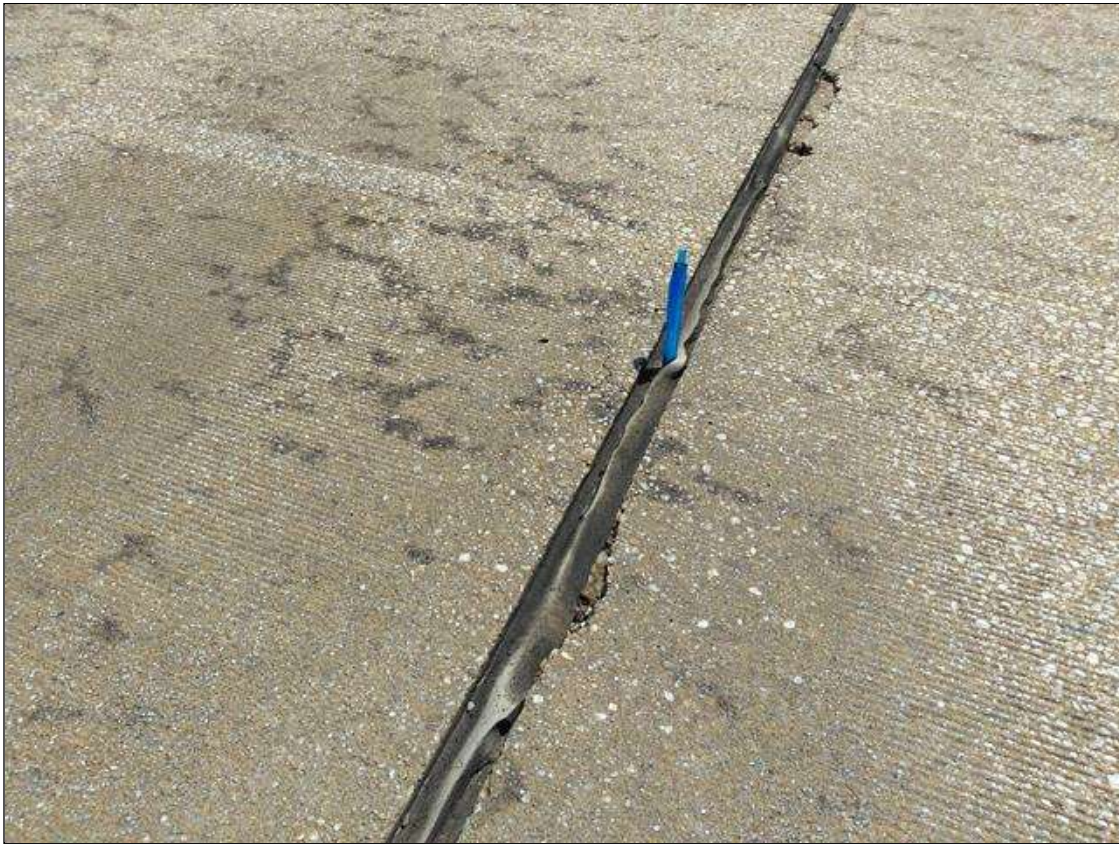
Span 172 Expansion Joint Bent 171: AT BENT 171, FULL WIDTH X FULL DEPTH WITH INTERMITTENT EDGE SPALLING UP TO 1 INCH WIDE

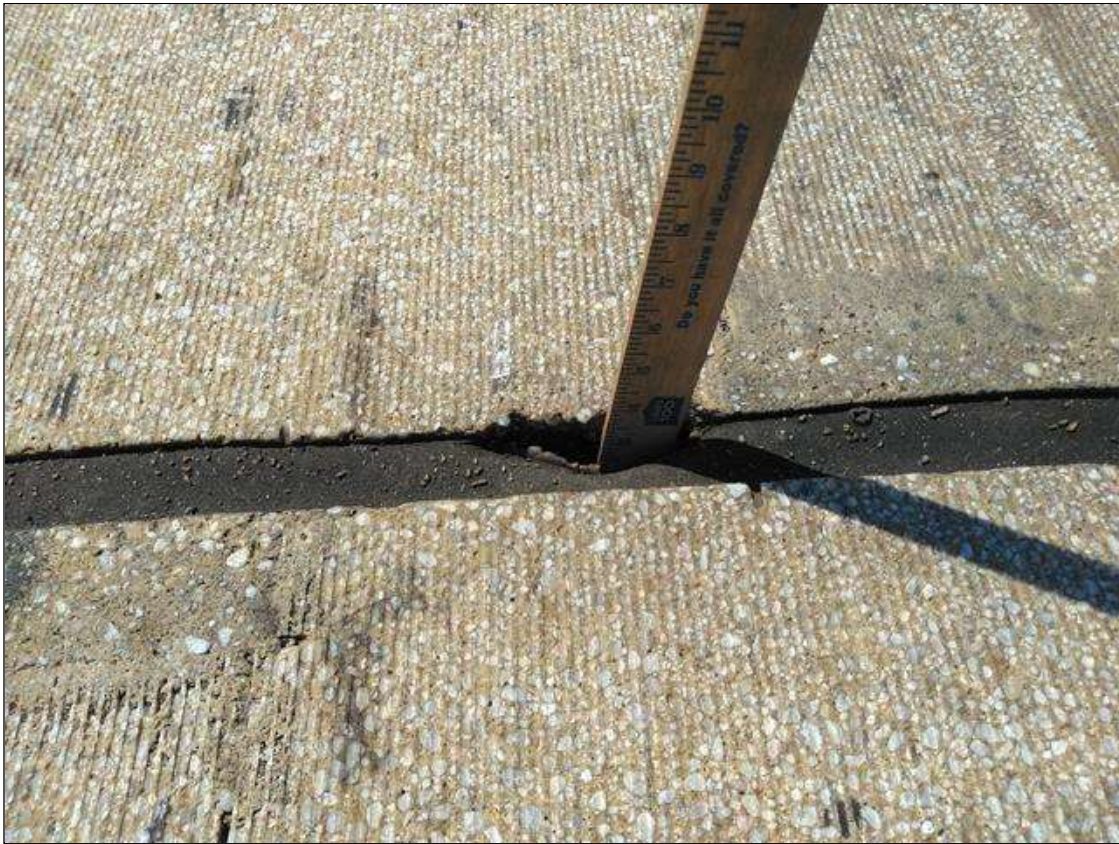
Span 179 Expansion Joint Bent 178: AT BENT 178, RIGHT LANE 5 INCH WIDE X 1 INCH LONG SPALL WITH NO JOINT SEAL ADHESION

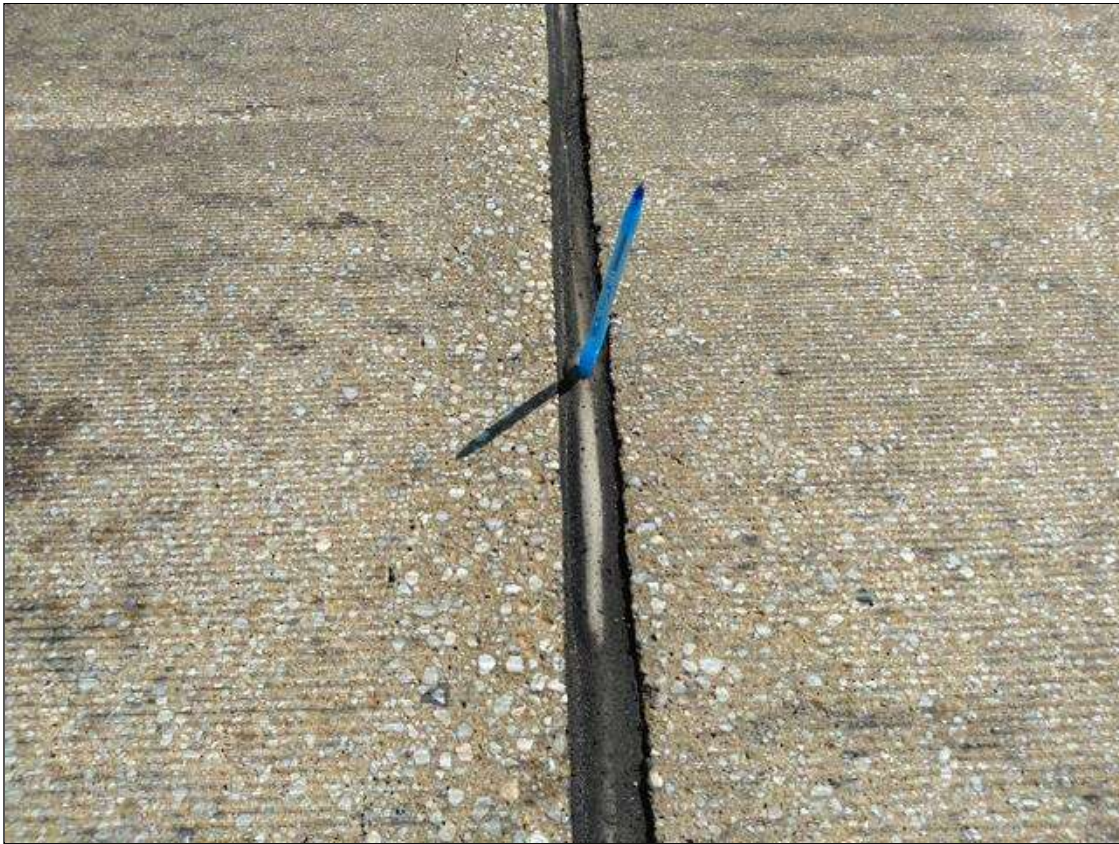
Span 200 Expansion Joint Bent 199: AT BENT 199, PARTIAL DEPTH CRACKS INTERMITTENT THROUGHOUT

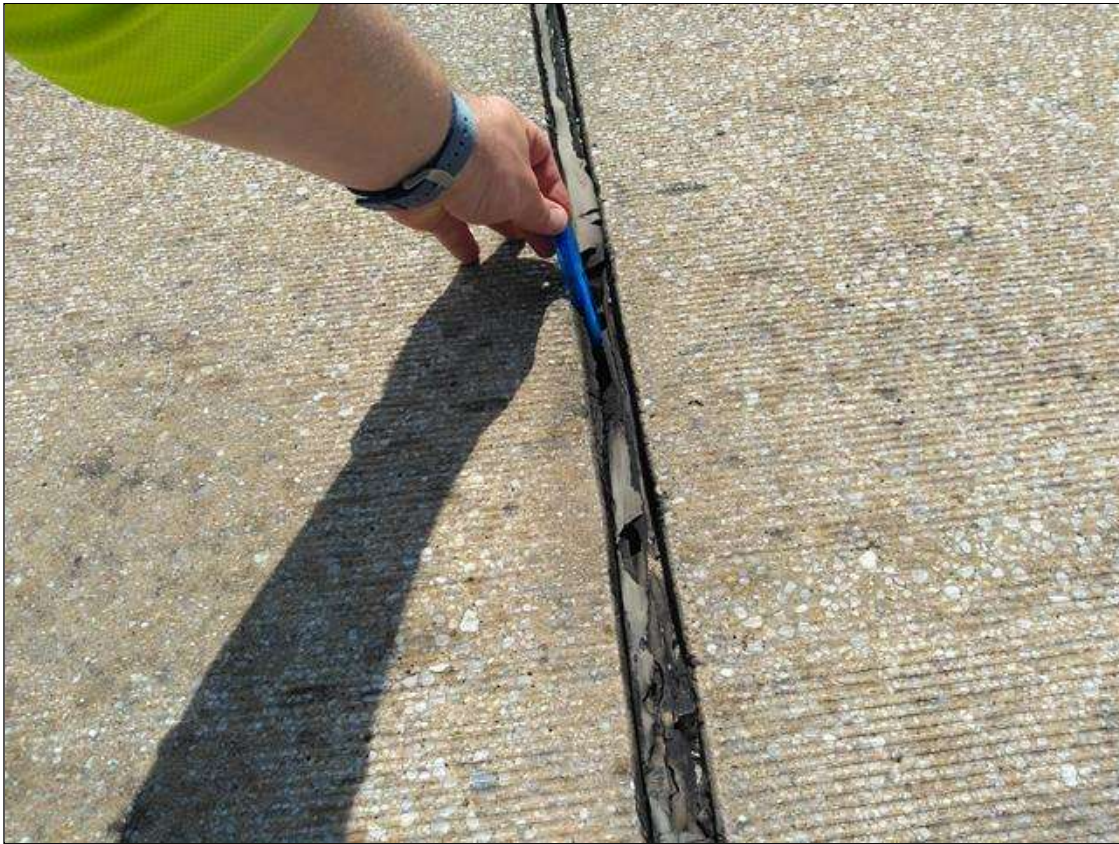
Span 170 Expansion Joint Bent 169: AT BENT 160, FULL WIDTH AND FULL DEPTH CRACKING, TORN, OR MISSING JOINT

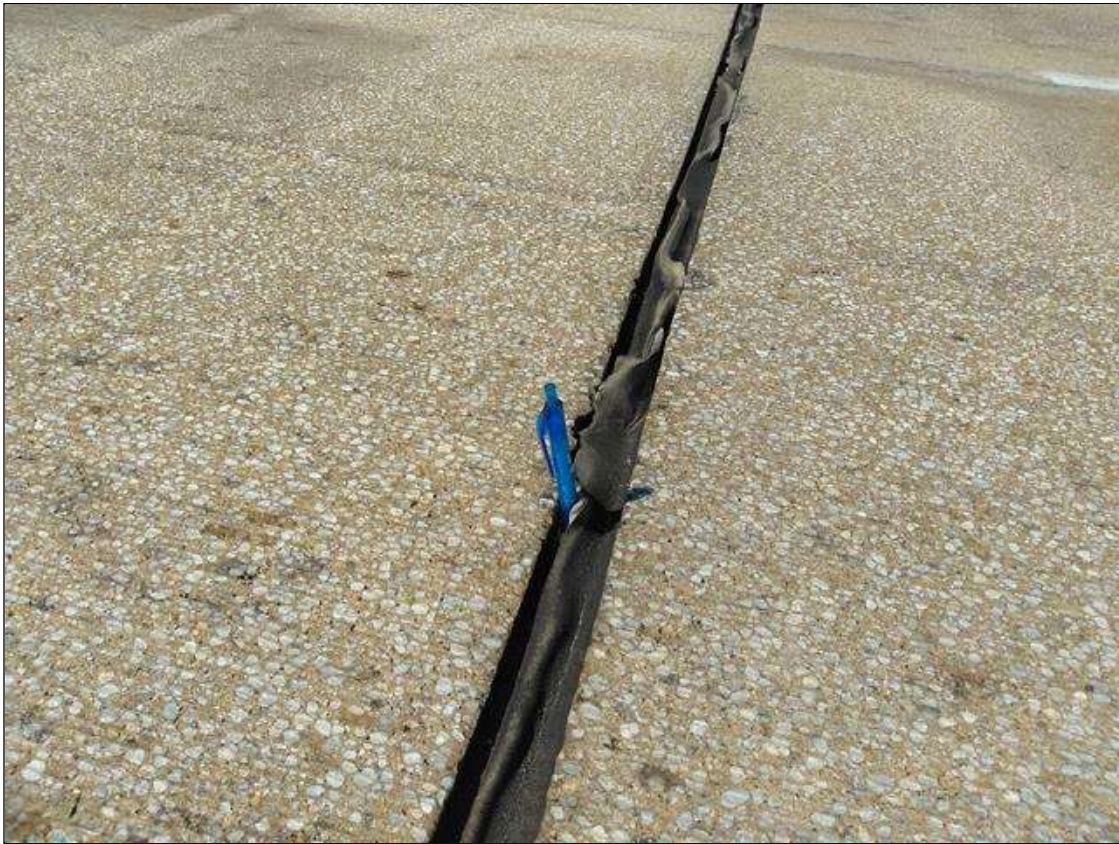
Span 192 Expansion Joint Bent 191: BENT 191, JOINT FULL WIDTH CRACKING AND TORN FULL DEPTH

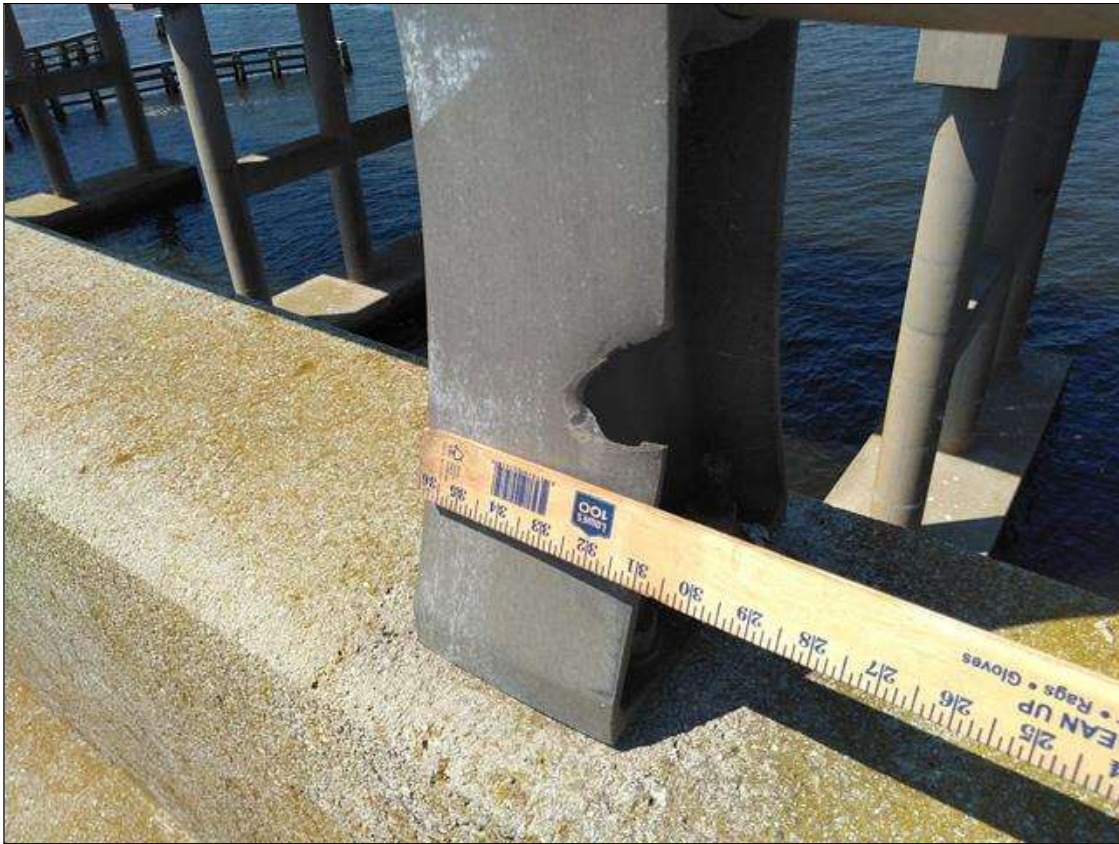
Span 183 Left Bridge Rail: RAILPOST 2, IMPACT DAMAGE (2 INCHES)

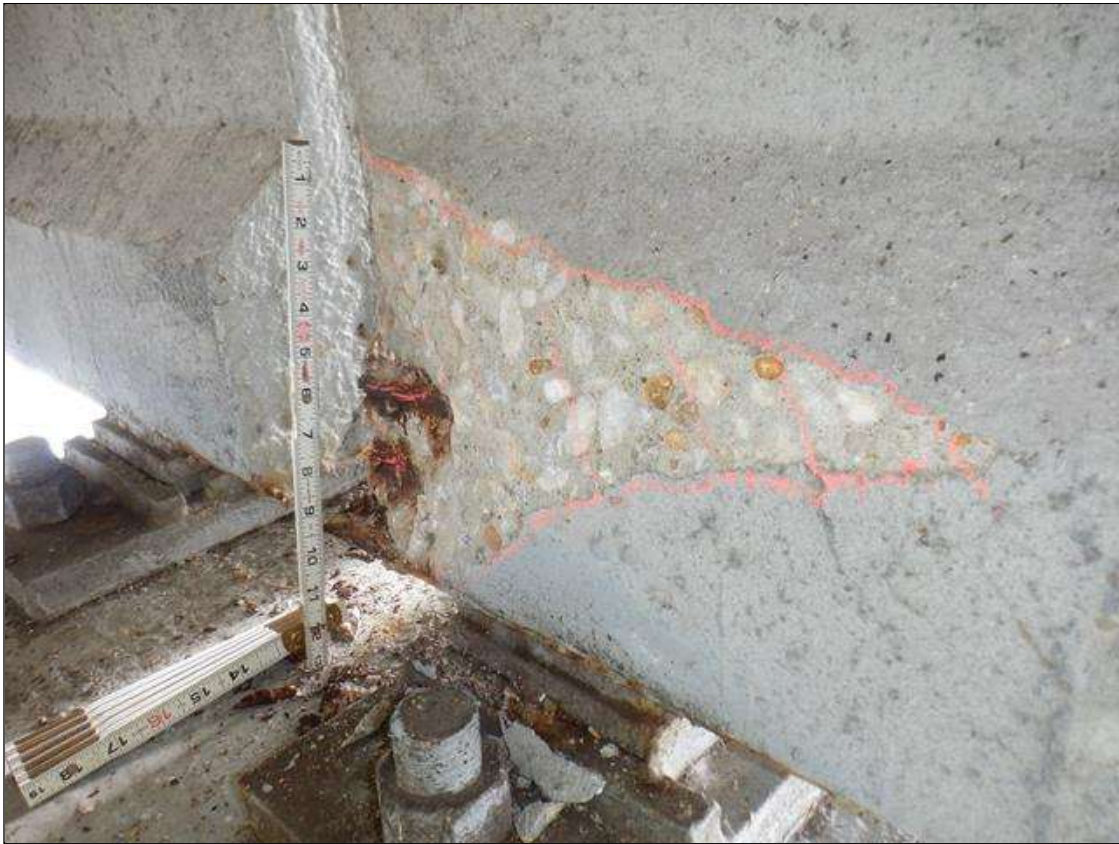
Priority Level	Defect Type	Quantity	Defect Description
2	Exposed Prestressing	2	Span 38 Beam 4: (PAR) BOTTOM FLANGE NORTH FACE AT BENT 38, SPALL (16 INCHES LONG X 8 INCHES HIGH X UP TO 3 INCHES DEEP) WITH TWO (2) EXPOSED RUSTED STRANDS (5% SECTION LOSS)

Span 38 Beam 4: (PAR) BOTTOM FLANGE NORTH FACE AT BENT 38, SPALL (16 INCHES LONG X 8 INCHES HIGH X UP TO 3 INCHES DEEP) WITH TWO (2) EXPOSED RUSTED STRANDS (5 PERCENT SECTION LOSS)

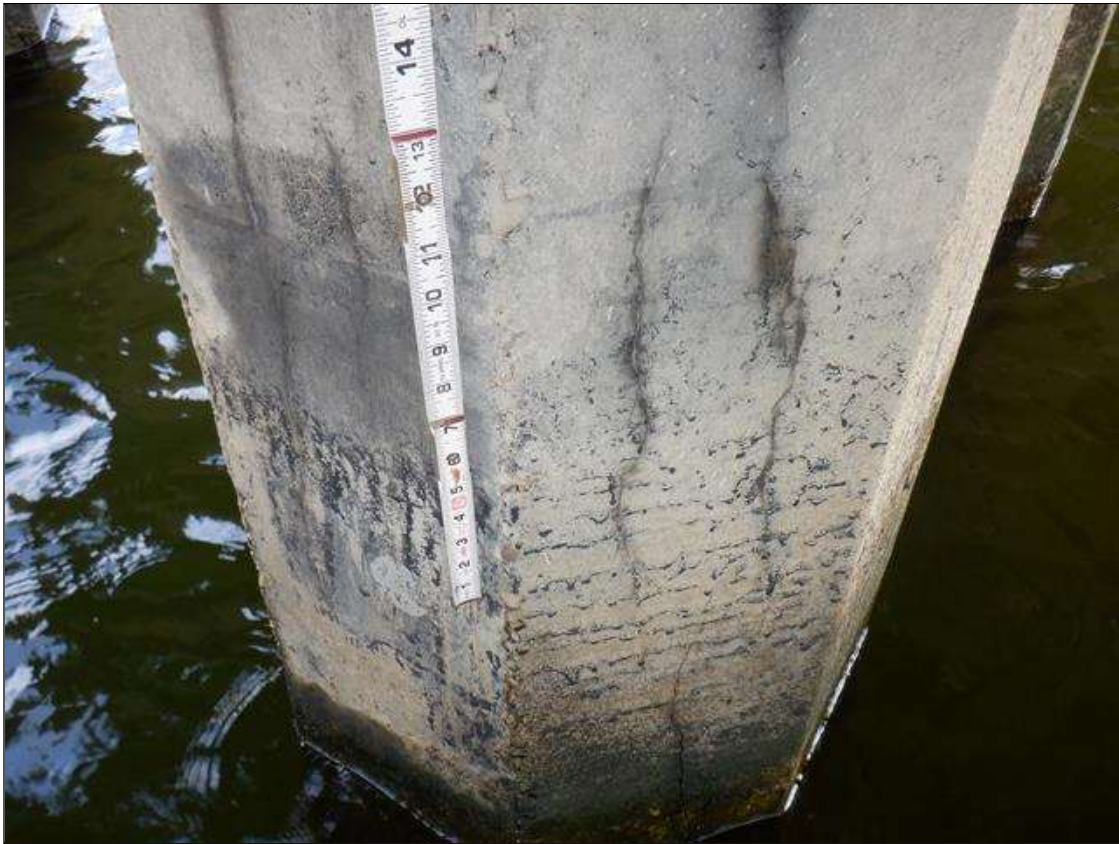
Bent 4 Pile 2: SCATTERED AROUND MULTIPLE FACES, VERTICAL CRACK (UP TO 4FEET X 1/32 INCHES)

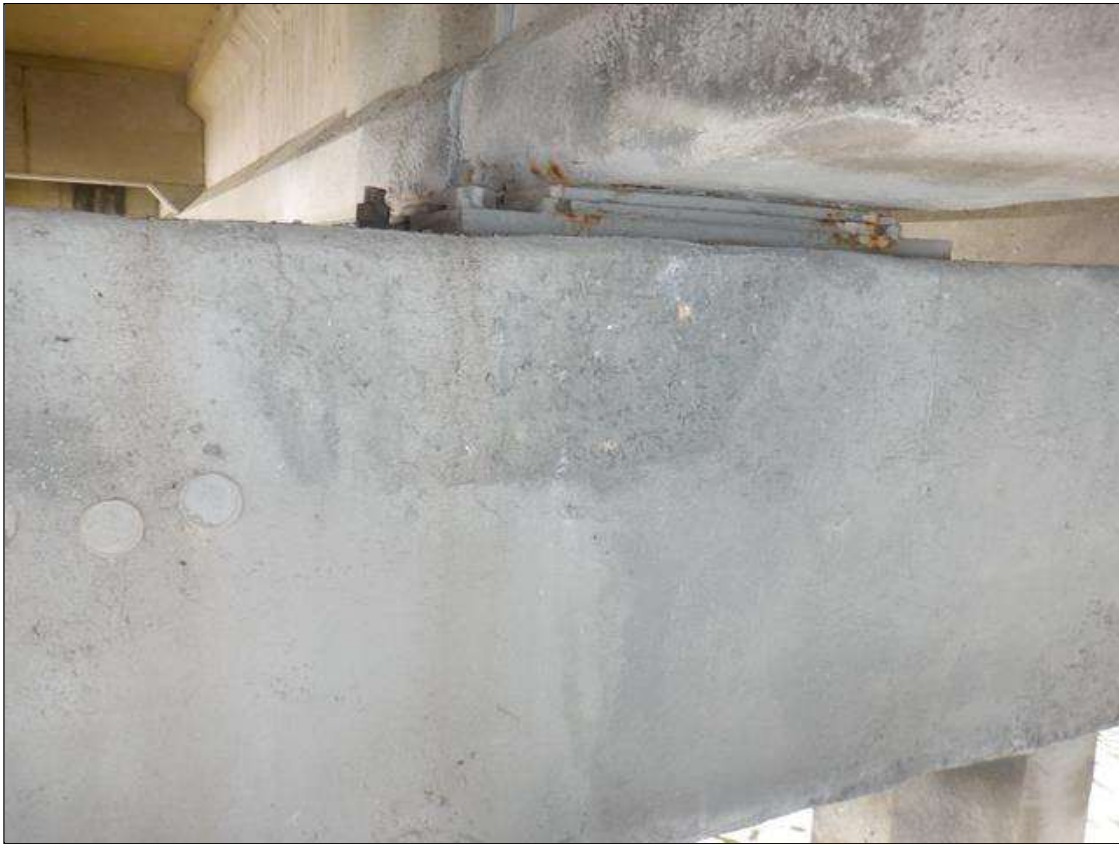
Bent 14 Cap 1: 6 INCHES X 6 INCHES DELAMINATION INCHES TOP EAST FACE CAP NEAR BEAM 2 , DID NOT FIND 9/12/22

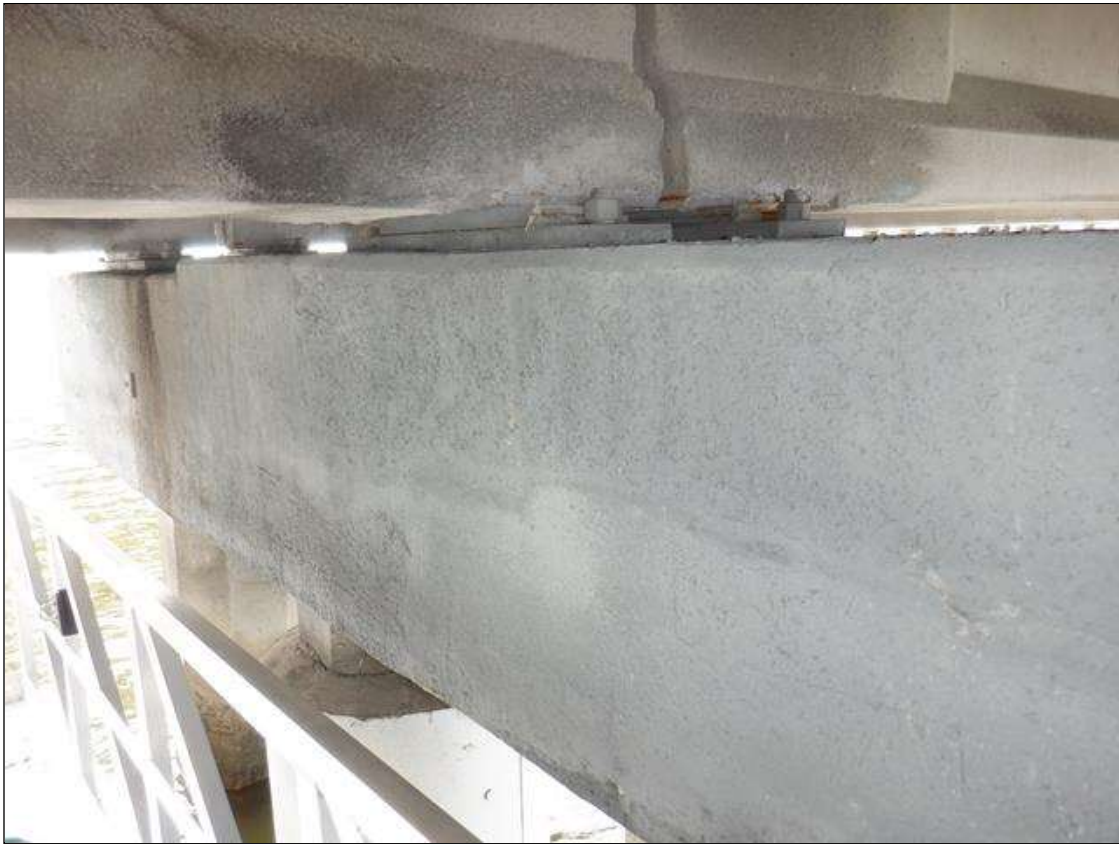
Bent 15 Cap 1: 5 FEET LONG X 1 FEET HIGH DELAMINATION ON TOP CAP STARTING AT BEAM 2

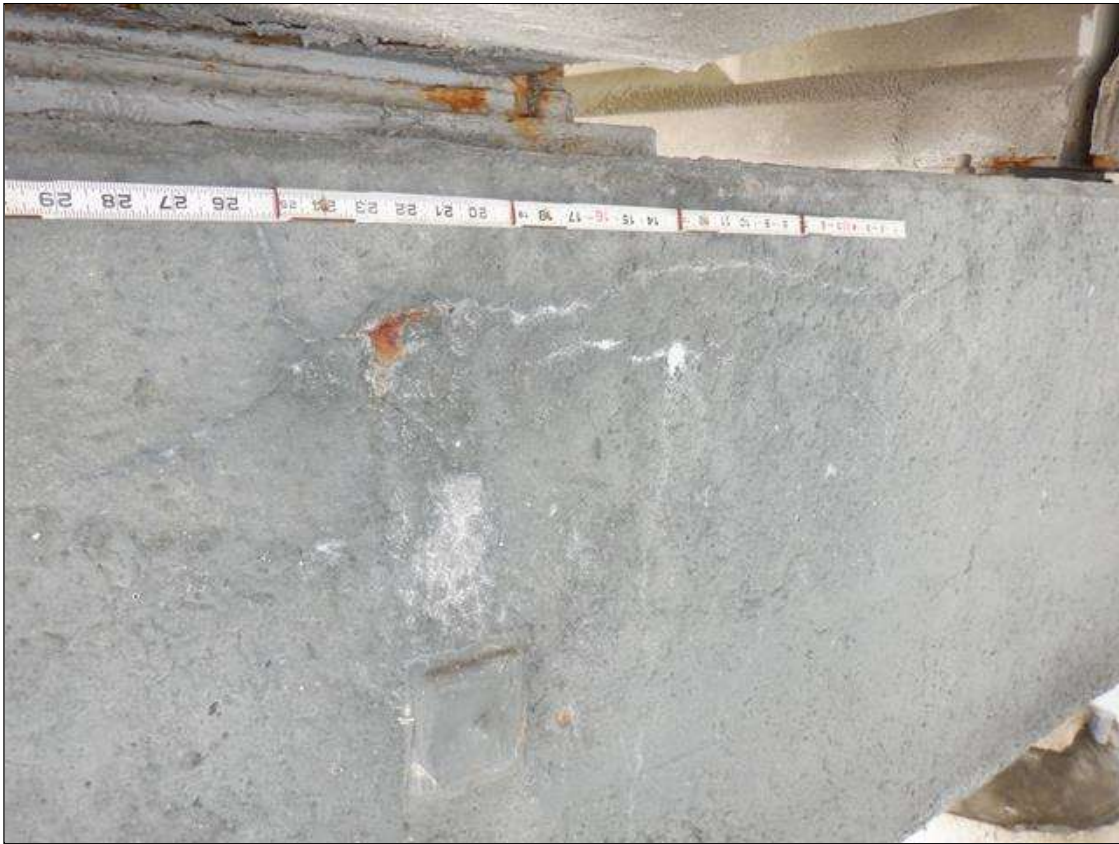
Bent 17 Cap 1: ALL FACES, SCATTERED PATCHED AREAS WITH MAP CRACKING (UP TO 1/32 INCHES), SOME WITH EFFLORESCENCE AND RUST STAIN

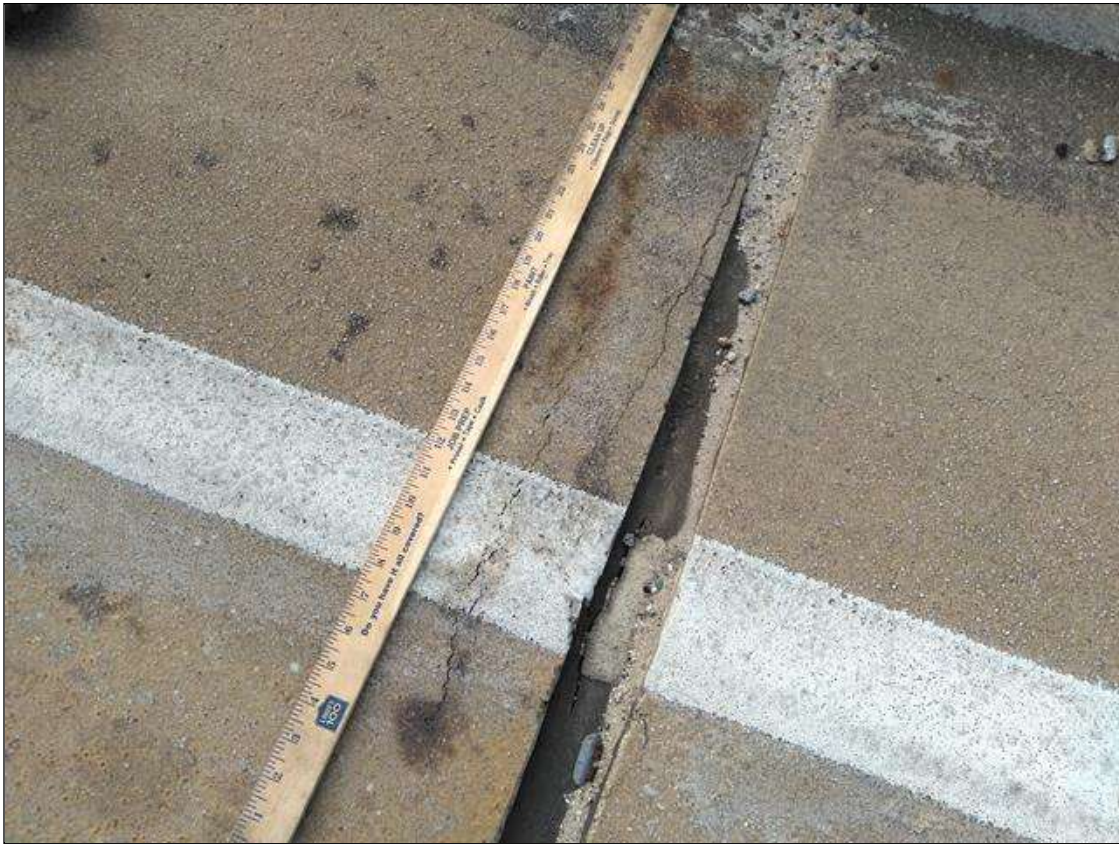
Span 202 Expansion Joint Bent 201: AT BENT 201, FULL DEPTH CRACKS AT BOTH SHOULDERS AND CENTERLINE

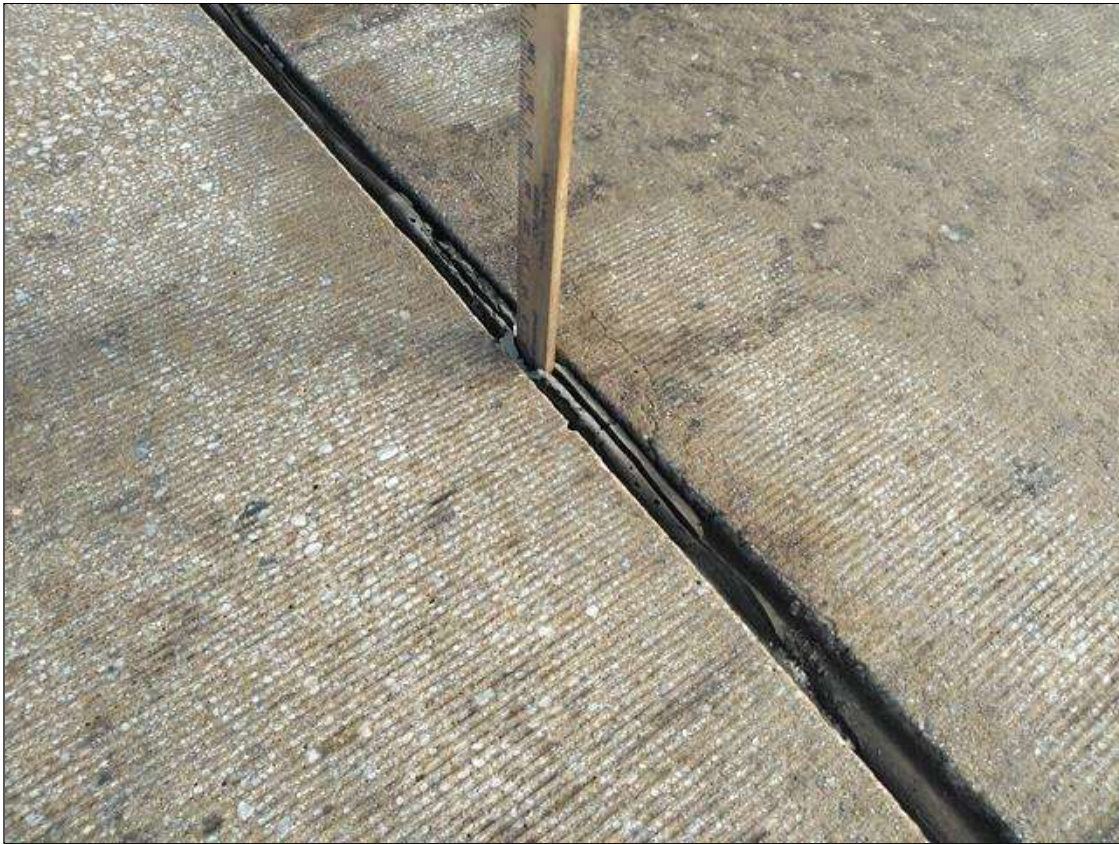
Span 205 Expansion Joint Bent 204: THROUGHOUT BOTH LANES, SEAL DAMAGED AND TORN FULL WIDTH X FULL DEPTH

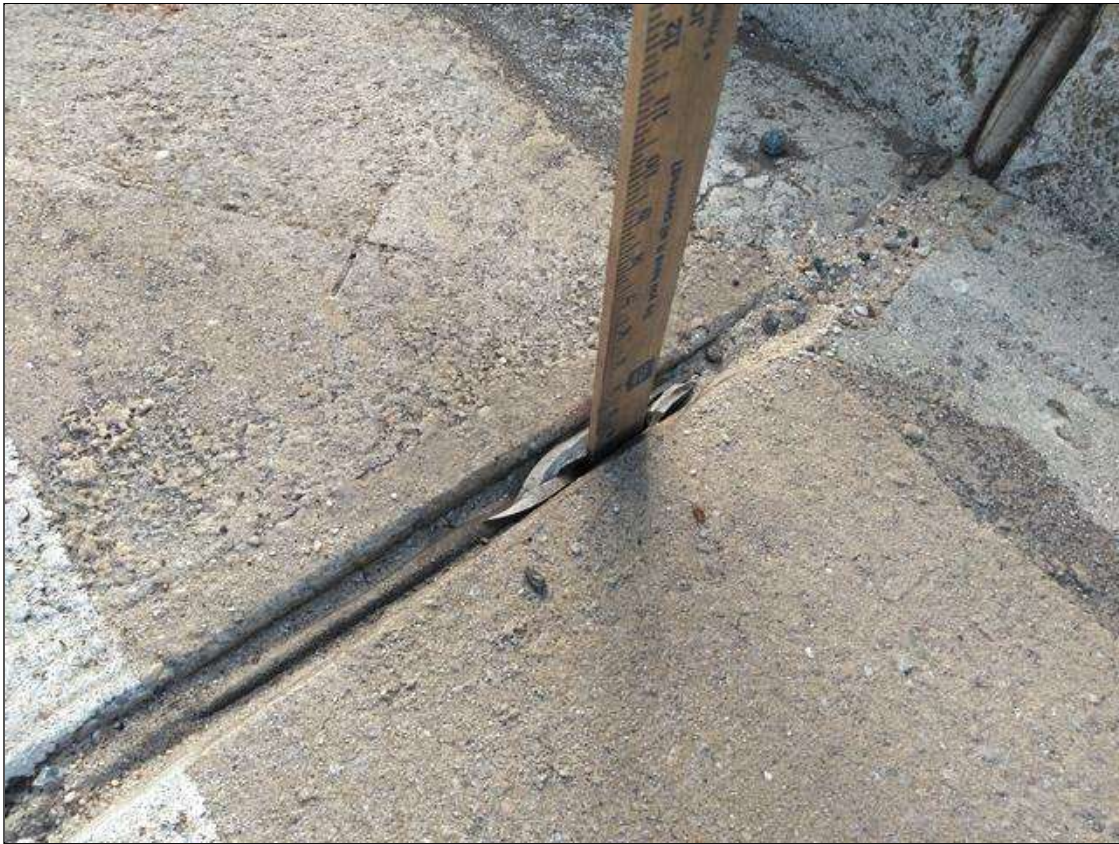
Span 208 Expansion Joint Bent 207: AT BENT 207, PARTIAL DEPTH CRACKING IN SHOULDERS AND CENTERLINE

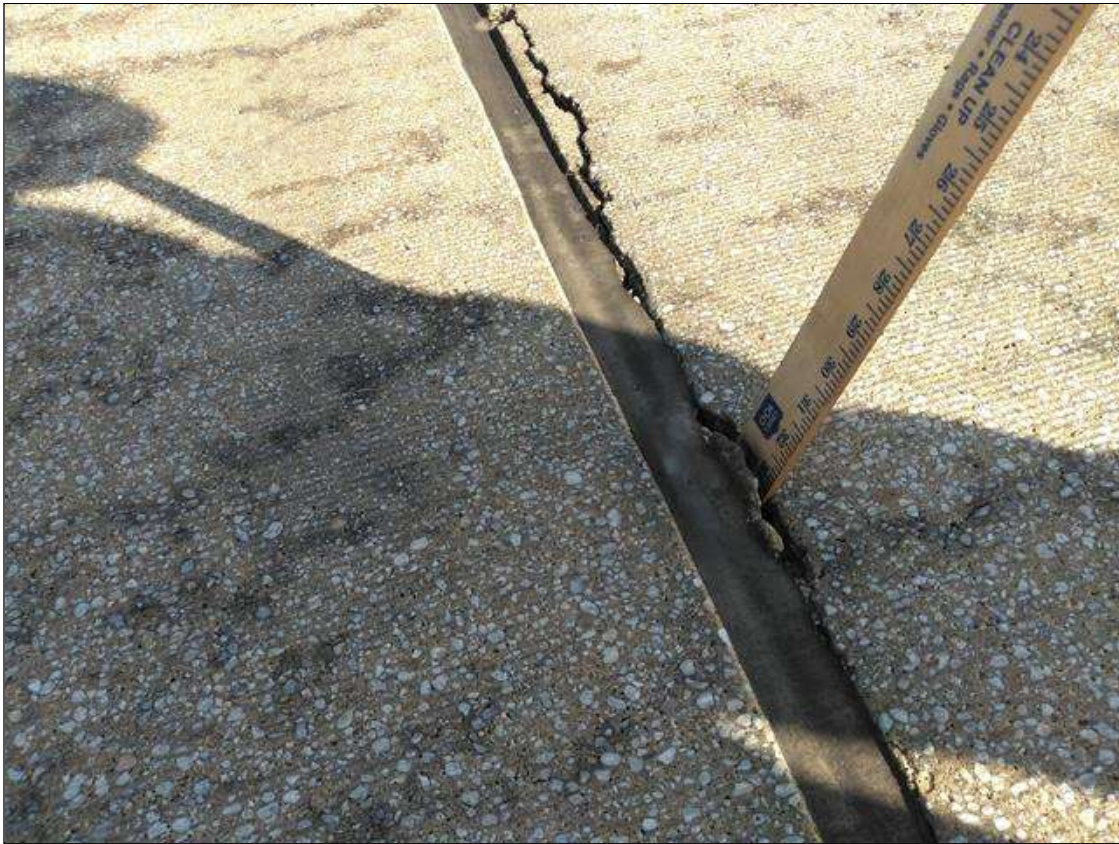
Span 213 Expansion Joint Bent 212: AT BENT 212, EDGD SPALLING IN RIGHT LANE ALONG JOINT, UP TO 7 FEET X 4 INCHES X PARTIAL DEPTH)
