NC DEPARTMENT OF TRANSPORTATION  
DIVISION OF HIGHWAYS  
STRUCTURE MANAGEMENT UNIT

## Structure Safety Report

### Routine Element Inspection - Contract

STRUCTURE NUMBER: 260016 SAP STRUCTURE NO: 0270016 FHWA STRUCTURE NO: 000000000530016  
DIVISION: 1 COUNTY: CURRITUCK INSPECTION DATE: 09/21/2022 FREQUENCY: 24 MONTHS  
FACILITY CARRIED: US158E MILE POST: \_\_\_\_\_  
LOCATION: .01 MI.E.JCT.SR1187  
FEATURE INTERSECTED: CURRITUCK SOUND  
LATITUDE: 36° 5' 11.69" LONGITUDE: 75° 46' 0.21"  
SUPERSTRUCTURE: RC FLOOR ON PPC GIRDERS & CORED SLAB  
SUBSTRUCTURE: EBTS:RC CAP/PPC PILES;IBTS:RCP&B & RC CAPS/PPC PILES  
SPANS: 248 SPANS. SEE SPAN PROFILE SHEET FOR SPAN DETAILS  
☐ FRACTURE CRITICAL ☐ TEMPORARY SHORING ☐ SCOUR CRITICAL ☐ SCOUR PLAN OF ACTION  
GRADES: (Inspector/NBI Coding) DECK 6 / 6 SUPERSTRUCTURE 5 / 5 SUBSTRUCTURE 6 / 6 CULVERT N / N  
POSTED SV: Not Posted POSTED TTST: Not Posted  
OTHER SIGNS PRESENT: None

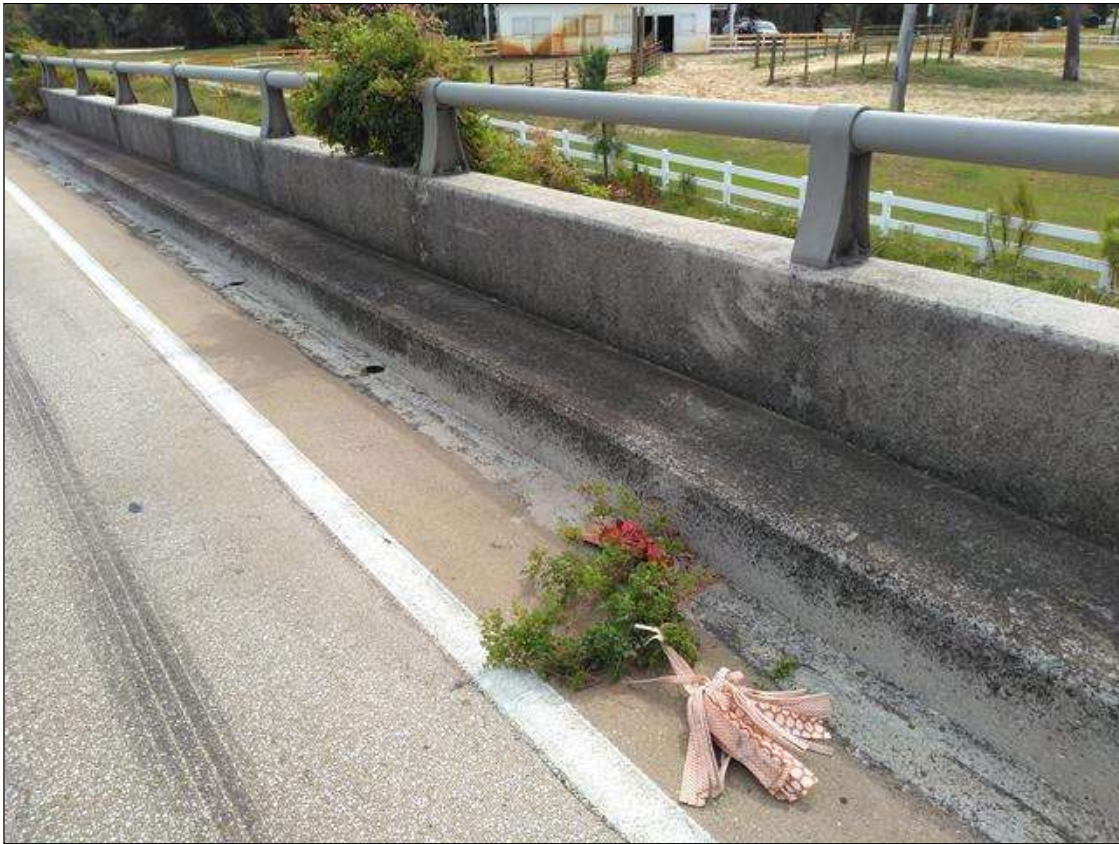
SPAN 247, RIGHT SHOULDER , 3RD SCUPPER CLOGGED BY VEGETATION AND OVERGROWTH OVER BARRIER THROUGHOUT

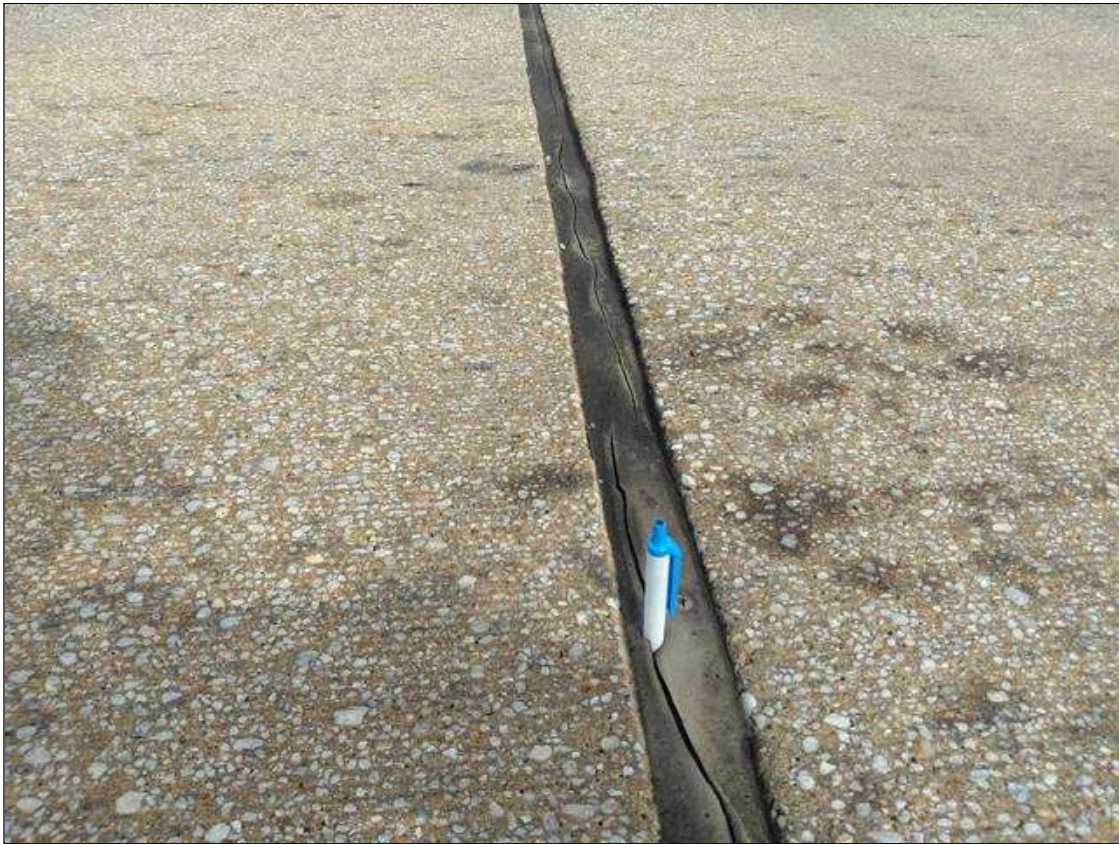
Span 237 Expansion Joint Bent 236: AT BENT 236, FULL DEPTH X FULL WIDTH CRACK

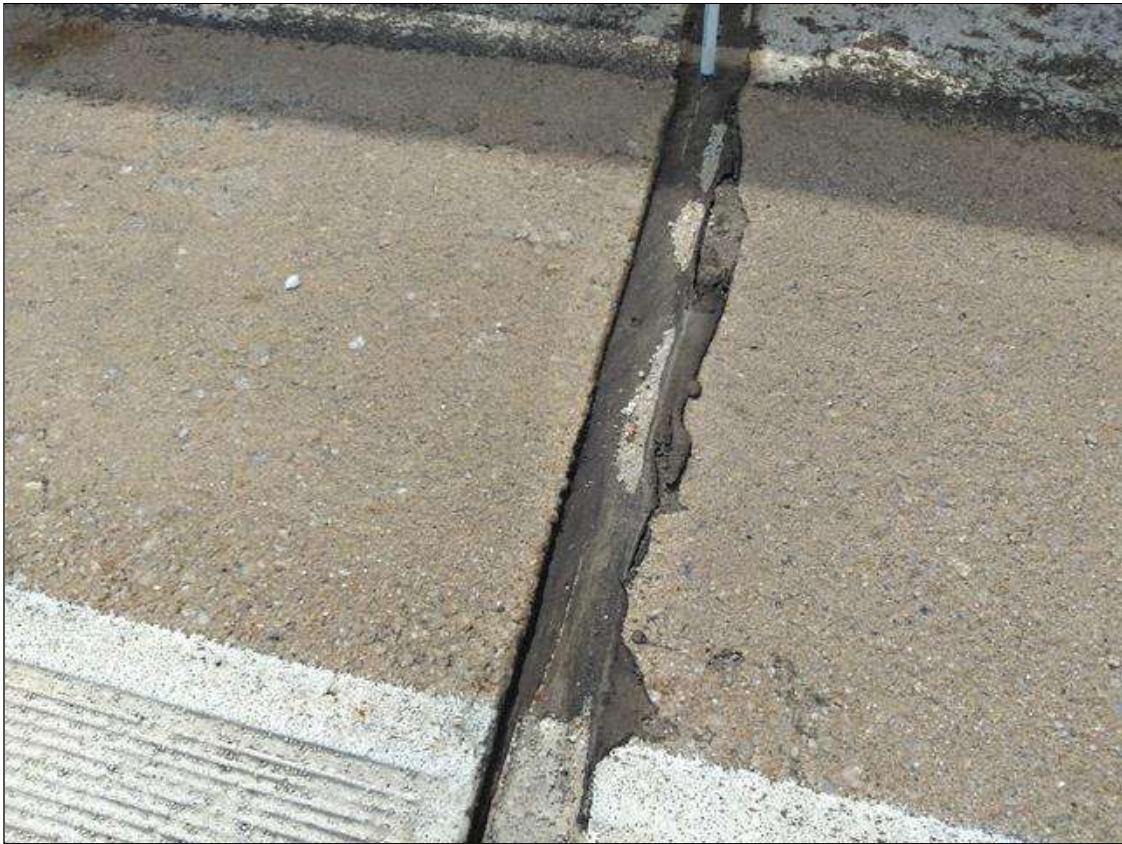
Span 241 Expansion Joint Bent 240: AT BENT 240, PARTIAL DEPTCH CRACKS IN BOTH SHOULDERS AND AT CENTER

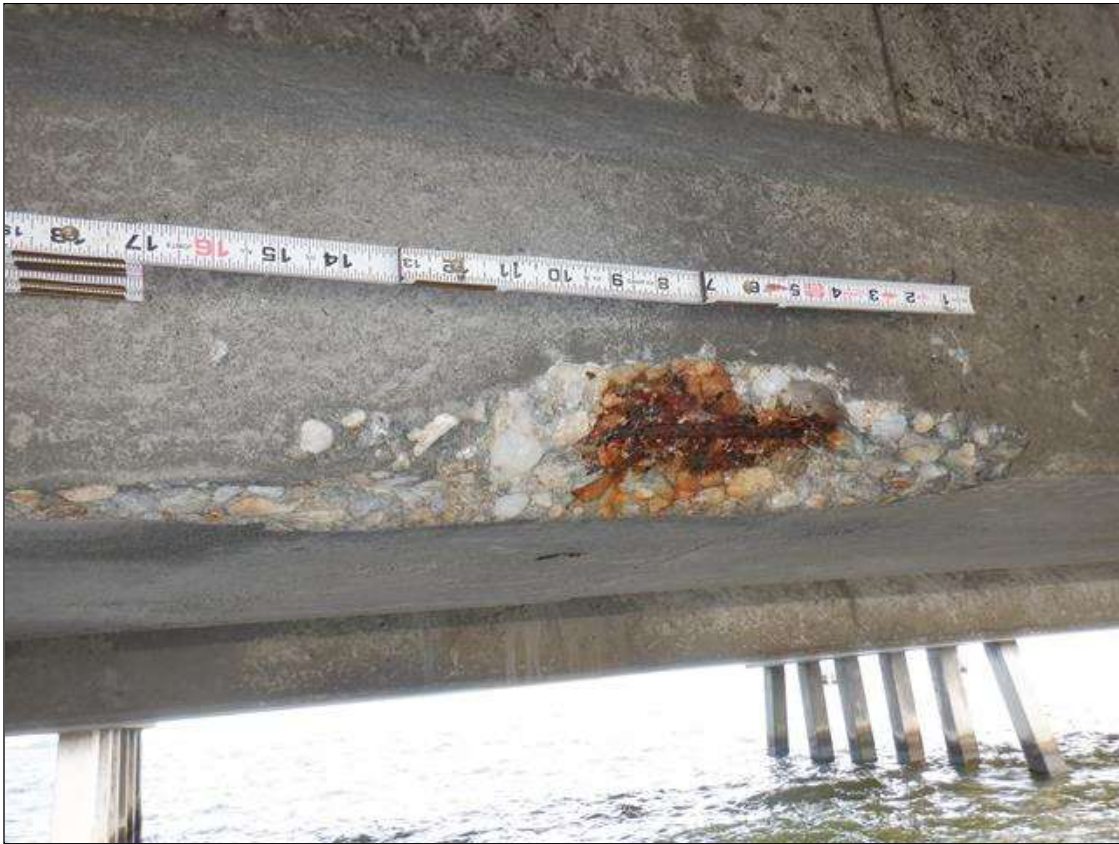
Priority Level	Defect Type	Quantity	Defect Description
2	Exposed Prestressing	2	Span 51 Beam 2: (PAR) SOUTH FACE OF BOTTOM FLANGE, AT 10FEET FROM BENT 50, SPALL (20INCHES X 5INCHES X 2INCHES) WITH EXPOSED RUSTED STRAND (10% SECTION LOSS)

Span 51 Beam 2: (PAR) SOUTH FACE OF BOTTOM FLANGE, AT 10 FEET FROM BENT 50, SPALL (20 INCHES X 5 INCHES X 2 INCHES) WITH EXPOSED RUSTED STRAND (10 PERCENT SECTION LOSS)

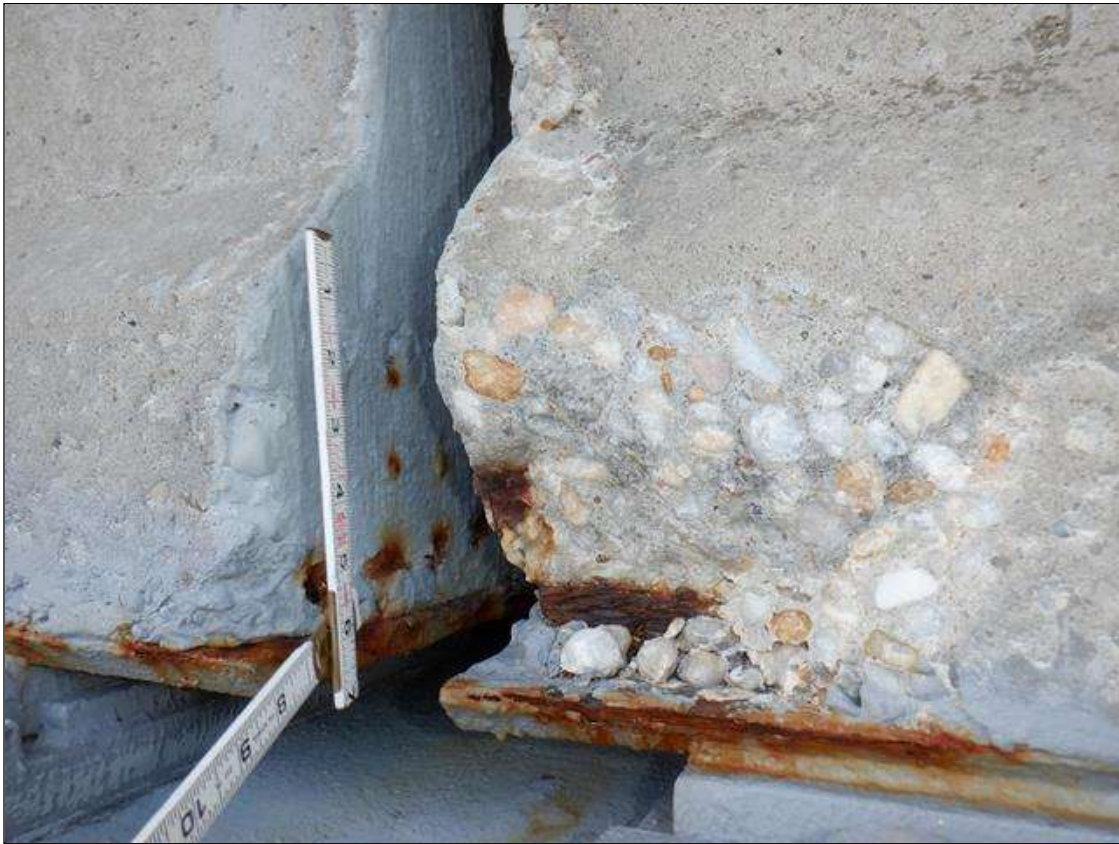
Priority Level	Defect Type	Quantity	Defect Description
2	Exposed Prestressing	1	Span 52 Beam 1: (PAR) NORTH FACE OF BOTTOM FLANGE AT BENT 52, SPALL (6INCHES X 5INCHES X UP TO 2 1/2INCH) WITH (2) EXPOSED RUSTED STRANDS (10% SECTION LOSS)

Span 52 Beam 1: (PAR) NORTH FACE OF BOTTOM FLANGE AT BENT 52, SPALL (6INCHES X 5INCHES X UP TO : 1/2INCH) WITH (2) EXPOSED RUSTED STRANDS (10 PERCENT SECTION LOSS)

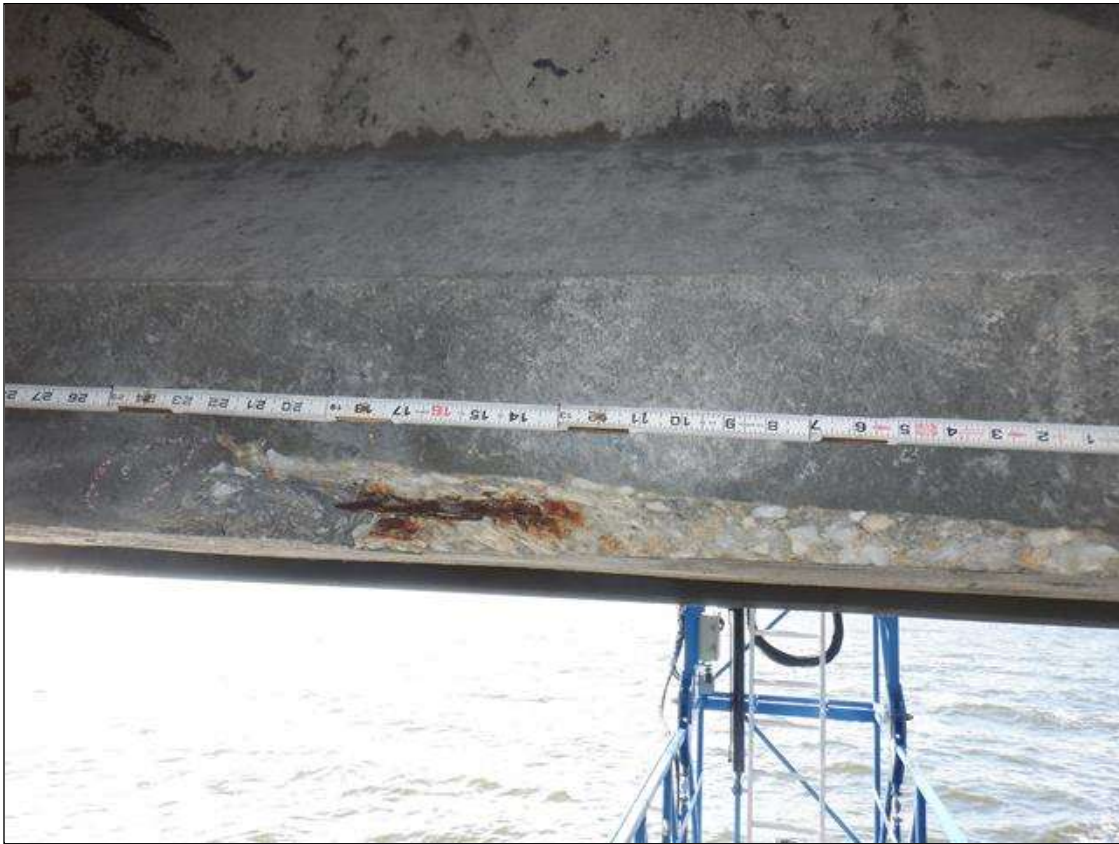
Span 54 Beam 3: (PAR) NORTH FACE OF BOTTOM FLANGE AT 15FEET FROM BENT 53, SPALL (UP TO 21 INCHES X 7 INCHES X 2 INCHES) WITH EXPOSED RUSTED STRAND, ADJACENT DELAMINATION (8INCHES DIAMETER) AND SECTION LOSS (10 PERCENT) ON STRAND

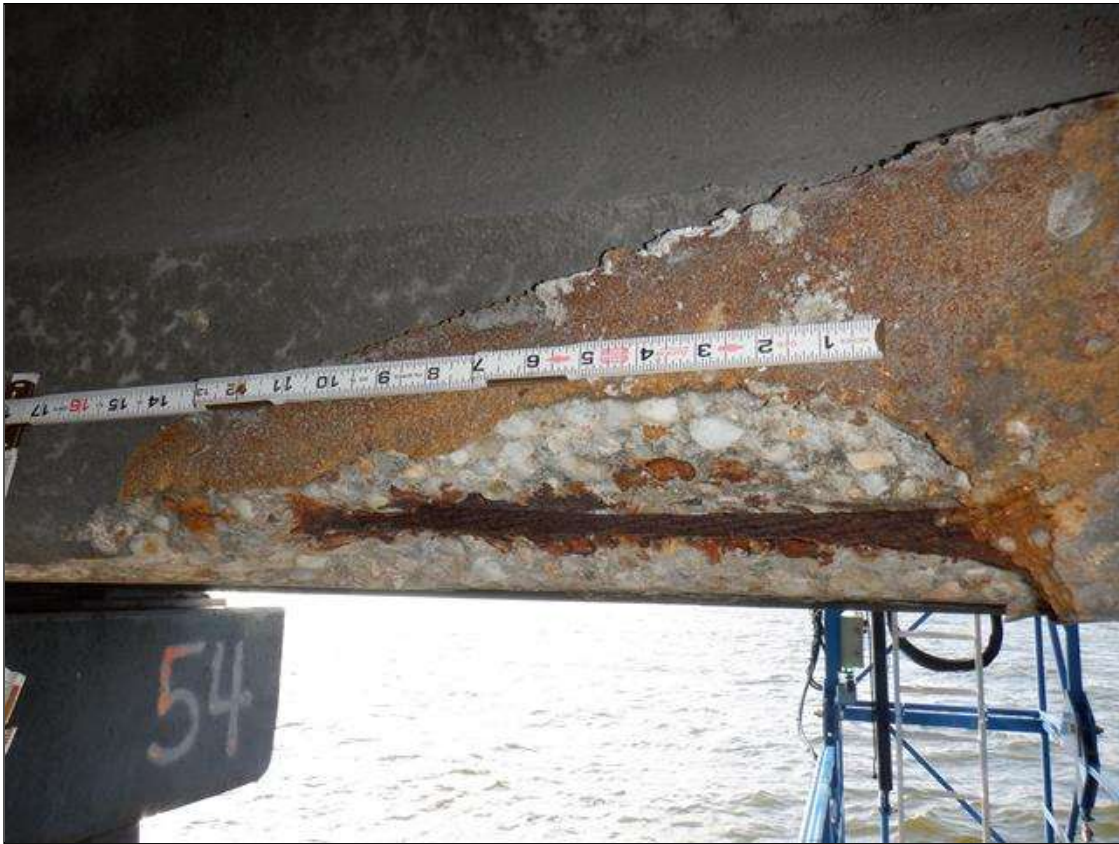
Span 54 Beam 3: (PAR) NORTH FACE OF BOTTOM FLANGE AT 9 FEET FROM BENT 54, SPALL (2 FEET X 9 INCHES X UP TO 3 INCHES) WITH (2) EXPOSED RUSTED STRANDS, SECTION LOSS (20 PERCENT)

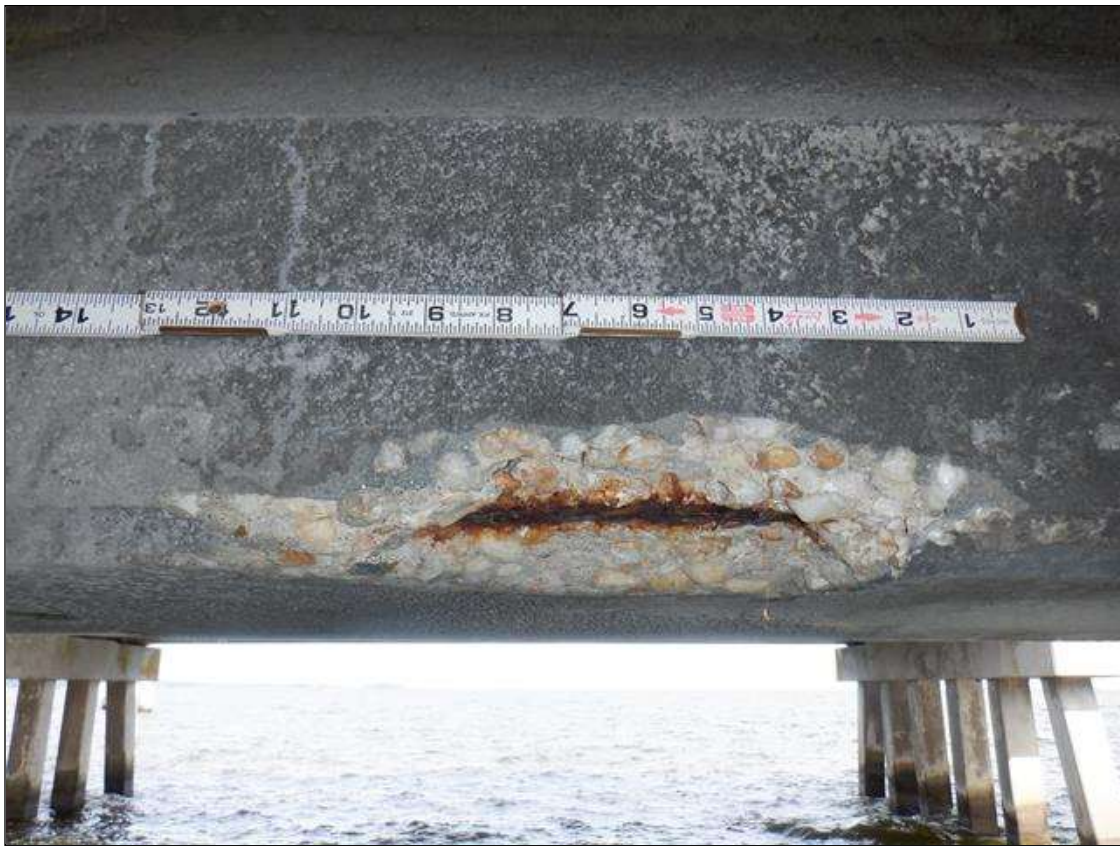
Priority Level	Defect Type	Quantity	Defect Description
<b>2</b>	Exposed Prestressing	1	Span 58 Beam 1: (PAR) SOUTH FACE OF BOTTOM FLANGE, AT 22FEET FROM BENT 58, FAILED PATCH/SPALL(12 INCHES X 5 INCHES X 2 INCHES) WITH EXPOSED RUSTED STRAND, SECTION LOSS (10 PERCENT)

Span 58 Beam 1: (PAR) SOUTH FACE OF BOTTOM FLANGE, AT 22 FEET FROM BENT 58, FAILED PATCH/SPALL (12 INCHES X 5 INCHES X 2 INCHES) WITH EXPOSED RUSTED STRAND, SECTION LOSS (10 PERCENT)

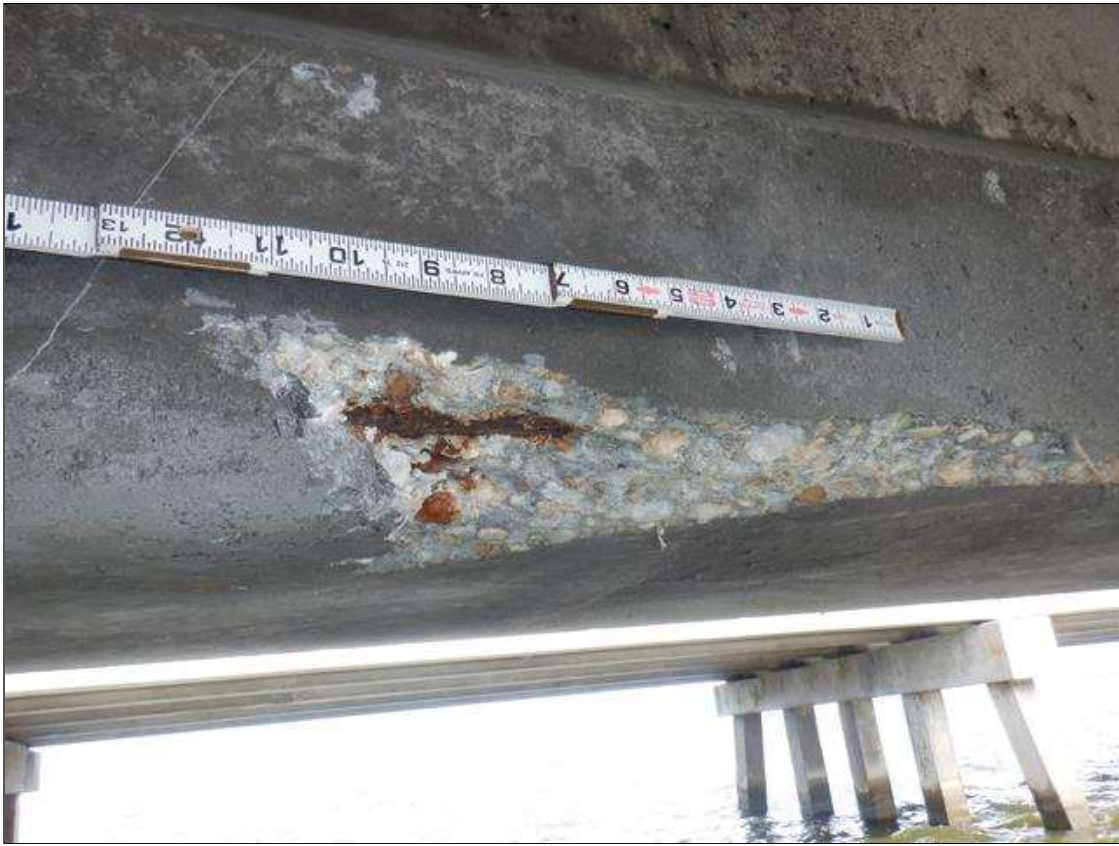
**2** Exposed Prestressing 3 Span 59 Beam 1: (PAR) SOUTH FACE OF BOTTOM FLANGE AT 12FEET FROM BENT 58, UNSOUND PATCHED AREA (30 INCHES X 12 INCHES) WITH SPALL (18 INCHES LONG X 7 INCHES HIGH X 2 INCHES DEEP) WITH EXPOSED RUSTED STRANDS (20 % SECTION LOSS)

Span 59 Beam 1: (PAR) SOUTH FACE OF BOTTOM FLANGE AT 12 FEET FROM BENT 58, UNSOUND PATCHED AREA (30 INCHES X 12 INCHES) WITH SPALL (18 INCHES LONG X 7 INCHES HIGH X 2 INCHES DEEP) WITH EXPOSED RUSTED STRANDS (20 PERCENT SECTION LOSS)

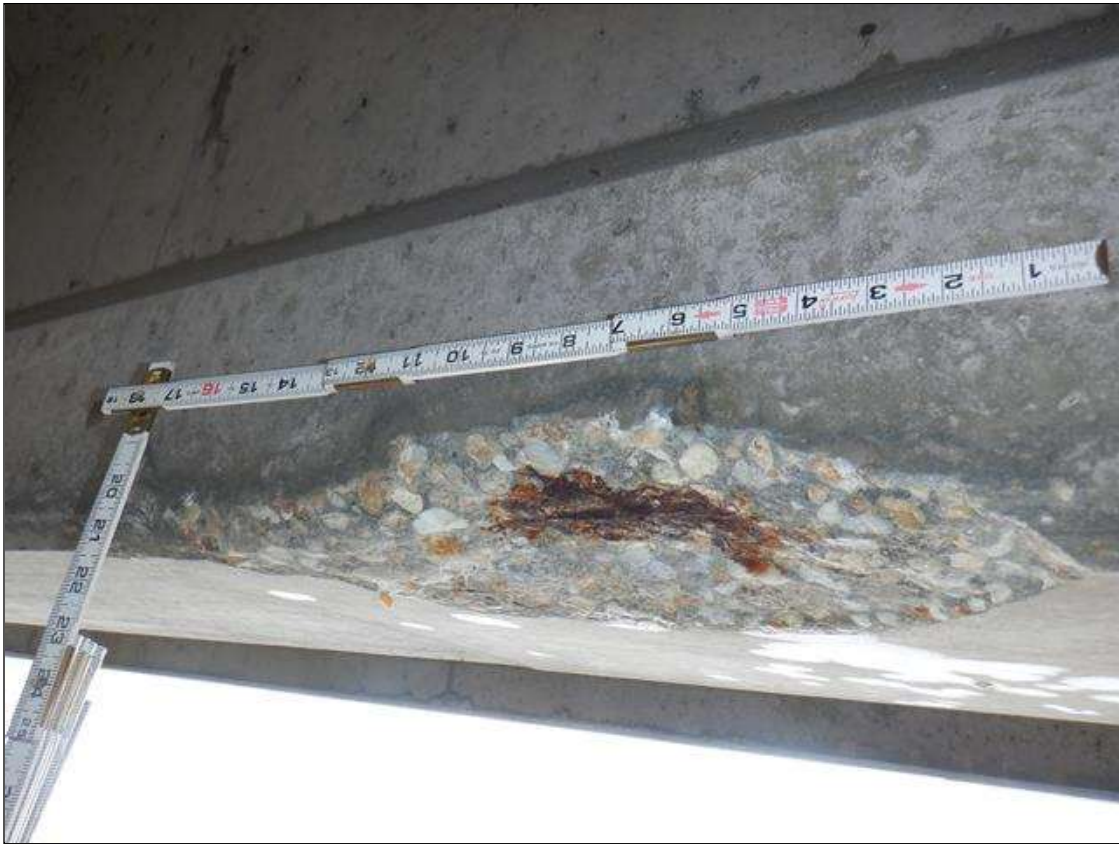
Priority Level	Defect Type	Quantity	Defect Description
<b>2</b>	Exposed Prestressing	2	Span 59 Beam 3: (PAR) BOTTOM FLANGE NORTH FACE AT 12 FEET FROM BENT 58, SPALL (18 INCHES LONG X 7 INCHES WIDE X UP TO 2 INCHES DEEP) WITH EXPOSED RUSTED STRANDS (30% SECTION LOSS)

Span 59 Beam 3: (PAR) BOTTOM FLANGE NORTH FACE AT 12 FEET FROM BENT 58, SPALL (18 INCHES LONG X 7 INCHES WIDE X UP TO 2 INCHES DEEP) WITH EXPOSED RUSTED STRANDS (30 PERCENT SECTION LOSS)

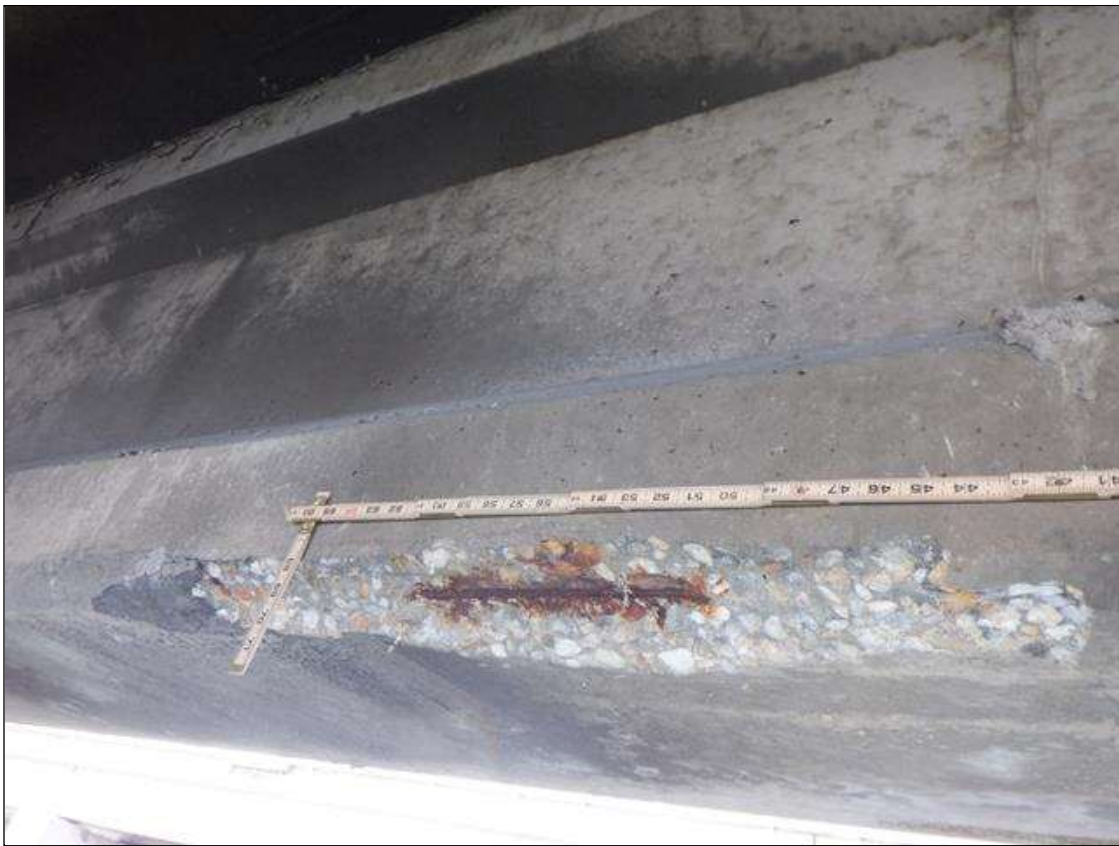
Span 112 Beam 1: (PAR) SOUTH FACE OF BOTTOM FLANGE AT BENT 111, SPALL (36 INCHES LONG X 2 INCHES HIGH X 6 INCHES ON BOTTOM X 1 INCH DEEP) WITH (1) EXPOSED STRAND (10 PERCENT LOSS)

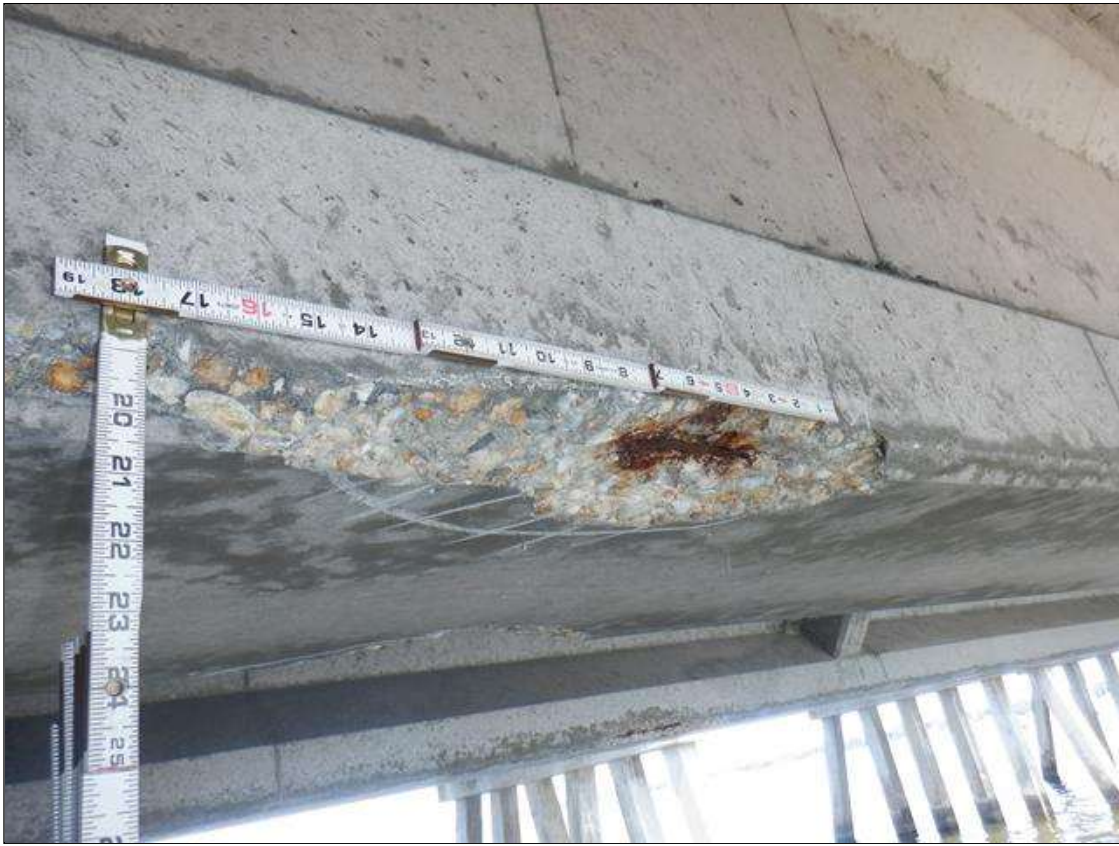
Span 163 Beam 2: (PAR) BOTTOM FLANGE, SOUTH AND BOTTOM FACES, 7 FEET FROM BENT 162, SPALL (24 INCHES X 6 INCHES X 1 INCH DEEP) WITH EXPOSED RUSTED STRANDS (10 PERCENT SECTION LOSS)

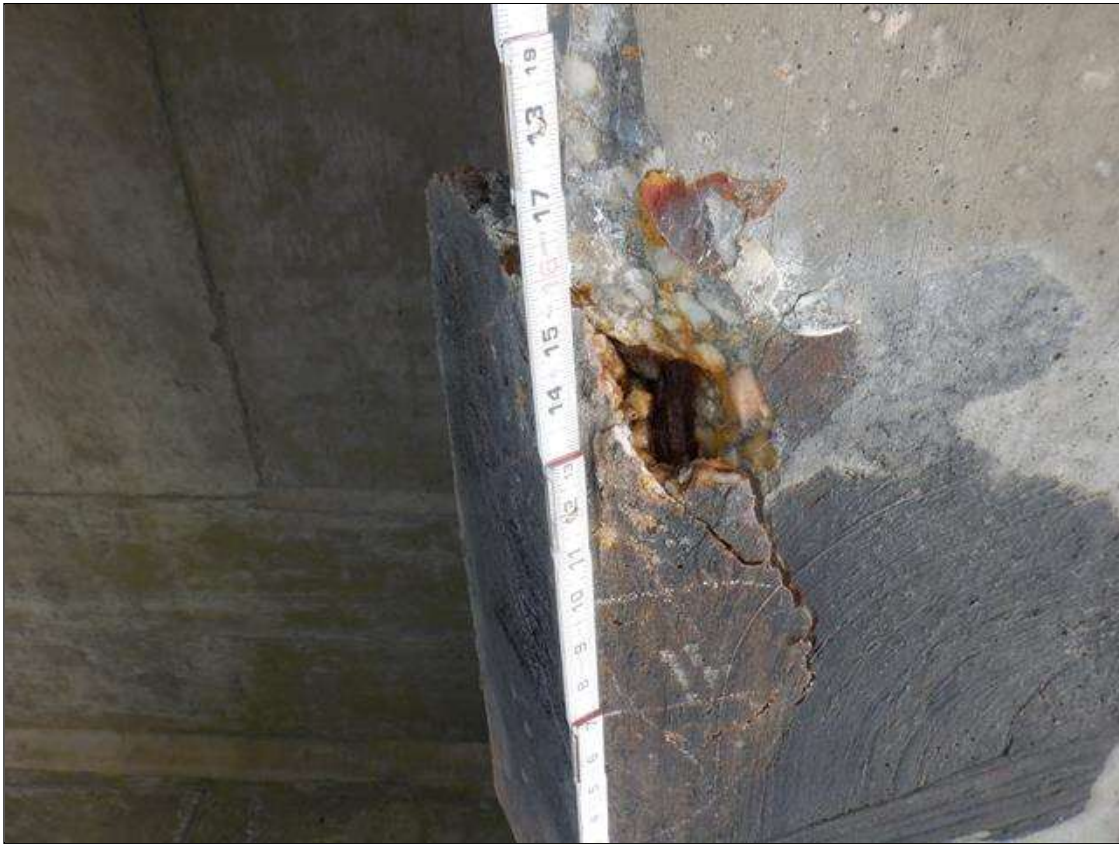
Span 203 Beam 3: (PAR) NORTH FACE OF BOTTOM FLANGE AT 13 FEET FROM BENT 202, FAILED PATCHED AREA (21 INCHES X 7 INCHES) WITH SPALL (4 INCHES X 3 INCHES X 1.5 INCHES DEEP) WITH EXPOSED RUSTED STRANDS (10 PERCENT SECTION LOSS)

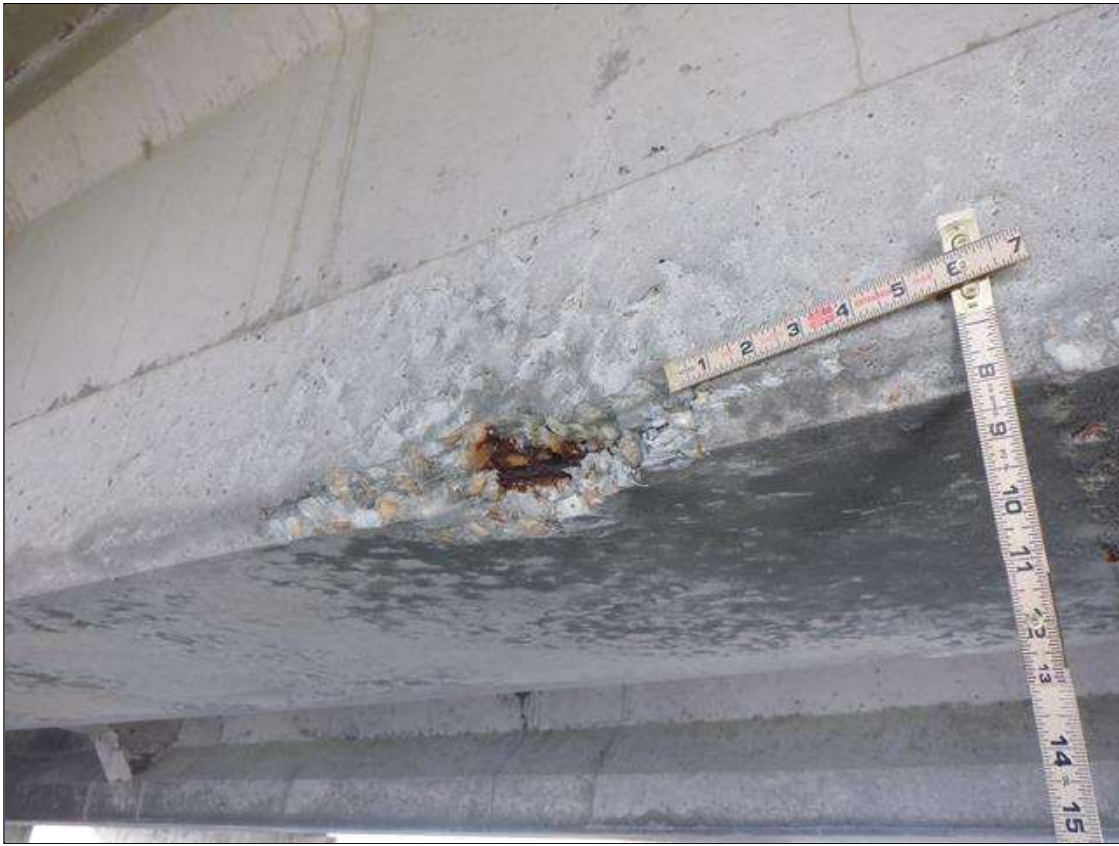
Span 121 Beam 2: (PAR) BOTTOM OF BOTTOM FLANGE AT MIDSPAN, SPALL/DELAMINATION (20 INCHES LONG X 3 INCHES HIGH X 5 INCHES WIDE X 1.5 INCHES DEEP) WITH (1) EXPOSED RUSTED STRAND (10 PERCENT SECTION LOSS)

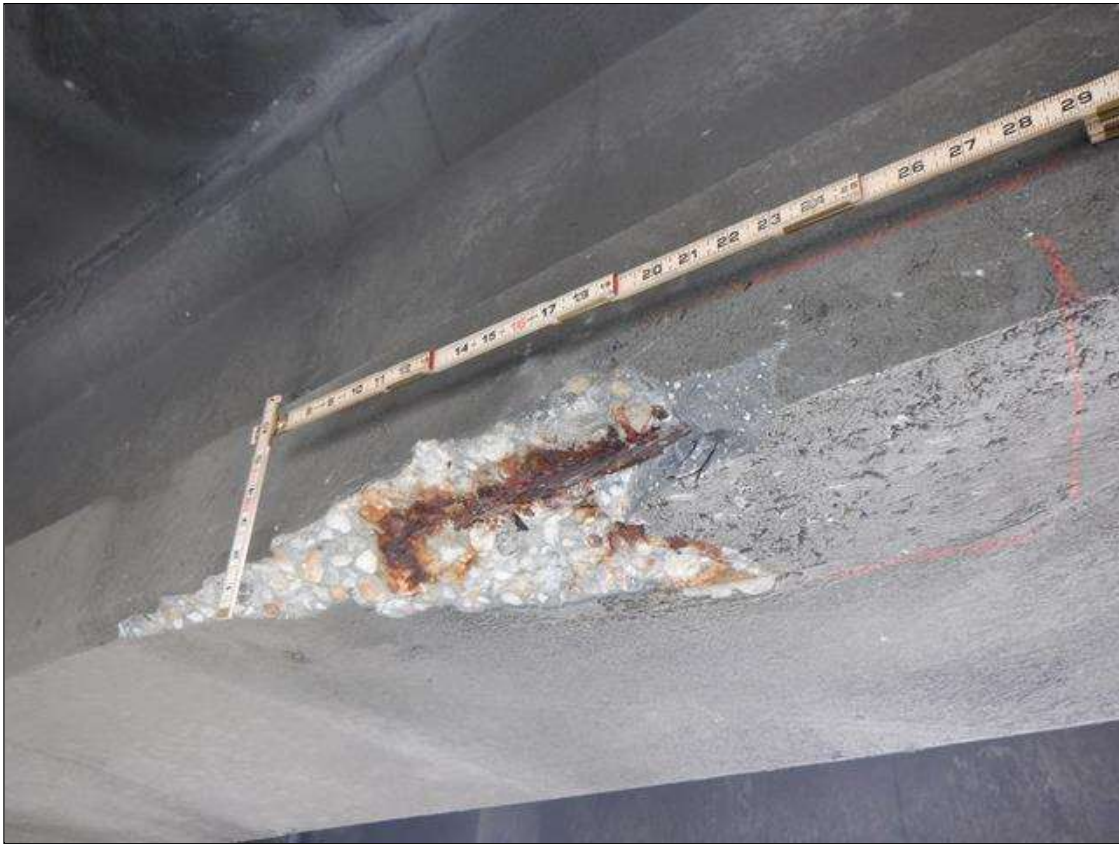
Span 124 Beam 2: (PAR) NORTH FACE OF BOTTOM FLANGE 10 FEET FROM BENT 124, UNSOUND PATCHED AREA (30 INCHES X 4 INCHES) WITH SPALL (16 INCHES X 5 INCHES X 2 INCHES X 1.5 INCHES DEEP) WITH (1) EXPOSED RUSTED STRAND (10 PERCENT SECTION LOSS)

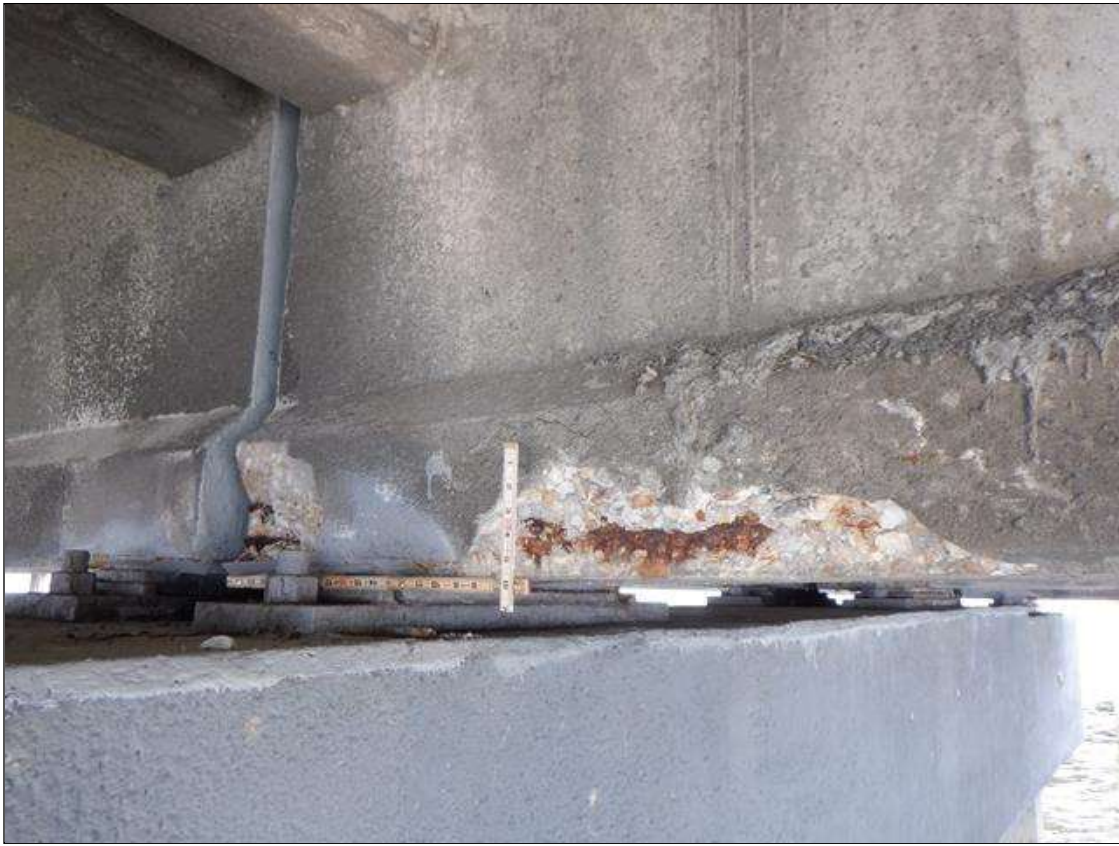
Span 127 Beam 3: (PAR) BOTTOM FLANGE SOUTH FACE AT BENT 126, (2) TWO SPALLS/DELAMINATIONS (UP TO 24 INCHES LONG X UP TO 8 INCHES HIGH X UP TO 2 INCHES DEEP) WITH (2) TWO EXPOSED RUSTED STRANDS (10 PERCENT SECTION LOSS)

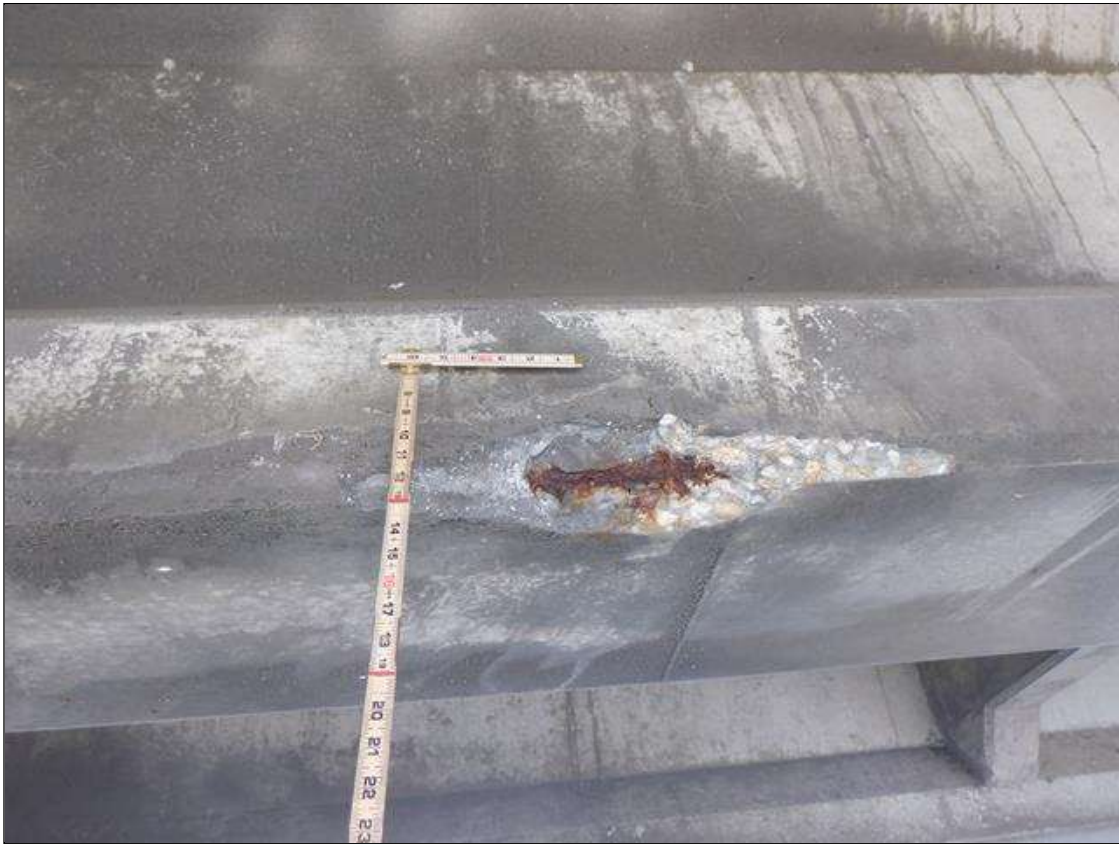
Span 130 Beam 3: (PAR) SOUTH FACE OF BOTTOM FLANGE AT 16 FEET FROM BENT 129, FAILED PATCH/SPALL (22 INCHES LONG X 3 INCHES HIGH X 4 INCHES WIDE X 1.5 INCHES DEEP) WITH (1) EXPOSED RUSTED STRAND (10 PERCENT SECTION LOSS)

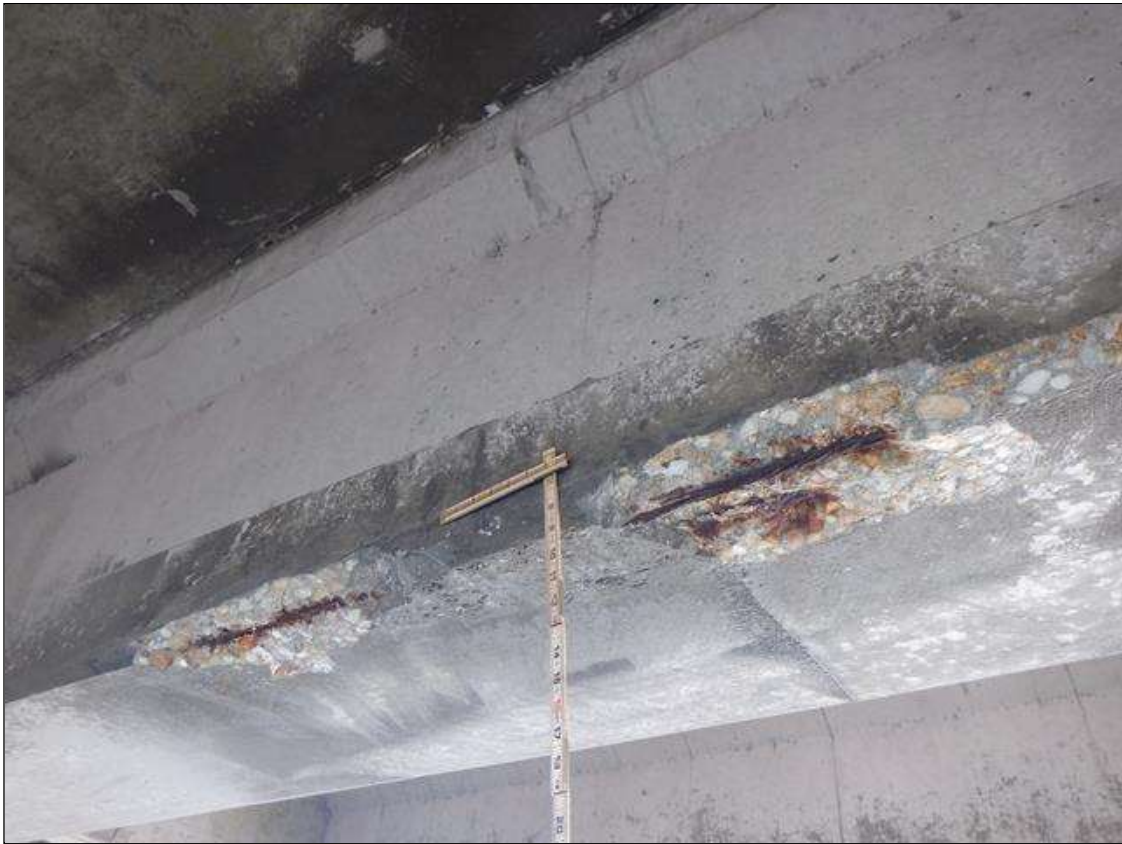
Span 133 Beam 3: (PAR) NORTH FACE OF BOTTOM FLANGE AT MIDSPAN, (2) TWO ADJACENT SPALLS (UP TO 24 INCHES X 6 INCHES X 2 INCHES) WITH BROKEN STRANDS (100 PERCENT SECTION LOSS) ON STRAND

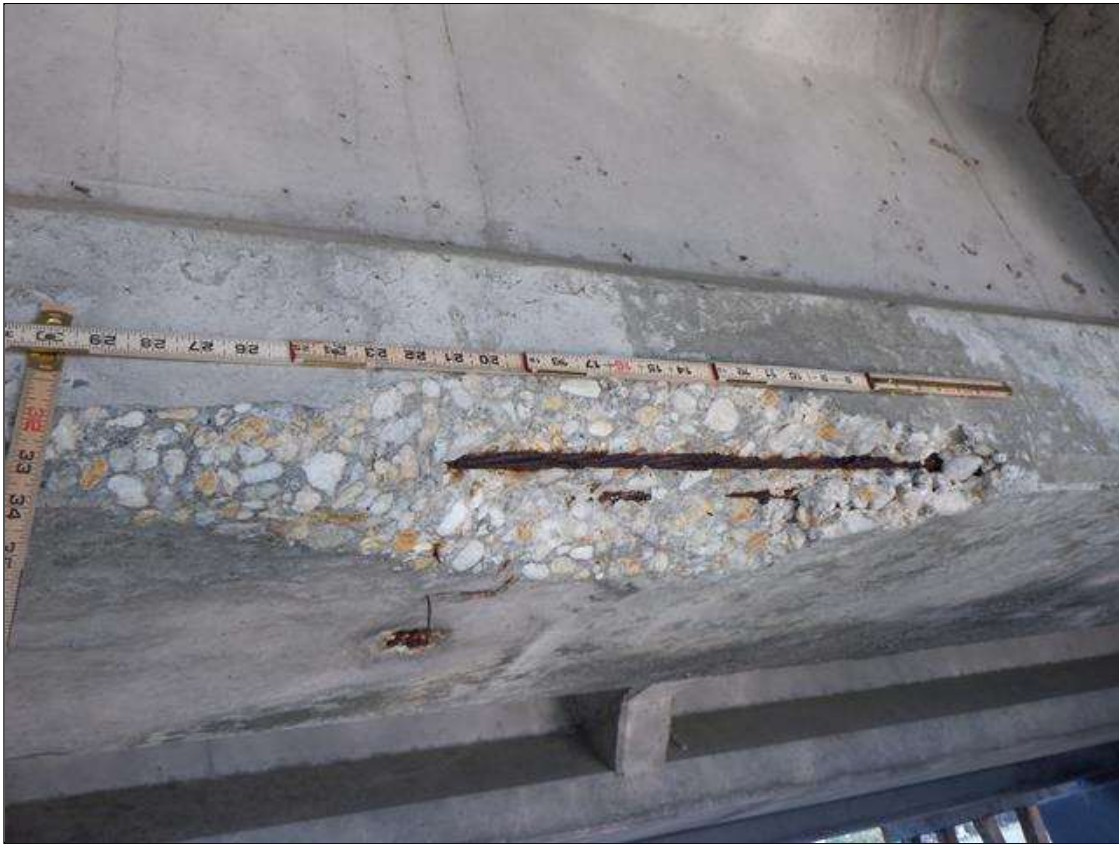
Span 221 Beam 3: (PAR) SOUTH FACE OF BOTTOM FLANGE, AT 22 FEET FROM BENT 221, SPALL (24INCHES X 8INCHES X 2 INCHES) WITH (2) EXPOSED RUSTED STRANDS (20 PERCENT SECTION LOSS) AND (1) ONE SEVERED STRAND

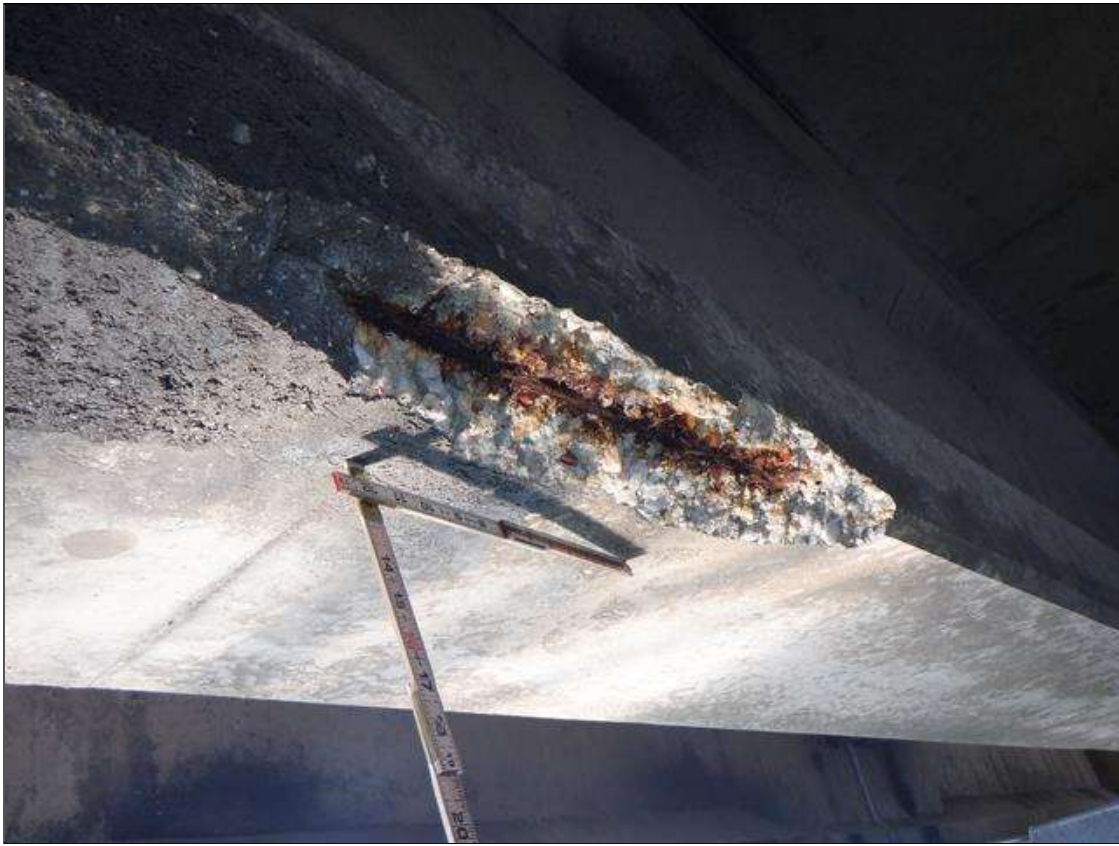
Span 221 Beam 3: (PAR) NORTH FACE OF BOTTOM FLANGE AT 20 FEET BENT 220, FAILED PATCHED/SPALL (30 INCHES X 2.5 INCHES HIGH X 4 INCHES WIDE X 1.5 INCH DEEP) WITH EXPOSED RUSTED STRANDS (20 PERCENT SECTION LOSS)

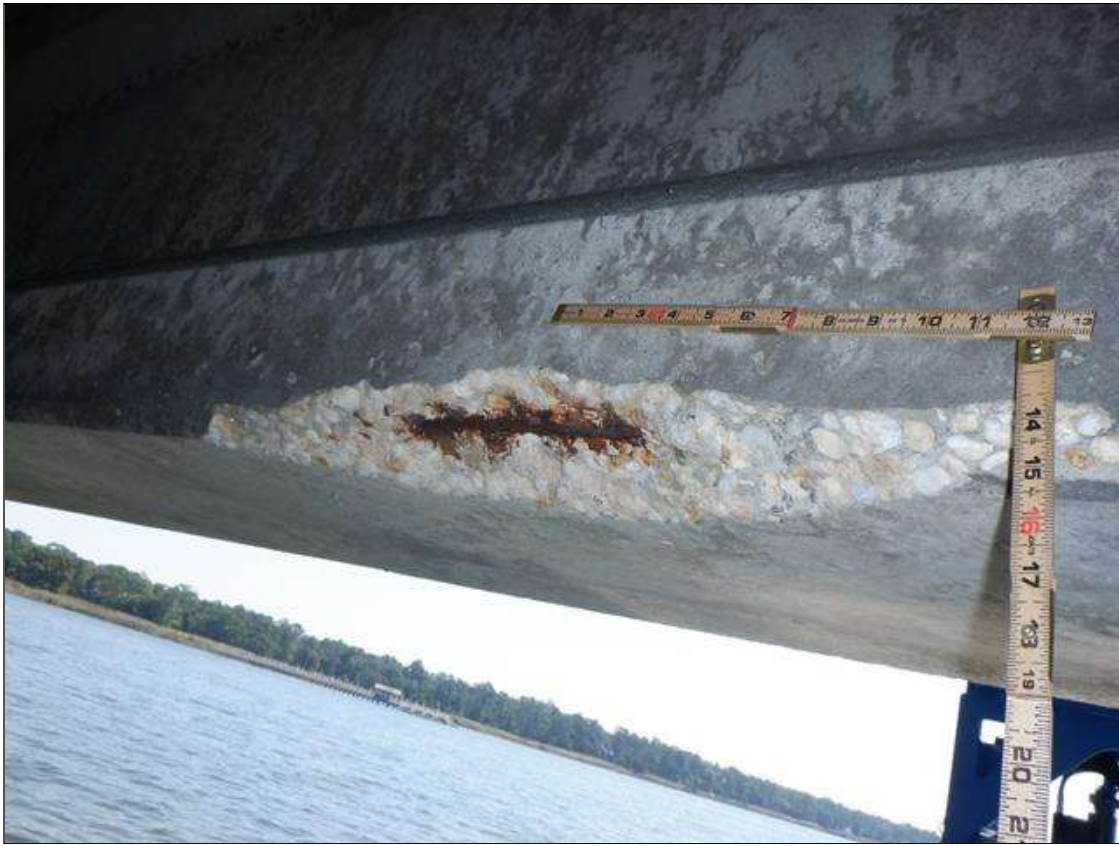
Span 229 Beam 4: (PAR) BOTTOM FLANGE NORTH FACE AT 5 FEET FROM BENT 228, SPALL (32 INCHES LONG X 3 INCHES HIGH X 5 INCHES WIDE X UP TO 1.5 INCHES DEEP) WITH EXPOSED RUSTED STRAND (20 PERCENT SECTION LOSS)

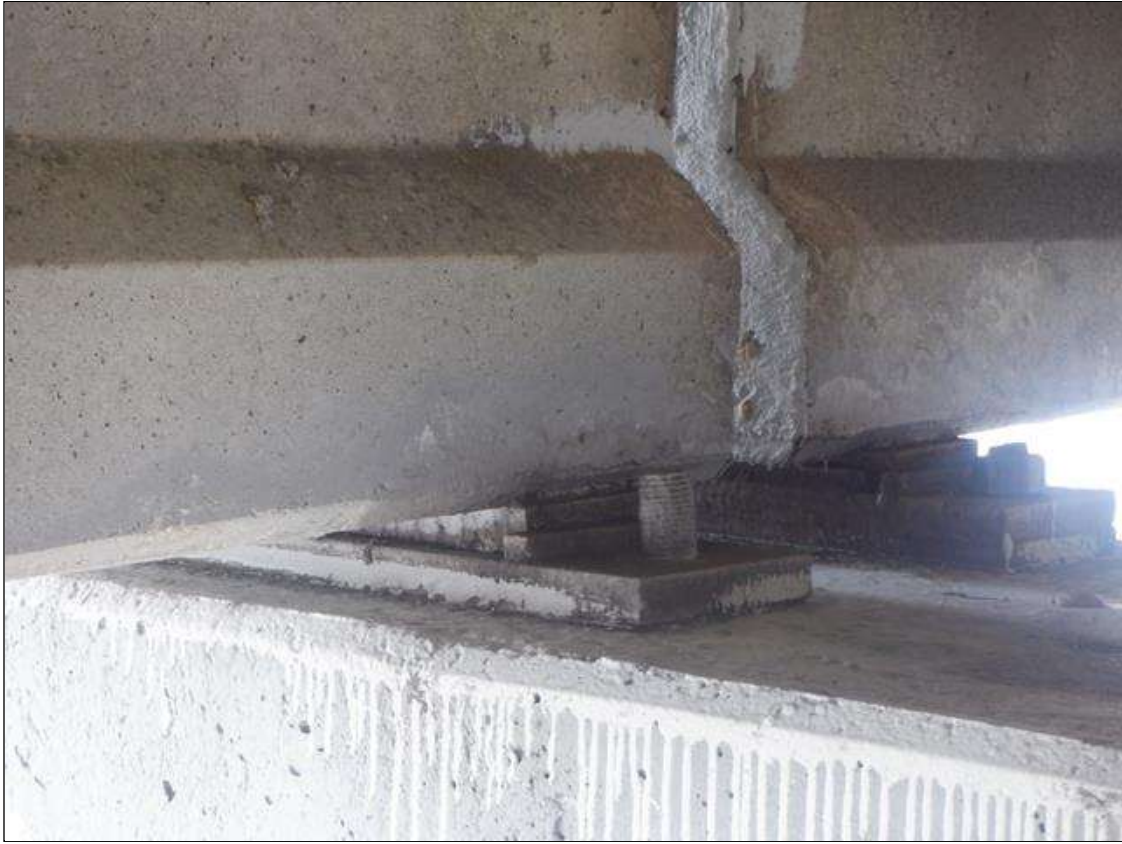
Span 191 Near Bearing: (PAR) AT NORTH FACE, MISSING ANCHOR BOLT NUT
