NC DEPARTMENT OF TRANSPORTATION  
DIVISION OF HIGHWAYS  
STRUCTURE MANAGEMENT UNIT

## Structure Safety Report

### Routine Element Inspection - Contract

STRUCTURE NUMBER: 260016 SAP STRUCTURE NO: 0270016 FHWA STRUCTURE NO: 000000000530016  
DIVISION: 1 COUNTY: CURRITUCK INSPECTION DATE: 09/21/2022 FREQUENCY: 24 MONTHS  
FACILITY CARRIED: US158E MILE POST: \_\_\_\_\_  
LOCATION: .01 MI.E.JCT.SR1187  
FEATURE INTERSECTED: CURRITUCK SOUND  
LATITUDE: 36° 5' 11.69" LONGITUDE: 75° 46' 0.21"  
SUPERSTRUCTURE: RC FLOOR ON PPC GIRDERS & CORED SLAB  
SUBSTRUCTURE: EBTS:RC CAP/PPC PILES;IBTS:RCP&B & RC CAPS/PPC PILES  
SPANS: 248 SPANS. SEE SPAN PROFILE SHEET FOR SPAN DETAILS  
☐ FRACTURE CRITICAL ☐ TEMPORARY SHORING ☐ SCOUR CRITICAL ☐ SCOUR PLAN OF ACTION  
GRADES: (Inspector/NBI Coding) DECK 6 / 6 SUPERSTRUCTURE 5 / 5 SUBSTRUCTURE 6 / 6 CULVERT N / N  
POSTED SV: Not Posted POSTED TTST: Not Posted  
OTHER SIGNS PRESENT: None

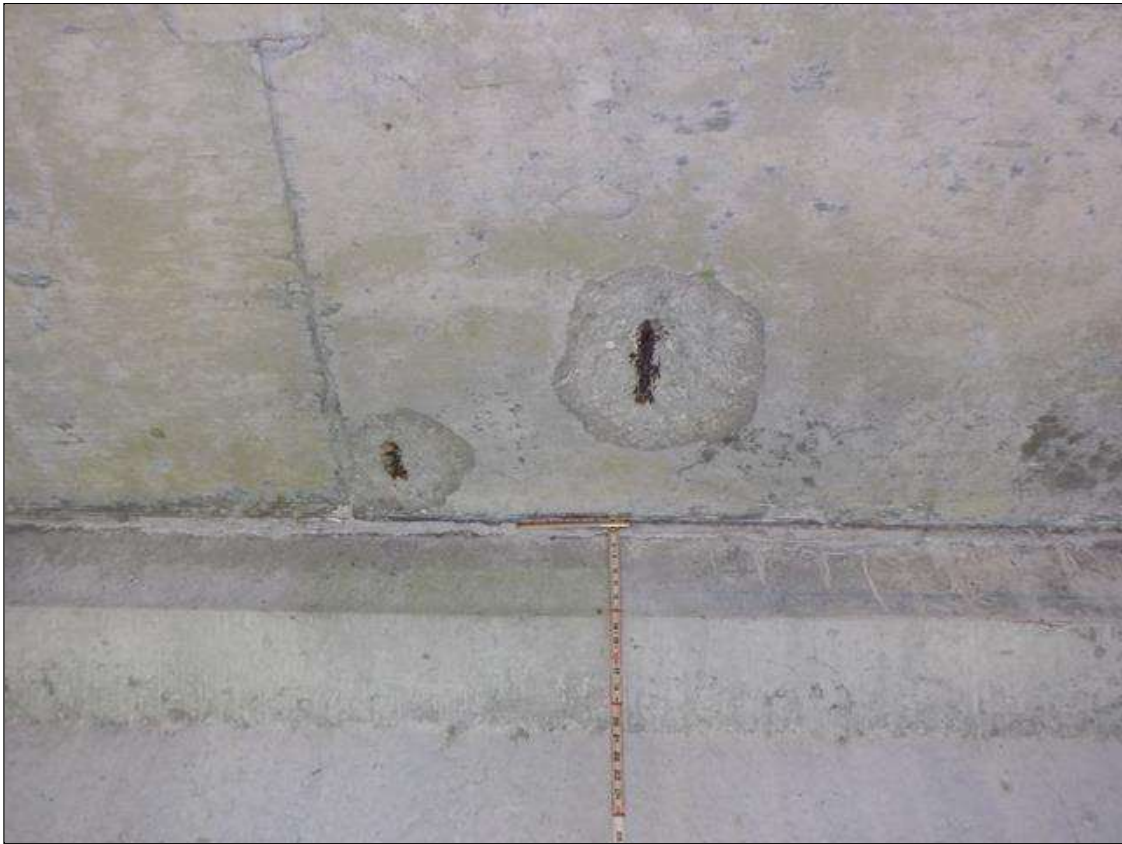
Span 117 Deck: UNDERSIDE OF DECK BAY 3 AT 16 FEET FROM BENT 117, (2) SPALLS (12 INCHES X 12 INCHES X 1 INCHES) WITH EXPOSED RUSTED REBAR

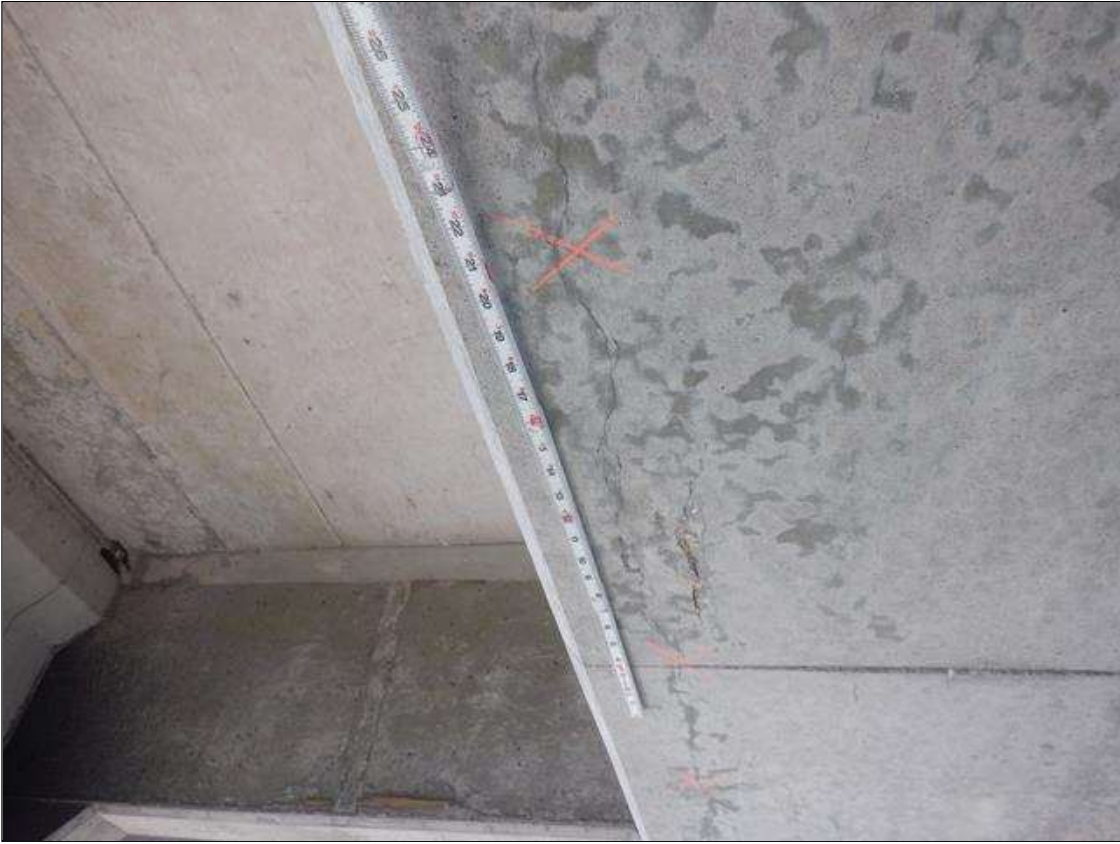
Span 174 Beam 3: BOTTOM OF BOTTOM FLANGE 20 FEET FROM BENT 174, LONGITUDINAL CRACK (10 FEET LONG X UP TO 0.012 INCHES WIDE) WITH ASSOCIATED EDGE SPALLING
