BRIDGE SCOUR REPORT

COUNTY: BUNCOMBE BRIDGE: 078 ROUTE: NC 197 STREAM CROSSED: N FORK IVY CK
ASSESSMENT YES EVALUATION BY: JJB DATE 3/26/09

Unknown Foundation Determination

**Buncombe 100078
NC 197 over North Fork Ivy Creek**

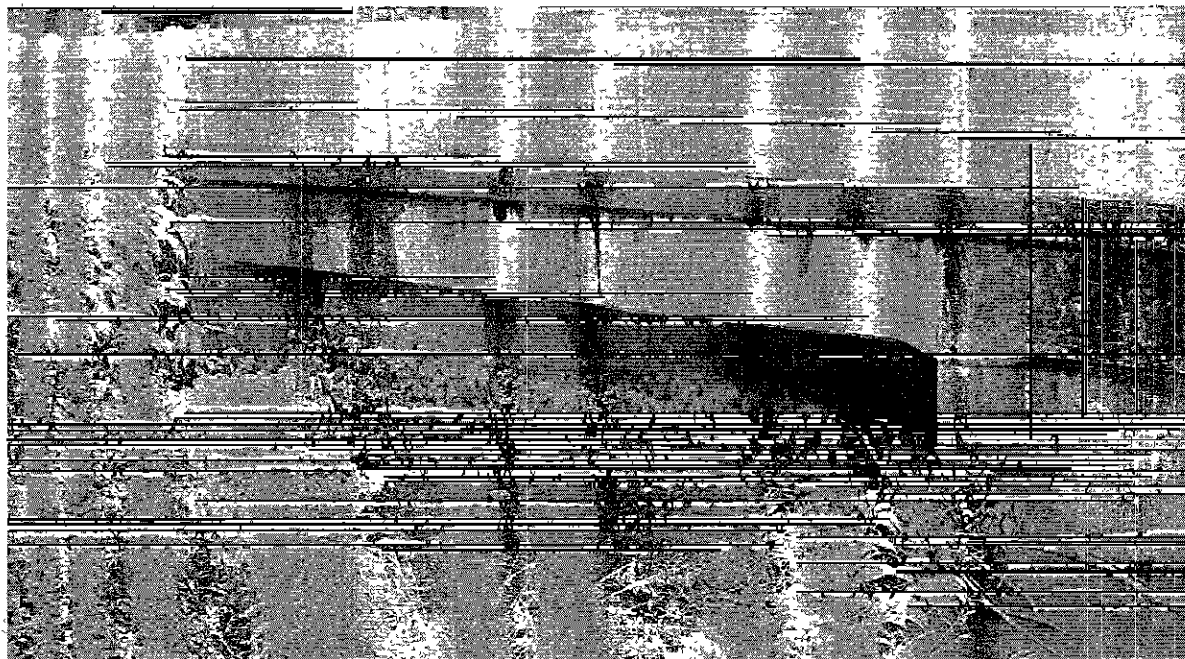
Requiring closure and inspection before reopening? No**Reported of apparent scour problem?** No scouring, has two tunnel like structures to stop debris from entering creek or getting stuck under bridge (See picture page 4)

First of four boxed concrete barrels under bridge.

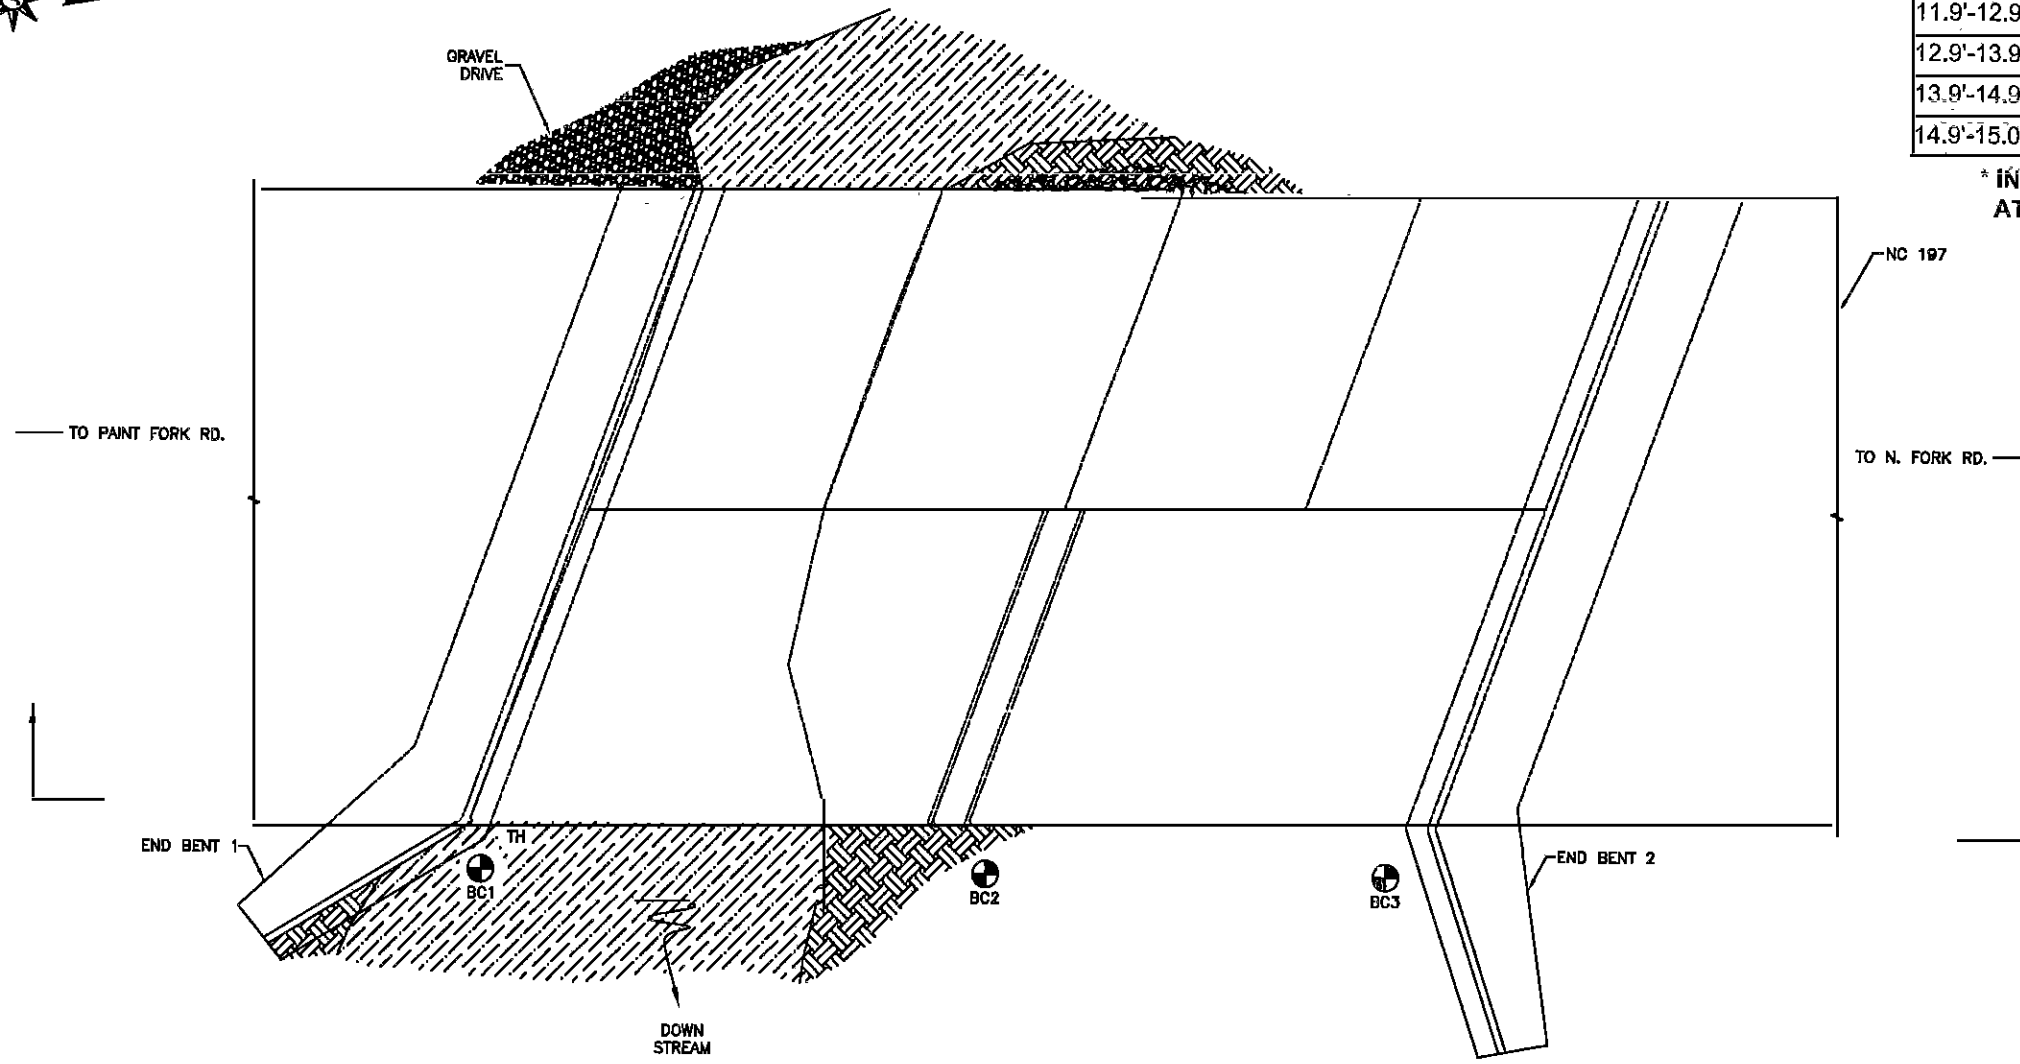
FOUNDATION PLAN
NTS

Foundation consists of concrete abutments and concrete footers. EB1 is 15.3 ft, B1 is 14.9 ft and EB2 is 14.8 ft from top of rail to bottom of abutment. Has four boxed concrete barrels (See picture page 4) Sounding data indicates EB1 is sitting on material too hard to penetrate with sounding rods. B1 is sitting on material of 136 BPF and EB2 is sitting on material of 150 BPF.

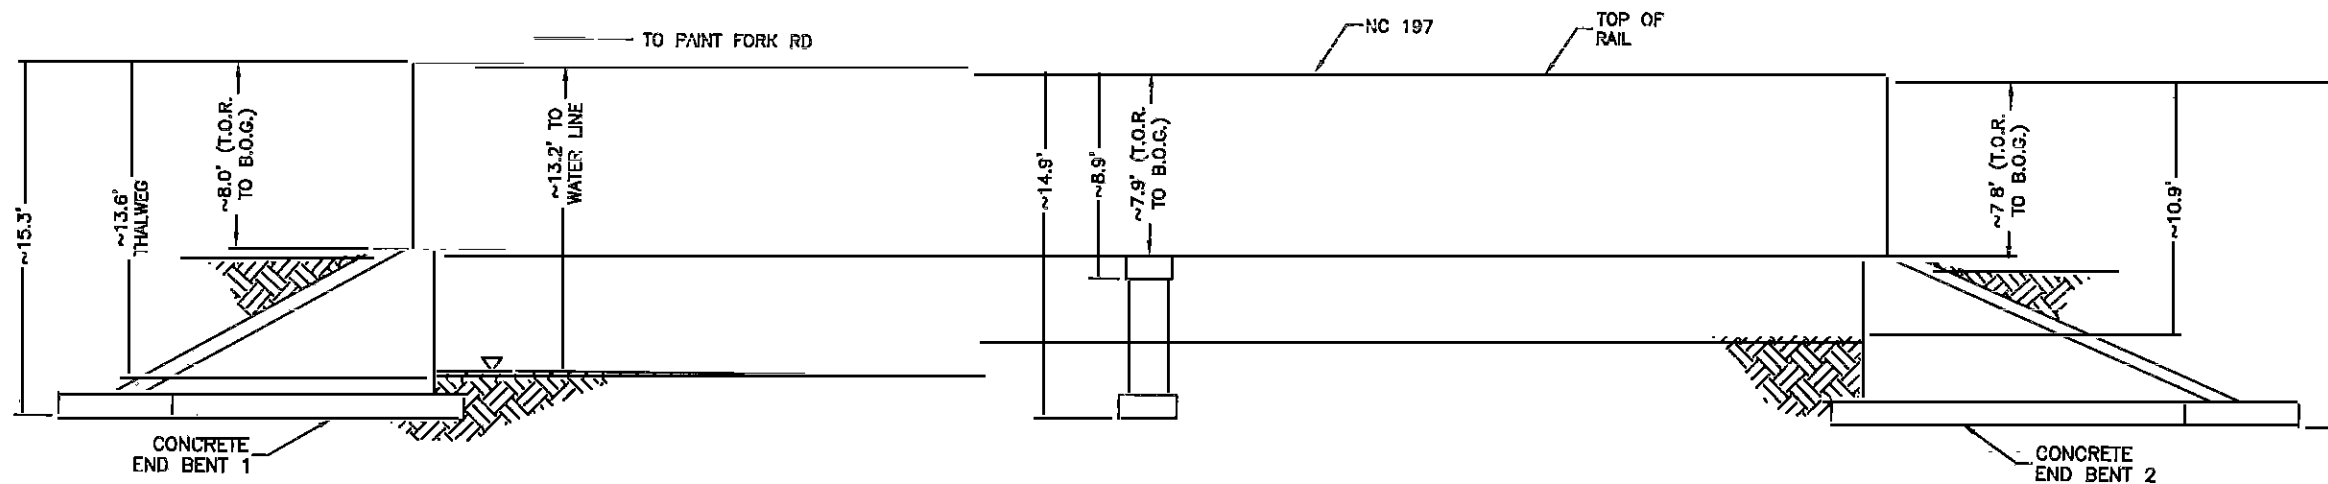
ELEVATION
NTS

BOTTOM OF FOOTING			
Pile and Footing Location	Test Method	Top of Rail to Bottom of Footing (FT)	Embedment Below Thalweg (FT)
EB1	DW/ROD	15.3	1.7
B1	ROD	14.9	1.3
EB2	DW/ROD	14.8	1.2
