NC DEPARTMENT OF TRANSPORTATION
 DIVISION OF HIGHWAYS
 STRUCTURE MANAGEMENT UNIT

Structure Safety Report

Routine Element Inspection

STRUCTURE NUMBER: 100078 SAP STRUCTURE NO: 0110078 FHWA STRUCTURE NO: 00000000210078

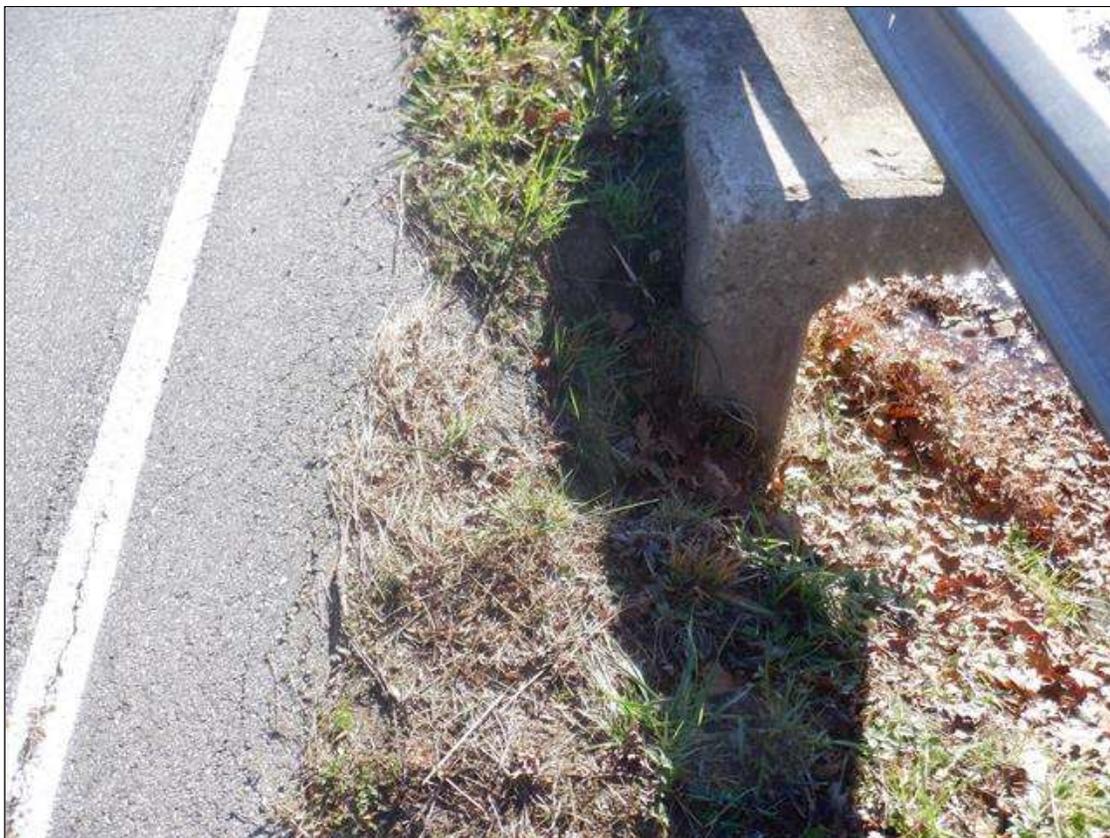
Details EROSION CAUSED BY STORMWATER RUNOFF AT THE SOUTH EAST CORNER 3 FEET WIDE X 6 FEET LONG X 1 FOOT DEEP CURRENTLY AT THE EDGE OF PAVEMENT. (PAR)

EROSION CAUSED BY STORMWATER RUNOFF AT THE SOUTH EAST CORNER 3 FEET WIDE X 6 FEET LONG X 1 FOOT DEEP CURRENTLY AT THE EDGE OF PAVEMENT. (PAR)

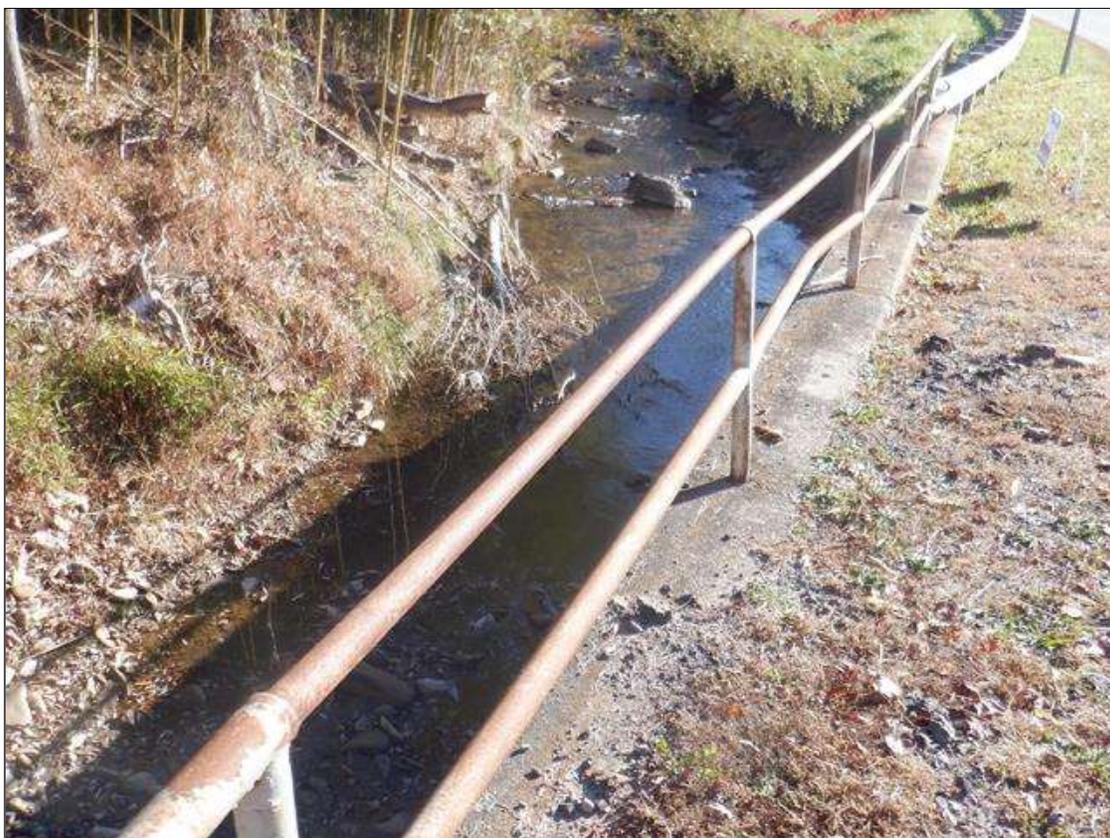
Span 2 - Slab Steel Rail 1: TWO POSTS LEANING WESTWARD 1 INCH AT THE TOP, AND BOTH RAILS ARE BENT AT FAR END OF THE SPAN.

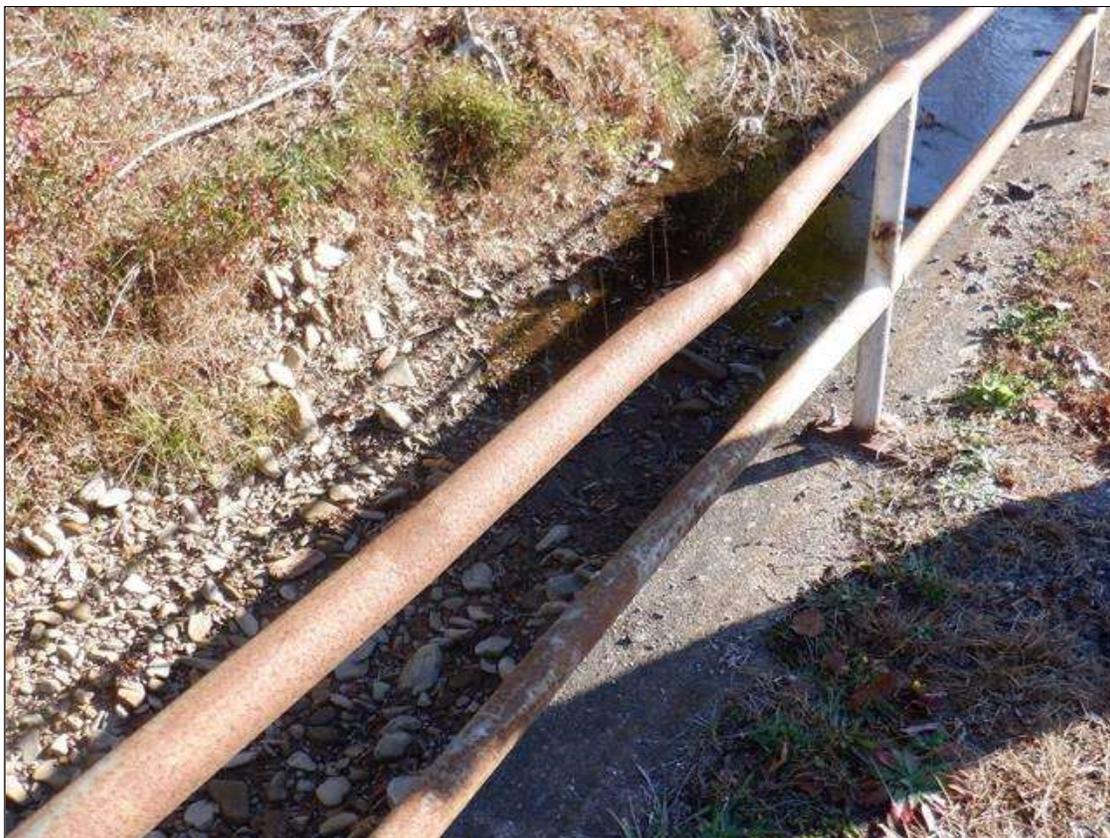
Span 2 - Slab Steel Rail 1: SURFACE CORROSION ON POSTS AND RAILS THE FULL LENGTH.

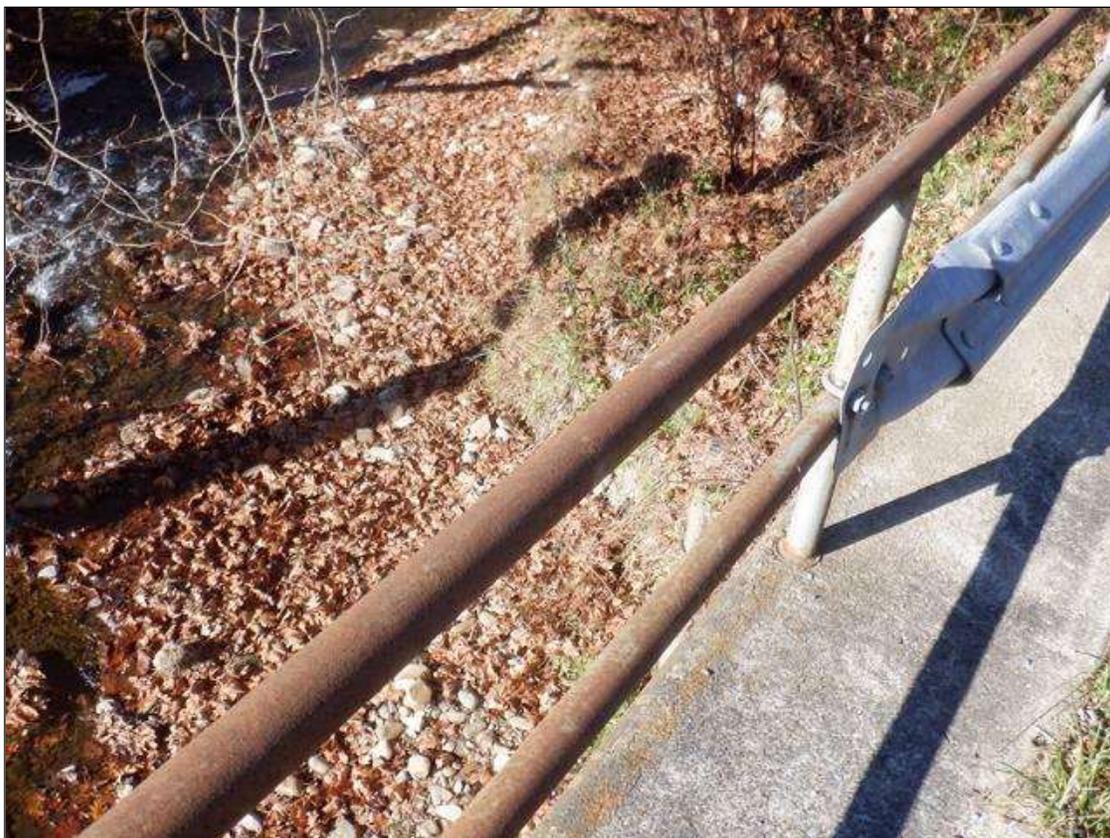
Span 2 - Slab Steel Rail 2: SURFACE CORROSION ON POSTS AND RAILS THE FULL LENGTH.

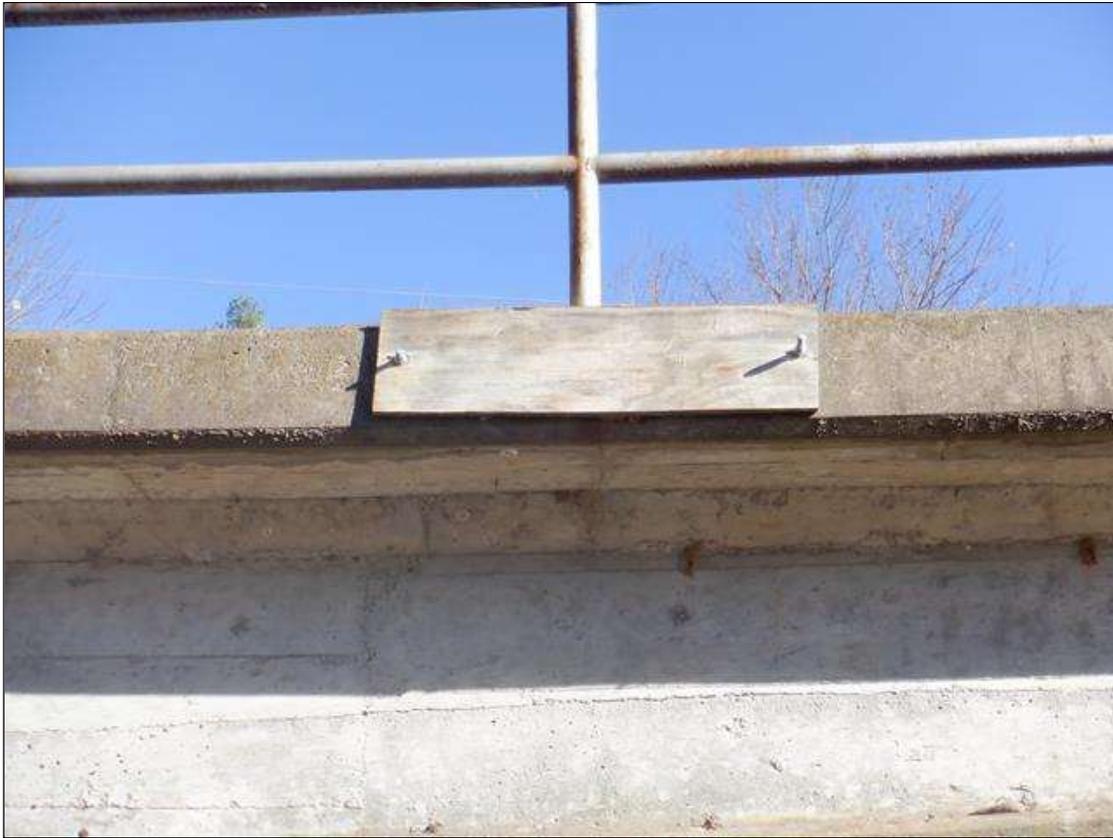
Span 1 - Slab Right Rail: PATCH TO BASE OF RAIL AT POST 4 WITH PLYWOOD FORM LEFT IN PLACE AS REPAIR TO PREVIOUS PAR.

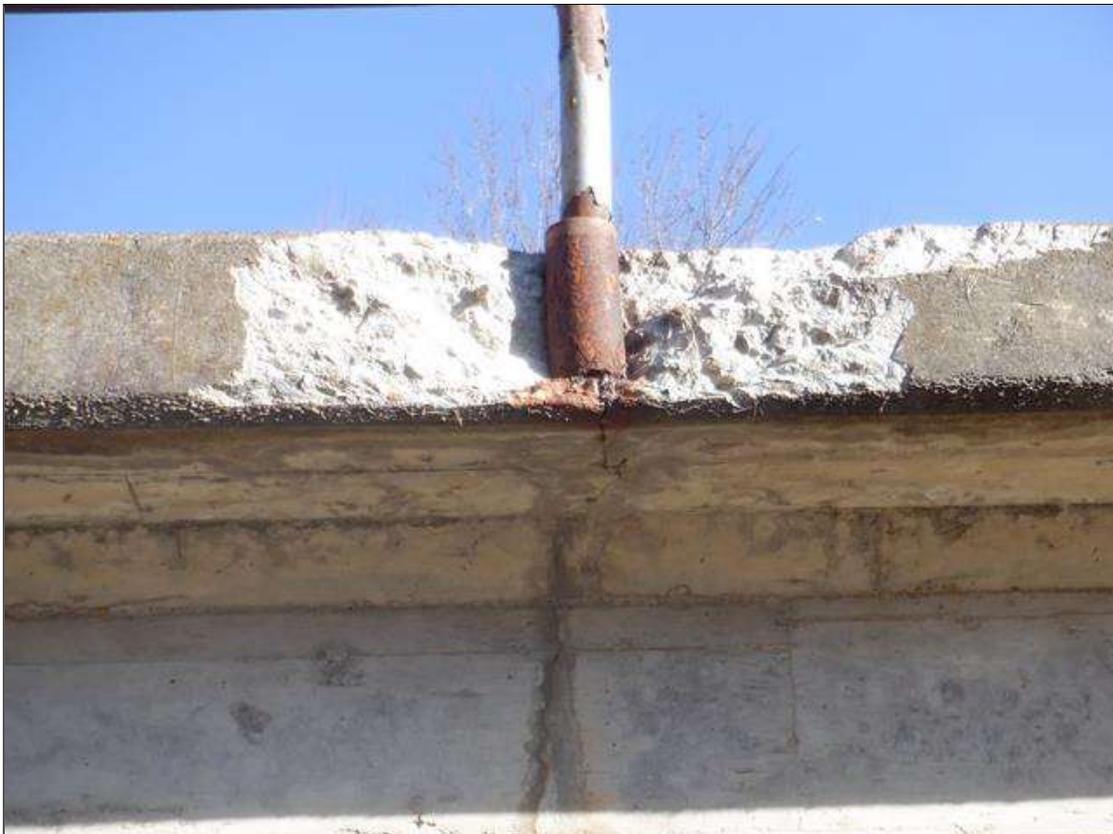
Span 1 - Slab Right Rail: 3 FEET WIDE X 9 INCH HIGH X 3 INCH DEEP SPALL OF THE CONCRETE AT THE BASE OF POST 5. THE ANCHOR OF THE POST IS COMPLETELY EXPOSED AND LOOSE. (PAR)

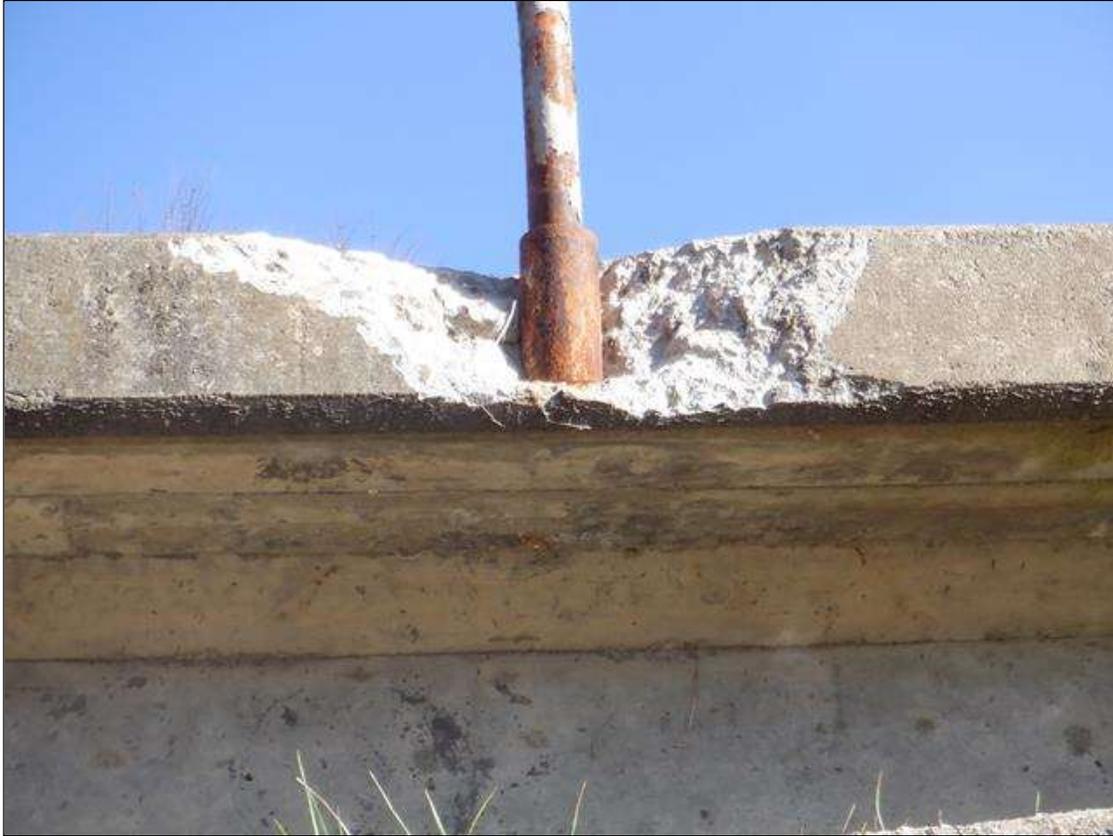
Priority Level	Defect Type	Quantity	Defect Description
2	Connection	1	Span 1 - Slab Right Rail: 2.5 FEET WIDE X 9 INCH HIGH X 3 INCH DEEP SPALL OF THE CONCRETE AT THE BASE OF POST 6. THE ANCHOR OF THE POST IS COMPLETELY EXPOSED AND LOOSE. (PAR)
2	Connection	1	Span 1 - Slab Right Rail: 3 FEET WIDE X 9 INCH HIGH X 3 INCH DEEP SPALL OF THE CONCRETE AT THE BASE OF POST 5. THE ANCHOR OF THE POST IS COMPLETELY EXPOSED AND LOOSE. (PAR)

Span 1 - Slab Right Rail: 2.5 FEET WIDE X 9 INCH HIGH X 3 INCH DEEP SPALL OF THE CONCRETE AT THE BASE OF POST 6. THE ANCHOR OF THE POST IS COMPLETELY EXPOSED AND LOOSE. (PAR)

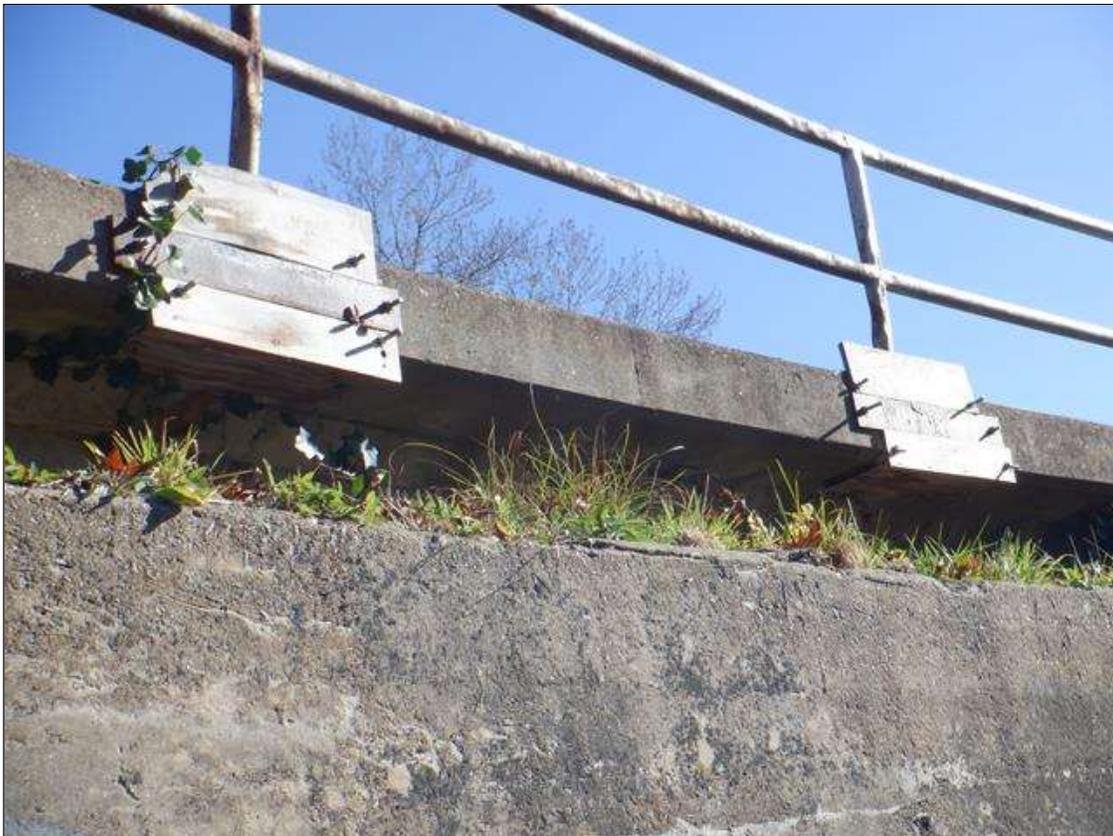
Span 2 - Slab Steel Rail 2: PATCH WITH PLYWOOD FORMS AND A STEEL PLATE AT THE BASE OF POSTS 7 AND 8 AS REPAIRS TO PREVIOUS PARS.

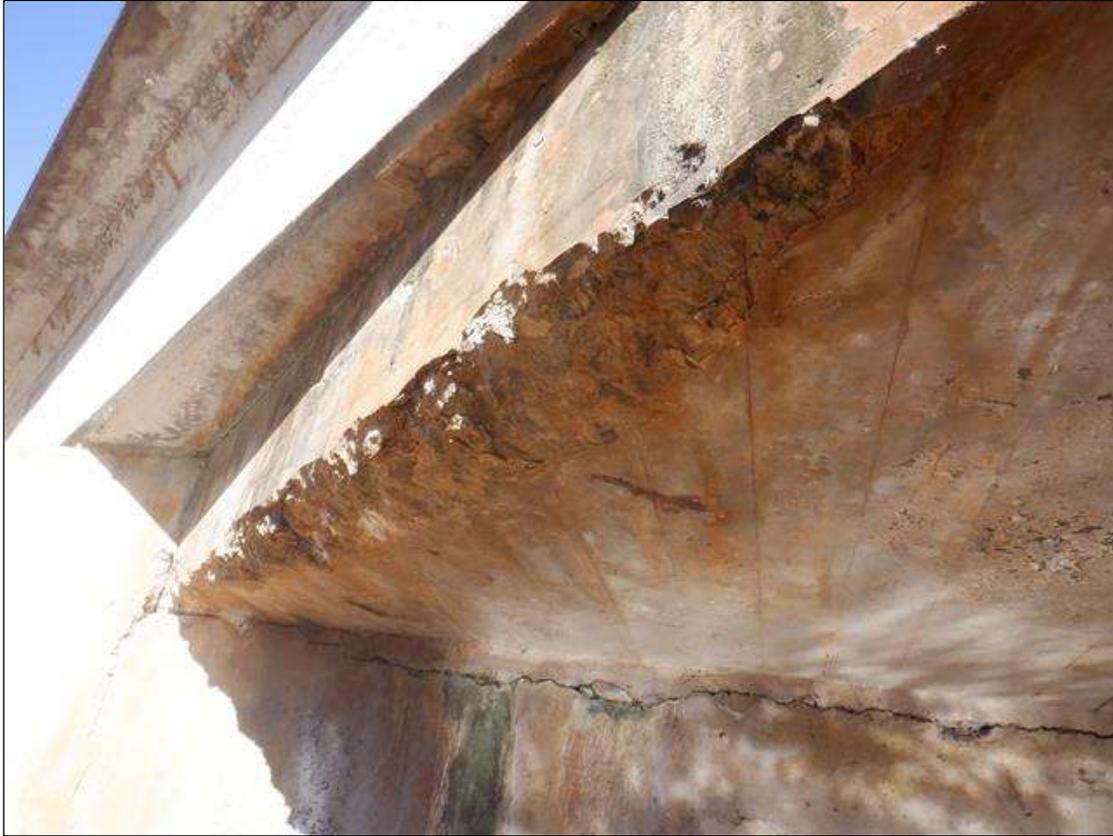
Span 1 - Slab Slab 1: 8 FEET LONG X 1 FOOT WIDE X 2 INCH DEEP SCALING DUE TO CONCRETE DETERIORATION AT THE RIGHT SIDE, NEAR END.

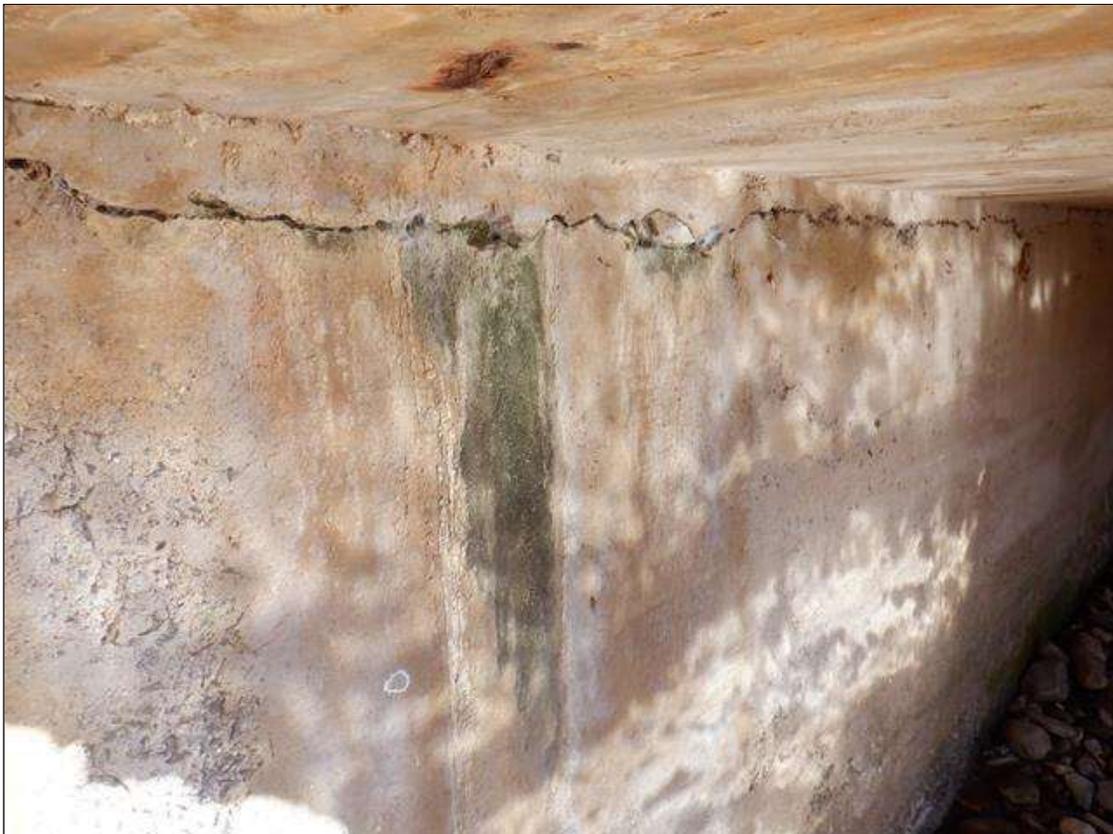
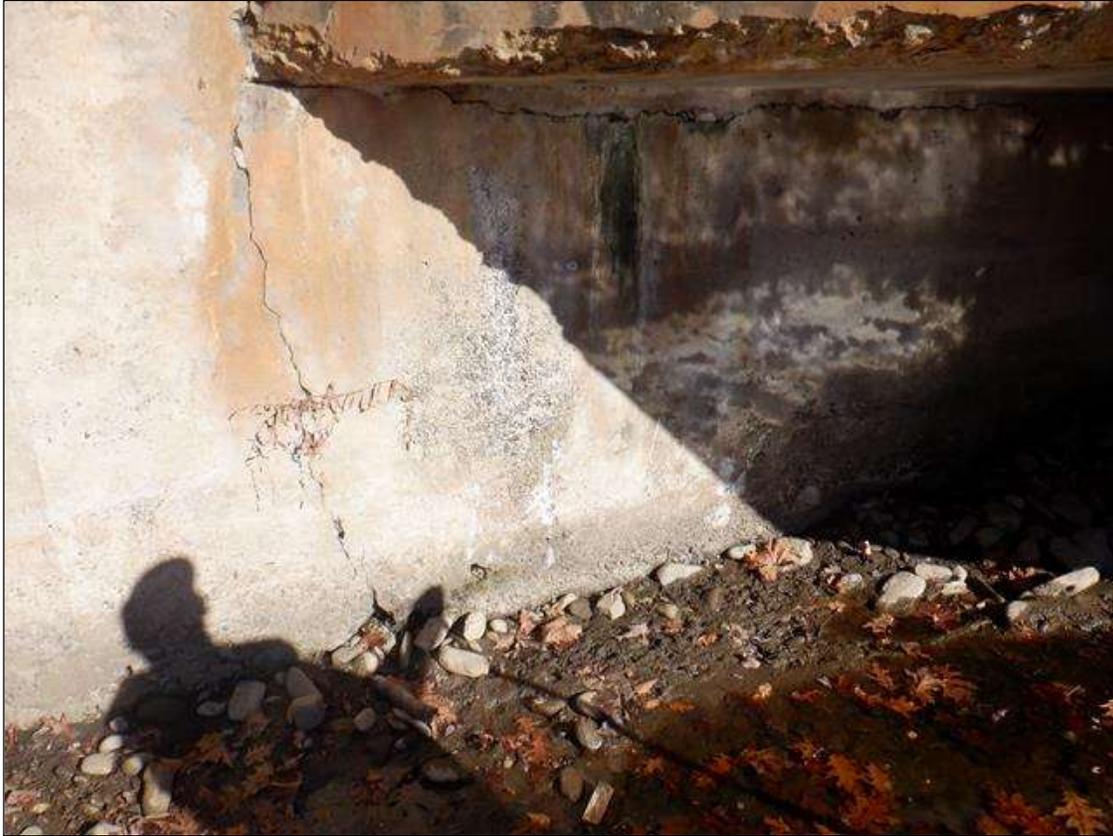
Priority Level	Defect Type	Quantity	Defect Description
2	Cracking (RC and ...)	13	End Bent 1 Abutment: FULL HEIGHT X 0.5 INCH WIDE VERTICAL CRACK AND 13 FEET LONG X 0.5 INCH WIDE HORIZONTAL CRACK AT THE RIGHT END OF THE ABUTMENT. (PAR)

End Bent 1 Abutment: FULL HEIGHT X 0.5 INCH WIDE VERTICAL CRACK AND 13 FEET LONG X 0.5 INCH WIDE HORIZONTAL CRACK AT THE RIGHT END OF THE ABUTMENT. (PAR)

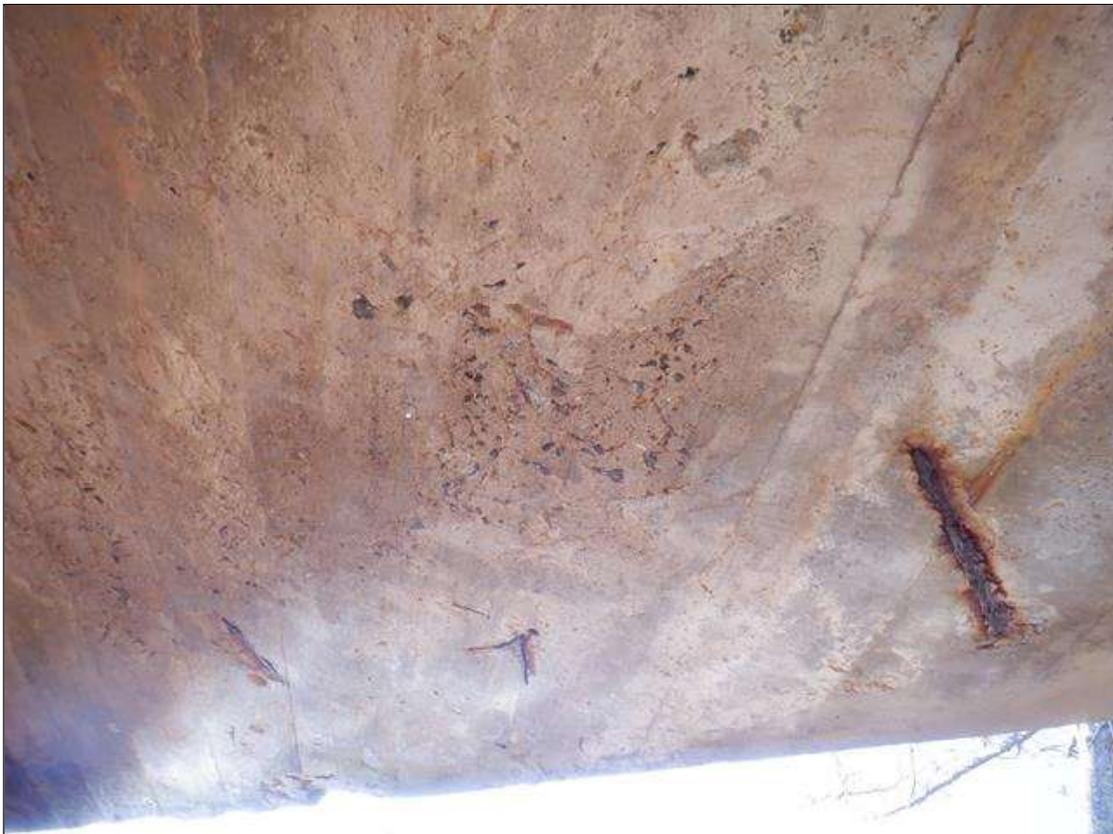
Span 1 - Slab Slab 1: NUMEROUS SPALLS ALONG RIGHT SIDE UP TO 6 INCHES IN DIAMETER WITH EXPOSED AND CORRODING REBAR WITH MEASUREABLE SECTION LOSS. (PAR)

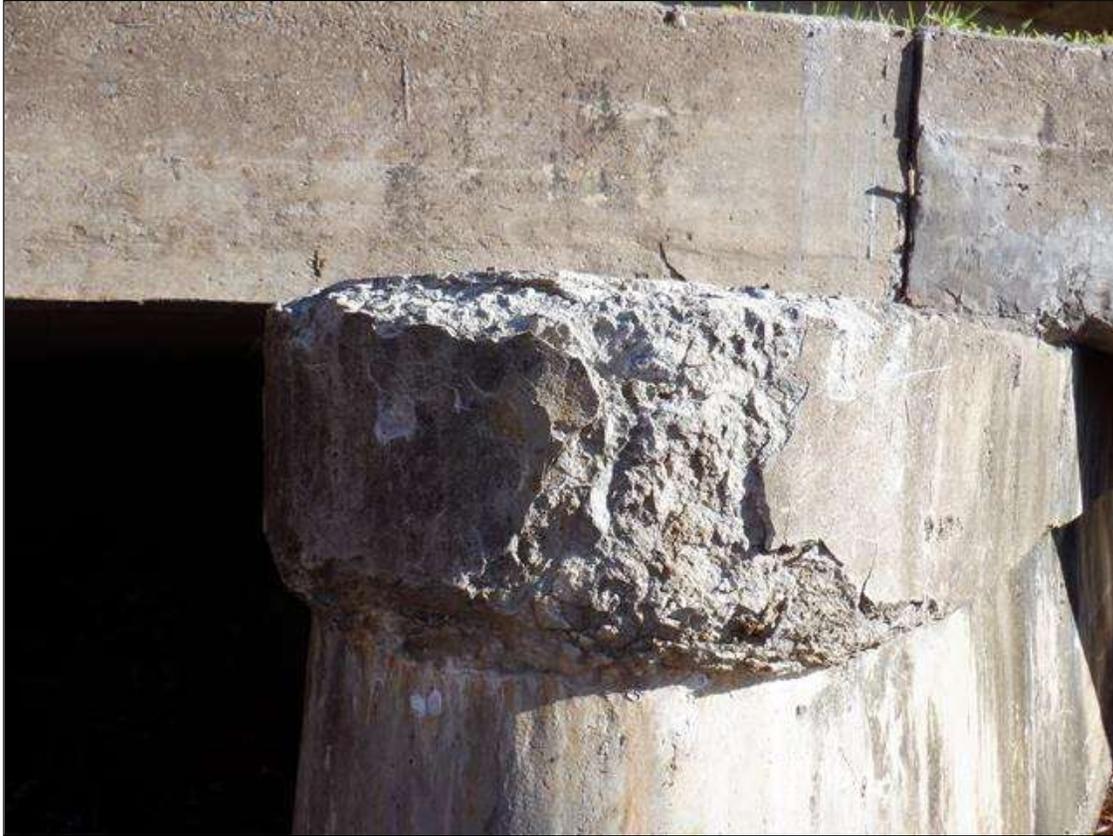
Element Number	Defect Type	Defect Description	CS	CS Qty	Maint Qty	
<input checked="" type="checkbox"/>	234	Delamination/Spall	3	3	3	Feet
		3 FEET LONG X 1 FOOT HIGH X 2 INCH DEEP SCALING DUE TO CONCRETE DETERIORATION AT THE RIGHT END OF THE CAP.

Pier 1 RC Cap: 3 FEET LONG X 1 FOOT HIGH X 2 INCH DEEP SCALING DUE TO CONCRETE DETERIORATION AT THE RIGHT END OF THE CAP.

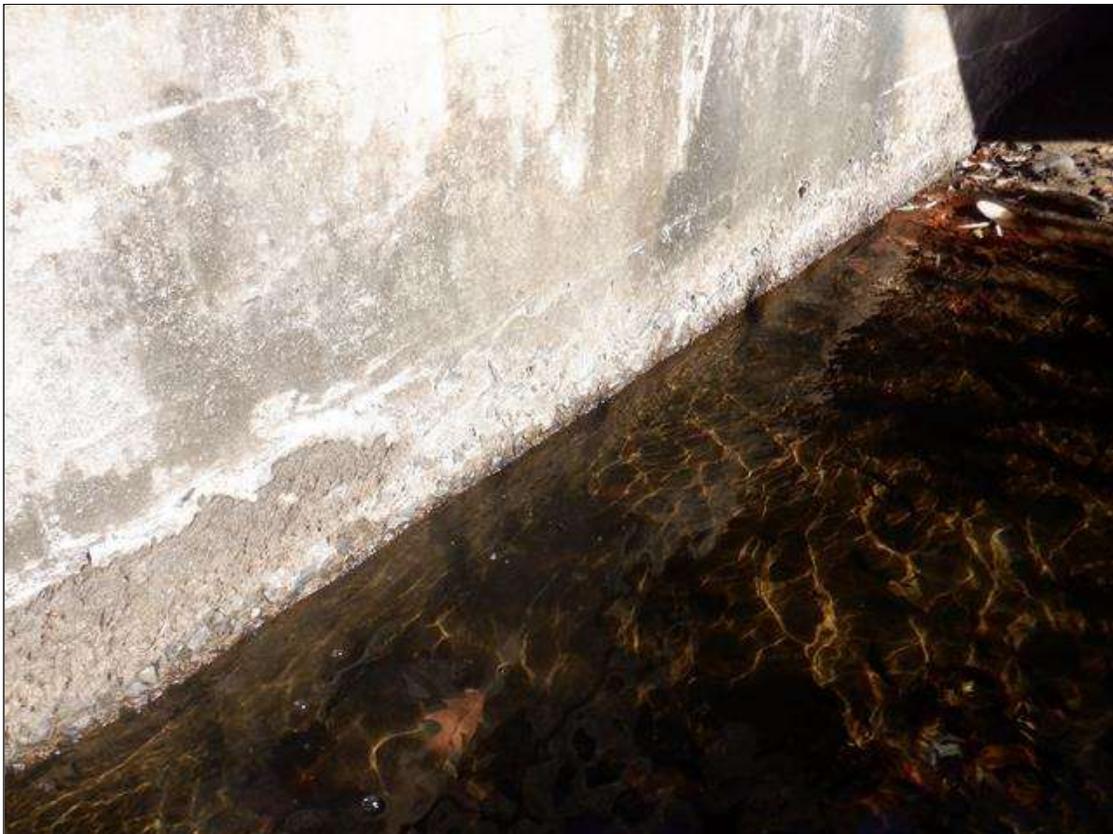
Pier 1 Pier Wall: ABRASION 1 FOOT HIGH X 20 FEET LONG BEGINNING AT THE RIGHT END WITH COARSE AGGREGATE INTACT.

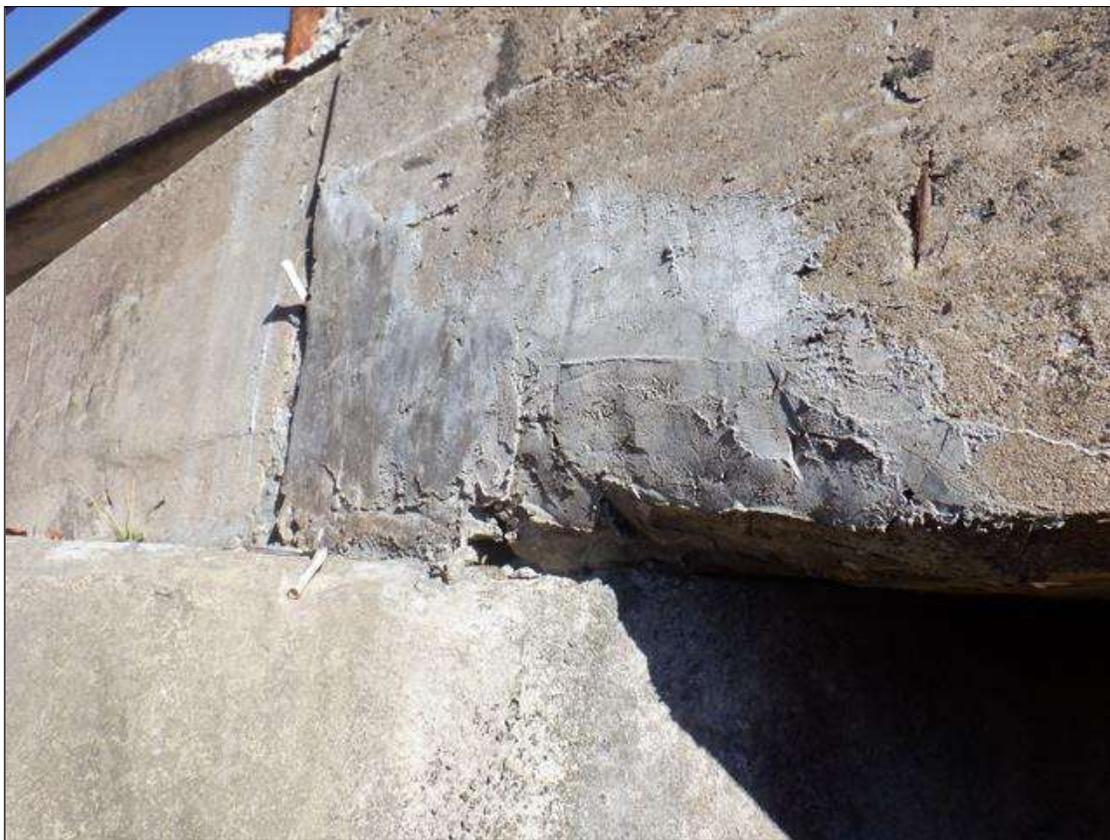
Span 2 - Slab Slab: 2 FEET LONG X 1 FOOT HIGH UNSOUND PATCH IN THE RIGHT FACE, NEAR END.

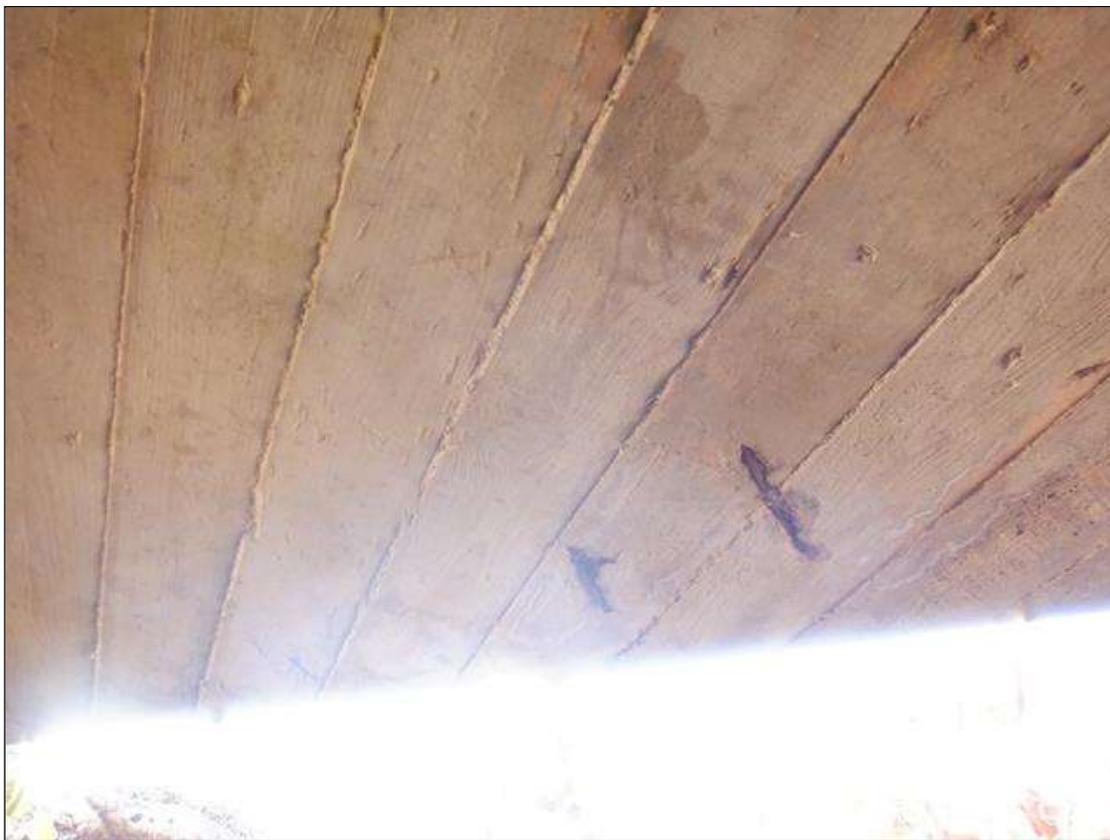
Span 2 - Slab Slab: NUMEROUS SPALLS UP TO 6 INCHES IN DIAMTER ALONG THE UNDERSIDE.

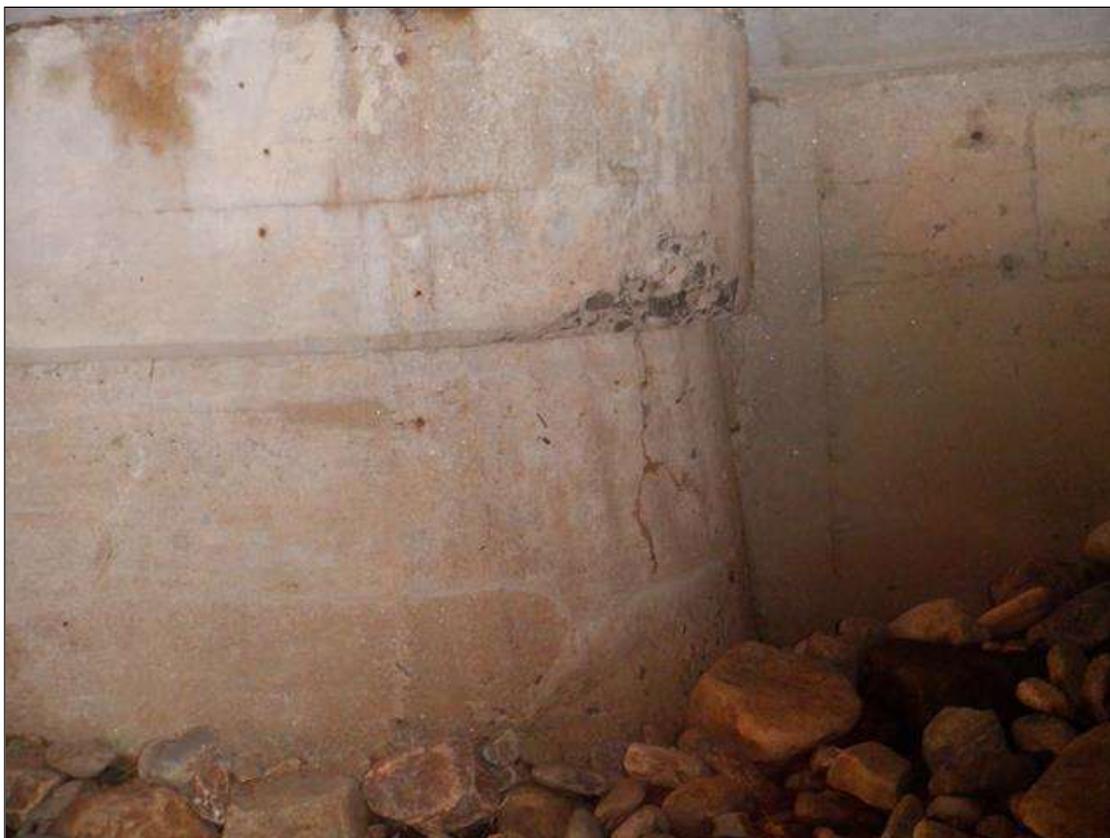
Pier 1 Pier Wall: FULL HEIGHT X 0.5 INCH WIDE VERTICAL CRACK AT THE LEFT END OF THE PIER WALL.

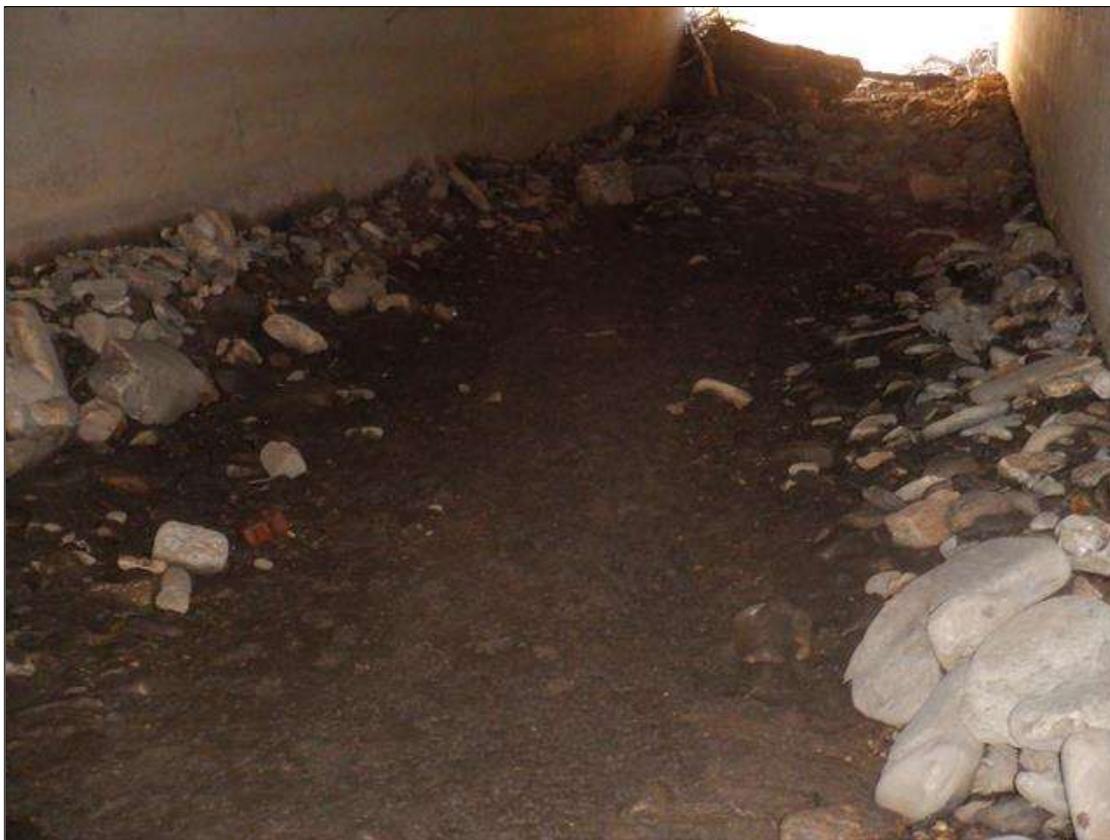
ROCK AND SEDIMENT BUILDUP UP TO 2 FEET DEEP IN ALL BARRELS.

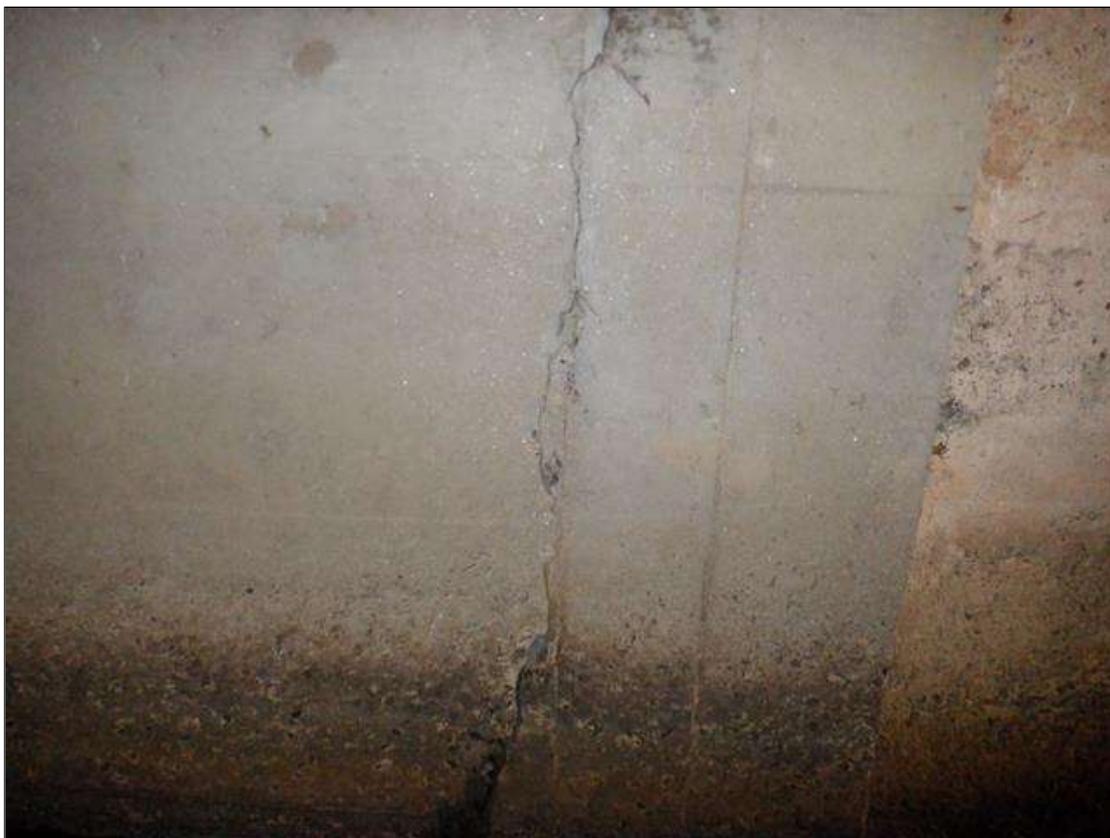
Barrel 4 - RCBC Barrel 4: FULL HEIGHT X 0.5 INCH WIDE VERTICAL CRACK IN EXTERIOR WALL AT DOWNSTREAM END OF THE BARREL.

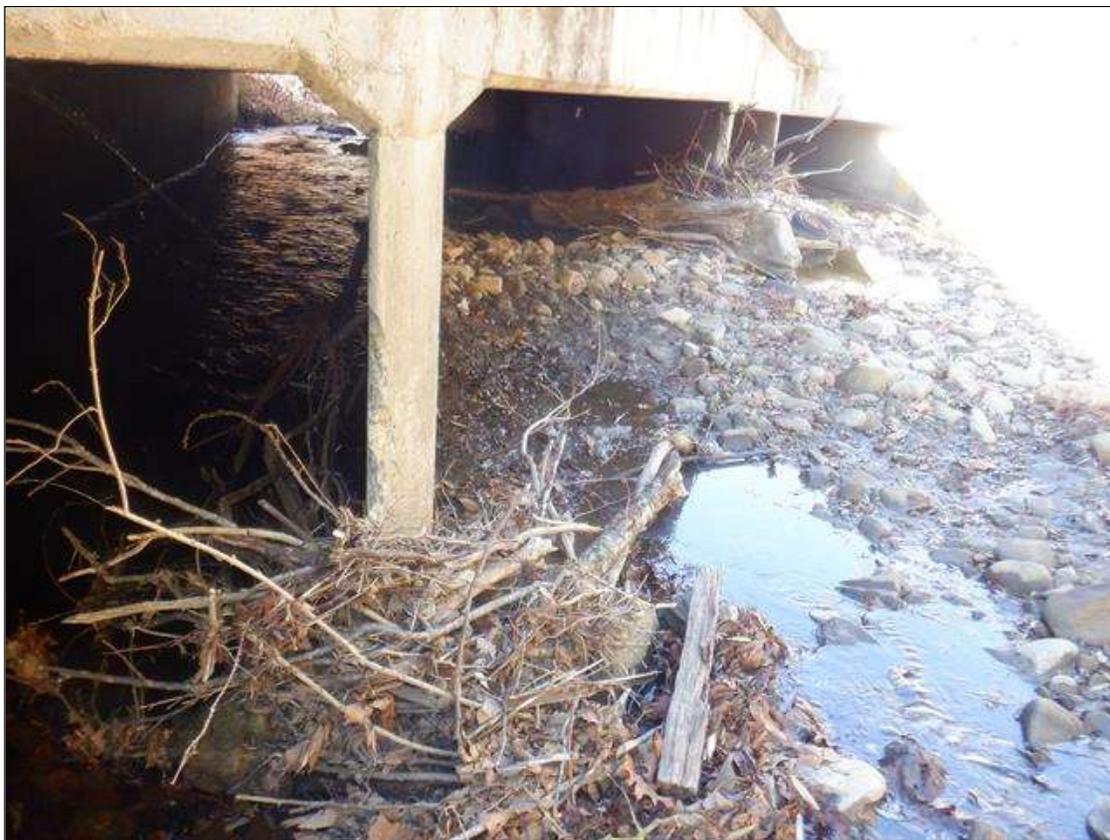
DRIFT 6 FEET WIDE X 3 FEET HIGH X 1 FOOT DEEP AGAINST EACH INTERIOR WALL.

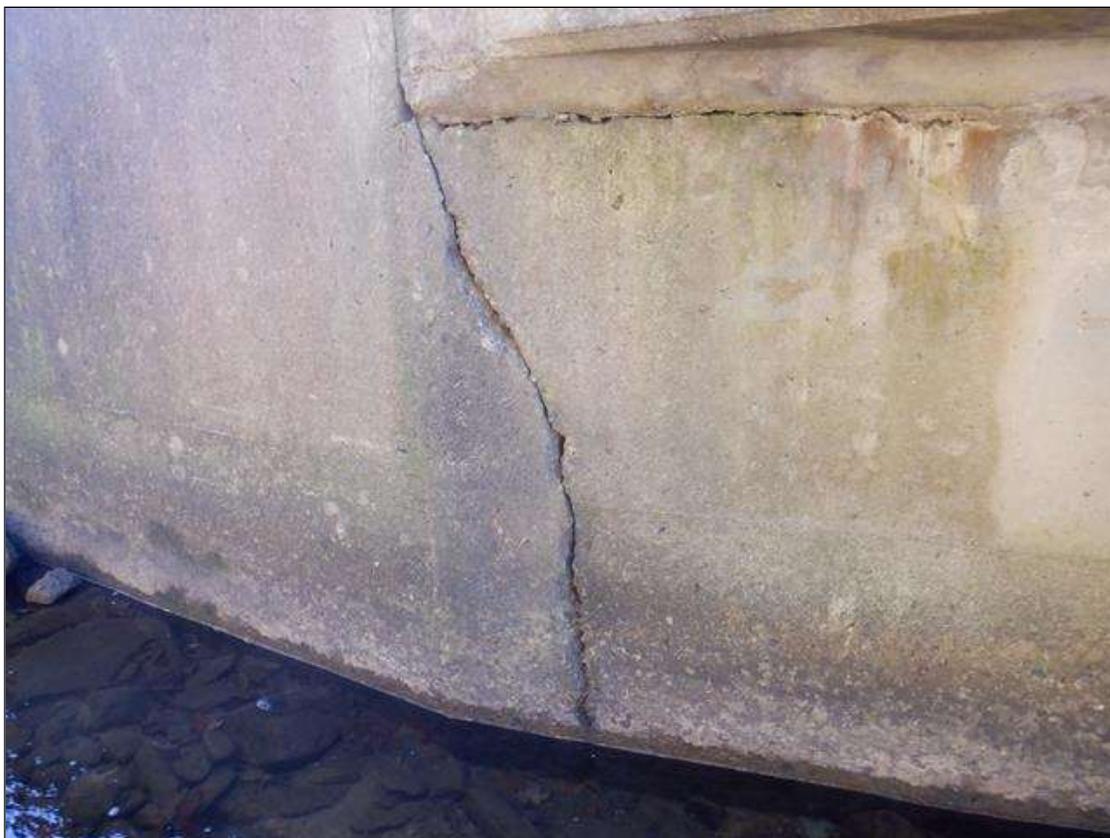
Barrel 4 - RCBC Barrel 4: FULL HEIGHT X 0.5 INCH WIDE VERTICAL CRACK IN EXTERIOR WALL AT UPSTREAM END OF THE BARREL.

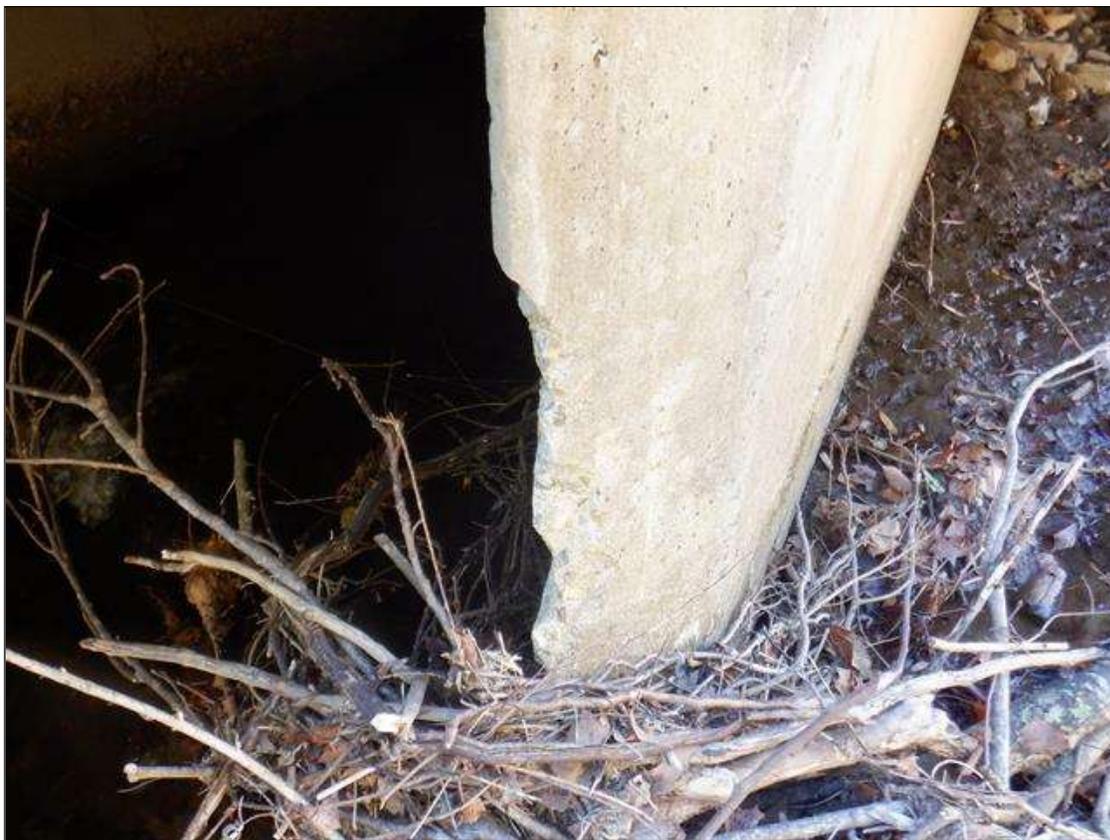
Barrel 4 - RCBC Barrel 4: SPALLS IN THE UPSTREAM END OF INTERIOR WALL 3 UP TO 1 INCH DEEP.

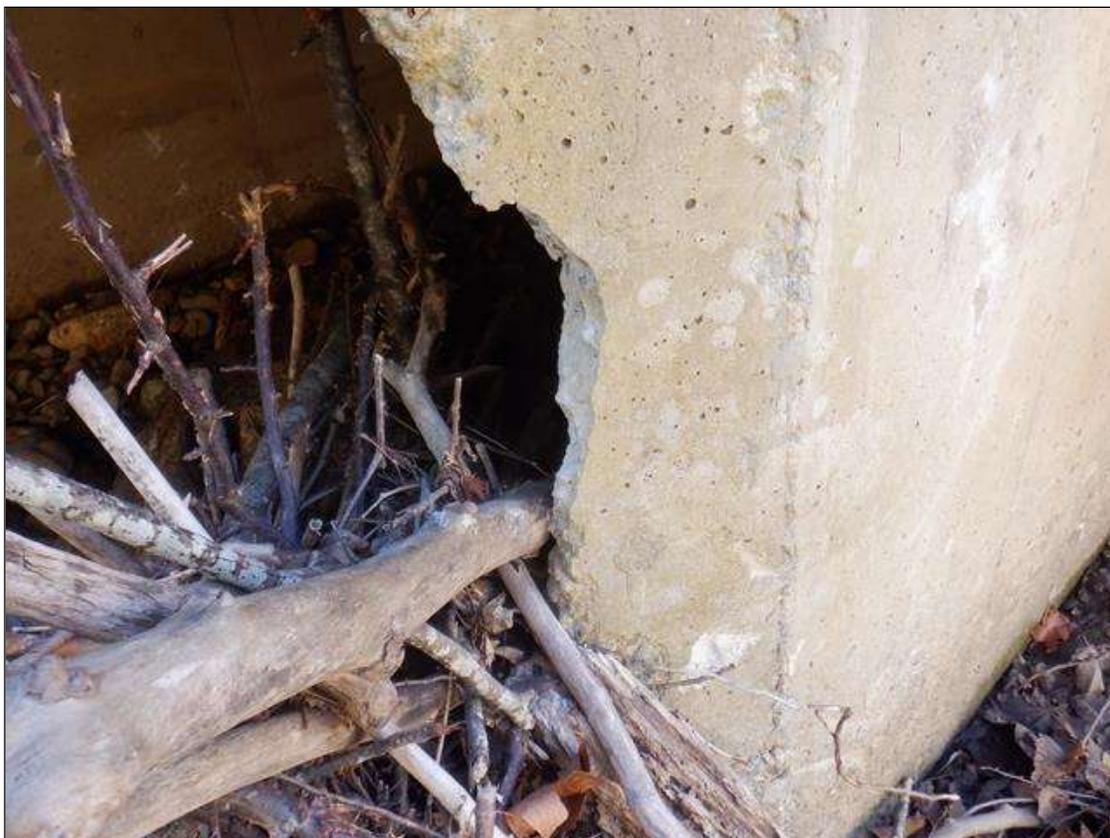
Element Number	Defect Type	Defect Description	CS	CS Qty	Maint Qty	
<input checked="" type="checkbox"/>	241	Delamination/Spall	SPALLS IN THE UPSTREAM END OF INTERIOR WALL 2 UP TO 3 INCHES DEEP.	3	1	1 Feet

Barrel 3 - RCBC Barrel 3: SPALLS IN THE UPSTREAM END OF INTERIOR WALL 2 UP TO 3 INCHES DEEP.
