NC DEPARTMENT OF TRANSPORTATION
 DIVISION OF HIGHWAYS
 STRUCTURE MANAGEMENT UNIT

Structure Safety Report

Routine Element Inspection

STRUCTURE NUMBER: 100078 SAP STRUCTURE NO: 0110078 FHWA STRUCTURE NO: 00000000210078

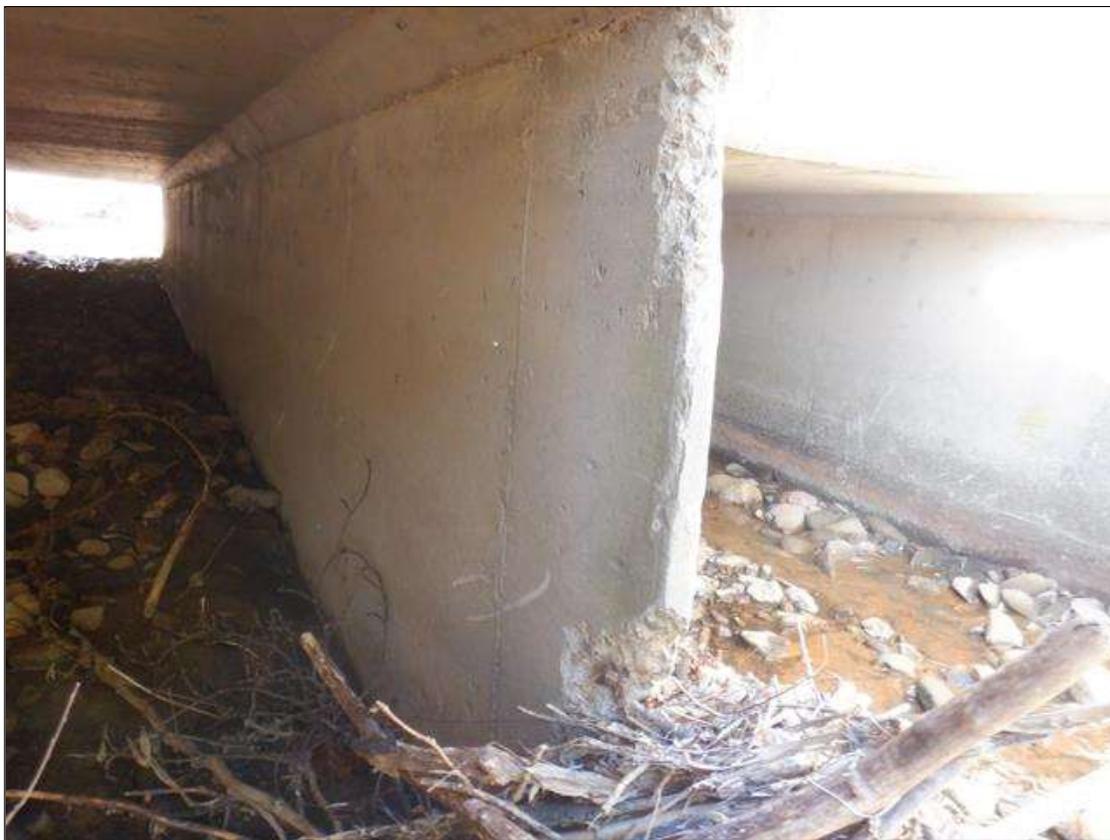
Element Number	Defect Type	Defect Description	CS	CS Qty	Maint Qty	
<input checked="" type="checkbox"/>	241	Delamination/Spall	SPALLS IN THE UPSTREAM END OF INTERIOR WALL 1 UP TO 3 INCHES DEEP.	3	1	1 Feet

Barrel 2 - RCBC Barrel 2: SPALLS IN THE UPSTREAM END OF INTERIOR WALL 1 UP TO 3 INCHES DEEP.

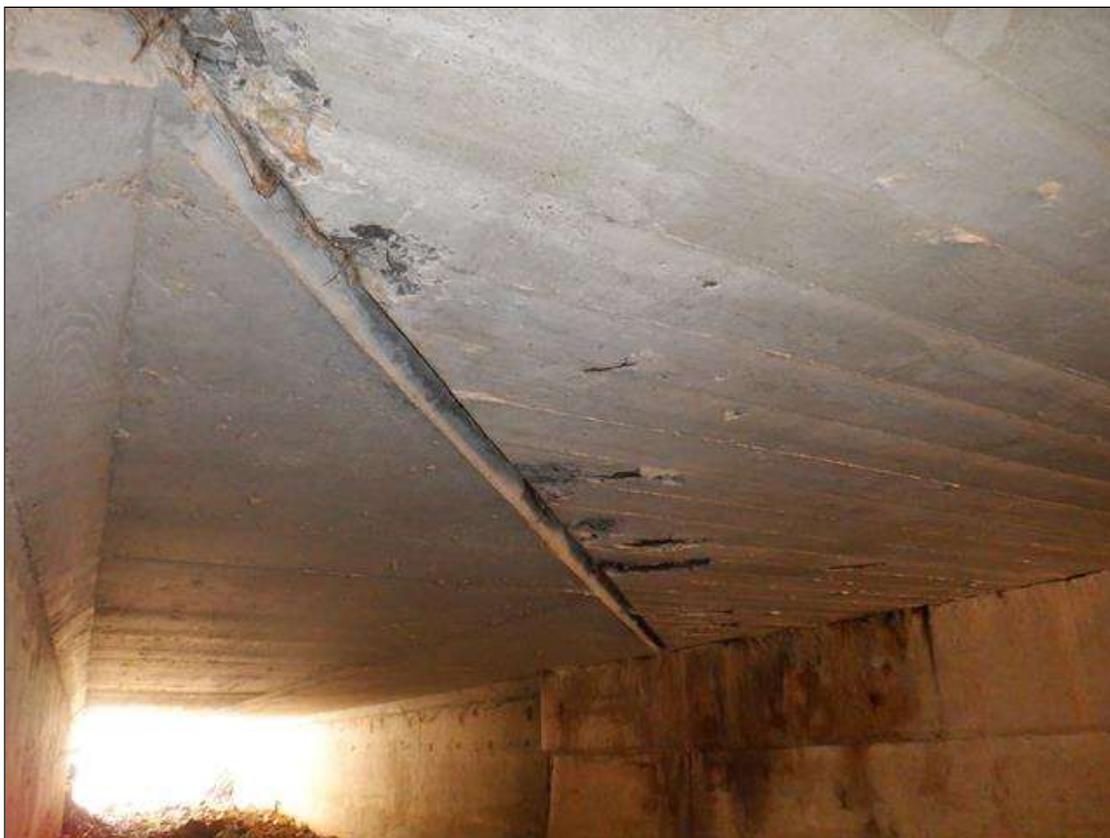
Span 1 - Slab Slab 1: NUMEROUS SPALLS UP TO 1 FOOT DIAMETER X 0.5 INCHES DEEP ALONG THE LEFT SIDE, SOME WITH EXPOSED REINFORCING. (PAR)

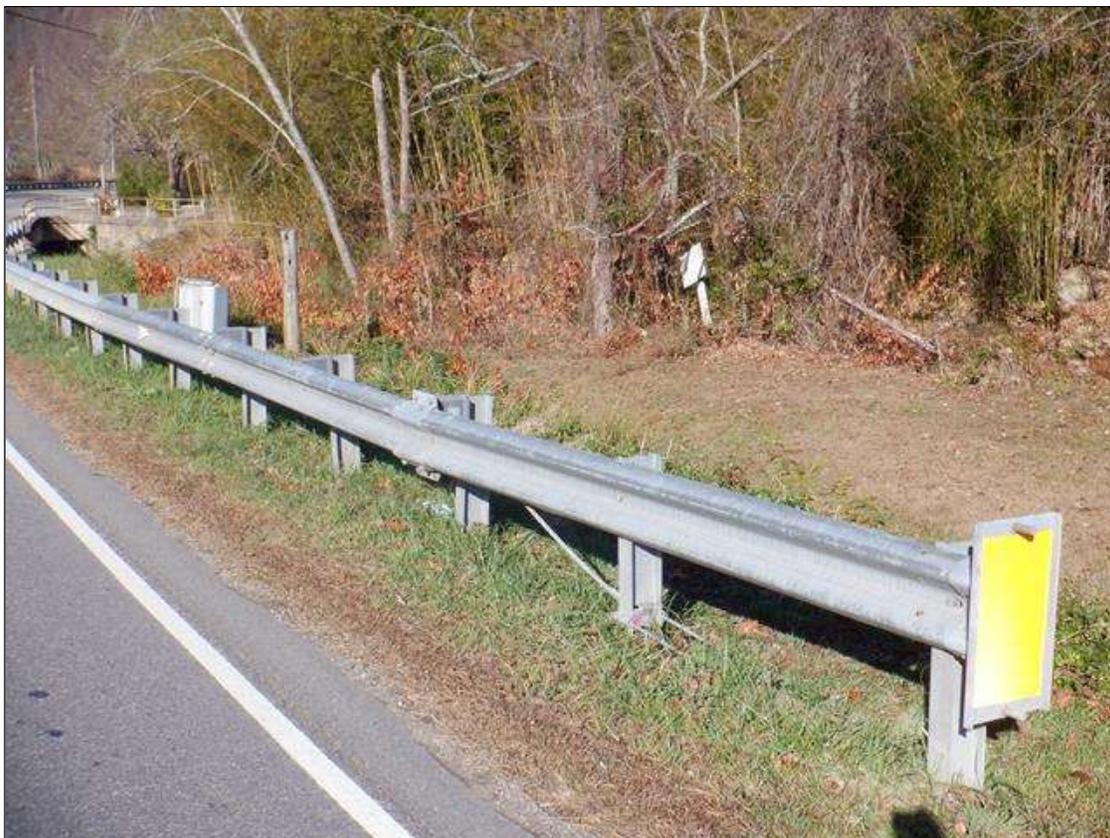
APPROACH RAIL END TREATMENT AT THE NORTH WEST CORNER. SOUTH EAST RAIL END IS OFF SITE.

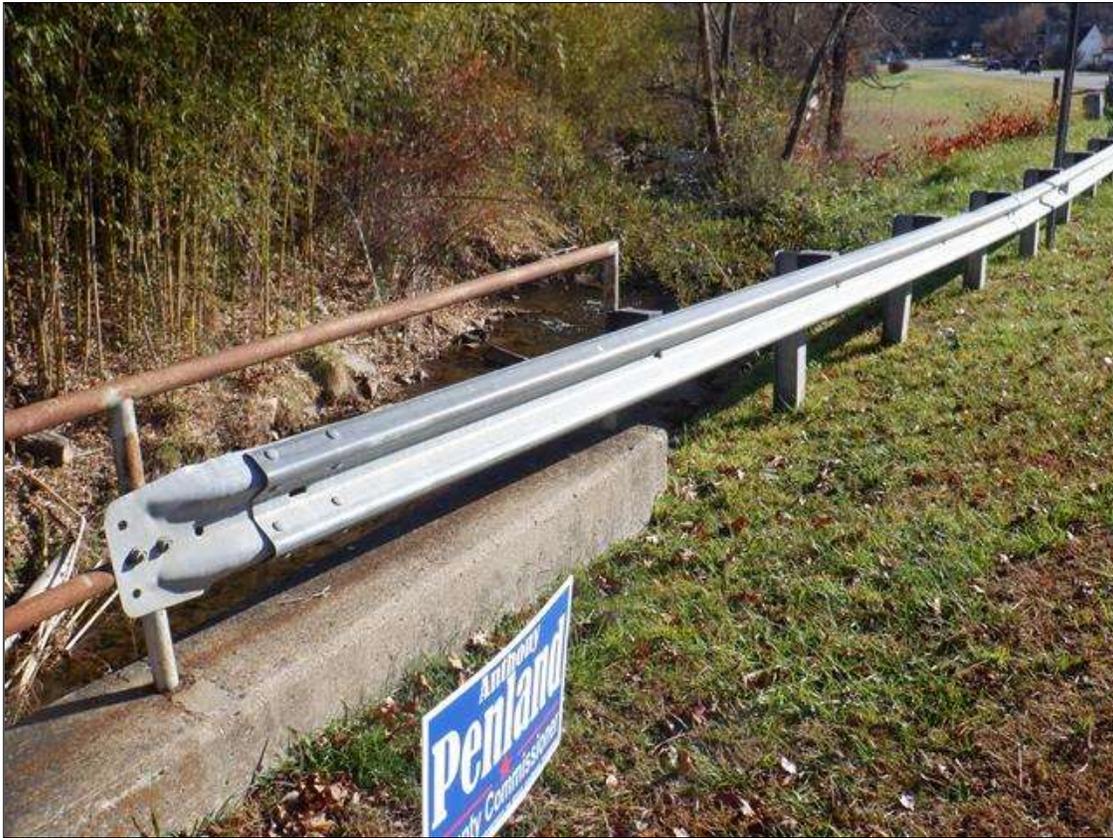
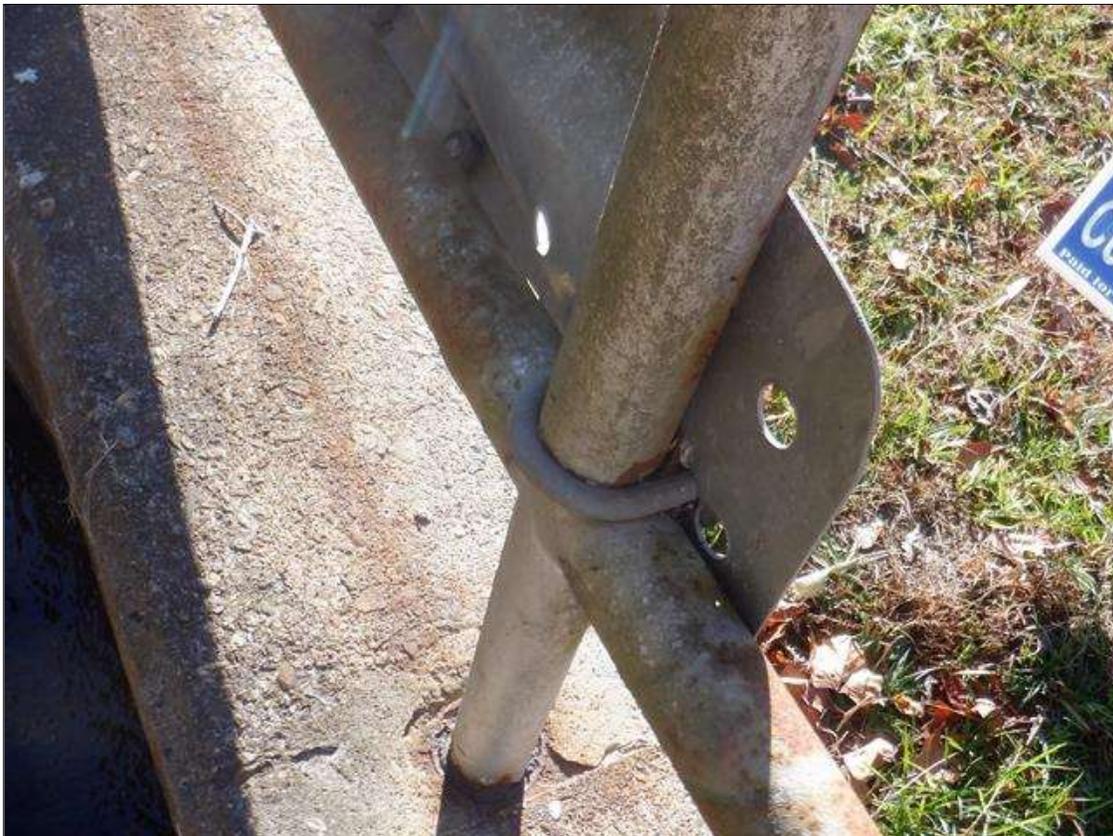
APPROACH RAILING AT NORTH WEST AND SOUTH EAST CORNER IS CONNECTED TO BRIDGE RAIL BY ONE U BOLT.
