BRIDGE SCOUR REPORT

COUNTY: BUNCOMBE BRIDGE: 154 ROUTE: SR 1003 STREAM CROSSED: BIG IVY CK

**Unknown Foundation Determination**  
**Substructure Report**  
**Buncombe 100154**  
**Paint Fork Rd. (SR 1003) over Big Ivy Creek**

FDH Project # 08-06077E

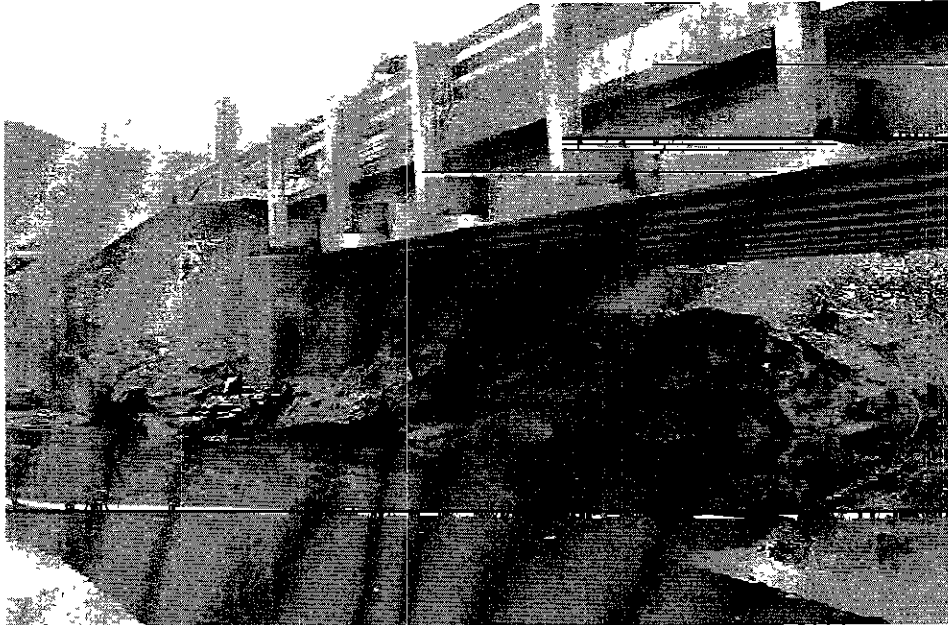
Foundation consists of concrete abutments with concrete footer and rock. We are unable to confirm the elevation of EB1 due to large rocks at the footer of the abutment (See Photos). B1 is 17.6 ft and EB2 is 14.1 ft from the top of rail to bottom of footer. Sounding data indicates EB2 is resting on material 50/1". B1 is resting on material too hard to penetrate with sounding rods.

**Large rocks on footer of EB1.**

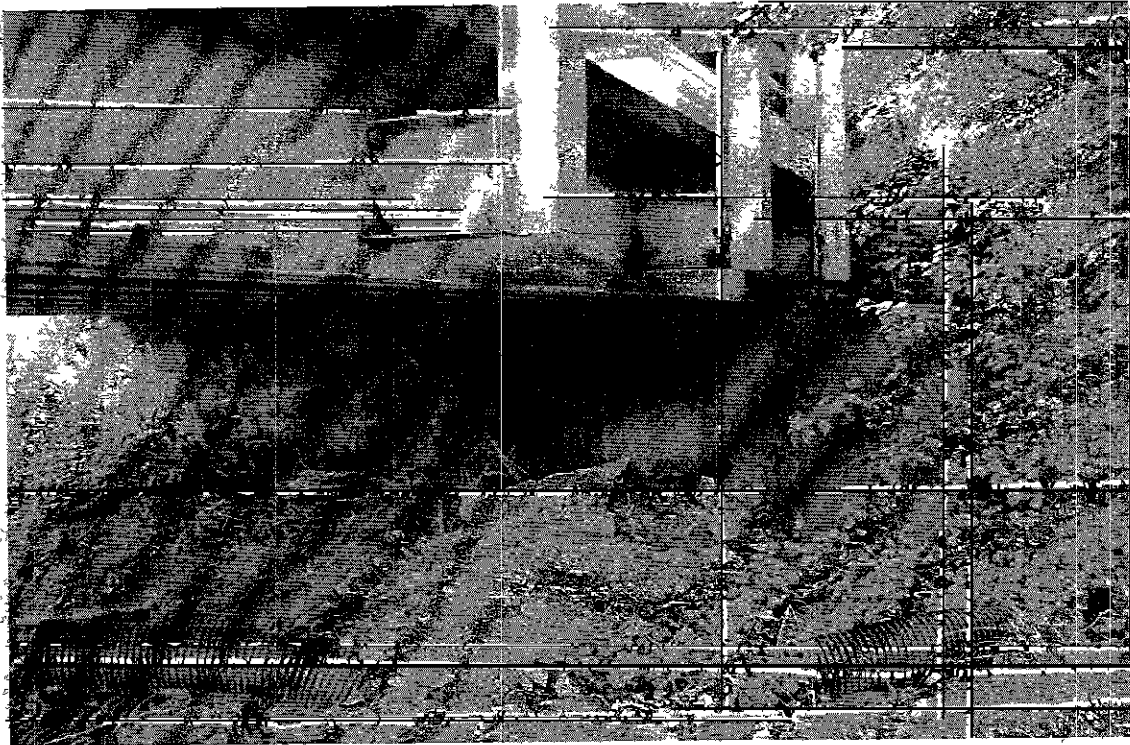
**View of EB2.**

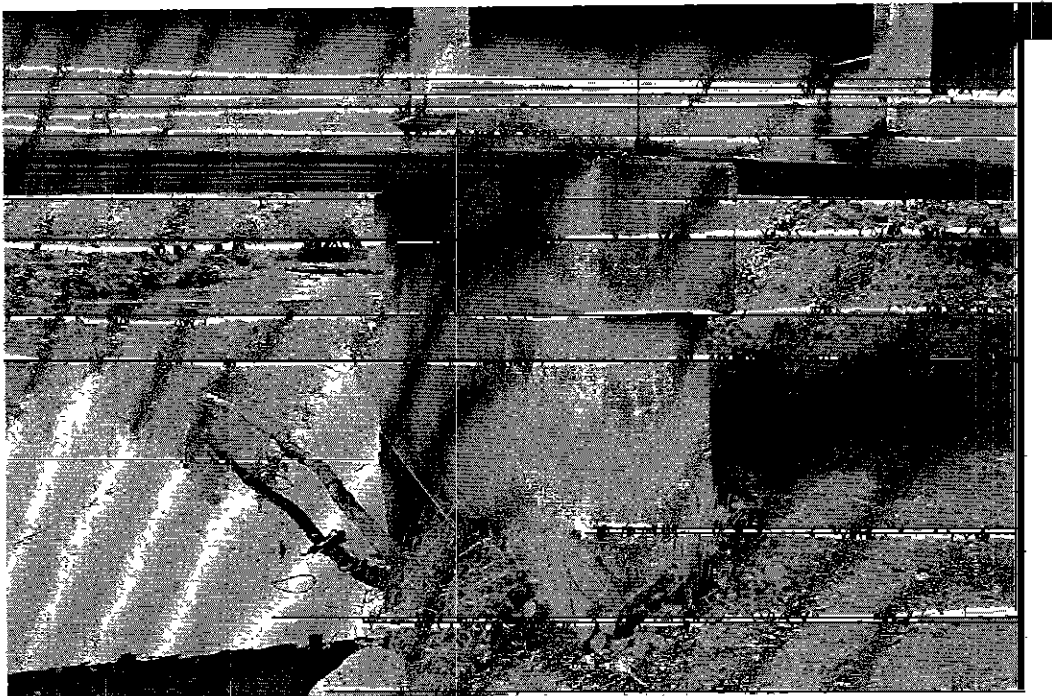
**View of B1.**
