NC DEPARTMENT OF TRANSPORTATION  
 DIVISION OF HIGHWAYS  
 STRUCTURE MANAGEMENT UNIT

# Structure Safety Report

## Routine Element Inspection - Contract

STRUCTURE NUMBER: 100154      SAP STRUCTURE NO: 0110154      FHWA STRUCTURE NO: 00000000210154

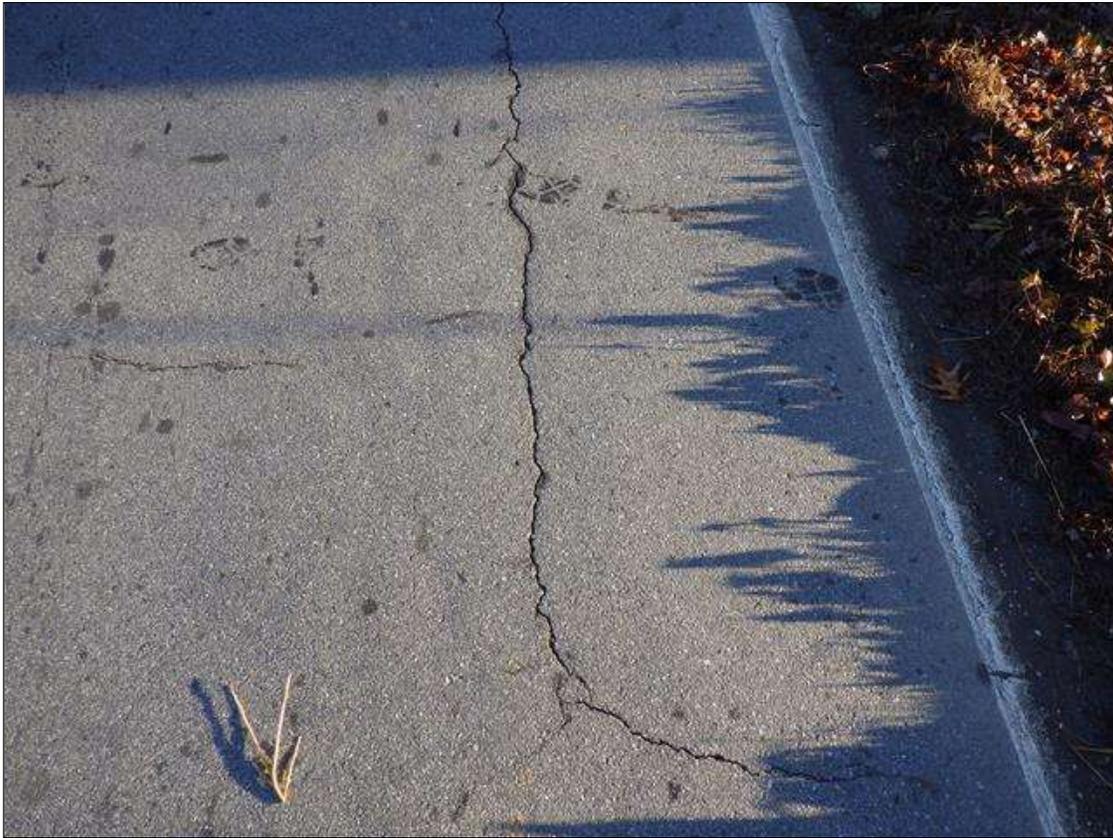
(2) LONGITUDINAL CRACKS UP TO INTERMITTENT 40 FEET LONG IN THE NORTHBOUND LANE OF THE NORTH APPROACH AT END BENT 2

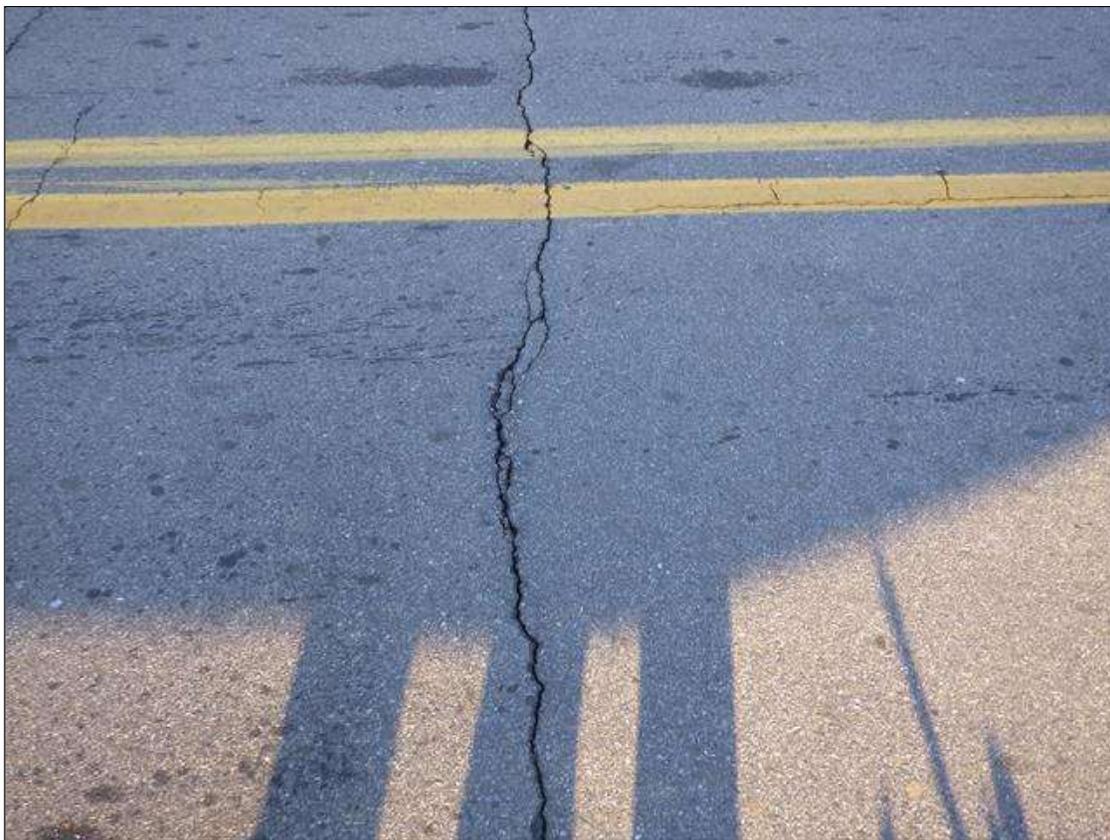
Span 2 Wearing Surface: TRANSVERSE CRACK UP TO FULL WIDTH X 1/4 INCH WIDE AT END BENT 2

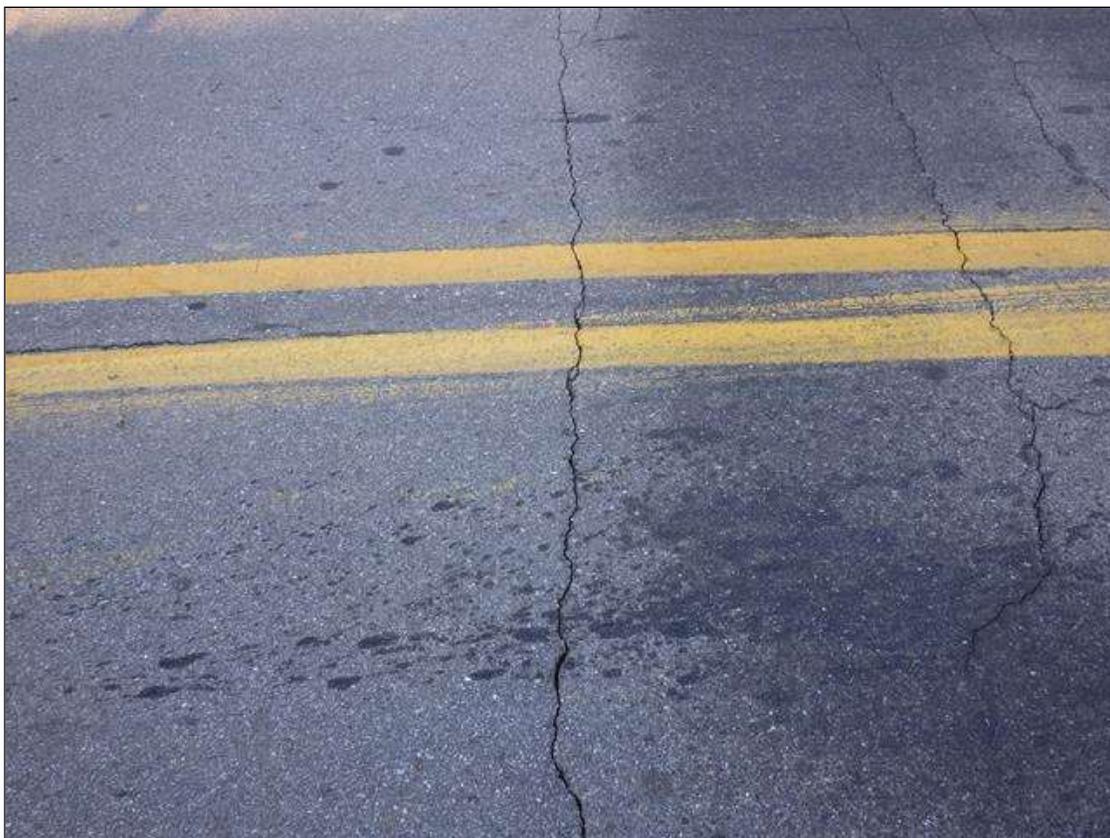
Span 1 Wearing Surface: TRANSVERSE CRACK UP TO FULL WIDTH X 1/4 INCH WIDE AT END BENT 1

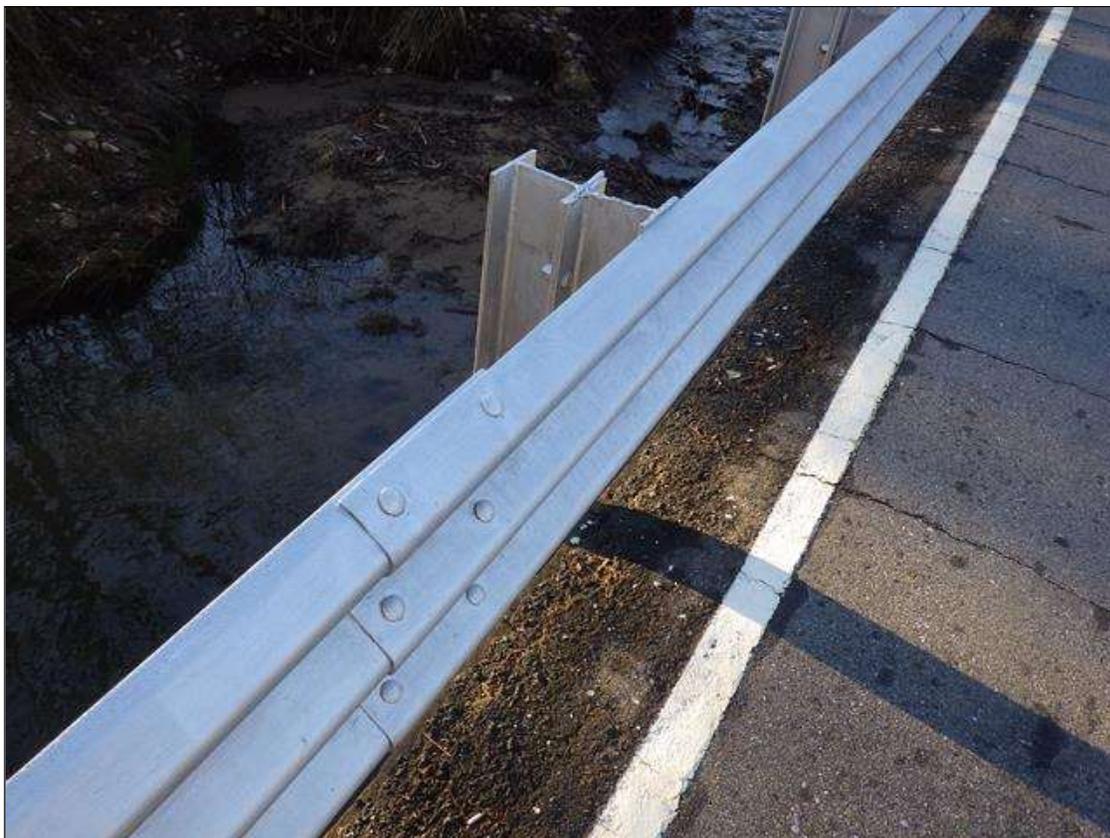
Span 2 Right Bridge Rail: RAIL HAS BEEN PAINTED PRIOR TO 2023 INSPECTION CYCLE

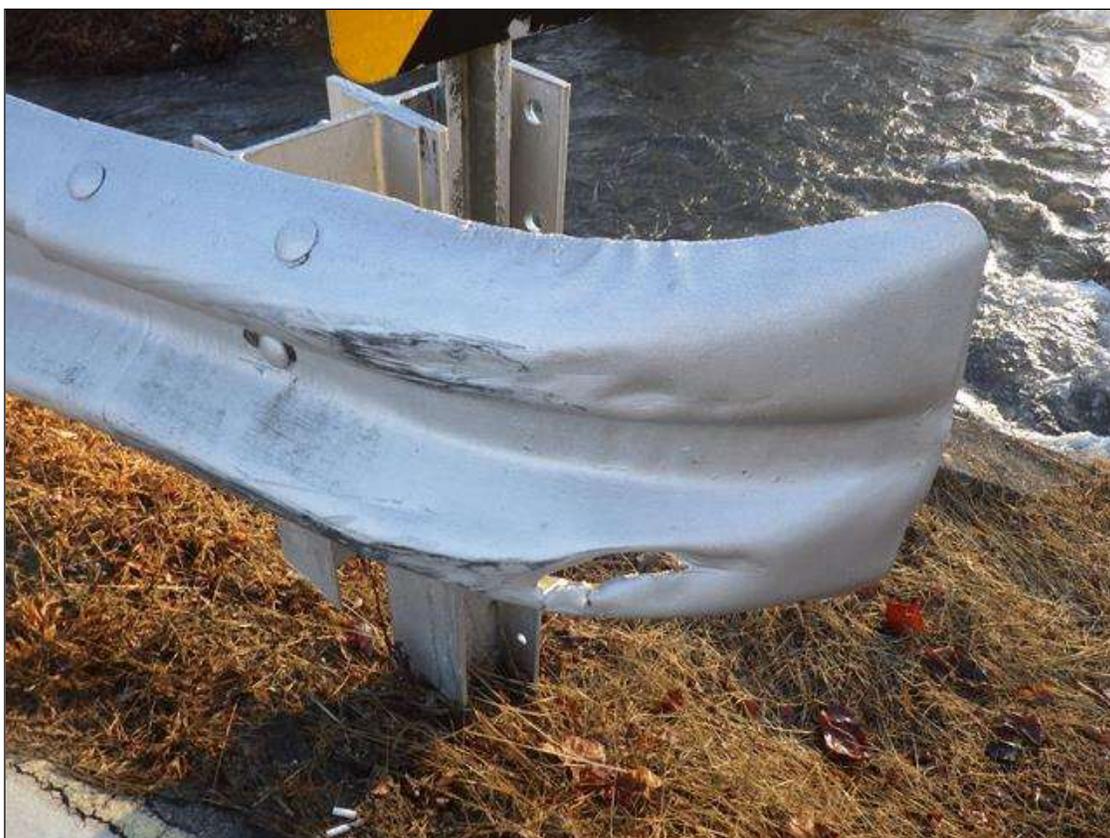
Span 1 Right Bridge Rail: IMPACT DAMAGE UP TO 2 FEET LONG WITH HOLE UP TO 3 INCHES LONG X 1 INCH HIGH IN THE SOUTH END TERMINAL (PRIORITY ACTION REQUEST)

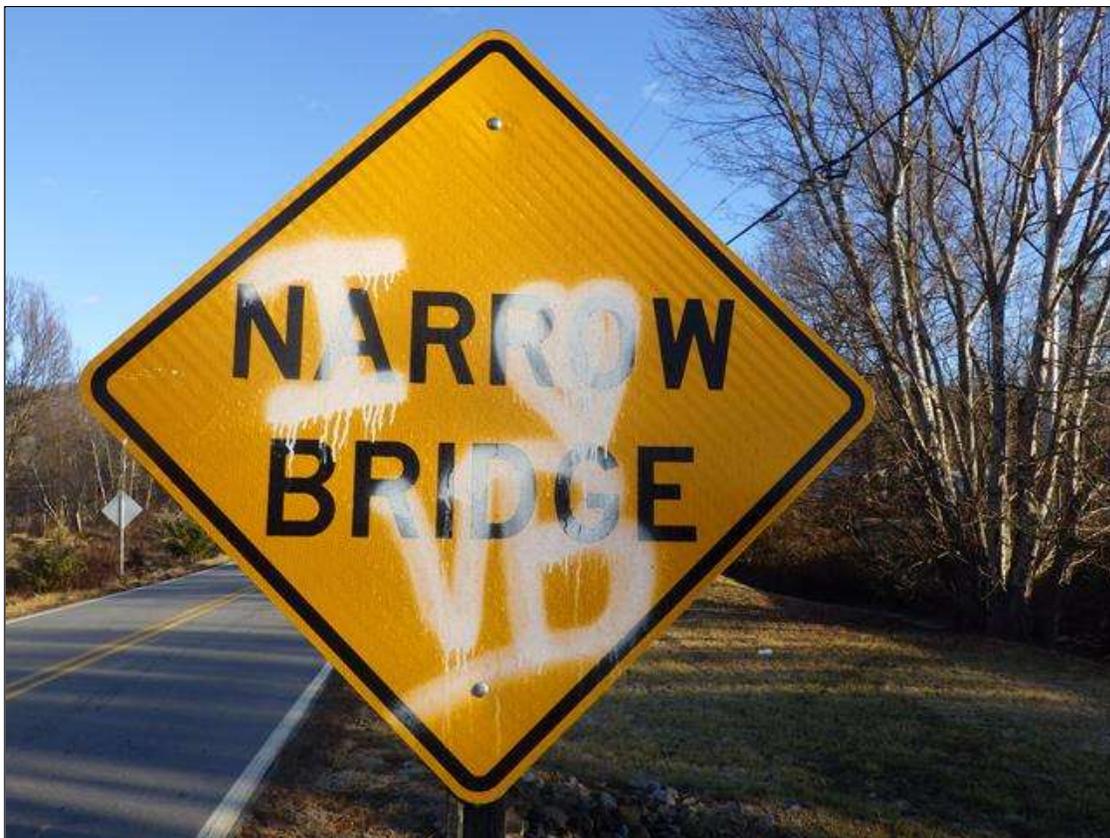
3250	Other Ground Mounted Signs	Other Ground Mounted Signs	
Priority Level	Defect Type	Quantity	Defect Description
2		1	SOUTHEAST NARROW BRIDGE SIGN IS DEFACED WITH PAINT (PRIORITY ACTION REQUEST)

SOUTHEAST NARROW BRIDGE SIGN IS DEFACED WITH PAINT (PRIORITY ACTION REQUEST)

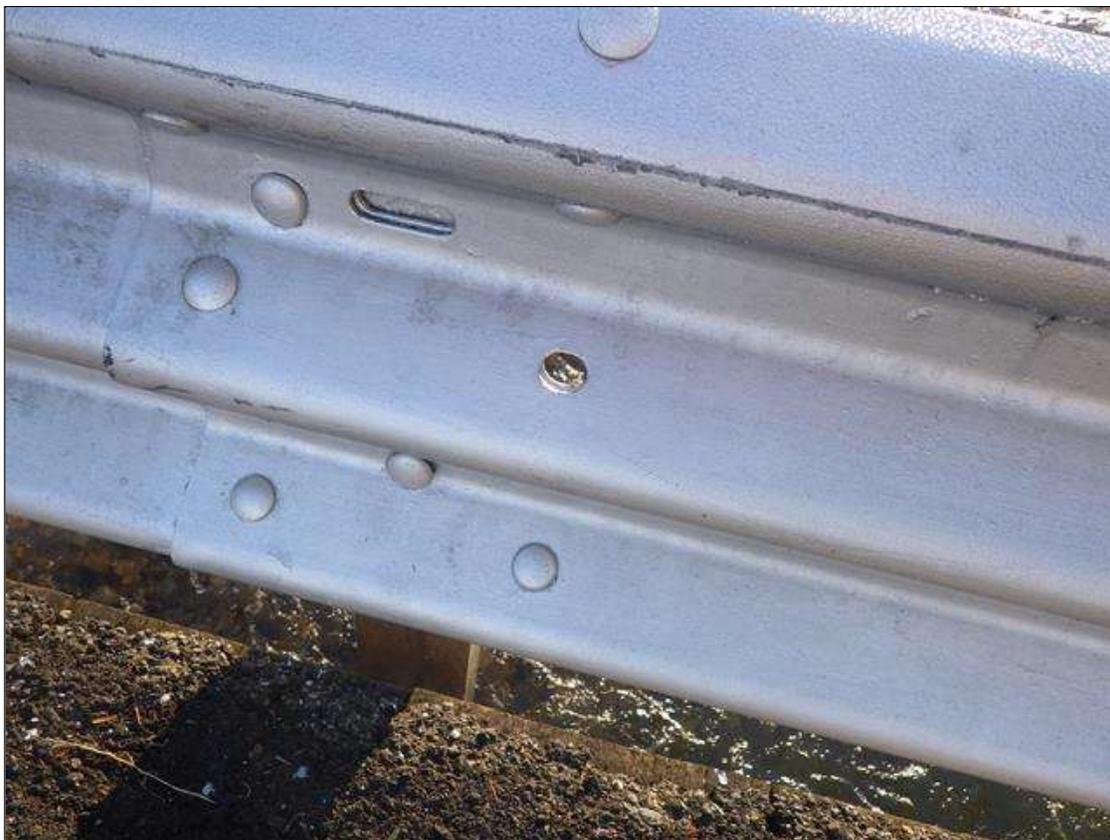
Span 1 Right Bridge Rail: MISSING (1) ANCHOR BOLT AT POST 3 (PRIORITY ACTION REQUEST)

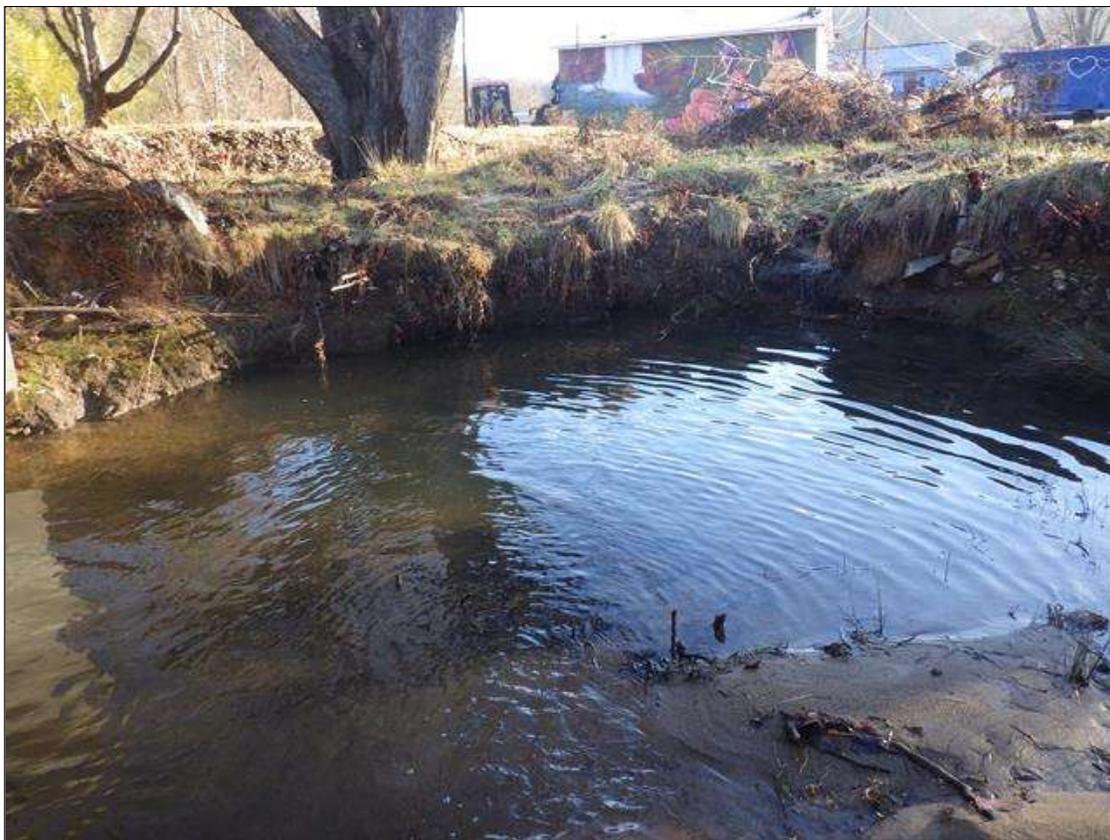
SCOUR HOLE UP TO 20 FEET DIAMETER X 3 FEET DEEP AT THE EAST END OF END BENT 2

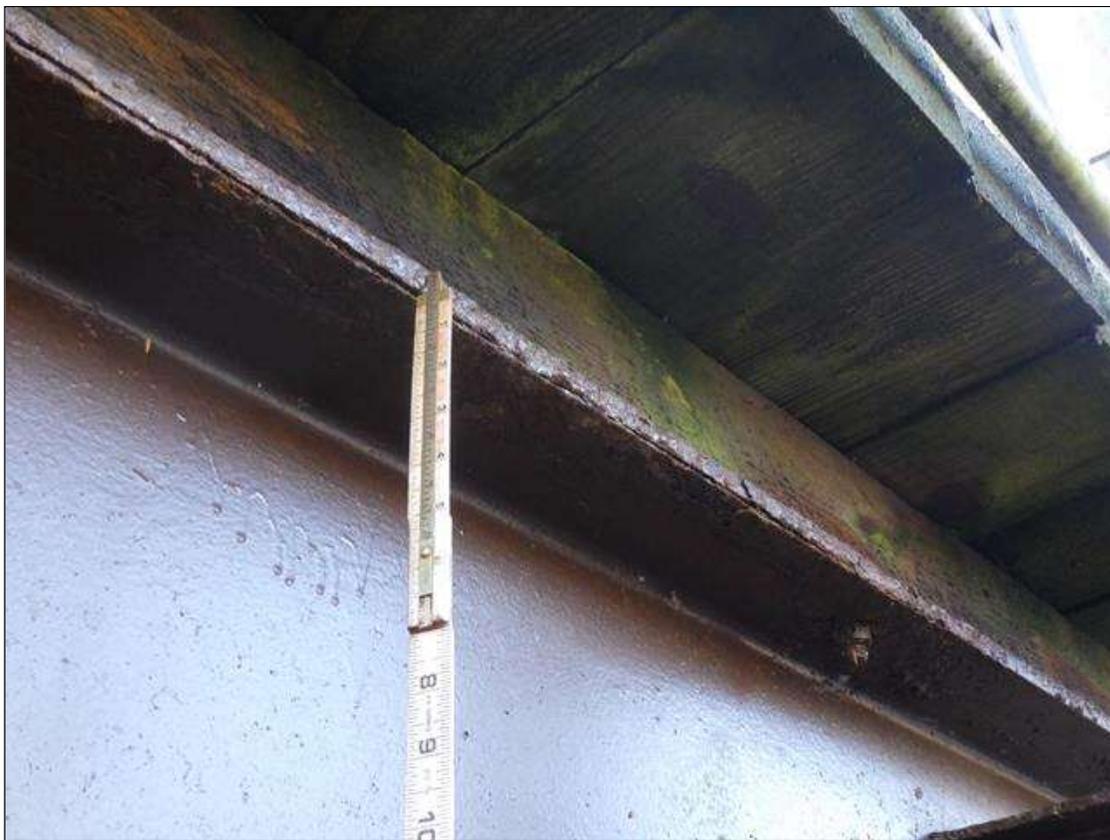
Span 2 Beam 1: ARRESTED CORROSION UP TO INTERMITTENT FULL LENGTH X FULL WIDTH WITH 7/16 INCH REMAINING (GREATER THAN OR EQUAL TO 1/16 INCH SECTION LOSS, LESS THAN 25 PERCENT SECTION LOSS) IN THE TOP FLANGE

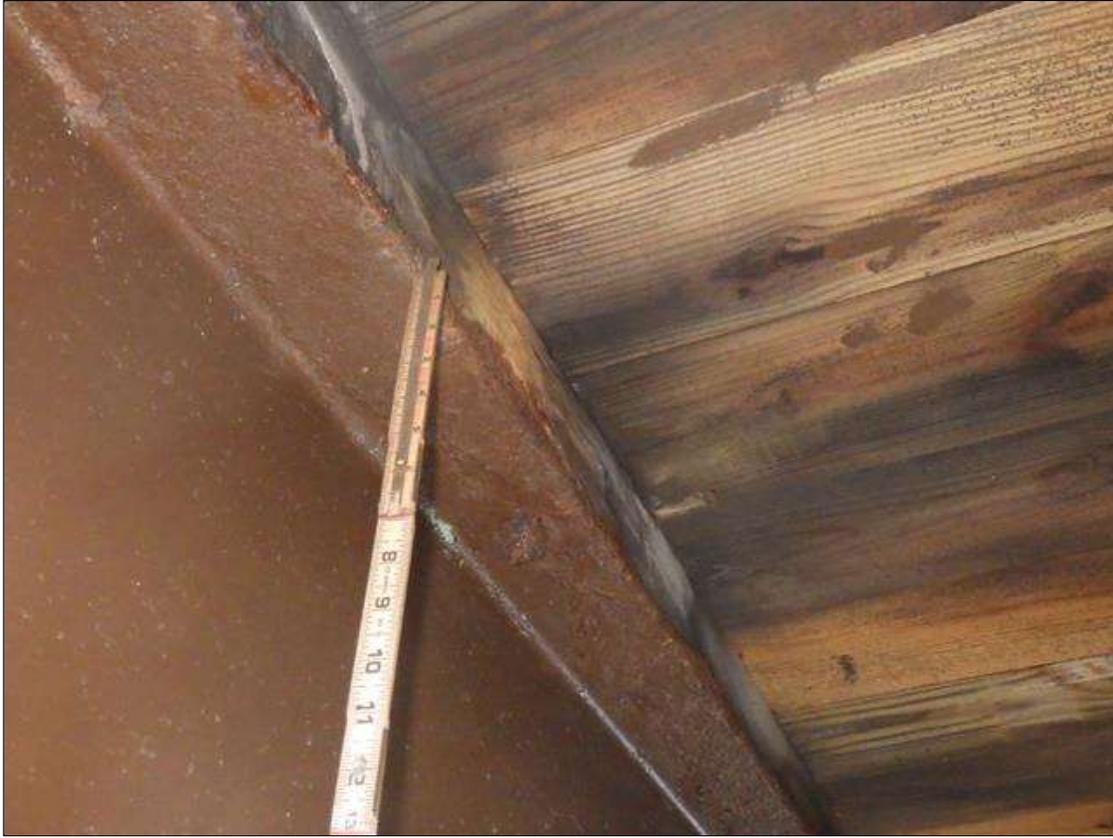
Span 2 Beam 2: ARRESTED CORROSION UP TO INTERMITTENT FULL LENGTH X FULL WIDTH WITH 7/16 INCH REMAINING (GREATER THAN OR EQUAL TO 1/16 INCH SECTION LOSS, LESS THAN 25 PERCENT SECTION LOSS) IN THE TOP FLANGE

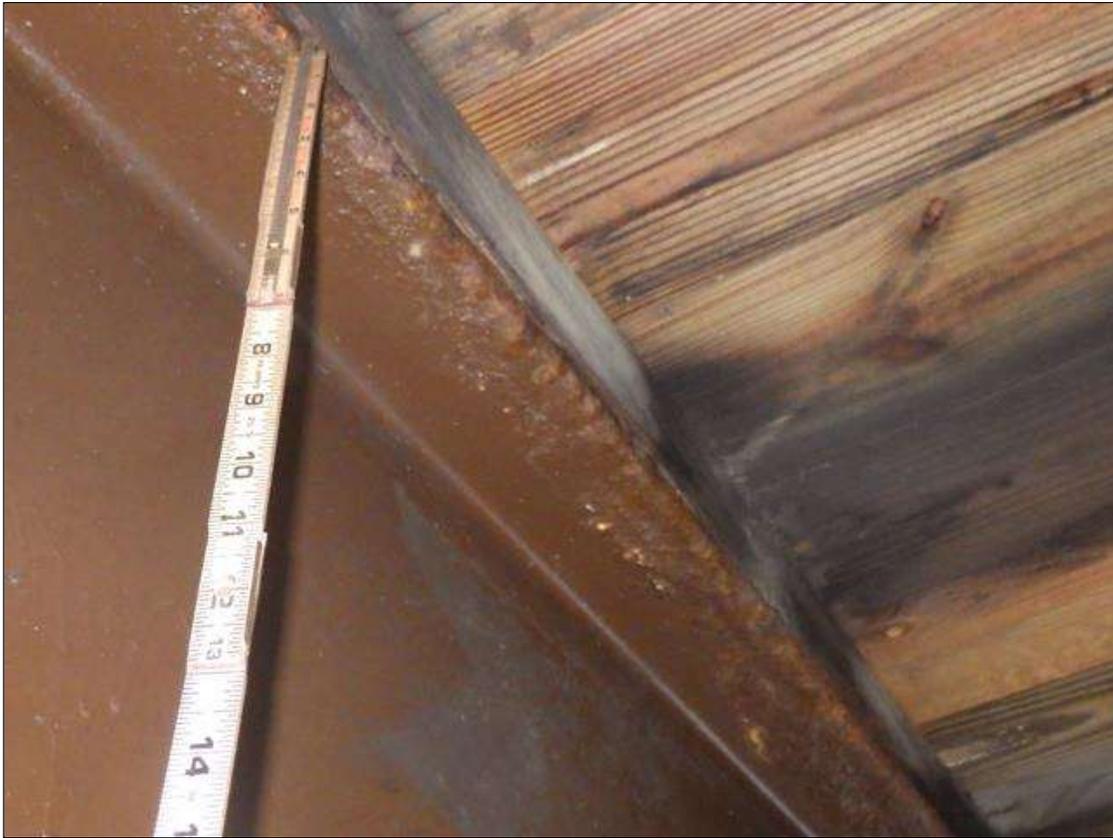
Span 2 Beam 3: ARRESTED CORROSION UP TO INTERMITTENT FULL LENGTH X FULL WIDTH WITH 7/16 INCH REMAINING (GREATER THAN OR EQUAL TO 1/16 INCH SECTION LOSS, LESS THAN 25 PERCENT SECTION LOSS) IN THE TOP FLANGE

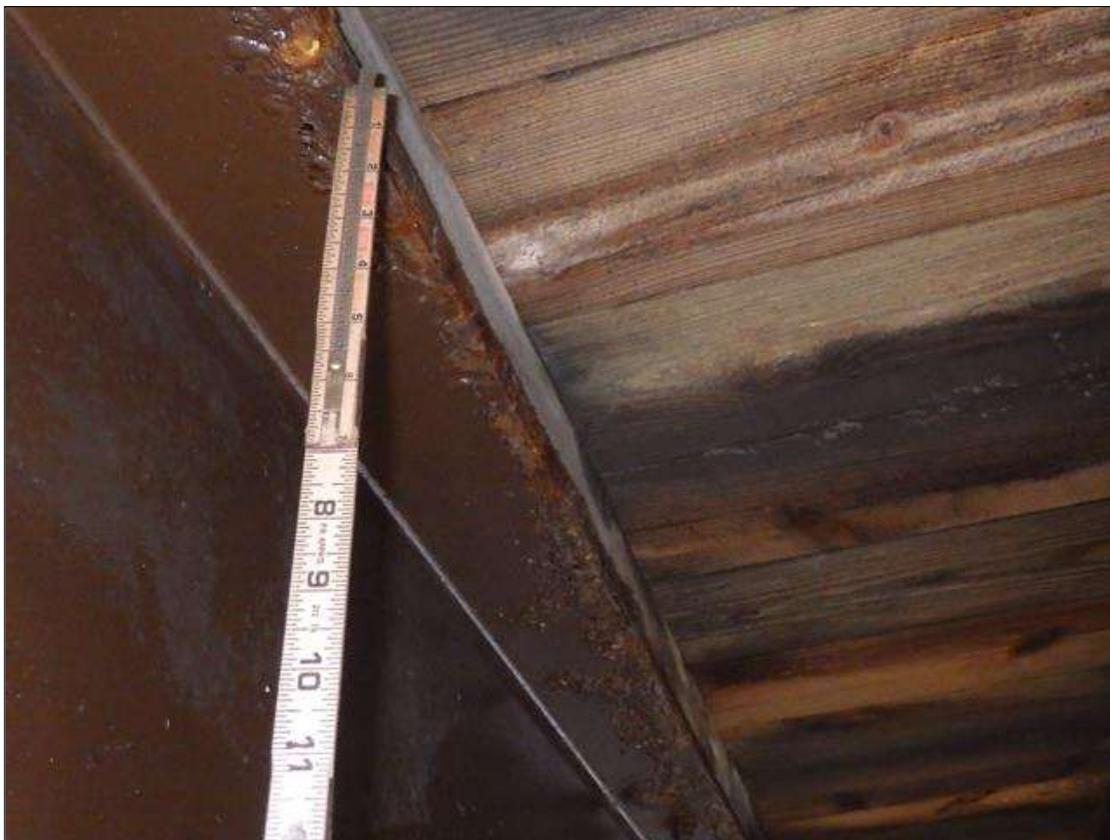
Span 2 Beam 4: ARRESTED CORROSION UP TO INTERMITTENT FULL LENGTH X FULL WIDTH WITH 7/16 INCH REMAINING (GREATER THAN OR EQUAL TO 1/16 INCH SECTION LOSS, LESS THAN 25 PERCENT SECTION LOSS) IN THE TOP FLANGE

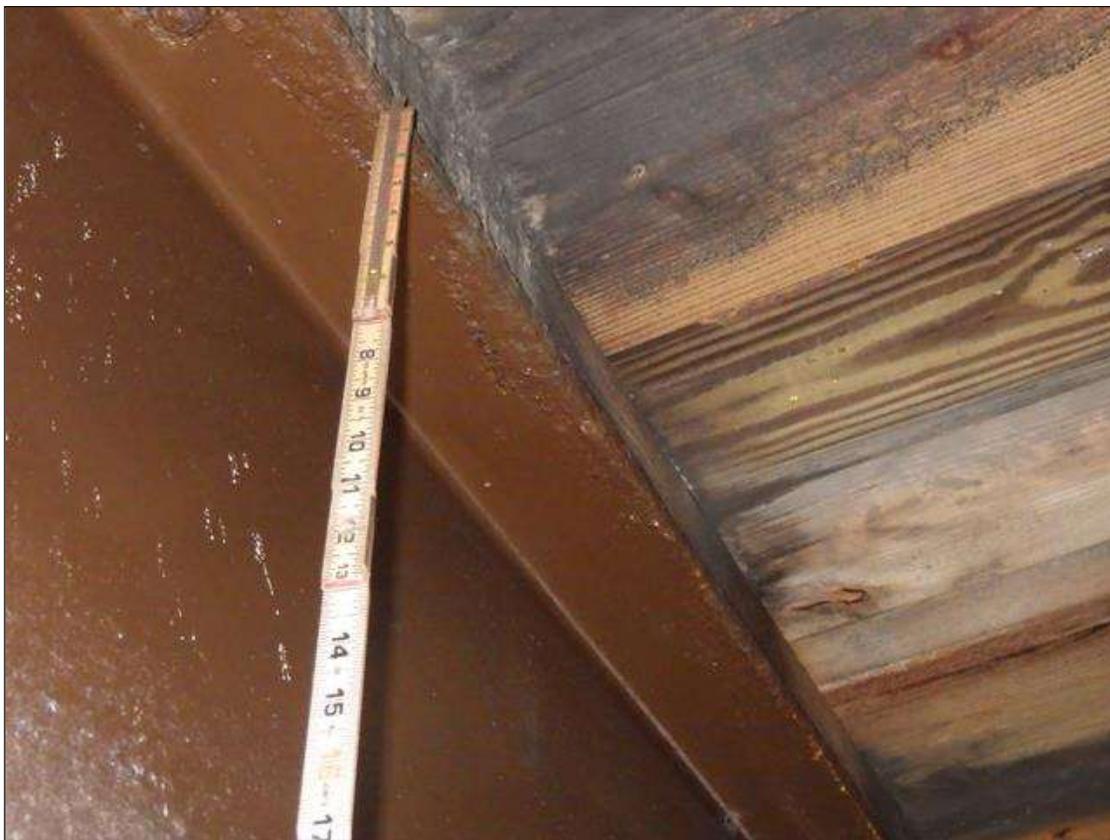
Span 2 Beam 5: ARRESTED CORROSION UP TO INTERMITTENT FULL LENGTH X FULL WIDTH WITH 7/16 INCH REMAINING (GREATER THAN OR EQUAL TO 1/16 INCH SECTION LOSS, LESS THAN 25 PERCENT SECTION LOSS) IN THE TOP FLANGE

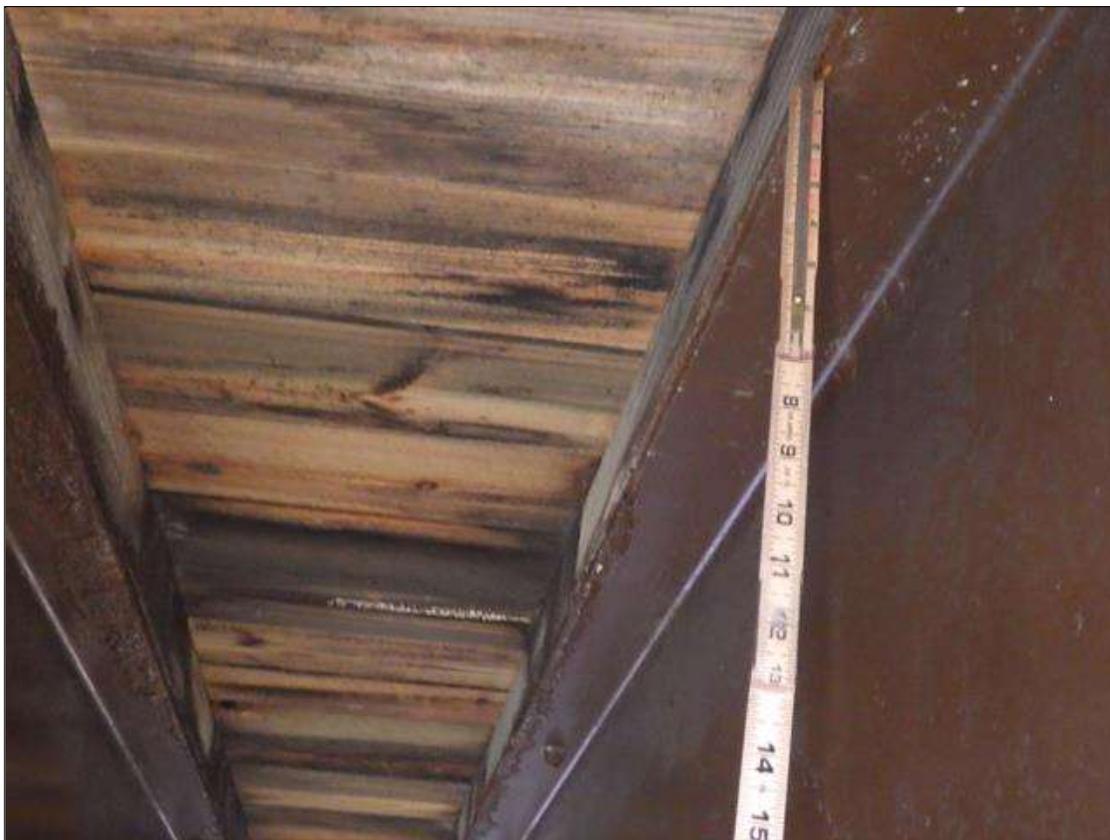
Span 2 Beam 7: ARRESTED CORROSION UP TO INTERMITTENT FULL LENGTH X FULL WIDTH WITH 7/16 INCH REMAINING (GREATER THAN OR EQUAL TO 1/16 INCH SECTION LOSS, LESS THAN 25 PERCENT SECTION LOSS) IN THE TOP FLANGE

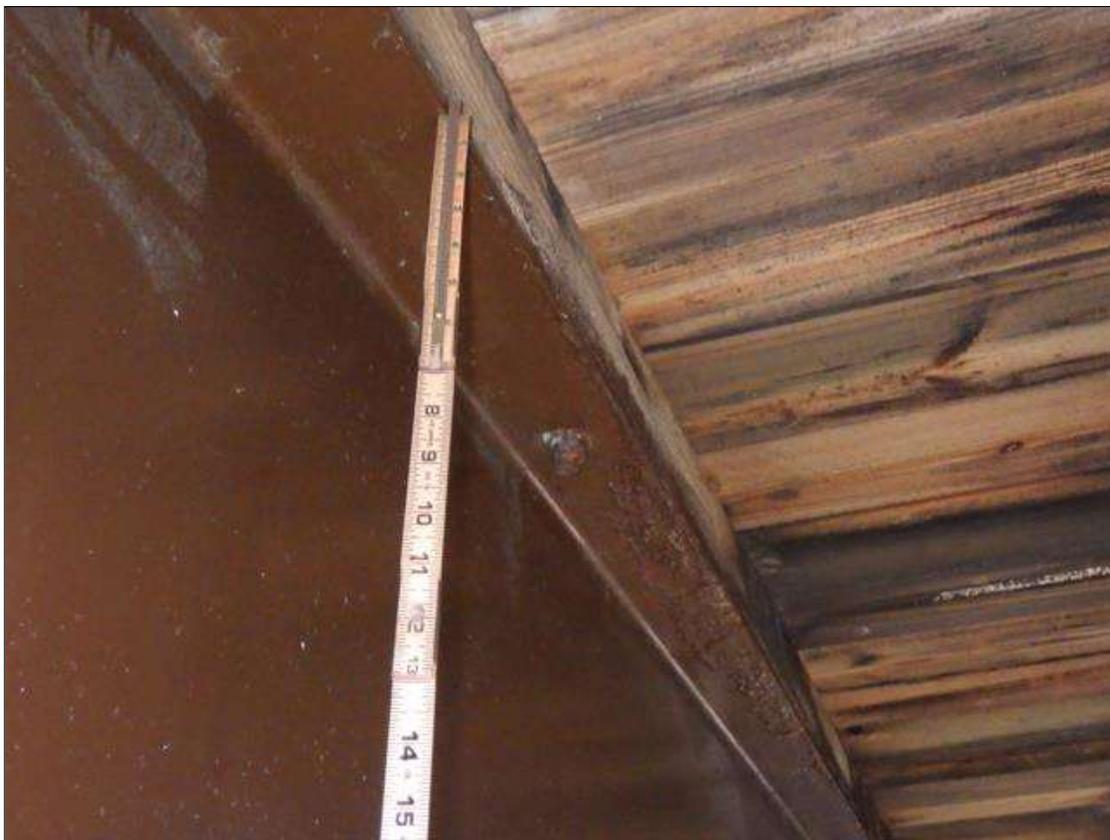
Span 2 Beam 8: ARRESTED CORROSION UP TO INTERMITTENT FULL LENGTH X FULL WIDTH WITH 7/16 INCH REMAINING (GREATER THAN OR EQUAL TO 1/16 INCH SECTION LOSS, LESS THAN 25 PERCENT SECTION LOSS) IN THE TOP FLANGE

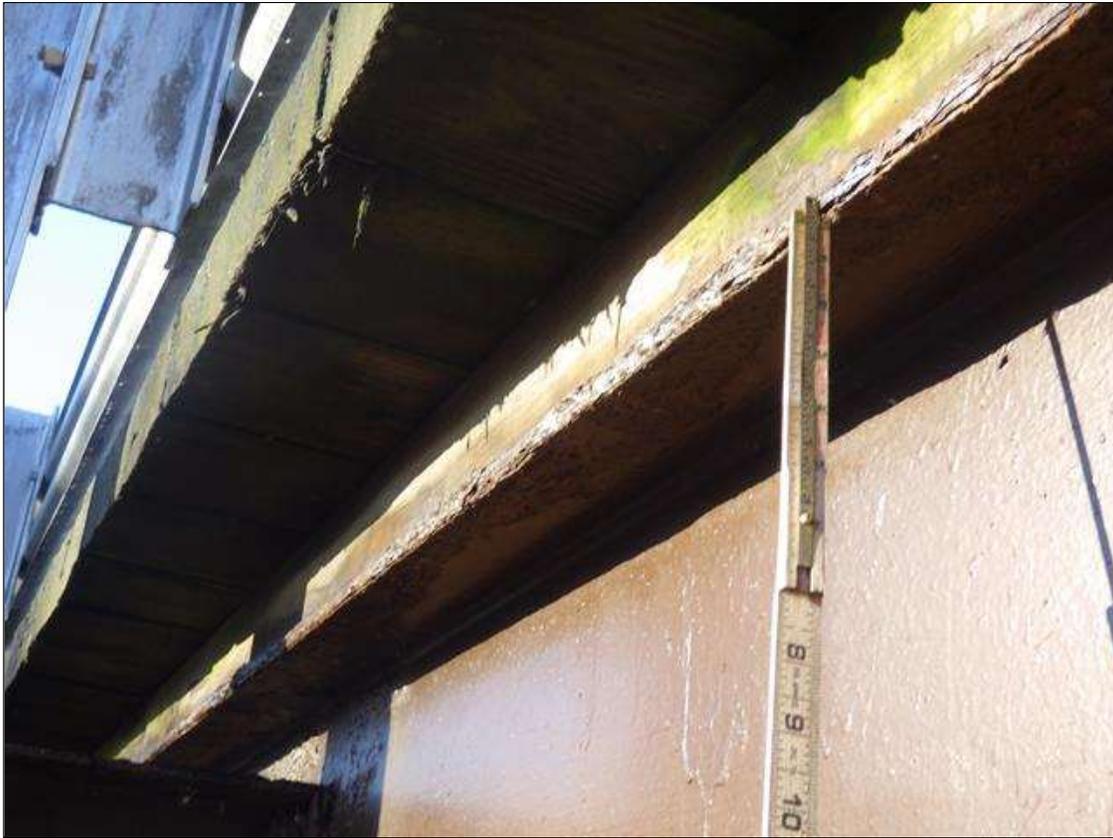
3314	Beam 9	Plate Girder		
Priority Level	Defect Type	Quantity	Defect Description	
2	Corrosion	41	Span 2 Beam 9: ARRESTED CORROSION UP TO INTERMITTENT FULL LENGTH X FULL WIDTH WITH 3/8 INCH REMAINING (GREATER THAN OR EQUAL TO

Span 2 Beam 9: ARRESTED CORROSION UP TO INTERMITTENT FULL LENGTH X FULL WIDTH WITH 3/8 INCH REMAINING (GREATER THAN OR EQUAL TO 1/16 INCH SECTION LOSS, GREATER THAN 25 PERCENT SECTION LOSS) IN THE TOP FLANGE (PRIORITY ACTION REQUEST)

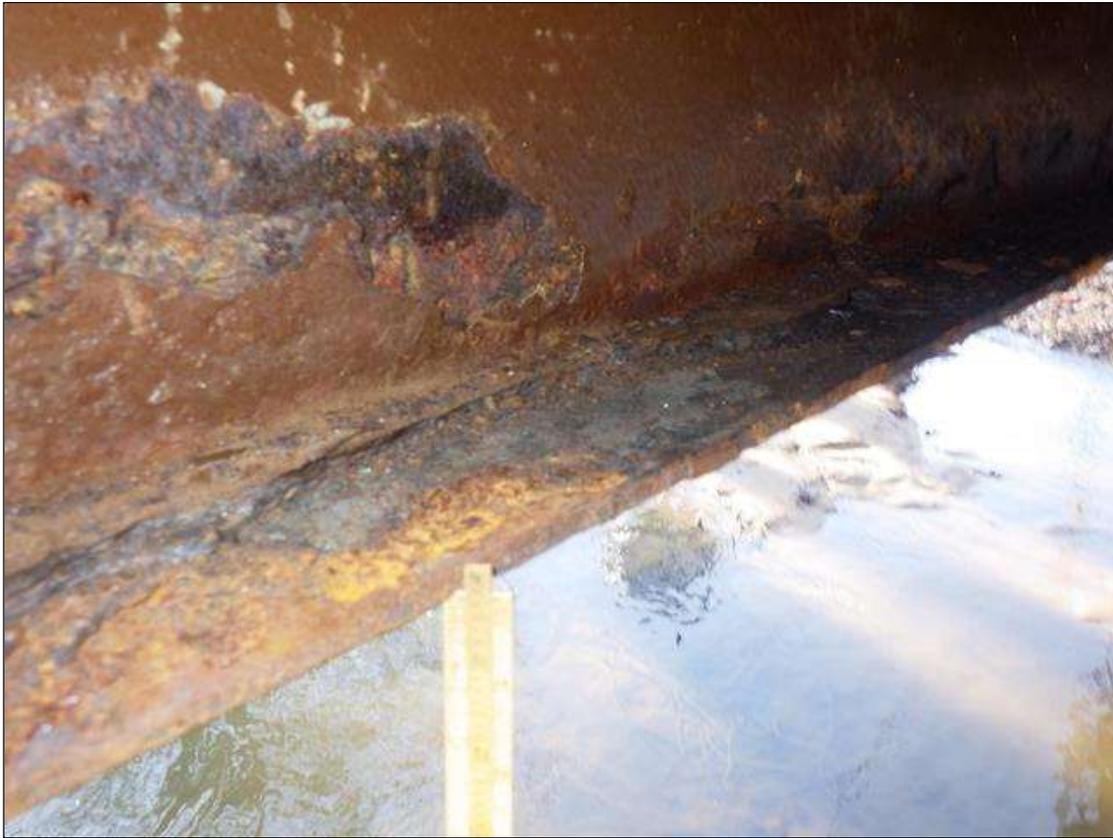
Span 2 Beam 9: ACTIVE CORROSION UP TO 7 FEET 8 INCHES LONG X FULL WIDTH WITH 3/16 INCH REMAINING (GREATER THAN OR EQUAL TO 1/16 INCH SECTION LOSS, GREATER THAN 25 PERCENT SECTION LOSS) IN THE BOTTOM FLANGE AT END BENT 2 (PRIORITY ACTION REQUEST)

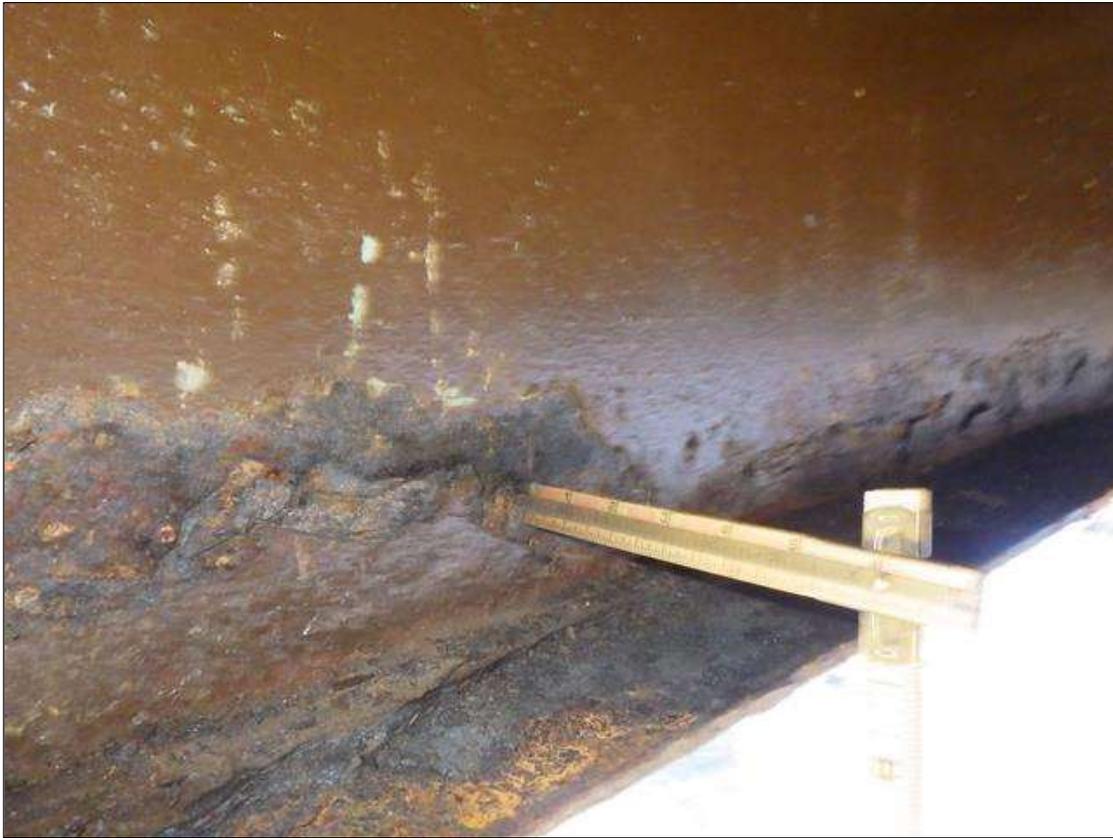
Span 2 Beam 9: ARRESTED CORROSION UP TO 7 FEET 8 INCHES LONG X 8 INCHES HIGH WITH 5/16 INCH REMAINING (GREATER THAN OR EQUAL TO 1/16 INCH SECTION LOSS, LESS THAN 25 PERCENT SECTION LOSS) IN THE WEB AT END BENT 2

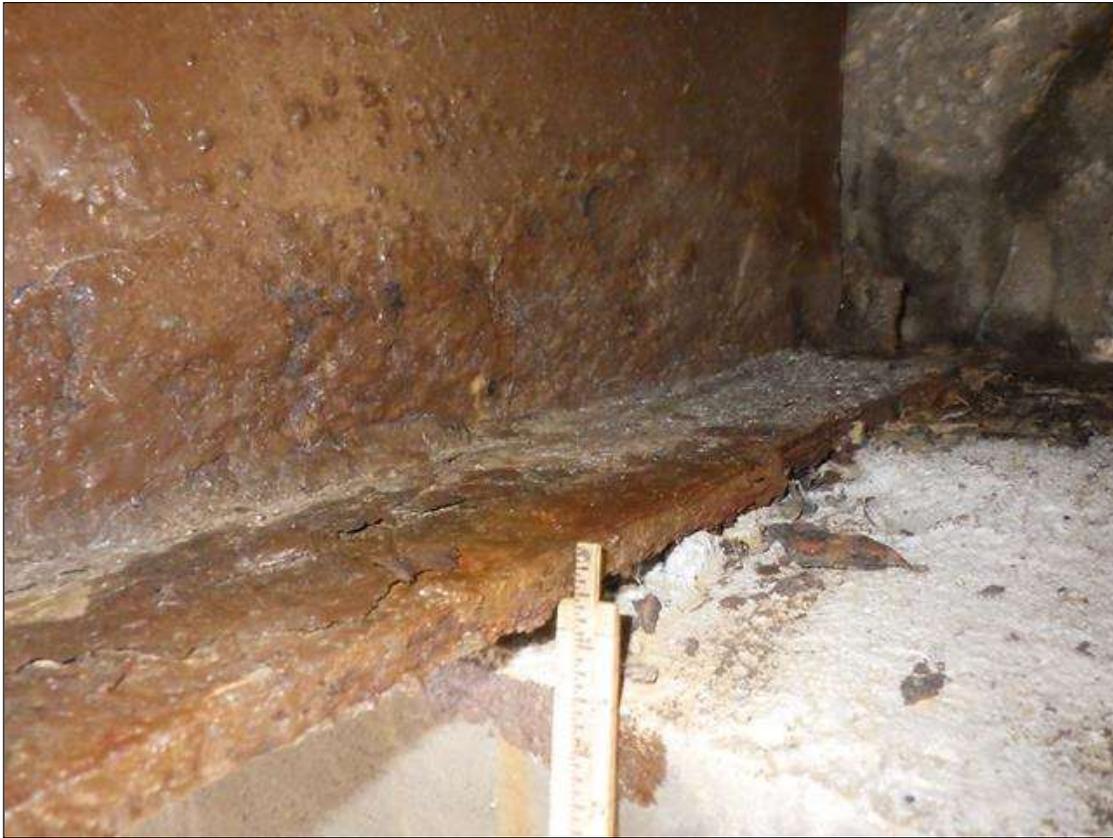
Span 2 Beam 8: ARRESTED CORROSION UP TO 1 FOOT 6 INCHES LONG X FULL WIDTH WITH 7/16 INCH REMAINING (GREATER THAN OR EQUAL TO 1/16 INCH SECTION LOSS, LESS THAN 25 PERCENT SECTION LOSS) IN THE BOTTOM FLANGE AT END BENT 2

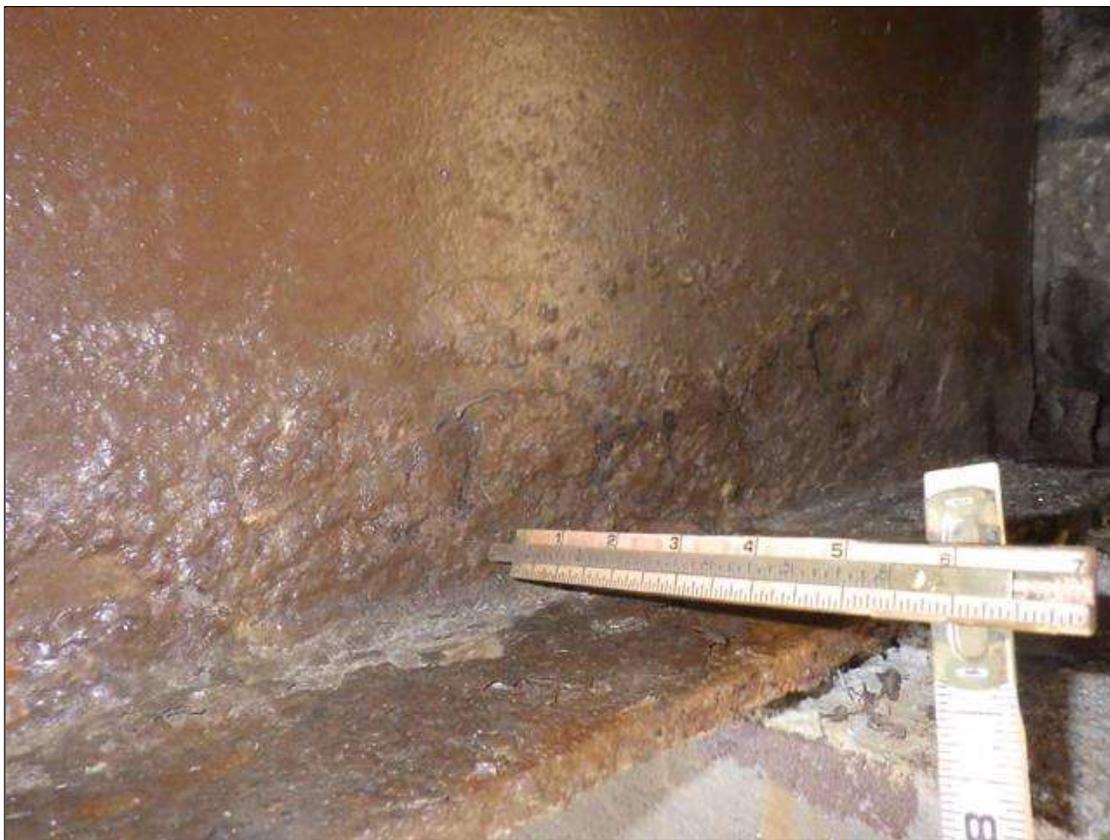
Span 2 Beam 8: ARRESTED CORROSION UP TO 1 FOOT 6 INCHES LONG X 4 INCHES HIGH WITH 5/16 INCH REMAINING (GREATER THAN OR EQUAL TO 1/16 INCH SECTION LOSS, LESS THAN 25 PERCENT SECTION LOSS) IN THE WEB AT END BENT 2

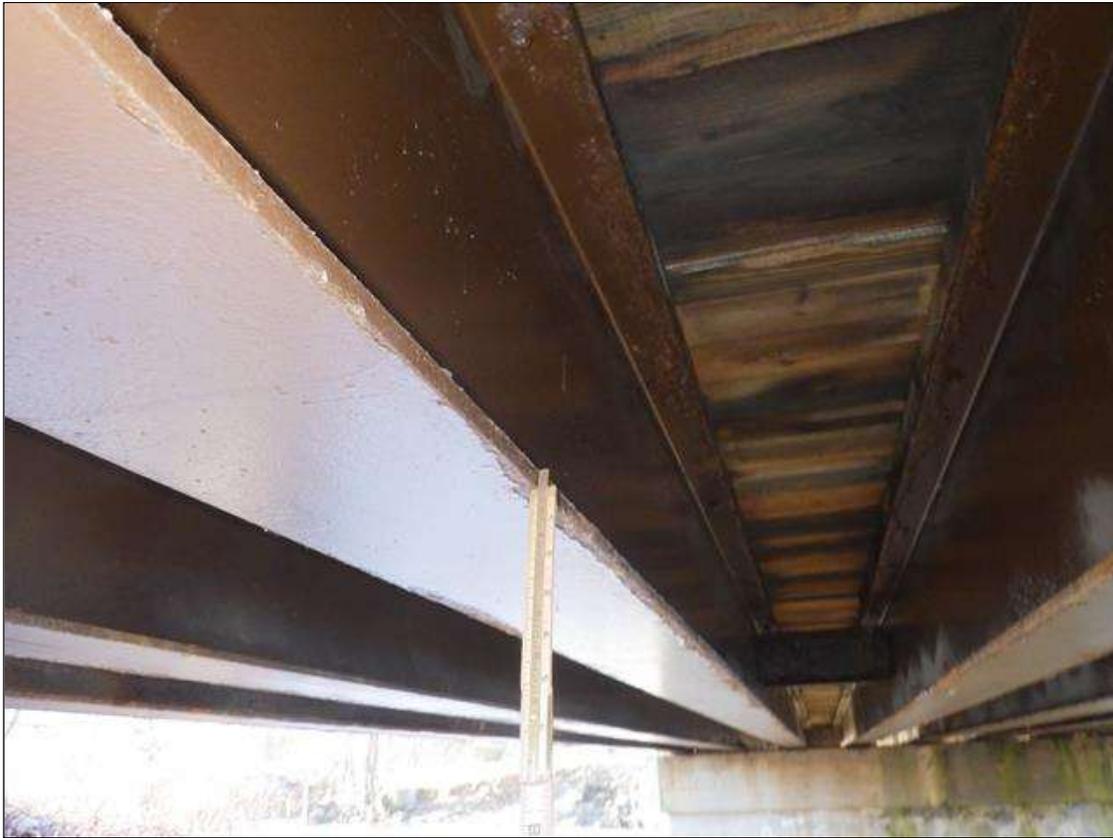
Span 2 Beam 7: ARRESTED CORROSION UP TO INTERMITTENT FULL LENGTH X FULL WIDTH WITH 1/32 INCH SECTION LOSS IN THE BOTTOM FLANGE

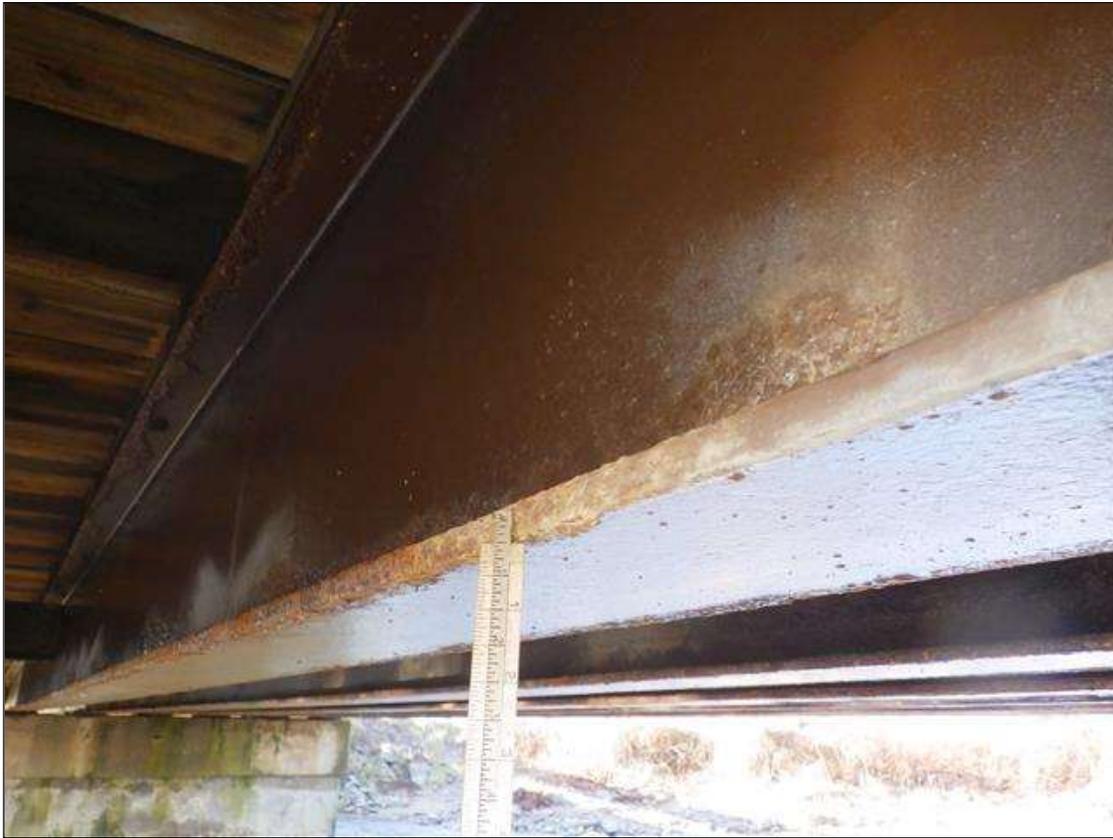
Span 2 Beam 6: ARRESTED CORROSION UP TO FULL LENGTH X INTERMITTENT FULL WIDTH WITH 7/16 INCH REMAINING (GREATER THAN OR EQUAL TO 1/16 INCH SECTION LOSS, LESS THAN 25 PERCENT SECTION LOSS) IN THE BOTTOM FLANGE

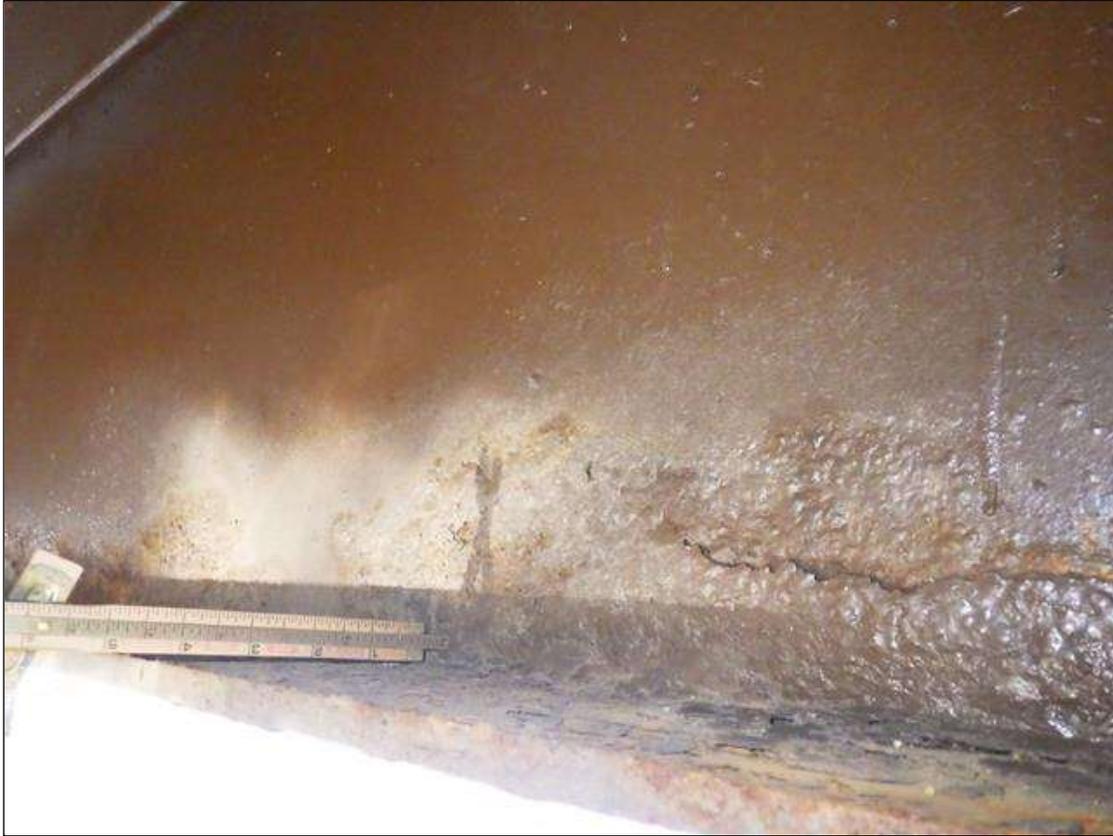
Span 2 Beam 6: ARRESTED CORROSION UP TO INTERMITTENT FULL LENGTH X 6 INCHES HIGH WITH 5/16 INCH REMAINING (GREATER THAN OR EQUAL TO 1/16 INCH SECTION LOSS, LESS THAN 25 PERCENT SECTION LOSS) IN THE WEB
