NC DEPARTMENT OF TRANSPORTATION  
 DIVISION OF HIGHWAYS  
 STRUCTURE MANAGEMENT UNIT

# Structure Safety Report

## Routine Element Inspection - Contract

STRUCTURE NUMBER: 100154      SAP STRUCTURE NO: 0110154      FHWA STRUCTURE NO: 00000000210154

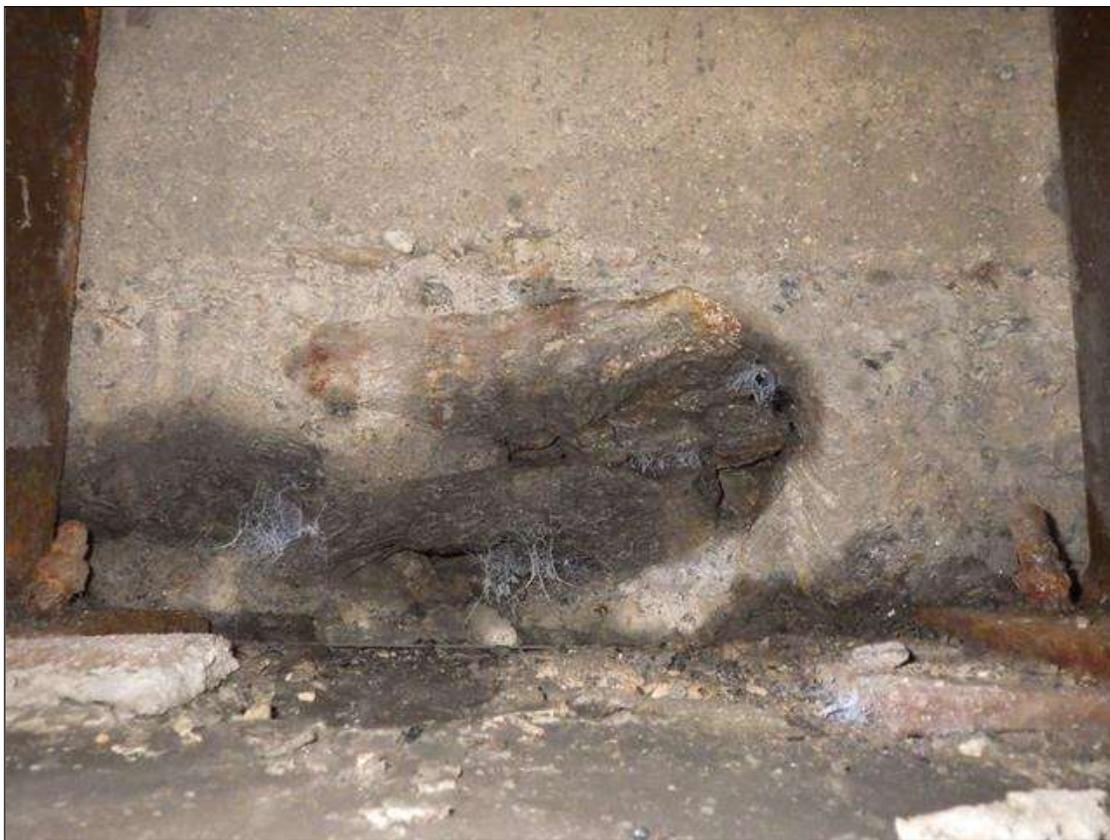
End Bent 2 Abutment: SPALLED AREA UP TO 9 INCHES LONG X 6 INCHES HIGH X 2 INCHES DEEP BELOW BAY 6 IN THE BACKWALL

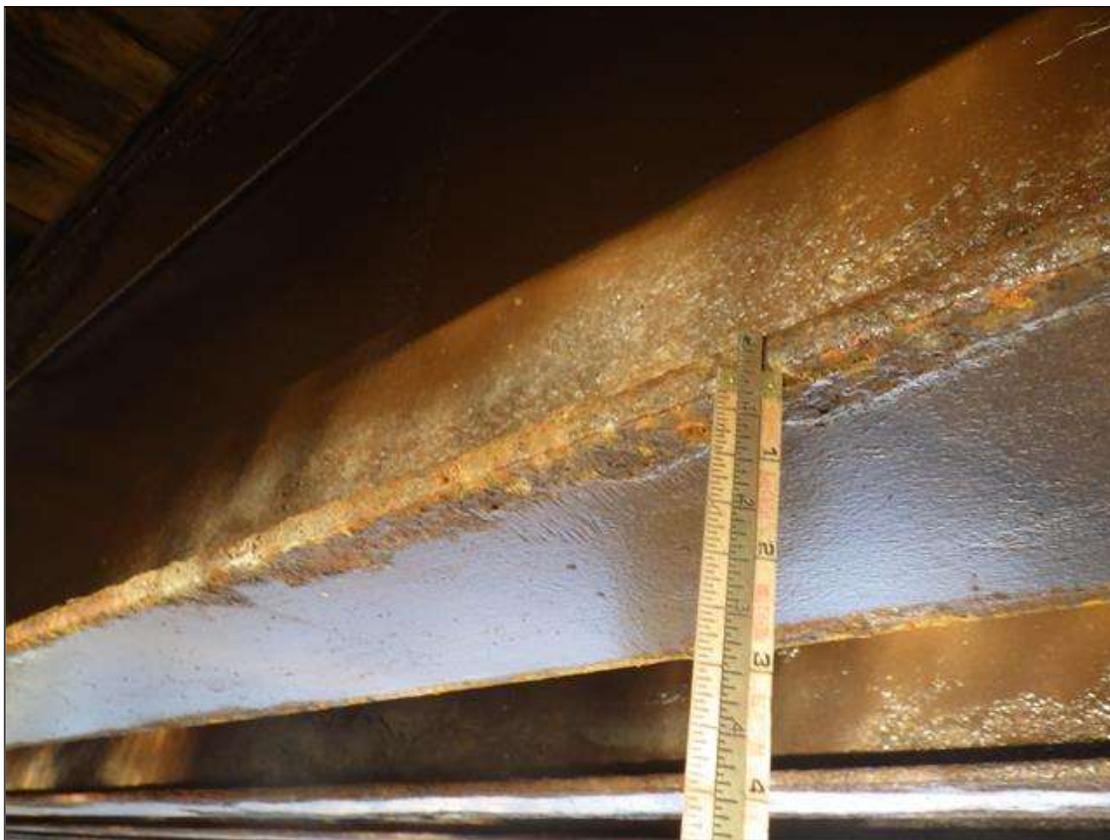
Span 2 Beam 5: ARRESTED CORROSION UP TO INTERMITTENT FULL LENGTH X INTERMITTENT FULL WIDTH WITH 7/16 INCH REMAINING (GREATER THAN OR EQUAL TO 1/16 INCH SECTION LOSS, LESS THAN 25 PERCENT SECTION LOSS) IN THE BOTTOM FLANGE

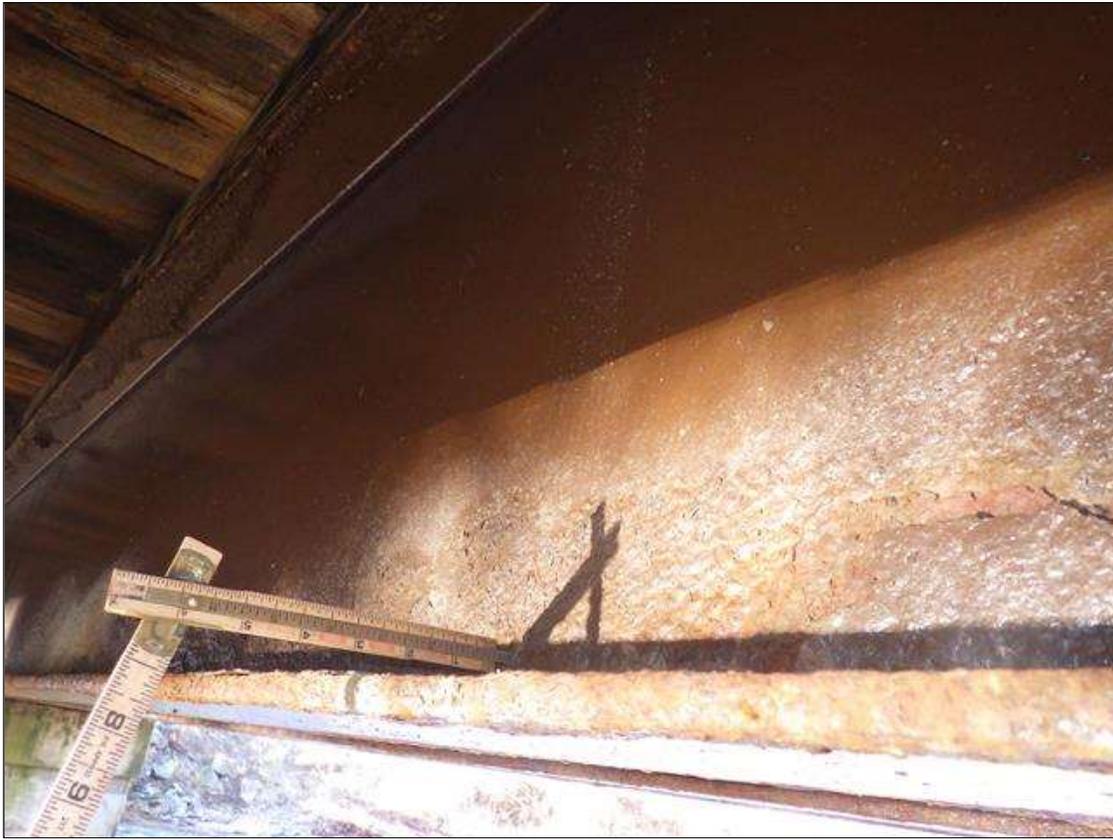
Span 2 Beam 5: ARRESTED CORROSION UP TO FULL LENGTH X 6 INCHES HIGH WITH 5/16 INCH REMAINING (GREATER THAN OR EQUAL TO 1/16 INCH SECTION LOSS, LESS THAN 25 PERCENT SECTION LOSS) IN THE WEB

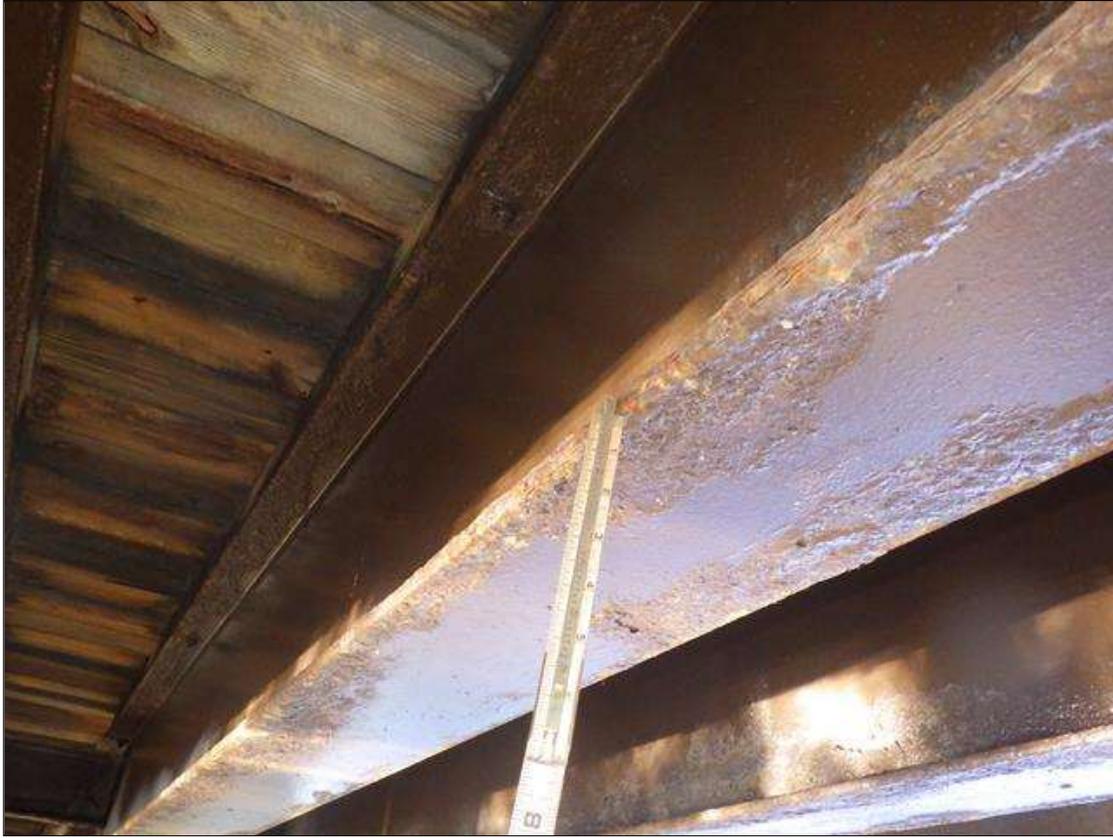
Span 2 Beam 4: ARRESTED CORROSION UP TO FULL LENGTH X FULL WIDTH WITH 7/16 INCH REMAINING (GREATER THAN OR EQUAL TO 1/16 INCH SECTION LOSS, LESS THAN 25 PERCENT SECTION LOSS) IN THE BOTTOM FLANGE

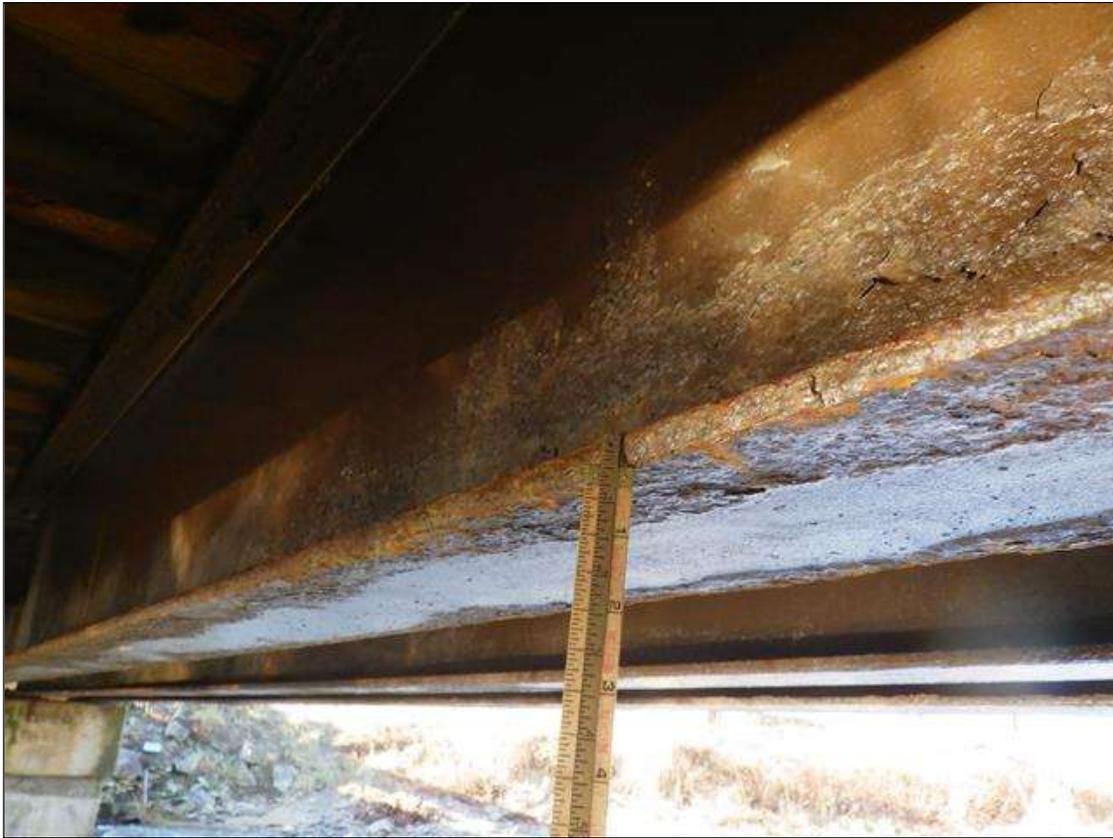
Span 2 Beam 3: ARRESTED CORROSION UP TO INTERMITTENT FULL LENGTH X FULL WIDTH WITH 7/16 INCH REMAINING (GREATER THAN OR EQUAL TO 1/16 INCH SECTION LOSS, LESS THAN 25 PERCENT SECTION LOSS) IN THE BOTTOM FLANGE

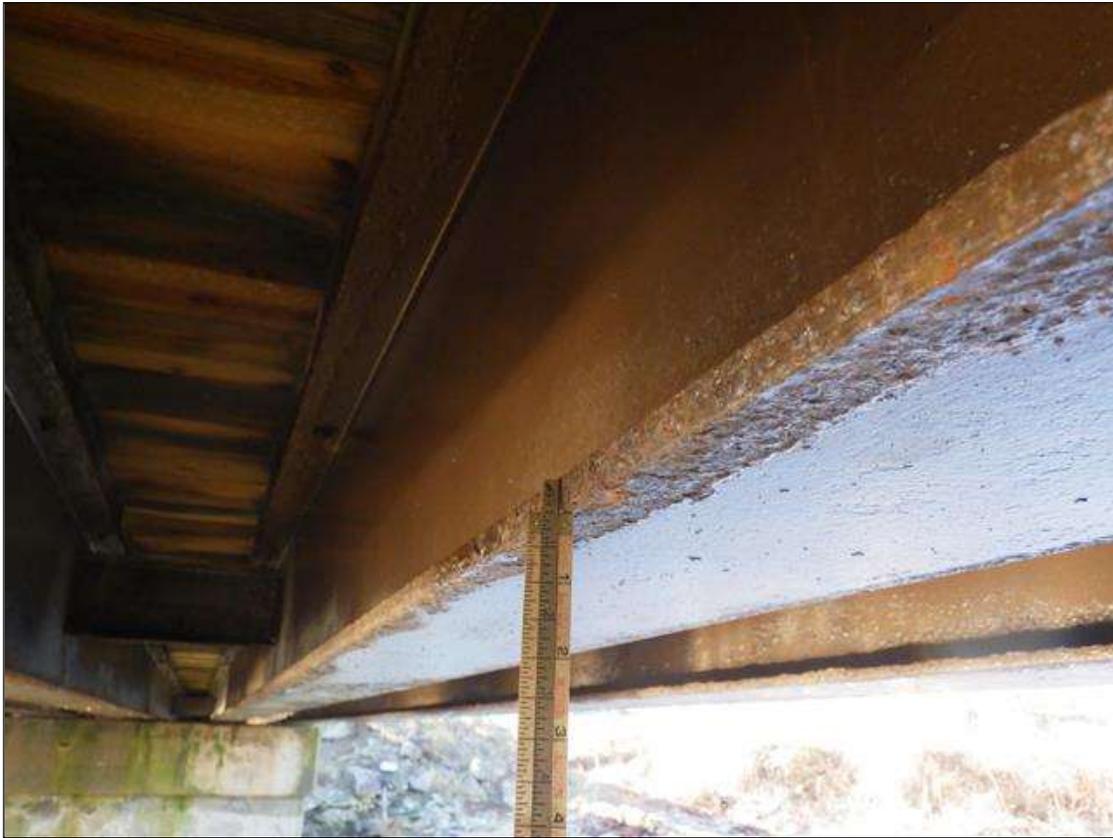
Span 2 Beam 2: ARRESTED CORROSION UP TO INTERMITTENT FULL LENGTH X FULL WIDTH WITH 1/32 INCH SECTION LOSS IN THE BOTTOM FLANGE

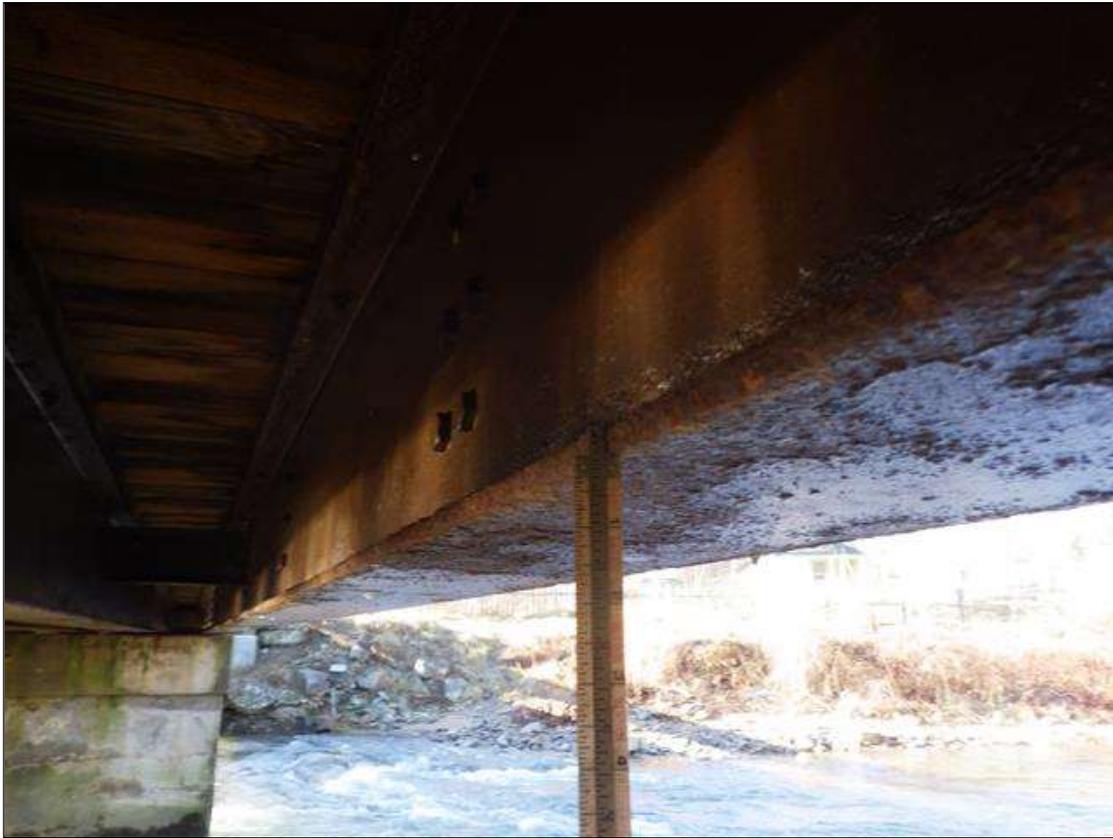
Span 2 Beam 1: ARRESTED CORROSION UP TO FULL LENGTH X FULL WIDTH WITH 7/16 INCH REMAINING (GREATER THAN OR EQUAL TO 1/16 INCH SECTION LOSS, LESS THAN 25 PERCENT SECTION LOSS) IN THE BOTTOM FLANGE

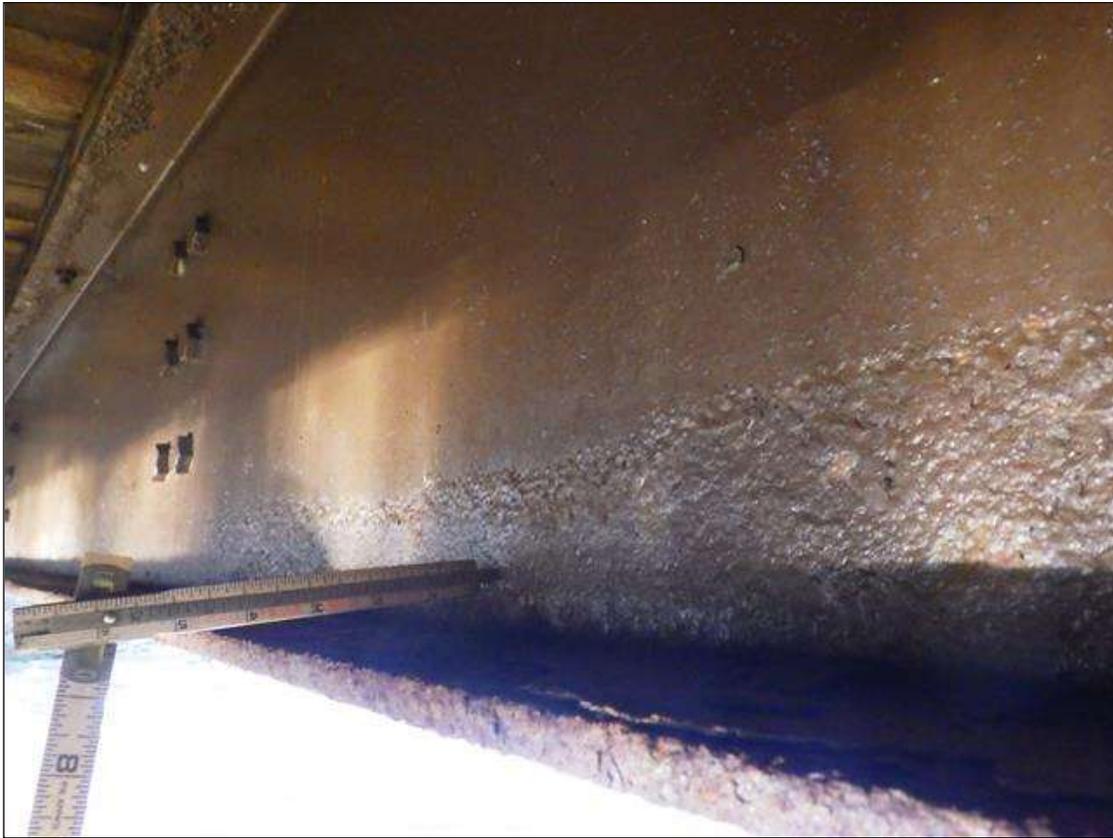
Span 2 Beam 1: ARRESTED CORROSION UP TO INTERMITTENT FULL LENGTH X 6 INCHES HIGH WITH 1/32 INCH SECTION LOSS IN THE WEB

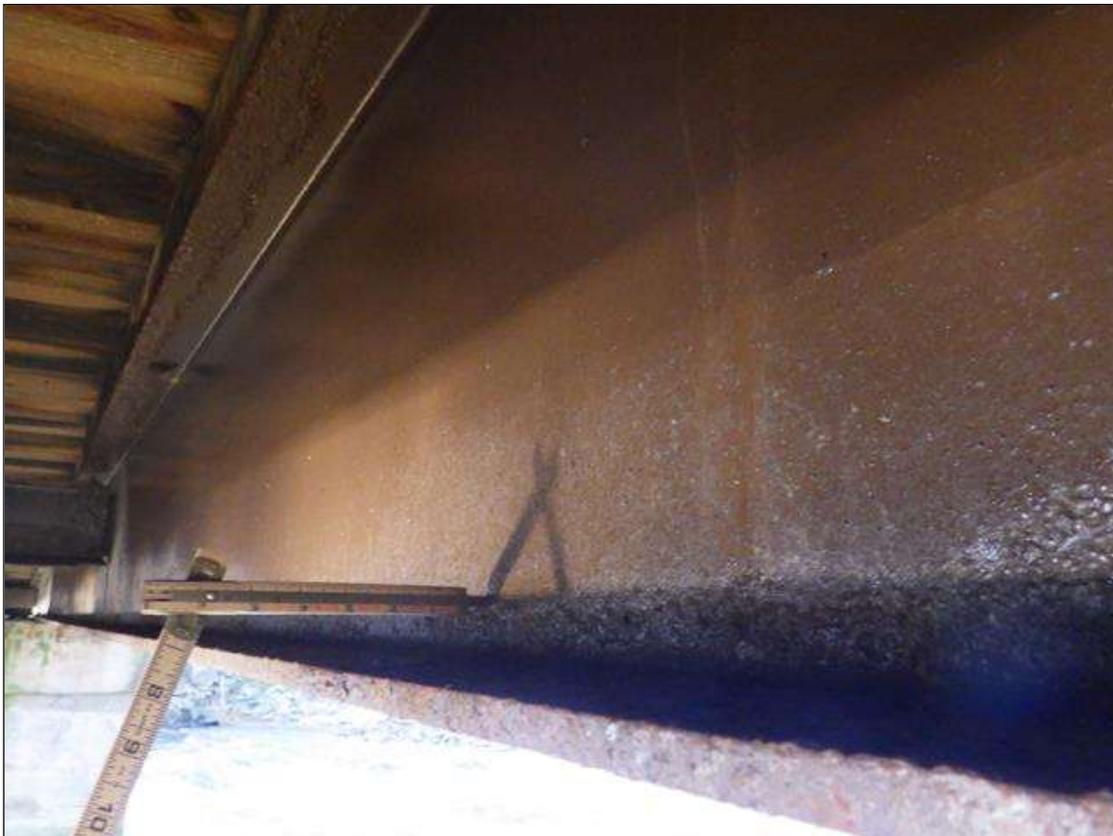
Span 2 Beam 2: ARRESTED CORROSION UP TO INTERMITTENT FULL LENGTH X 8 INCHES HIGH WITH 1/32 INCH SECTION LOSS IN THE WEB

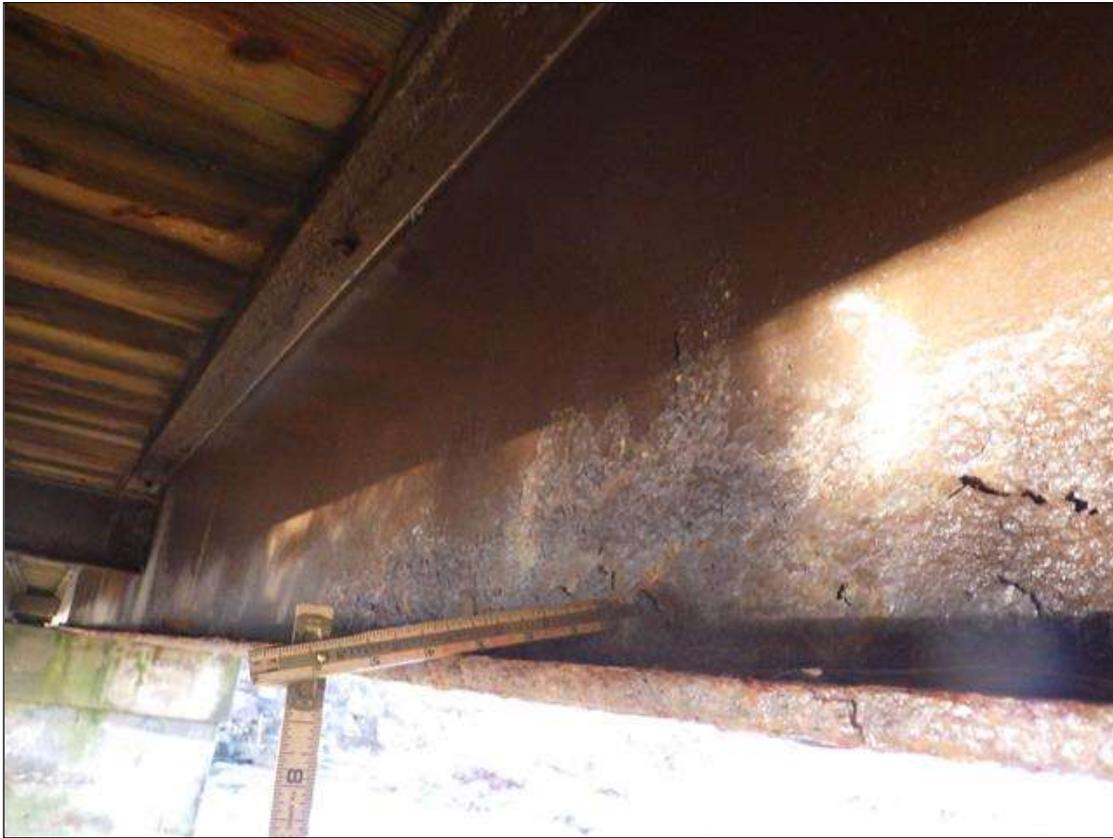
Span 2 Beam 3: ARRESTED CORROSION UP TO INTERMITTENT FULL LENGTH X INTERMITTENT FULL HEIGHT WITH 5/16 INCH REMAINING (GREATER THAN OR EQUAL TO 1/16 INCH SECTION LOSS, LESS THAN 25 PERCENT SECTION LOSS) IN THE WEB

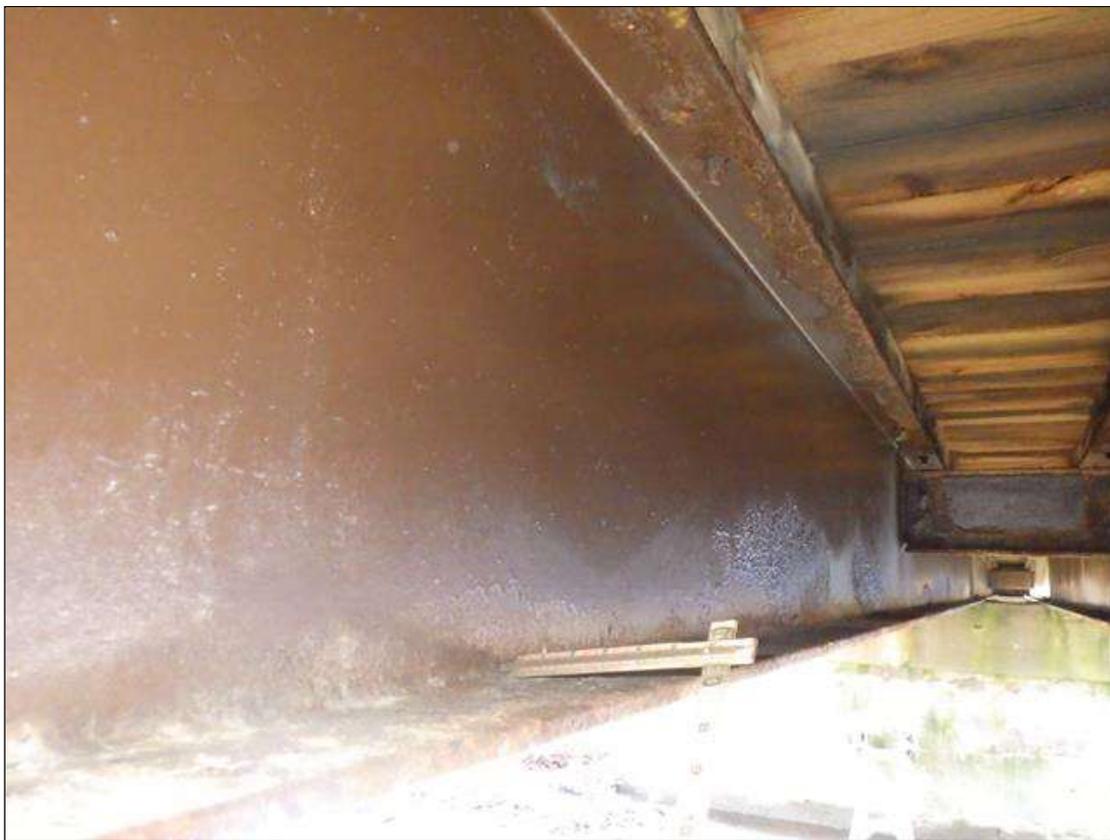
Span 2 Beam 4: ARRESTED CORROSION UP TO INTERMITTENT FULL LENGTH X 8 INCHES HIGH WITH 5/16 INCH REMAINING (GREATER THAN OR EQUAL TO 1/16 INCH SECTION LOSS, LESS THAN 25 PERCENT SECTION LOSS) IN THE WEB

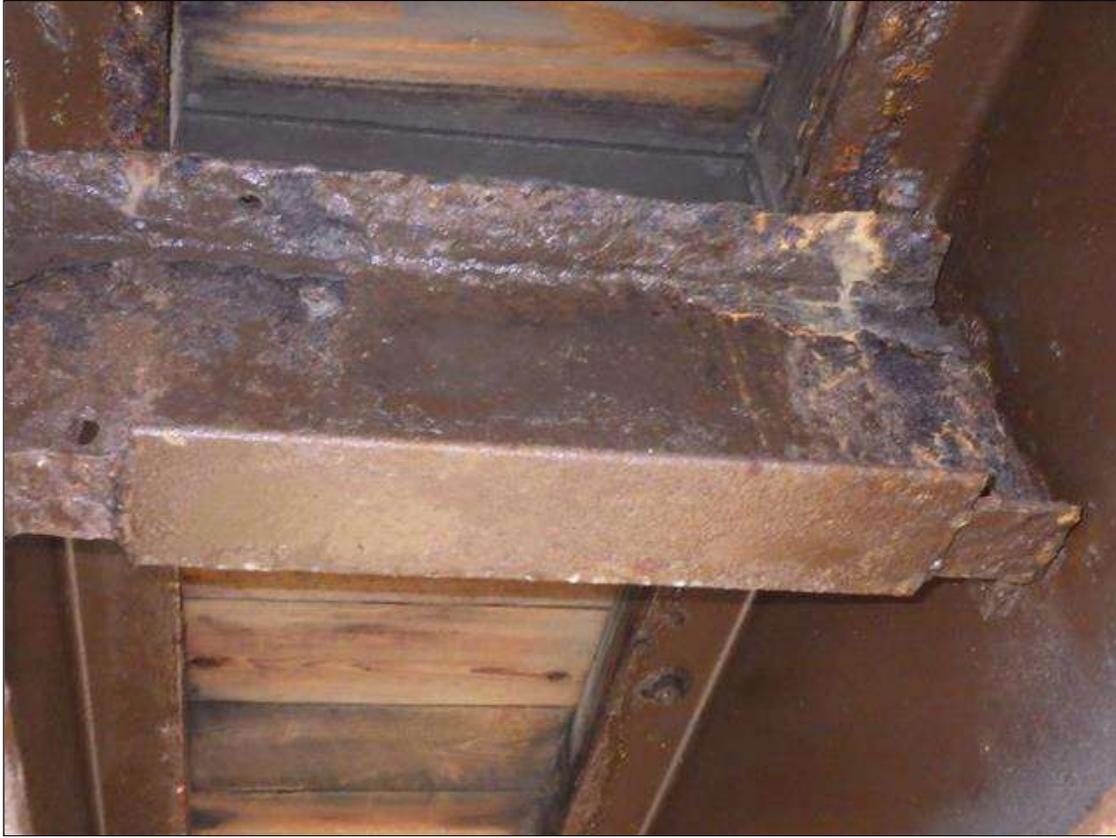
Span 2 Beam 6: REPAIR ANGLE UP TO 1 FOOT LONG X 4 INCHES WIDE X 4 INCHES HIGH IN BAY 6 INTERMEDIATE DIAPHRAGM

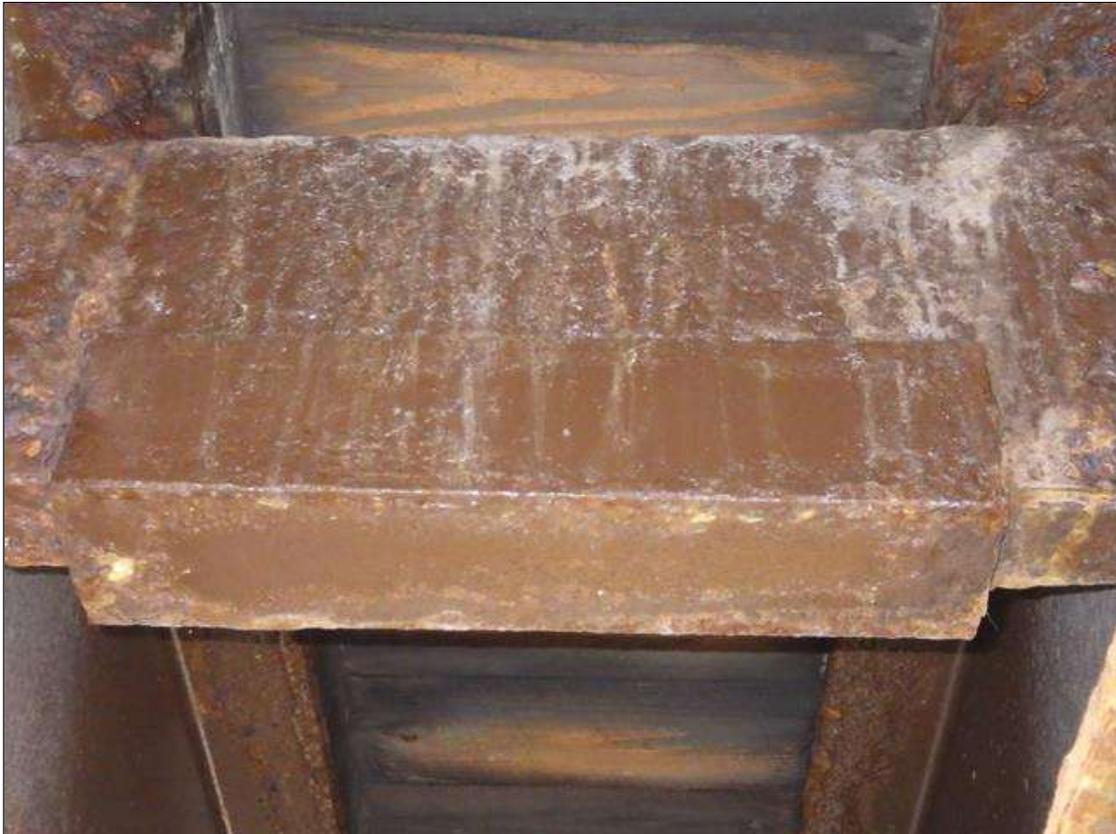
Span 2 Beam 2: REPAIR ANGLE UP TO 1 FOOT LONG X 4 INCHES WIDE X 4 INCHES HIGH IN BAY 2 INTERMEDIATE DIAPHRAGM

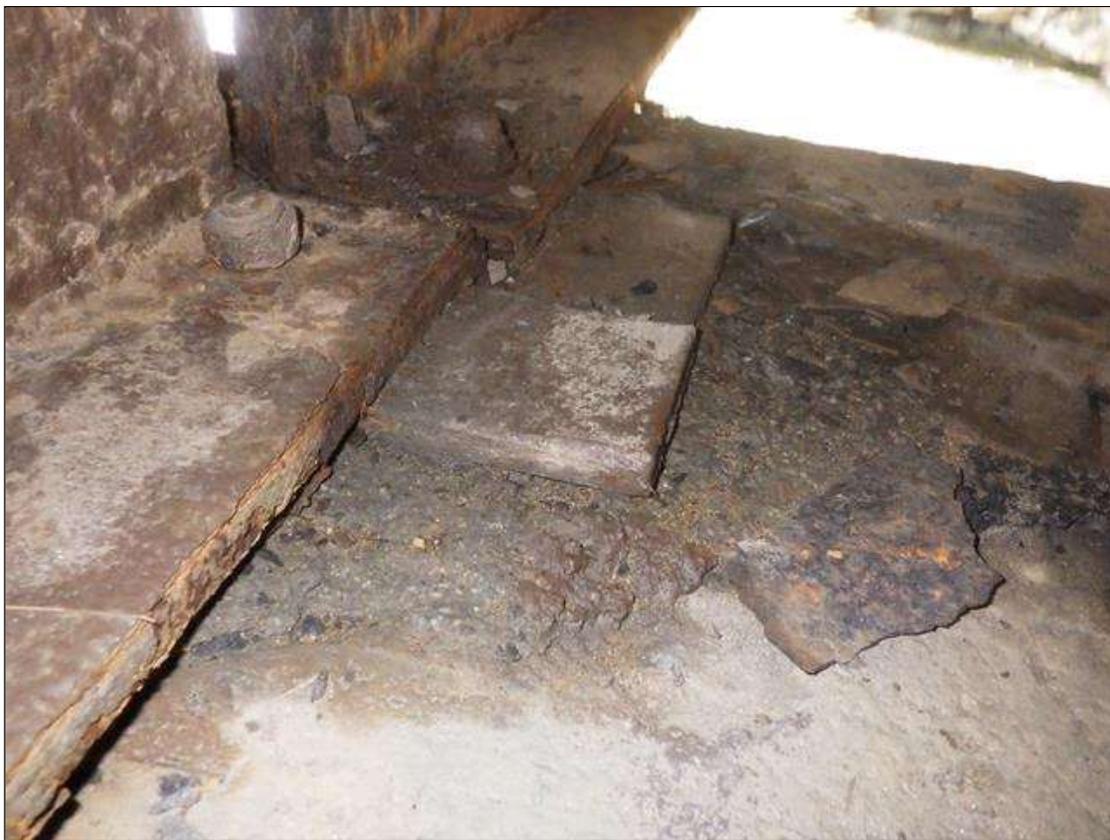
BEAM 6 BEARING AT BENT 1 REPAINTED PRIOR TO 2023 INSPECTION CYCLE (OTHERS SIMILAR)

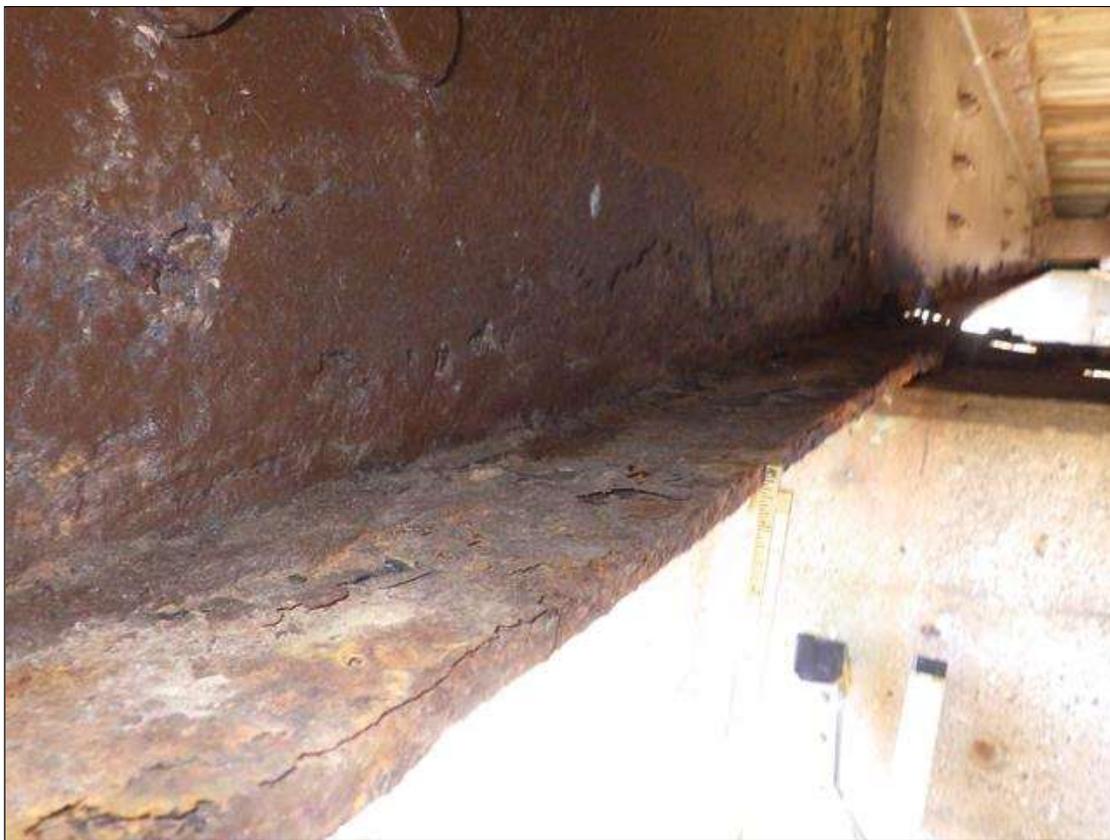
1/16 INCH SECTION LOSS, GREATER THAN 25 PERCENT SECTION LOSS) IN THE TOP FLANGE // ARRESTED CORROSION UP TO 7 FEET 8 INCHES LONG X FULL WIDTH WITH 3/16 INCH REMAINING (GREATER THAN OR EQUAL TO 1/16 INCH SECTION LOSS, GREATER THAN 25 PERCENT SECTION LOSS) IN THE BOTTOM FLANGE AT END BENT 2 // ARRESTED CORROSION UP TO 16 FEET 9 INCHES LONG X FULL WIDTH WITH 3/8 INCH REMAINING (GREATER THAN OR EQUAL TO 1/16 INCH SECTION LOSS, GREATER THAN 25 PERCENT SECTION LOSS) IN THE BOTTOM FLANGE AT BENT 1 (PRIORITY ACTION REQUEST)

Span 2 Beam 9: ARRESTED CORROSION UP TO 16 FEET 9 INCHES LONG X FULL WIDTH WITH 3/8 INCH REMAINING (GREATER THAN OR EQUAL TO 1/16 INCH SECTION LOSS, GREATER THAN 25 PERCENT SECTION LOSS) IN THE BOTTOM FLANGE AT BENT 1 (PRIORITY ACTION REQUEST)

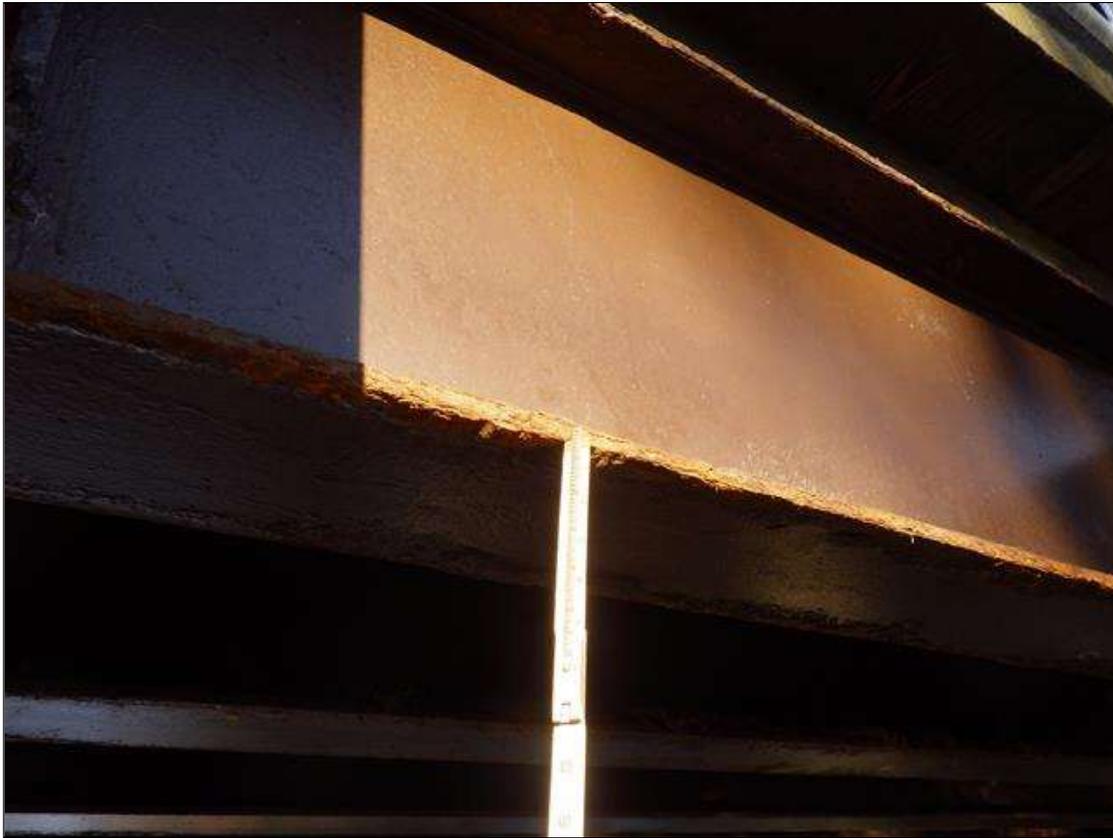
Span 2 Beam 9: ARRESTED CORROSION UP TO 15 FEET 7 INCHES LONG X FULL WIDTH WITH 7/16 INCH REMAINING (GREATER THAN OR EQUAL TO 1/16 INCH SECTION LOSS, LESS THAN 25 PERCENT SECTION LOSS) IN THE BOTTOM FLANGE AT BENT 1

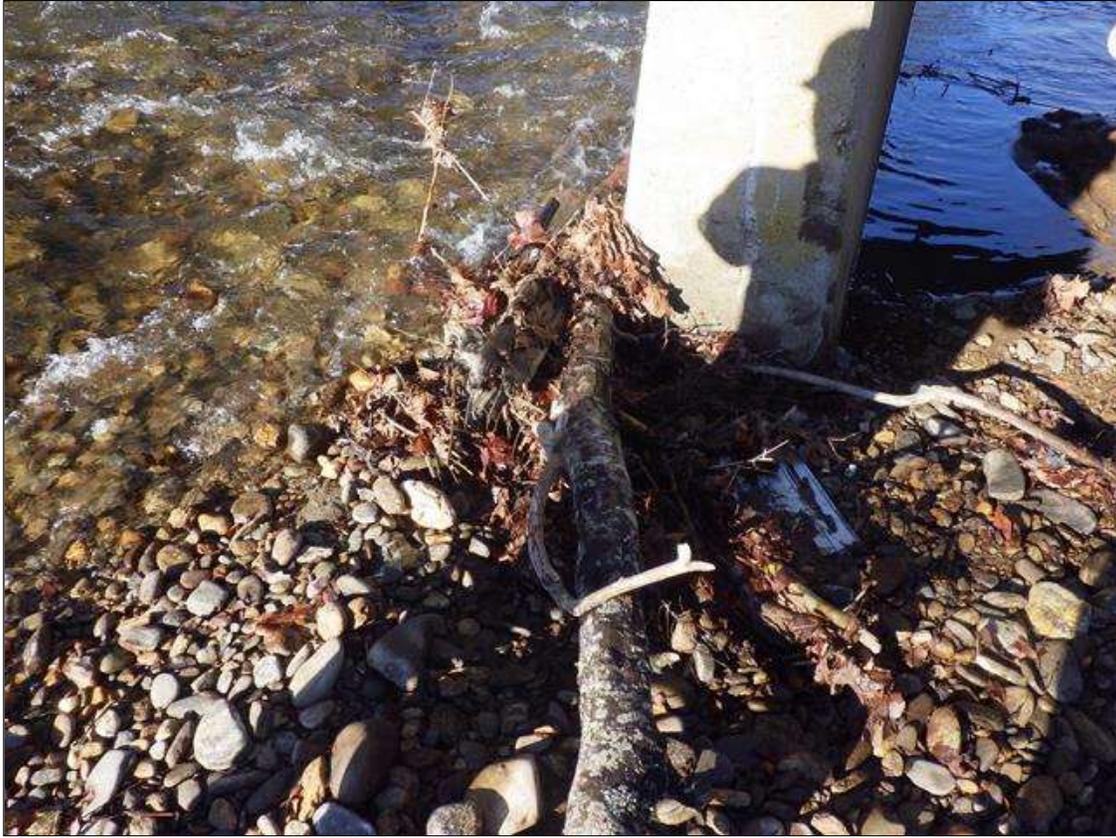
DRIFT UP TO 2 FEET DIAMETER X 30 FEET LONG AT THE UPSTREAM END OF BENT 1

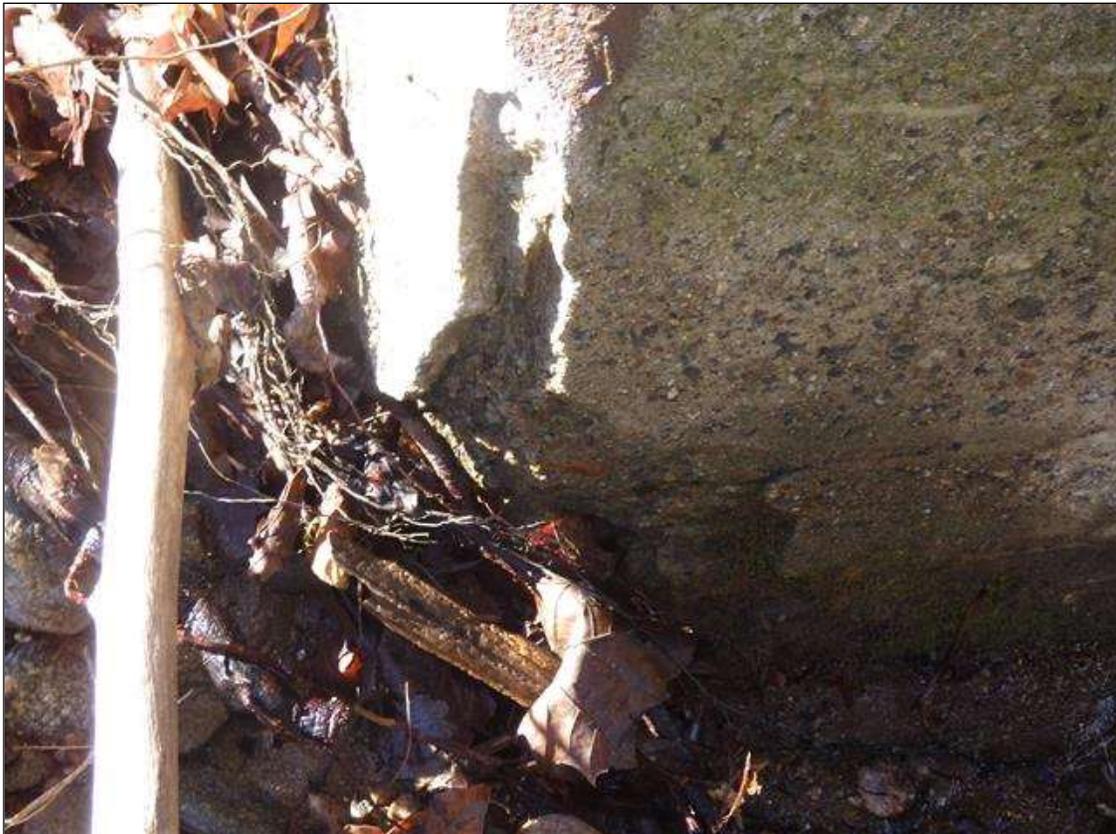
Bent 1 Pile 1: SPALLED AREA UP TO 6 INCHES LONG X 5 INCHES WIDE X 1 FOOT HIGH IN THE NORTHEAST CORNER, 3 FEET BELOW CAP

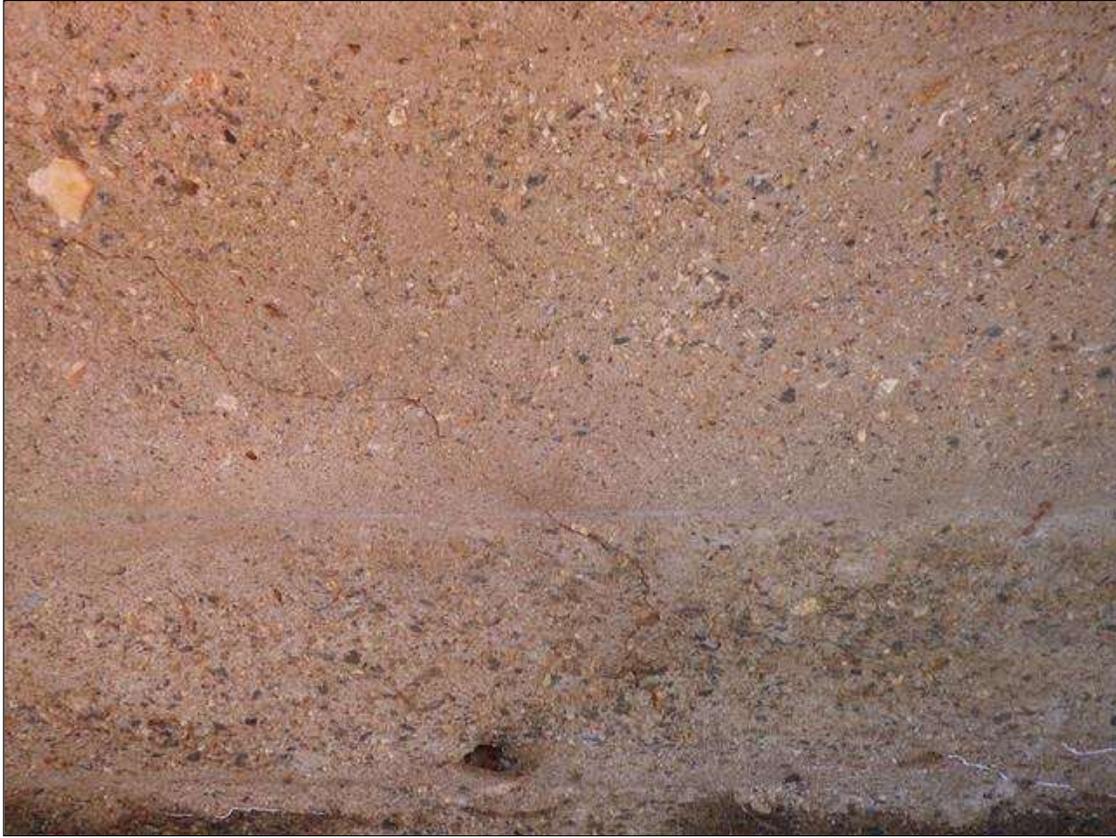
Bent 1 Pile 1: MAP CRACKING UP TO FULL LENGTH X FULL HEIGHT X 1/32 INCH WIDE IN THE NORTH AND SOUTH FACES

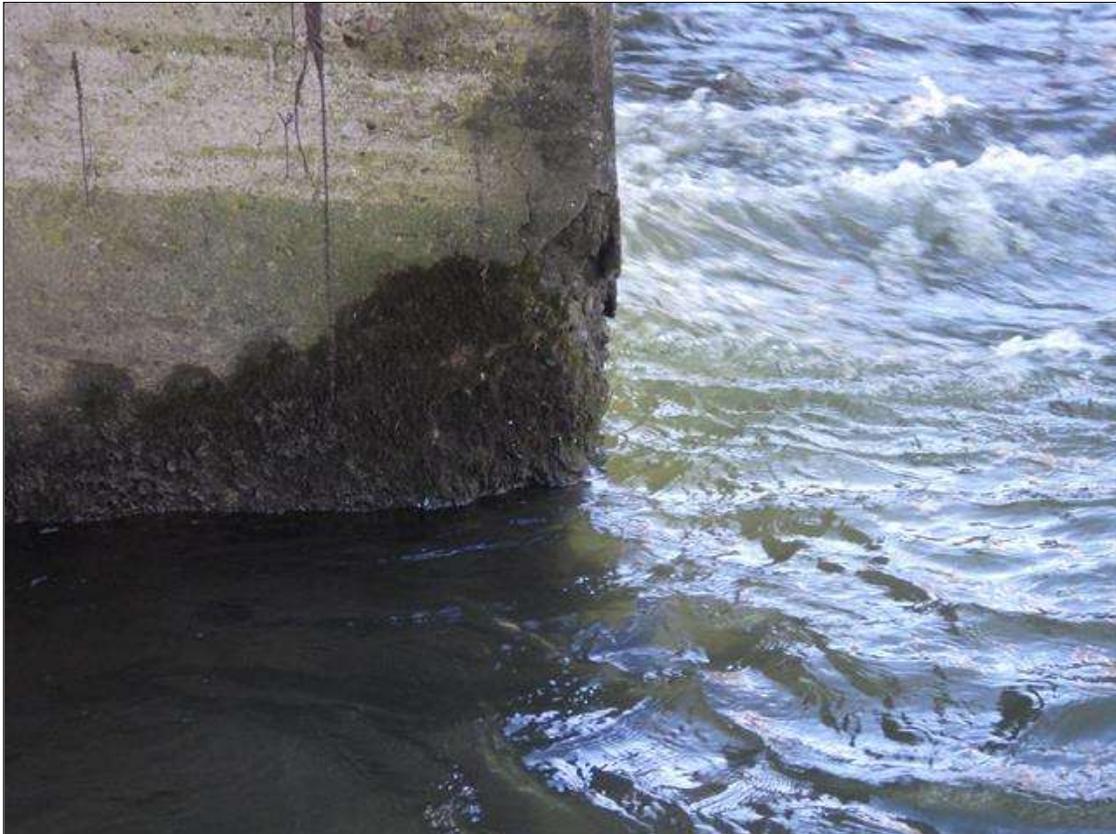
Bent 1 Pile 1: SPALLED AREA UP TO 6 INCHES LONG X 2 FEET WIDE X 4 FEET HIGH WITH EXPOSED REINFORCEMENT IN THE NORTHWEST CORNER, 4 FEET BELOW CAP

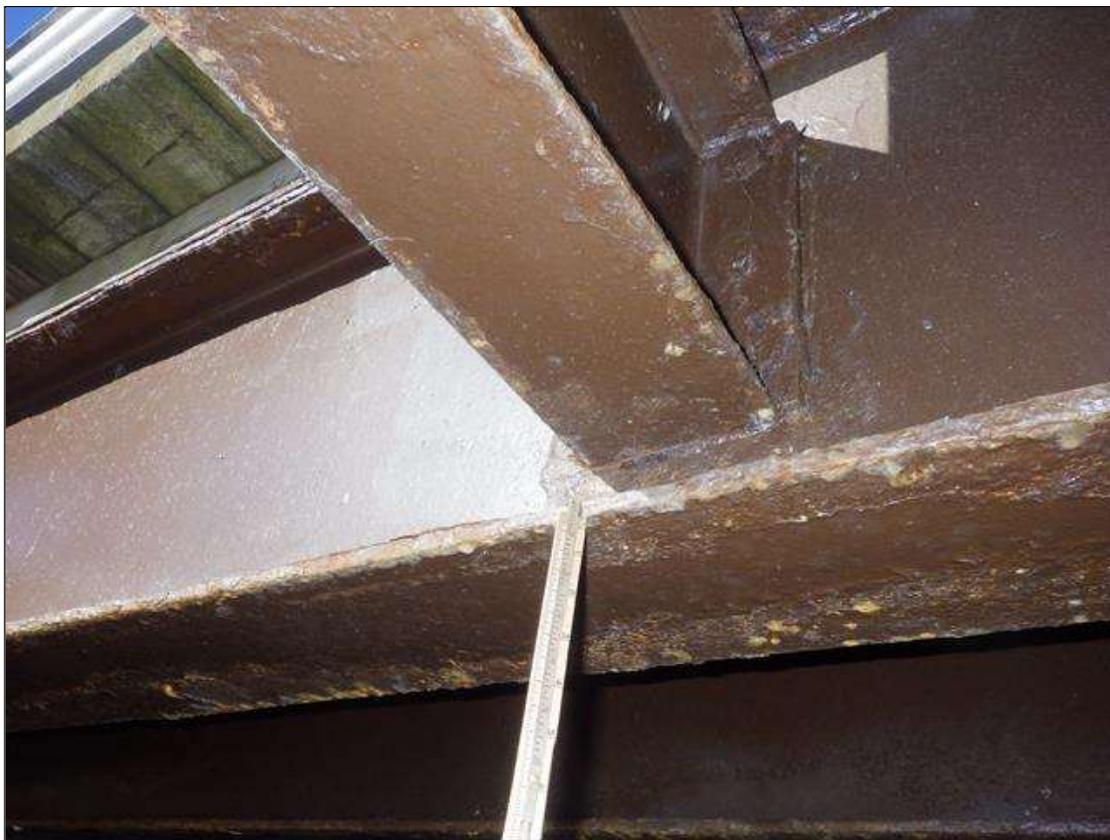
Span 1 Beam 9: ARRESTED CORROSION UP TO INTERMITTENT FULL LENGTH X FULL WIDTH WITH 7/16 INCH REMAINING (GREATER THAN OR EQUAL TO 1/16 INCH SECTION LOSS, LESS THAN 25 PERCENT SECTION LOSS) IN THE BOTTOM FLANGE

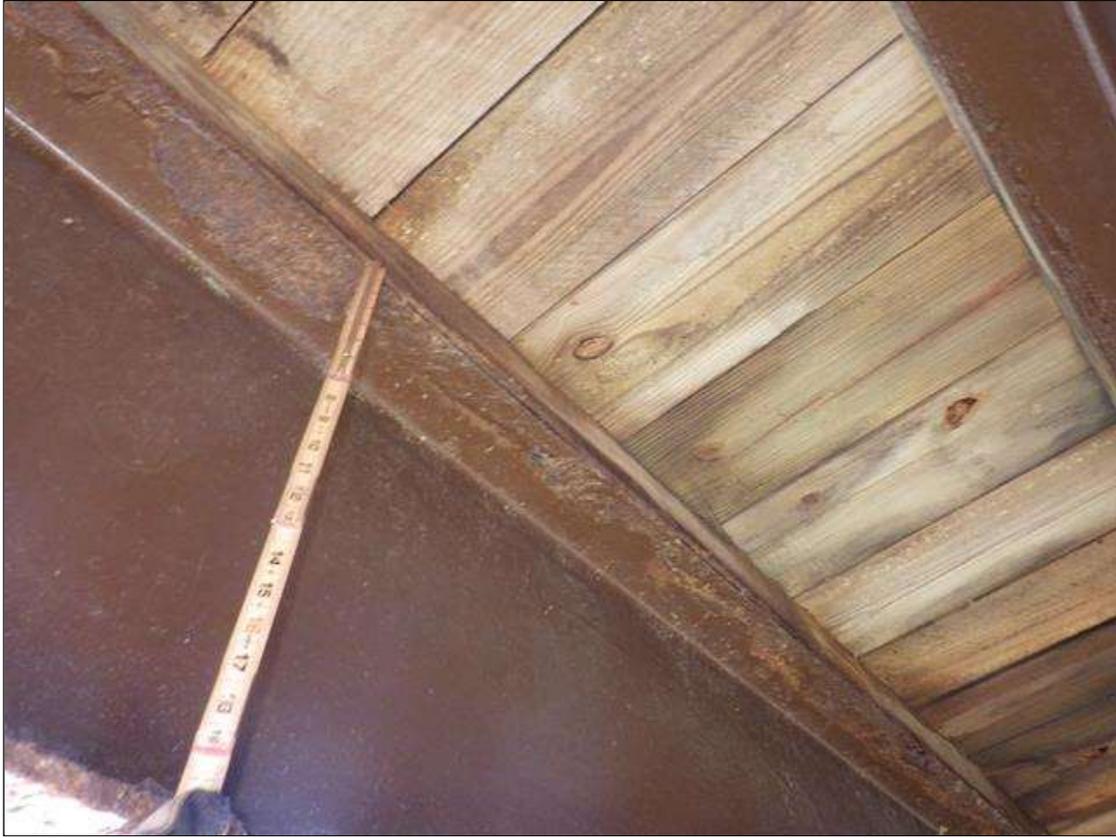
Span 1 Beam 9: ARRESTED CORROSION UP TO FULL LENGTH X FULL WIDTH WITH 7/16 INCH REMAINING (GREATER THAN OR EQUAL TO 1/16 INCH SECTION LOSS, LESS THAN 25 PERCENT SECTION LOSS) IN THE TOP FLANGE

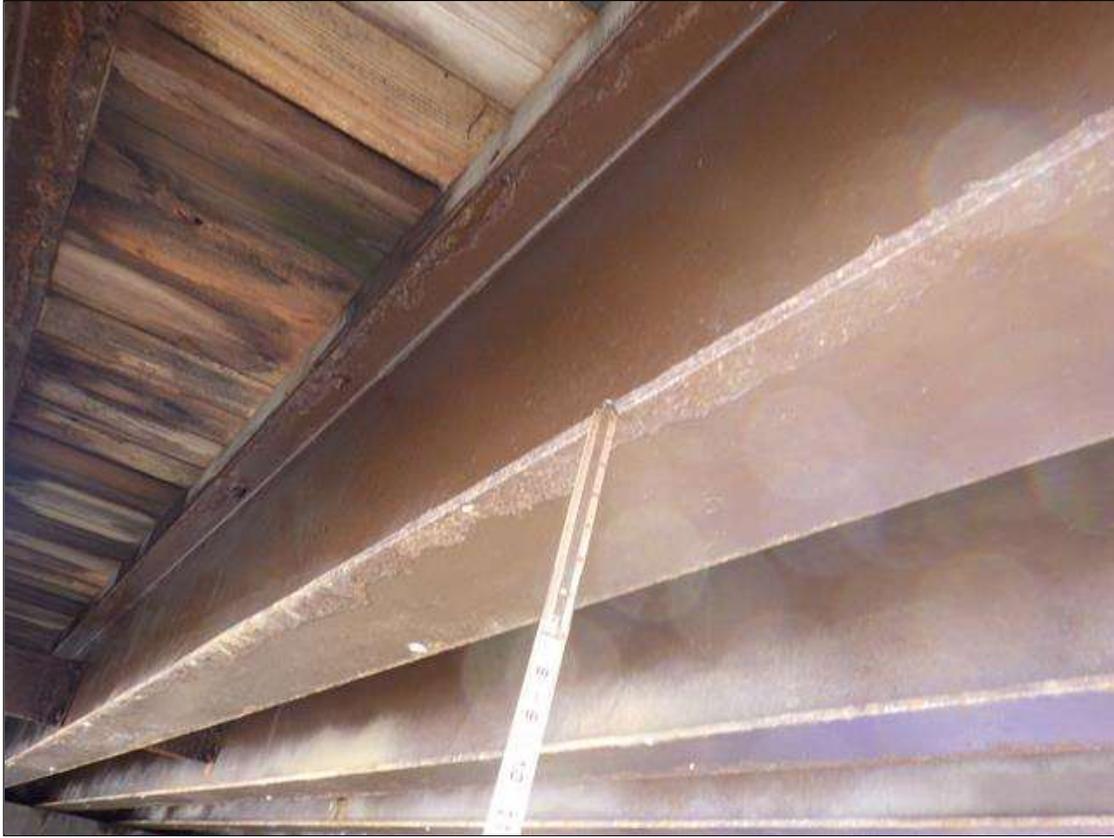
Span 1 Beam 8: ARRESTED CORROSION UP TO INTERMITTENT FULL LENGTH X INTERMITTENT FULL WIDTH WITH 1/32 INCH SECTION LOSS IN THE BOTTOM FLANGE
