NC DEPARTMENT OF TRANSPORTATION  
 DIVISION OF HIGHWAYS  
 STRUCTURE MANAGEMENT UNIT

# Structure Safety Report

## Routine Element Inspection - Contract

STRUCTURE NUMBER: 100154      SAP STRUCTURE NO: 0110154      FHWA STRUCTURE NO: 00000000210154

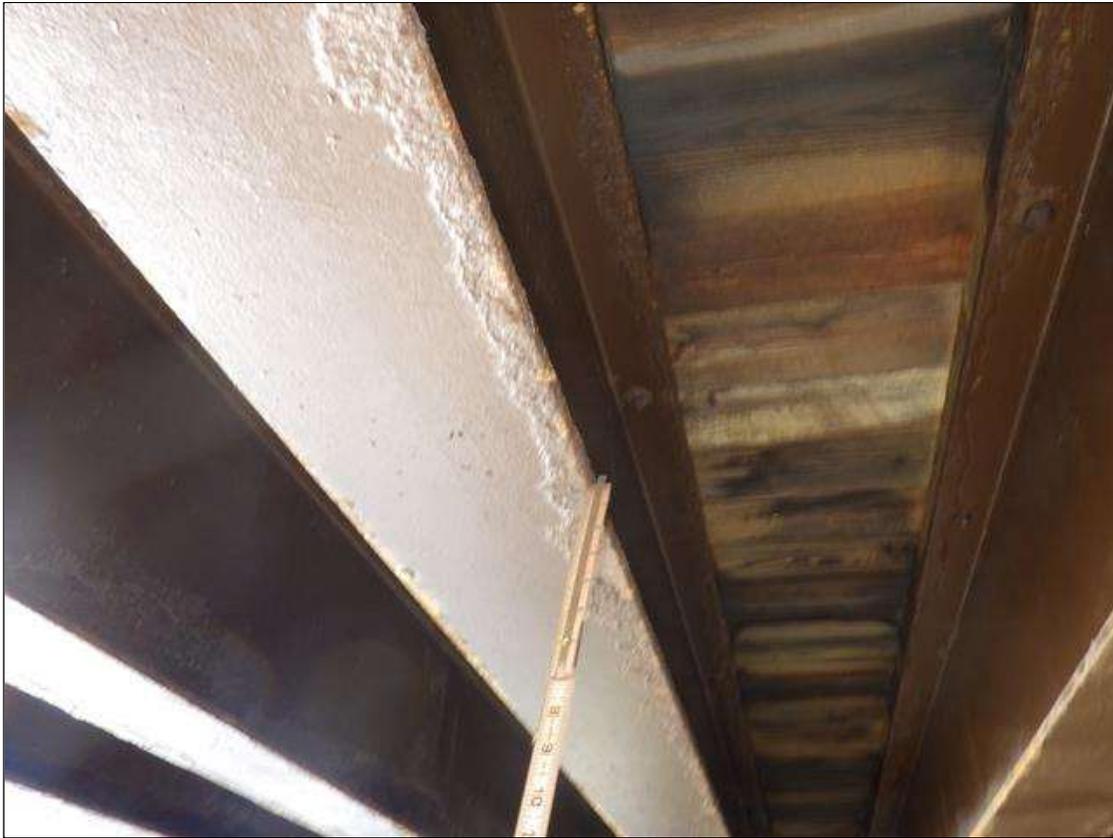
Span 1 Beam 7: ARRESTED CORROSION UP TO INTERMITTENT FULL LENGTH X INTERMITTENT FULL WIDTH WITH 1/32 INCH SECTION LOSS IN THE BOTTOM FLANGE

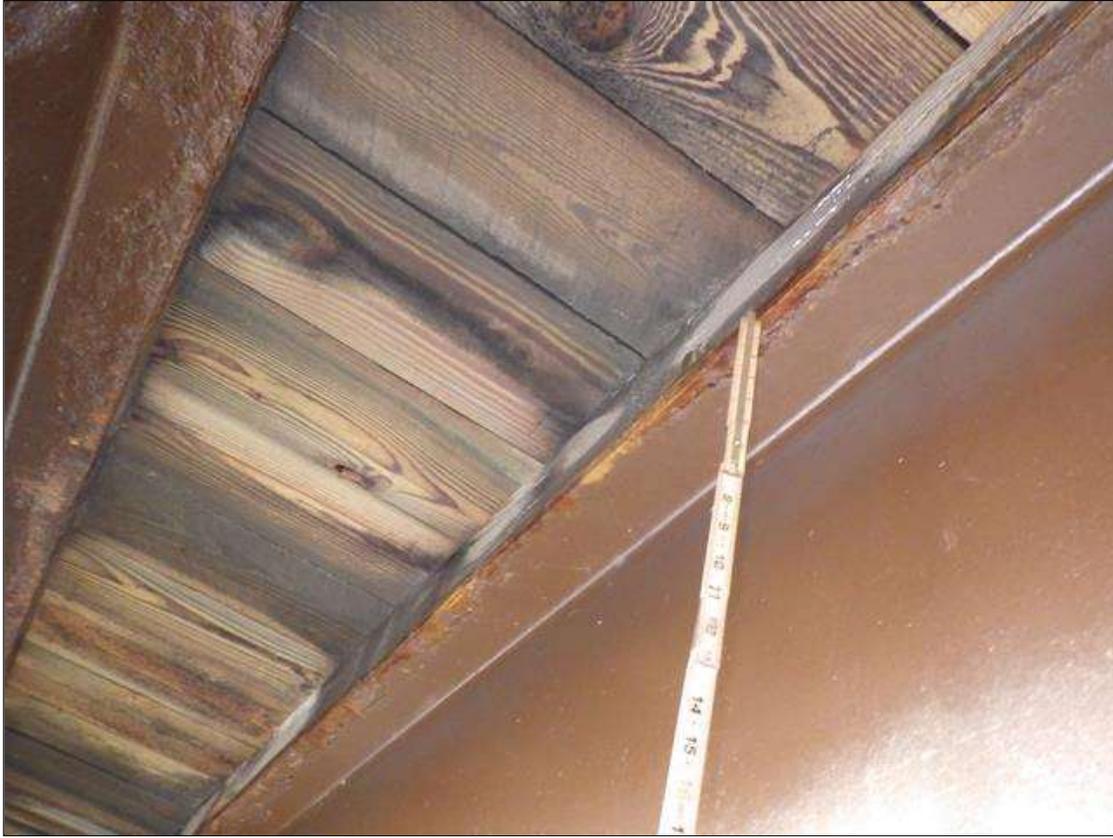
Span 1 Beam 7: ARRESTED CORROSION UP TO FULL LENGTH X FULL WIDTH WITH 7/16 INCH REMAINING (GREATER THAN OR EQUAL TO 1/16 INCH SECTION LOSS, LESS THAN 25 PERCENT SECTION LOSS) IN THE TOP FLANGE

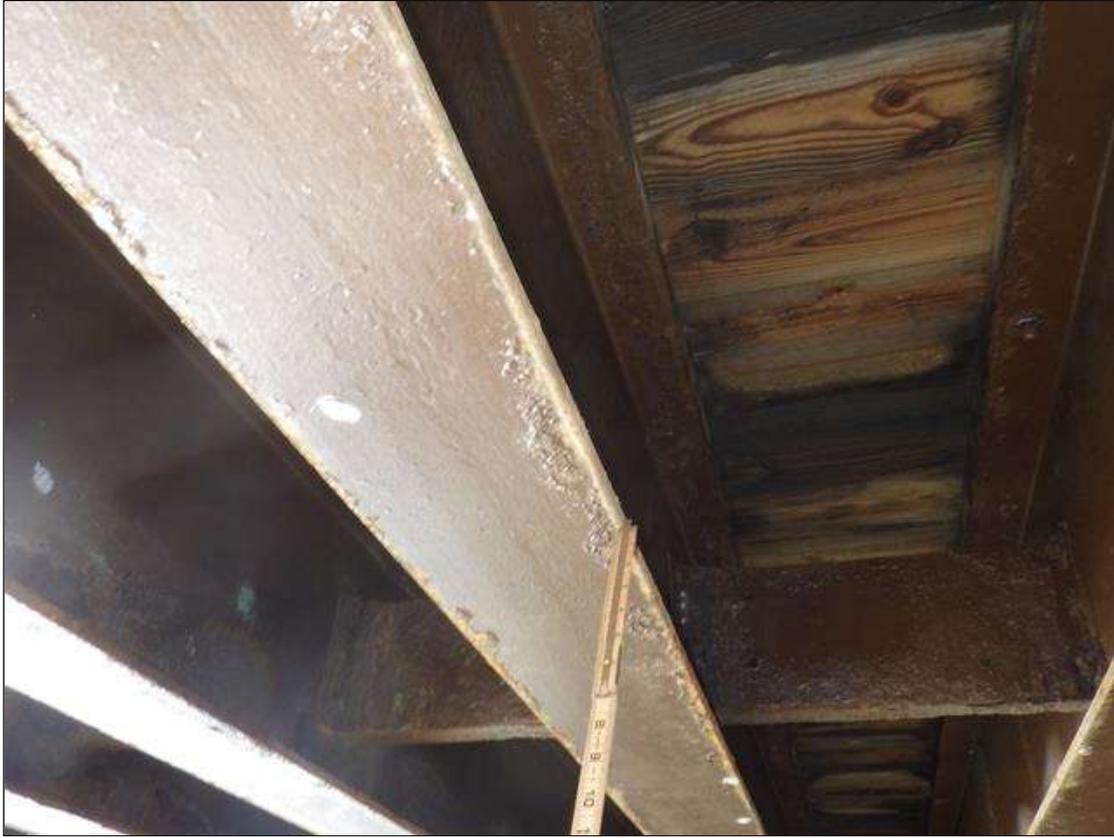
Span 1 Beam 6: ARRESTED CORROSION UP TO INTERMITTENT FULL LENGTH X INTERMITTENT FULL WIDTH WITH 1/32 INCH SECTION LOSS IN THE BOTTOM FLANGE

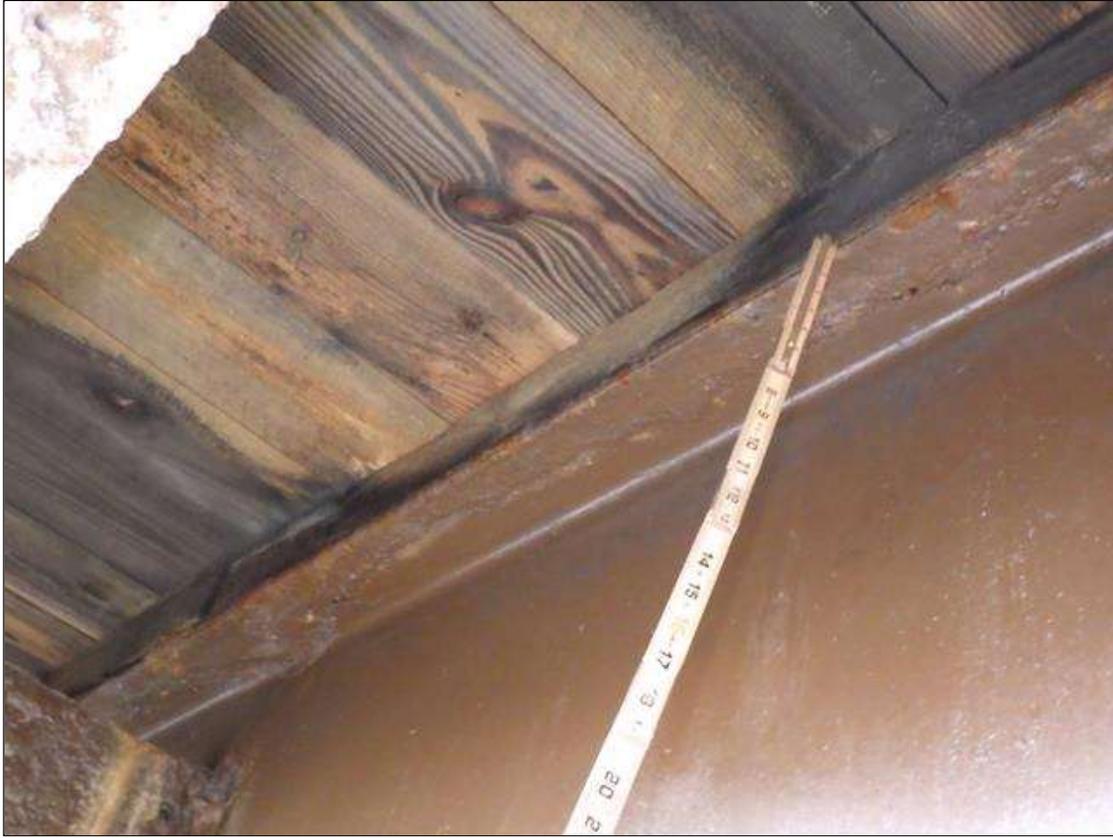
Span 1 Beam 6: ARRESTED CORROSION UP TO FULL LENGTH X FULL WIDTH WITH 7/16 INCH REMAINING (GREATER THAN OR EQUAL TO 1/16 INCH SECTION LOSS, LESS THAN 25 PERCENT SECTION LOSS) IN THE TOP FLANGE

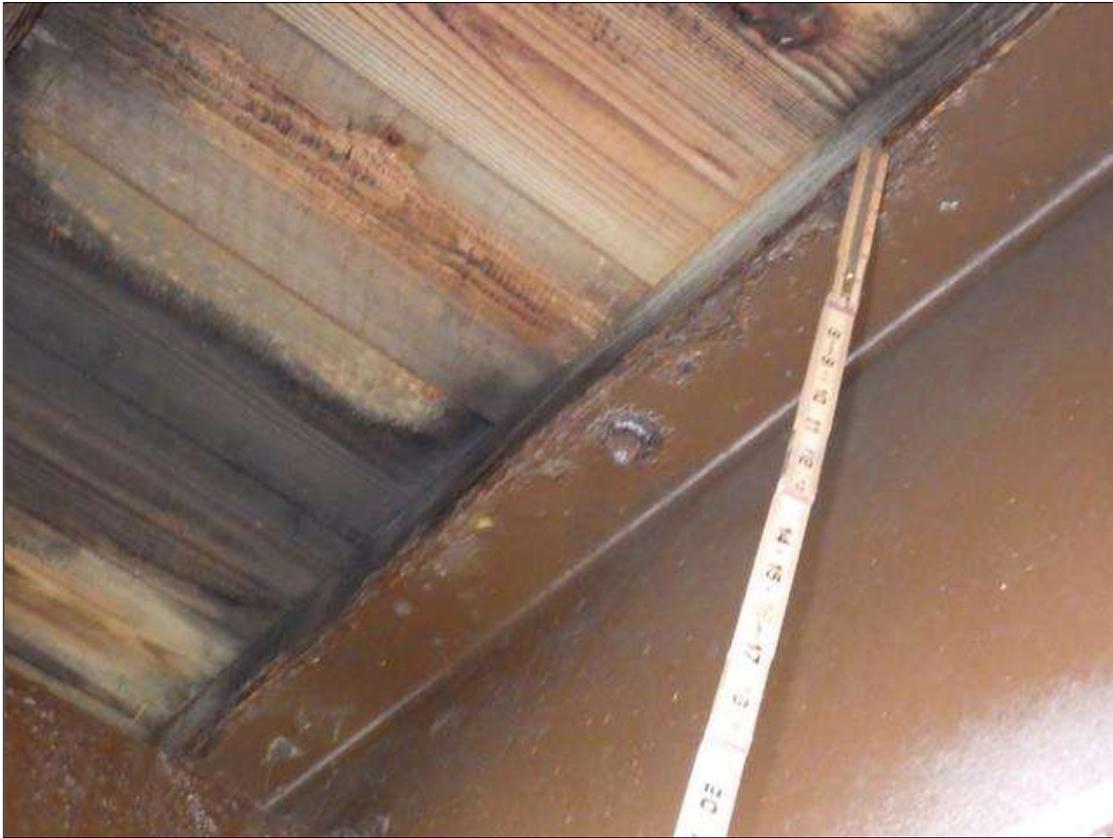
Span 1 Beam 5: ARRESTED CORROSION UP TO INTERMITTENT FULL LENGTH X 1 INCH WIDE WITH 7/16 INCH REMAINING (GREATER THAN OR EQUAL TO 1/16 INCH SECTION LOSS, LESS THAN 25 PERCENT SECTION LOSS) IN THE TOP FLANGE EDGES

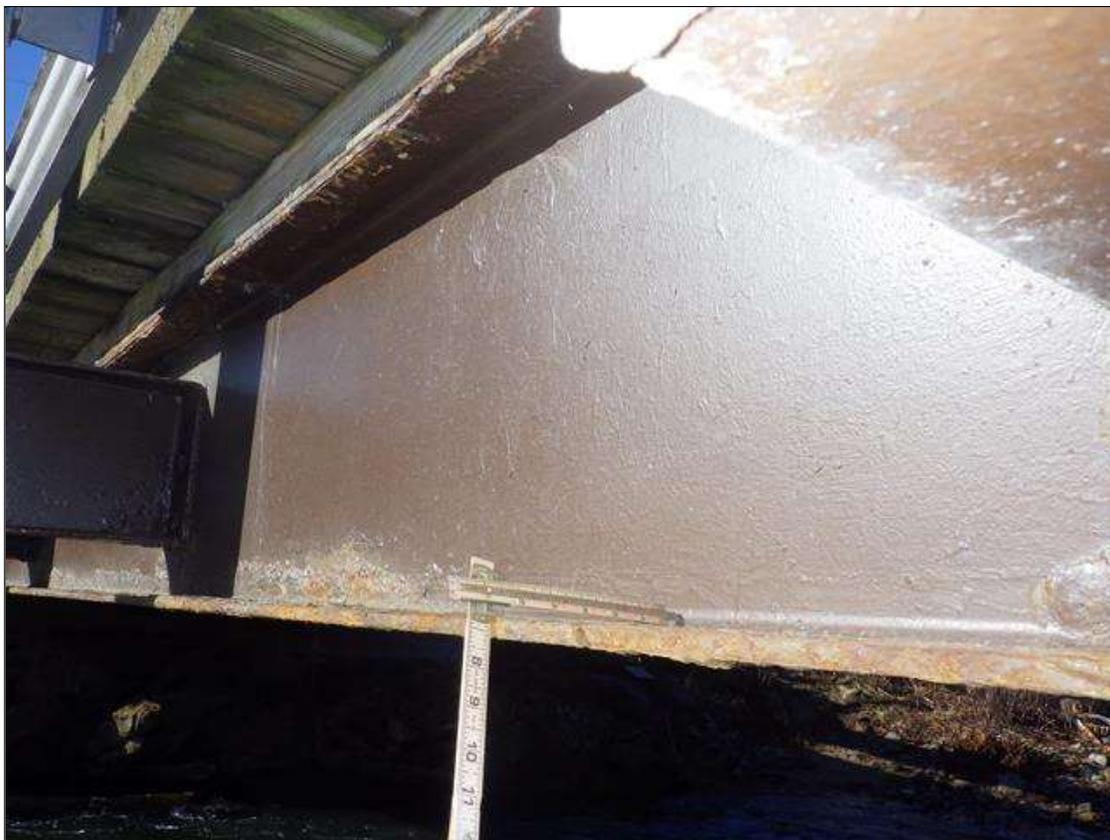
Span 1 Beam 9: ARRESTED CORROSION UP TO INTERMITTENT FULL LENGTH X 5 INCHES HIGH WITH 5/16 INCH REMAINING (GREATER THAN OR EQUAL TO 1/16 INCH SECTION LOSS, LESS THAN 25 PERCENT SECTION LOSS) IN THE WEB

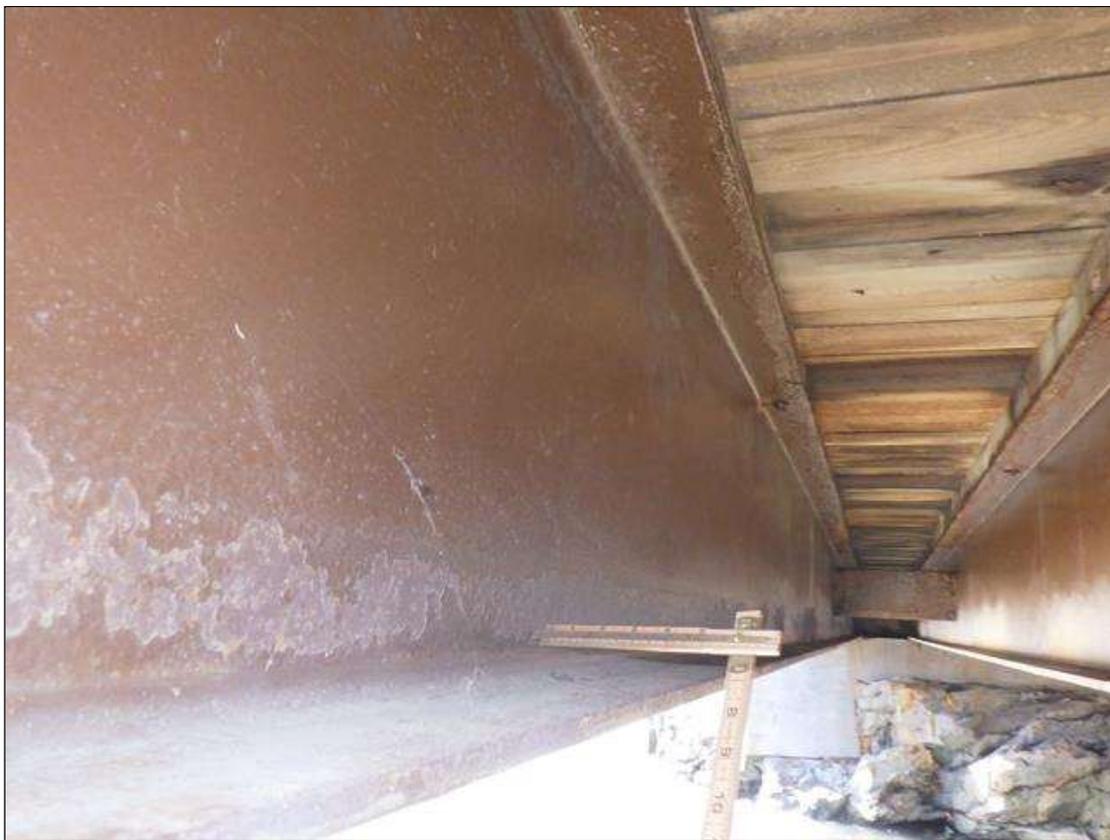
Span 1 Beam 8: ARRESTED CORROSION UP TO INTERMITTENT FULL LENGTH X 8 INCHES HIGH WITH 1/32 INCH SECTION LOSS IN THE WEB

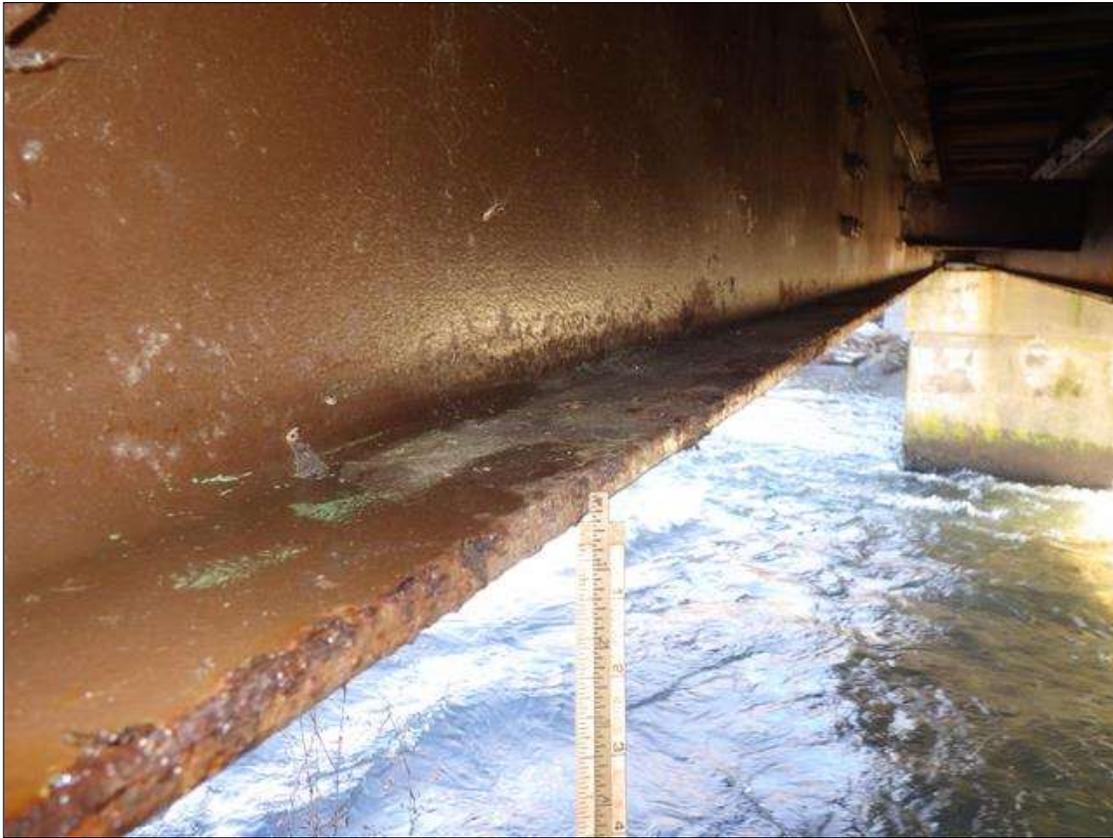
Span 1 Beam 1: ARRESTED CORROSION UP TO INTERMITTENT FULL LENGTH X FULL WIDTH WITH 1/32 INCH SECTION LOSS IN THE BOTTOM FLANGE

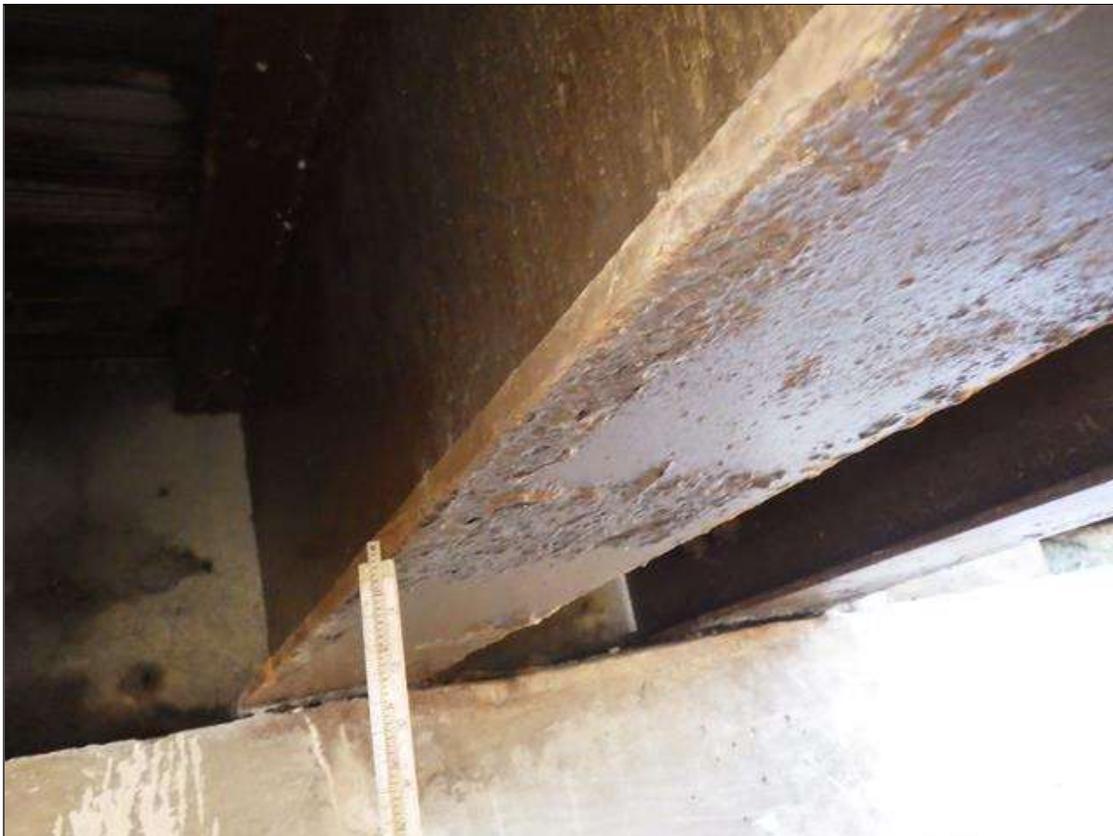
Span 1 Beam 2: ARRESTED CORROSION UP TO 4 FEET 6 INCHES LONG X FULL WIDTH WITH 1/32 INCH SECTION LOSS IN THE BOTTOM FLANGE AT END BENT 1

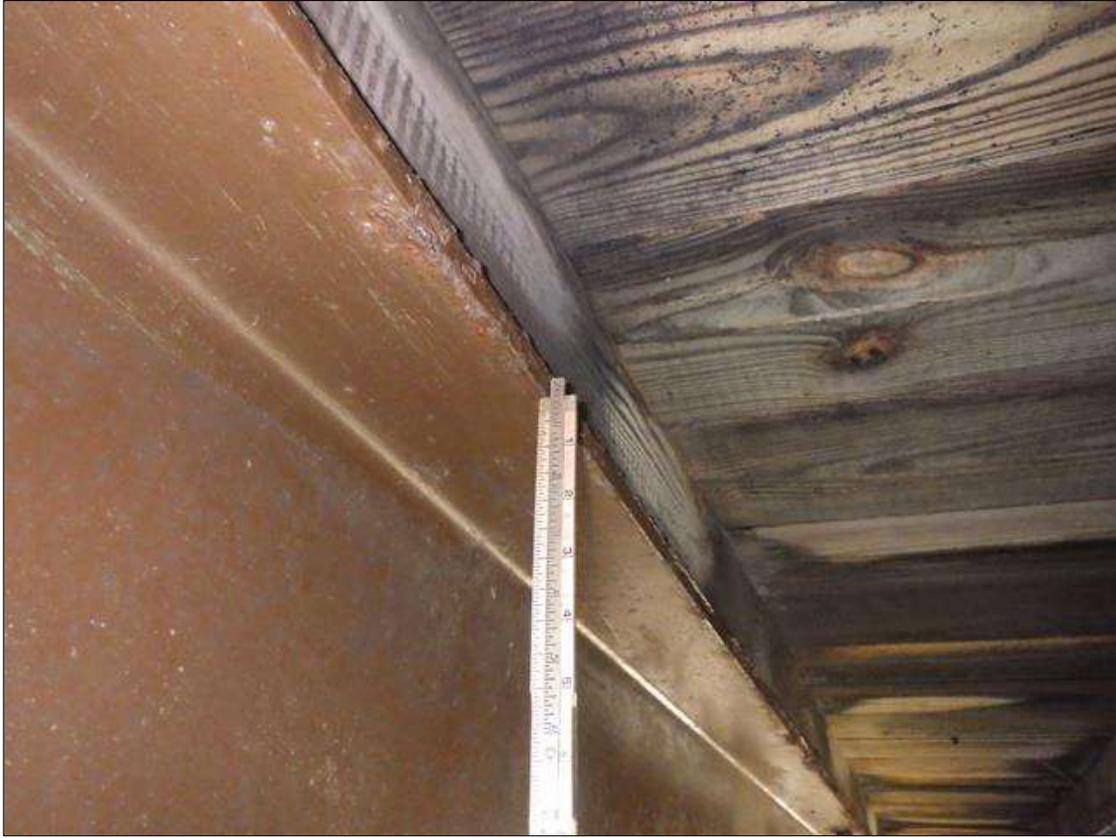
Span 1 Beam 2: ARRESTED CORROSION UP TO FULL LENGTH X 1 INCH WIDE WITH 1/32 INCH SECTION LOSS IN THE TOP FLANGE EDGES

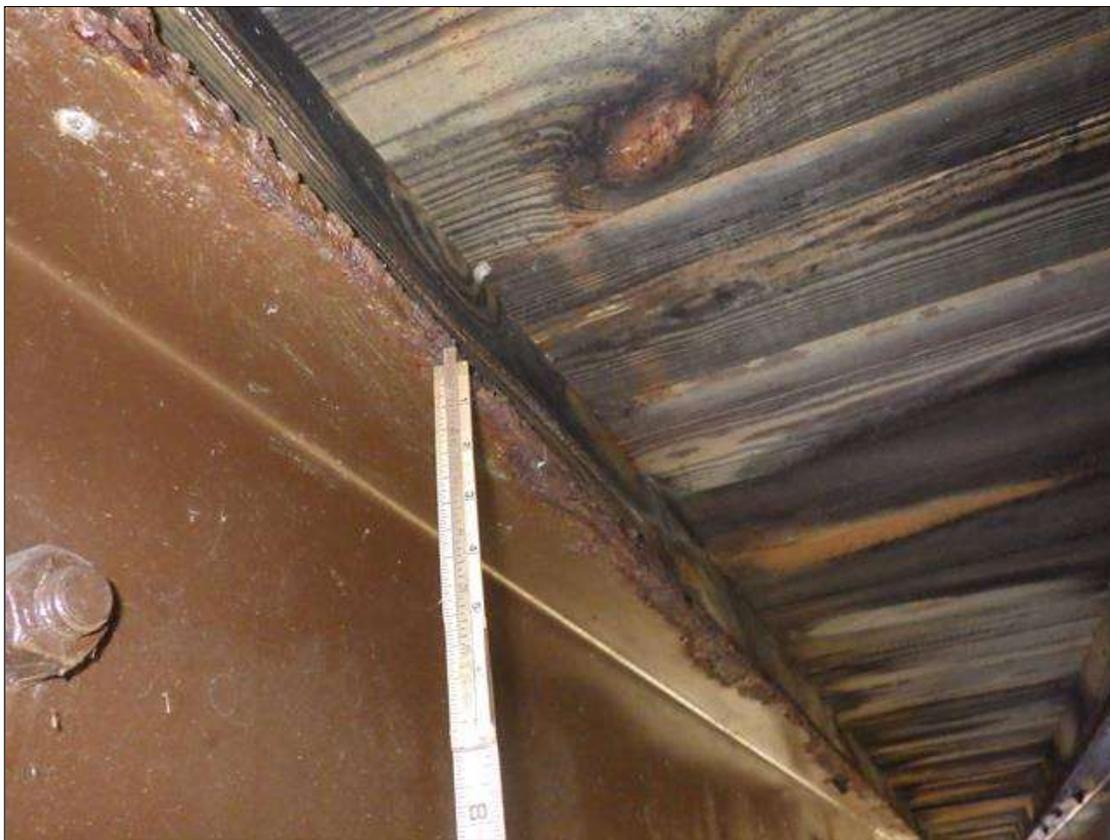
Span 1 Beam 1: ARRESTED CORROSION UP TO FULL LENGTH X FULL HEIGHT WITH 5/16 INCH REMAINING (GREATER THAN OR EQUAL TO 1/16 INCH SECTION LOSS, LESS THAN 25 PERCENT SECTION LOSS) IN THE WEB

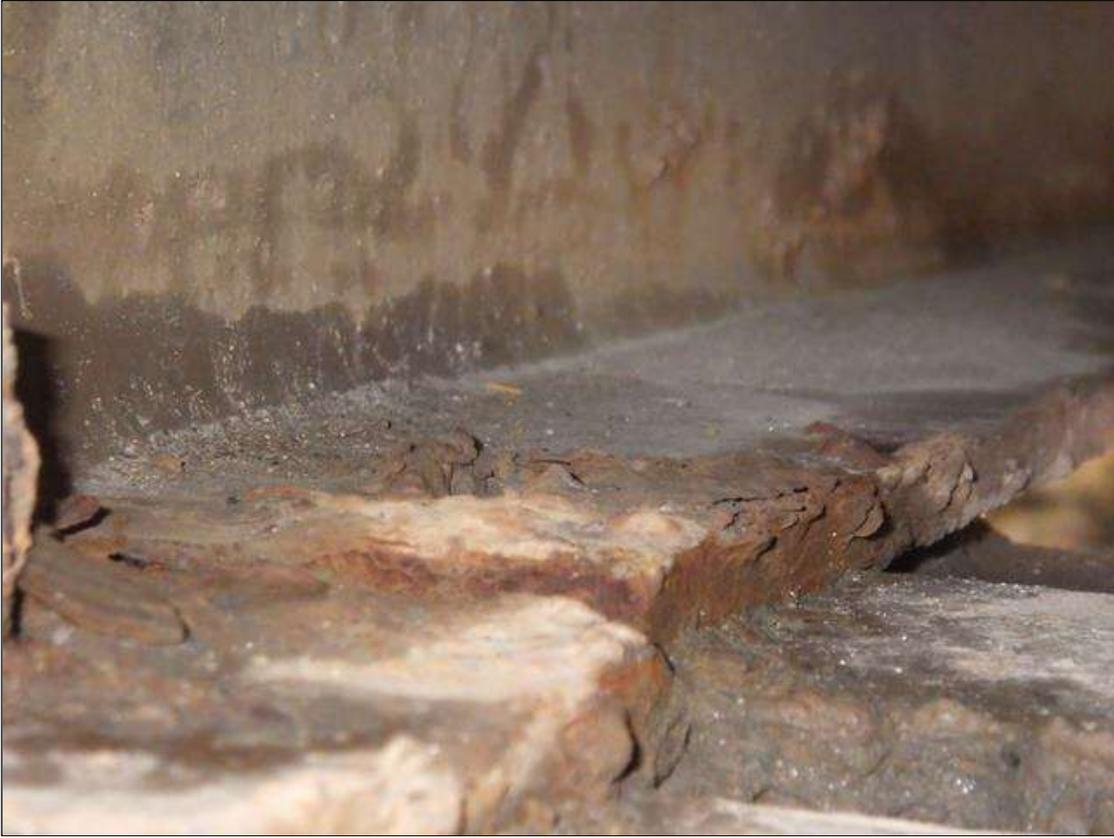
Span 1 Near Bearing: MISSING LEFT ANCHOR BOLT AND ANCHOR BOLT NUT IN BEAM 4 BEARING (PRIORITY ACTION REQUEST)

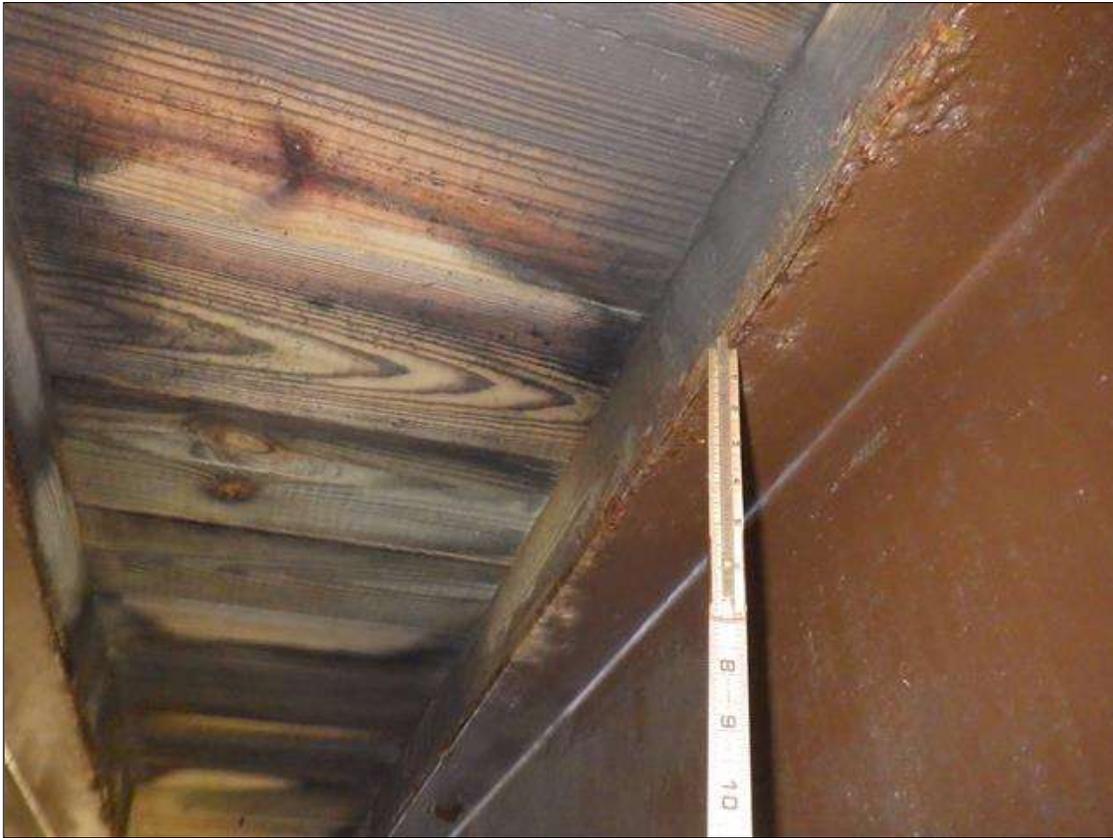
Span 1 Beam 3: ARRESTED CORROSION UP TO INTERMITTENT FULL LENGTH X FULL WIDTH WITH 1/32 INCH SECTION LOSS IN THE TOP FLANGE

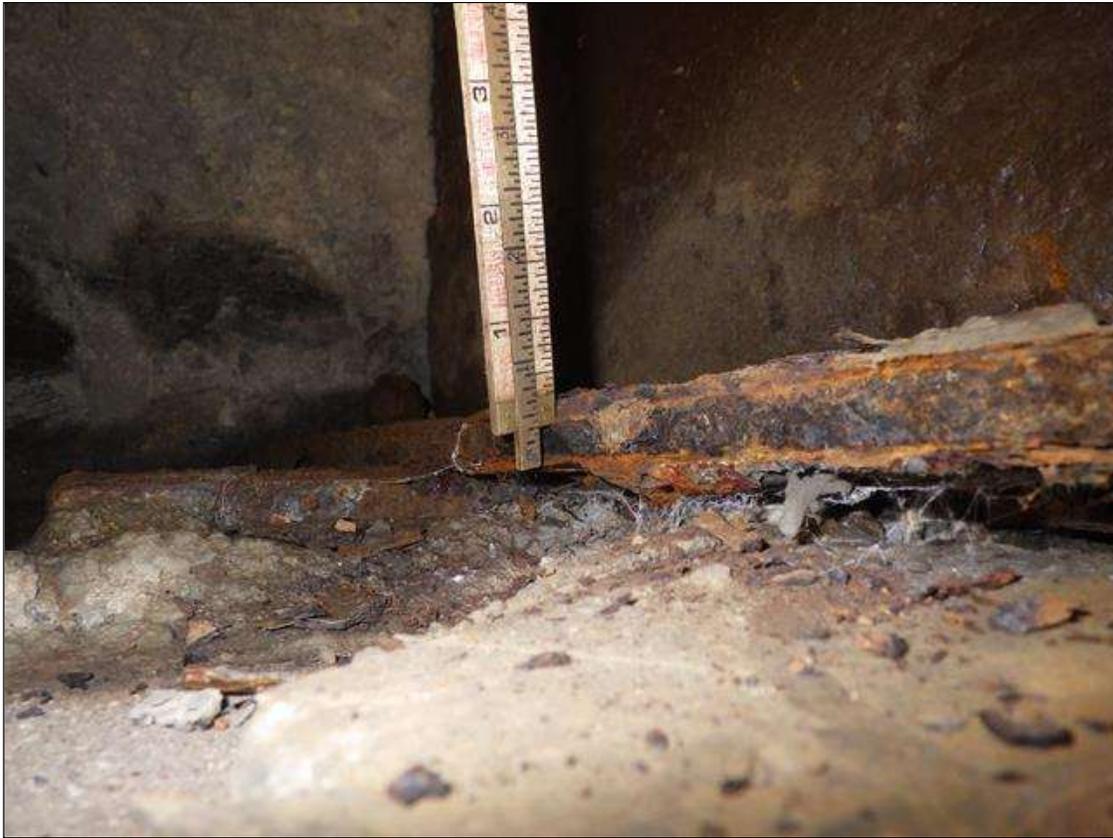
Span 1 Beam 3: ACTIVE CORROSION UP TO 1 FOOT 4 INCHES LONG X FULL WIDTH WITH 3/8 INCH REMAINING (GREATER THAN OR EQUAL TO 1/16 INCH SECTION LOSS, GREATER THAN 25 PERCENT SECTION LOSS) IN THE BOTTOM FLANGE AT END BENT 1 (PRIORITY ACTION REQUEST)

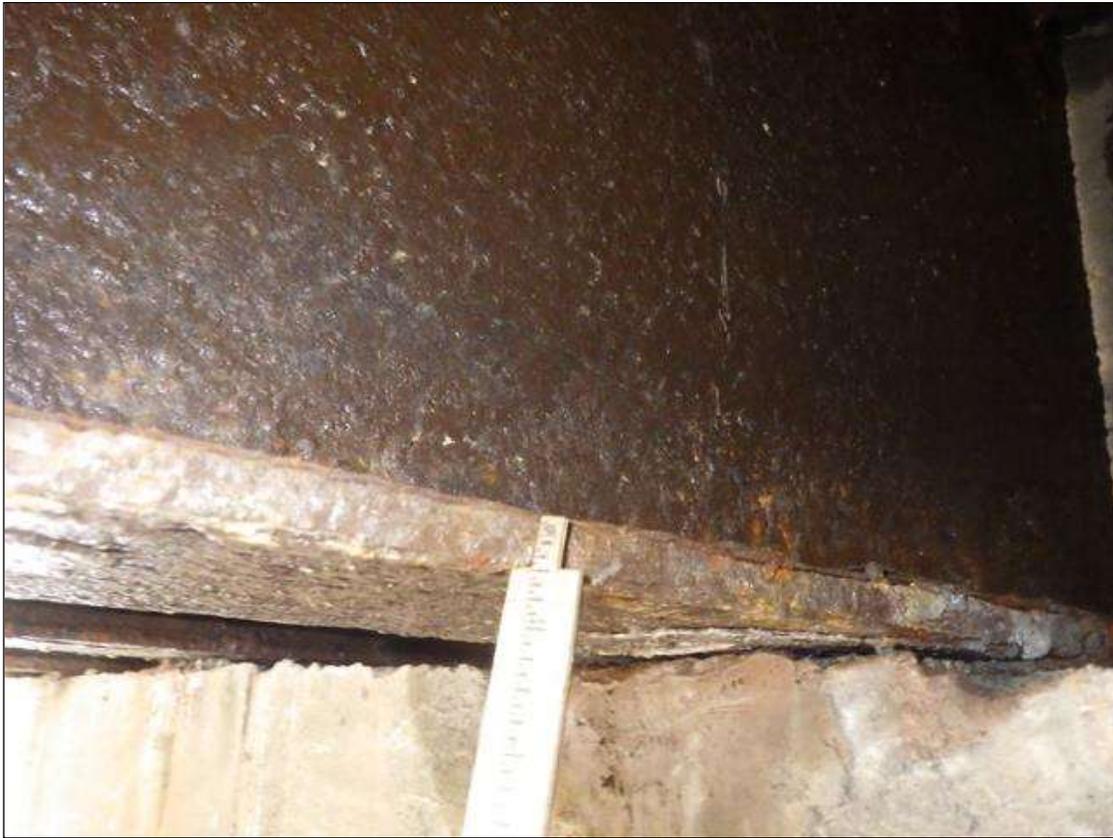
Span 1 Beam 6: ARRESTED CORROSION UP TO 3 FEET 4 INCHES LONG X FULL WIDTH WITH 7/16 INCH REMAINING (GREATER THAN OR EQUAL TO 1/16 INCH SECTION LOSS, LESS THAN 25 PERCENT SECTION LOSS) IN THE BOTTOM FLANGE AT END BENT 1

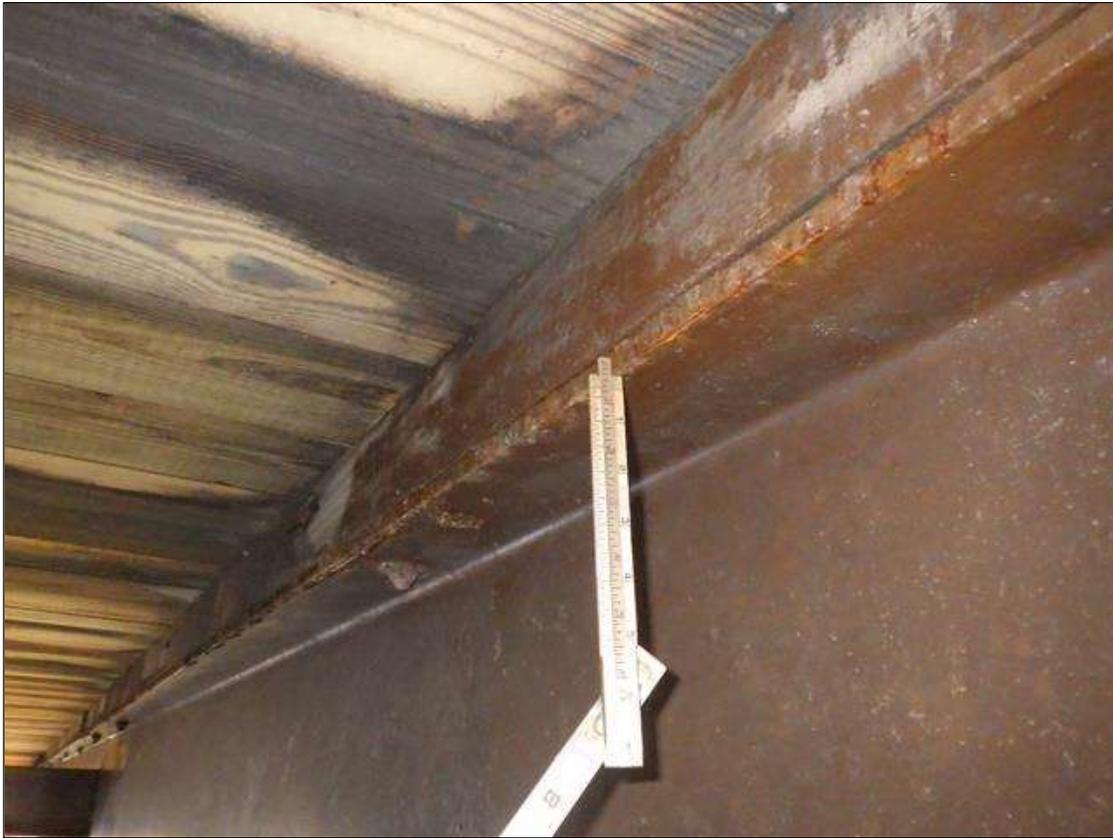
Span 1 Beam 4: ARRESTED CORROSION UP TO INTERMITTENT FULL LENGTH X FULL WIDTH WITH 1/32 INCH SECTION LOSS IN THE TOP FLANGE

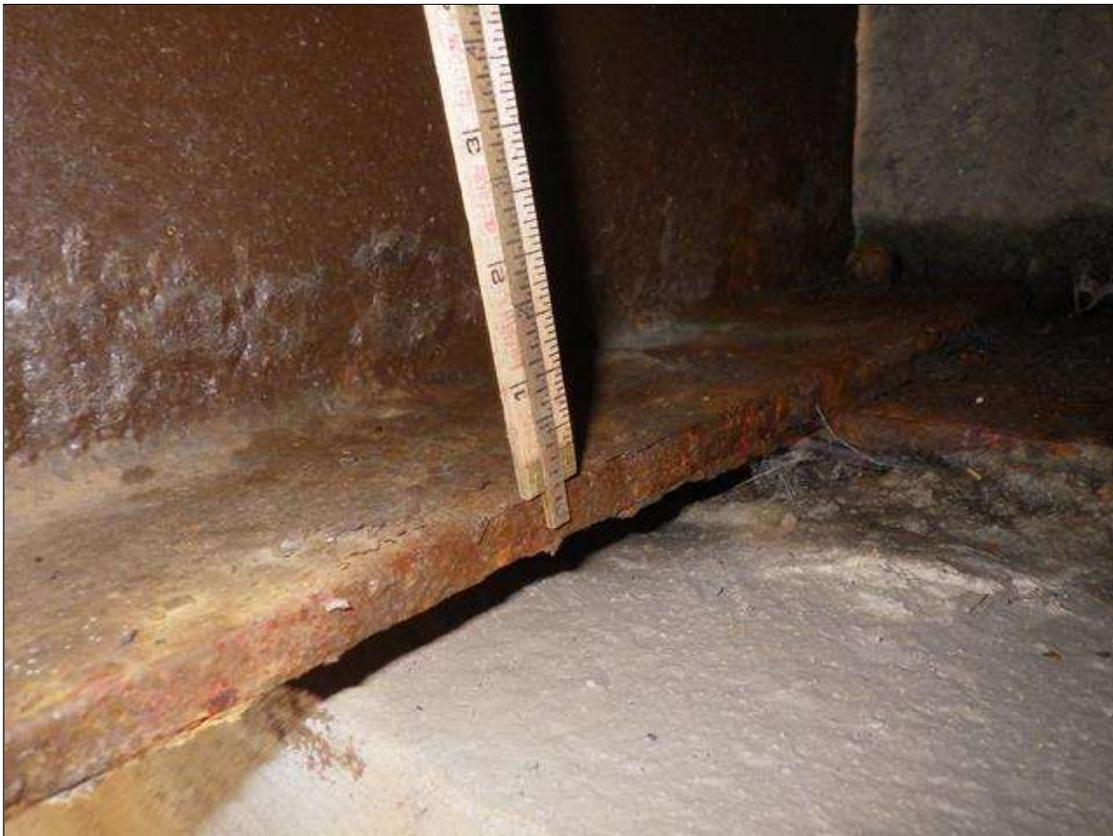
Span 1 Beam 4: ARRESTED CORROSION UP TO 2 FEET LONG X FULL WIDTH WITH 1/32 INCH SECTION LOSS IN THE BOTTOM FLANGE AT END BENT 1

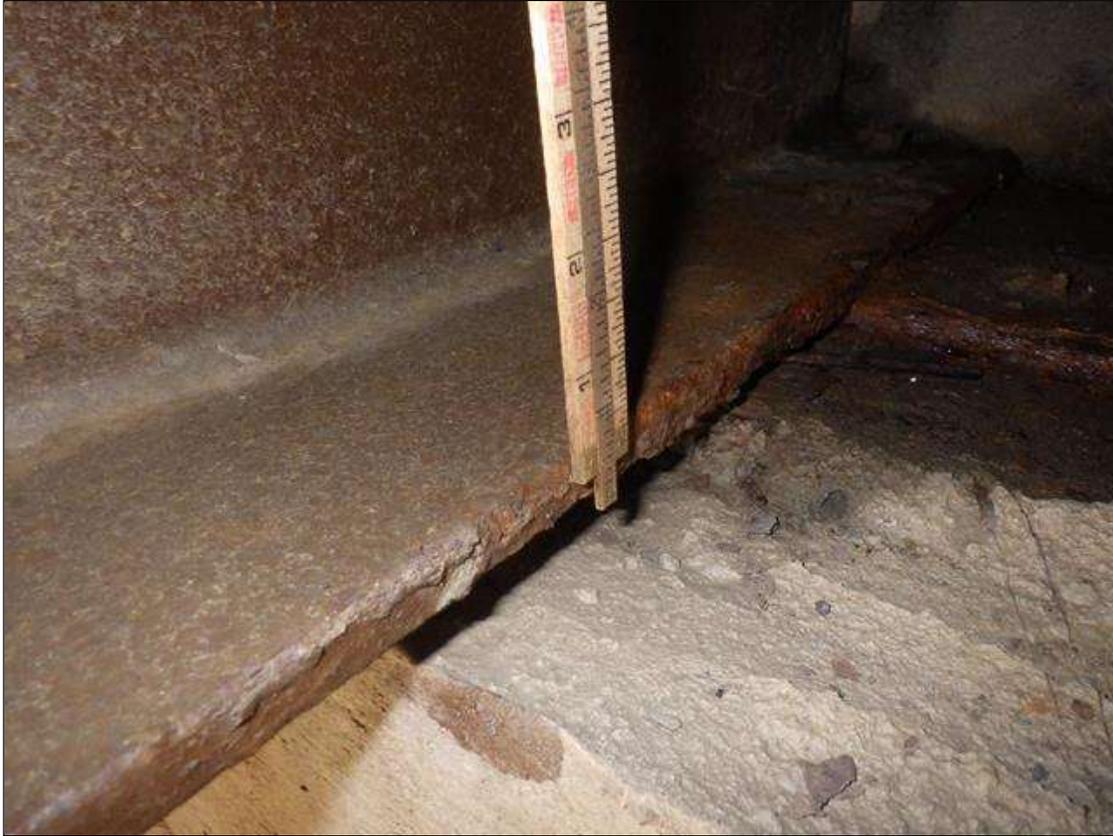
Span 1 Beam 5: ARRESTED CORROSION UP TO 1 FOOT 6 INCHES LONG X FULL WIDTH WITH 1/32 INCH SECTION LOSS IN THE BOTTOM FLANGE AT END BENT 1

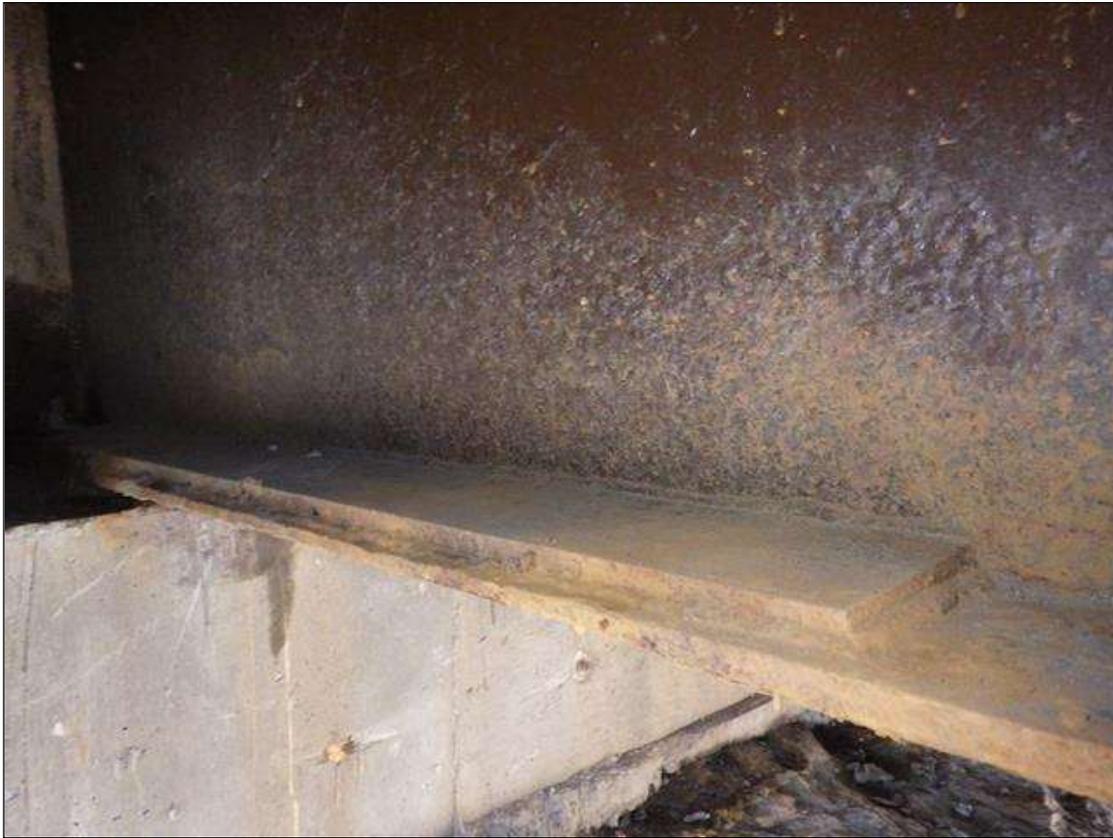
Span 1 Beam 7: (2) REPAIR PLATES UP TO 2 FEET 6 INCHES LONG X 3 1/2 INCHES WIDE X 1/2 INCH THICK IN THE BOTTOM LEFT FLANGE AND 3 FEET 4 INCHES LONG X 3 1/2 INCHES WIDE X 1/2 INCH THICK IN THE BOTTOM RIGHT FLANGE AT END BENT 1

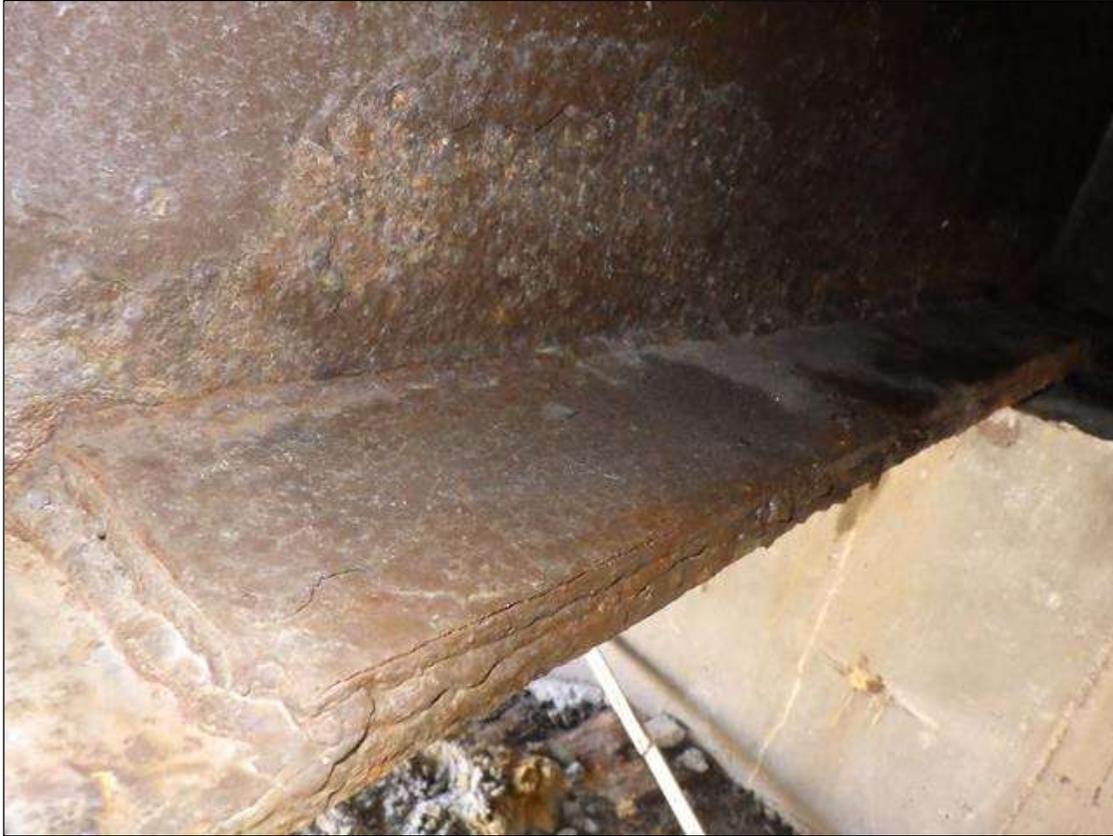
Span 1 Beam 7: (2) REPAIR PLATES UP TO 2 FEET 6 INCHES LONG X 3 1/2 INCHES WIDE X 1/2 INCH THICK IN THE BOTTOM LEFT FLANGE AND 3 FEET 4 INCHES LONG X 3 1/2 INCHES WIDE X 1/2 INCH THICK IN THE BOTTOM RIGHT FLANGE AT END BENT 1

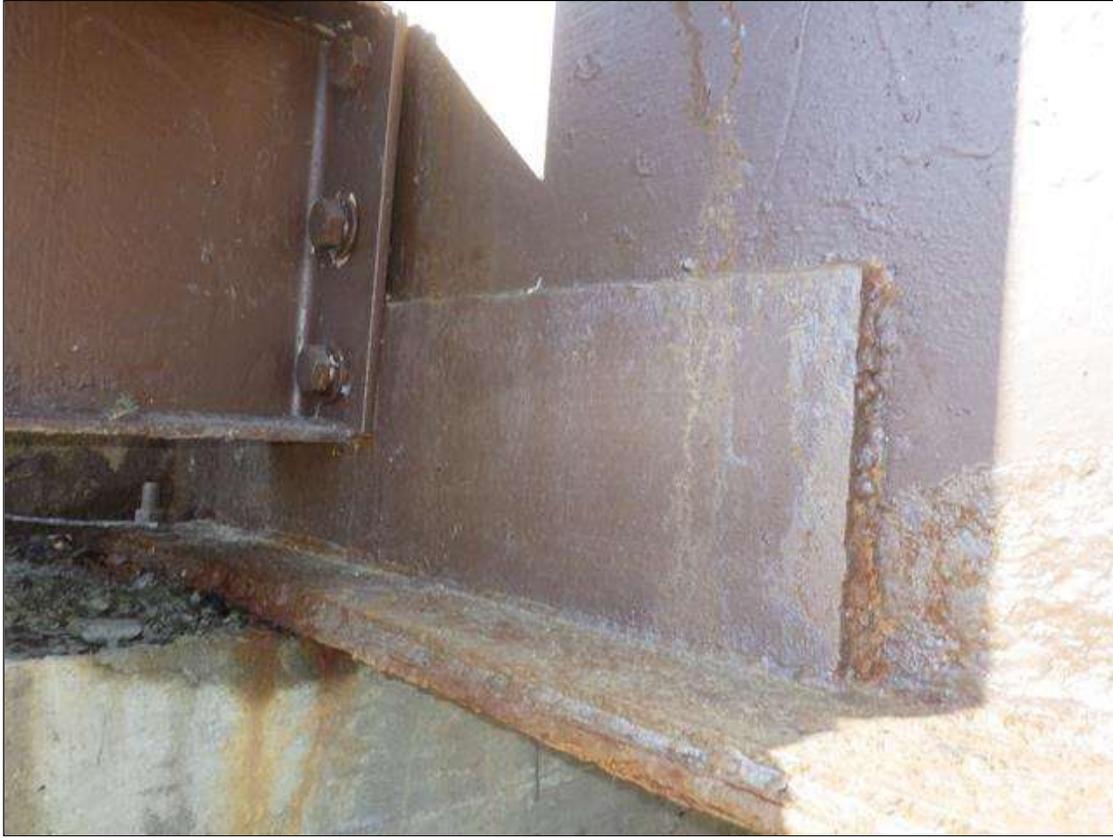
Span 1 Beam 9: (4) REPAIR PLATES (1) UP TO 3 FEET LONG X 3 1/2 INCHES WIDE X 1/2 INCH THICK IN THE LEFT BOTTOM FLANGE, (2) UP TO 2 FEET LONG X 7 INCHES HIGH X 3/4 INCH THICK IN THE LEFT AND RIGHT SIDES OF THE WEB, AND (1) UP TO 4 FEET LONG X 3 1/2 INCHES WIDE X 1/2 INCH THICK IN THE RIGHT BOTTOM FLANGE AT END BENT 1
