NC DEPARTMENT OF TRANSPORTATION  
 DIVISION OF HIGHWAYS  
 STRUCTURE MANAGEMENT UNIT

# Structure Safety Report

## Routine Element Inspection - Contract

STRUCTURE NUMBER: 100203      SAP STRUCTURE NO: 0110203      FHWA STRUCTURE NO: 00000000210203

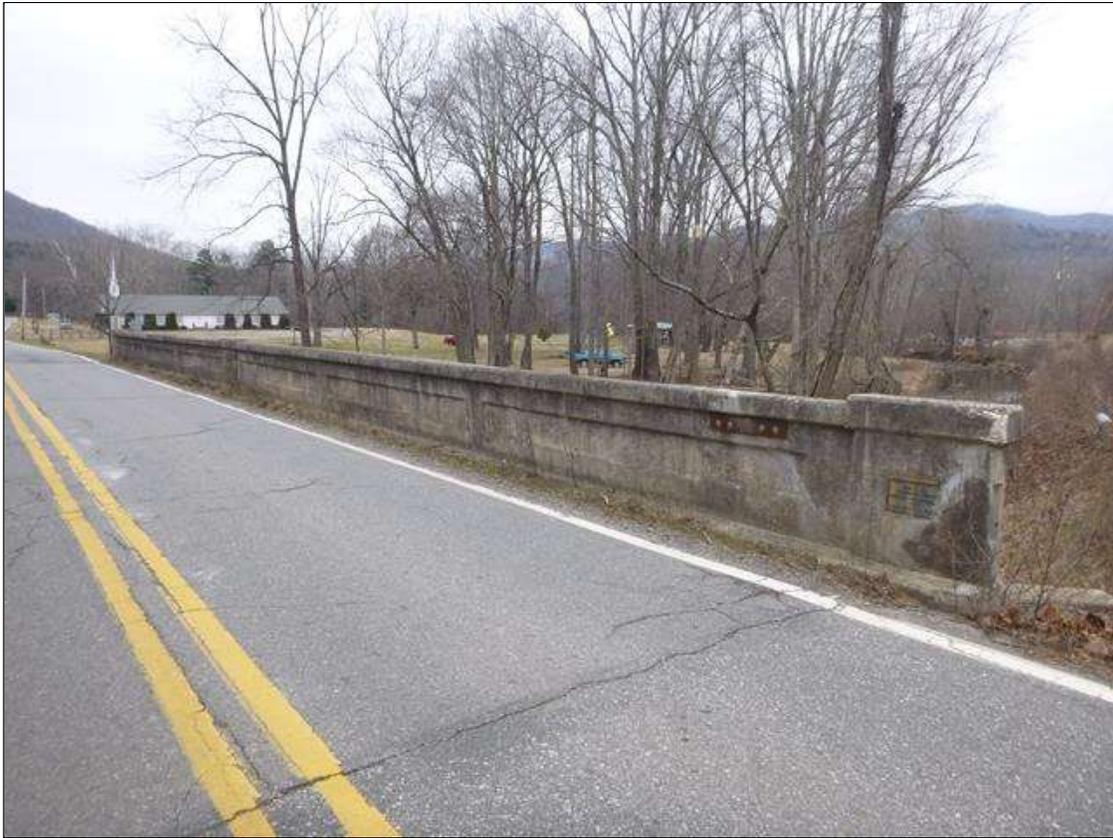
DIRT AND DEBRIS ALONG CURB

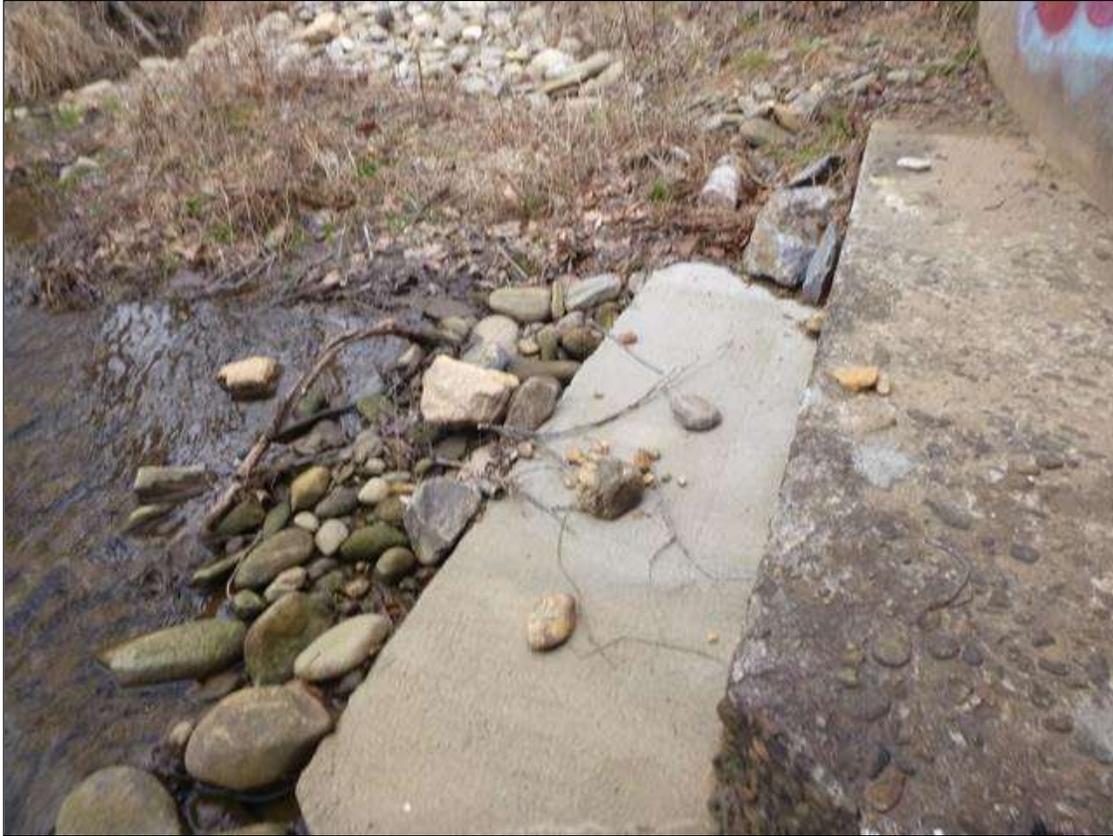
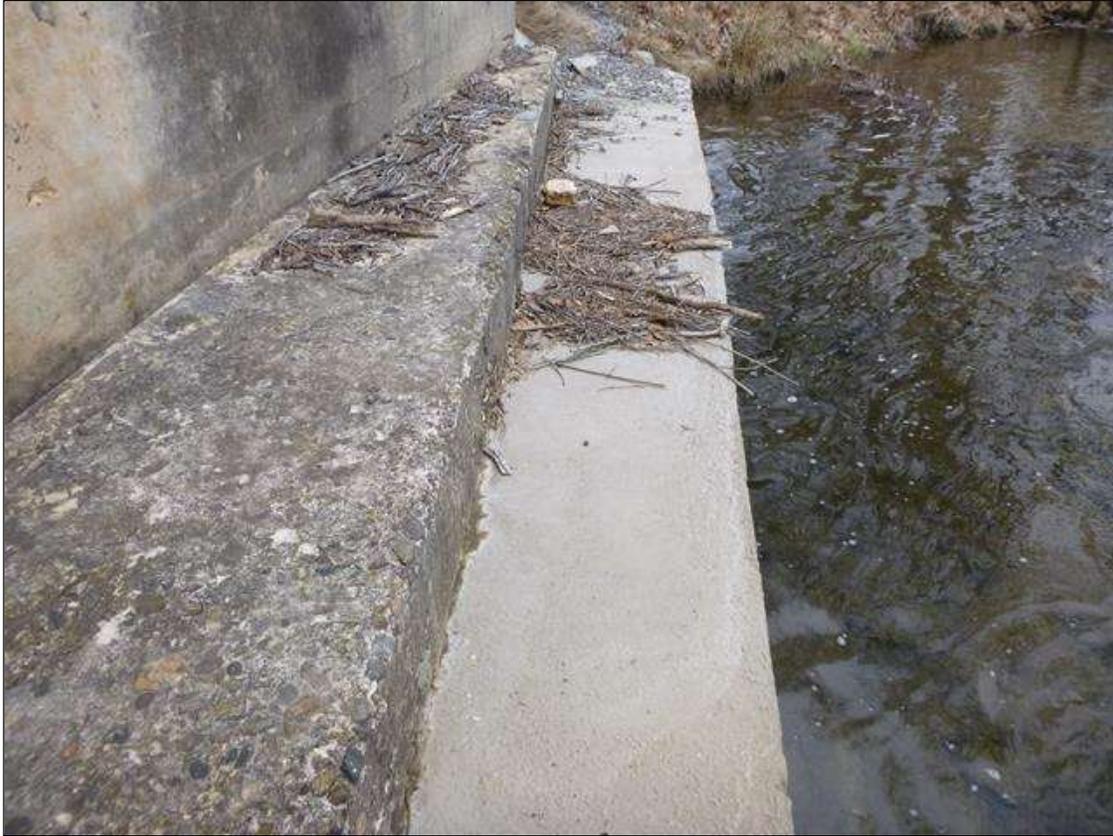
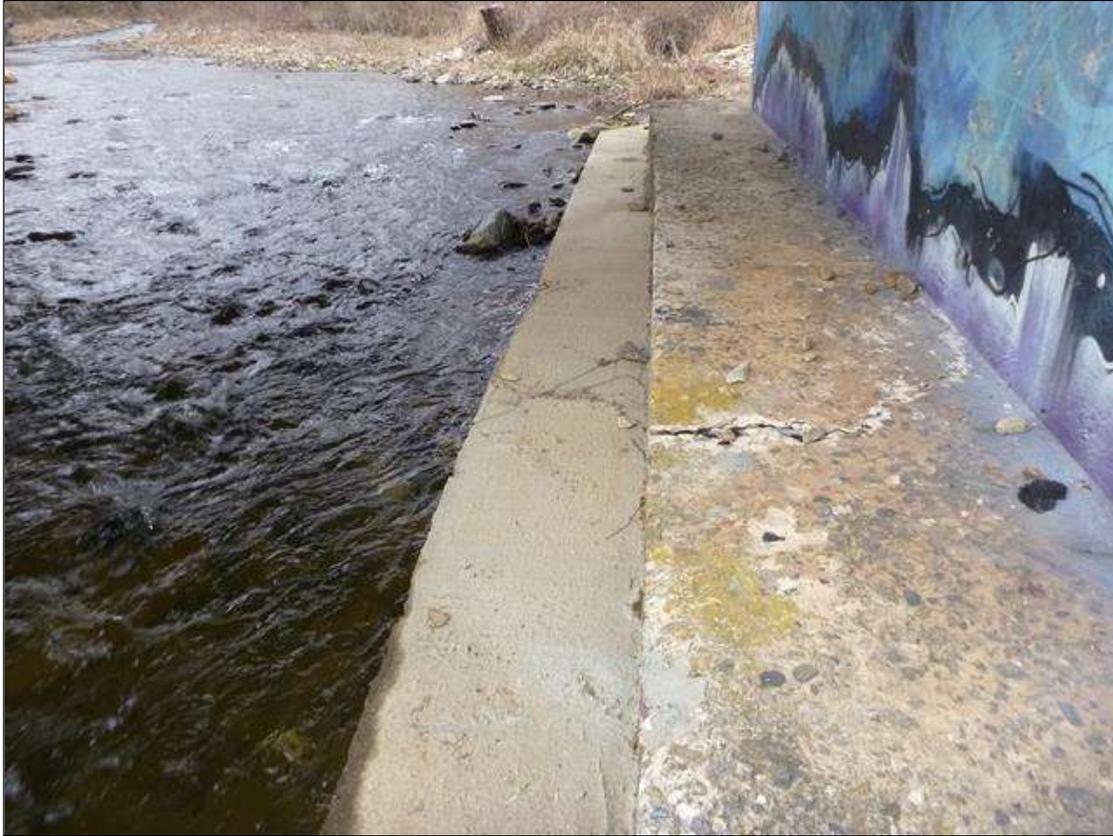
End Bent 2 Abutment: NEW REPAIR : 58 FOOT LONG BY 2 FOOT WIDE CONCRETE REPAIR ON STREAM FACE OF FOOTING, PREVIOUSLY: SCOUR FULL LENGTH OF ABUTMENT WITH UP TO 2 FEET DEEP UNDERMINING (MEASURED 8 FEET FROM UPSTREAM TURNBACK) STARTING AT UPSTREAM TURNBACK. SCOUR HEIGHT FROM TOP OF FOOTING TO STREAMBED IS UP TO 8 FEET WITH WATER DEPTH OF 7 FEET. (MEASURED AT DOWN STREAM TURNBACK). EXTENT OF UNDERMINING IF ANY COULD NOT BE DETERMINED AT DOWNSTREAM END DUE TO WATER DEPTH. SUPPLEMENTAL UNDERWATER INSPECTION REQUESTED.

RECOMMEND SUPPLEMENTAL UNDERWATER INSPECTION FOR SCOUR/UNDERMINING AT DOWNSTREAM END AMUTMENT 2 DUE TO WATER DEPTH

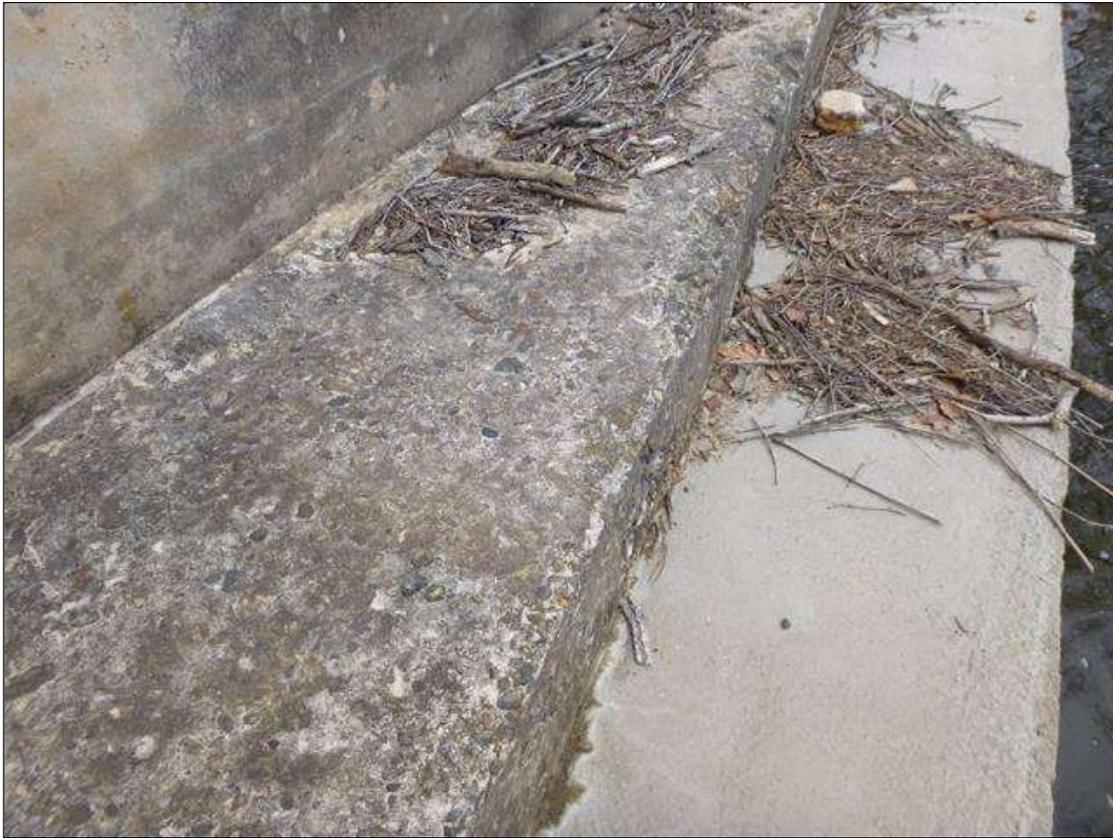
End Bent 2 Abutment: HEAVY SCALING/SPALLING (22 FEET X 1 FEET X 4 INCHES) IN FOOTING APRON AT DOWNSTREAM END

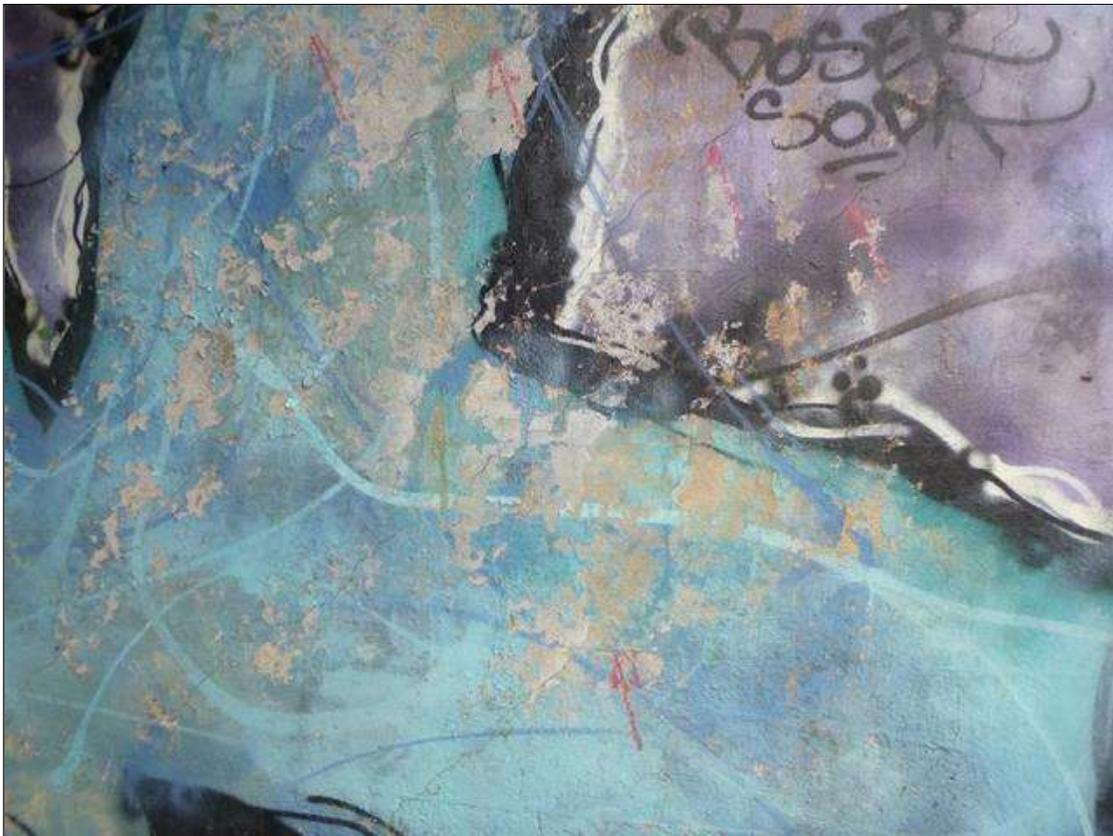
End Bent 2 Abutment: (5) DIAGONAL CRACKS 1/32 INCH WIDE UP TO 10 FEET LONG UNDER BEAM 3

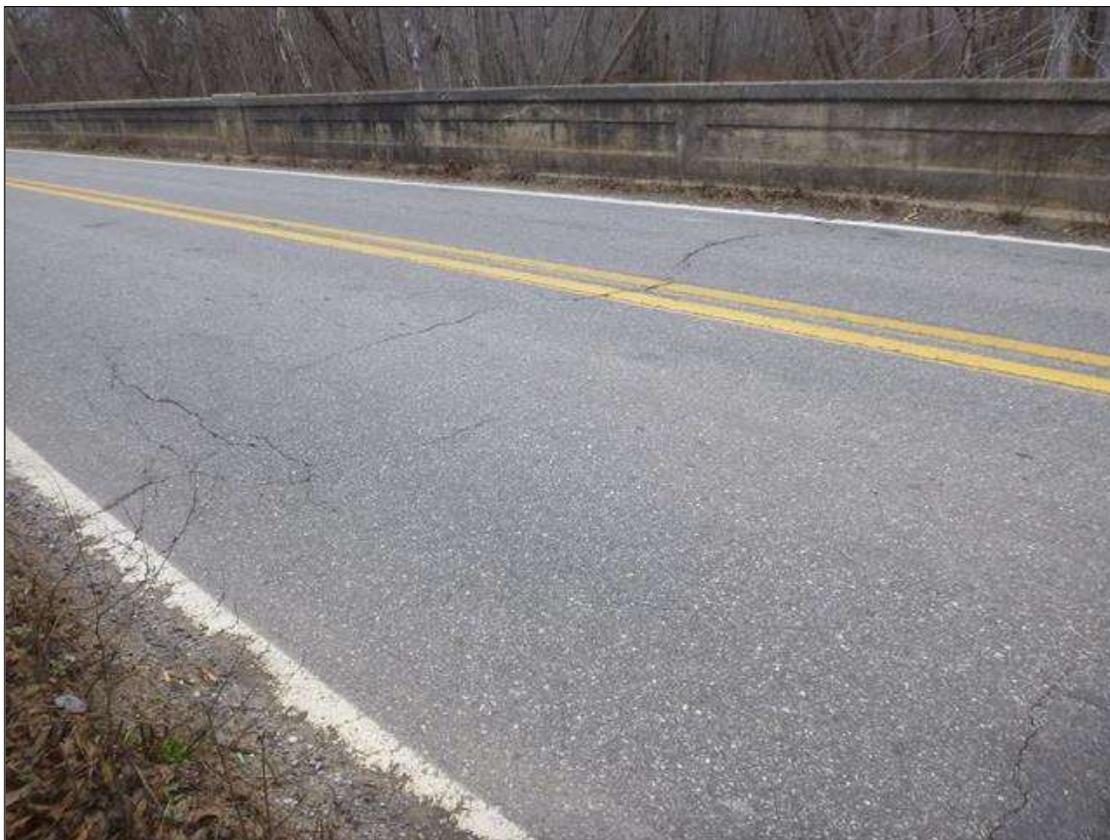
Span 2 Wearing Surface: INTERMITTENT TRANSVERSE, LONGITUDINAL AND MAP CRACKING (UP TO 1/2 INCH) THROUGHOUT ASPHALT WEARING SURFACE.

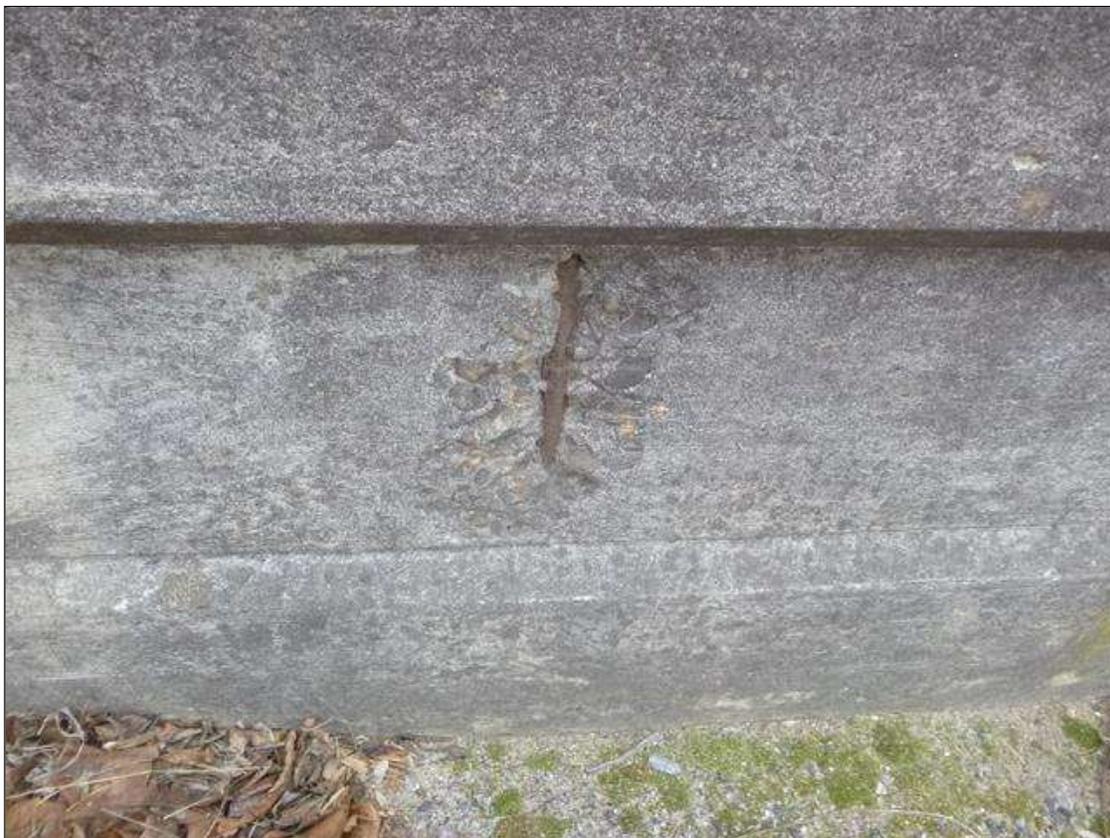
Span 2 Right Bridge Rail: (6) SPALLING WITH EXPOSED REBAR THROUGHOUT INSIDE SIDE OF PARAPET (UP TO 10 INCHES X 6 INCHES X 3/4 INCH)

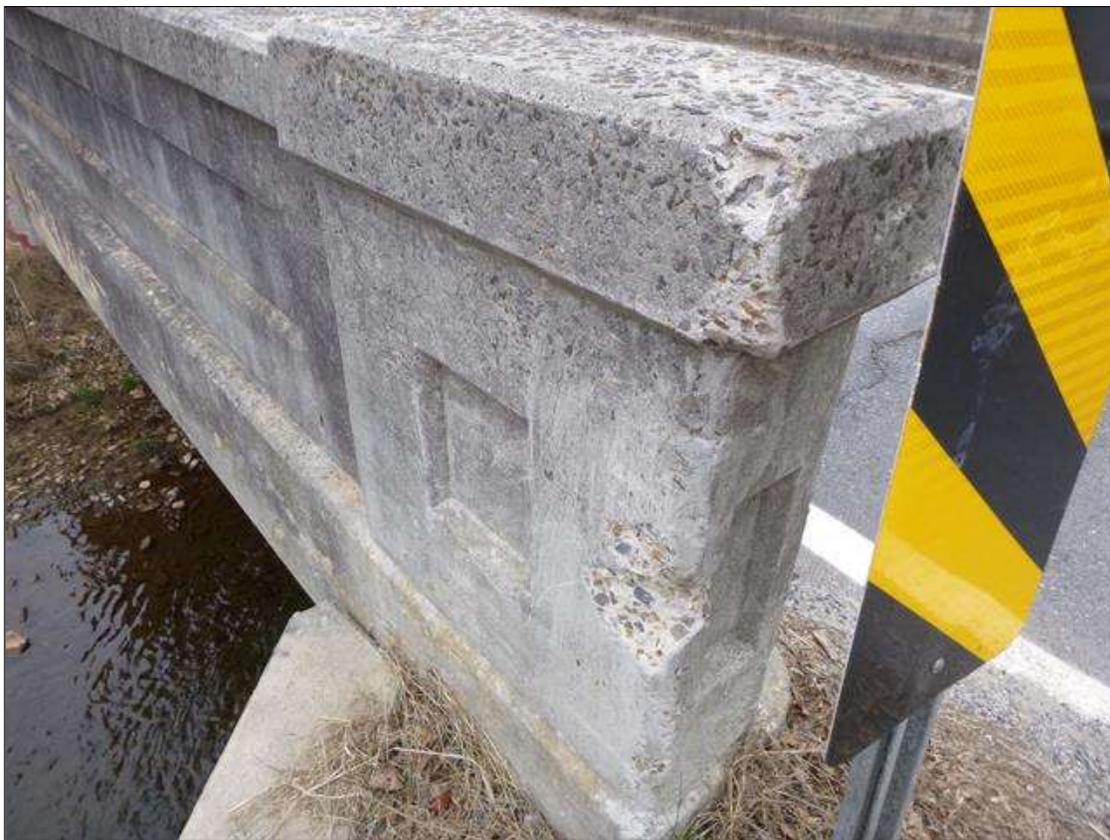
Span 2 Right Bridge Rail: AT END OF RAIL, (2) SPALLS UP TO 7 INCH DIAMETER BY 1/2 INCH DEEP

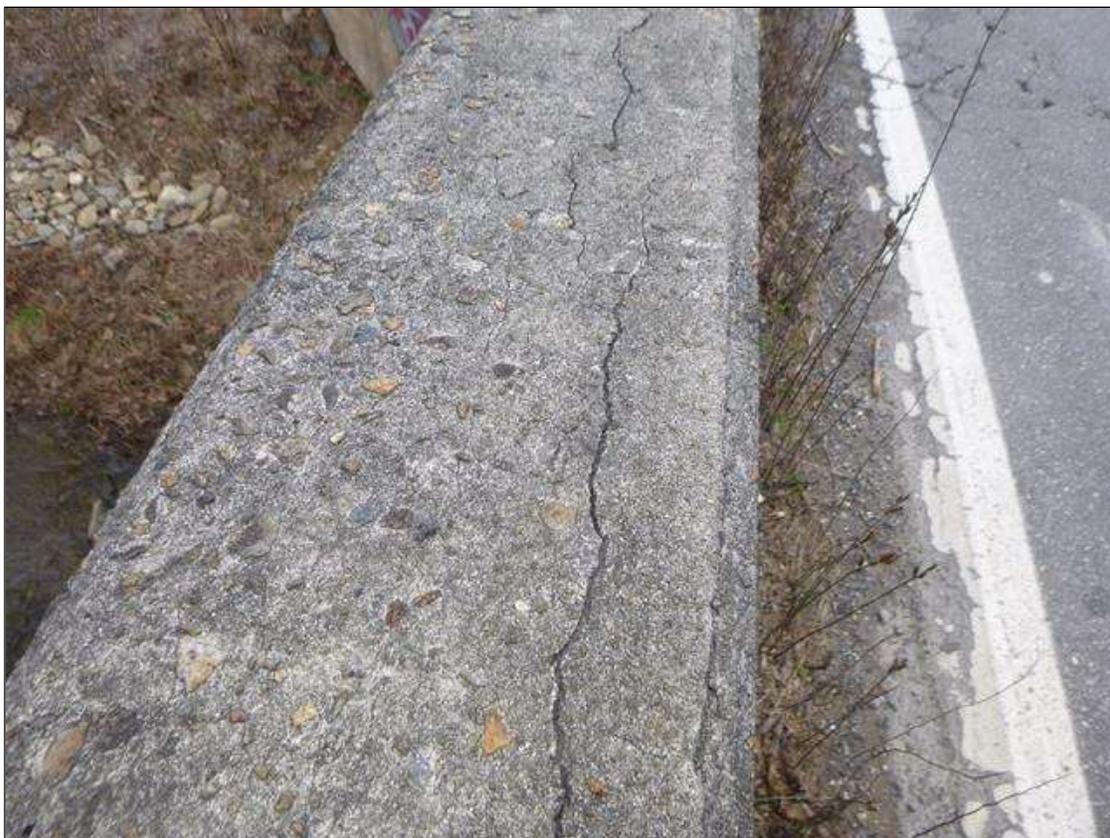
Span 2 Left Bridge Rail: LONGITUDINAL CRACKING TO FULL LENGTH OF TOP OF RAIL

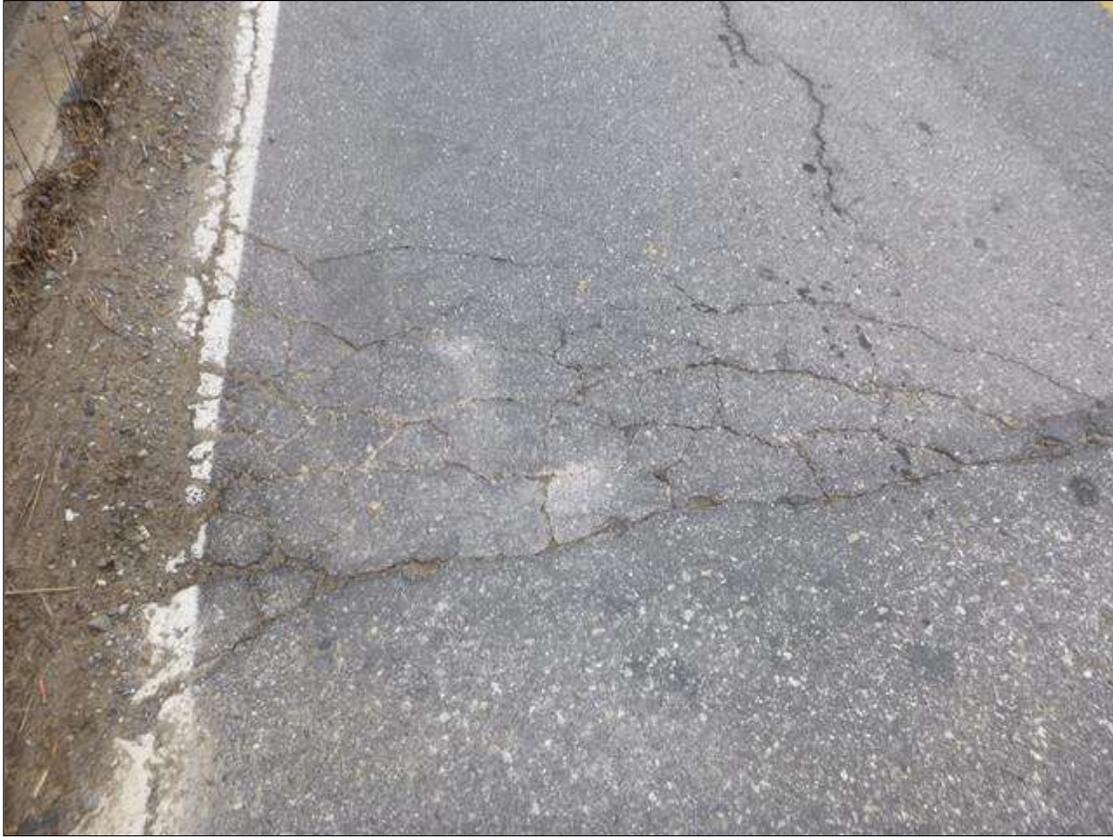
Span 1 Wearing Surface: 5 SQUARE FEET OF MAP CRACKING (UP TO 1/4 INCH) IN ASPHALT WEARING SURFACE AT NEAR LEFT SIDE. 3 SQUARE FEET OF MAP CRACKING (UP TO 1/4 INCH) IN ASPHALT WEARING SURFACE AT NEAR RIGHT SIDE.

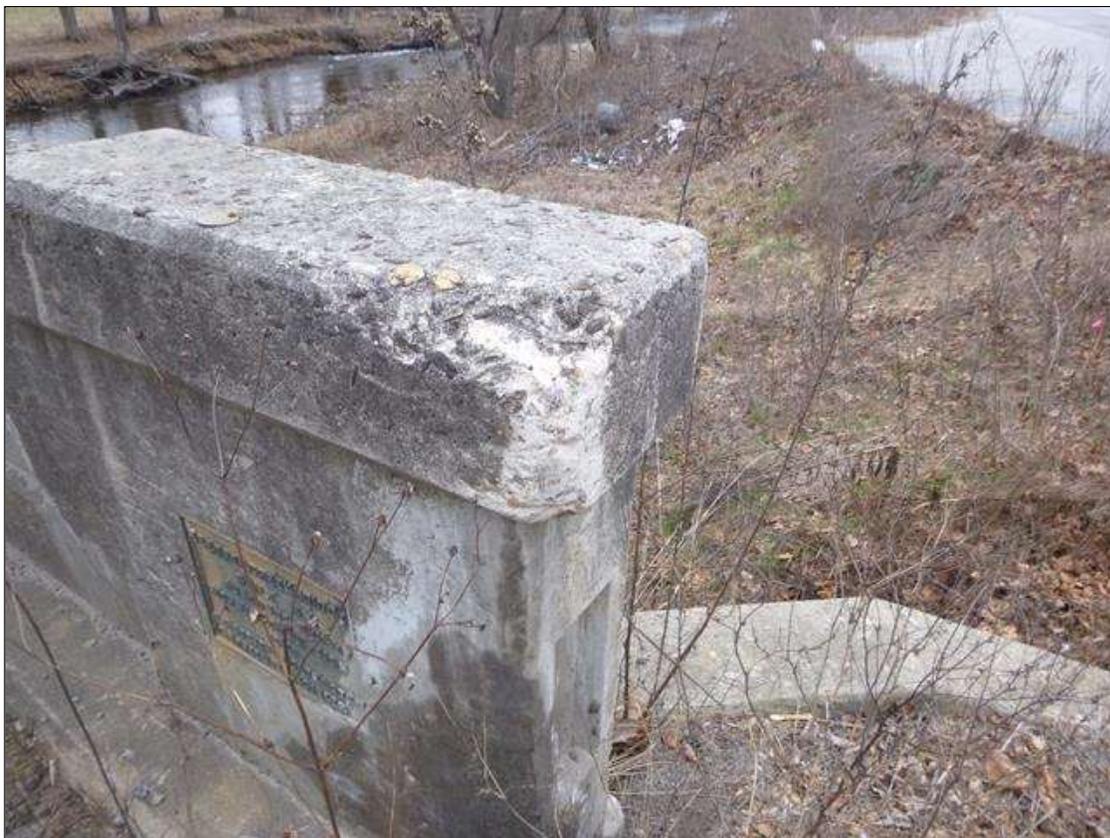
Span 1 Right Bridge Rail: 10 INCHES LONG X 6 INCHES HIGH X 1 INCH DEEP SPALL IN TOP OF RAIL AT ABUTMENT 1

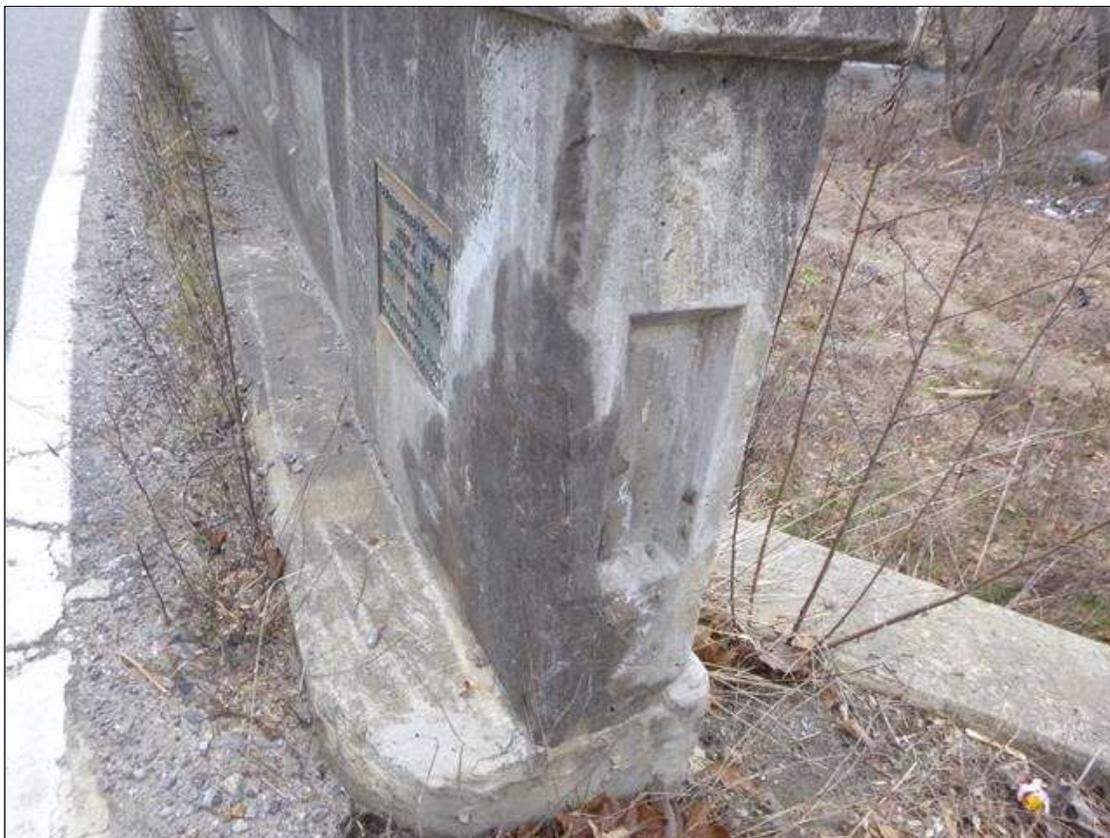
Span 1 Right Bridge Rail: AT WEST END, 3 SQUARE FEET OF UNSOUND PATH WITH EFFLORESCENCE

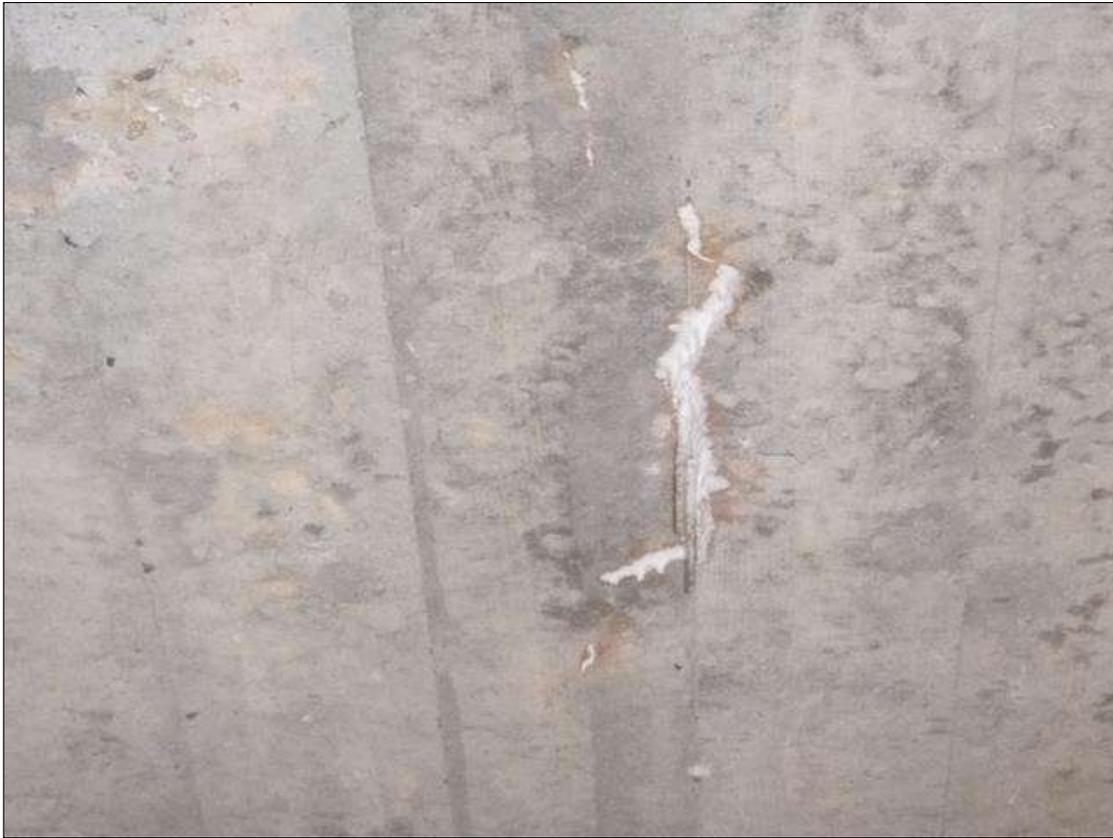
Span 1 Deck: 12 INCHES OF EFFLORESCENCE BUILDUP IN BOTTOM OF DECK, MIDSPAN BAY 1

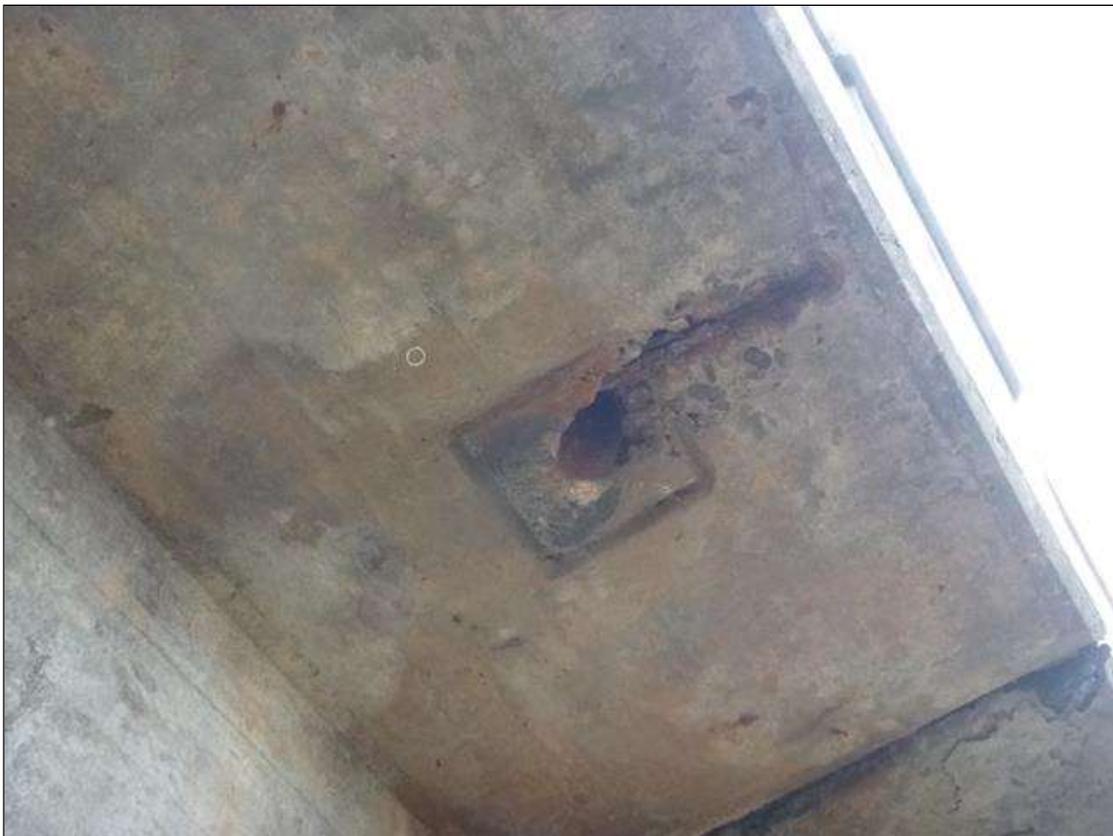
Span 1 Deck: SPALL (10 INCHES X 6 INCHES X 1 INCH) WITH EXPOSED REBAR WITH SECTION LOSS AT FAR RIGHT DECK OVERHANG 2 FEET FROM PIER 1

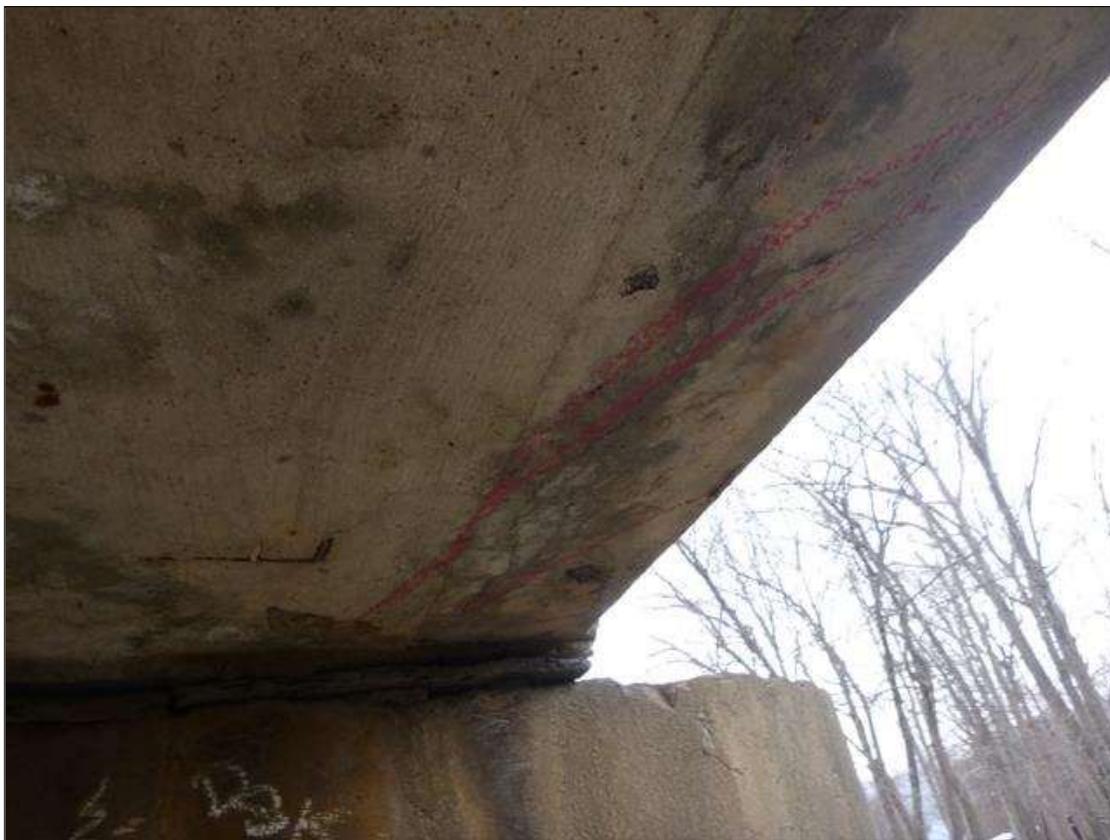
Span 1 Beam 3: BOTTOM OF BEAM AT PIER 1, DELAMINATION 18 INCHES LONG BY 6 INCHES WIDE

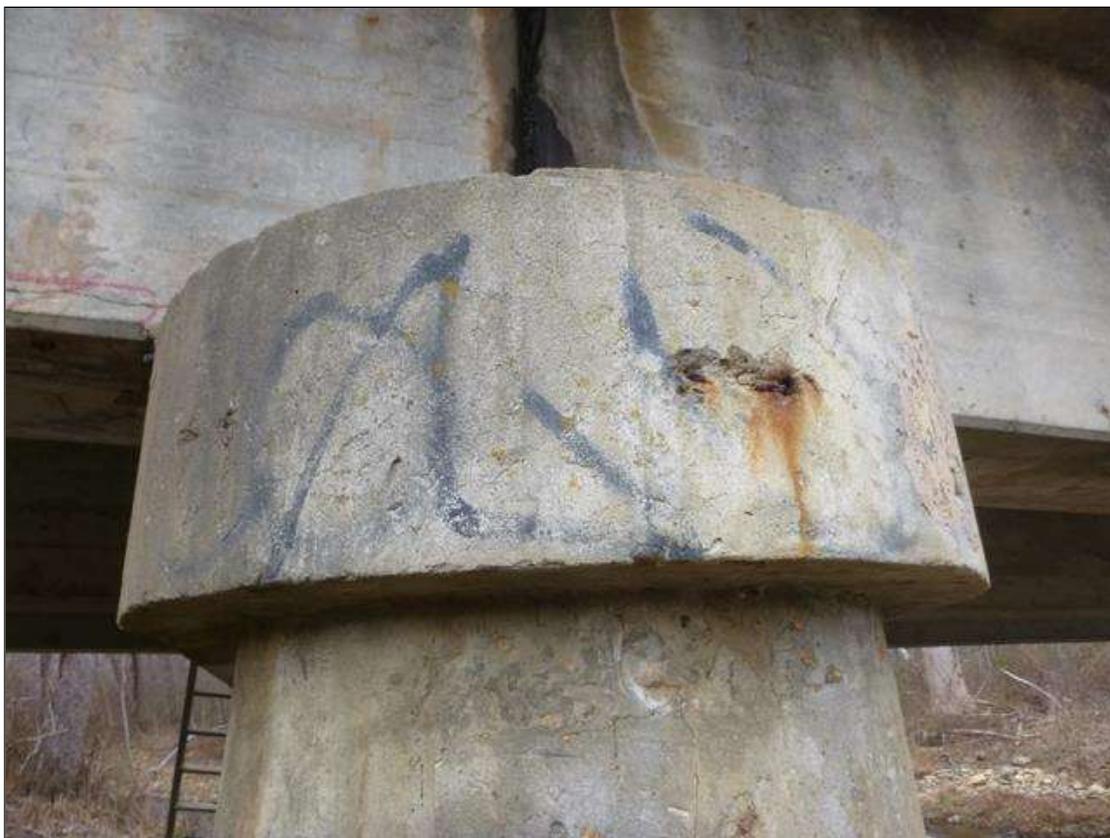
Bent 1 Cap 1: MAP AND VERTICAL HAIRLINE CRACKING TO RIGHT END OF CAP

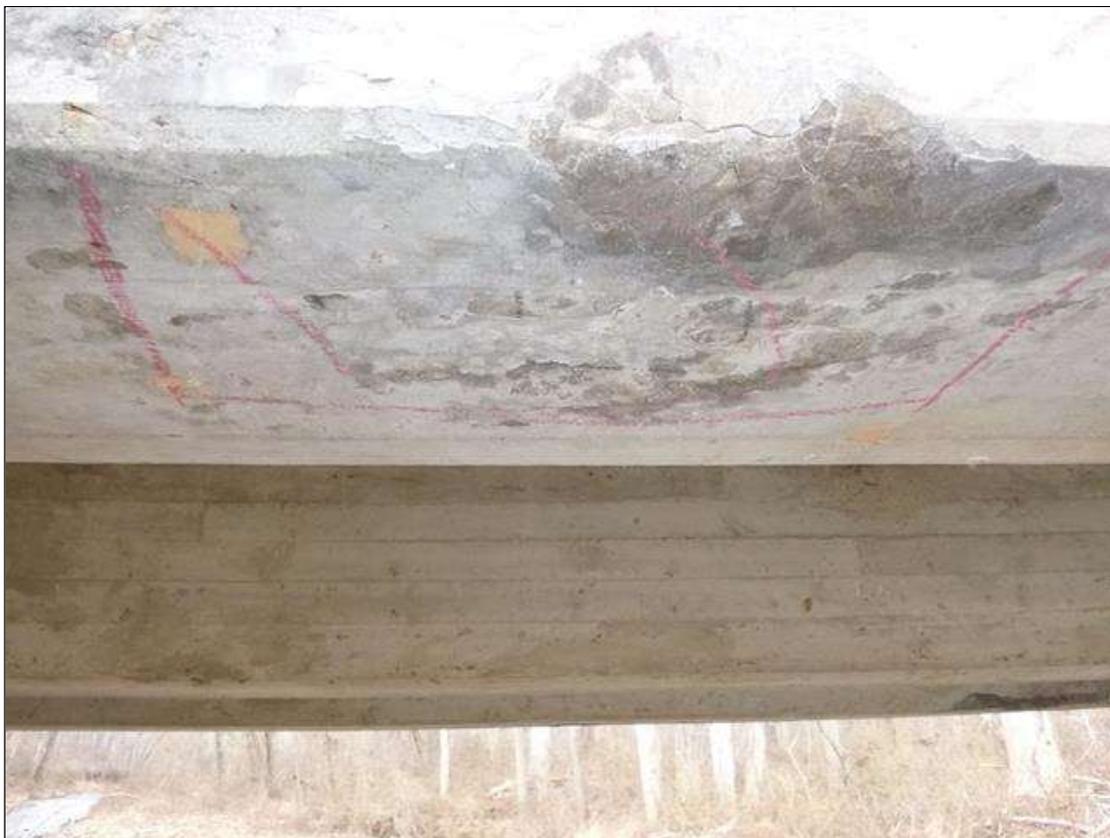
Span 2 Beam 3: 17 FEET FROM BENT 1, UNSOUND PATCH ON BOTTOM OF BEAM, 2 FEET LONG BY 1 FOOT WIDE

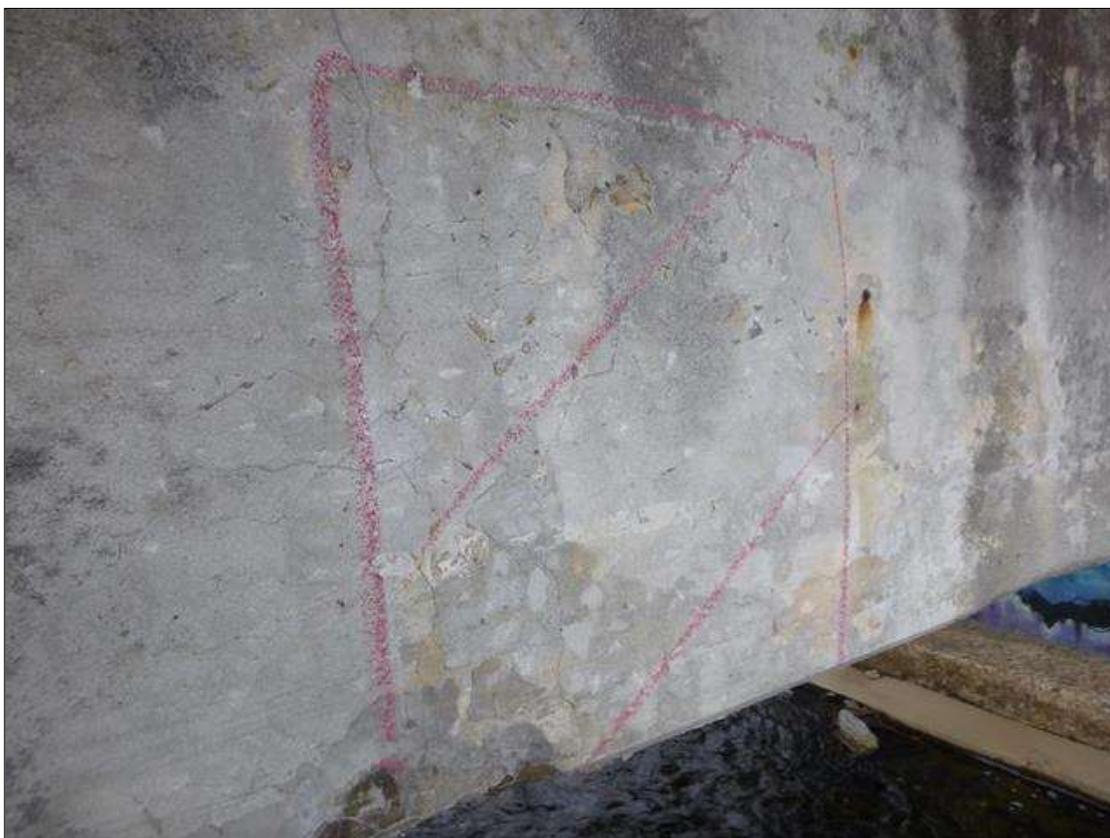
Span 2 Beam 3: 18 FEET FROM BENT 1, DELAMINATION ON RIGHT FACE OF BEAM 18 INCHES LONG BY 18 INCHES HIGH

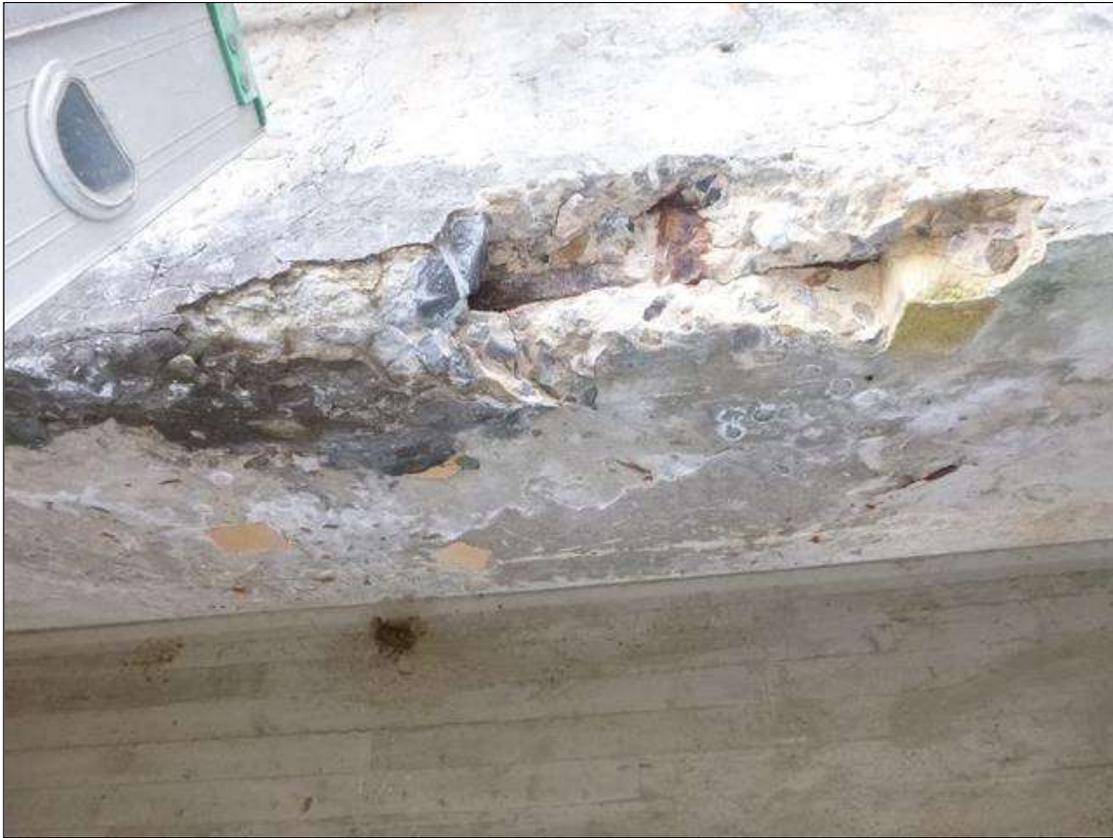
Priority Level	Defect Type	Quantity	Defect Description
2	Delamination/Spall	3	Span 2 Beam 3: (PROMPT ACTION REQUEST) 23 FEET FROM BENT 1, BOTTOM RIGHT CORNER OF BEAM, SPALL WITH EXPOSED MAIN REINFORCING 3 FEET LONG BY 9 INCHES WIDE BY 2 INCHES DEEP

Span 2 Beam 3: (PROMPT ACTION REQUEST) 23 FEET FROM BENT 1, BOTTOM RIGHT CORNER OF BEAM, SPALL WITH EXPOSED MAIN REINFORCING 3 FEET LONG BY 9 INCHES WIDE BY 2 INCHES DEEP

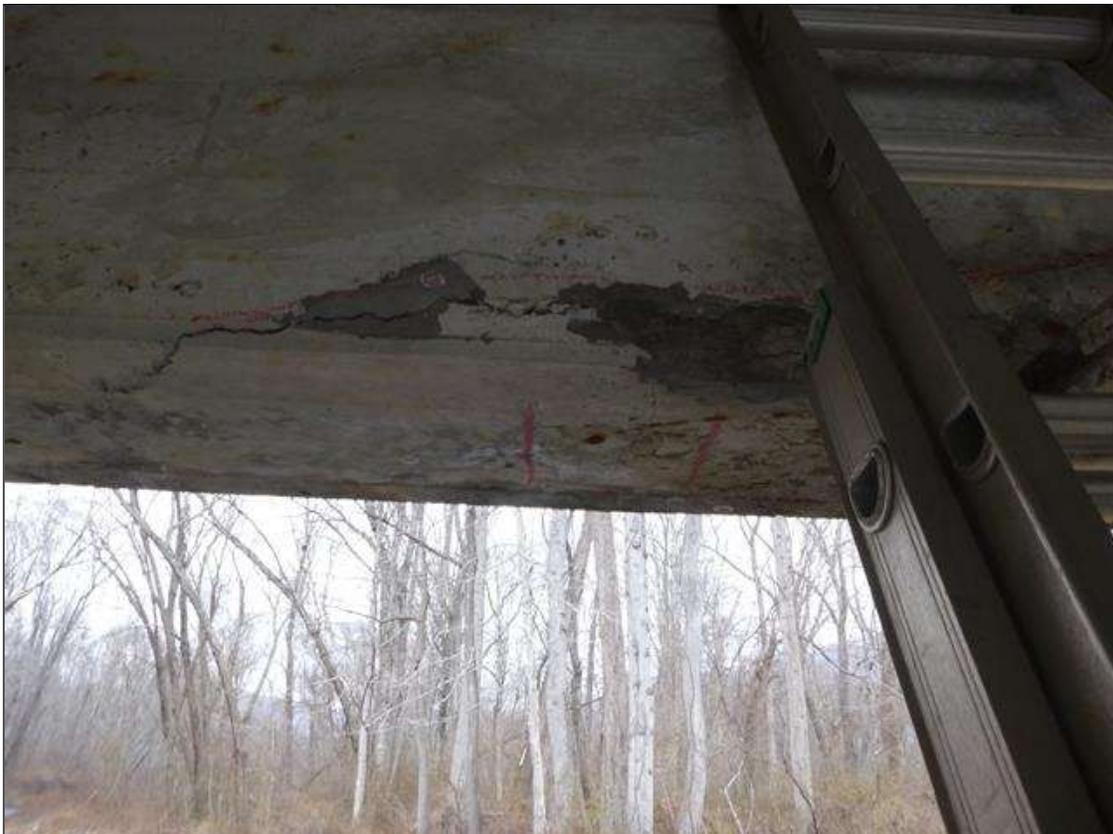
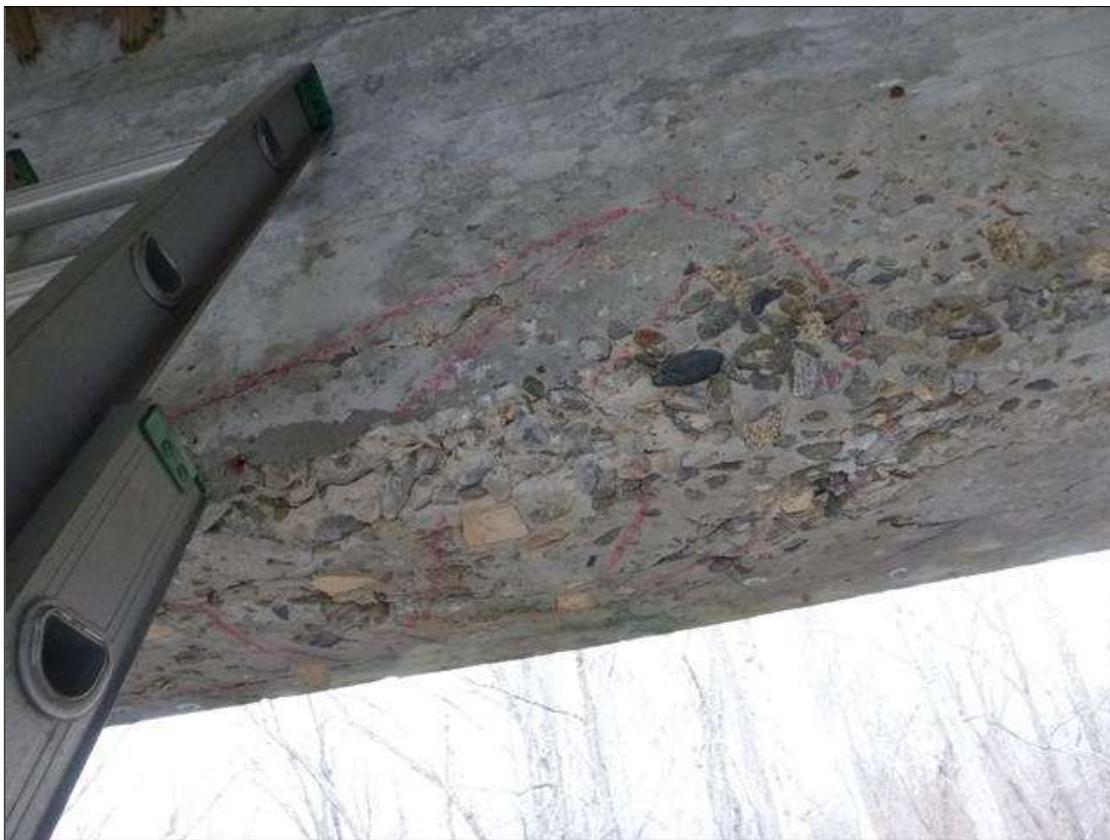
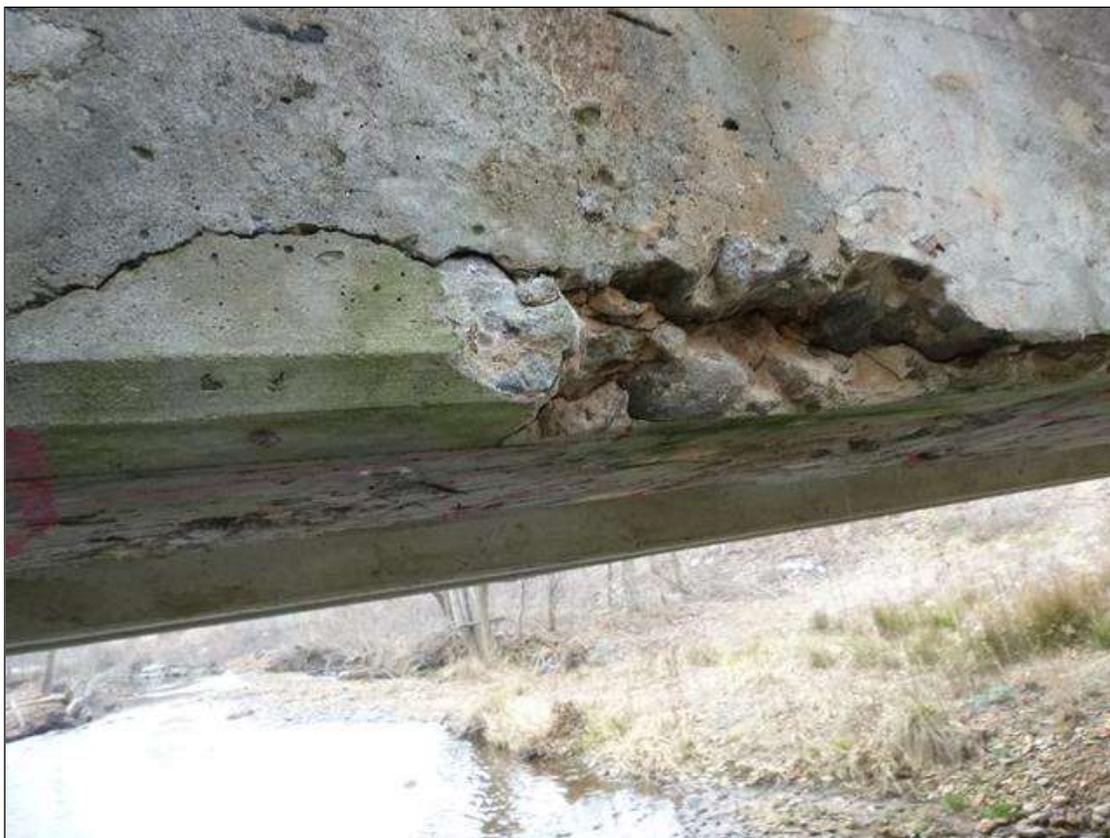
Span 2 Beam 1: 9 FEET FROM END BENT 2, ON BOTTOM AND SOUTH FACE OF BEAM, DELAMINATION 56 INCHES LONG BY 12 INCHES WIDE ON BOTTOM AND 10 INCHES HIGH ON SOUTH FACE

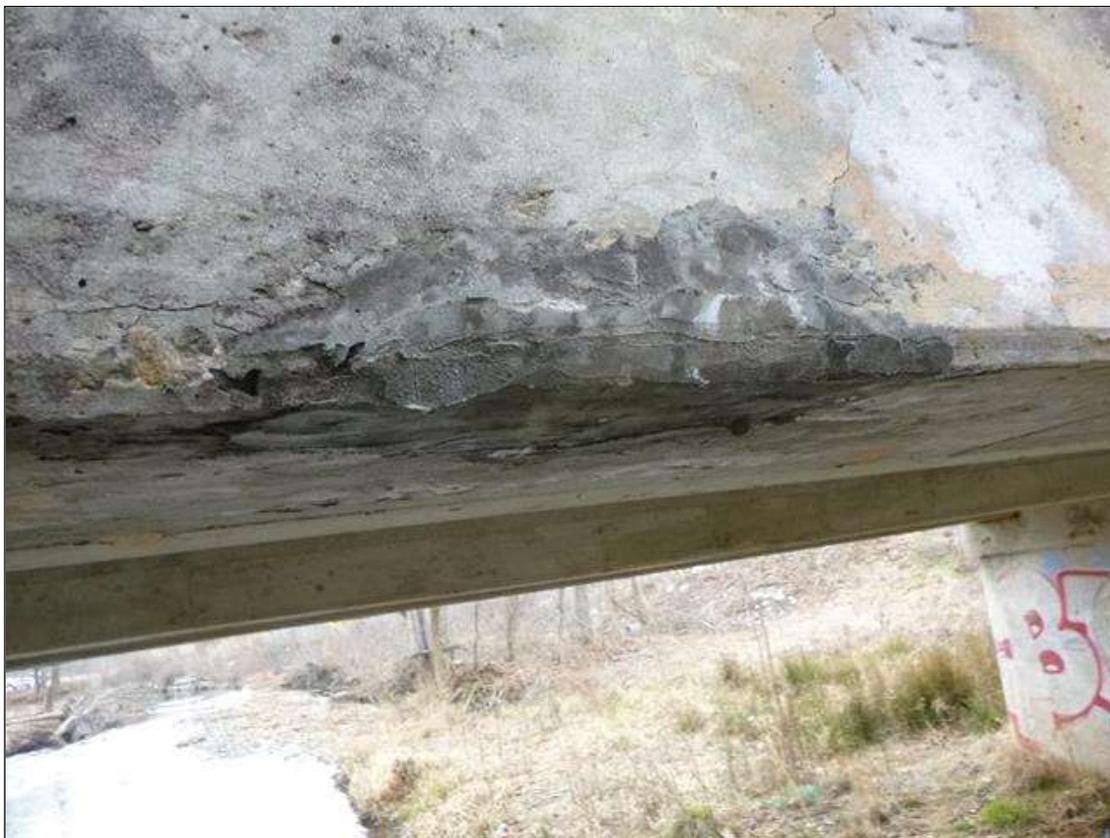
Span 2 Beam 1: SOUND PATCH AT MIDSPAN, BOTTOM LEFT OF BEAM 12 INCHES BY 6 INCHES
