NC DEPARTMENT OF TRANSPORTATION  
 DIVISION OF HIGHWAYS  
 STRUCTURE MANAGEMENT UNIT

# Structure Safety Report

## Routine Element Inspection - Contract

STRUCTURE NUMBER: 100203      SAP STRUCTURE NO: 0110203      FHWA STRUCTURE NO: 00000000210203

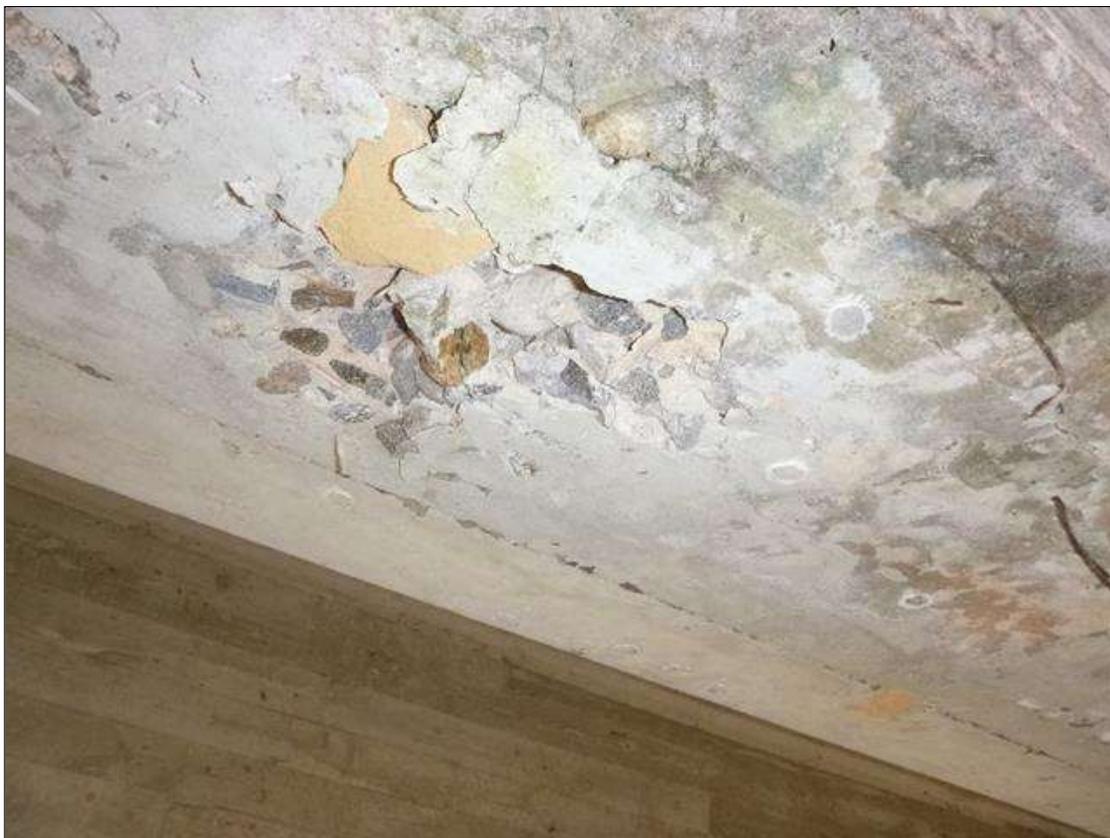
Span 2 Beam 1: 21 FEET FROM BENT 1, BOTTOM OF BEAM, 9 INCH DIAMETER BY 1/2 INCH DEEP SPALL

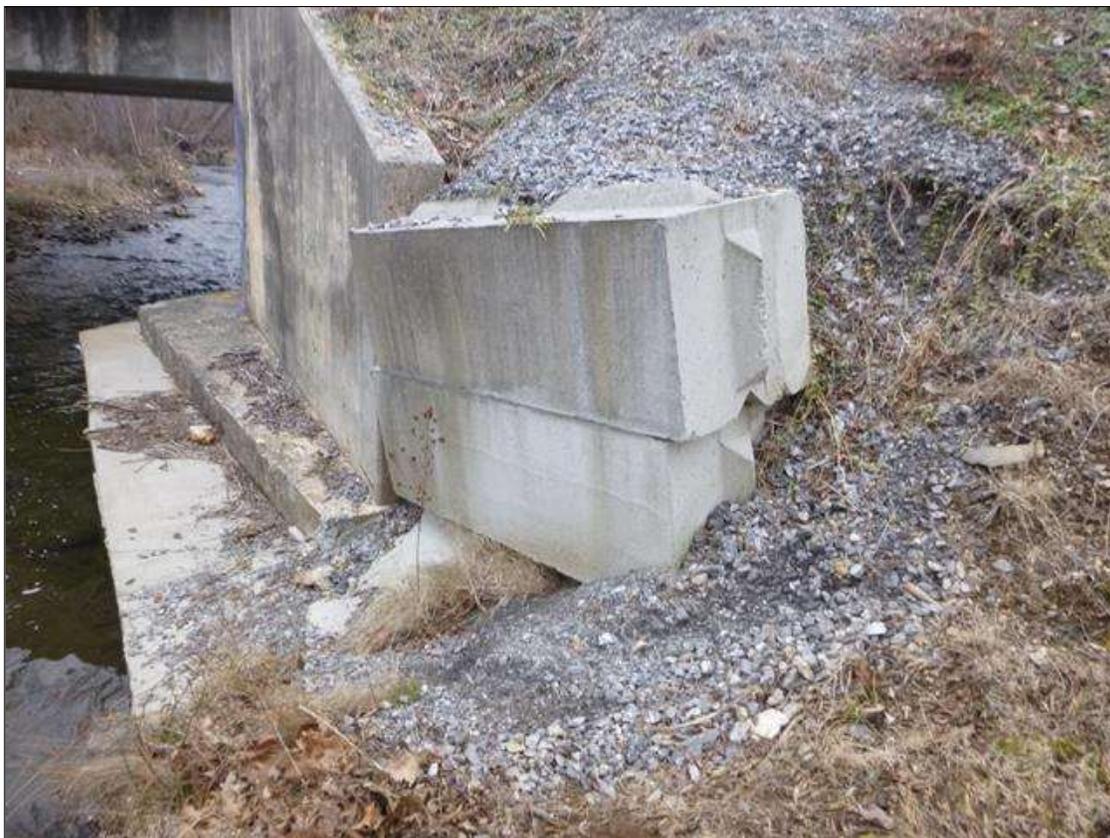
CONCRETE WINGWALL AT SOUTHEAST CORNER IS ROTATED TOWARD THE STREAM.

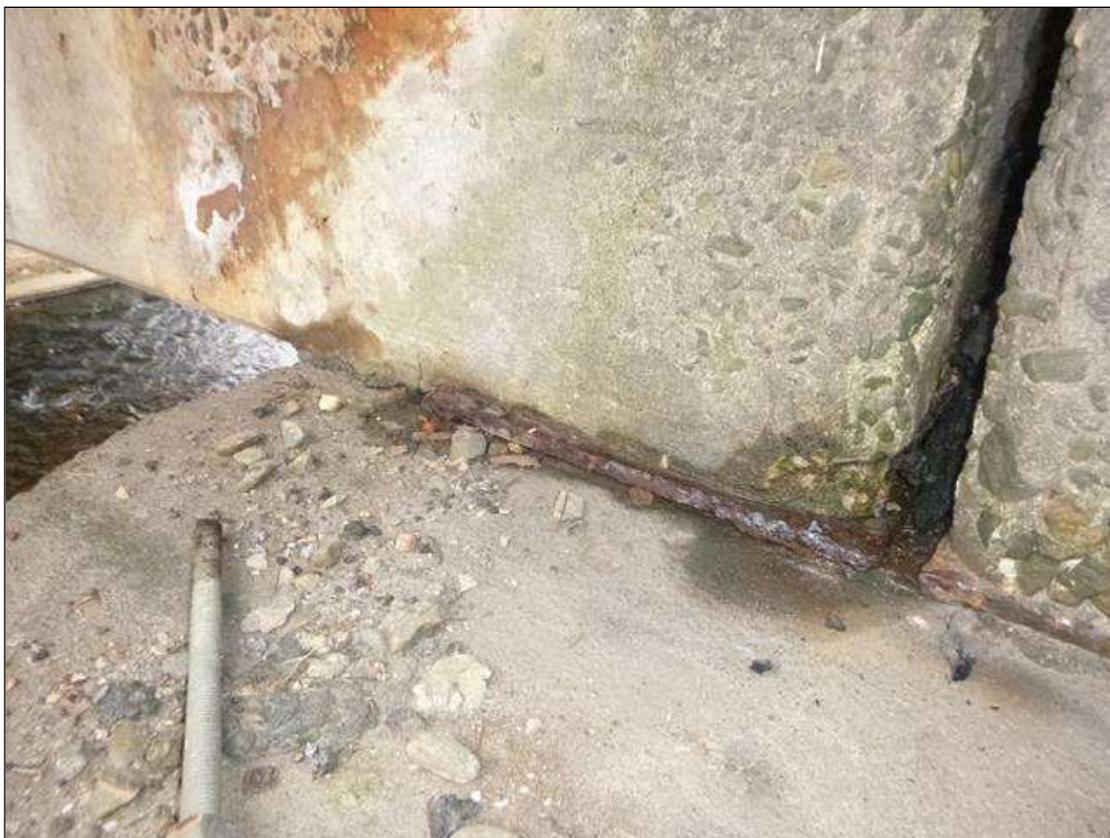
Span 2 Beam 1 - Near Bearing 1: SURFACE CORROSION
