BRIDGE SCOUR REPORT

COUNTY: BUNCOMBE BRIDGE: 203 ROUTE: SR 2416 STREAM CROSSED: BEE TREE CR

**Unknown Foundation Determination**  
**Substructure Report**  
**Buncombe 100203**  
**Warren Wilson College Rd. over Bee Tree Creek**

March 23, 2009

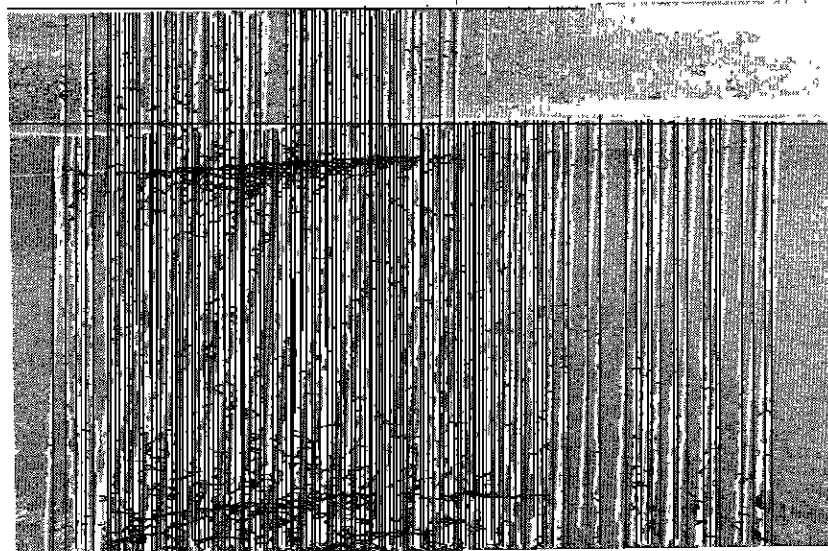
**Comments:** Slight scouring has occurred at the footer of end bent two.

Any Scouring Noted Scour at EB2

**Scouring has occurred along EB2.**

PLACE CONCRETE & CLASS II RIP RAP @ EB2 TO REPAIR SCOUR. SEE ATTACHED PLAN.

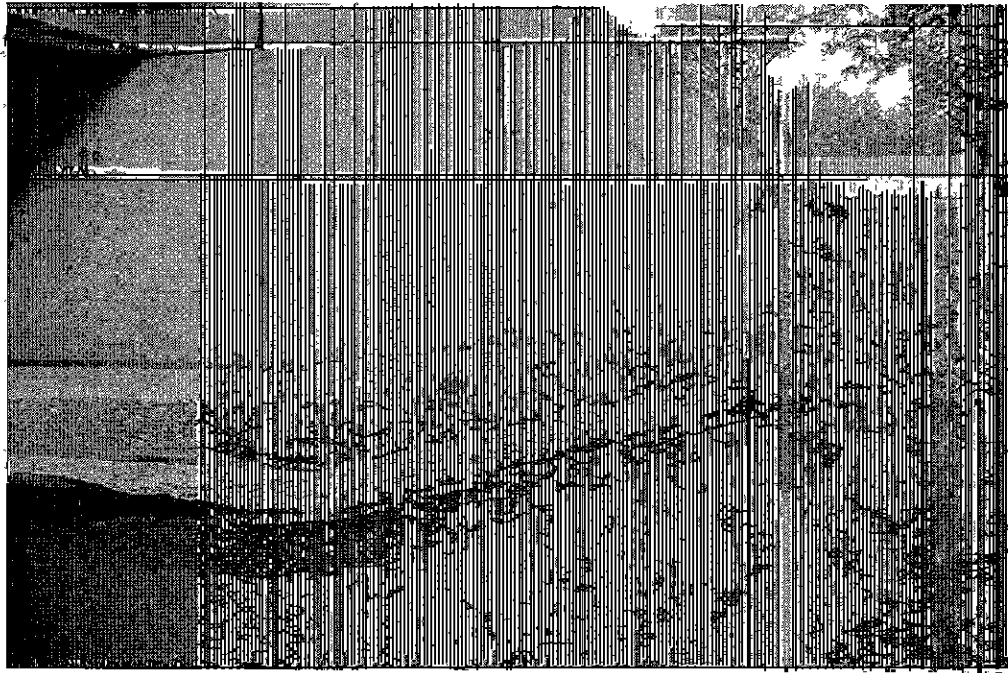
**EB2**

EB2 bottom of footing 20.7' below TOR on weight of hammer material & 100 blow/4" & 100 blow/6" material.

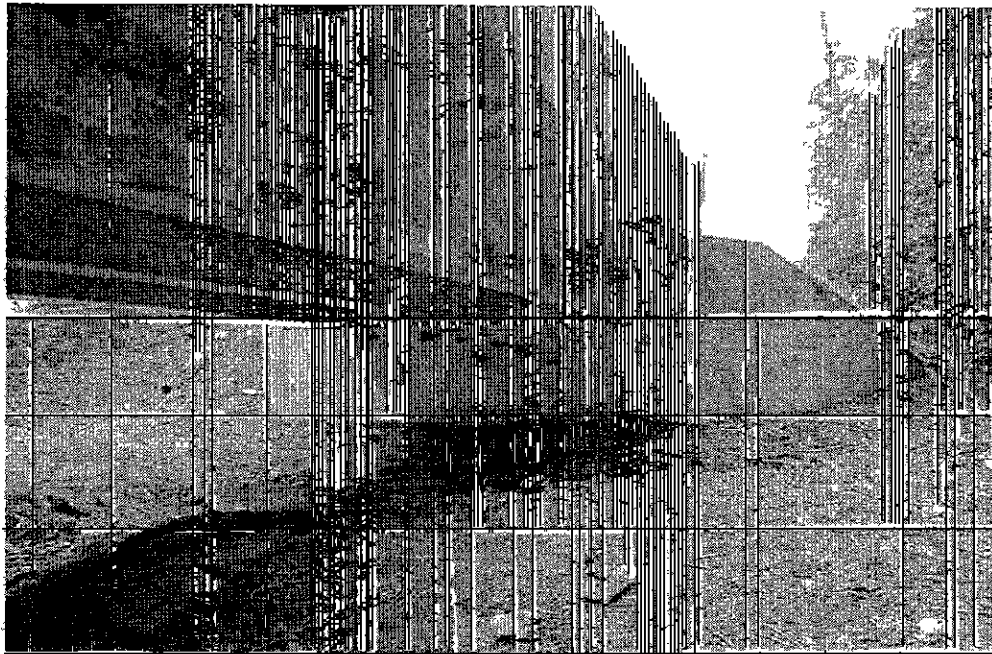
**EB1**

EB1 bottom of footing 18.5' below Top of Rail below 100 blow/1" & 100 blow/6" material
