NC DEPARTMENT OF TRANSPORTATION  
 DIVISION OF HIGHWAYS  
 STRUCTURE MANAGEMENT UNIT

# Structure Safety Report

## Routine Element Inspection - Contract

DIVISION: 13 COUNTY: MADISON STRUCTURE NUMBER: 560149 FREQUENCY: 24 MONTHS

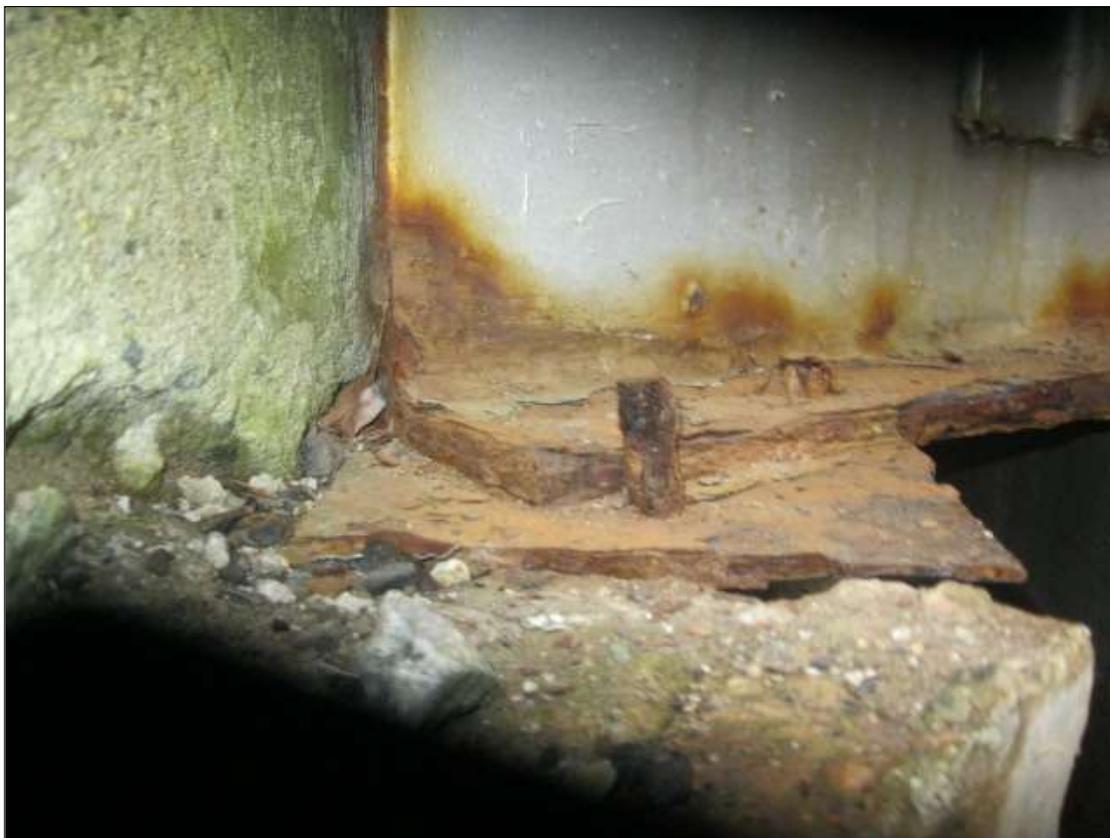
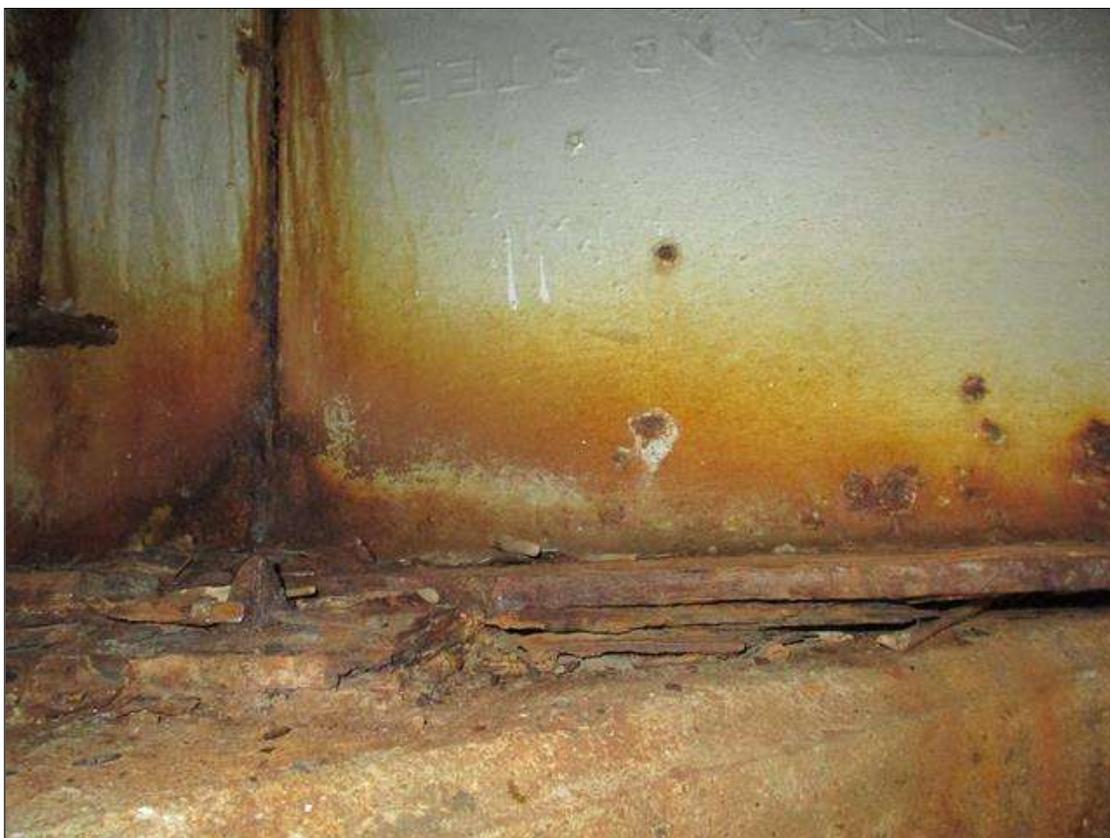
TYPICAL CORROSION WITH SECTION LOSS BEGGINING ON ALL BEARINGS @ END BENT 1, END BENT 2, & BENT 1

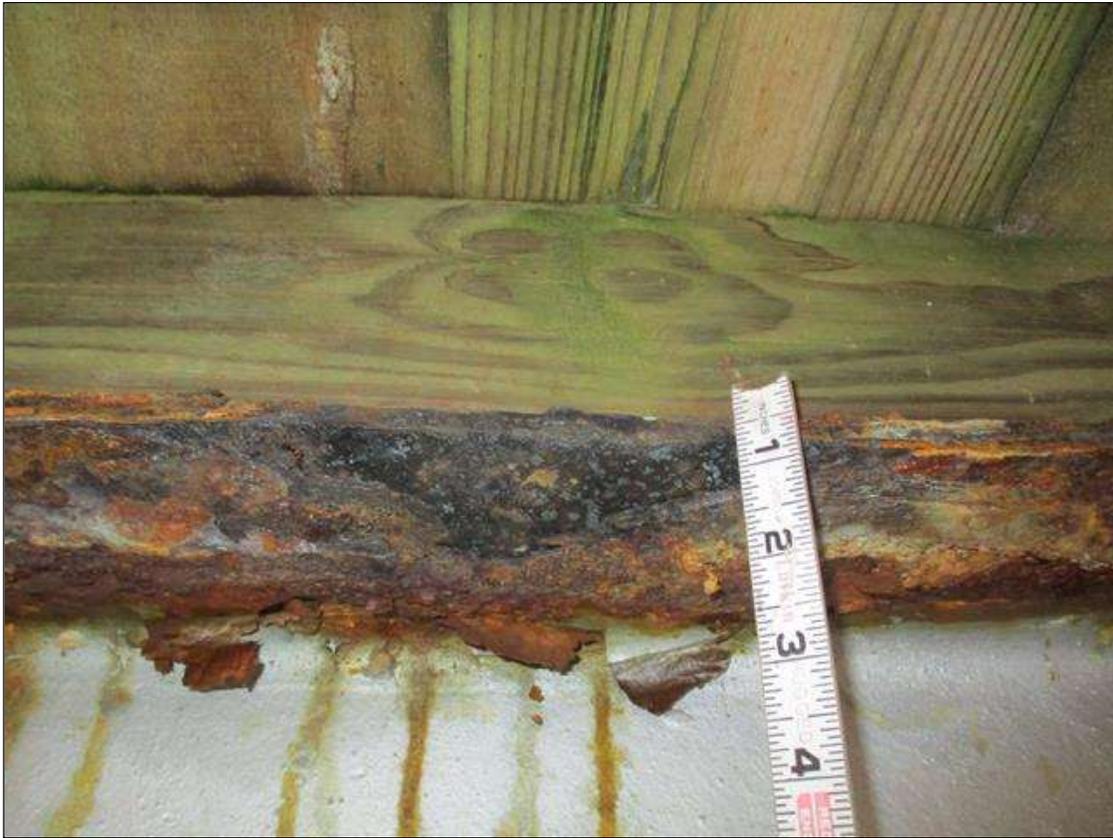
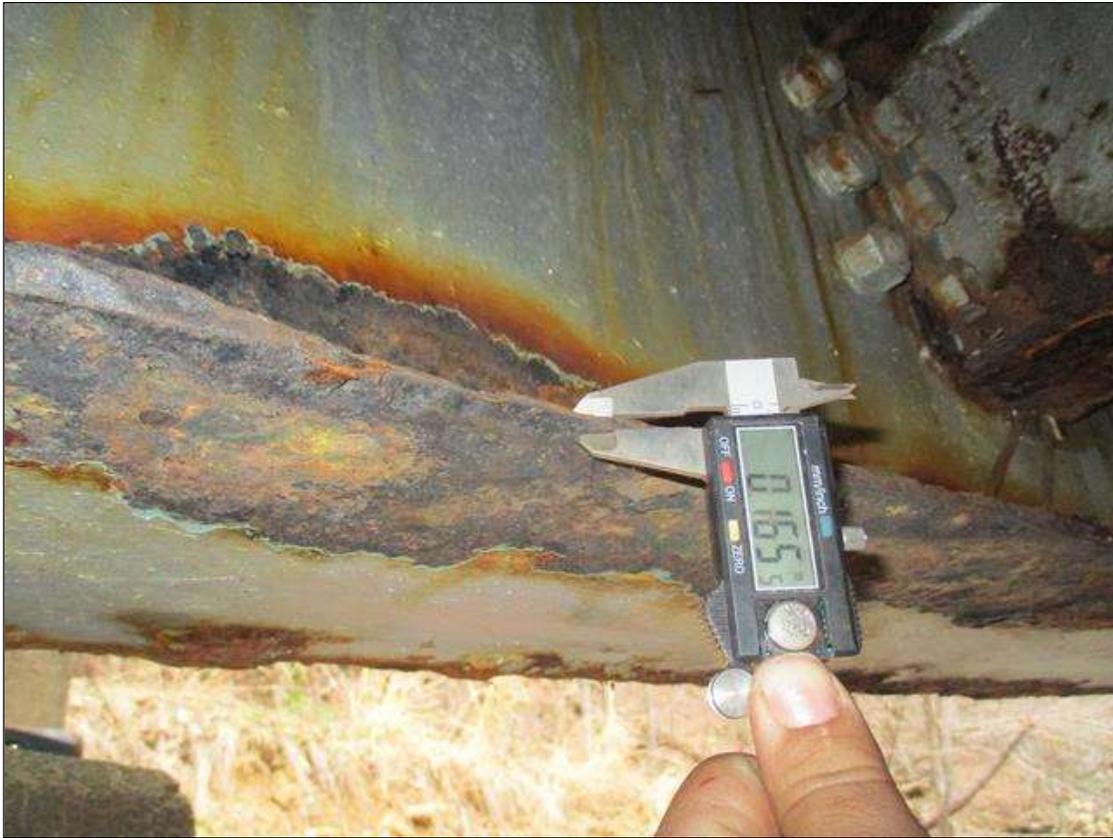
3314	Beam 1	Plate Girder	
Priority Level	Defect Type	Quantity	Defect Description
2	Corrosion	39	Span 1 Beam 1: (PAR) CORROSION ALONG BOTH FACES OF WEB AND EDGES OF BOTH FLANGES UP TO FULL LENGTH X 4" HIGH DOWN TO 1/4" RESIDUAL WEB, FULL LENGTH X 4" WIDE DOWN TO KNIFE'S EDGE RESIDUAL TOP FLANGE, AND FULL LENGTH X 4" WIDE DOWN TO KNIFE'S EDGE 0.16" BOTTOM FLANGE

Span 1 Beam 1: (PAR) CORROSION ALONG BOTH FACES OF WEB AND EDGES OF BOTH FLANGES UP TO FULL LENGTH X 4" HIGH DOWN TO 1/4" RESIDUAL WEB, FULL LENGTH X 4" WIDE DOWN TO KNIFE'S EDGE RESIDUAL TOP FLANGE, AND FULL LENGTH X 4" WIDE DOWN TO KNIFE'S EDGE 0.16" BOTTOM FLANGE

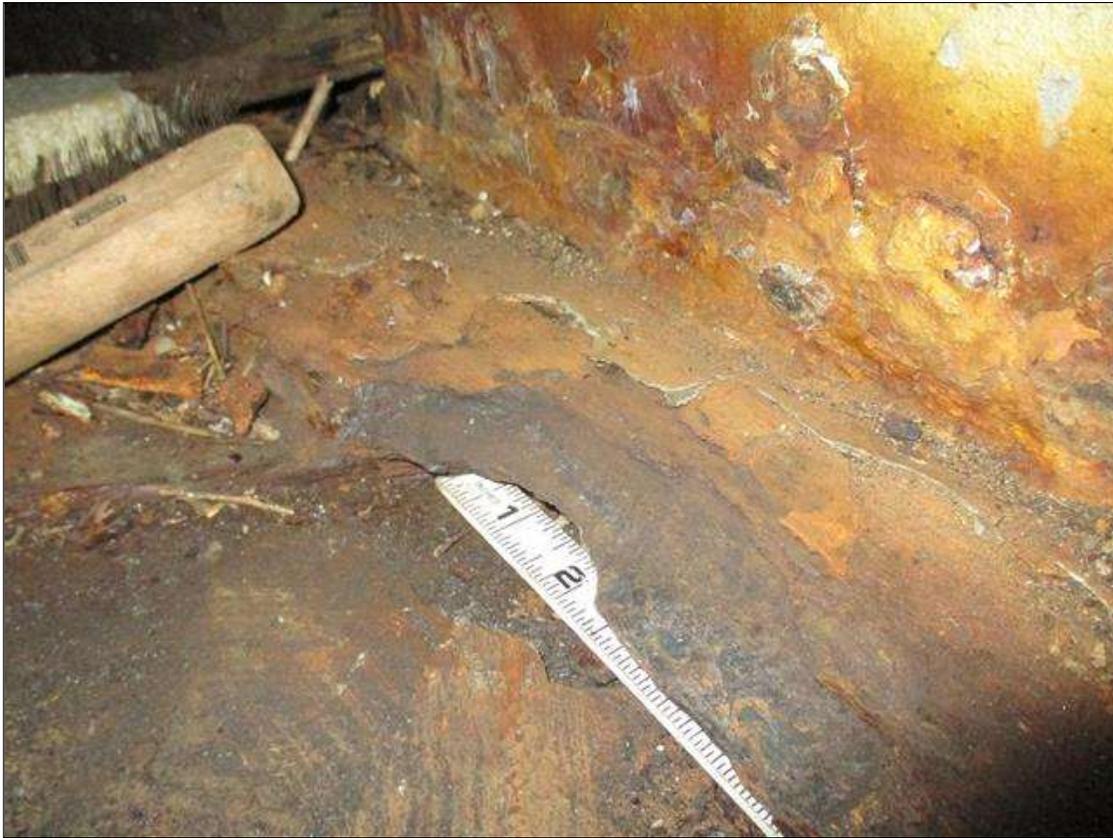
Span 1 Beam 2: (PAR) AT END BENT 1, CORROSION ALONG RIGHT EDGE OF BOTTOM FLANGE WITH 2" LONG X 1/2" WIDE HOLE

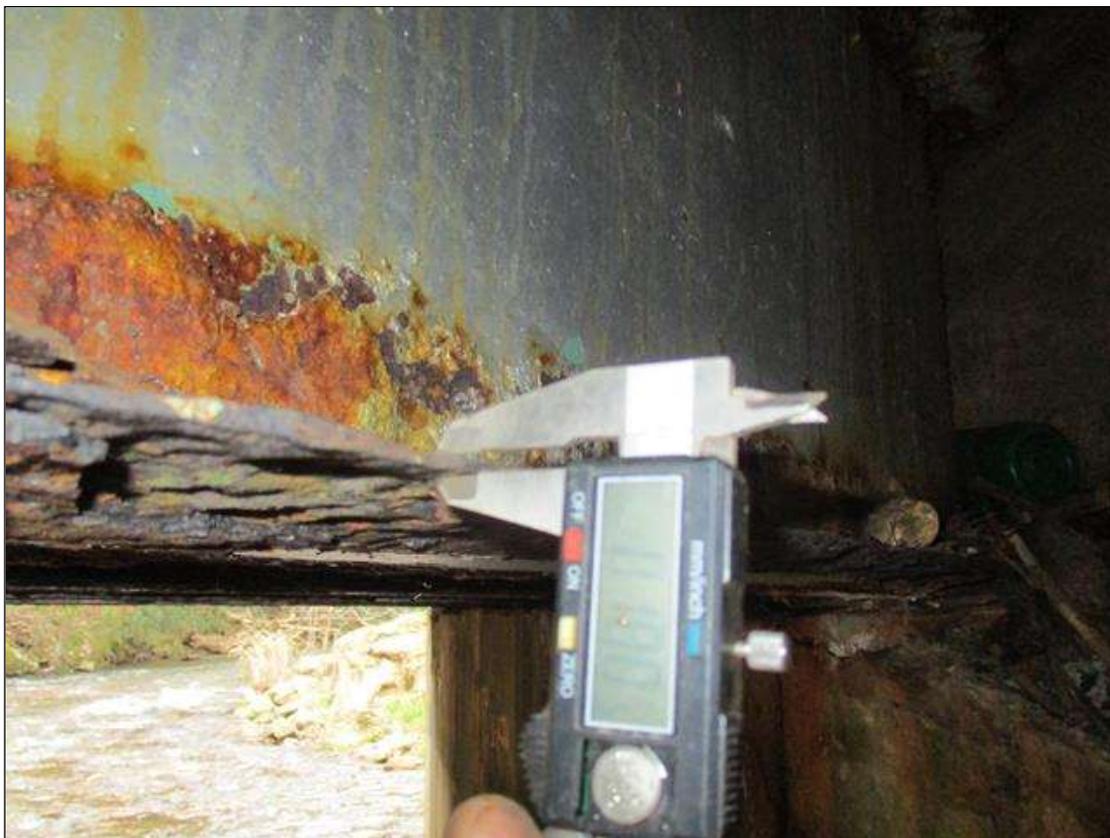
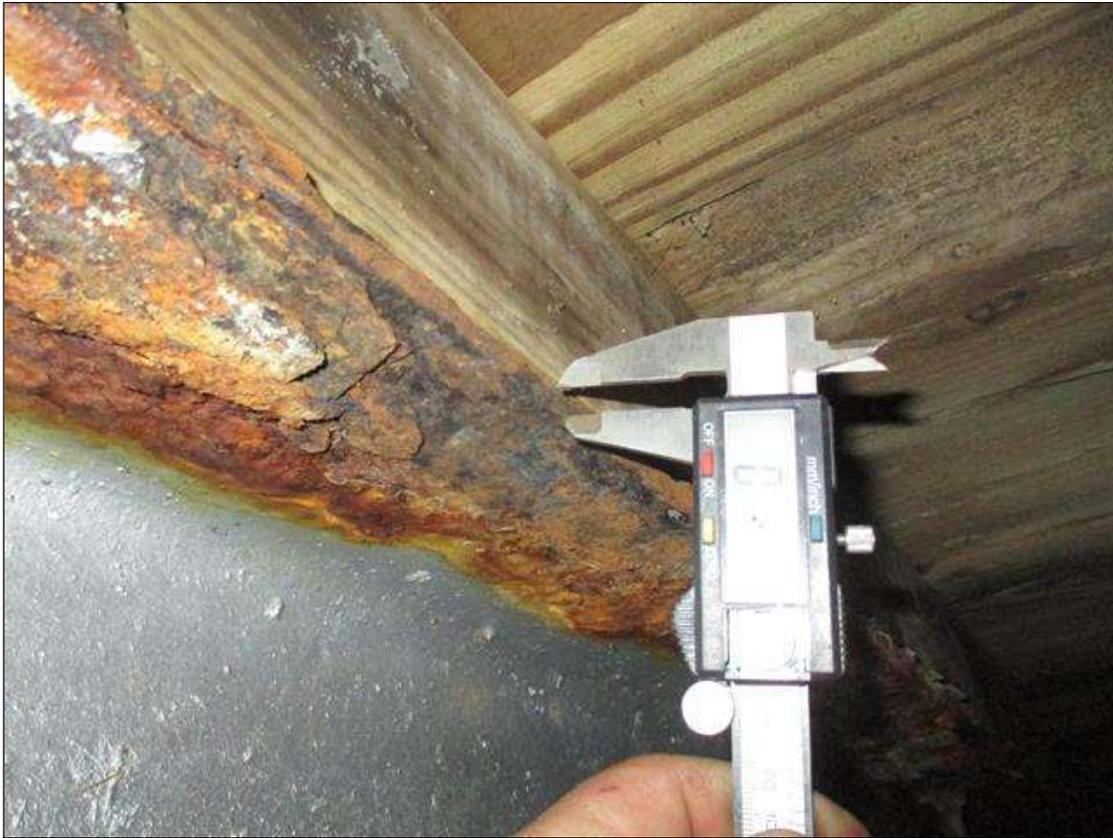
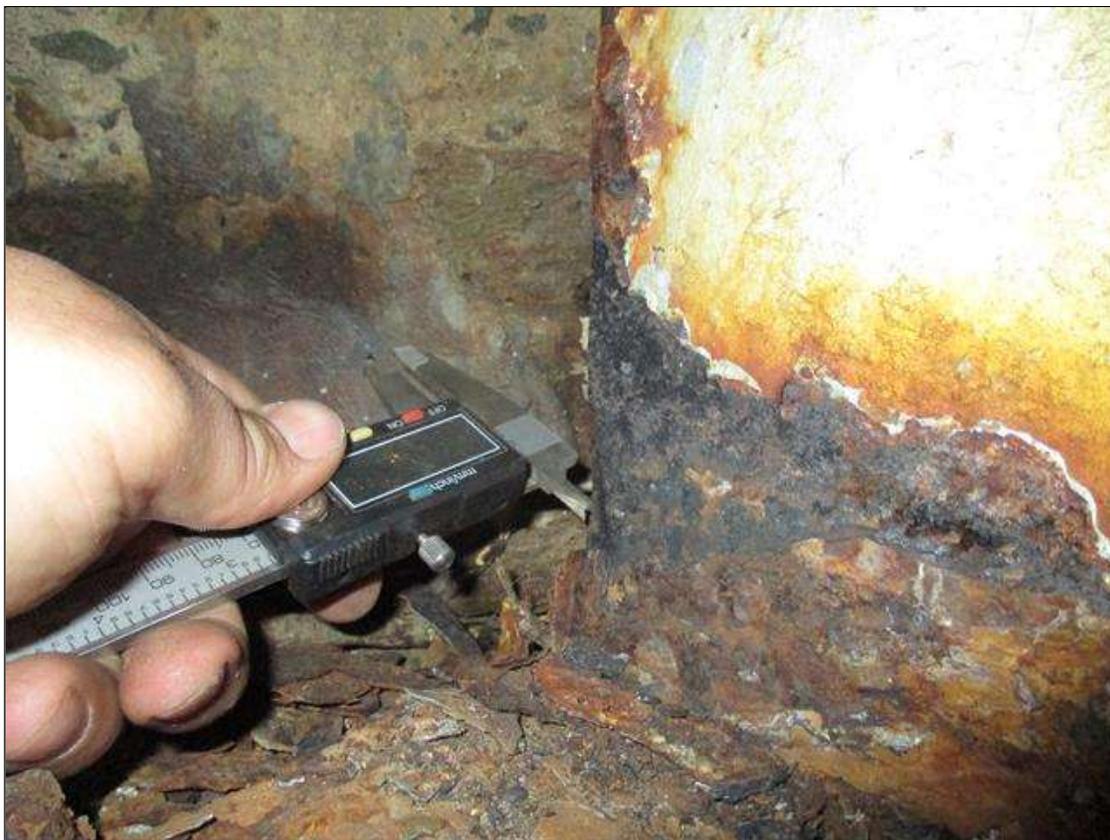
Span 1 Beam 2: (PAR) CORROSION ALONG BOTH FACES OF WEB AND EDGES OF BOTH FLANGES UP TO FULL LENGTH X 4" HIGH DOWN TO 0.25" RESIDUAL WEB, FULL LENGTH X 4" WIDE DOWN TO 0.28" RESIDUAL TOP FLANGE, AND FULL LENGTH X 4" WIDE DOWN TO 0.18" RESIDUAL BOTTOM FLANGE

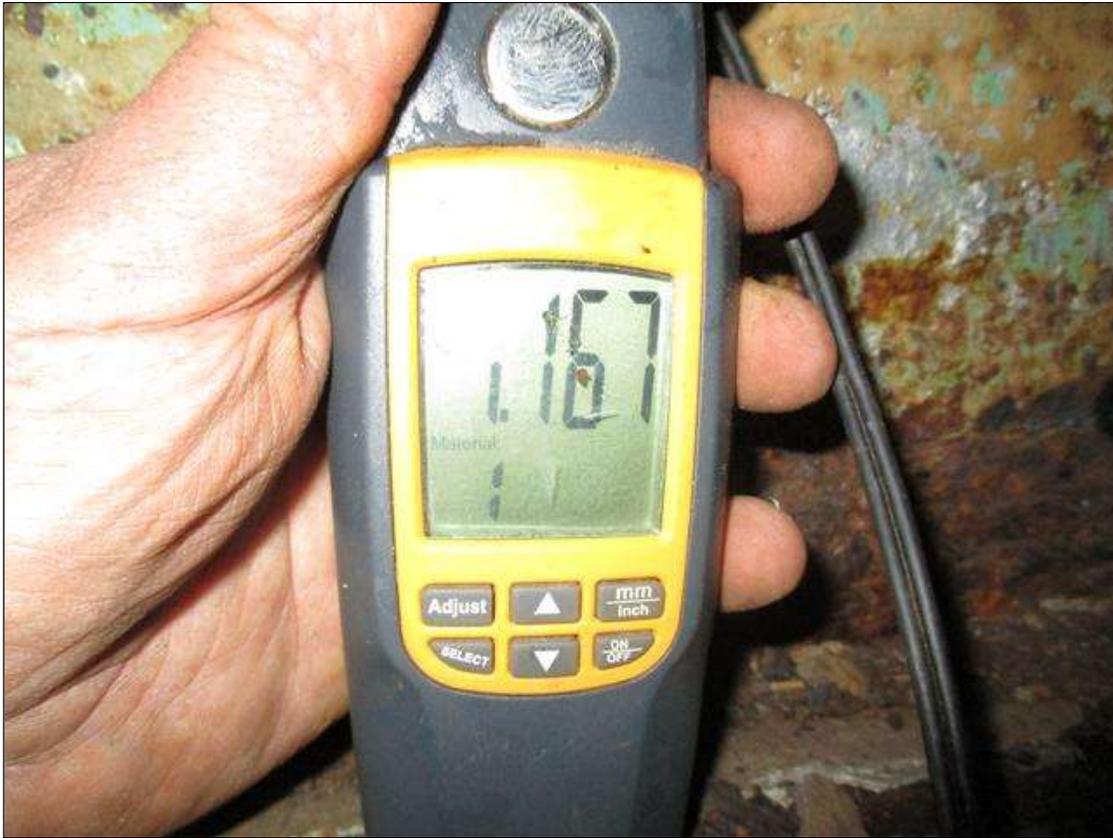
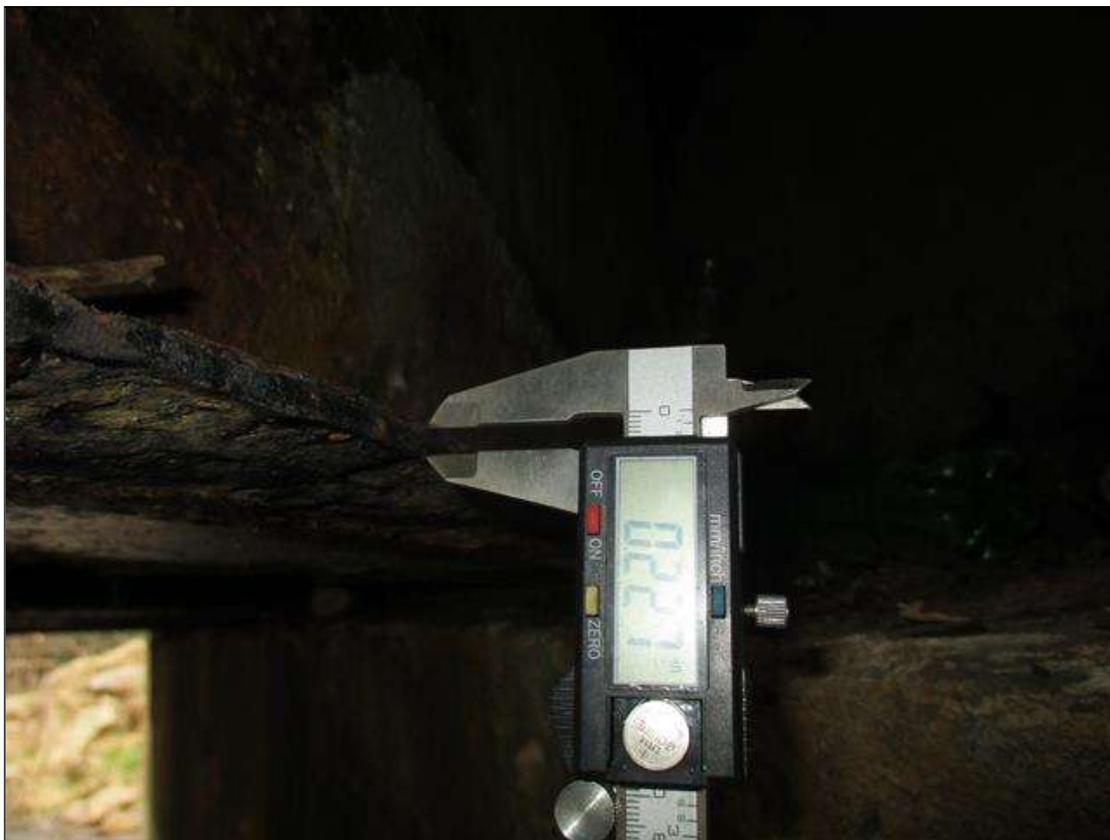
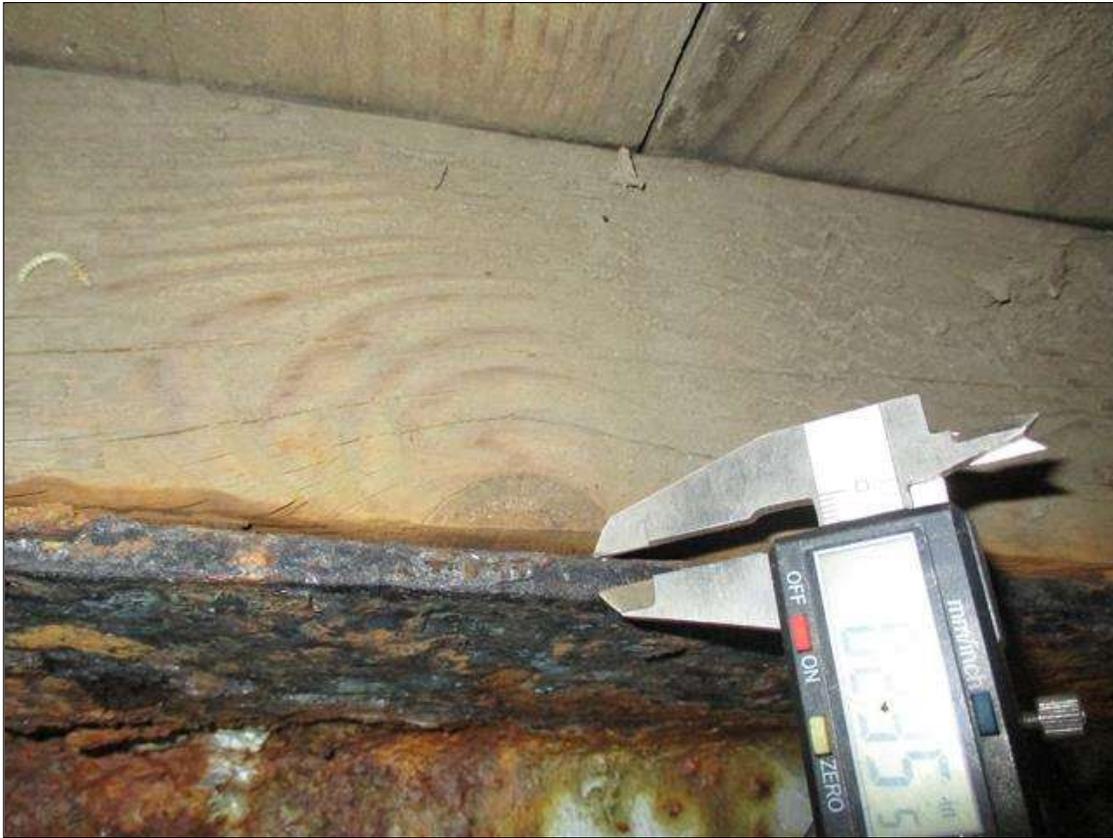
3314	Beam 3	Plate Girder	
Priority Level	Defect Type	Quantity	Defect Description
2	Corrosion	39	Span 1 Beam 3: (PAR) CORROSION ALONG BOTH FACES OF WEB AND EDGES OF BOTH FLANGES UP TO FULL LENGTH X 10" HIGH DOWN TO 0.16" RESIDUAL WEB, FULL LENGTH X 4" WIDE DOWN TO 0.23" RESIDUAL TOP FLANGE, AND FULL LENGTH X 4" WIDE DOWN TO 0.22" RESIDUAL BOTTOM FLANGE

Span 1 Beam 3: (PAR) CORROSION ALONG BOTH FACES OF WEB AND EDGES OF BOTH FLANGES UP TO FULL LENGTH X 10" HIGH DOWN TO 0.16" RESIDUAL WEB, FULL LENGTH X 4" WIDE DOWN TO 0.23" RESIDUAL TOP FLANGE, AND FULL LENGTH X 4" WIDE DOWN TO 0.22" RESIDUAL BOTTOM FLANGE

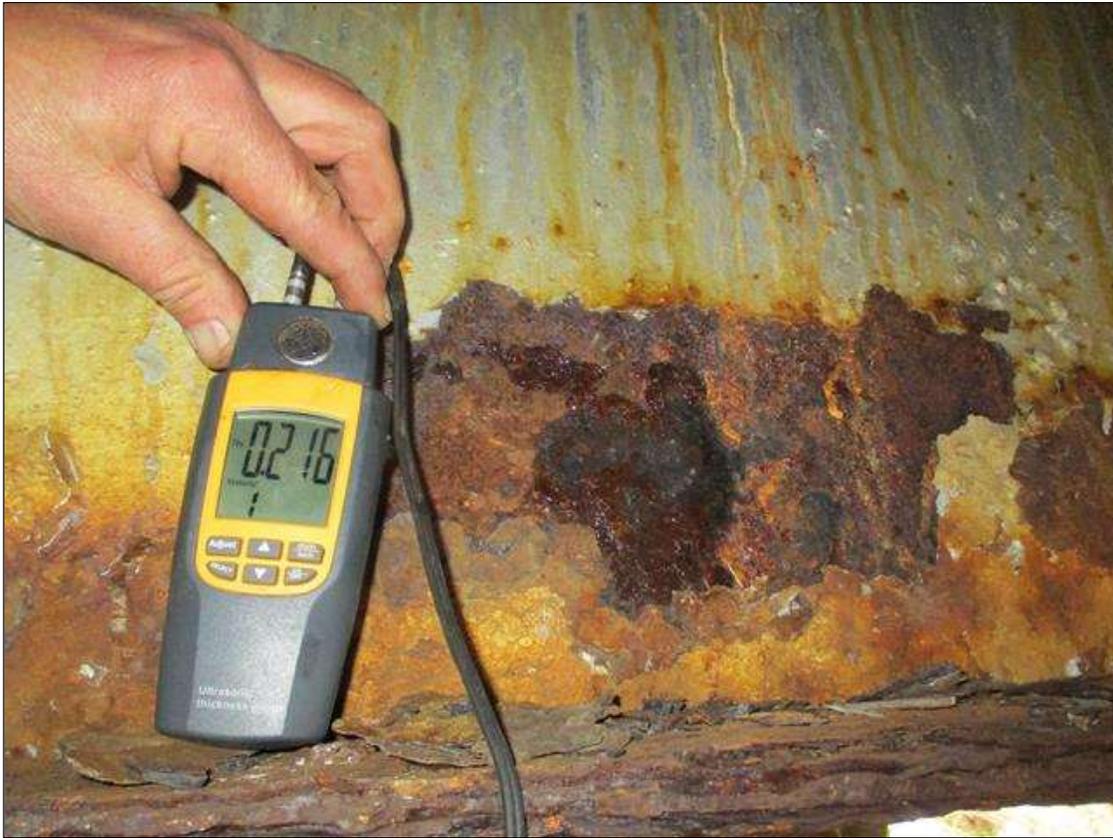
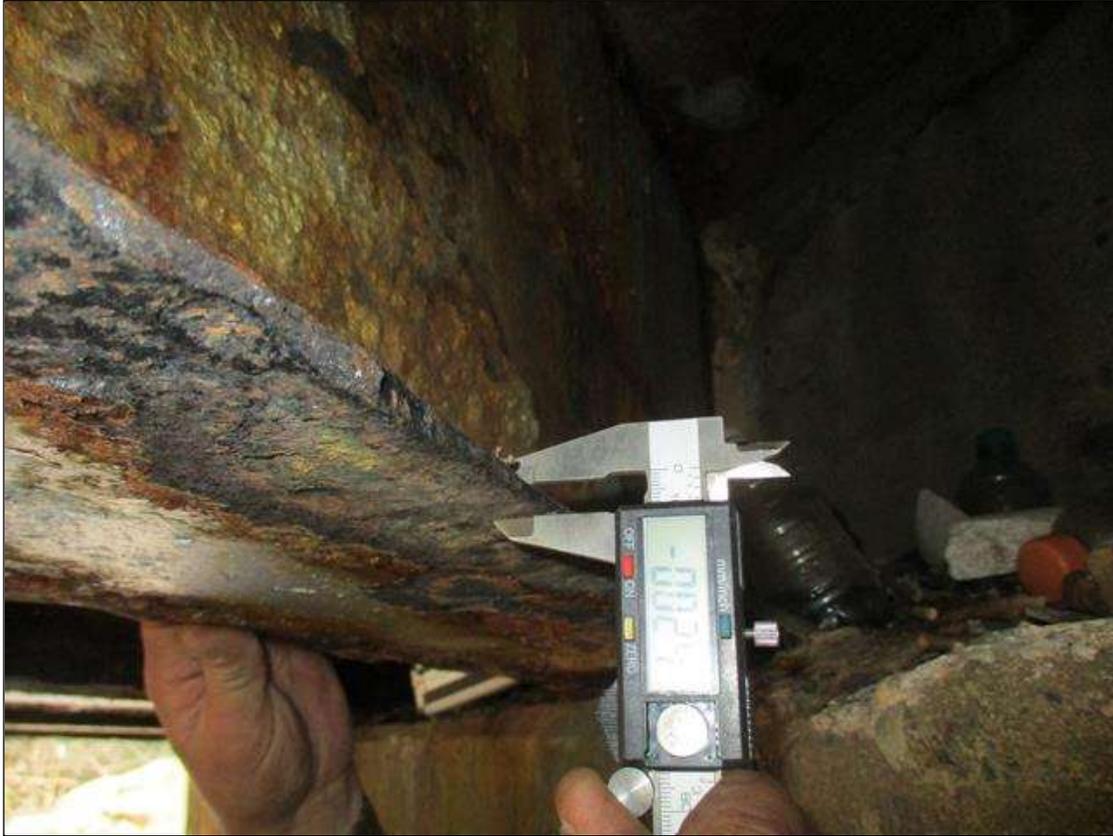
3314	Beam 4	Plate Girder	
Priority Level	Defect Type	Quantity	Defect Description
2	Corrosion	39	Span 1 Beam 4: (PAR) CORROSION ALONG BOTH FACES OF WEB AND EDGES OF BOTH FLANGES UP TO FULL LENGTH X 8" HIGH DOWN TO 0.216" RESIDUAL WEB, FULL LENGTH X 4" WIDE DOWN TO 0.02" RESIDUAL TOP FLANGE, AND FULL LENGTH X 4" WIDE DOWN TO 0.02" RESIDUAL BOTTOM FLANGE

Span 1 Beam 4: (PAR) CORROSION ALONG BOTH FACES OF WEB AND EDGES OF BOTH FLANGES UP TO FULL LENGTH X 8" HIGH DOWN TO 0.216" RESIDUAL WEB, FULL LENGTH X 4" WIDE DOWN TO 0.02" RESIDUAL TOP FLANGE, AND FULL LENGTH X 4" WIDE DOWN TO 0.02" RESIDUAL BOTTOM FLANGE

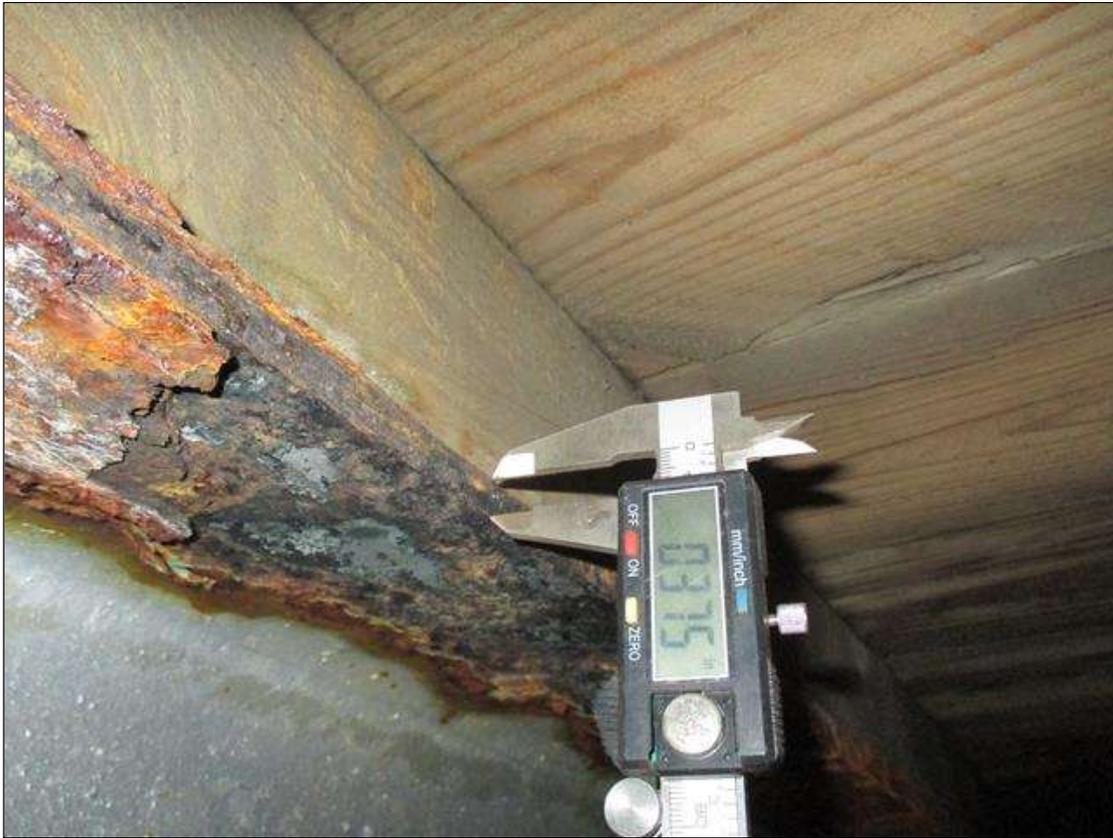
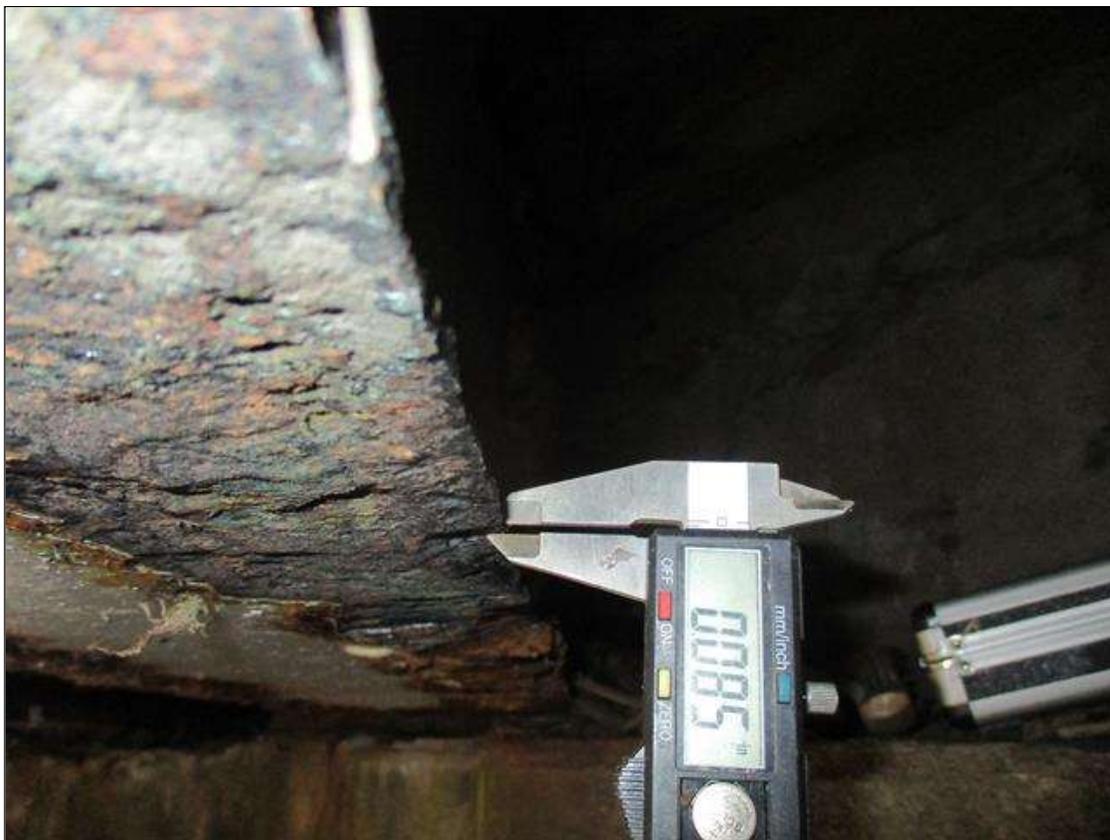
3314	Beam 5	Plate Girder	
Priority Level	Defect Type	Quantity	Defect Description
2	Corrosion	39	Span 1 Beam 5: (PAR) CORROSION ALONG BOTH FACES OF WEB AND EDGES OF BOTH FLANGES UP TO FULL LENGTH X 2" HIGH DOWN TO 5/16" RESIDUAL WEB, FULL LENGTH X 4" WIDE DOWN TO 0.37" RESIDUAL TOP FLANGE, AND FULL LENGTH X 4" WIDE DOWN 0.08" TO KNIFE'S EDGE RESIDUAL BOTTOM FLANGE

Span 1 Beam 5: (PAR) CORROSION ALONG BOTH FACES OF WEB AND EDGES OF BOTH FLANGES UP TO FULL LENGTH X 2" HIGH DOWN TO 5/16" RESIDUAL WEB, FULL LENGTH X 4" WIDE DOWN TO 0.37" RESIDUAL TOP FLANGE, AND FULL LENGTH X 4" WIDE DOWN 0.08" TO KNIFE'S EDGE RESIDUAL BOTTOM FLANGE

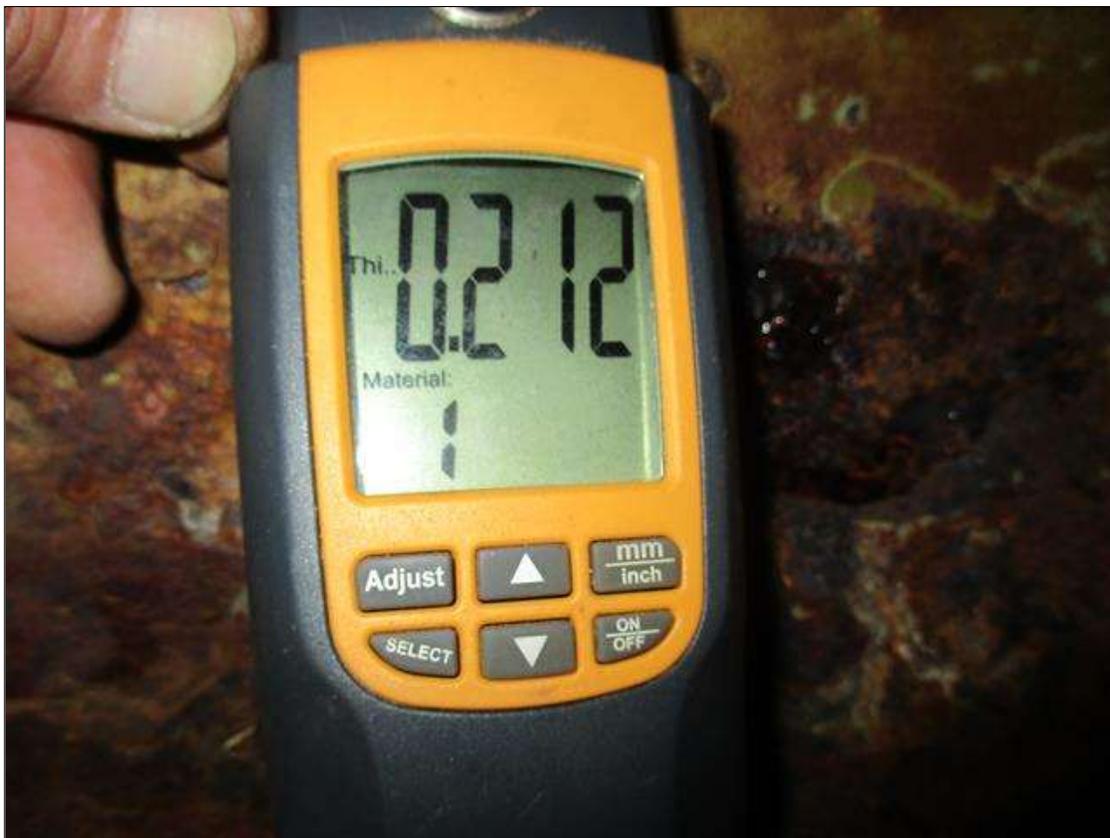
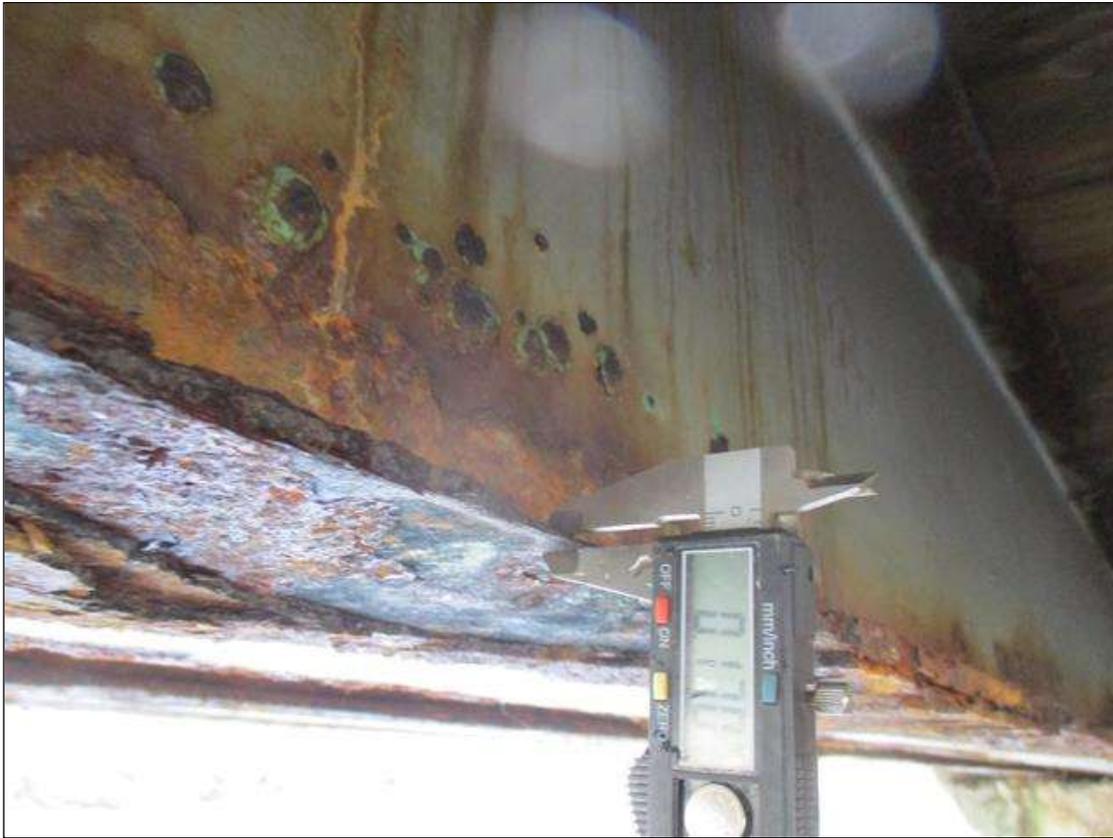
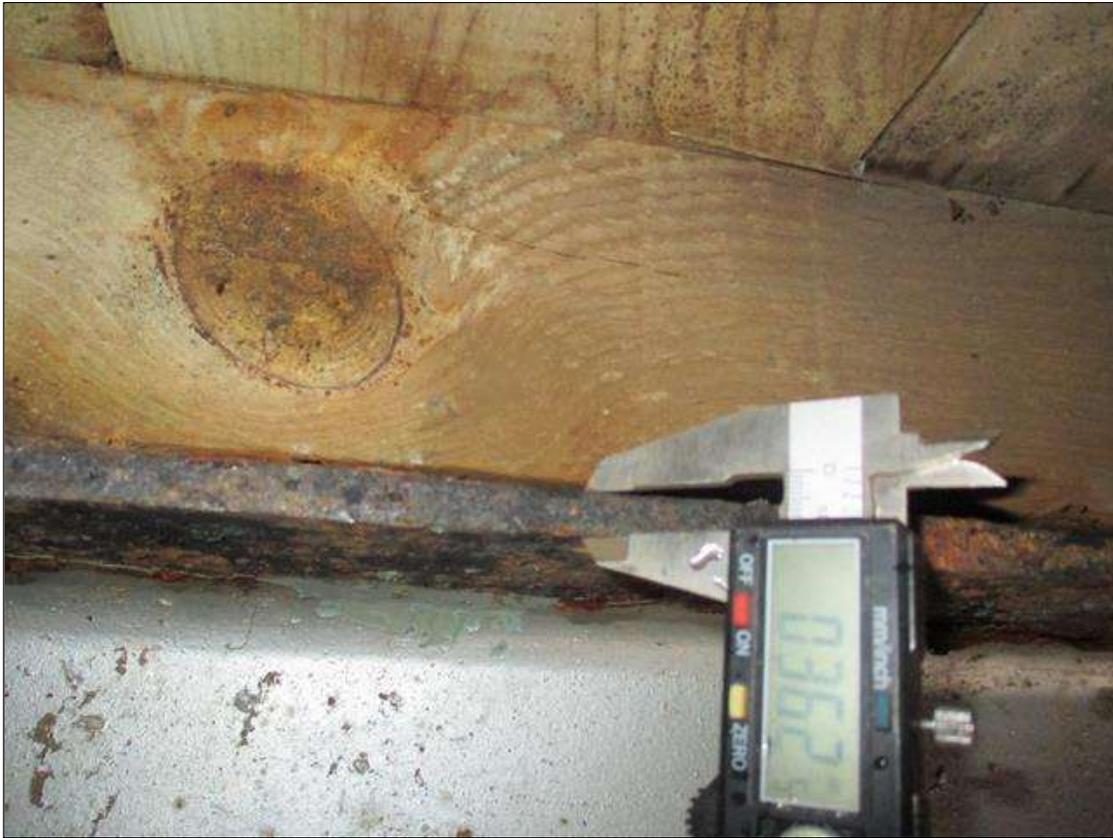
Span 1 Beam 6: (PAR) CORROSION ALONG LEFT FACE OF WEB AND EDGES OF BOTH FLANGES 4' FROM END BENT 1 DOWN TO 0.21" RESIDUAL WEB, 4' FROM END BENT 1 DOWN TO 0.36" RESIDUAL TOP FLANGE, AND NEAR MIDSPAN DOWN TO 0.17" WITH AREAS DOWN TO KNIFE'S EDGE RESIDUAL BOTTOM FLANGE

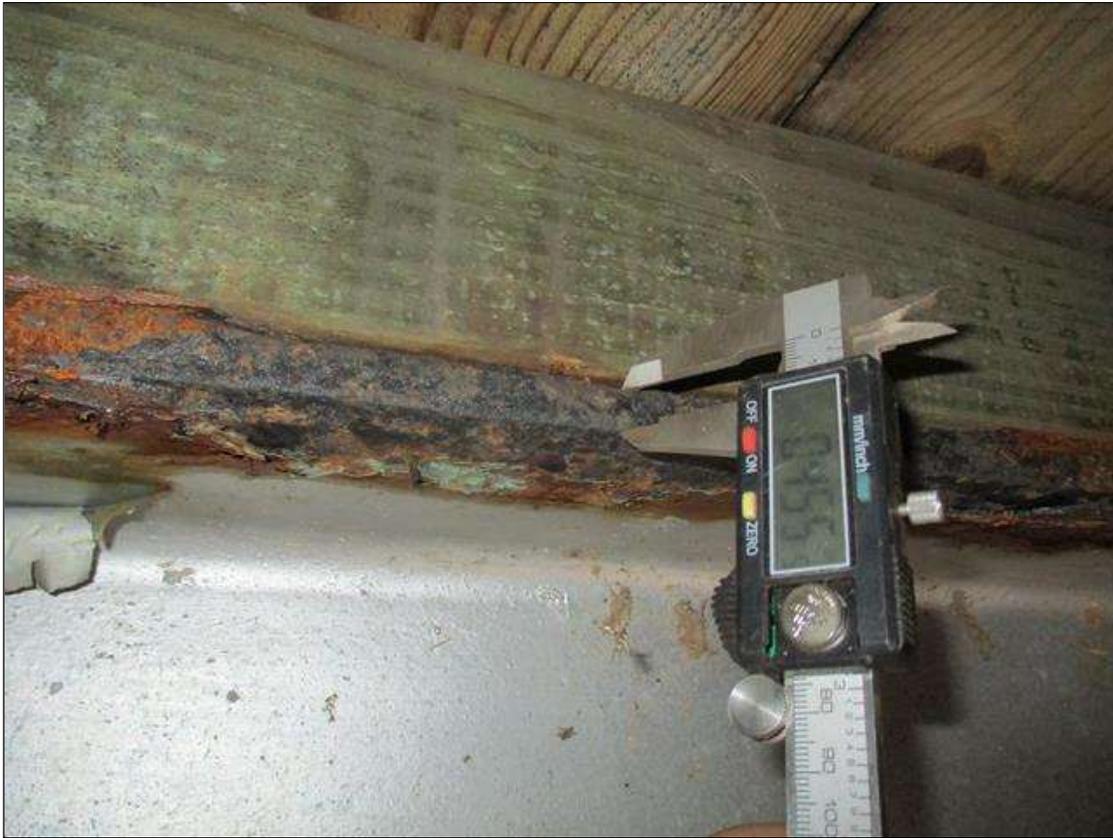
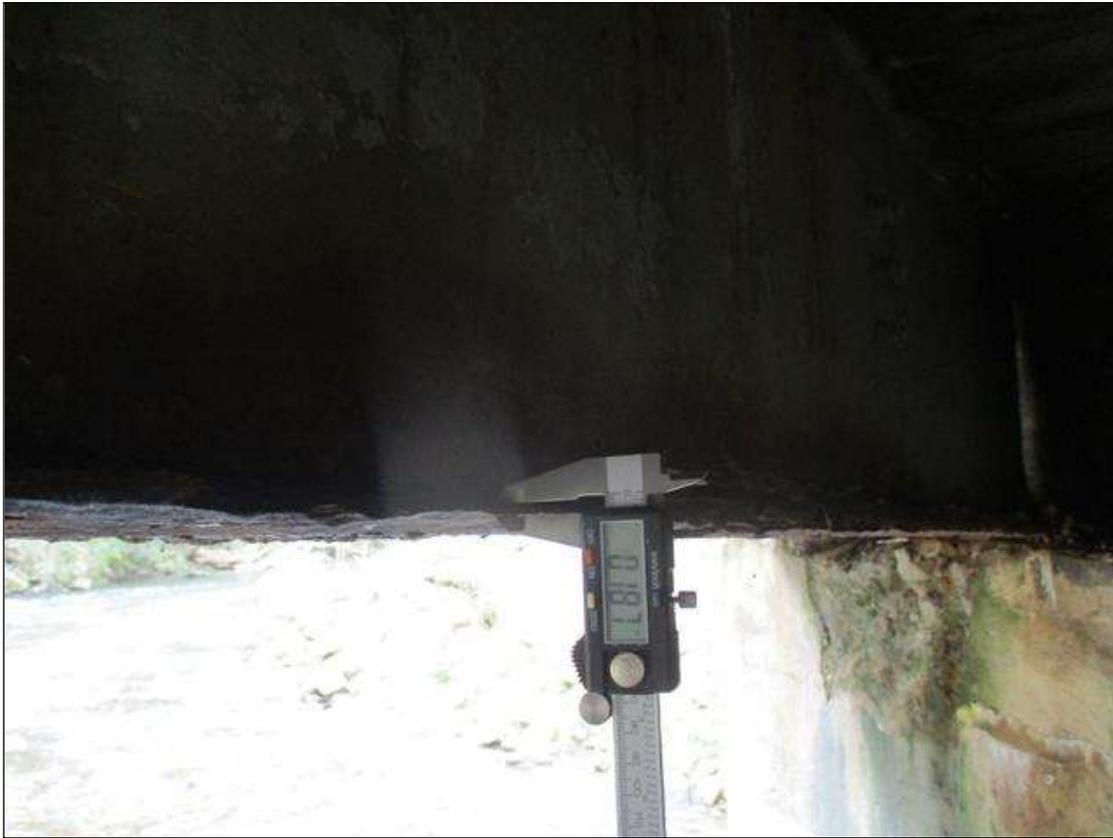
Priority Level	Defect Type	Quantity	Defect Description
2	Corrosion	39	Span 1 Beam 7: (PAR) CORROSION ALONG EDGES OF BOTH FLANGES UP TO FULL LENGTH X 4" WIDE DOWN TO 0.45" RESIDUAL TOP FLANGE, AND UP TO 4' FROM END BENT 1 DOWN TO 0.18" RESIDUAL BOTTOM FLANGE

Span 1 Beam 7: (PAR) CORROSION ALONG EDGES OF BOTH FLANGES UP TO FULL LENGTH X 4" WIDE DOWN TO 0.45" RESIDUAL TOP FLANGE, AND UP TO 4' FROM END BENT 1 DOWN TO 0.18" RESIDUAL BOTTOM FLANGE

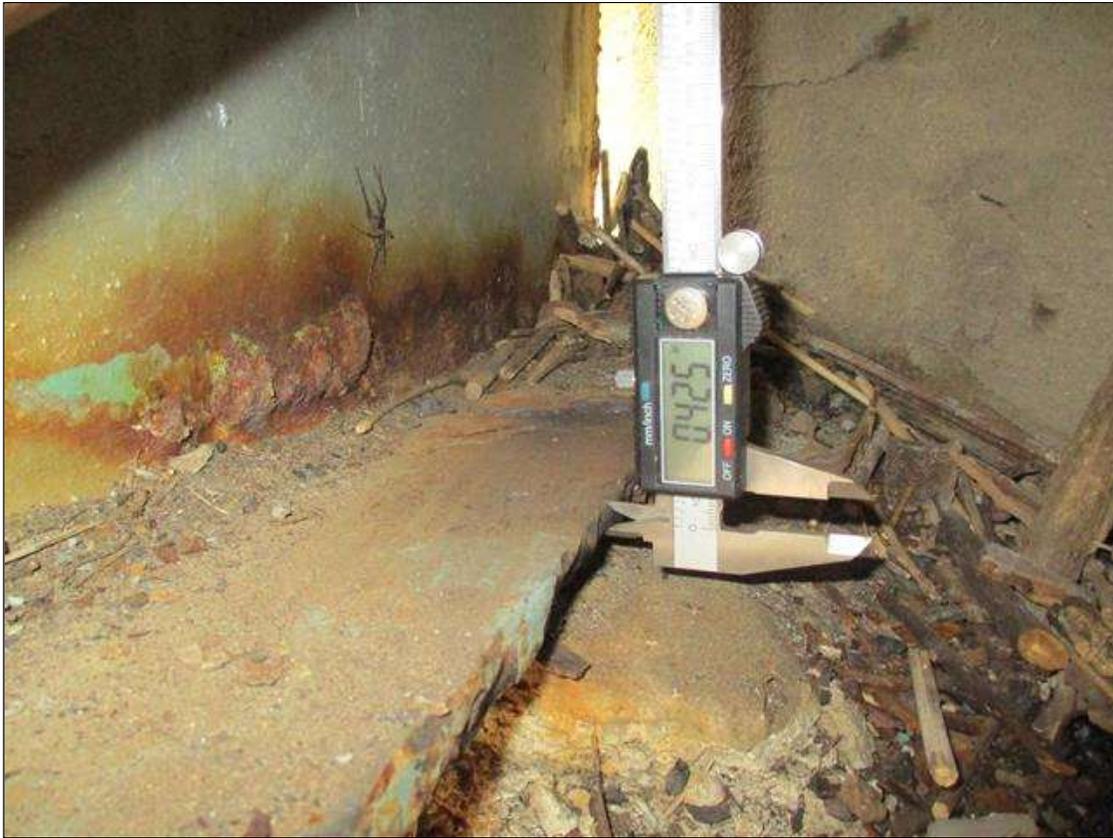
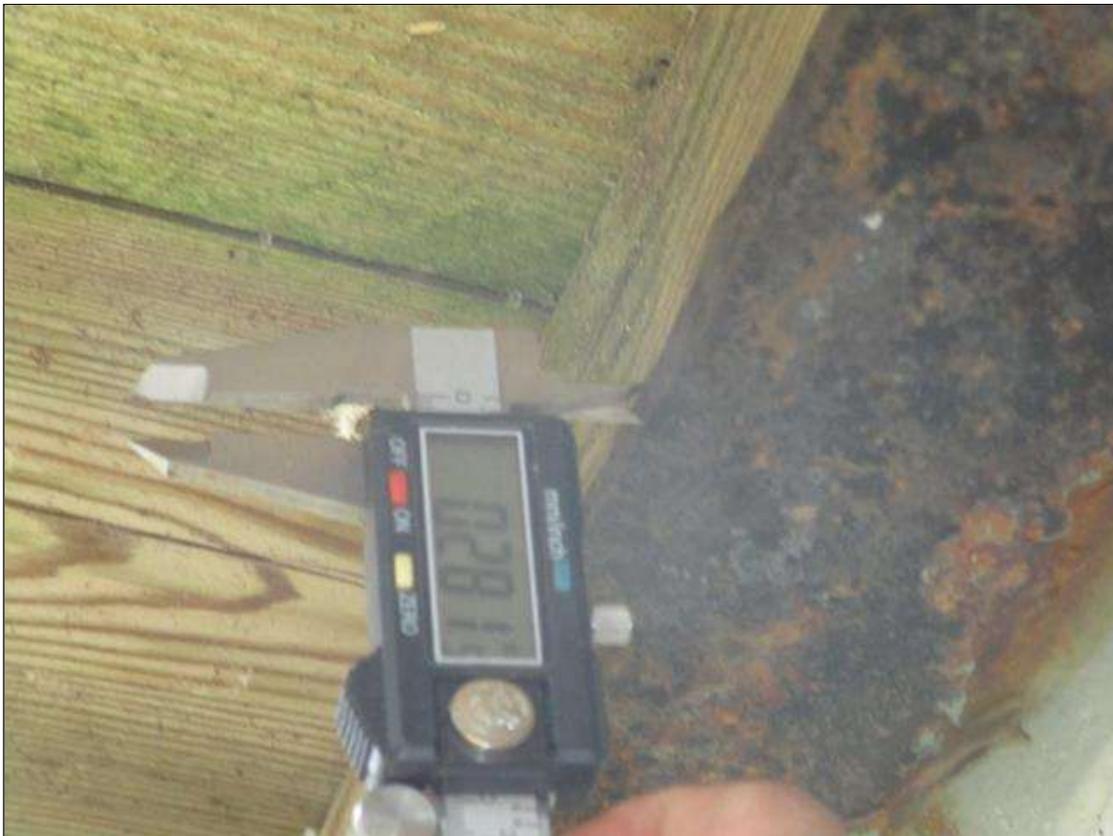
Priority Level	Defect Type	Quantity	Defect Description
2	Corrosion	39	Span 1 Beam 8: (PAR) CORROSION ALONG EDGES OF BOTH FLANGES @ END BENT 1, 0.28" RESIDUAL TOP FLANGE, AND 0.42" RESIDUAL BOTTOM FLANGE

Span 1 Beam 8: (PAR) CORROSION ALONG EDGES OF BOTH FLANGES @ END BENT 1, 0.28" RESIDUAL TOP FLANGE, AND 0.42" RESIDUAL BOTTOM FLANGE

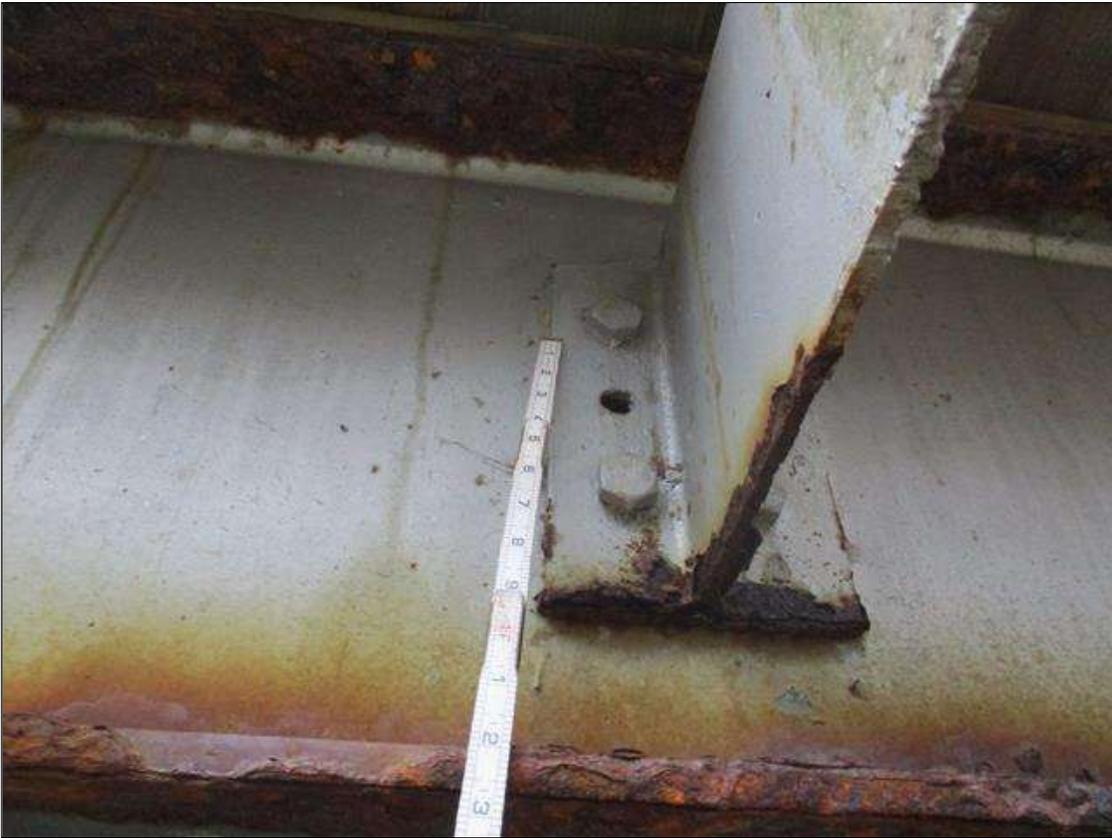
Priority Level	Defect Type	Quantity	Defect Description
2	Connection	2	Span 2 Left Bridge Rail: (PAR) RAIL POSTS 5 AND 6, TWO (2) MISSING BOLTS AT

Span 2 Left Bridge Rail: (PAR) RAIL POSTS 5 AND 6, TWO (2) MISSING BOLTS AT CONNECTION TO BEAM 1
