NC DEPARTMENT OF TRANSPORTATION  
 DIVISION OF HIGHWAYS  
 STRUCTURE MANAGEMENT UNIT

# Structure Safety Report

## Routine Element Inspection - Contract

DIVISION: 13 COUNTY: MADISON STRUCTURE NUMBER: 560149 FREQUENCY: 24 MONTHS

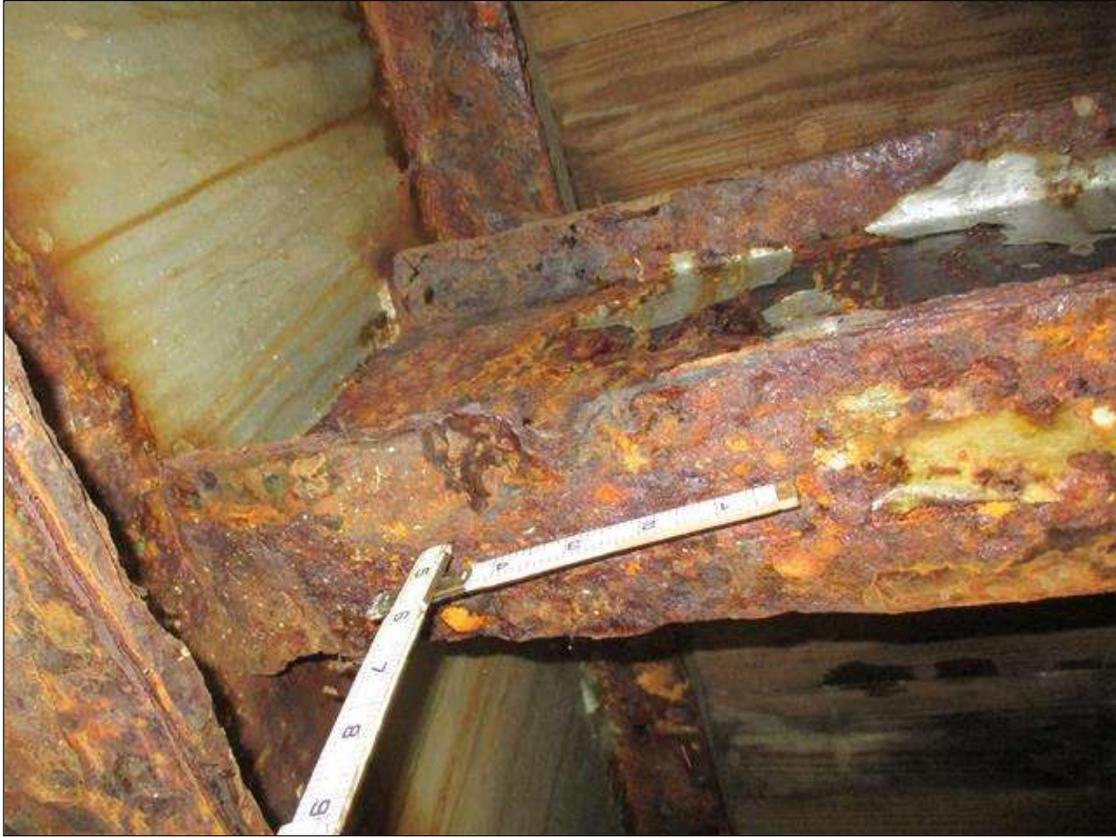
Span 2 Beam 1: (PAR) Bay 1 Diaphragm, 5ft from Pier: CORROSION THROUGHOUT DIAPHRAGM WITH TWO (2) 4" LONG X 2" WIDE HOLES IN TOP FLANGE

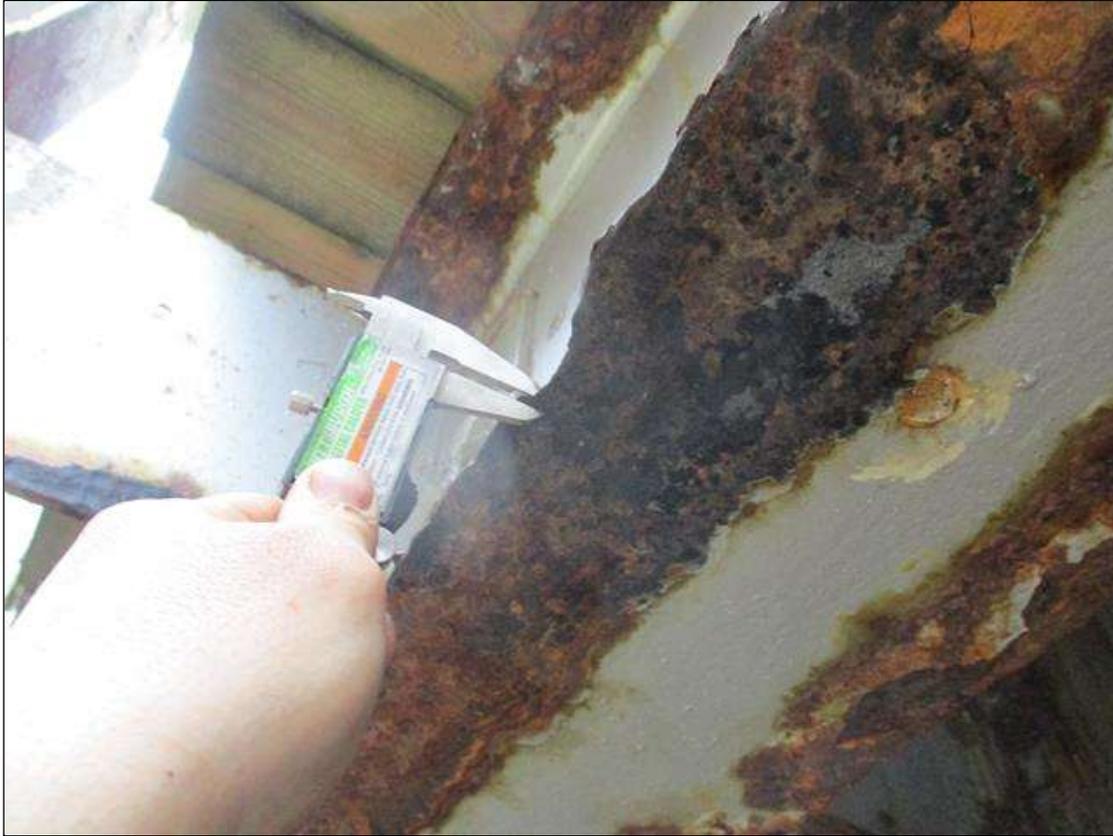
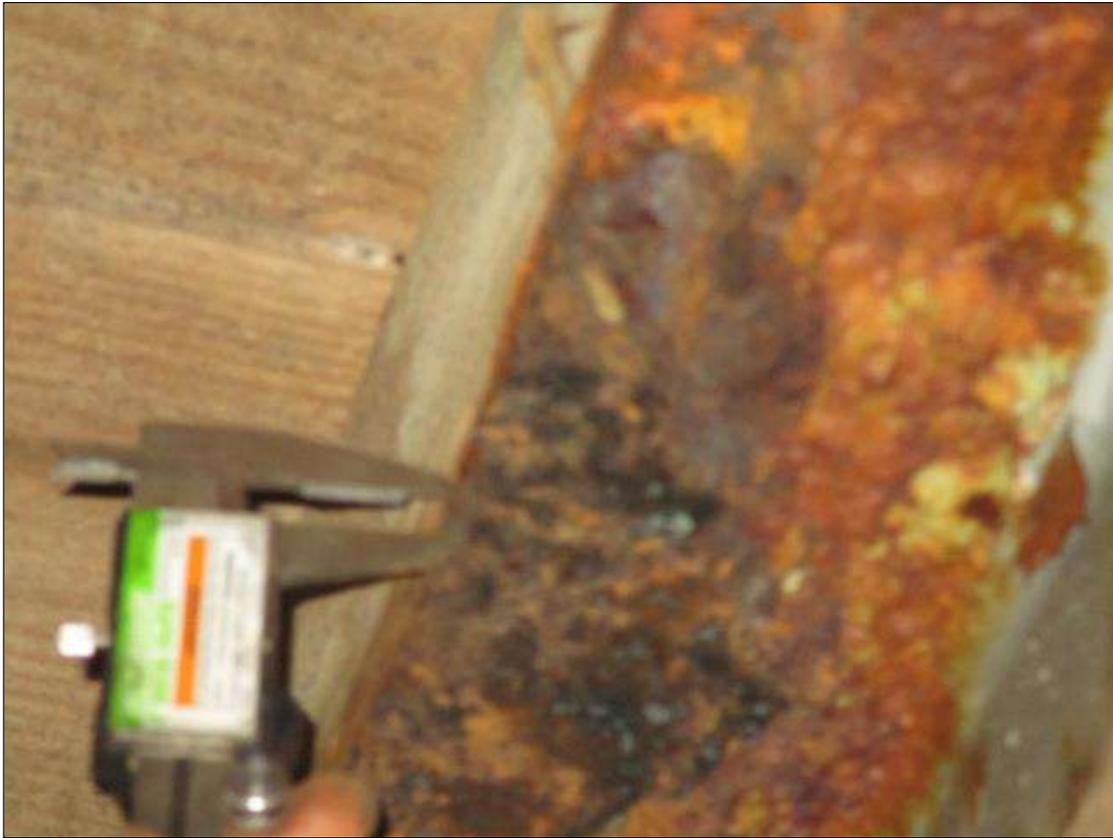
Span 2 Beam 1: (PAR) CORROSION ALOG BOTH FACES OF WEB AND EDGES OF BOTH FLANGES UP TO FULL LENGTH X 4" HIGH DOWN TO 1/4" RESIDUAL WEB, NEAR MIDSPAN DOWN TO 0.23 RESIDUAL IN TOP FLANGE AND DOWN TO 0.18" RESIDUAL IN BOTTOM FLANGE, 5' FROM END BENT 2 HAS 100% SECTION LOSS FOR 1' IN BOTTOM LEFT FLANGE

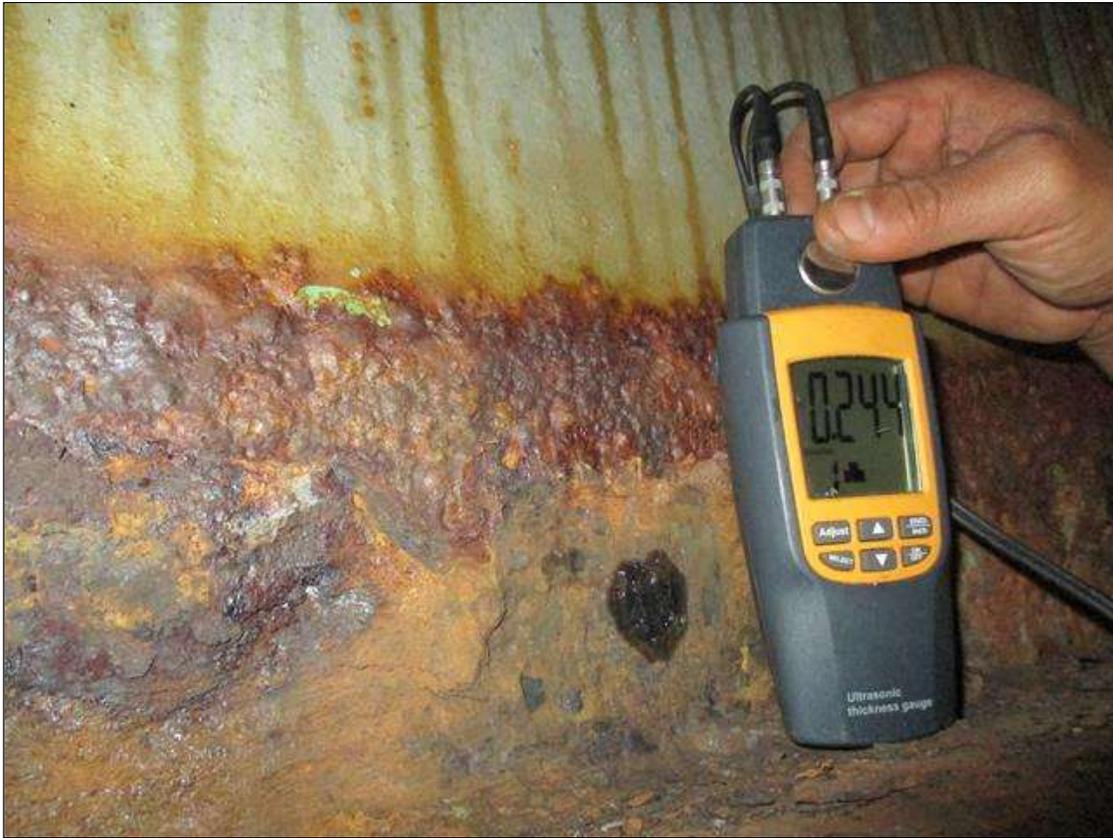
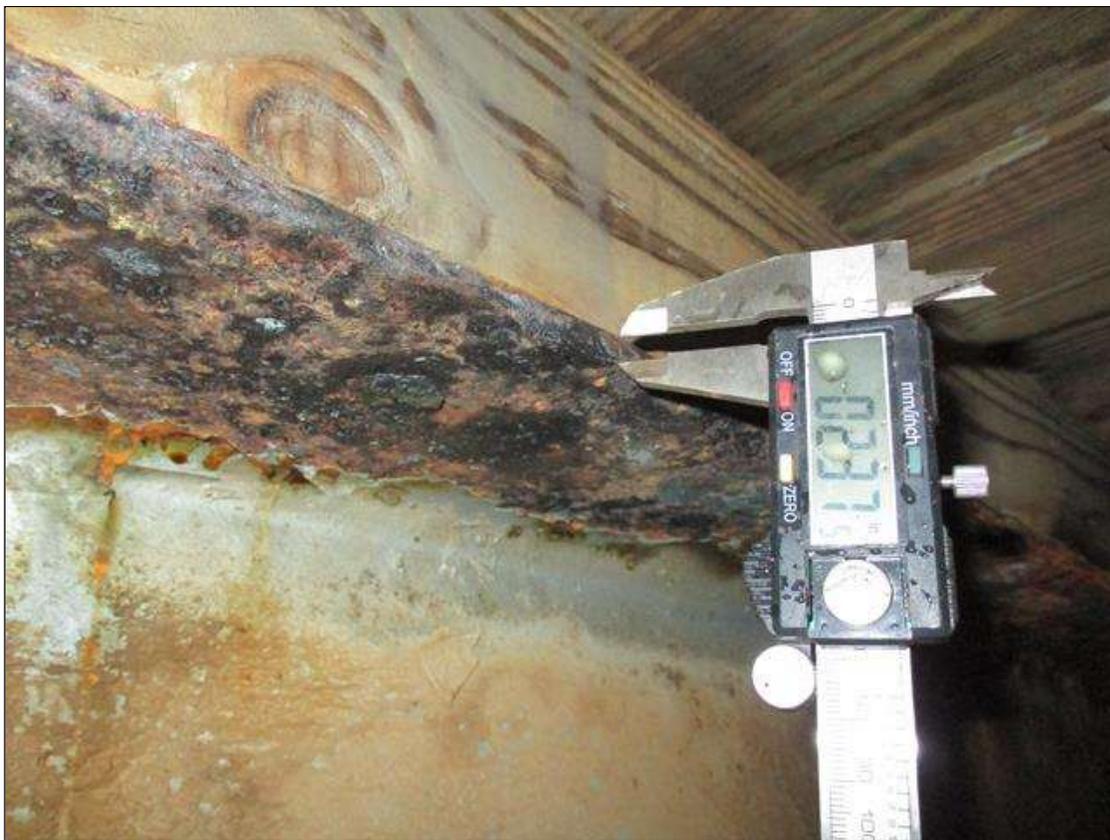
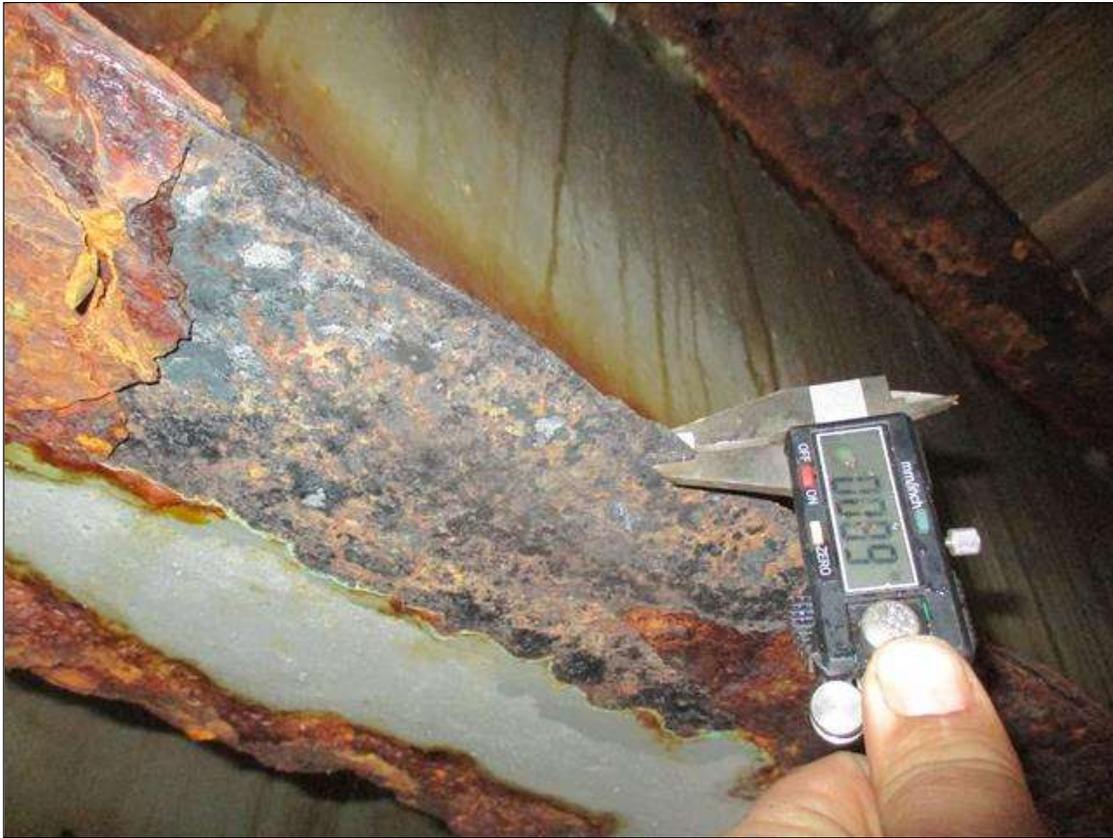
3314	Beam 2	Plate Girder		
Priority Level	Defect Type	Quantity	Defect Description	
2	Corrosion	39	Span 2 Beam 2: (PAR) CORROSION ALONG BOTH FACES OF WEB AND EDGES OF BOTH FLANGES NEAR END BENT 2 DOWN TO 0.24" RESIDUAL WEB, NEAR END BENT 2 DOWN TO 0.23" RESIDUAL TOP FLANGE, AND NEAR END BENT 2 DOWN TO 0.08" RESIDUAL BOTTOM FLANGE	
3314	Beam 3	Plate Girder		
Priority Level	Defect Type	Quantity	Defect Description	
2	Corrosion	39	Span 2 Beam 3: (PAR) CORROSION ALONG BOTH FACES OF WEB AND EDGES OF BOTH FLANGES NEAR MIDSPAN DOWN TO 0.25" RESIDUAL WEB, NEAR END BENT 2 0.20" RESIDUAL TOP FLANGE, AND NEAR END BENT 2 DOWN TO 0.30" RESIDUAL BOTTOM FLANGE	
3314	Beam 4	Plate Girder		
Priority Level	Defect Type	Quantity	Defect Description	
2	Corrosion	39	Span 2 Beam 4: (PAR) CORROSION ALONG BOTH FACES OF WEB AND EDGES OF BOTH FLANGES UP TO FULL LENGTH X 16" HIGH DOWN TO 0.24" RESIDUAL WEB, FULL LENGTH X 4" WIDE DOWN TO 0.20" RESIDUAL TOP FLANGE, AND FULL LENGTH X 4" WIDE DOWN TO 0.18" RESIDUAL BOTTOM FLANGE

Span 2 Beam 2: (PAR) CORROSION ALONG BOTH FACES OF WEB AND EDGES OF BOTH FLANGES NEAR END BENT 2 DOWN TO 0.24" RESIDUAL WEB, NEAR END BENT 2 DOWN TO 0.23" RESIDUAL TOP FLANGE, AND NEAR END BENT 2 DOWN TO 0.08" RESIDUAL BOTTOM FLANGE

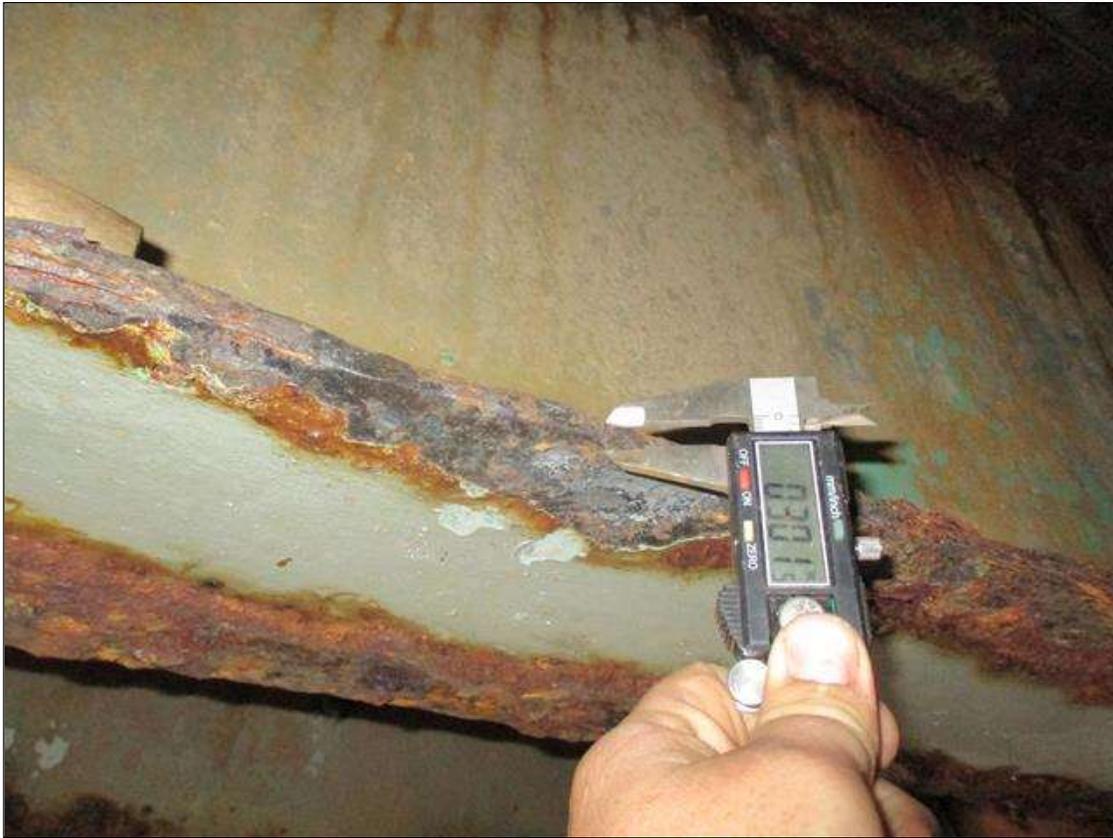
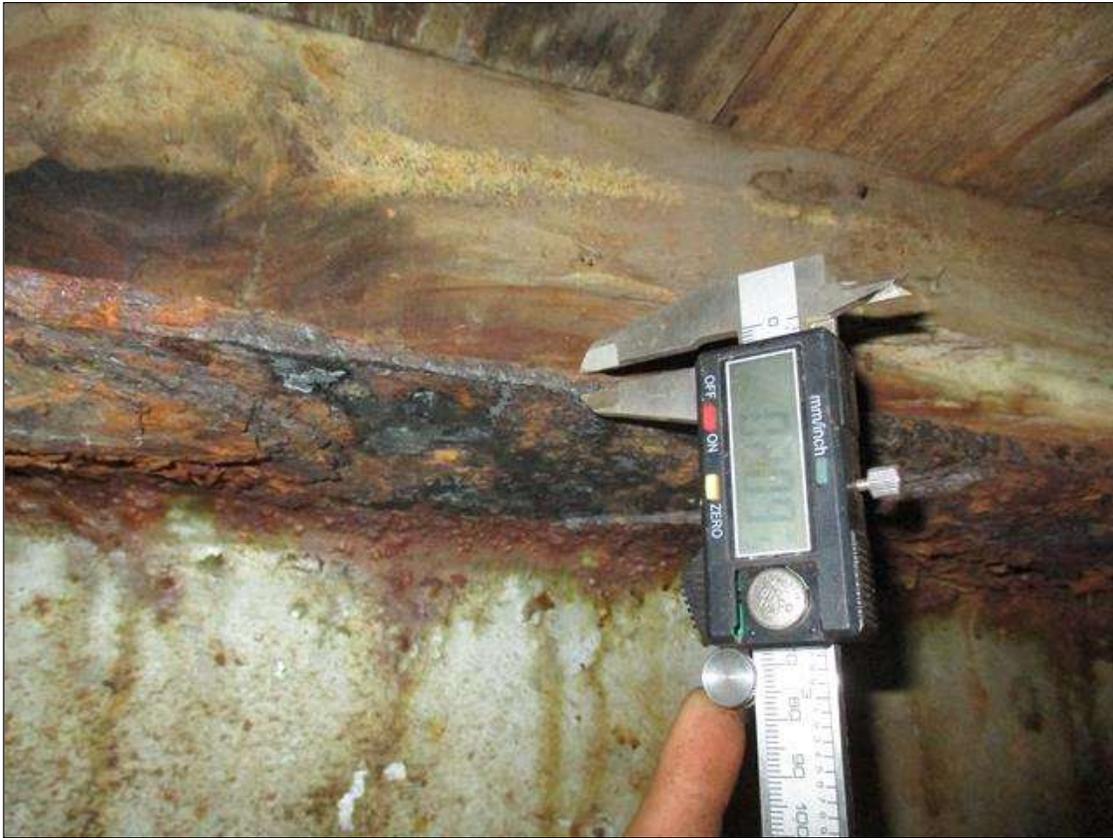
Span 2 Beam 3: (PAR) CORROSION ALONG BOTH FACES OF WEB AND EDGES OF BOTH FLANGES NEAR MIDSPAN DOWN TO 0.25" RESIDUAL WEB, NEAR END BENT 2 0.20" RESIDUAL TOP FLANGE, AND NEAR END BENT 2 DOWN TO 0.30" RESIDUAL BOTTOM FLANGE

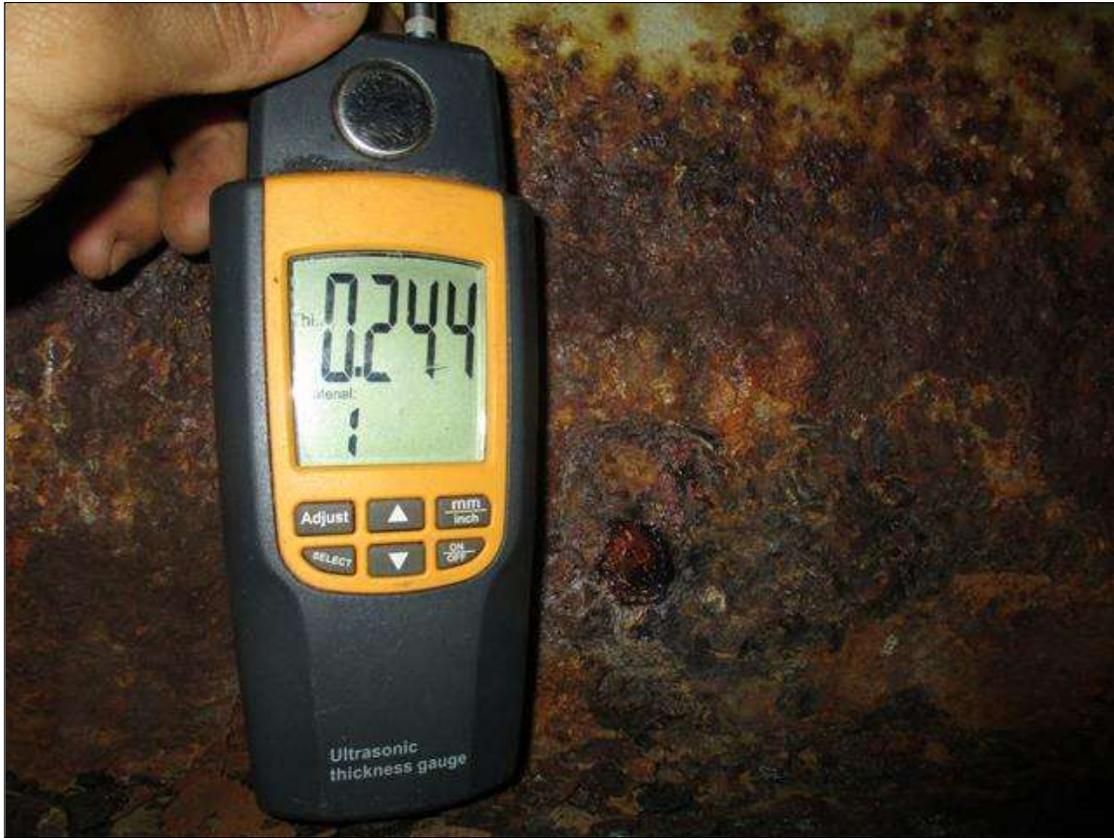
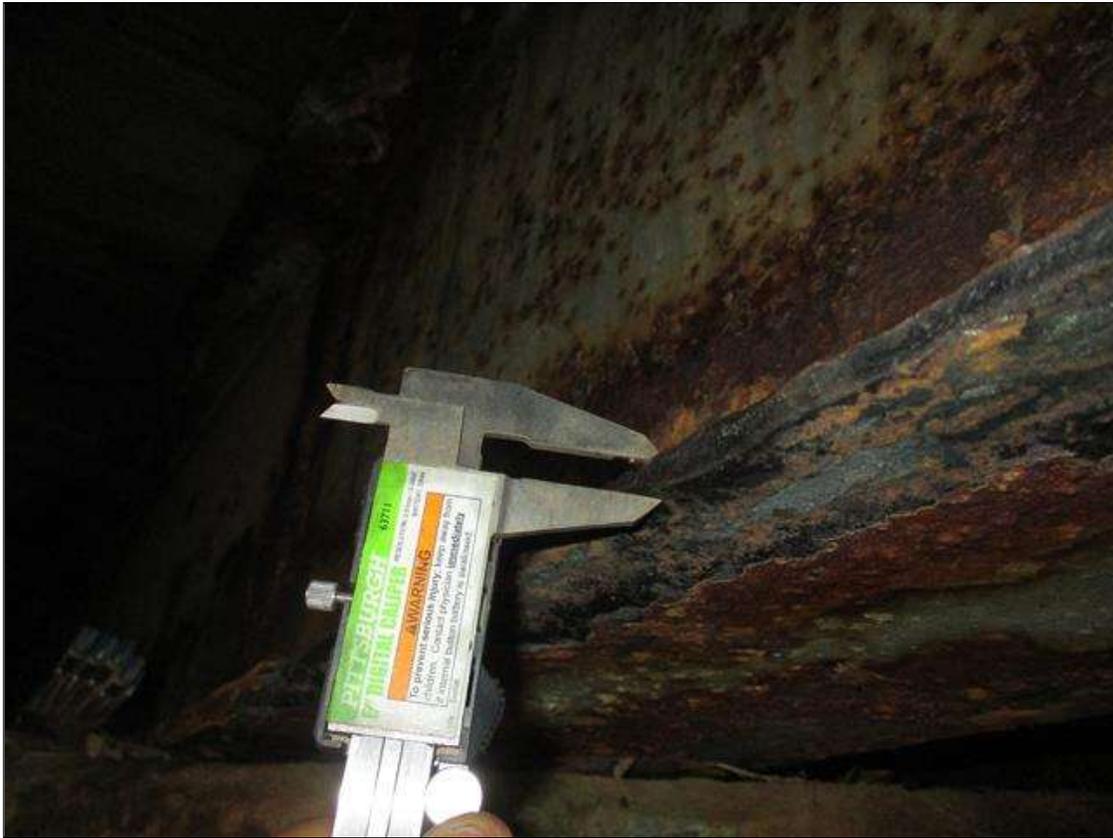
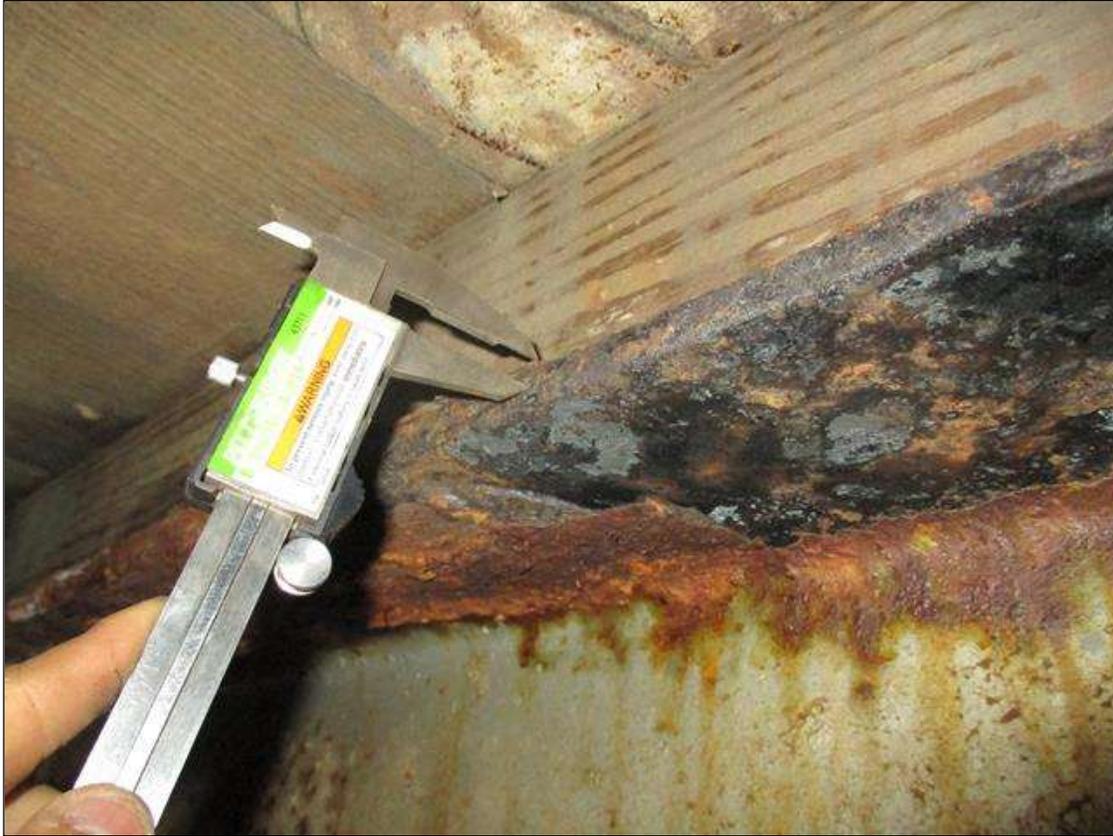
Span 2 Beam 4: (PAR) CORROSION ALONG BOTH FACES OF WEB AND EDGES OF BOTH FLANGES UP TO FULL LENGTH X 16" HIGH DOWN TO 0.24" RESIDUAL WEB, FULL LENGTH X 4" WIDE DOWN TO 0.20" RESIDUAL TOP FLANGE, AND FULL LENGTH X 4" WIDE DOWN TO 0.18" RESIDUAL BOTTOM FLANGE

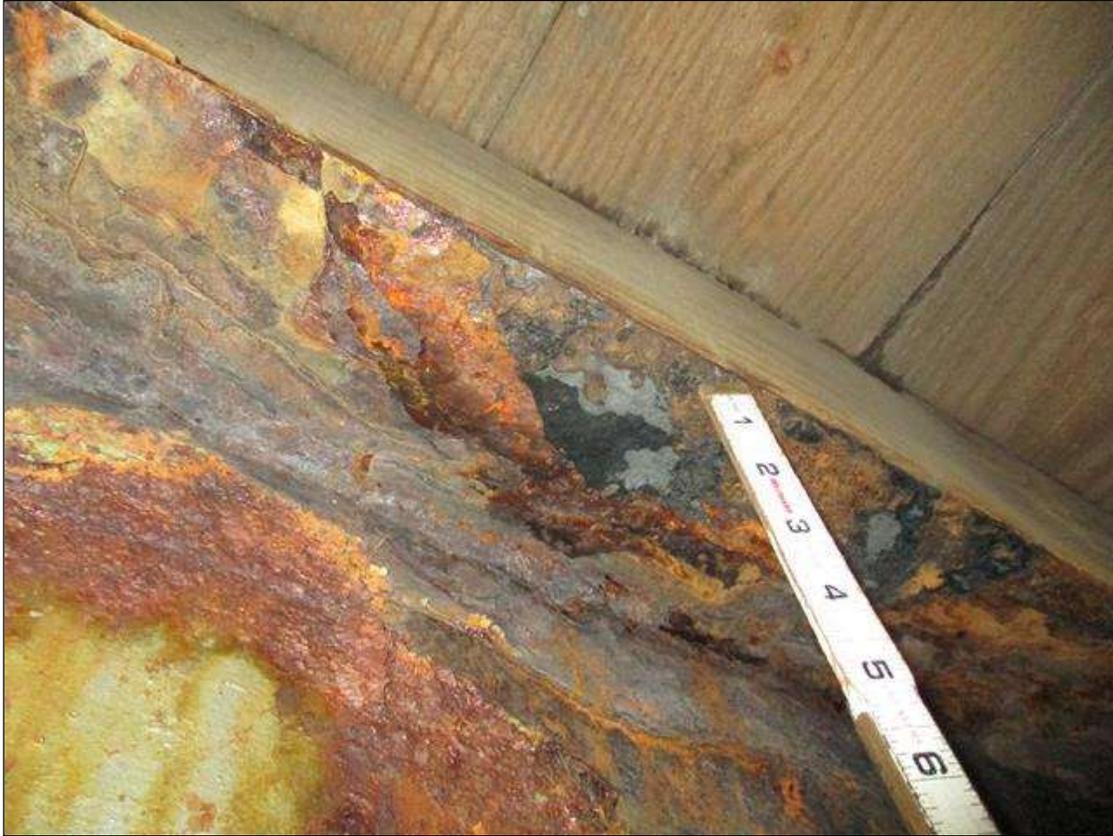
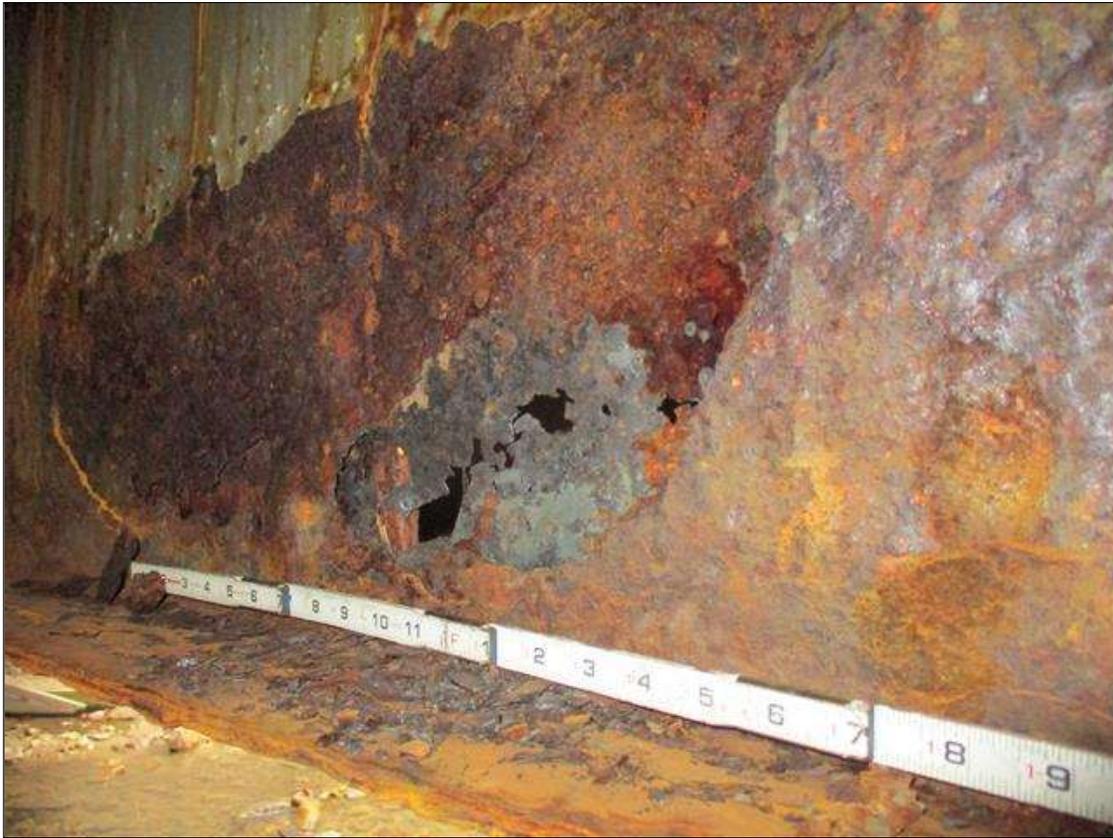
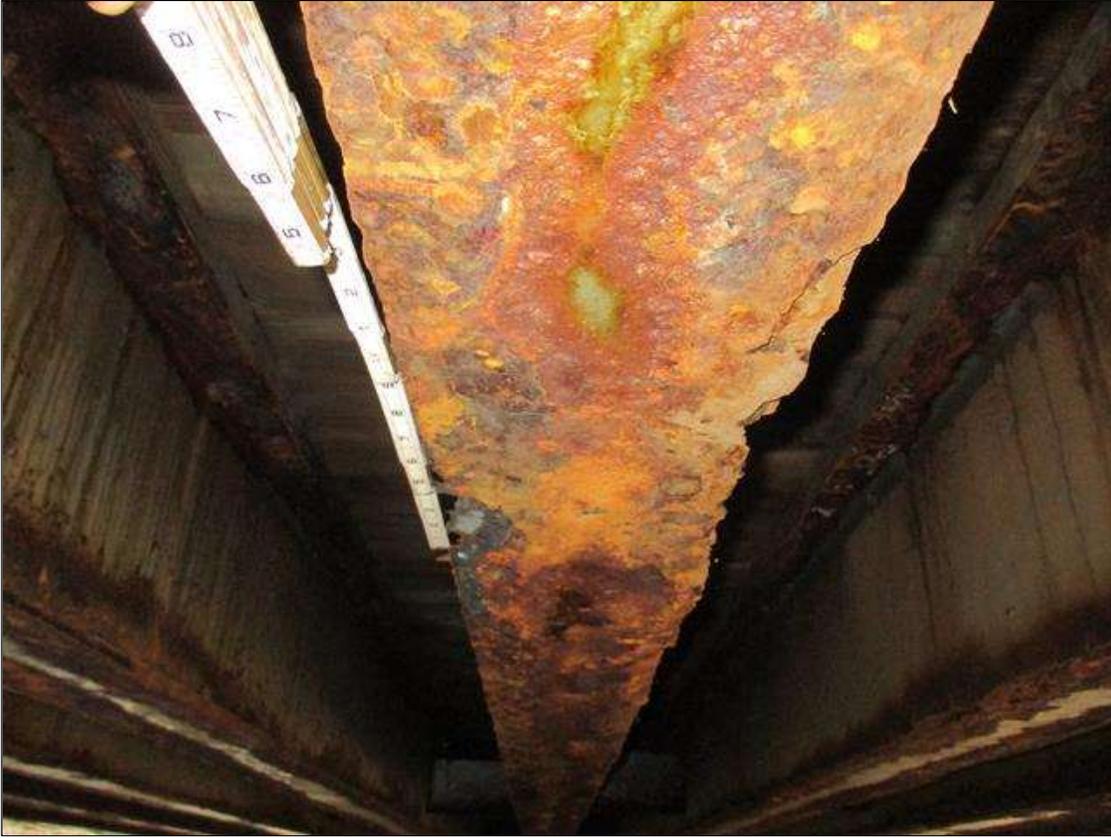
Span 2 Beam 5: (PAR) CORROSION ALONG BOTH FACES OF WEB AND EDGES OF BOTH FLANGES 8' FROM BENT 1 AND @ BEAM END PATCH HAS 100% SECTION LOSS IN WEB, FULL LENGTH X 4" WIDE DOWN TO 0.20" & KNIFE'S EDGE RESIDUAL TOP FLANGE, AND FULL LENGTH X 4" WIDE AREAS DOWN TO KNIFE'S EDGE & 100% SECTION LOSS IN BOTTOM FLANGE

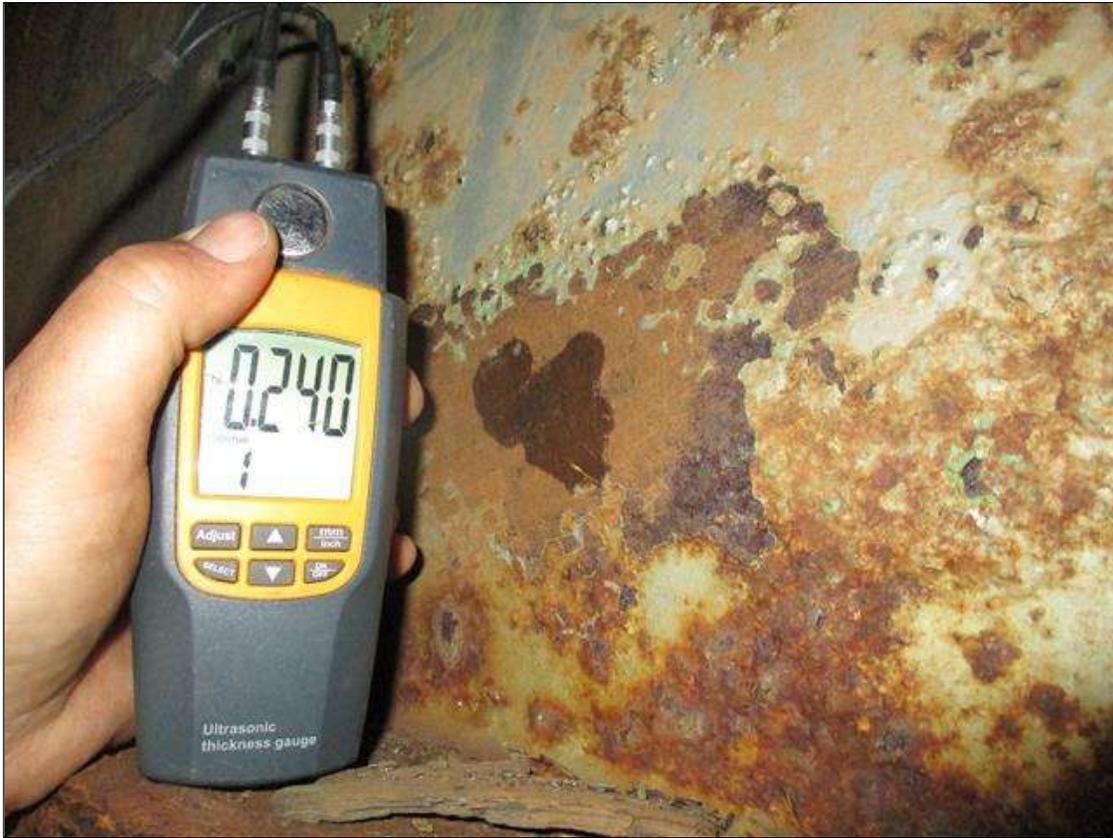
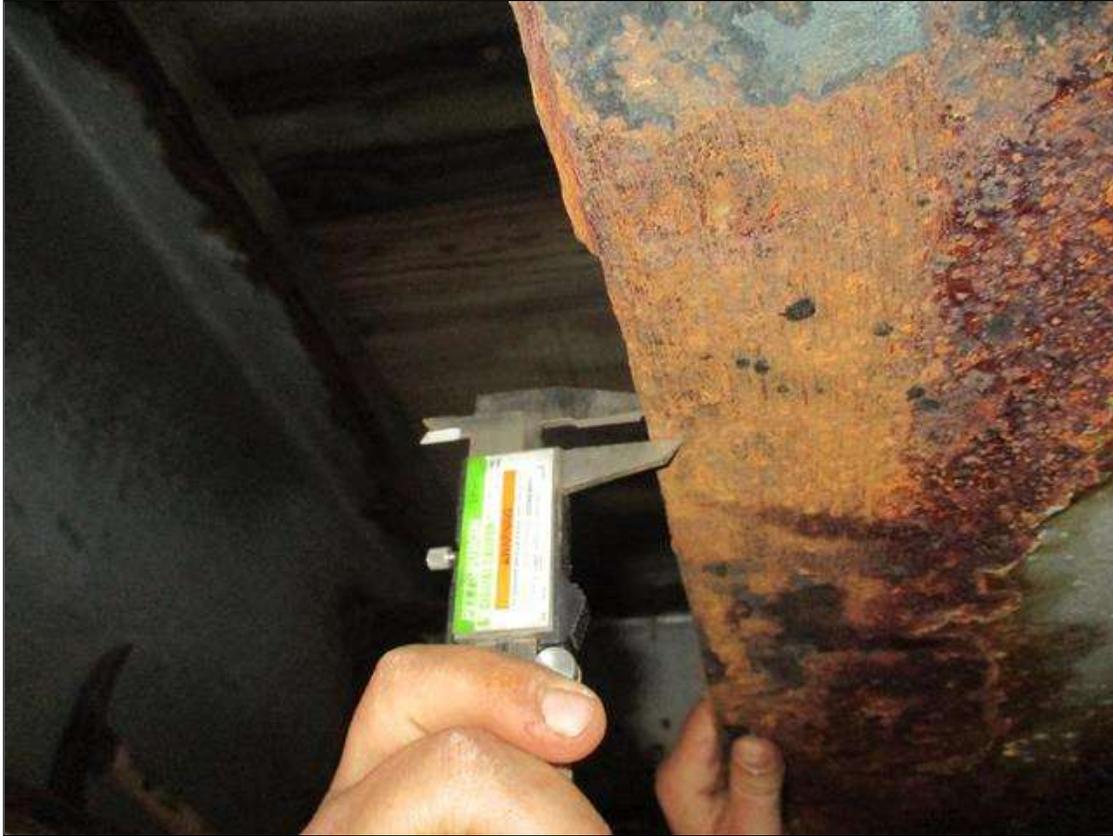
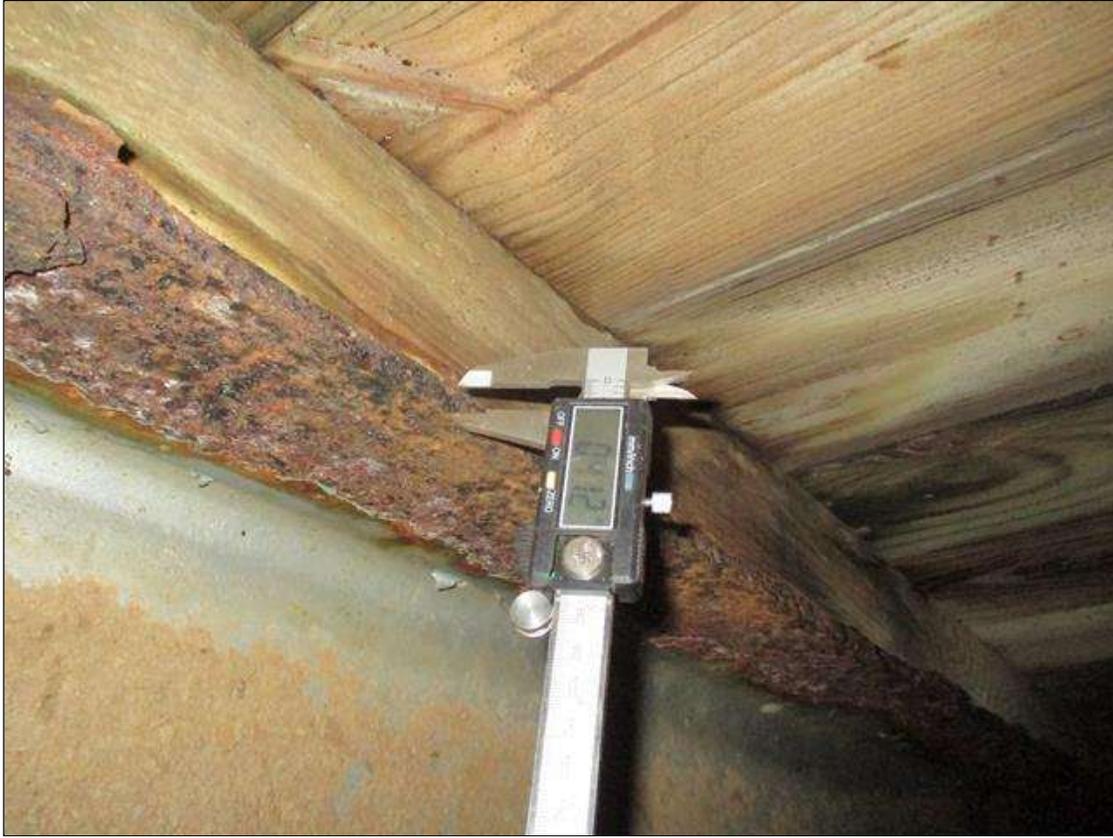
Span 2 Beam 7: (PAR) CORROSION ALONG BOTH FACES OF WEB AND EDGES OF BOTH FLANGES UP TO FULL LENGTH X 4" HIGH DOWN TO 0.24" RESIDUAL WEB, FULL LENGTH X 4" WIDE DOWN TO 0.41" RESIDUAL TOP FLANGE, AND FULL LENGTH X 4" WIDE DOWN TO 0.303" WITH AREAS DOWN TO KNIFE'S EDGE RESIDUAL BOTTOM FLANGE

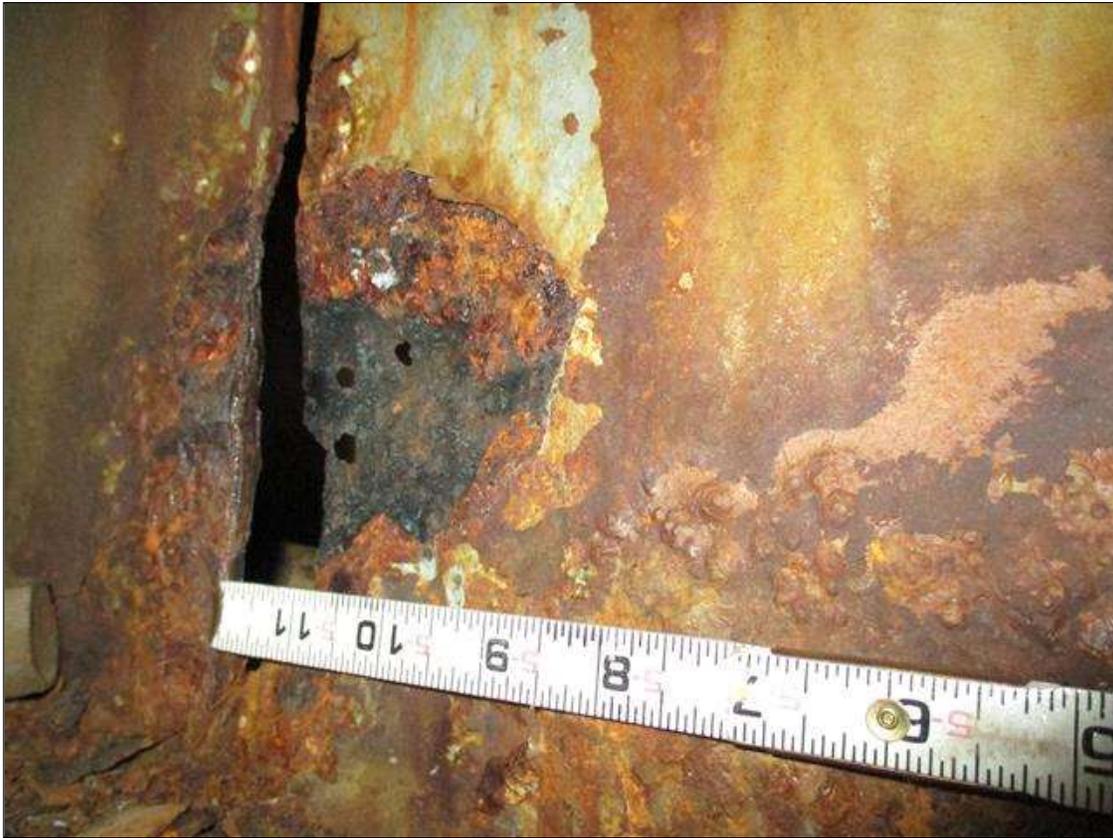
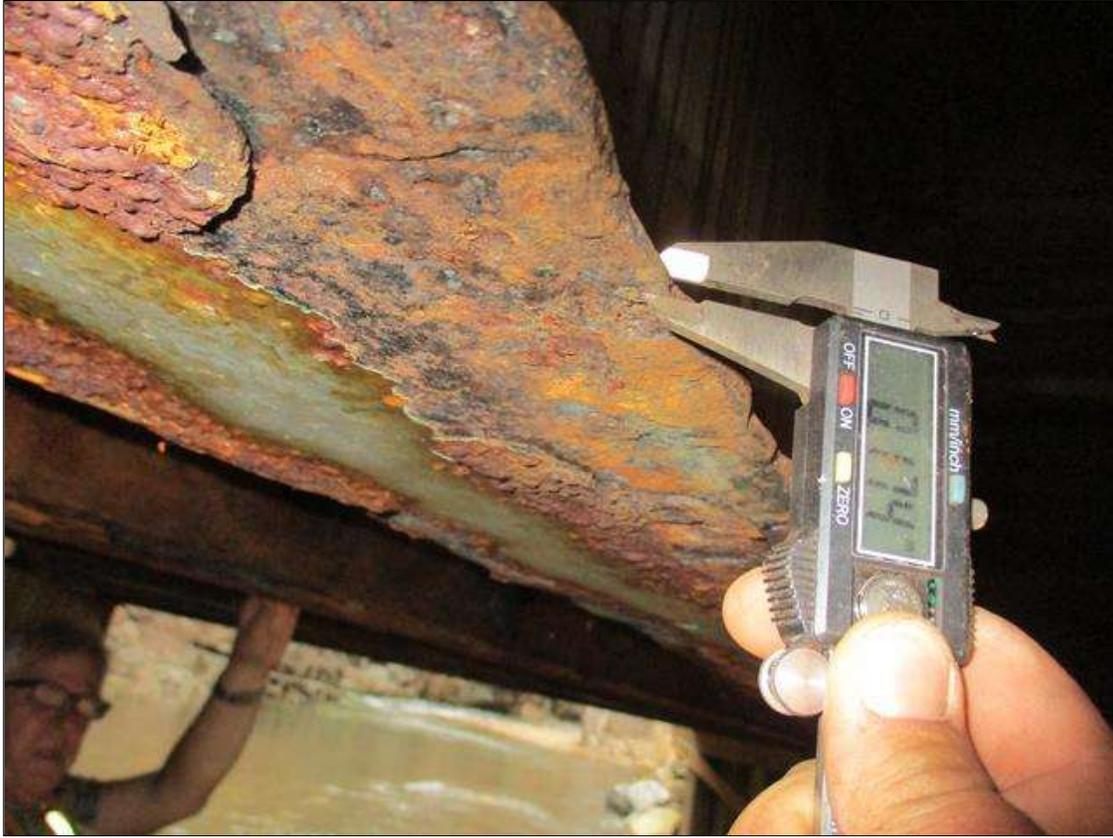
Span 2 Beam 6: (PAR) CORROSION ALONG BOTH FACES OF WEB AND EDGES OF BOTH FLANGES UP TO FULL LENGTH X 4" HIGH AREAS OF KNIFE'S EDGE & 100% SECTION LOSS IN WEB, FULL LENGTH X 4" WIDE DOWN TO 0.25" RESIDUAL TOP FLANGE, AND FULL LENGTH X 4" WIDE DOWN TO 0.17" RESIDUAL BOTTOM FLANGE

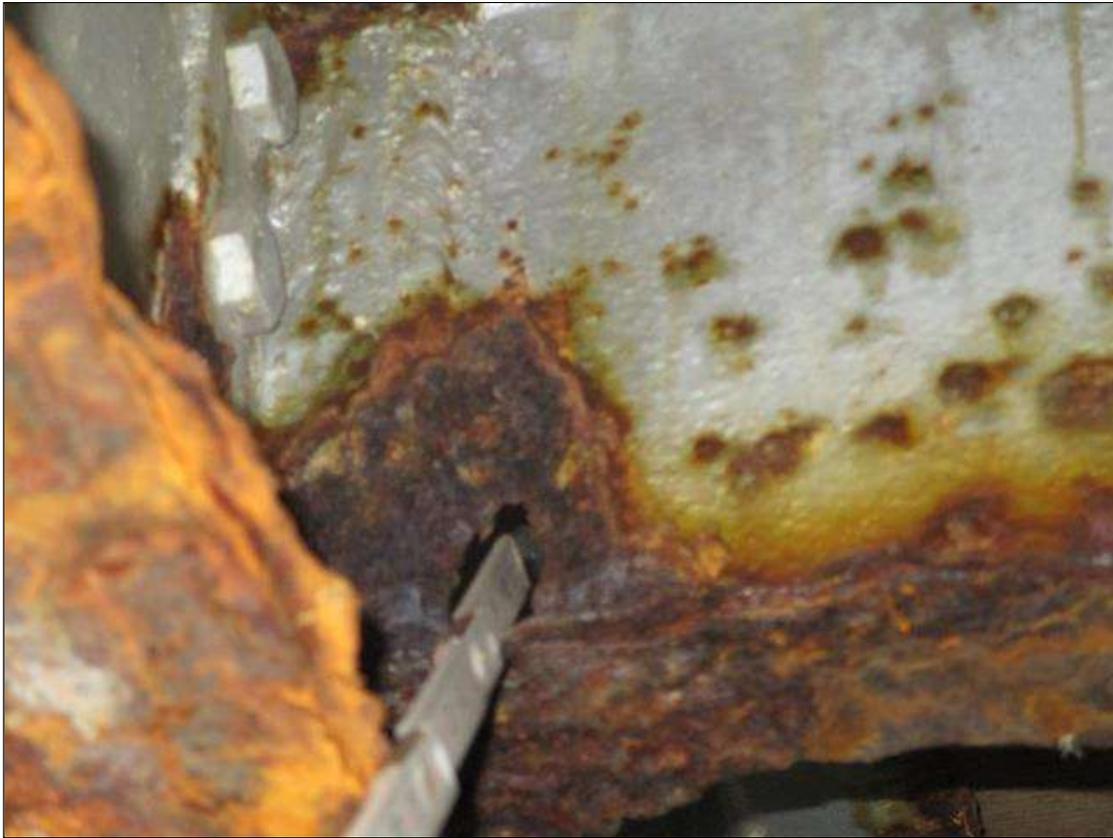
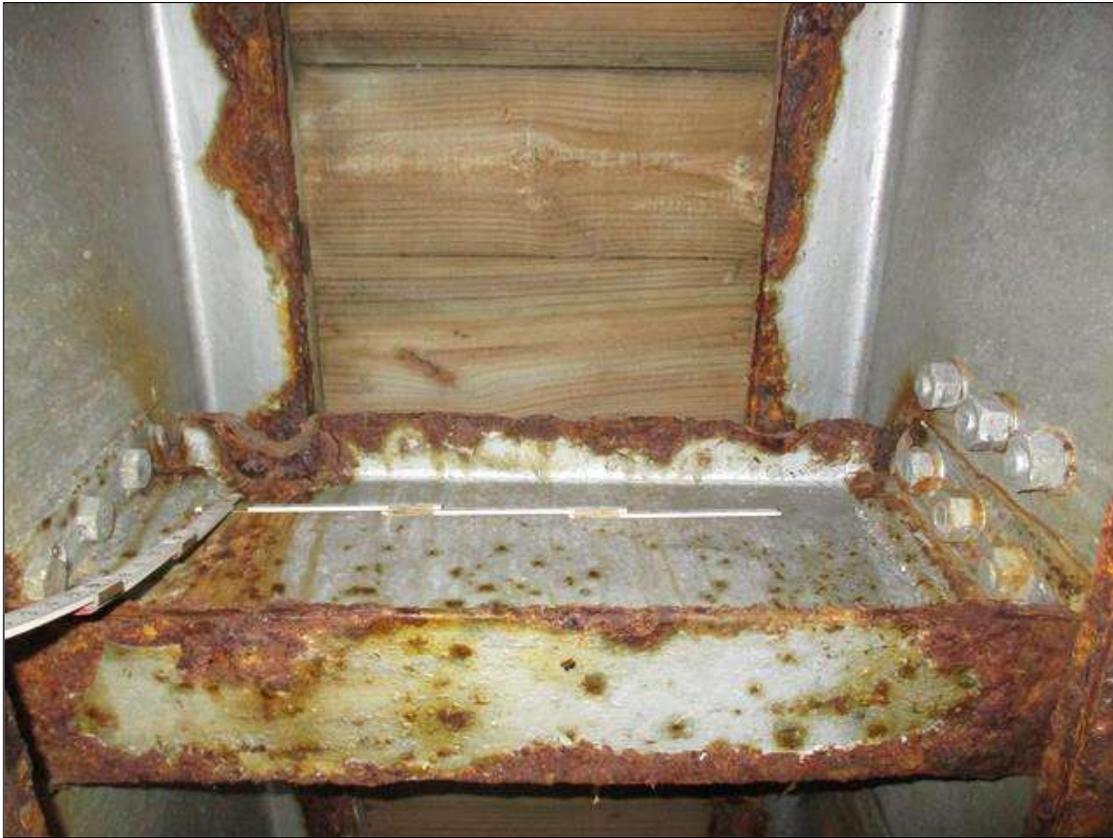
Span 2 Beam 7: (PAR) Span 2 Bay 7 Diaphragm 10ft from Pier: CORROSION THROUGHOUT DIAPHRAGM WITH TWO (2) 3" LONG X 1" WIDE HOLES IN TOP FLANGE, TWO (2) 3" LONG X 1" WIDE HOLES IN BOTTOM FLANGE, AND 3" HIGH X 1 1/2" WIDE HOLE IN WEB

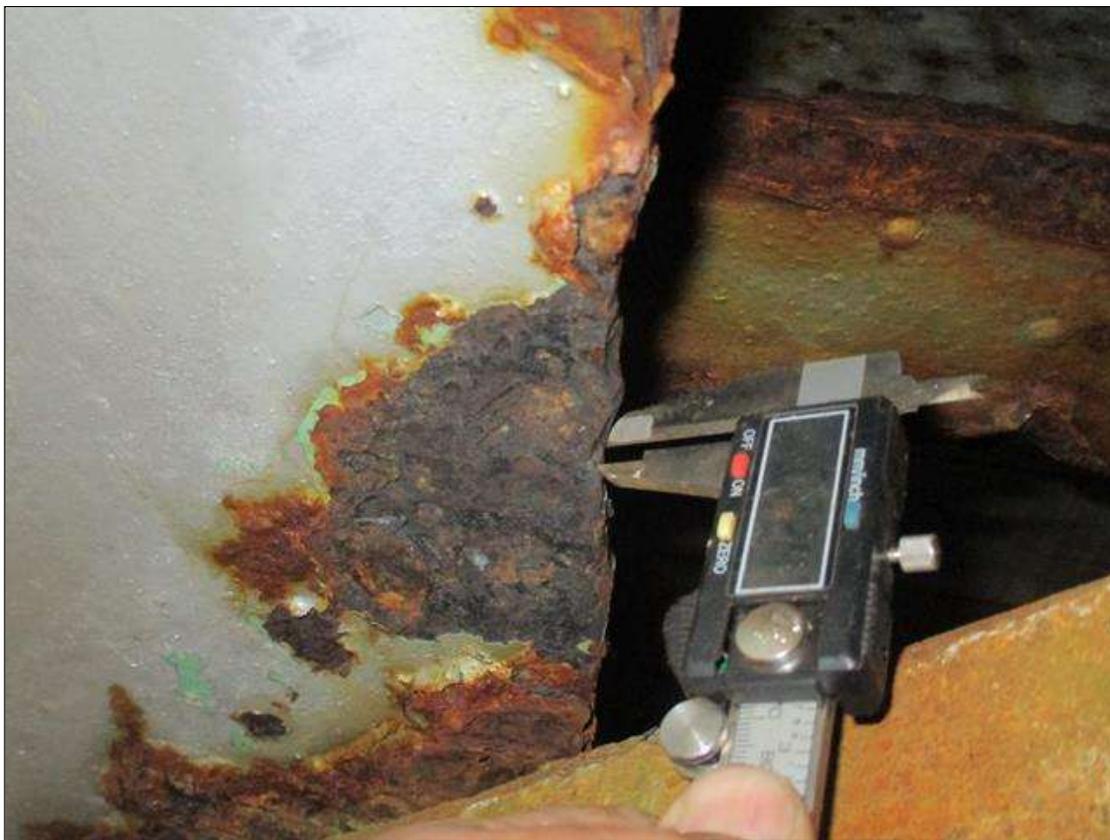
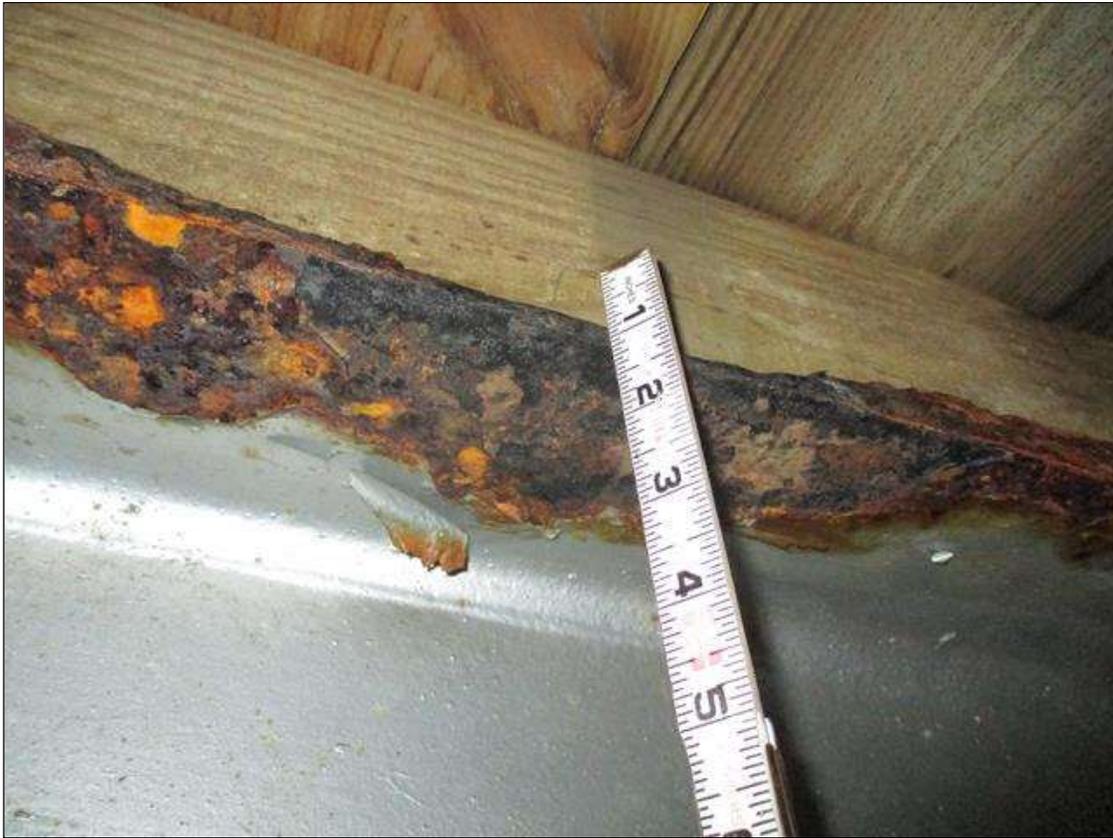
Priority Level	Defect Type	Quantity	Defect Description
2	Corrosion	39	Span 2 Beam 8: (PAR) CORROSION ALONG BOTH FACES OF WEB AND EDGES OF BOTH FLANGES UP TO FULL LENGTH X 4" HIGH DOWN TO 3/8" RESIDUAL WEB, FULL LENGTH X 4" WIDE DOWN TO 0.19" & KNIFE'S EDGE RESIDUAL TOP FLANGE, AND FULL LENGTH X 4" WIDE DOWN TO 0.22" RESIDUAL BOTTOM FLANGE

Span 2 Beam 8: (PAR) CORROSION ALONG BOTH FACES OF WEB AND EDGES OF BOTH FLANGES UP TO FULL LENGTH X 4" HIGH DOWN TO 3/8" RESIDUAL WEB, FULL LENGTH X 4" WIDE DOWN TO 0.19" & KNIFE'S EDGE RESIDUAL TOP FLANGE, AND FULL LENGTH X 4" WIDE DOWN TO 0.22" RESIDUAL BOTTOM FLANGE
