NC DEPARTMENT OF TRANSPORTATION  
 DIVISION OF HIGHWAYS  
 STRUCTURE MANAGEMENT UNIT

# Structure Safety Report

## Routine Element Inspection - Contract

DIVISION: 13 COUNTY: MADISON STRUCTURE NUMBER: 560149 FREQUENCY: 24 MONTHS

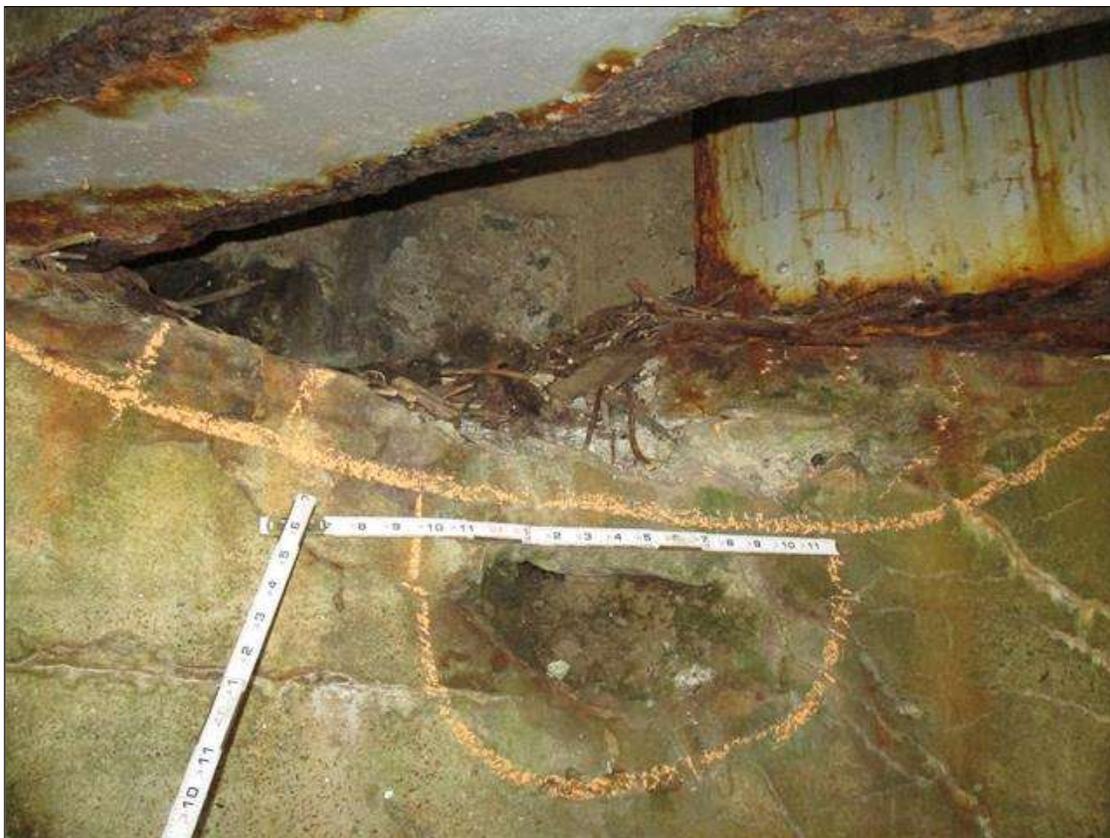
Priority Level	Defect Type	Quantity	Defect Description
2	Delamination/Spall	3	End Bent 1 Abutment: (PAR) 38" X 7" X UP TO 4" DEEP SPALL IN FACE OF CAP BENEATH BEAMS 1 AND 2, WITH 3" X 1" LOSS OF BEARING BELOW BEAM 1

End Bent 1 Abutment: (PAR) 38" X 7" X UP TO 4" DEEP SPALL IN FACE OF CAP BENEATH BEAMS 1 AND 2, WITH 3" X 1" LOSS OF BEARING BELOW BEAM 1

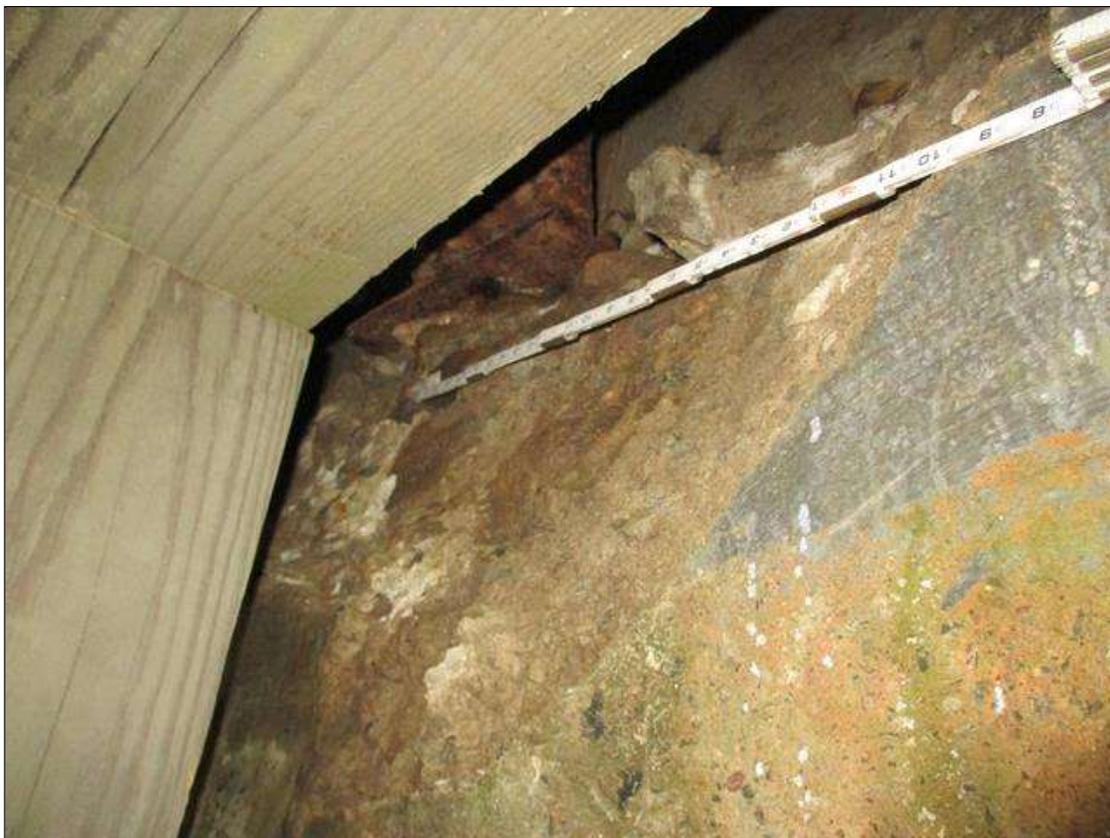
End Bent 2 Abutment: (PAR) FROM BEAM 2 TO BAY 3, 60"x 2"x 6" DEEP SPALL WITH 1" LOSS OF BEAM 3 BEARING. FROM RIGHT END TO BEAM 4, 14' LONG x 21" HIGH FAILED REPAIR WITH UP TO 2" DEEP UNDERMINING AT BEAM 5

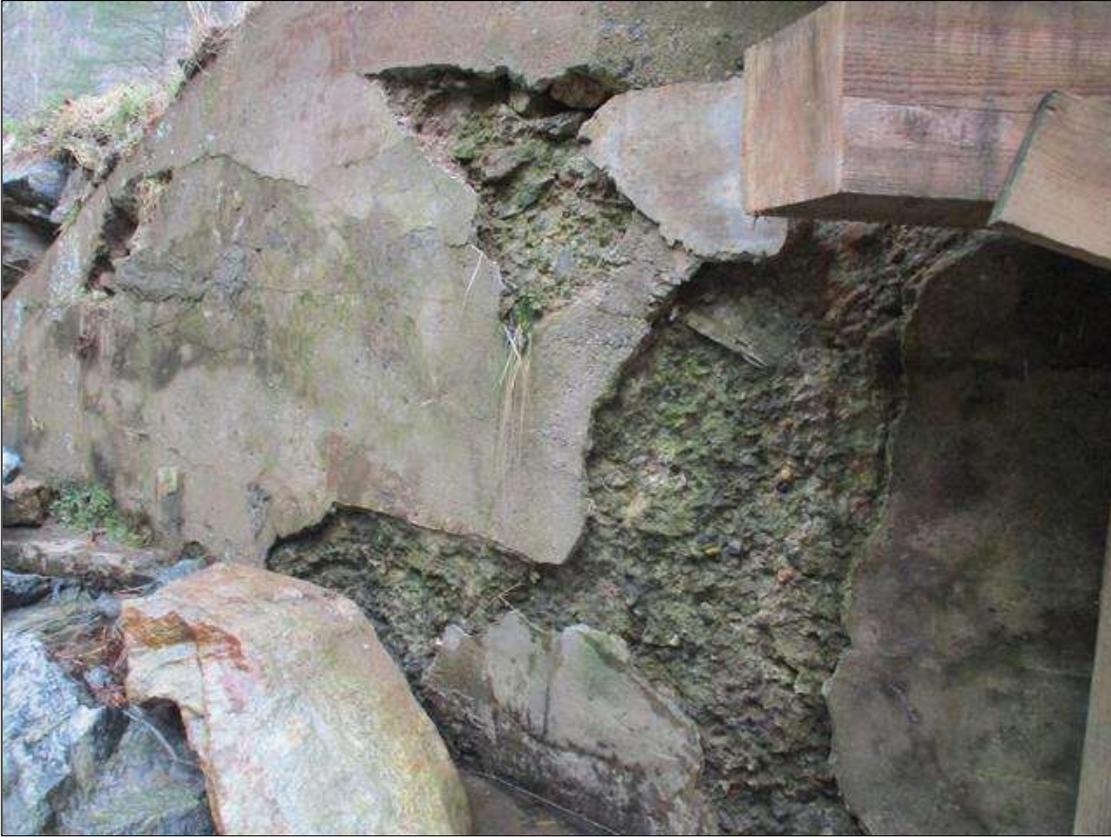
End Bent 2 Abutment: (PAR) NORTHEAST WINGWALL EXTENSION, 11'x 5" AREA OF DELAMINATION FOUR (4) SPALLS UP TO 3'x 3'x 5" DEEP WITH UP TO 1/8" MAP CRACKING WITH EFFLORESCENCE IN FACE

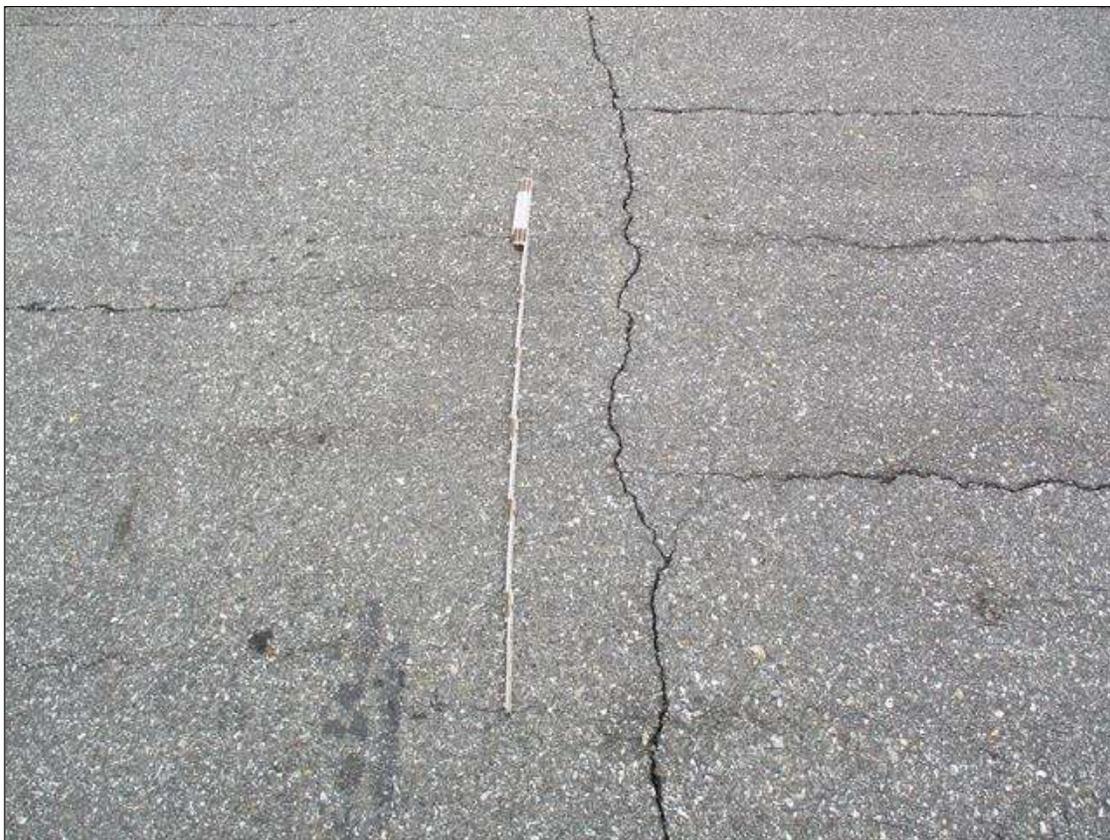
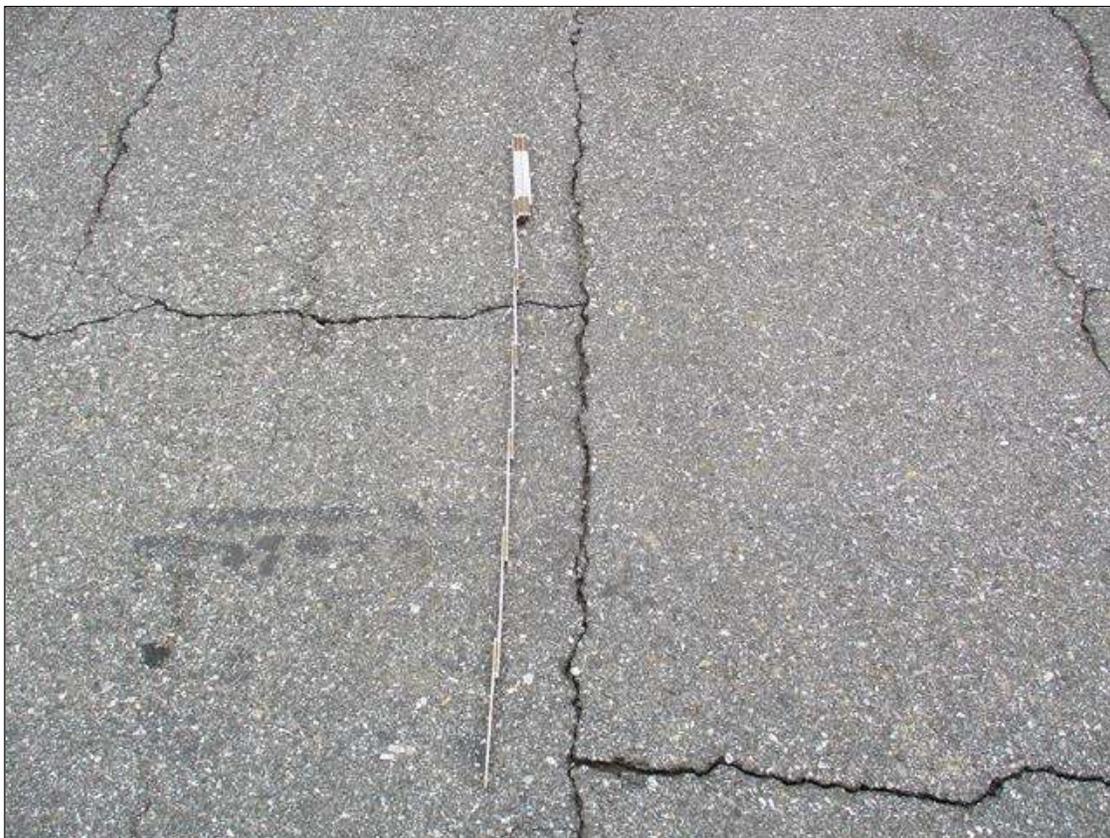
Element Number	Defect Type	Defect Description	CS	CS Qty	Maint Qty	
510	Crack (Wearing Surface)	UP TO 1/4" TRANSVERSE AND LONGITUDINAL CRACKS IN VARIOUS LOCATIONS THROUGHOUT	3	550	550	Square Feet

Span 1 Wearing Surface: UP TO 1/4" TRANSVERSE AND LONGITUDINAL CRACKS IN VARIOUS LOCATIONS THROUGHOUT

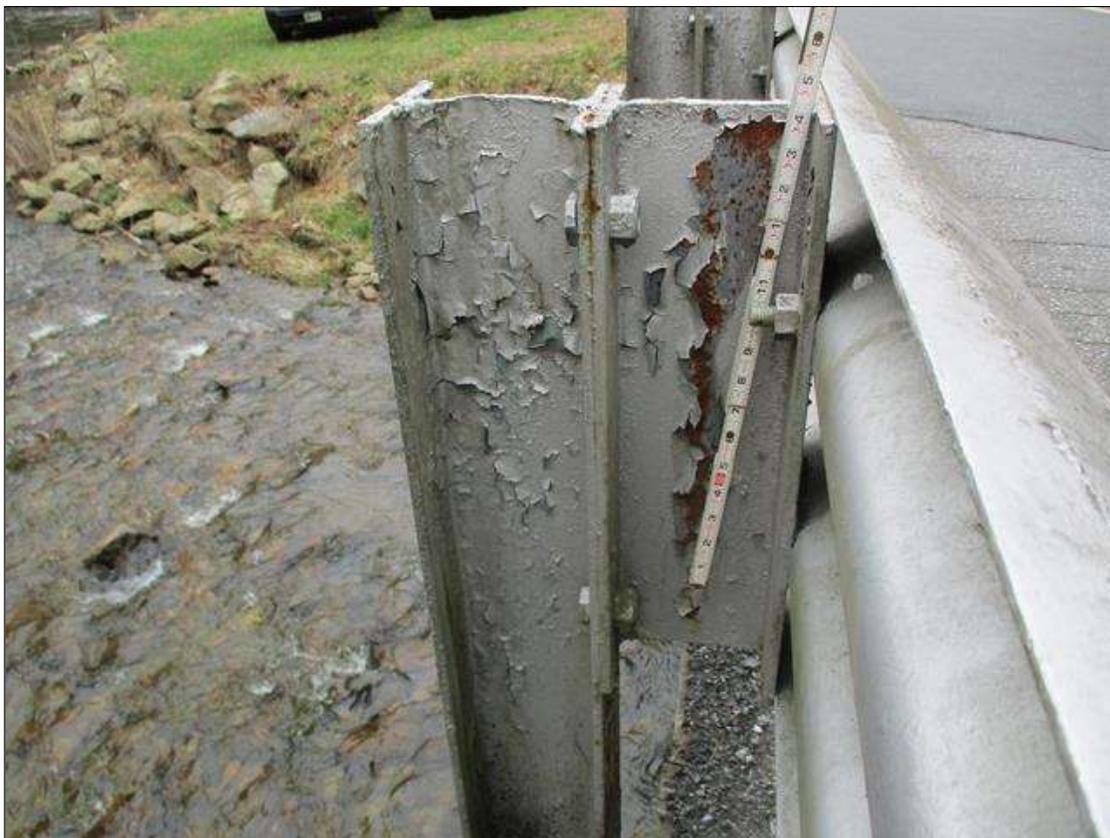
Span 1 Right Bridge Rail: AREAS OF CORROSION IN RAIL POSTS

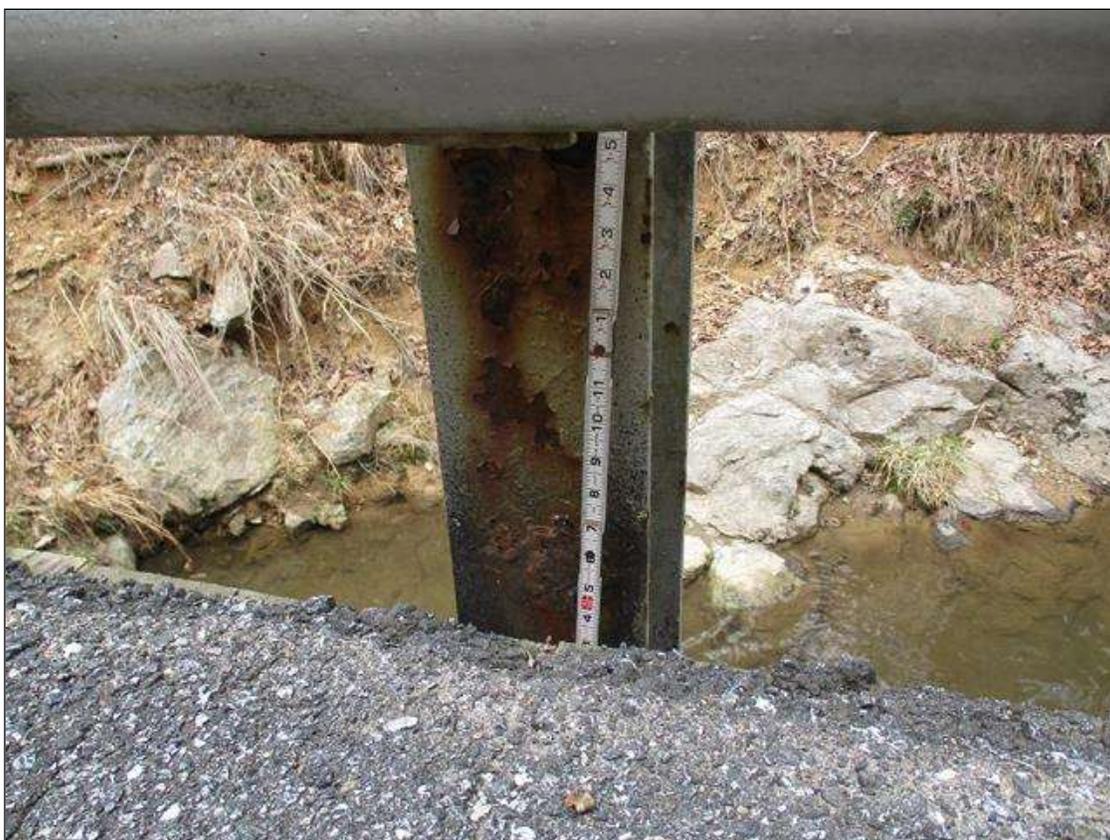
Span 1 Left Bridge Rail: AREAS OF CORROSION IN RAIL POSTS

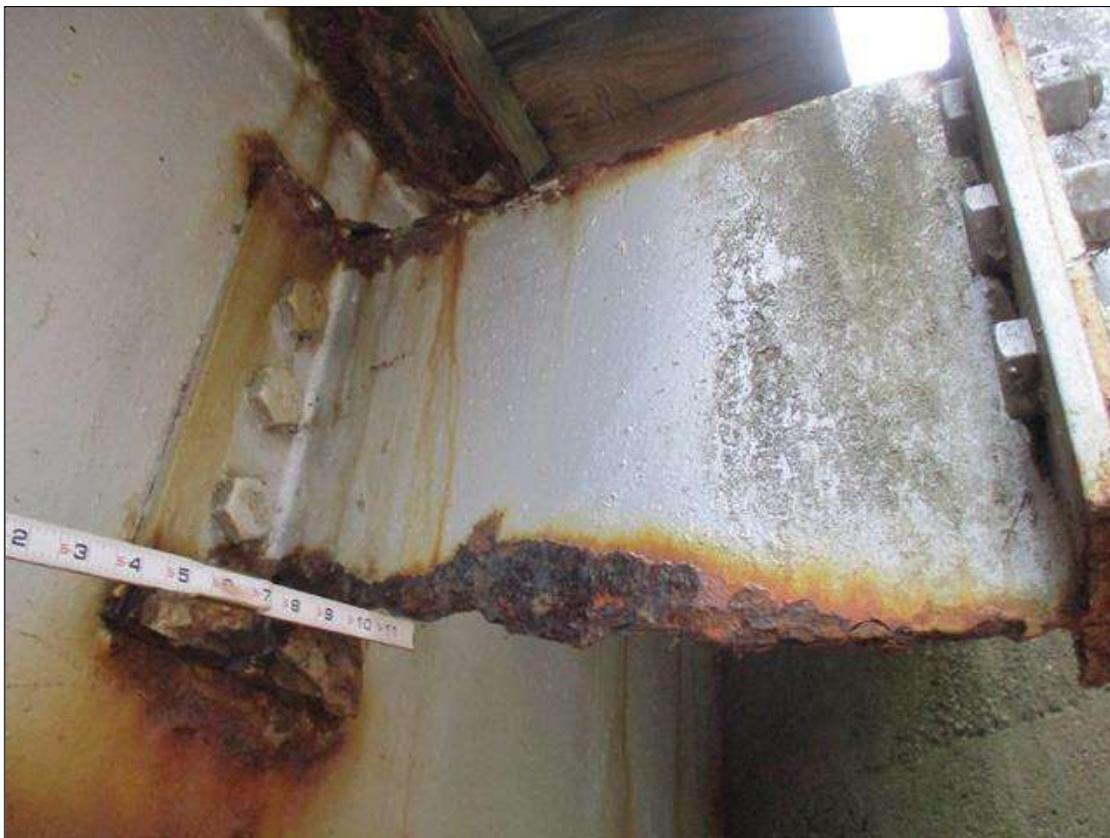
BRIDGE RAIL CONNECTION TO BEAM HAS CORROSION & SECTION LOSS UP TO 100% (TYPICAL ALL BRIDGE RAIL CONNECTIONS)

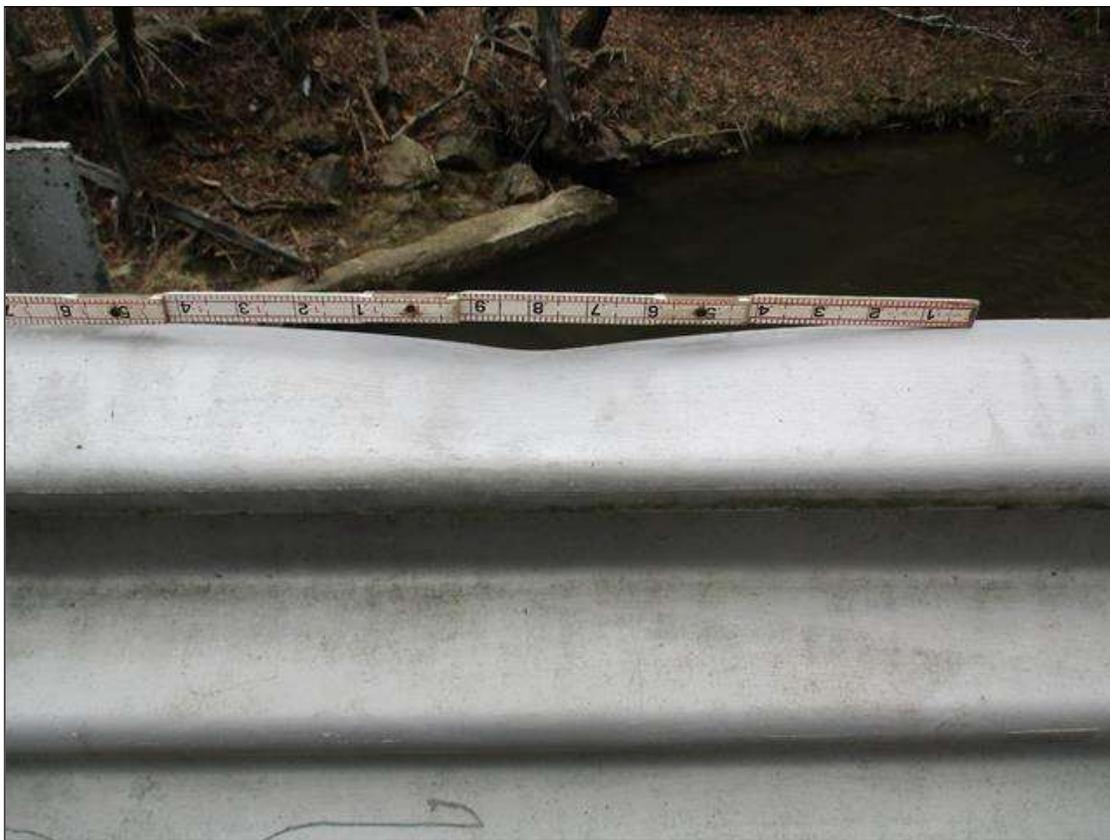
Span 2 Left Bridge Rail: 16" X 1" DEEP DISTORTION IN TOP OF RAIL, APPROXIMATELY 10' FROM PIER

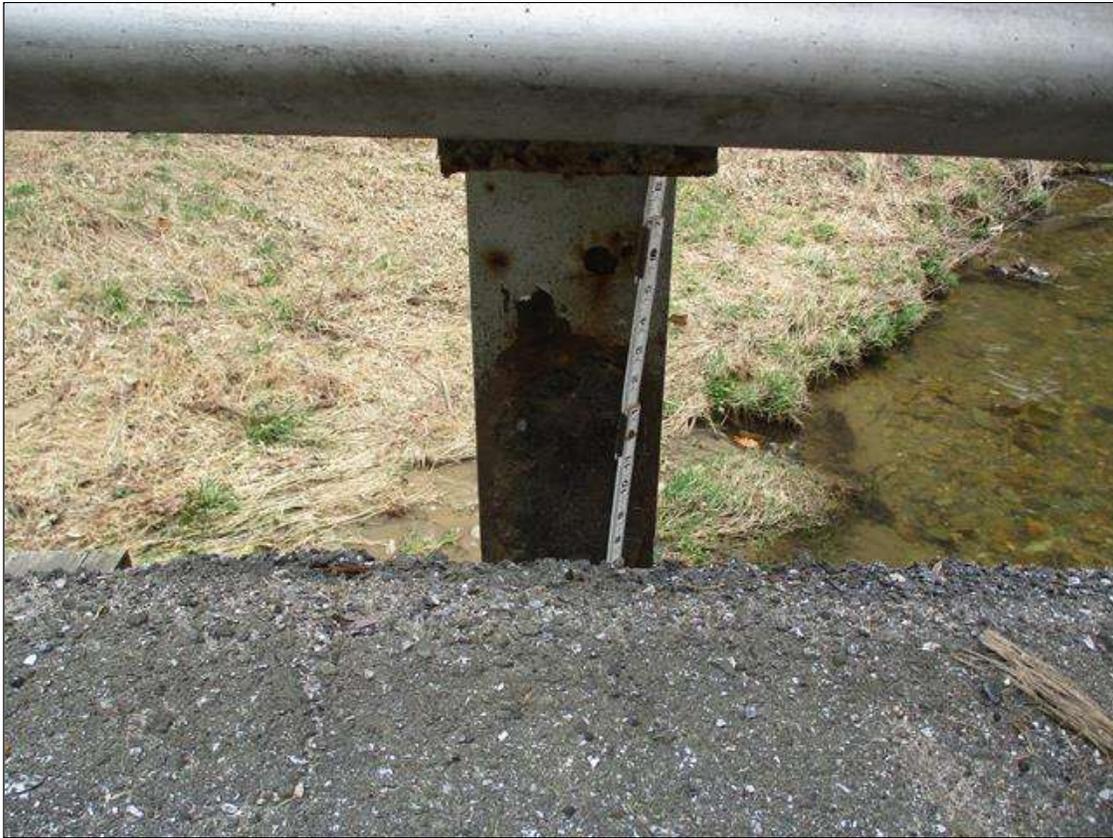
Span 2 Right Bridge Rail - Protective System: AREAS OF DETERIORATED PAINT SYSTEM IN RAIL POSTS

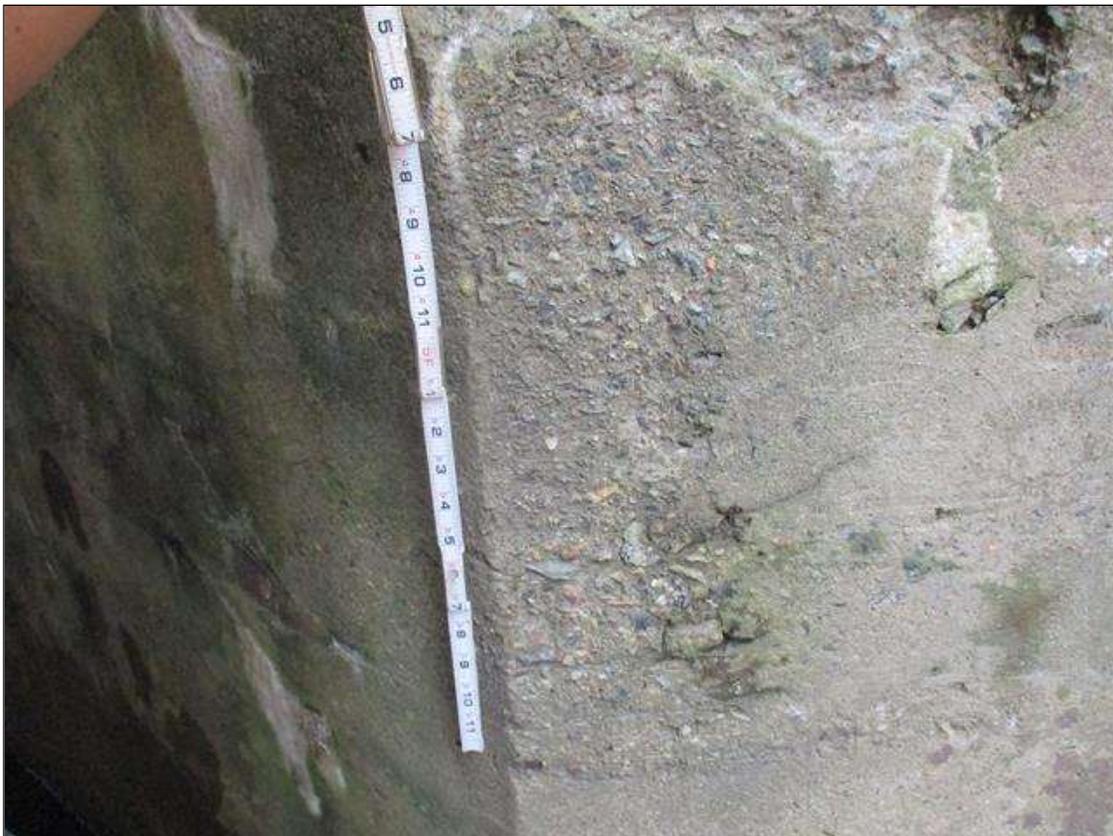
End Bent 1 Abutment: 48' OF UP TO 12" HIGH X 5" DEEP SCALING WITH EXPOSED AGGREGATE THROUGHOUT FACE OF BREASTWALL AT WATER SURFACE WITH UP TO 1/16IN VERTICAL AND HORIZONTAL CRACKS

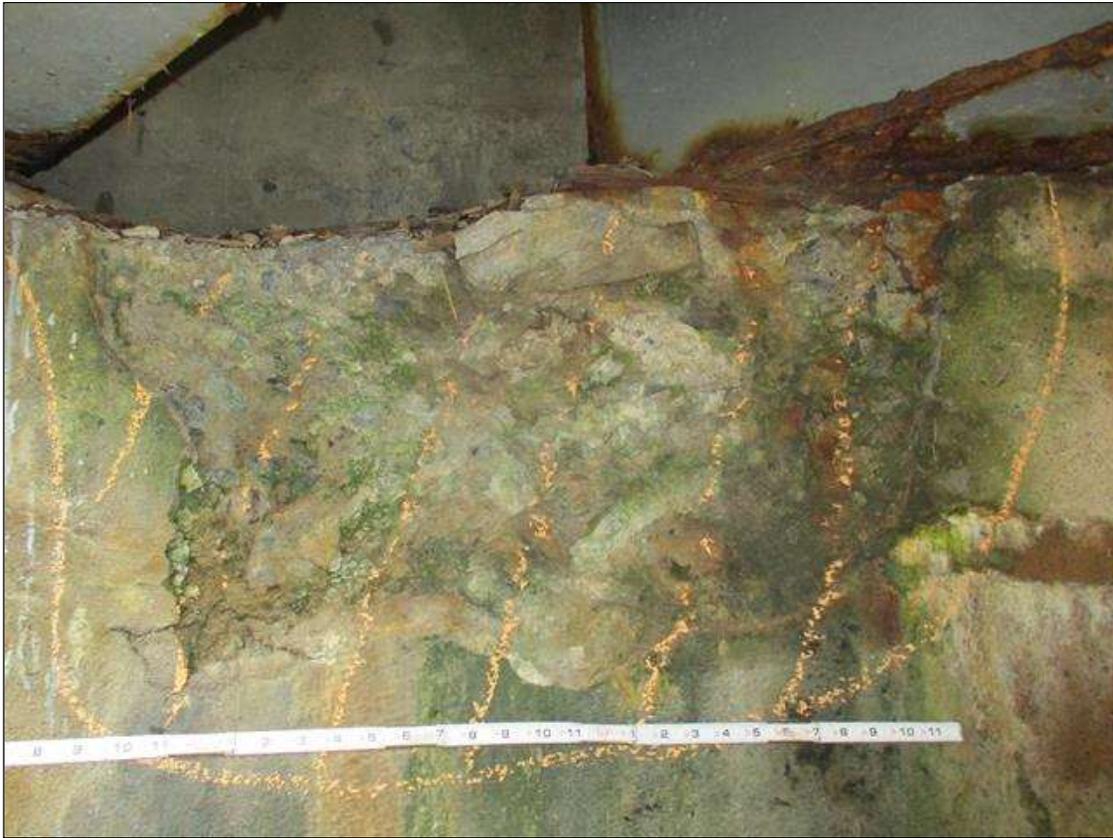
End Bent 1 Abutment: 32" X 16" X UP TO 1" DEEP SPALL IN FACE OF CAP BENEATH BAY 7; NO LOSS OF BEARING NOTED

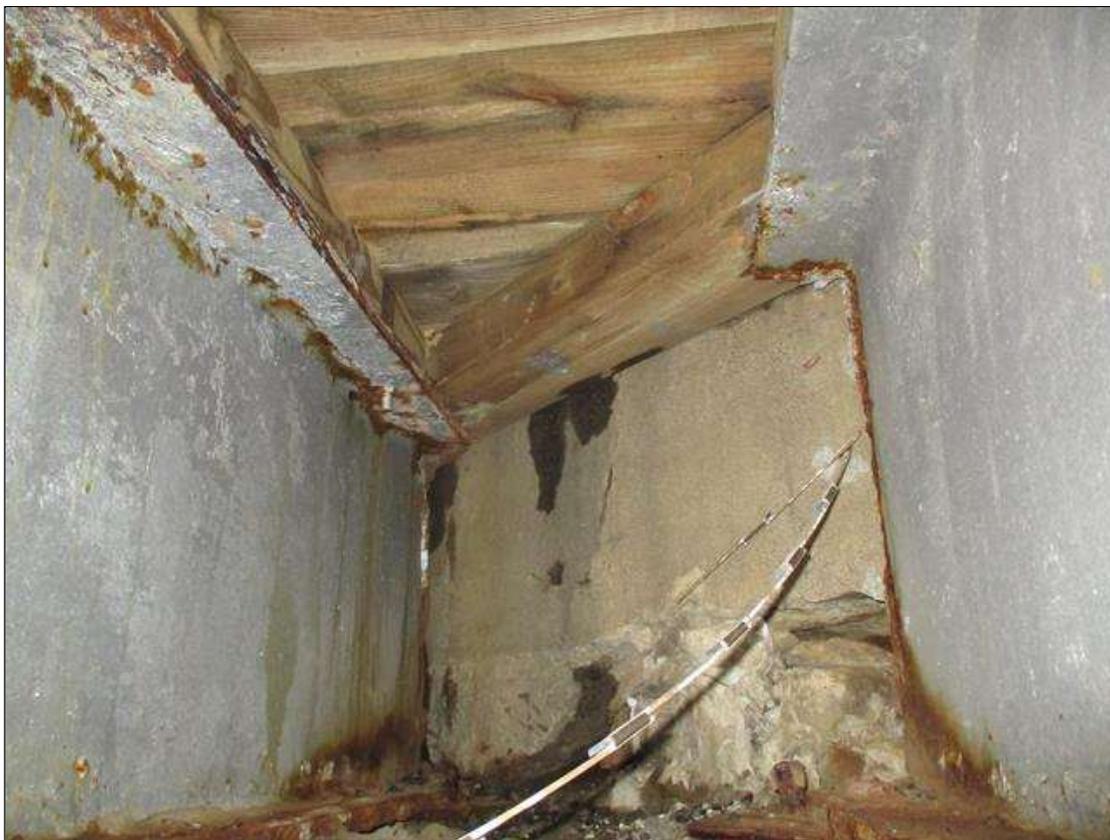
End Bent 2 Abutment: BAY 2 BACKWALL, SPALL 2FT X 10IN X 5IN DEEP
