NC DEPARTMENT OF TRANSPORTATION
 DIVISION OF HIGHWAYS
 STRUCTURE MANAGEMENT UNIT

Structure Safety Report

Routine Element Inspection

STRUCTURE NUMBER: 560531 SAP STRUCTURE NO: 0570531 FHWA STRUCTURE NO: 000000001150531

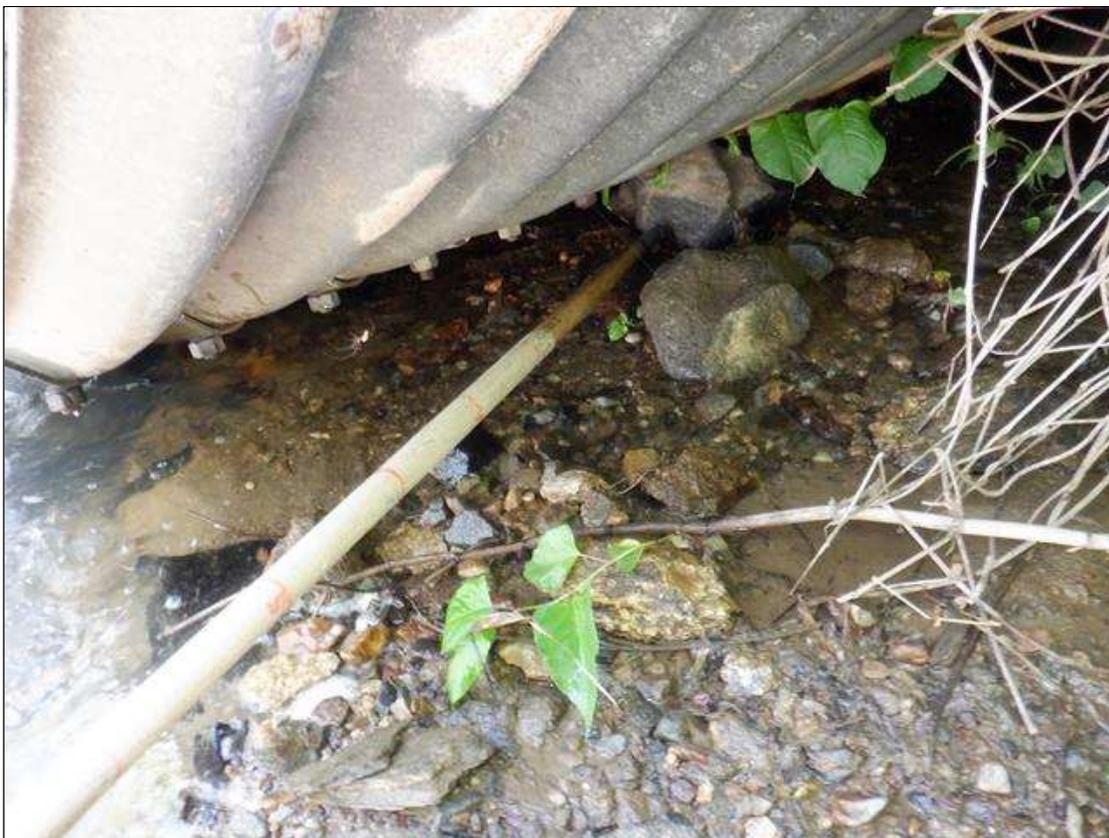
Span 3 Culvert Section 12: FULL WIDTH X 2.5' HIGH X 3' BACK SCOUR AT THE OUTLET END.

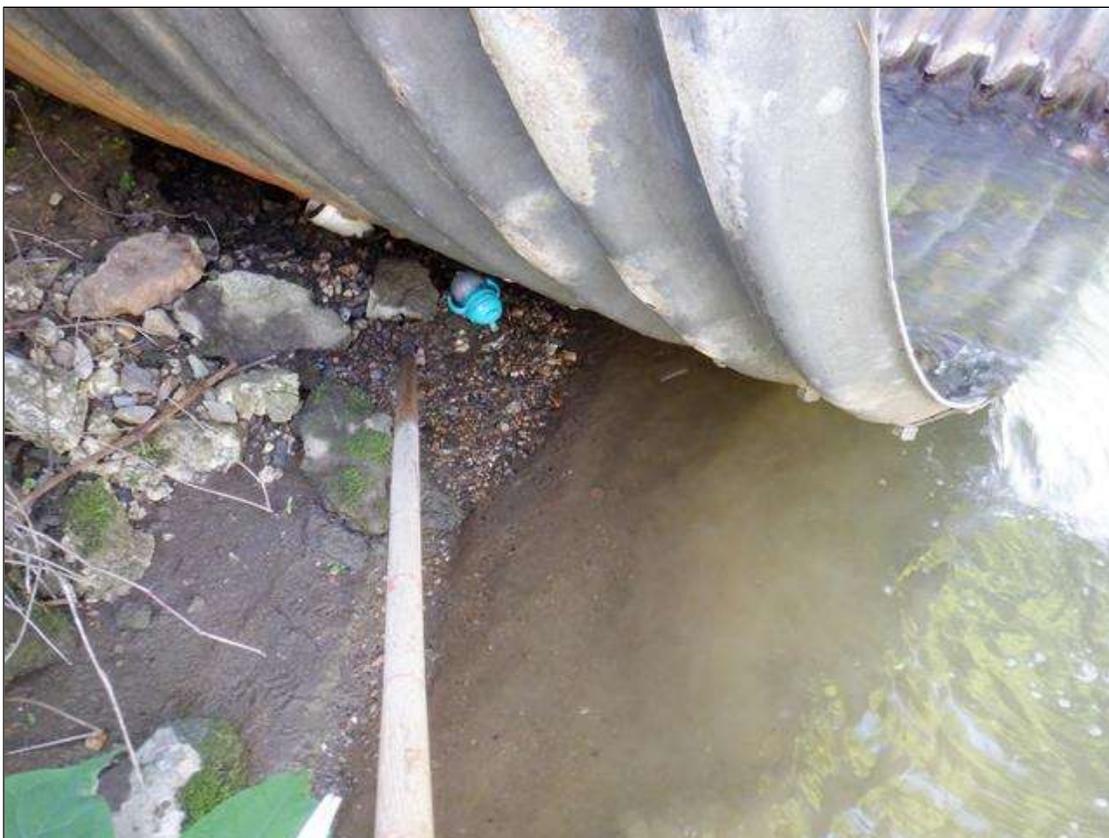
Span 2 Culvert Section 12: FULL WIDTH X 2.333' HIGH X 4' BACK SCOUR AT THE OUTLET END.

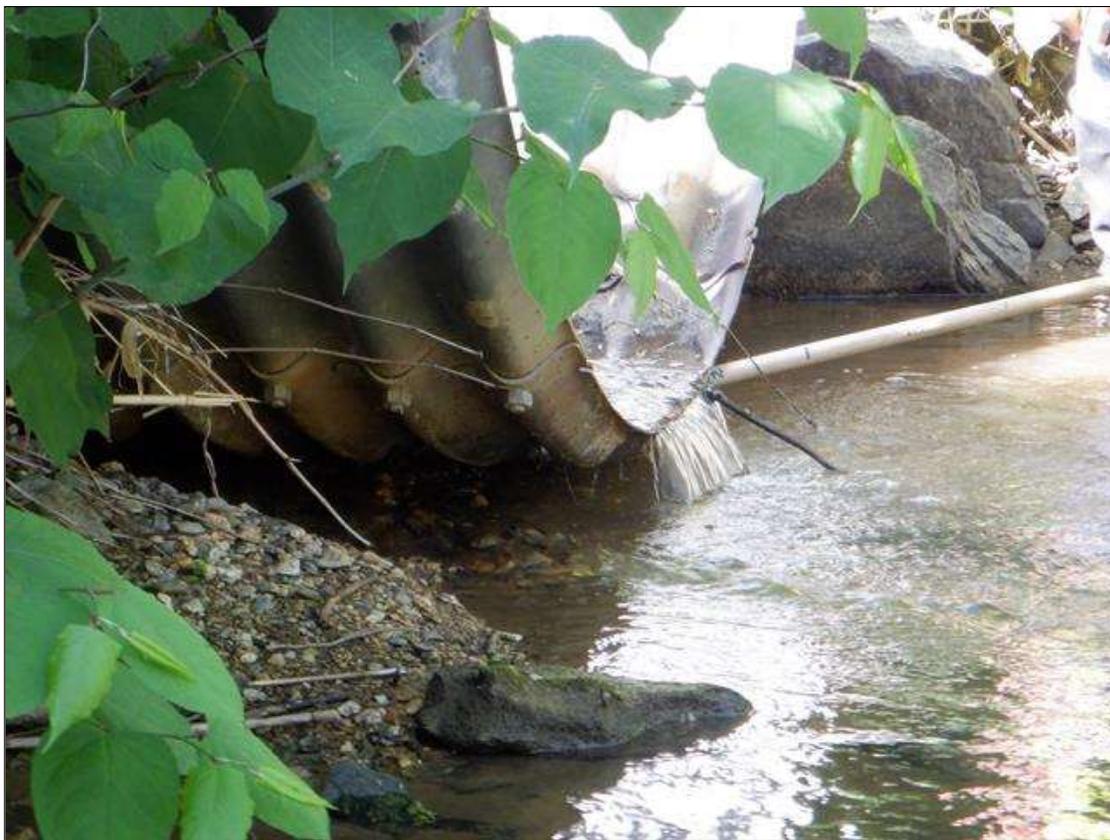
Span 1 Culvert Section 12: FULL WIDTH X 0.5' HIGH X 3' BACK SCOUR AT THE OUTLET END.

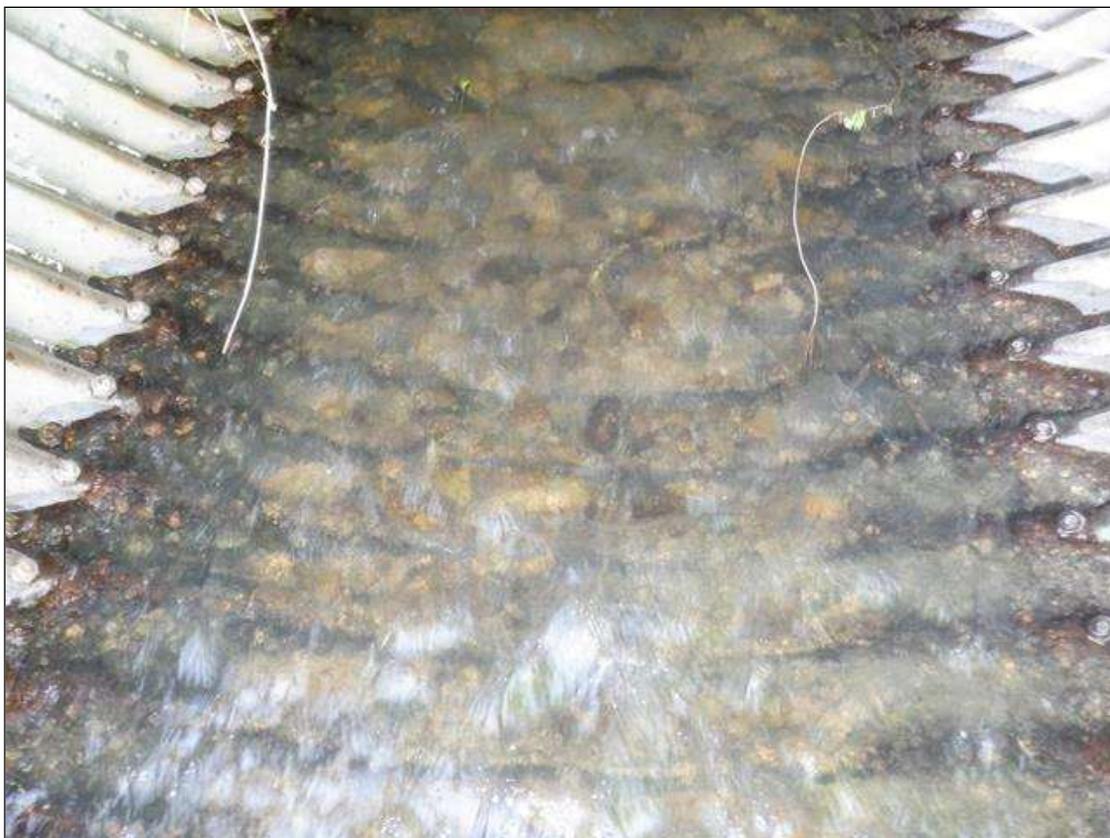
Span 2 Culvert Section 1: CORROSION WITH 0.0625" PITTING AND SCALE LOSS ALONG THE WATERLINE. BOTTOM PORTION NOT VISIBLE DUE TO ROCK AND SEDIMENT BUILDUP.

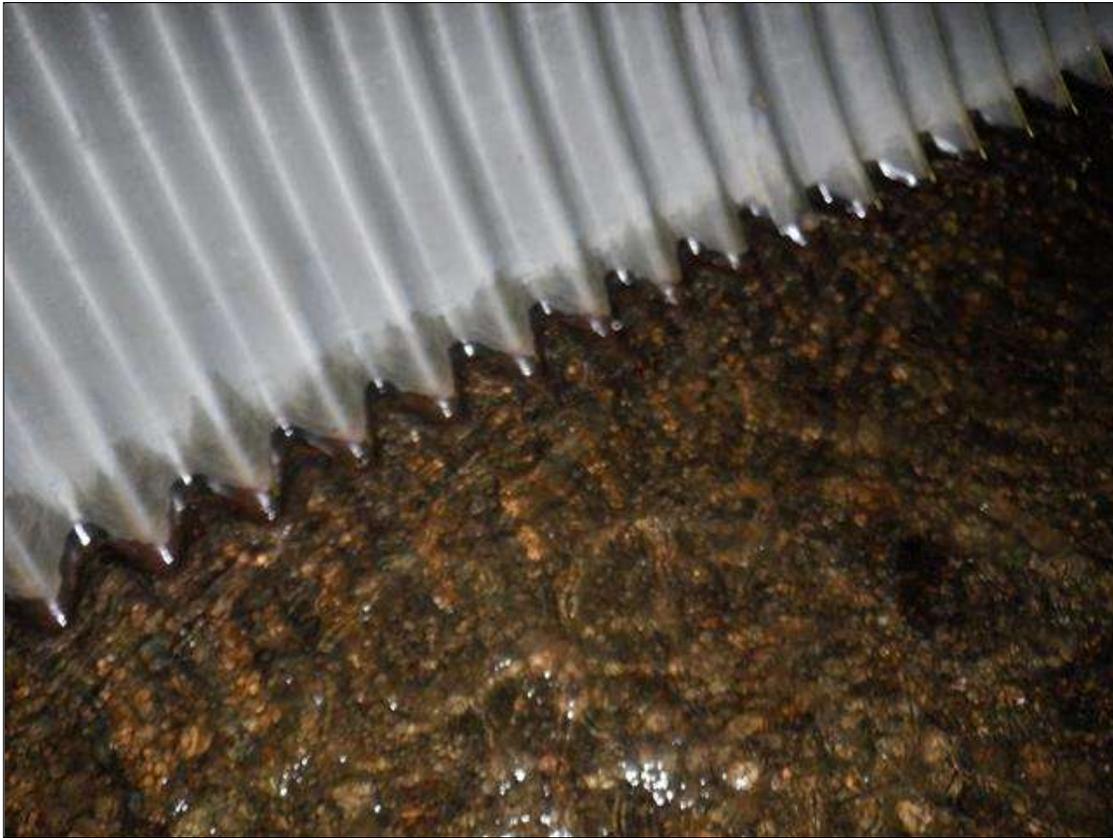
Span 2 Culvert Section 2: CORROSION WITH 0.0625" PITTING AND SCALE LOSS ALONG THE WATERLINE. BOTTOM PORTION NOT VISIBLE DUE TO ROCK AND SEDIMENT BUILDUP.

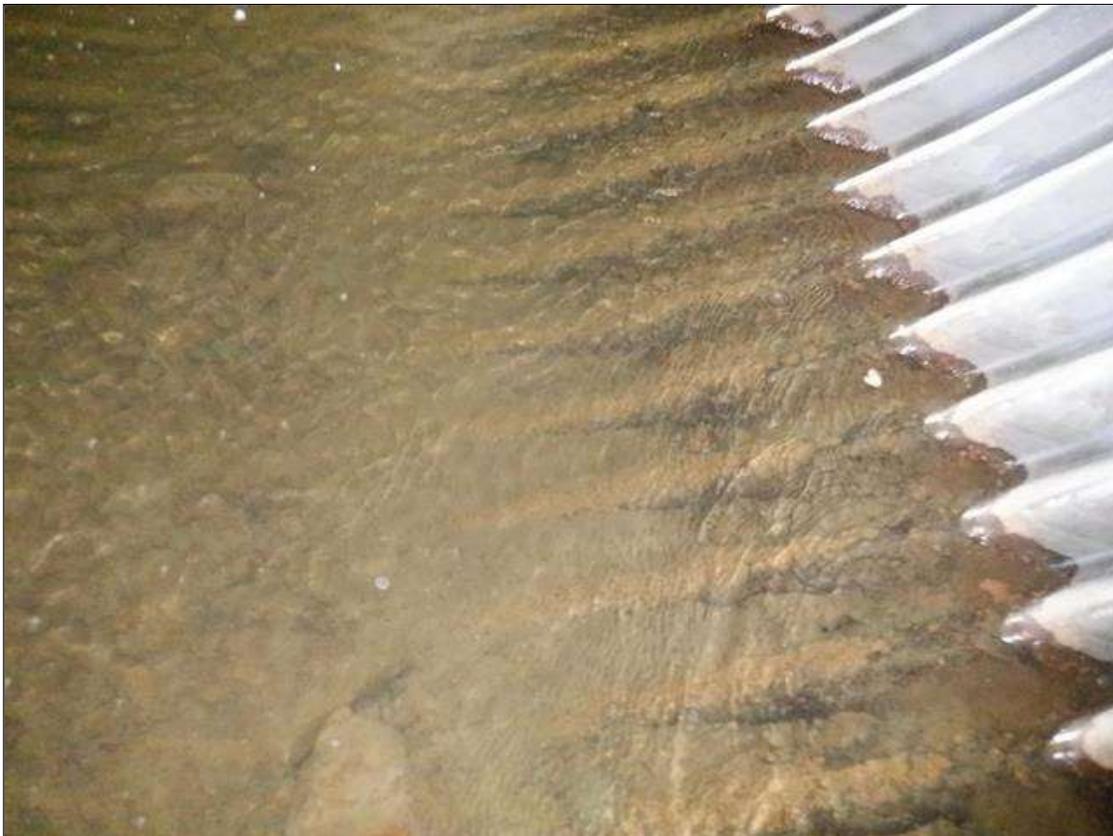
Span 2 Culvert Section 3: CORROSION WITH 0.0625" PITTING AND SCALE LOSS ALONG THE WATERLINE. BOTTOM PORTION NOT VISIBLE DUE TO ROCK AND SEDIMENT BUILDUP.

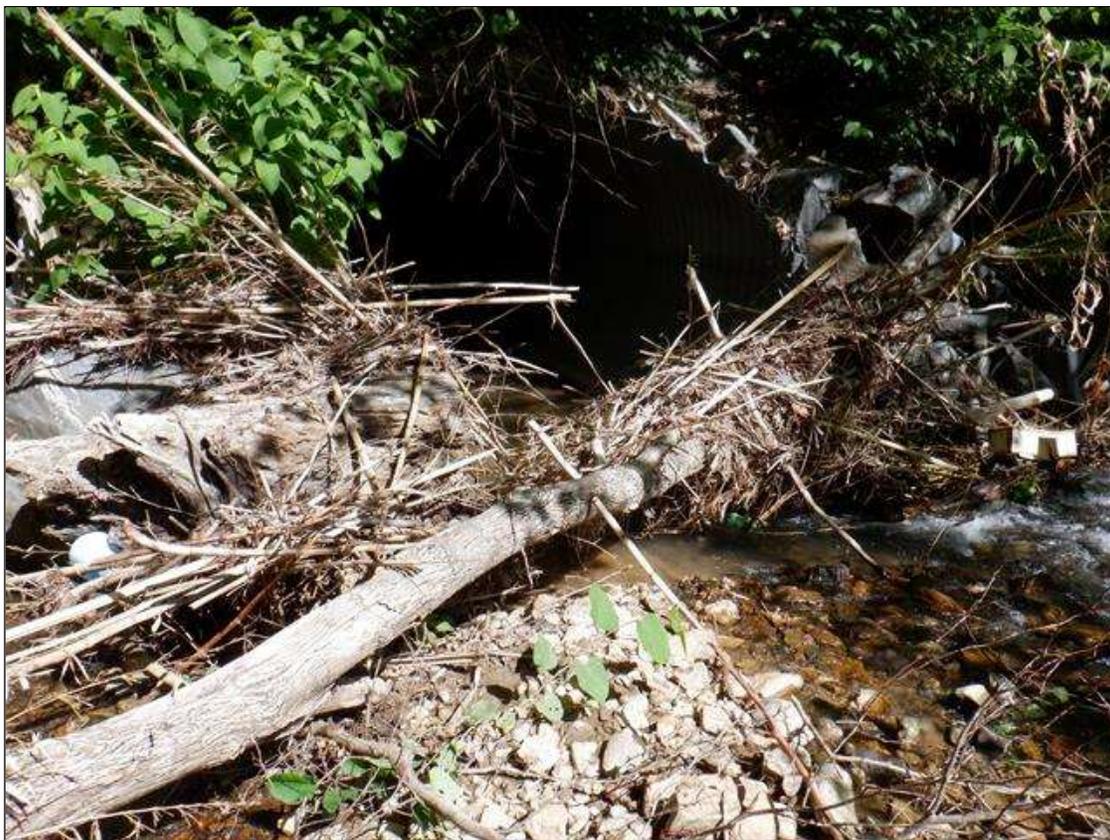
Item	Drift	Grade F	Maint Code 3366	Qty. 30
Details	25' WIDE X 5' HIGH X 3' DEEP DRIFT ACROSS BARREL 2 BARREL 2 AND 3: ROCK AND SEDIMENT BUILDUP UP TO 1' DEEP THE FULL LENGTH. SCATTERED BUILDUP IN BARREL 1.

DRIFT 25' WIDE X 5' HIGH X 3' DEEP ACROSS BARREL 2.

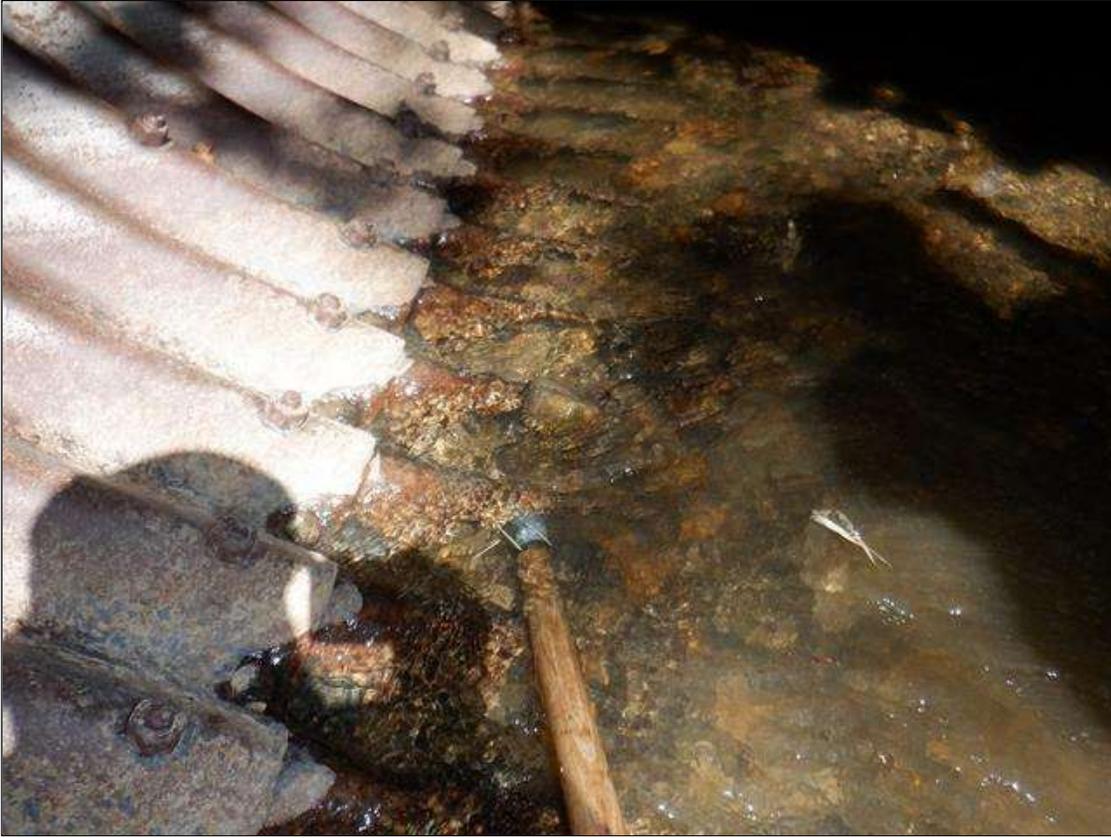
3370	Culvert Section 1	Steel Round Structural Plate		
Priority Level	Defect Type	Quantity	Defect Description	
2	Corrosion	25	Span 1 Culvert Section 1: SEDIMENT AND ROCK HAS WASHED OUT OF THE PIPE EXPOSING THE INVERT. CORROSION WITH MULTIPLE AREAS OF COMPLETE LOSS IN THE CORRUGATIONS UP TO 5' WIDE X 3" LONG. THE STREAM IS INTRUDING UNDERNEATH THE CULVERT. (PAR)	
3370	Culvert Section 2	Steel Round Structural Plate		
Priority Level	Defect Type	Quantity	Defect Description	
2	Corrosion	20	Span 1 Culvert Section 2: SEDIMENT AND ROCK HAS WASHED OUT OF THE PIPE EXPOSING THE INVERT. CORROSION WITH MULTIPLE AREAS OF COMPLETE LOSS IN THE CORRUGATIONS UP TO 5' WIDE X 3" LONG. THE STREAM IS INTRUDING UNDERNEATH THE CULVERT. (PAR)	
3370	Culvert Section 3	Steel Round Structural Plate		
Priority Level	Defect Type	Quantity	Defect Description	
2	Corrosion	20	Span 1 Culvert Section 3: SEDIMENT AND ROCK HAS WASHED OUT OF THE PIPE EXPOSING THE INVERT. CORROSION WITH MULTIPLE AREAS OF COMPLETE LOSS IN THE CORRUGATIONS UP TO 5' WIDE X 3" LONG. THE STREAM IS INTRUDING UNDERNEATH THE CULVERT. (PAR)

Span 1 Culvert Section 1: SEDIMENT AND ROCK HAS WASHED OUT OF THE PIPE EXPOSING THE INVERT. CORROSION WITH MULTIPLE AREAS OF COMPLETE LOSS IN THE CORRUGATIONS UP TO 5' WIDE X 3" LONG. THE STREAM IS INTRUDING UNDERNEATH THE CULVERT. (PAR)

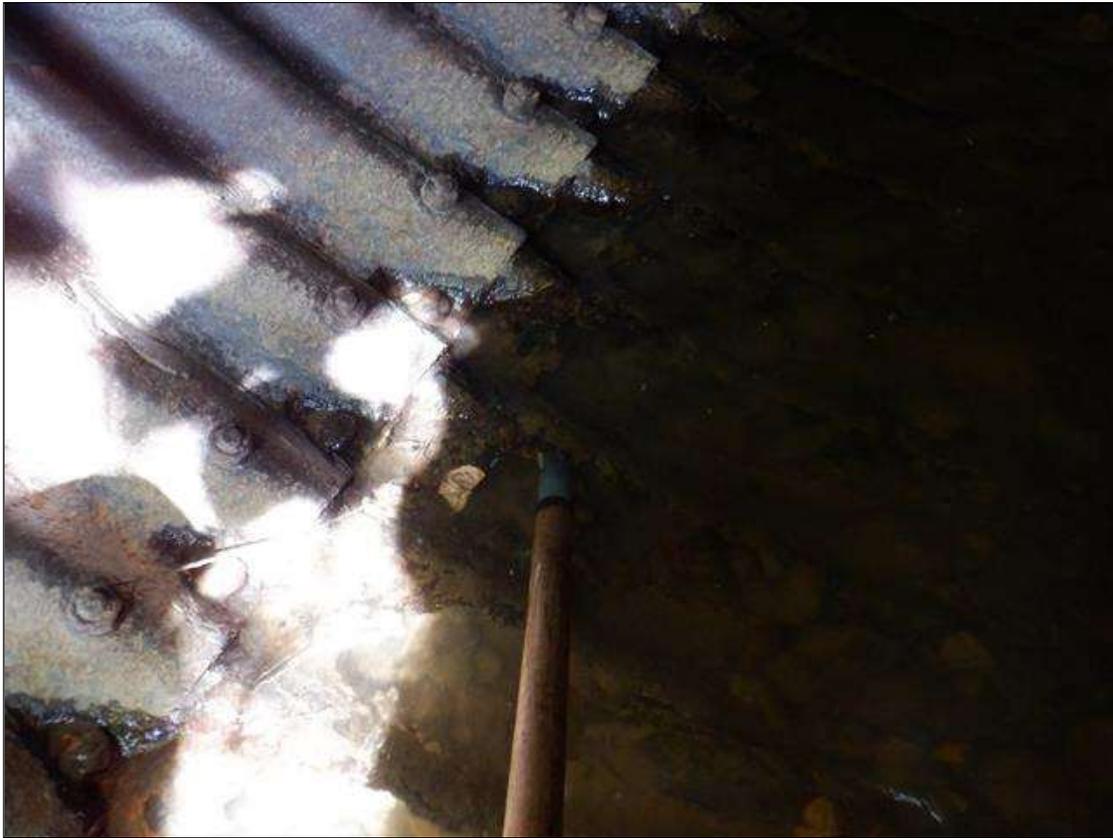
Span 1 Culvert Section 2: SEDIMENT AND ROCK HAS WASHED OUT OF THE PIPE EXPOSING THE INVERT. CORROSION WITH MULTIPLE AREAS OF COMPLETE LOSS IN THE CORRUGATIONS UP TO 5' WIDE X 3" LONG. THE STREAM IS INTRUDING UNDERNEATH THE CULVERT. (PAR)

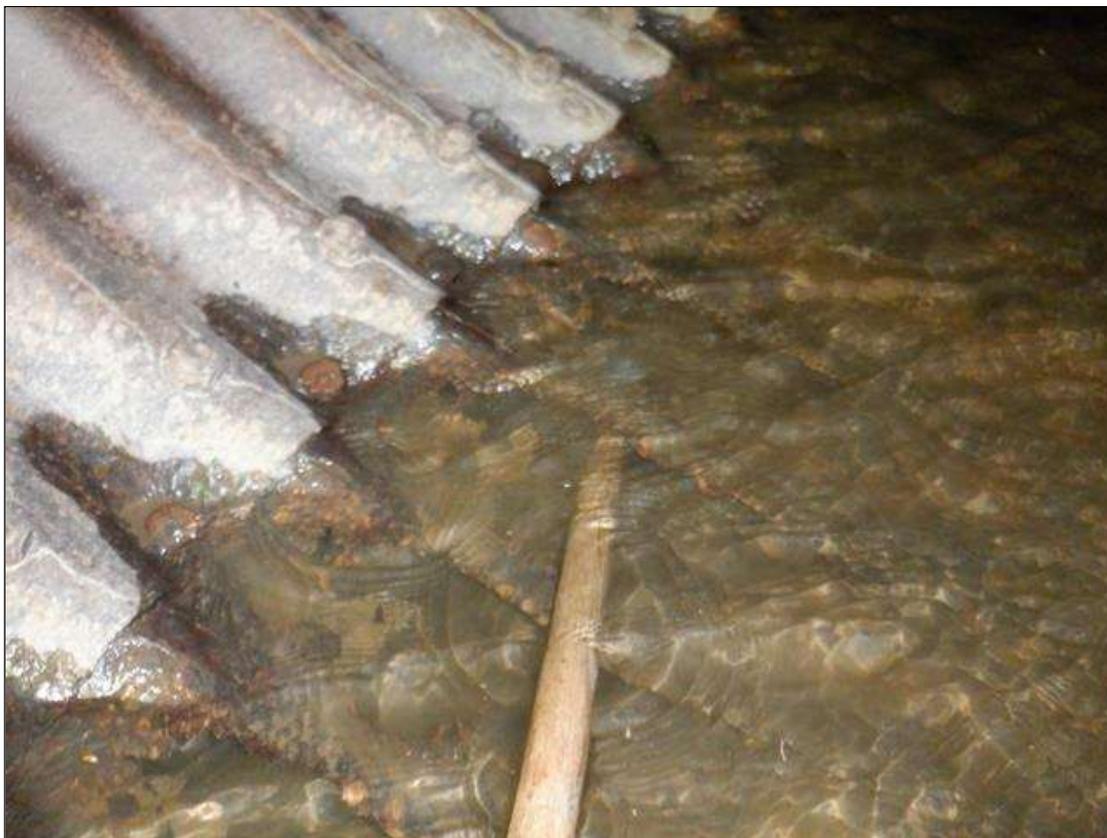
Span 1 Culvert Section 3: SEDIMENT AND ROCK HAS WASHED OUT OF THE PIPE EXPOSING THE INVERT. CORROSION WITH MULTIPLE AREAS OF COMPLETE LOSS IN THE CORRUGATIONS UP TO 5' WIDE X 3" LONG. THE STREAM IS INTRUDING UNDERNEATH THE CULVERT. (PAR)

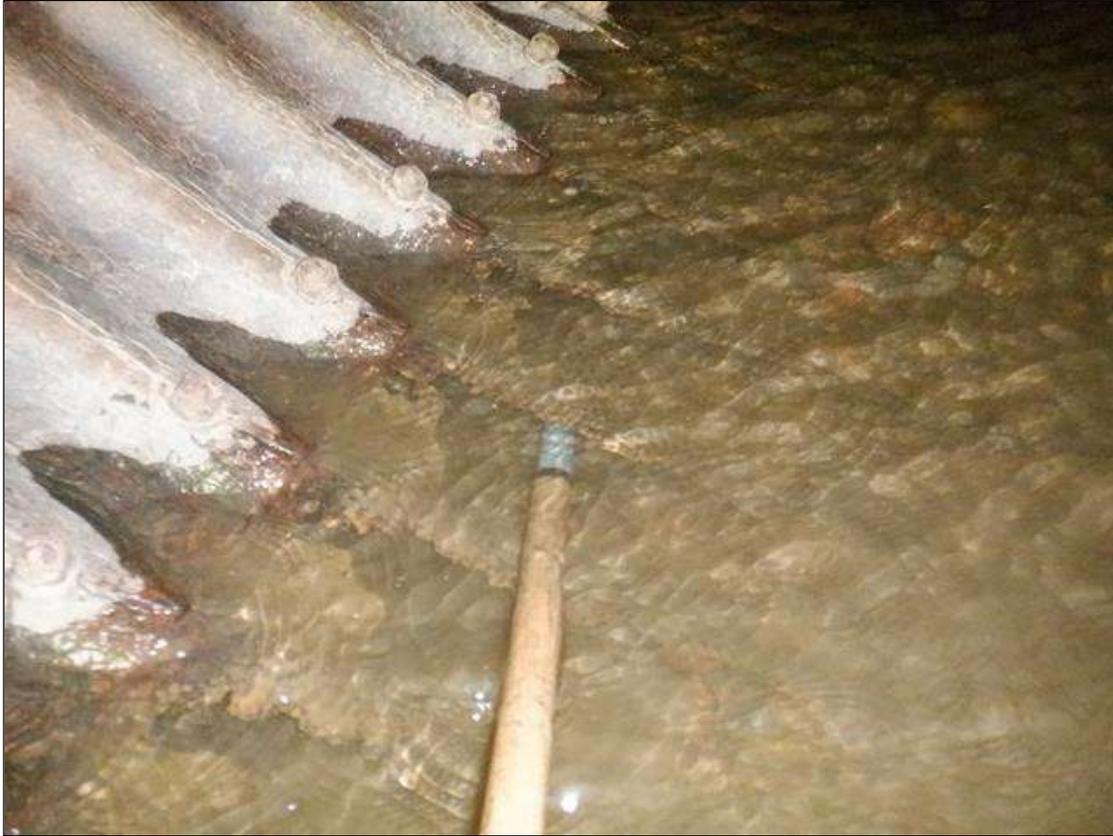
3370	Culvert Section 4	Steel Round Structural Plate		
Priority Level	Defect Type	Quantity	Defect Description	
2	Corrosion	20	Span 1 Culvert Section 4: SEDIMENT AND ROCK HAS WASHED OUT OF THE PIPE EXPOSING THE INVERT. CORROSION WITH MULTIPLE AREAS OF COMPLETE LOSS IN THE CORRUGATIONS UP TO 5' WIDE X 3" LONG. THE STREAM IS INTRUDING UNDERNEATH THE CULVERT. (PAR)	
3370	Culvert Section 5	Steel Round Structural Plate		
Priority Level	Defect Type	Quantity	Defect Description	
2	Corrosion	20	Span 1 Culvert Section 5: SEDIMENT AND ROCK HAS WASHED OUT OF THE PIPE EXPOSING THE INVERT. CORROSION WITH MULTIPLE AREAS OF COMPLETE LOSS IN THE CORRUGATIONS UP TO 5' WIDE X 3" LONG. THE STREAM IS INTRUDING UNDERNEATH THE CULVERT. (PAR)	
3370	Culvert Section 6	Steel Round Structural Plate		
Priority Level	Defect Type	Quantity	Defect Description

Span 1 Culvert Section 4: SEDIMENT AND ROCK HAS WASHED OUT OF THE PIPE EXPOSING THE INVERT. CORROSION WITH MULTIPLE AREAS OF COMPLETE LOSS IN THE CORRUGATIONS UP TO 5' WIDE X 3" LONG. THE STREAM IS INTRUDING UNDERNEATH THE CULVERT. (PAR)

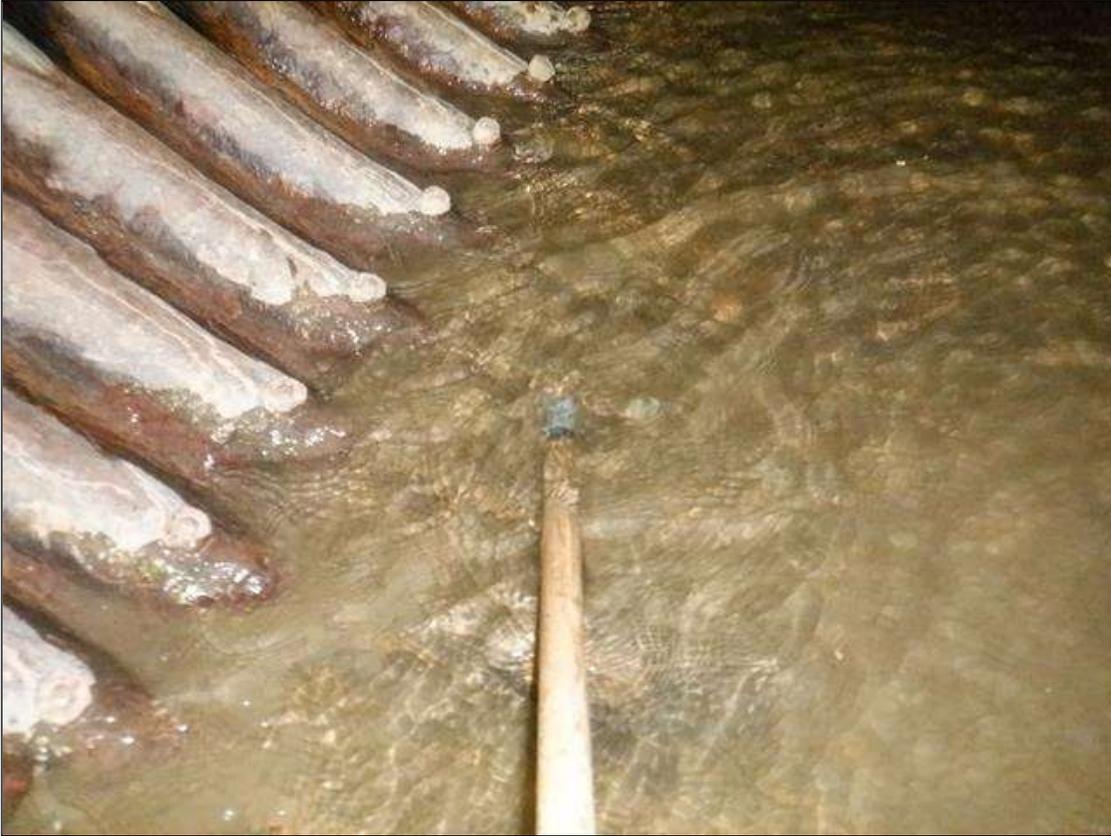
Span 1 Culvert Section 5: SEDIMENT AND ROCK HAS WASHED OUT OF THE PIPE EXPOSING THE INVERT. CORROSION WITH MULTIPLE AREAS OF COMPLETE LOSS IN THE CORRUGATIONS UP TO 5' WIDE X 3" LONG. THE STREAM IS INTRUDING UNDERNEATH THE CULVERT. (PAR)

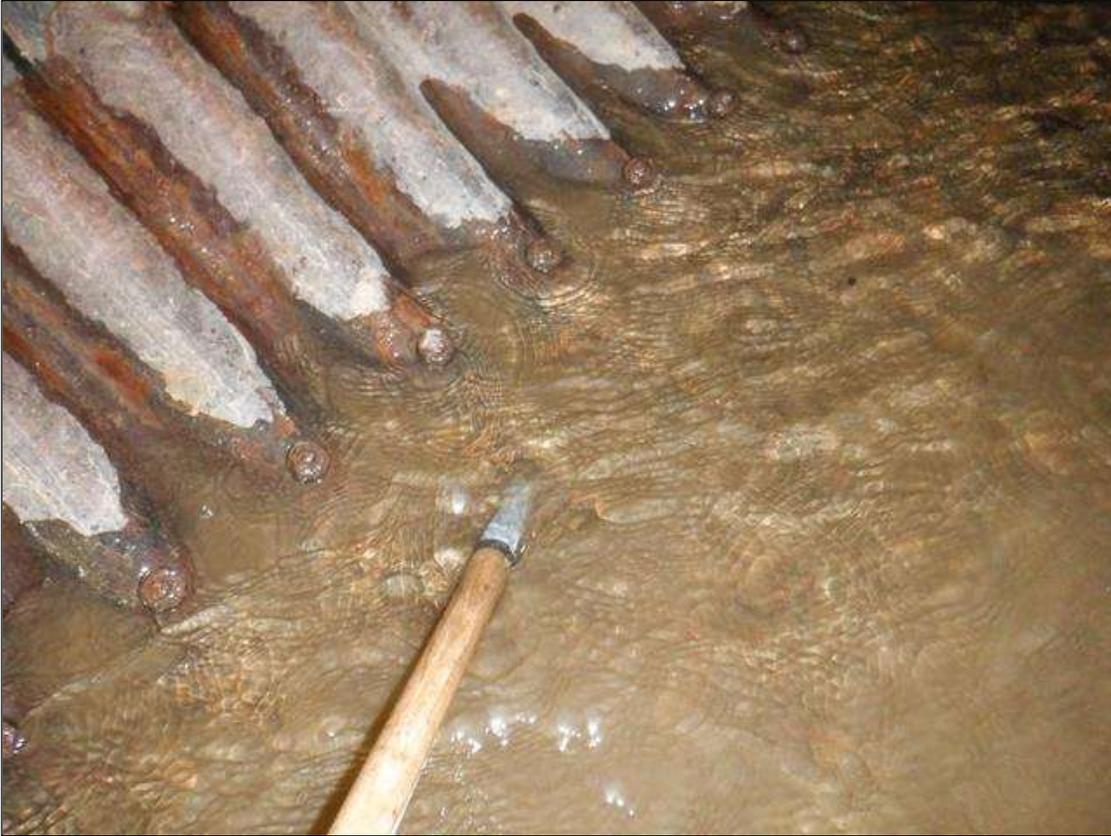
② Corrosion 20 Span 1 Culvert Section 6: SEDIMENT AND ROCK HAS WASHED OUT OF THE PIPE EXPOSING THE INVERT. CORROSION WITH MULTIPLE AREAS OF COMPLETE LOSS IN THE CORRUGATIONS UP TO 5' WIDE X 3" LONG. THE STREAM IS INTRUDING UNDERNEATH THE CULVERT. (PAR)

Span 1 Culvert Section 6: SEDIMENT AND ROCK HAS WASHED OUT OF THE PIPE EXPOSING THE INVERT. CORROSION WITH MULTIPLE AREAS OF COMPLETE LOSS IN THE CORRUGATIONS UP TO 5' WIDE X 3" LONG. THE STREAM IS INTRUDING UNDERNEATH THE CULVERT. (PAR)

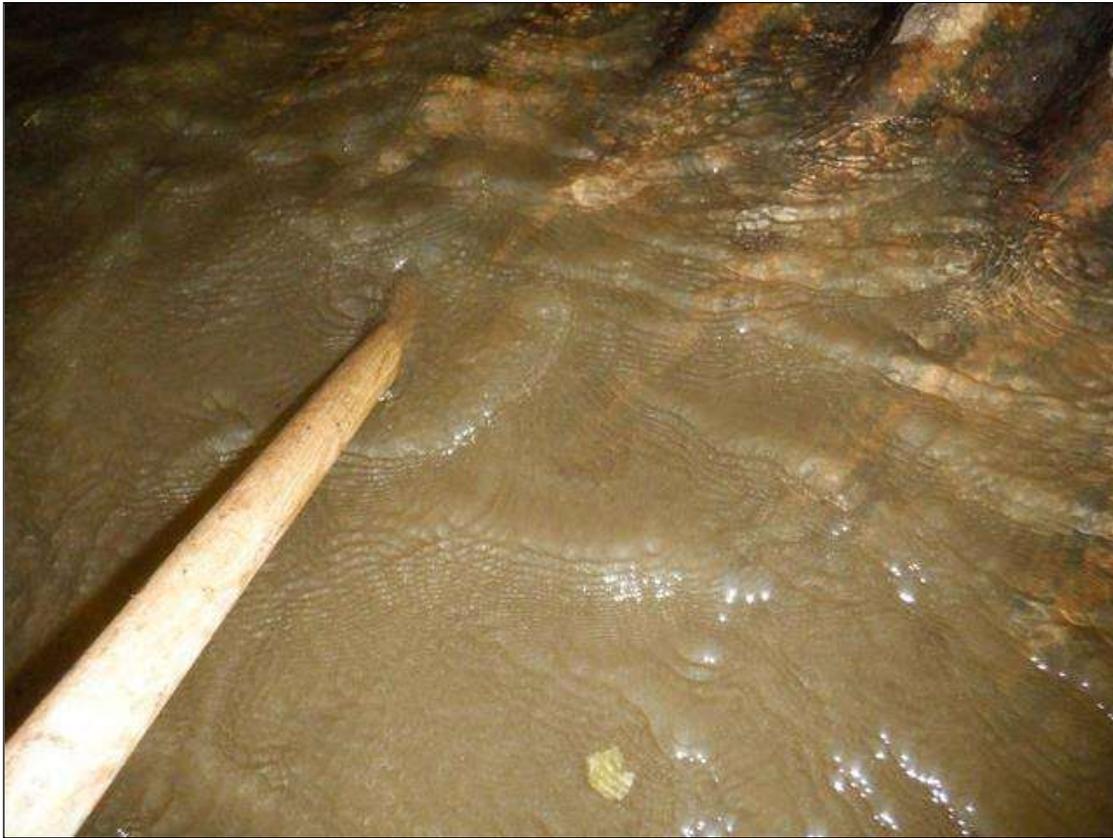
Priority Level	Defect Type	Quantity	Defect Description
②	Corrosion	20	Span 1 Culvert Section 7: SEDIMENT AND ROCK HAS WASHED OUT OF THE PIPE EXPOSING THE INVERT. CORROSION WITH MULTIPLE AREAS OF COMPLETE LOSS IN THE CORRUGATIONS UP TO 5' WIDE X 3" LONG. THE STREAM IS INTRUDING UNDERNEATH THE CULVERT. (PAR)

Span 1 Culvert Section 7: SEDIMENT AND ROCK HAS WASHED OUT OF THE PIPE EXPOSING THE INVERT. CORROSION WITH MULTIPLE AREAS OF COMPLETE LOSS IN THE CORRUGATIONS UP TO 5' WIDE X 3" LONG. THE STREAM IS INTRUDING UNDERNEATH THE CULVERT. (PAR)

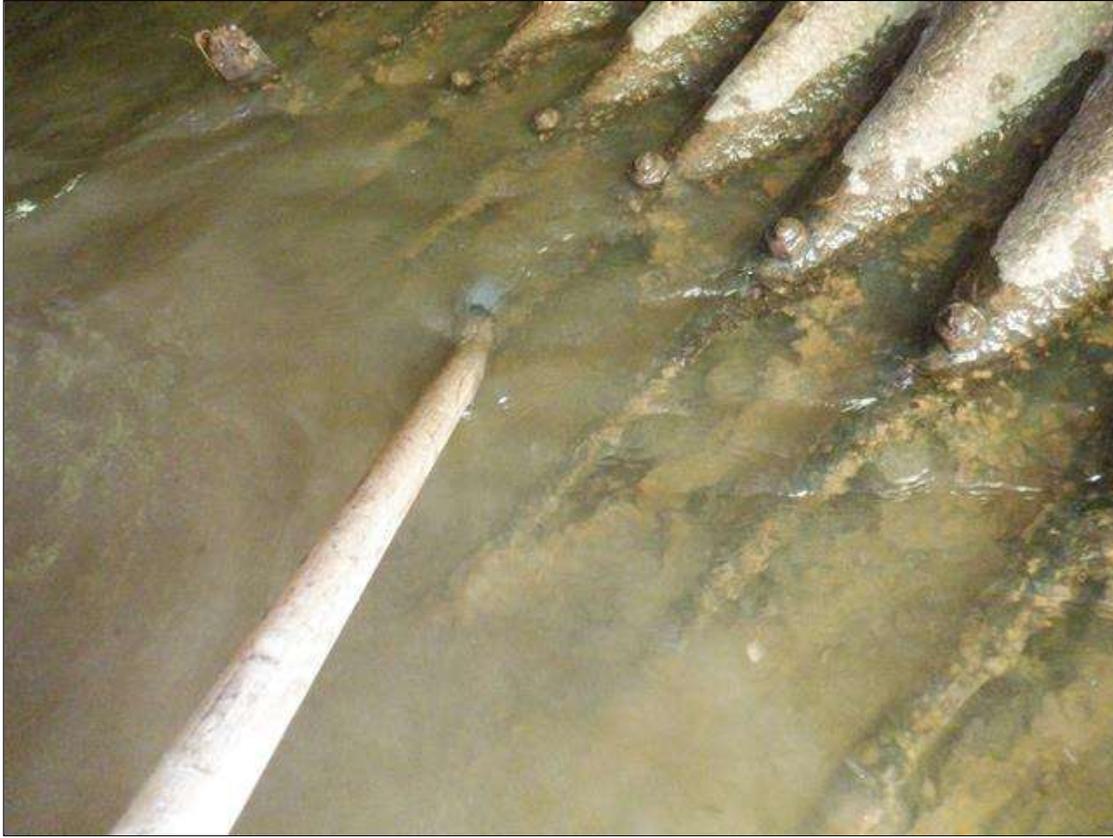
Priority Level	Defect Type	Quantity	Defect Description
②	Corrosion	20	Span 1 Culvert Section 8: SEDIMENT AND ROCK HAS WASHED OUT OF THE PIPE EXPOSING THE INVERT. CORROSION WITH MULTIPLE AREAS OF COMPLETE LOSS IN THE CORRUGATIONS UP TO 5' WIDE X 3" LONG. THE STREAM IS INTRUDING UNDERNEATH THE CULVERT. (PAR)

Span 1 Culvert Section 8: SEDIMENT AND ROCK HAS WASHED OUT OF THE PIPE EXPOSING THE INVERT. CORROSION WITH MULTIPLE AREAS OF COMPLETE LOSS IN THE CORRUGATIONS UP TO 5' WIDE X 3" LONG. THE STREAM IS INTRUDING UNDERNEATH THE CULVERT. (PAR)

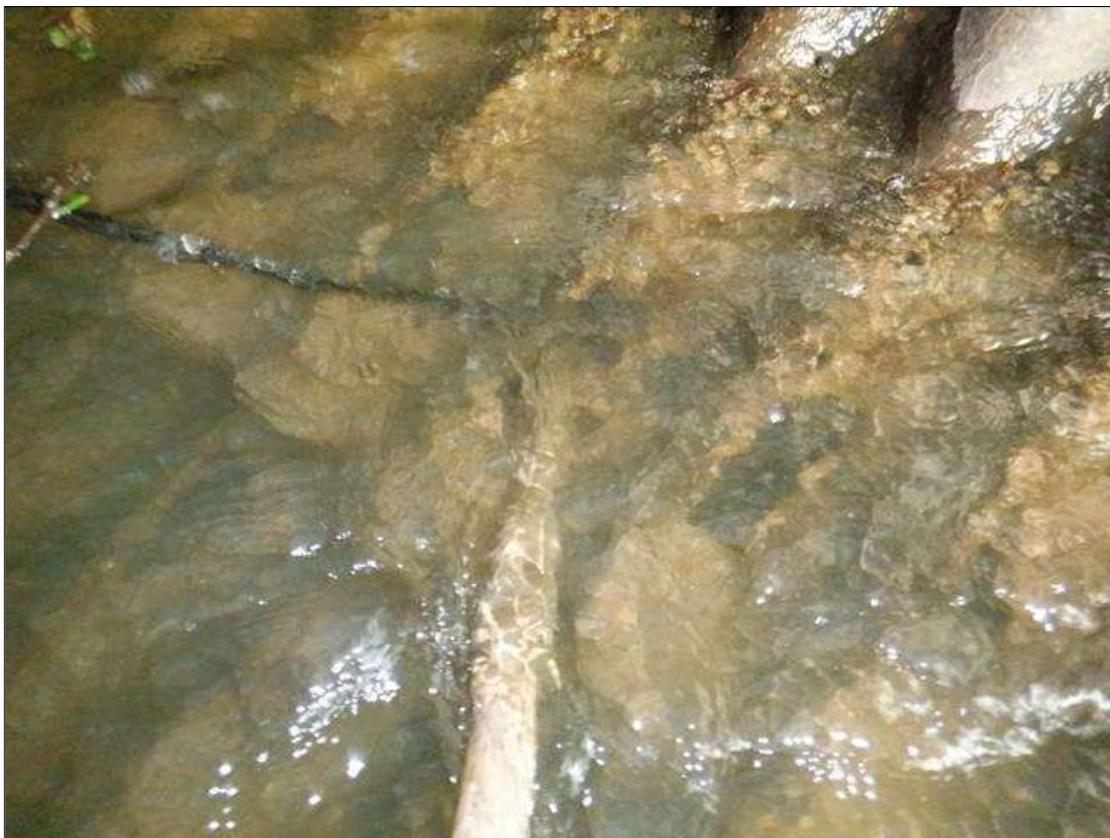
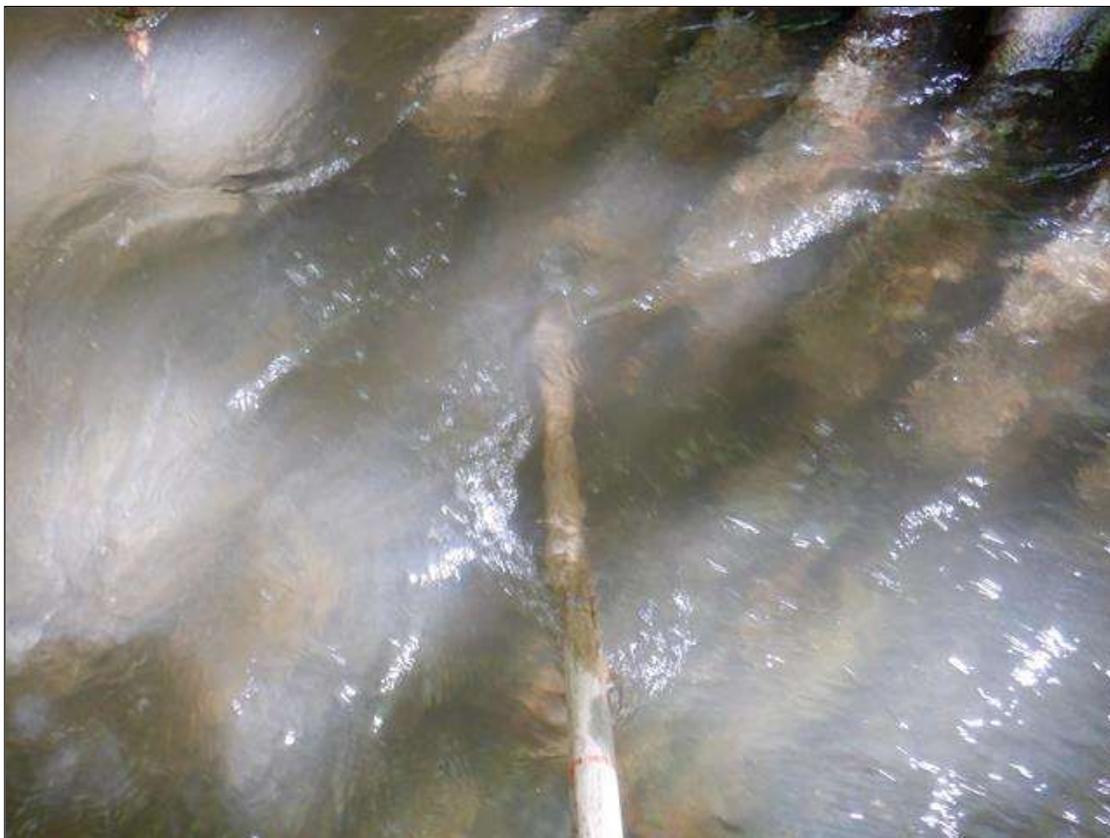
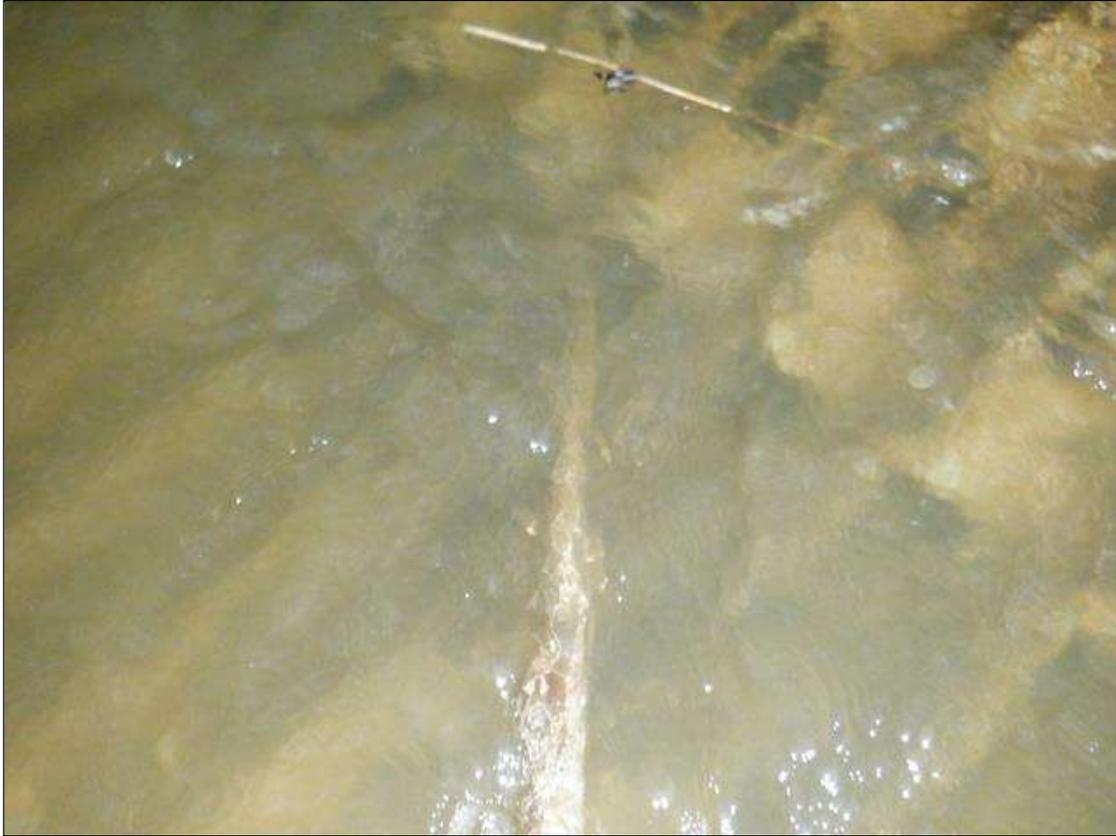
Priority Level	Defect Type	Quantity	Defect Description
2	Corrosion	25	Span 3 Culvert Section 1: SEDIMENT AND ROCK WASHED OUT OF PIPE FOR 25' BEGINNING AT THE INLET. EXPOSED MULTIPLE AREAS OF COMPLETE LOSS IN THE CORRUGATIONS UP TO 5' WIDE X 6" DEEP. (PAR)

Span 3 Culvert Section 1: SEDIMENT AND ROCK WASHED OUT OF PIPE FOR 25' BEGINNING AT THE INLET. EXPOSED MULTIPLE AREAS OF COMPLETE LOSS IN THE CORRUGATIONS UP TO 5' WIDE X 6" DEEP. (PAR)

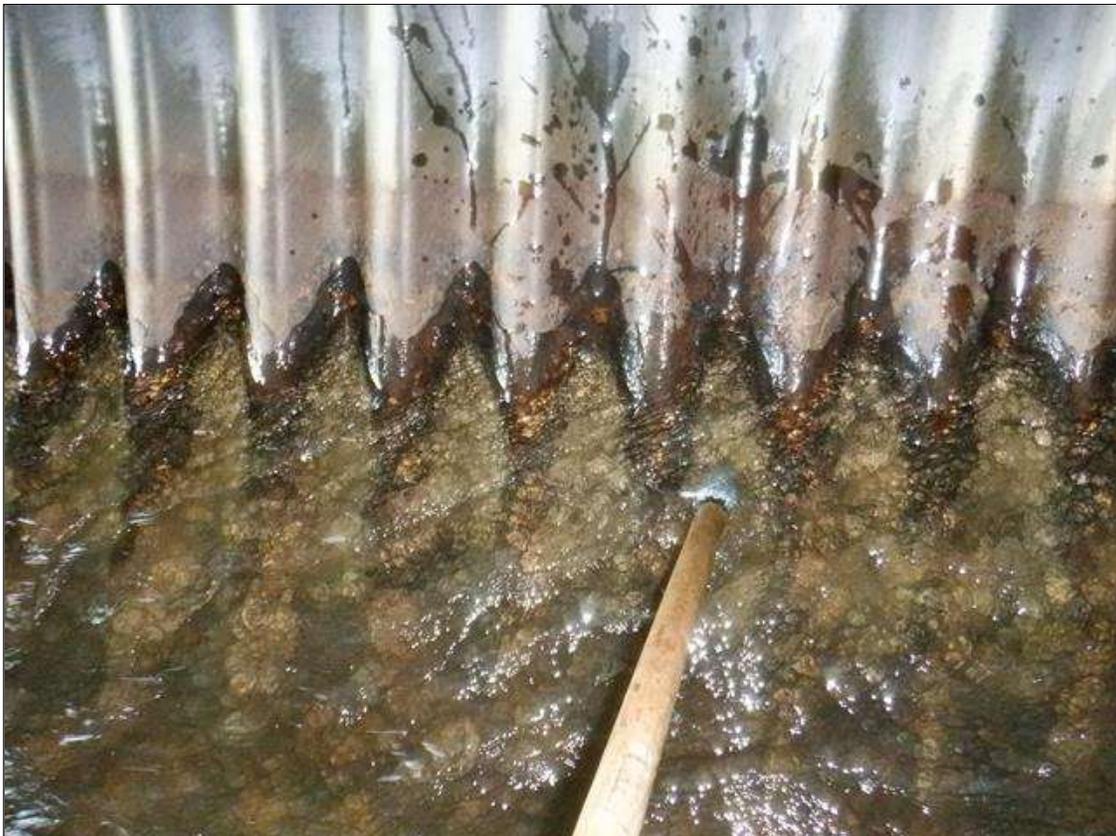
Span 3 Culvert Section 12: CORROSION WITH UP TO 0.0625" PITTING ALONG THE INVERT, UNDERNEATH THE WATER LINE.
