Spot Safety Project Evaluation

Spot Safety Project # 06-99-218

Spot Safety Project Evaluation of the Standard Flasher and Double Posted Stop Sign Installation at the Intersection of SR 1500 (Benson Rd) and SR 1006 (Old Stage Rd) in Harnett Co.

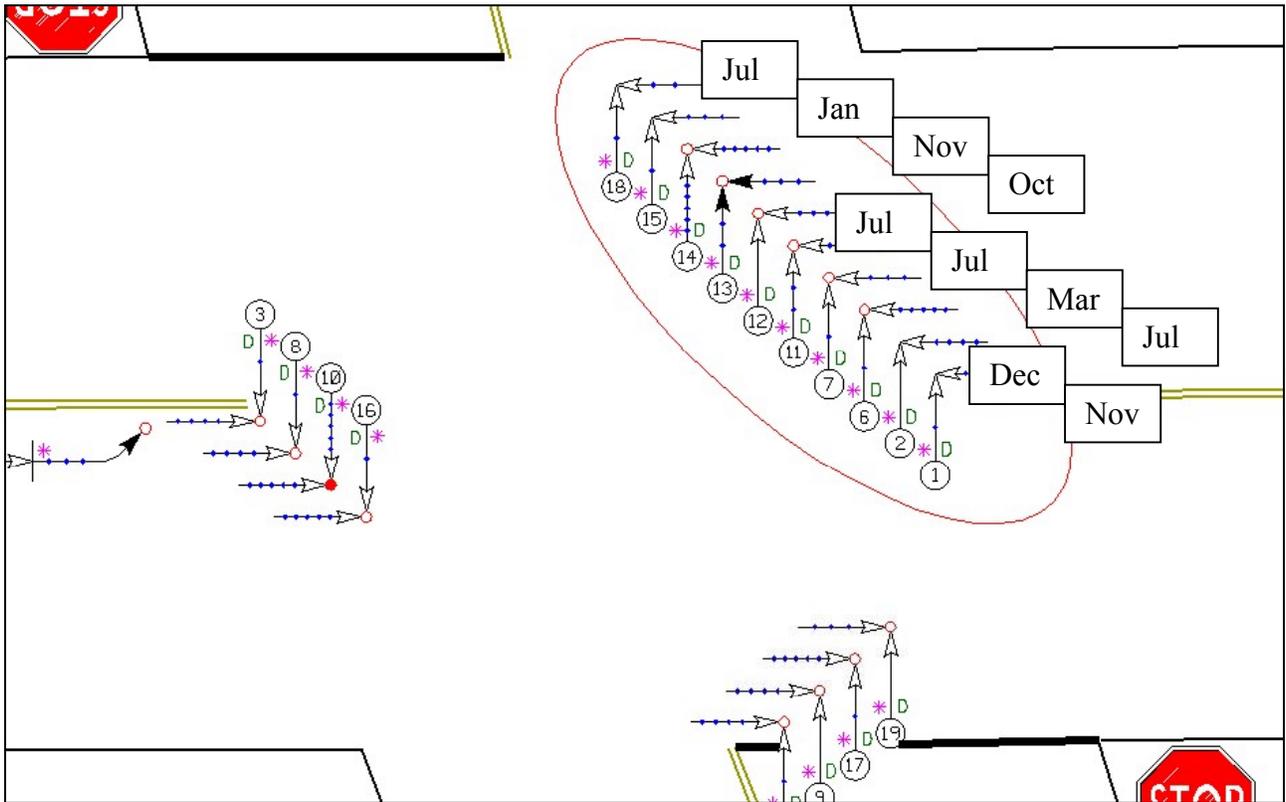
Figure 1.

The original problem statement was that vehicles were having trouble coming to a complete stop at the treatment intersection. Upon reviewing the before period crash reports and collision diagram below, it appears that 4 of the 18 (22%) frontal impact crashes in the before period had a vehicle running the stop sign. Three occurred on the northbound leg of SR 1006 and 1 occurred on the southbound leg on SR 1006 resulting in a fatal crash. Referencing Figure 1 again, a majority of the angle crashes are occurring after a vehicle has crossed one lane of travel. This information suggests there may be more of an issue than vehicles not coming to a complete stop, such as poor gap selection.

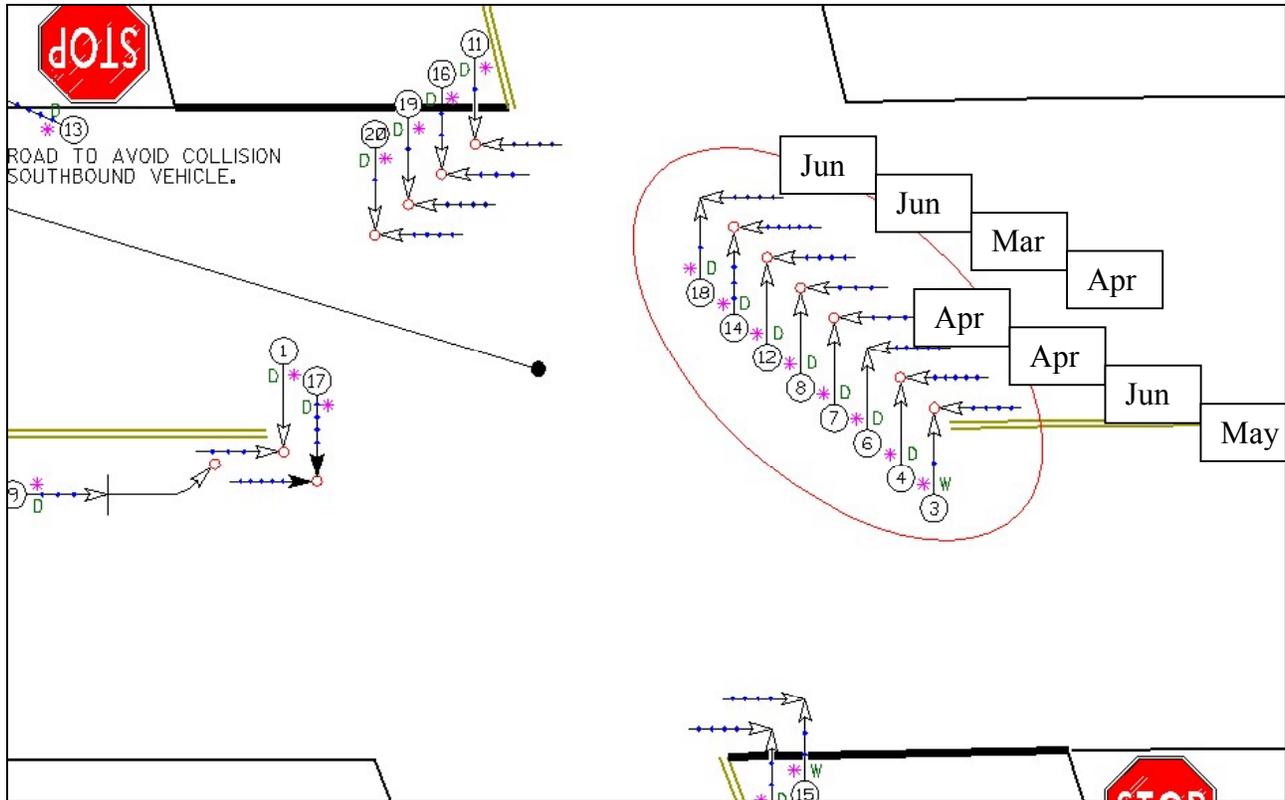
Figure 2.

The same pattern also exists in the after period (Figure 2) along with lower estimated speeds by the “vehicle at fault”. Upon reviewing the after period crash reports and collision diagram, it appears that 5 of the 16 (31%) frontal impact crashes had a vehicle running the stop sign. Three occurred on the northbound leg of SR 1006 and two occurred on the southbound leg of SR 1006. Again, this information suggests there may be more than just a problem with stop sign running.

Upon further investigation of the after period crash data, all crashes in the circled area of Figure 2 occur in the spring and early summer months. This may indicate that the foliage in the southeast quadrant causes a potential sight distance problem when the foliage is in the growth period and out of the dormant cycle. If this is true, foliage maintenance in the southeast quadrant may be needed.

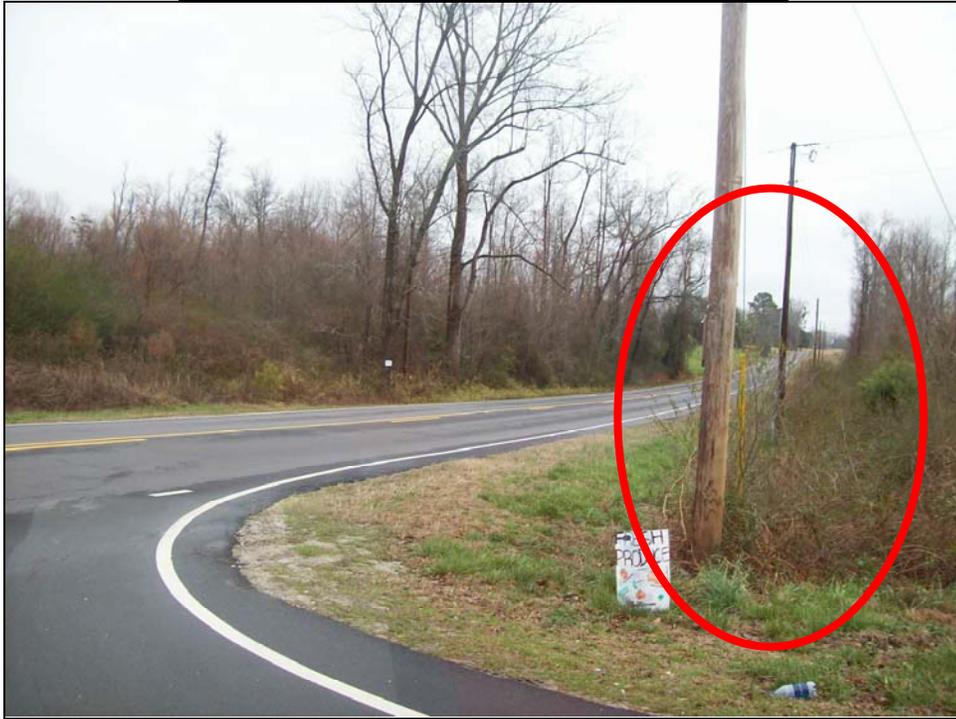
On SR 1006 driving north looking east

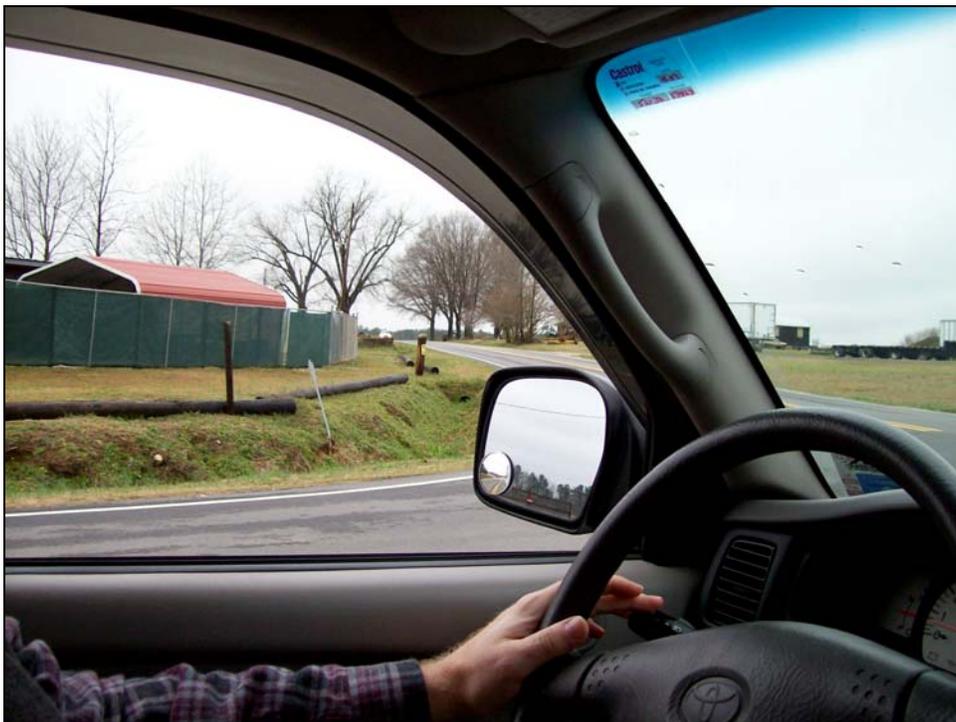
On SR 1006 driving north looking west

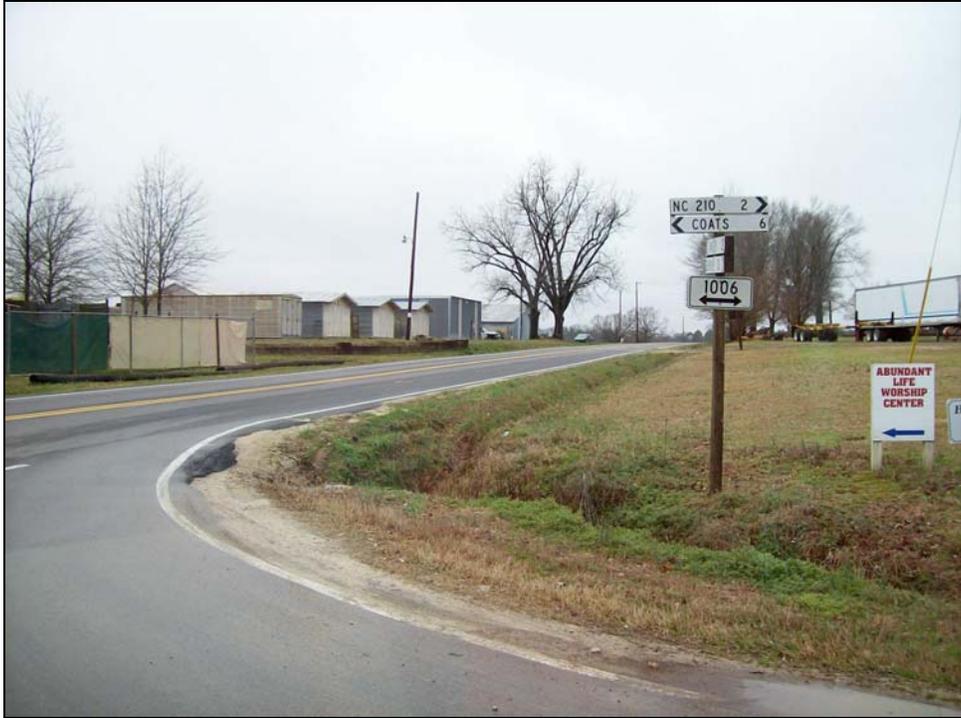
On SR 1006 driving south looking west

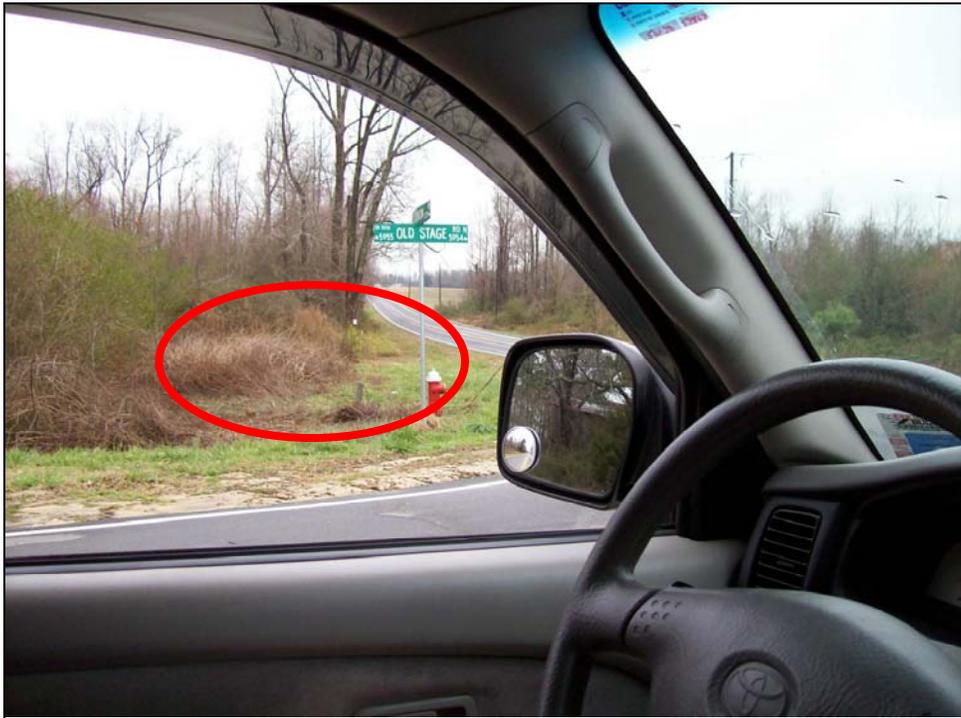
On SR 1006 driving south looking east
