Memo to: Pre-bid Attendees
From: Rick Nelson, Asst. State Bridge Management Engineer *EBN*
Subject: Pre-bid Minutes
Projects F-150029, F-150068 & F-150073

FIELD INSPECTION REPORT
BRIDGE INSPECTION & ANALYSIS

Bridge No 150029

PILE RECORD FOR THE BEAUFORT
CHANNEL FENDER SYSTEM

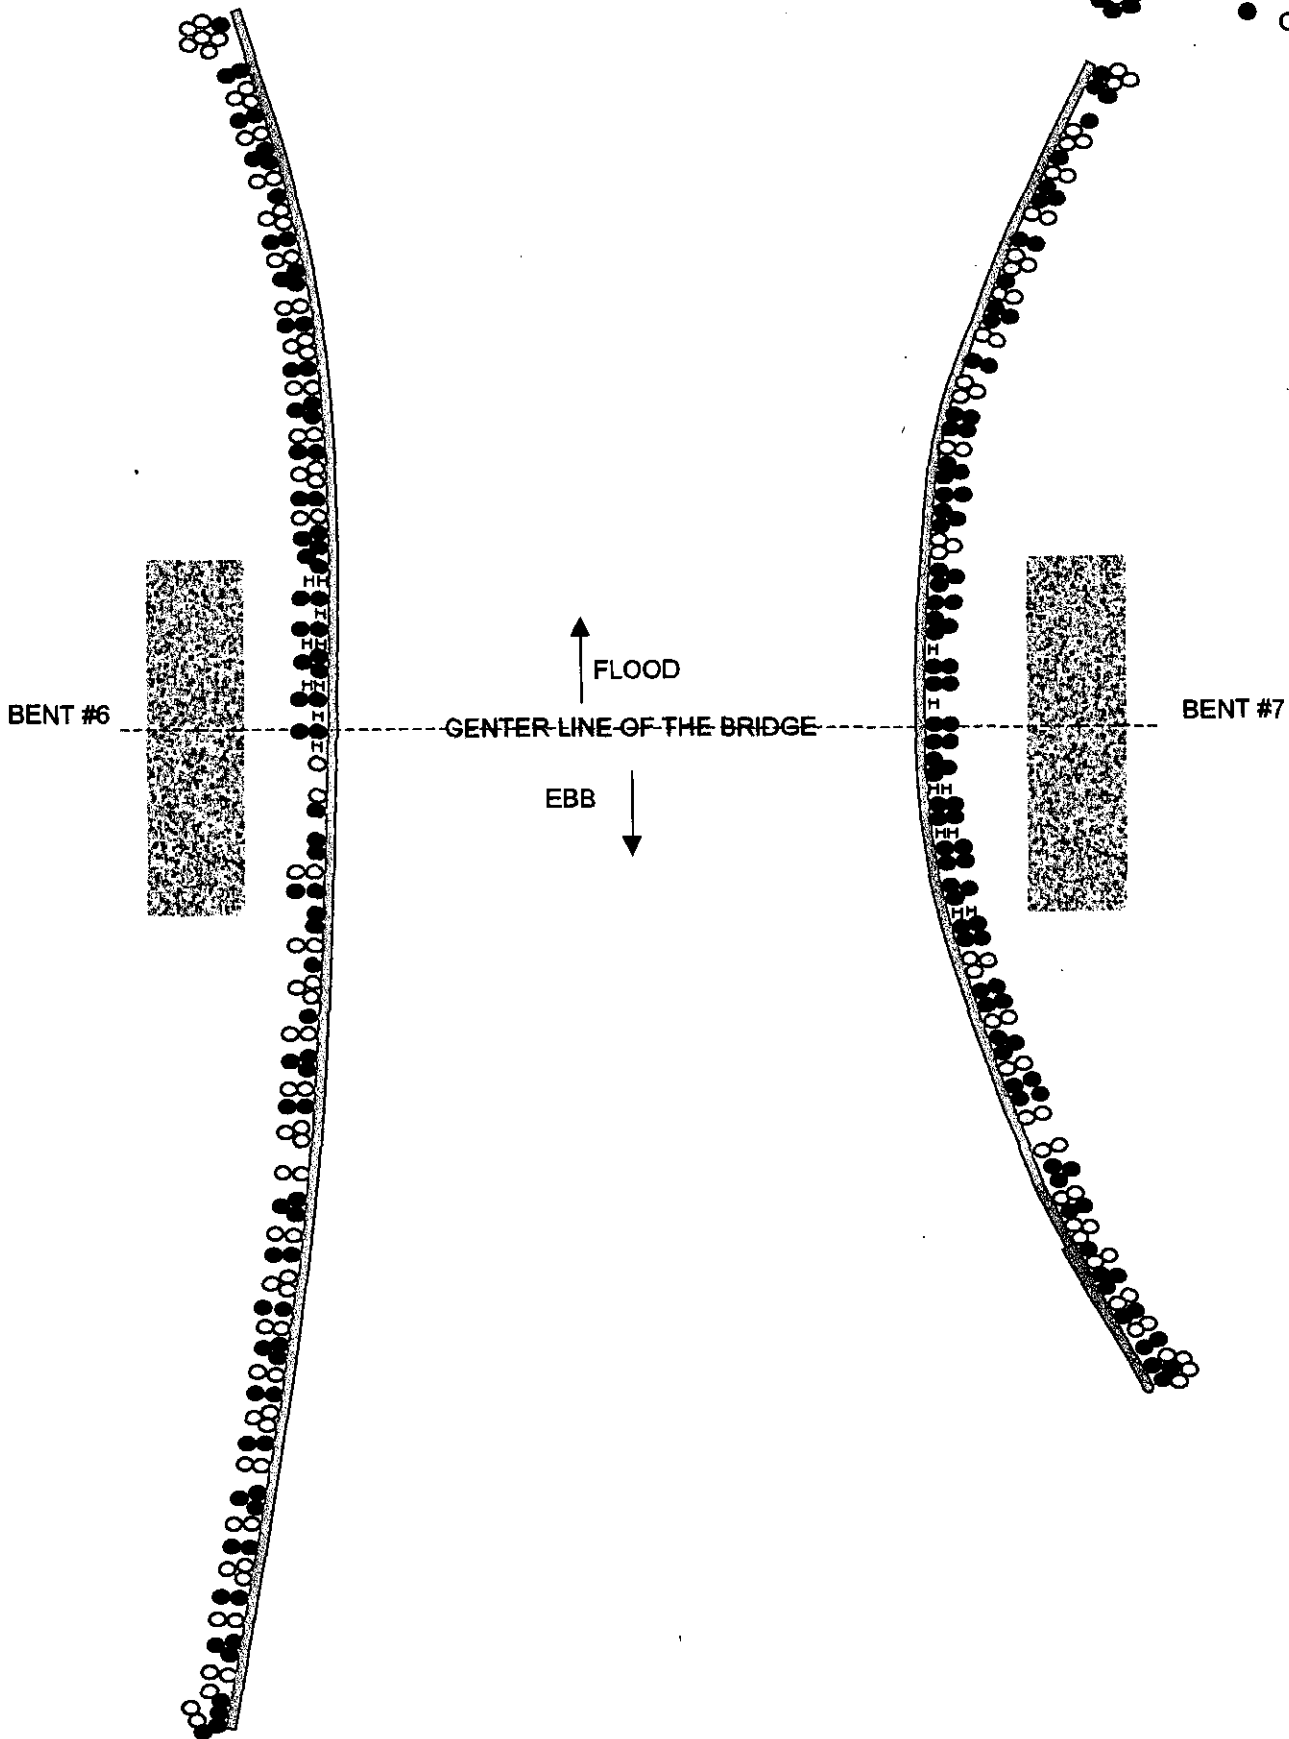
STEEL H-PILES ARE HEAVILY RUSTED AND SCALED WITH SECTION LOSS TO 100% OF FLANGE ABOVE THE WATERLINE. THE BEST REMAINING FLANGE SECTION IS 1/16" OR LESS OF RUSTED MALLEABLE STEEL. H-PILES BELOW THE WATERLINE ARE HEAVILY RUSTED AND SCALED WITH LOSS TO 1/8". THERE ARE RANDOM AREAS OF THE FLANGE EDGE THAT IS MISSING. WEBS ARE RUSTED AND SCALED WITH LOSS UP TO 1/16". THERE ARE ALSO HOLES IN THE WEB ABOVE THE WATERLINE.

THE OLD CREO. TIMBER PILES ARE BORER DECAYED TO 100% MAX. LOSS OF SECTION IN THE TIDAL ZONE. ALL OF THE OLD CREO. TIMBER PILES ARE DECAYED TO THE POINT OF BEING COMPLETELY INEFFECTIVE EVEN WITH SOME OF THEM HAVING MINIMAL REMAINING CORES OR OUTER SHELLS. MANY PILE SECTIONS ARE LOOSE AND HANGING FROM THE WALERS. THE PILE SECTIONS HANGING HAVE CREATED AN UNDUE DEAD LOAD TO THE FENDER. SOME HAVE DETACHED AND OTHERS MAY DETACH AND CREATE A NAVIGATIONAL HAZARD. THE LOWER PILE SECTIONS ARE OUT OF PLUMB AND MANY ARE LEANING INTO THE WATERWAY CREATING AN UNDERWATER OBSTRUCTION.

C.C.A. PILES (TREATED REPLACEMENT PILES) SHOW MINOR BORER DAMAGE IN TIDAL ZONE AND AROUND THE BOLT CONNECTIONS, BUT ARE BASICALLY SOUND. THERE ARE THOUGH SOME C.C.A. AND CREO. PILES BROKEN AND LYING AT THE BOTTOM ON THE BACK SIDE OF THE FENDER FROM THE MUDLINE AND UP ABOUT 4' THE N.E. DOLPHINS HAVE 2 OR MORE OLD CREO. PILES WITH UP TO 100% SECTION LOSS IN THE TIDAL ZONE. THE N.W. DOLPHIN IS MISSING.
NO VERTICAL CLEARANCE MARKER AT NORTH CHANNEL APPROACH.

THE EXISTING BOLT HEADS INDICATE THAT 2 ROWS OF WALERS ARE MISSING NEAR THE LOW TIDAL RANGE. THE PROJECTED THIRD LINE (NEAR THE HIGH TIDAL RANGE) IS HEAVILY BORER DECAYED WITH LARGE AREAS OF SECTION LOSS ALONG THE LOWER PORTIONS WITH SOME TIMBERS SHOWING LOSS UP TO 100%. THE BOLTED CONNECTIONS AND CABLES ARE HEAVILY RUSTED WITH MODERATE TO HEAVY LOSS. THERE ARE RANDOM TIMBERS HANGING BY SOME OF THESE MINIMAL BOLT CONNECTIONS. THE WALERS ARE NOT LAPPED BETWEEN SECTIONS RESULTING IN THE POSSIBILITY OF TOTAL COLLAPSE OF ONE OR MORE SECTIONS AT THE JUNCTION OF THE N.E. FLARE AND AT THE CENTER SECTION OF THE EAST FENDER THERE IS NO SUPPORT FOR AT LEAST 8' +/- WITH 100% LOSS ON THE CRE PILES. THE RESULT OF THIS IS LATERAL MOVEMENT OF THE SECTIONS IN THE WIND AND FROM BOAT WAKES ABOUT 10" +/- . THERE ARE ONLY 2 C.C.A. PILES AT THIS SECTION (CENTER/EAST FENDER). THE EAST FENDER CENTER SECTION HAS ONLY 2 HEAVILY DETERIORATED STEEL PILES SUPPORTING THIS SECTION.
