NC DEPARTMENT OF TRANSPORTATION
DIVISION OF HIGHWAYS
STRUCTURE MANAGEMENT UNIT

ATTENTION: PAR SUBMITTED

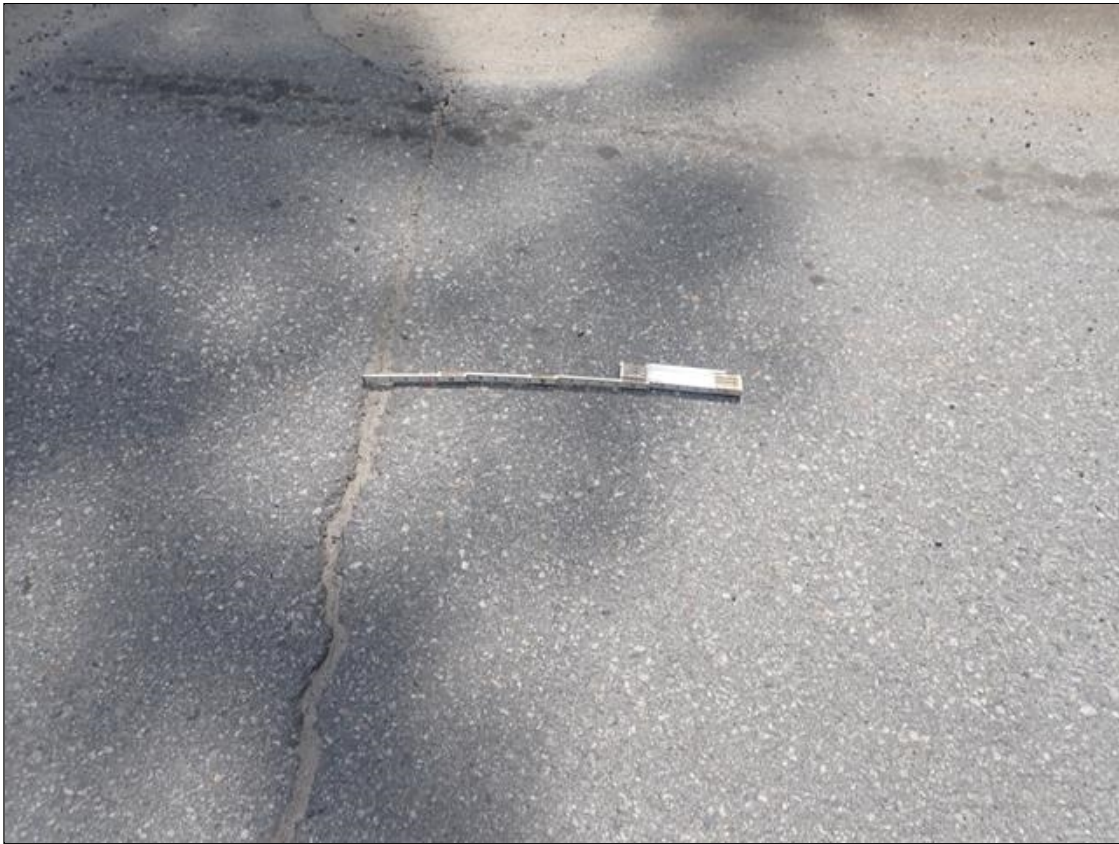
Span 1 Wearing Surface: UP TO 1 INCH WIDE TRANSVERSE CRACKING AT RANDOM THROUGHOUT (PHOTO TAKEN 5 FEET FROM END BENT 1)

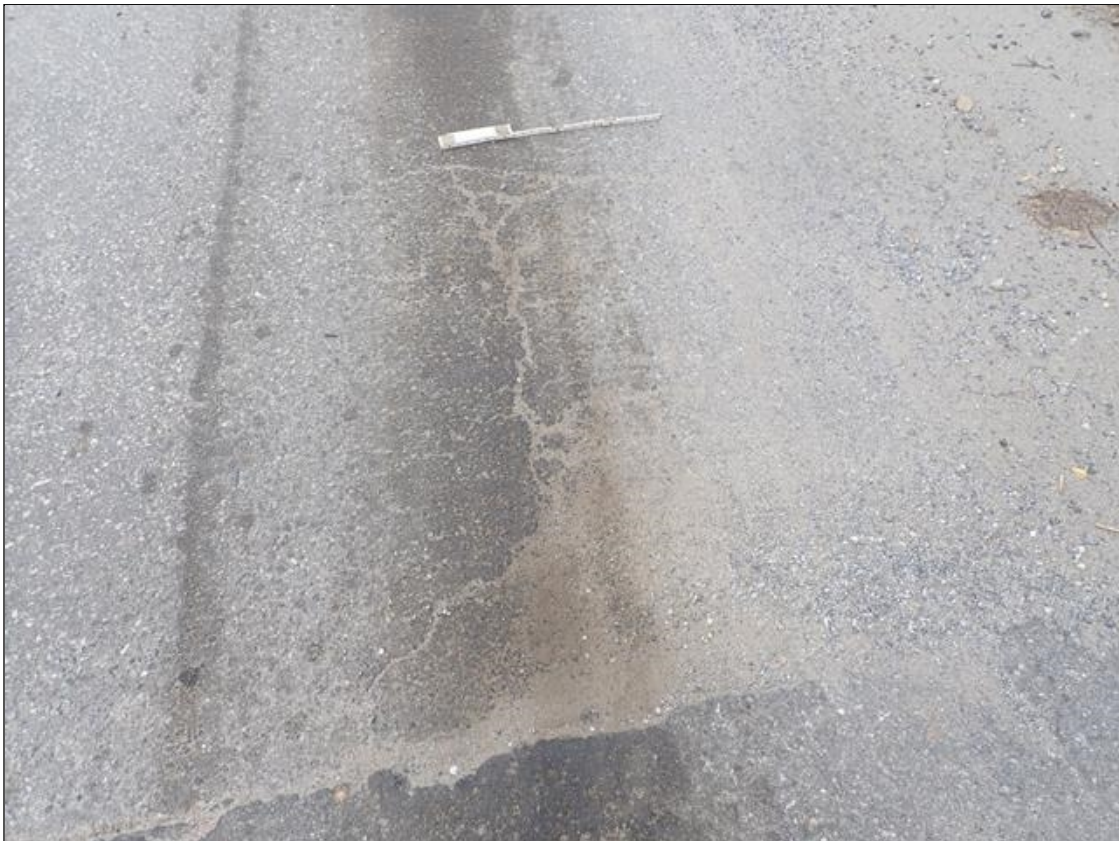
Span 1 Wearing Surface: UP TO 1 INCH WIDE MAP CRACKING AT RANDOM THROUGHOUT (PHOTO TAKEN AT END BENT 2)

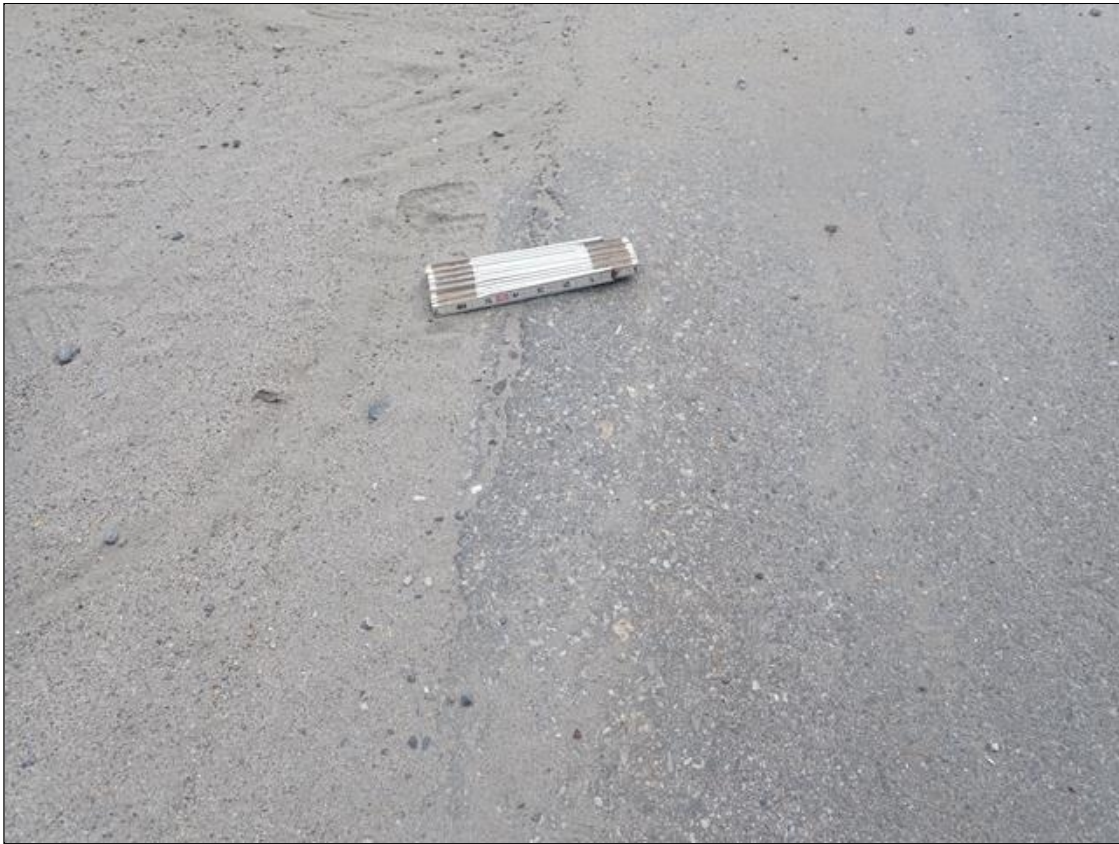
Span 1 Wearing Surface: UP TO 1/2 INCH WIDE X 3 FEET LONG LONGITUDINAL CRACK, APPROXIMATELY 10 FEET FROM END BENT 1

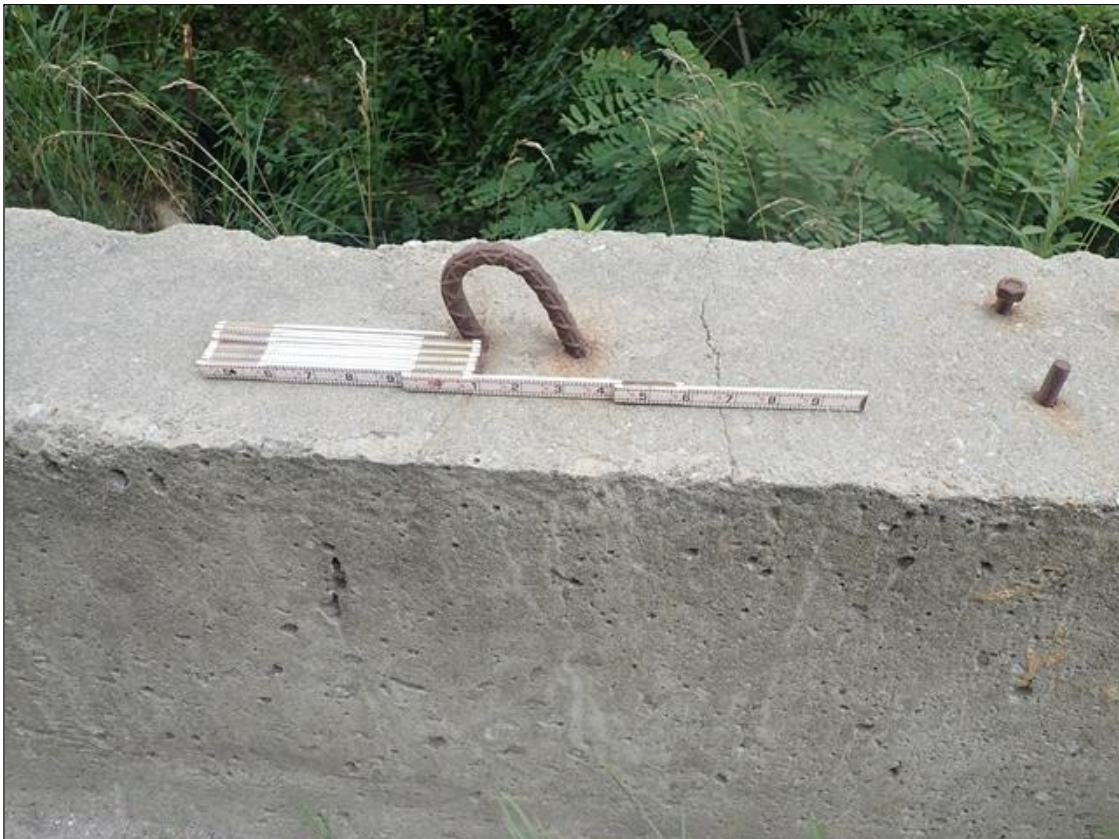
Span 1 Right Bridge Rail: UP TO 1/32 INCH WIDE TRANSVERSE CRACKS IN TOP FACE OF RAIL, 9 FEET FROM END BENT 2

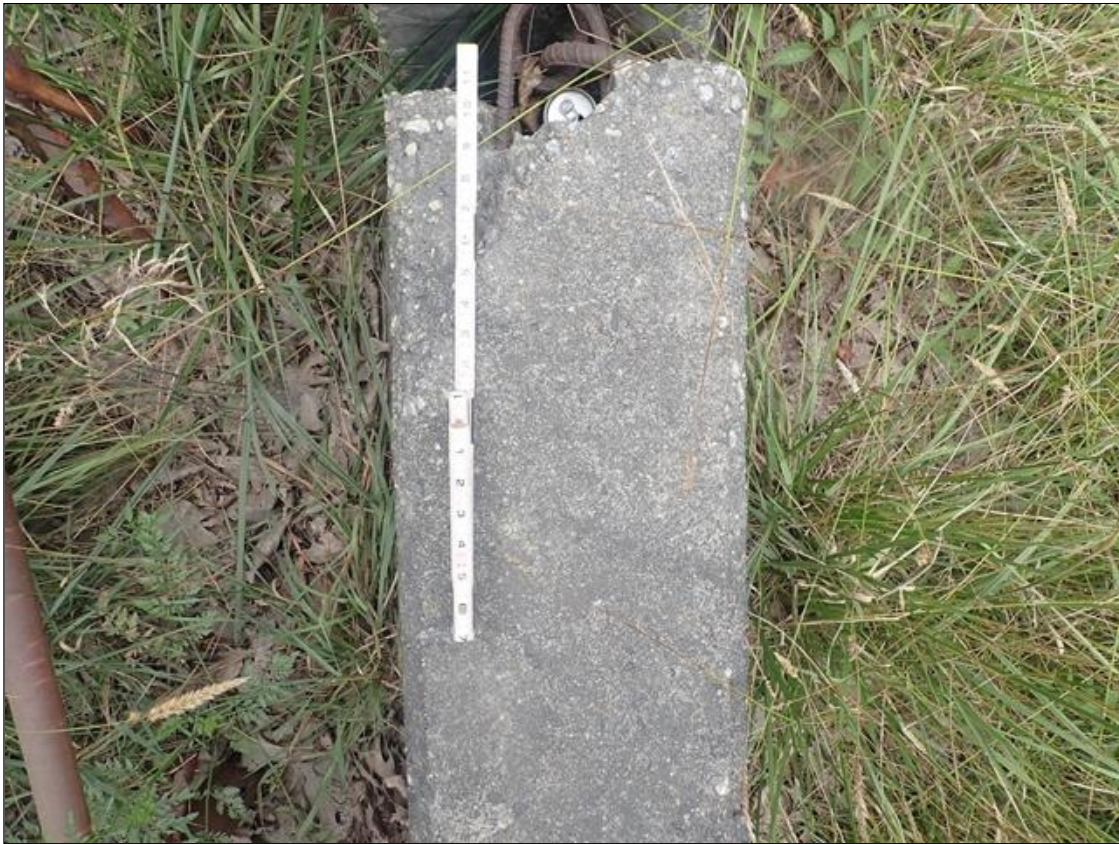
Span 1 Right Bridge Rail: UP TO 14 INCH LONG X 8 INCH WIDE X 4 INCH DEEP SPALLS WITH NO EXPOSED REINFORCING AT RANDOM THROUGHOUT ALL FACES OF RAIL (PHOTO TAKEN AT 2ND BARRIER NORTH OF END BENT 2)

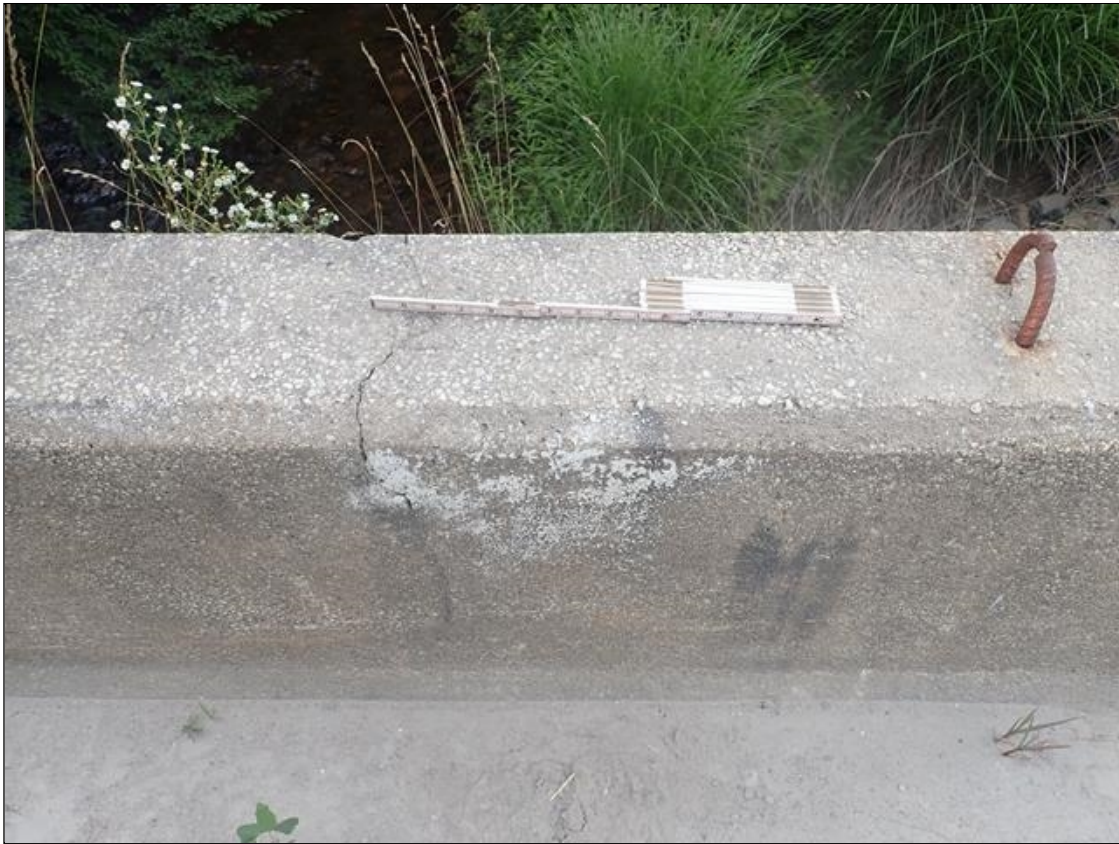
Span 1 Right Bridge Rail: UP TO 1/16 INCH WIDE WRAP AROUND CRACKING AT RANDOM THROUGHOUT (PHOTO TAKEN AT 12 FEET FROM END BENT 1)

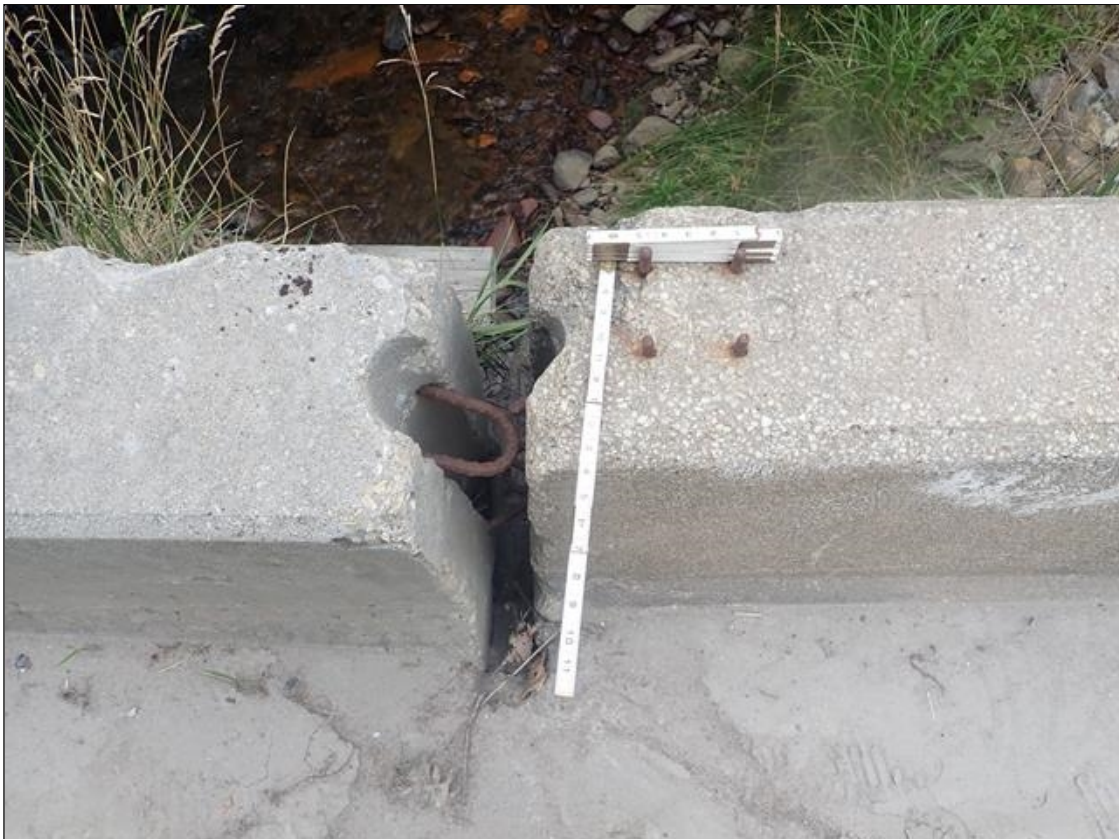
Span 1 Right Bridge Rail: UP TO 4 INCH LATERAL MISALIGNMENT THROUGHOUT BRIDGE RAIL (PHOTO TAKEN NEAR MID SPAN)

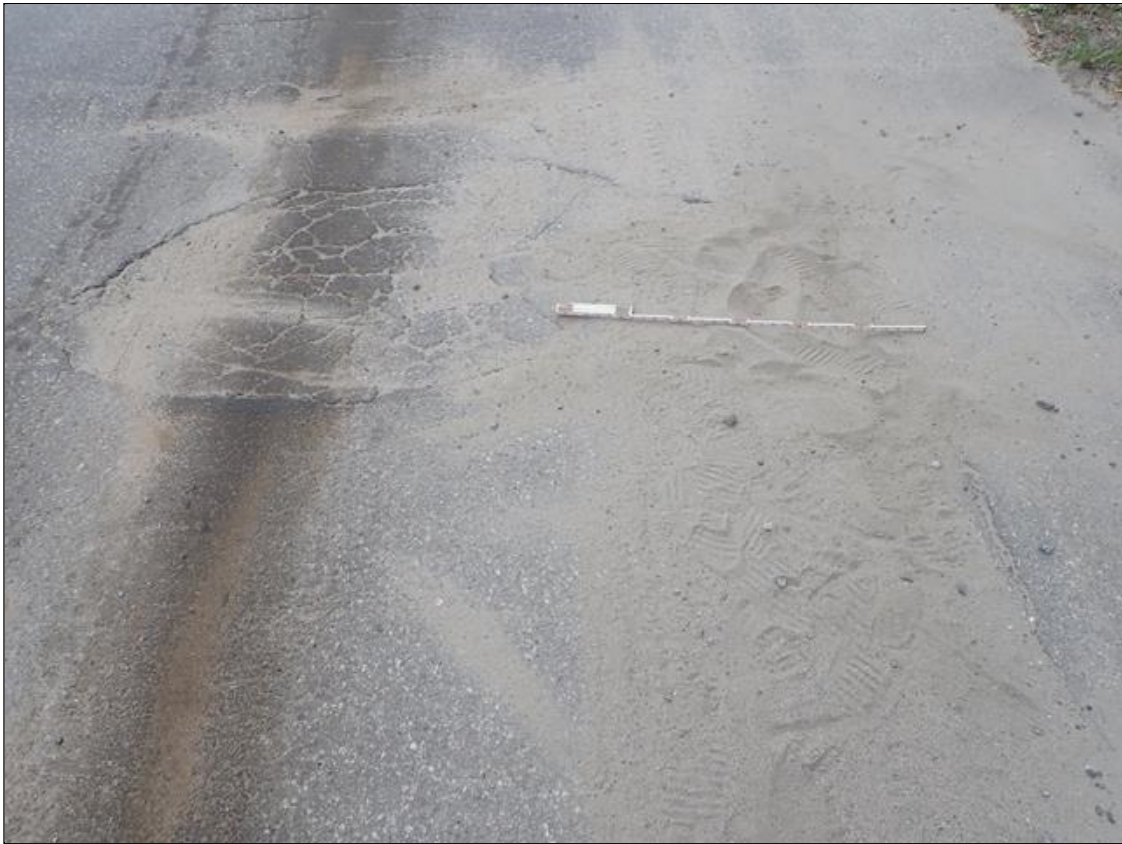
Span 1 Wearing Surface: UP TO 6 FEET LONG X 8 FEET WIDE X 2 INCH DEEP DEPRESSED AREA IN THE SOUTHBOUND LANE AT END BENT 1

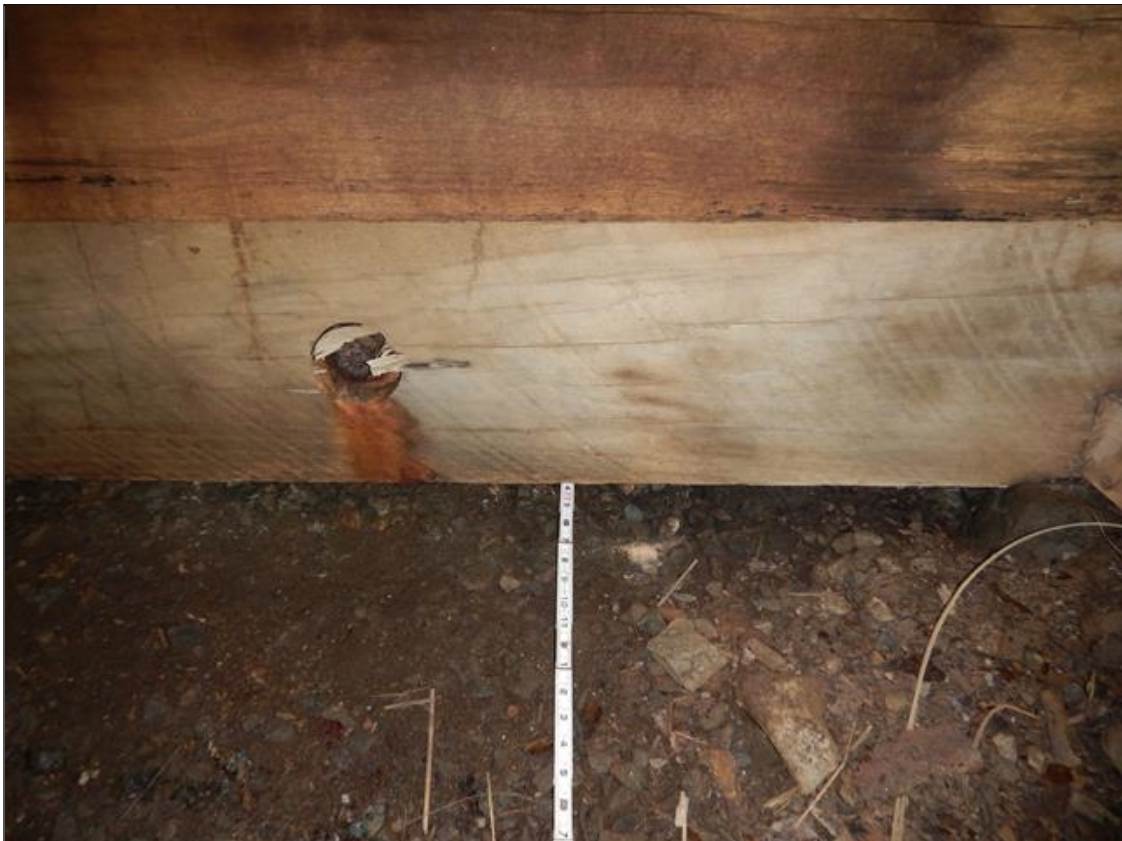
End Bent 1 Cap 1: EROSION WITH UNDERMINING (UP TO 6 INCH DEEP X 3 FEET LONG) BELOW BAY 1, AND UNDERMINING (UP TO 6 INCH DEEP X 3 FEET LONG) BELOW BAY 5 (PAR)

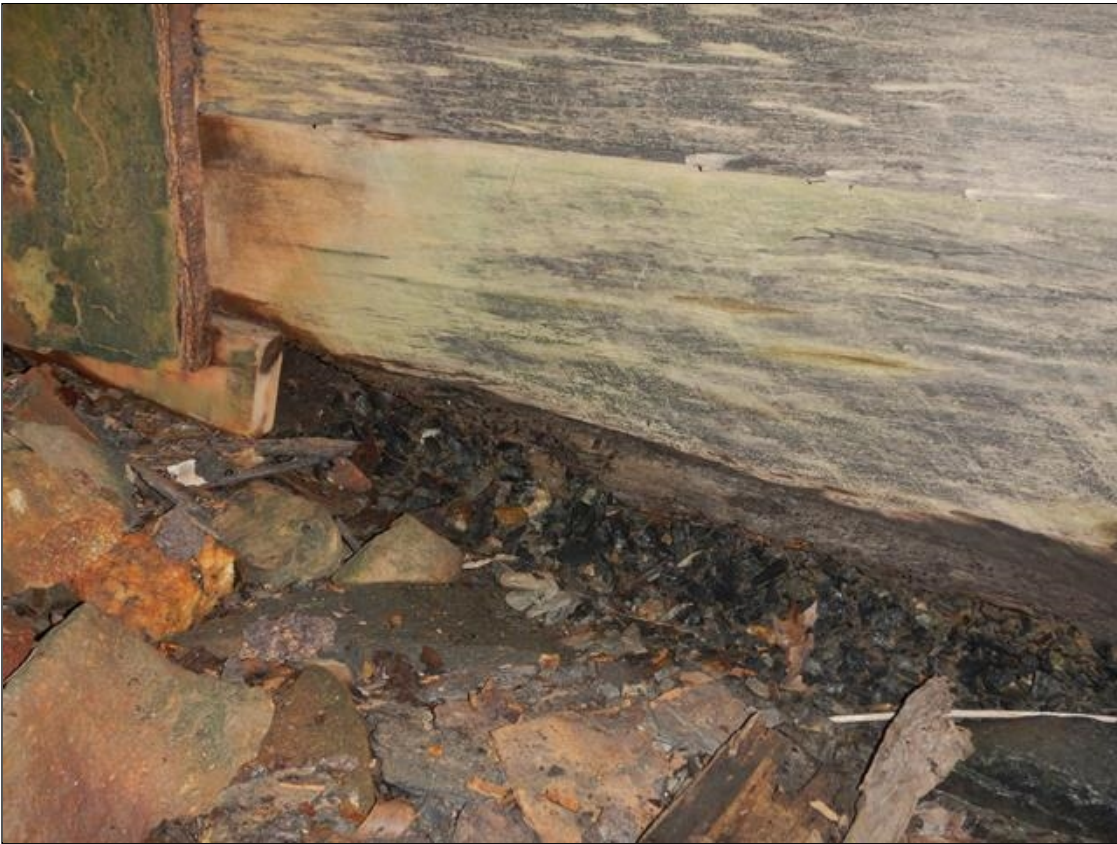
End Bent 1 Cap 1: UP TO 3 FEET LONG X FULL DEPTH X 4 INCH HIGH AREA OF DECAY TO EAST BOTTOM EDGE BENEATH BEAM 6

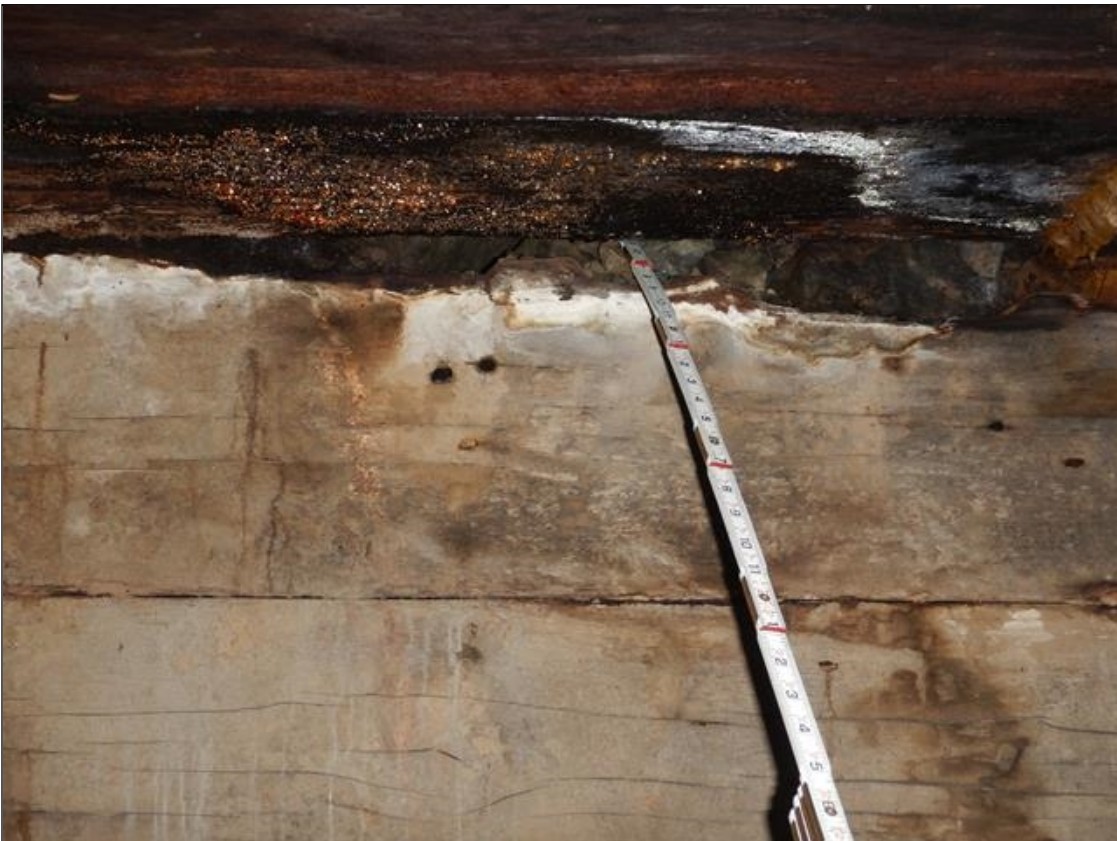
End Bent 1 Abutment: 53 INCH LONG X 3 INCH HIGH X FULL DEPTH AREA OF DECAY WITH SOIL INFILTRATION ON TOP BOARD BETWEEN BEAMS 4 AND 5 (PAR)

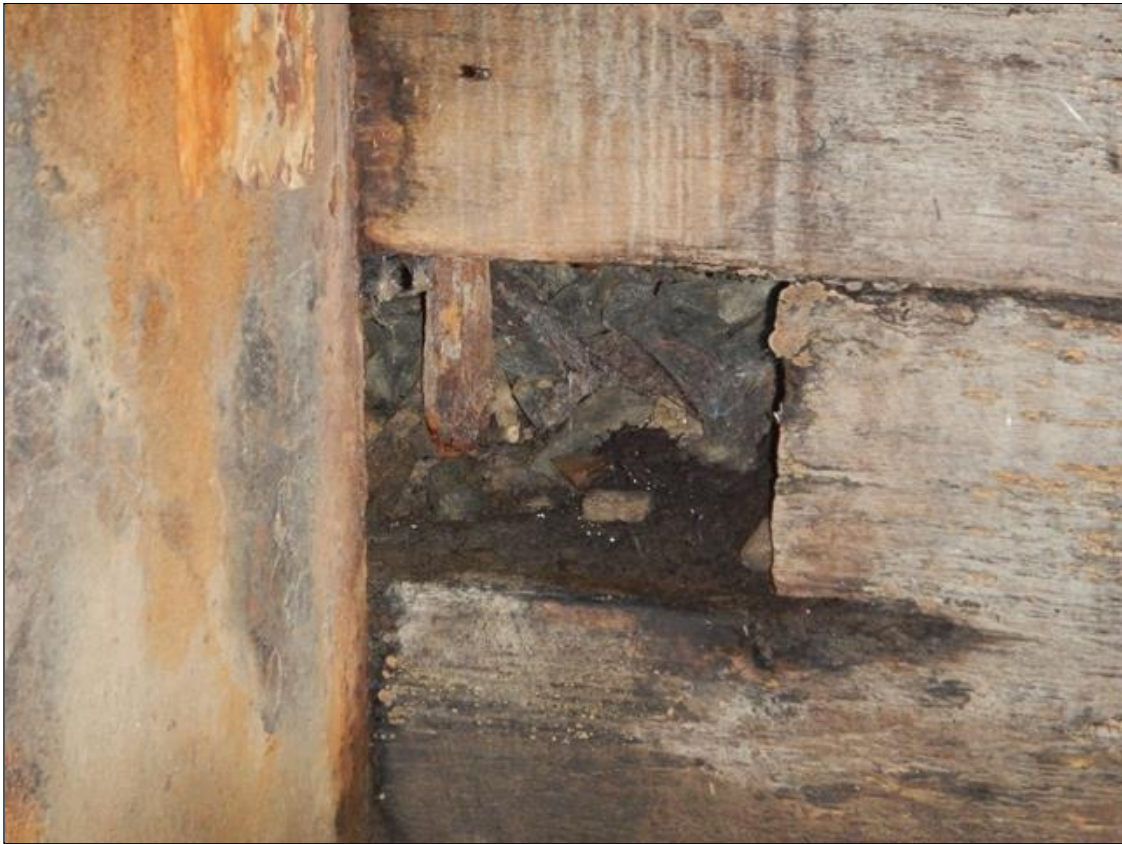
End Bent 1 Abutment: 8 INCH X 6 INCH SECTION OF MISSING BACKWALL BETWEEN BEAMS 5 AND 6 NEAR BEAM 6 (PAR)

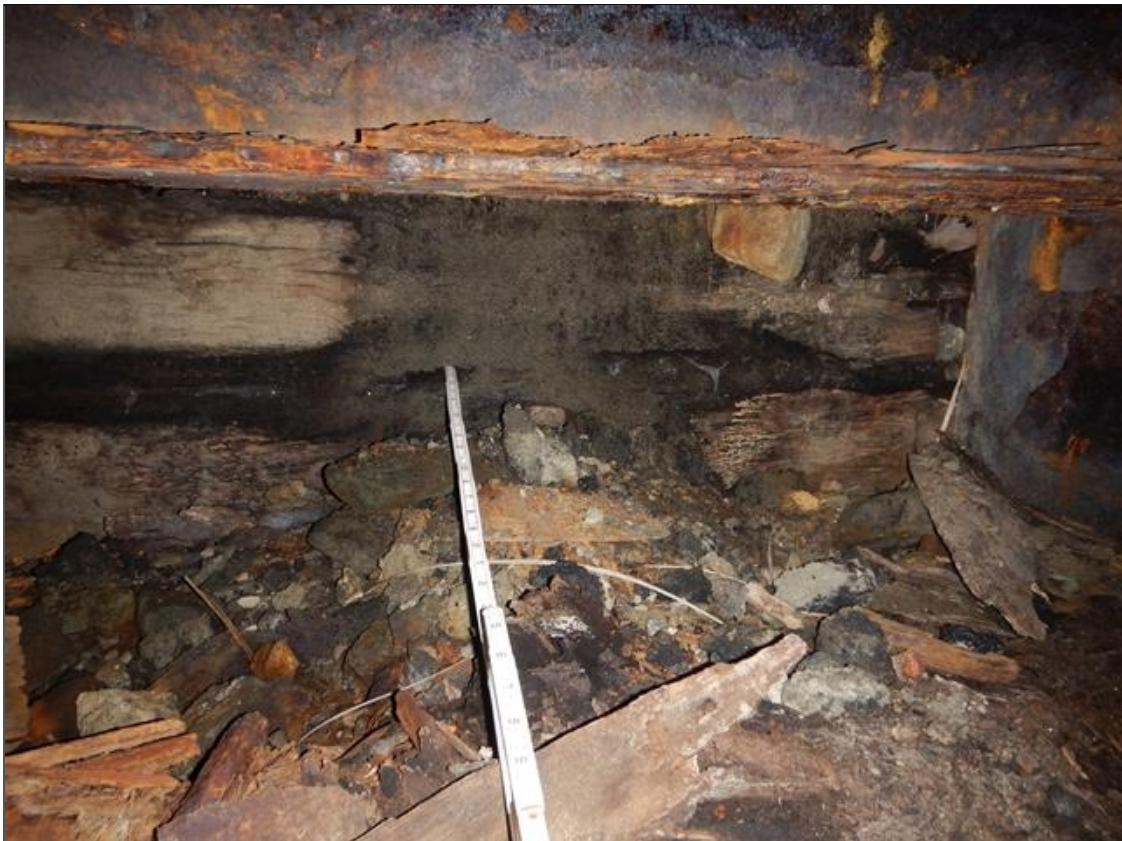
End Bent 1 Abutment: 3 FEET WIDE X FULL HEIGHT X UP TO 100 PERCENT AREA OF DECAY WITH SOIL INFILTRATION BETWEEN BEAMS 1 AND 2 (PAR)

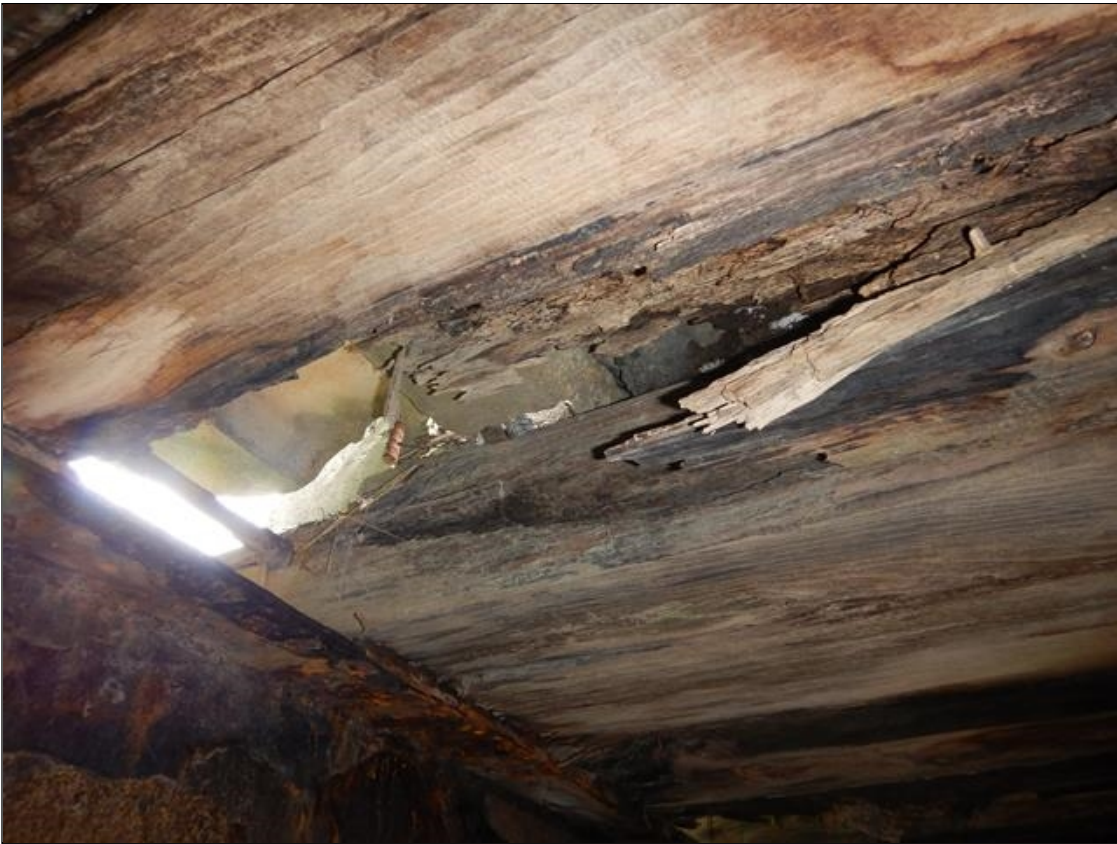
Span 1 Deck: UP TO COMPLETE DECAY AT RANDOM THROUGHOUT DECK TIMBERS IN EAST OVERHANG EXTENDING UP TO 4 FEET INTO BETWEEN BEAMS 5 AND 6 (PAR)

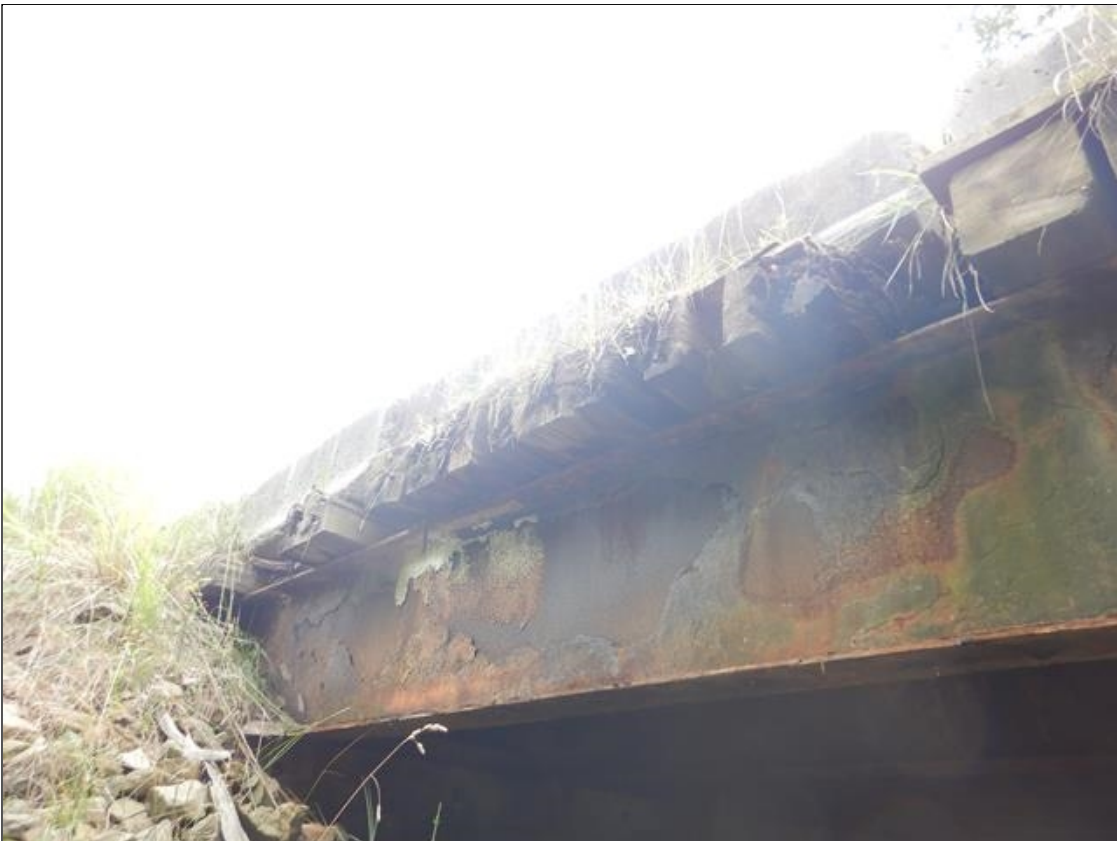
Span 1 Deck: UP TO COMPLETE DECAY AT RANDOM THROUGHOUT DECK TIMBERS IN EAST OVERHANG EXTENDING UP TO 4 FEET INTO BETWEEN BEAMS 5 AND 6 (PAR)

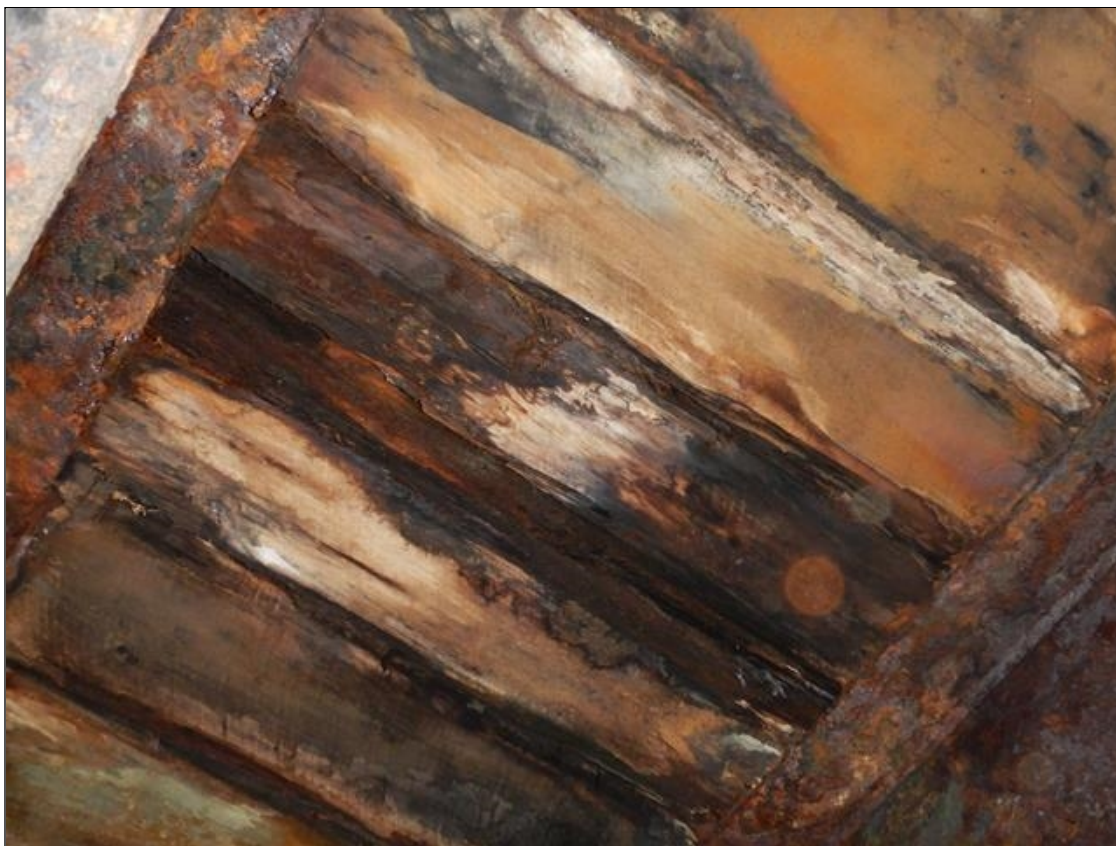
Span 1 Deck: 4 FEET X 5 FEET AREA OF UP TO FULL HEIGHT DECAY IN DECK TIMBERS BETWEEN BEAMS 4 AND 5 AT MID SPAN (PAR)

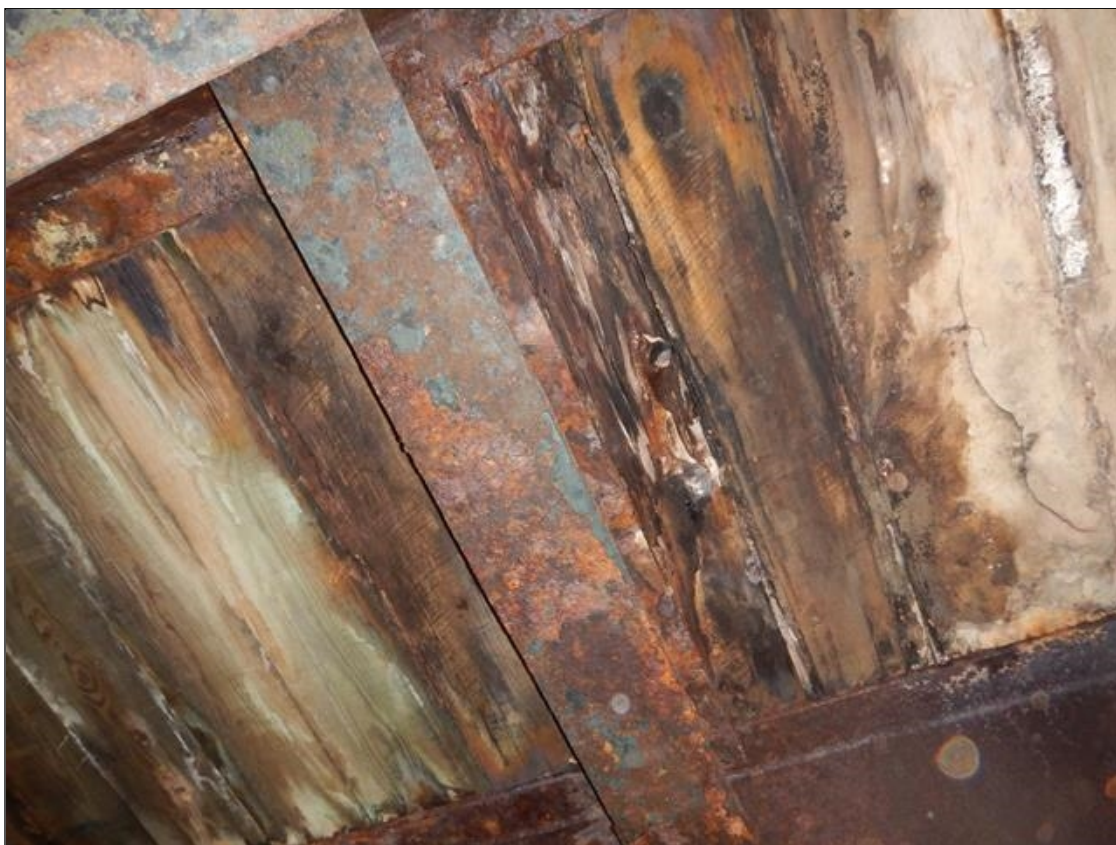
Span 1 Deck: DECAY UP TO 5.5 INCH DEEP X 5 FEET LONG X FULL BAY WIDTH AT MIDSPAN DIAPHRAGM (PAR)

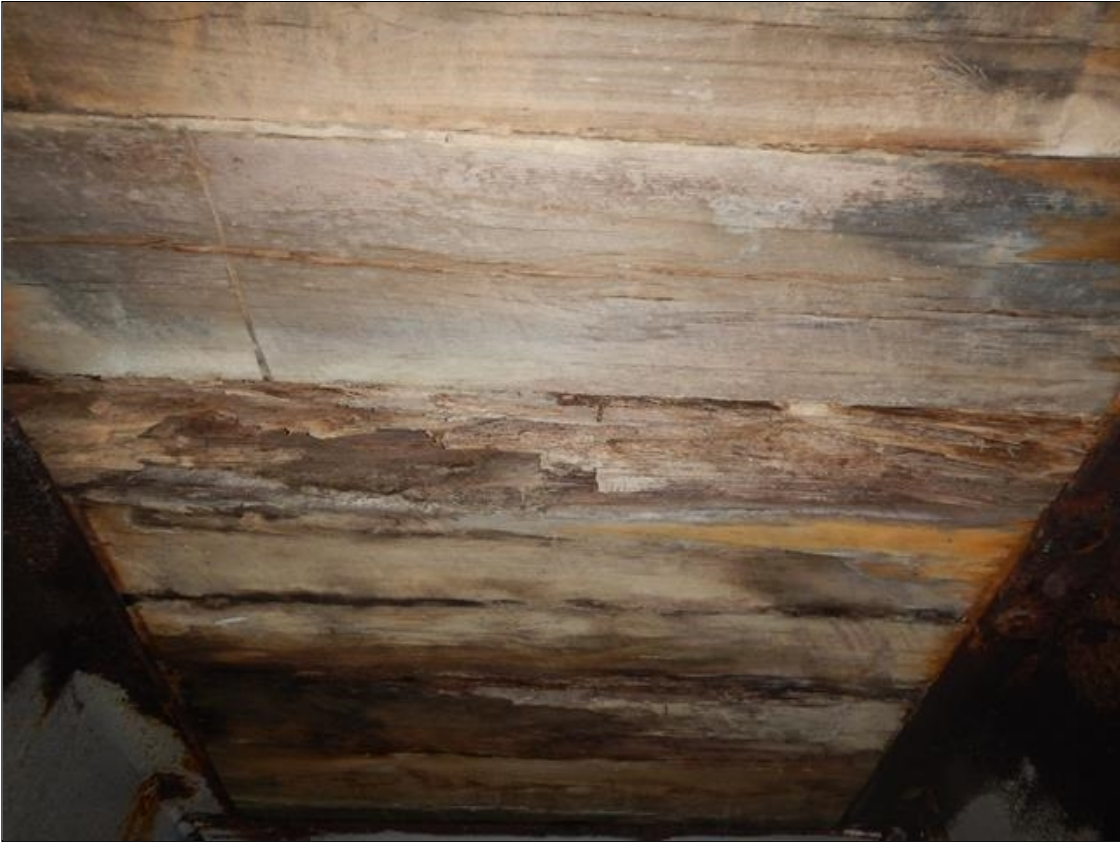
Span 1 Deck: DECAY UP TO 10 INCHES DEEP X FULL BAY WIDTH X 1 FOOT LONG BETWEEN BEAMS 3 AND 4 6 FEET FROM END BENT 2 (PAR)

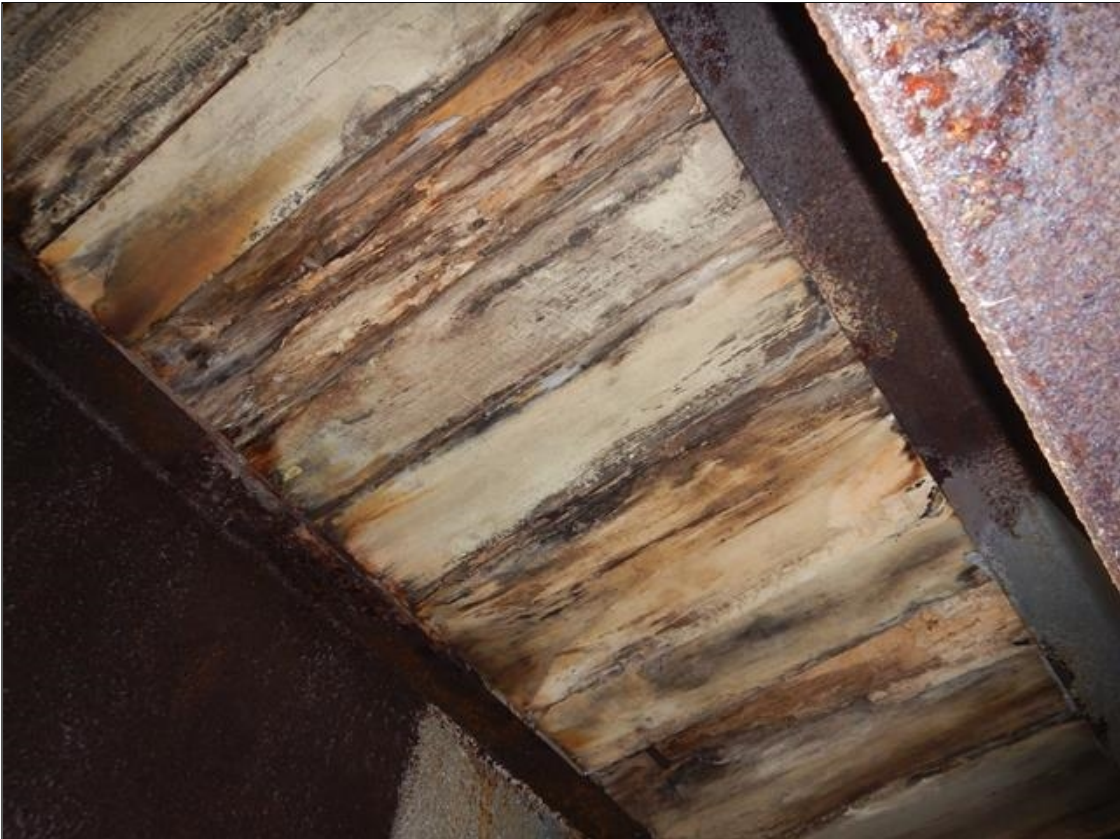
Span 1 Deck: (2) DECK TIMBERS ARE DECAYED UP TO FULL BAY WIDTH X UP TO 9 INCHES DEEP NEAR THE 3/4 POINT (PAR)

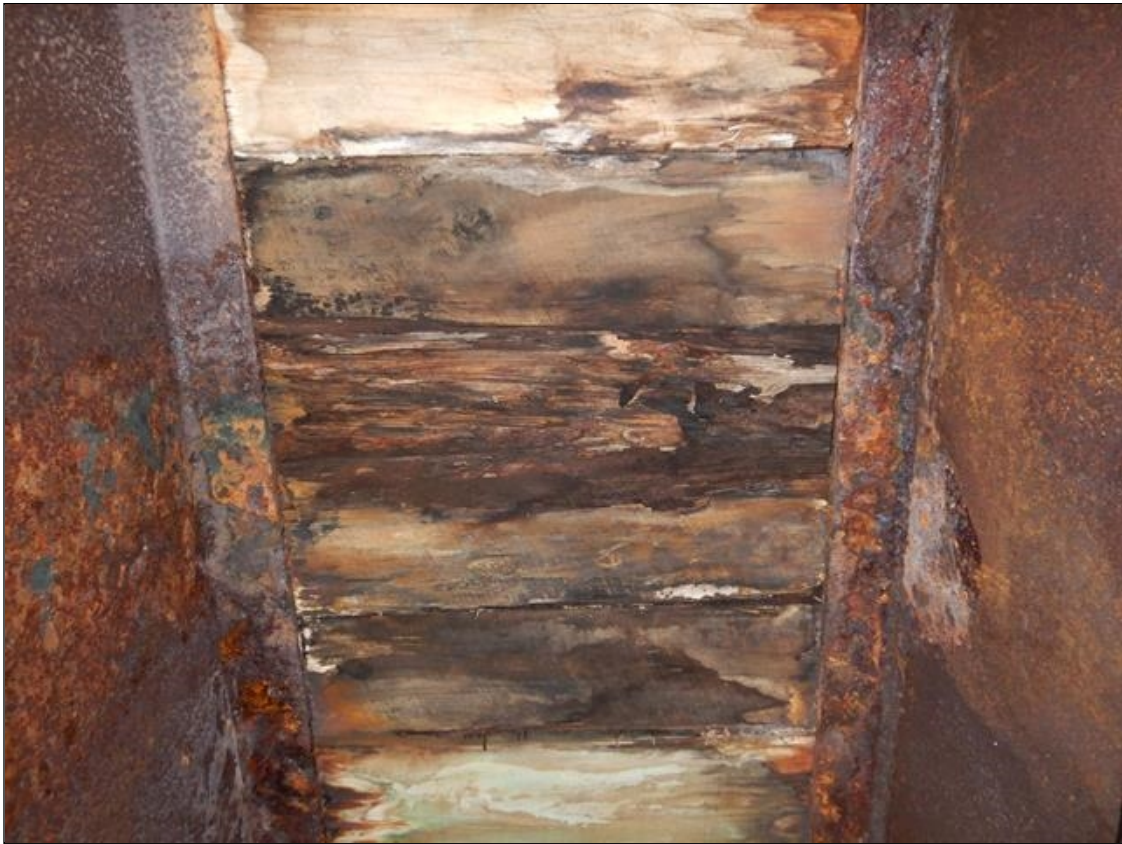
Span 1 Deck: DECAYED DECK TIMBER UP TO FULL HEIGHT BETWEEN BEAMS 2 AND 3 NEAR MID SPAN (PAR)

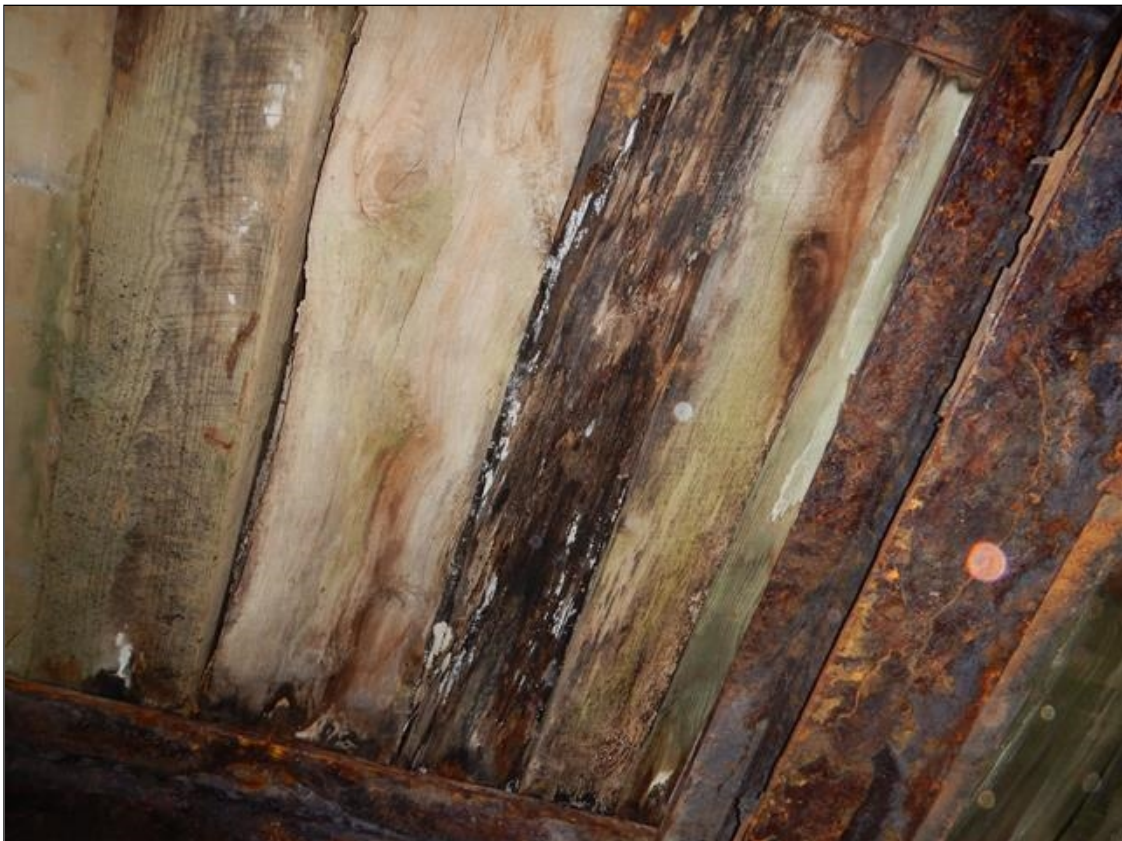
Span 1 Deck: UP TO COMPLETE DECAY AT RANDOM THROUGHOUT DECK TIMBERS IN WEST OVERHANG EXTENDING UP TO 5 FEET INTO BETWEEN BEAMS 1 AND 2 (PAR)

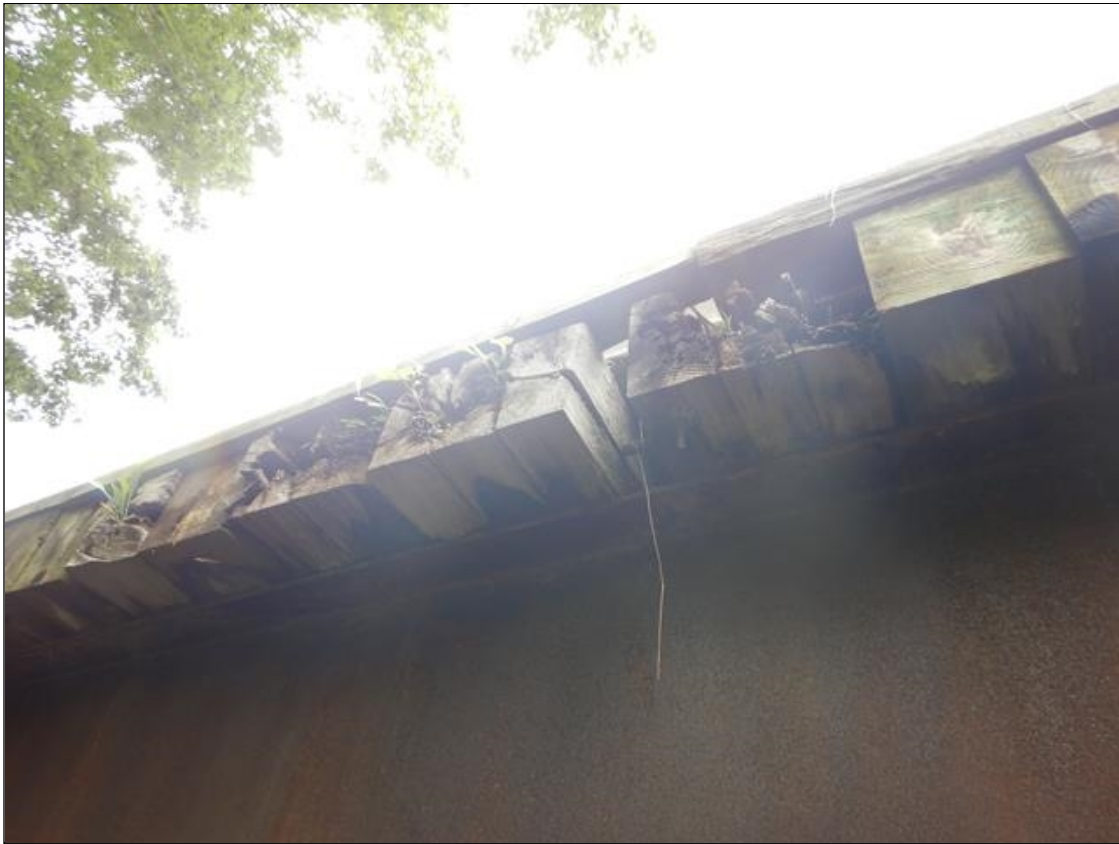
Span 1 Deck: UP TO COMPLETE DECAY AT RANDOM THROUGHOUT DECK TIMBERS IN WEST OVERHANG EXTENDING UP TO 5 FEET INTO BETWEEN BEAMS 1 AND 2 (PAR)

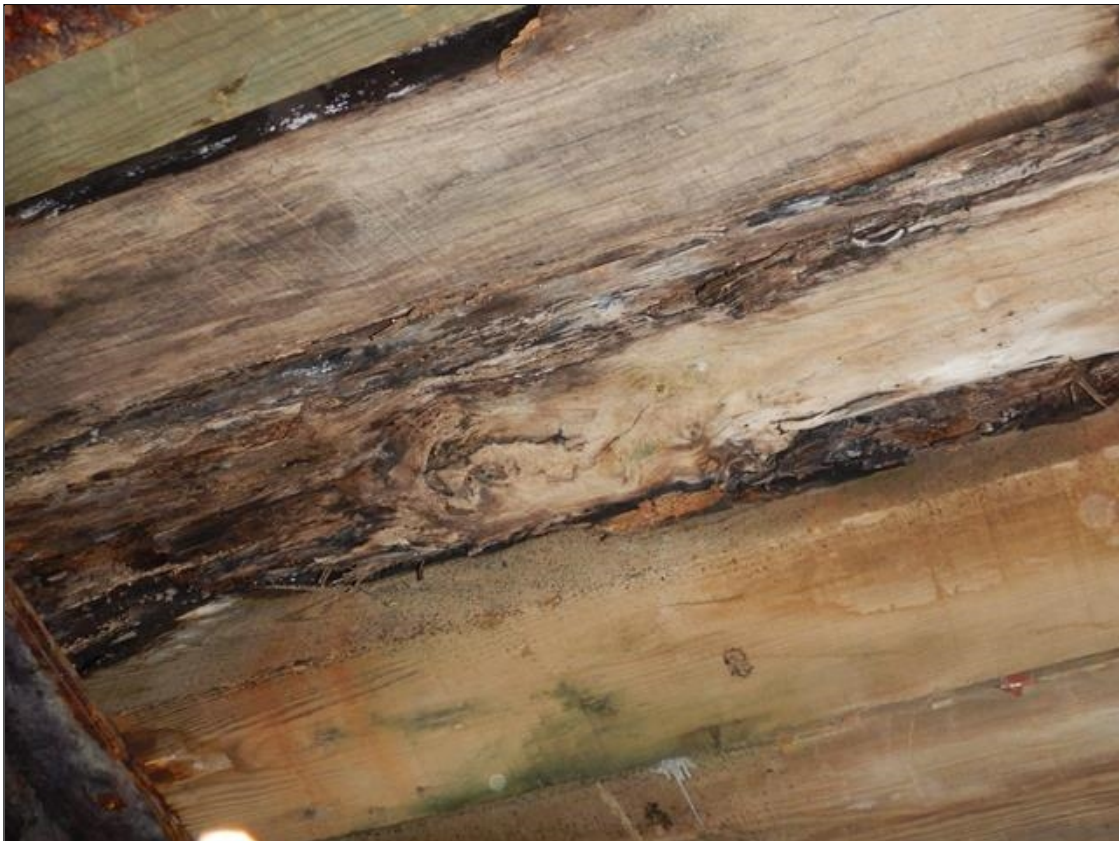
Span 1 Deck: UP TO COMPLETE DECAY AT RANDOM THROUGHOUT DECK TIMBERS IN WEST OVERHANG EXTENDING UP TO 5 FEET INTO BETWEEN BEAMS 1 AND 2 (PAR)
