NC DEPARTMENT OF TRANSPORTATION
DIVISION OF HIGHWAYS
STRUCTURE MANAGEMENT UNIT

ATTENTION: PAR SUBMITTED

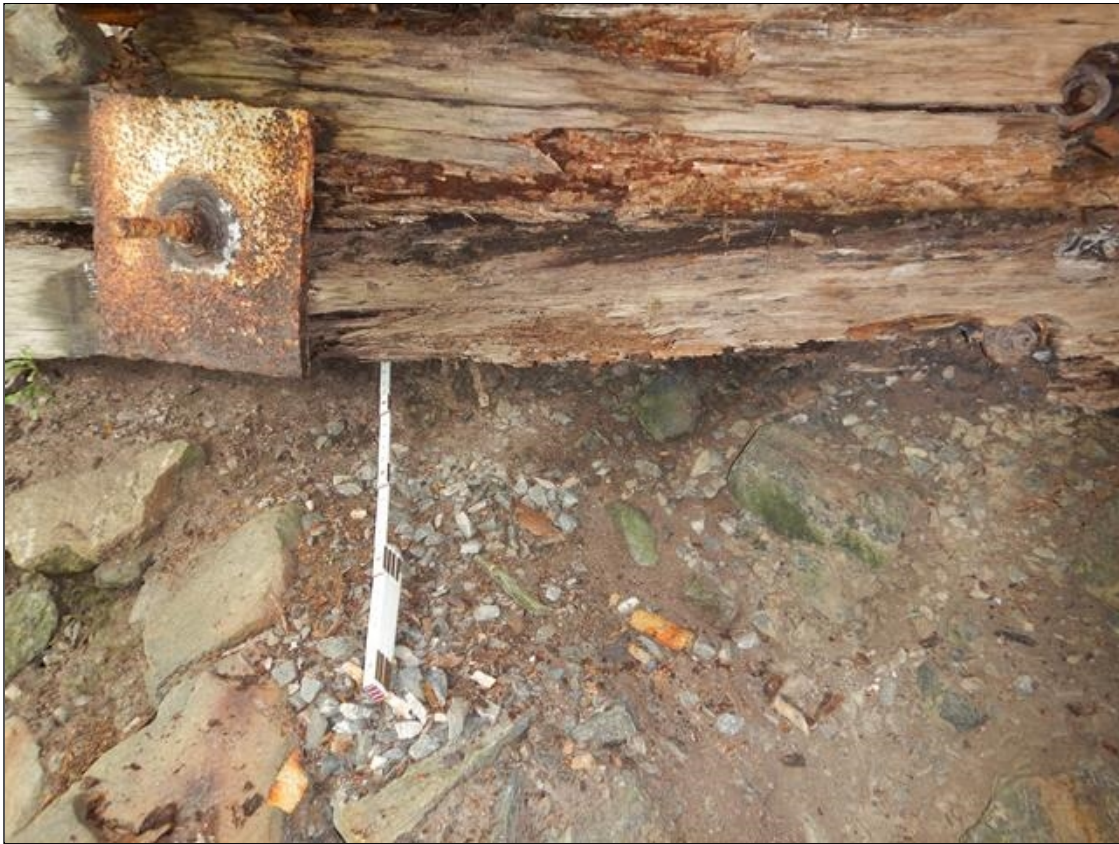
End Bent 2 Cap 1: EROSION WITH UNDERMINING UP TO 6 FEET LONG X 1 FOOT DEEP AT WEST END (PAR)

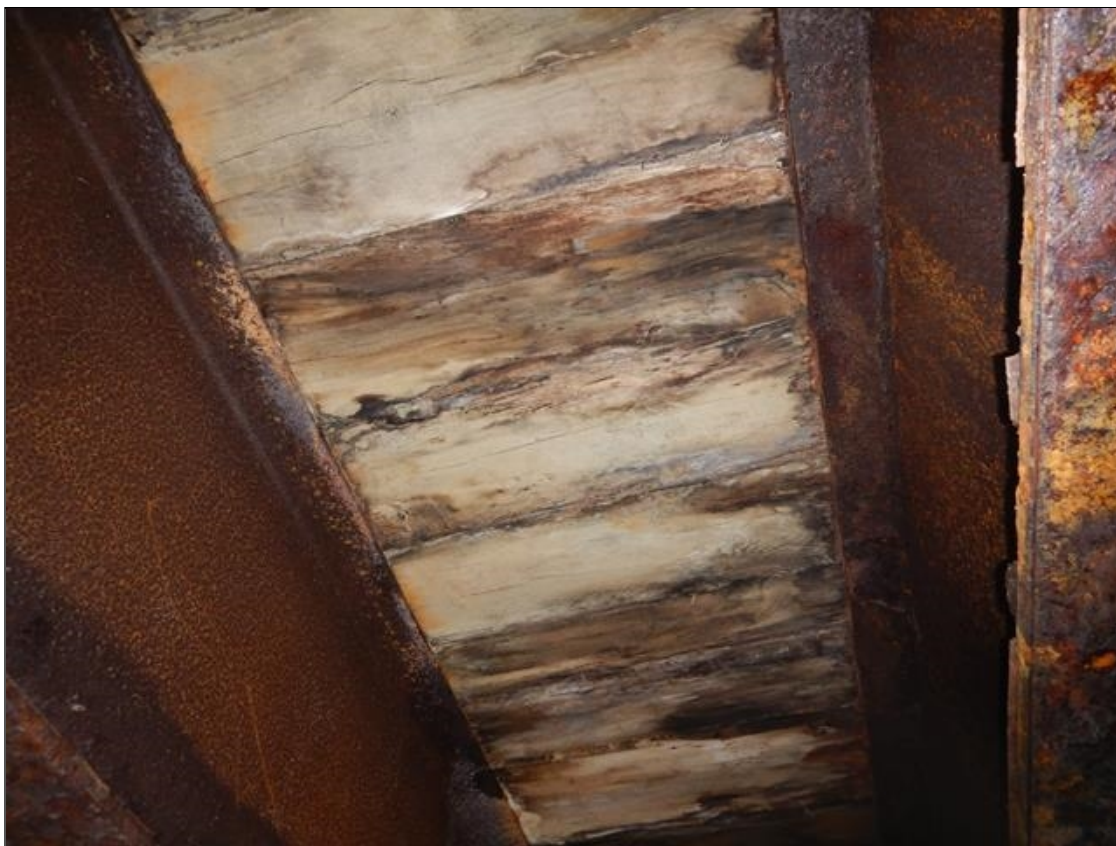
Span 1 Deck: DECAY UP TO 1 INCH DEEP AND SATURATION THROUGHOUT UNDERSIDE OF DECK (PHOTO TAKEN BETWEEN BEAMS 2 AND 3 NEAR MID SPAN)

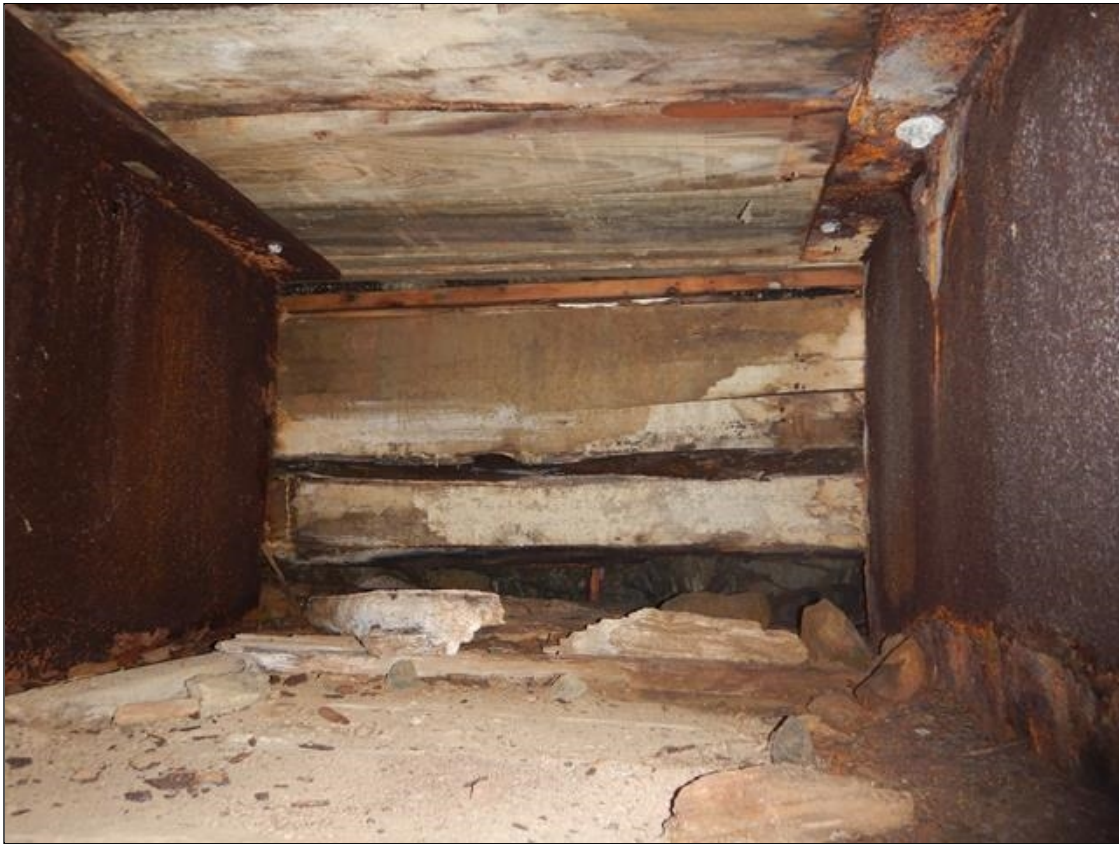
End Bent 2 Abutment: COMPLETE DECAY UP TO 1.5 FEET HIGH IN HEADWALL BOARDS BETWEEN BEAMS 1 AND 6 WITH LARGE VOIDS IN ALL BAYS AND AREAS OF SOIL INFILTRATION (PHOTO TAKEN BETWEEN BEAMS 4 AND 5) (PAR)

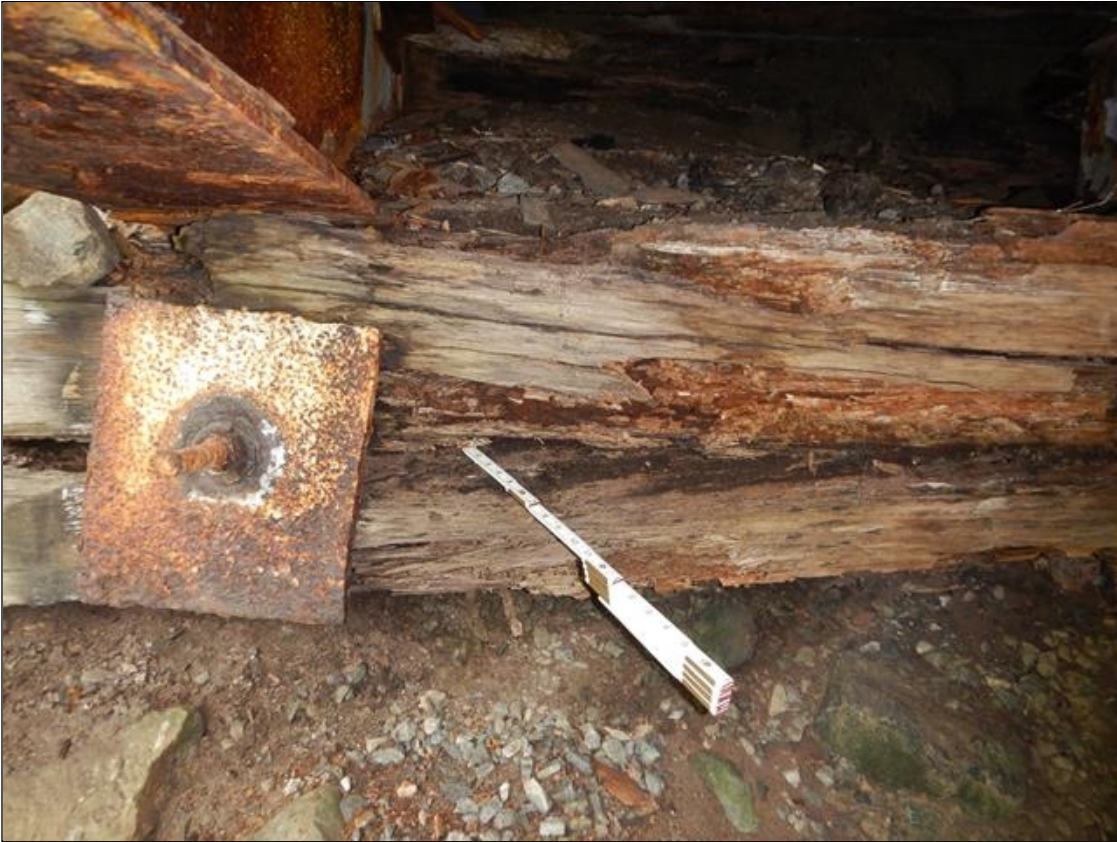
End Bent 2 Cap 1: 8 FEET LONG X FULL HEIGHT X UP TO FULL DEPTH AREA OF DECAY AT WEST END (PAR)

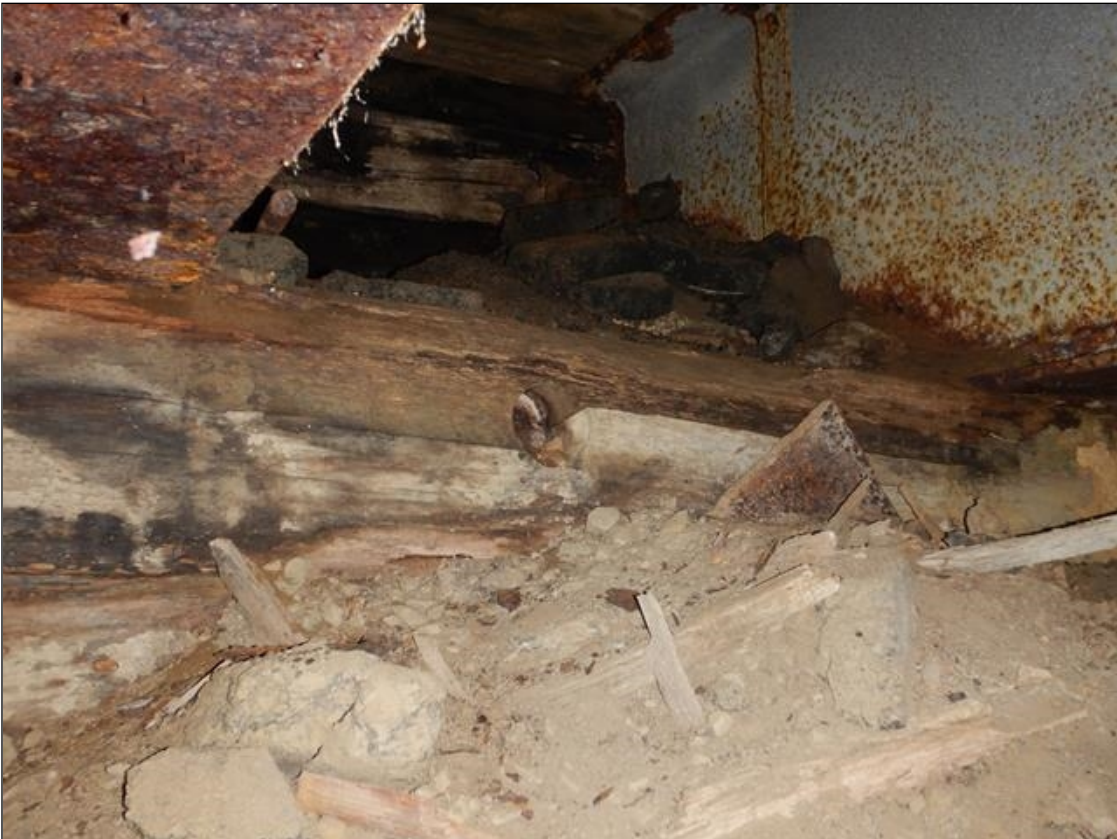
End Bent 2 Cap 1: DECAY/SECTION LOSS UP TO 4.5 FEET LONG X 4 INCH HIGH X 3.5 INCH DEEP TO SOUTH TOP EDGE BETWEEN BEAMS 2 AND 3

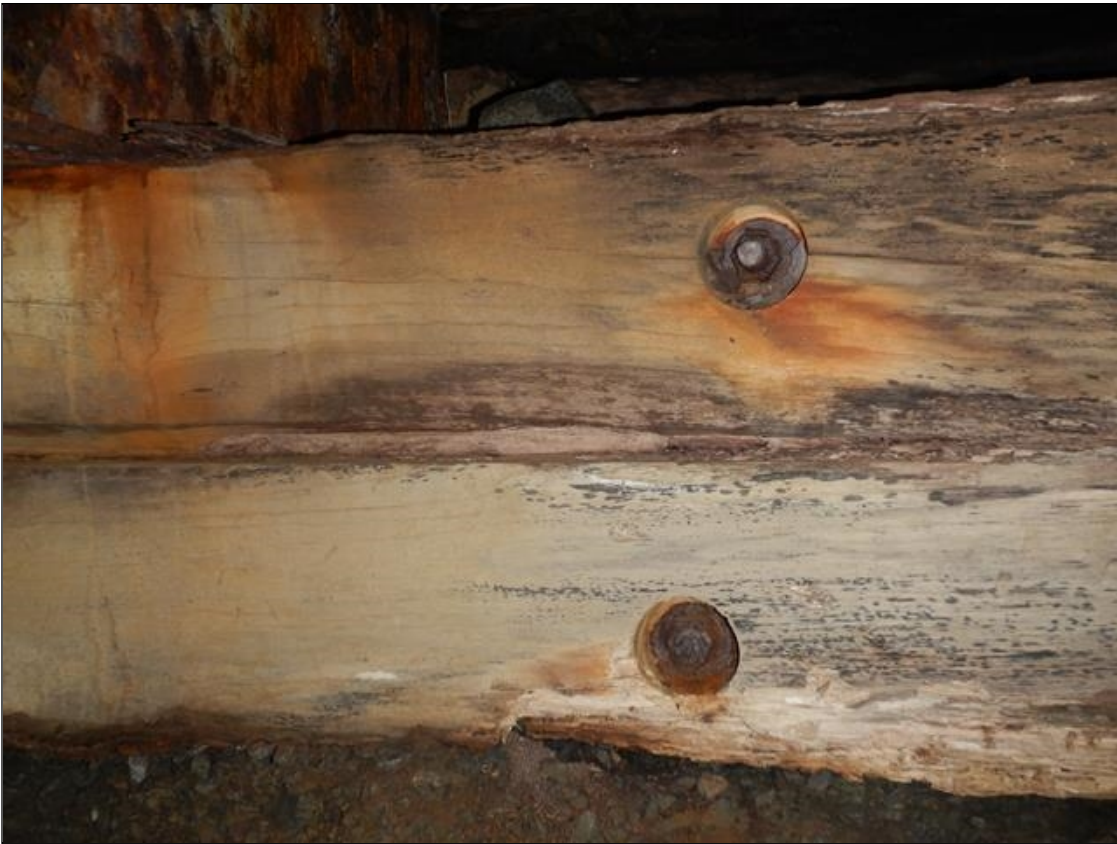
End Bent 2 Cap 1: 6 FEET LONG X 10 INCH HIGH X 2.5 INCH DEEP AREA OF DECAY ON BOTTOM SOUTH CORNER AT EAST END (PAR)

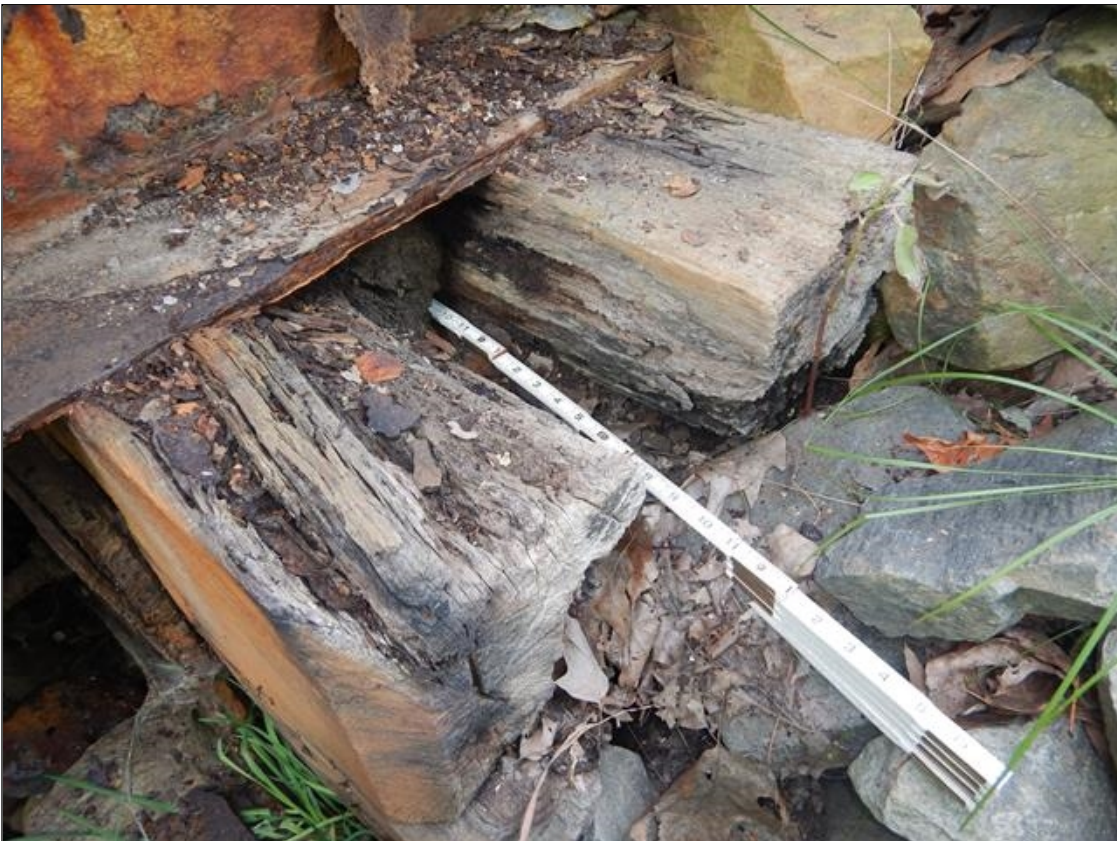
End Bent 2 Cap 1: 2 FEET LONG X 2 FEET WIDE X UP TO FULL HEIGHT AREA OF DECAY AT EAST END EXTENDING BENEATH BEAM 6 BEARING (PAR)

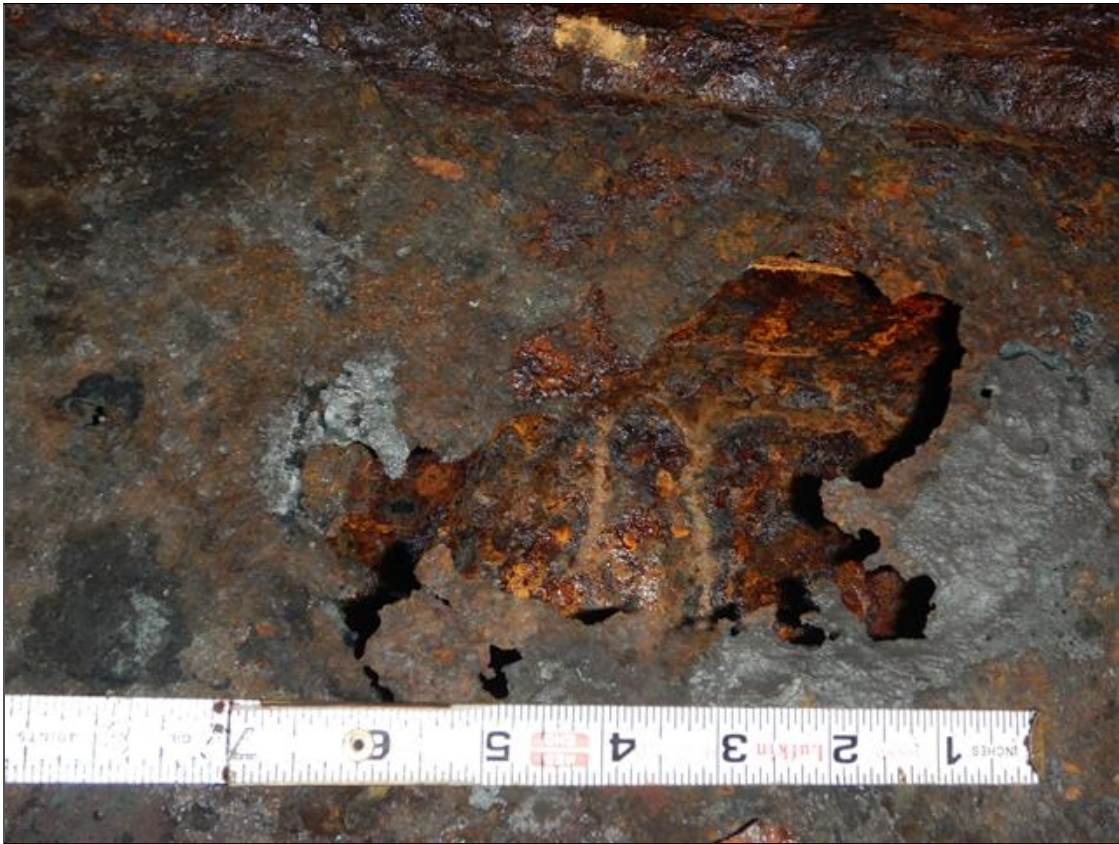
Span 1 Beam 5: RUST SCALE THROUGHOUT 1/4 POINT DIAPHRAGM FLANGES AND WEB WITH 1/4 INCH REMAINING IN BOTTOM FLANGE, 5/16 INCH REMAINING IN TOP FLANGE, AND WEB HOLES UP TO 7 INCH X 4 INCH (PAR)

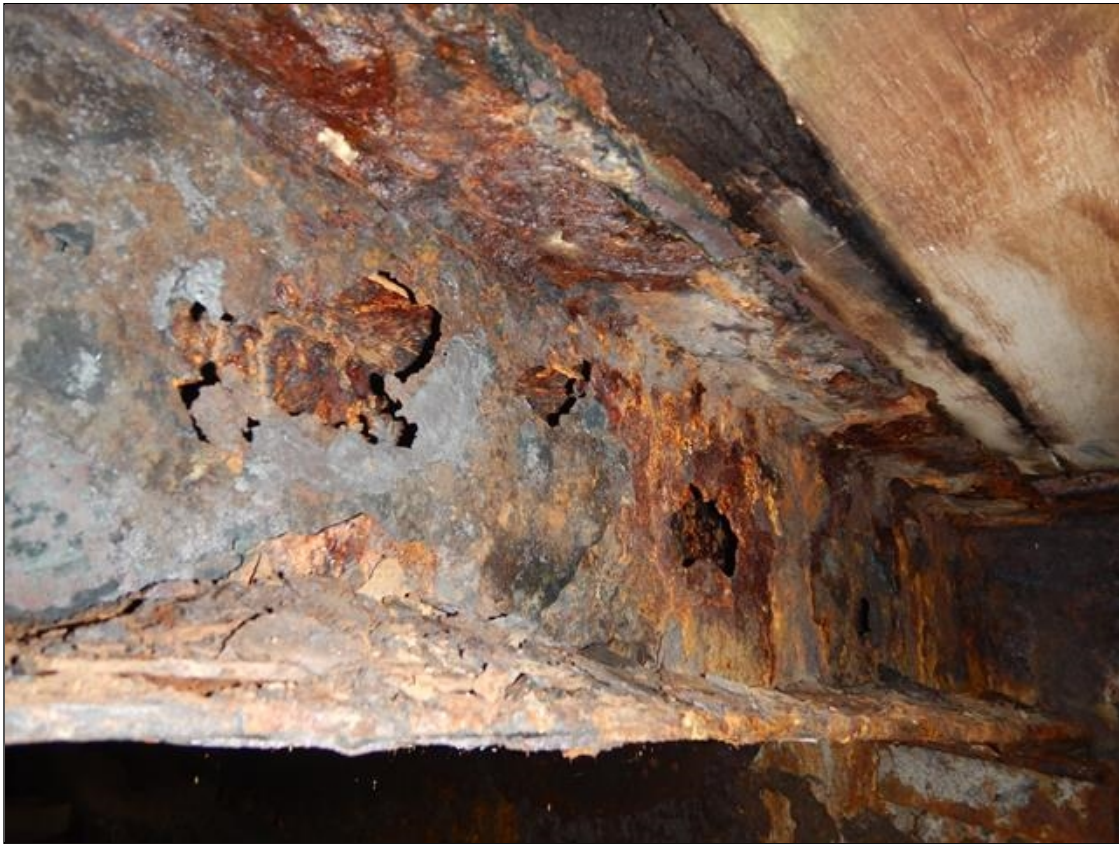
Span 1 Beam 5: RUST SCALE THROUGHOUT 1/4 POINT DIAPHRAGM FLANGES AND WEB WITH 1/4 INCH REMAINING IN BOTTOM FLANGE, 5/16 INCH REMAINING IN TOP FLANGE, AND WEB HOLES UP TO 7 INCH X 4 INCH (PAR)

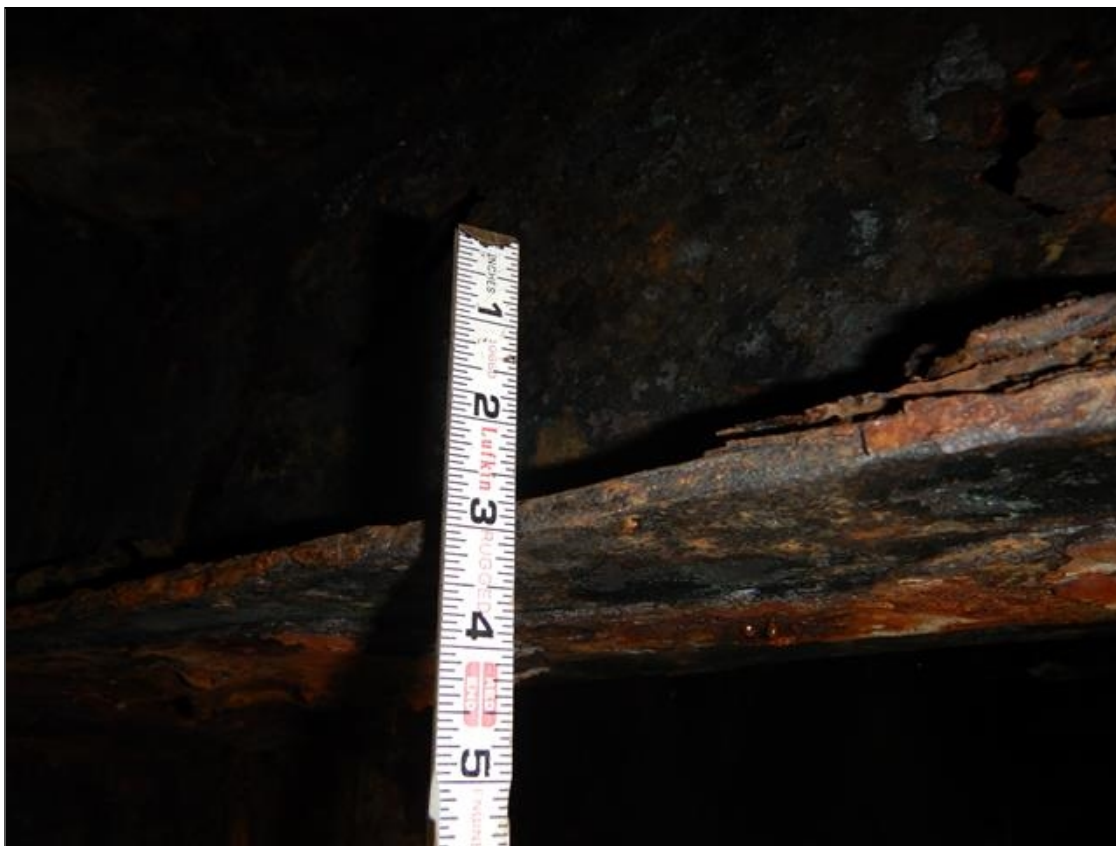
Span 1 Beam 5: RUST SCALE THROUGHOUT 1/4 POINT DIAPHRAGM FLANGES AND WEB WITH 1/4 INCH REMAINING IN BOTTOM FLANGE, 5/16 INCH REMAINING IN TOP FLANGE, AND WEB HOLES UP TO 7 INCH X 4 INCH (PAR)

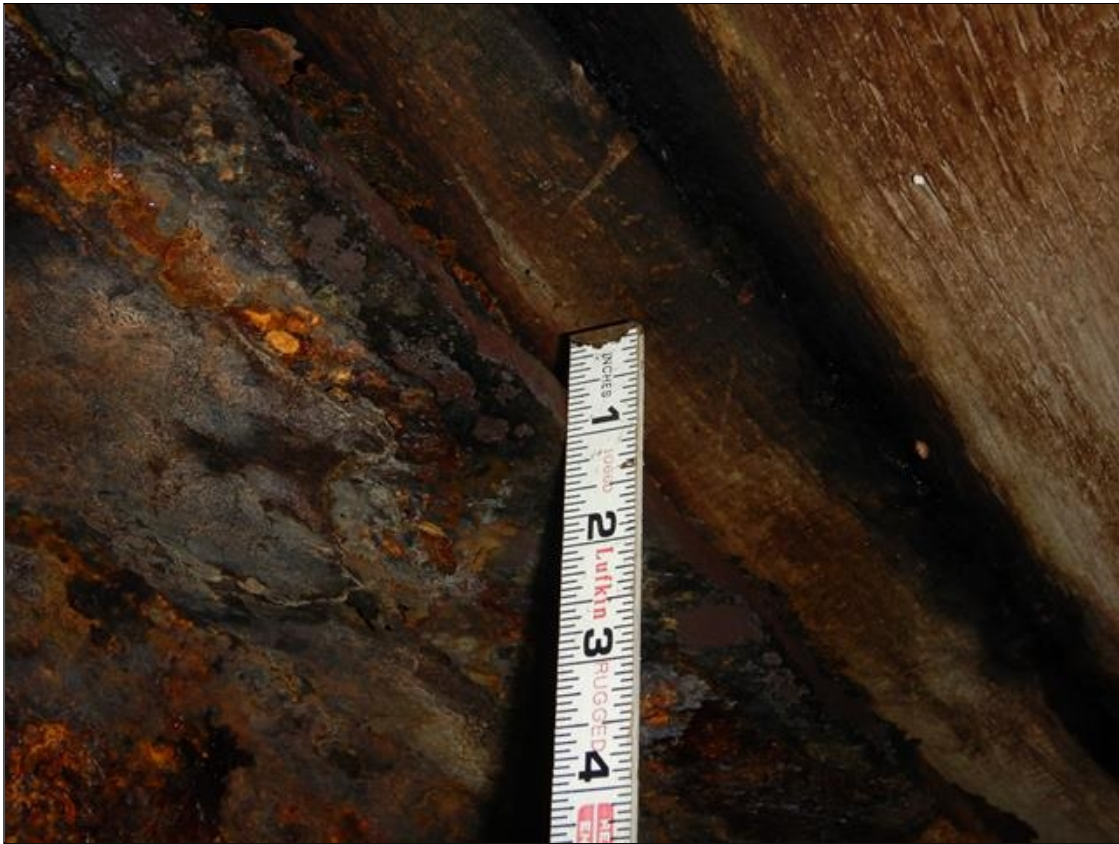
Span 1 Beam 5: RUST SCALE THROUGHOUT 1/4 POINT DIAPHRAGM FLANGES AND WEB WITH 1/4 INCH REMAINING IN BOTTOM FLANGE, 5/16 INCH REMAINING IN TOP FLANGE, AND WEB HOLES UP TO 7 INCH X 4 INCH (PAR)

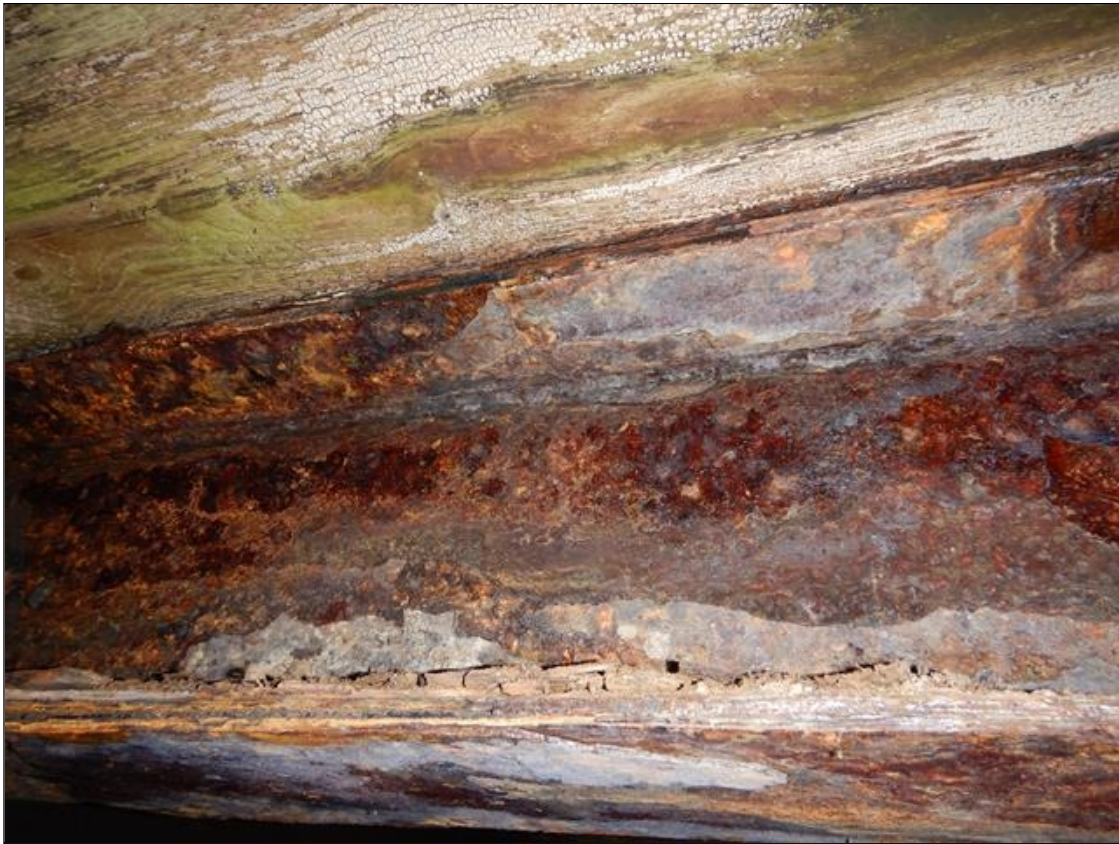
Span 1 Beam 1: RUST SCALE THROUGHOUT 1/4 POINT DIAPHRAGM FLANGES AND WEB WITH 3/16 INCH REMAINING IN BOTTOM FLANGE, 5/16 INCH REMAINING IN TOP FLANGE, AND UP TO 1/16 INCH SECTION LOSS IN WEB (PAR)

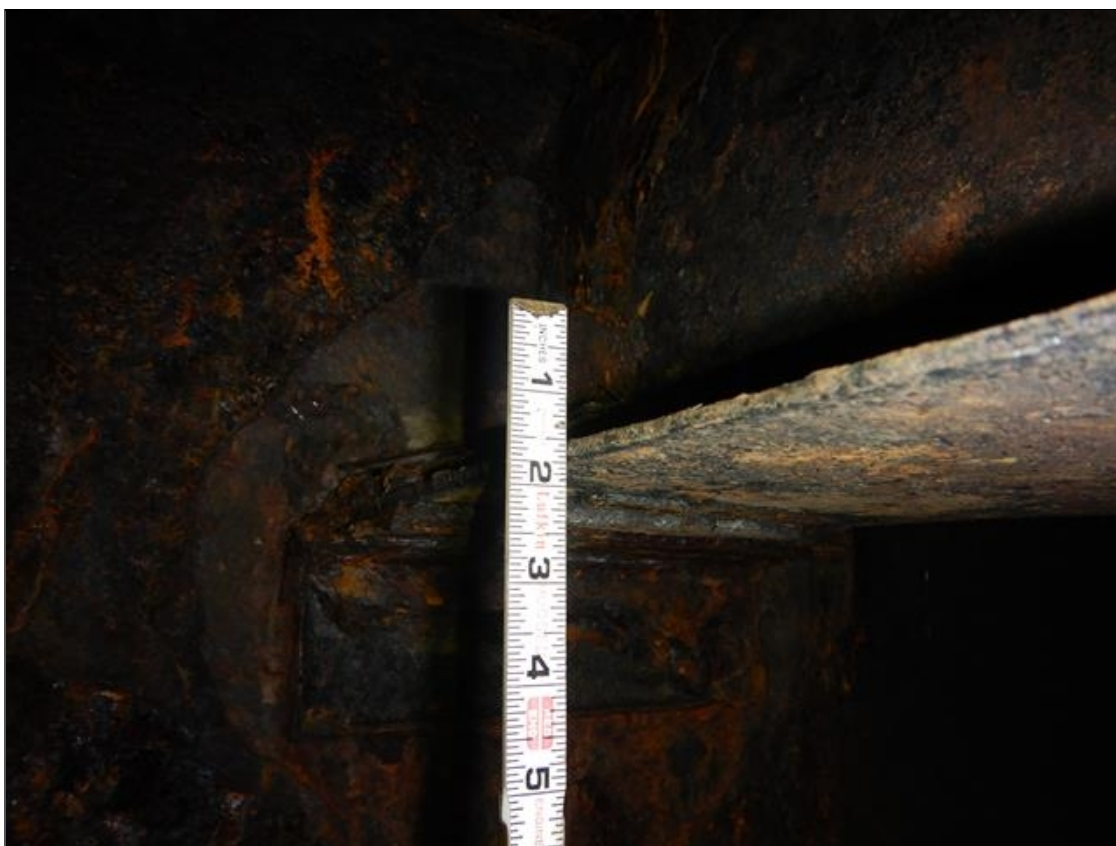
Span 1 Beam 1: RUST SCALE THROUGHOUT 1/4 POINT DIAPHRAGM FLANGES AND WEB WITH 3/16 INCH REMAINING IN BOTTOM FLANGE, 5/16 INCH REMAINING IN TOP FLANGE, AND UP TO 1/16 INCH SECTION LOSS IN WEB (PAR)

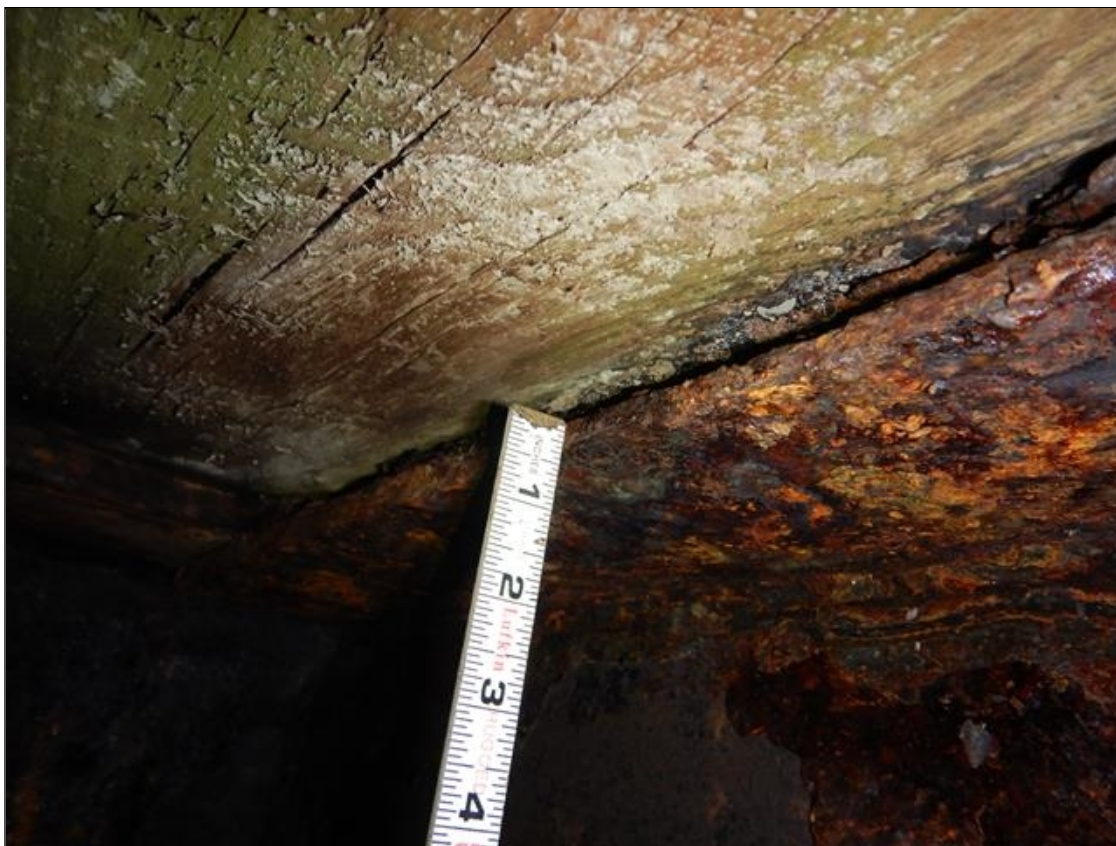
Span 1 Beam 1: RUST SCALE THROUGHOUT 1/4 POINT DIAPHRAGM FLANGES AND WEB WITH 3/16 INCH REMAINING IN BOTTOM FLANGE, 5/16 INCH REMAINING IN TOP FLANGE, AND UP TO 1/16 INCH SECTION LOSS IN WEB (PAR)

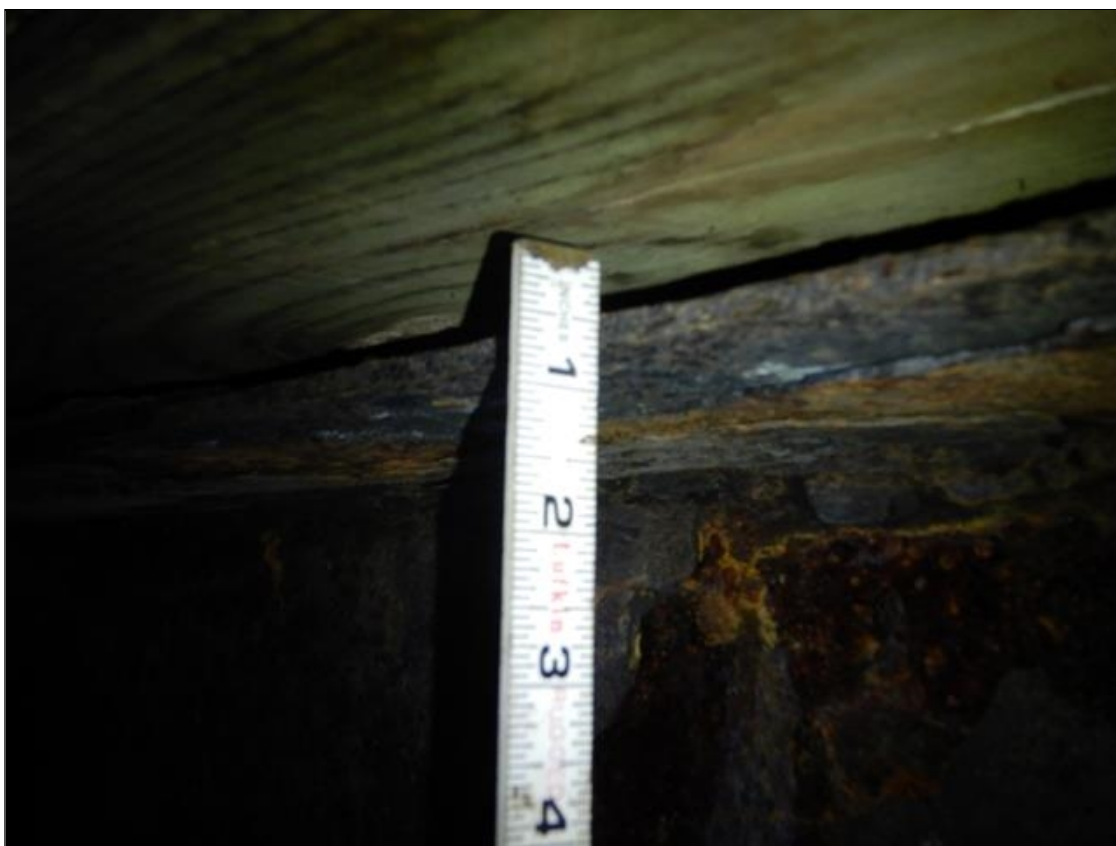
Span 1 Beam 1: RUST SCALE THROUGHOUT 3/4 POINT DIAPHRAGM FLANGES AND WEB WITH 1/4 INCH REMAINING IN BOTTOM FLANGE, 1/4 INCH REMAINING IN TOP FLANGE, AND UP TO 1/16 INCH SECTION LOSS IN WEB (PAR)

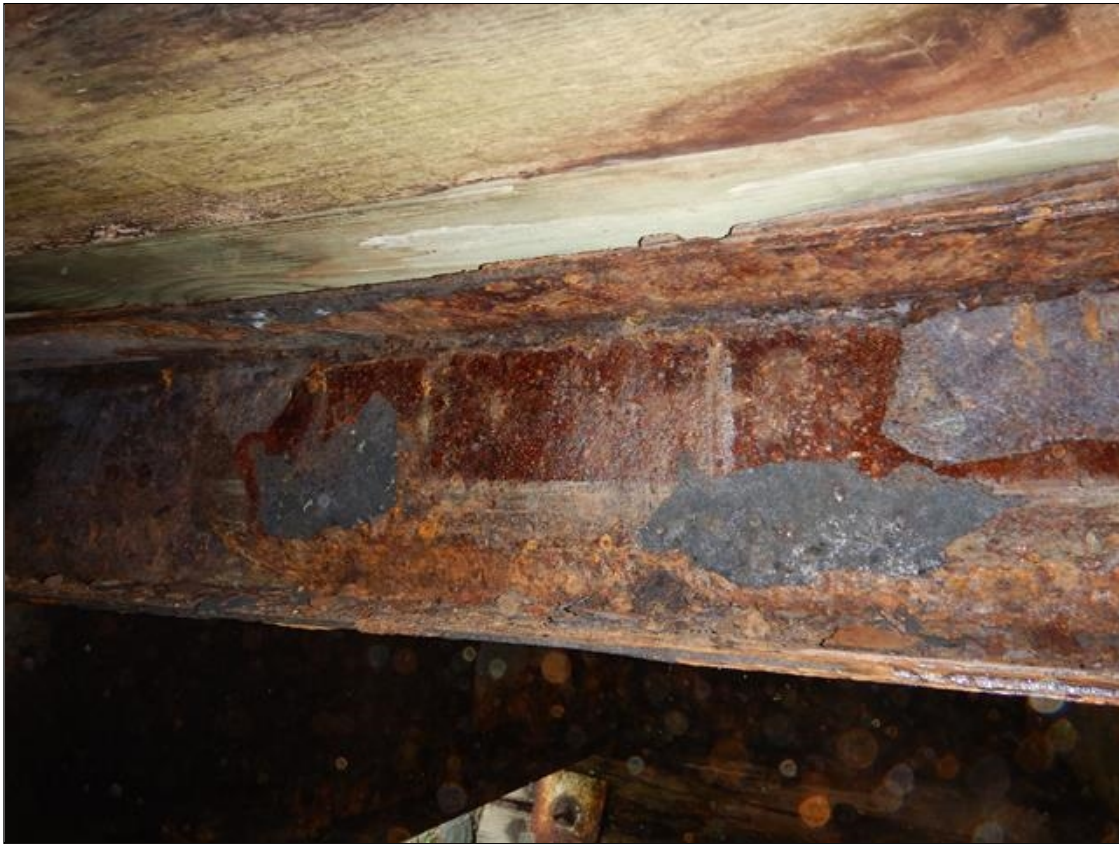
Span 1 Beam 1: RUST SCALE THROUGHOUT 3/4 POINT DIAPHRAGM FLANGES AND WEB WITH 1/4 INCH REMAINING IN BOTTOM FLANGE, 1/4 INCH REMAINING IN TOP FLANGE, AND UP TO 1/16 INCH SECTION LOSS IN WEB (PAR)

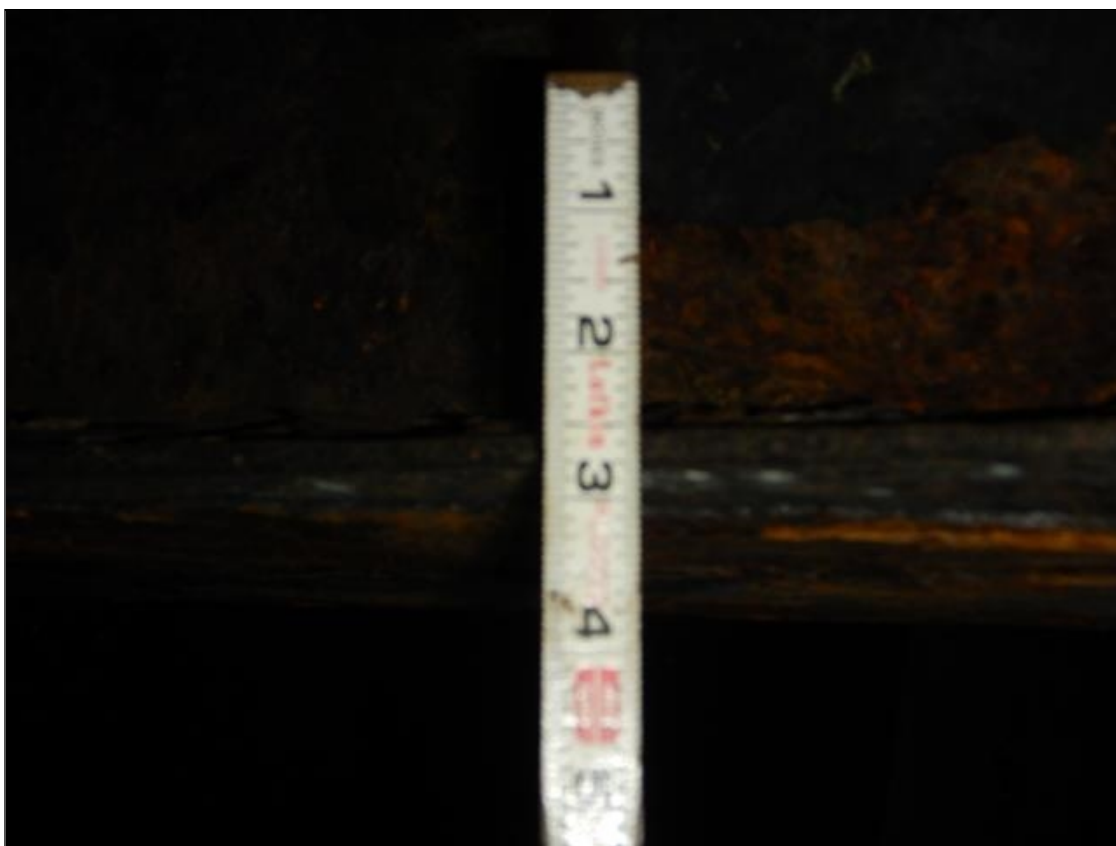
Span 1 Beam 1: RUST SCALE THROUGHOUT 3/4 POINT DIAPHRAGM FLANGES AND WEB WITH 1/4 INCH REMAINING IN BOTTOM FLANGE, 1/4 INCH REMAINING IN TOP FLANGE, AND UP TO 1/16 INCH SECTION LOSS IN WEB (PAR)

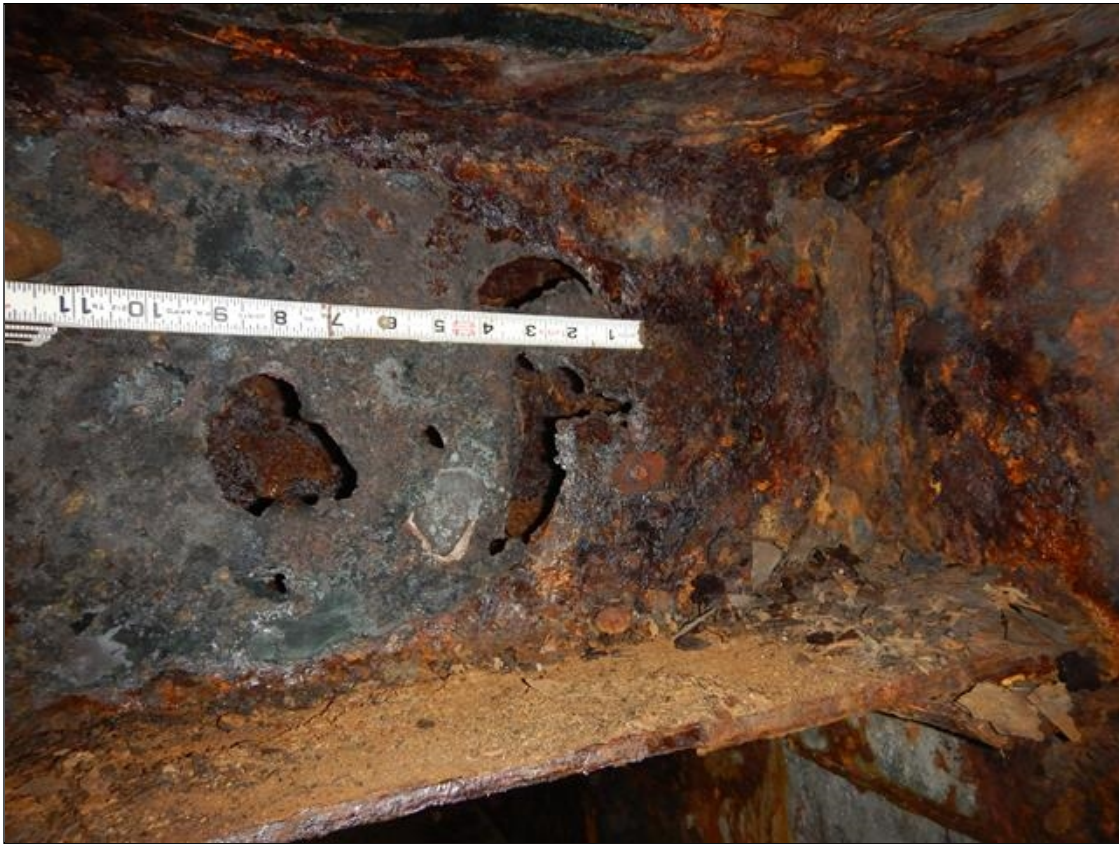
Span 1 Beam 5: RUST SCALE THROUGHOUT 3/4 POINT DIAPHRAGM FLANGES AND WEB WITH 3/16 INCH REMAINING IN BOTTOM FLANGE, 3/16 INCH REMAINING IN TOP FLANGE, AND WEB HOLES UP TO 3 INCH X 4 INCH (PAR)

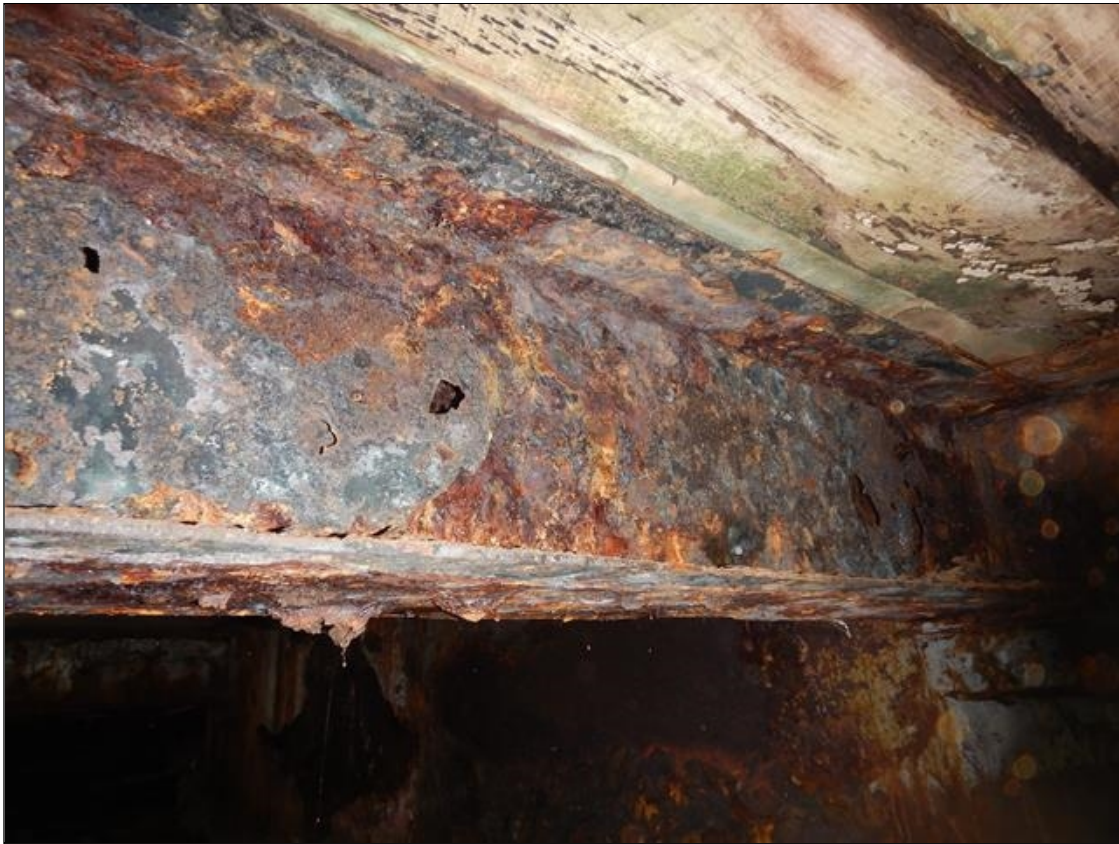
Span 1 Beam 5: RUST SCALE THROUGHOUT 3/4 POINT DIAPHRAGM FLANGES AND WEB WITH 3/16 INCH REMAINING IN BOTTOM FLANGE, 3/16 INCH REMAINING IN TOP FLANGE, AND WEB HOLES UP TO 3 INCH X 4 INCH (PAR)

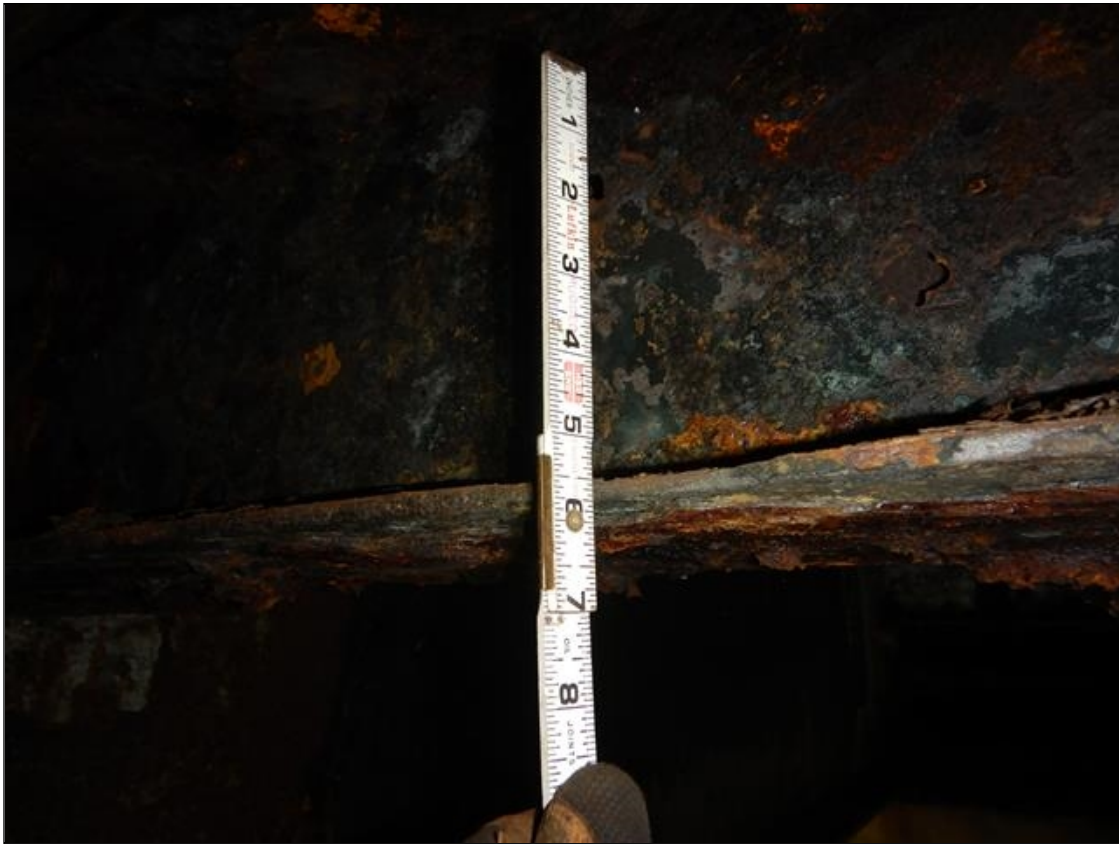
Span 1 Beam 5: RUST SCALE THROUGHOUT 3/4 POINT DIAPHRAGM FLANGES AND WEB WITH 3/16 INCH REMAINING IN BOTTOM FLANGE, 3/16 INCH REMAINING IN TOP FLANGE, AND WEB HOLES UP TO 3 INCH X 4 INCH (PAR)

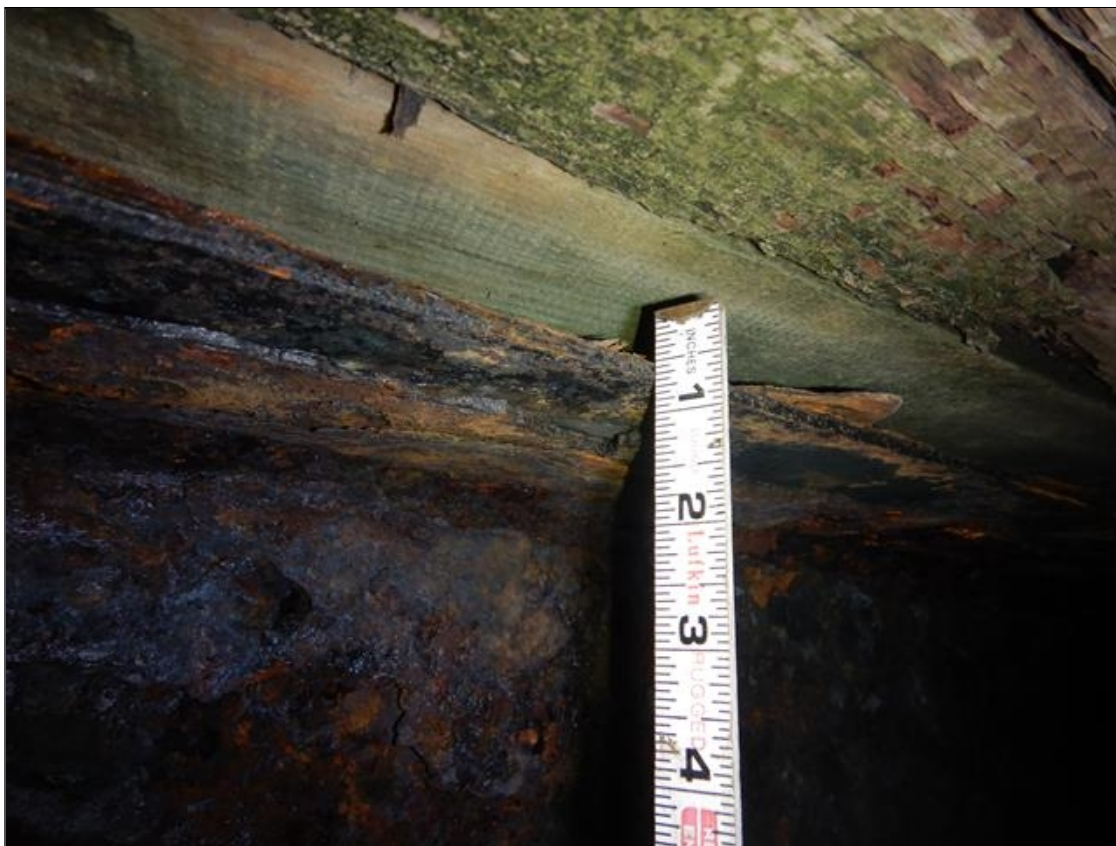
Span 1 Beam 5: RUST SCALE THROUGHOUT 3/4 POINT DIAPHRAGM FLANGES AND WEB WITH 3/16 INCH REMAINING IN BOTTOM FLANGE, 3/16 INCH REMAINING IN TOP FLANGE, AND WEB HOLES UP TO 3 INCH X 4 INCH (PAR)

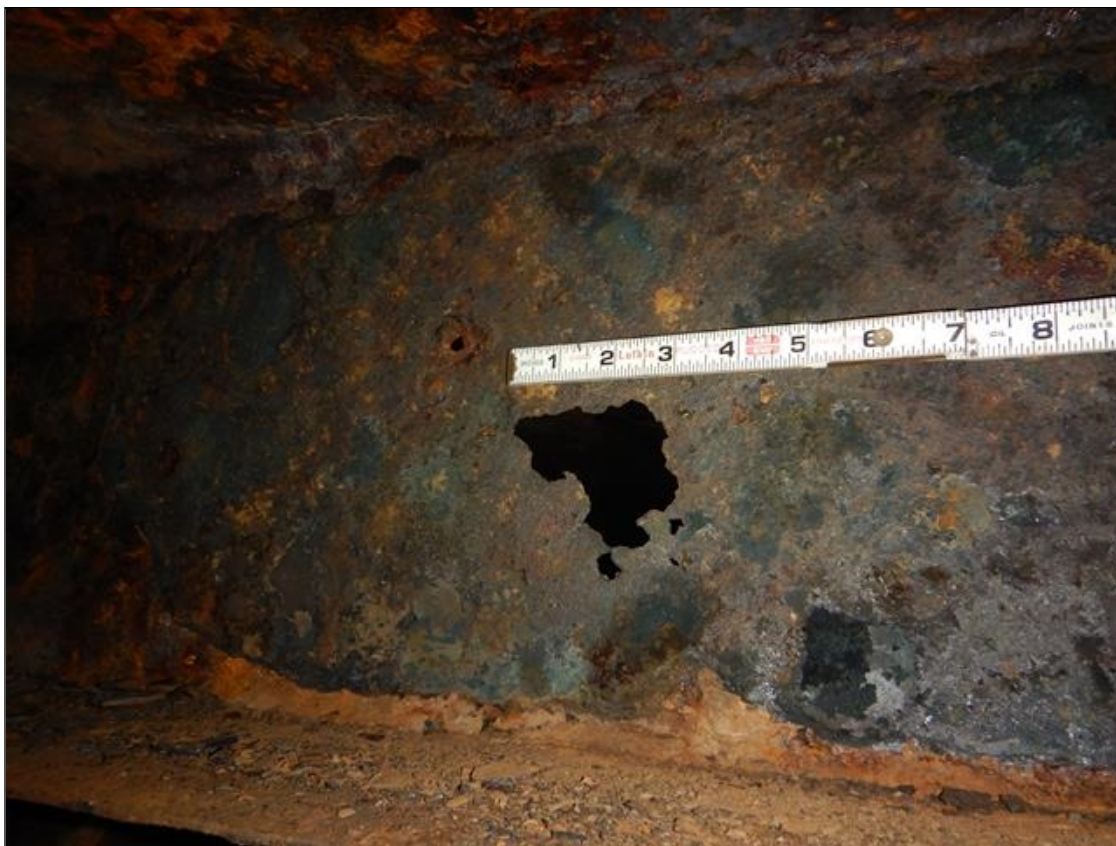
Span 1 Beam 5: RUST SCALE THROUGHOUT 1/2 POINT DIAPHRAGM FLANGES AND WEB WITH 1/8 INCH REMAINING IN BOTTOM FLANGE, 1/4 INCH REMAINING IN TOP FLANGE, AND WEB HOLES UP TO 3 INCH X 3 INCH (PAR)

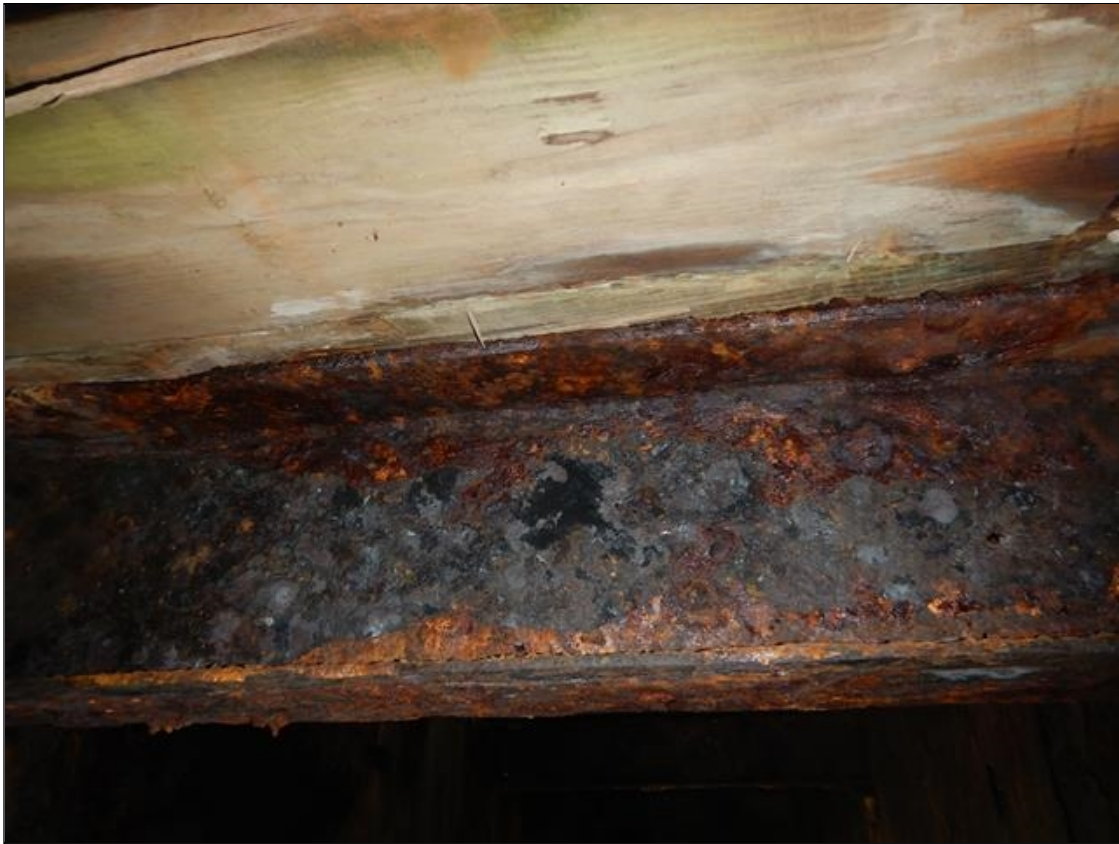
Span 1 Beam 5: RUST SCALE THROUGHOUT 1/2 POINT DIAPHRAGM FLANGES AND WEB WITH 1/8 INCH REMAINING IN BOTTOM FLANGE, 1/4 INCH REMAINING IN TOP FLANGE, AND WEB HOLES UP TO 3 INCH X 3 INCH (PAR)
