NC DEPARTMENT OF TRANSPORTATION
DIVISION OF HIGHWAYS
STRUCTURE MANAGEMENT UNIT

ATTENTION: PAR SUBMITTED

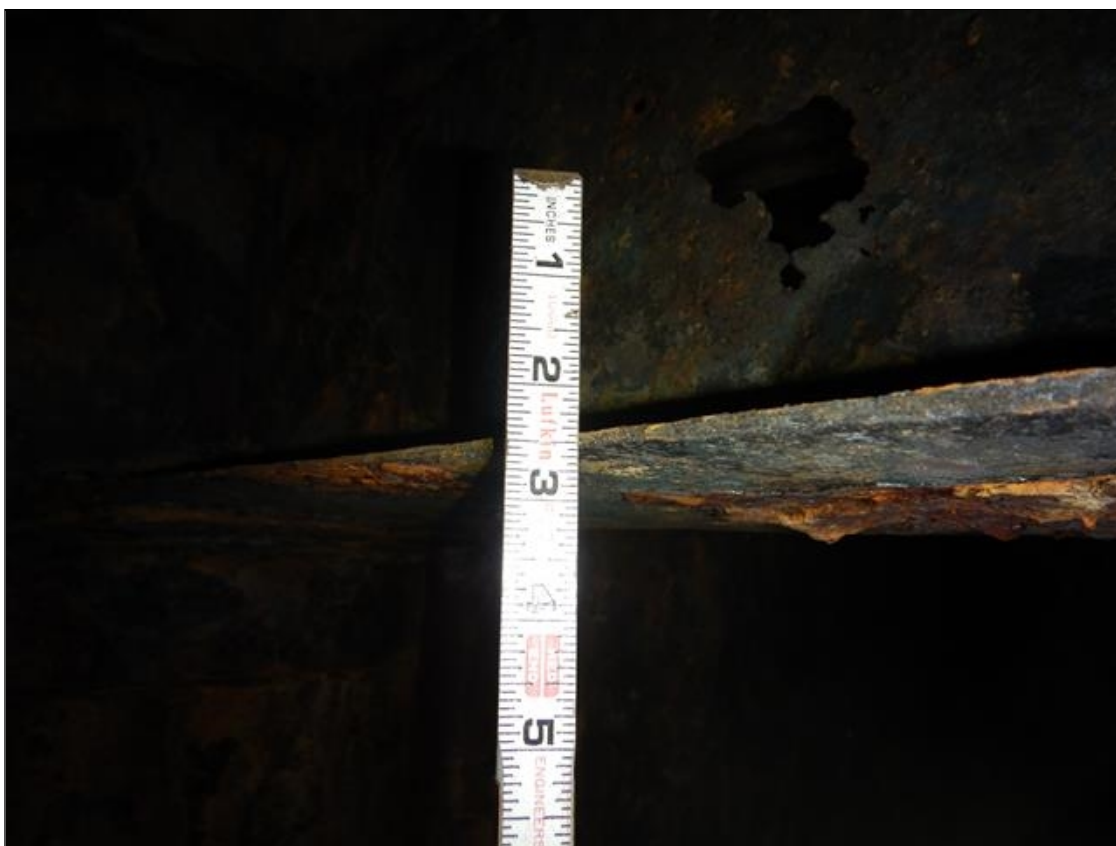
Span 1 Beam 5: RUST SCALE THROUGHOUT 1/2 POINT DIAPHRAGM FLANGES AND WEB WITH 1/8 INCH REMAINING IN BOTTOM FLANGE, 1/4 INCH REMAINING IN TOP FLANGE, AND WEB HOLES UP TO 3 INCH X 3 INCH (PAR)

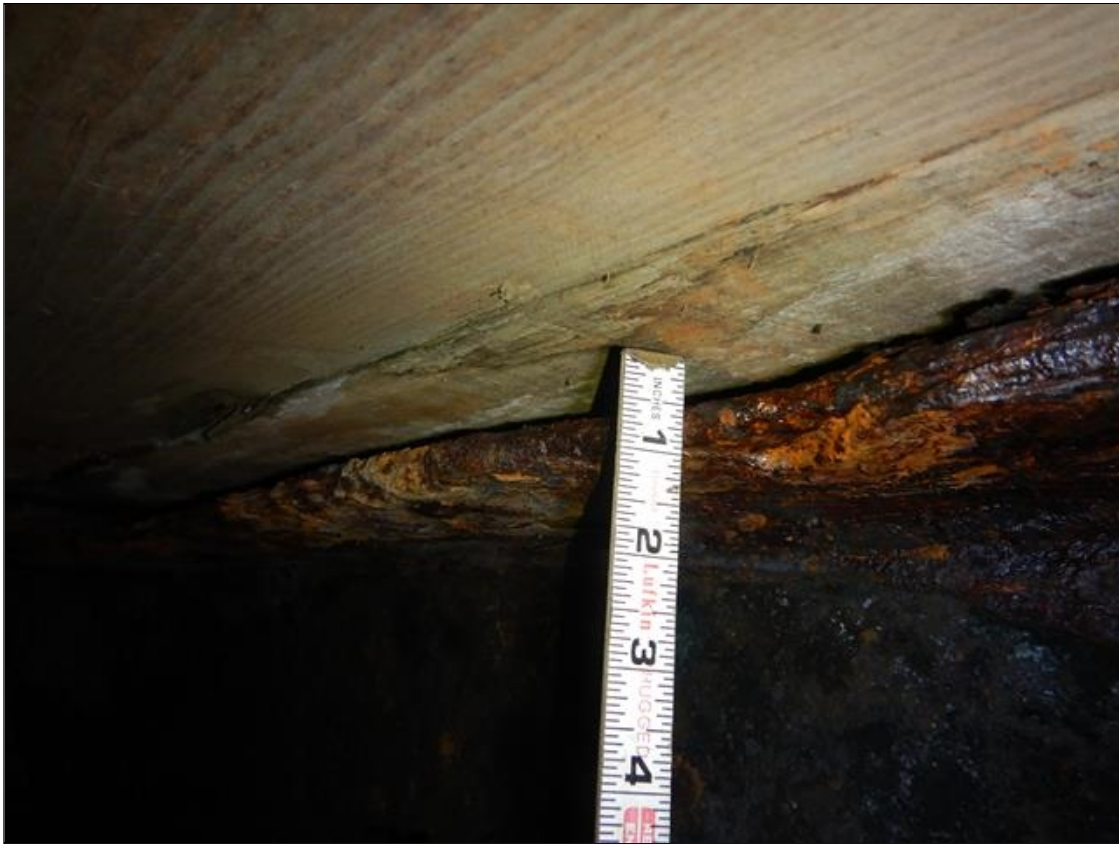
Span 1 Beam 5: RUST SCALE THROUGHOUT 1/2 POINT DIAPHRAGM FLANGES AND WEB WITH 1/8 INCH REMAINING IN BOTTOM FLANGE, 1/4 INCH REMAINING IN TOP FLANGE, AND WEB HOLES UP TO 3 INCH X 3 INCH (PAR)

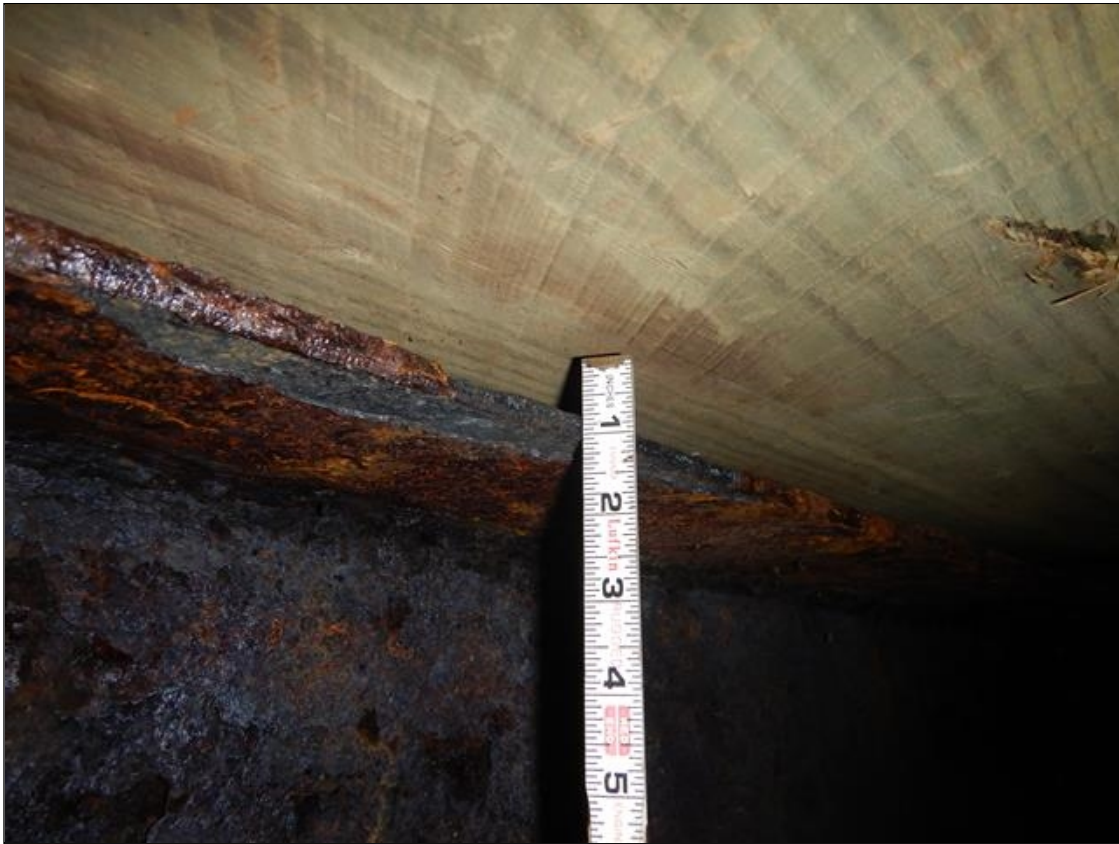
Span 1 Beam 1: RUST SCALE THROUGHOUT 1/2 POINT DIAPHRAGM FLANGES AND WEB WITH 5/16 INCH REMAINING IN BOTTOM FLANGE, 1/4 INCH REMAINING IN TOP FLANGE, AND UP TO 1/16 INCH SECTION LOSS IN WEB (PAR)

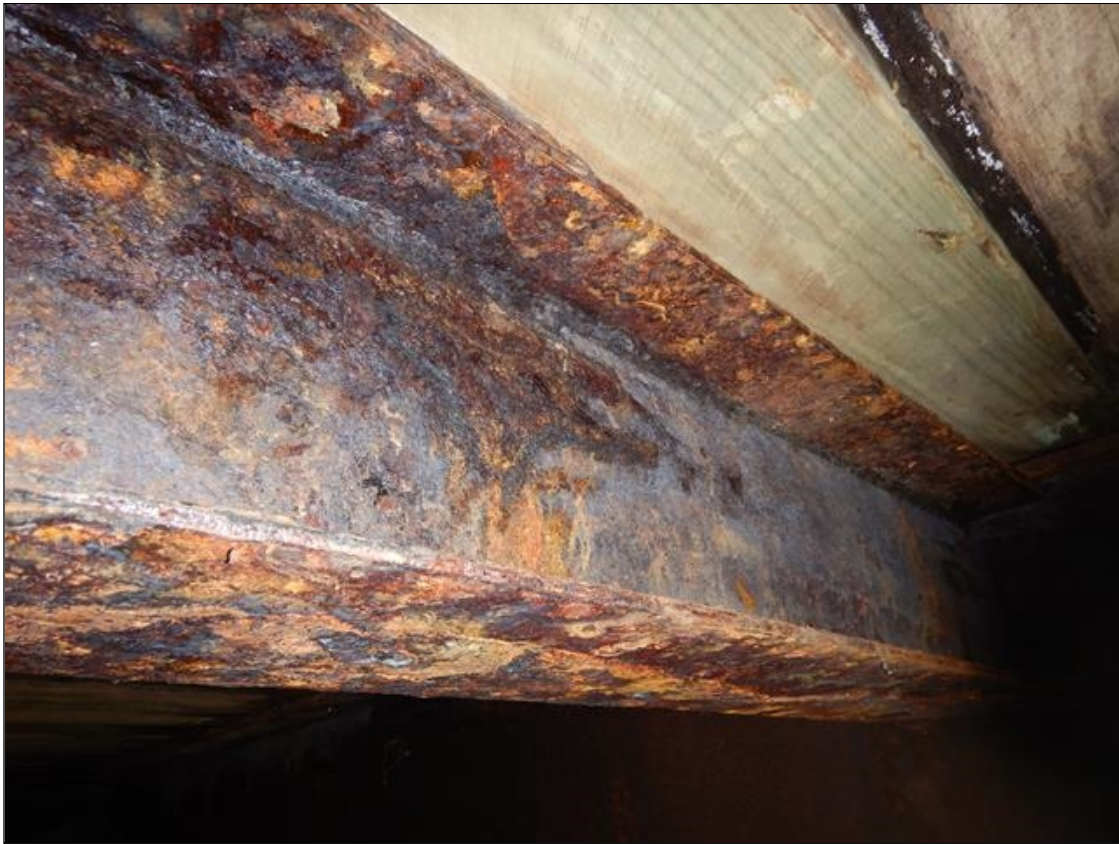
Span 1 Beam 1: RUST SCALE THROUGHOUT 1/2 POINT DIAPHRAGM FLANGES AND WEB WITH 5/16 INCH REMAINING IN BOTTOM FLANGE, 1/4 INCH REMAINING IN TOP FLANGE, AND UP TO 1/16 INCH SECTION LOSS IN WEB (PAR)

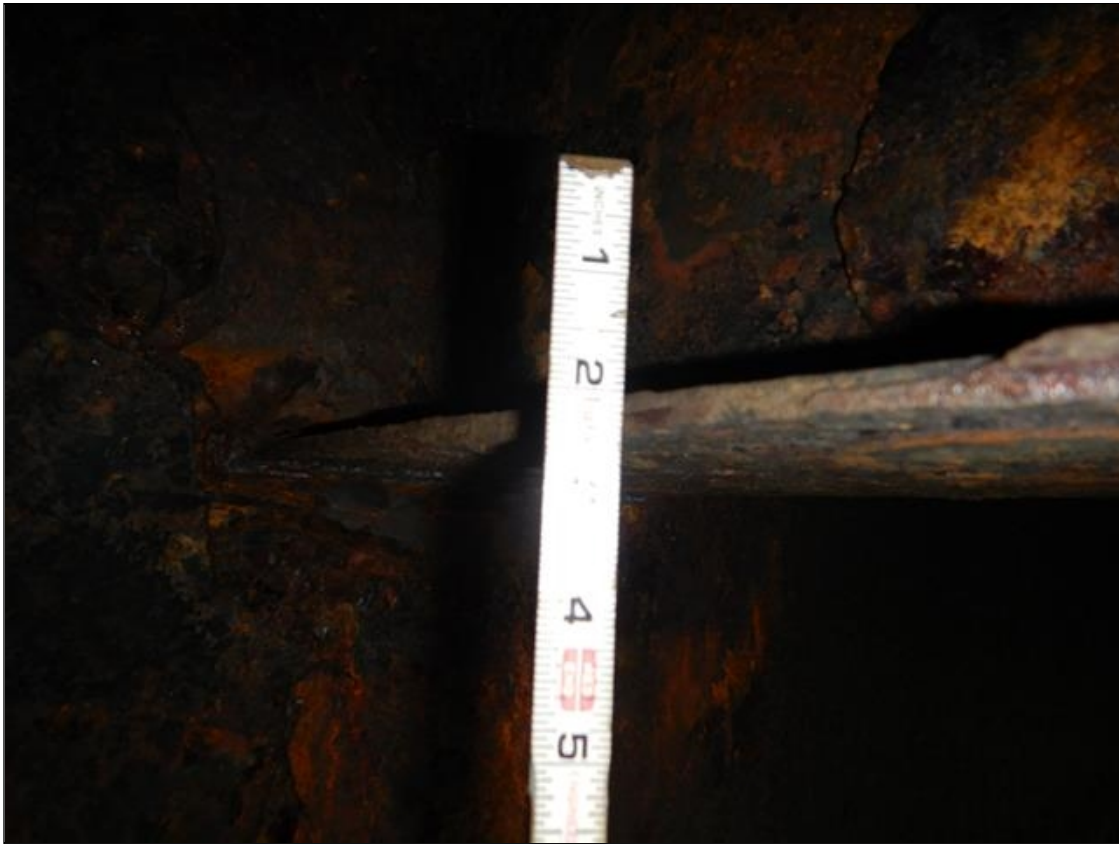
Span 1 Beam 1: RUST SCALE THROUGHOUT 1/2 POINT DIAPHRAGM FLANGES AND WEB WITH 5/16 INCH REMAINING IN BOTTOM FLANGE, 1/4 INCH REMAINING IN TOP FLANGE, AND UP TO 1/16 INCH SECTION LOSS IN WEB (PAR)

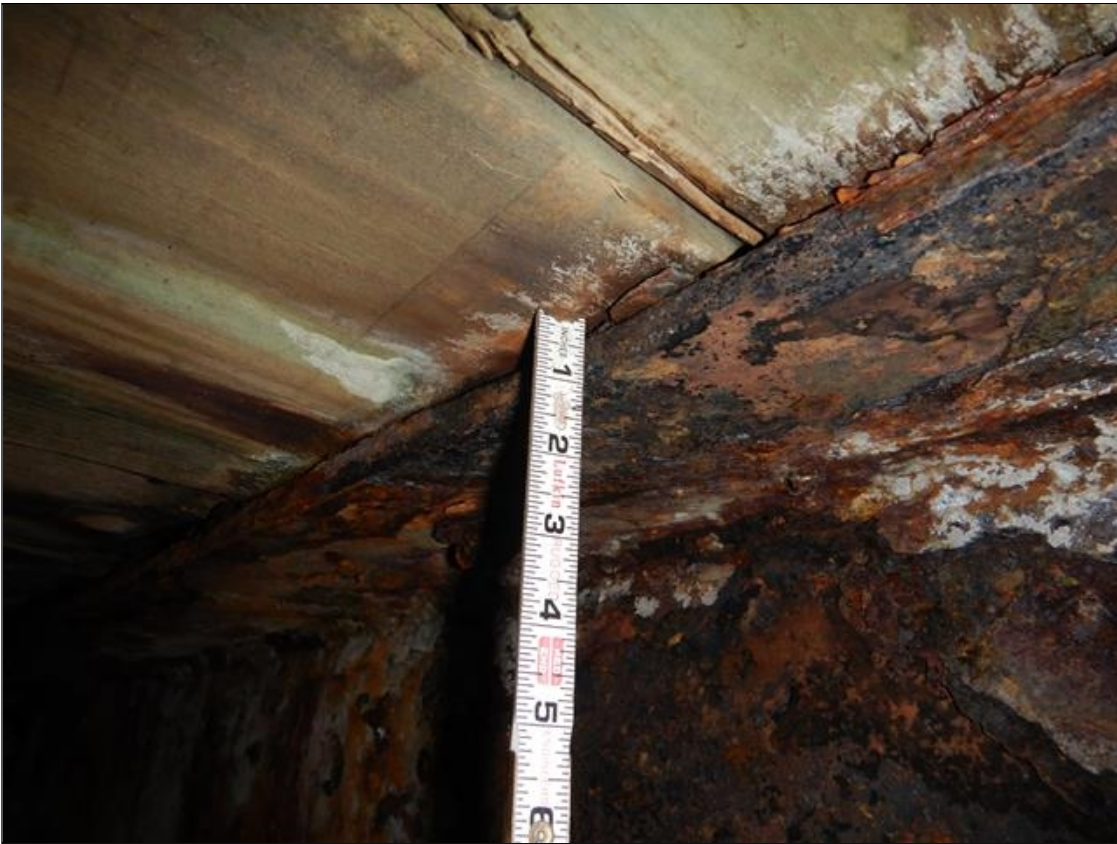
Span 1 Beam 6: RUST SCALE ON TOP AND BOTTOM FLANGES AND UP TO FULL HEIGHT IN WEB WITH UP TO 1/8 INCH SECTION LOSS IN THE WEB, 3/8 INCH REMAINING IN BOTTOM FLANGE AND 9/16 INCH REMAINING IN TOP FLANGE NEAR END BENT 1, 5/16 INCH REMAINING IN BOTTOM FLANGE AND 1/2 INCH REMAINING IN TOP FLANGE AT MID SPAN, 7/16 INCH REMAINING IN BOTTOM FLANGE, AND 5/8 INCH REMAINING IN TOP FLANGE AT END BENT 2 (PAR)

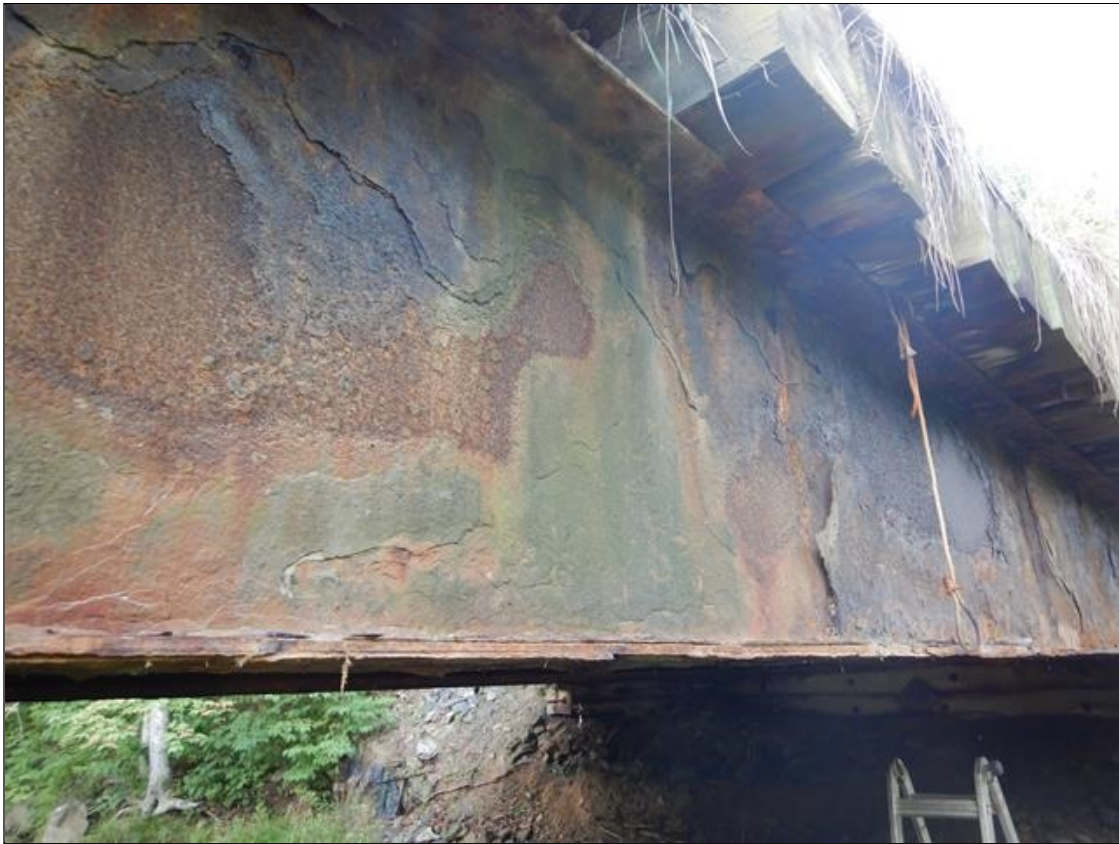
Span 1 Beam 6: RUST SCALE ON TOP AND BOTTOM FLANGES AND UP TO FULL HEIGHT IN WEB WITH UP TO 1/8 INCH SECTION LOSS IN THE WEB, 3/8 INCH REMAINING IN BOTTOM FLANGE AND 9/16 INCH REMAINING IN TOP FLANGE NEAR END BENT 1, 5/16 INCH REMAINING IN BOTTOM FLANGE AND 1/2 INCH REMAINING IN TOP FLANGE AT MID SPAN, 7/16 INCH REMAINING IN BOTTOM FLANGE, AND 5/8 INCH REMAINING IN TOP FLANGE AT END BENT 2 (PAR)

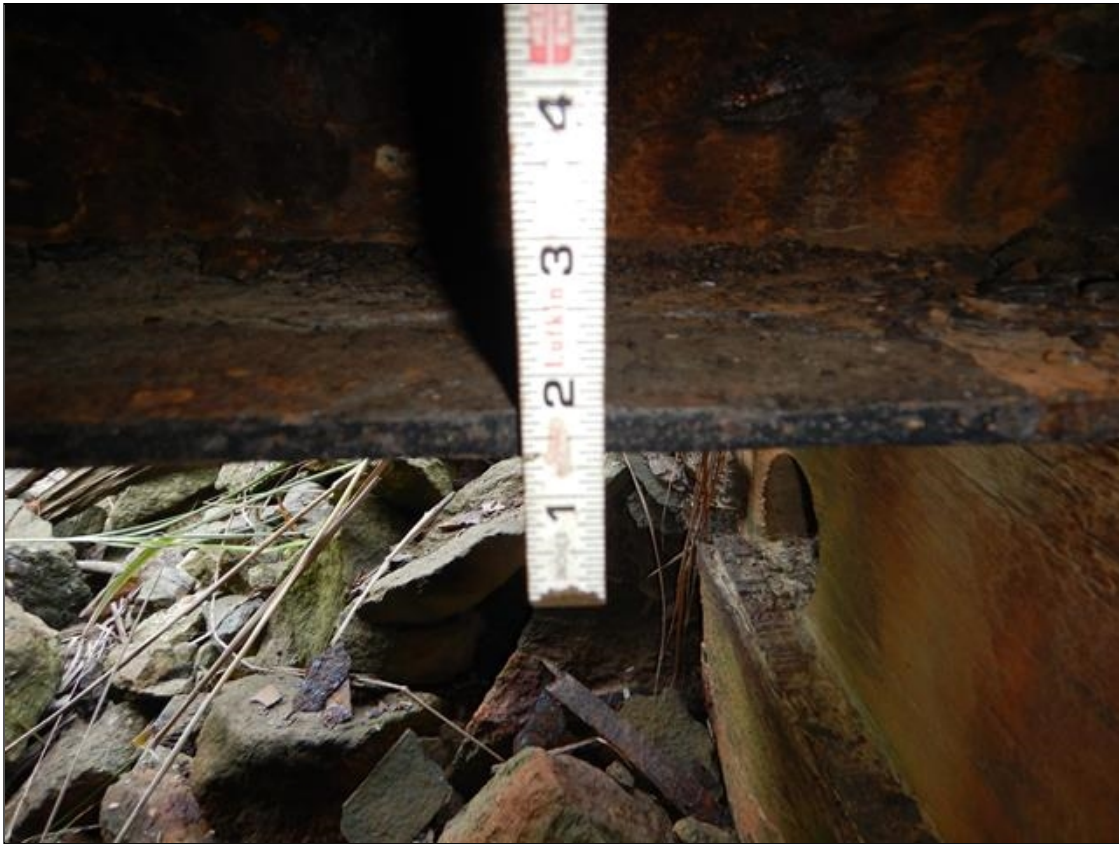
Span 1 Beam 6: RUST SCALE ON TOP AND BOTTOM FLANGES AND UP TO FULL HEIGHT IN WEB WITH UP TO 1/8 INCH SECTION LOSS IN THE WEB, 3/8 INCH REMAINING IN BOTTOM FLANGE AND 9/16 INCH REMAINING IN TOP FLANGE NEAR END BENT 1, 5/16 INCH REMAINING IN BOTTOM FLANGE AND 1/2 INCH REMAINING IN TOP FLANGE AT MID SPAN, 7/16 INCH REMAINING IN BOTTOM FLANGE, AND 5/8 INCH REMAINING IN TOP FLANGE AT END BENT 2 (PAR)

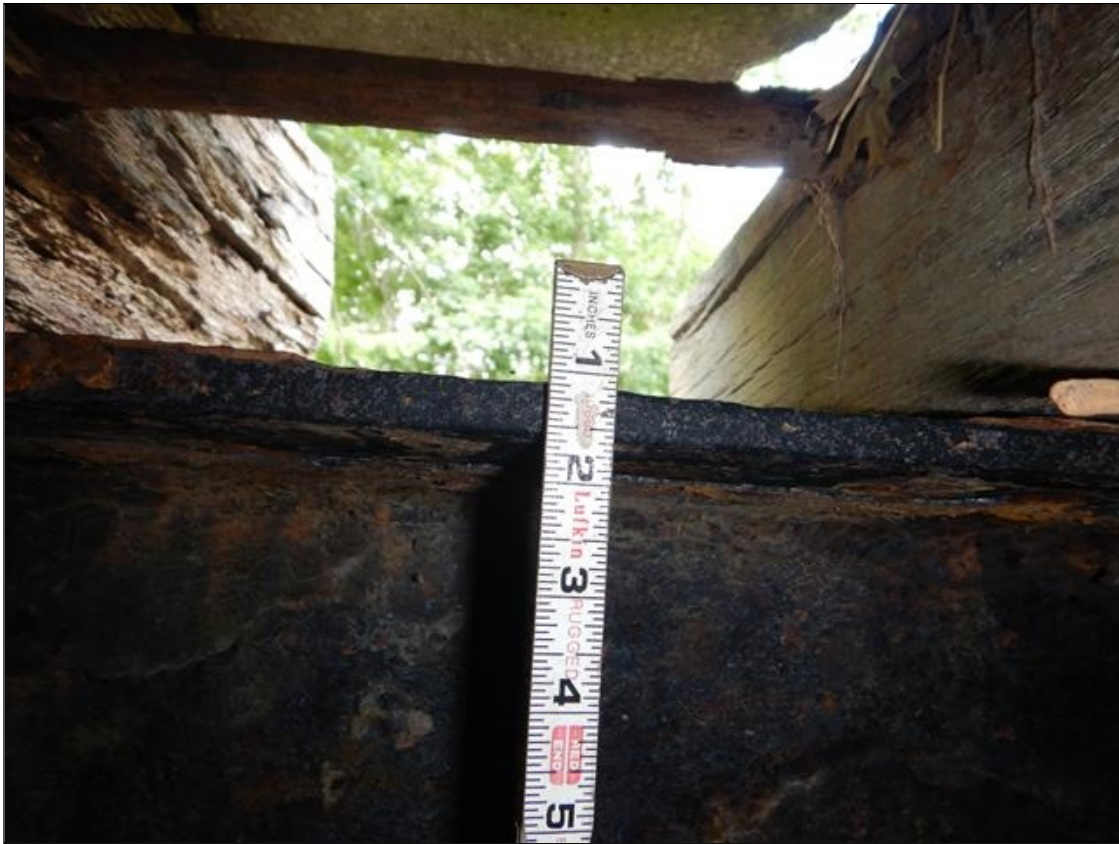
Span 1 Beam 6: RUST SCALE ON TOP AND BOTTOM FLANGES AND UP TO FULL HEIGHT IN WEB WITH UP TO 1/8 INCH SECTION LOSS IN THE WEB, 3/8 INCH REMAINING IN BOTTOM FLANGE AND 9/16 INCH REMAINING IN TOP FLANGE NEAR END BENT 1, 5/16 INCH REMAINING IN BOTTOM FLANGE AND 1/2 INCH REMAINING IN TOP FLANGE AT MID SPAN, 7/16 INCH REMAINING IN BOTTOM FLANGE, AND 5/8 INCH REMAINING IN TOP FLANGE AT END BENT 2 (PAR)

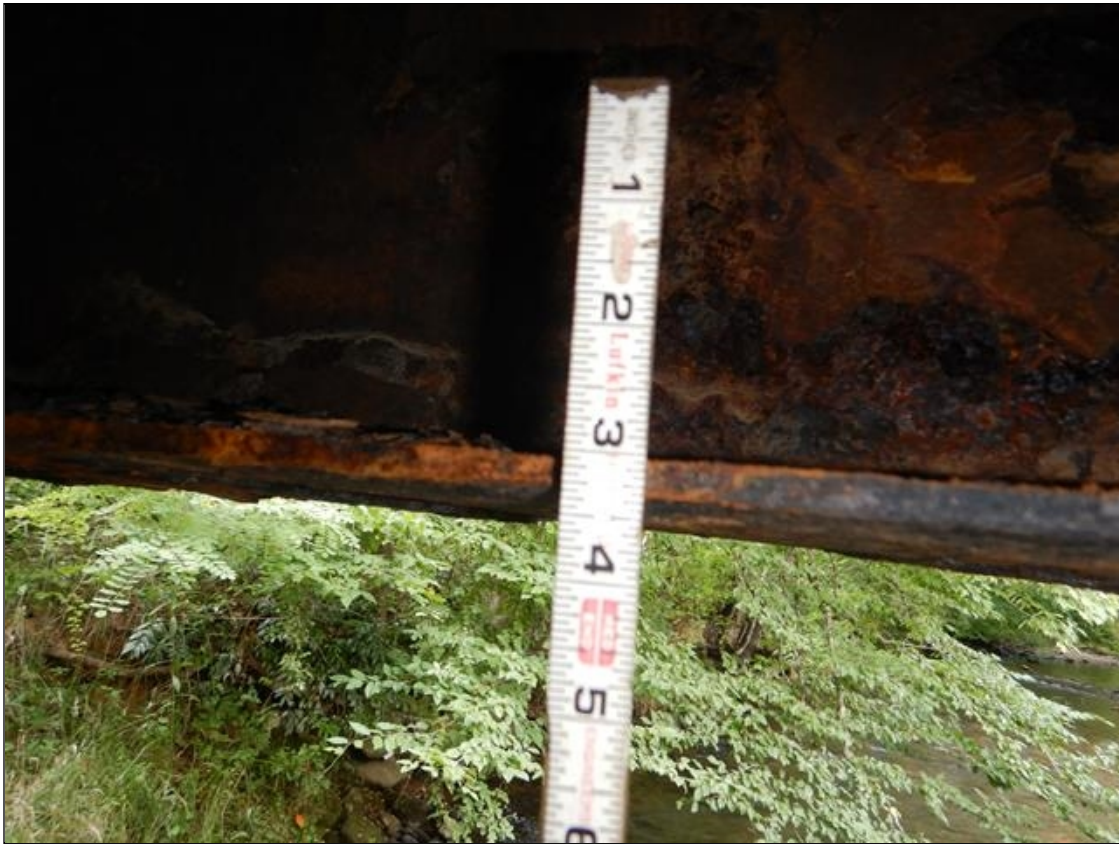
Span 1 Beam 6: RUST SCALE ON TOP AND BOTTOM FLANGES AND UP TO FULL HEIGHT IN WEB WITH UP TO 1/8 INCH SECTION LOSS IN THE WEB, 3/8 INCH REMAINING IN BOTTOM FLANGE AND 9/16 INCH REMAINING IN TOP FLANGE NEAR END BENT 1, 5/16 INCH REMAINING IN BOTTOM FLANGE AND 1/2 INCH REMAINING IN TOP FLANGE AT MID SPAN, 7/16 INCH REMAINING IN BOTTOM FLANGE, AND 5/8 INCH REMAINING IN TOP FLANGE AT END BENT 2 (PAR)

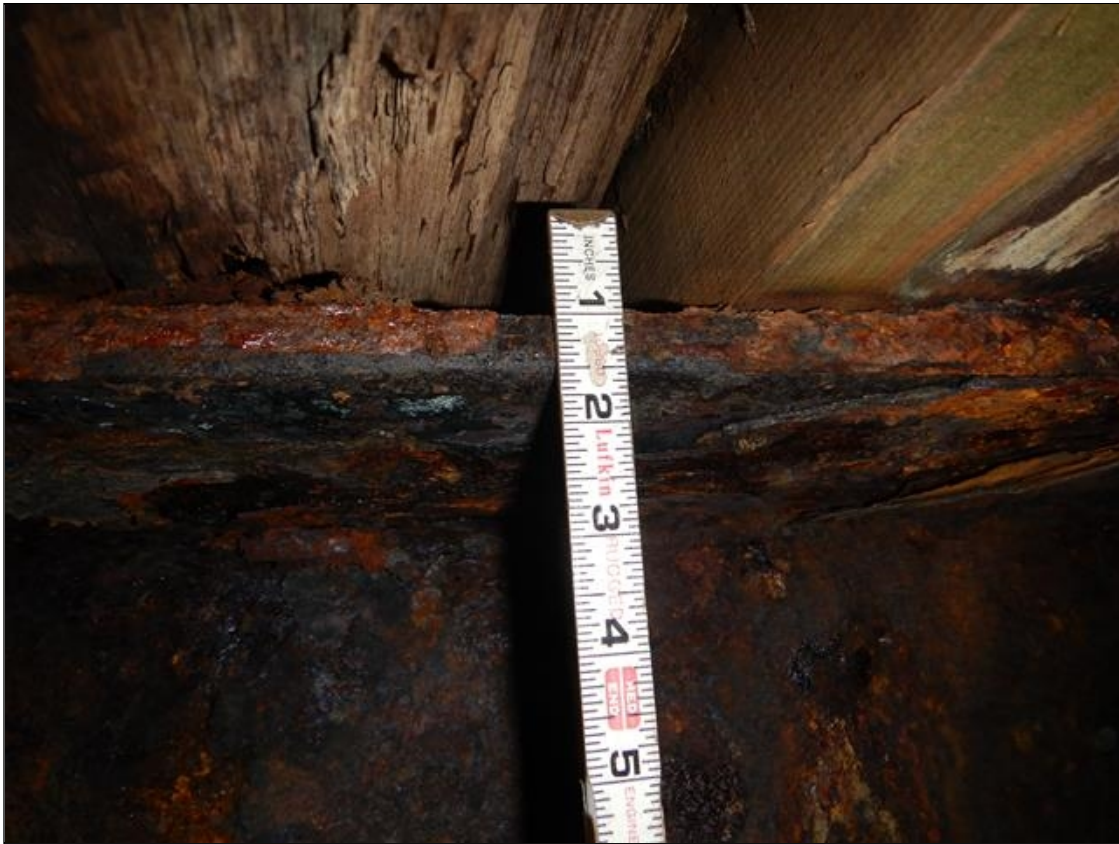
Span 1 Beam 6: RUST SCALE ON TOP AND BOTTOM FLANGES AND UP TO FULL HEIGHT IN WEB WITH UP TO 1/8 INCH SECTION LOSS IN THE WEB, 3/8 INCH REMAINING IN BOTTOM FLANGE AND 9/16 INCH REMAINING IN TOP FLANGE NEAR END BENT 1, 5/16 INCH REMAINING IN BOTTOM FLANGE AND 1/2 INCH REMAINING IN TOP FLANGE AT MID SPAN, 7/16 INCH REMAINING IN BOTTOM FLANGE, AND 5/8 INCH REMAINING IN TOP FLANGE AT END BENT 2 (PAR)

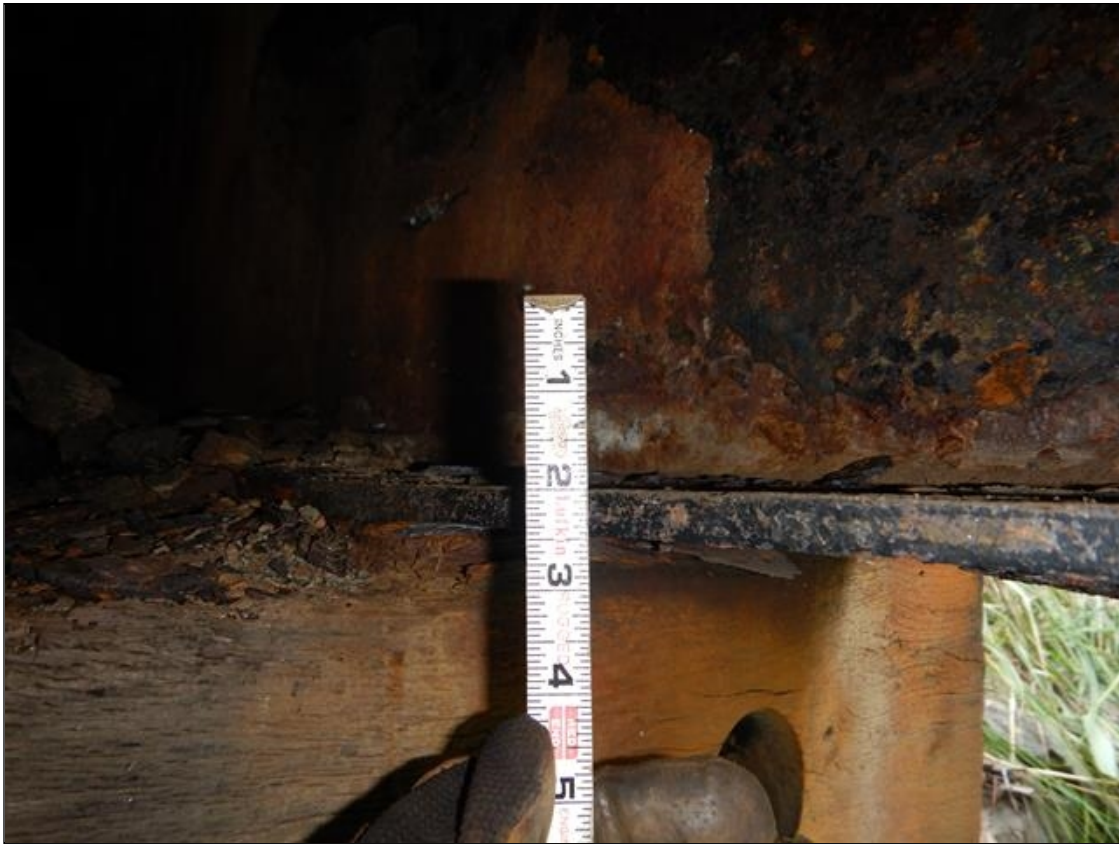
Span 1 Beam 6: RUST SCALE ON TOP AND BOTTOM FLANGES AND UP TO FULL HEIGHT IN WEB WITH UP TO 1/8 INCH SECTION LOSS IN THE WEB, 3/8 INCH REMAINING IN BOTTOM FLANGE AND 9/16 INCH REMAINING IN TOP FLANGE NEAR END BENT 1, 5/16 INCH REMAINING IN BOTTOM FLANGE AND 1/2 INCH REMAINING IN TOP FLANGE AT MID SPAN, 7/16 INCH REMAINING IN BOTTOM FLANGE, AND 5/8 INCH REMAINING IN TOP FLANGE AT END BENT 2 (PAR)

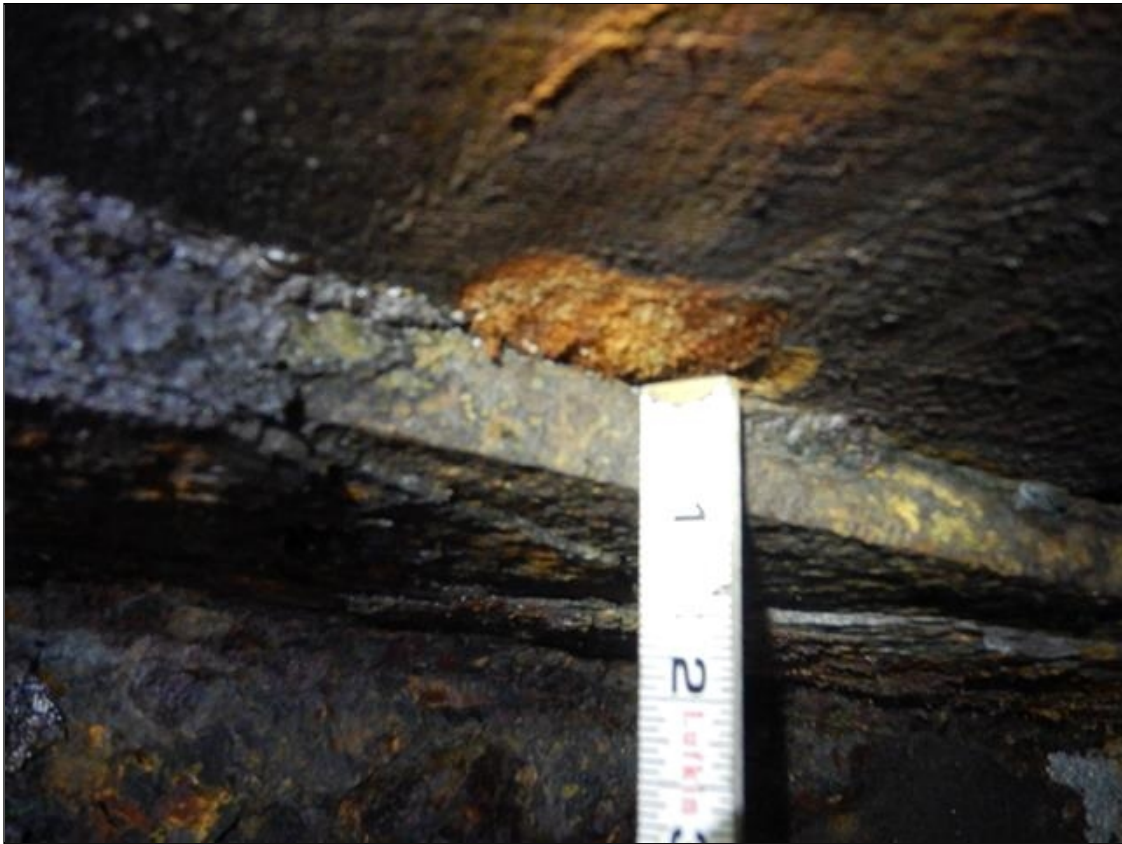
Span 1 Beam 5: RUST SCALE ON TOP AND BOTTOM FLANGES AND UP TO FULL HEIGHT IN WEB WITH UP TO 1/8 INCH SECTION LOSS IN THE WEB, 9/16 INCH REMAINING IN BOTTOM FLANGE AND 11/16 INCH REMAINING IN TOP FLANGE NEAR END BENT 1, 9/16 INCH REMAINING IN BOTTOM FLANGE AND 9/16 INCH REMAINING IN TOP FLANGE AT MID SPAN, 9/16 INCH REMAINING IN BOTTOM FLANGE, AND 11/16 INCH REMAINING IN TOP FLANGE AT END BENT 2 (PAR)

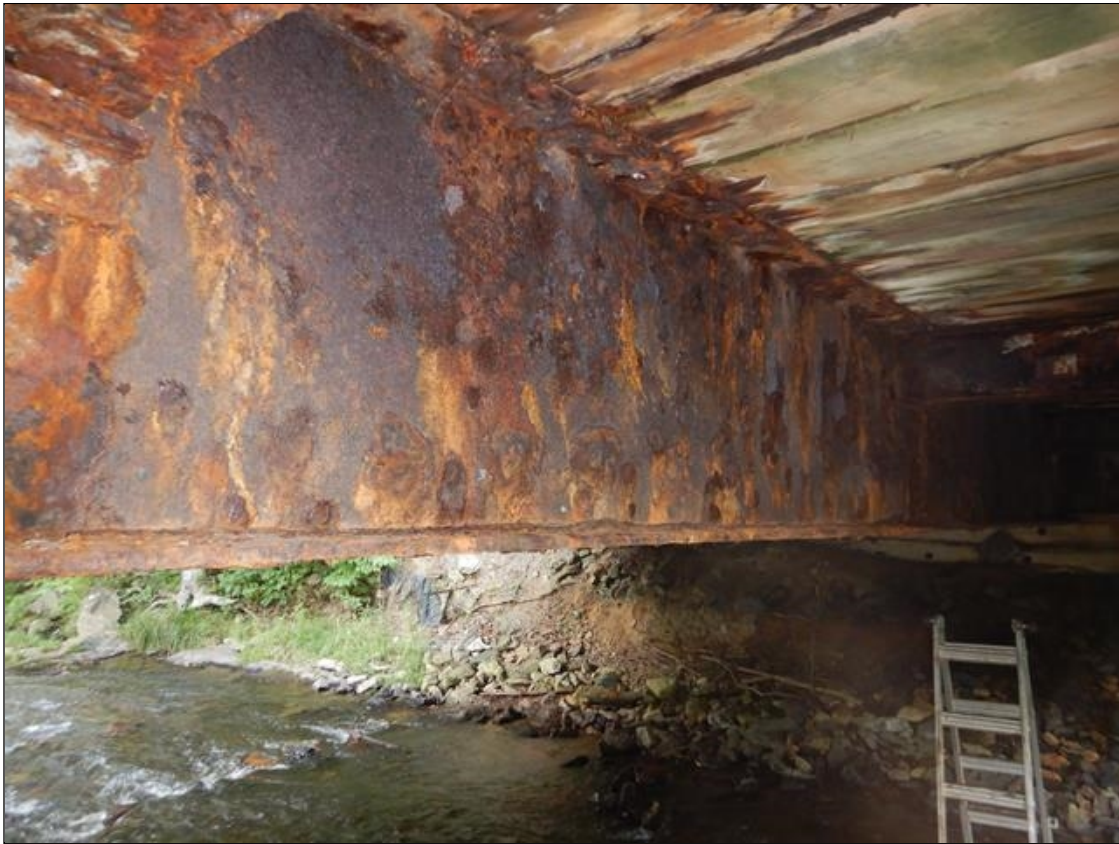
Span 1 Beam 5: RUST SCALE ON TOP AND BOTTOM FLANGES AND UP TO FULL HEIGHT IN WEB WITH UP TO 1/8 INCH SECTION LOSS IN THE WEB, 9/16 INCH REMAINING IN BOTTOM FLANGE AND 11/16 INCH REMAINING IN TOP FLANGE NEAR END BENT 1, 9/16 INCH REMAINING IN BOTTOM FLANGE AND 9/16 INCH REMAINING IN TOP FLANGE AT MID SPAN, 9/16 INCH REMAINING IN BOTTOM FLANGE, AND 11/16 INCH REMAINING IN TOP FLANGE AT END BENT 2 (PAR)

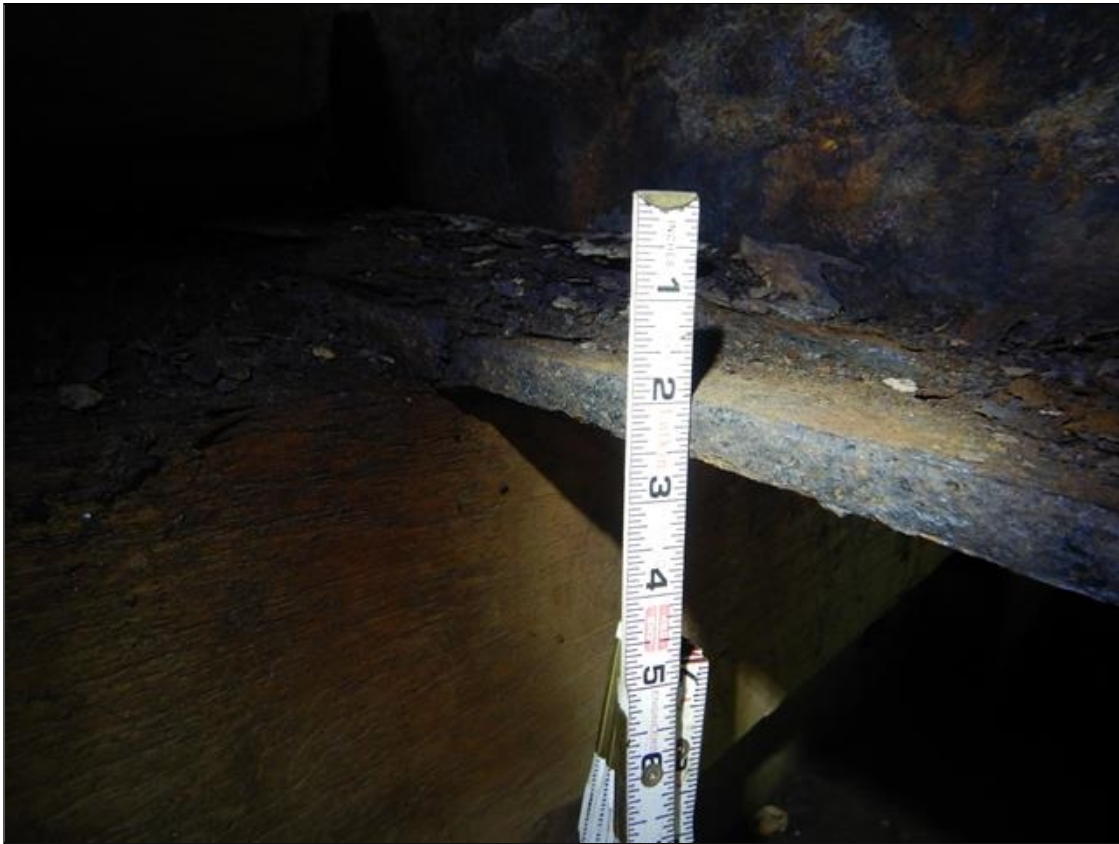
Span 1 Beam 5: RUST SCALE ON TOP AND BOTTOM FLANGES AND UP TO FULL HEIGHT IN WEB WITH UP TO 1/8 INCH SECTION LOSS IN THE WEB, 9/16 INCH REMAINING IN BOTTOM FLANGE AND 11/16 INCH REMAINING IN TOP FLANGE NEAR END BENT 1, 9/16 INCH REMAINING IN BOTTOM FLANGE AND 9/16 INCH REMAINING IN TOP FLANGE AT MID SPAN, 9/16 INCH REMAINING IN BOTTOM FLANGE, AND 11/16 INCH REMAINING IN TOP FLANGE AT END BENT 2 (PAR)

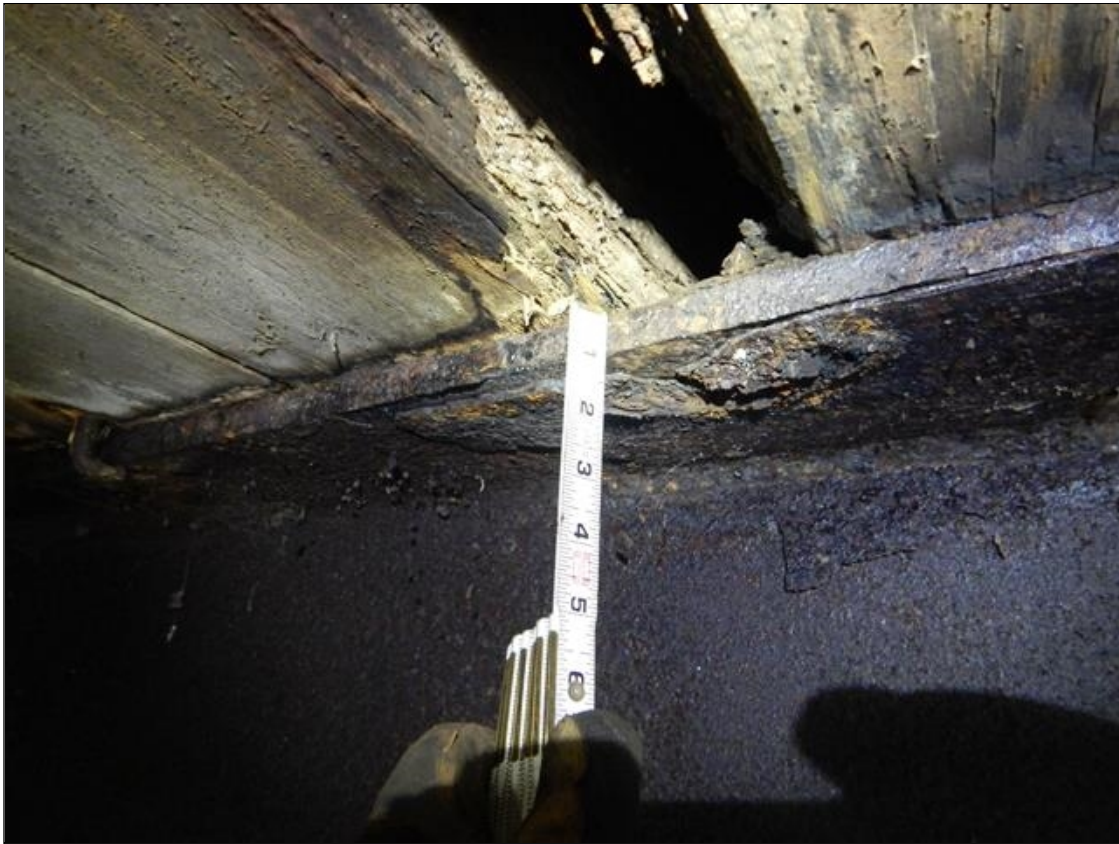
Span 1 Beam 5: RUST SCALE ON TOP AND BOTTOM FLANGES AND UP TO FULL HEIGHT IN WEB WITH UP TO 1/8 INCH SECTION LOSS IN THE WEB, 9/16 INCH REMAINING IN BOTTOM FLANGE AND 11/16 INCH REMAINING IN TOP FLANGE NEAR END BENT 1, 9/16 INCH REMAINING IN BOTTOM FLANGE AND 9/16 INCH REMAINING IN TOP FLANGE AT MID SPAN, 9/16 INCH REMAINING IN BOTTOM FLANGE, AND 11/16 INCH REMAINING IN TOP FLANGE AT END BENT 2 (PAR)

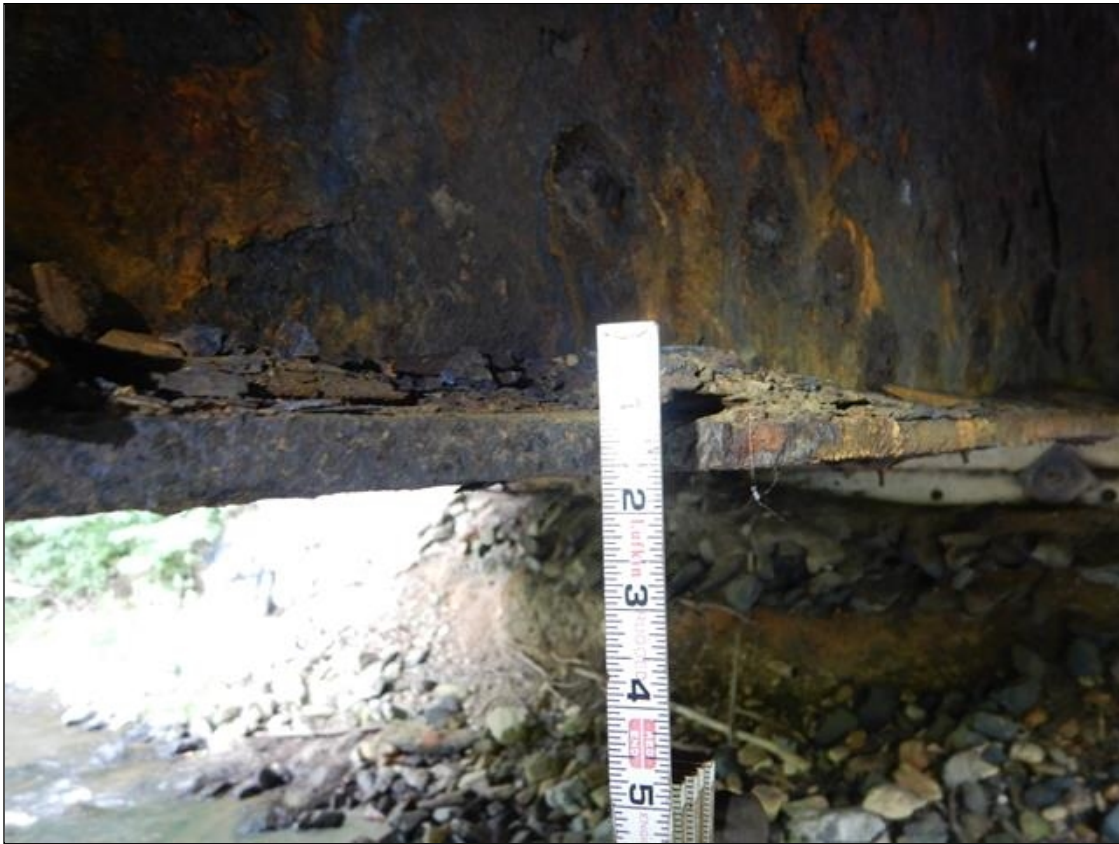
Span 1 Beam 5: RUST SCALE ON TOP AND BOTTOM FLANGES AND UP TO FULL HEIGHT IN WEB WITH UP TO 1/8 INCH SECTION LOSS IN THE WEB, 9/16 INCH REMAINING IN BOTTOM FLANGE AND 11/16 INCH REMAINING IN TOP FLANGE NEAR END BENT 1, 9/16 INCH REMAINING IN BOTTOM FLANGE AND 9/16 INCH REMAINING IN TOP FLANGE AT MID SPAN, 9/16 INCH REMAINING IN BOTTOM FLANGE, AND 11/16 INCH REMAINING IN TOP FLANGE AT END BENT 2 (PAR)

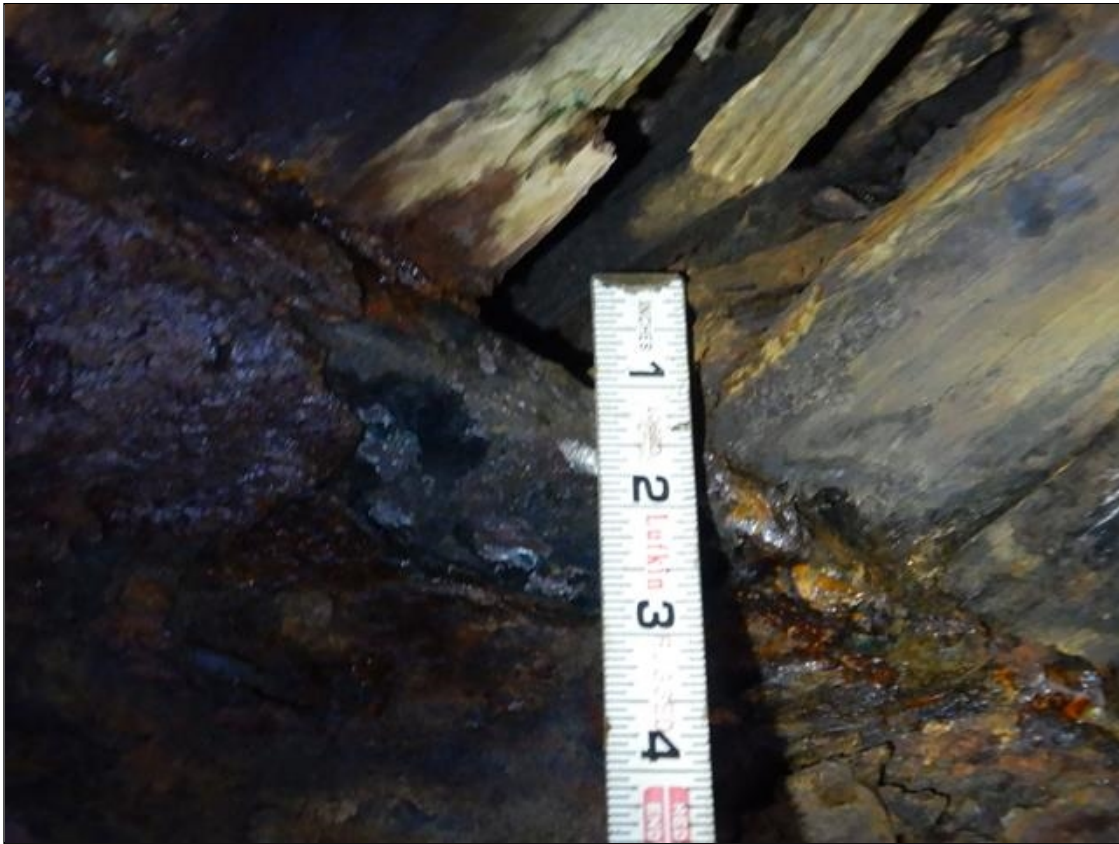
Span 1 Beam 5: RUST SCALE ON TOP AND BOTTOM FLANGES AND UP TO FULL HEIGHT IN WEB WITH UP TO 1/8 INCH SECTION LOSS IN THE WEB, 9/16 INCH REMAINING IN BOTTOM FLANGE AND 11/16 INCH REMAINING IN TOP FLANGE NEAR END BENT 1, 9/16 INCH REMAINING IN BOTTOM FLANGE AND 9/16 INCH REMAINING IN TOP FLANGE AT MID SPAN, 9/16 INCH REMAINING IN BOTTOM FLANGE, AND 11/16 INCH REMAINING IN TOP FLANGE AT END BENT 2 (PAR)

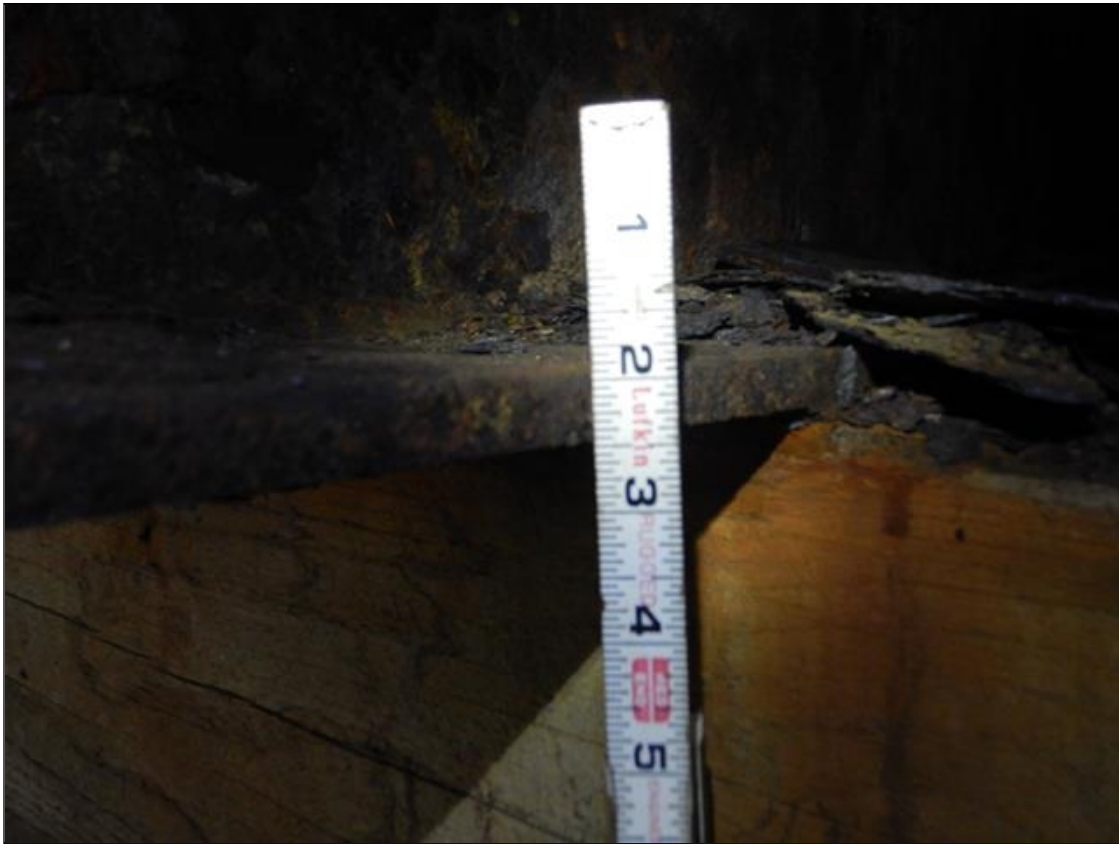
Span 1 Beam 5: RUST SCALE ON TOP AND BOTTOM FLANGES AND UP TO FULL HEIGHT IN WEB WITH UP TO 1/8 INCH SECTION LOSS IN THE WEB, 9/16 INCH REMAINING IN BOTTOM FLANGE AND 11/16 INCH REMAINING IN TOP FLANGE NEAR END BENT 1, 9/16 INCH REMAINING IN BOTTOM FLANGE AND 9/16 INCH REMAINING IN TOP FLANGE AT MID SPAN, 9/16 INCH REMAINING IN BOTTOM FLANGE, AND 11/16 INCH REMAINING IN TOP FLANGE AT END BENT 2 (PAR)

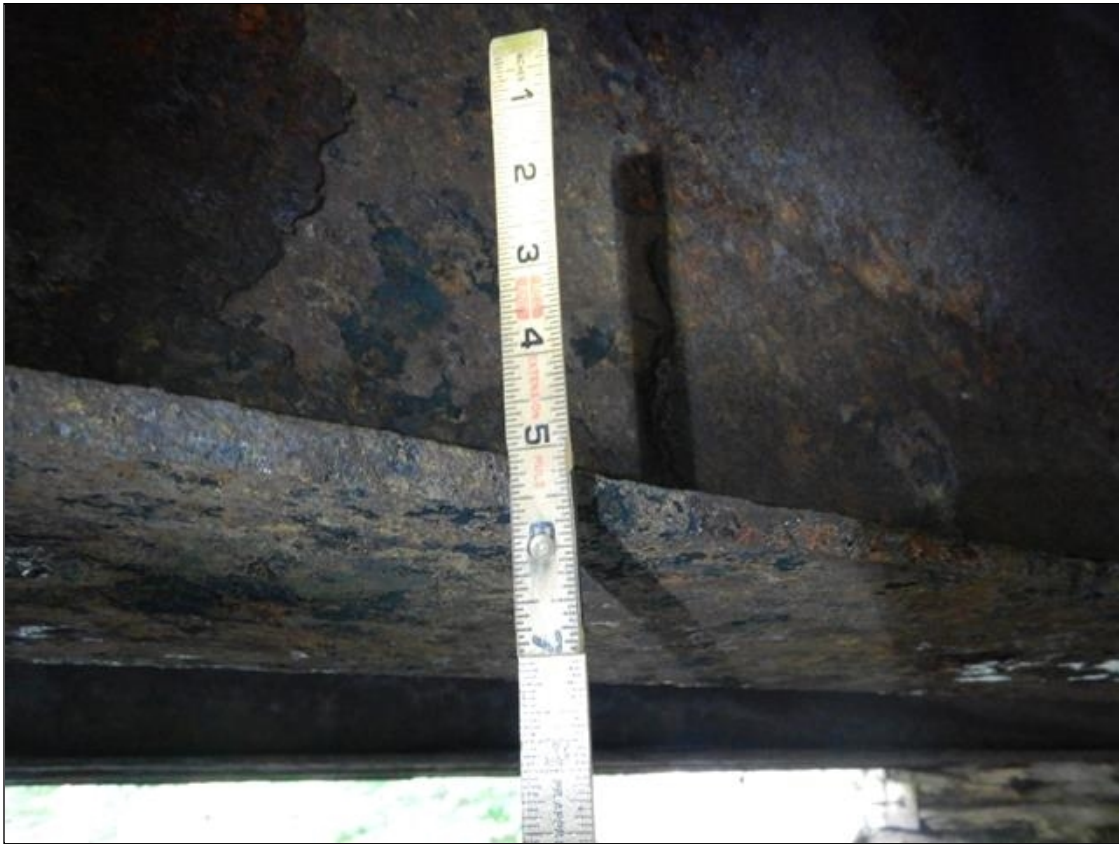
Span 1 Beam 4: 4 FEET OF RUST SCALE ON BOTTOM FLANGE NEAR MID SPAN WITH 1/2 INCH REMAINING (PAR)

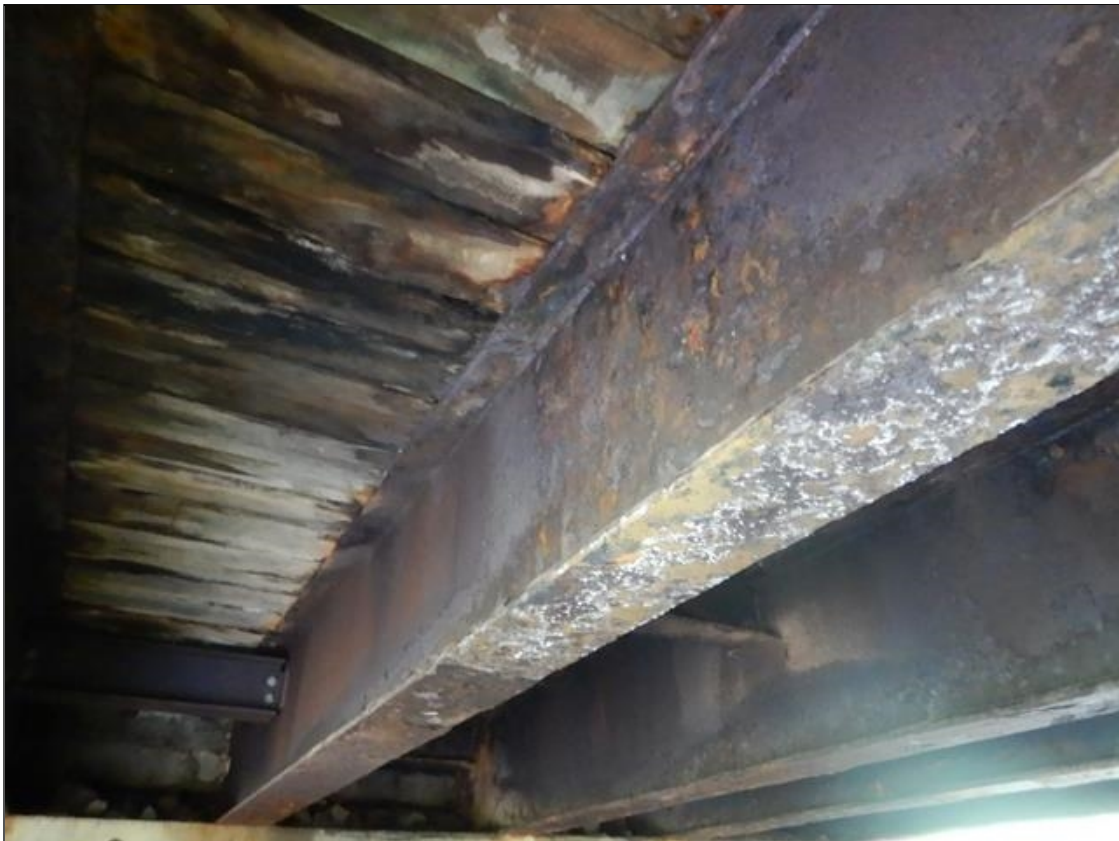
Span 1 Beam 4: LIGHT SCALING THROUGHOUT TOP AND BOTTOM FLANGES AND WEB WITH UP TO 1/16 INCH SECTION LOSS IN TOP AND BOTTOM FLANGES AND WEB

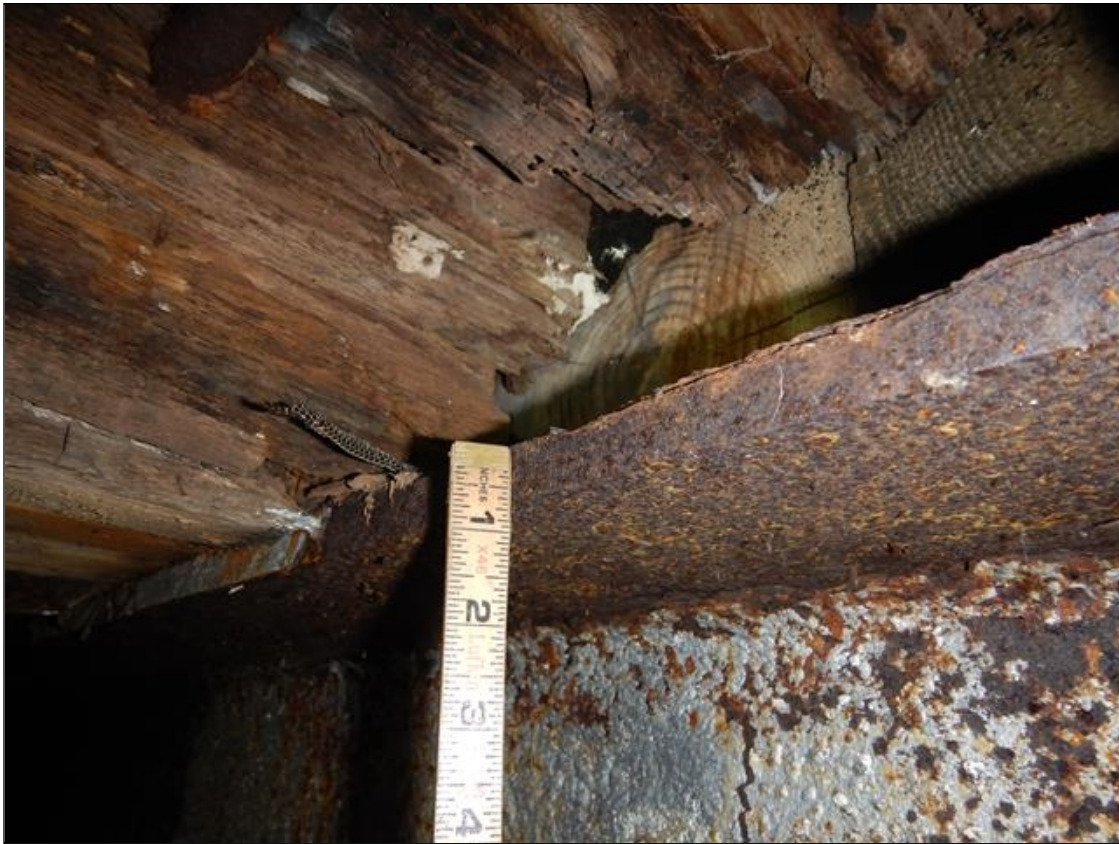
Span 1 Beam 2: RUST SCALE ON TOP AND BOTTOM FLANGES AND UP TO FULL HEIGHT IN WEB WITH UP TO 1/8 INCH SECTION LOSS IN THE WEB, 9/16 INCH REMAINING IN BOTTOM FLANGE AND 11/16 INCH REMAINING IN TOP FLANGE NEAR END BENT 1, 9/16 INCH REMAINING IN BOTTOM FLANGE AND 5/8 INCH REMAINING IN TOP FLANGE AT MID SPAN, 5/8 INCH REMAINING IN BOTTOM FLANGE, AND 5/8 INCH REMAINING IN TOP FLANGE AT END BENT 2 (PAR)
