NC DEPARTMENT OF TRANSPORTATION
DIVISION OF HIGHWAYS
STRUCTURE MANAGEMENT UNIT

ATTENTION: PAR SUBMITTED

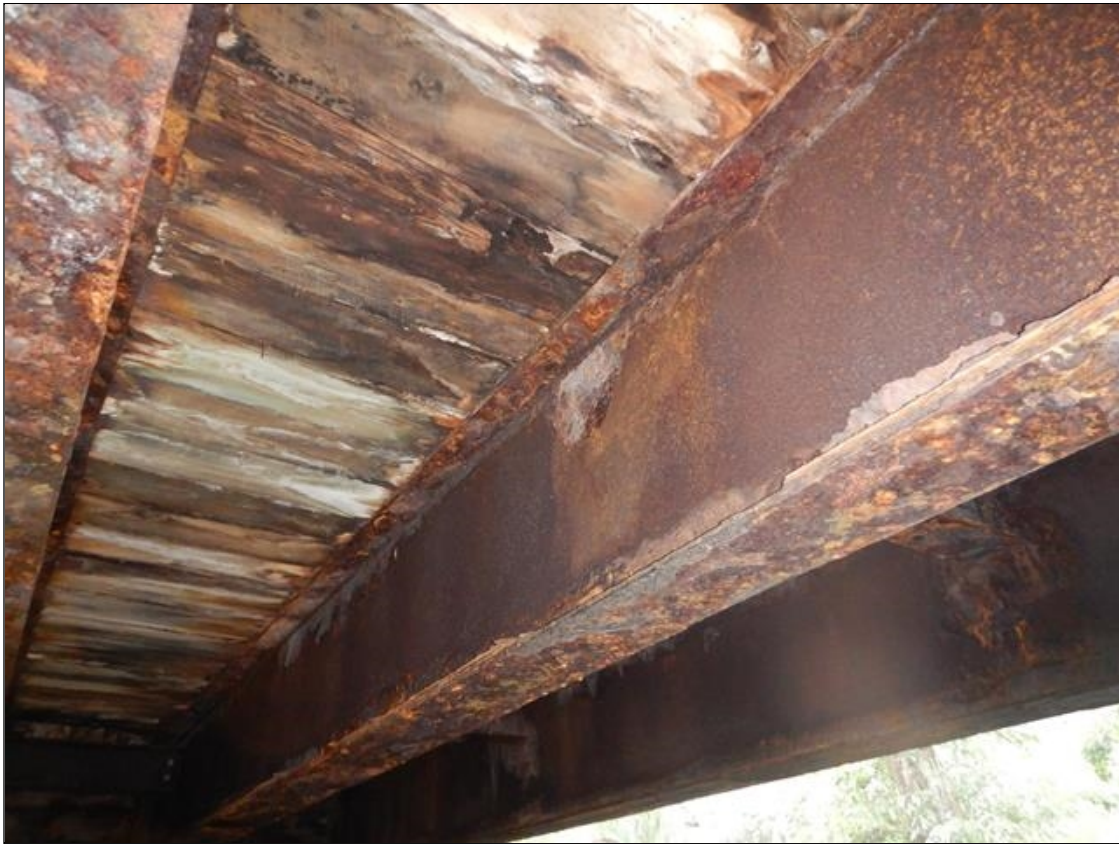
Span 1 Beam 2: RUST SCALE ON TOP AND BOTTOM FLANGES AND UP TO FULL HEIGHT IN WEB WITH UP TO 1/8 INCH SECTION LOSS IN THE WEB, 9/16 INCH REMAINING IN BOTTOM FLANGE AND 11/16 INCH REMAINING IN TOP FLANGE NEAR END BENT 1, 9/16 INCH REMAINING IN BOTTOM FLANGE AND 5/8 INCH REMAINING IN TOP FLANGE AT MID SPAN, 5/8 INCH REMAINING IN BOTTOM FLANGE, AND 5/8 INCH REMAINING IN TOP FLANGE AT END BENT 2 (PAR)

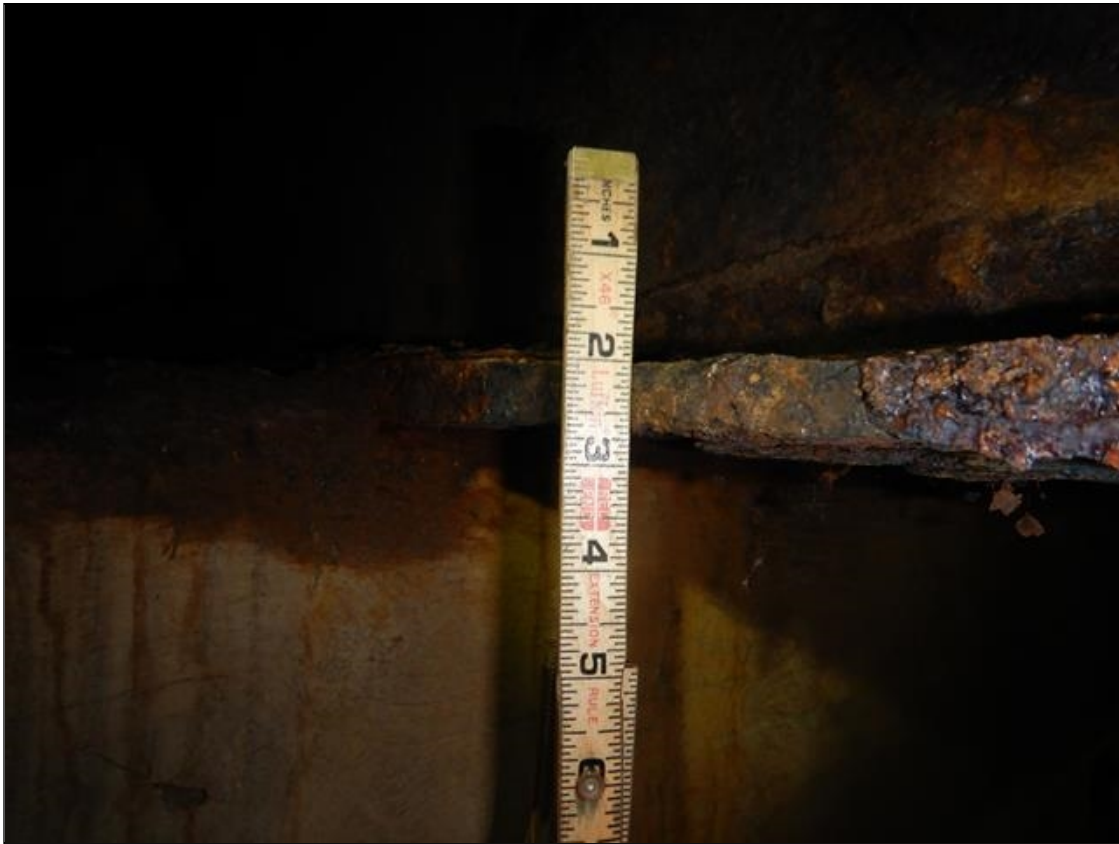
Span 1 Beam 2: RUST SCALE ON TOP AND BOTTOM FLANGES AND UP TO FULL HEIGHT IN WEB WITH UP TO 1/8 INCH SECTION LOSS IN THE WEB, 9/16 INCH REMAINING IN BOTTOM FLANGE AND 11/16 INCH REMAINING IN TOP FLANGE NEAR END BENT 1, 9/16 INCH REMAINING IN BOTTOM FLANGE AND 5/8 INCH REMAINING IN TOP FLANGE AT MID SPAN, 5/8 INCH REMAINING IN BOTTOM FLANGE, AND 5/8 INCH REMAINING IN TOP FLANGE AT END BENT 2 (PAR)

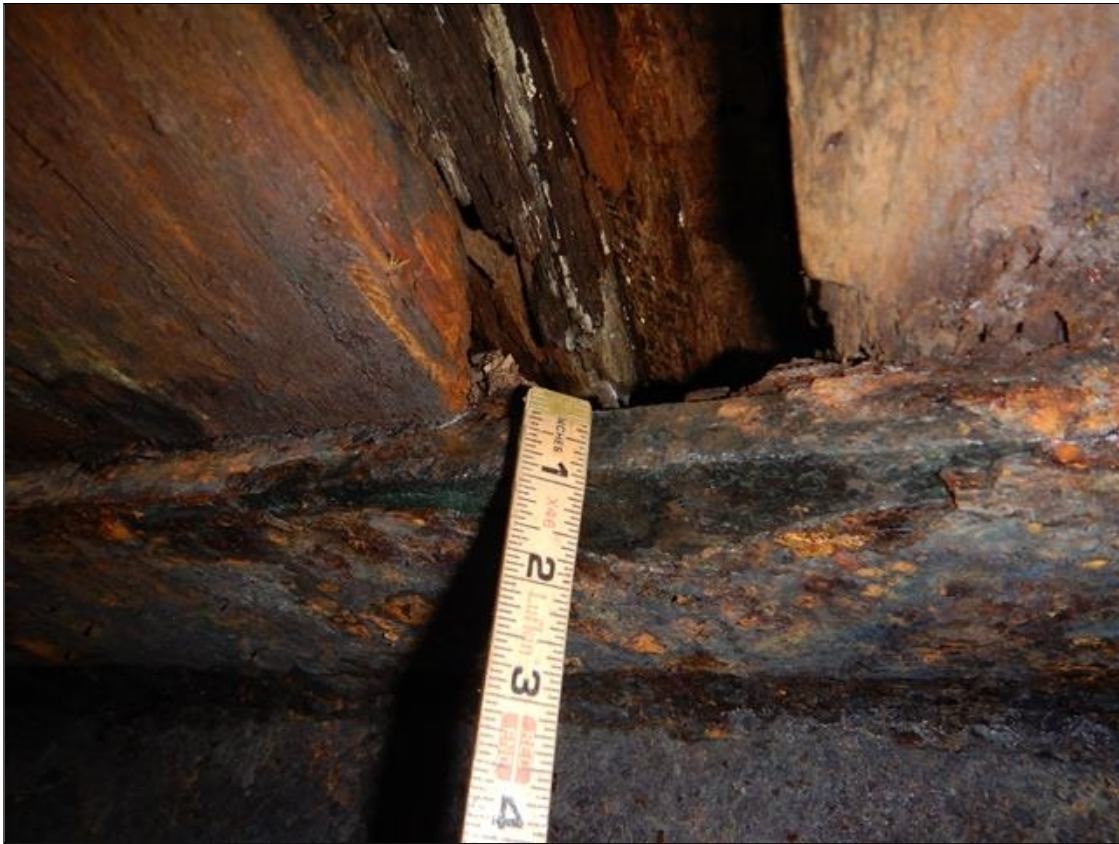
Span 1 Beam 2: RUST SCALE ON TOP AND BOTTOM FLANGES AND UP TO FULL HEIGHT IN WEB WITH UP TO 1/8 INCH SECTION LOSS IN THE WEB, 9/16 INCH REMAINING IN BOTTOM FLANGE AND 11/16 INCH REMAINING IN TOP FLANGE NEAR END BENT 1, 9/16 INCH REMAINING IN BOTTOM FLANGE AND 5/8 INCH REMAINING IN TOP FLANGE AT MID SPAN, 5/8 INCH REMAINING IN BOTTOM FLANGE, AND 5/8 INCH REMAINING IN TOP FLANGE AT END BENT 2 (PAR)

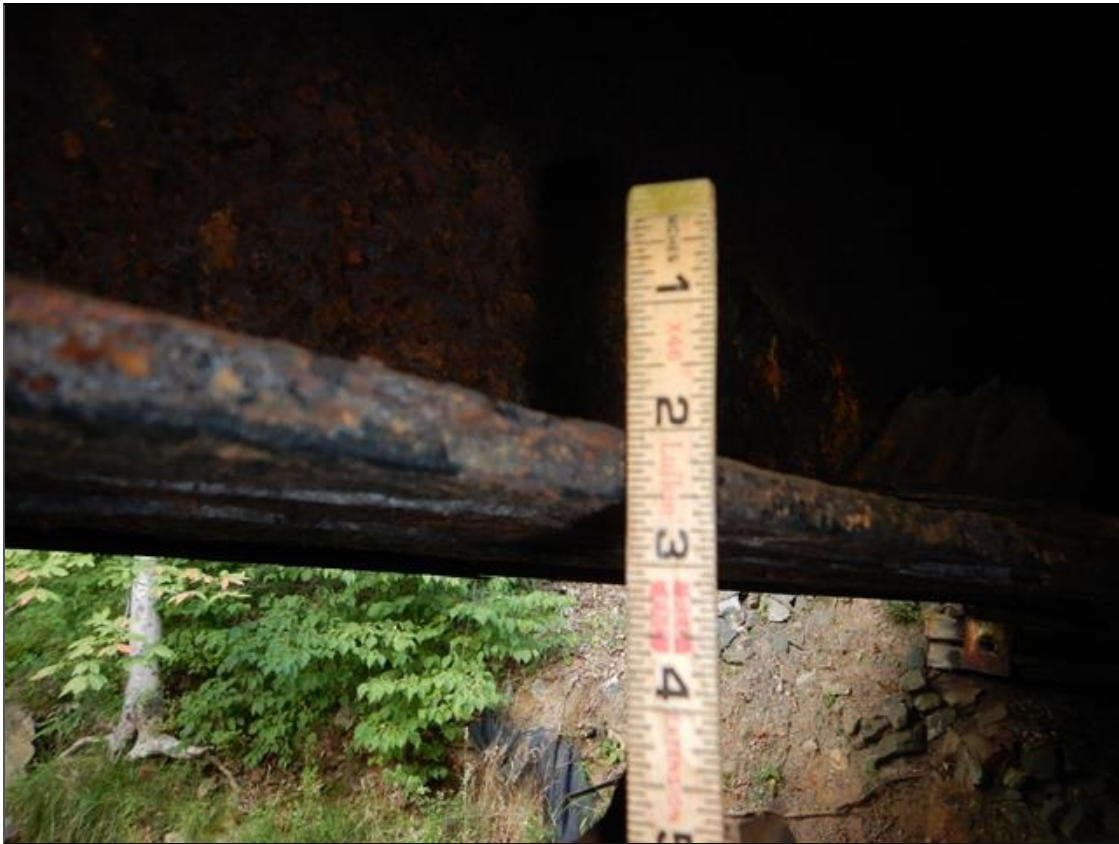
Span 1 Beam 2: RUST SCALE ON TOP AND BOTTOM FLANGES AND UP TO FULL HEIGHT IN WEB WITH UP TO 1/8 INCH SECTION LOSS IN THE WEB, 9/16 INCH REMAINING IN BOTTOM FLANGE AND 11/16 INCH REMAINING IN TOP FLANGE NEAR END BENT 1, 9/16 INCH REMAINING IN BOTTOM FLANGE AND 5/8 INCH REMAINING IN TOP FLANGE AT MID SPAN, 5/8 INCH REMAINING IN BOTTOM FLANGE, AND 5/8 INCH REMAINING IN TOP FLANGE AT END BENT 2 (PAR)

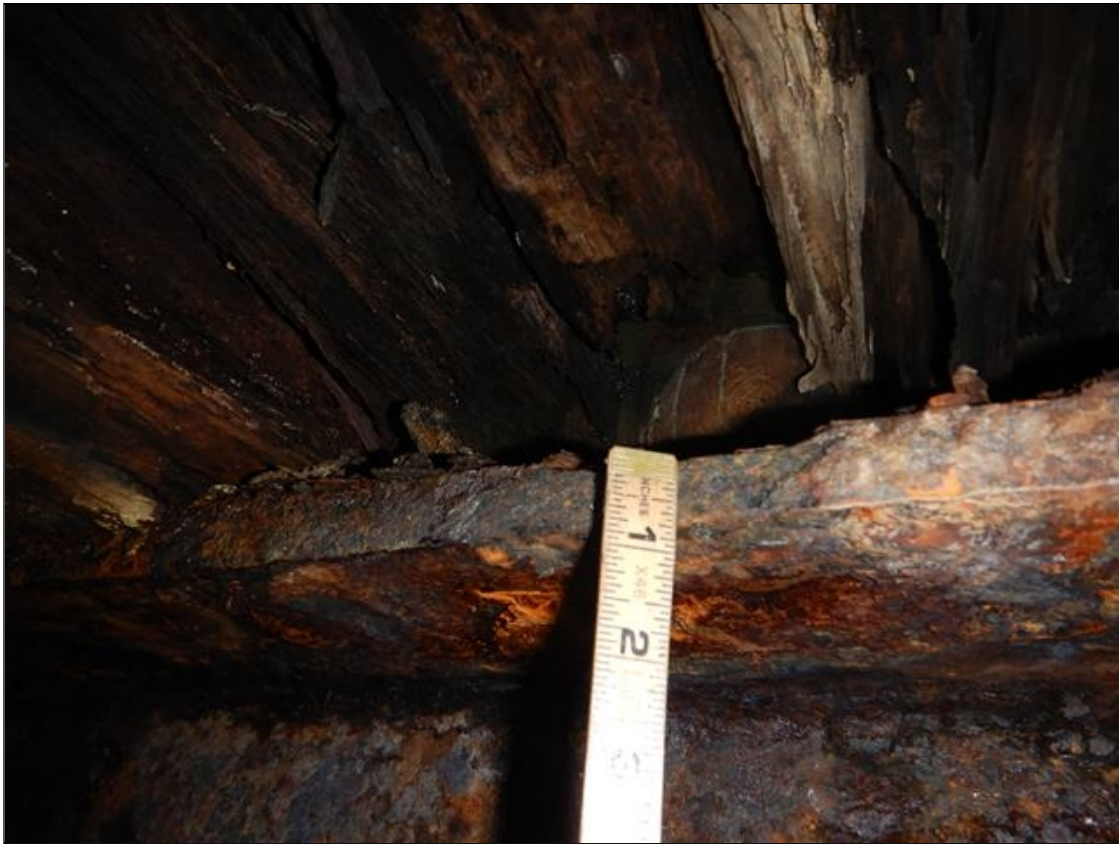
Span 1 Beam 2: RUST SCALE ON TOP AND BOTTOM FLANGES AND UP TO FULL HEIGHT IN WEB WITH UP TO 1/8 INCH SECTION LOSS IN THE WEB, 9/16 INCH REMAINING IN BOTTOM FLANGE AND 11/16 INCH REMAINING IN TOP FLANGE NEAR END BENT 1, 9/16 INCH REMAINING IN BOTTOM FLANGE AND 5/8 INCH REMAINING IN TOP FLANGE AT MID SPAN, 5/8 INCH REMAINING IN BOTTOM FLANGE, AND 5/8 INCH REMAINING IN TOP FLANGE AT END BENT 2 (PAR)

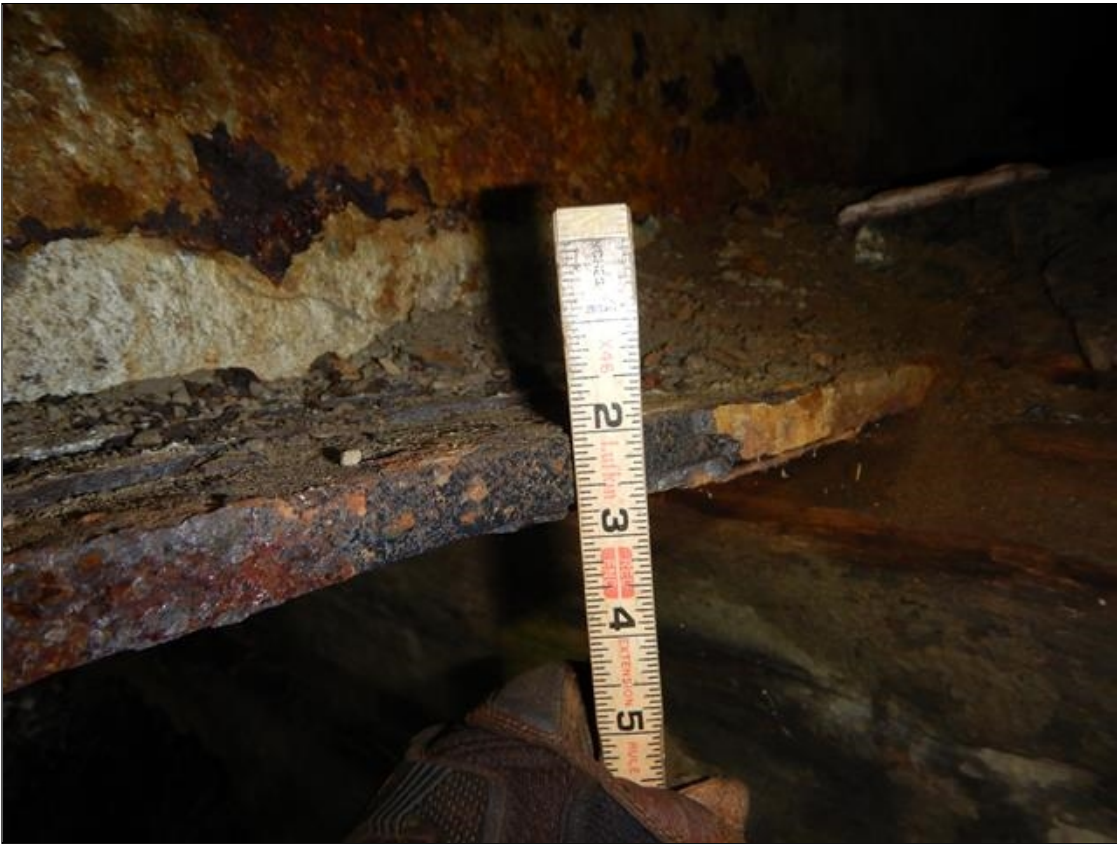
Span 1 Beam 2: RUST SCALE ON TOP AND BOTTOM FLANGES AND UP TO FULL HEIGHT IN WEB WITH UP TO 1/8 INCH SECTION LOSS IN THE WEB, 9/16 INCH REMAINING IN BOTTOM FLANGE AND 11/16 INCH REMAINING IN TOP FLANGE NEAR END BENT 1, 9/16 INCH REMAINING IN BOTTOM FLANGE AND 5/8 INCH REMAINING IN TOP FLANGE AT MID SPAN, 5/8 INCH REMAINING IN BOTTOM FLANGE, AND 5/8 INCH REMAINING IN TOP FLANGE AT END BENT 2 (PAR)

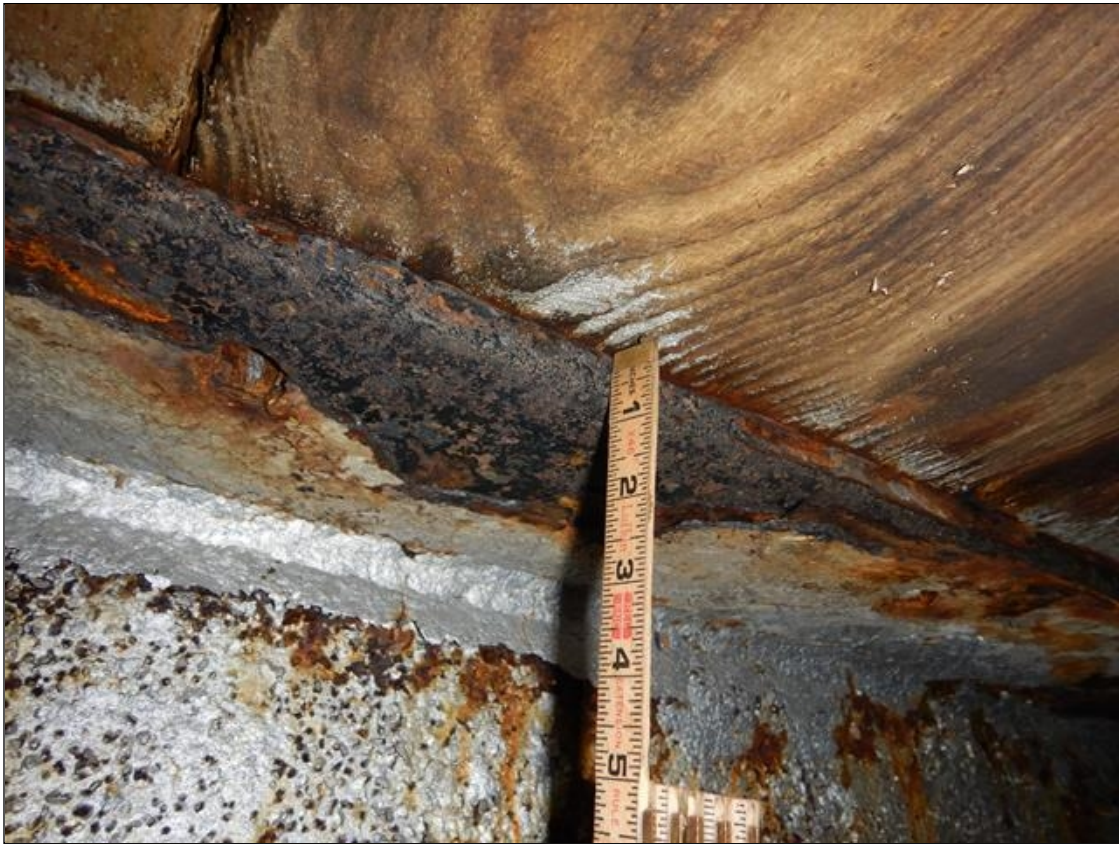
Span 1 Beam 1: RUST SCALE ON TOP AND BOTTOM FLANGES AND UP TO FULL HEIGHT IN WEB WITH UP TO 1/8 INCH SECTION LOSS IN THE WEB, 1/4 INCH REMAINING IN BOTTOM FLANGE AND 9/16 INCH REMAINING IN TOP FLANGE NEAR END BENT 1, 9/16 INCH REMAINING IN BOTTOM FLANGE AND 1/2 INCH REMAINING IN TOP FLANGE AT MID SPAN, 9/16 INCH REMAINING IN BOTTOM FLANGE, AND 5/8 INCH REMAINING IN TOP FLANGE AT END BENT 2 (PAR)

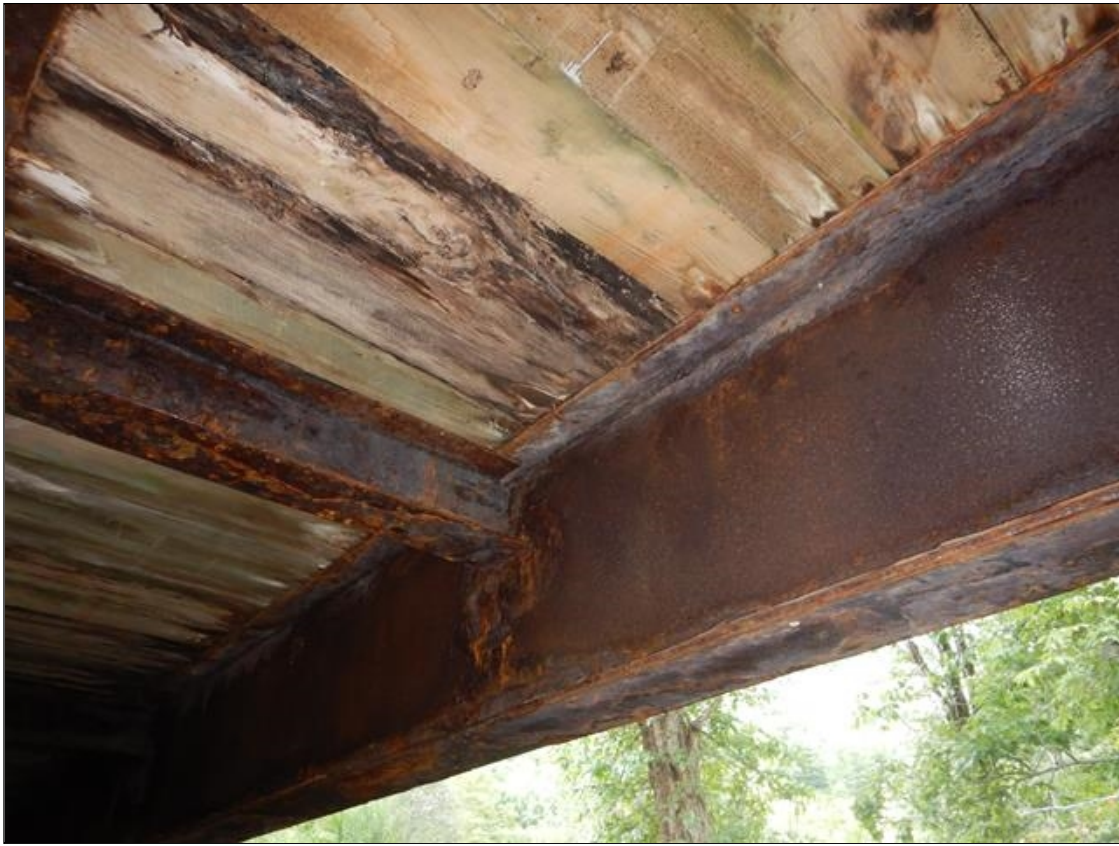
Span 1 Beam 1: RUST SCALE ON TOP AND BOTTOM FLANGES AND UP TO FULL HEIGHT IN WEB WITH UP TO 1/8 INCH SECTION LOSS IN THE WEB, 1/4 INCH REMAINING IN BOTTOM FLANGE AND 9/16 INCH REMAINING IN TOP FLANGE NEAR END BENT 1, 9/16 INCH REMAINING IN BOTTOM FLANGE AND 1/2 INCH REMAINING IN TOP FLANGE AT MID SPAN, 9/16 INCH REMAINING IN BOTTOM FLANGE, AND 5/8 INCH REMAINING IN TOP FLANGE AT END BENT 2 (PAR)

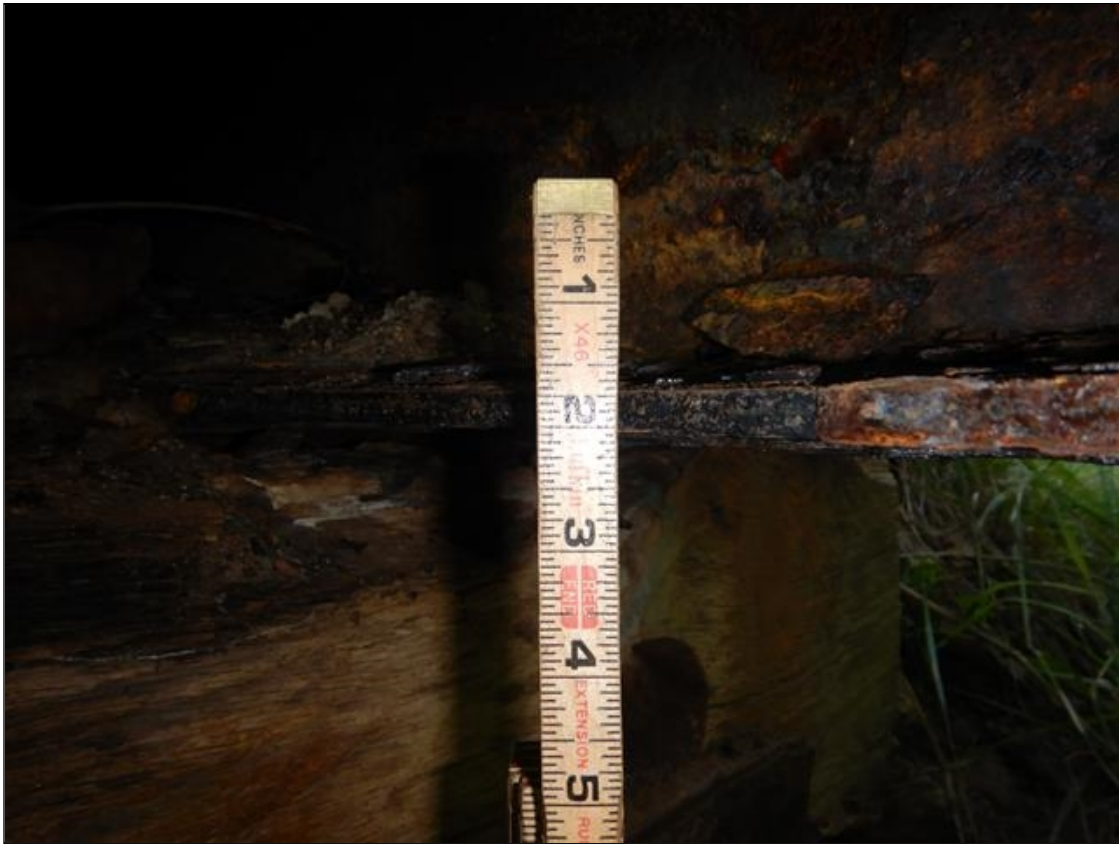
Span 1 Beam 1: RUST SCALE ON TOP AND BOTTOM FLANGES AND UP TO FULL HEIGHT IN WEB WITH UP TO 1/8 INCH SECTION LOSS IN THE WEB, 1/4 INCH REMAINING IN BOTTOM FLANGE AND 9/16 INCH REMAINING IN TOP FLANGE NEAR END BENT 1, 9/16 INCH REMAINING IN BOTTOM FLANGE AND 1/2 INCH REMAINING IN TOP FLANGE AT MID SPAN, 9/16 INCH REMAINING IN BOTTOM FLANGE, AND 5/8 INCH REMAINING IN TOP FLANGE AT END BENT 2 (PAR)

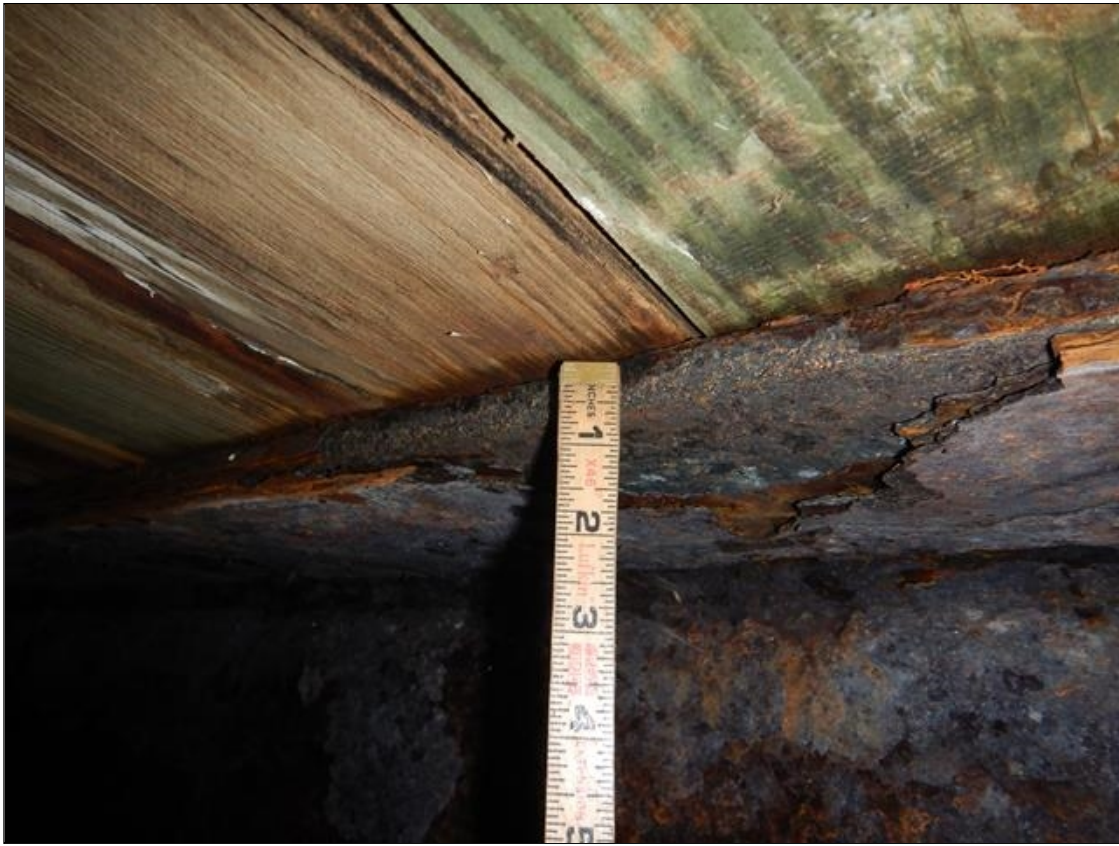
Span 1 Beam 1: RUST SCALE ON TOP AND BOTTOM FLANGES AND UP TO FULL HEIGHT IN WEB WITH UP TO 1/8 INCH SECTION LOSS IN THE WEB, 1/4 INCH REMAINING IN BOTTOM FLANGE AND 9/16 INCH REMAINING IN TOP FLANGE NEAR END BENT 1, 9/16 INCH REMAINING IN BOTTOM FLANGE AND 1/2 INCH REMAINING IN TOP FLANGE AT MID SPAN, 9/16 INCH REMAINING IN BOTTOM FLANGE, AND 5/8 INCH REMAINING IN TOP FLANGE AT END BENT 2 (PAR)

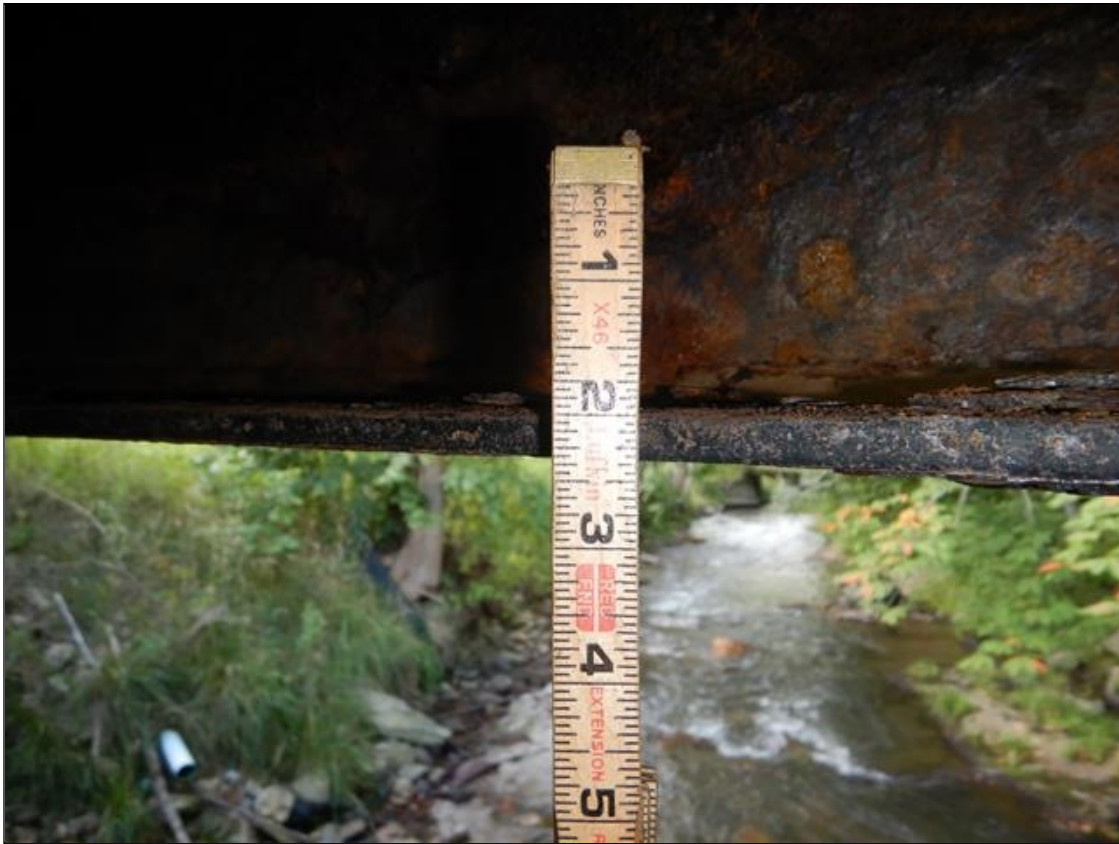
Span 1 Beam 1: RUST SCALE ON TOP AND BOTTOM FLANGES AND UP TO FULL HEIGHT IN WEB WITH UP TO 1/8 INCH SECTION LOSS IN THE WEB, 1/4 INCH REMAINING IN BOTTOM FLANGE AND 9/16 INCH REMAINING IN TOP FLANGE NEAR END BENT 1, 9/16 INCH REMAINING IN BOTTOM FLANGE AND 1/2 INCH REMAINING IN TOP FLANGE AT MID SPAN, 9/16 INCH REMAINING IN BOTTOM FLANGE, AND 5/8 INCH REMAINING IN TOP FLANGE AT END BENT 2 (PAR)

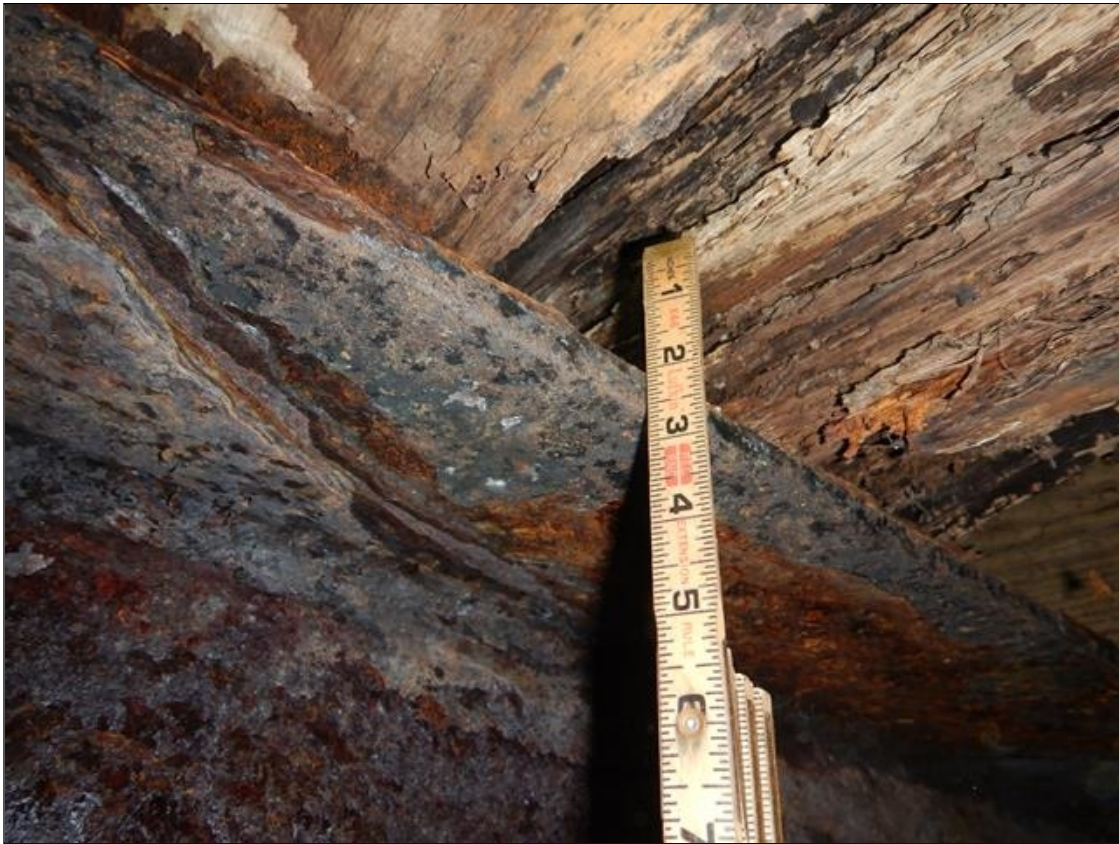
Span 1 Beam 1: RUST SCALE ON TOP AND BOTTOM FLANGES AND UP TO FULL HEIGHT IN WEB WITH UP TO 1/8 INCH SECTION LOSS IN THE WEB, 1/4 INCH REMAINING IN BOTTOM FLANGE AND 9/16 INCH REMAINING IN TOP FLANGE NEAR END BENT 1, 9/16 INCH REMAINING IN BOTTOM FLANGE AND 1/2 INCH REMAINING IN TOP FLANGE AT MID SPAN, 9/16 INCH REMAINING IN BOTTOM FLANGE, AND 5/8 INCH REMAINING IN TOP FLANGE AT END BENT 2 (PAR)

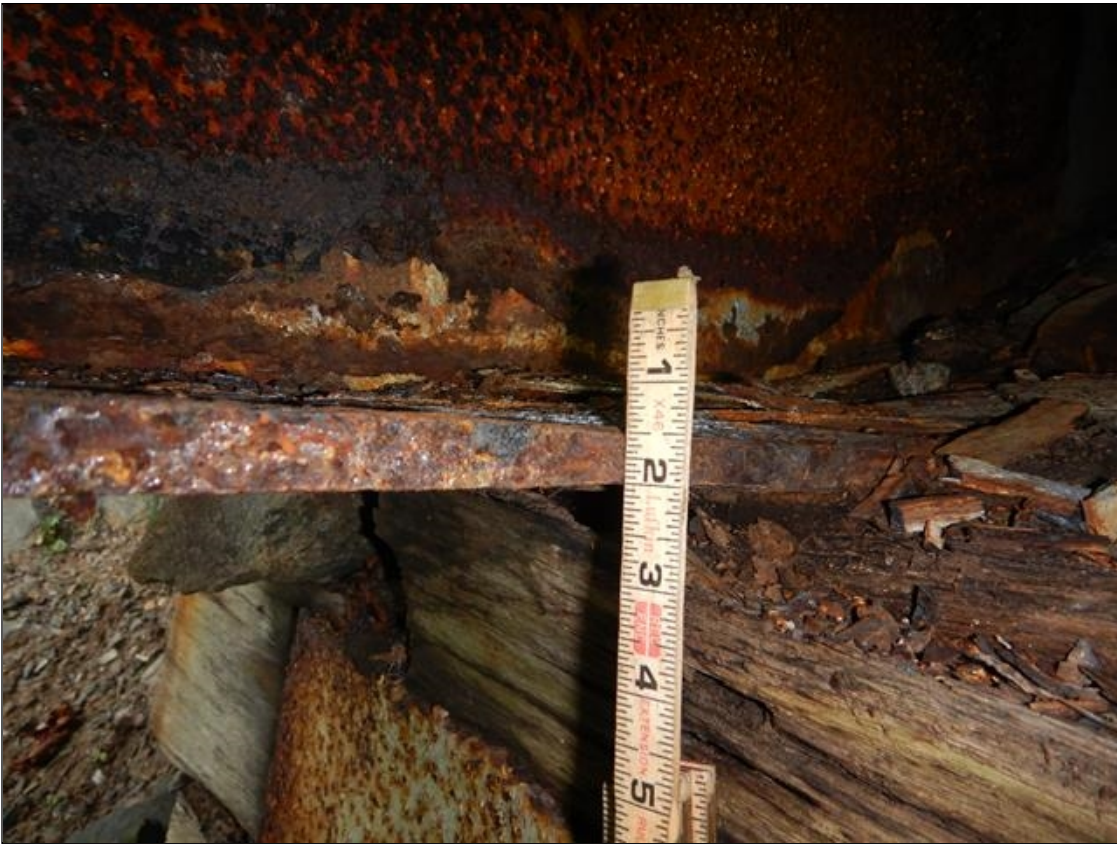
Span 1 Beam 1: RUST SCALE ON TOP AND BOTTOM FLANGES AND UP TO FULL HEIGHT IN WEB WITH UP TO 1/8 INCH SECTION LOSS IN THE WEB, 1/4 INCH REMAINING IN BOTTOM FLANGE AND 9/16 INCH REMAINING IN TOP FLANGE NEAR END BENT 1, 9/16 INCH REMAINING IN BOTTOM FLANGE AND 1/2 INCH REMAINING IN TOP FLANGE AT MID SPAN, 9/16 INCH REMAINING IN BOTTOM FLANGE, AND 5/8 INCH REMAINING IN TOP FLANGE AT END BENT 2 (PAR)

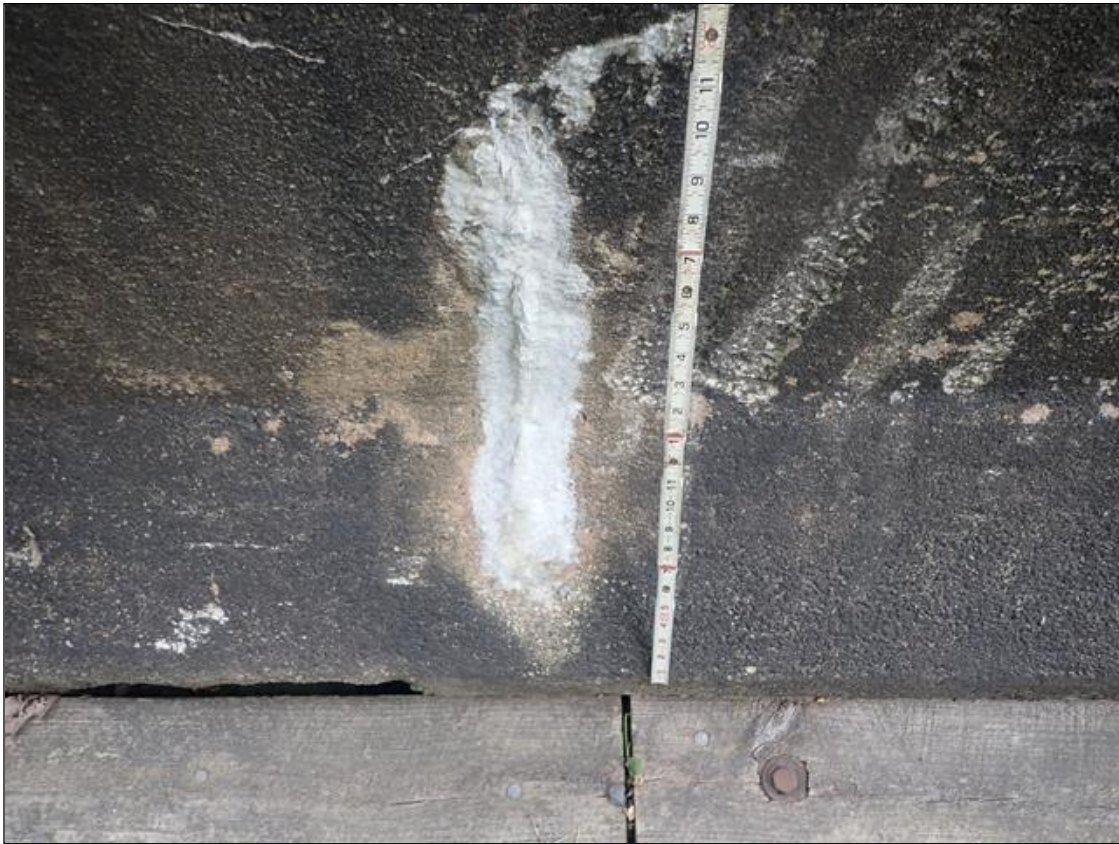
Span 1 Left Bridge Rail: UP TO 1/64 INCH HORIZONTAL AND VERTICAL CRACKS WITH EFFLORESCENCE ON WEST FACE OF RAIL, APPROXIMATELY AT MIDSPAN

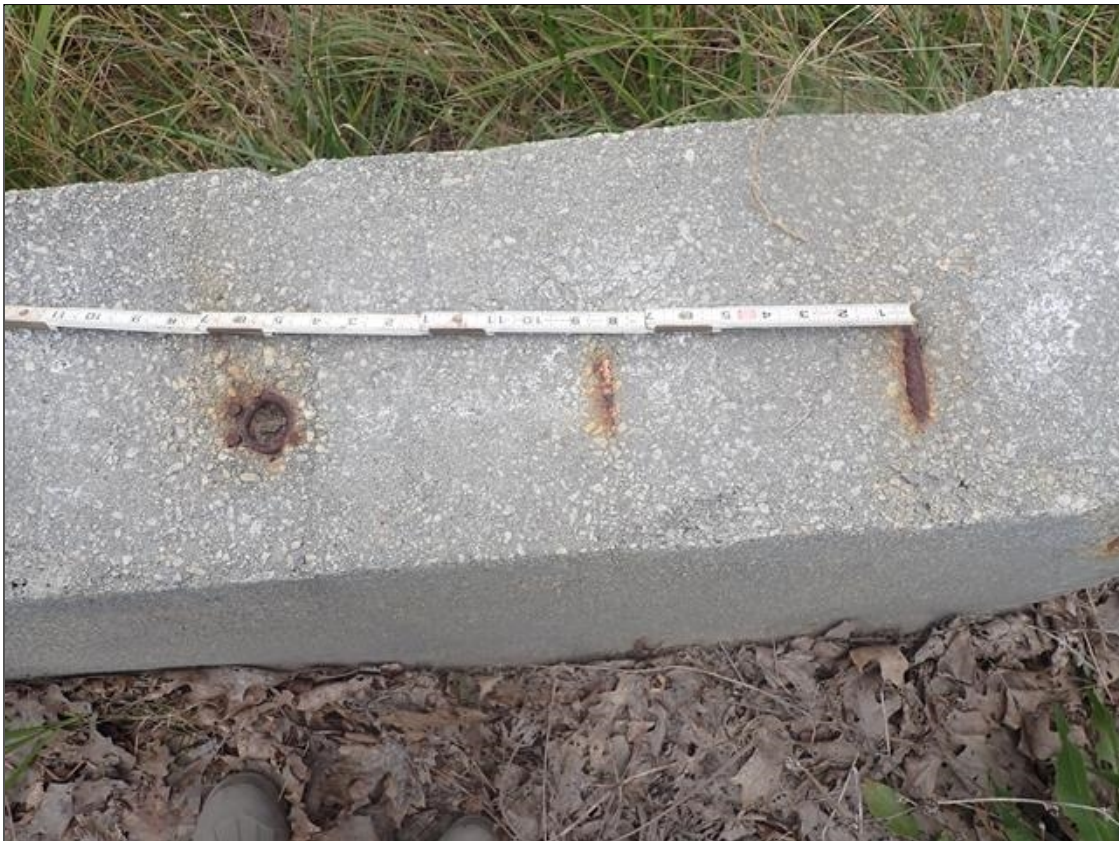
Span 1 Left Bridge Rail: (2) AREAS OF EXPOSED REINFORCING ON TOP FACE OF RAIL 5 FEET SOUTH OF END BENT 1

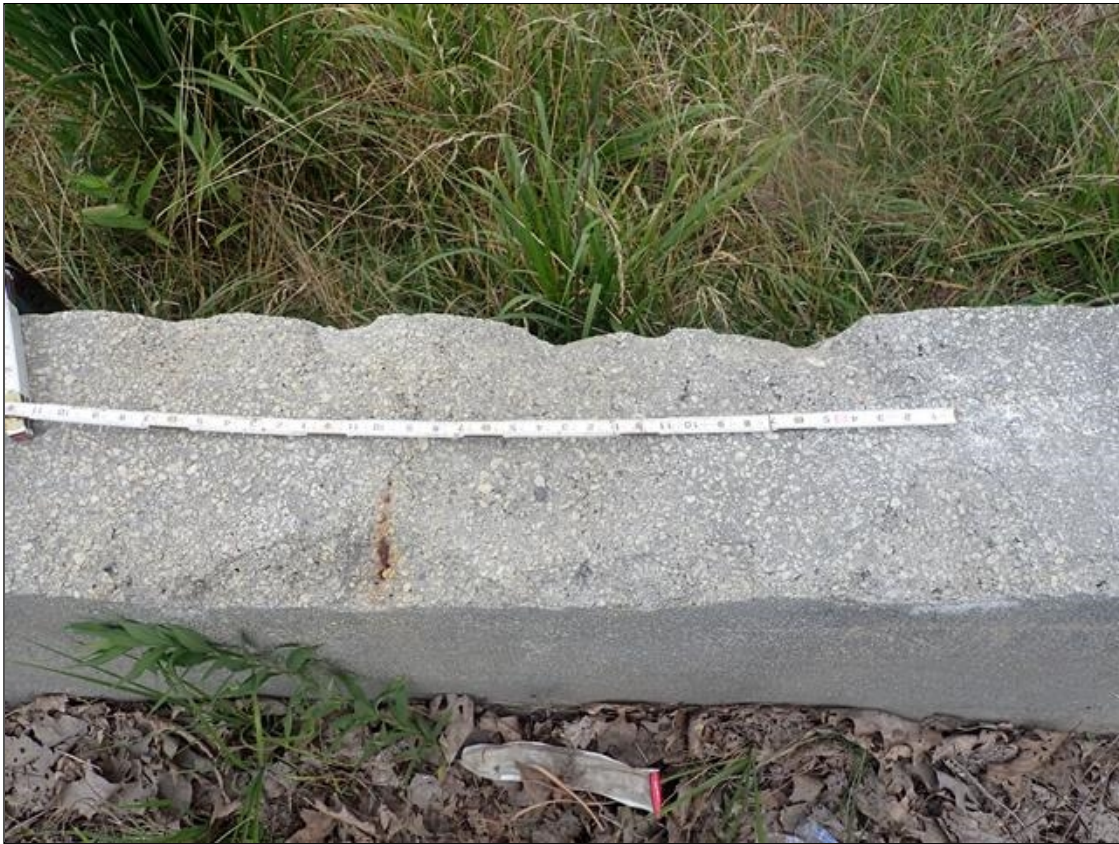
Span 1 Left Bridge Rail: UP TO 12 INCH X 6 INCH X 1.5 INCH SPALLS, SOME WITH EXPOSED REINFORCING, AT RANDOM THROUGHOUT ALL FACES (PHOTO TAKEN 5 FEET SOUTH OF END BENT 1)

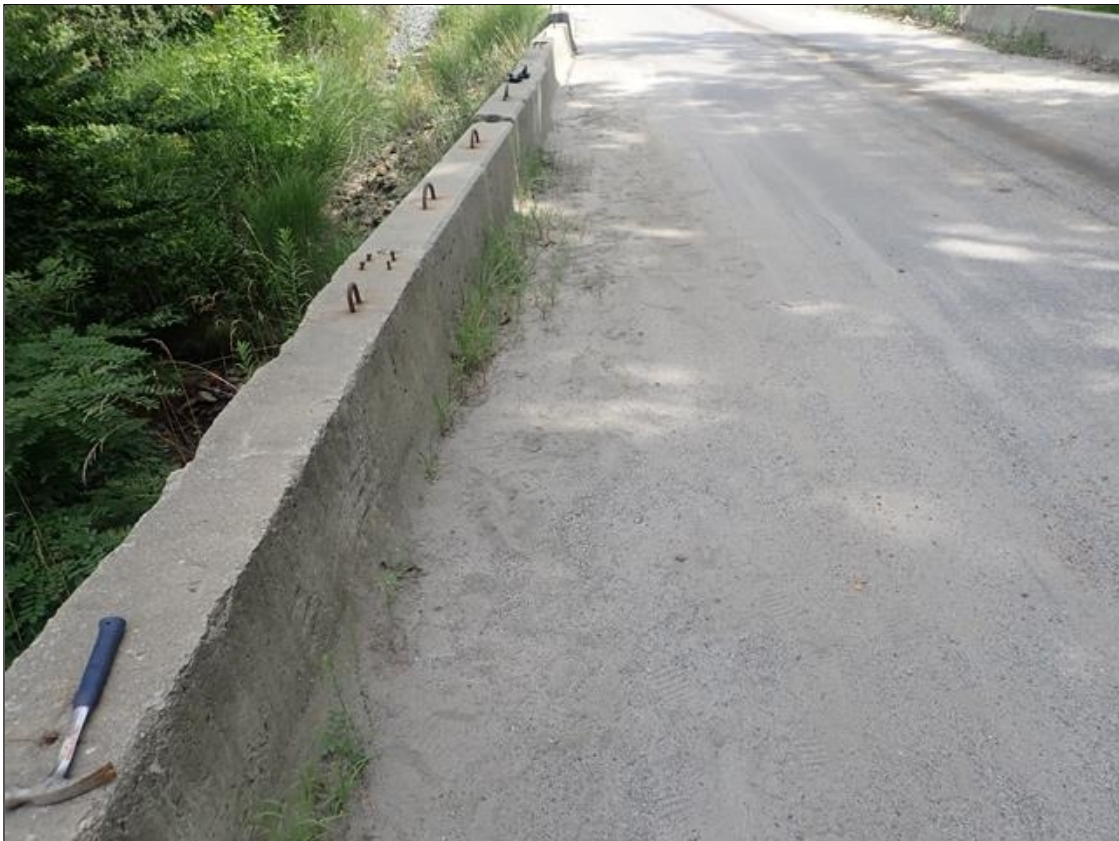
Deck Debris: UP TO 6 FEET OF LOOSE GRANULAR DEBRIS THROUGHOUT BOTH SHOULDERS (PHOTO TAKEN IN EAST SHOULDER)

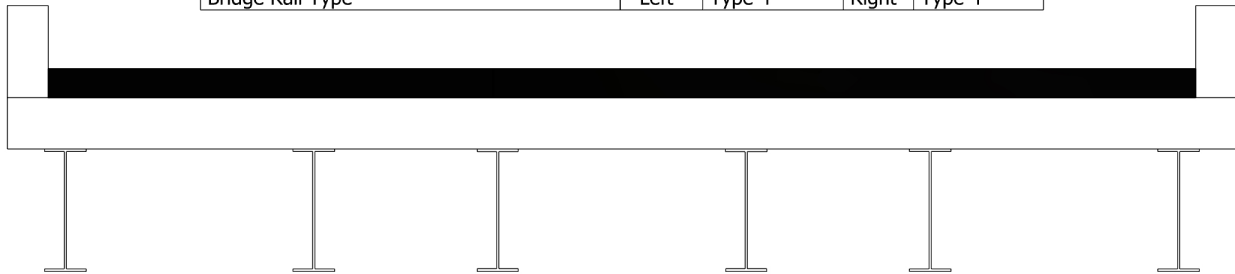
Measurements for Span #	1		
Deck Thickness	15in	Left Overhang	1.417ft
Top of Rail to Bottom of Beam (Avg)	6.49ft	Right Overhang	1.417ft

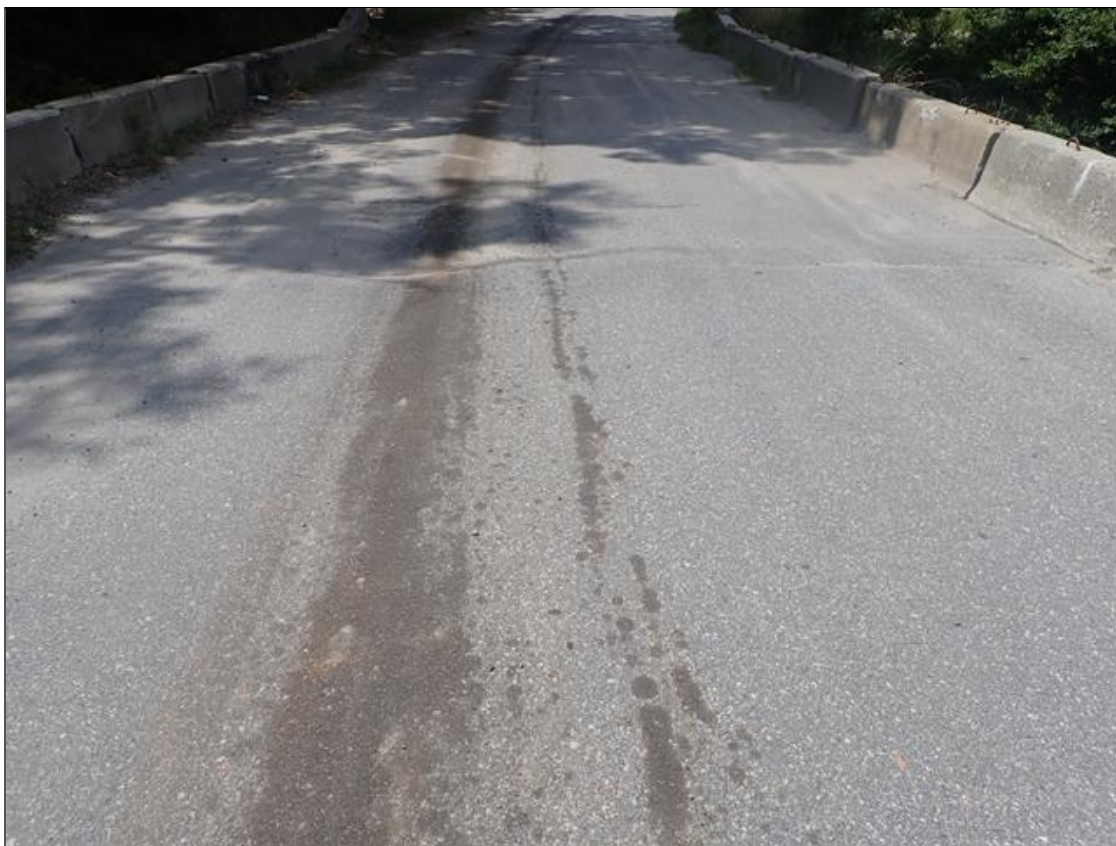
ASPHALT WEARING SURFACE, SPAN 1, LOOKING NORTH
