NC DEPARTMENT OF TRANSPORTATION  
 DIVISION OF HIGHWAYS  
 BRIDGE MANAGEMENT UNIT

PRIORITY MAINT. SUBMITTED.  
 SIGN NOTICE SUBMITTED.  
 SHORED.

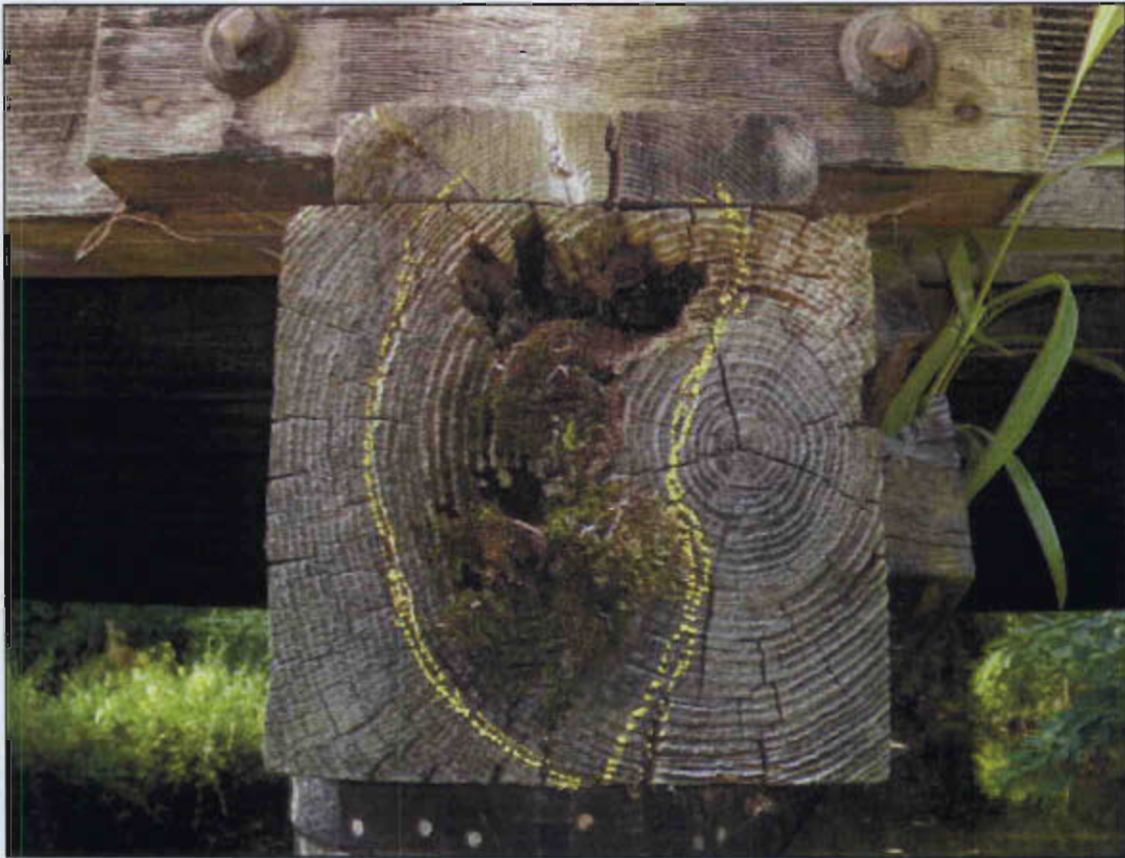
NORTH END OF BENT 1 CAP DECAYED 5" WIDE X 10" HIGH X 12" DEEP.(PRIORITY MAINTENANCE)

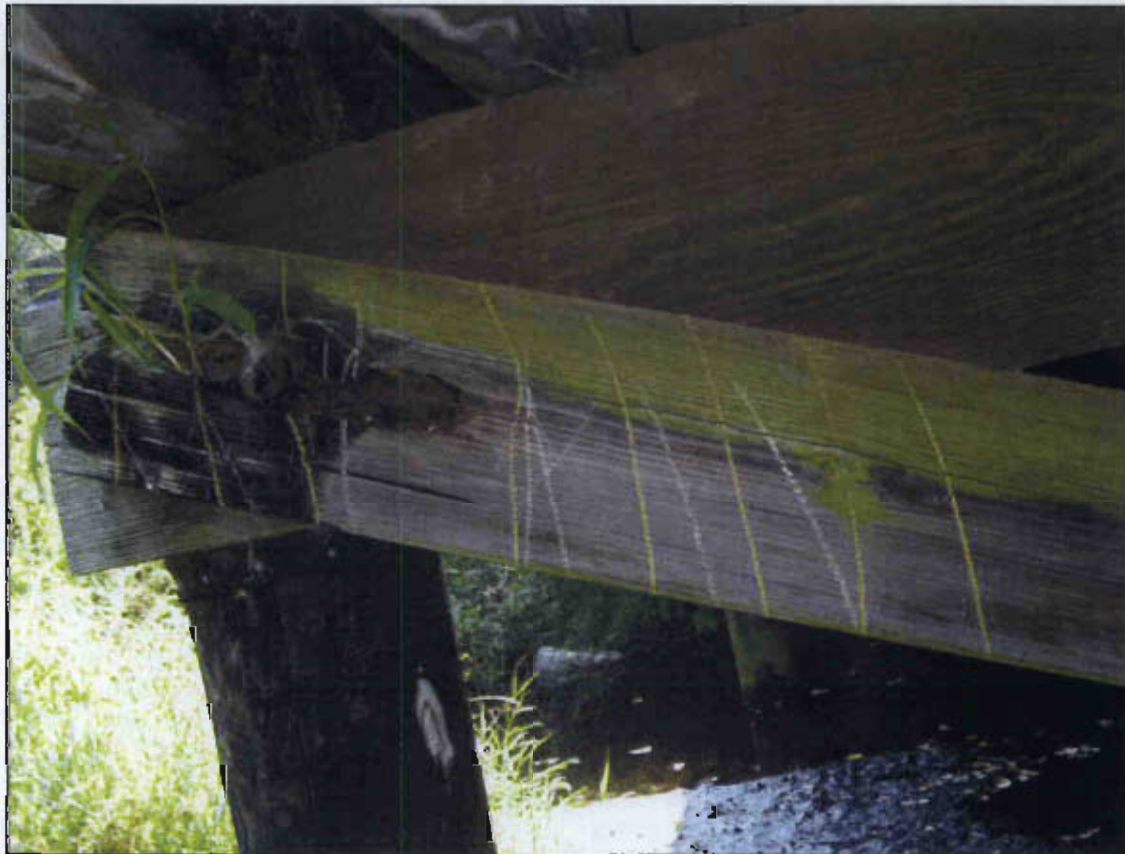
BENT 1 CROSSBRACE SPAN 1 SIDE AT PILE 1 DECAYED 4' LONG.

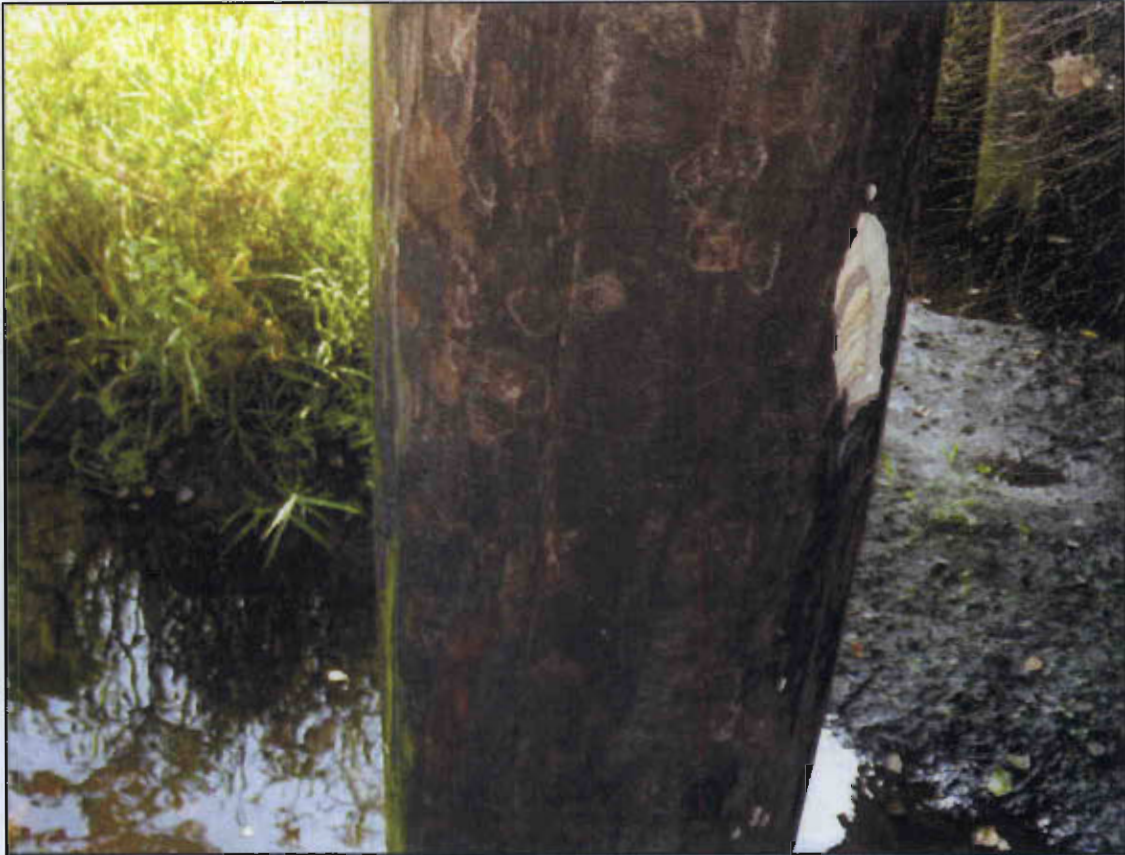
LONGITUDINAL CRACKING IN PILES UP TO 1/8" WIDE

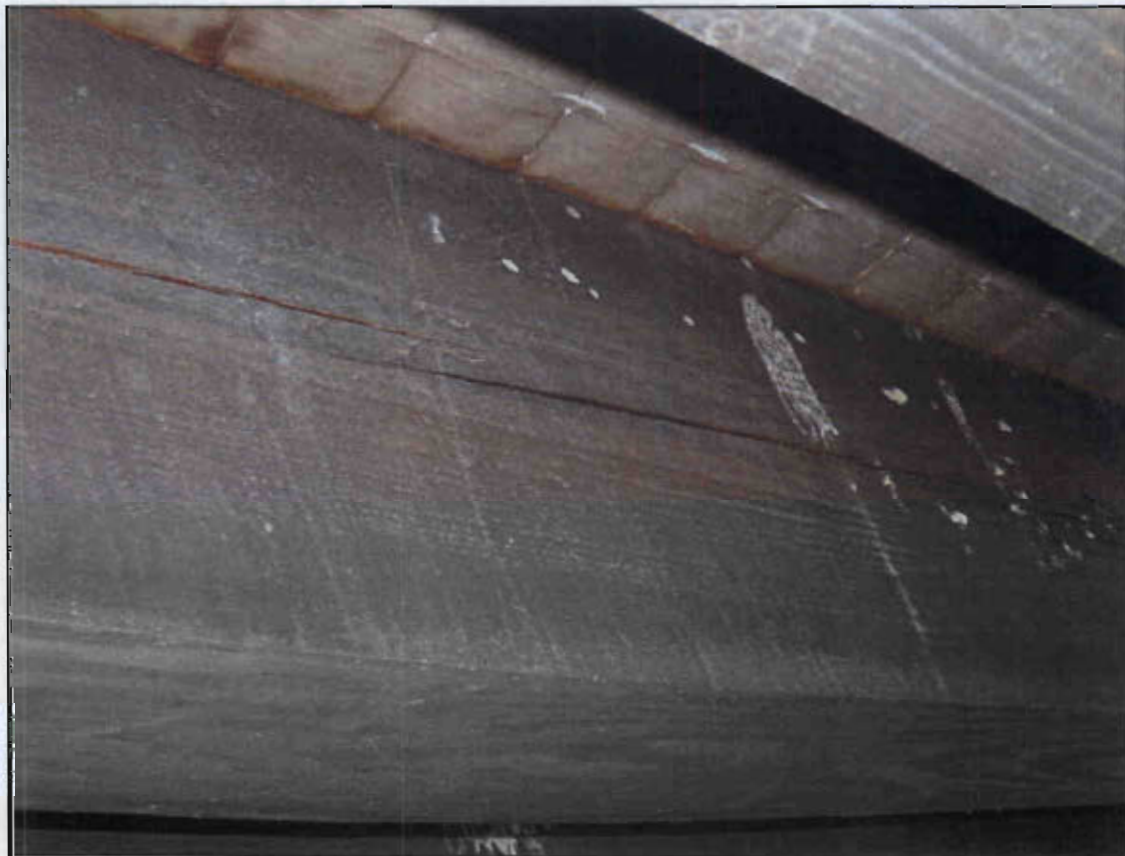
LONGITUDINAL CRACKING ALONG JOIST UP TO 1/8" WIDE.

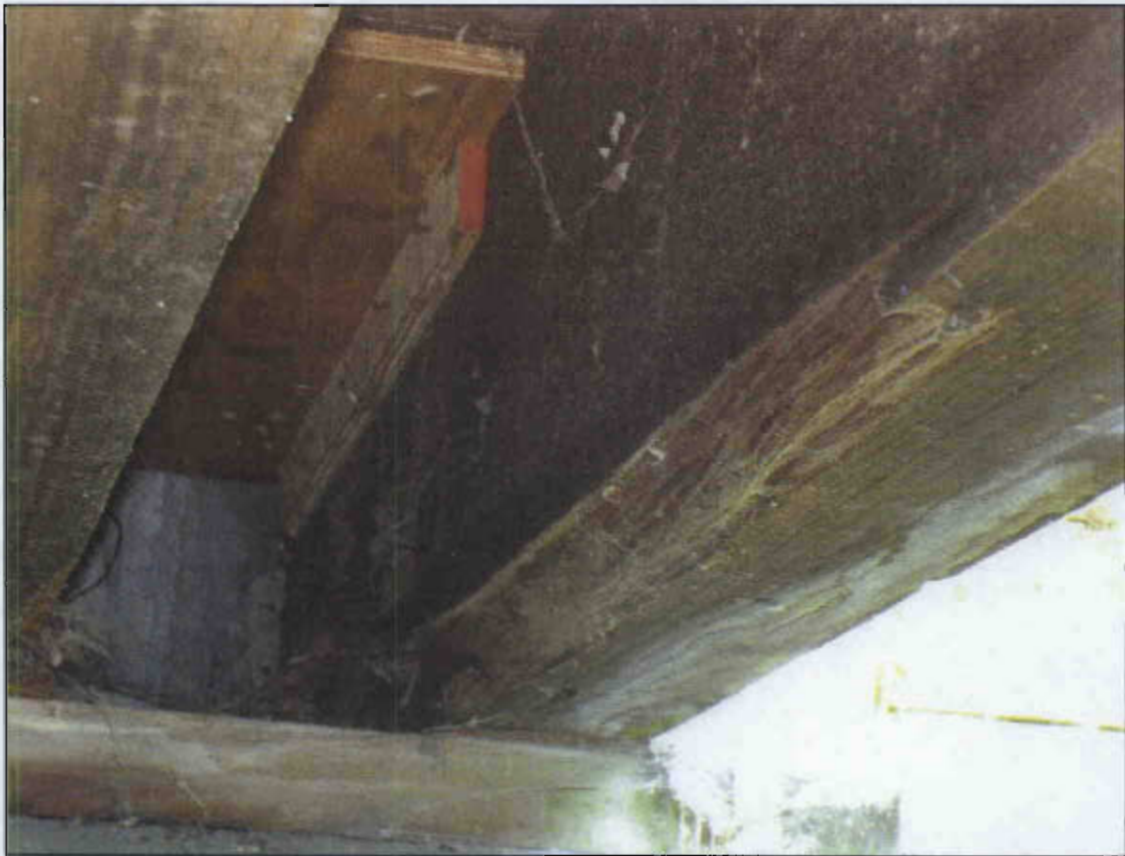
JOIST 1 IN SPAN 1 AT END BENT 1 SECTION LOSS 38" LONG X 2" WIDE X 2" HIGH

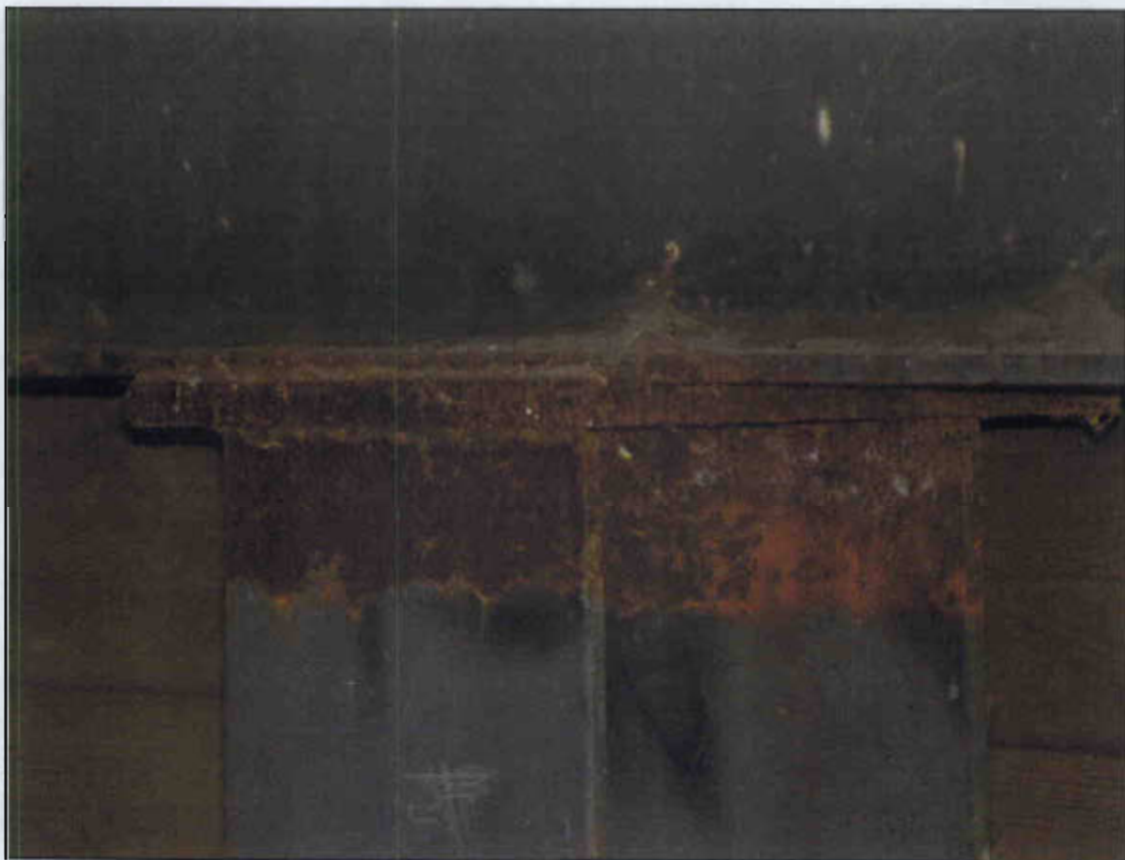
PAINT PEELING WITH SURFACE RUST ON TOP PORTION OF STEEL PILES AT END BENT 1

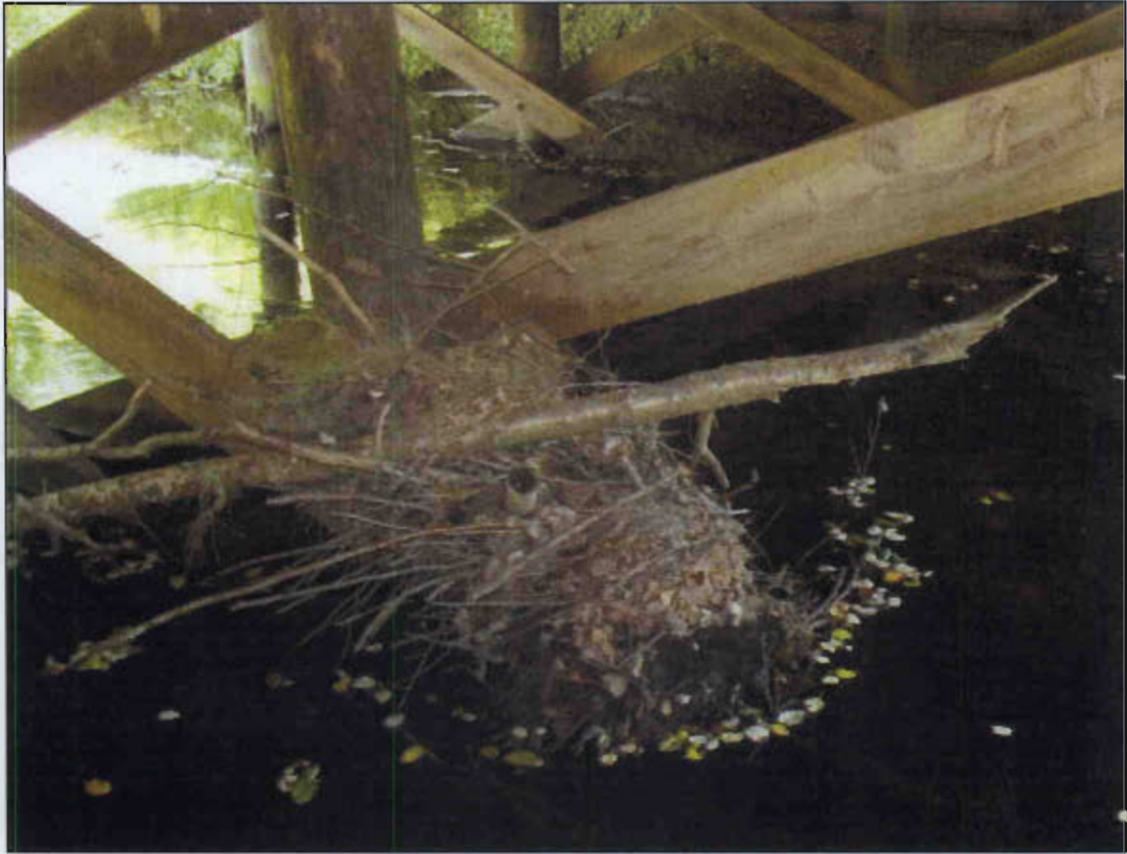
DRIFT COLLECTING AT PILE 3 OF BENT 1

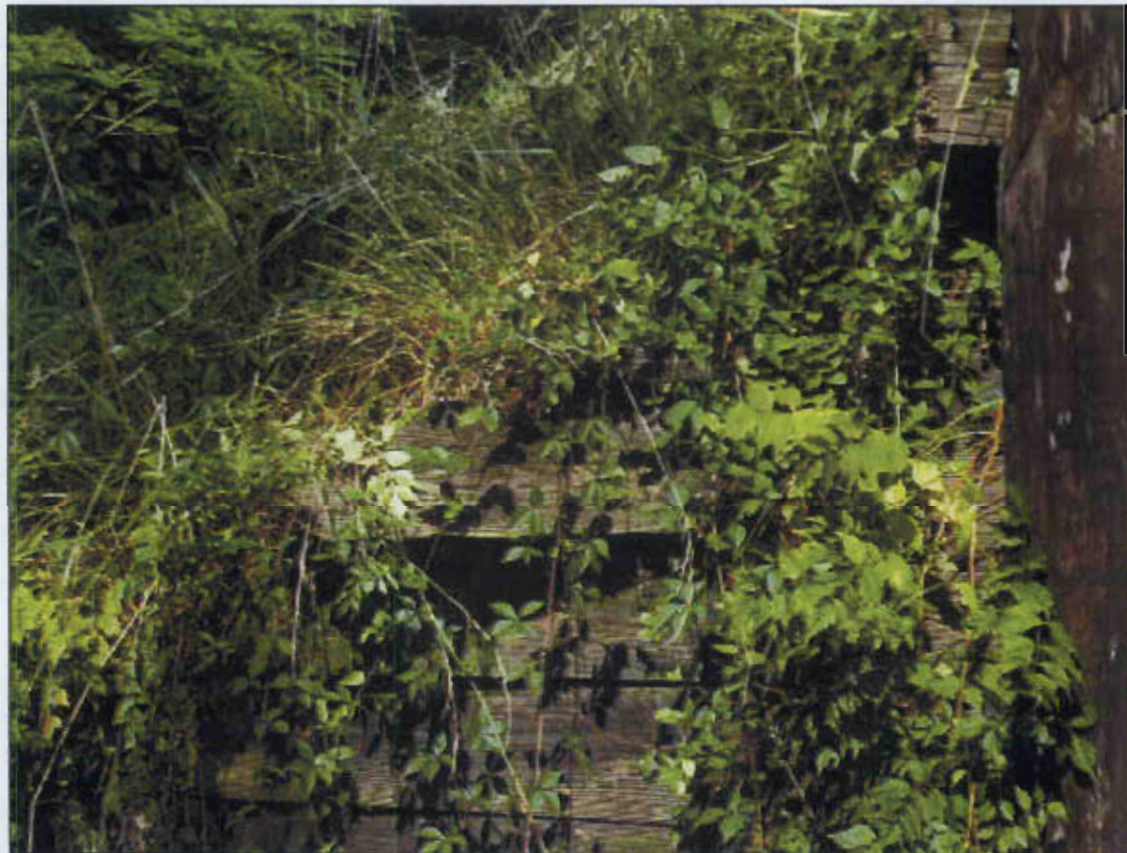
SOUTHWEST WINGWALL DISPLACED AND DECAYED BOARDS WITH FILL LEAKAGE AT TOP PORTION

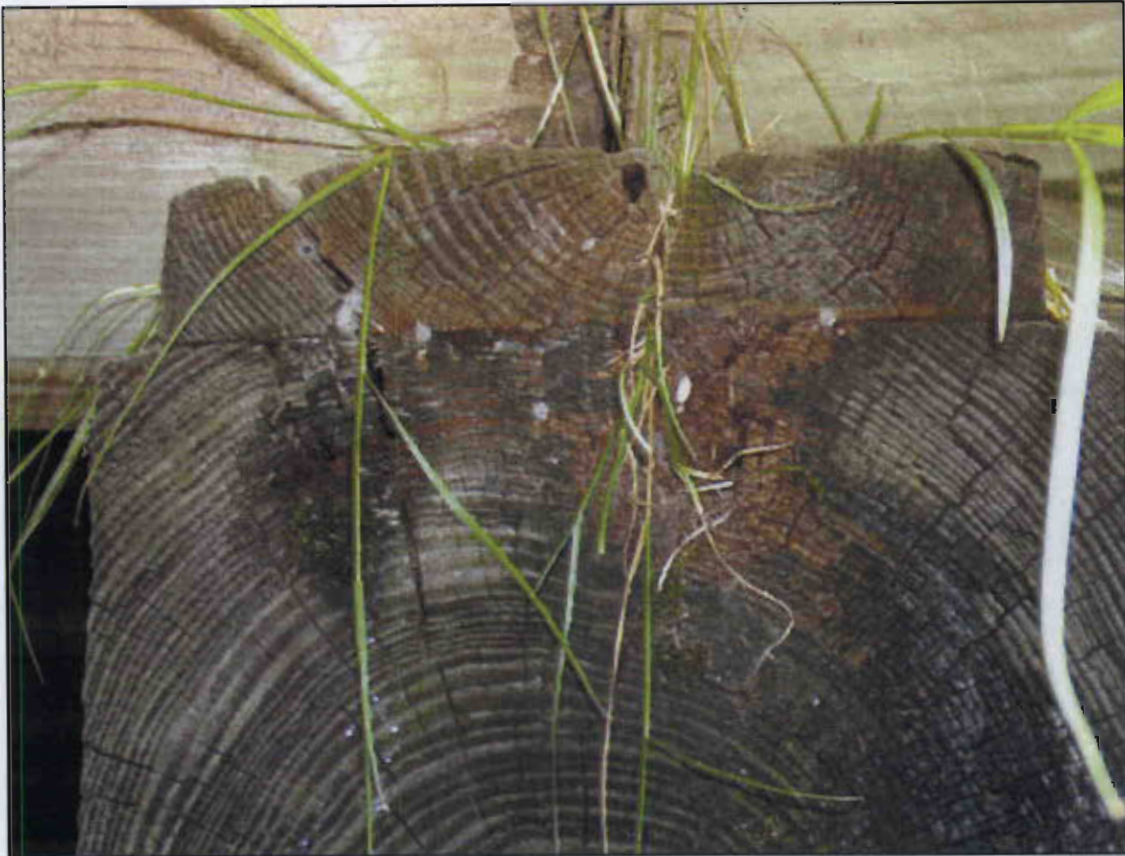
BENT 1 CAP AT SOUTH END 2 DECAYED AREAS 2" DIA. X 6" DEEP

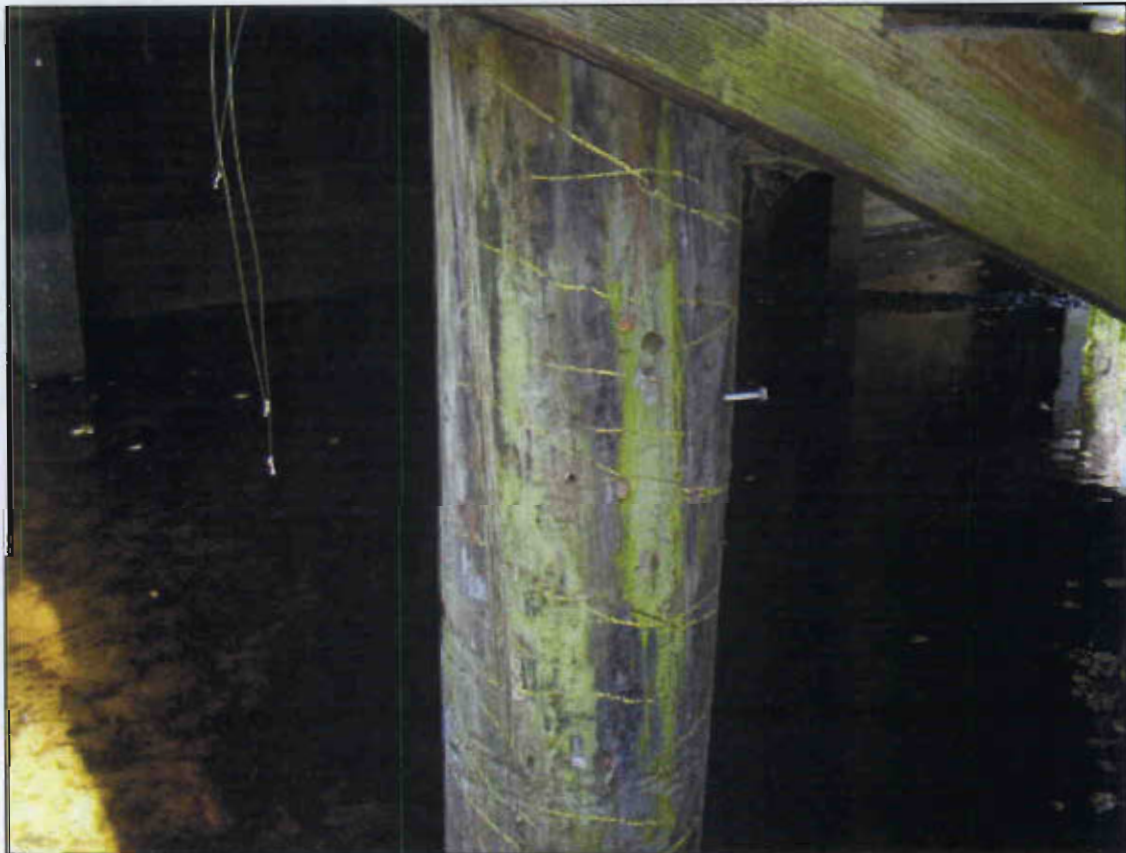
PILE 1 AT BENT 1 EAST SIDE DECAYED 32" HIGH X 6" DEEP X 1/2 CIRCUMFERENCE.(PRIORITY MAINTENANCE)

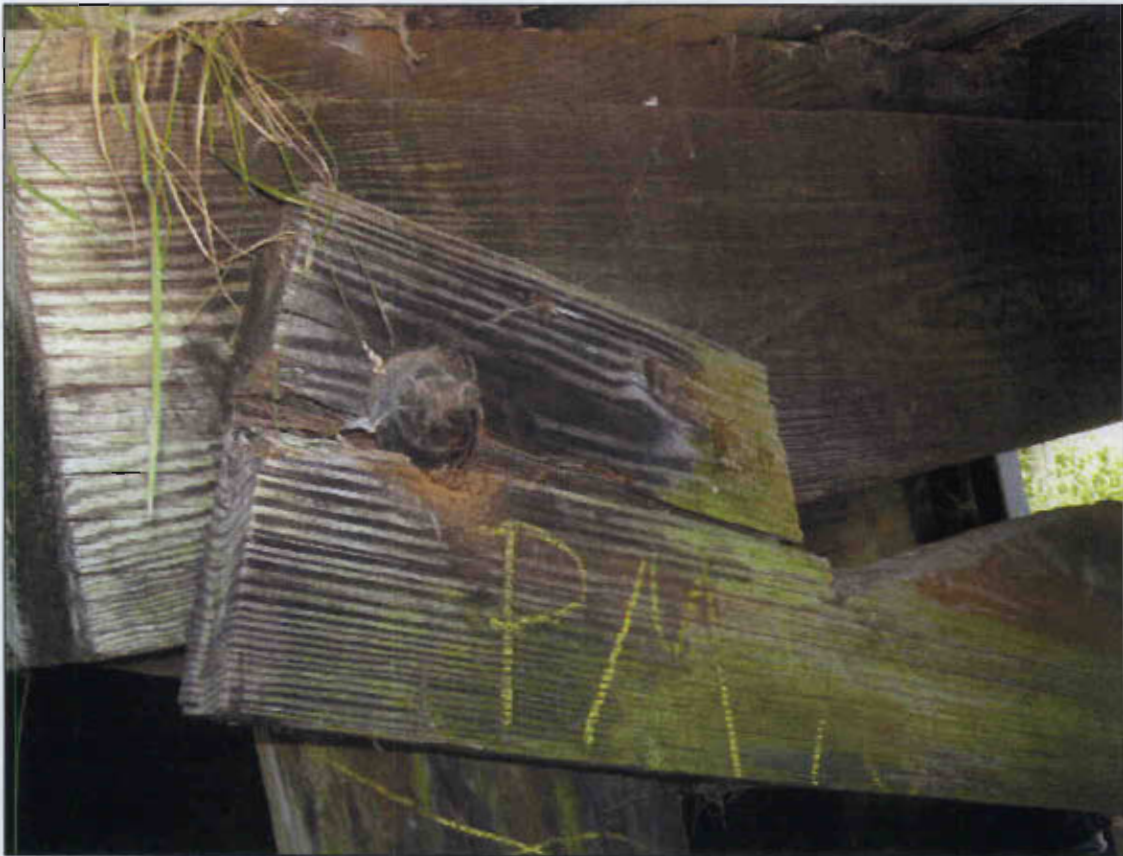
CROSSBRACE AT BENT 1 EAST SIDE AT PILE 4 SPLIT AT CONNECTION BOLT 1" WIDE X 15" LONG.

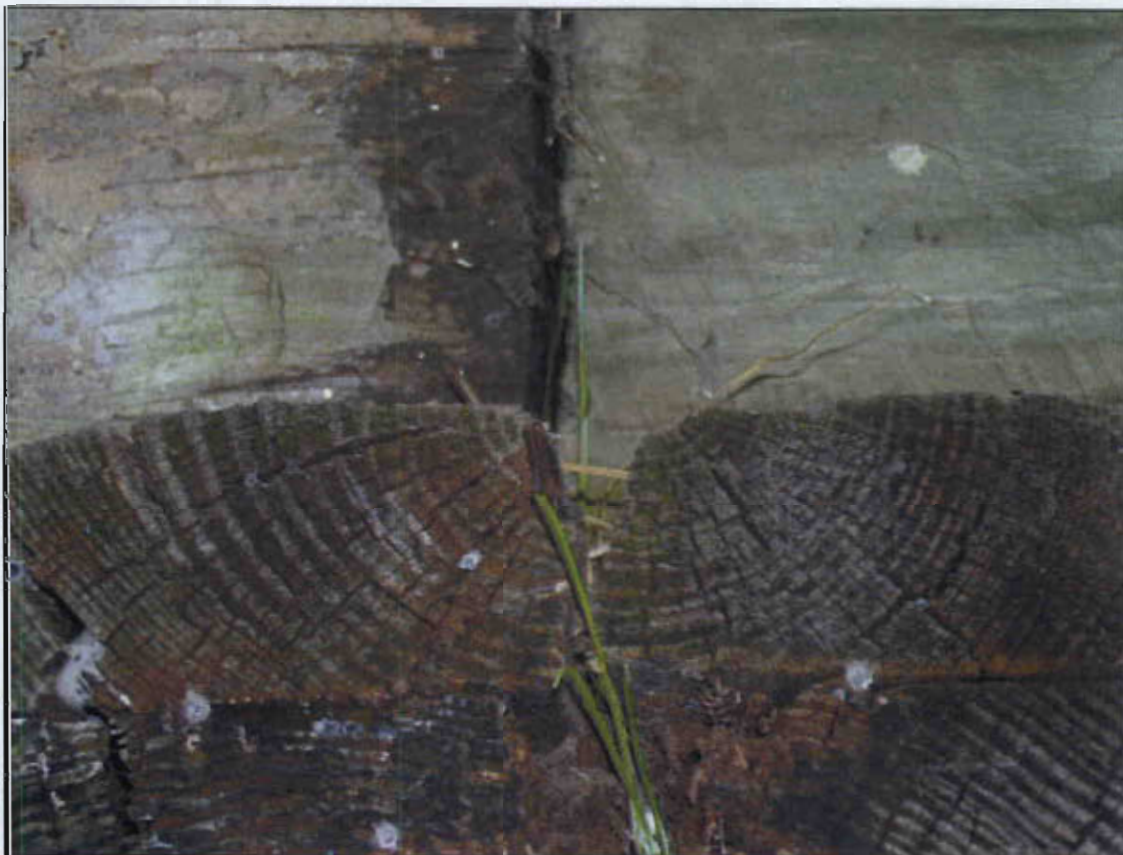
BENT 1 CROWNSTRIP AT SOUTH END DECAYED 1" WIDE X 20" LONG.

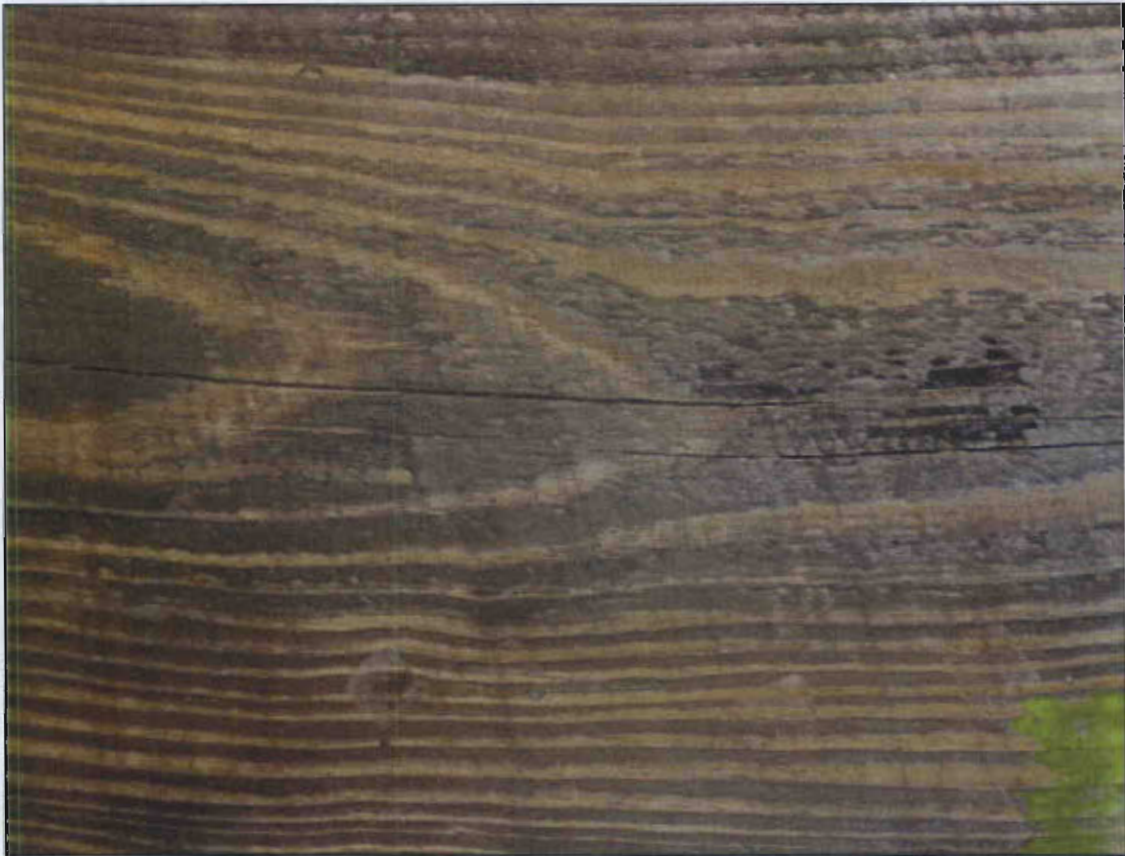
LONGITUDINAL CRACKING ALONG CAPS UP TO 1/8" WIDE

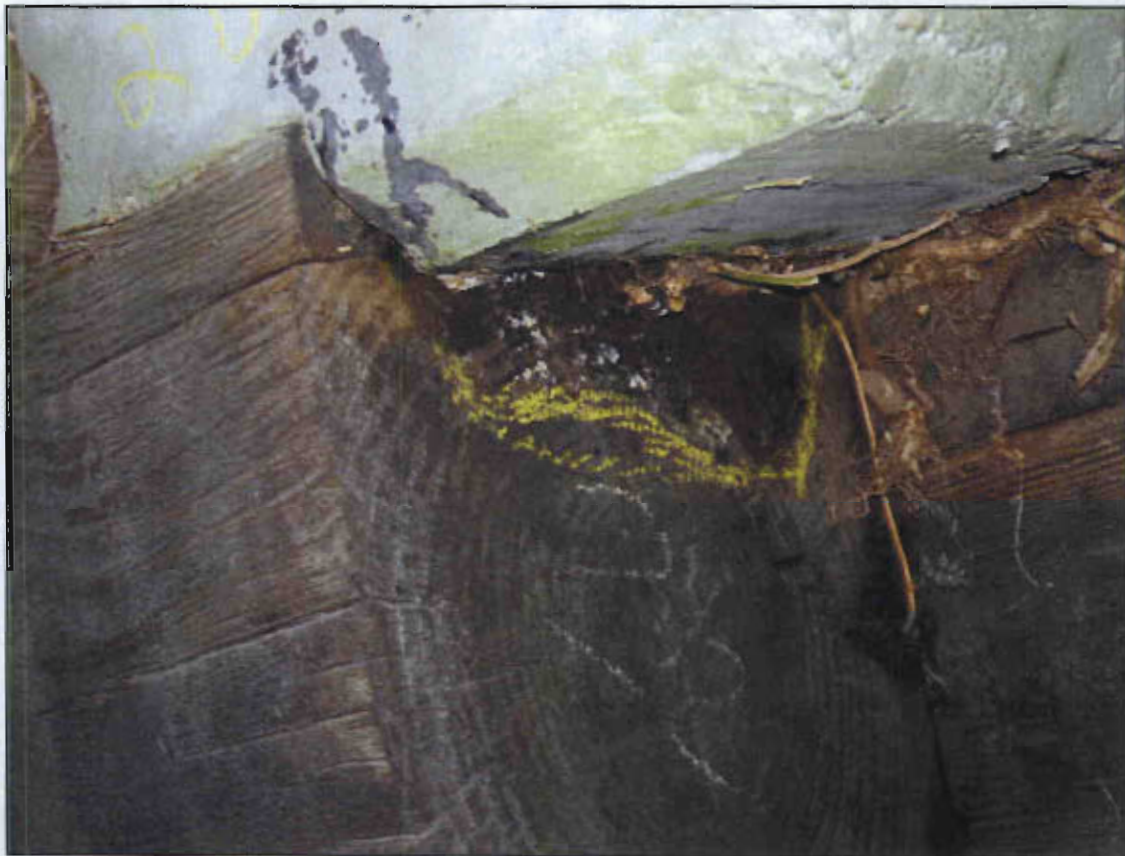
SOUTH END OF END BENT 2 CAP DECAYED 10" WIDE X 3" HIGH X 2" DEEP.

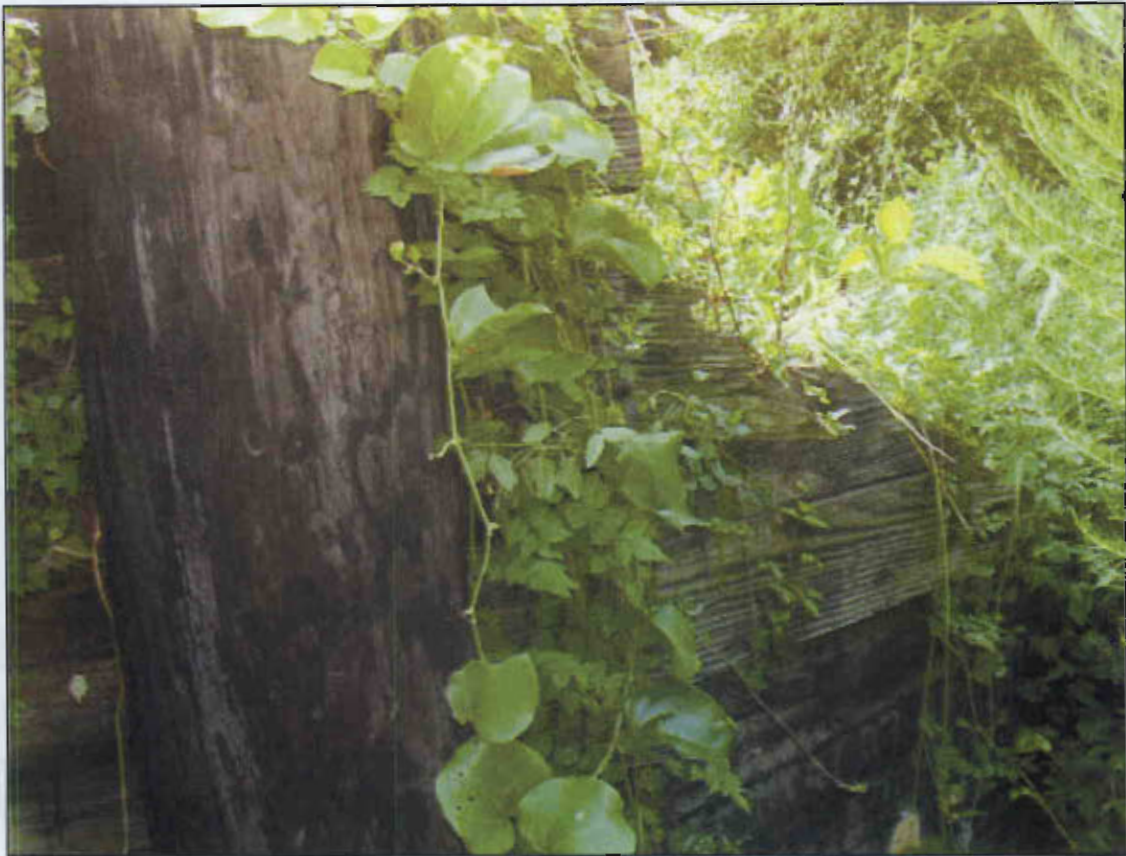
SOUTHEAST EXTERIOR BULKHEAD/WINGWALL DECAYED AND DISPLACED BOARDS

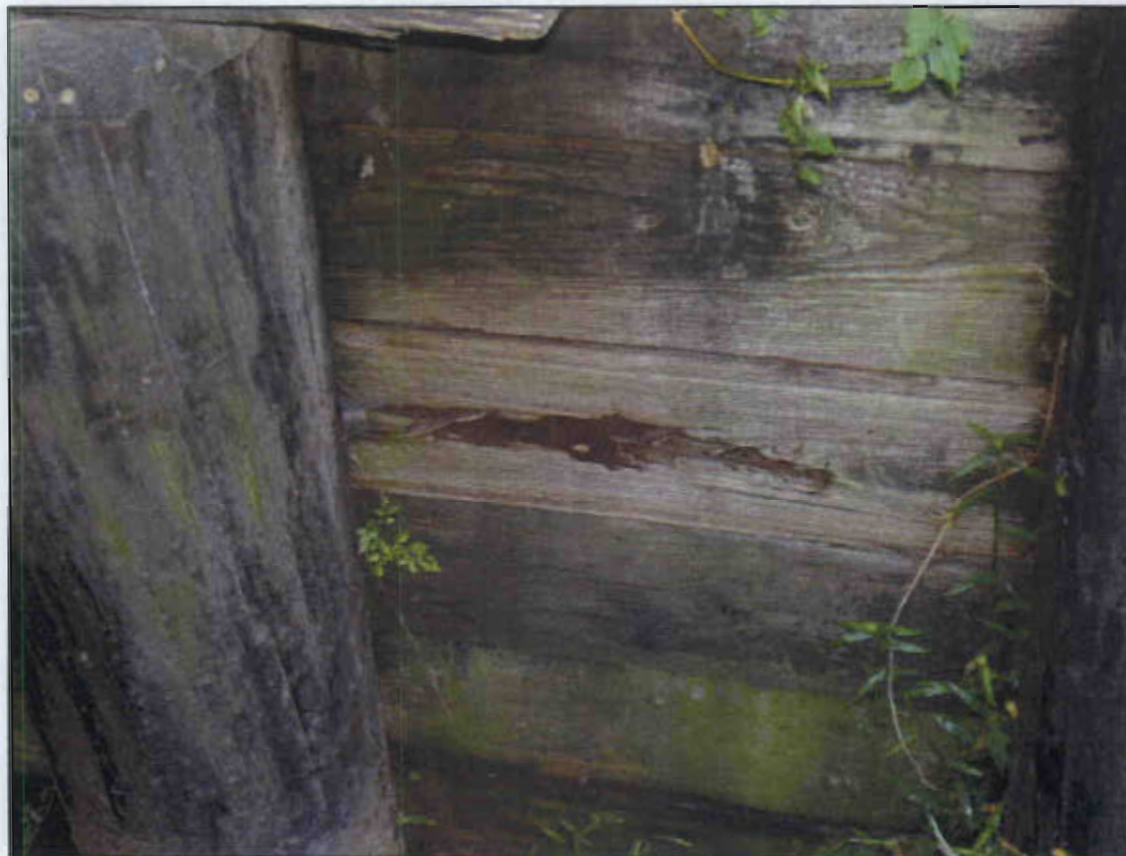
END BENT 2 BULKHEAD AT PILE 5 DECAYED AREA WITH EXPOSED FILL

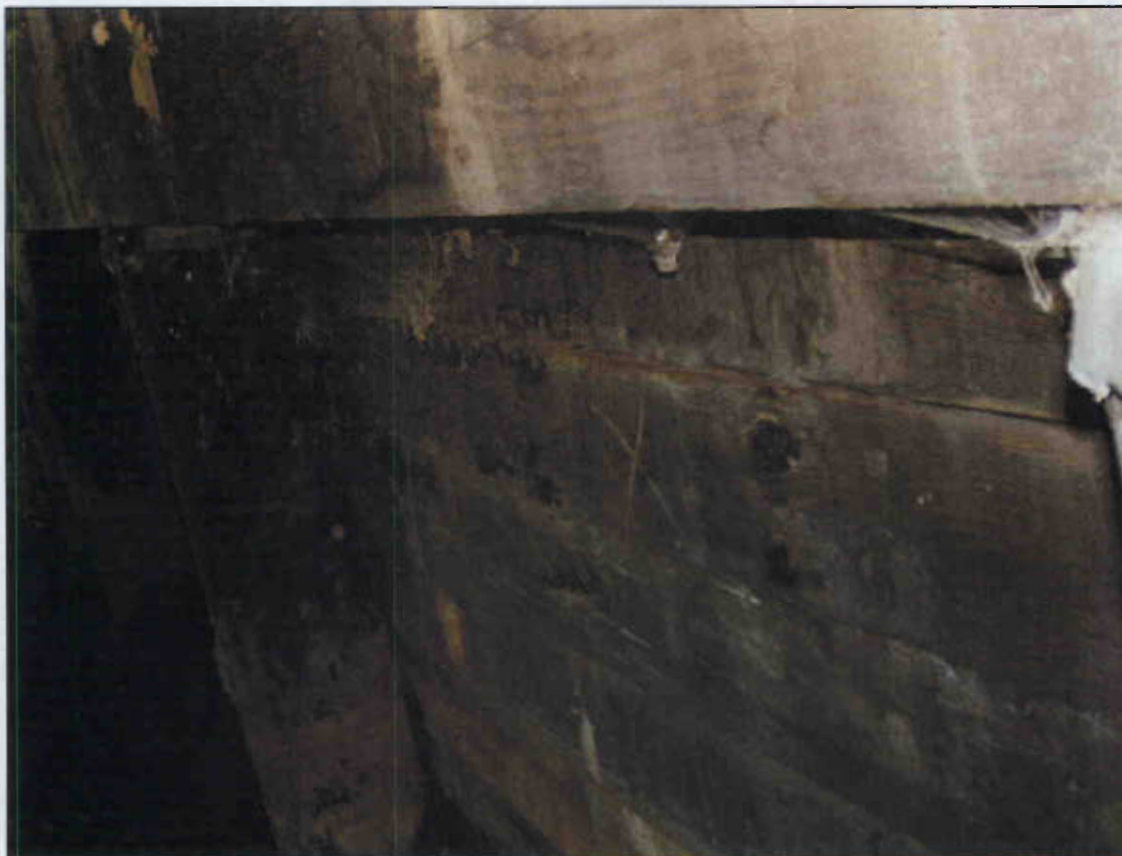
END BENT 2 BULKHEAD BOARDS PUSHED OUT UP TO 1"

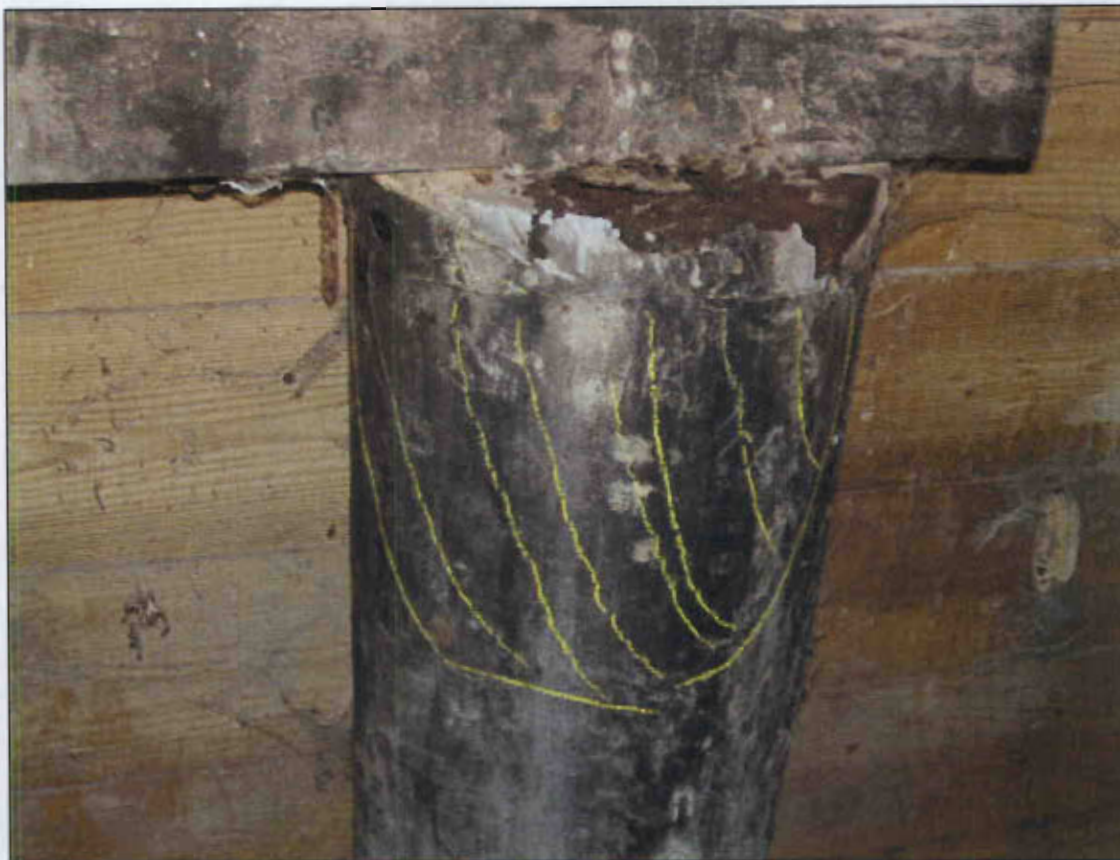
PILE 3 AT END BENT 2 DECAYED AT TOP PORTION 12" WIDE X 12" HIGH X 8" DEEP.(PRIORITY MAINT.)

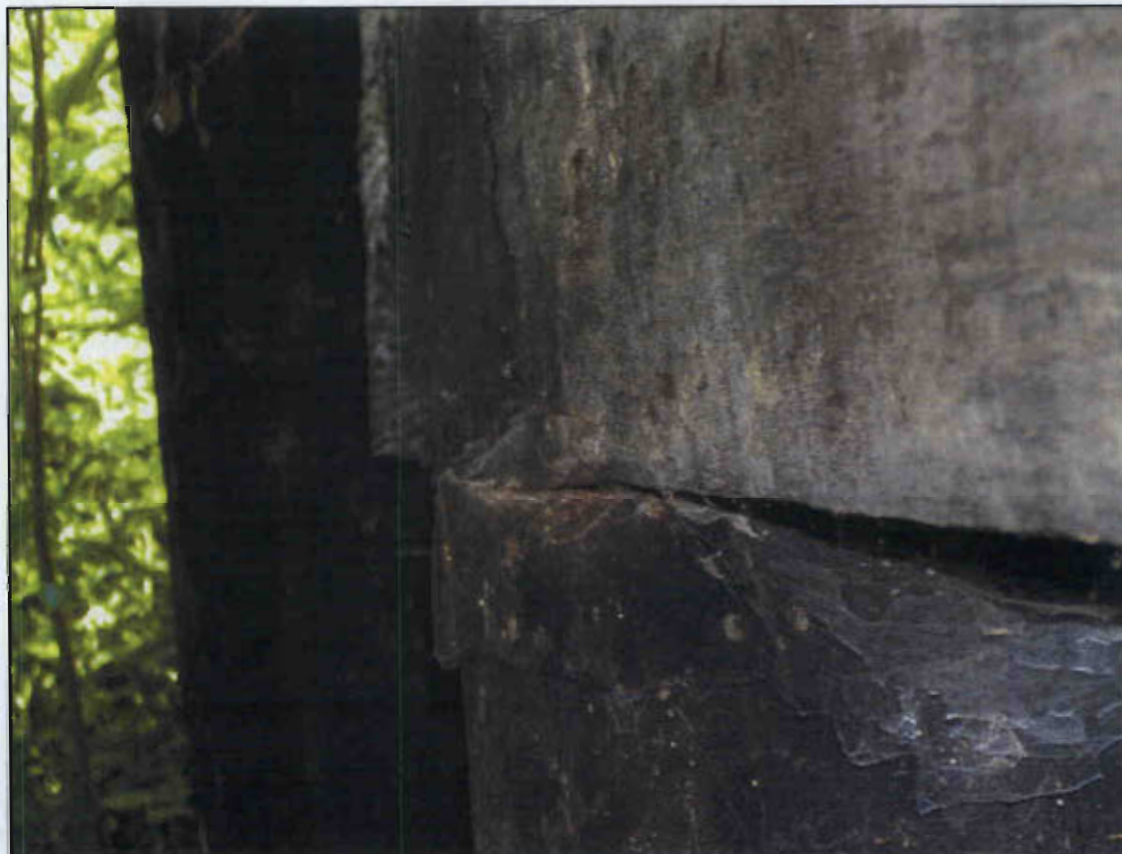
PILE 1 AT END BENT 2 PUSHED OUT 1" DUE TO BULKHEAD PRESSURE (PRIORITY MAINTENANCE)

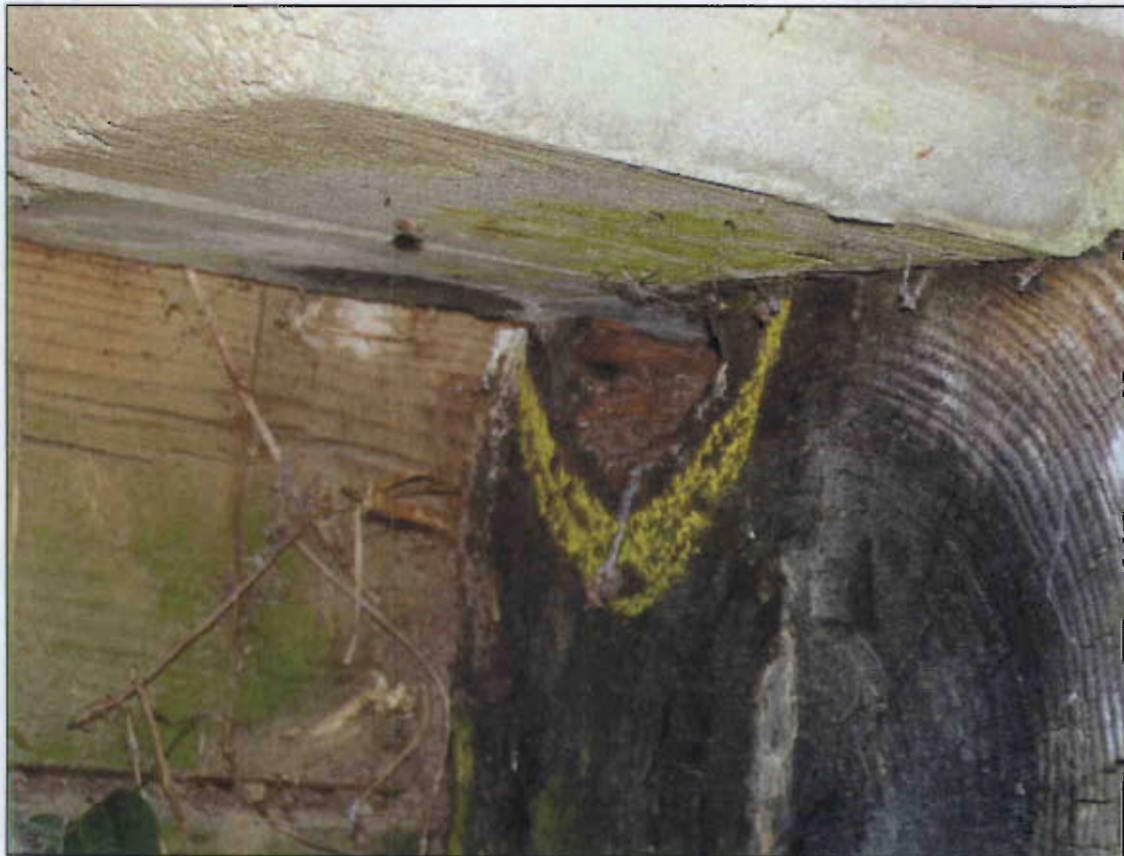
NORTH END OF END BENT 2 CAP DECAYED 12" LONG X 4" WIDE X 2" HIGH

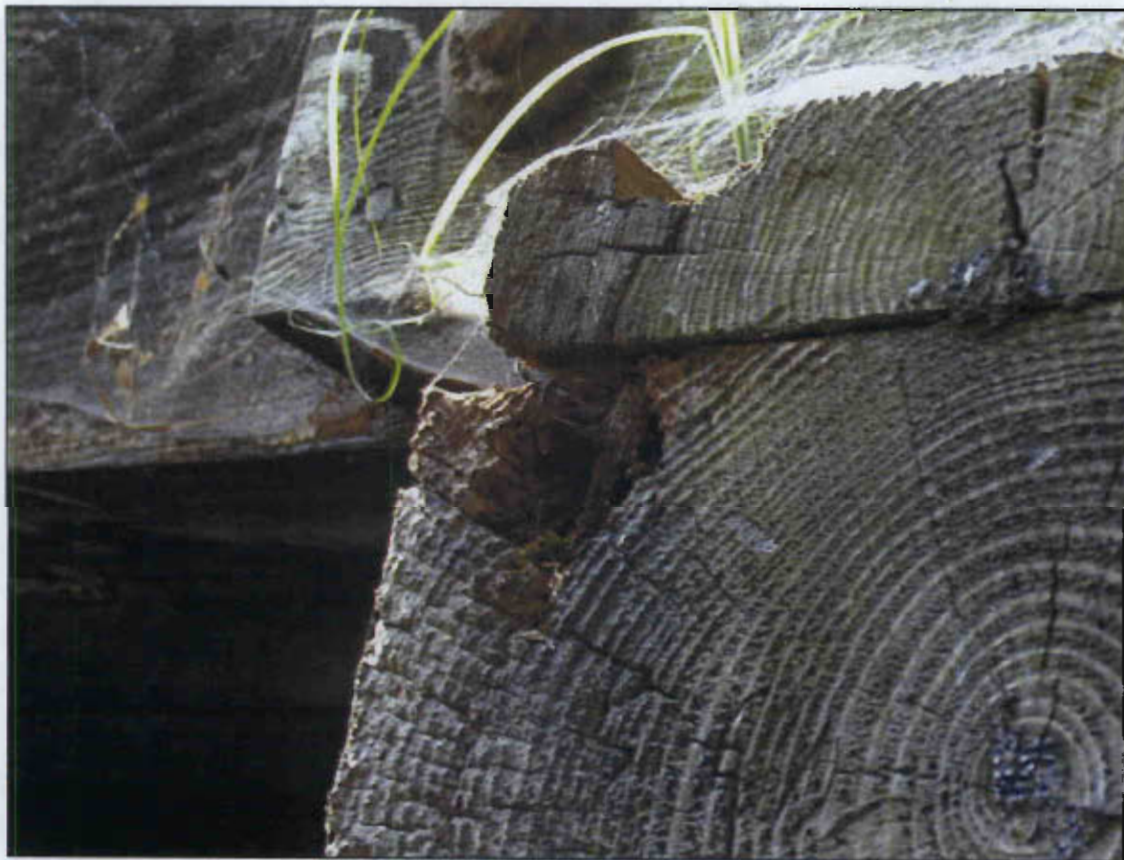
NORTH END OF BENT 2 CAP DECAYED AT TOP LEFT CORNER 3" DIA. X 3" DEEP.

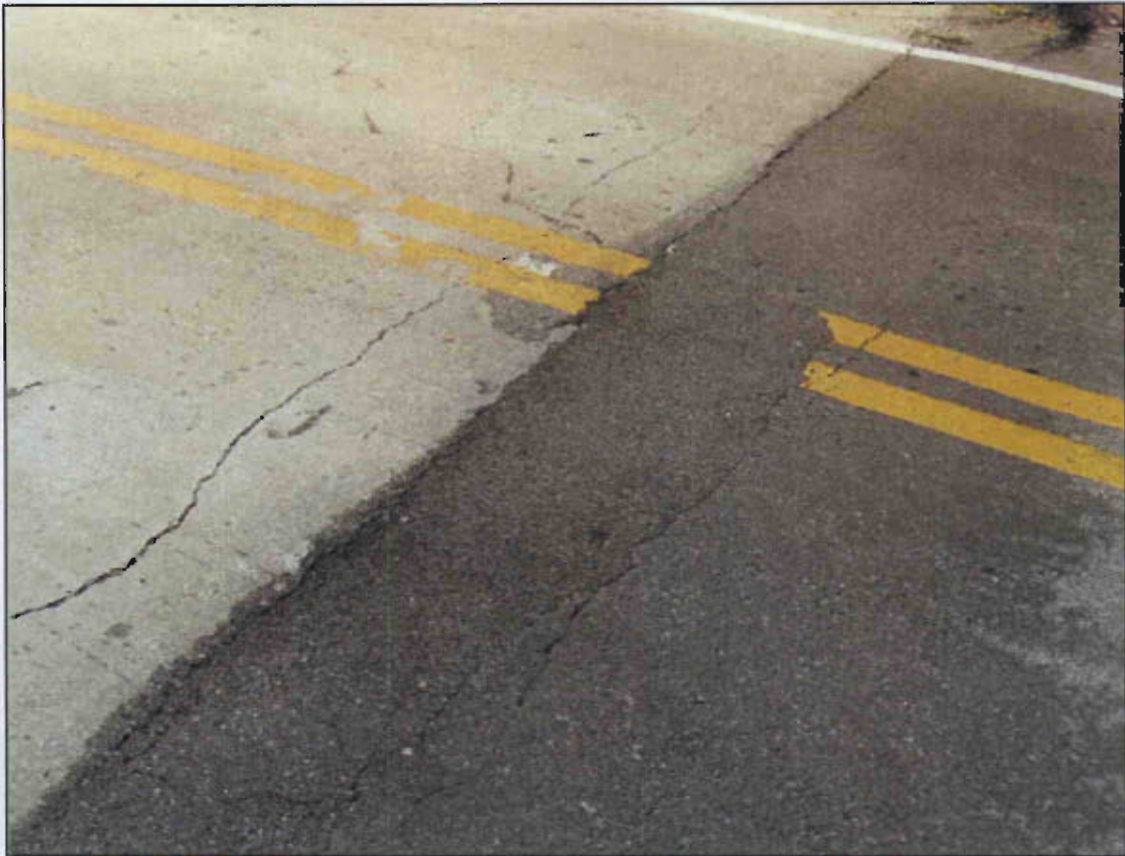
WEST APPROACH ASPHALT WEARING SURFACE CRACKED AND SETTLED UP TO 2"

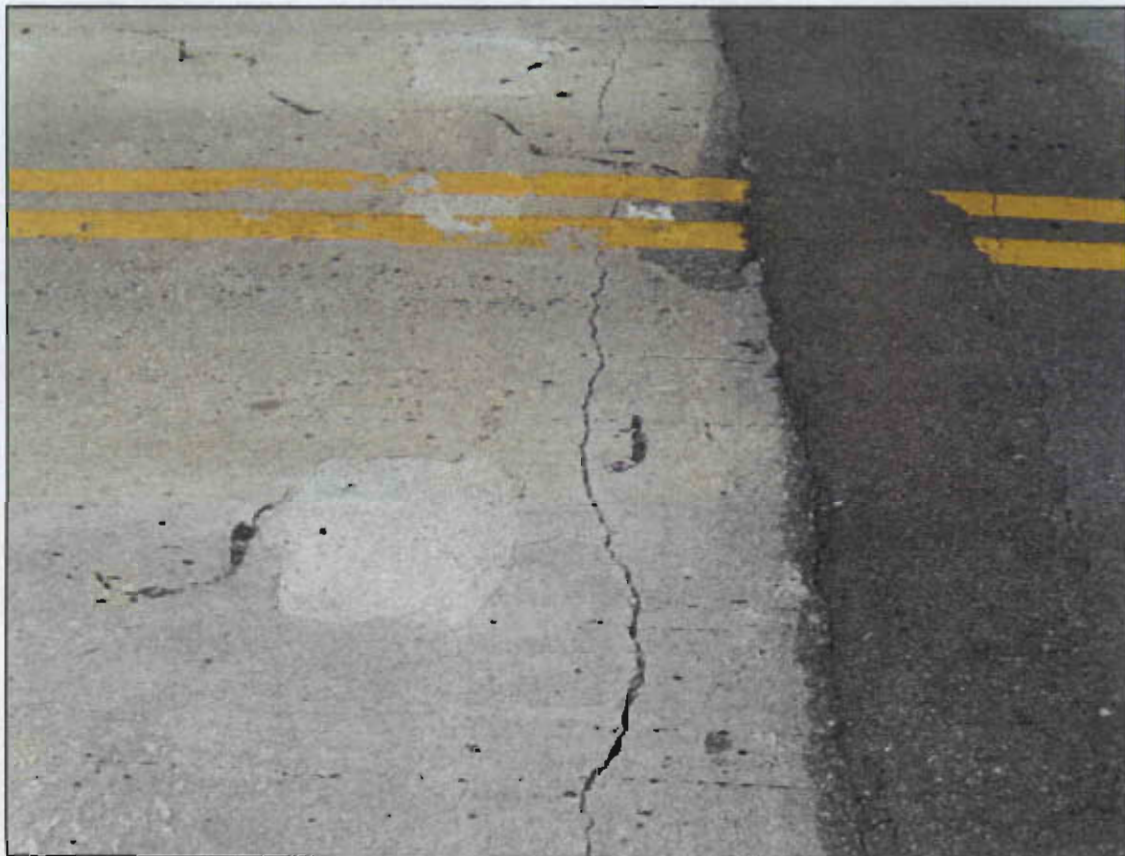
TRANSVERSE CRACKING IN DECK OVER END BENTS UP TO 1/8" WIDE.
