NC DEPARTMENT OF TRANSPORTATION  
 DIVISION OF HIGHWAYS  
 BRIDGE MANAGEMENT UNIT

PRIORITY MAINT. SUBMITTED.  
 SIGN NOTICE SUBMITTED.  
 SHORED.

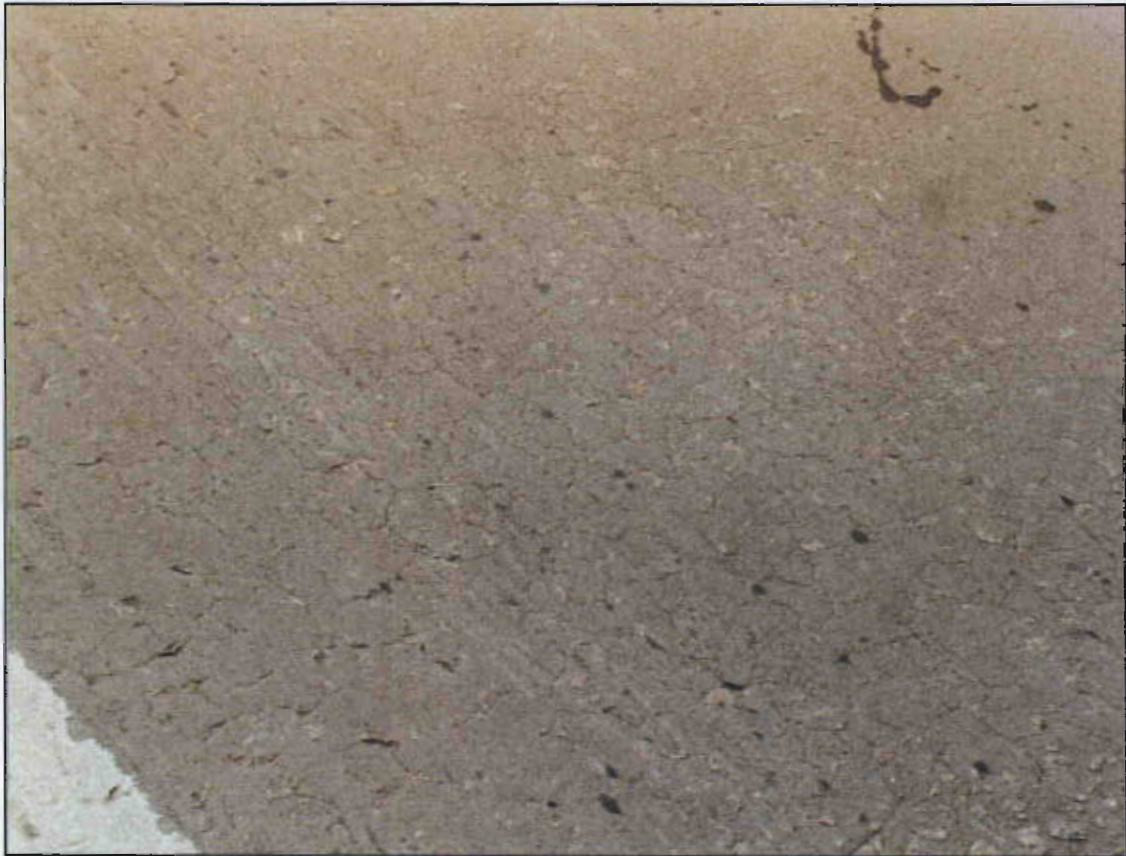
HAIRLINE MAPCRACKING IN DECK IN ALL SPANS

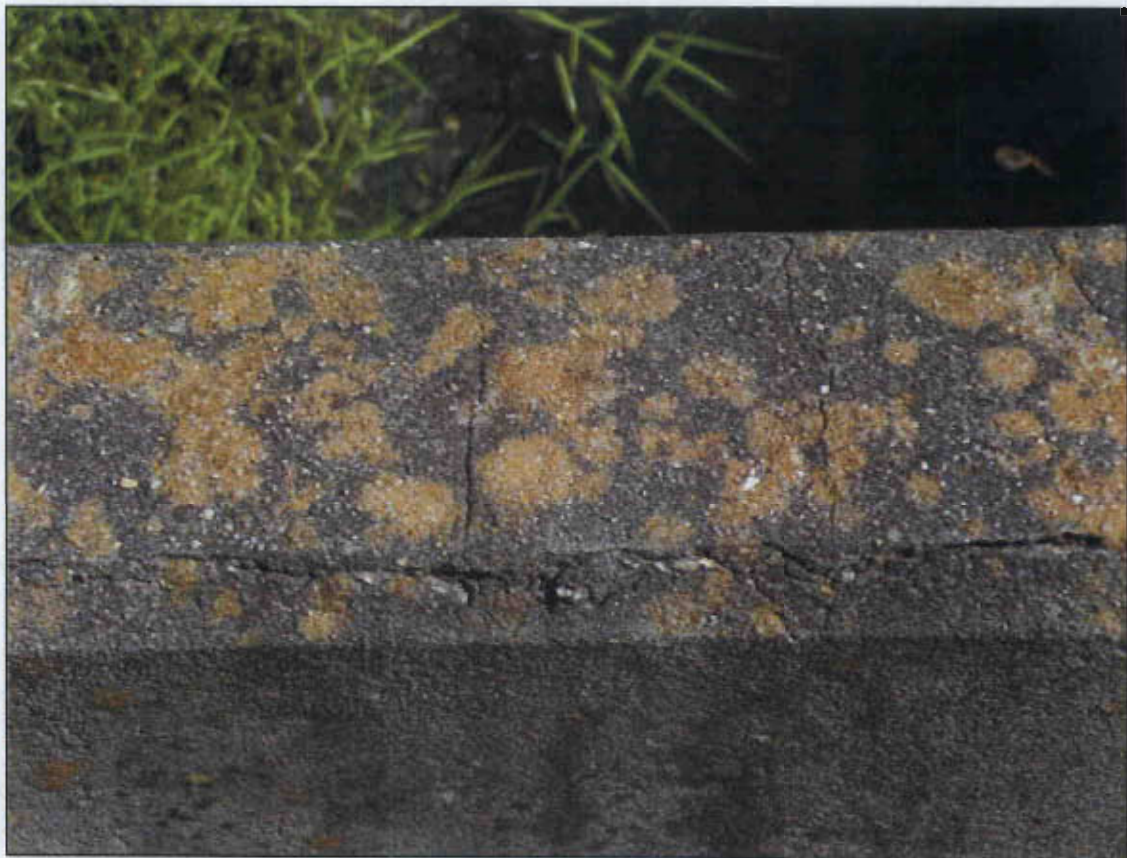
HORIZONTAL CRACKING ALONG NORTH RAIL BAR

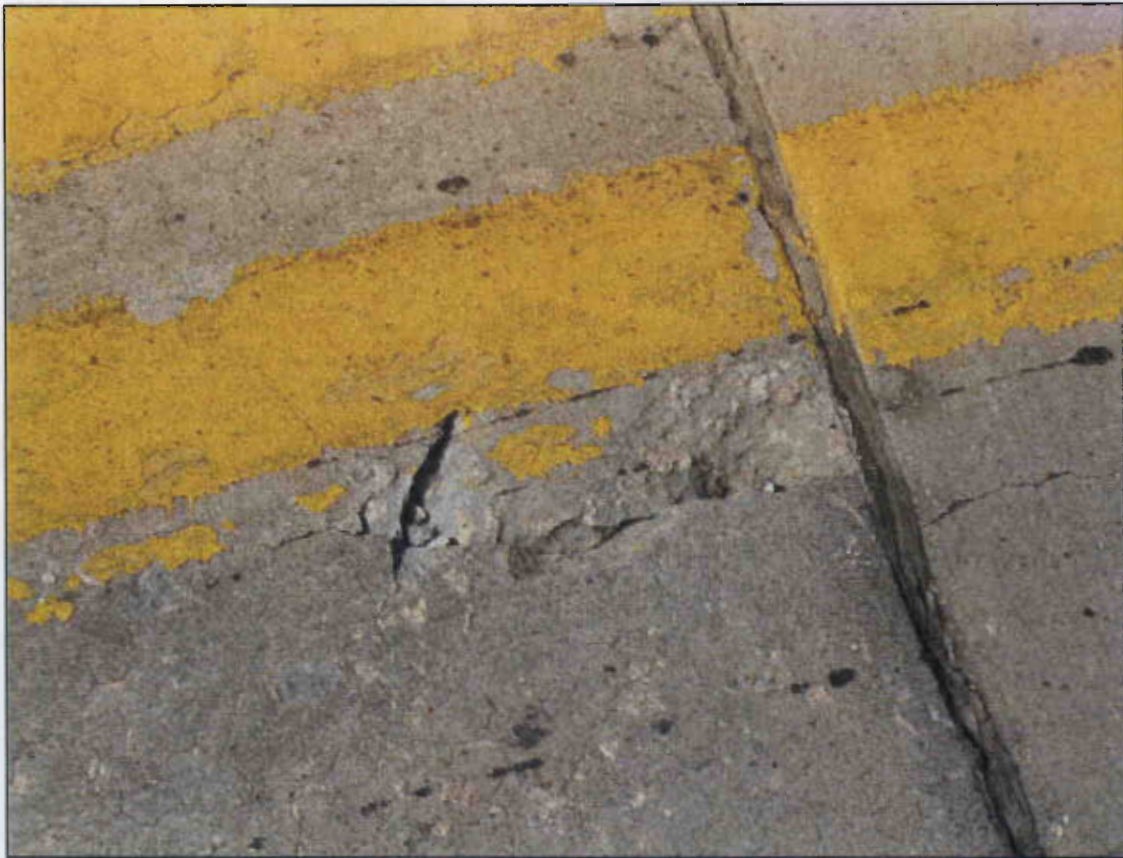
SPAN 3 DECK AT CENTERLINE ALONG BENT 2 CRACKED AND SPALLED AREA 4" WIDE X 12" LONG X 1" DEEP

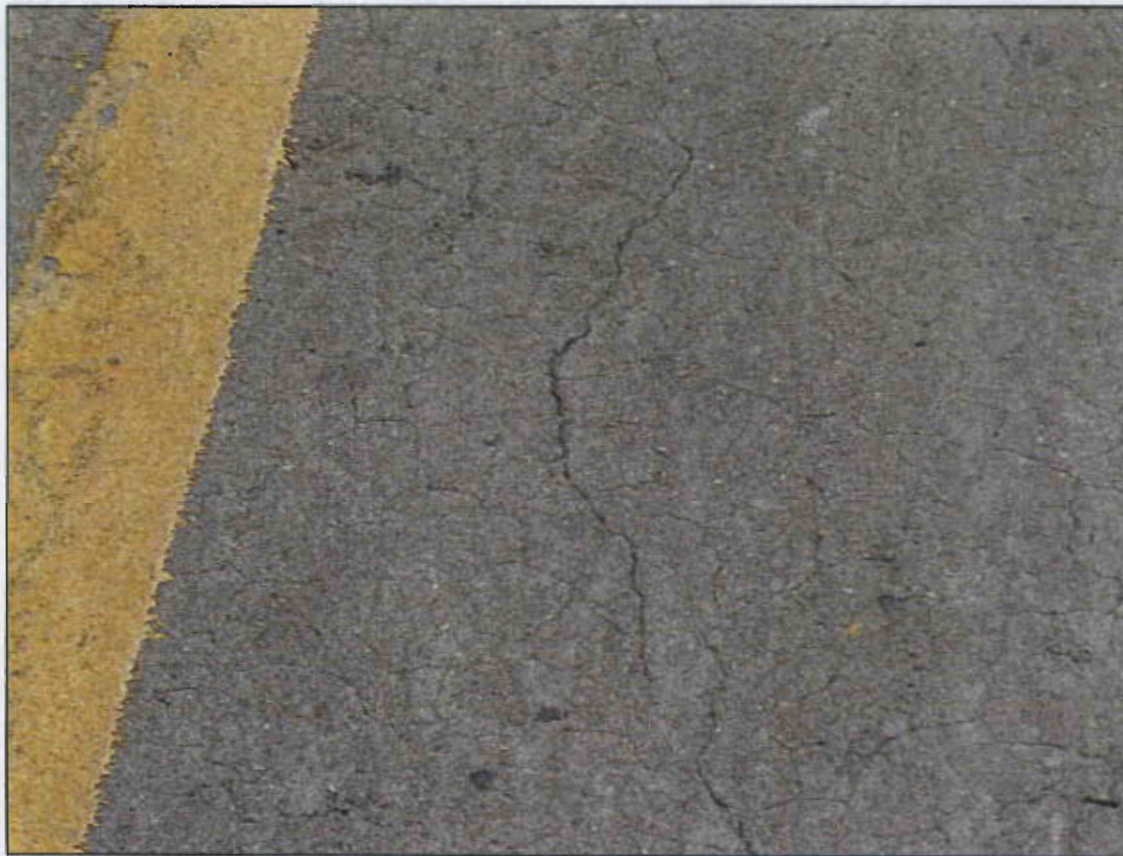
LONGITUDINAL CRACKING IN SPAN 2 DECK UP TO .013" WIDE

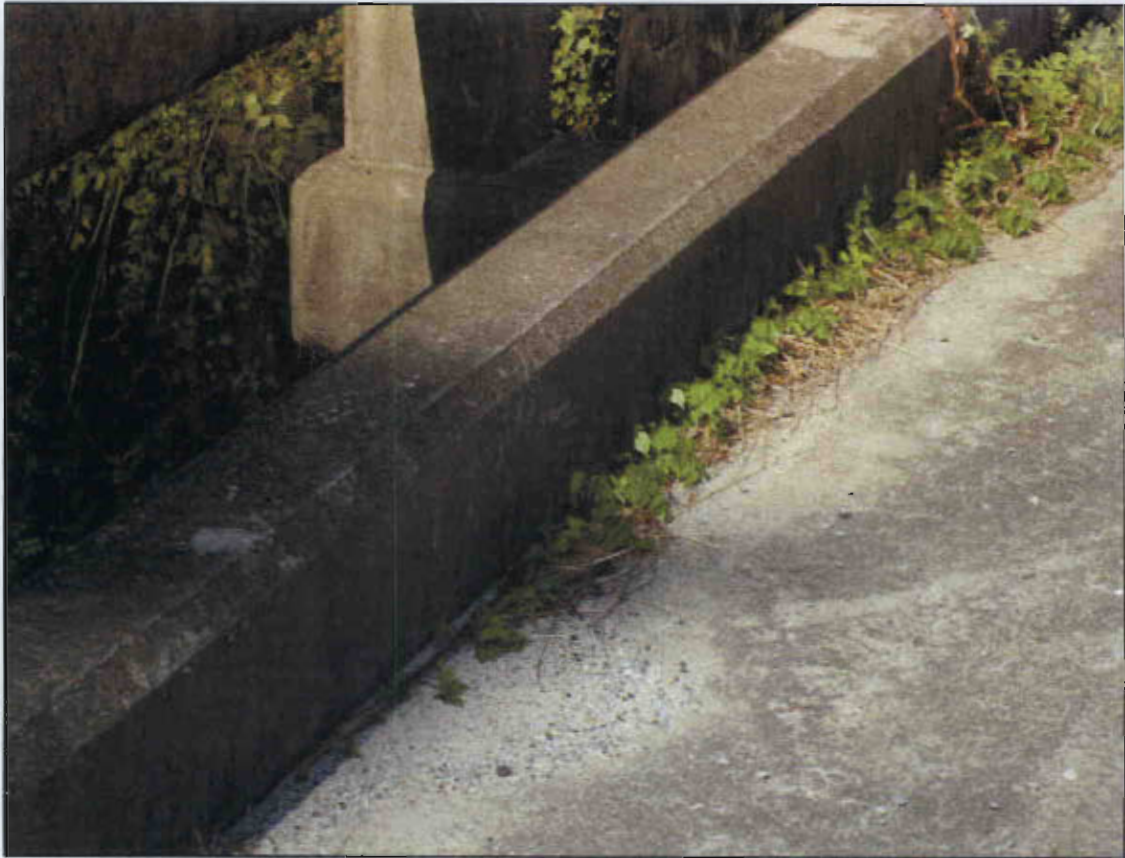
GROWTH AND DEBRIS ALONG SOUTH CURB IN SPAN 1

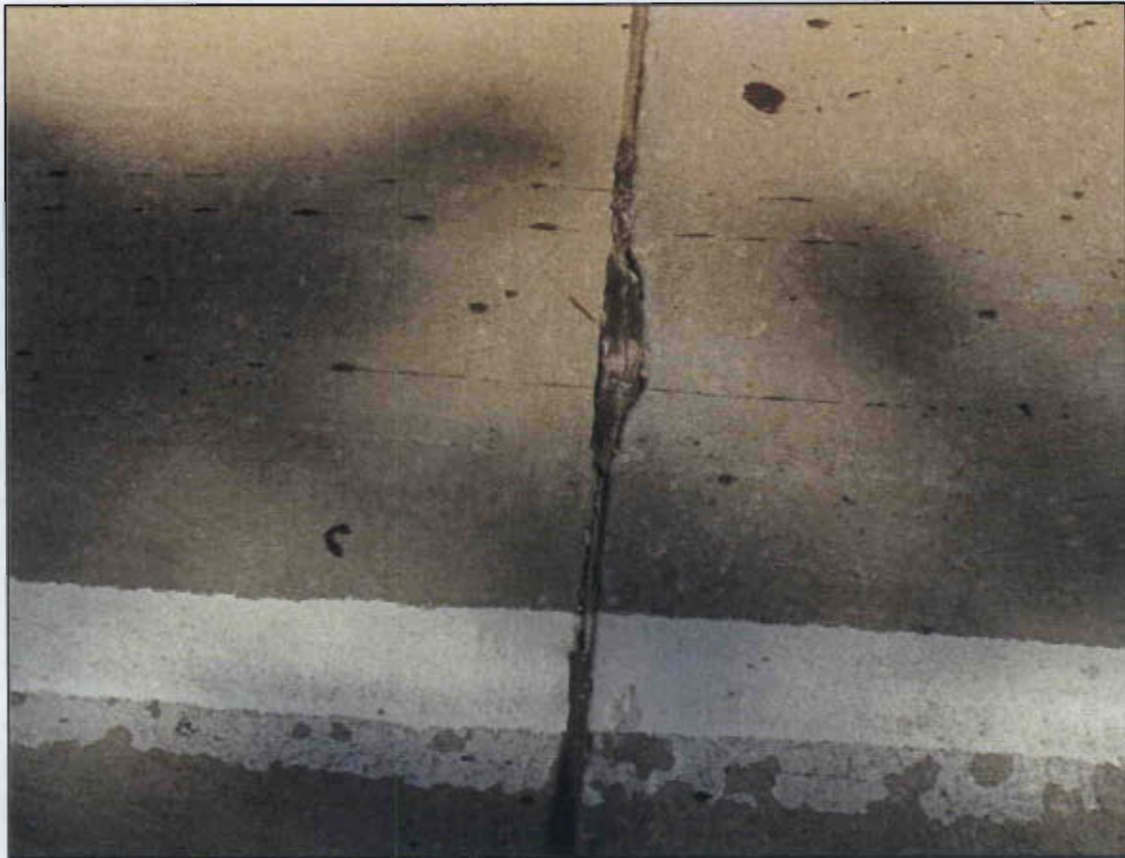
BENT 2 JOINT MATERIAL MISSING AND LOOSE IN A 2' LONG AREA.

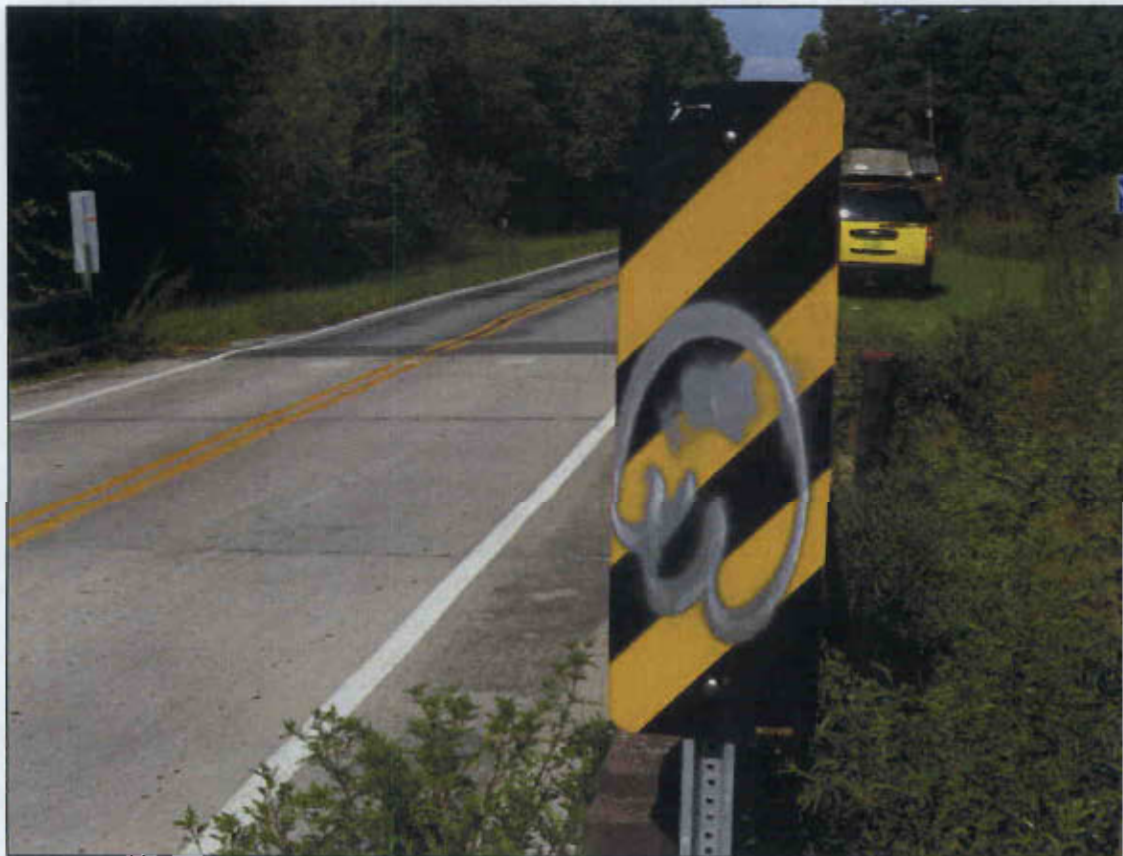
NORTHEAST DELINEATOR DAMAGED

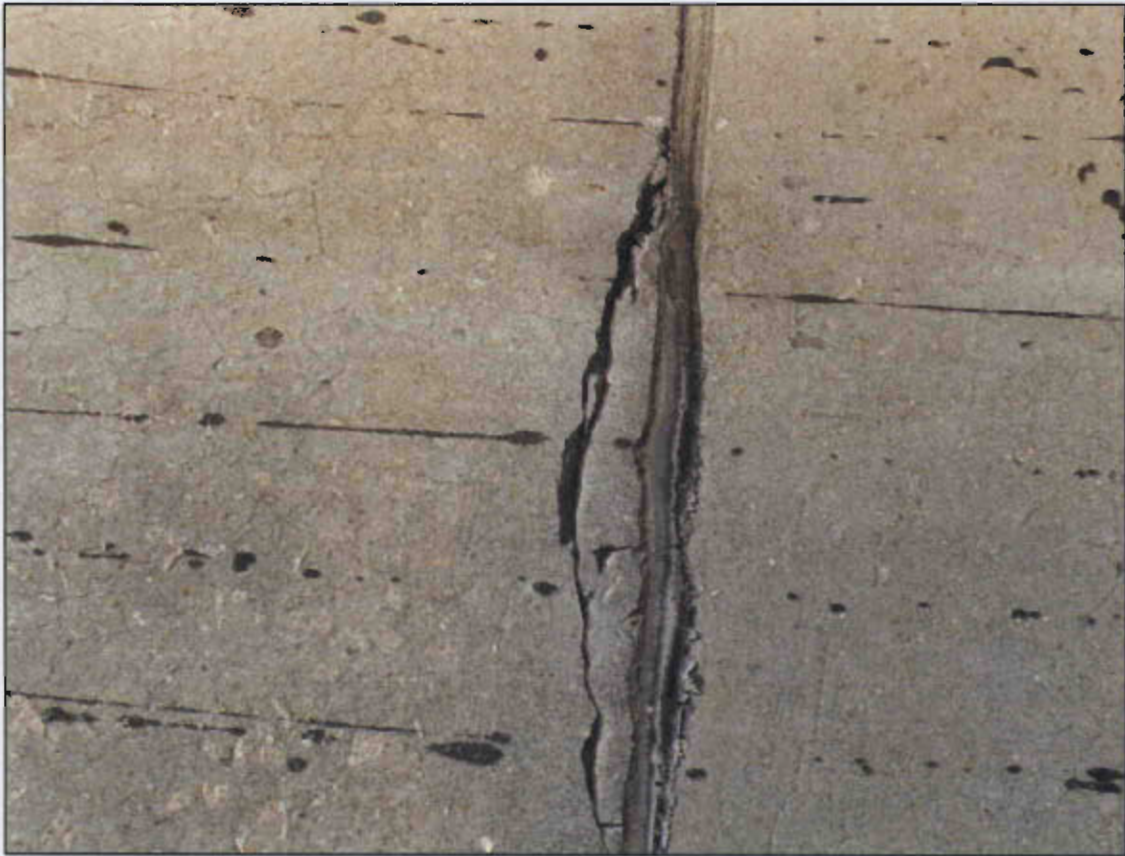
SPAN 3 DECK CRACKED AND DELAMINATED AREA ALONG BENT 2 JOINT IN WEST BOUND LANE 18" LONG X 2" WIDE.

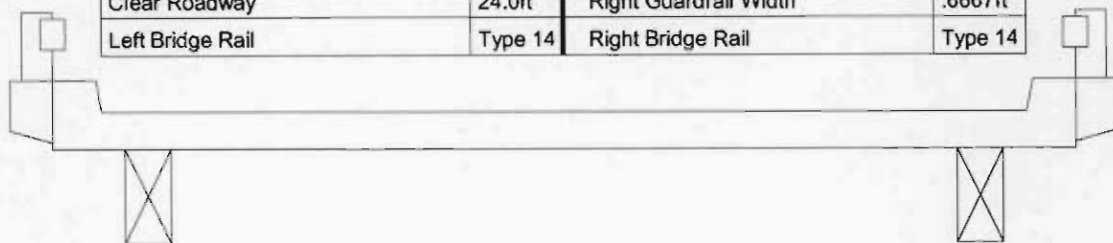
Measurements for Span #	1		
Deck Thickness	.4167	Left Overhang	.4167
Top of Rail to Bottom of Beam	4.1667	Right Overhang	.4167
