NC DEPARTMENT OF TRANSPORTATION
 DIVISION OF HIGHWAYS
 BRIDGE MANAGEMENT UNIT

ATTENTION **SHORED**

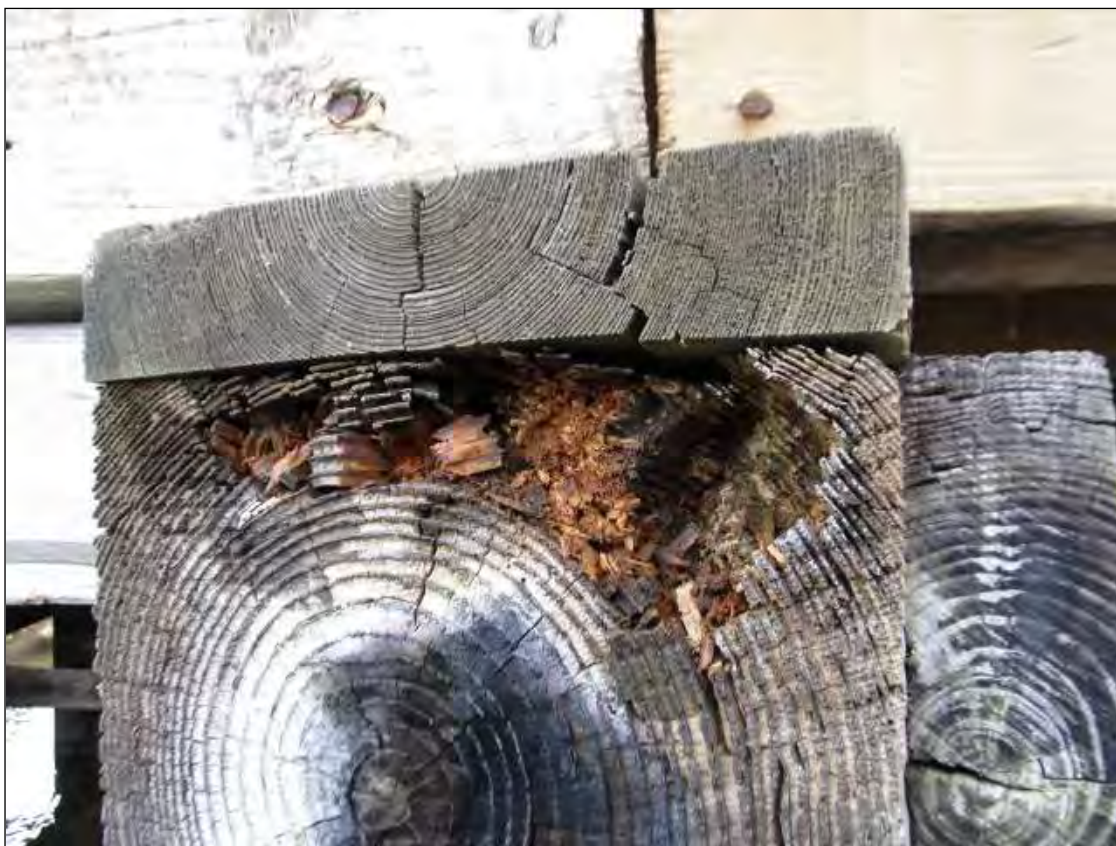
BENT 1 CAP AT NORTH END DECAYED AREA 10" WIDE X 2" TO 5" HIGH X 5" LONG.

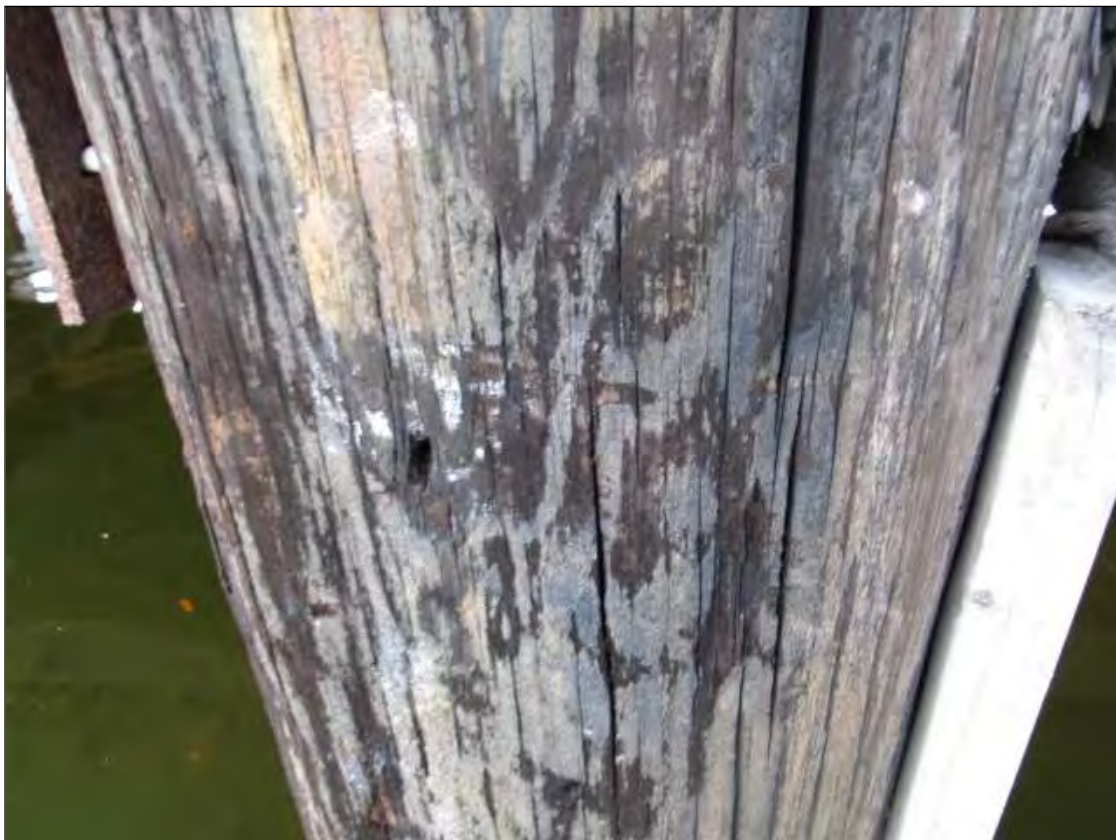
LONGITUDINAL CRACKING ALONG TIMBER PILES UP TO 1/8" WIDE

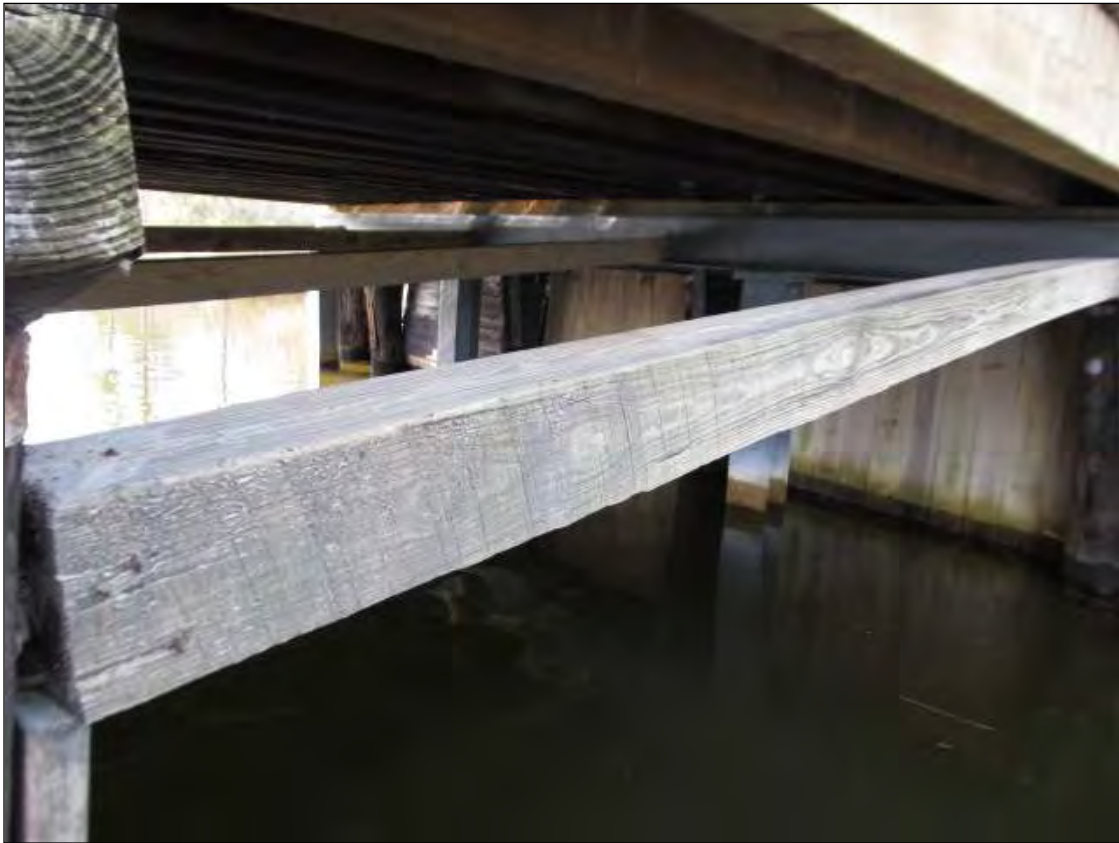
LONGITUDINAL BRACING IN PLACE AT BENT 1 PILES IN SPAN 1 SIMILAR AT BENT 2 IN SPAN 3 AND SPAN 2.

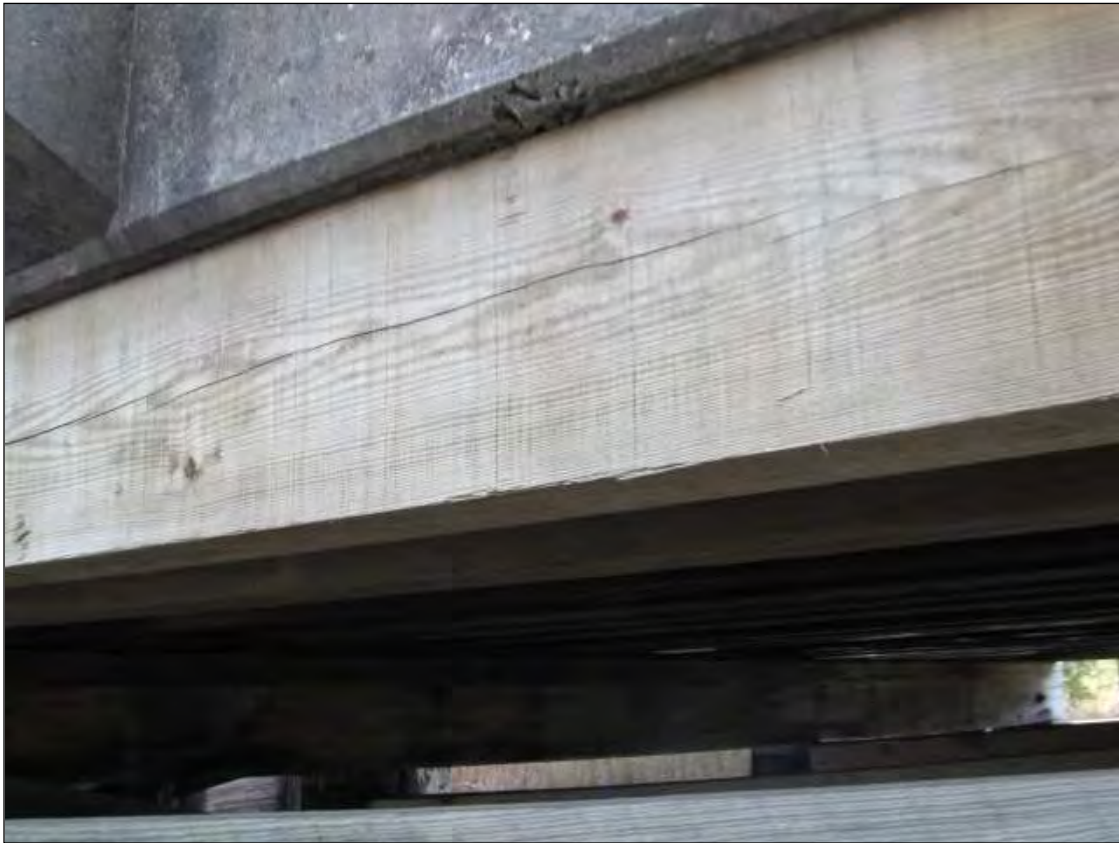
JOIST 1 IN SPAN 1 REPLACED WITH CCA MATERIAL

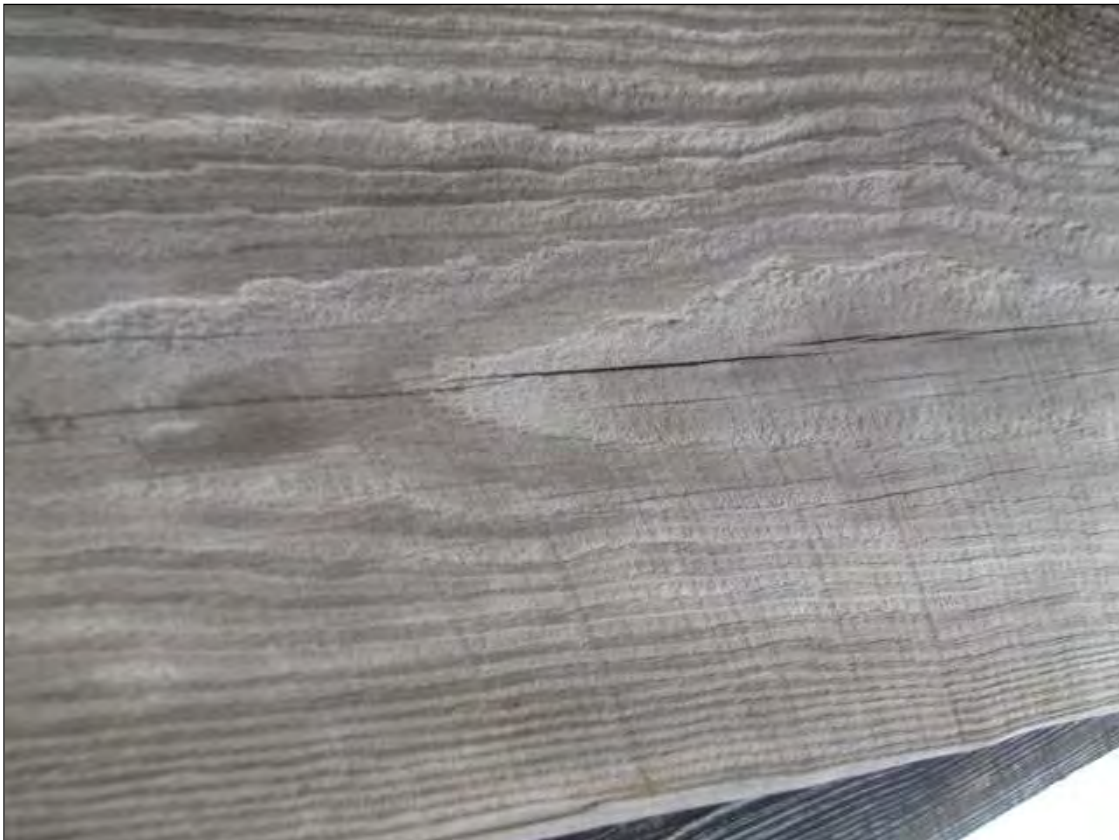
LONGITUDINAL CRACKING ALONG TIMBER CAPS UP TO 1/8" WIDE.

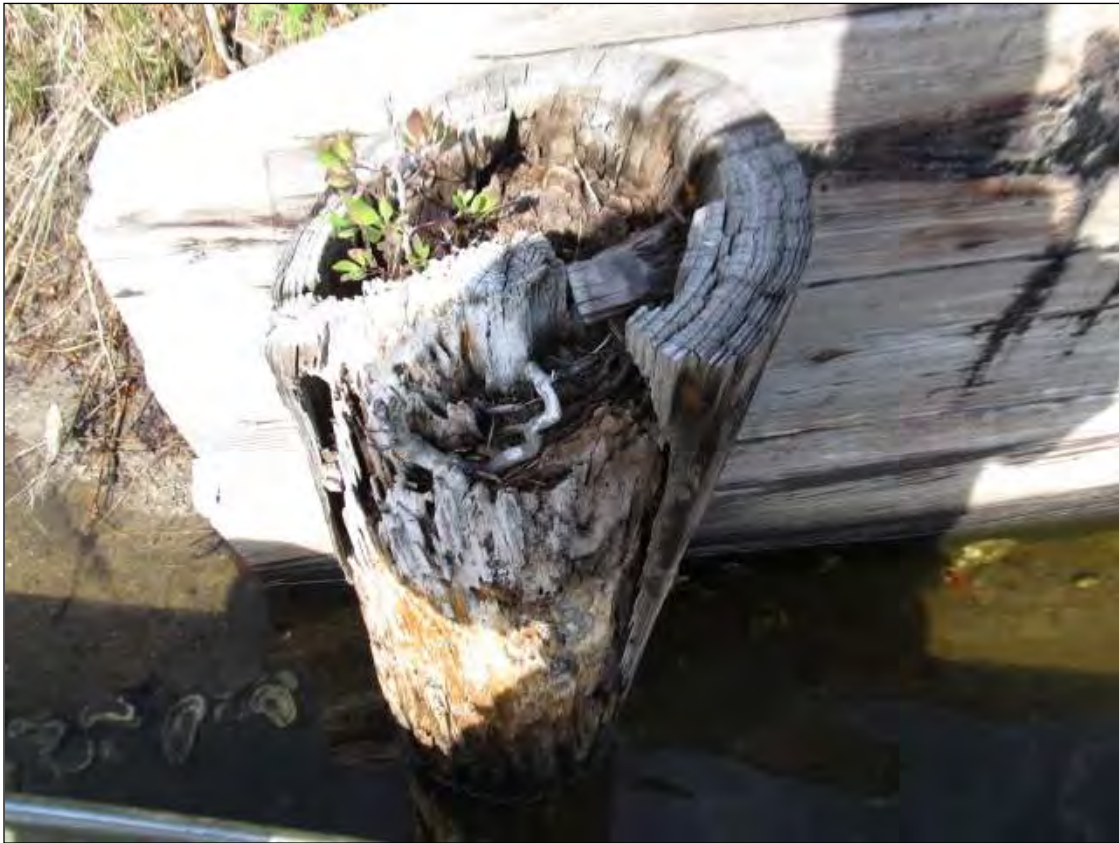
SOUTHWEST WINGPILE DECAYED AND HOLLOW

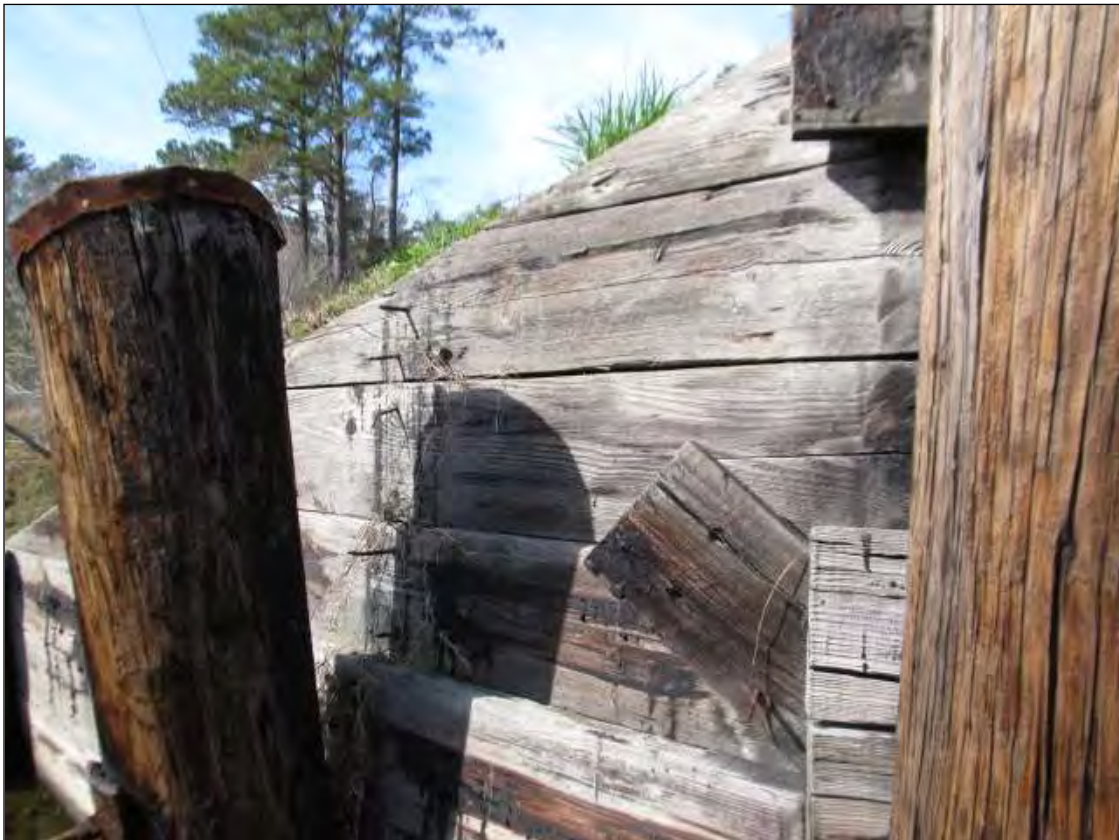
SOUTHWEST WINGWALL TOP 3 BOARDS ROLLED BACK AND DISPLACED UP TO 1"

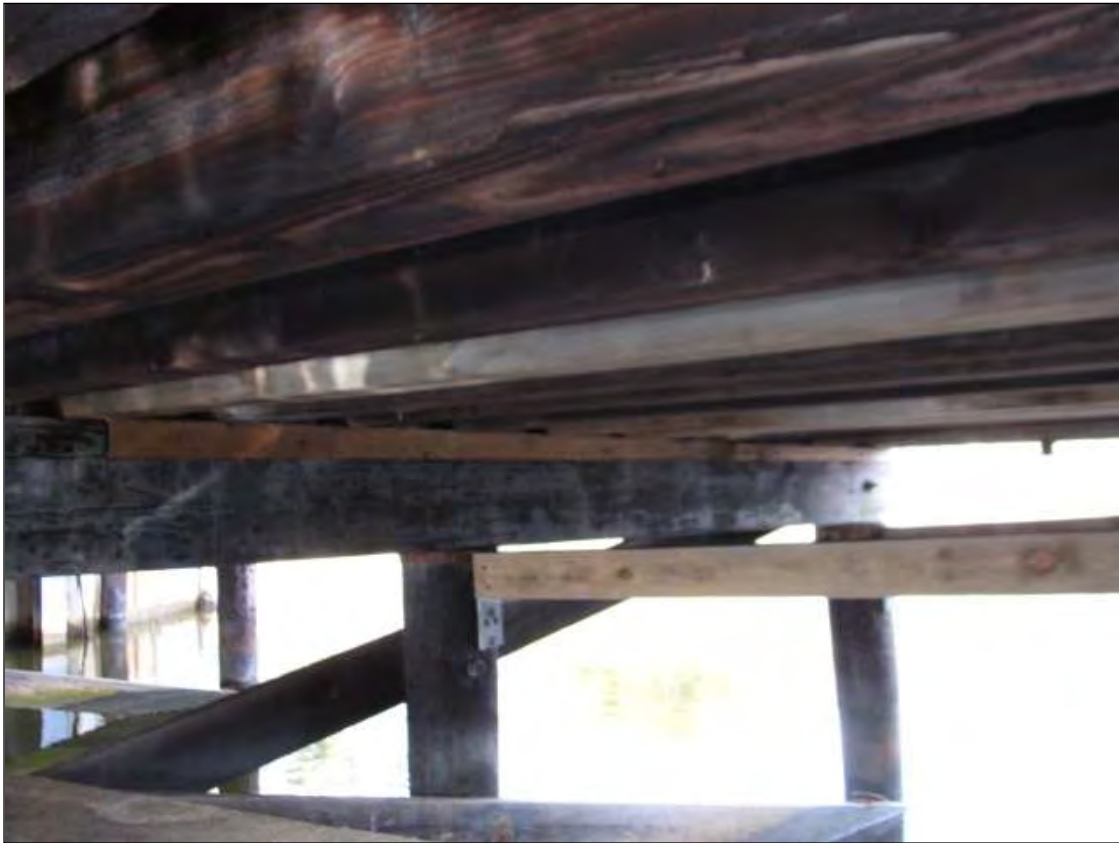
BENT 2 CROWN STRIP REPLACED WITH CCA MATERIAL AT JOIST 1-10

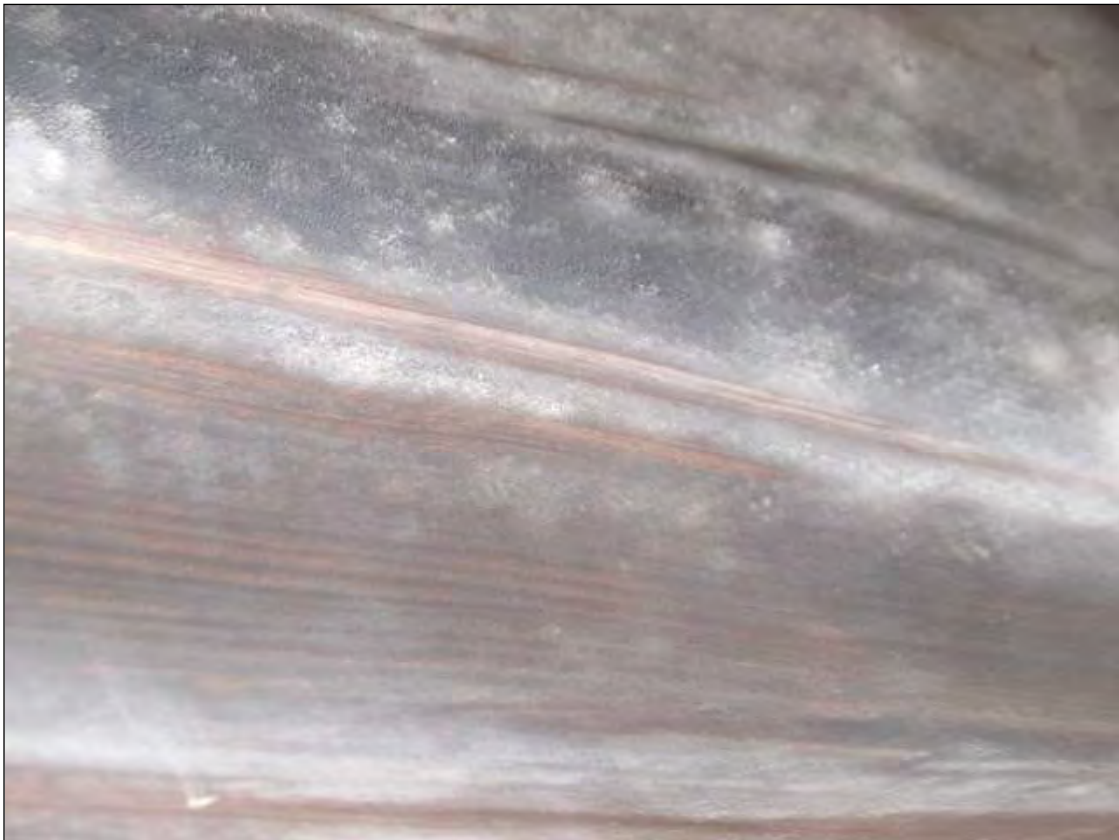
LONGITUDINAL CRACKING ALONG JOIST UP TO 1/8" WIDE

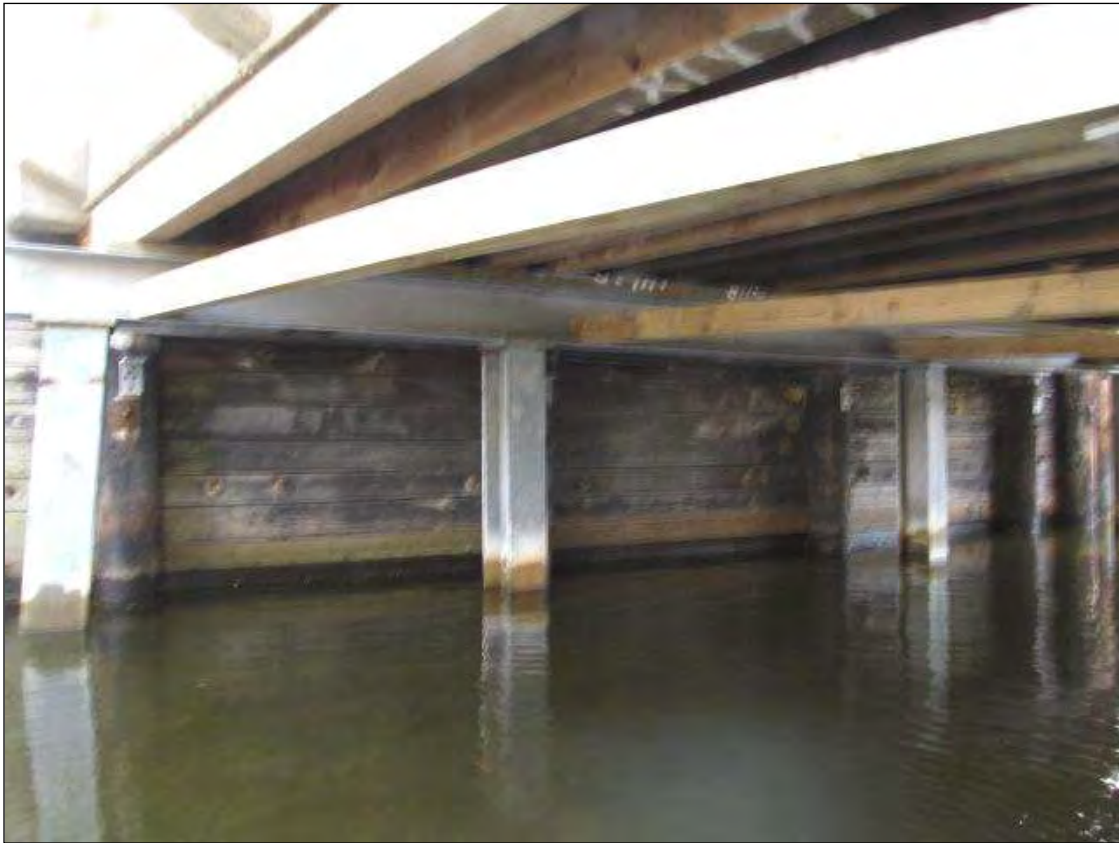
STEEL CRUTCH BENT IN PLACE AT END BENT 2

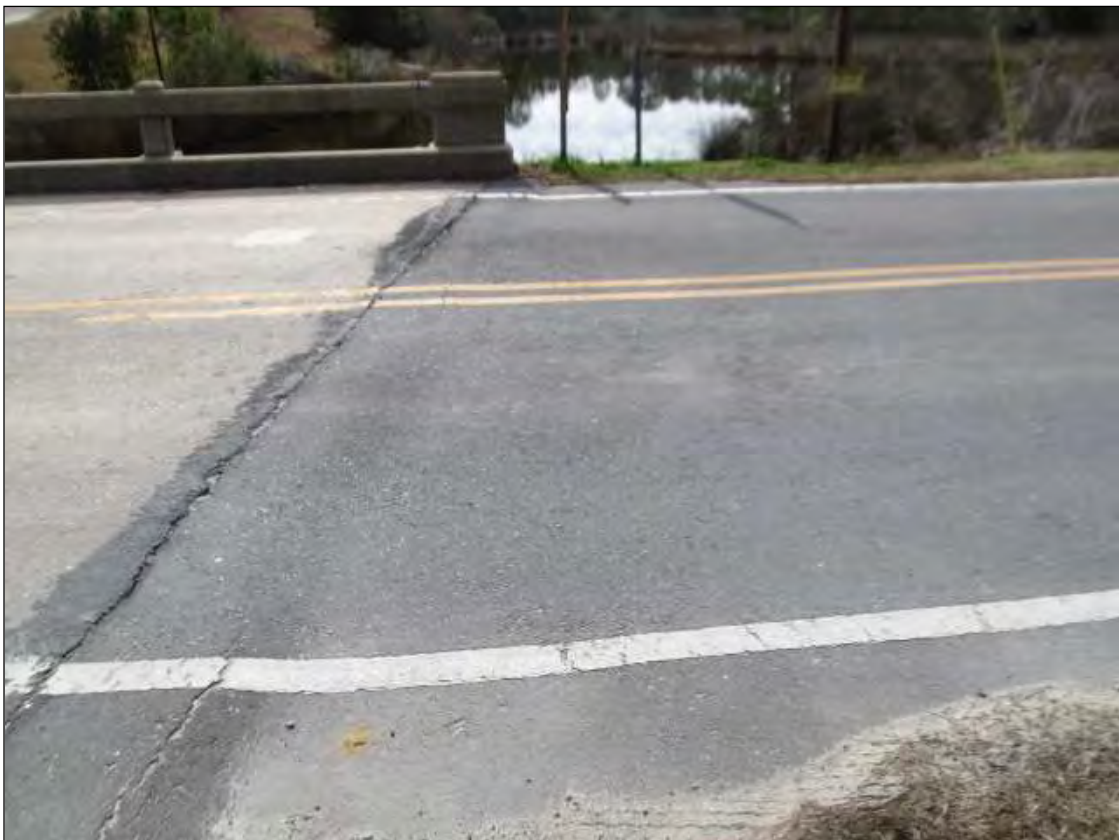
WEST APPROACH ASPHALT WEARING SURFACE SETTLED 2"

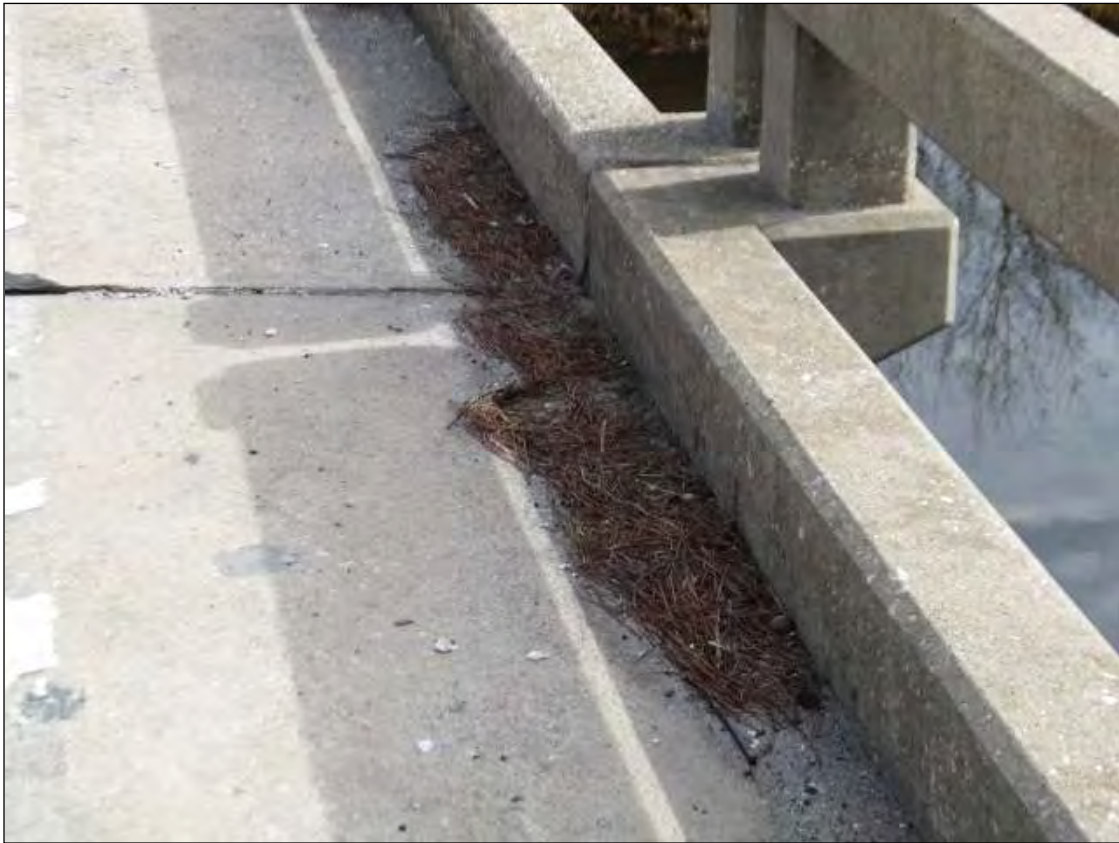
DEBRIS ALONG SOUTH CURB BLOCKING DRAINS

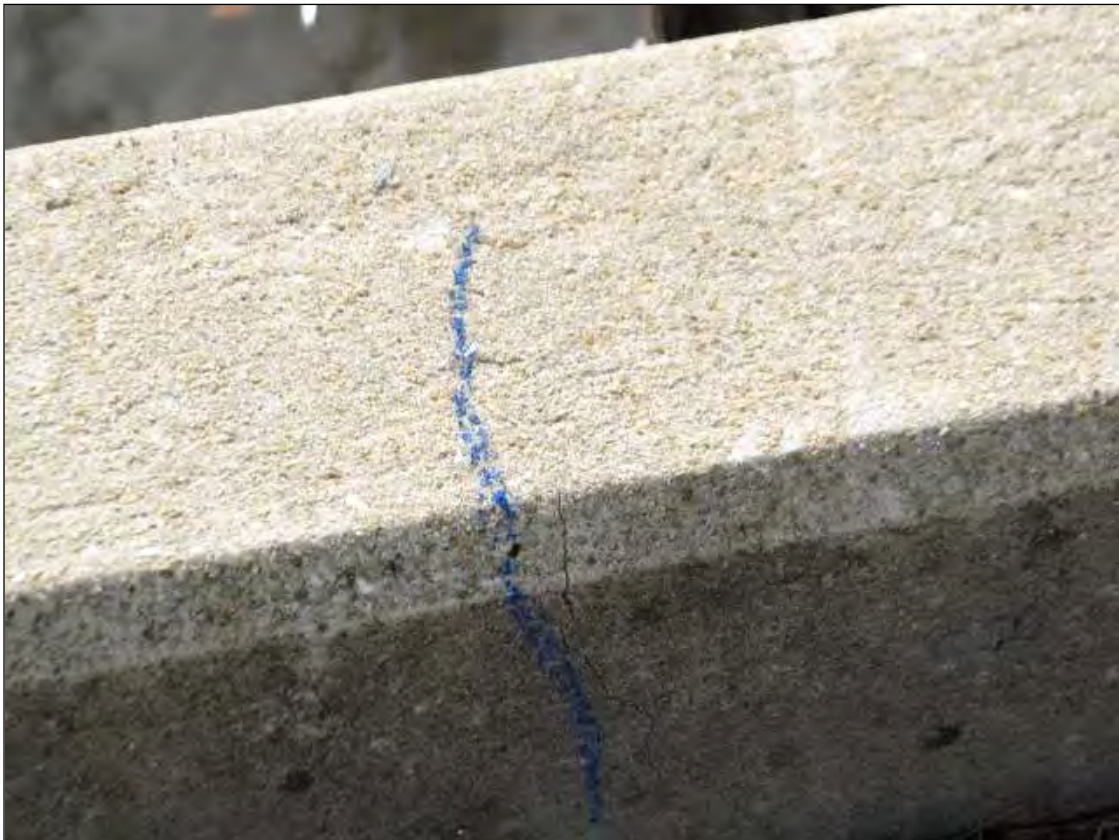
TRANSVERSE CRACKING/VERTICAL CRACKING ALONG CURBS

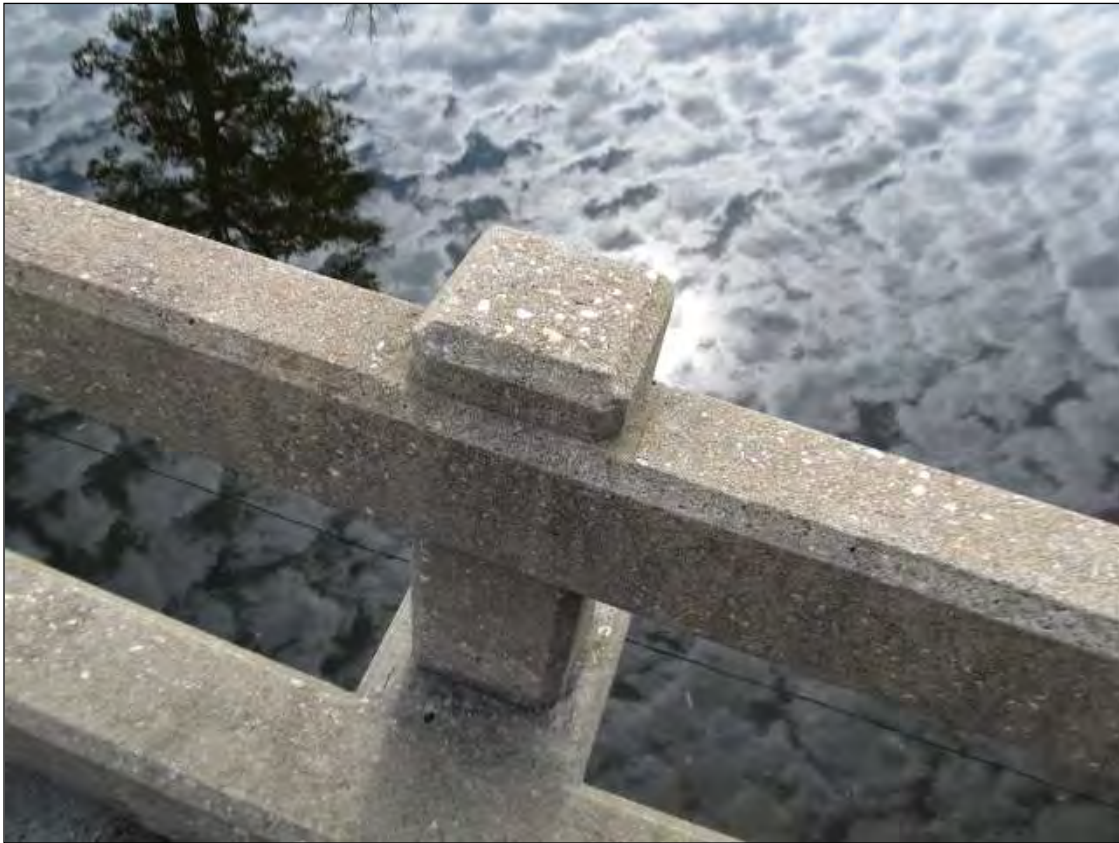
RAILS WEATHERED WITH EXPOSED AGGREGATE

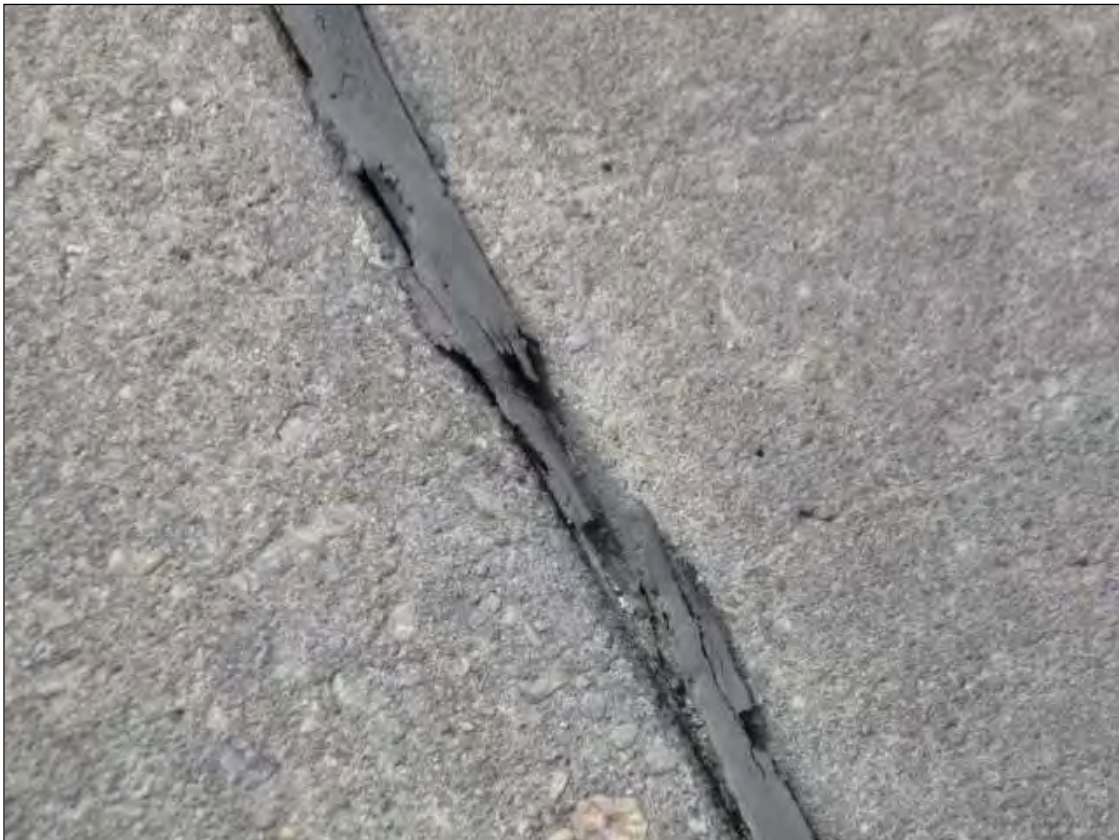
TOP SEAL ALONG JOINTS DETERIORATED

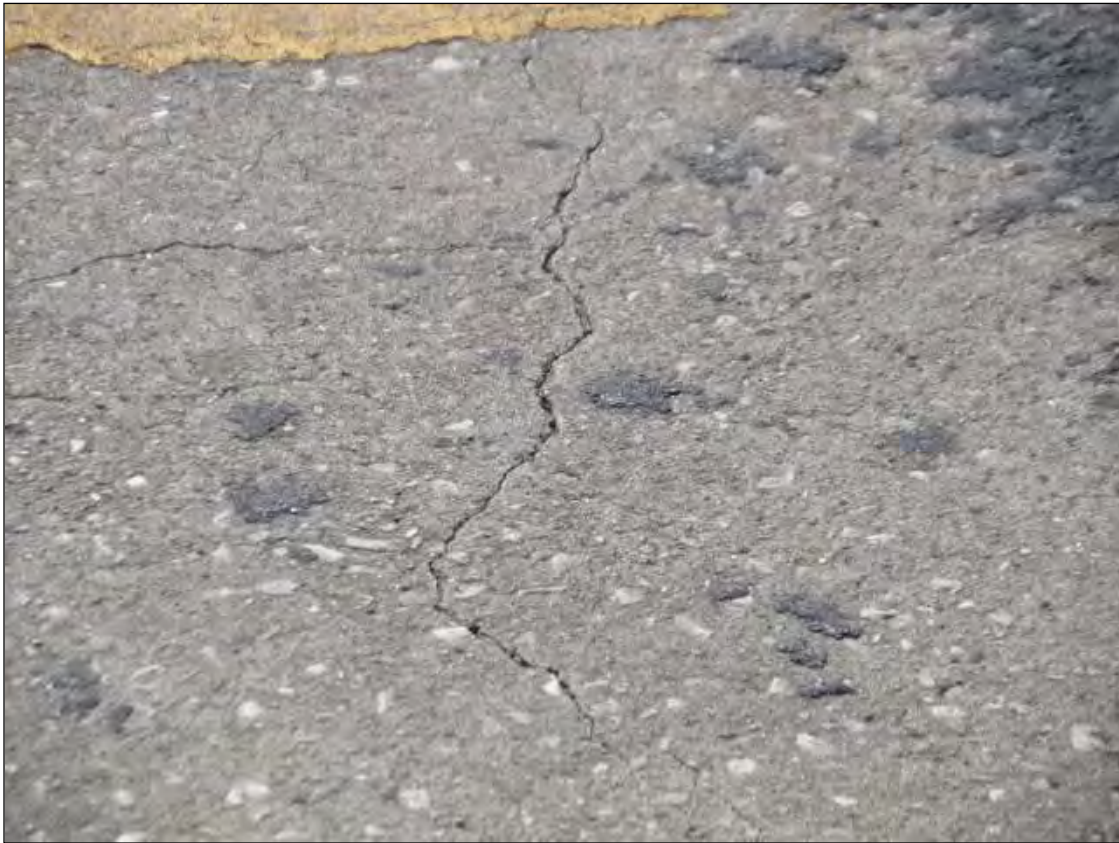
TRANSVERSE CRACKING IN DECK OVER END BENTS UP TO .020" WIDE

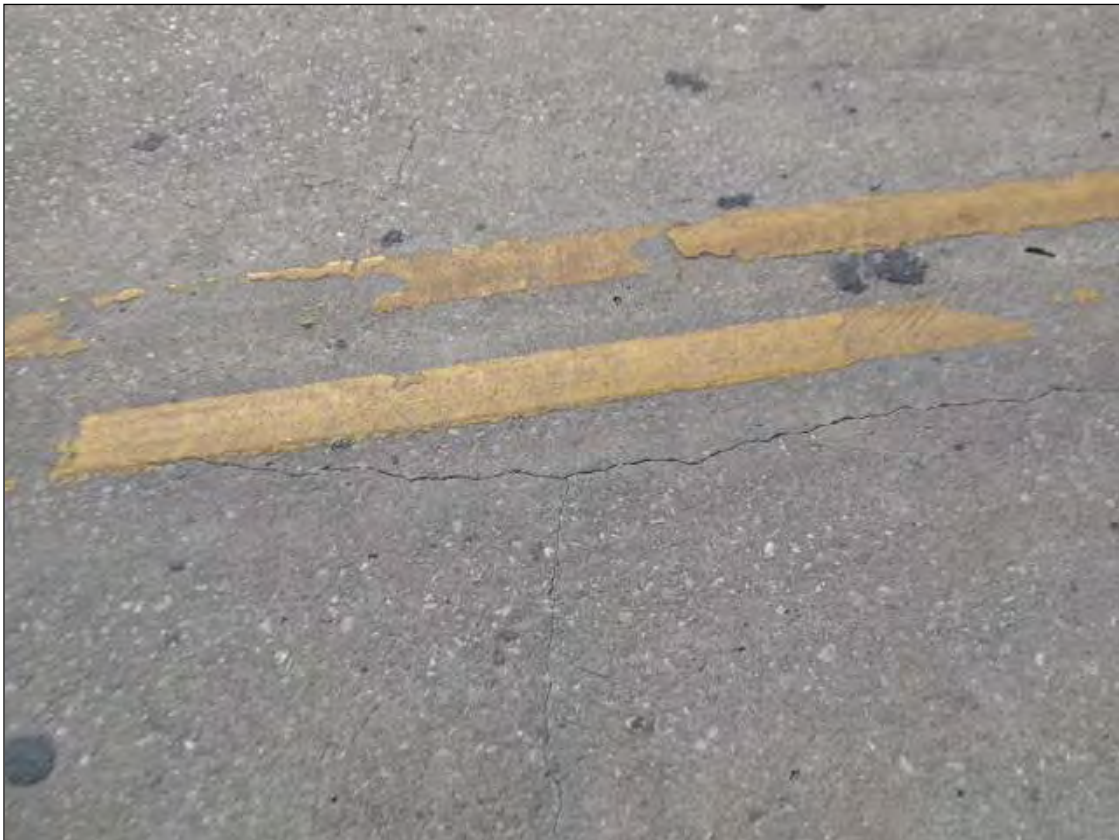
TRANSVERSE CRACKING/LONGITUDINAL CRACKING IN DECK IN ALL SPANS UP TO .040" WIDE

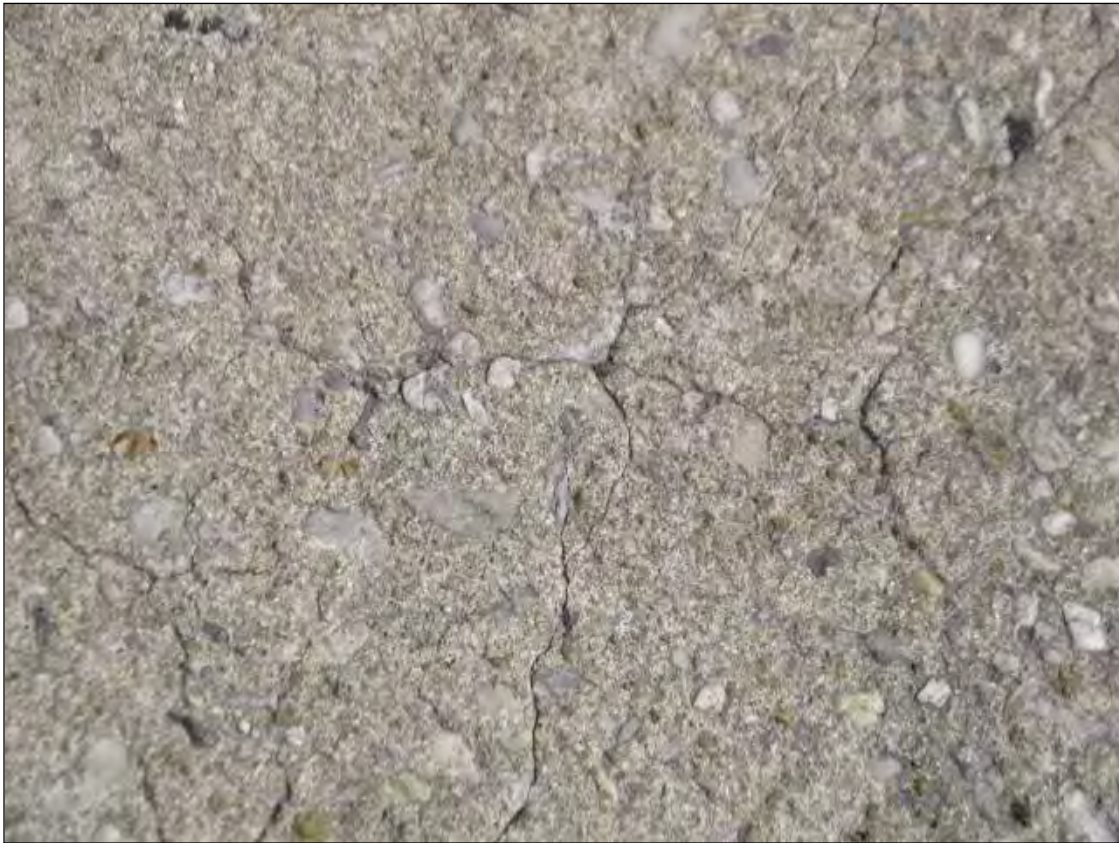
HAIRLINE MAPCRACKING IN DECK IN ALL SPANS

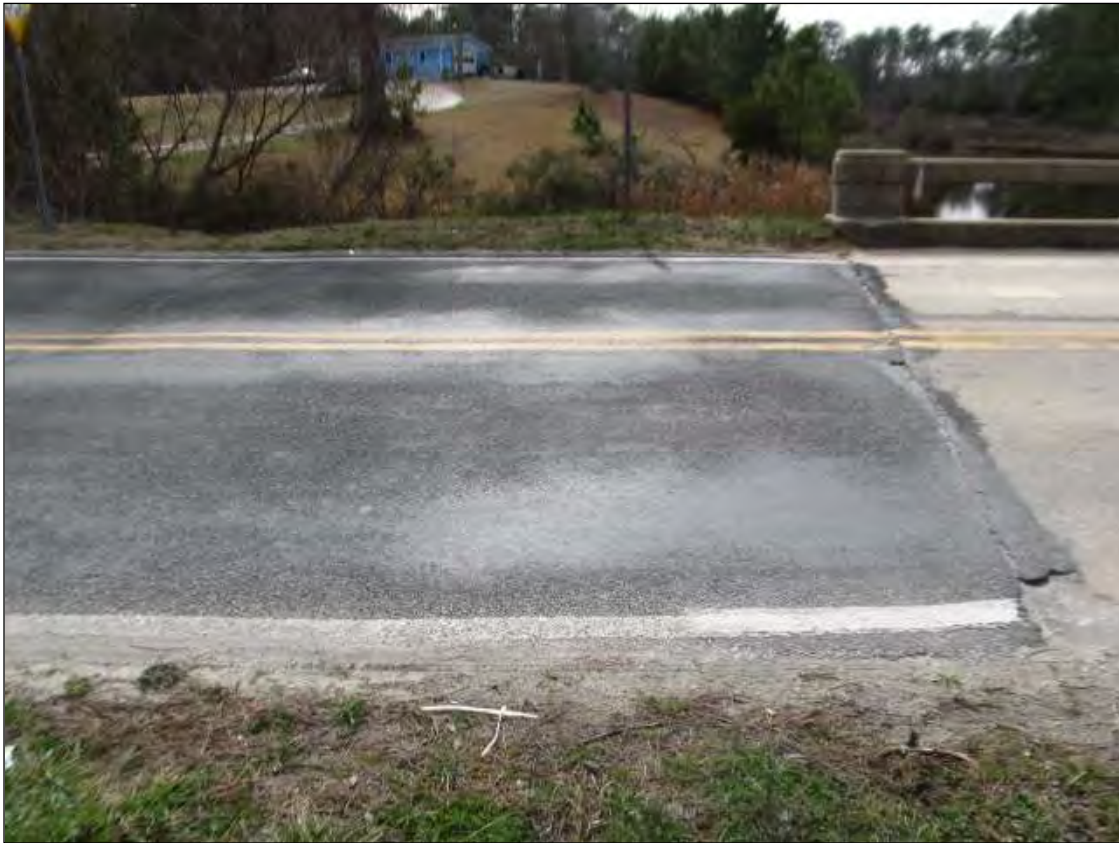
EAST APPROACH ASPHALT WEARING SURFACE SETTLED 1"

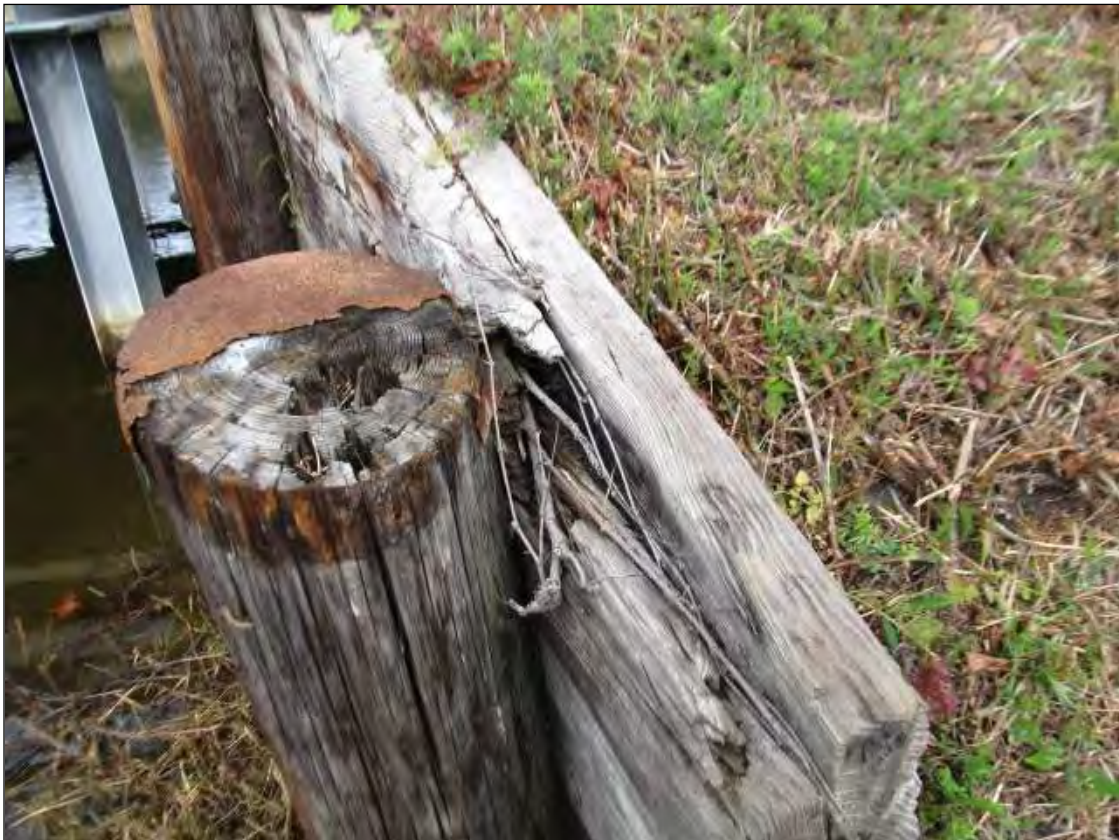
SOUTHEAST WINGWALL BOARDS DECAYED AT END PORTION

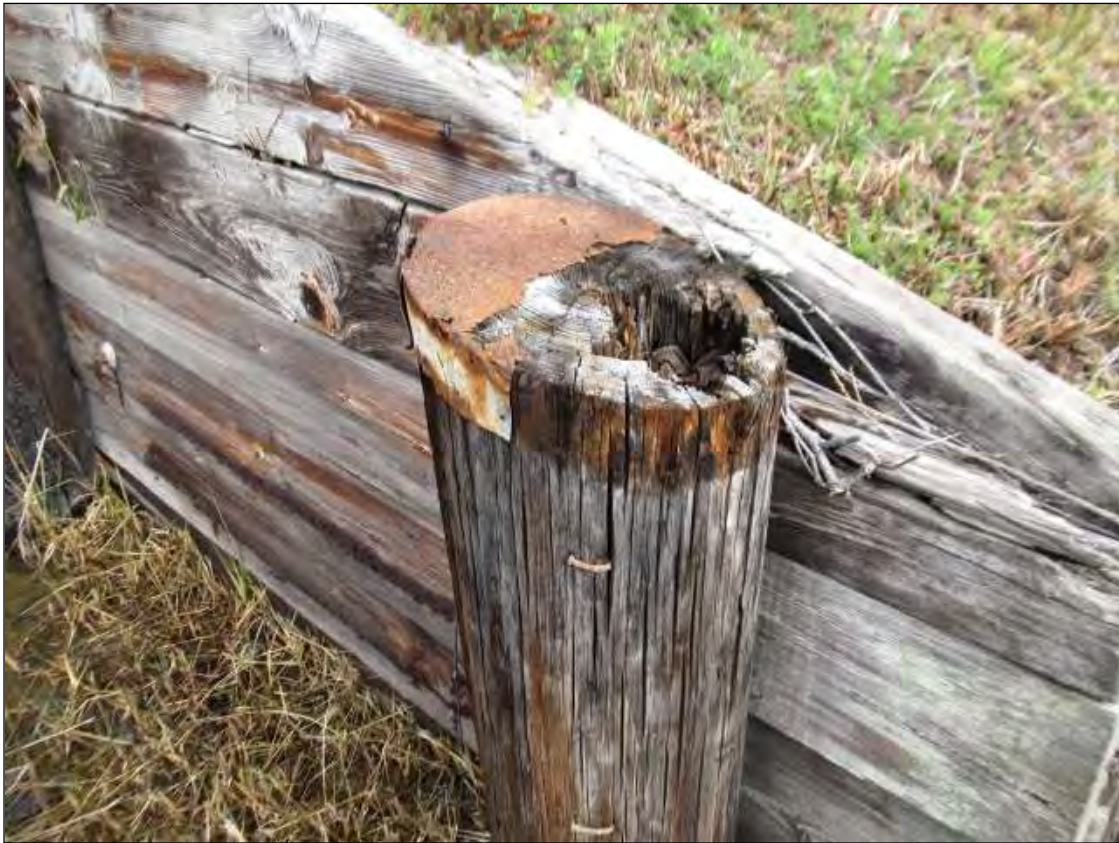
SOUTHEAST WINGPILE HOLLOW

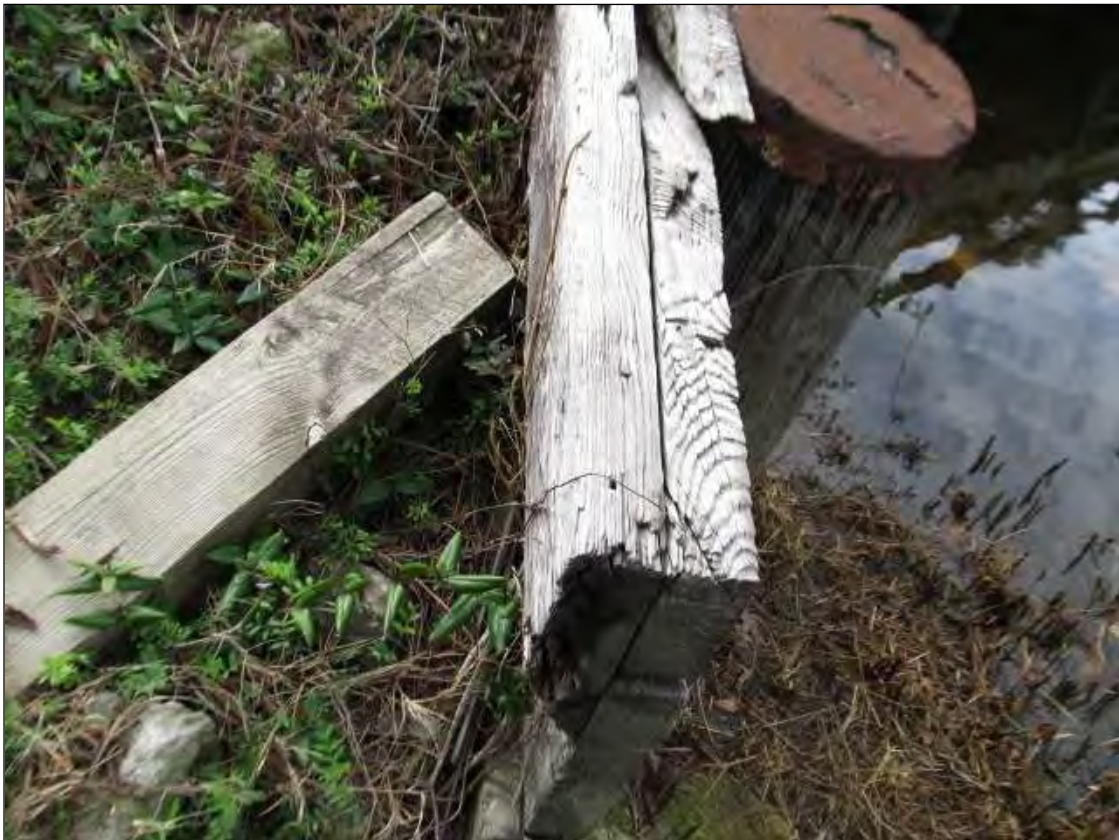
NORTHEAST WINGWALL BOARDS DECAYED AT END PORTION

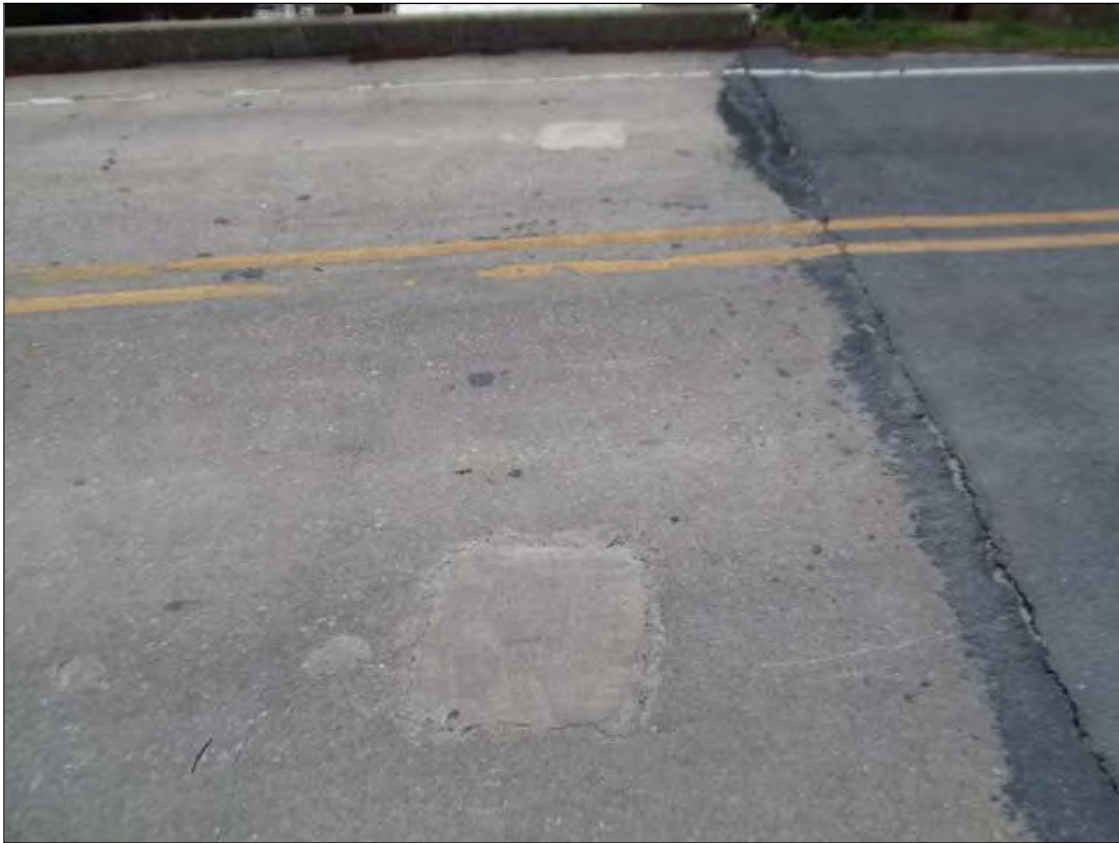
PATCHES IN SPAN 1 DECK AT WEST END

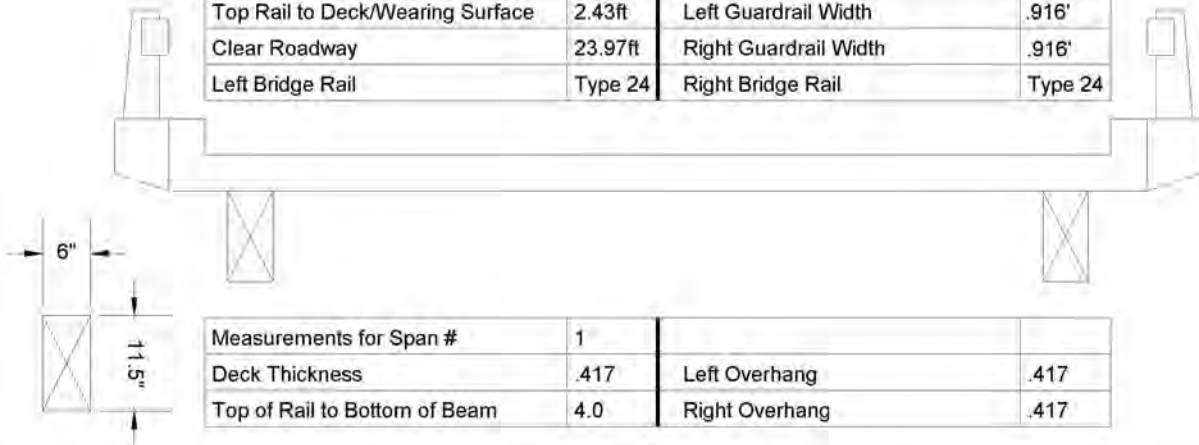
Beam No	Beam Type	Spacing	Comments
1	Timber (Rectangular)	1.80ft	NEW JOIST SIZE- 5.5" W X 11.5" H
2	Timber (Rectangular)	1.35ft	
3	Timber (Rectangular)	1.27ft	
4	Timber (Rectangular)	1.38ft	
5	Timber (Rectangular)	1.32ft	
6	Timber (Rectangular)	1.33ft	
7	Timber (Rectangular)	1.35ft	
8	Timber (Rectangular)	1.32ft	
9	Timber (Rectangular)	1.33ft	
10	Timber (Rectangular)	1.34ft	
11	Timber (Rectangular)	1.29ft	
12	Timber (Rectangular)	1.38ft	
13	Timber (Rectangular)	1.33ft	
14	Timber (Rectangular)	1.35ft	
15	Timber (Rectangular)	1.28ft	
16	Timber (Rectangular)	1.34ft	
17	Timber (Rectangular)	1.29ft	
18	Timber (Rectangular)	1.30ft	
19	Timber (Rectangular)
