NC DEPARTMENT OF TRANSPORTATION
 DIVISION OF HIGHWAYS
 BRIDGE MANAGEMENT UNIT

ATTENTION **SHORED**

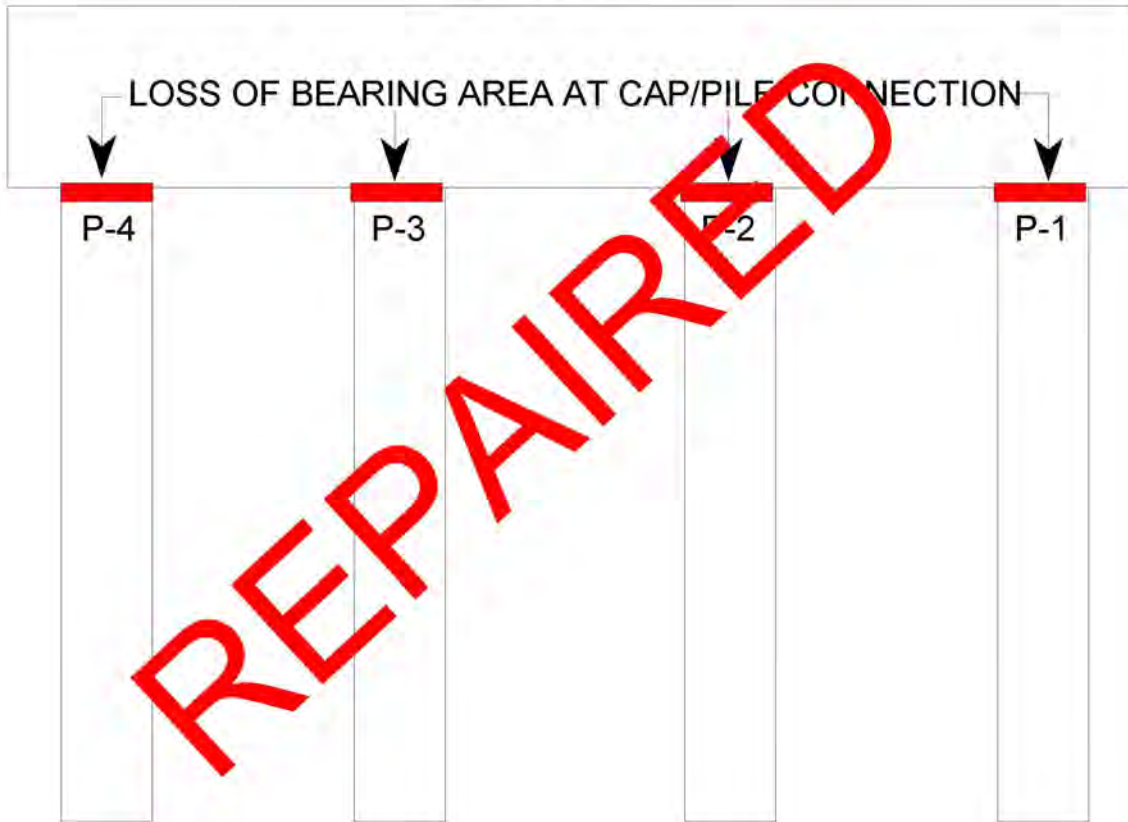
PILES PUSHING OUT TO THE EAST

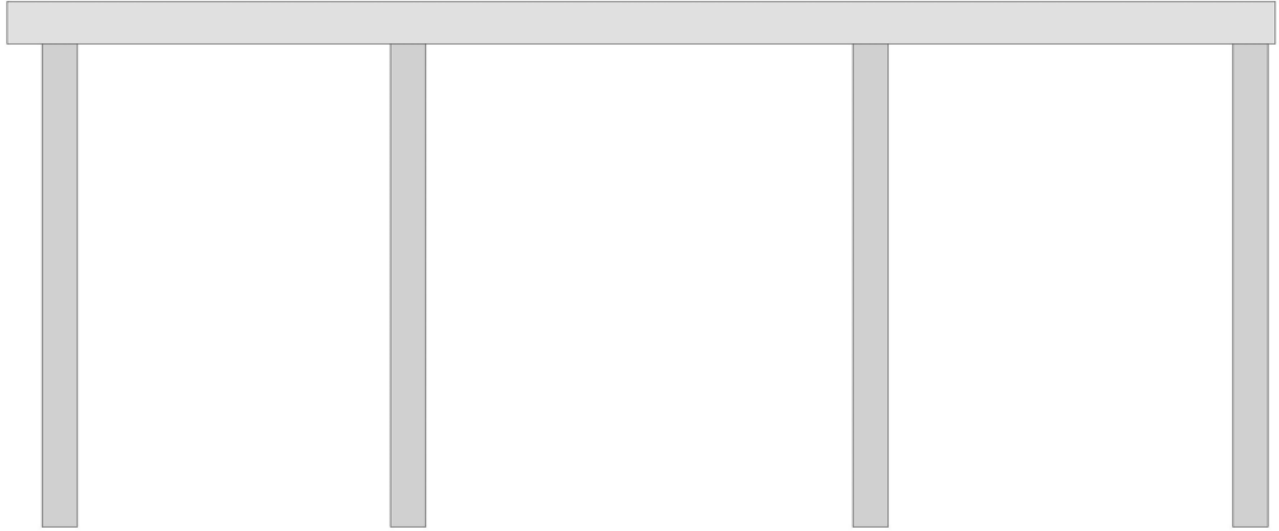
Cap Information			Material Steel							
Length	Width	Height	Left Overhang	Right Overhang	Left Beam to End of Cap.	Right Beam to End of Cap.				
30.041 ft.	1.000 ft.	1.000 ft.	1.250 ft.	.583 ft.	2.833 ft.	2.250 ft.				
Subcap Information			Material							
Length	Width	Height	Left Overhang	Right Overhang	Left Pile to Splice.					
Sill Information			Material							
Length	Width	Height								
Pile #	Material	Spacing	Width/Dia.	Height	Length	Orientation	Driven?	Replacement?	Removed?	Collar?
1	Steel	8.250 ft.	.833 ft.			Vertical	Yes	No	No	No
2	Steel	10.958 ft.	.833 ft.			Vertical	Yes	No	No	No
3	Steel	9 ft.	.833 ft.			Vertical	Yes	No	No	No
4	Steel		0.833 ft.			Vertical	Yes	No	No	No
Bent/Abutment #: 1		Similar Bents:

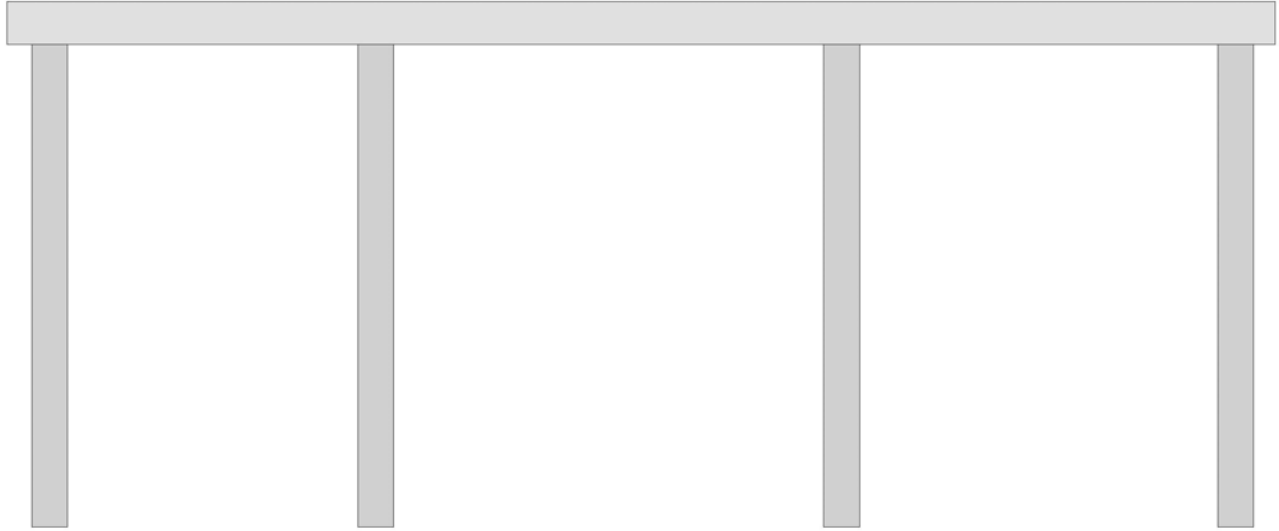
Cap Information			Material Steel							
Length	Width	Height	Left Overhang	Right Overhang	Left Beam to End of Cap.	Right Beam to End of Cap.				
29.500 ft.	1.000 ft.	1.000 ft.	1.000 ft.	.917 ft.	2.083 ft.	2.458 ft.				
Subcap Information			Material							
Length	Width	Height	Left Overhang	Right Overhang	Left Pile to Splice.					
Sill Information			Material							
Length	Width	Height								
Pile #	Material	Spacing	Width/Dia.	Height	Length	Orientation	Driven?	Replacement?	Removed?	Collar?
1	Steel	7.583 ft.	.833 ft.			Vertical	Yes	No	No	No
2	Steel	10.833 ft.	.833 ft.			Vertical	Yes	No	No	No
3	Steel	9.167 ft.	.833 ft.			Vertical	Yes	No	No	No
4	Steel		0.833 ft.			Vertical	Yes	No	No	No
Bent/Abutment #: 2			Similar Bents:

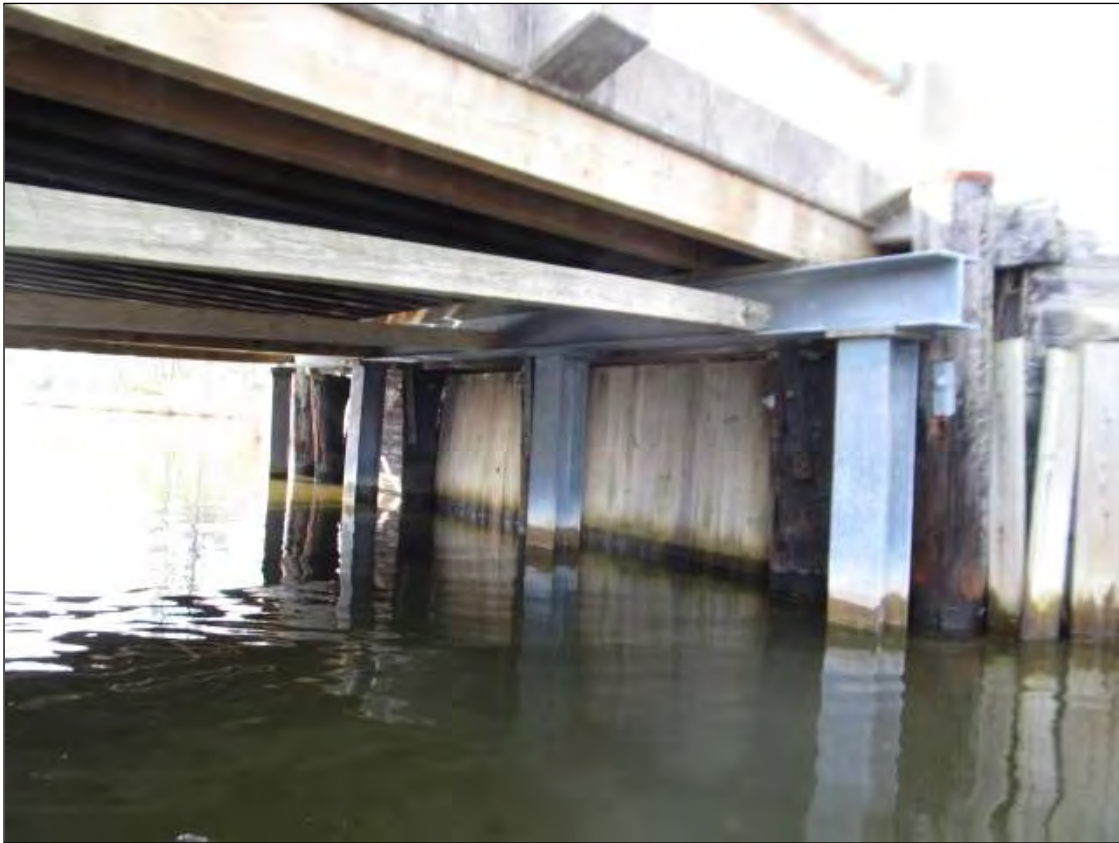
STEEL CRUTCH BENT IN PLACE AT END BENT 1
