STRUCTURE BULLETIN

NCDOT Construction Unit

Current Issues: Capturing Barrier Rail Concrete

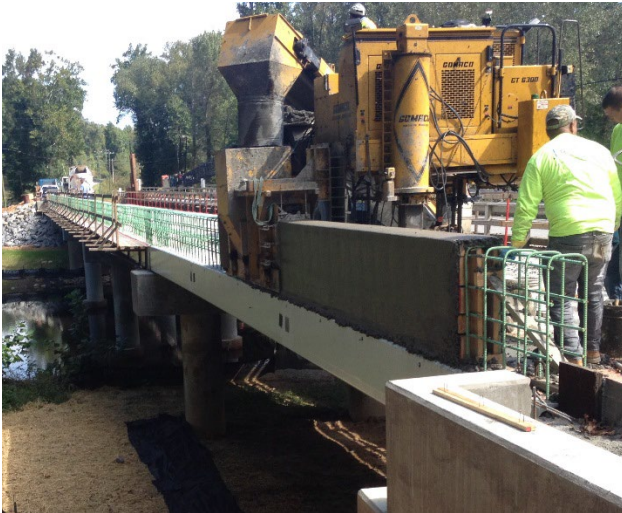
Second, is the use of the optional insert detail in the exterior slabs. In the picture above, the contractor had the exterior beams fabricated with the inserts and has installed an overhang on the span over the water. This will catch the material and provide access to the exterior face of the wall. You can also see they have installed fabric on the slope under the end span to catch excess material that falls in this area.

There are many possibilities, but the contractor should never be allowed to drop excess concrete into water or traffic. If they do not have a method to catch the material in these situations, work should be suspended until the problem is addressed. This should be discussed with the Contractor before the barrier rail subcontractor shows up on the job to avoid possible delays.
