BRIDGE INSPECTION RECORD AND SUMMARY FOR SHORED STRUCTURES OR STRUCTURES WITH TEMPORARY REPAIRS MADE TO KEEP A BRIDGE OPEN

BRIDGE: **500085** COUNTY: **Johnston** DATE: **6/28/2012**

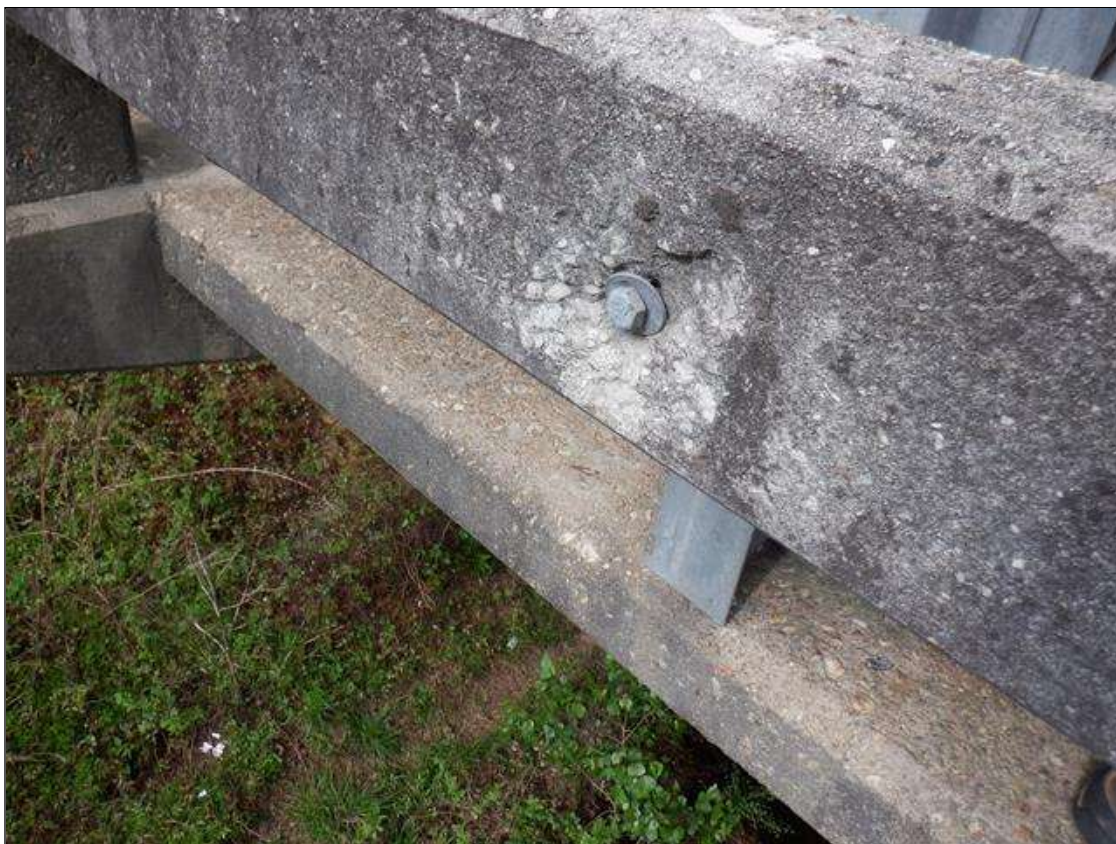
Span 1 Right Concrete Rail: 2- UP TO 7 INCHES X 6 INCHES X 1 INCHES SPALLS IN OUTSIDE FACE OF RAIL NEAR BENT 1

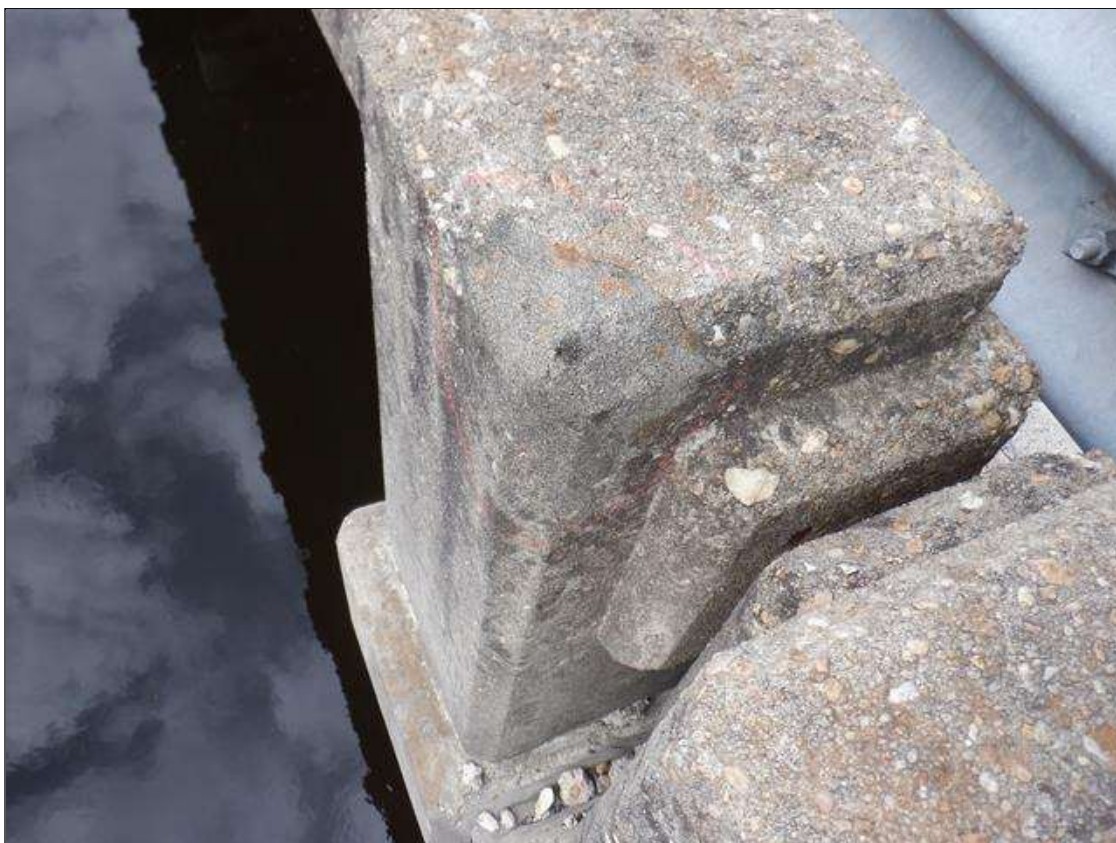
Span 2 Right Concrete Rail: 4 INCHES X 3 INCHES X UP TO 3 INCHES SOUND PATCHED AREA ON TOP OF POST

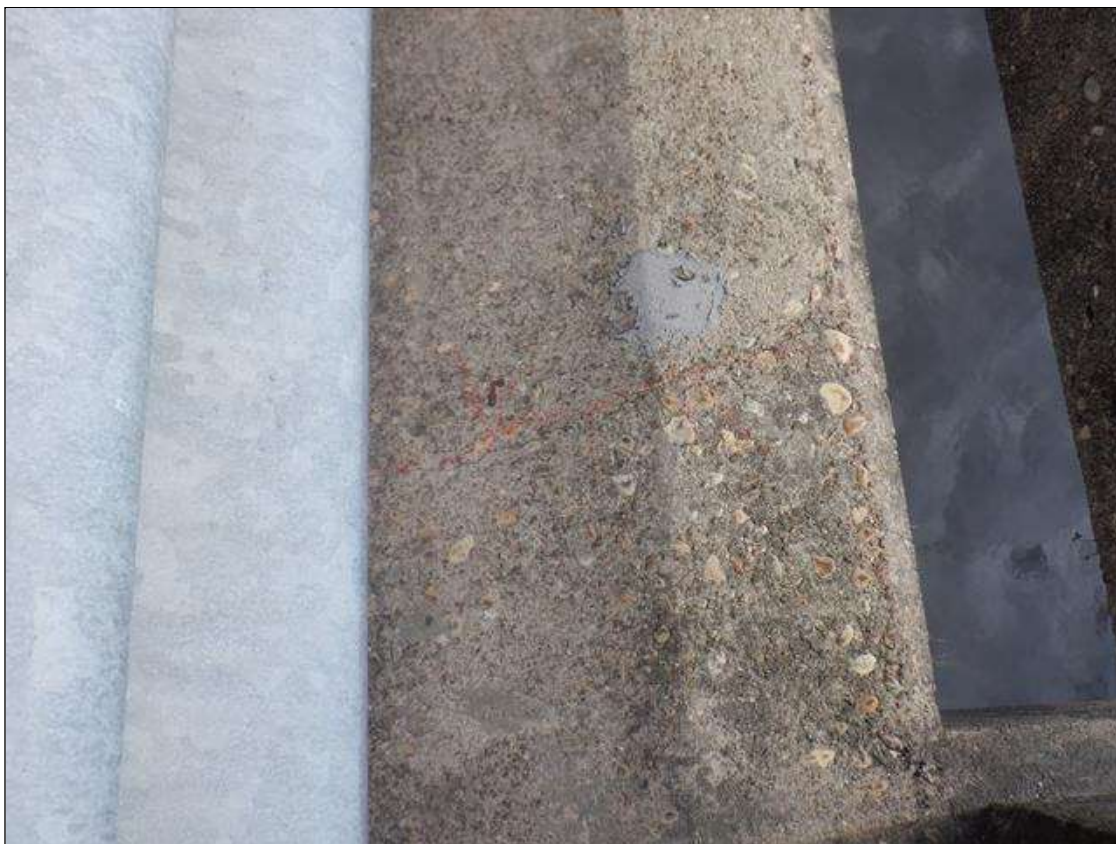
Span 3 Right Concrete Rail: (5) UP TO 1/64 INCHES VERTICAL AND TRANSVERSE CRACKS ON CONCRETE RAIL AND CURB, AT RANDOM

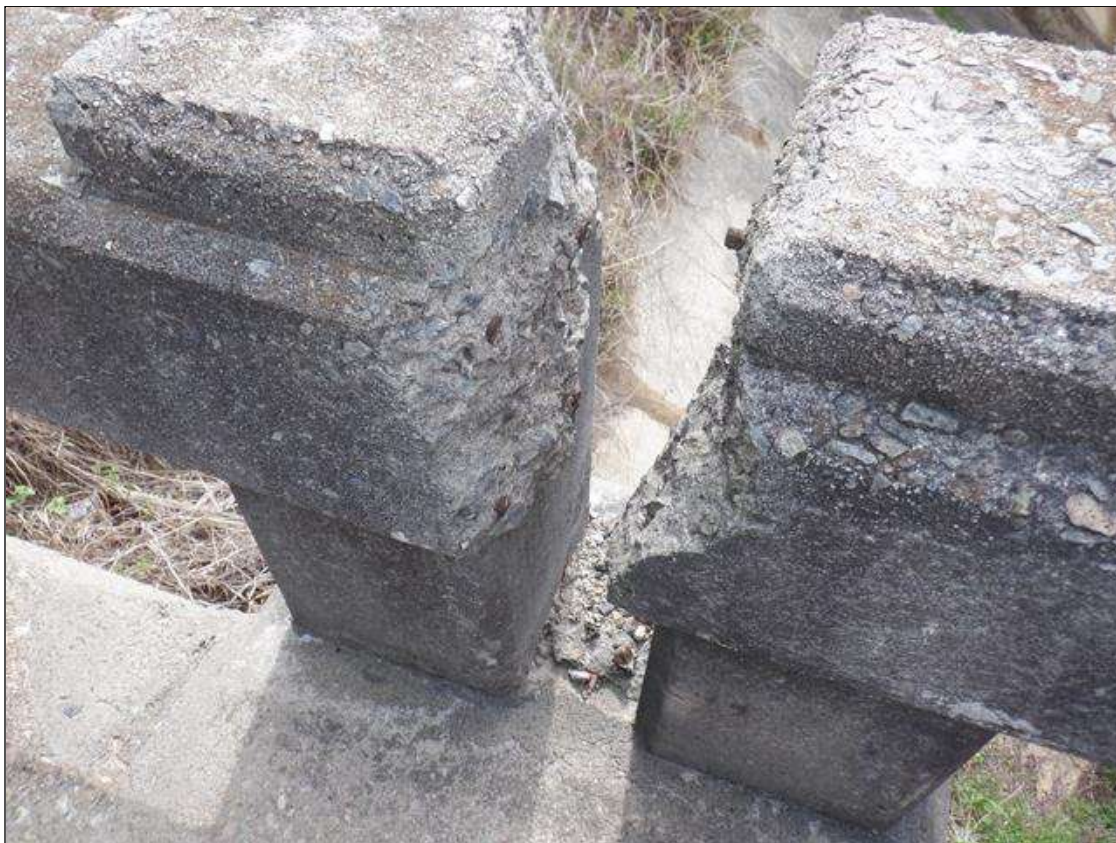
Span 4 Right Concrete Rail: 2 INCHES X 8 INCHES X 10 INCHES DEEP SPALL WITH EXPOSED REBAR ON CONCRETE POSTS 6 AND 7

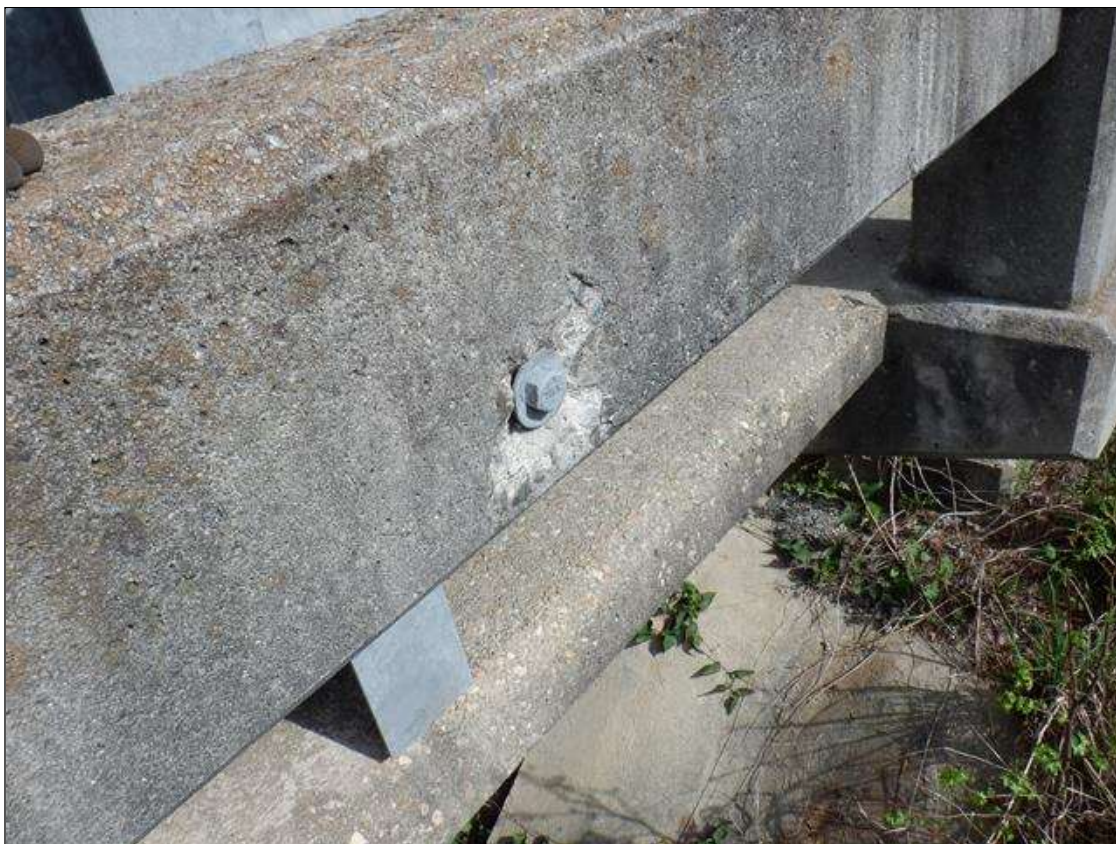
Span 4 Right Concrete Rail: 5 INCHES X 4 INCHES X 1/2 INCHES DEEP SPALL ON OUTSIDE FACE OF CONCRETE RAIL BETWEEN POSTS 7 & 8.

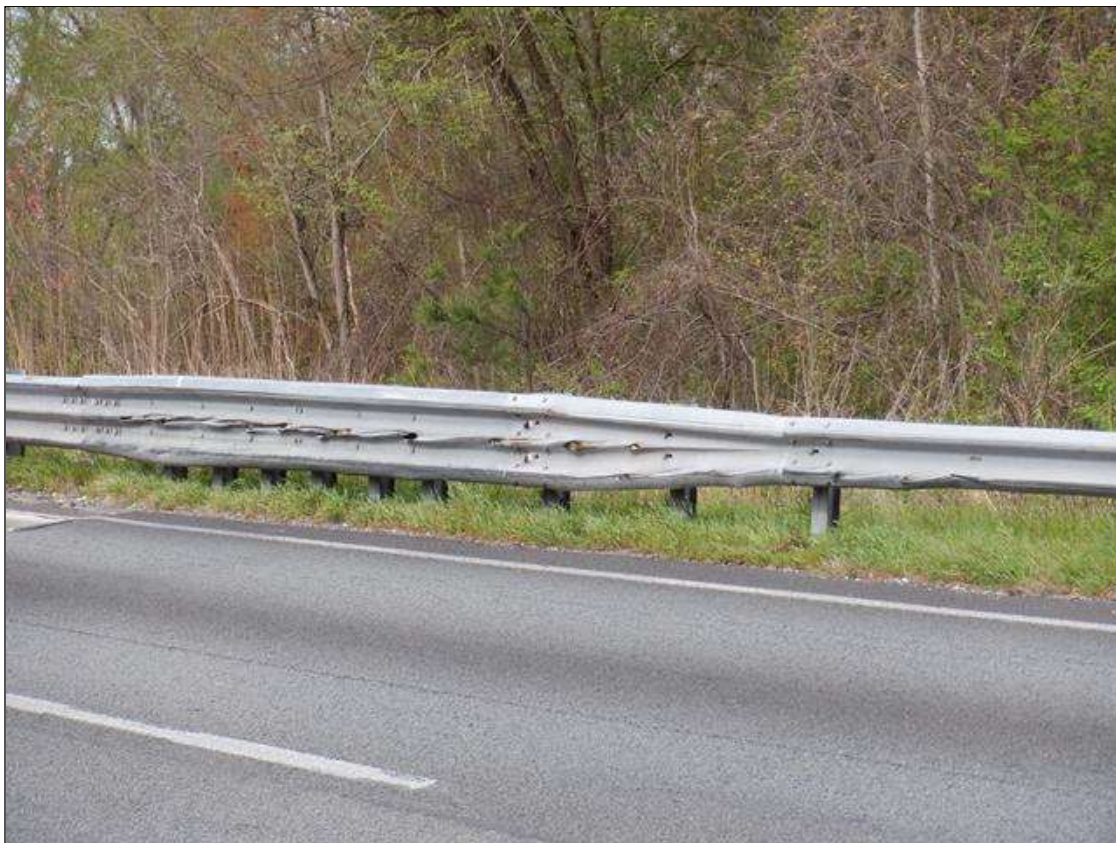
General Comments and Misc. Items: (PAR) 20 FEET OF IMPACT DAMAGE WITH 12- UP TO 10 INCHES X 1.5 INCHES GOUGES IN NORTHWEST GUARDRAIL, 15 FEET FROM END BENT 2.

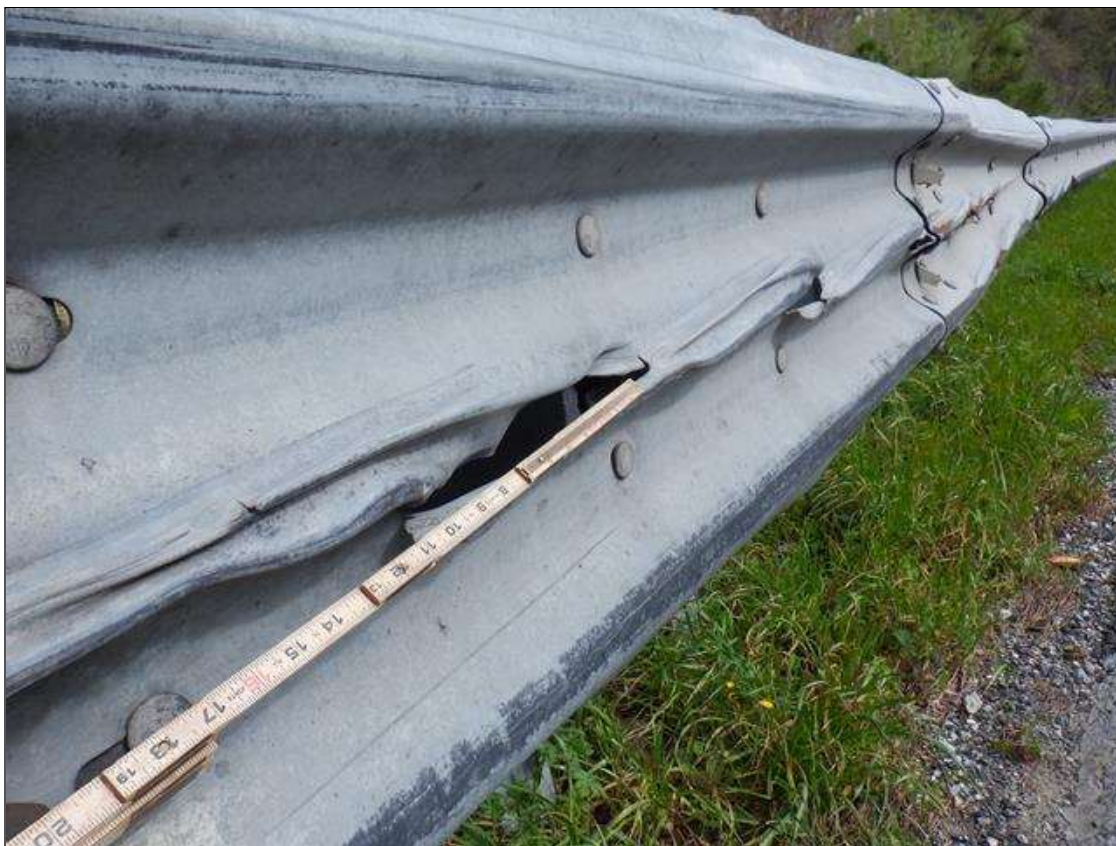
General Comments and Misc. Items: (PAR) 20 FEET OF IMPACT DAMAGE WITH 12- UP TO 10 INCHES X 1.5 INCHES GOUGES IN NORTHWEST GUARDRAIL, 15 FEET FROM END BENT 2.

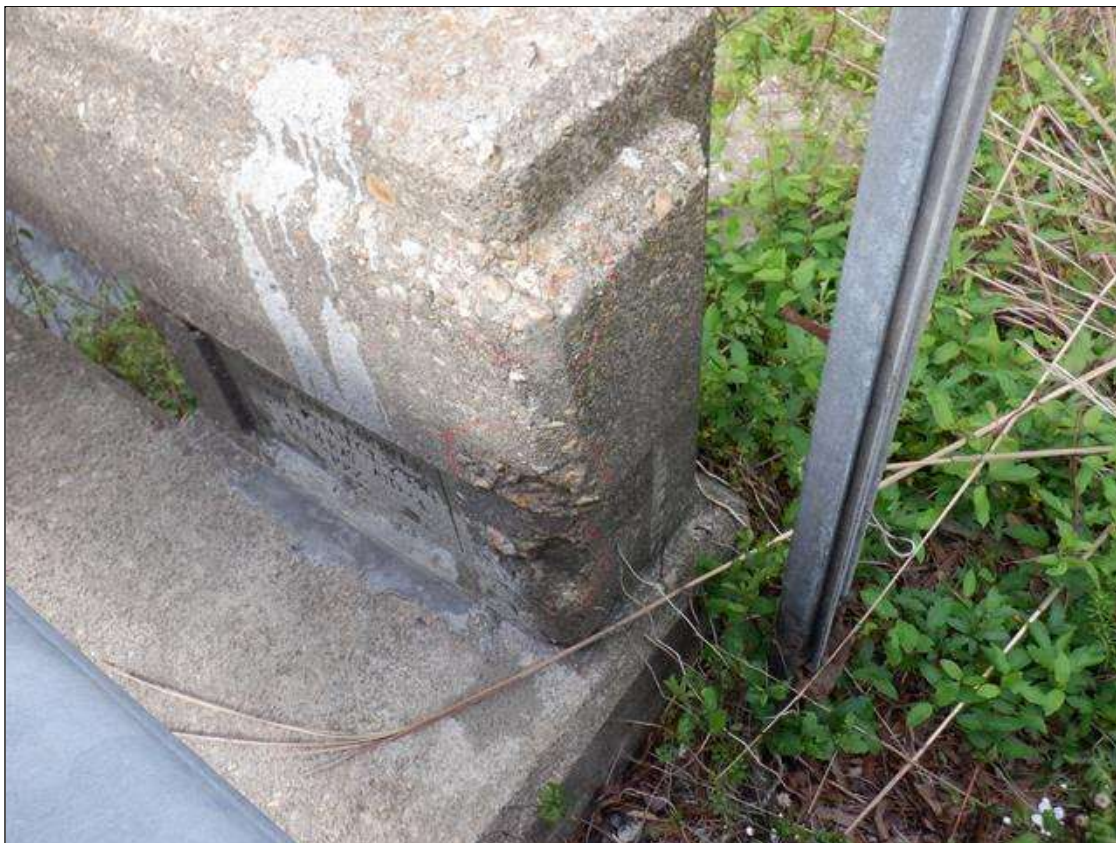
Span 4 Left Concrete Rail: (3) UP TO 3 INCHES X 5 INCHES X 1 INCHES DEEP SPALLS ON END POST

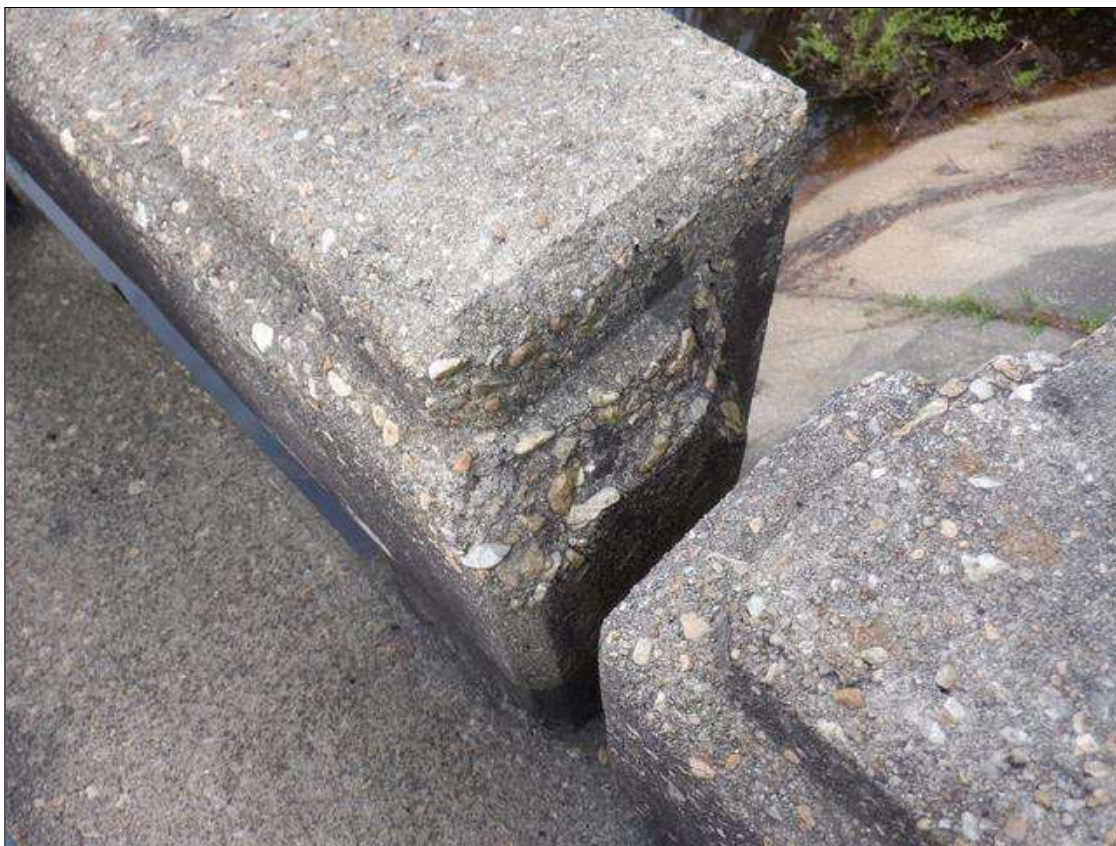
Span 4 Left Concrete Rail: 1 INCHES X 4 INCHES X 2 INCHES DEEP SPALL ON CONCRETE POST 6

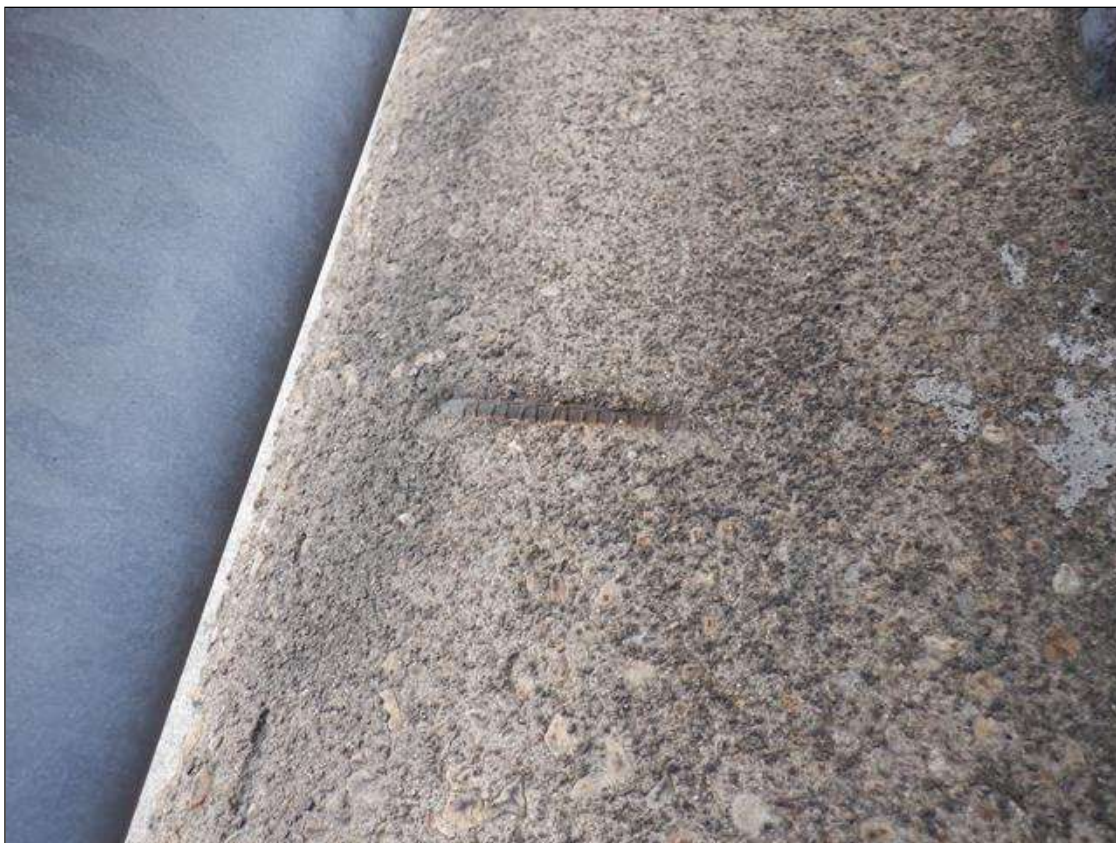
Span 4 Left Concrete Rail: 6 INCHES X 1 INCHES X 1/2 INCHES DEEP SPALL WITH EXPOSED REBAR IN TOP OF CURB, 7 FEET FROM BENT 3.

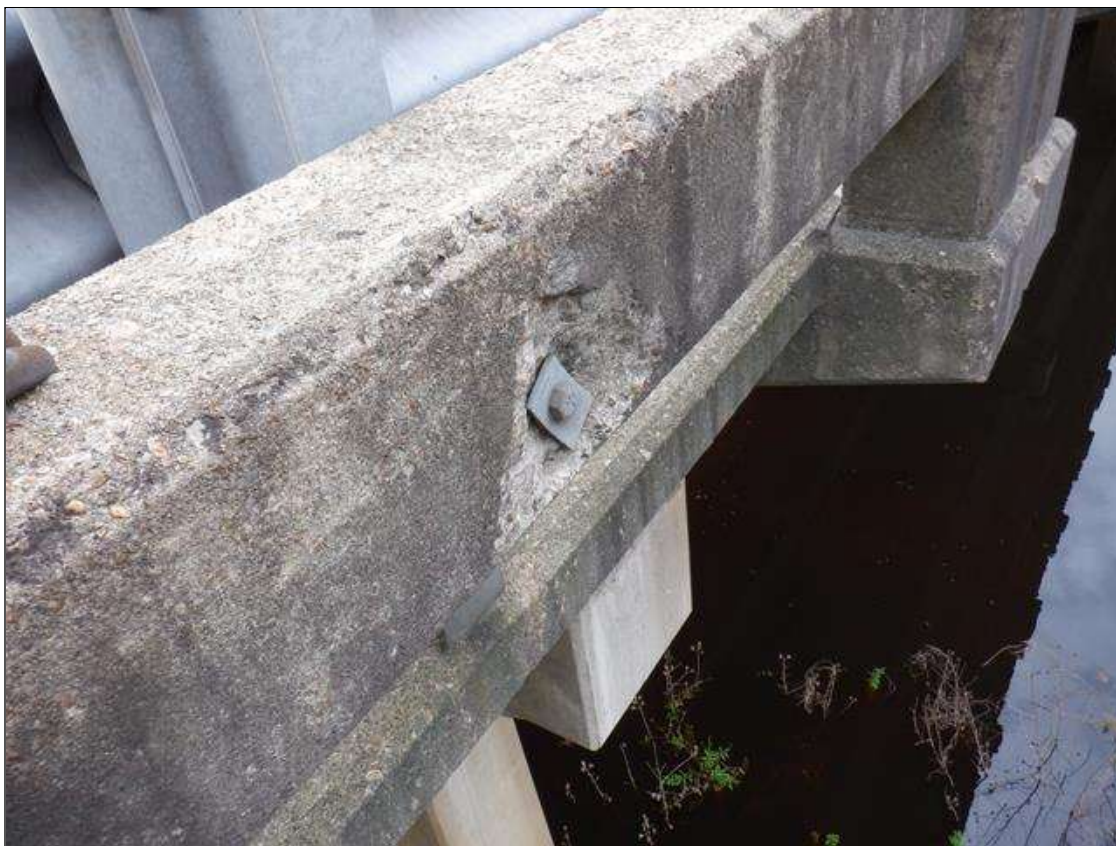
Span 4 Left Concrete Rail: (4) UP TO 10 INCHES X 9 INCHES X 1 INCHES DEEP SPALLS IN OUTSIDE FACE OF CONCRETE RAIL, AT RANDOM

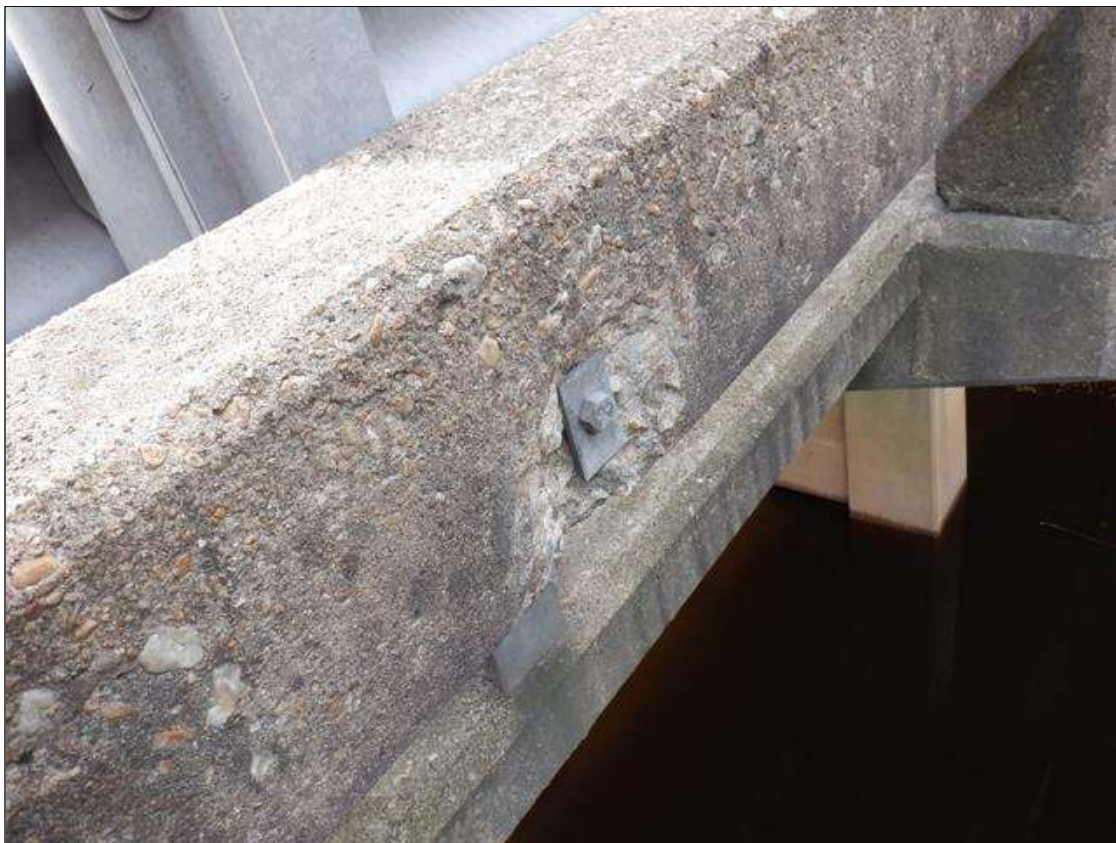
Span 2 Left Concrete Rail: (4) UP TO 9 INCHES X 6 INCHES X 1 INCHES DEEP SPALLS IN OUTSIDE FACE OF CONCRETE RAIL, AT RANDOM

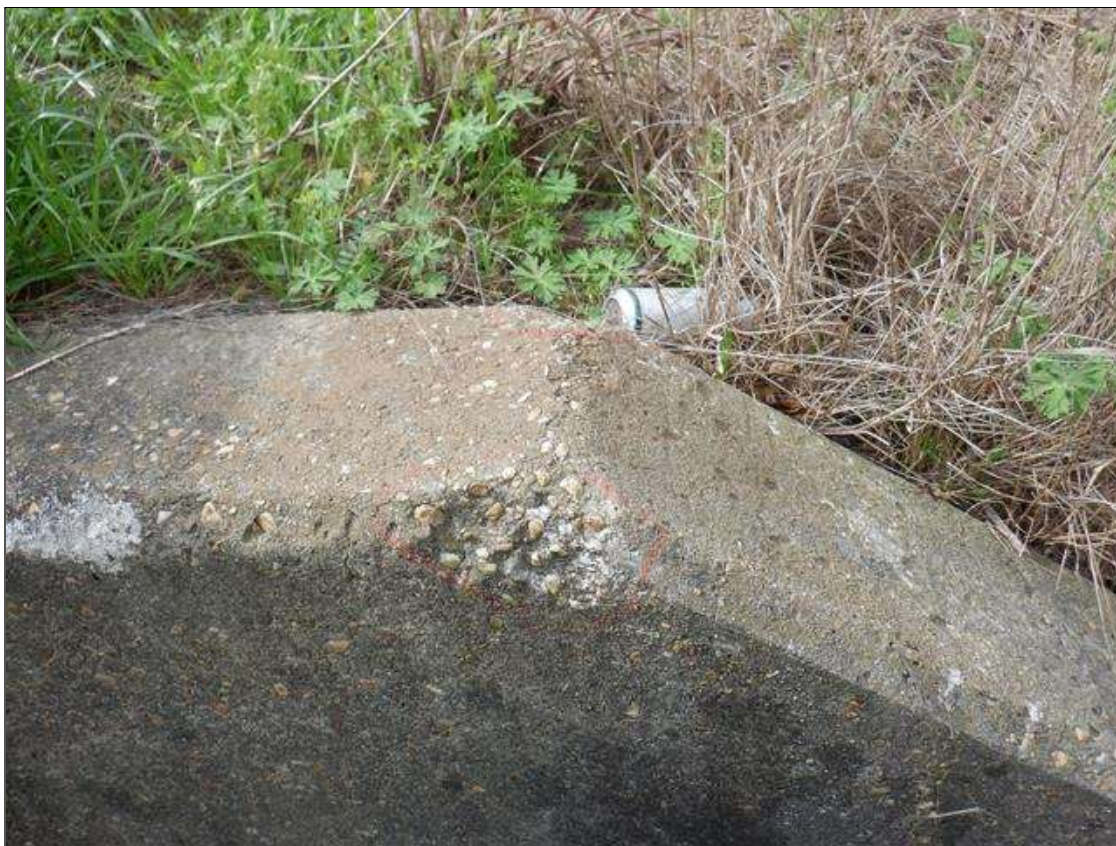
Wingwalls: 2- UP TO 6 INCHES X 3 INCHES X 1 INCHES SPALLS IN TO OF SOUTHWEST WINGWALL

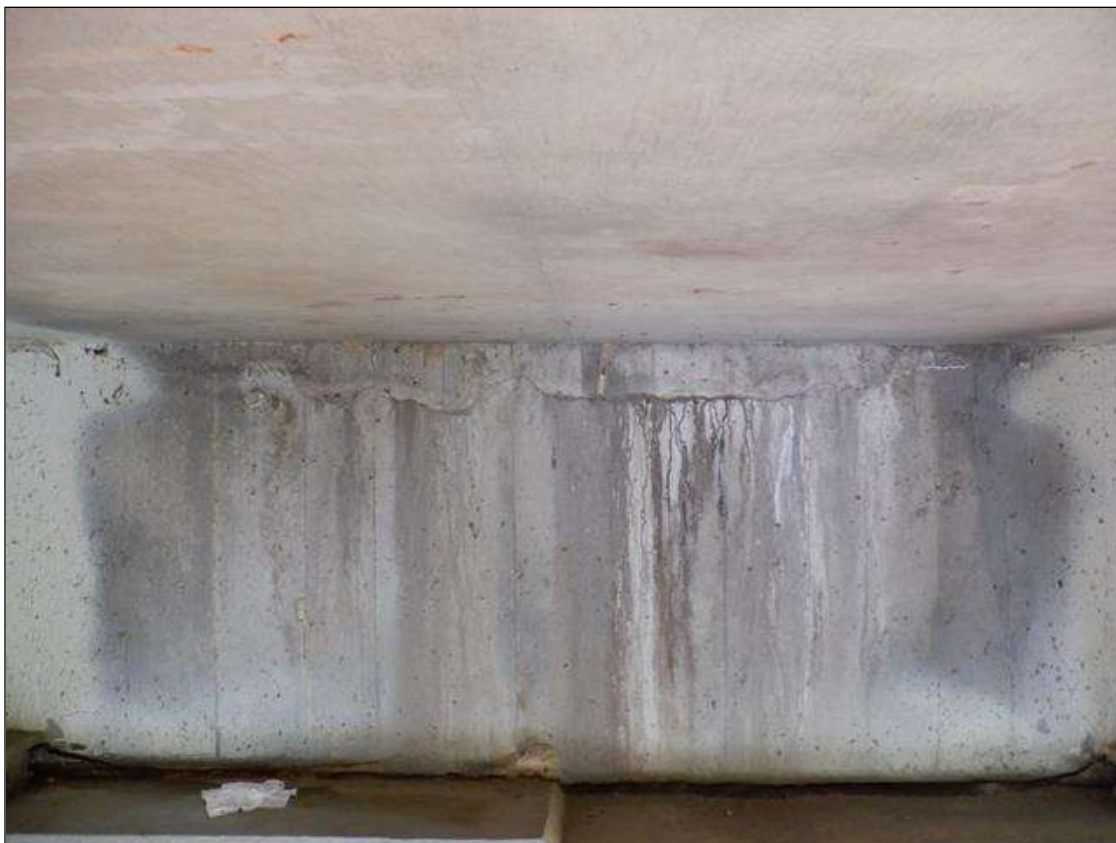
End Bent 1 Abutment: 6 FEET X UP TO 1/32 INCHES HORIZONTAL CRACK WITH EFFLORESCENCE IN BAY 1
(BAYS 2 AND 3 SIMILAR)

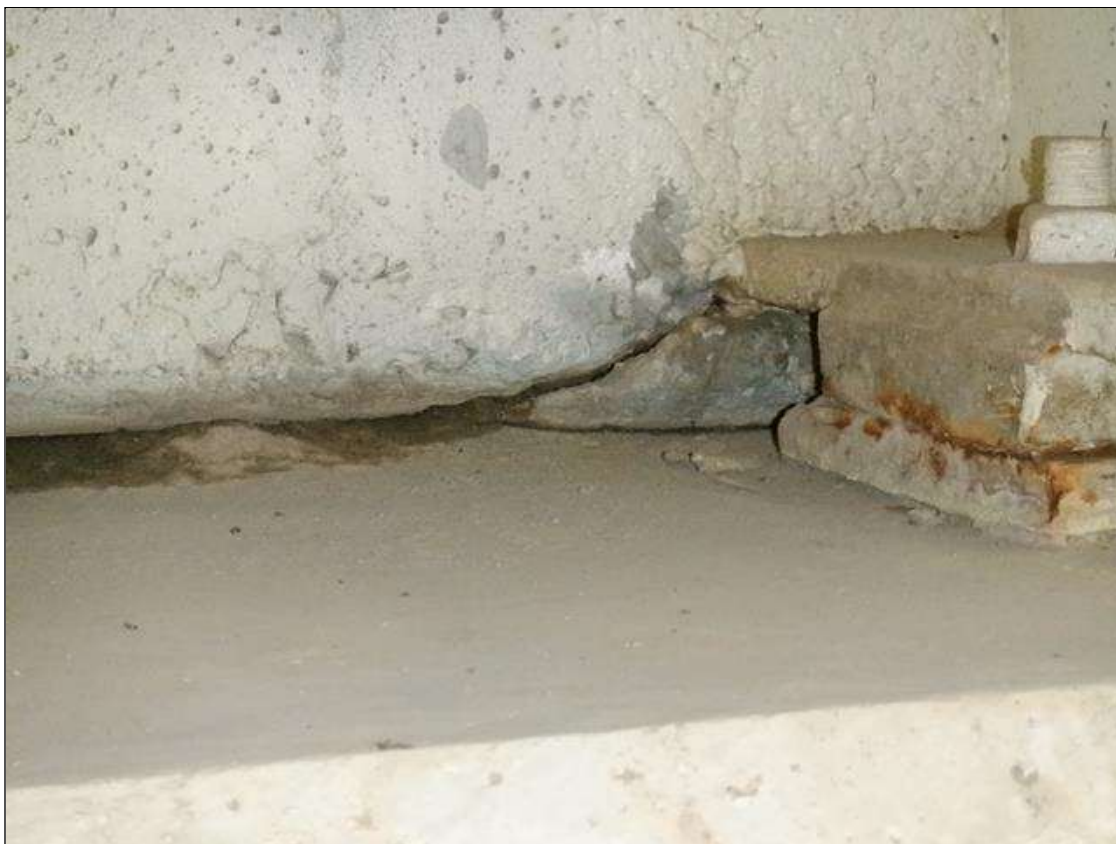
End Bent 1 Abutment: 8 INCHES X UP TO 1/4 INCHES DIAGONAL CRACK WITH ADJACENT 5 INCHES X UP TO 3 INCHES DELAMINATION ADJACENT TO BEAM 1. (ADJACENT TO ALL BEAMS SIMILAR)

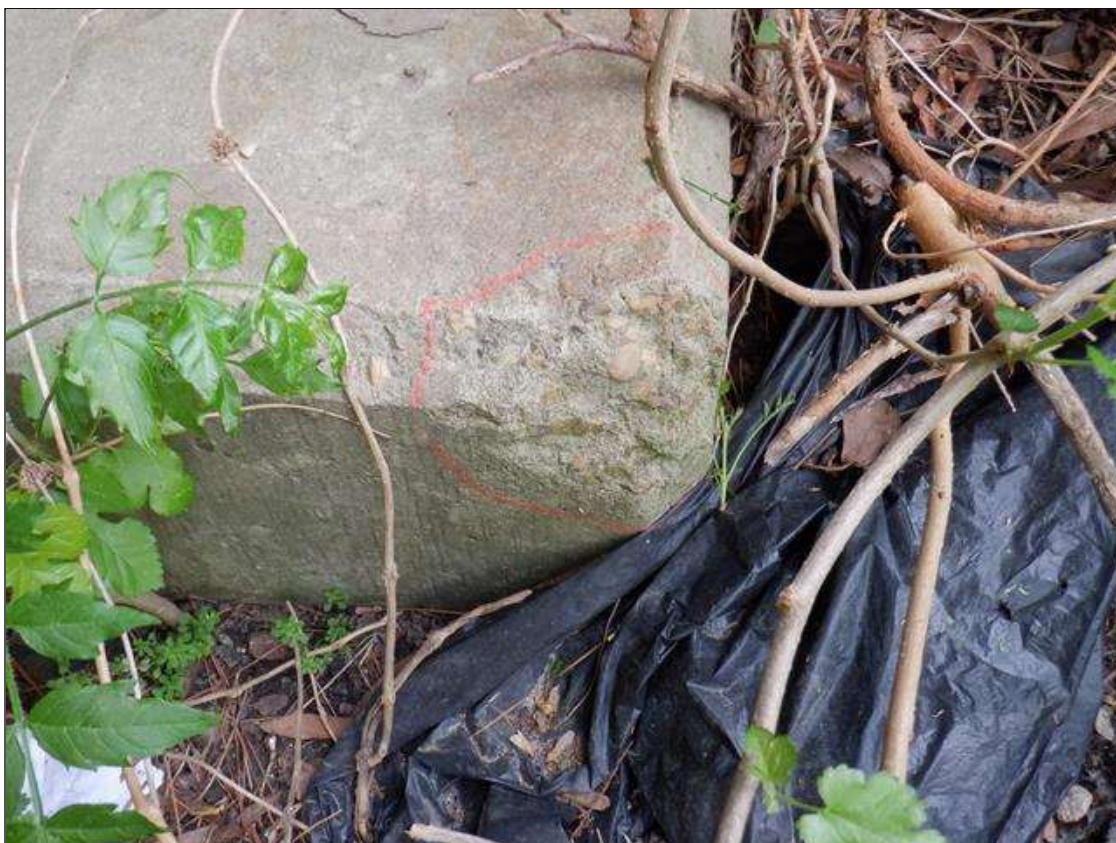
End Bent 1 Cap 1: 4 INCHES X 4 INCHES X 2 INCHES DEEP SPALL IN BRACE PILE CAP 1.

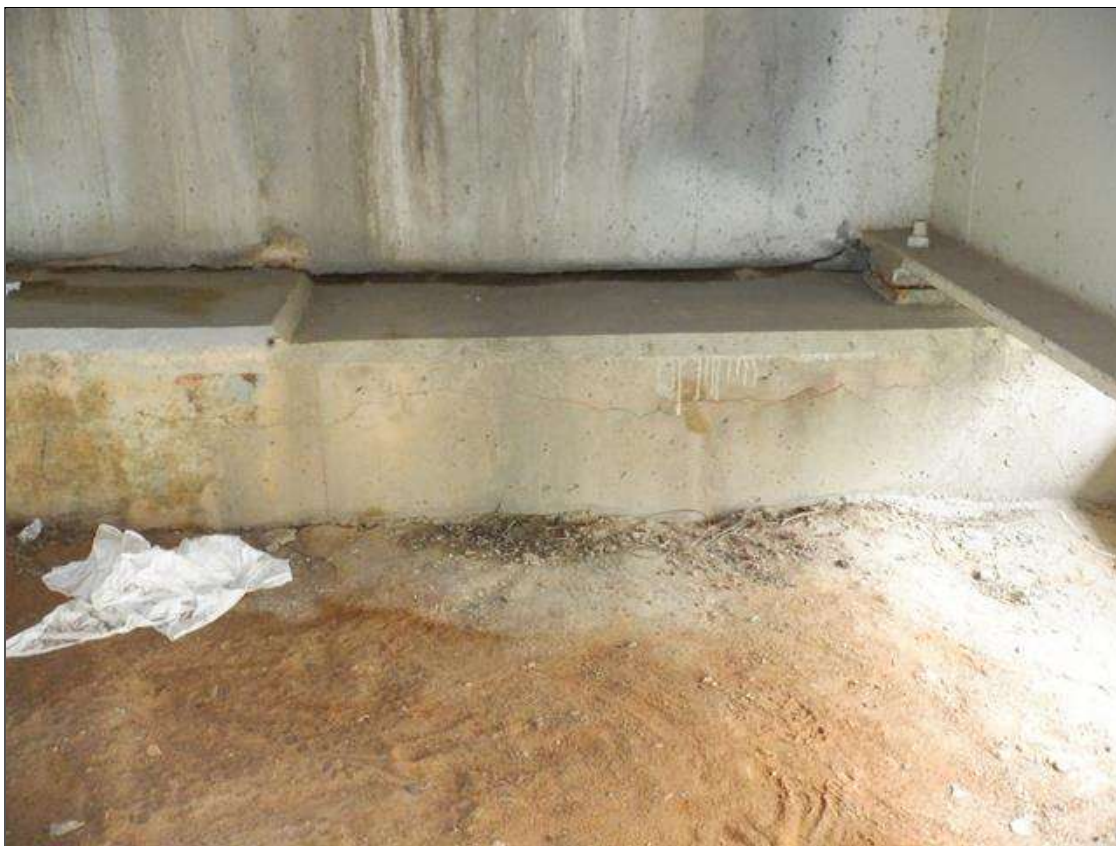
End Bent 1 Cap 1: 5 FEET UP TO 1/32 INCHES HORIZONTAL CRACK WITH RUST STAINING UNDER BAY 1

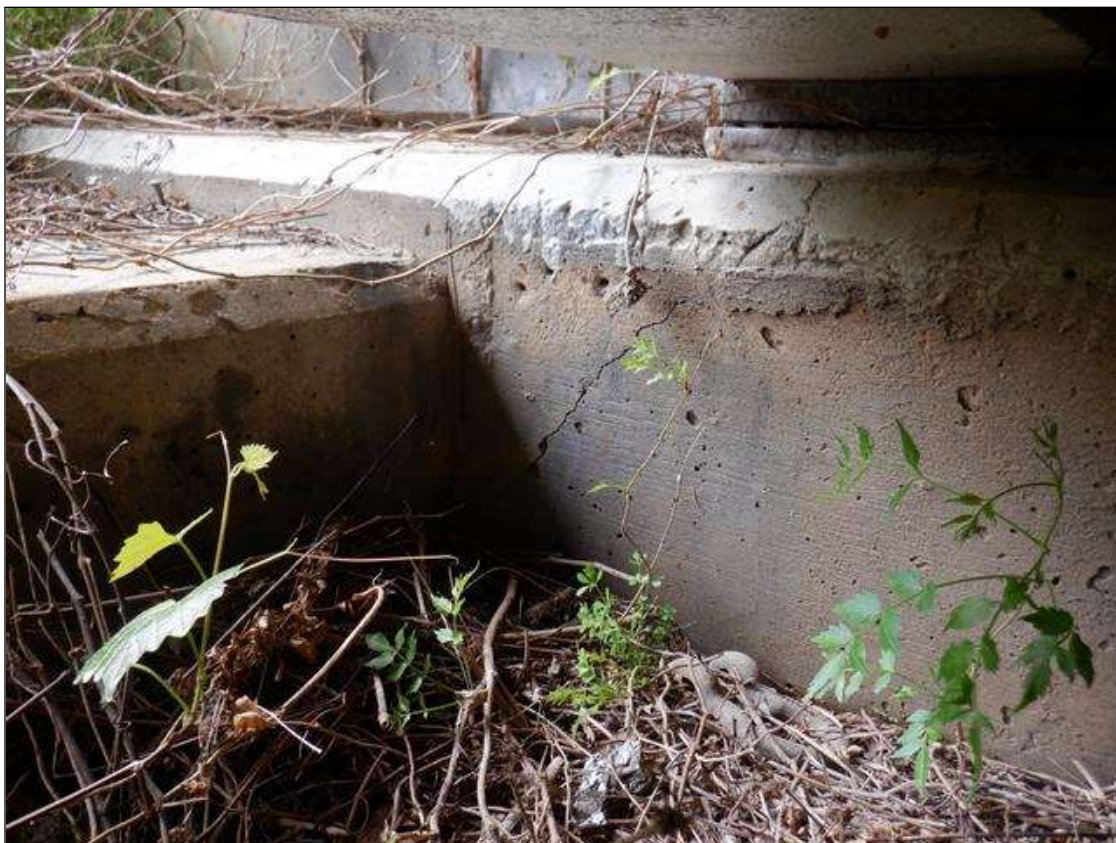
End Bent 1 Cap 1: 16 INCHES UP TO 1/16 INCHES DIAGONAL CRACK UNDER BEAM 4 (BELOW BEAM 1 SIMILAR)

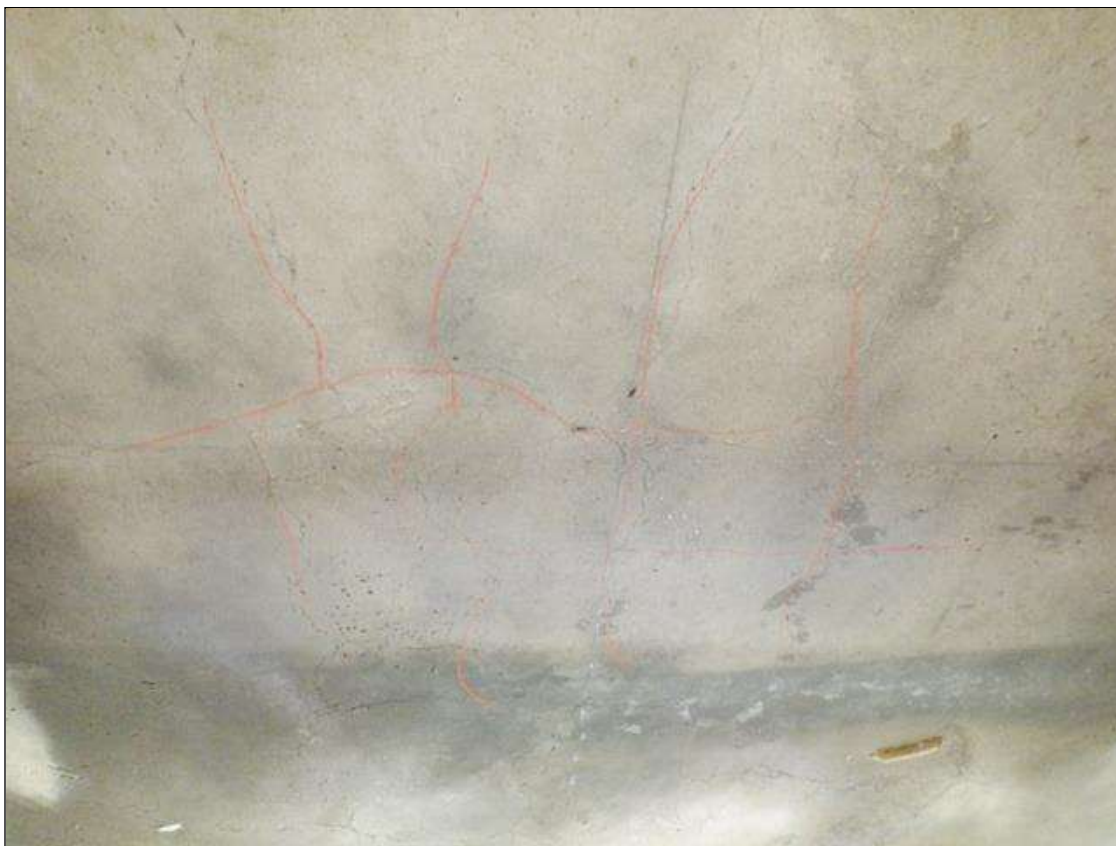
Span 1 Deck: 400 SQUARE FEET OF MAP CRACKING UP TO 1/32 INCHES AT RANDOM THROUGHOUT UNDERSIDE OF DECK (PHOTO TAKEN IN BAY 2)

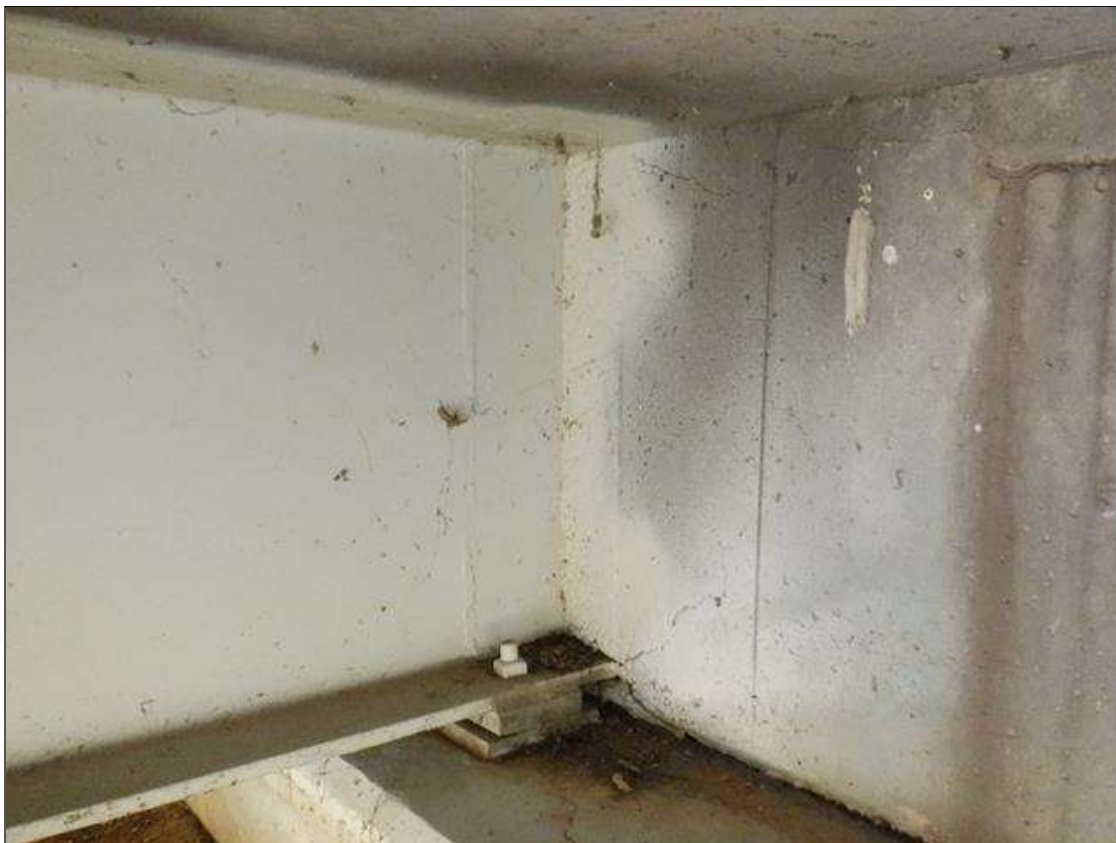
Span 1 Beam 3: 7 INCHES X 31 INCHES AREA OF REPLACED BEAM AT END BENT 1 (OTHER BEAMS AT END BENT 1 SIMILAR)

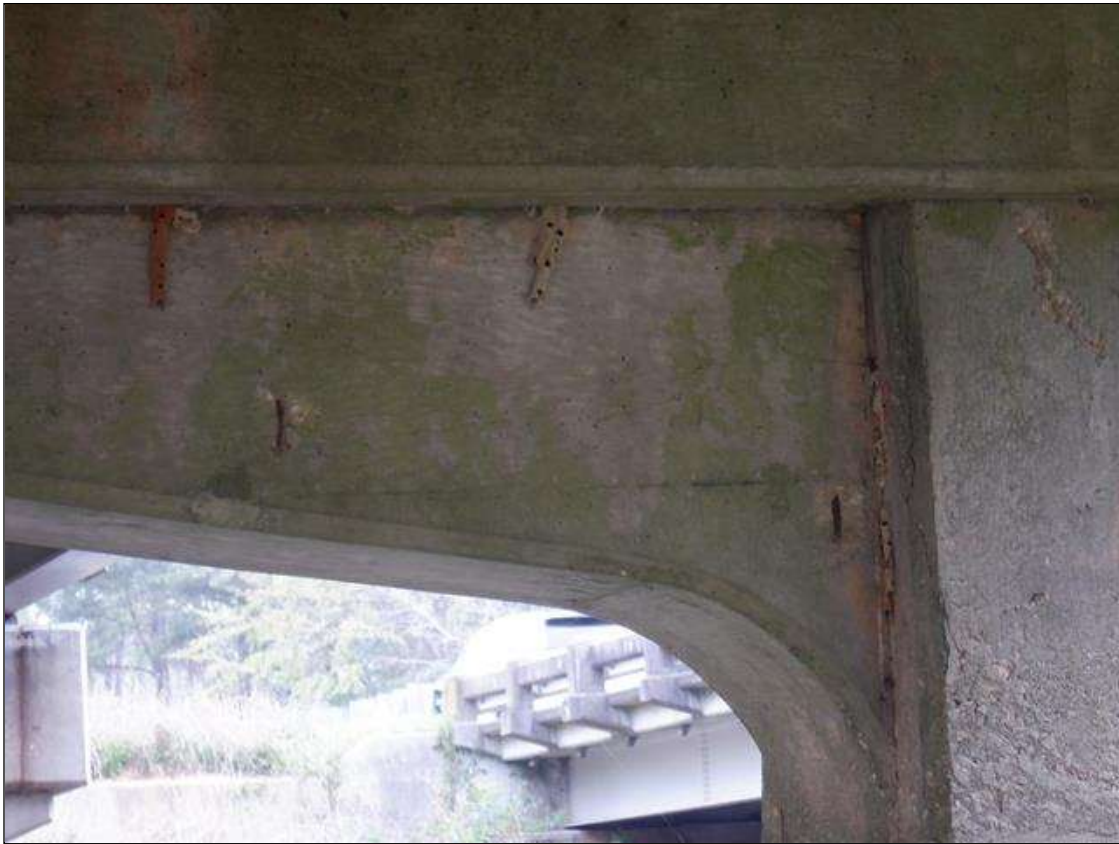
Bent 1 Cap 1: (2) UP TO 3 INCHES X 3 INCHES X 1 INCHES DEEP SPALLS WITH EXPOSED REBAR ON CORBEL OF SPAN 1 FACE

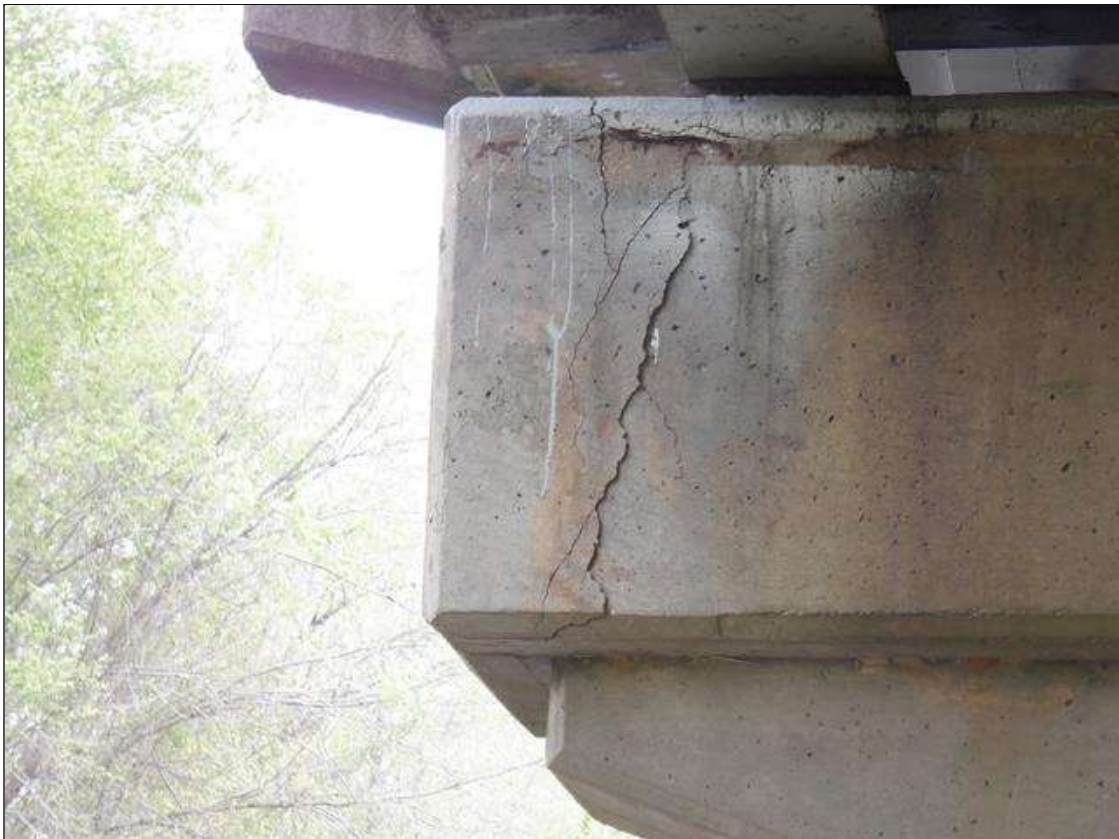
Bent 1 Cap 1: 12 INCHES X 24 INCHES AREA OF DELAMINATION WITH UP TO 1/8 INCHES VERTICAL AND DIAGONAL CRACKS ON SPAN 1 FACE AT WEST END

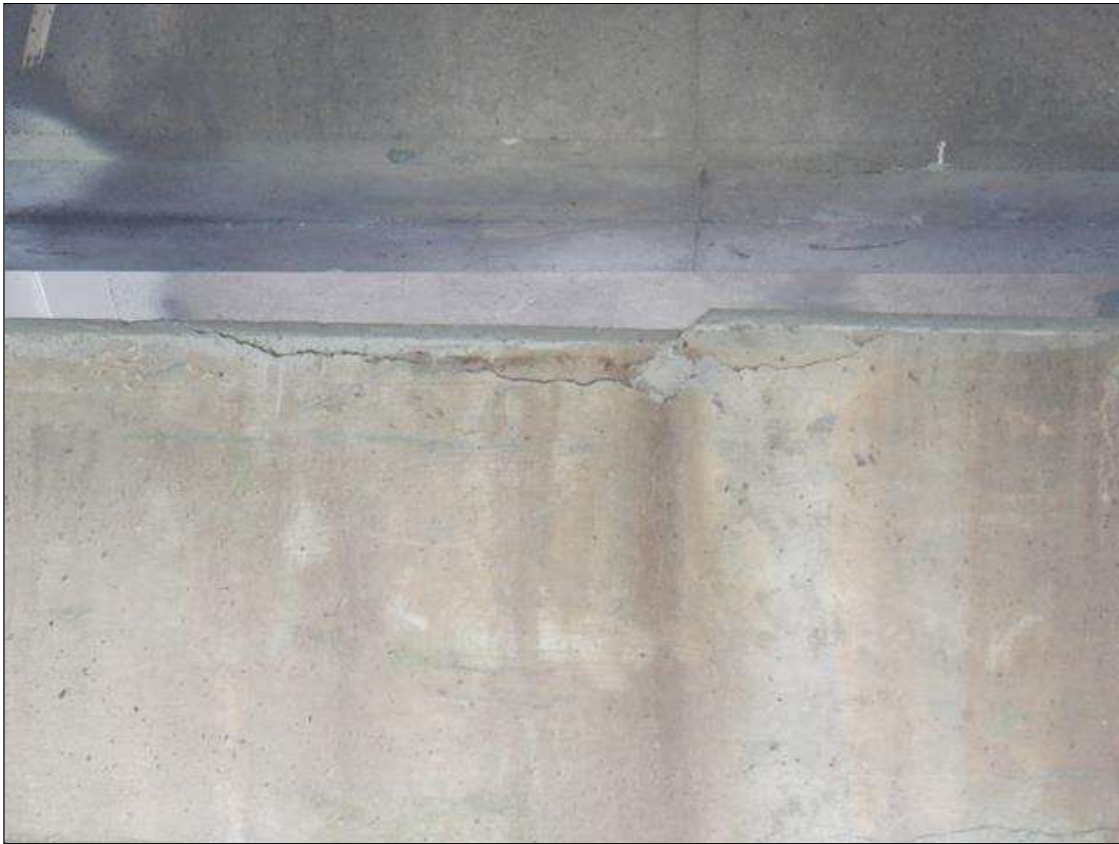
Bent 1 Cap 1: 3 FEET X UP TO 1/8 INCHES HORIZONTAL CRACK ON SPAN 1 FACE UNDER BAY 1
