BRIDGE INSPECTION RECORD AND SUMMARY FOR SHORED STRUCTURES OR STRUCTURES WITH TEMPORARY REPAIRS MADE TO KEEP A BRIDGE OPEN

BRIDGE: **500085** COUNTY: **Johnston** DATE: **6/28/2012**

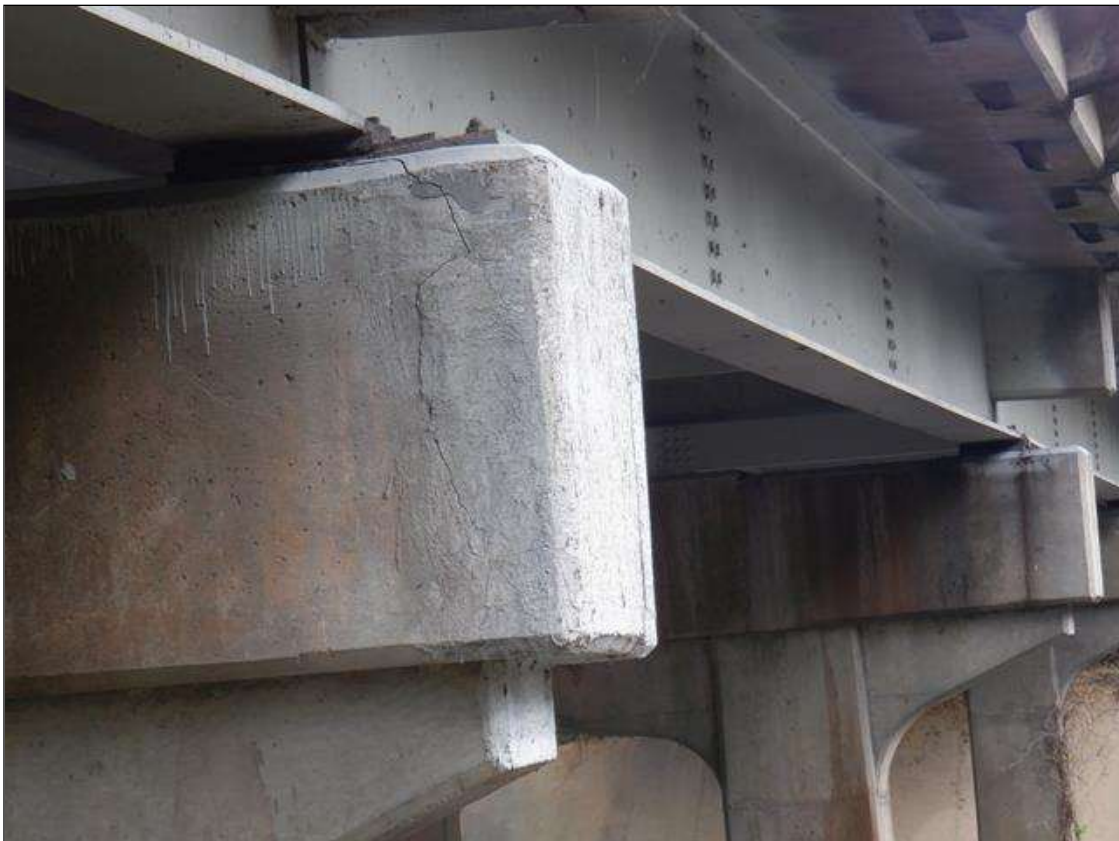
Bent 1 Cap 1: FULL HEIGHT X FULL WIDTH CRACKED PATCHED AREA UP TO 1/16 INCHES ON EAST END OF CAP, EXTENDING 9 INCHES ONTO SOUTH FACE.

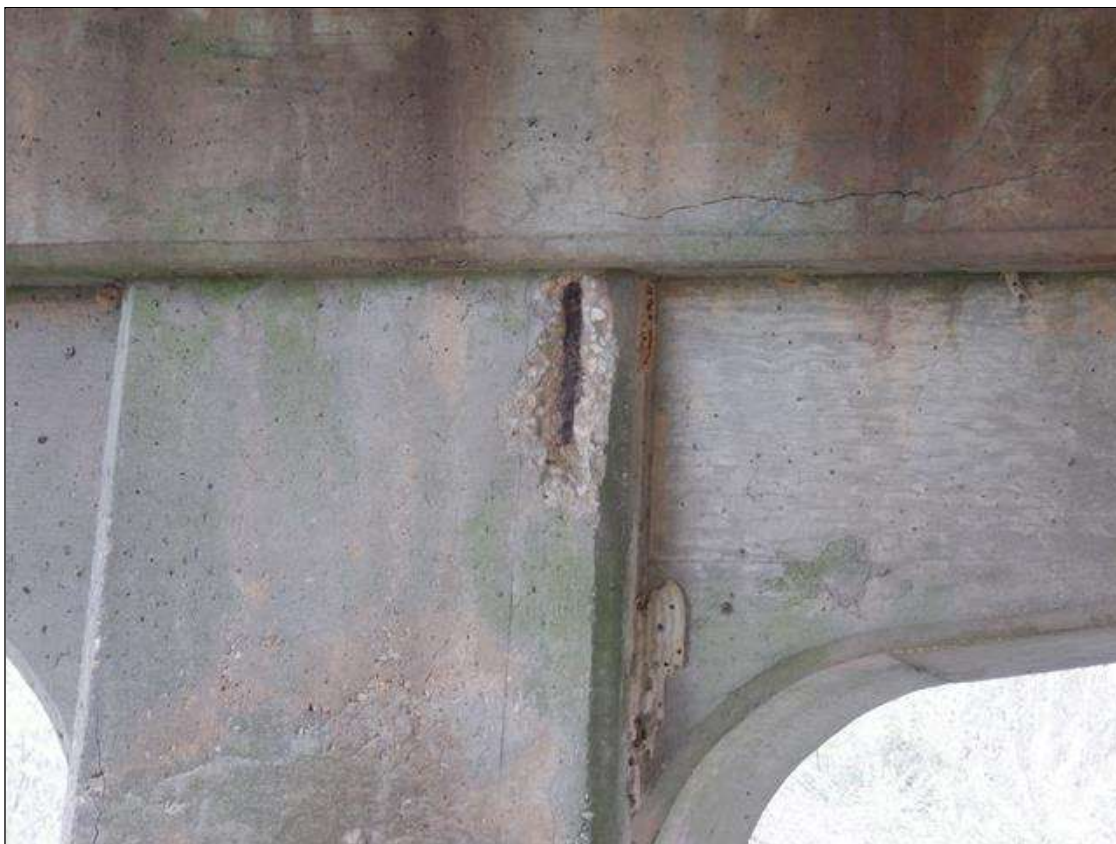
Bent 1 Pile 1: (PAR) 12 INCHES X 5 INCHES X 1 INCHES SPALL WITH EXPOSED REBAR ON SOUTH FACE AT BOTTOM OF CAP

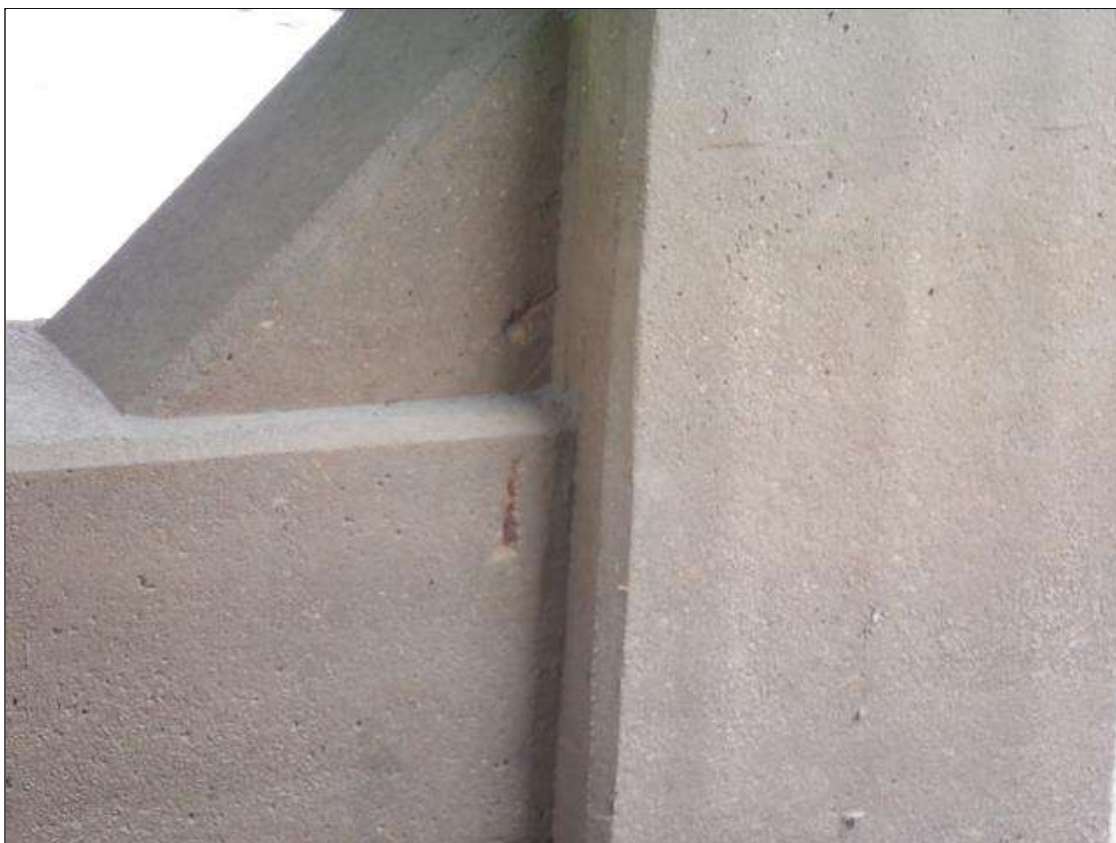
Bent 1 Pile 2: (2) UP TO 3 INCHES X 2 INCHES X 1/2 INCHES DEEP SPALLS WITH EXPOSED REBAR ON CORBEL AND STRUT ON SPAN 1 FACE

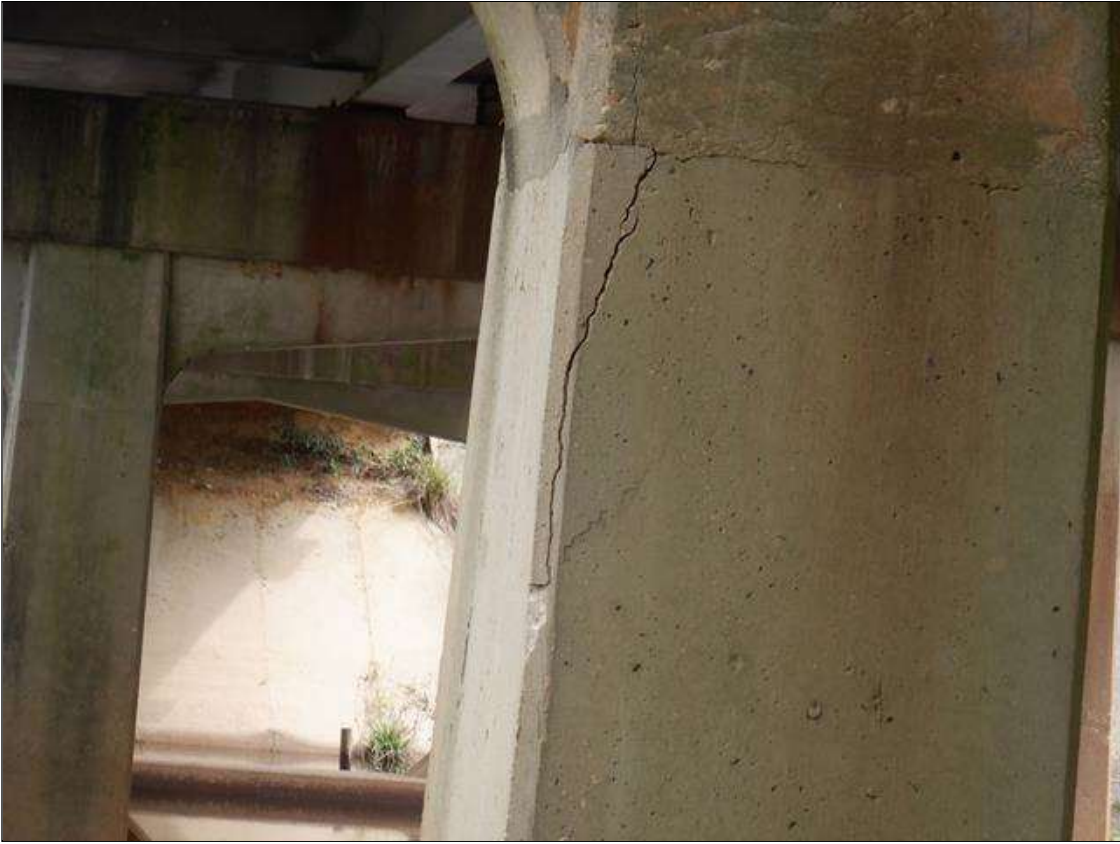
Bent 1 Pile 1: 42 INCHES X UP TO 1/4 INCHES VERTICAL CRACK WITH ADJACENT 4 FEET X UP TO 5 INCHES X 3 INCHES DELAMINATION ON SPAN 1 FACE

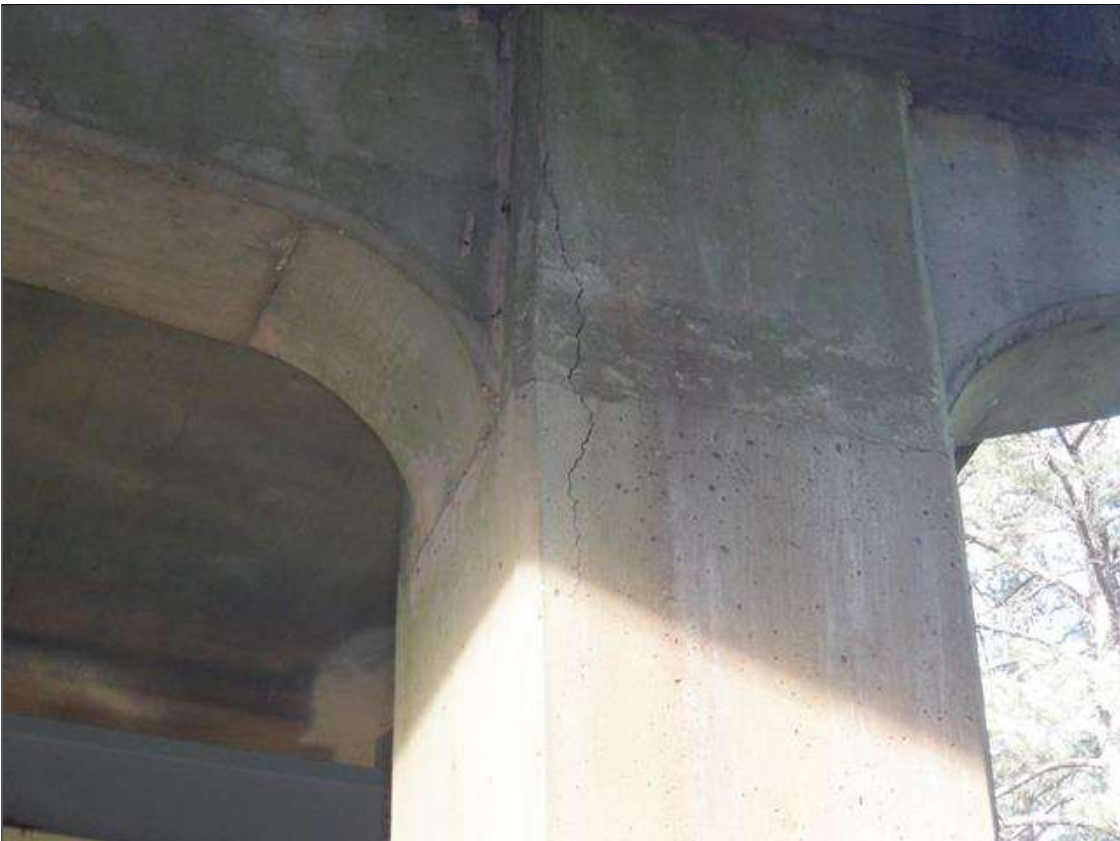
Bent 1 Pile 1: 6 FEET X UP TO 1/8 INCHES VERTICAL CRACK IN NORTHEAST CORNER, 1 FEET FROM BOTTOM OF CAP.

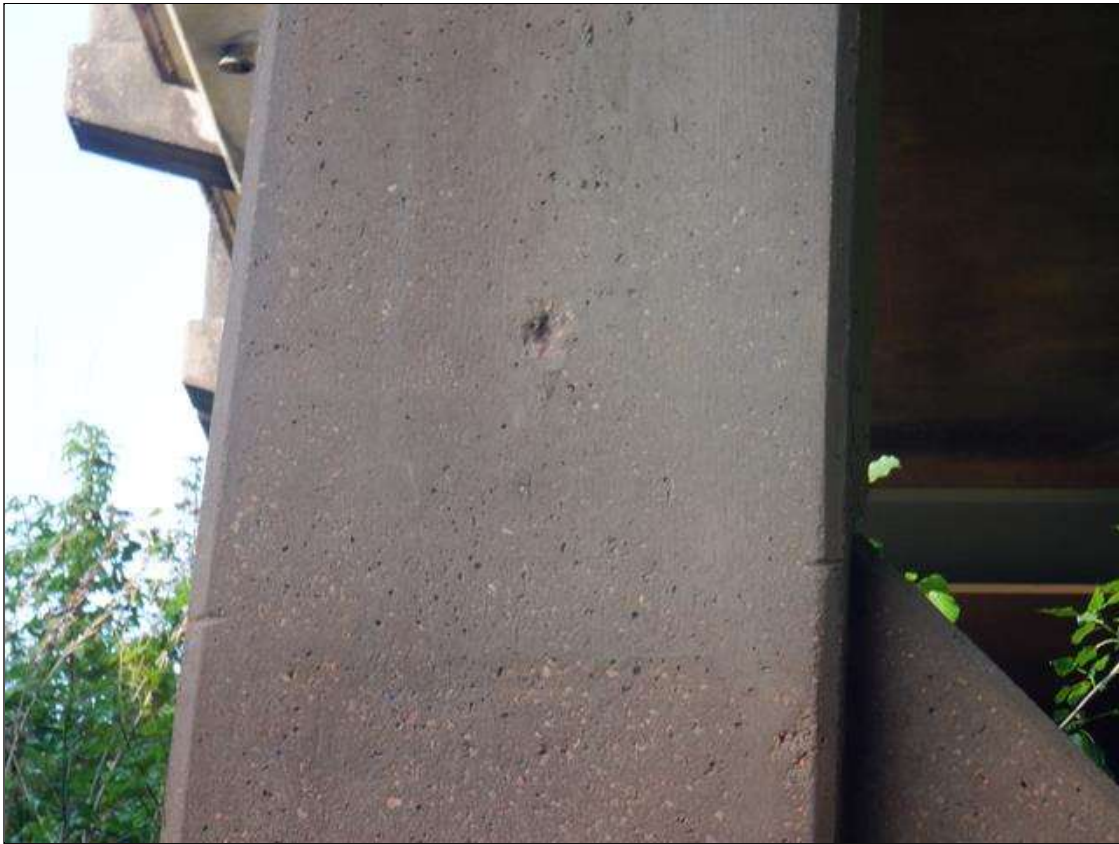
Bent 1 Pile 2: 6 INCHES DIAMETER X UP TO 1/2 INCHES SPALL WITH EXPOSED REINFORCING IN NORTH FACE, 4 FEET FROM TOP OF STRUT.

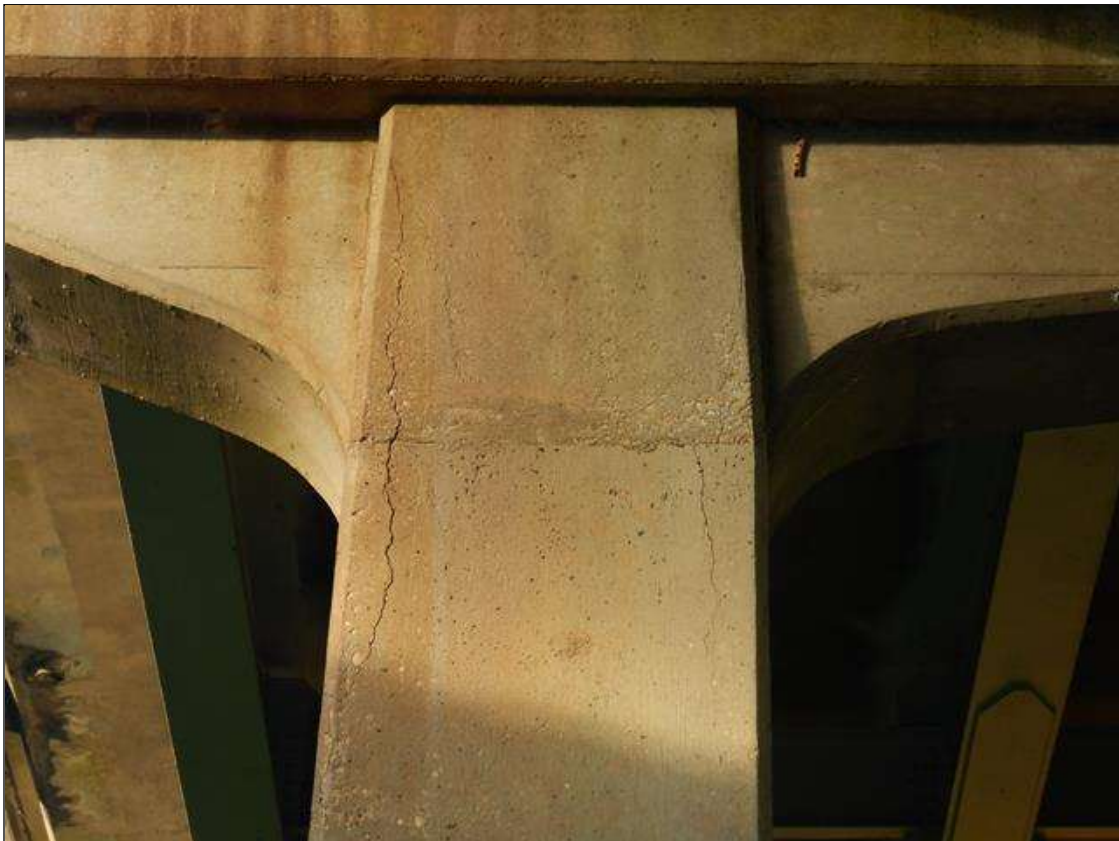
Bent 1 Pile 2: 2- UP TO 7 FEET X 1/8 INCHES VERTICAL CRACKS IN NORTH FACE AT BOTTOM OF CAP.

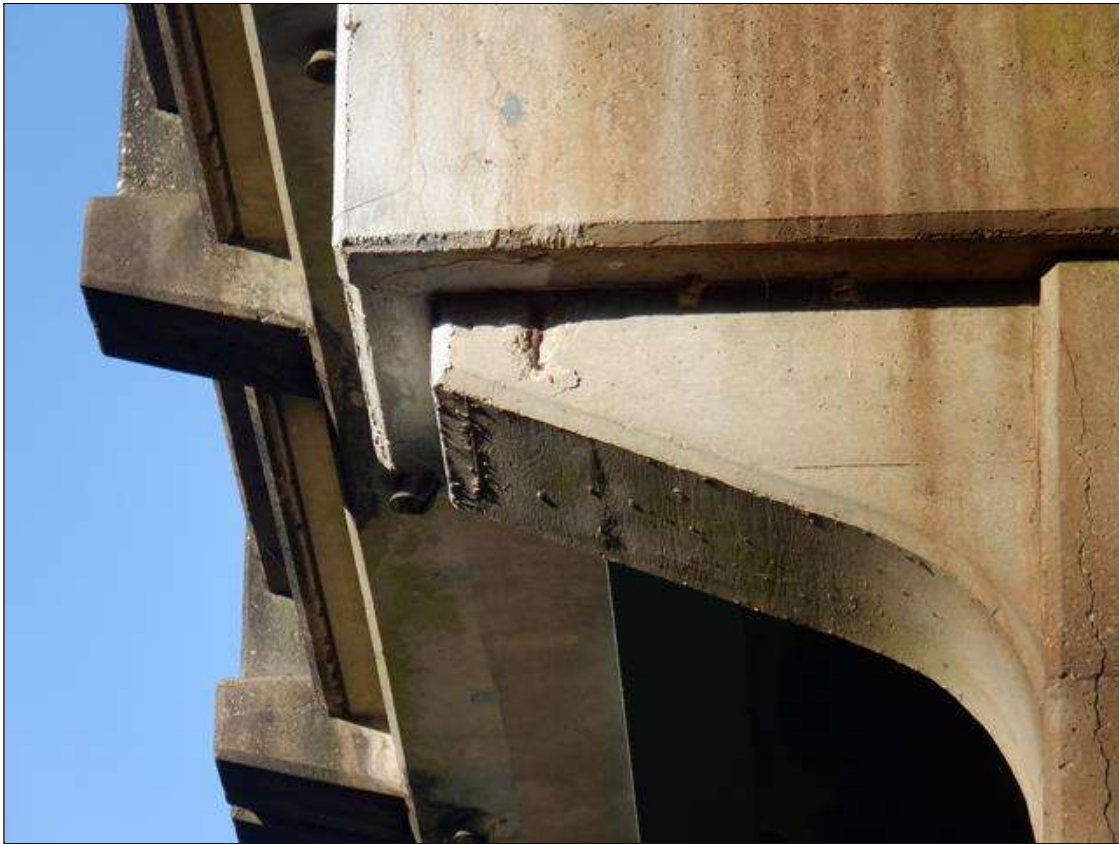
Bent 1 Pile 2: 6 INCHES X 8 INCHES X UP TO 1/2 INCHES SPALL WITH EXPOSED REINFORCING IN NORTH FACE OF CORBEL, UNDER BEAM 4.

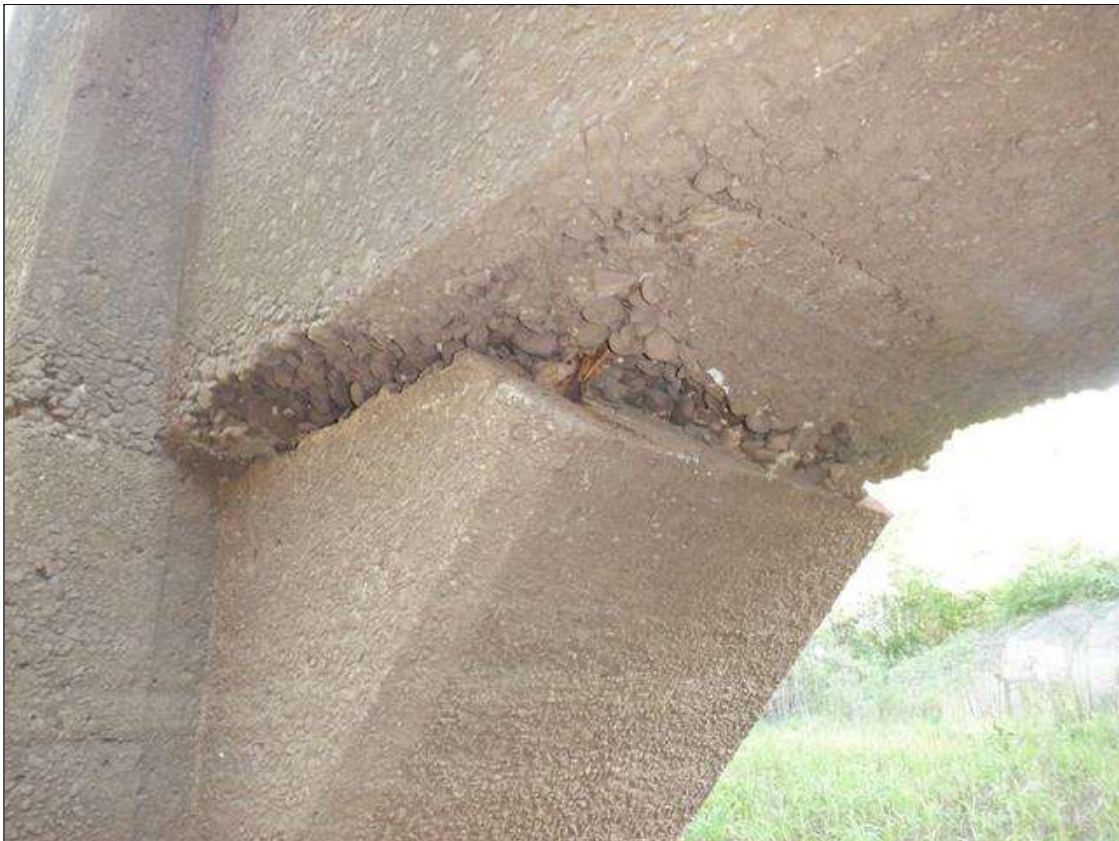
Bent 2 Pile 1: 20 INCHES X UP TO 4 INCHES X 18 INCHES SPALL WITH EXPOSED REINFORCING ON WEST CORBEL UNDER STRUT.

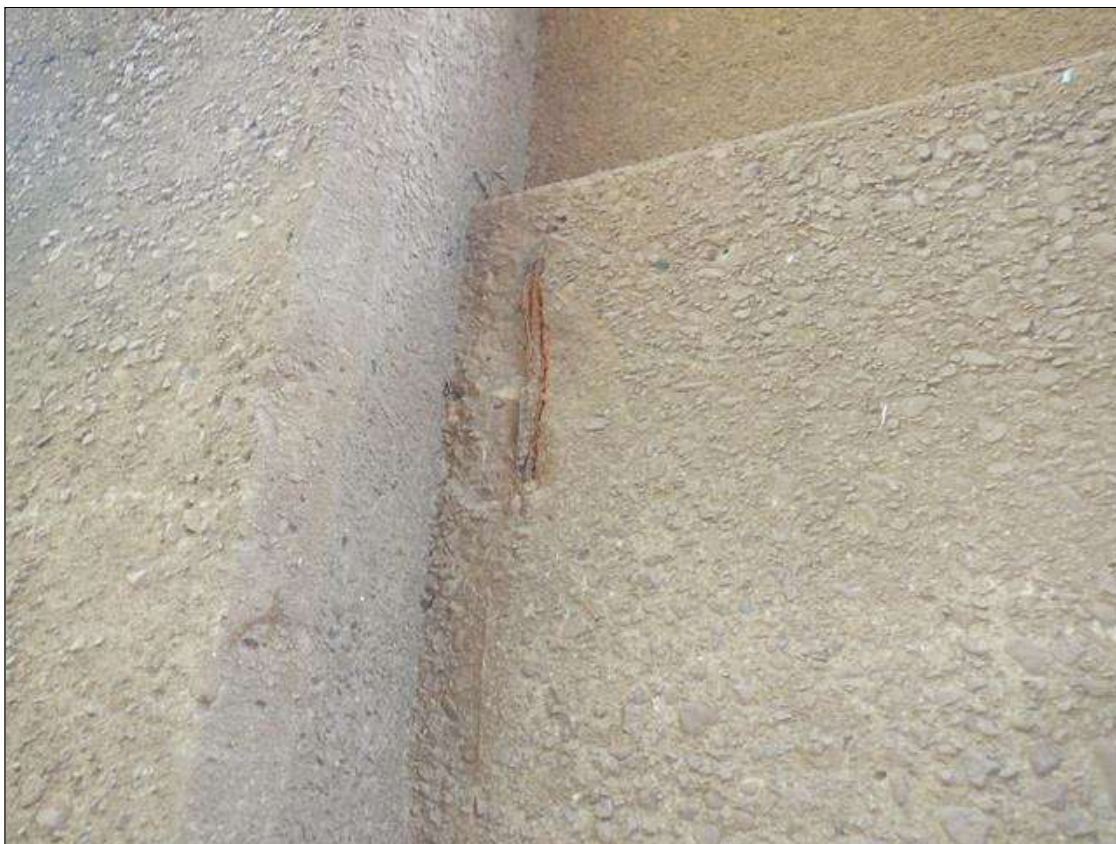
Bent 2 Pile 1: 4 INCHES X UP TO 9 INCHES X 1/2 INCHES SPALL WITH EXPOSED REINFORCING ON SOUTH OF STRUT, NEAR PILE 1.

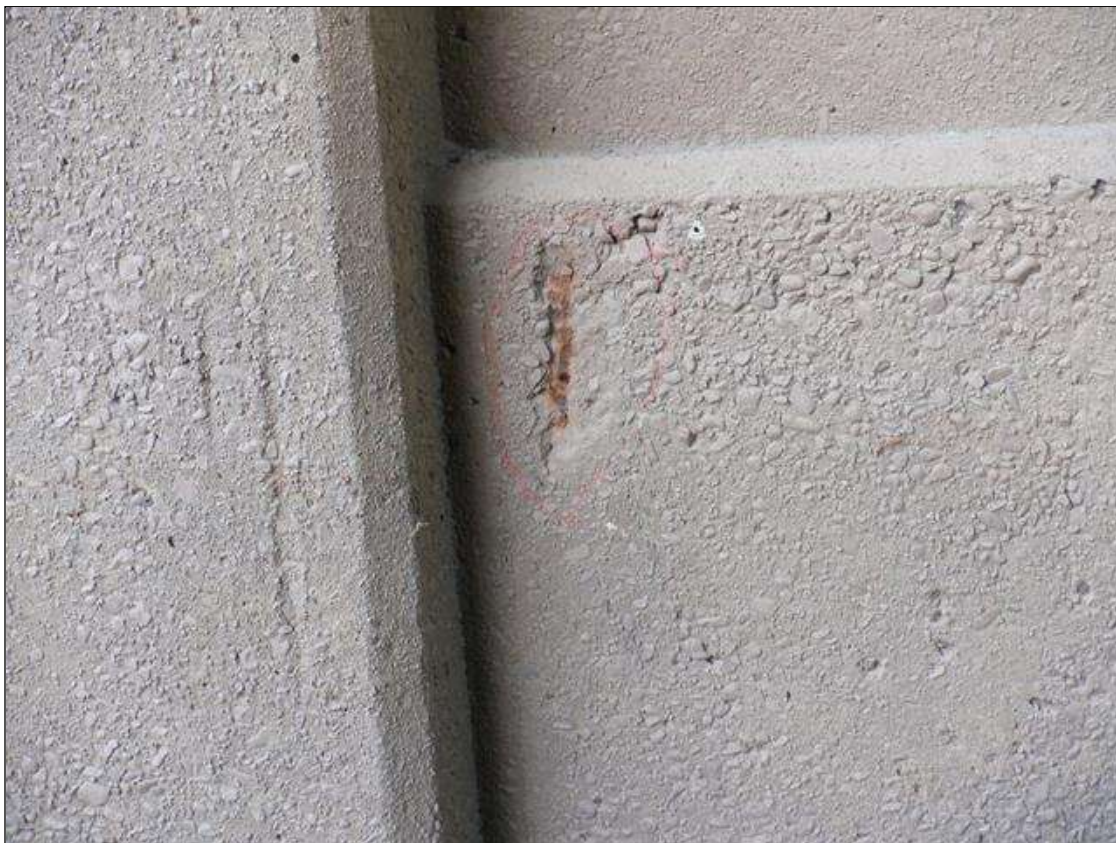
Bent 2 Pile 2: 2 INCHES X UP TO 6 INCHES X 1/2 INCHES SPALL WITH EXPOSED REBAR ON NORTH FACE OF STRUT, NEAR PILE 2.

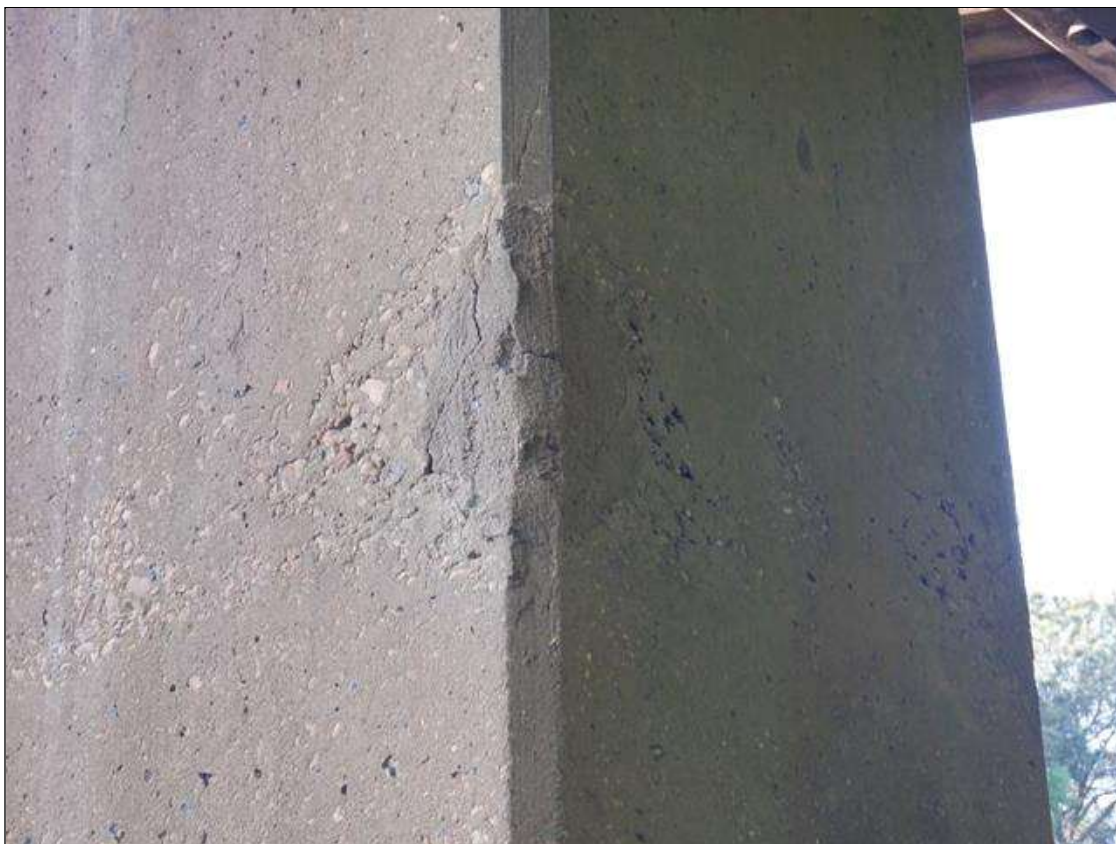
Bent 2 Pile 2: 12 INCHES X 8 INCHES X 4 INCHES CRACKED PATCHED AREA WITH UP TO 1/16 INCHES CRACKING ON NORTHWEST CORNE, 7 FEET FROM BOTTOM OF CAP.

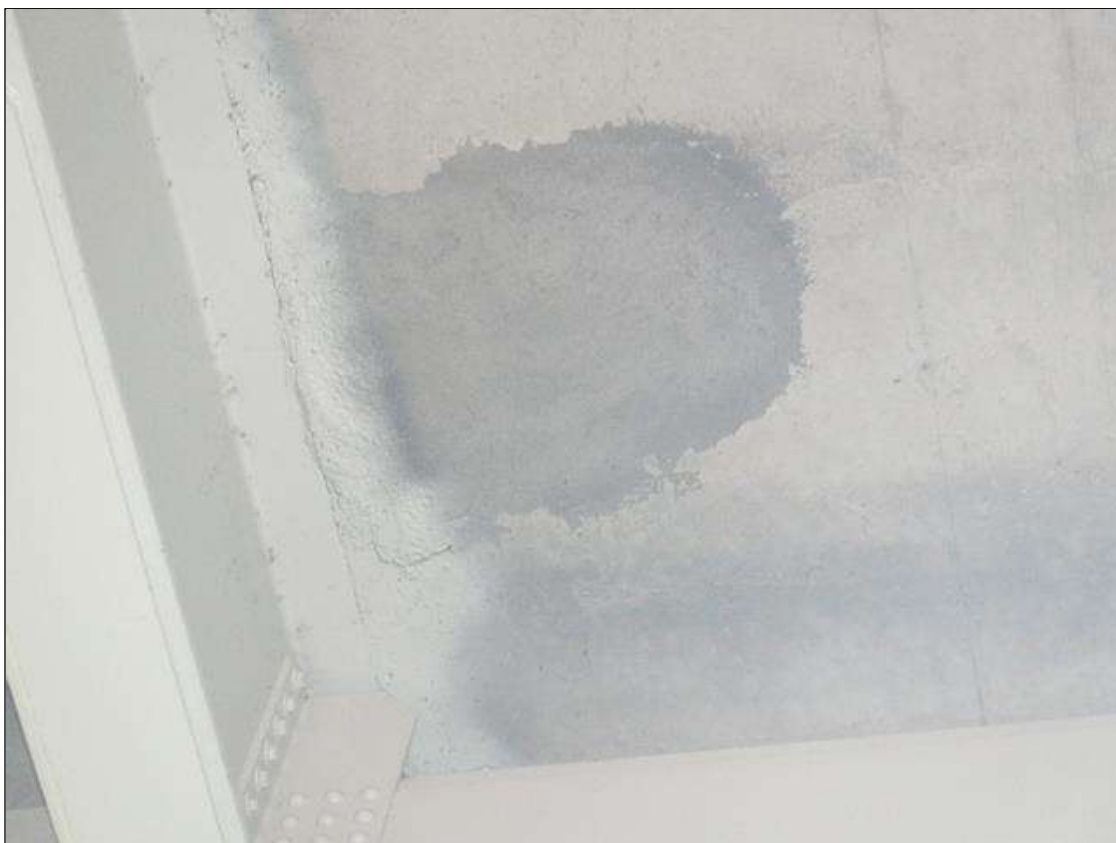
Span 3 Deck: 2.5 FEET X 2.5 FEET SOUND PATCH IN BAY 3, 16 FEET FROM BENT 2.

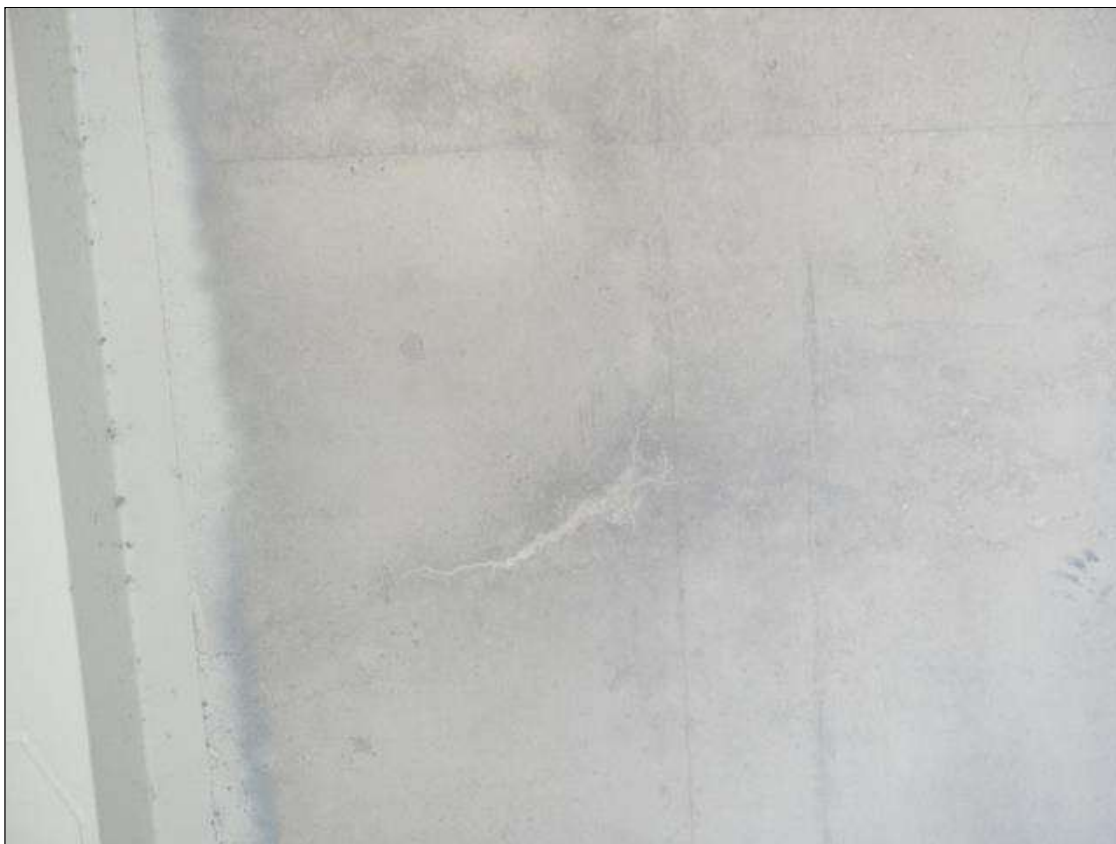
Span 3 Deck: 400 SQUARE FEET OF MAP CRACKING UP TO 1/32 INCHES, SOME WITH EFFLORESCENCE, AT RANDOM THROUGHOUT UNDERSIDE OF DECK (PHOTO TAKEN IN BAY 3)

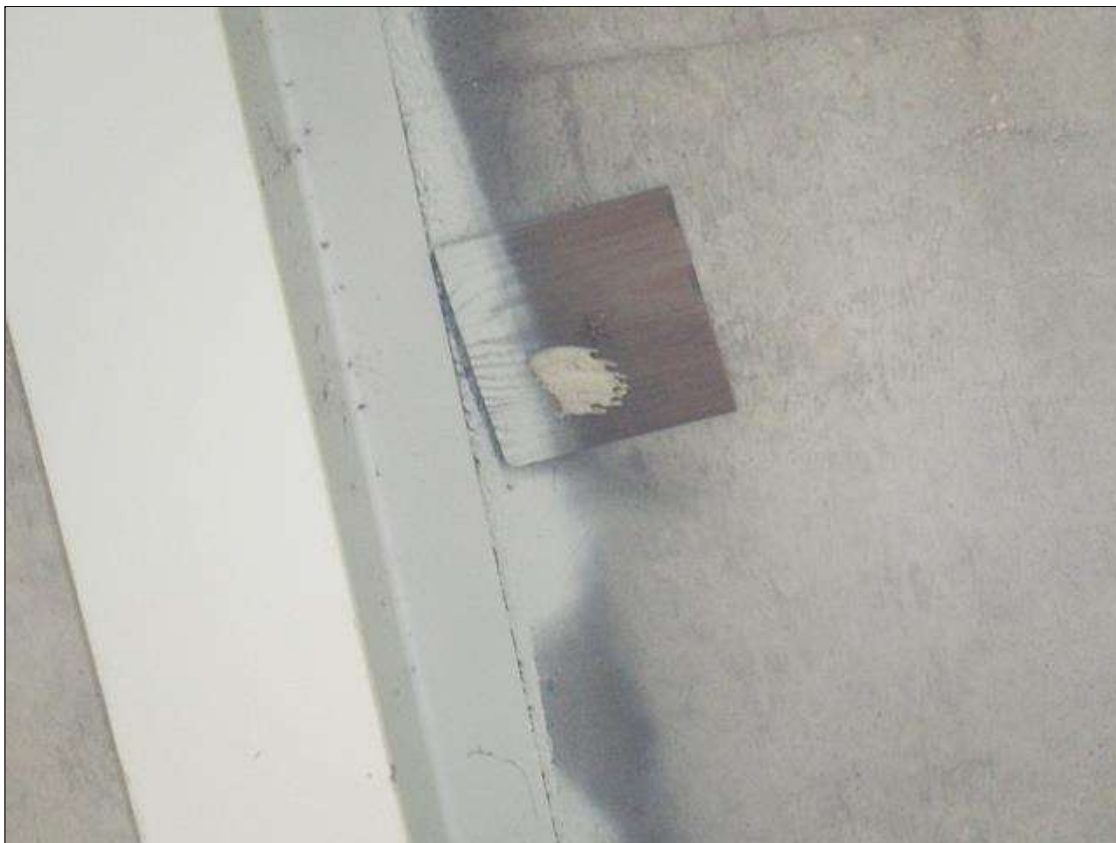
Span 3 Deck: 1 FEET X 1 FEET TIMBER PATCH IN BAY 2, 8 FEET FROM BENT 2, ADJACCENT TO BEAM 3.

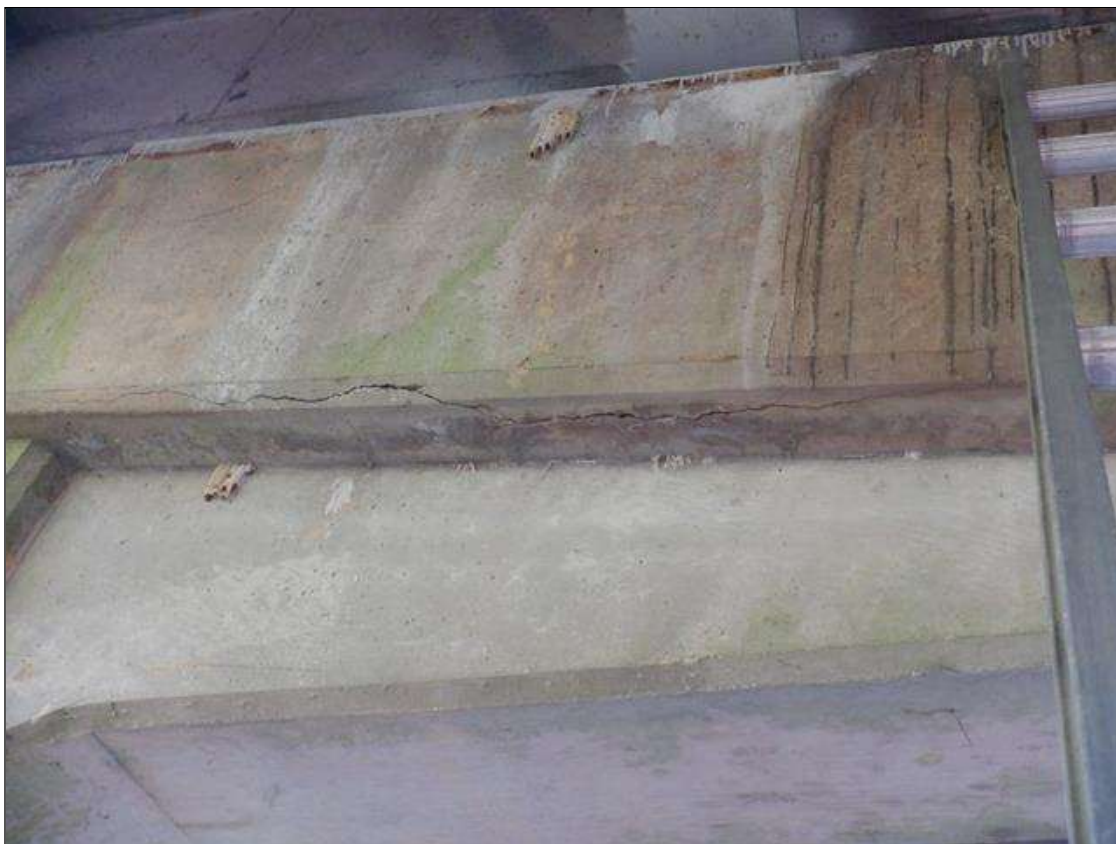
Bent 3 Cap 1: 6 FEET X UP TO 1/8 INCHES HORIZONTAL CRACK ON SOUTH BOTTOM FACE UNDER BEAM 2

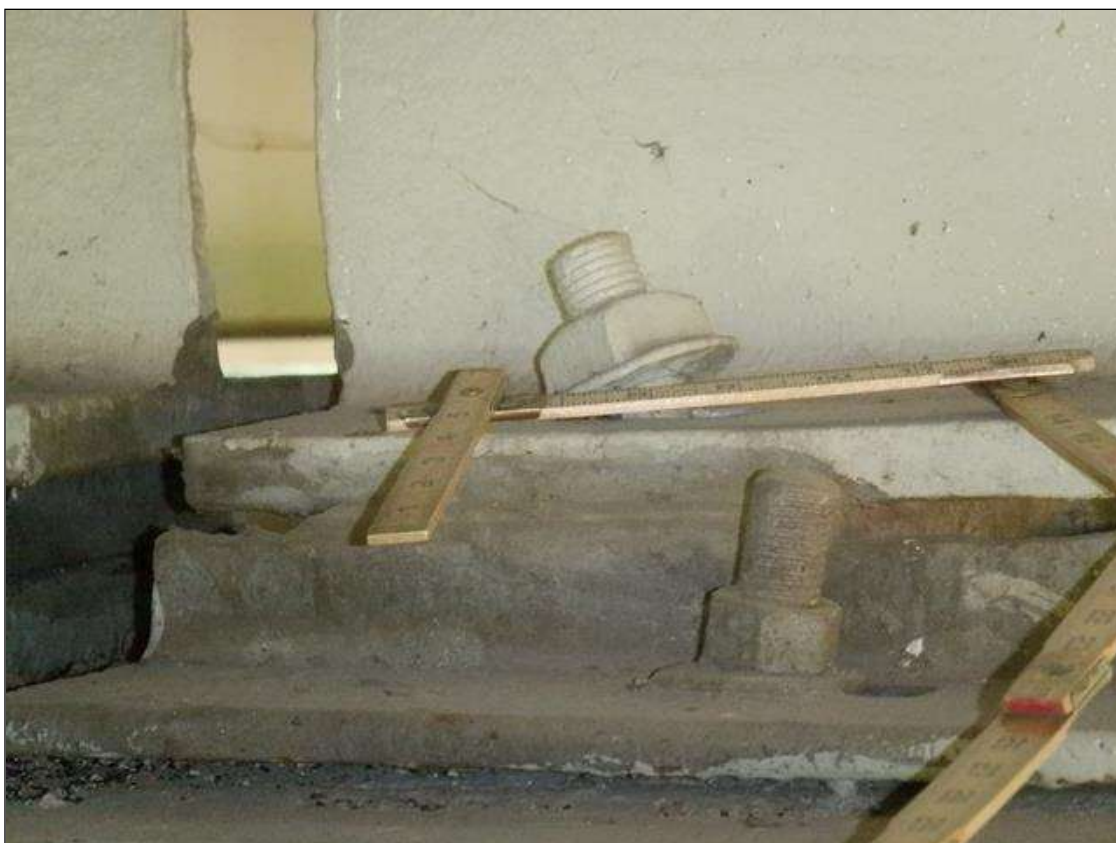
Span 3 Beam 3-Far Bearing 3: WEST ANCHOR BOLT IS BENT UP TO 1 INCHES NORTH.

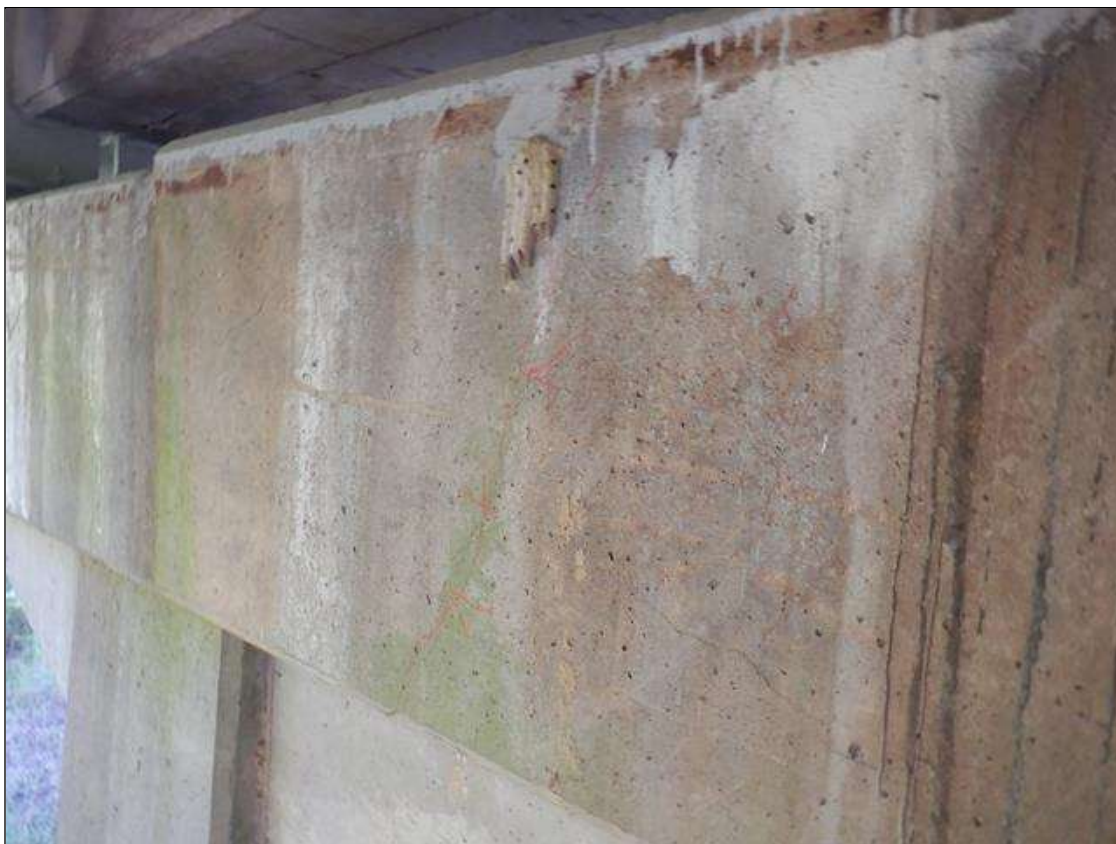
Bent 3 Cap 1: 12 FEET OF VERTICAL AND HORIZONTAL CRACKS UP TO 1/32 INCHES AT RANDOM THROUGHOUT

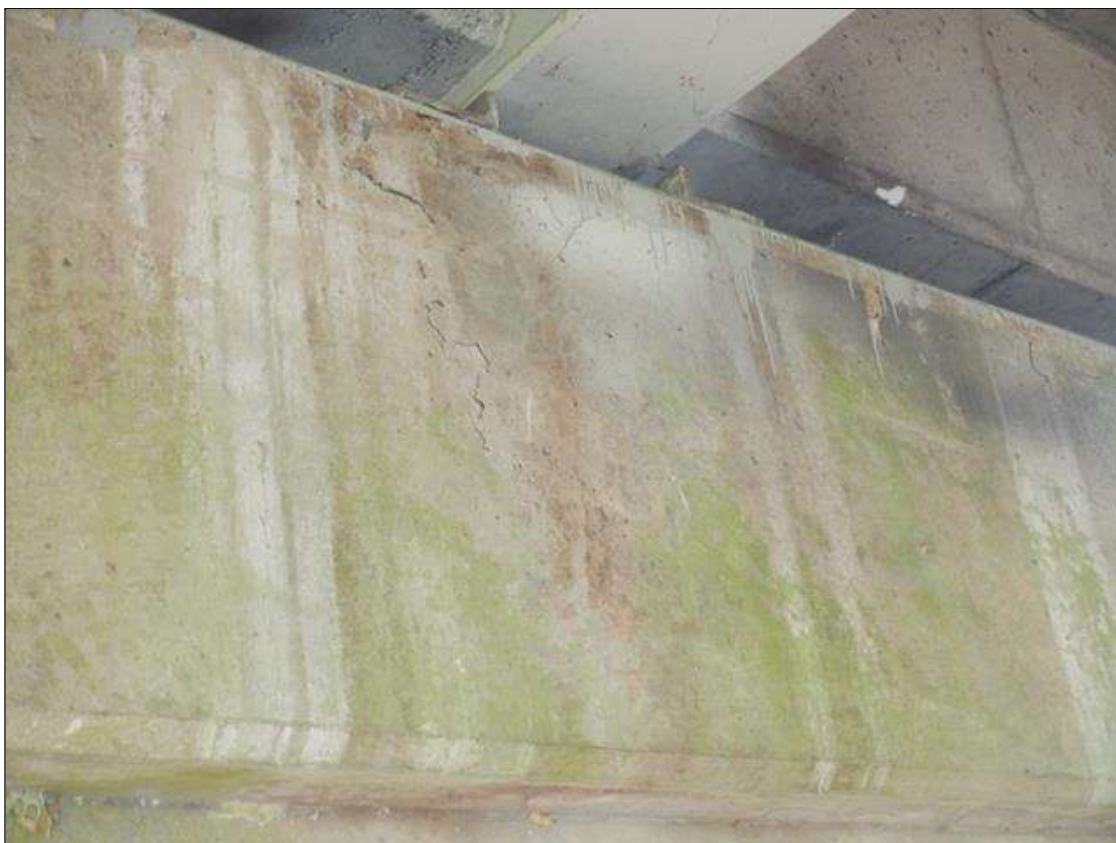
Bent 3 Cap 1: 3- UP TO 2 FEET X 20 INCHES DELAMINATIONS WITH UP TO 1/32 INCHES MAP CRACKING AT RANDOM THROUGHOUT SOUTH FACE (PHOTO TAKEN UNDER BEAM 2)

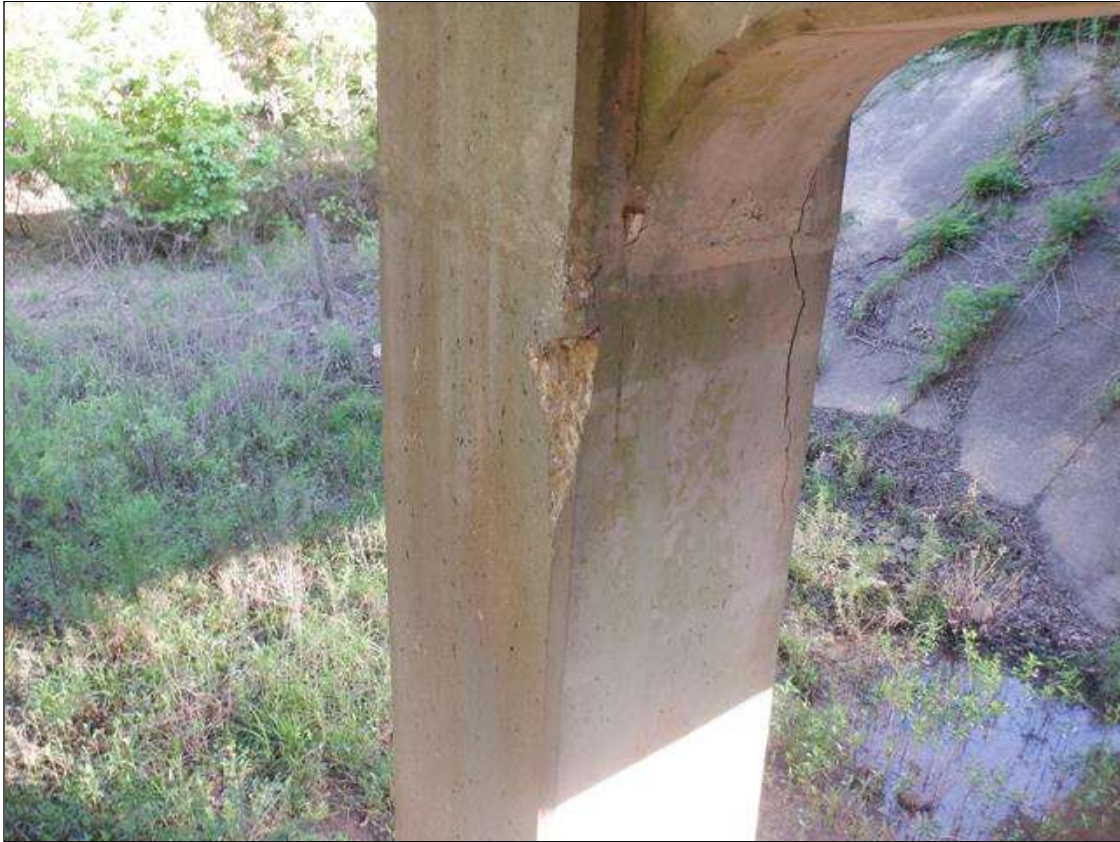
Bent 3 Pile 1: 14 INCHES X UP TO 6 INCHES X 2 INCHES SPALL WITH ADJACENT 1 FEET DIAMETER DELAMINATION ON SOUTHEAST CORNER, 2 FEET FROM BOTTOM OF CAP

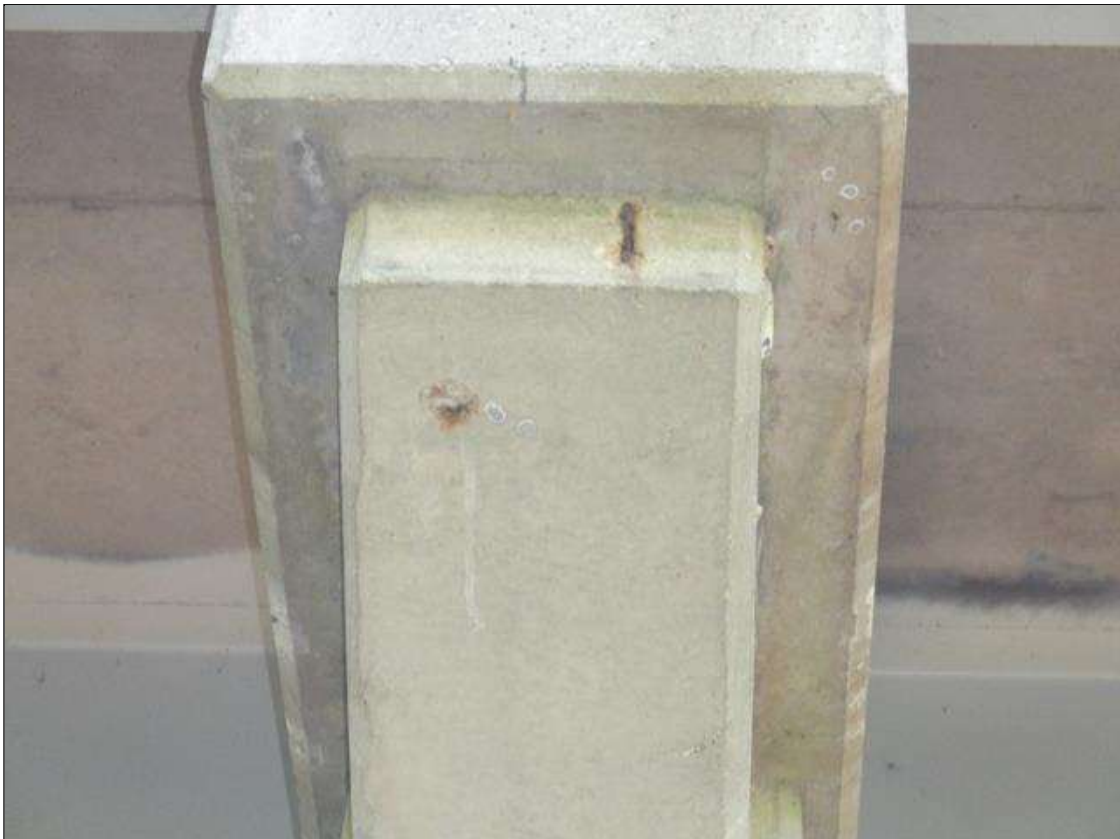
Bent 3 Pile 1: (2) UP TO 3 INCHES X 6 INCHES X 1 INCHES DEEP SPALLS WITH EXPOSED REBAR ON WEST AND BOTTOM FACE OF CORBEL.

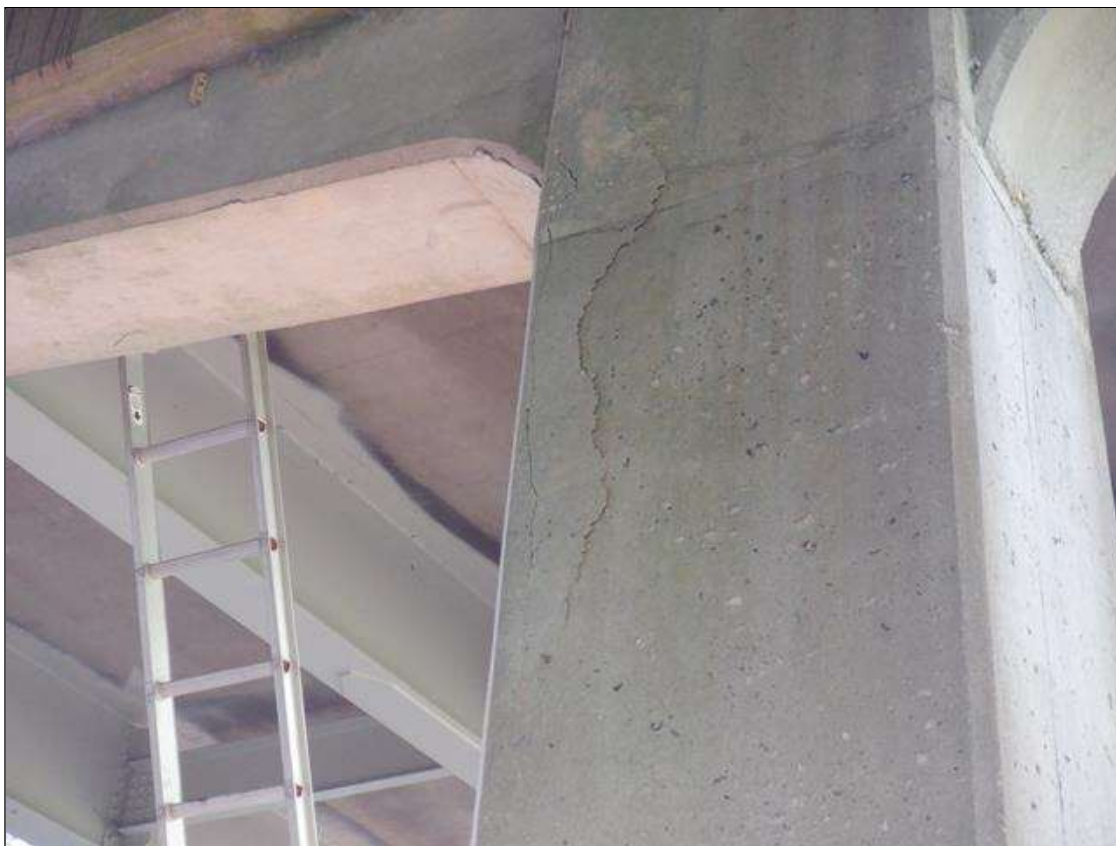
Bent 3 Pile 1: 6 FEET X UP TO 1 FEET X 8 INCHES DELAMINATION WITH UP TO 1/16 INCHES CRACKING AT NORTHEAST CORNER, 2 FEET BELOW CAP.

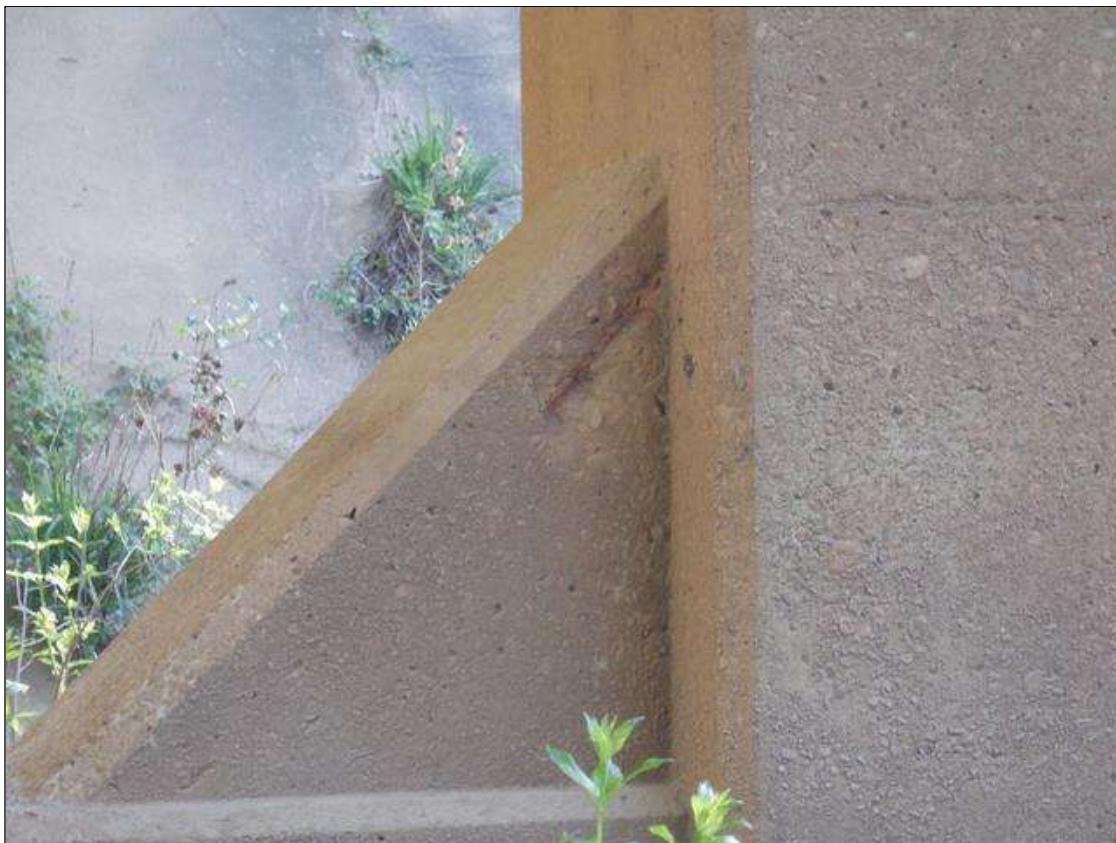
Bent 3 Pile 2: 8 INCHES X 4 INCHES X UP TO 1/2 INCHES SPALL WITH EXPOSED REINFORCING ON SPAN 3 FACE OF CORBEL UNDER STRUT.
