BRIDGE INSPECTION RECORD AND SUMMARY FOR SHORED STRUCTURES OR STRUCTURES WITH TEMPORARY REPAIRS MADE TO KEEP A BRIDGE OPEN

BRIDGE: **500085** COUNTY: **Johnston** DATE: **6/28/2012**

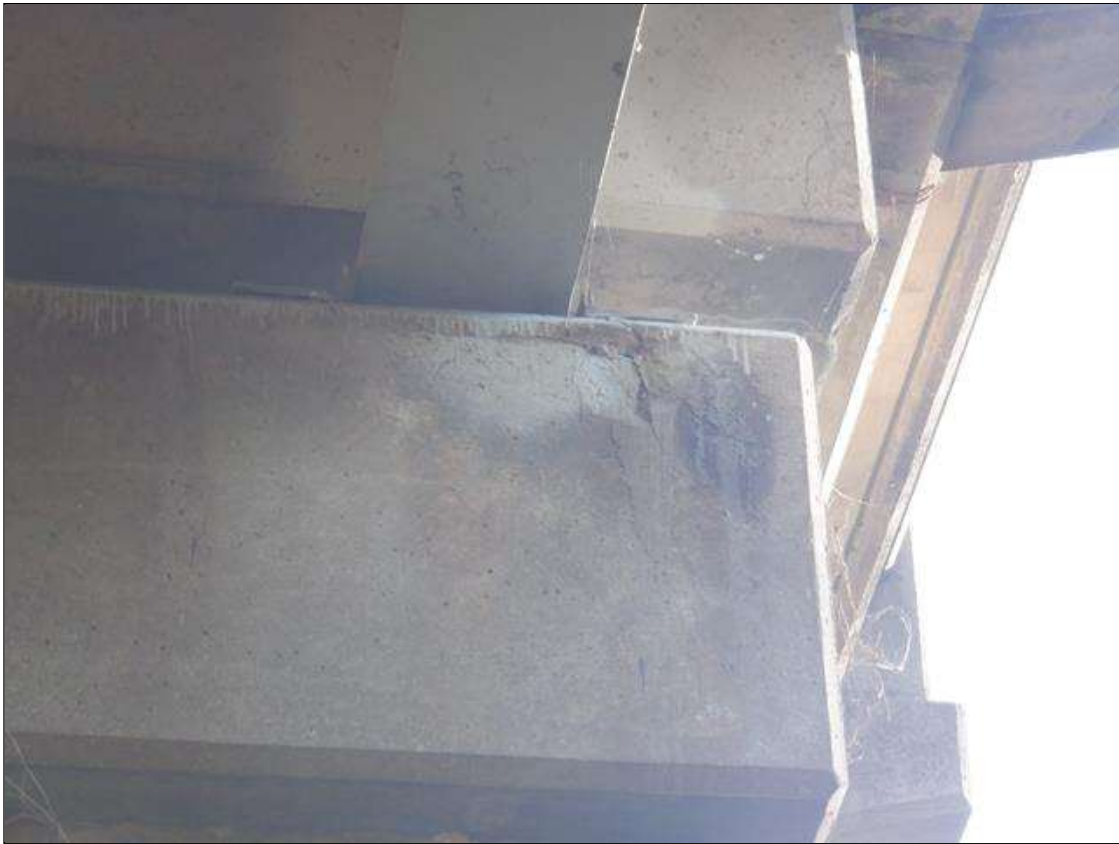
Bent 3 Cap 1: 4 INCHES X 6 INCHES X 1 INCHES DEEP SPALL WITH EXPOSED REBAR WITH ADJACENT UP TO 1/16 INCHES MAP CRACKING ON SPAN 3 FACE AT EAST END

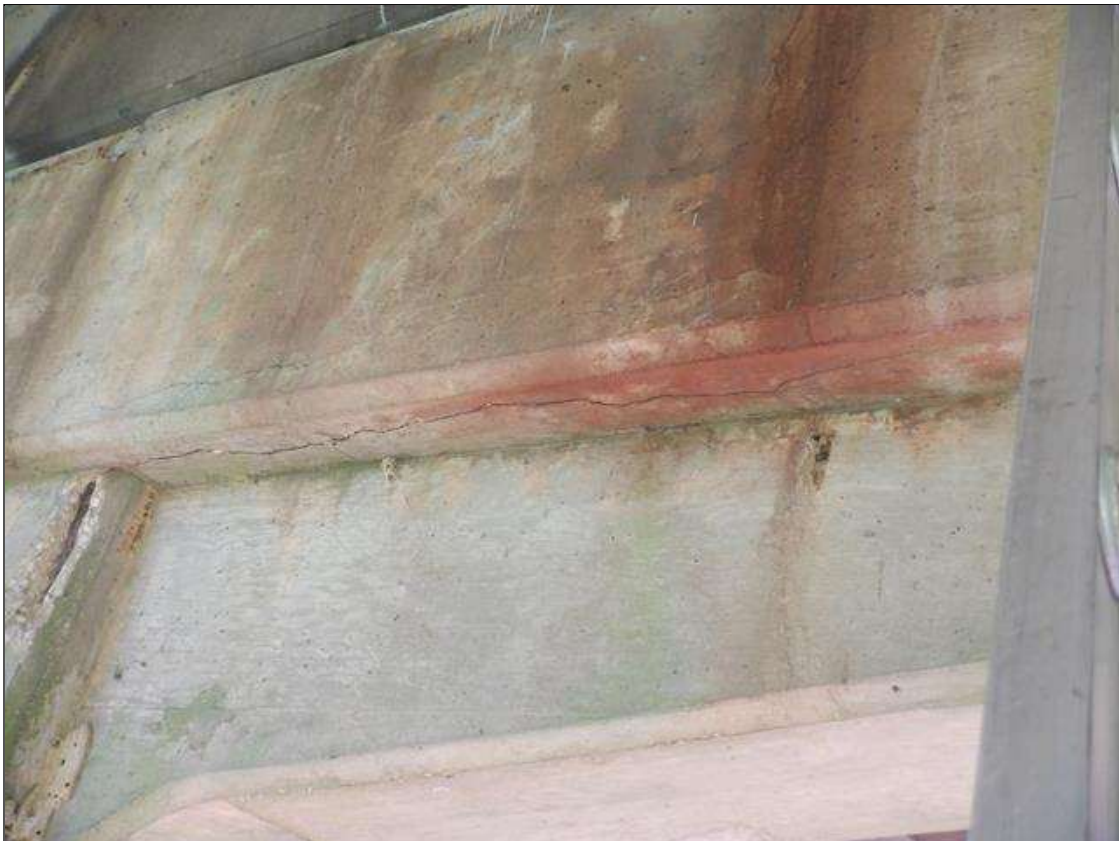
Bent 1 Cap 1: 2- UP TO 6 FEET X 1 INCHES LONGITUDINAL CRACKS WITH ADJACENT 6 FEET X 5 INCHES X 4 INCHES DELAMINATION IN BOTTOM OF SOUTH FACE UNDER BEAM 2.

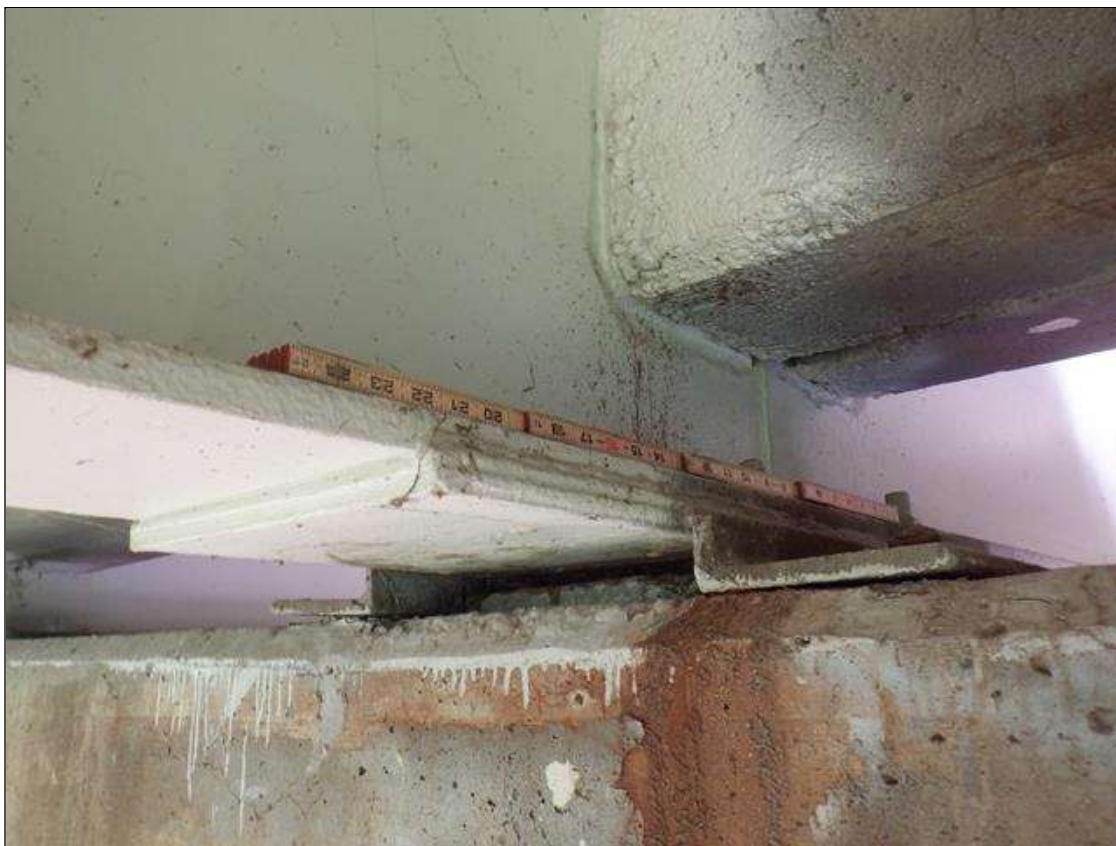
Span 1 Beam 2: 20 INCHES X 12 INCHES X 3/4 INCHES PLATE WELDED TO BOTTOM OF BOTTOM FLANGE AT BENT 1

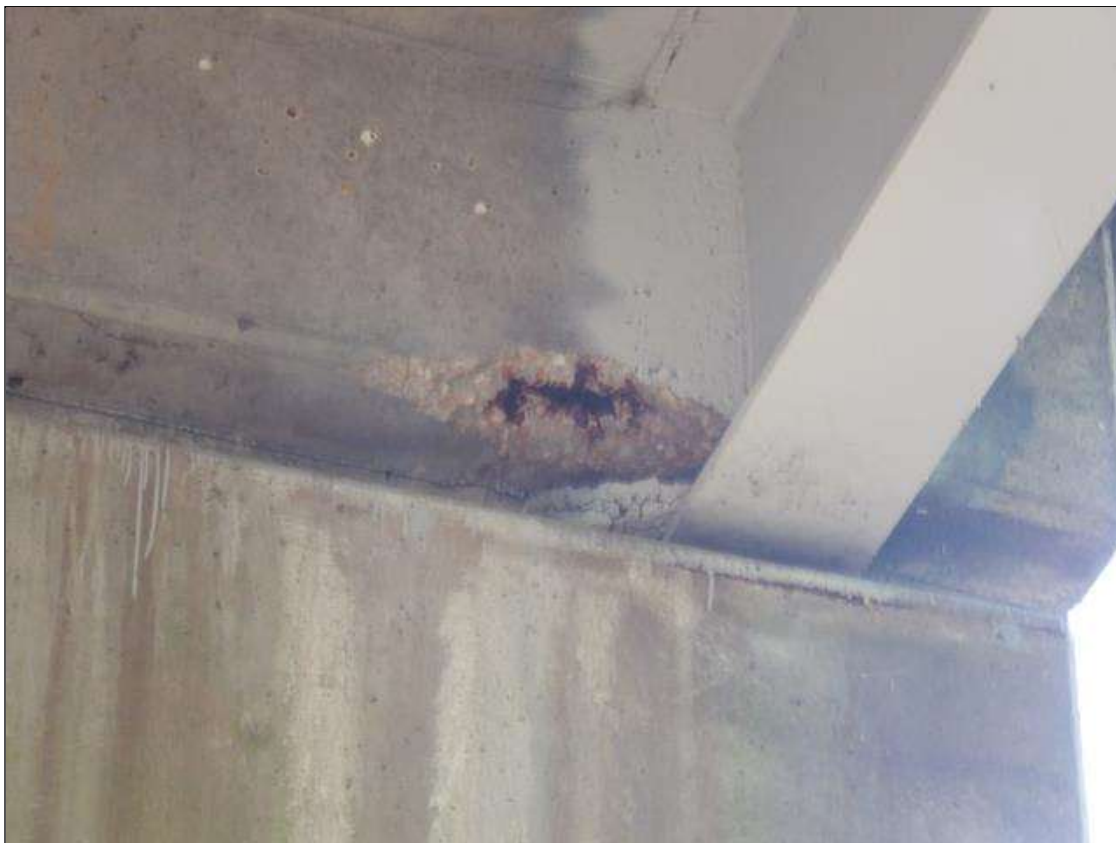
Span 4 Deck: 2 FEET X 6 INCHES X 6 INCHES SPALL WITH EXPOSED REBAR IN BENT 3 DIAPHRAGM, BAY 1 ADJACENT TO BEAM 1

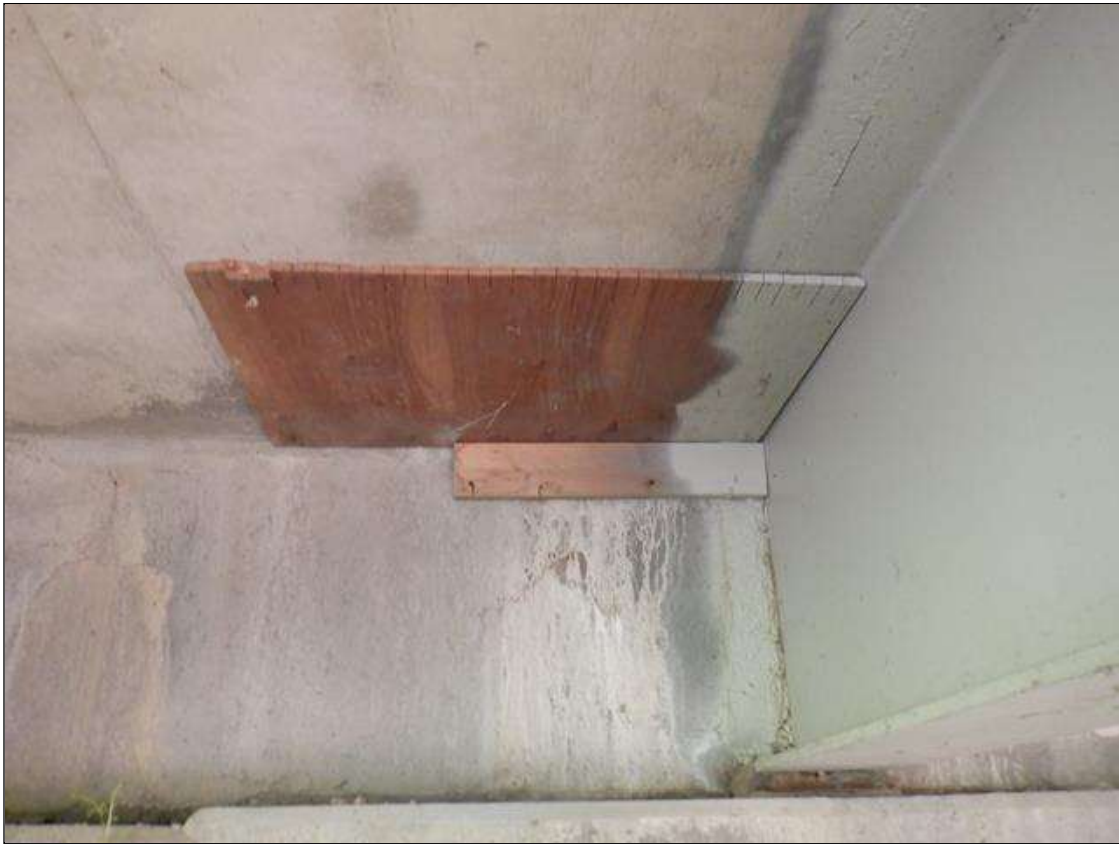
Span 4 Deck: 4 FEET X 2.5 FEET TIMBER STAY IN PLACE FORMWORK IN BAY 1 AT END BENT 2. (1 FEET X 1 FEET SIMILAR IN BAY 3)

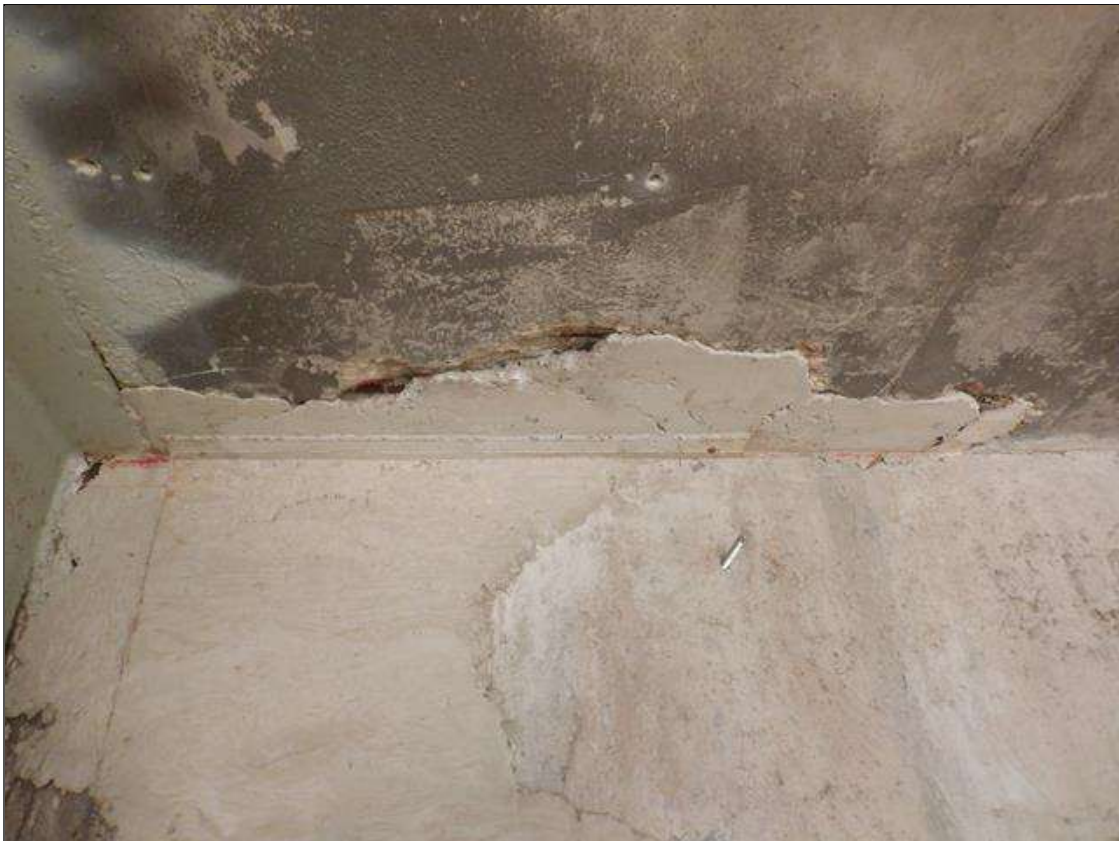
Span 4 Deck: 17 INCHES X 4 INCHES X 2 INCHES DEEP SPALL WITH EXPOSED REINFORCING AND ADJACENT 5 FEET X UP TO 18 INCHES PATCHED AREA IN UNDERSIDE OF DECK IN BAY 2 AT END BENT 2

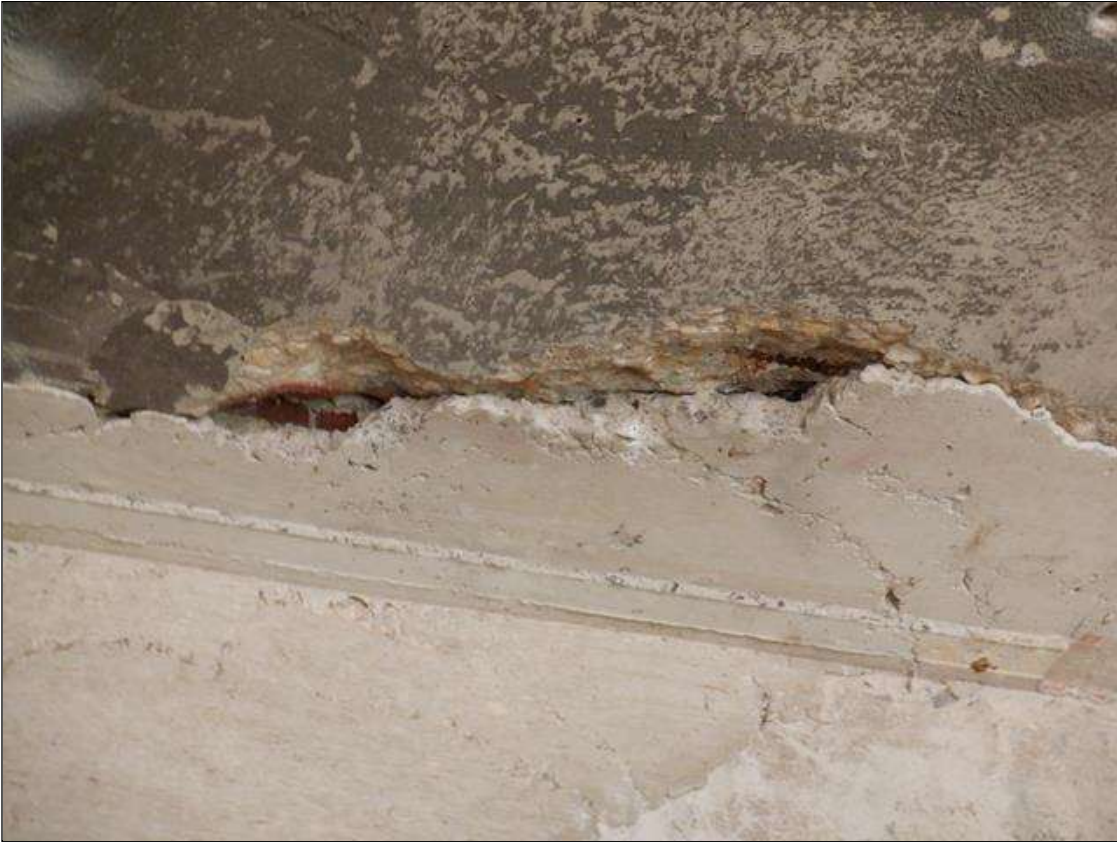
Span 4 Deck: 17 INCHES X 4 INCHES X 2 INCHES DEEP SPALL WITH EXPOSED REINFORCING AND ADJACENT 5 FEET X UP TO 18 INCHES PATCHED AREA IN UNDERSIDE OF DECK IN BAY 2 AT END BENT 2

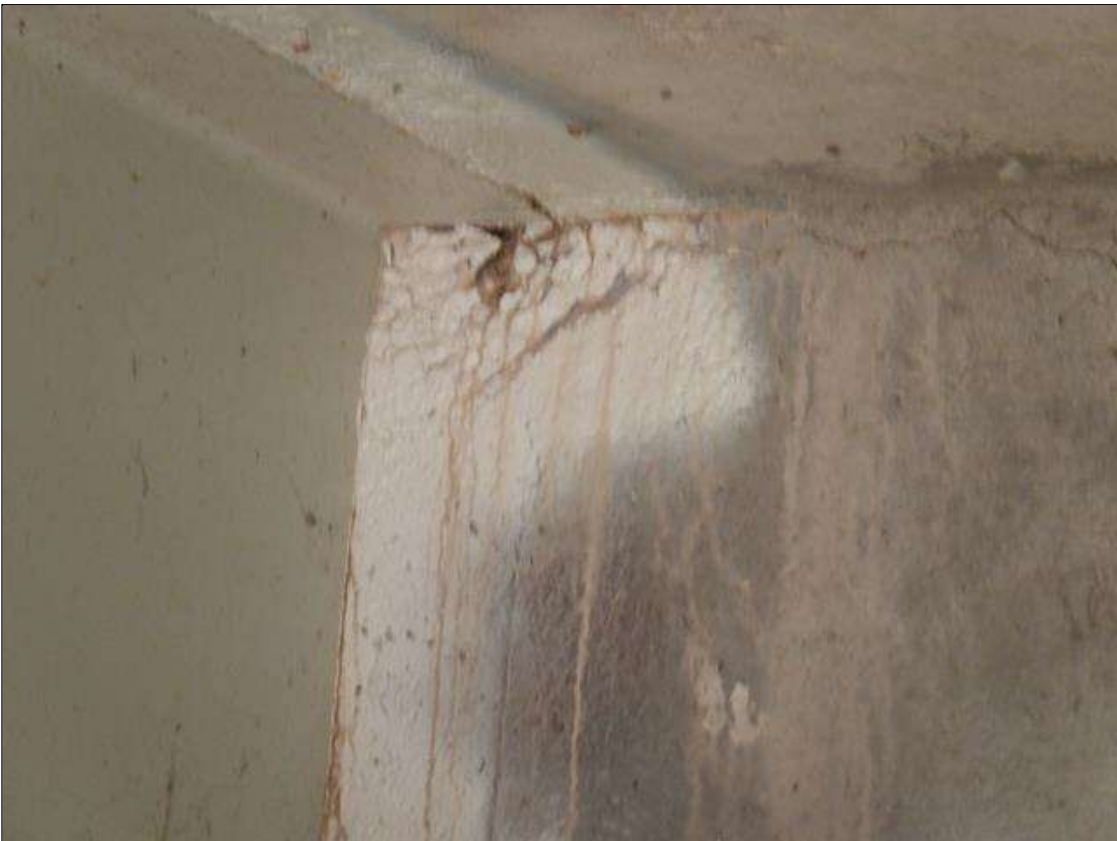
End Bent 2 Abutment: 10 INCHES X UP TO 6 INCHES X 3/4 INCHES SPALL IN BAY 1, ADJACENT TO TOP FLANGE OF BEAM 1.

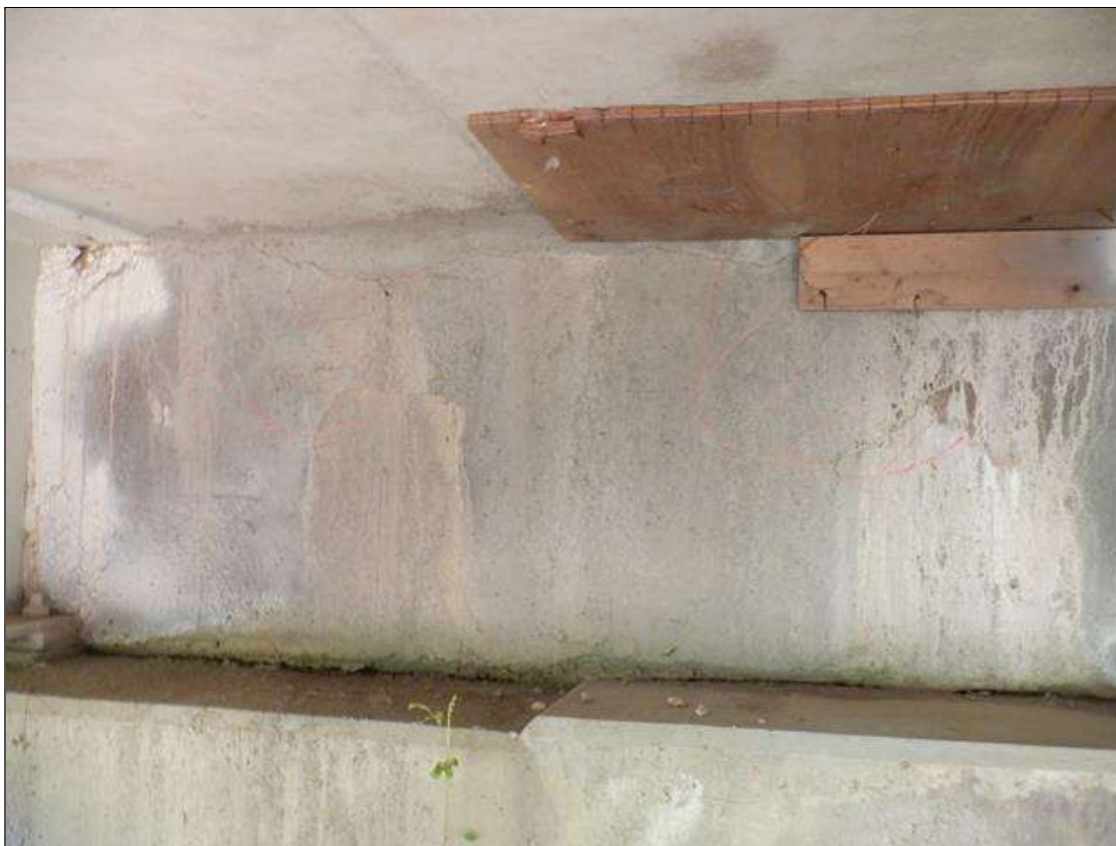
End Bent 2 Abutment: (2) UP TO 24 INCHES X 12 INCHES AREAS OF DELAMINATION IN BAY 1

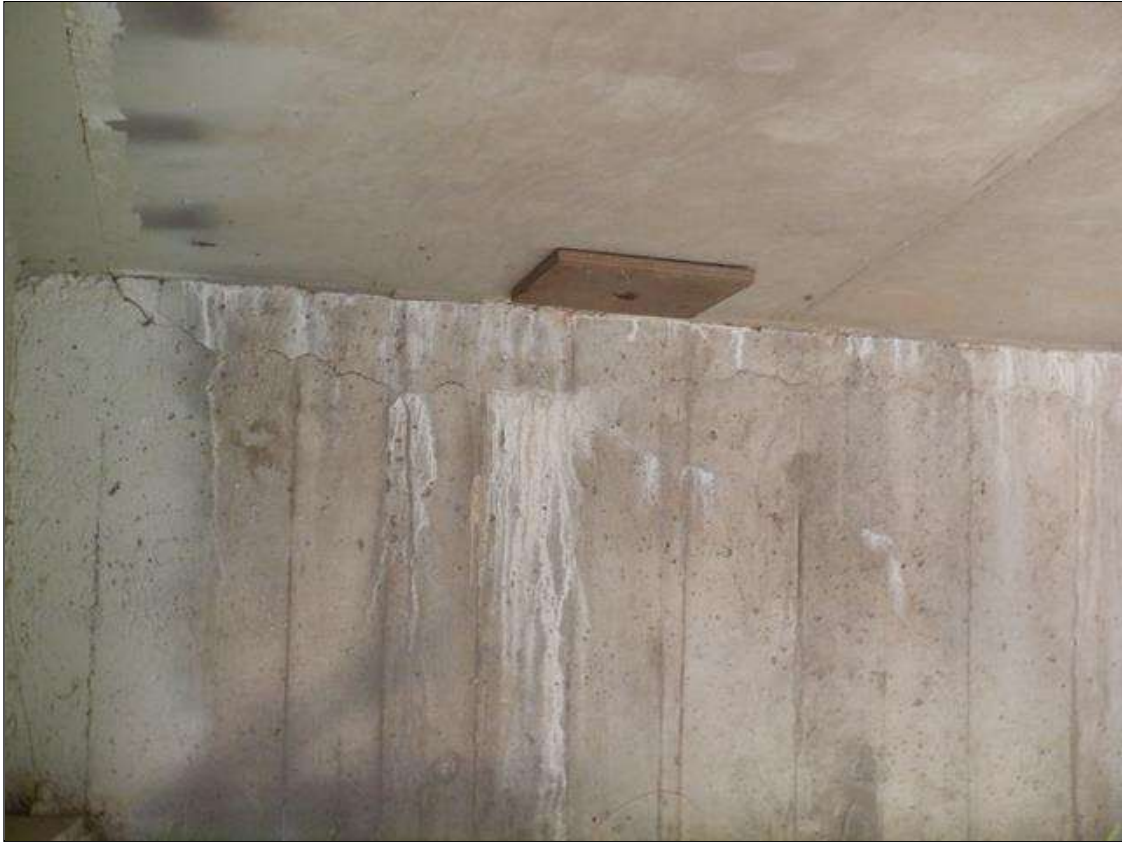
End Bent 2 Abutment: 7 FEET X UP TO 1/16 INCHES HORIZONTAL CRACK WITH EFFLORESCENCE IN BAY 3

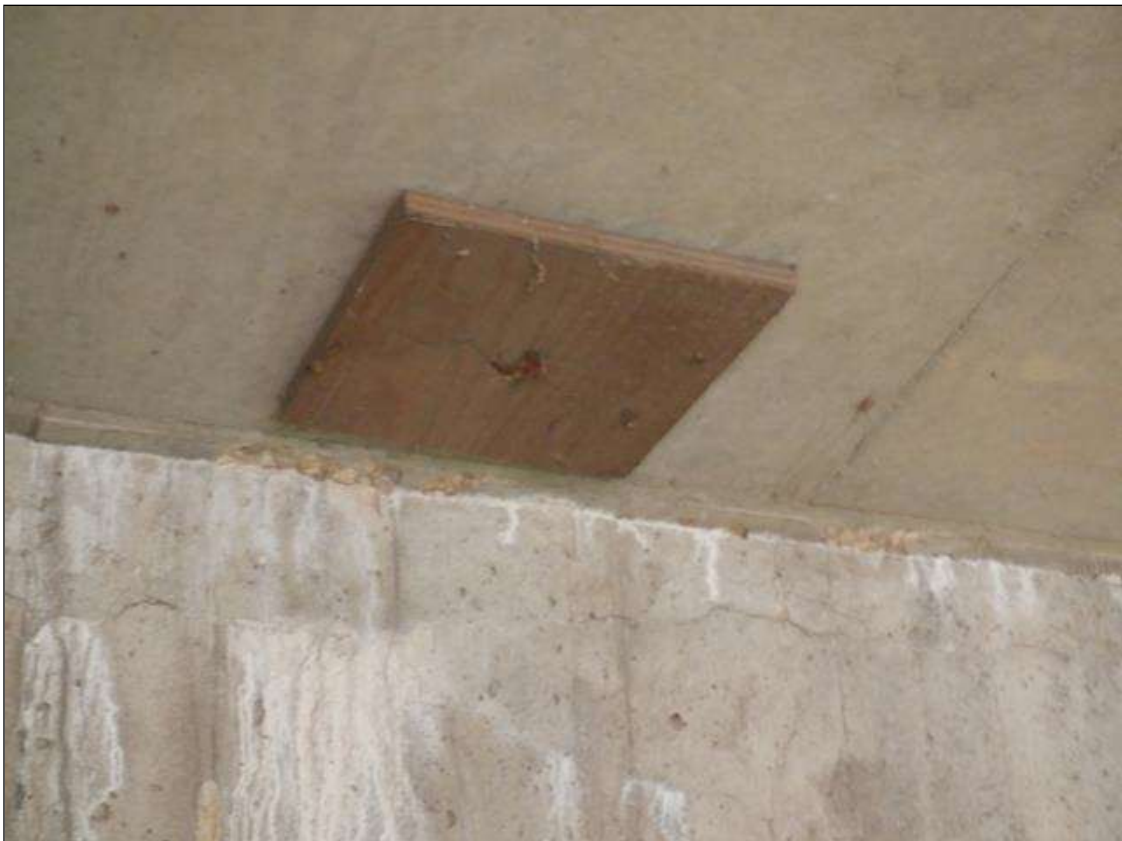
Span 4 Deck: 1 FEET X 1 FEET TIMBER PATCH IN BAY 3 AT END BENT 2.

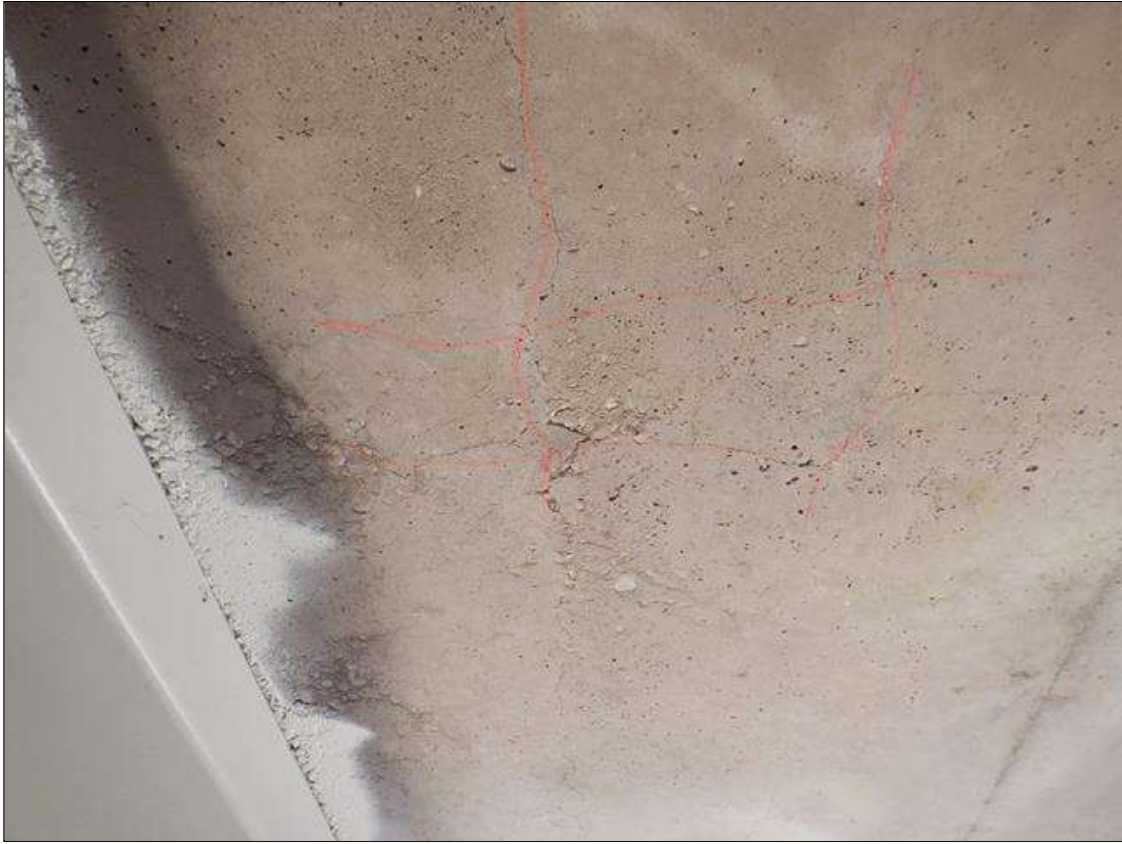
Span 4 Deck: 400 SQUARE FEET OF MAP CRACKING UP TO 1/32 INCHES AT RANDOM THROUGHOUT UNDERSIDE OF DECK

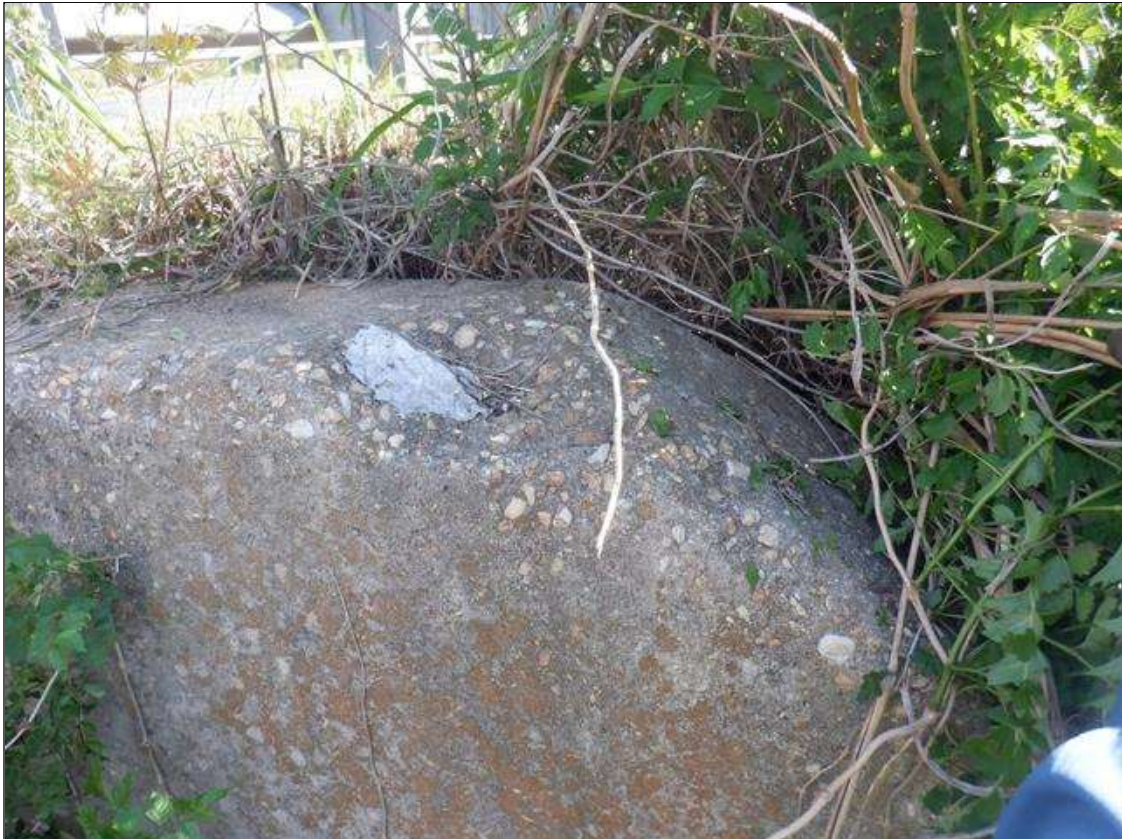
Wingwalls: 2 FEET X UP TO 1 FOOT X 2 INCHES SPALL IN TOP OF NORTHEAST WINGWALL.

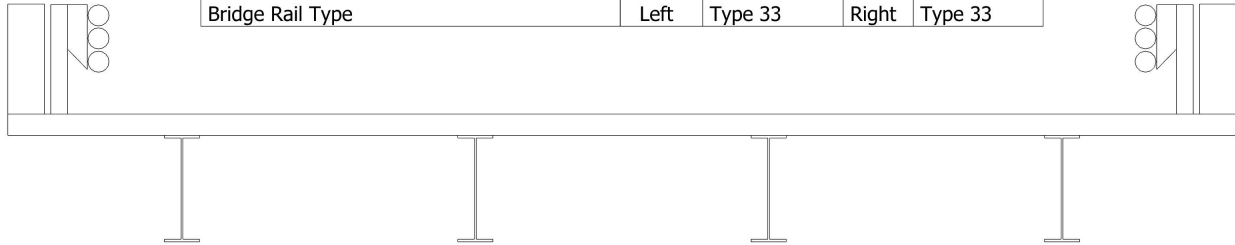
Measurements for Span #	1	Spans 2-4 Similar	
Deck Thickness	8.75in	Left Overhang	4.75ft
Top of Rail to Bottom of Beam (Avg)	6.49ft	Right Overhang	4.75ft

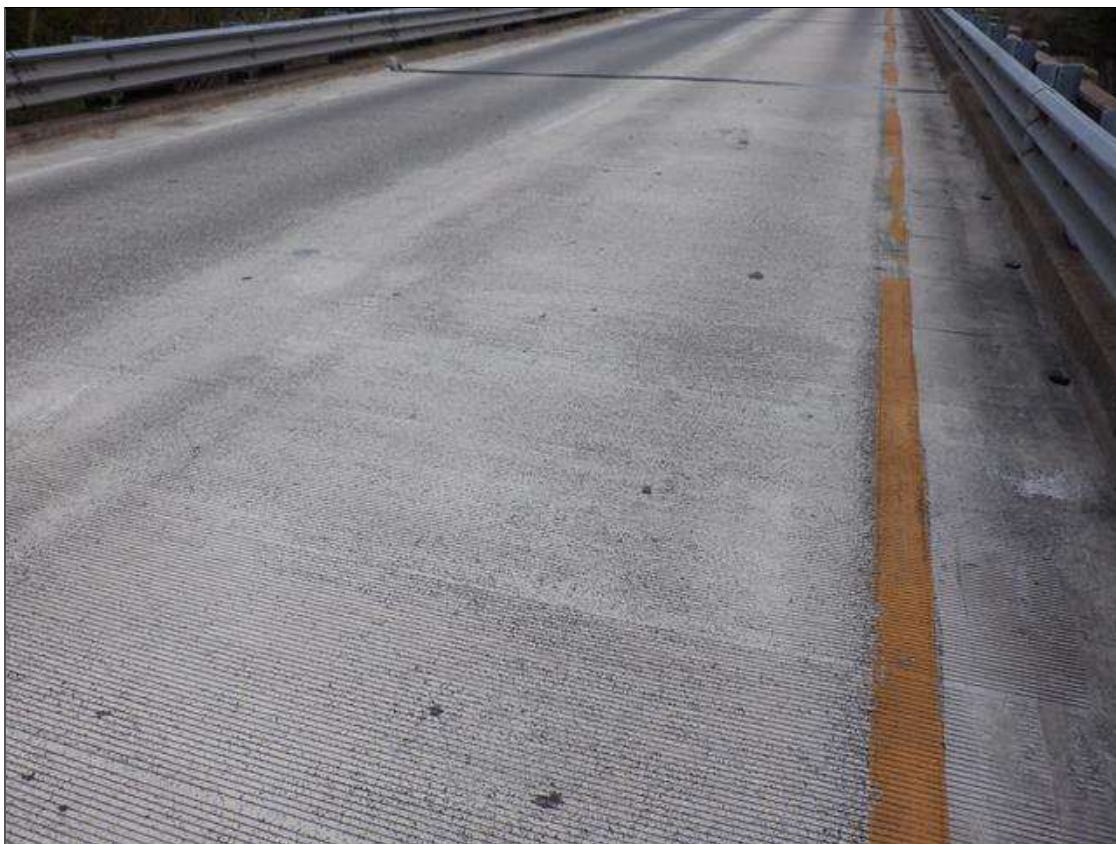
SPAN 1 CONCRETE WEARING SURFACE LOOKING NORTH

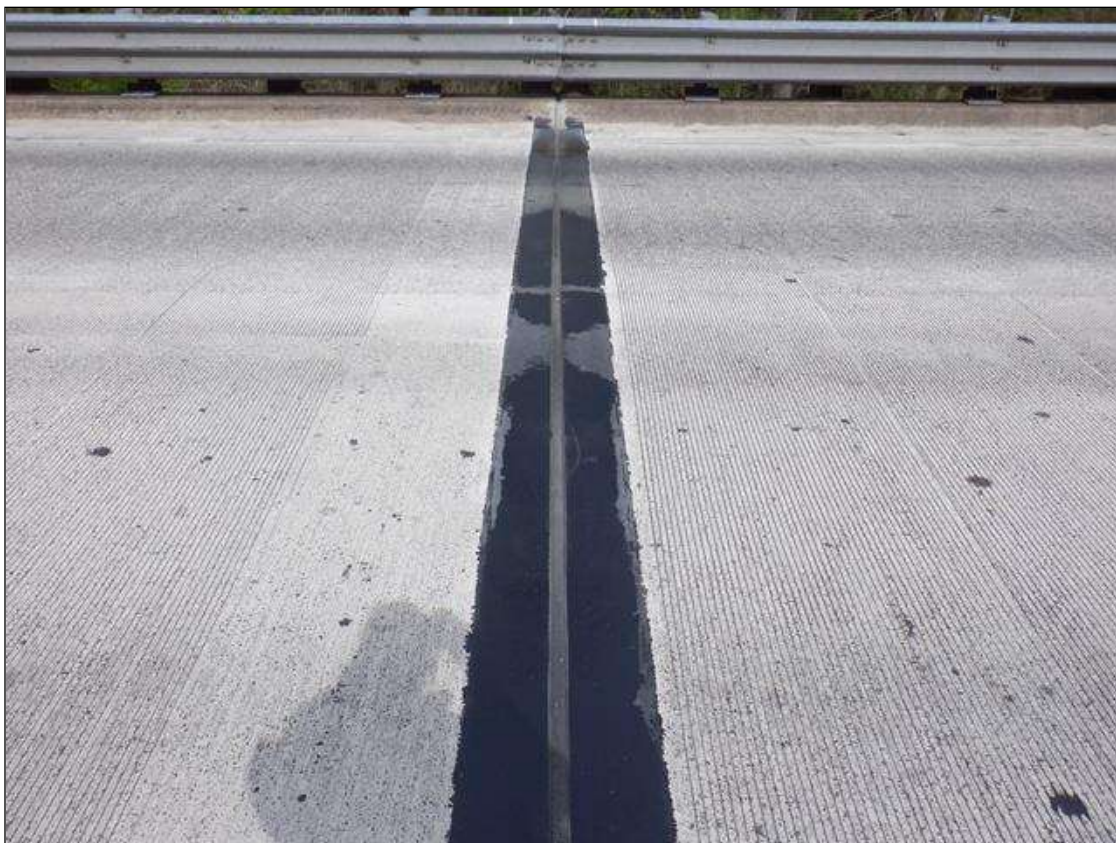
JOINT OVER BENT 1 LOOKING WEST
