NC DEPARTMENT OF TRANSPORTATION
 DIVISION OF HIGHWAYS
 STRUCTURE MANAGEMENT UNIT

ATTENTION: **prompt action request; sketches revised; span 3 clearances revised**

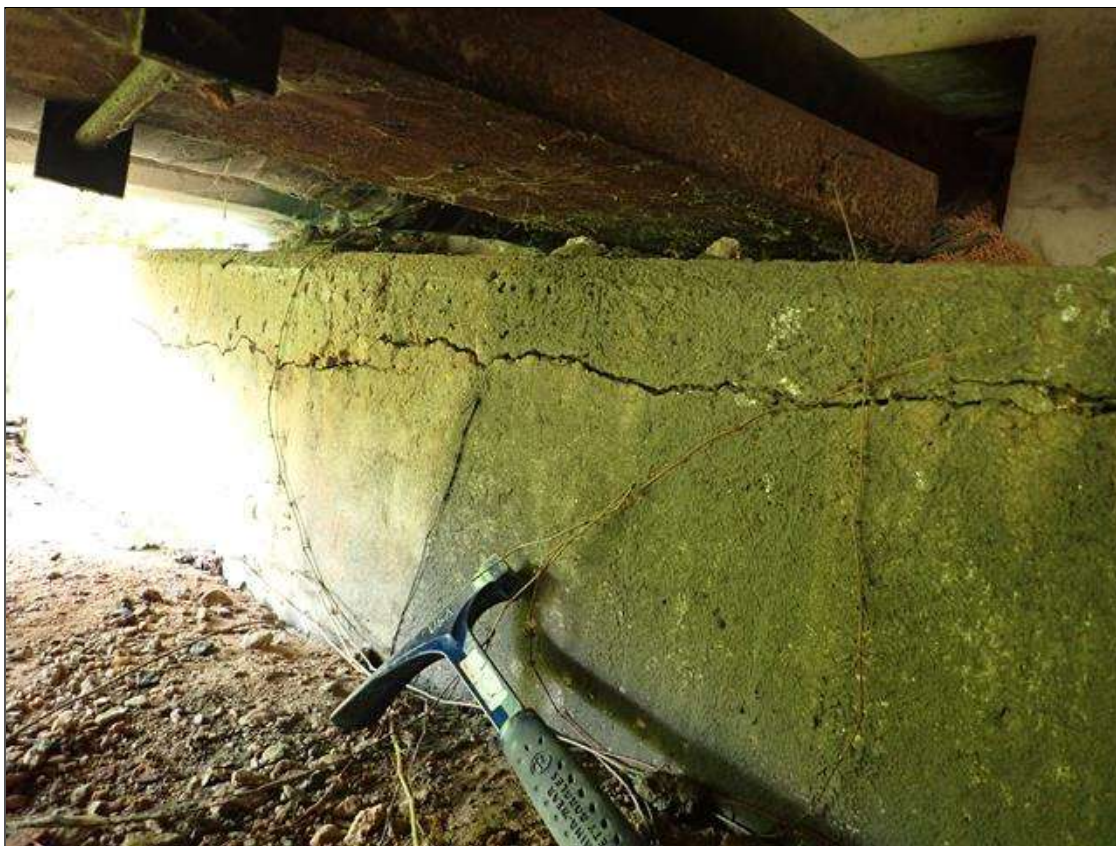
End Bent 1 Cap 1: (PAR) END BENT 1 CAP HAS A DELAMINATION 8 FOOT X 6 INCH X 6 INCH WITH CRACKS UP TO 1/4 INCH CRACKS WITH EFFLORESCENCE AND RUST STAINS VISIBLE, UNDER BAY 9.

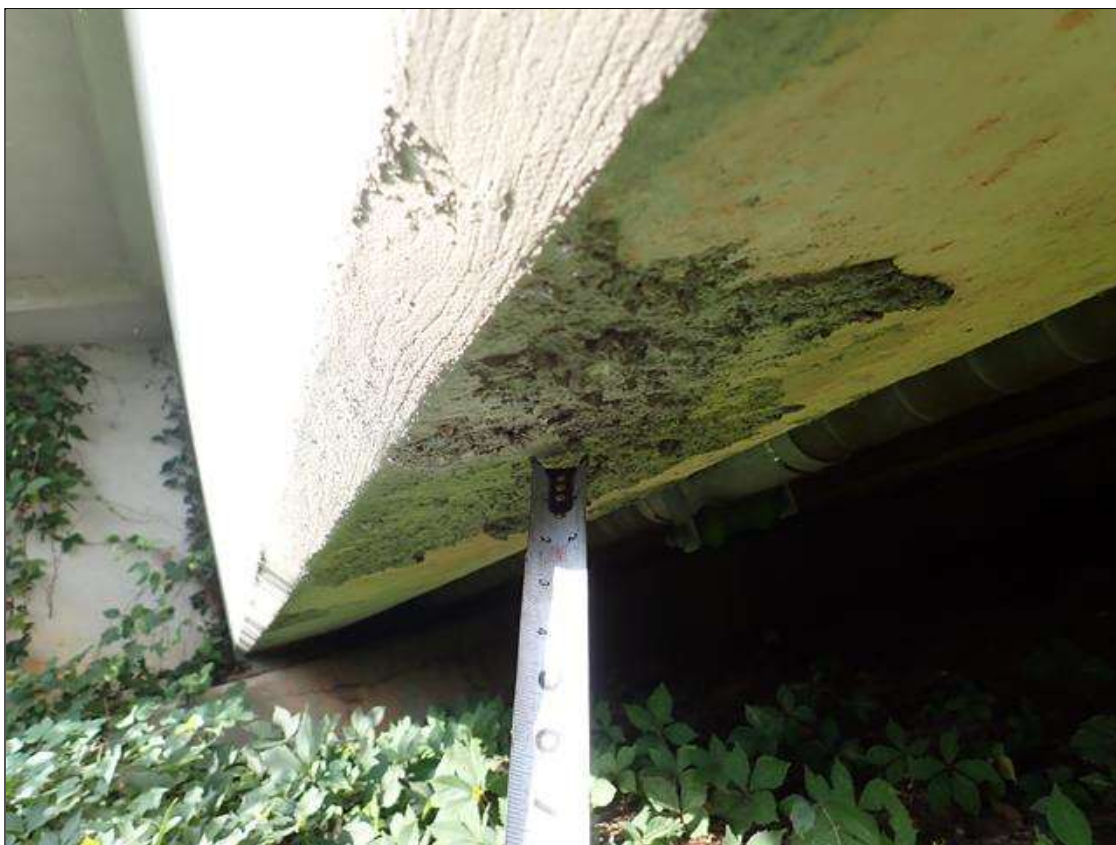
Span 1 Beam 10: 10.5 foot from end bent 1, underside, patched area (2 foot x 8 inch)

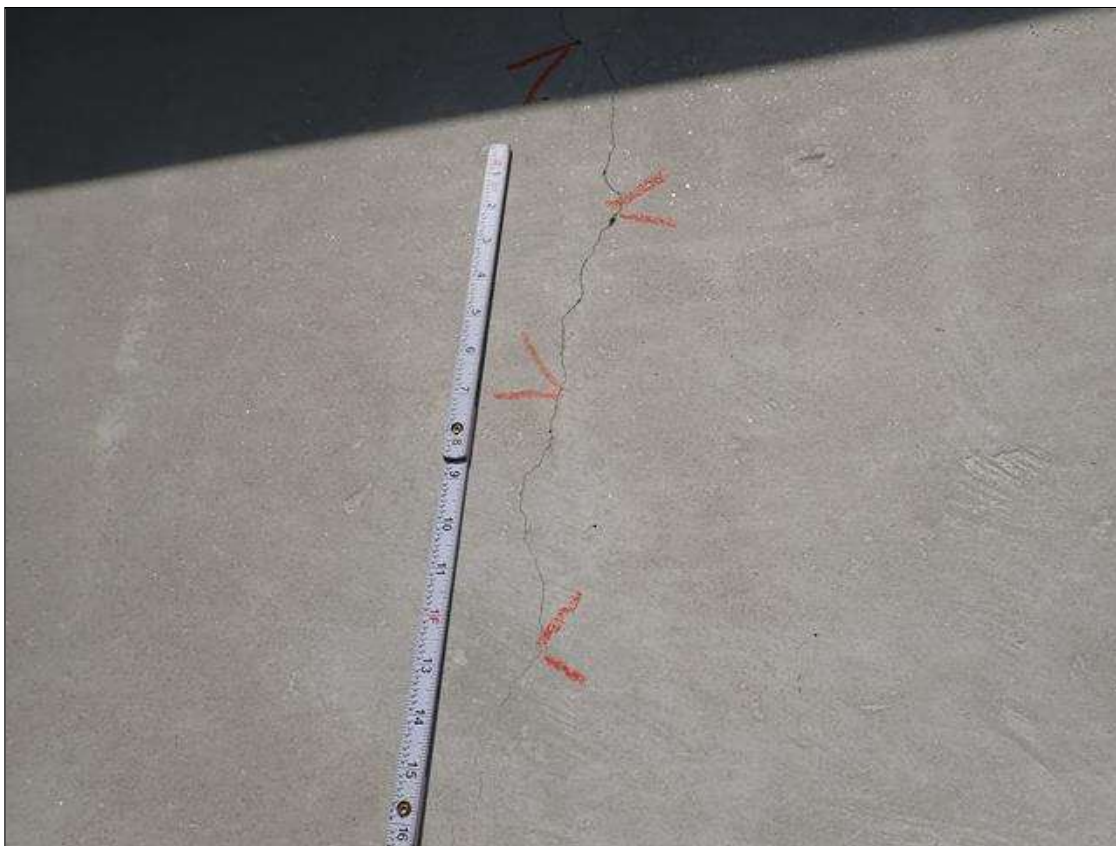
Span 1 Beam 10: along length, multiple vertical cracks [up to full height x 1/32 inch]

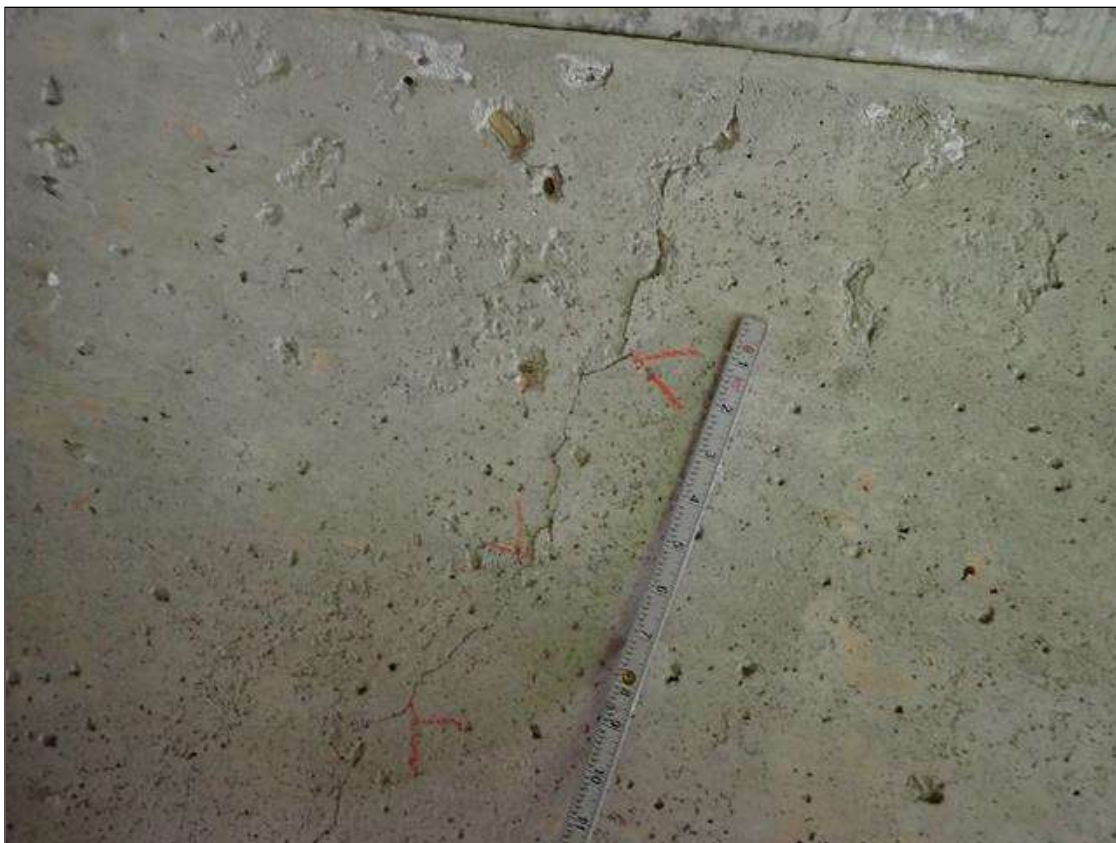
Span 1 Beam 9: along the length of the beam, vertical cracks (up to 1/32 inch x full height) at random

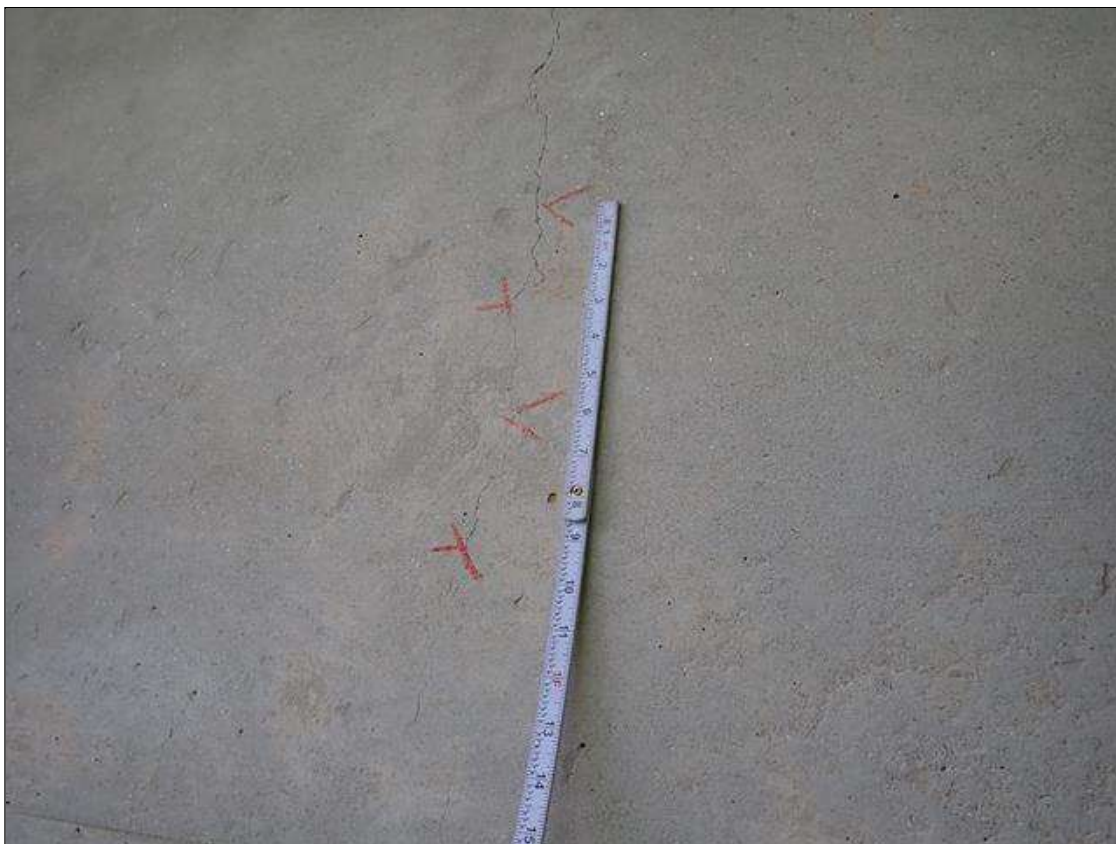
Span 1 Beam 1: along the length of the beam, vertical cracks (up to 1/32 inch x full height) at random

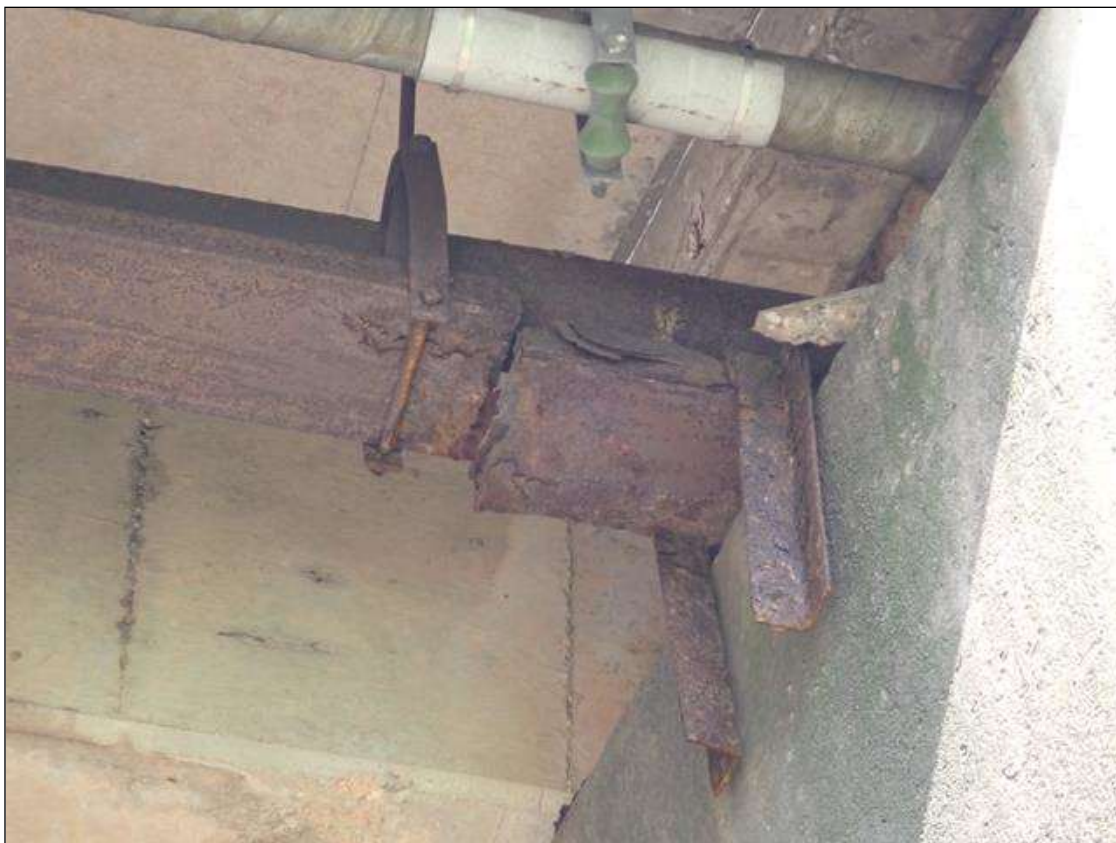
(PAR) at bent 2, bay 9 utility, metal platform, corroded and sheared

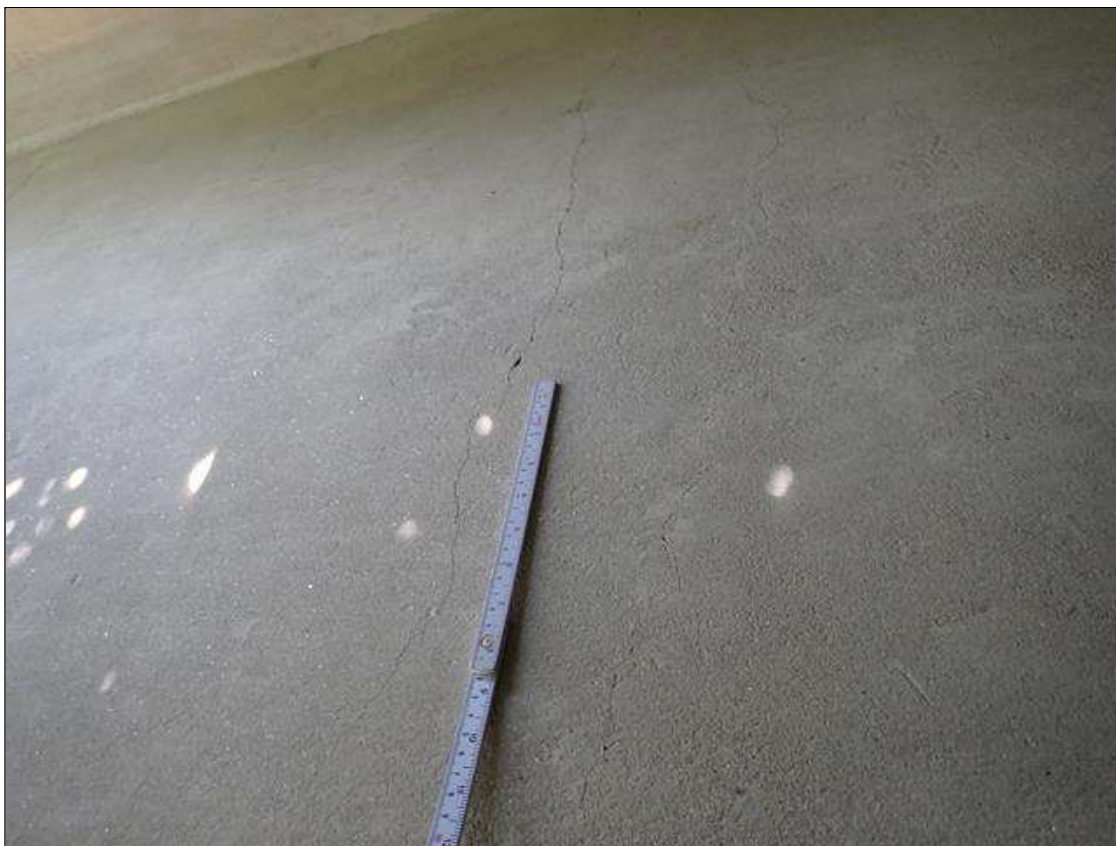
Span 4 Beam 10: along the length of the beam, vertical cracks (up to 1/32 inch x full height) at random

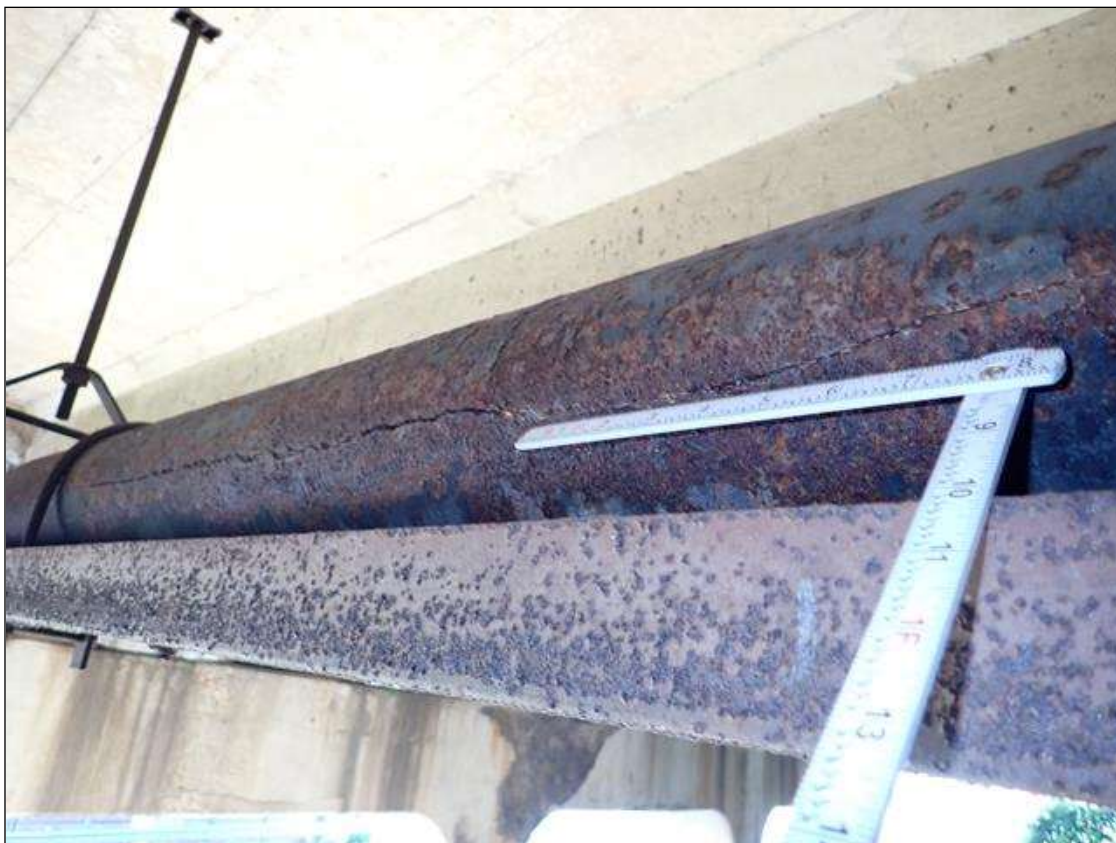
(PAR) span 4, bay 9 utility, near half, broken/cracked

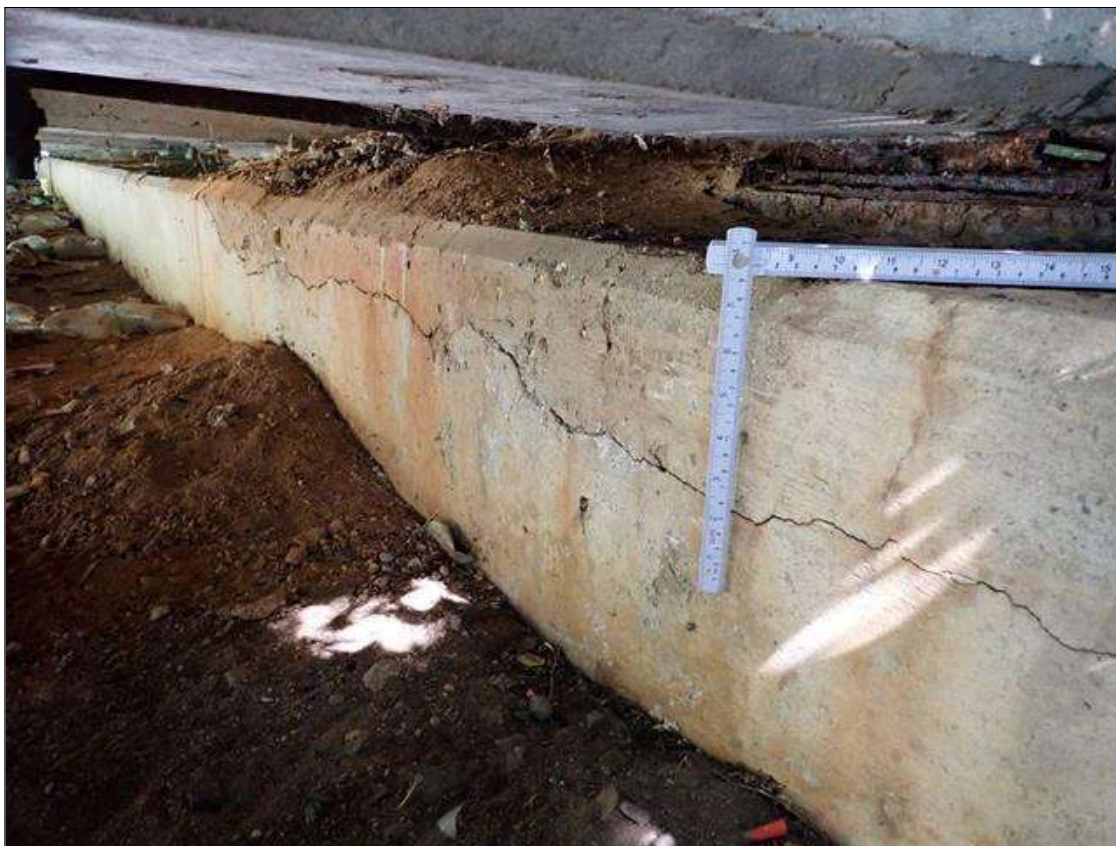
End Bent 2 Cap 1: below bay 9, delamination (8 foot x 5 inch x 5 inch) with cracks (up to 3/16 inch)

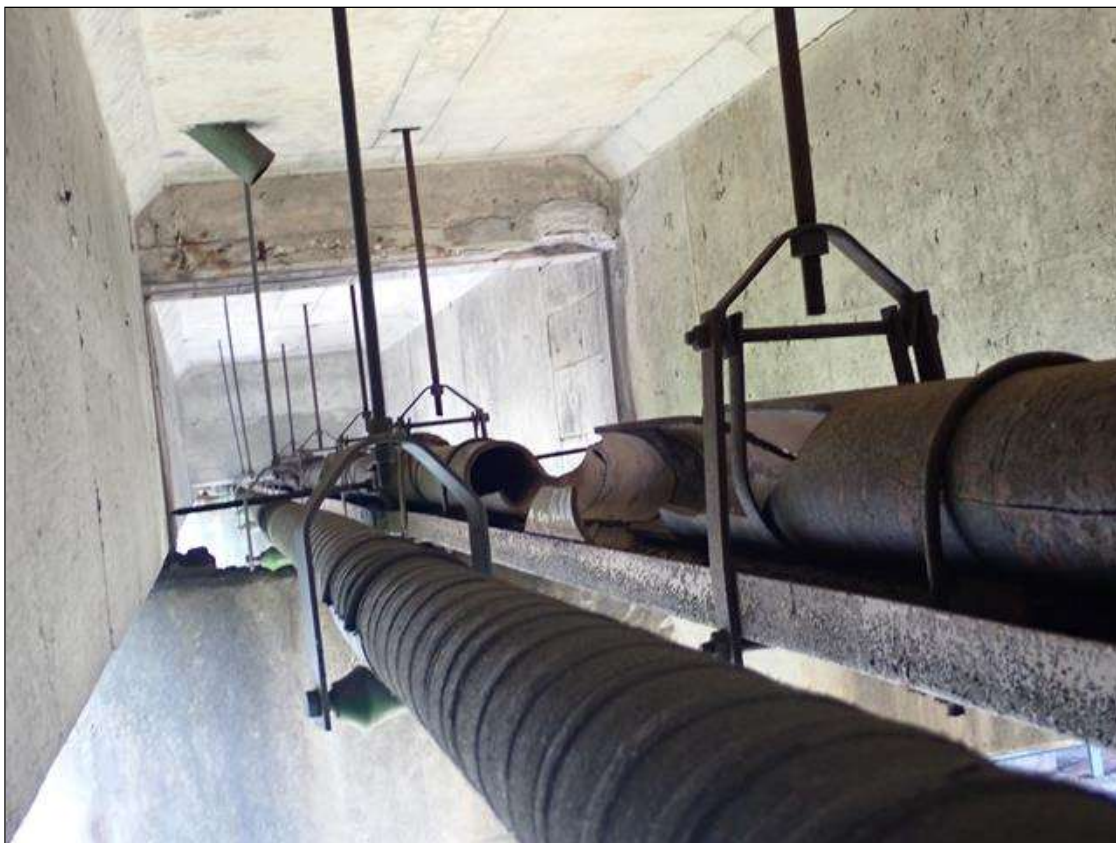
(PAR) span 4, bay 9 utility, near half, broken/cracked

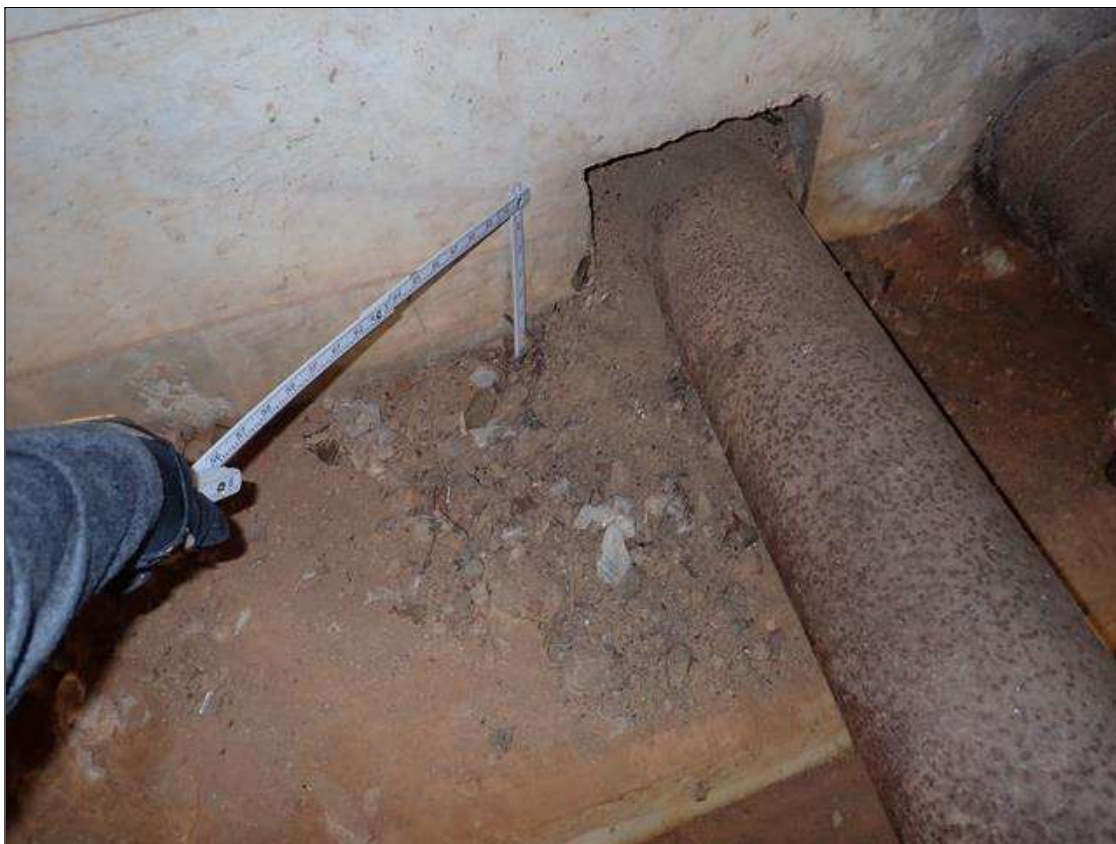
End Bent 2 Abutment: (PAR) SOIL INFILTRATION THROUGH UTILITY ACCESS HOLE, BAY 9.

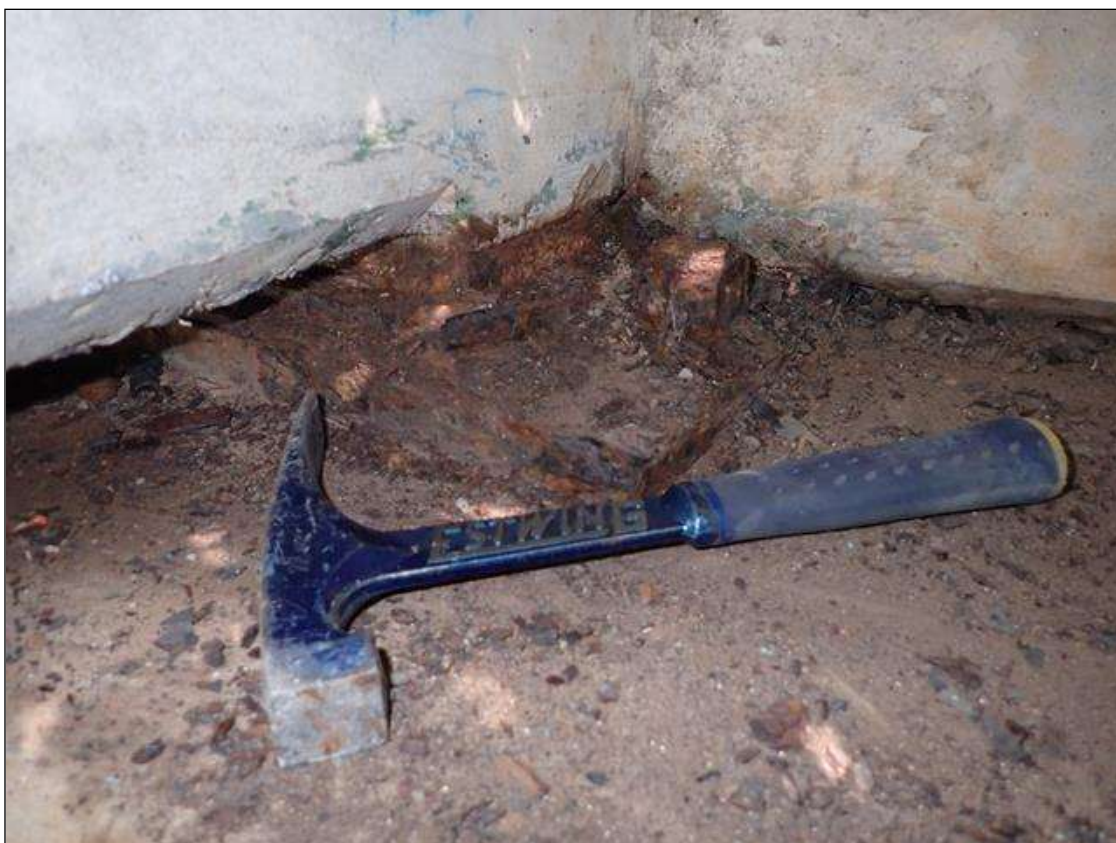
Span 4 Beam 10 - Far Bearing 10: active corrosion with section loss [up to 1/8 inch on plates]

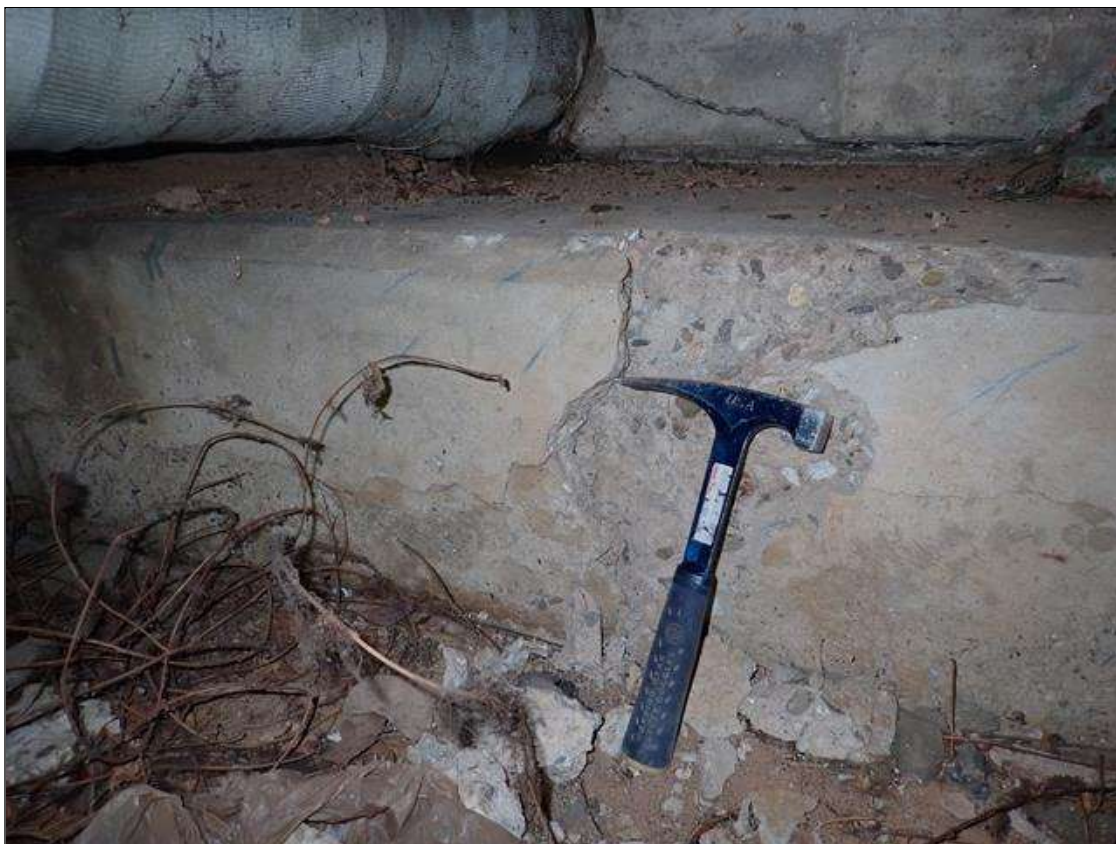
End Bent 2 Cap 1: below bay 1, spall/delamination (7 foot x 15 inch x 4 inch x 2 inch deep)

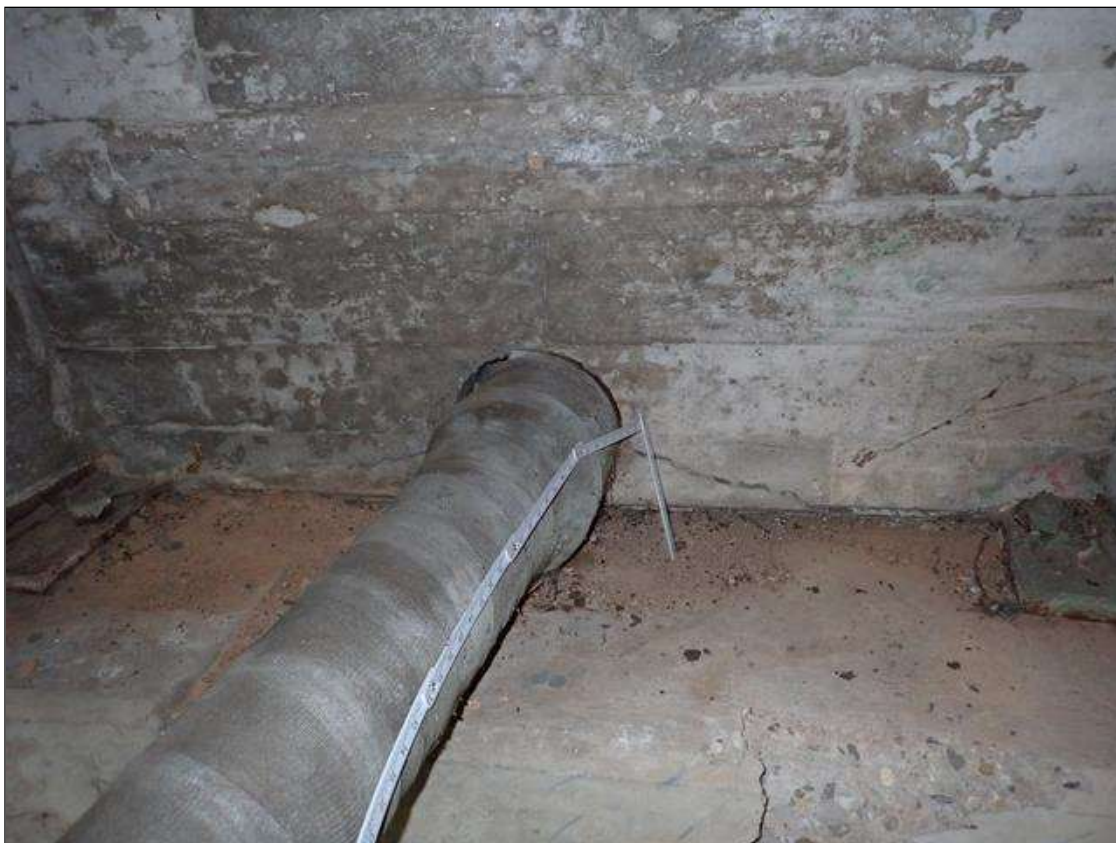
End Bent 2 Abutment: at bay 1 utility penetration, delamination (4 foot x 4 inch) with cracks (up to 1/4 inch)

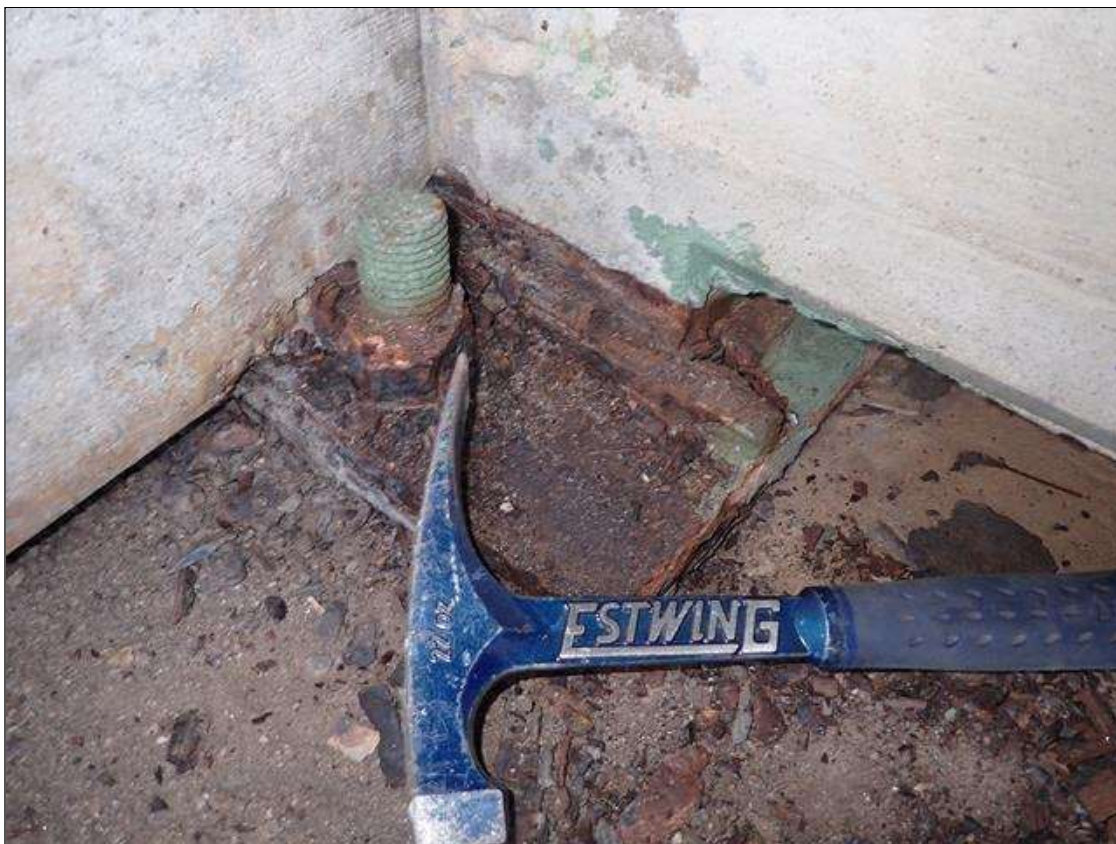
Span 4 Beam 1 - Far Bearing 1: corrosion with section loss (up to 1/8 inch loss)

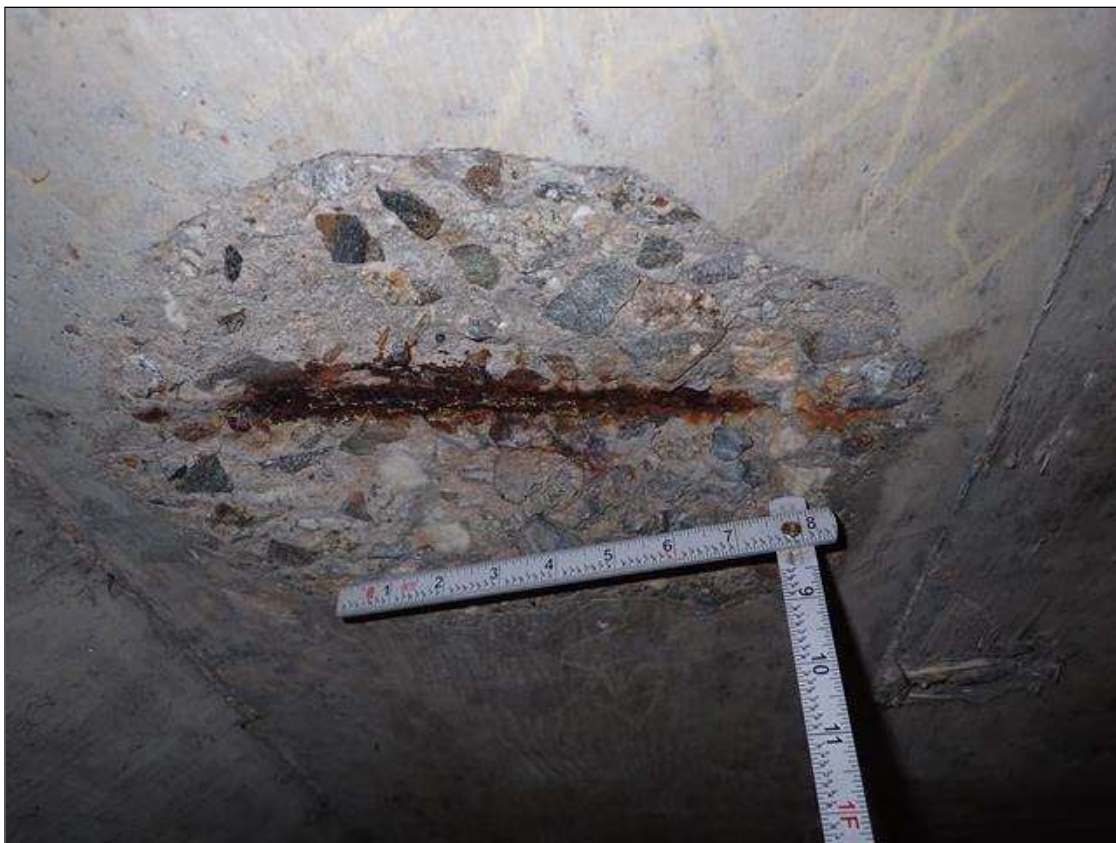
Span 4 Deck: (PAR) under bay 1 at 6 foot from end bent 2, spall [10 inch x 11 inch x up to 1 inch deep] with exposed rusted reinforcing [loss up to 1/16 inch]

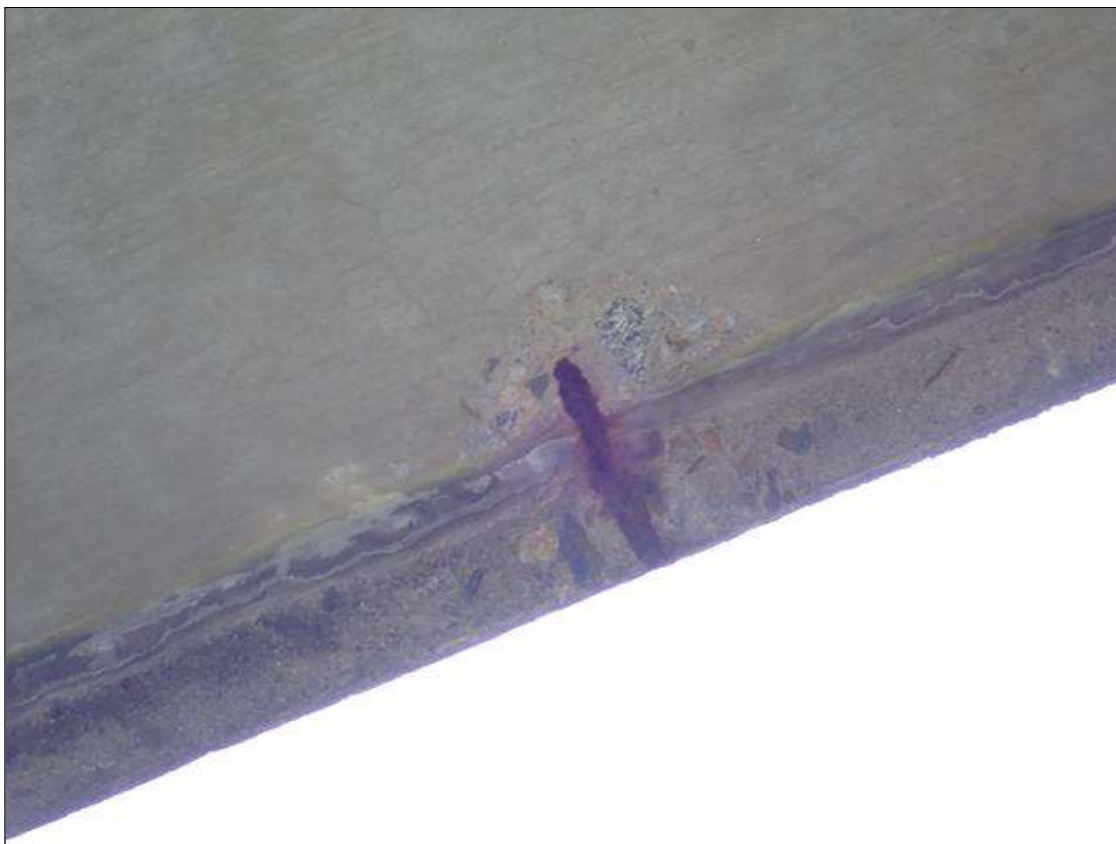
Span 4 Deck: (PAR) along underside left overhang, three [3] spalls [up to 6 inch diameter x 1/2 inch deep] with exposed rusted reinforcing [no loss noted]

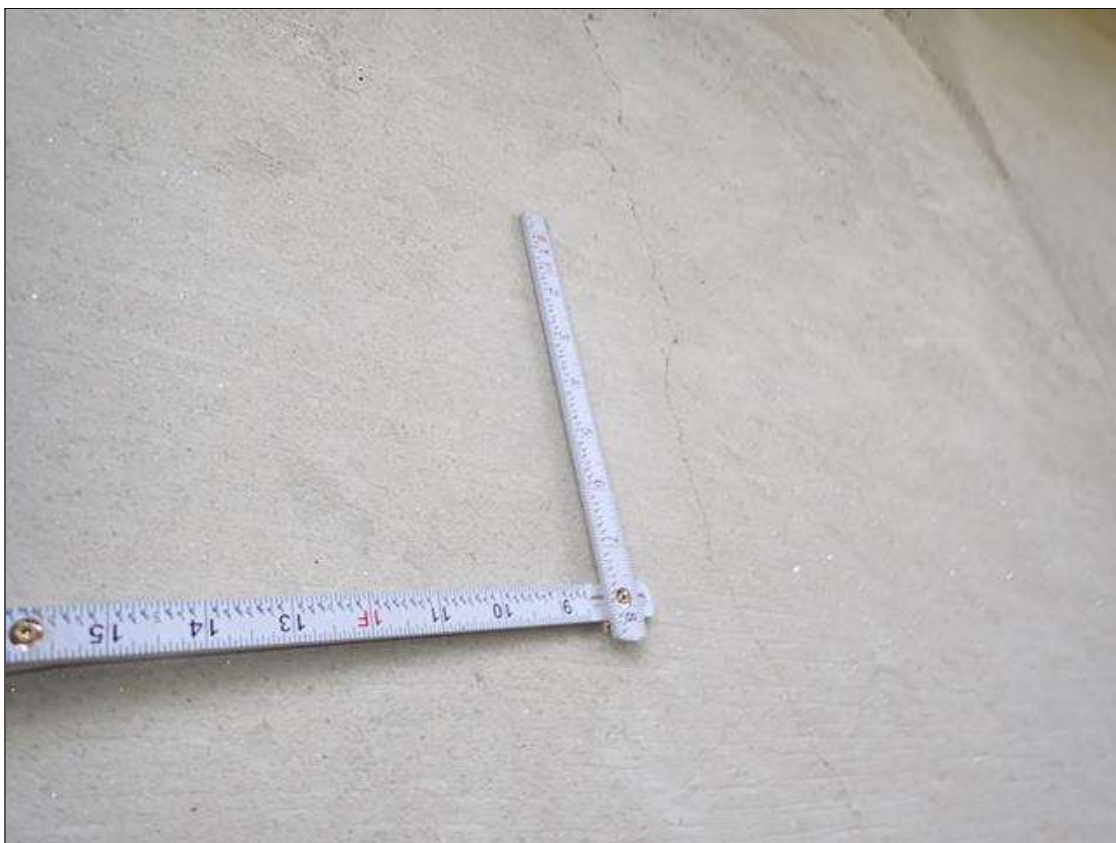
Span 4 Beam 1: along the length of the beam, vertical cracks (up to 1/32 inch x full height) at random

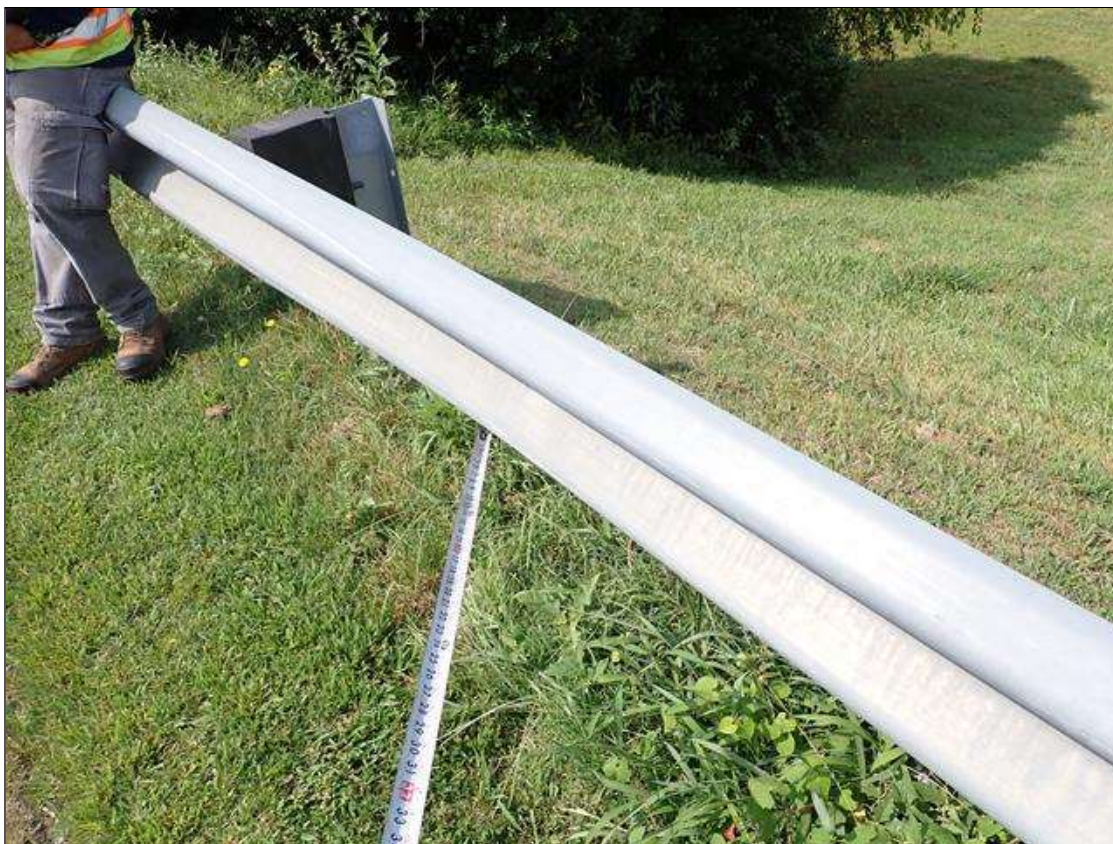
(PAR) northwest guardrail near termination, (2) areas of impact damage (up to 10 foot); 18 foot total

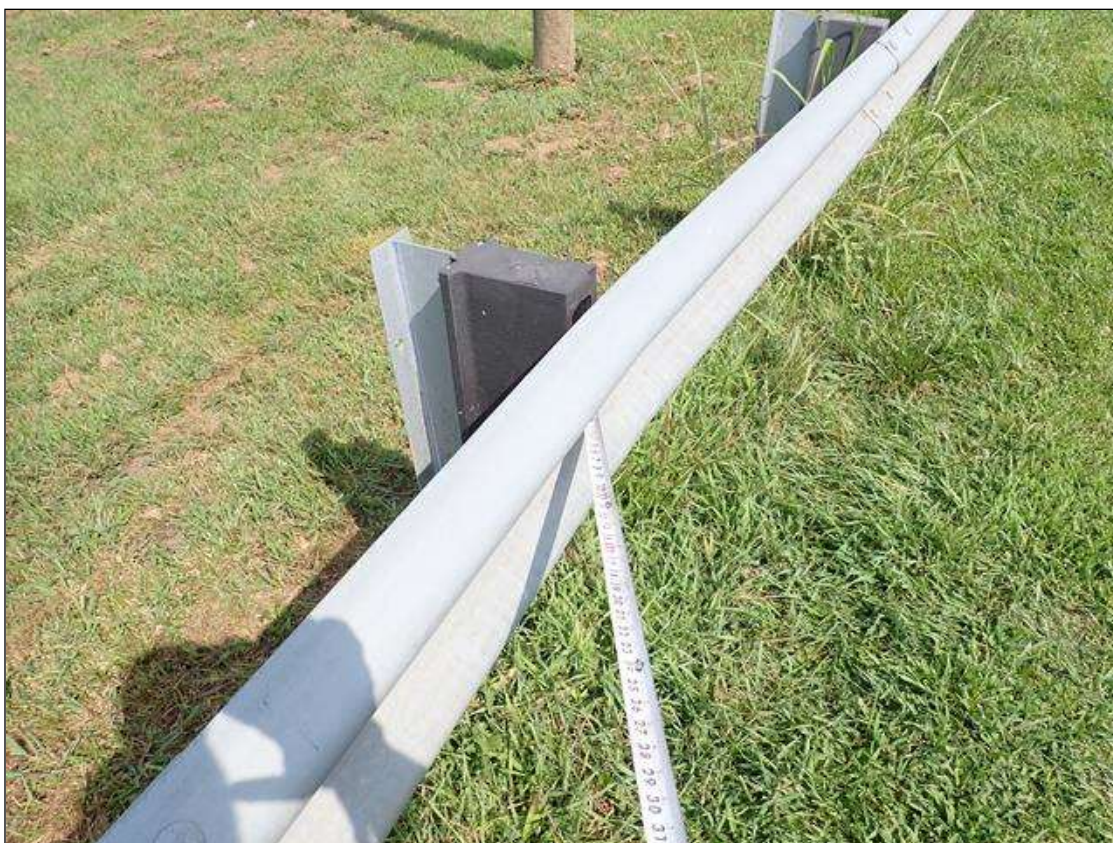
(PAR) northwest guardrail near termination, (2) areas of impact damage (up to 10 foot); 18 foot total

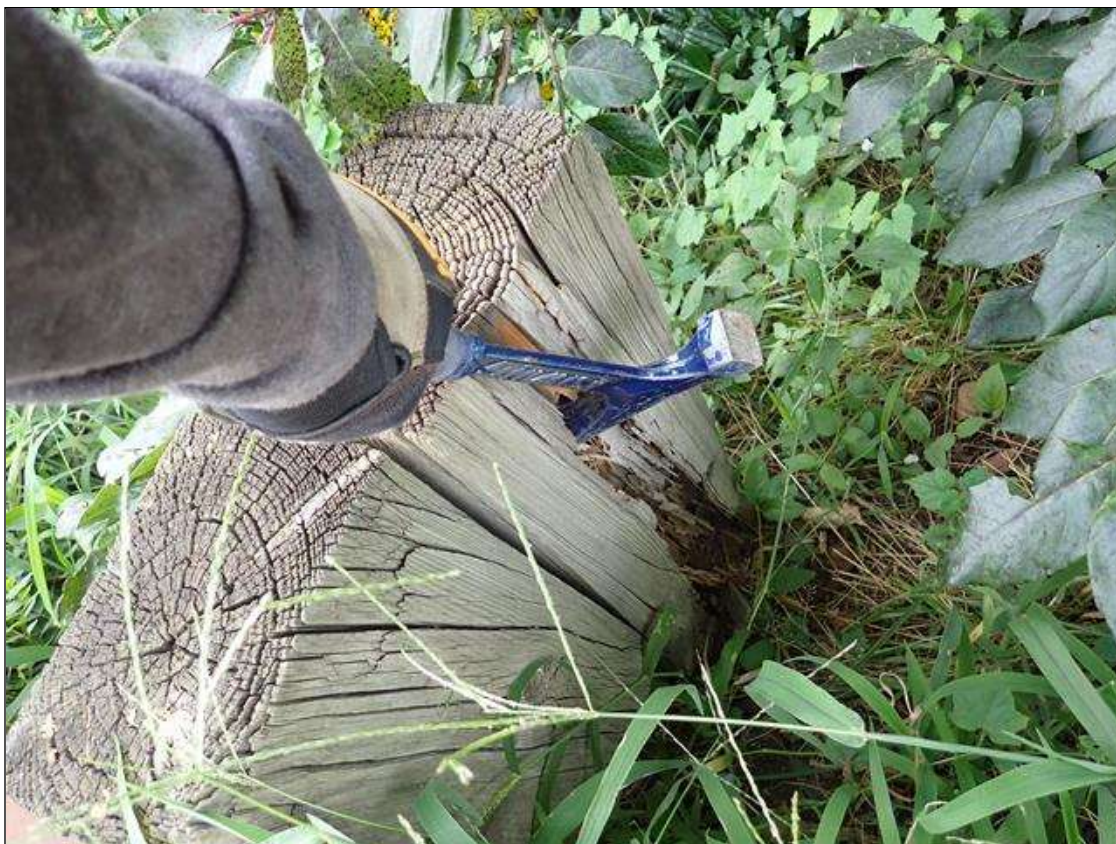
(PAR) southeast guardrail, timber posts 7, 12 and 14, decay/section loss (up to full width x full height x full depth)

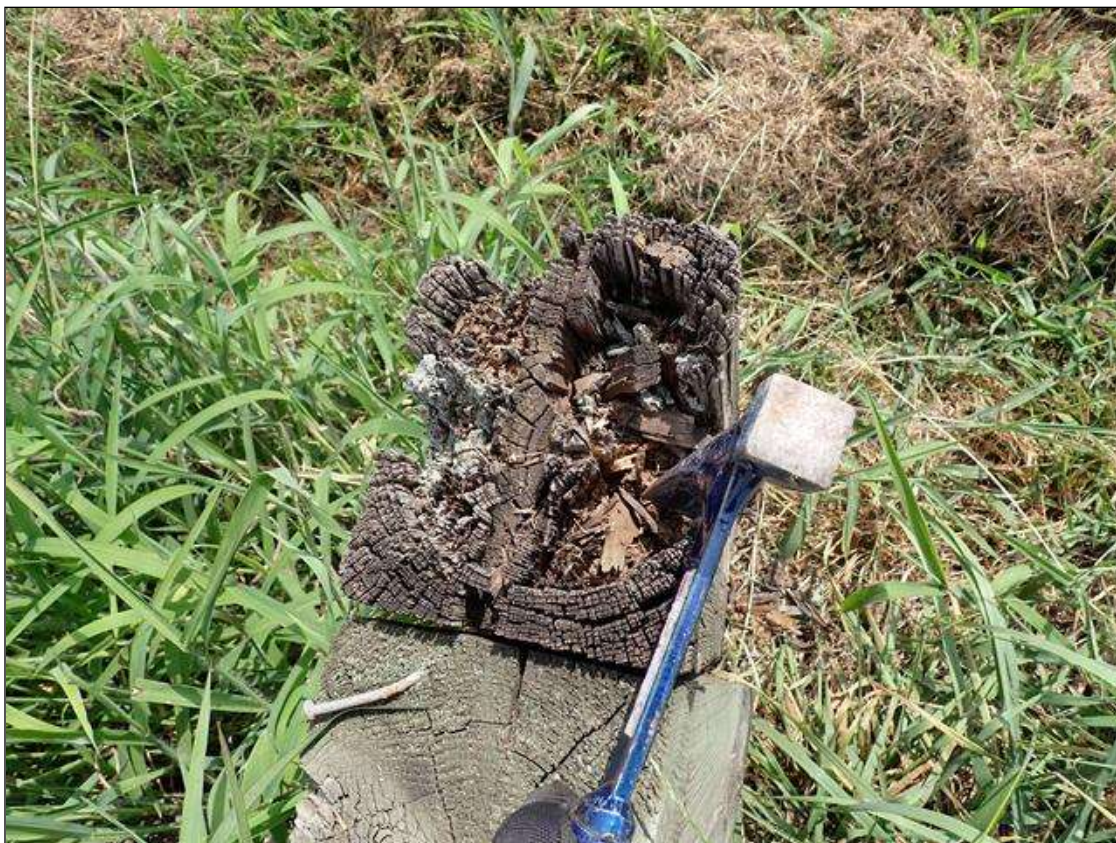
(PAR) southeast guardrail, timber posts 7, 12 and 14, decay/section loss (up to full width x full height x full depth)

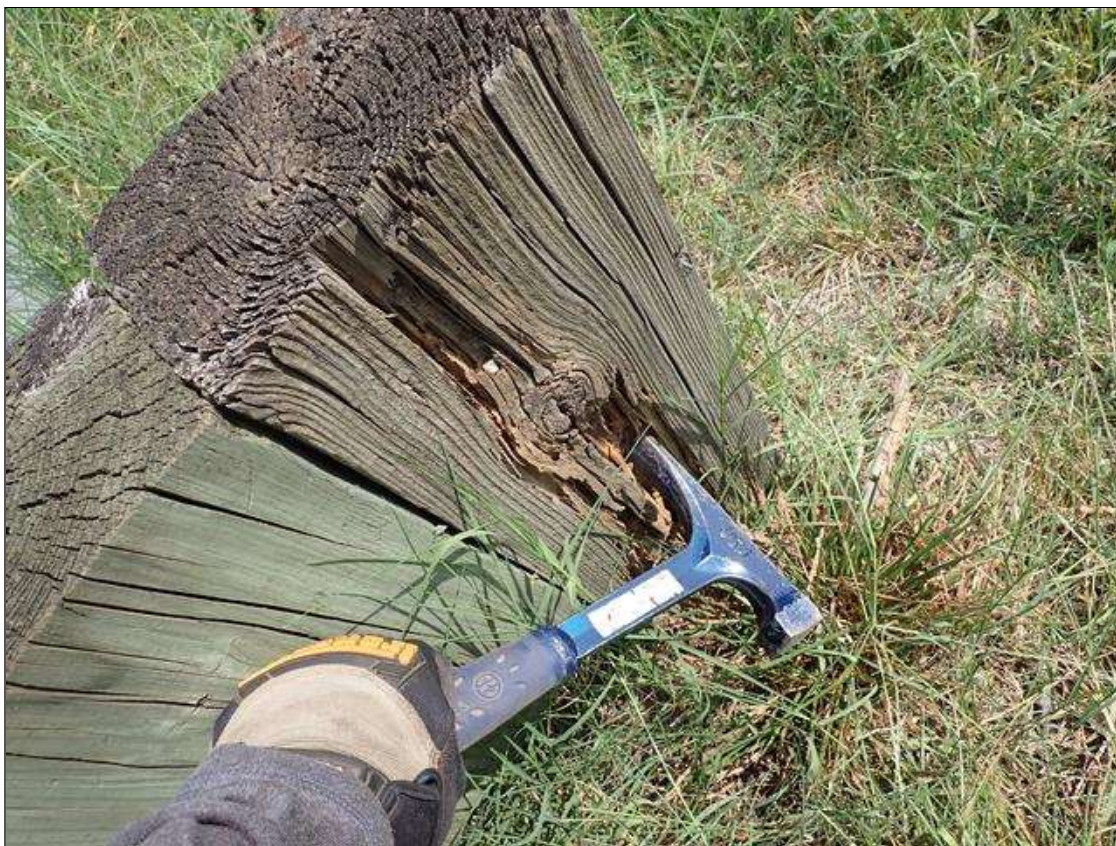
(PAR) southeast guardrail, timber posts 7, 12 and 14, decay/section loss (up to full width x full height x full depth)

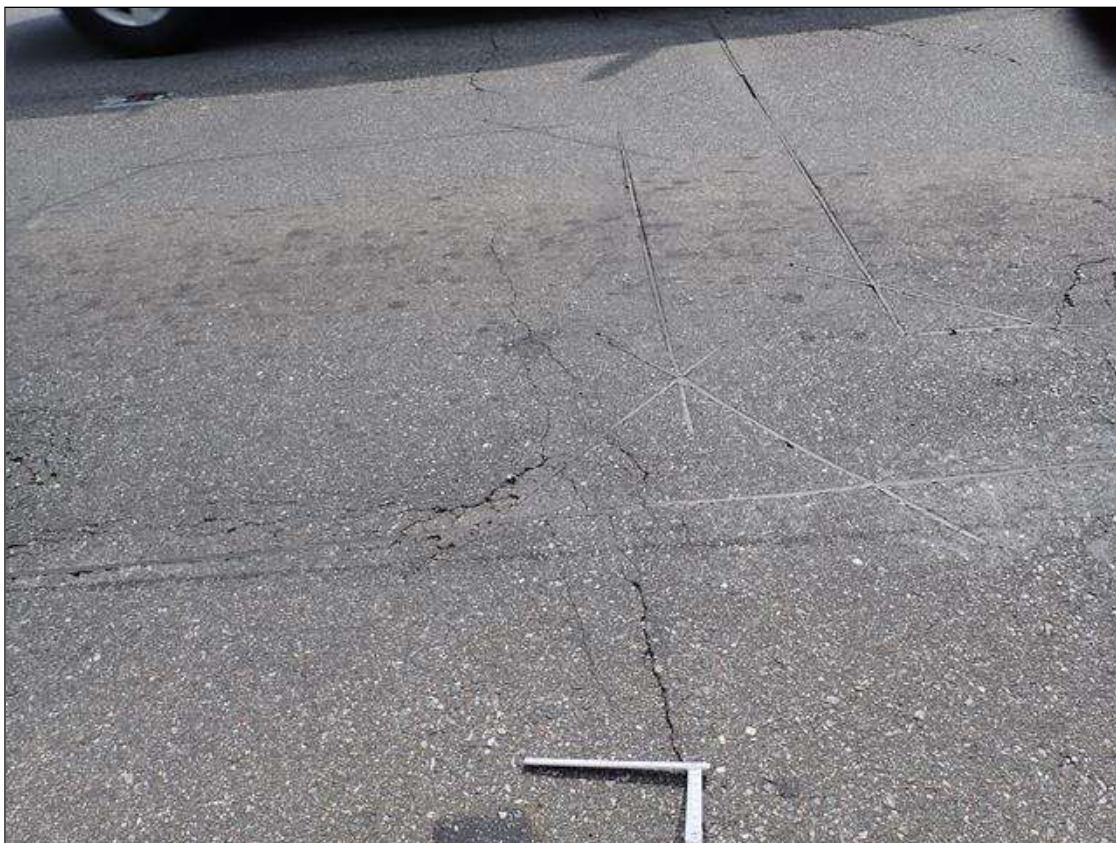
Span 1 Wearing Surface: FULL ROADWAY WIDTH X UP TO 1/8 INCH TRANSVERSE CRACK, OVER END BENT 1.
