NC DEPARTMENT OF TRANSPORTATION
 DIVISION OF HIGHWAYS
 STRUCTURE MANAGEMENT UNIT

ATTENTION: **prompt action request; sketches revised; span 3 clearances revised**

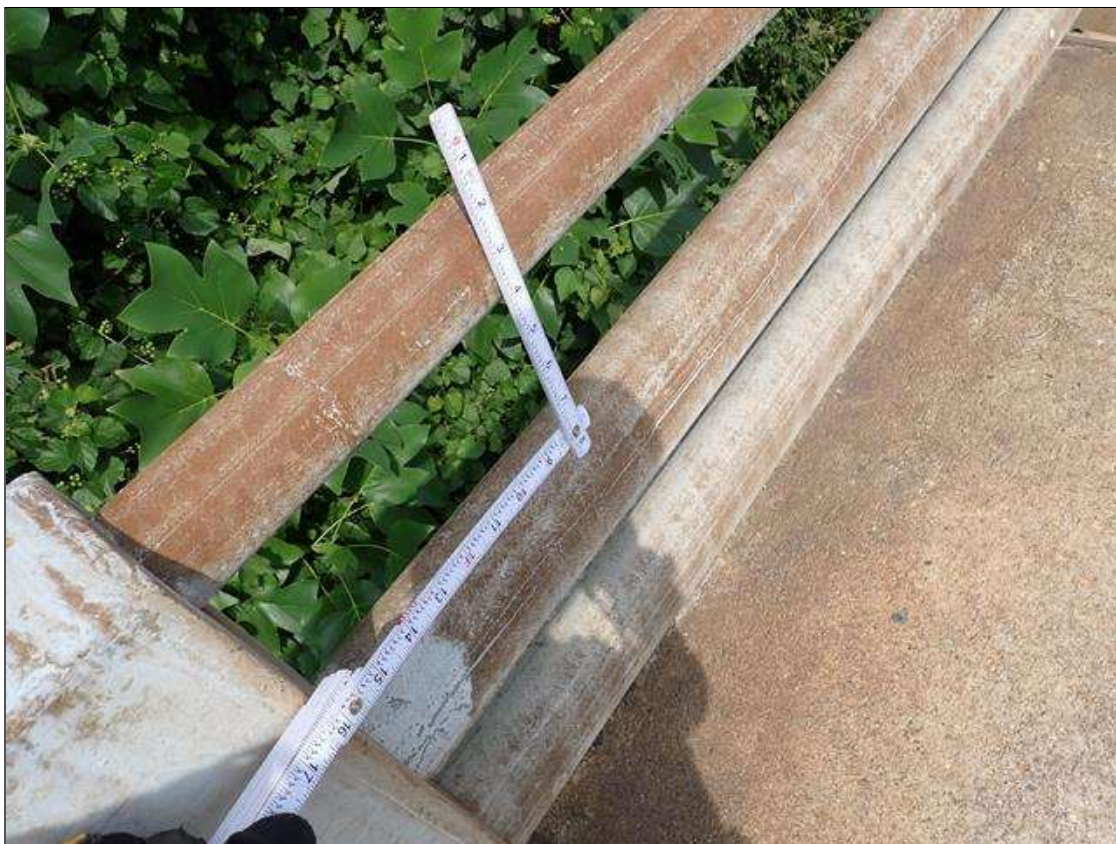
Span 1 Left Bridge Rail: surface rust at random

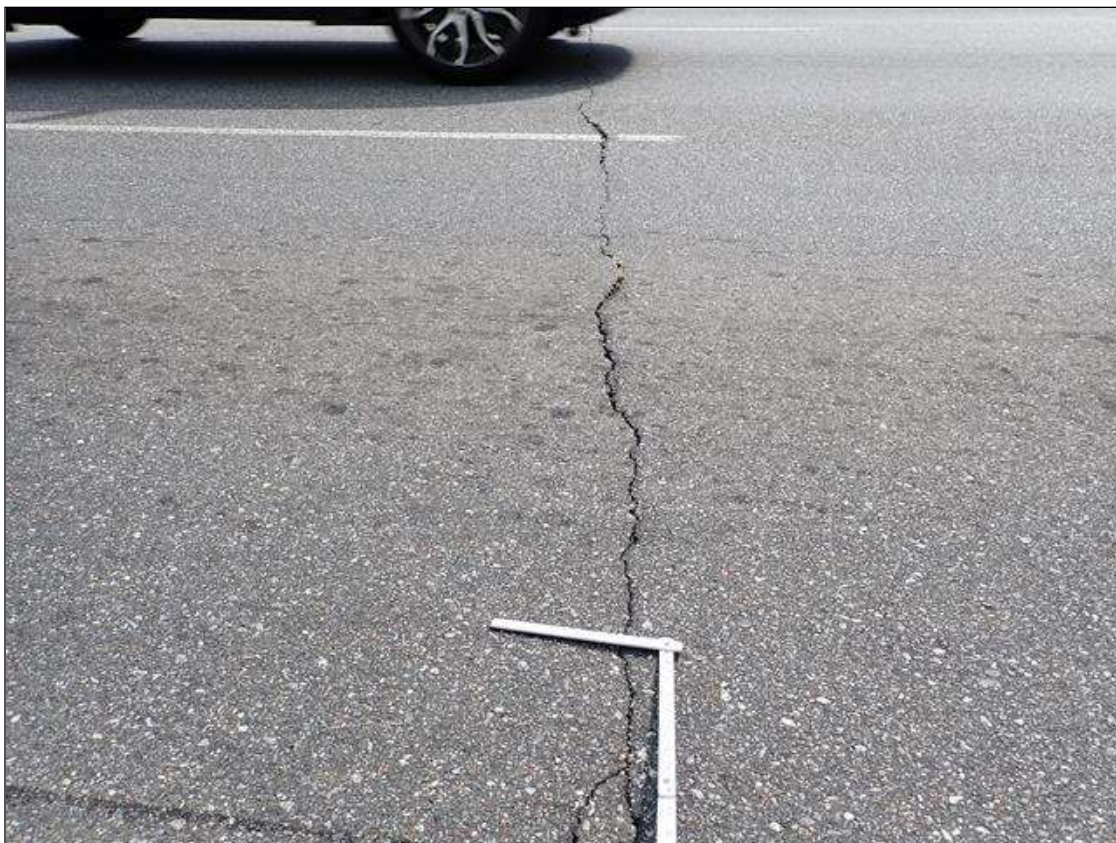
Span 2 Wearing Surface: 58 FOOT X UP TO 1/4 INCH TRANSVERSE CRACK, OVER BENT 1.

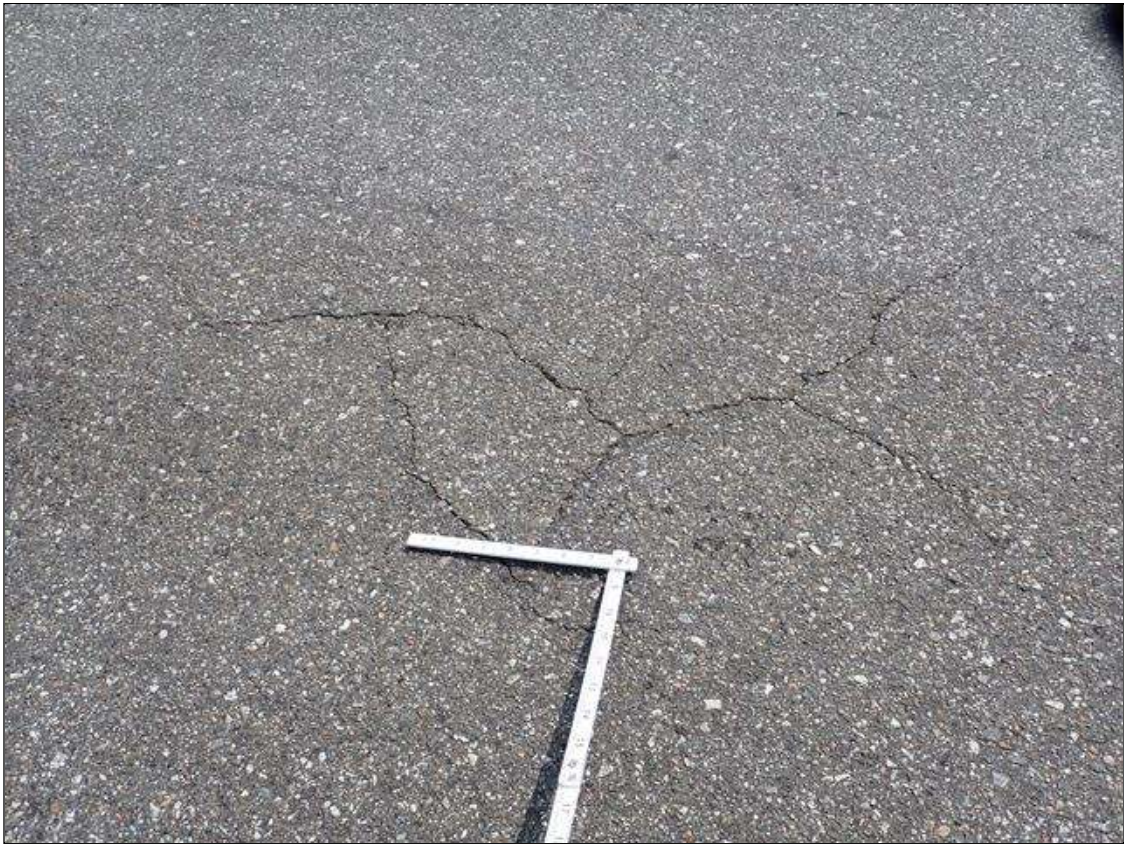
Span 2 Wearing Surface: throughout asphalt wearing surface, map cracks (up to 1/32 inch) at random

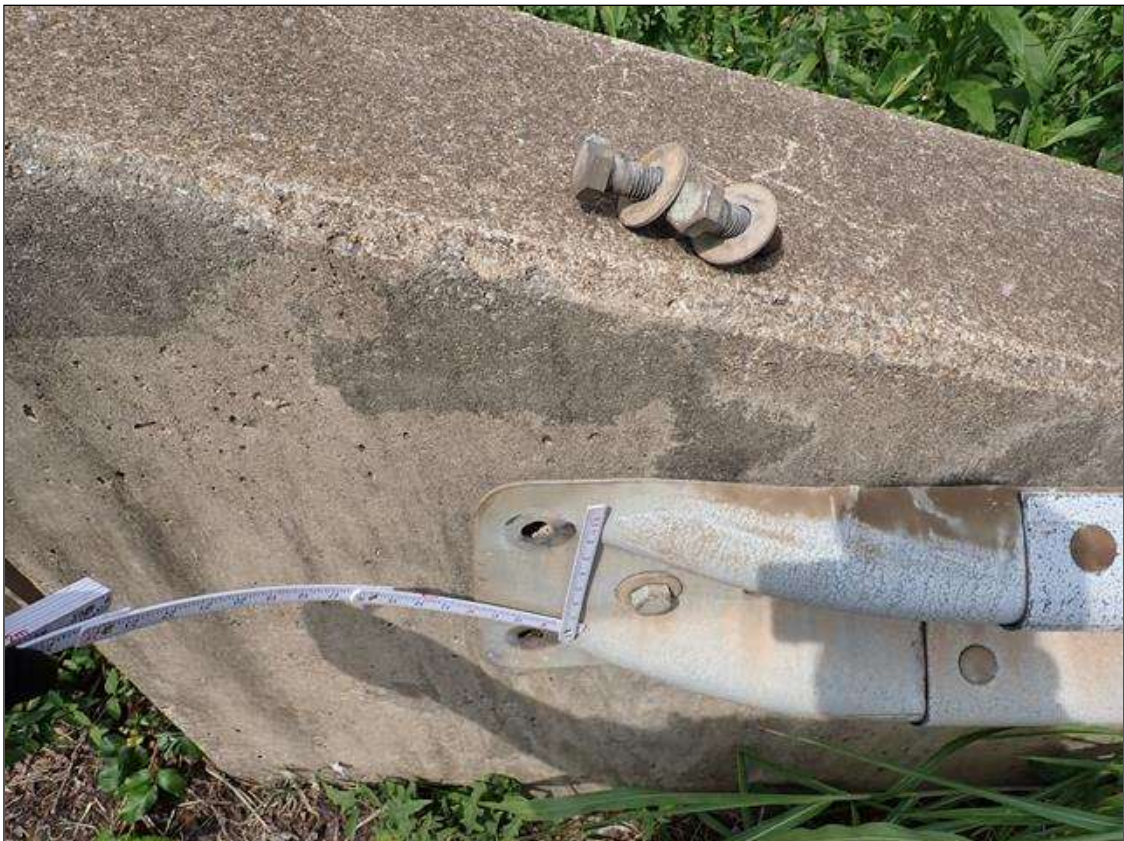
(PAR) northwest guardrail attachment, (2) missing/detached bolts

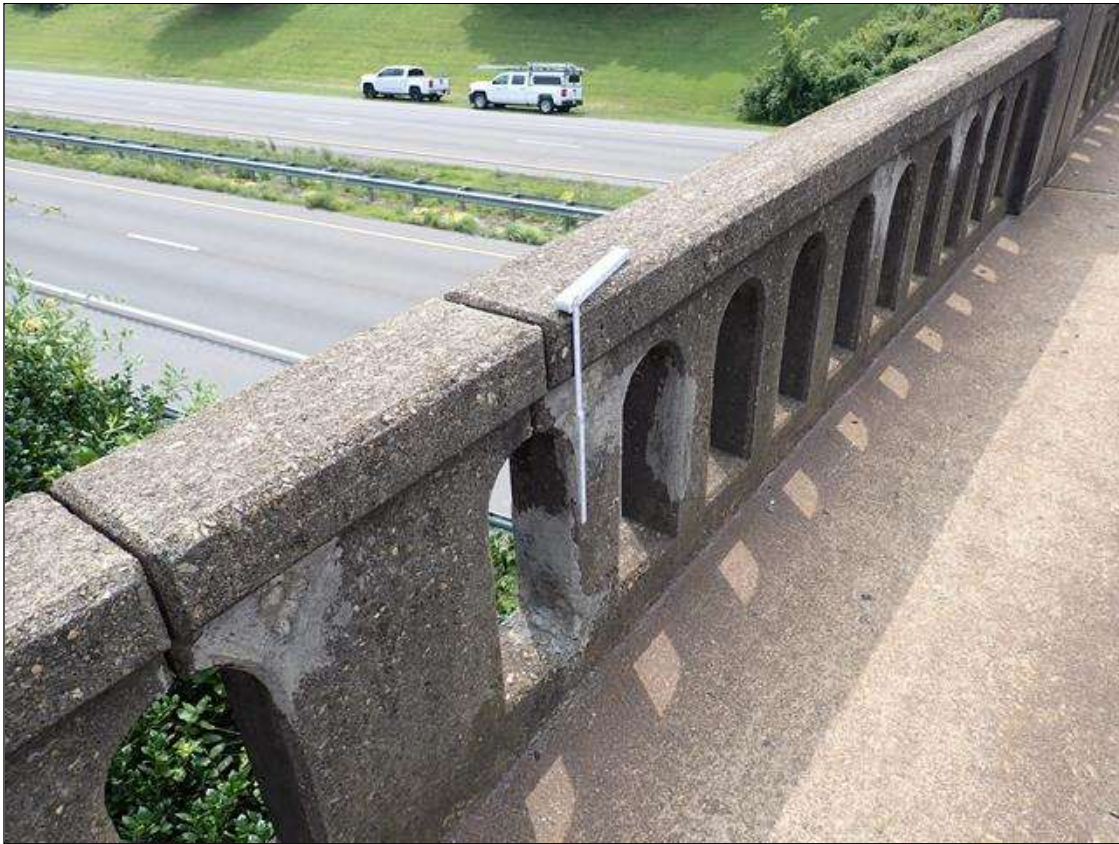
Span 4 Right Bridge Rail: SPAN 4 RIGHT RAIL HAS (7) PATCHED AREAS (UP TO 1 FOOT X 8 INCH) WITH HAIRLINE CRACKS.

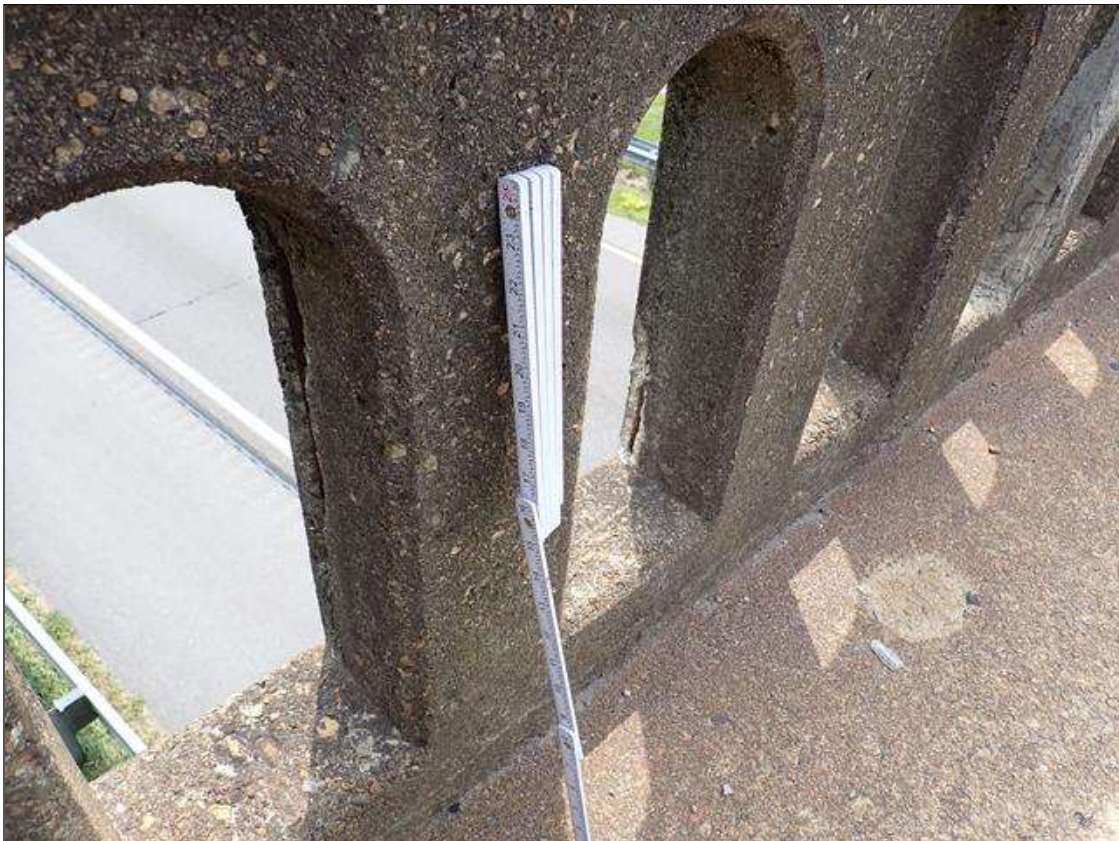
Span 3 Right Bridge Rail: at 6 foot from bent 3, two [2] spalls [up to 18 inch x 2 inch x 3/4 inch deep], both with exposed rusted reinforcing [no loss noted]

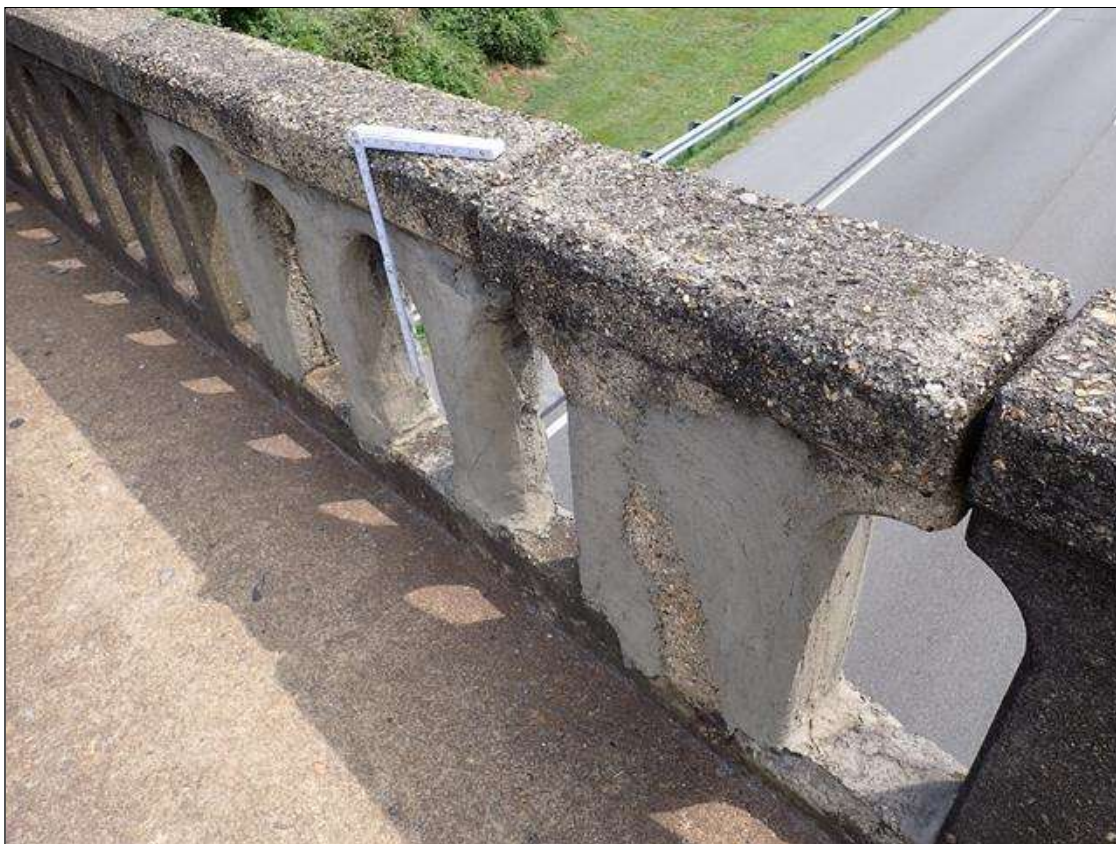
Span 3 Right Bridge Rail: SPAN 3 RIGHT RAIL HAS MULTIPLE PATCHED AREAS (2 FOOT X 7 INCH) WITH HAIRLINE CRACKS

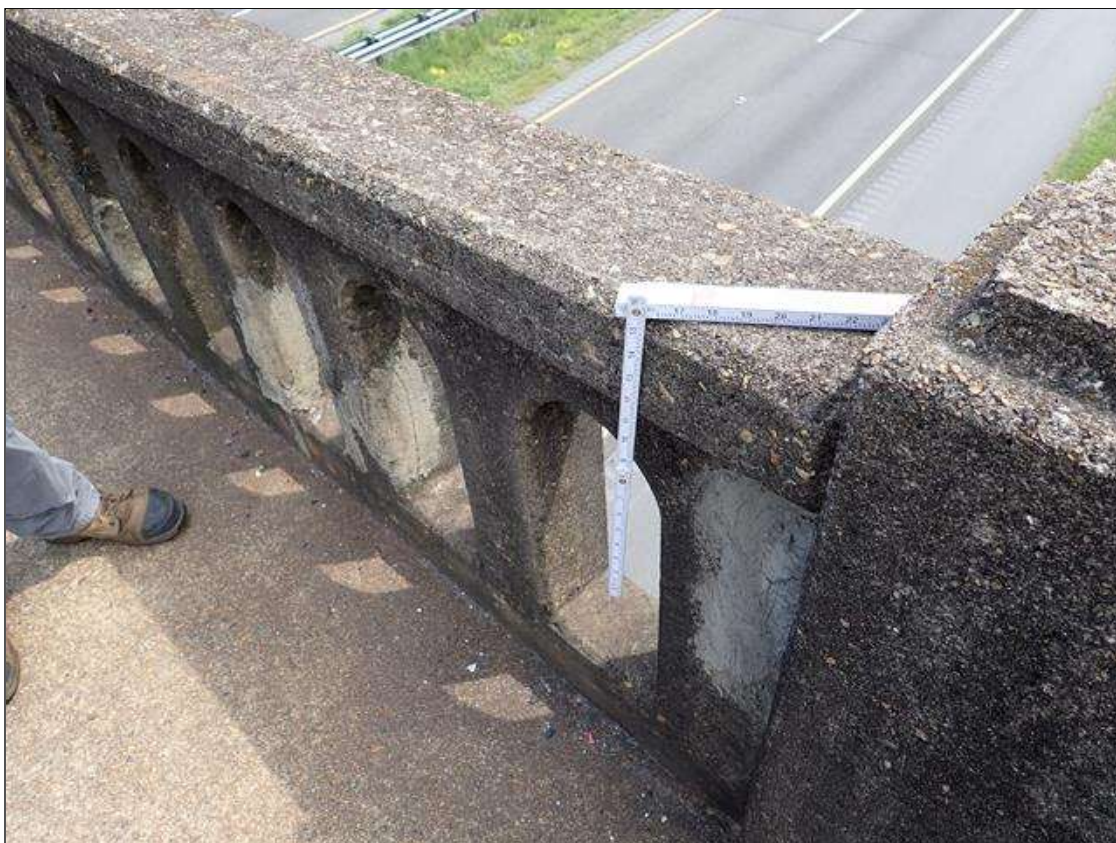
Span 2 Right Bridge Rail: SPAN 2 RIGHT RAIL HAS (11) PATCHED AREAS UP TO 8 INCH X 1 FOOT WITH HAIRLINE CRACKS.

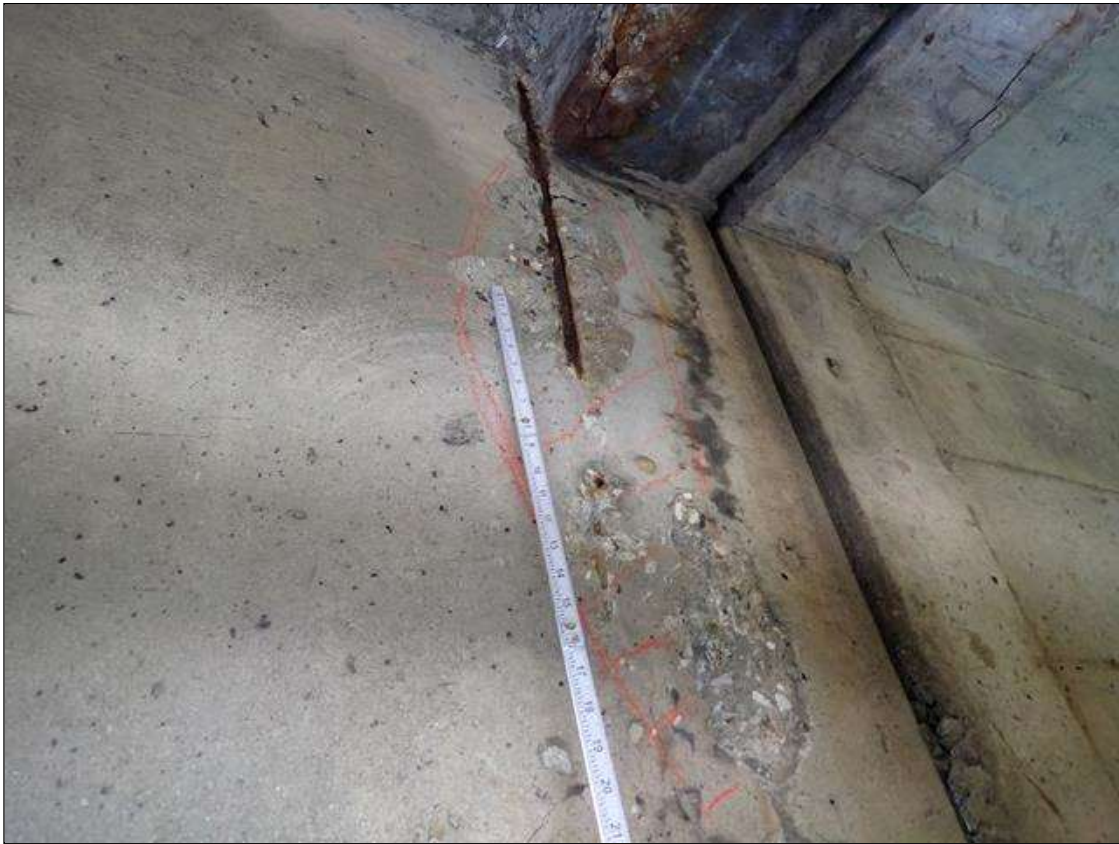
Span 3 Beam 1: (PAR) 10 INCH X 39 INCH X 1 INCH DEEP SPALL/DELAMINATION WITH EXPOSED REINFORCING WITH APPROXIMATELY 25 PERCENT LOSS, EAST FACE OF WEB, AT BENT 3.

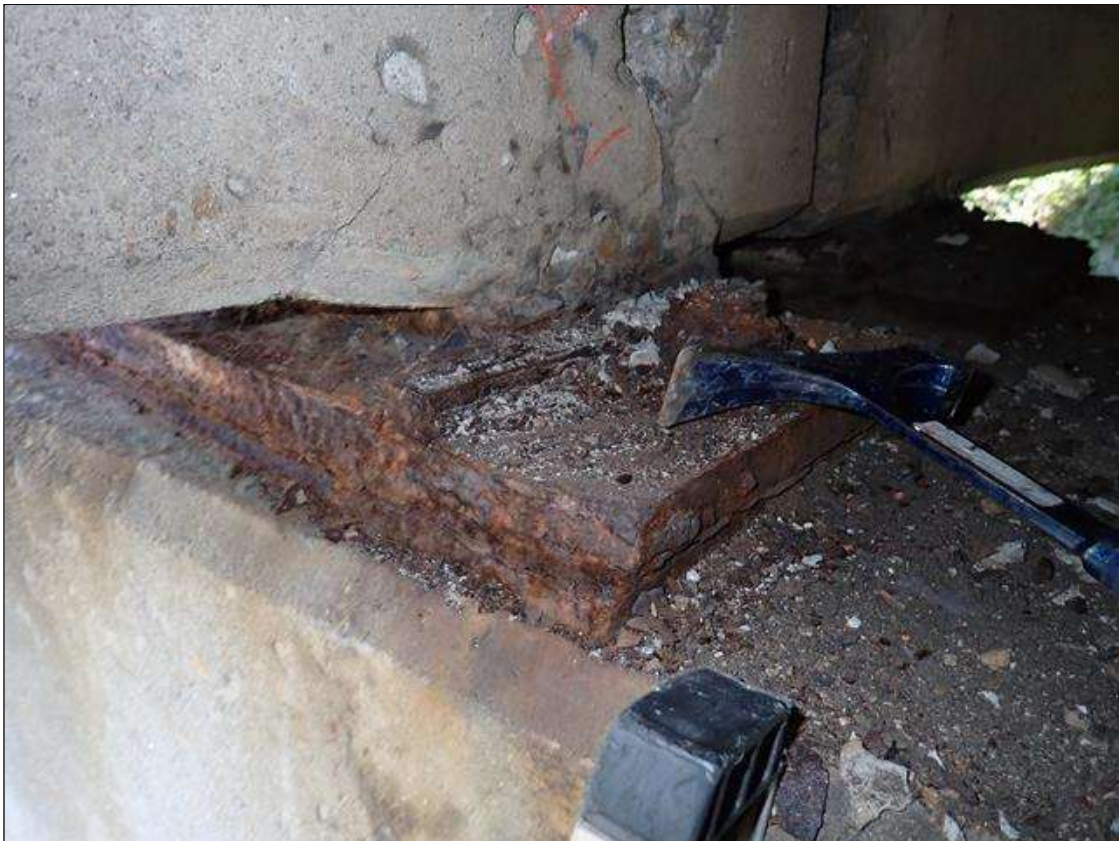
Span 3 Beam 1 - Far Bearing 1: active corrosion with section loss [up to 1/8 inch loss on plates]; anchor bolts, corrosion with section loss [approximately 75 percent remaining]

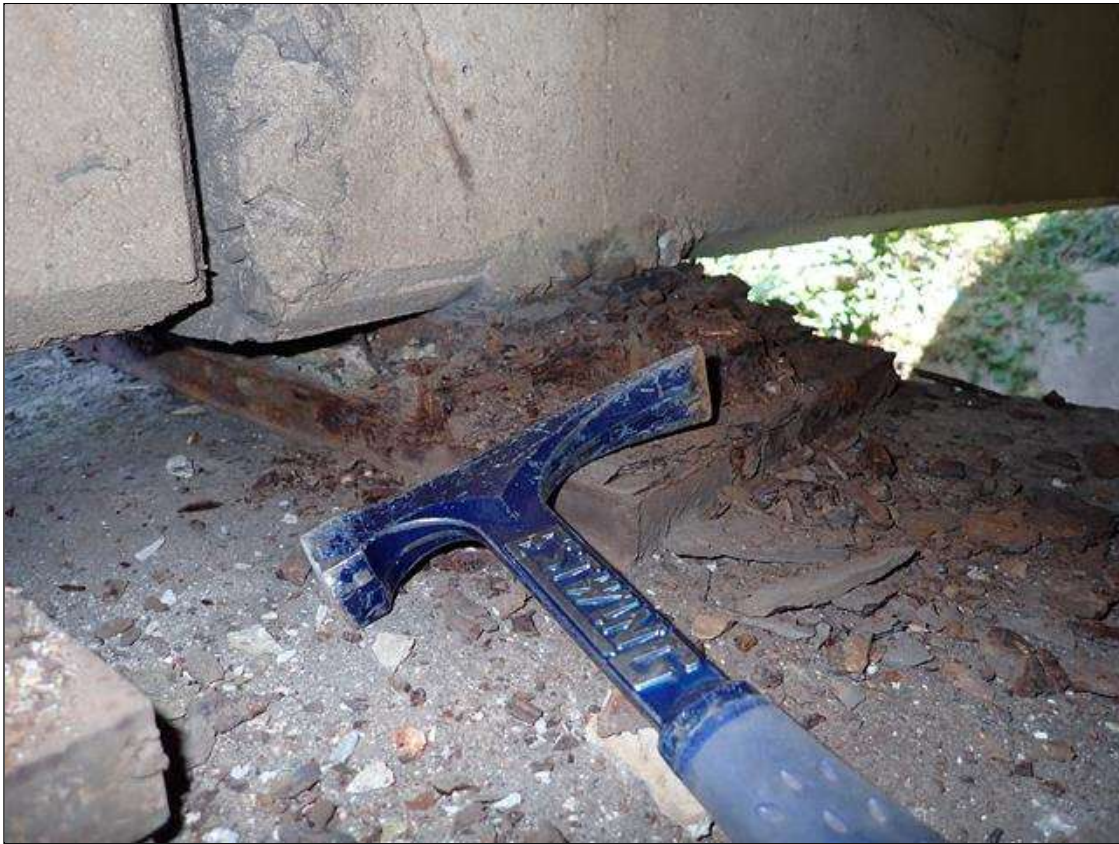
Span 4 Beam 1 - Near Bearing 1: active corrosion with section loss [up to 1/8 inch loss on plates]; anchor bolts, corrosion with section loss [approximately 75 percent remaining]

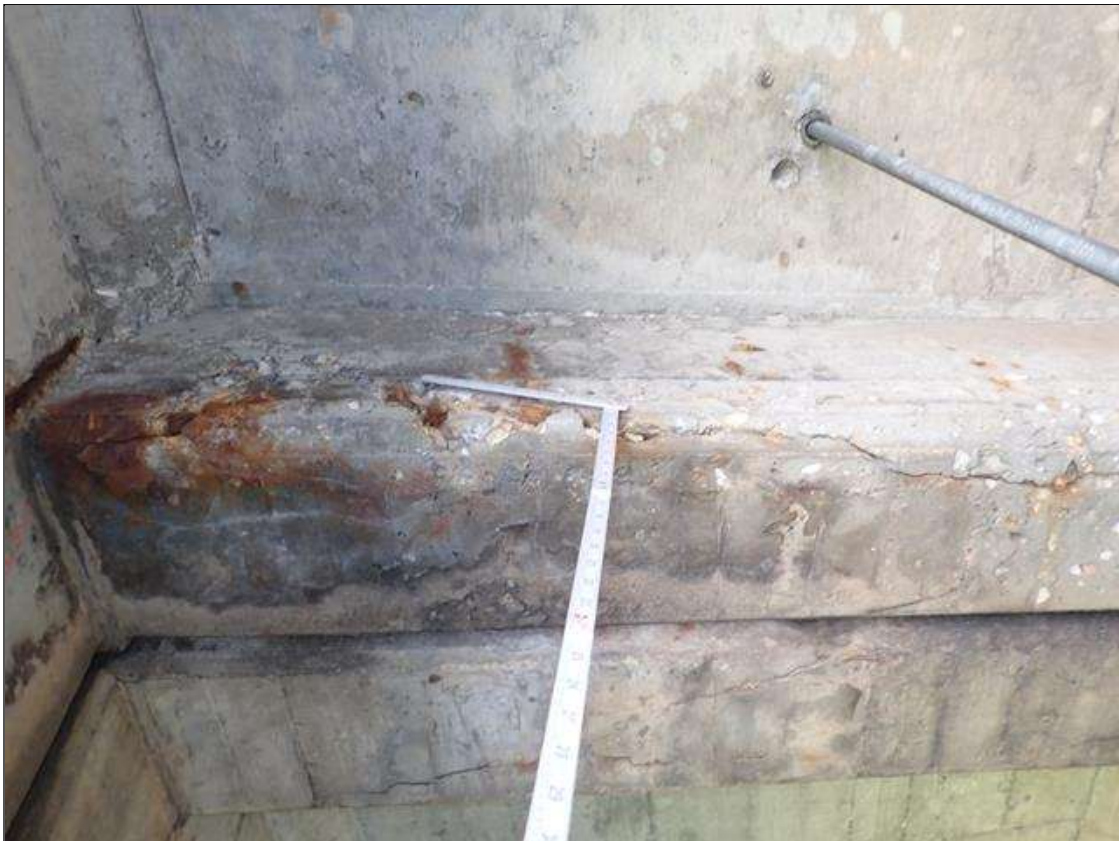
Span 3 Beam 1: (PAR) at bent 3, bay 1 end diaphragm, delamination (full width x full height) with cracks (up to 1/2 inch deep) with rust stains

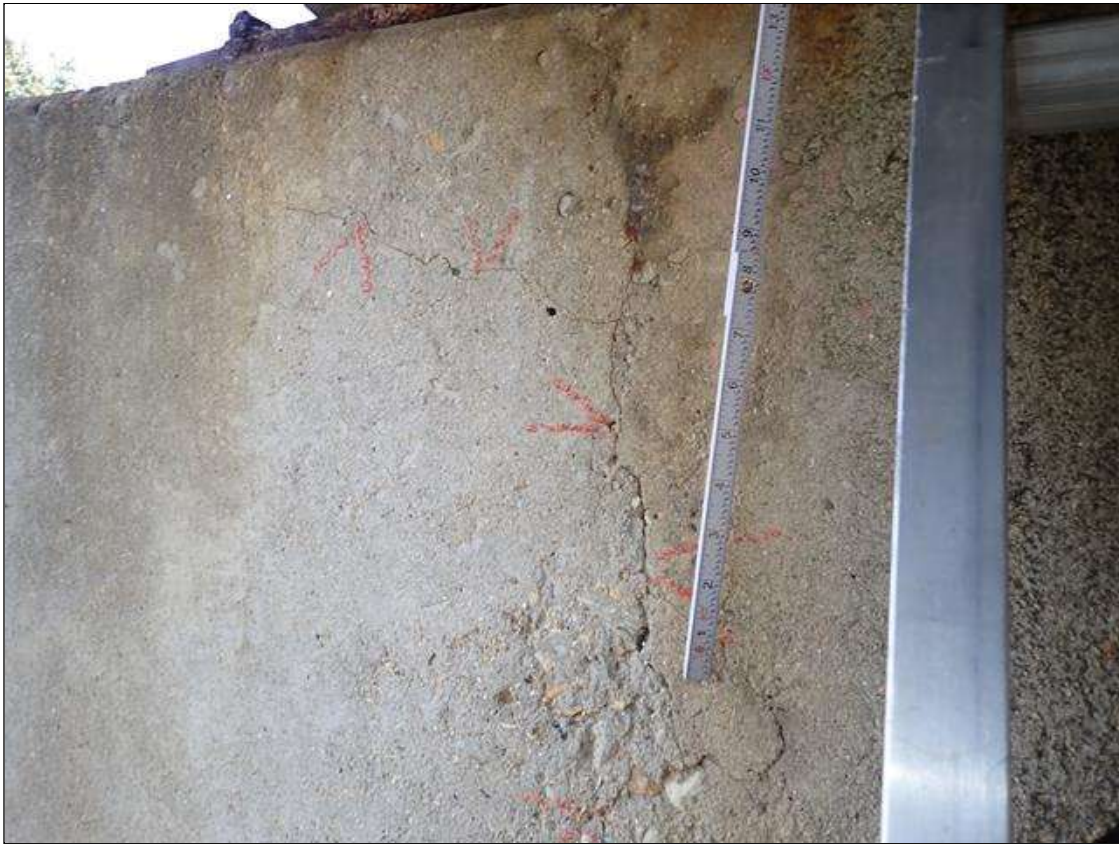
Bent 3 Cap 1: along the length of the cap, vertical cracks (up to 1/32 inch x full height) and map cracks (hairline) at random

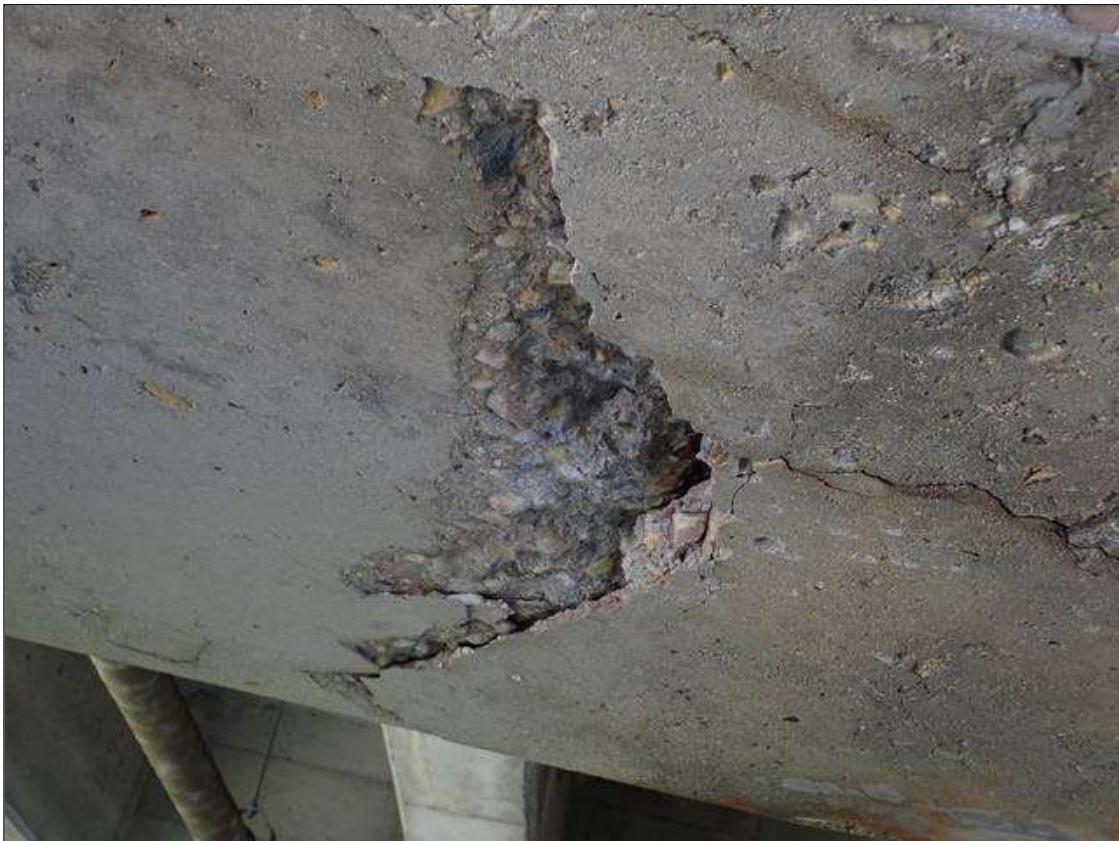
Bent 3 Cap 1: (PAR) underside of cap between all piles, delaminations/spalls [up to 8 foot x full width x 2 inch deep], extend up vertical face (4 inch) with cracks (up to 1/4 inch)

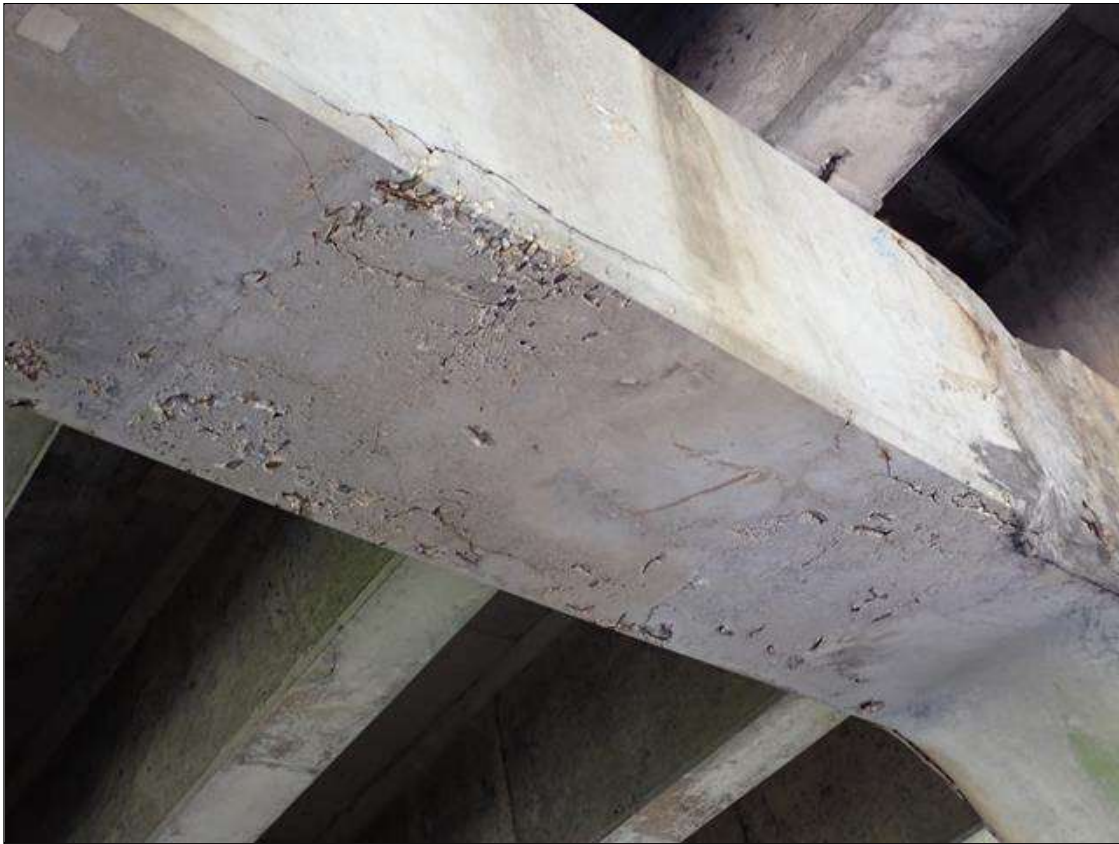
Bent 3 Cap 1: (PAR) underside of cap between all piles, delaminations/spalls [up to 8 foot x full width x 2 inch deep], extend up vertical face (4 inch) with cracks (up to 1/4 inch)

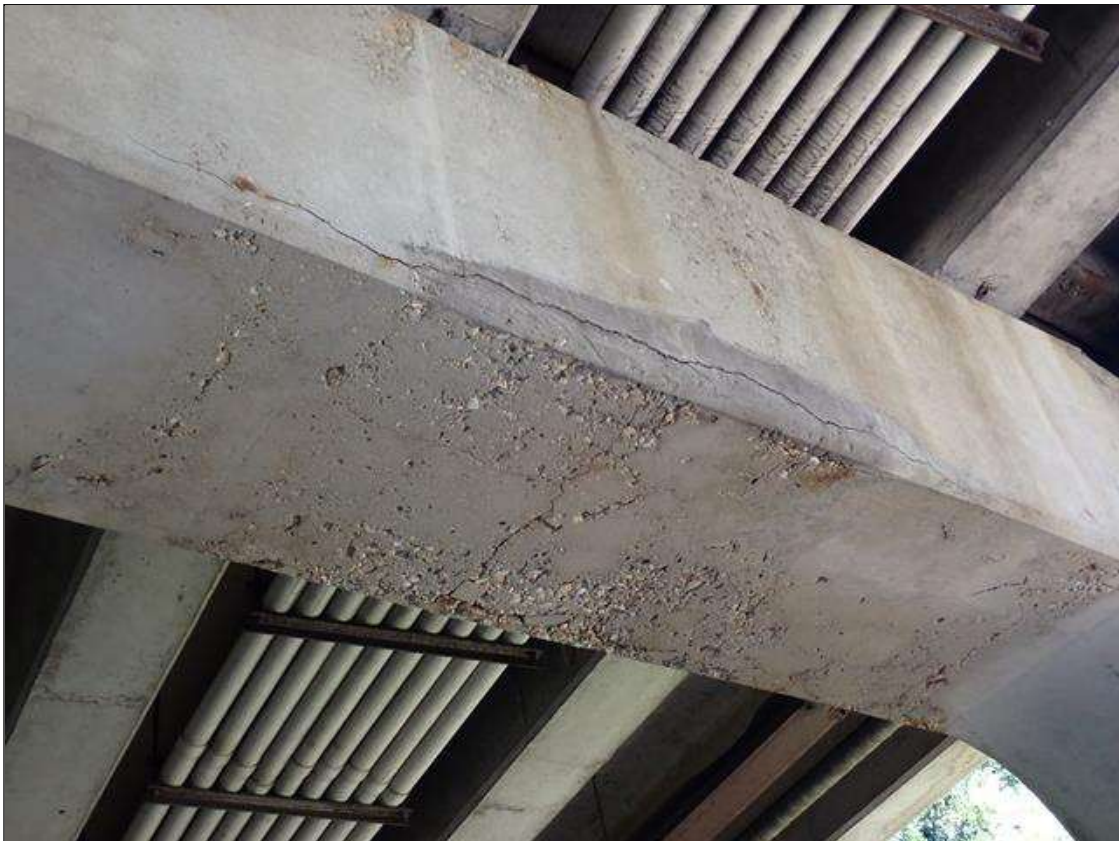
Bent 3 Cap 1: (PAR) underside of cap between all piles, delaminations/spalls [up to 8 foot x full width x 2 inch deep], extend up vertical face (4 inch) with cracks (up to 1/4 inch)

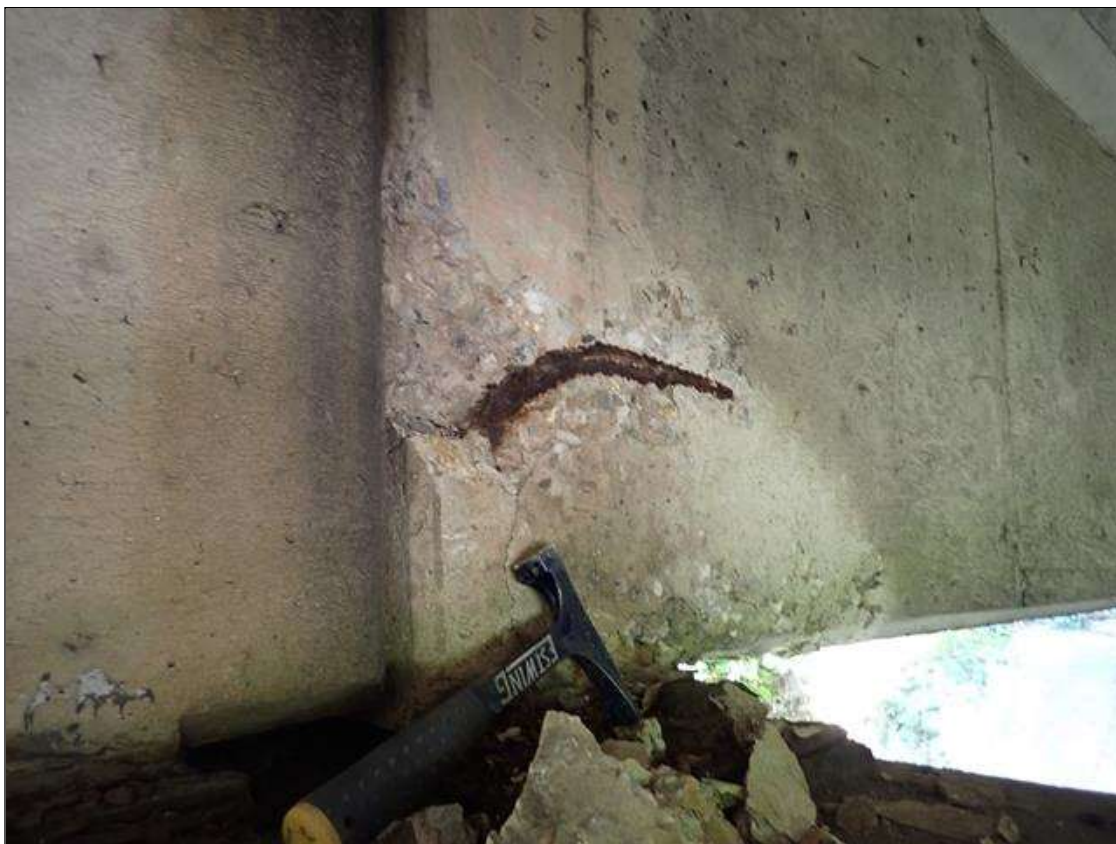
Span 4 Beam 2: (PAR) at near end, east face, spall/delamination [18 inch x 18 inch x up to 2 inch deep] with exposed rusted reinforcing [section loss up to 1/16 inch]

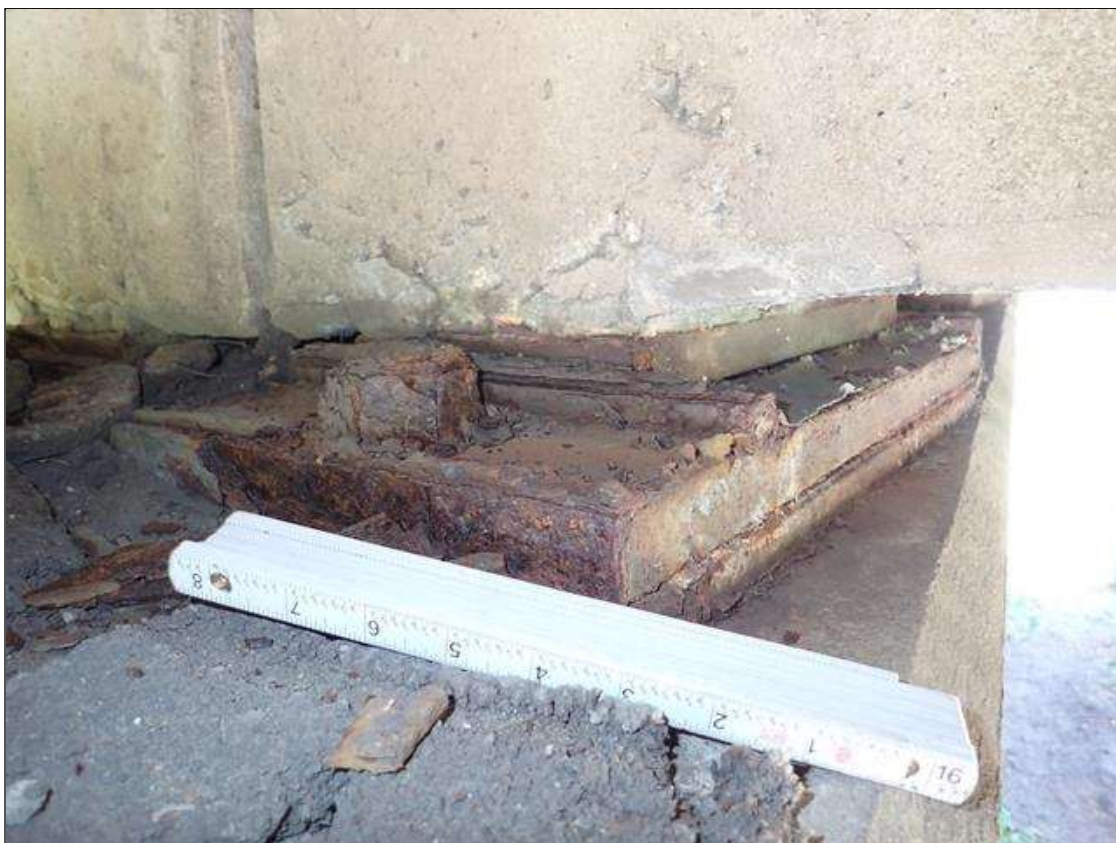
Span 3 Beam 3 - Far Bearing 3: active corrosion with section loss [up to 1/16 inch loss on plates]

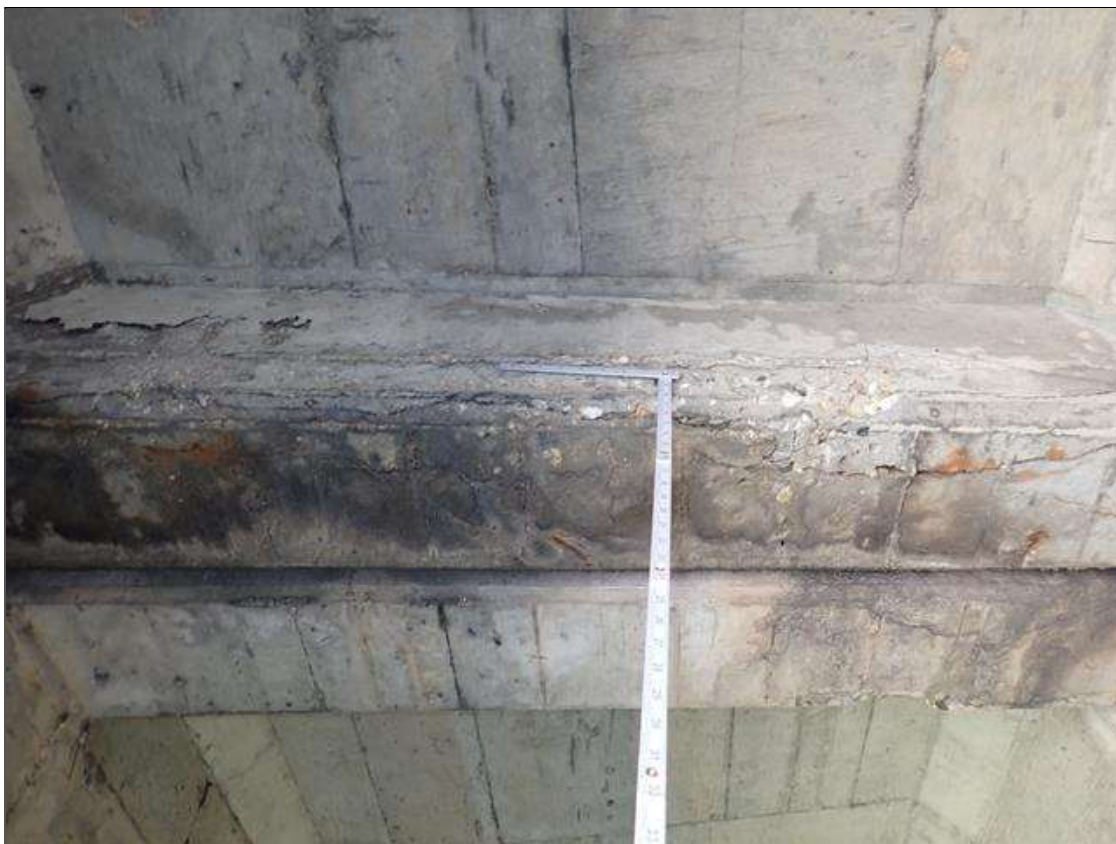
Span 3 Beam 2: (PAR) at bent 3, bay 2 end diaphragm, delamination (full width x 8 inch) with cracks (up to 1/2 inch deep) with rust stains

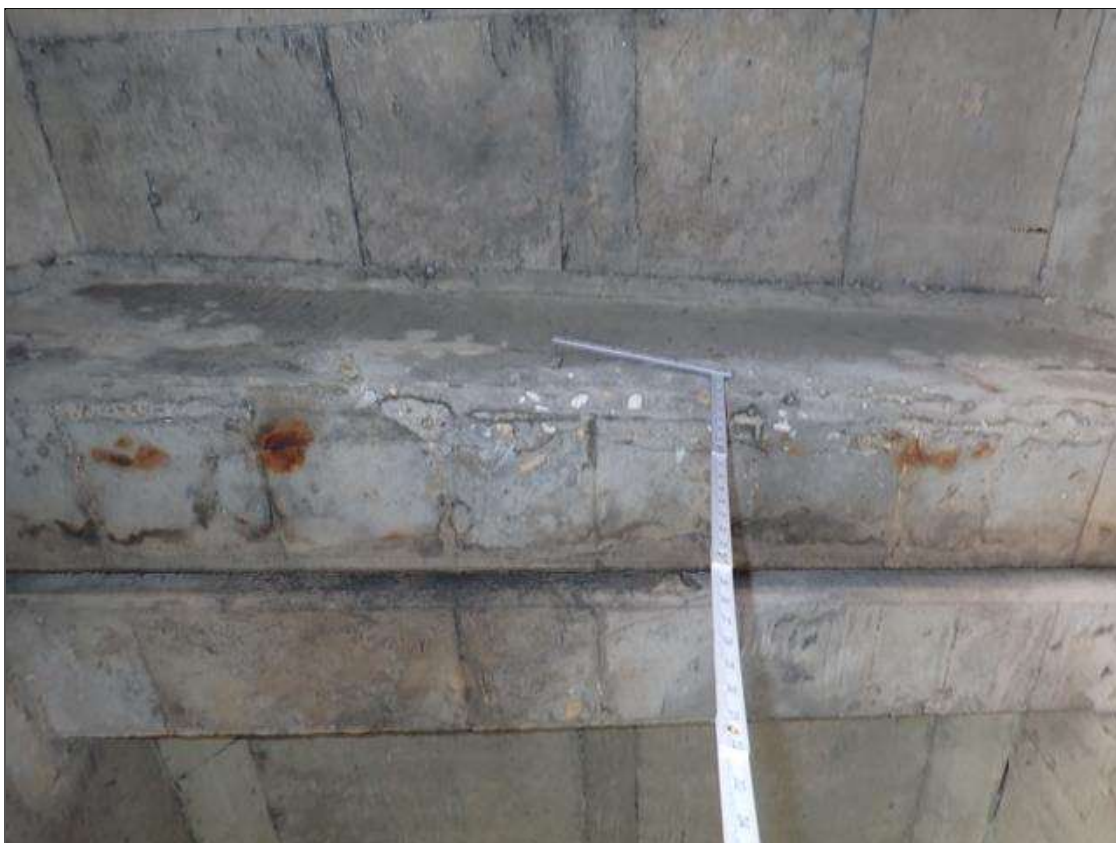
Span 3 Beam 3: (PAR) at bent 3, bay 3 end diaphragm, delamination (full width x 8 inch) with cracks (up to 1/4 inch deep) with rust stains

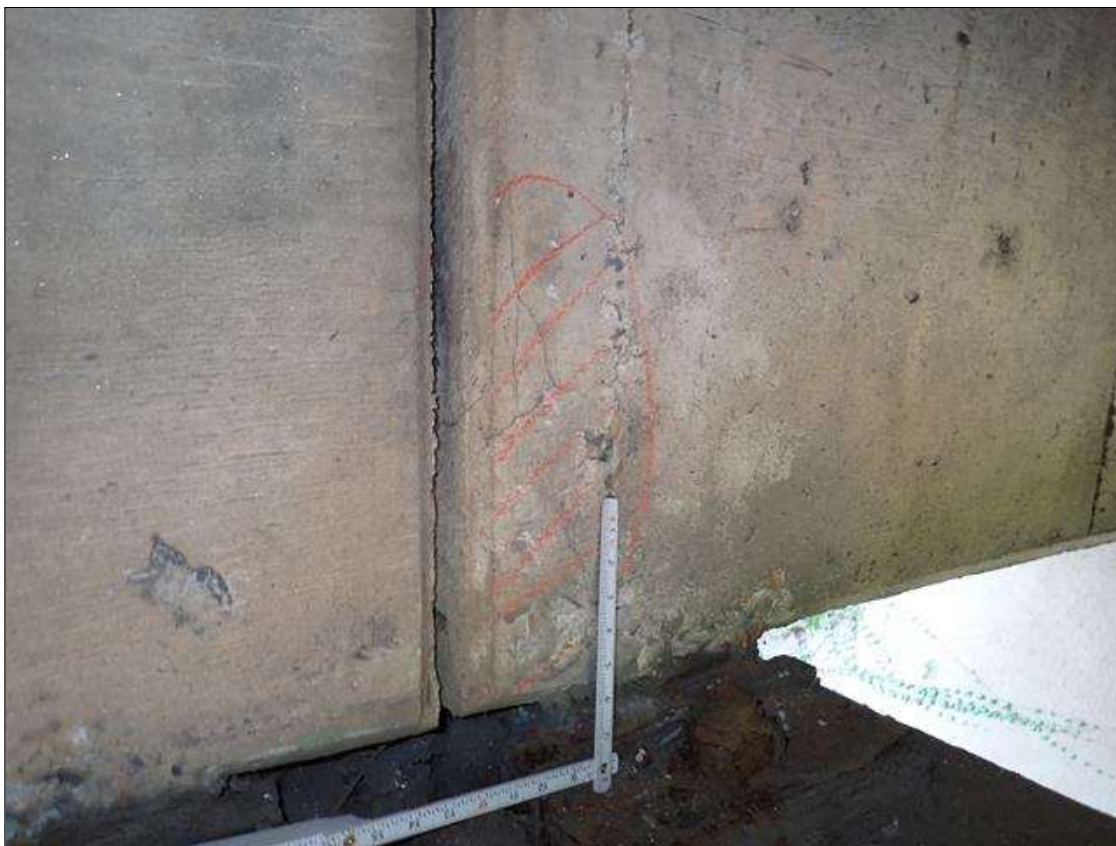
Span 4 Beam 3: at bent 3, east face, delamination (6 inch x 15 inch) with cracks (up to 1/32 inch)

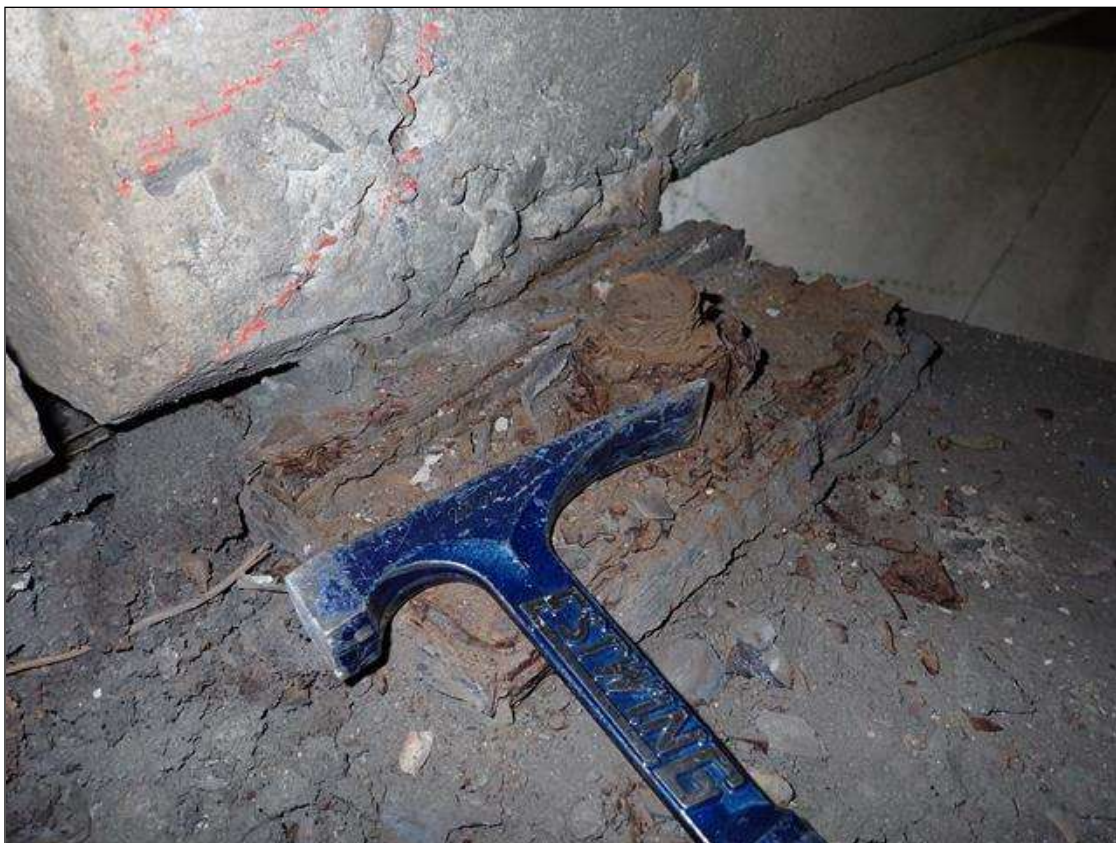
Span 4 Beam 3 - Near Bearing 3: active corrosion with section loss [up to 1/8 inch loss on plates]; anchor bolts, corrosion with section loss [approximately 75 percent remaining]

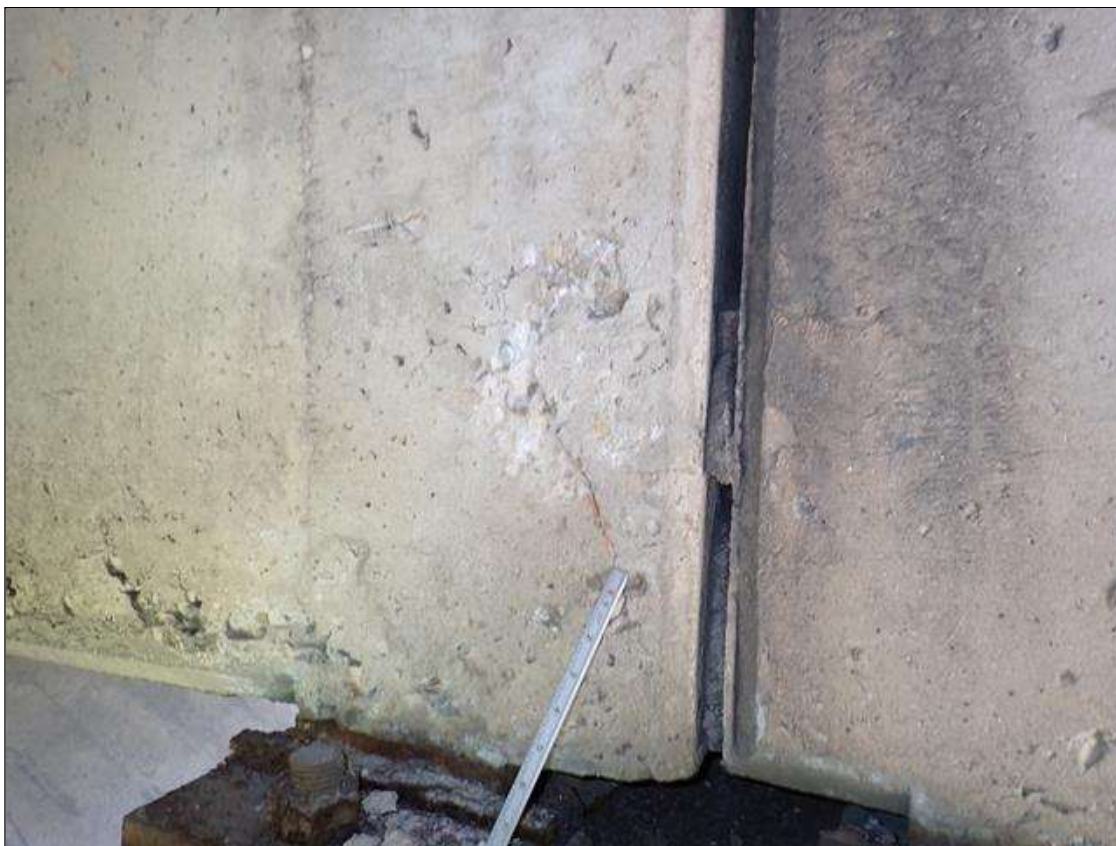
Span 4 Beam 4: at bent 3, west face, spall/delamination (10 inch x 6 inch x 1/2 inch deep)
