NC DEPARTMENT OF TRANSPORTATION
 DIVISION OF HIGHWAYS
 STRUCTURE MANAGEMENT UNIT

ATTENTION: **prompt action request; sketches revised; span 3 clearances revised**

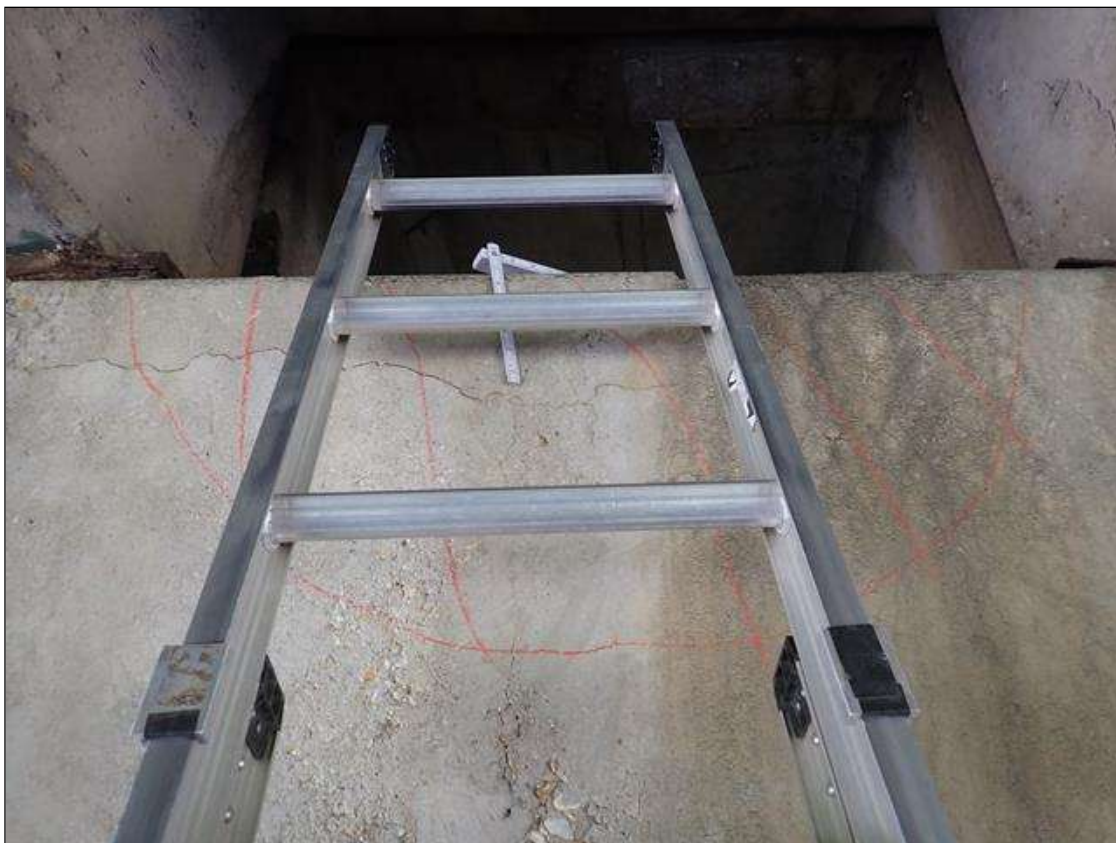
Bent 3 Cap 1: south face in bay 4, delamination (4 foot x 1.5 foot) with cracks (up to 1/32 inch)

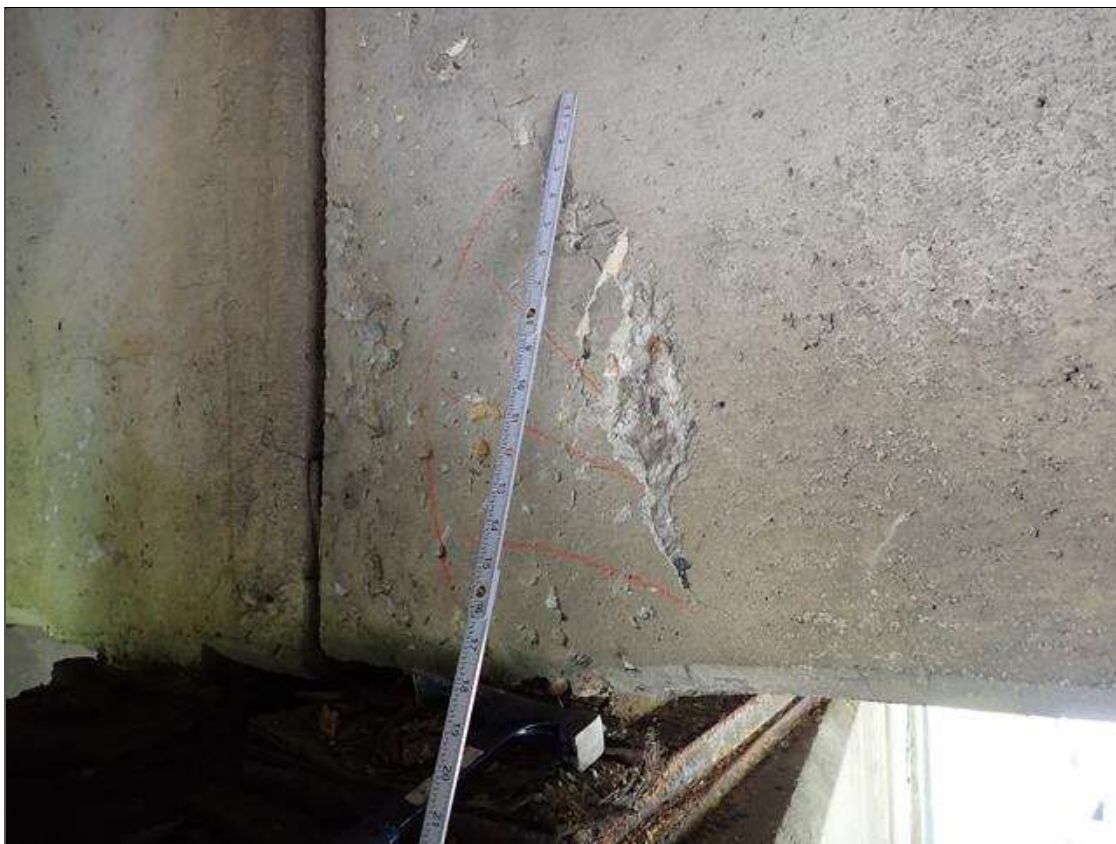
Span 3 Beam 5: at bent 3, west face, spall/delamination (1 foot x 1.5 foot x 1 inch deep)

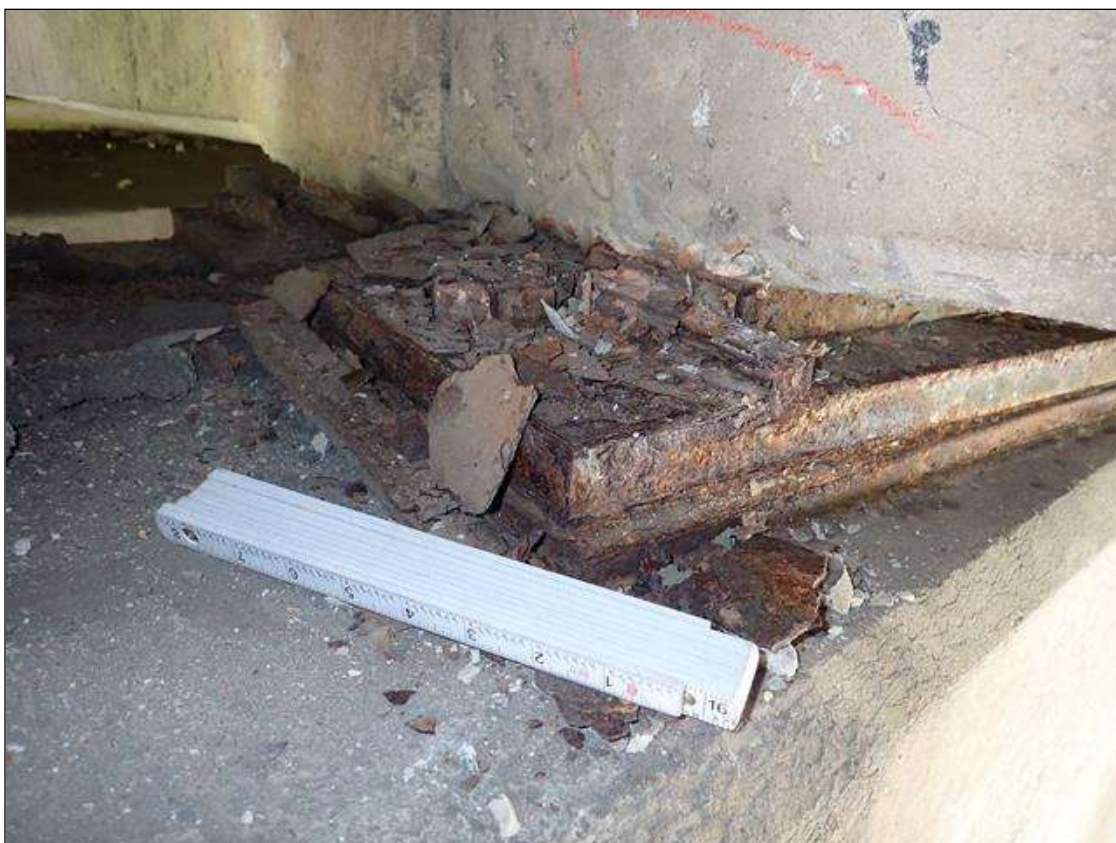
Span 3 Beam 5 - Far Bearing 5: active corrosion with section loss [up to 1/16 inch loss on plates]; anchor bolts, corrosion with section loss [approximately 75 percent remaining]

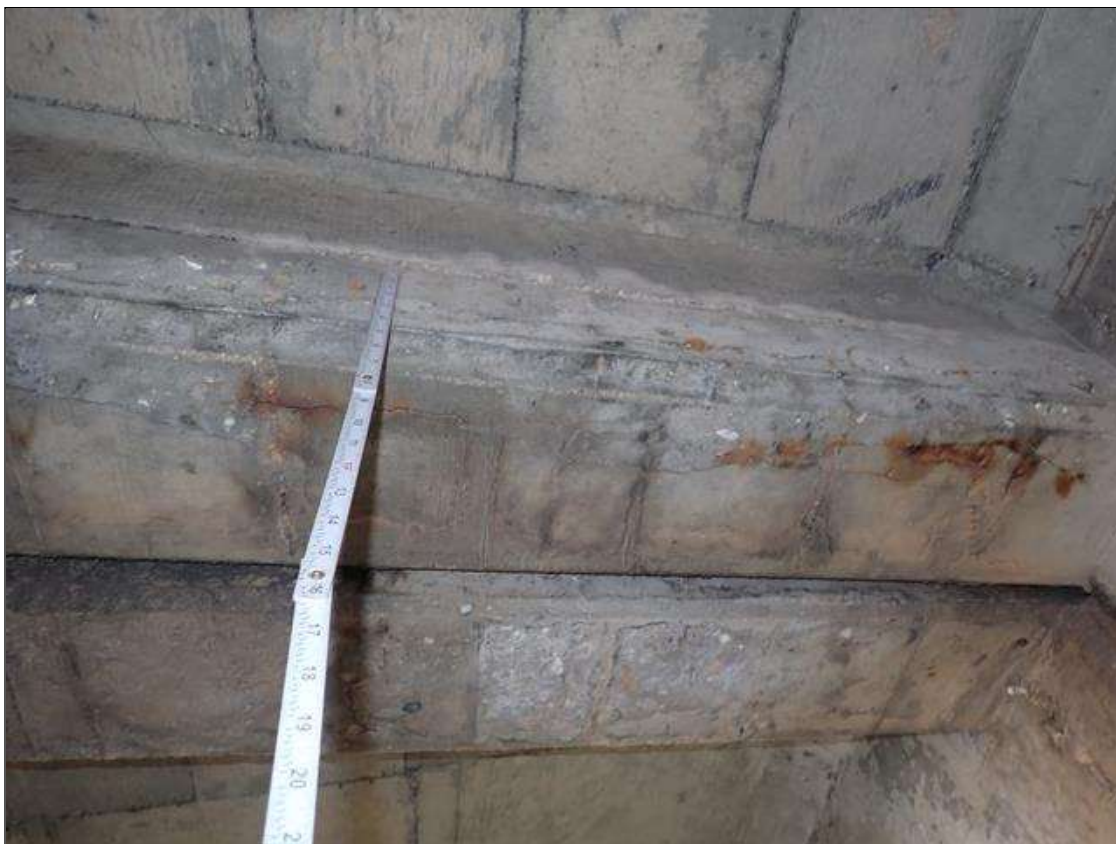
Span 3 Beam 4: (PAR) at bent 3, bay 4 end diaphragm, delamination (full width x 5 inch) with cracks (up to 1/4 inch deep) with rust stains

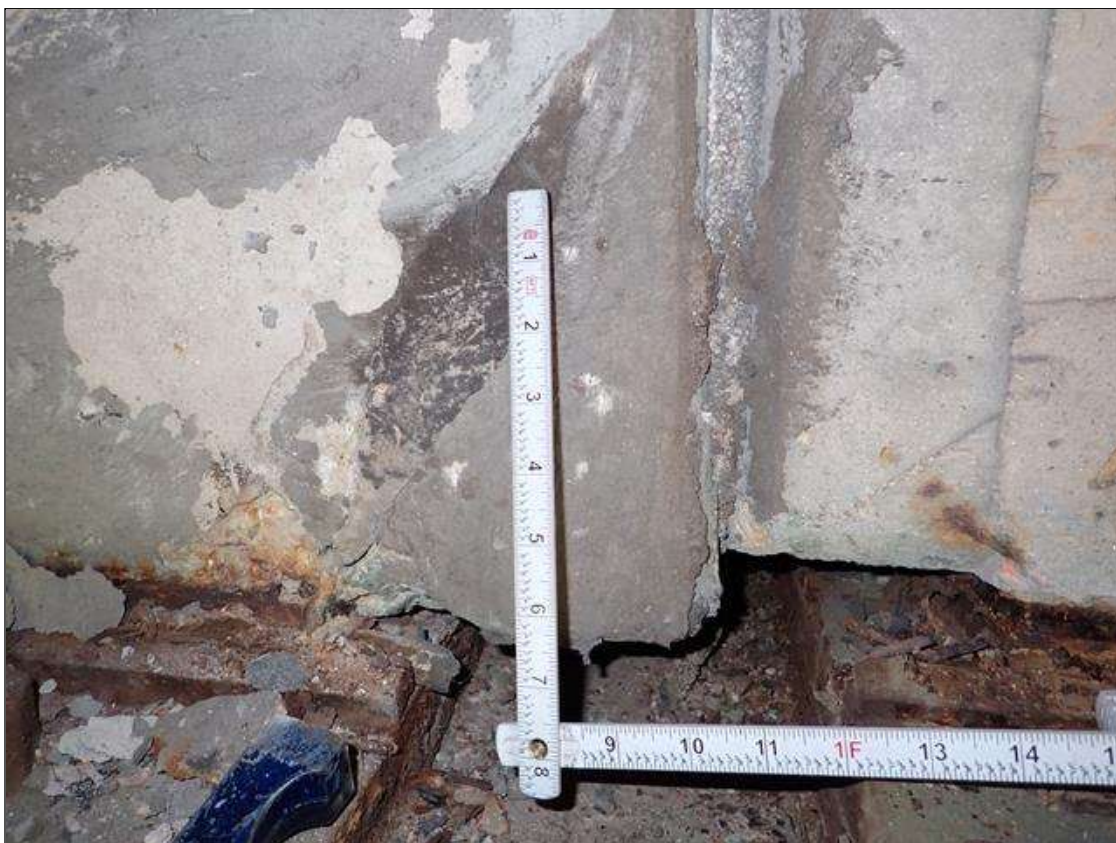
Span 4 Beam 6: at bent 3, west face, failed patch (8 inch x 8 inch x 3/4 inch deep)

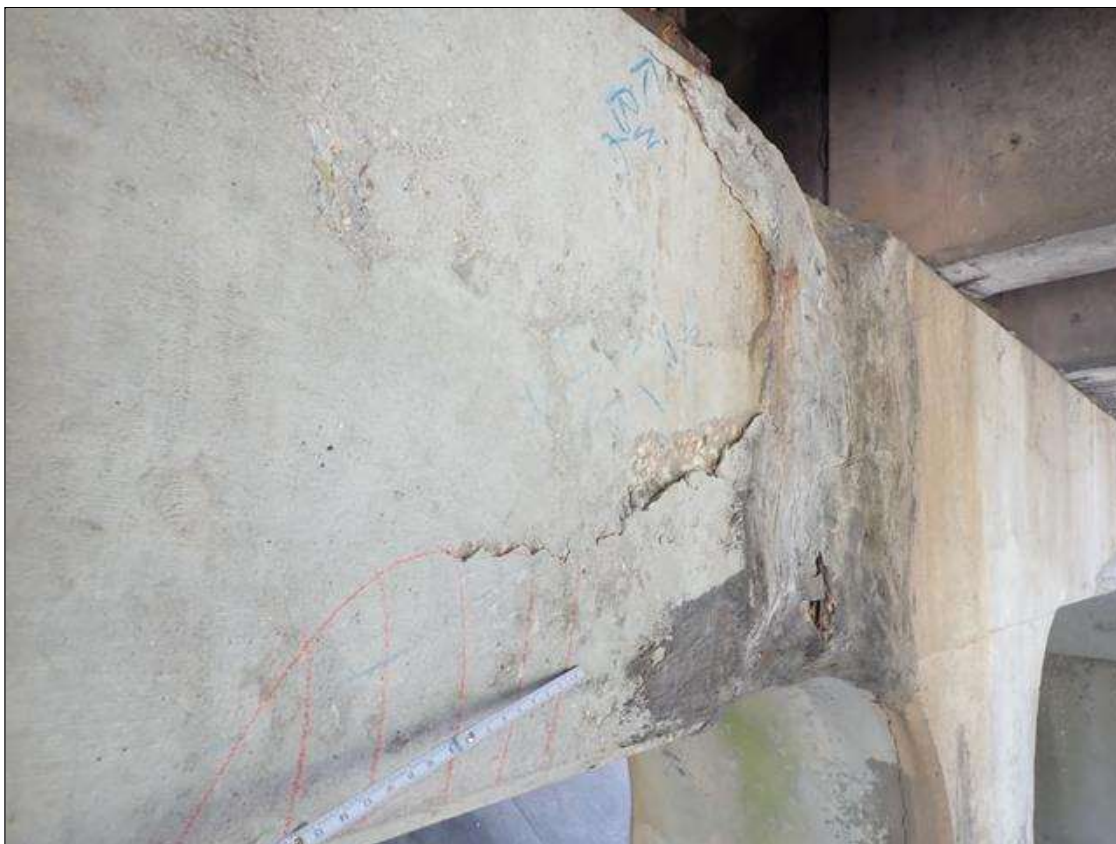
Bent 3 Cap 1: (PAR) south face in bay 6, failed patch (5 foot x full height x 3 inch deep) with exposed rusted rebar (approximately 25 percent loss)

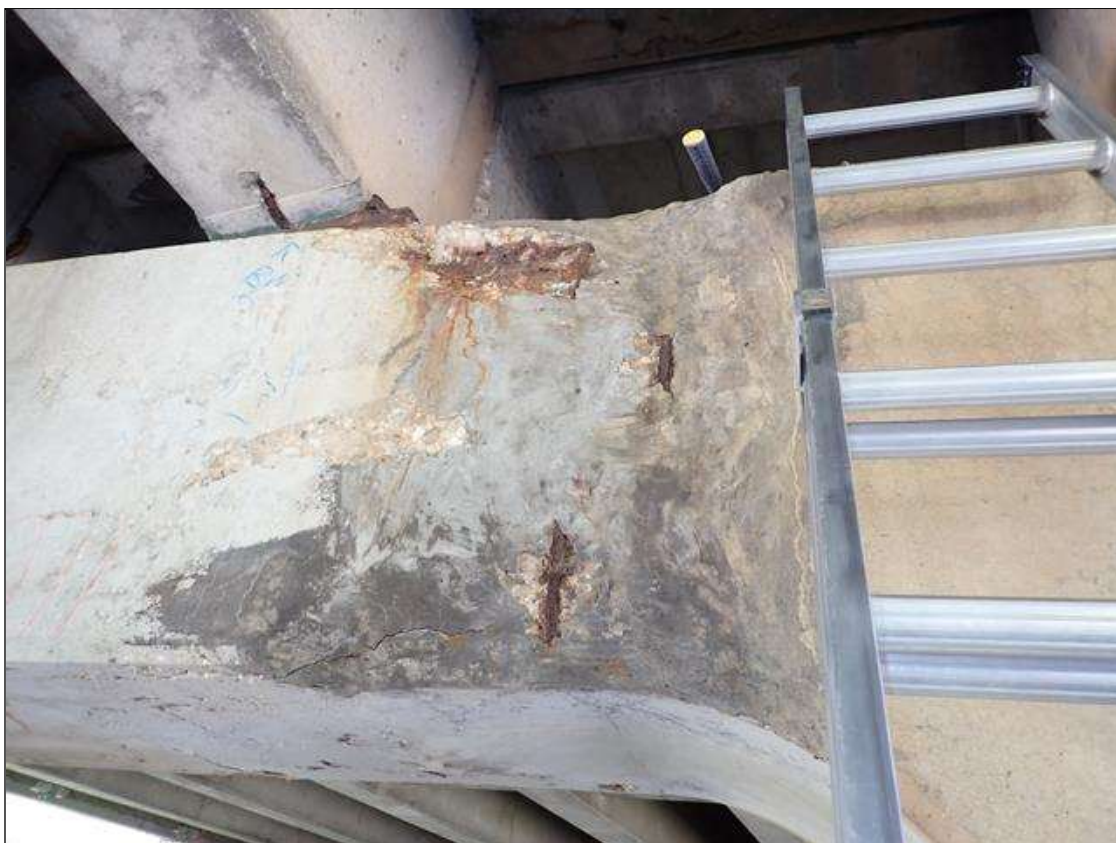
Bent 3 Cap 1: (PAR) south face in bay 6, failed patch (5 foot x full height x 3 inch deep) with exposed rusted rebar (approximately 25 percent loss)

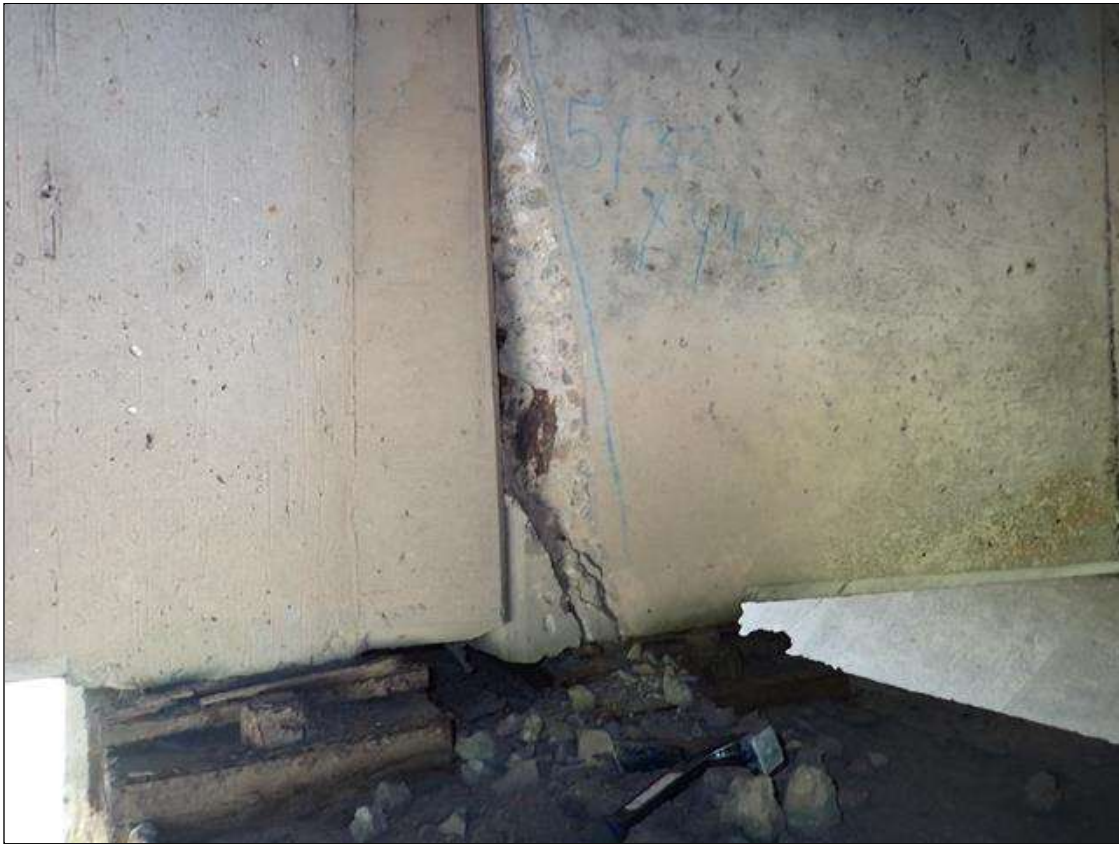
Span 4 Beam 6: (PAR) SPAN 4 BEAM 6 EAST WEB OVER BENT 3. HAS A CRACK/SPALL AND DELAMINATED AREA WITH REBAR WITH APPROXIMATELY 25 PERCENT LOSS AND RUST STAINS VISIBLE. AREA IS: 5 INCH X 32 INCH X 4 INCH DEEP.

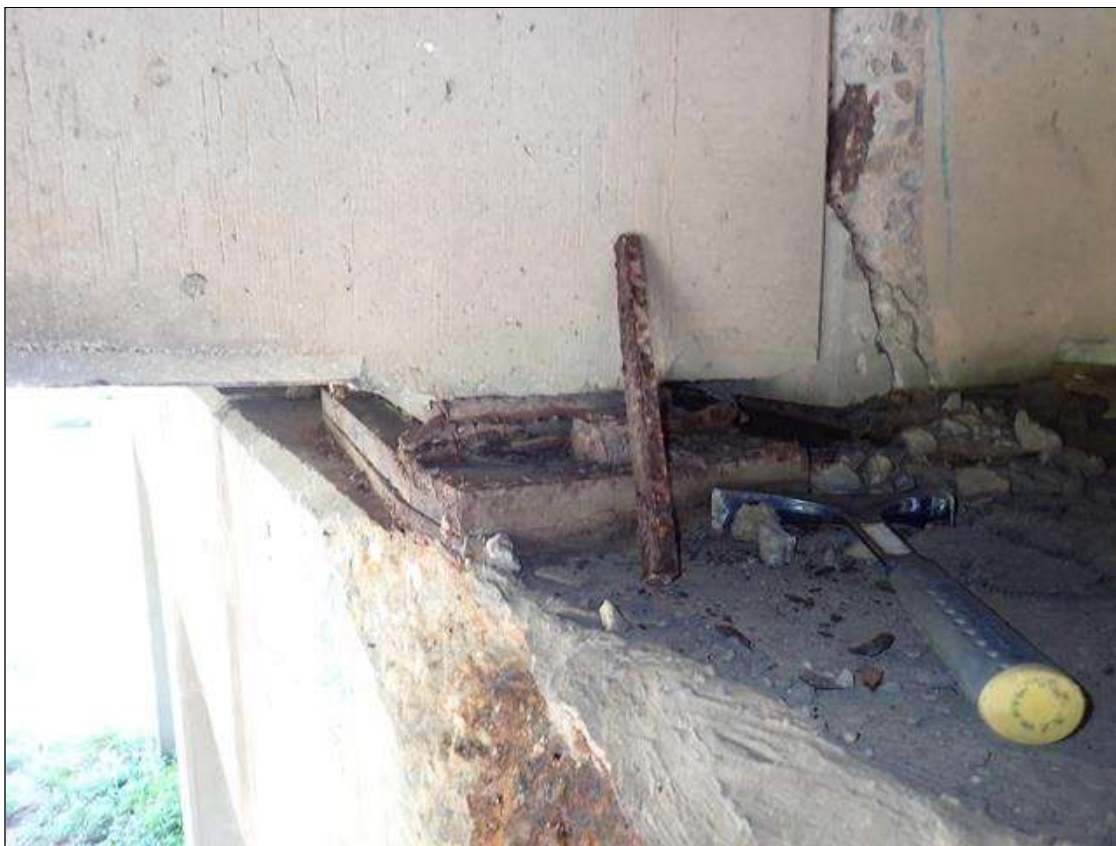
Span 3 Beam 6 - Far Bearing 6: (PAR) active corrosion with section loss [up to 1/16 inch loss on plates]; east guide rail, sheared

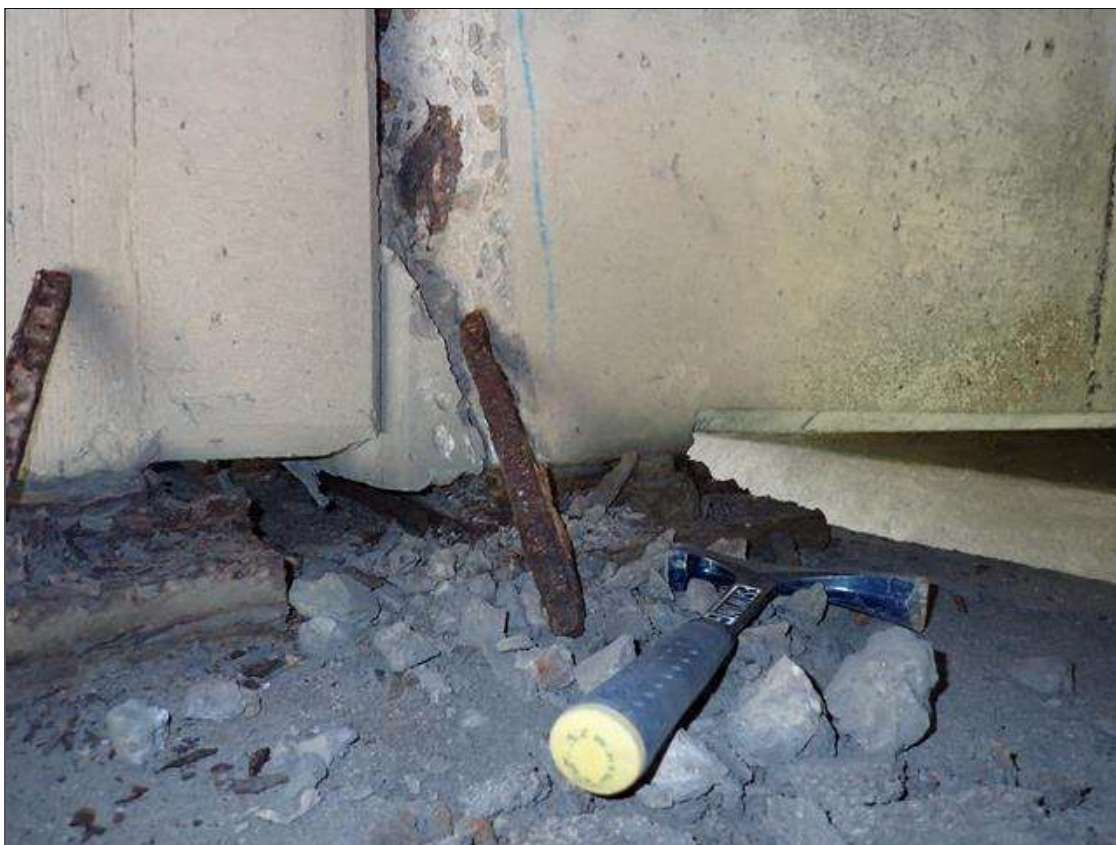
Span 4 Beam 6 - Near Bearing 6: (PAR) active corrosion with section loss [up to 1/16 inch loss on plates]; east guide rail, sheared

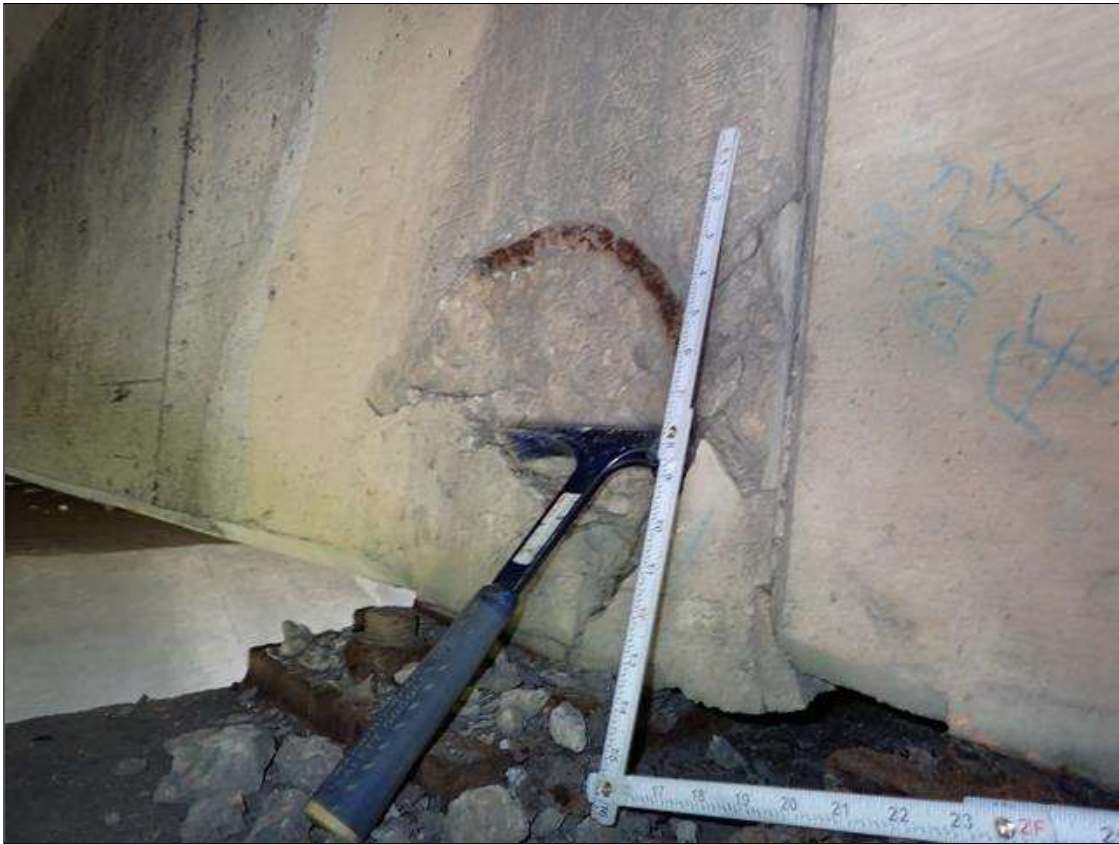
Span 4 Beam 7: (PAR) SPAN 4 BEAM 7 WEST WEB OVER BENT 3. HAS A CRACK/SPALL AND DELAMINATED AREA WITH REBAR EXPOSED WITH APPROXIMATELY 25 PERCENT LOSS. AREA IS: 20 INCH X 15 INCH X 2 INCH DEEP.

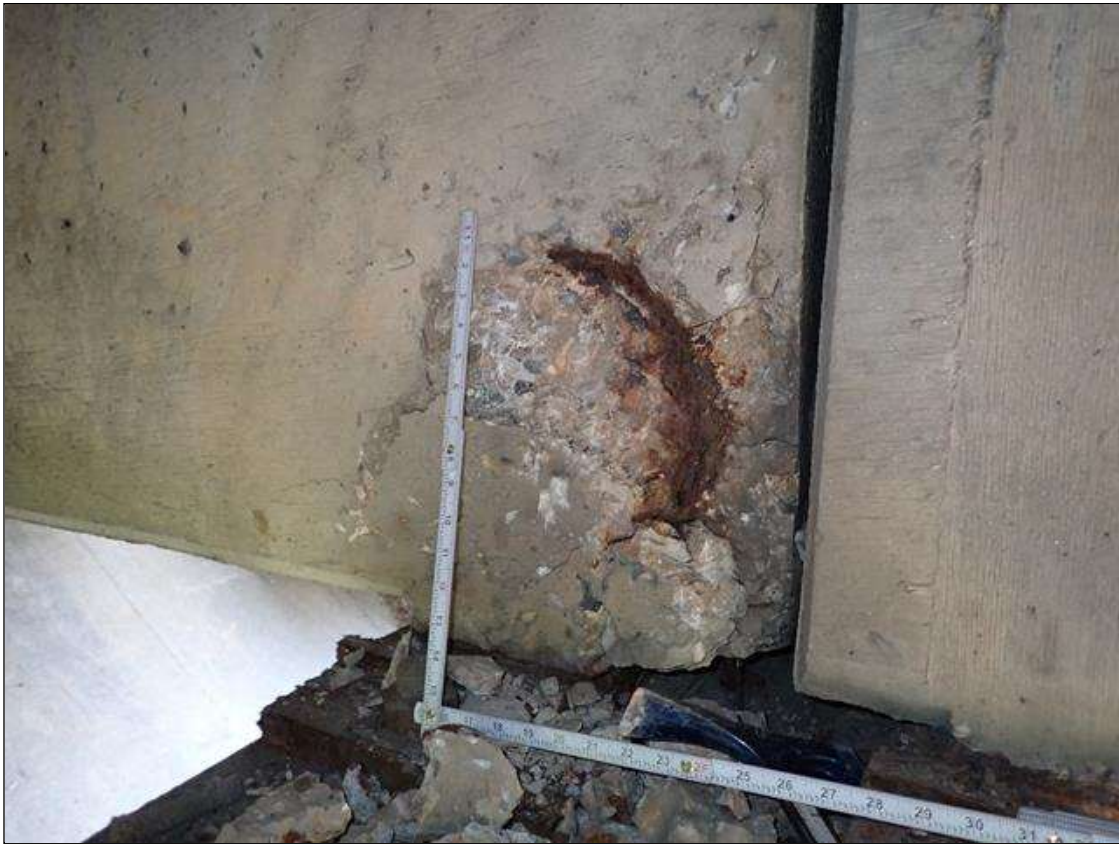
Span 4 Beam 8: (PAR) at bent 3, west face, spall/delamination (17 inch x 15 inch x 1.5 inch deep) with exposed rusted rebar (approximately 25 percent loss)

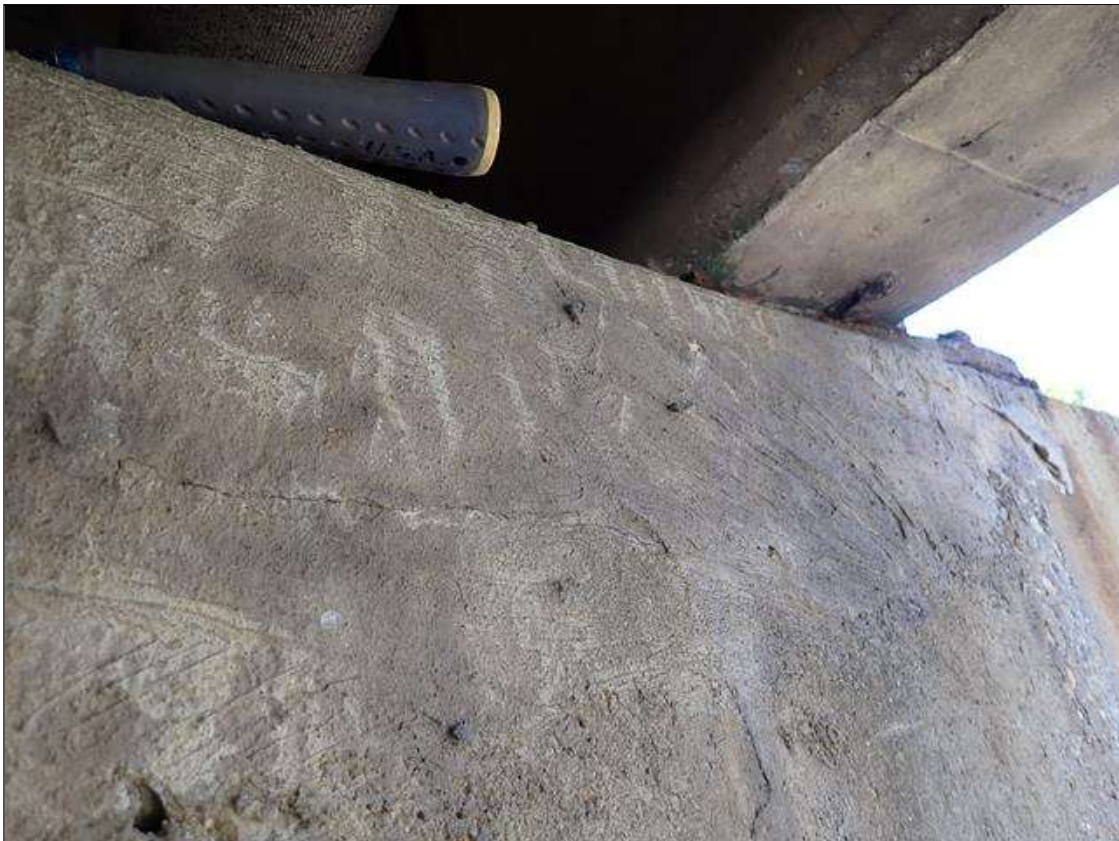
Bent 3 Cap 1: (PAR) BENT 3 CAP TOP AND SOUTH FACE BAY 9. HAS AN UNSOUND PATCHED AREA 6 FOOT X INCH X 12 INCH WITH SCATTERED HAIRLINE CRACKS, EFFLORESCENCE AND RUST STAINS

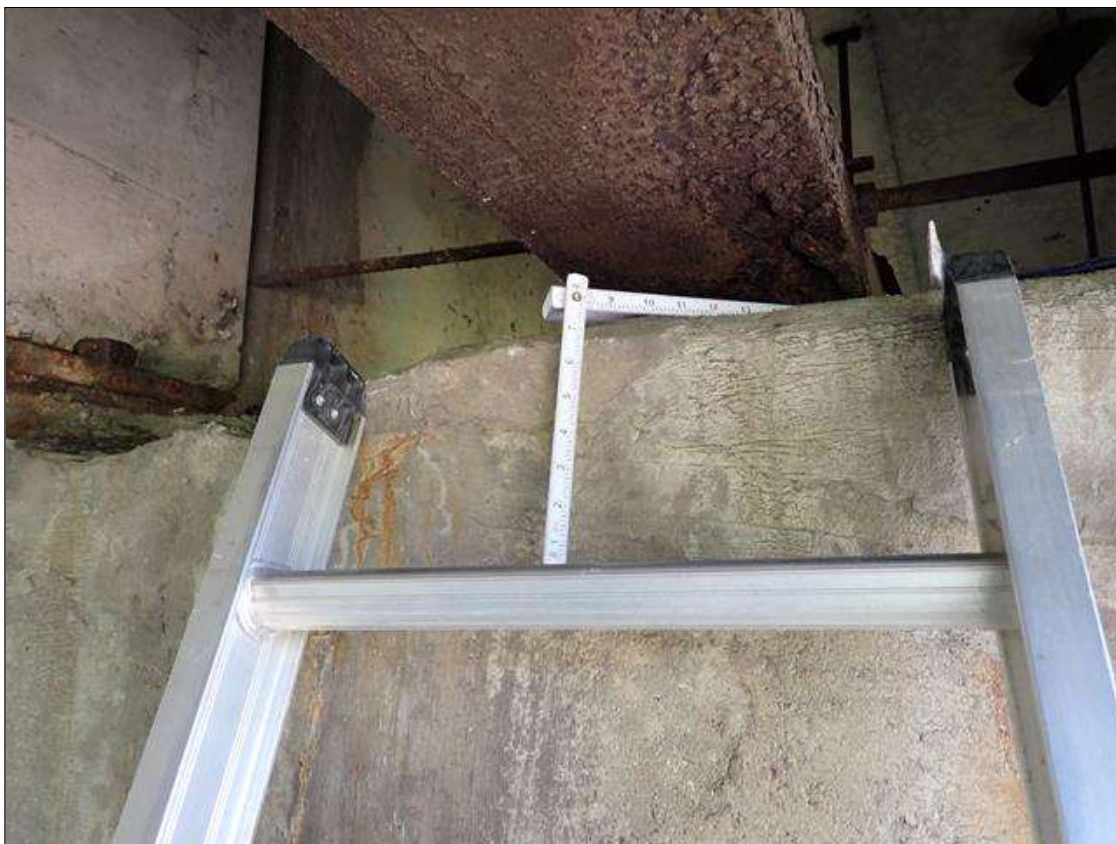
Bent 3 Cap 1: (PAR) BENT 3 CAP TOP AND SOUTH FACE BAY 9. HAS AN UNSOUND PATCHED AREA 6 FOOT X INCH X 12 INCH WITH SCATTERED HAIRLINE CRACKS, EFFLORESCENCE AND RUST STAINS

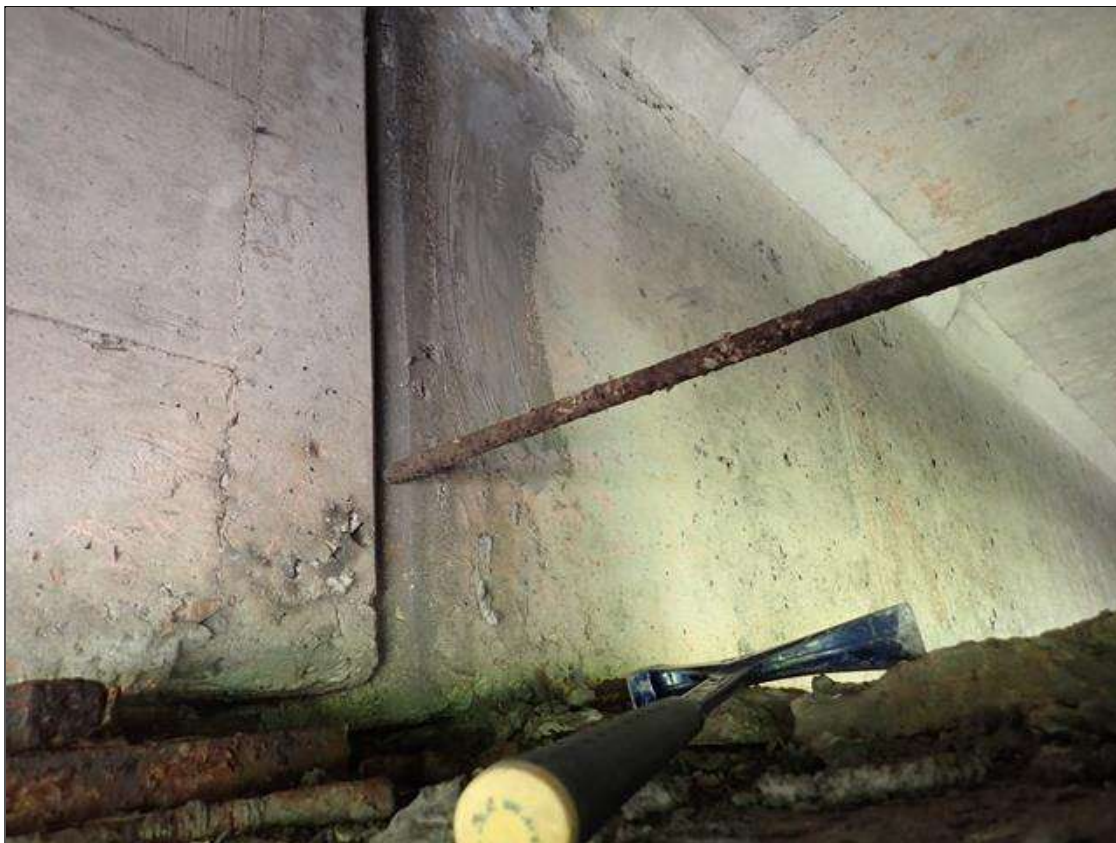
Span 4 Beam 9: East face at near end, patched area [16 inch x 8 inch]

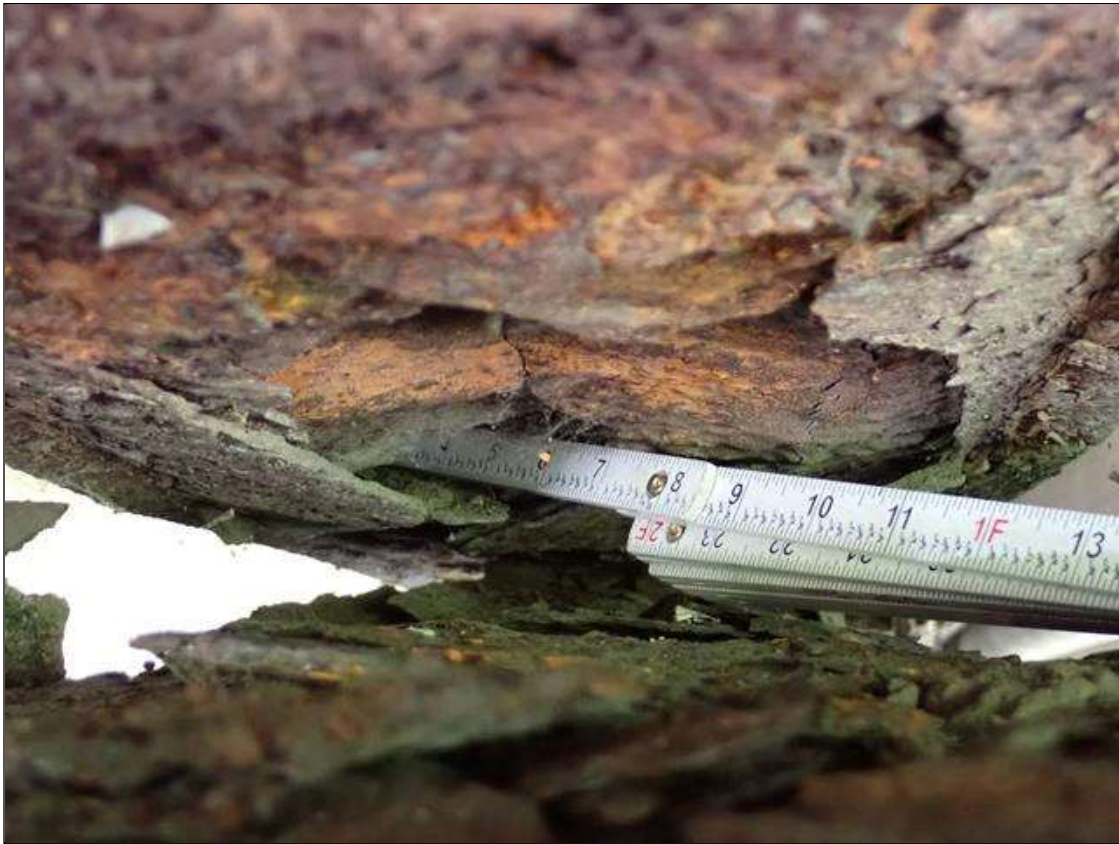
(PAR) at bent 3, utility platform, corrosion with section loss (up to 100 percent loss) with corrosion holes (up to 3 inch diameter); hanger connection, corrosion with section loss (up to 100 percent loss)

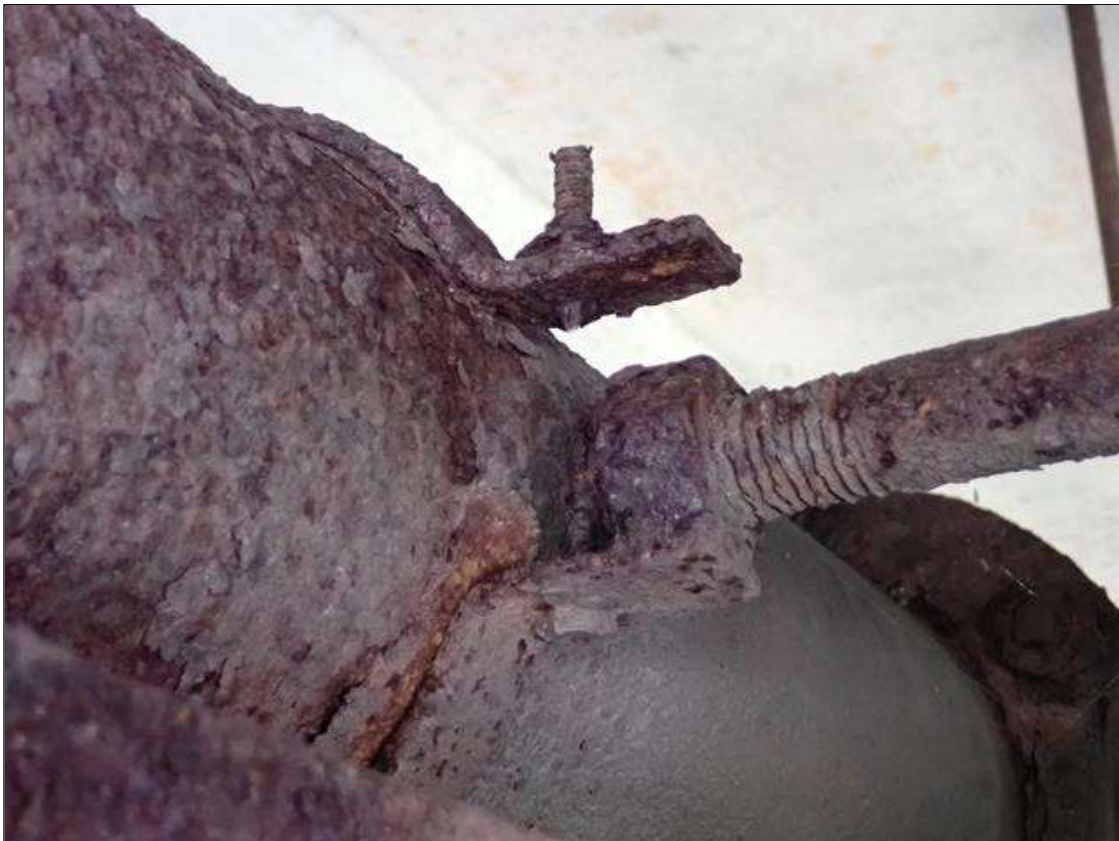
(PAR) at bent 3, utility platform, corrosion with section loss (up to 100 percent loss) with corrosion holes (up to 3 inch diameter); hanger connection, corrosion with section loss (up to 100 percent loss)

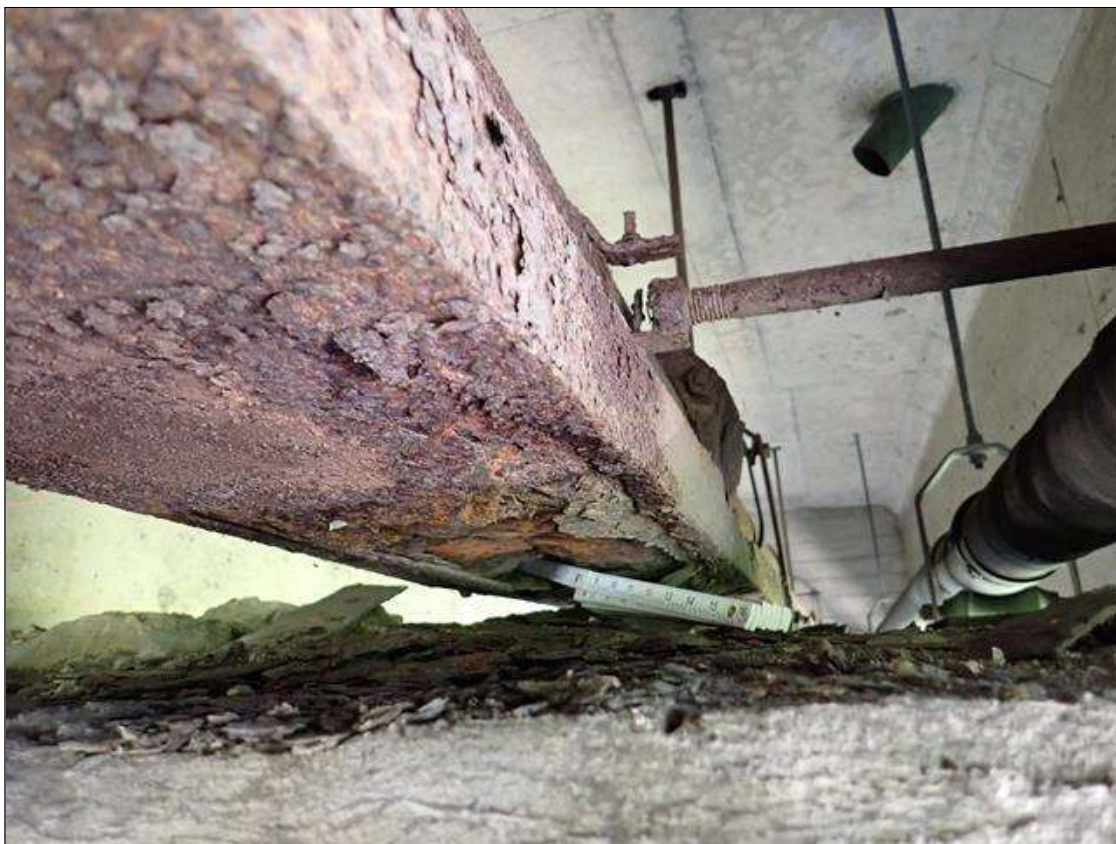
(PAR) at bent 3, utility platform, corrosion with section loss (up to 100 percent loss) with corrosion holes (up to 3 inch diameter); hanger connection, corrosion with section loss (up to 100 percent loss)

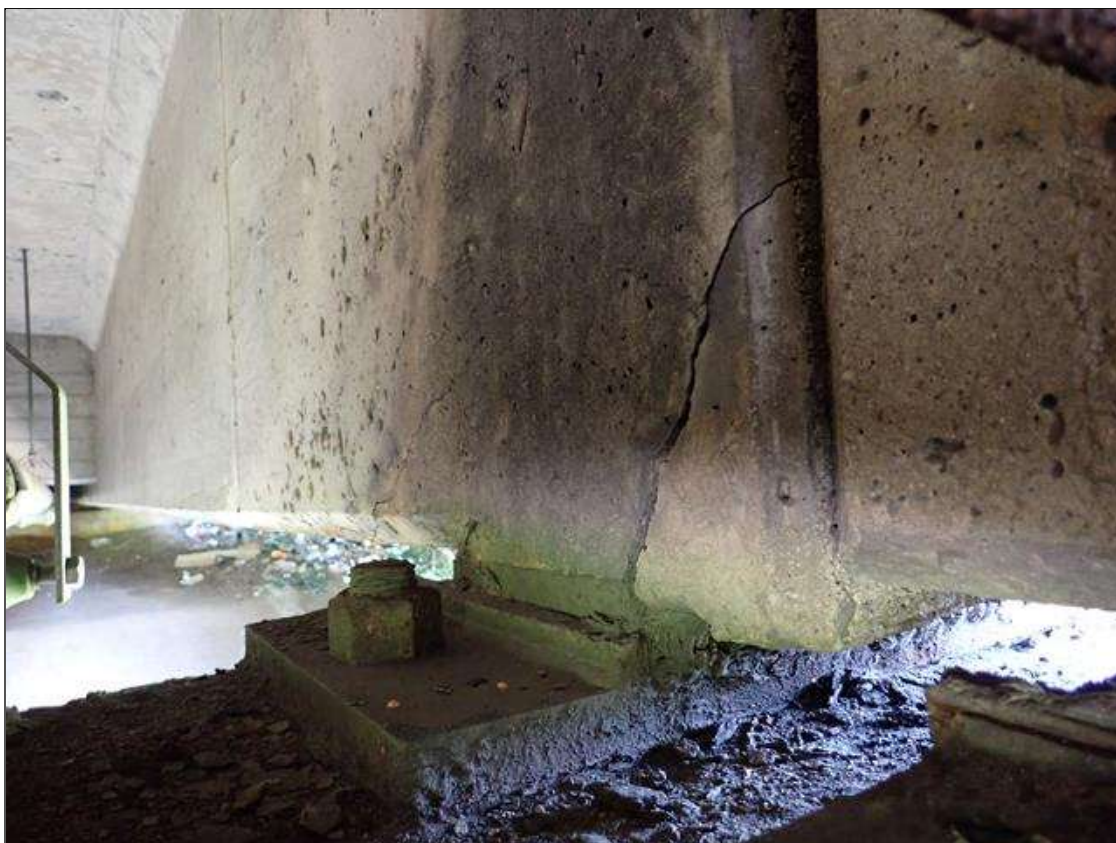
Span 4 Beam 10: West face at near end, delamination [3 foot x up to full height] with cracks [up to 1/8 inch]

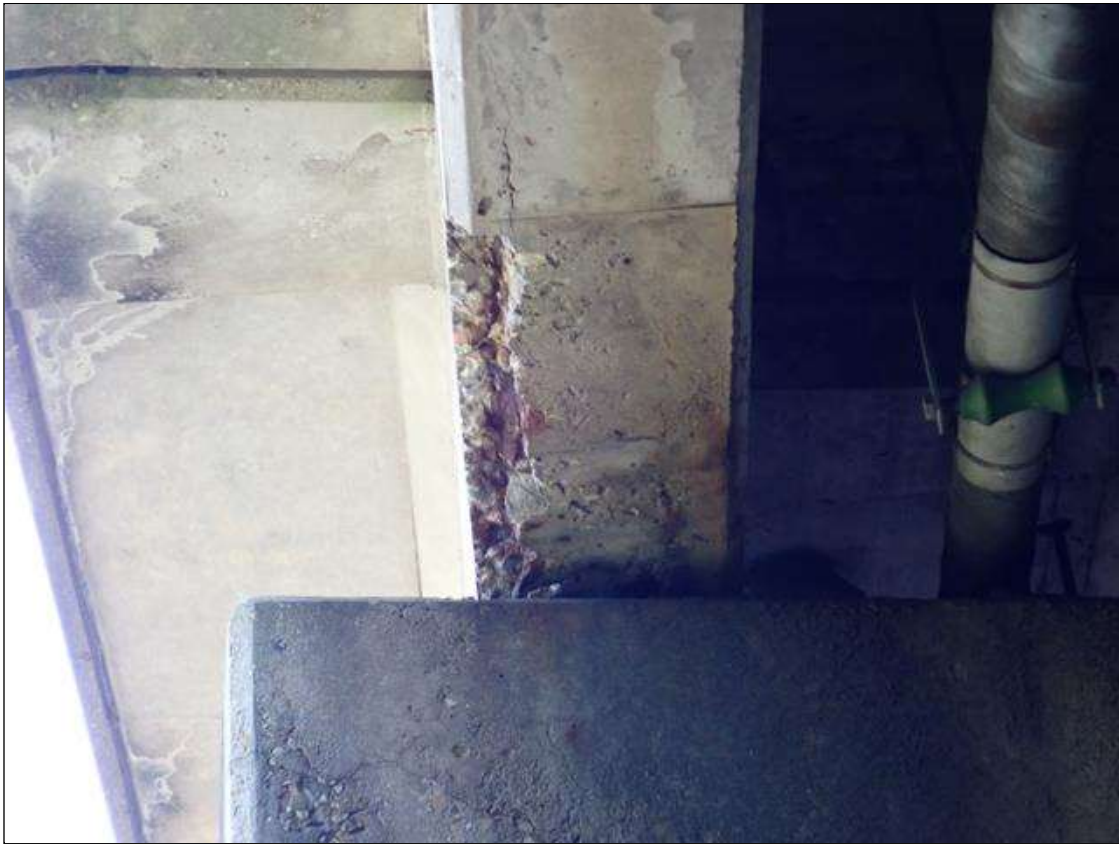
Span 4 Beam 10: (PAR) 2.5 FOOT X 2.5 INCH X 2 INCH DEEP SPALL/DELAMINATION WITH EXPOSED REBAR [SECTION LOSS UP TO 1/16 INCH DEEP], EAST AND BOTTOM FACES, AT BENT 3.

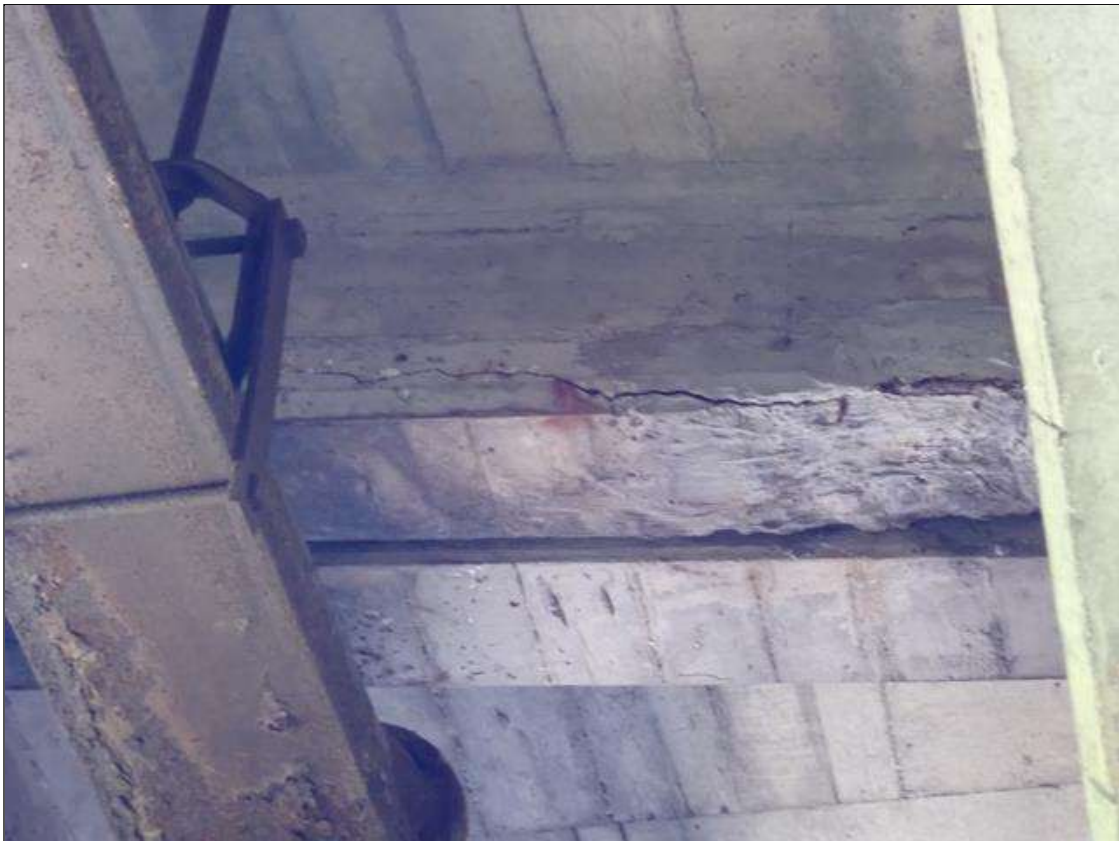
Span 4 Beam 9: (PAR) FULL LENGTH X 8 INCH X FULL WIDTH FAILED PATCH/DELAMINATION WITH CRACKS (UP TO 1/4 INCH) WITH RUST STAINS, IN BENT 3 DIAPHRAGM, BAY 9

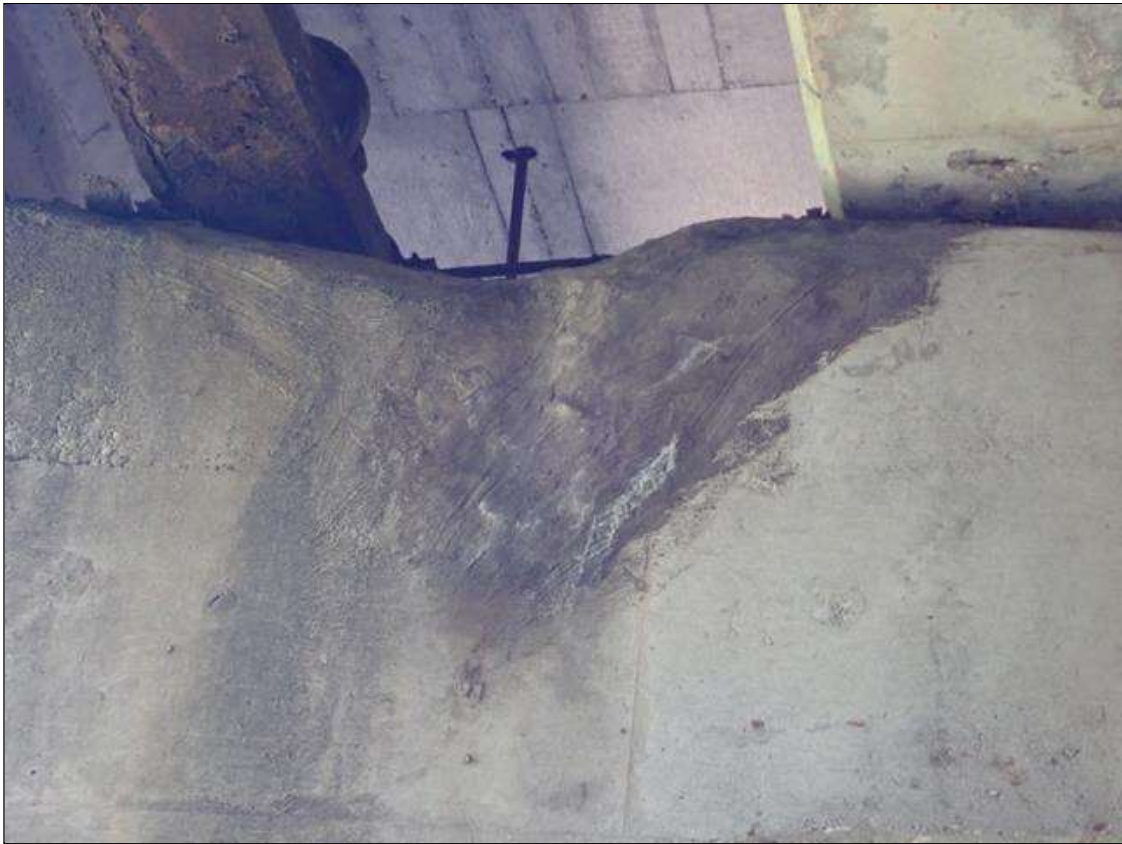
Bent 3 Cap 1: BENT 3 CAP NORTH FACE BAY 9. HAS A PATCHED AREA 3 FOOT X 2 FOOT WITH SCATTERED HAIRLINE CRACKS WITH EFFLORESCENCE VISIBLE

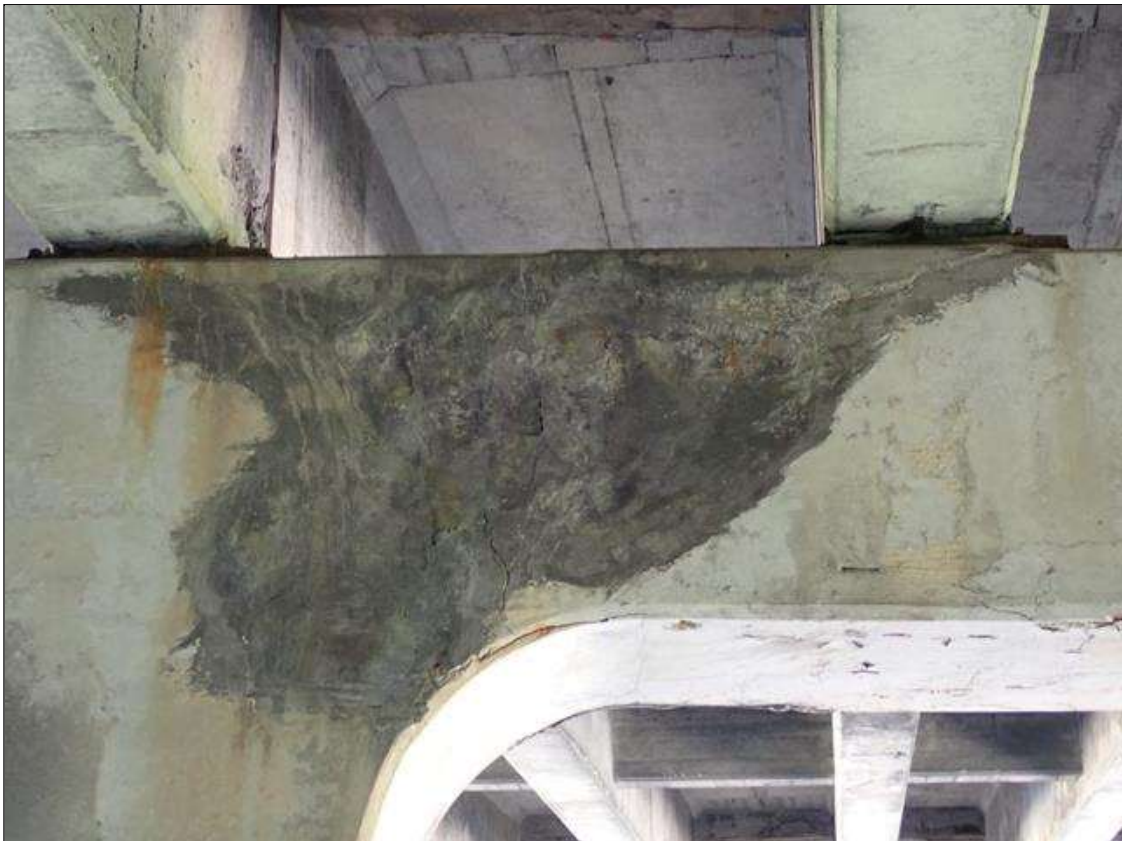
Bent 3 Cap 1: (PAR) BENT 3 CAP NORTH FACE BAY 6. FAILED PATCH [7 FOOT X UP TO 40 INCH] WITH MULTIPLE ADJACENT DELAMINATION [UP TO 28 INCH X 18 INCH], RUST STAIN AND EFFLORESCENCE
